# Nunavut Impact Review Board 2019

## Site Visit Report

***Meadowbank Gold Project*** (NIRB File No. 03MN107) and ***Whale Tail Pit Project*** (NIRB File No. 16MN056)

Agnico Eagle Mines Ltd.

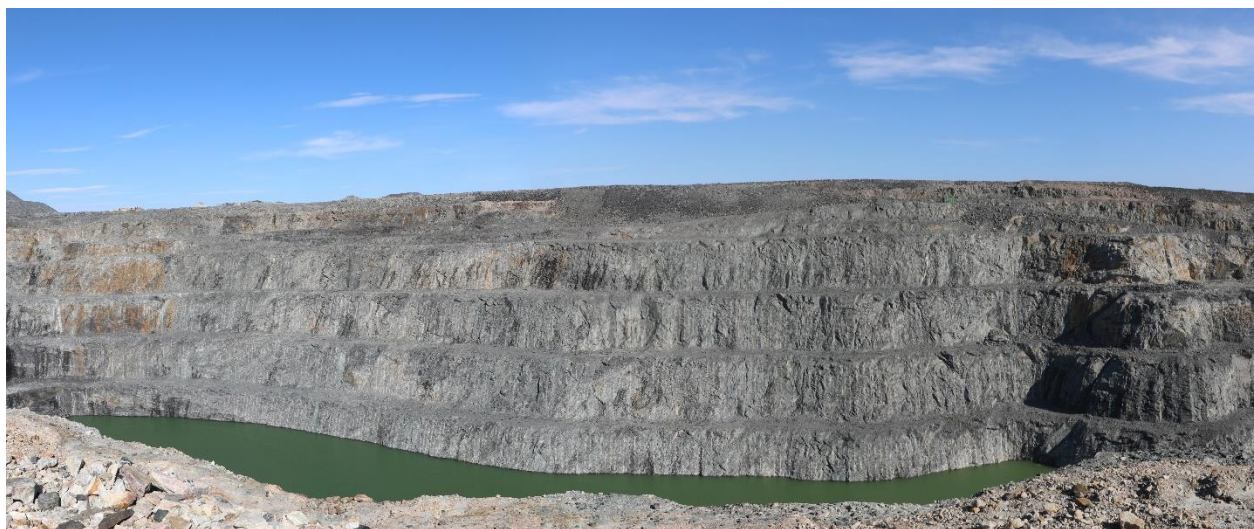
**Photo 11: Portage Pit A**

- a) Active drilling was ongoing at Portage Pit (see [Photo 11](#) and [Photo 12](#)), while mining ended earlier in the year at Vault Pit (see [Photo 13](#) and [Photo 14](#)) and at the Phaser and BB Pits (see [Photo 15](#) and [Photo 16](#)). Mining at the Goose Pit had ended in early 2015 and the pit has been allowed to slowly fill in naturally with water (see [Photo 17](#))
- b) As noted last year, an ice sheet was observed on the walls of the Vault Pit (see [Photo 13](#)) and it continues to be there this year.
- c) During the site visit, tailings were being disposed of into Goose Pit (see [Photo 18](#)) as one of the two (2) in-pit tailings facilities at the time of the site visit.

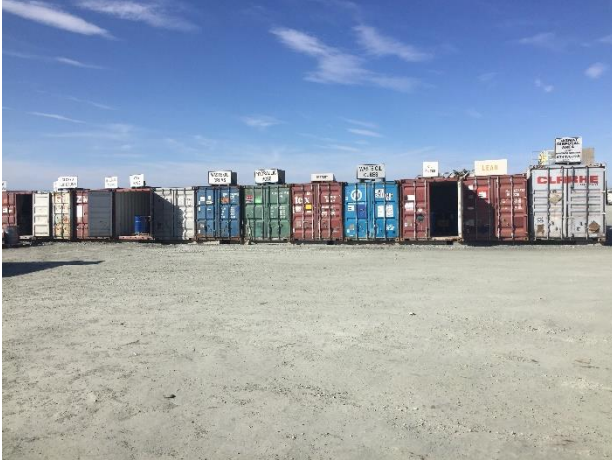
**Photo 21: Seacans used for waste segregation and storage area at Meadowbank Mine Site**

- f) As per previous NIRB site visits, and during the 2019 site visit that Agnico Eagle continues to segregate and store all domestic, hazardous, and combustible wastes in marked seacans prior to these materials being incinerated or shipped to the appropriate and approved off-site disposal facilities (see [Photo 21](#)).
- g) Agnico Eagle stated that the landfill is frequently inspected by employees to ward off any wildlife that may be present, to ensure wastes are segregated appropriately, and that wastes designated to the incinerator or metal dump do not end up in the landfill (see [Photo 22](#)).

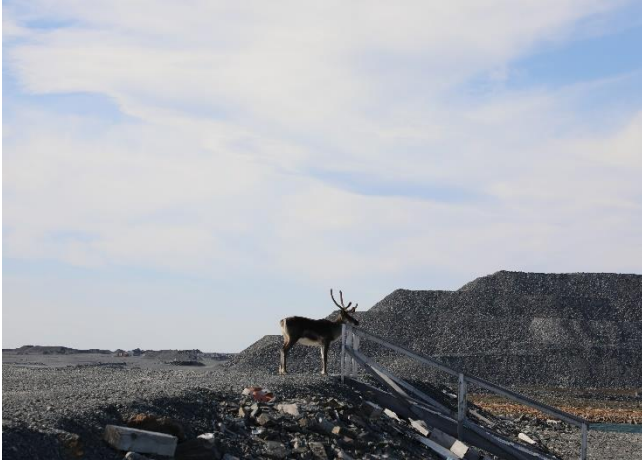
**Photo 24: Caribou observed at the Vault Pit area**

- i) During the site visit, a caribou was observed near the Vault Pit area (see [Photo 24](#)), while a young Arctic fox was observed at the Meadowbank site (see [Photo 25](#)).

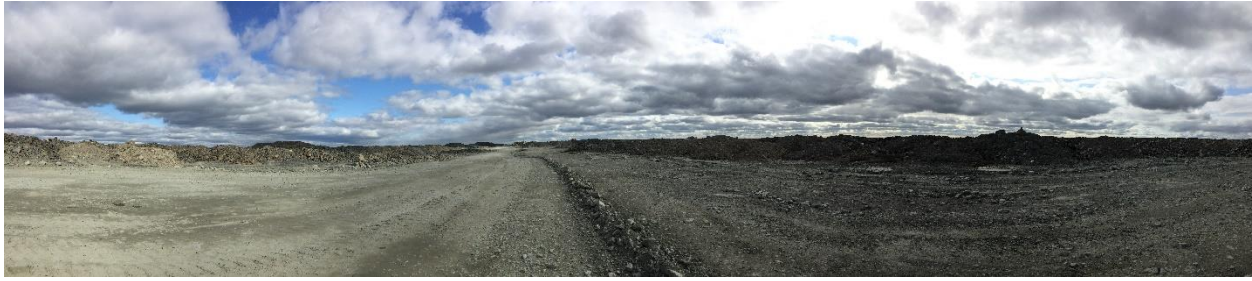
**Photo 40: Overview of the Whale Tail Pit Site**

- a) The Whale Tail site was extremely active with drilling occurring at the North Basin and the site moving into full operations (see [Photo 40](#) through [Photo 44](#)).
- b) Exploration activities were also ongoing with haul trucks moving rock and ore from the underground via the portal (see [Photo 45](#) and [Photo 46](#)).
