Full Report Title: 2012 Site Visit Report for the Nunavut Impact Review Board's Monitoring of Agnico-Eagle Mines Ltd.'s Meadowbank Gold Project (NIRB File No. 03MN107)

Project: Meadowbank Gold Project
Project Location: Kivalliq Region, Nunavut

Site visit dates: September 12-13, 2012
Last site visit: September 12-13, 2011

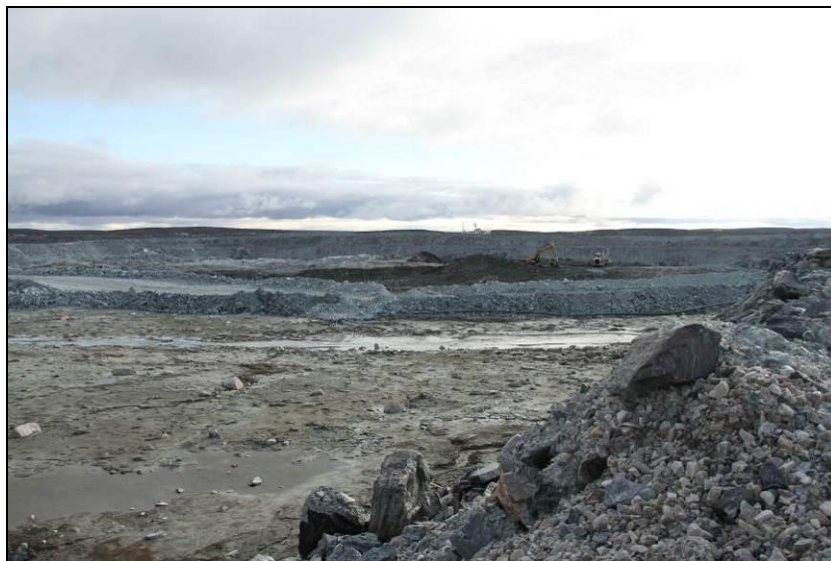
- i. Development of the Bay-Goose Dike and causeway was completed in 2010 with the instrumentation on the Bay-Goose Dike and the jet grouting program completed in 2011. Mining of the Bay-Goose basin started in May 2012. During the 2012 site visit, it was noted that the Bay-Goose basin was still being dewatered (Photo 10). Water from the Bay-Goose basin has been treated at the water treatment facility on an on-going basis prior to discharge into the environment (Photo 11).

Photo 10: Bay-Goose basin

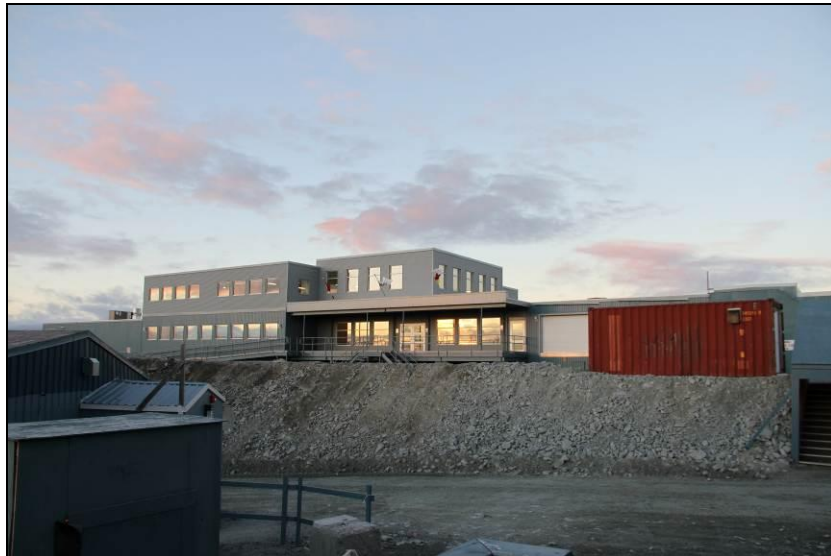
- k. In March 2011, a fire at the Meadowbank mine destroyed the kitchen and dining facilities, certain camp offices and the security office. By the end of 2011 the construction of the new kitchen was completed, with the new facility becoming operational on December 17, 2011 (see Photo 14).

Photo 14: New kitchen facility

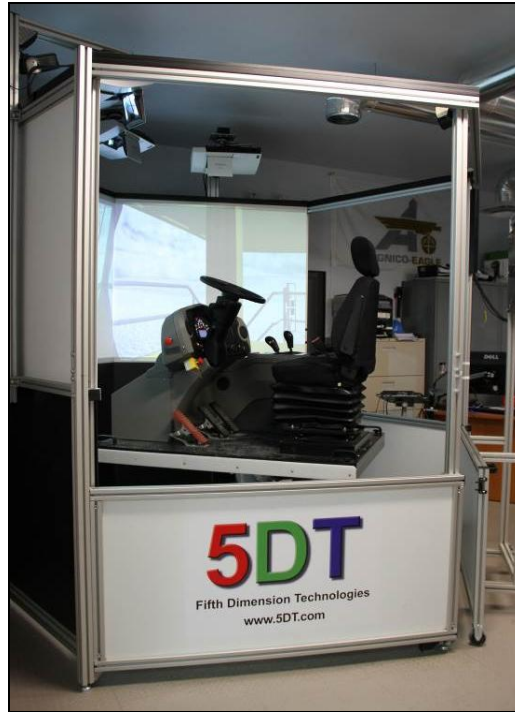
- l. AEM purchased a heavy equipment training simulator in 2011 which is used to train site employees in the operation of a variety of heavy equipment (see Photo 15).

Photo 15: Heavy equipment training simulator on site

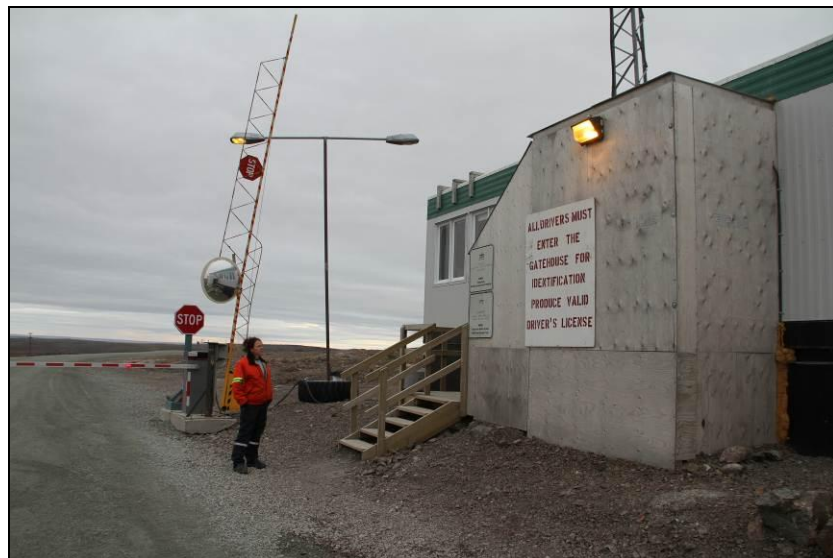
AEM maintains one gatehouse at kilometre 5 of the access road, and another gatehouse close to the entrance to the mine site and camp at Meadowbank. Both gatehouses are manned by guards who monitor the safety and security of all personnel using the road. All traffic is required to check in (via radio or in person) with the employee at the gatehouse prior to proceeding past either gatehouse along the road (see Photo 27). The AEM employee manning the kilometre 5 gatehouse maintains a daily logbook of all persons travelling the access road for non-mine use. Members of the public travelling along the road are required to sign AEM's *All Weather Private Access Road Safety Rules & Procedures for Road Access* prior to being granted access to the road.

The Monitoring Officer reviewed the sign-in sheet at the gatehouse and noted that approximately 215 community members had signed in to use the road between September 1st and September 13th. The employee at the gatehouse also indicated that the road is most commonly used by community members on Saturdays.

Photo 27: Gatehouse at kilometre 5, near Baker Lake
