2009 Annual Geotechnical Inspection, Meadowbank Gold Project, Nunavut

2009 Annual Geotechnical Inspection - Meadowbank Gold Project, Nunavut

Agnico-Eagle Mines Limited
Meadowbank Division
P.O. Box 540
Baker Lake, Nunavut
X0C 0A0

Project Number: 09-1428-0018
Doc. No. 969 Ver. 0

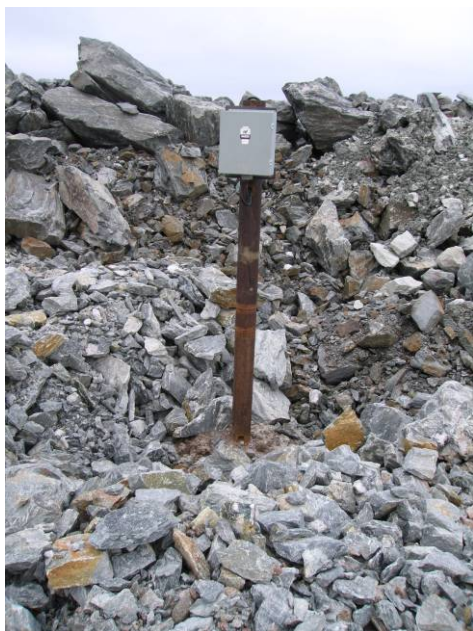
PHOTOGRAPH 1 – East Dike

Description: RST instrument box used to record piezometric levels at St. 60+150.

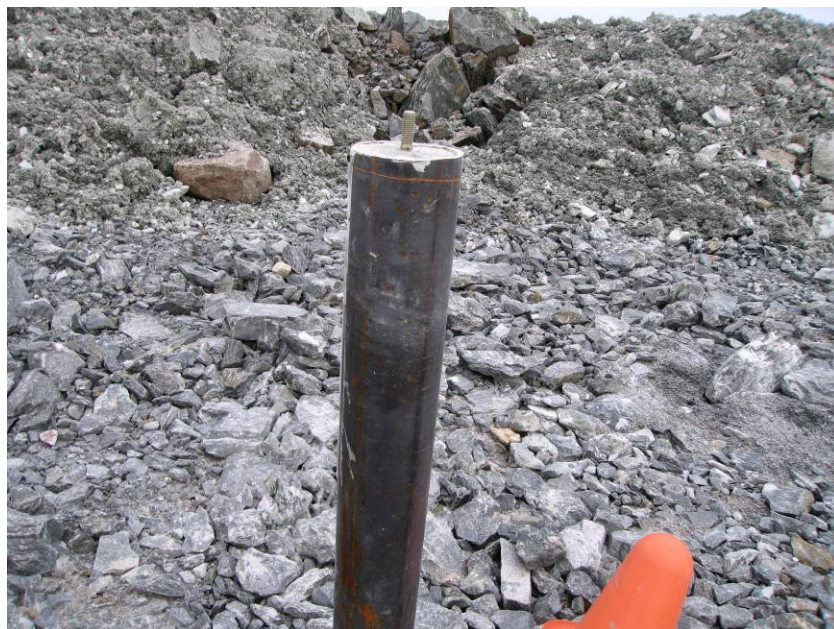
PHOTOGRAPH 3 – East Dike

Description: Settlement monitoring point.

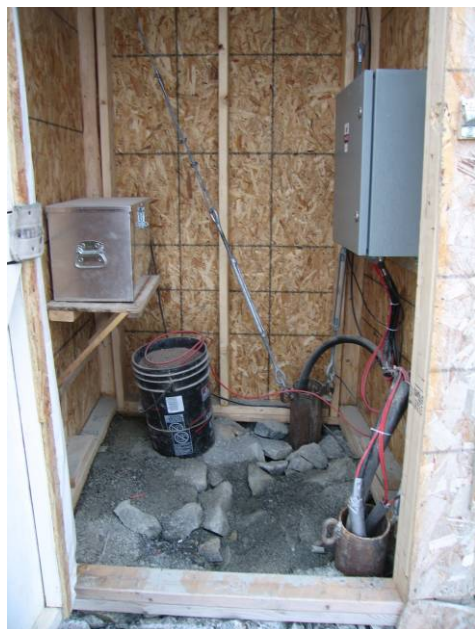
PHOTOGRAPH 5 – East Dike

Description: Instrument cabin.

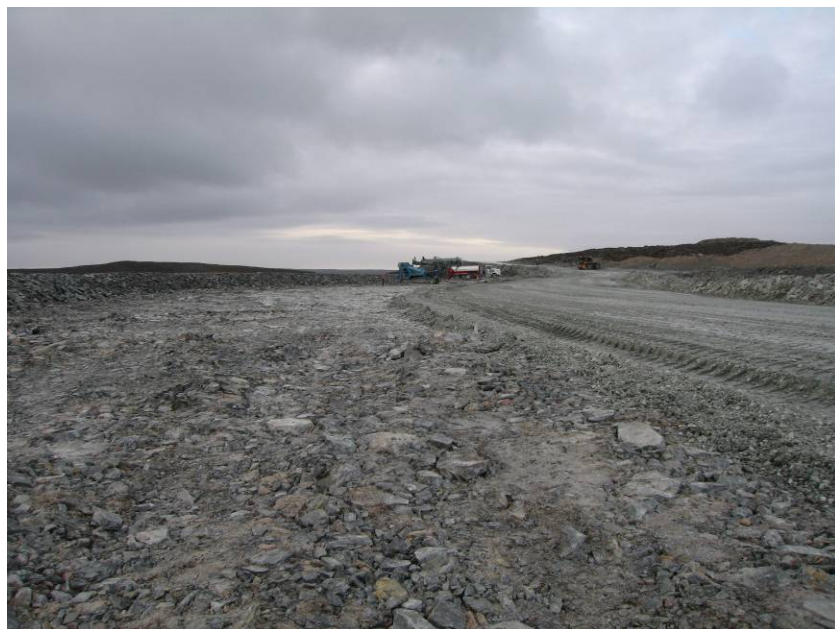
PHOTOGRAPH 7 – East Dike

Description: View along crest of dike, looking south towards Bay Goose from approximately Sta. 60+250.

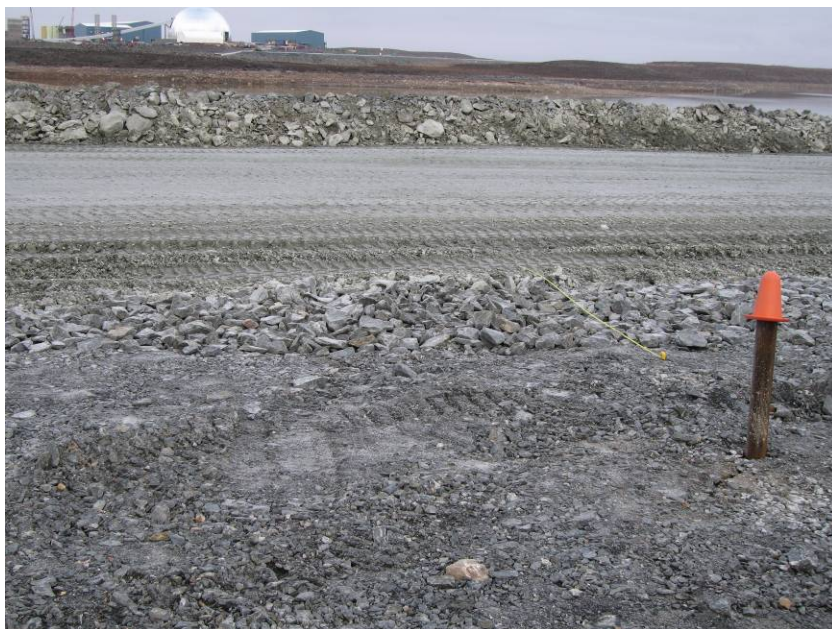
PHOTOGRAPH 9 – East Dike

Description: Haul truck edge of road not clearly defined on upstream side, photograph looking west.

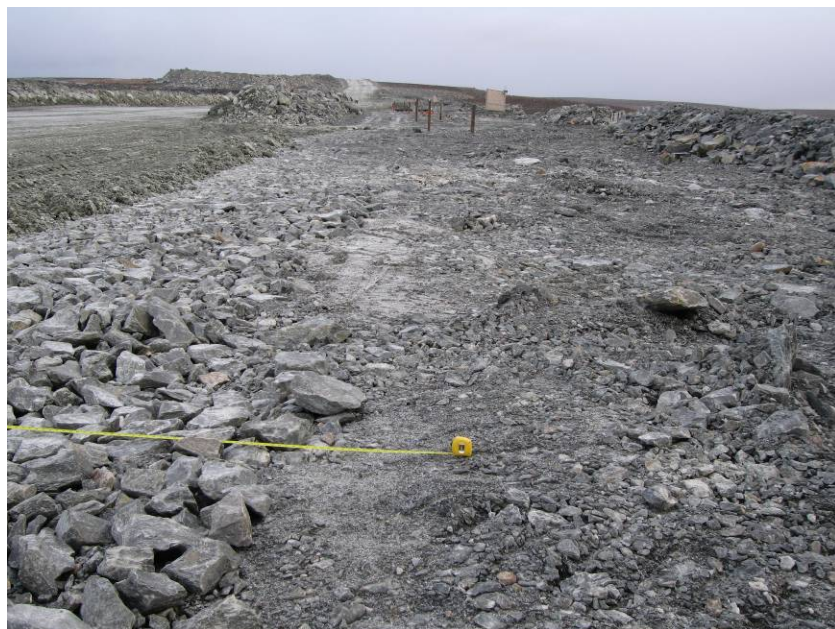
PHOTOGRAPH 11 – East Dike

Description: View of dike crest looking north from approximately Sta. 60+350.

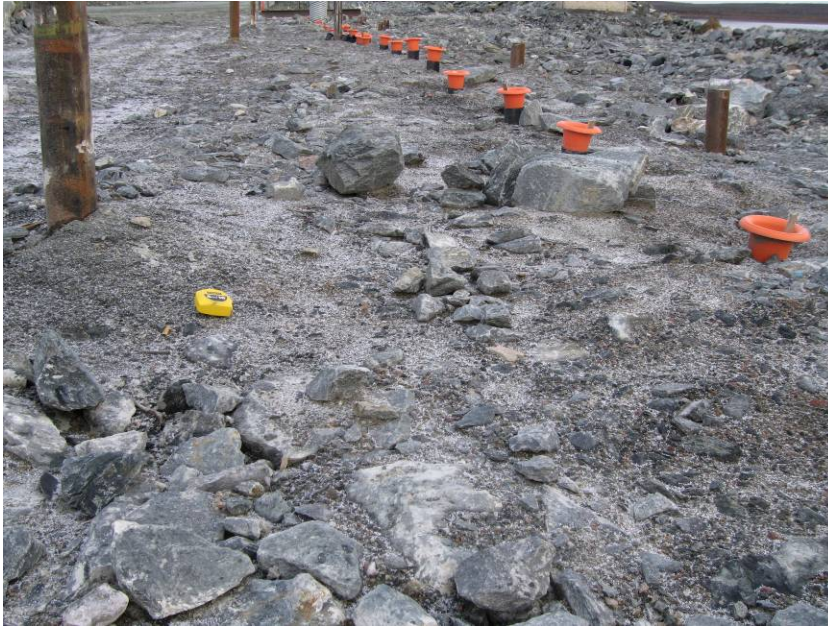
PHOTOGRAPH 13 – East Dike

Description: View of remediation grouting hole and CPT investigation holes near the sinkhole between Sta. 60+452 and Sta. 60+490. Settlement near downstream piezometer is evident.

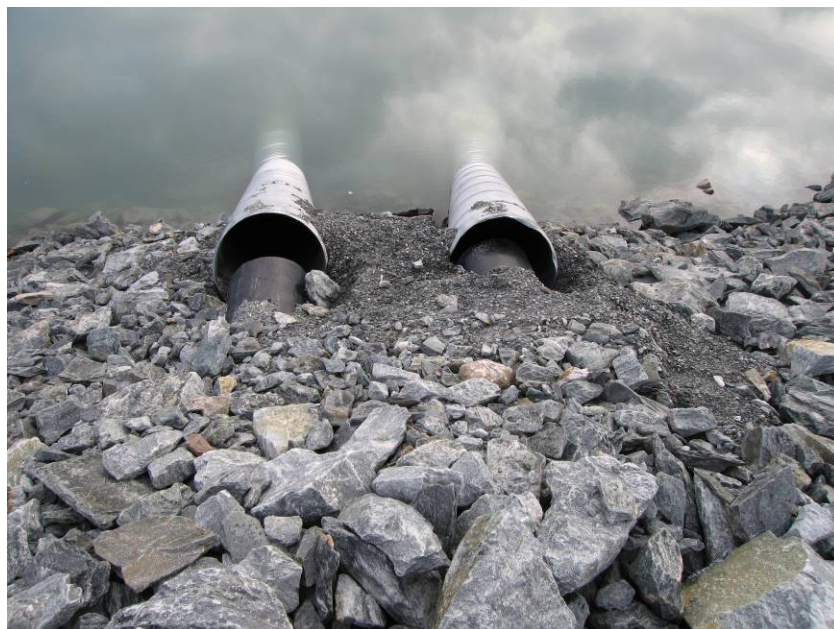
PHOTOGRAPH 15 – East Dike

Description: Discharge pipes used during winter dewatering, inactive.

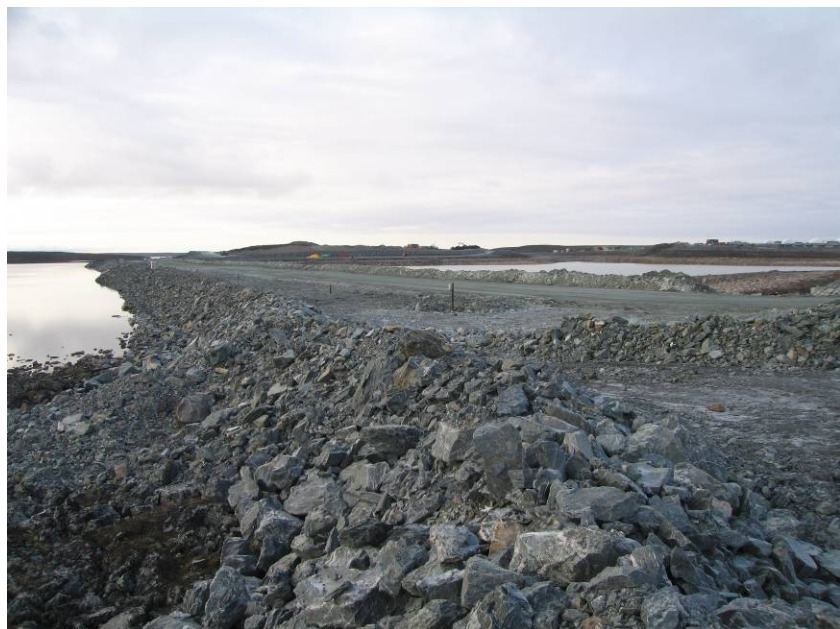
PHOTOGRAPH 17 – East Dike

Description: Upstream view of abutment and dike from north abutment, looking south towards Bay Goose.

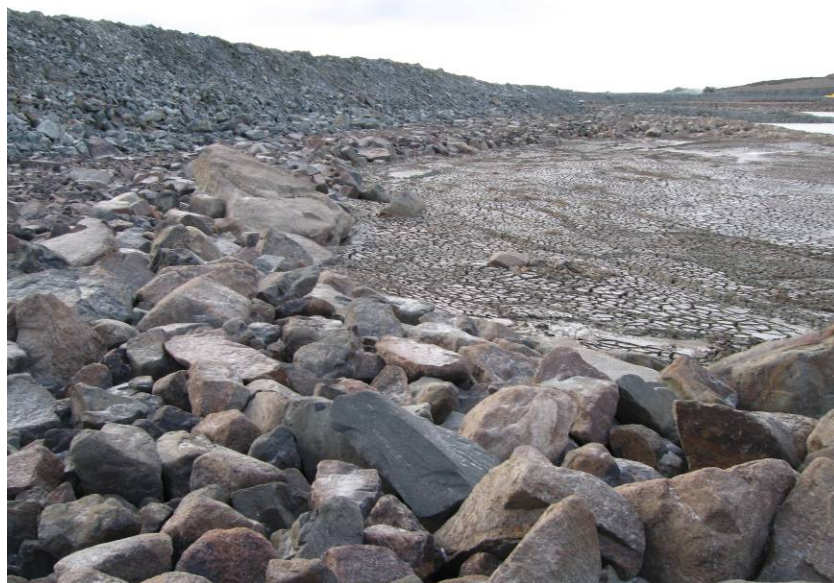
PHOTOGRAPH 19 – East Dike

Description: Downstream view of toe of dike from north abutment, looking southeast at approximately Sta.60+750.

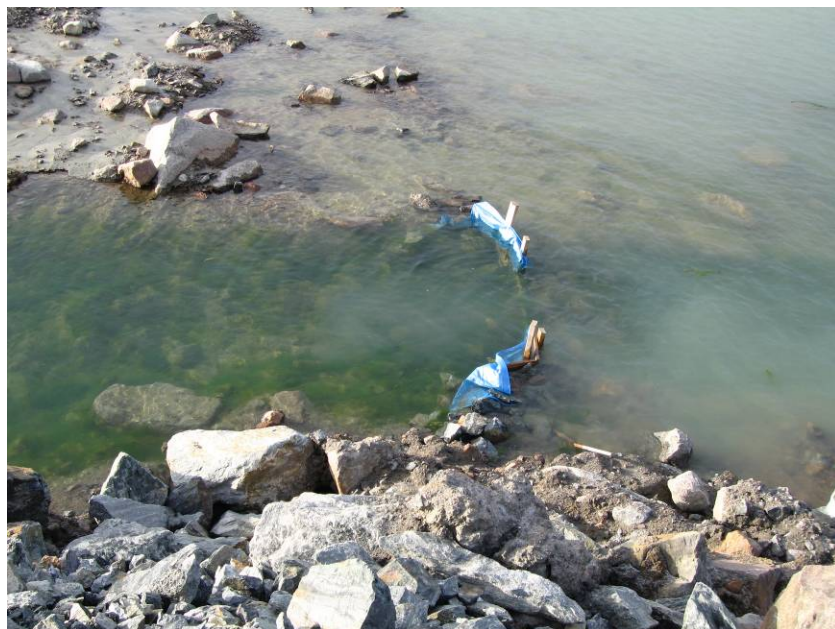
PHOTOGRAPH 211 – East Dike

Description: Submerged weir near Sta. 60+500, previously used to monitor seepage on the downstream side of the dike.

3.5 Seepage or Wet Areas	Not apparent.		
3.6 Vegetation Growth	None observed.		
3.7 Other Unusual Conditions			
4. DOWNSTREAM TOE AREA			
4.1 Seepage from Dam	Yes		Seepage downstream of Sta. 60+450, where weir was installed, currently submerged. Water on downstream side of dike in contact with the toe, as shown in photos between Sta. 60+175 and 60+250; 60+400 and 60+550, therefore unable to detect seepage.

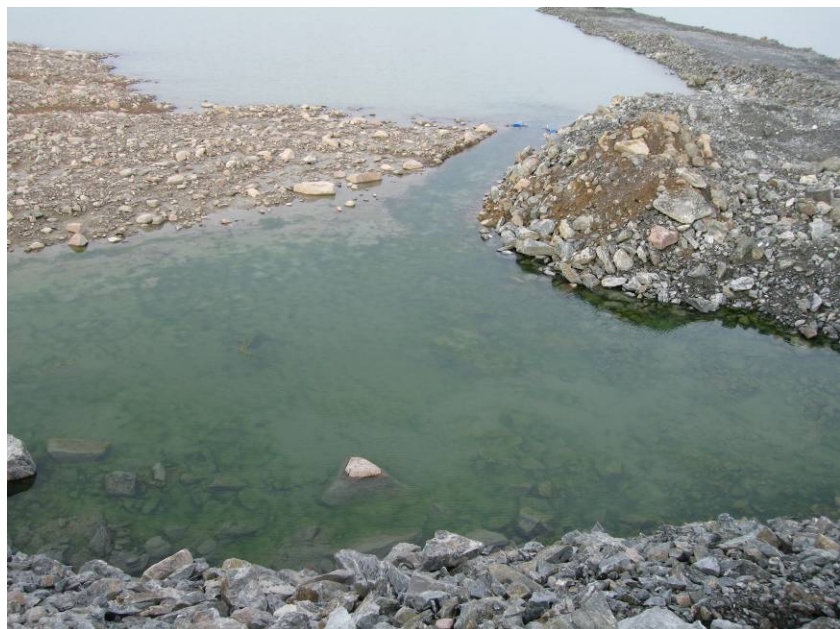
PHOTOGRAPH 23 – East Dike

Description: View of downstream toe of dike, looking west from crest of dike, submerged weir is evident.

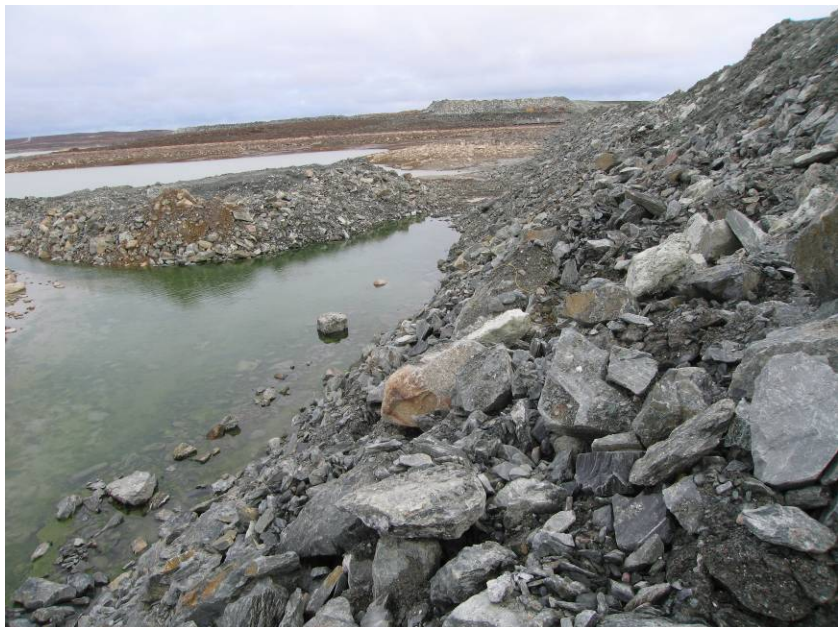
PHOTOGRAPH 25 – East Dike

Description: Downstream view from dike crest looking north at the dike toe, approximately from Sta. 60+450.

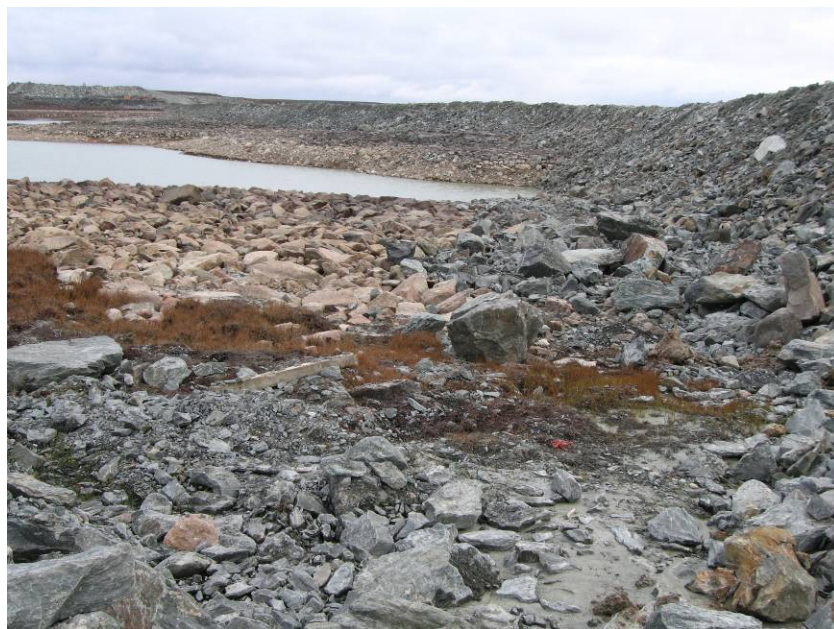
PHOTOGRAPH 27 – East Dike

Description: Downstream view of toe of dike from south abutment, looking north.

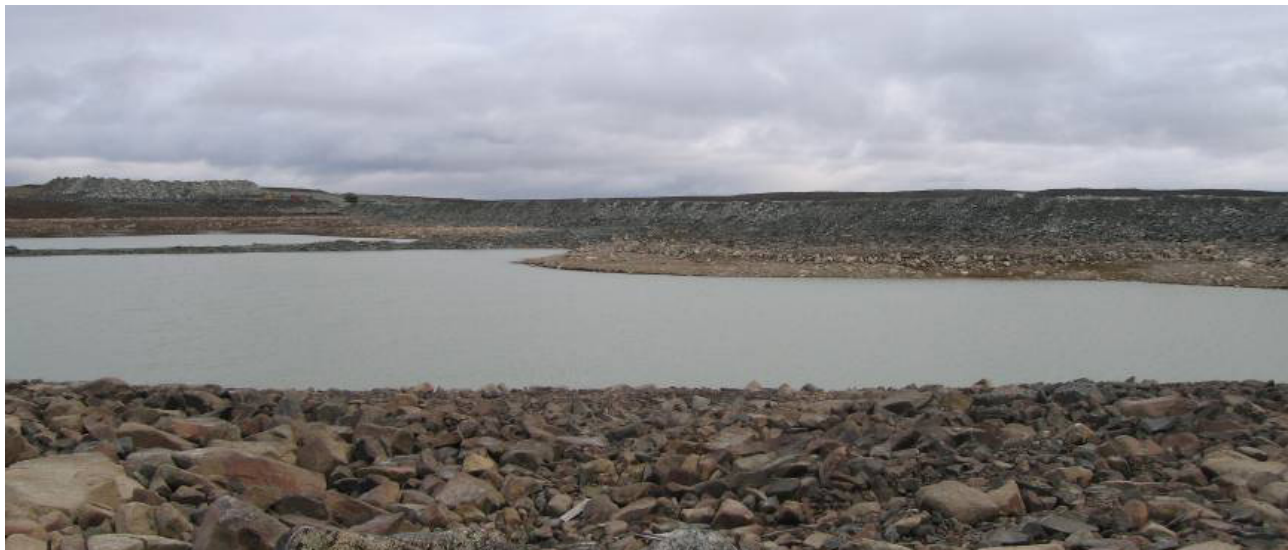
PHOTOGRAPH 289 – East Dike

Description: Downstream view of dike, looking northeast.

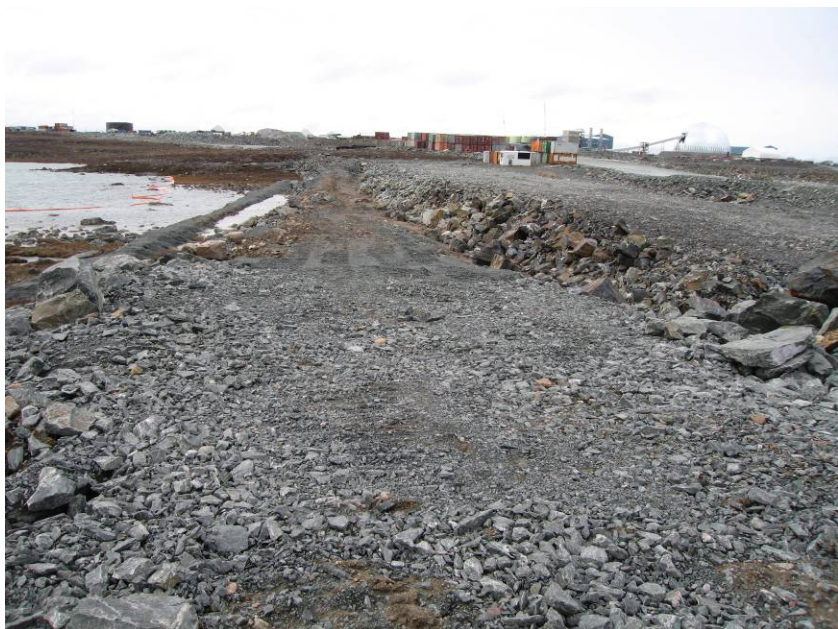
PHOTOGRAPH 1 – West Channel Dike

Description: From east abutment looking towards the west abutment along the upstream side of the dike. Surcharge load placed over the till core is evident.

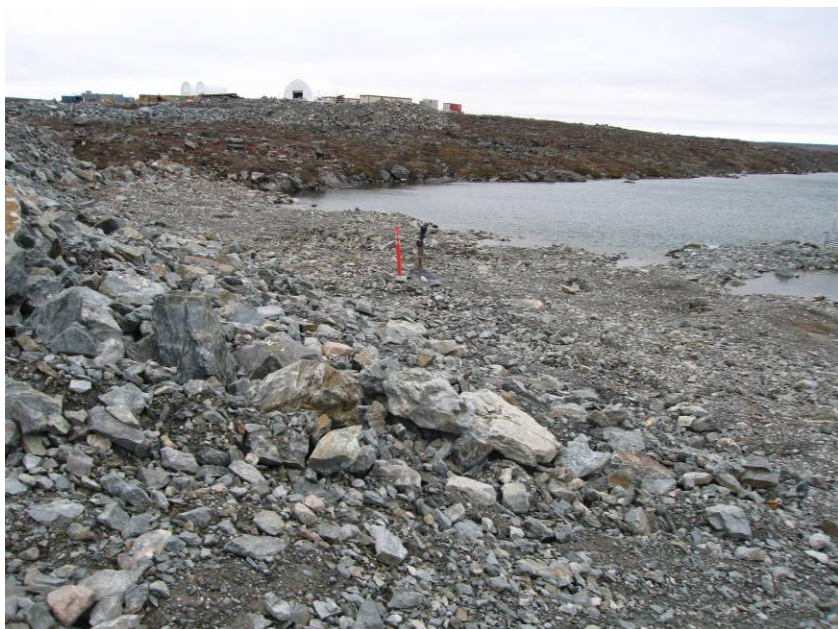
PHOTOGRAPH 1 – South Camp Dike

Description: Upstream side, looking towards the south abutment. Thermistor location evident.

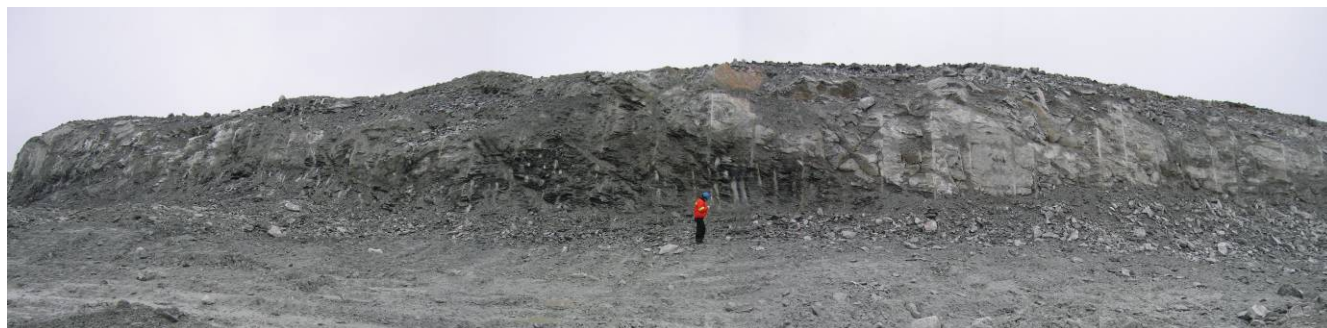
PHOTOGRAPH 1 – North Portage Pit

Description: Final northeast wall of North Portage Pit to first bench. Scaling has not been completed.

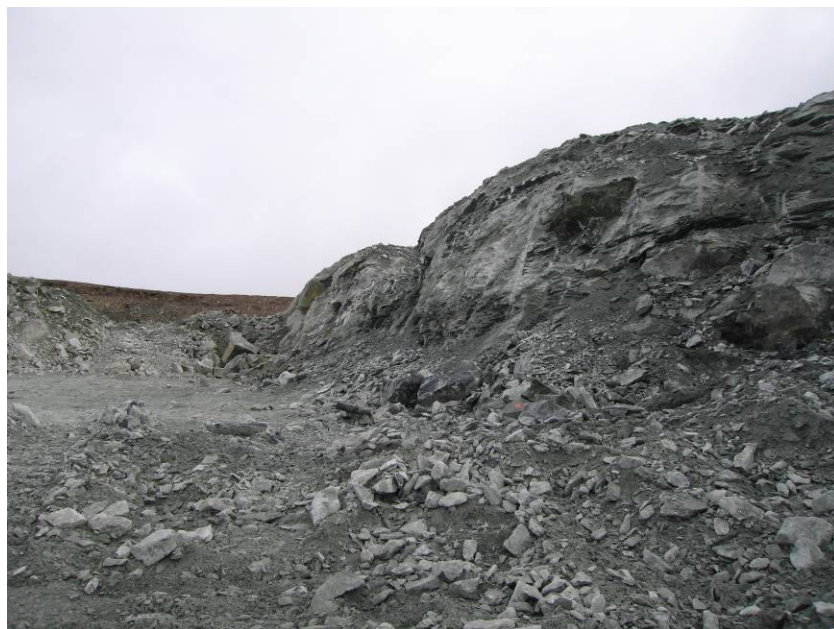
PHOTOGRAPH 3 – North Portage Pit

Description: Looking north along northeast final wall of North Portage Pit.

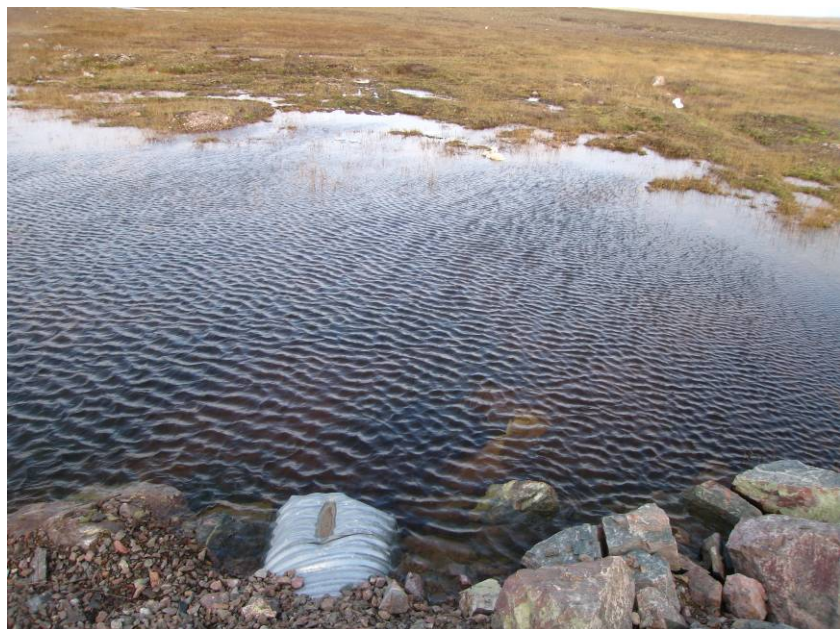
PHOTOGRAPH 1 – PRC-1, km 0+430

Description: Upstream view of culvert. Culvert is full, in good condition, uniform grade and no obstructions.

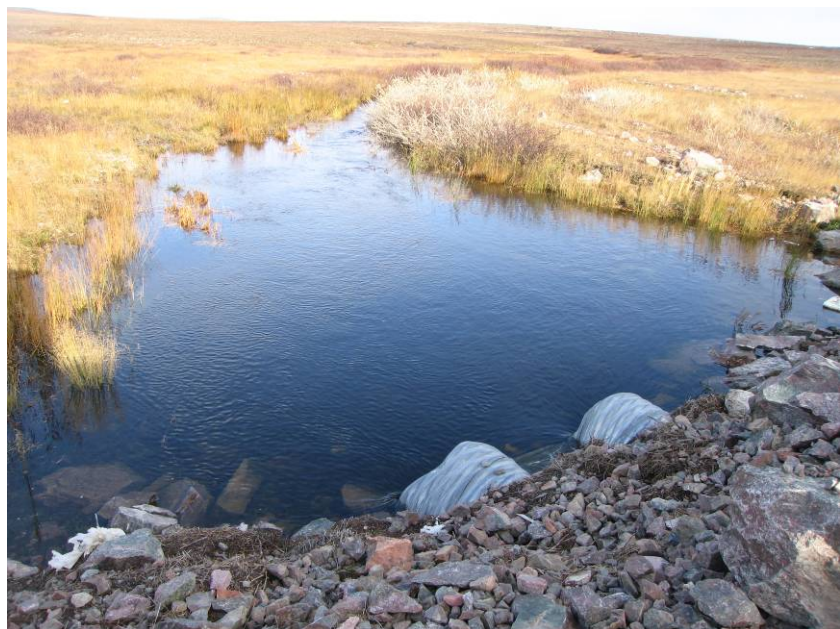
PHOTOGRAPH 3 – PRC-2, km 0+470

Description: Upstream view of culverts. Culverts are mostly full, in good condition, uniform grade, and no obstructions.

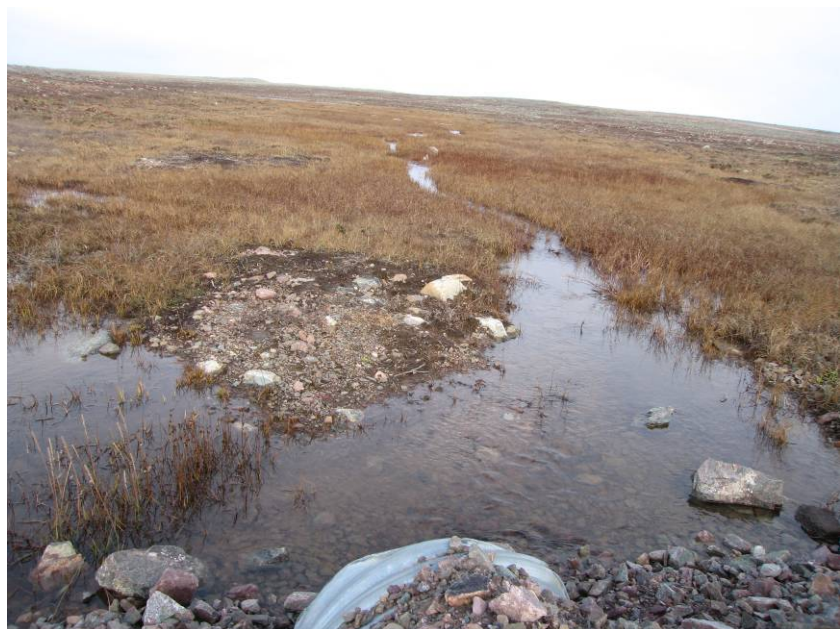
PHOTOGRAPH 5 – PRC-3, km 1+380

Description: Upstream view of culvert. Culvert is in good condition, uniform grade, and no obstructions.

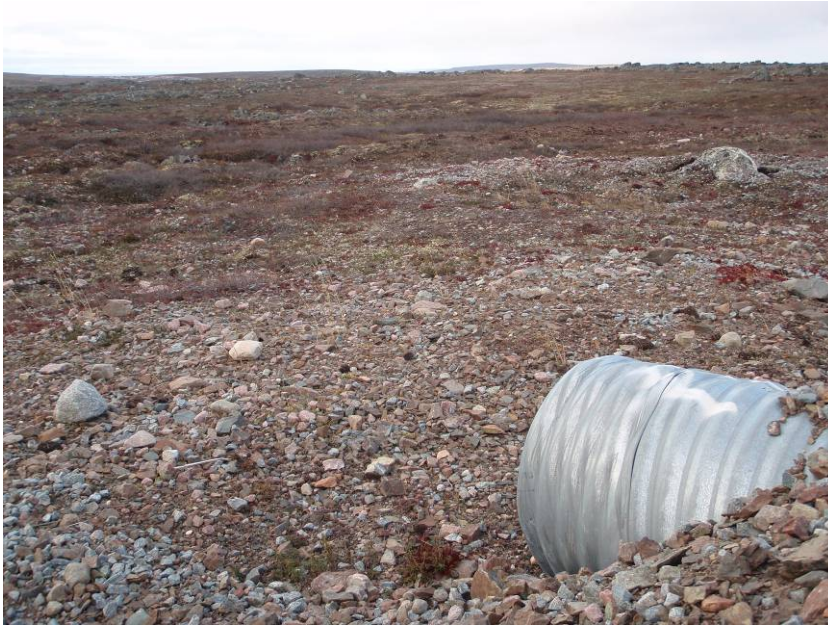
PHOTOGRAPH 7 – R-00A, km 2+550

Description: Downstream view of culvert. No apparent channel, dry. Uniform grade.

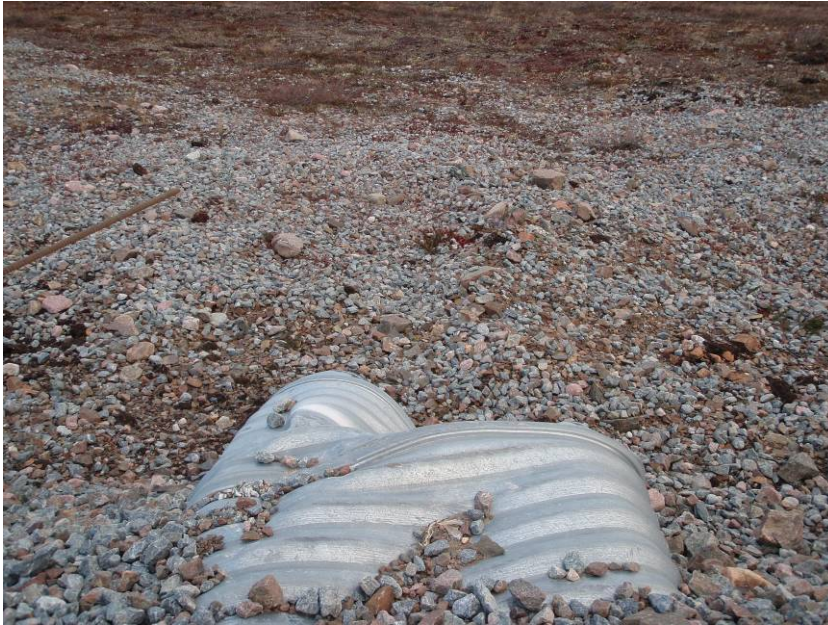
PHOTOGRAPH 9 – R-00A, km 2+550

Description: View of upstream end of culvert. Culvert crushed on top.

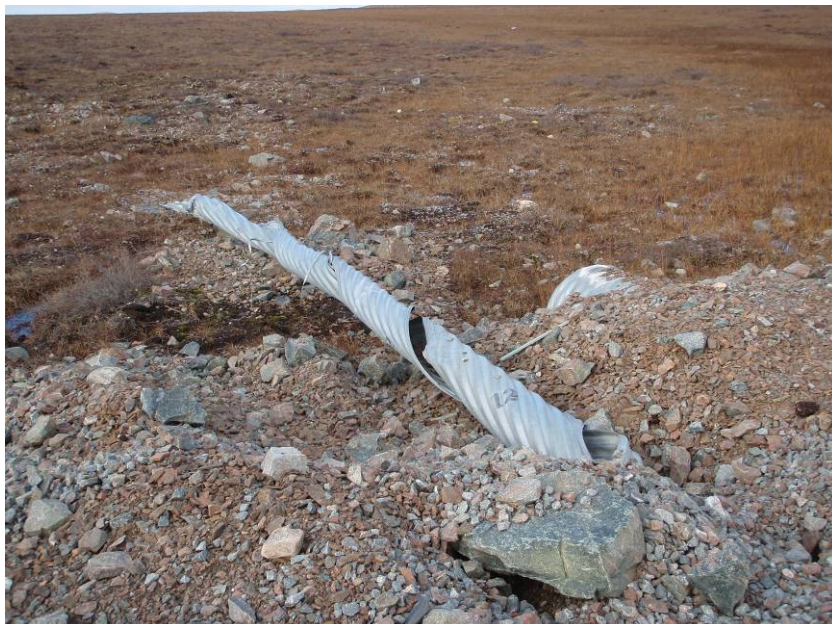
PHOTOGRAPH 11 – PC-14, km 4+260

Description: Upstream view of culverts. Culvert closer to Baker Lake is damaged on upstream side. Other culvert has minimal crushing on haunch of culvert near the center of the road. Uniform grade, no obstructions.

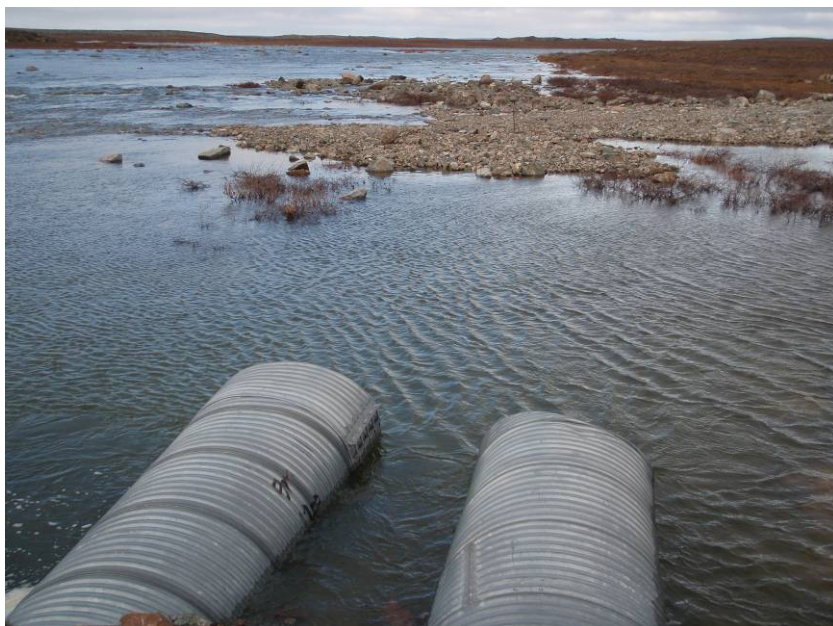
PHOTOGRAPH 15 – PC-17, km 8+830

Description: Upstream view of culverts. Culverts in good condition.

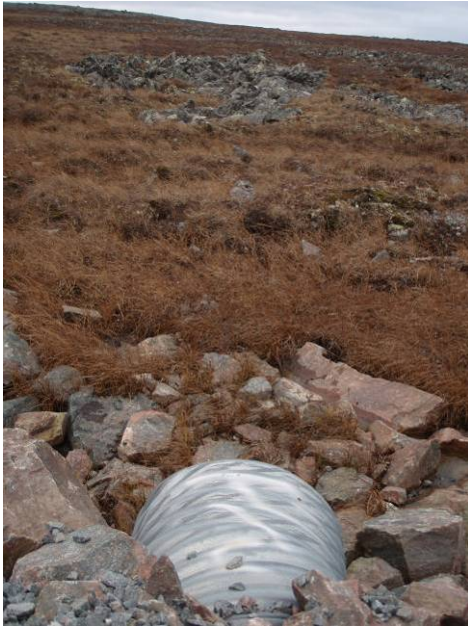
PHOTOGRAPH 17 – PC-1, km 9+952

Description: Upstream view of culvert, in good condition, uniform grade and no obstructions.

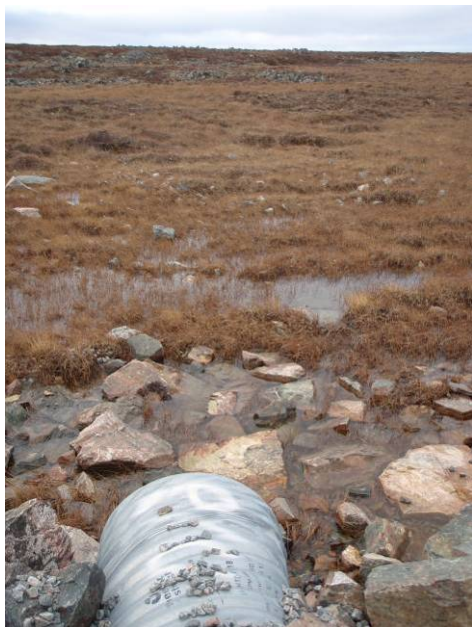
PHOTOGRAPH 19 – R-03, km 10+580

Description: Upstream view of culvert. Culvert is in good condition, uniform grade, and no obstructions. Water flowing through culvert is orange, oxidized.

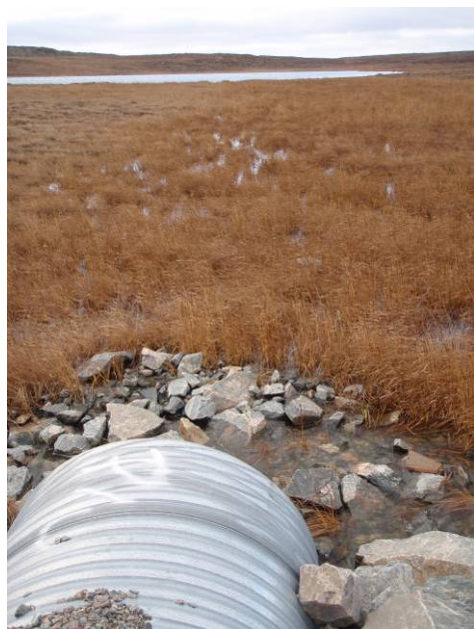
PHOTOGRAPH 21 – R-04, km 12+050

Description: Upstream view of culvert. Culvert is in good condition, very minor deflection in haunch of culvert, uniform grade, and no obstructions. Stream bed consists of cobbles, boulders and grass. Very broad drainage area, no definitive channel.

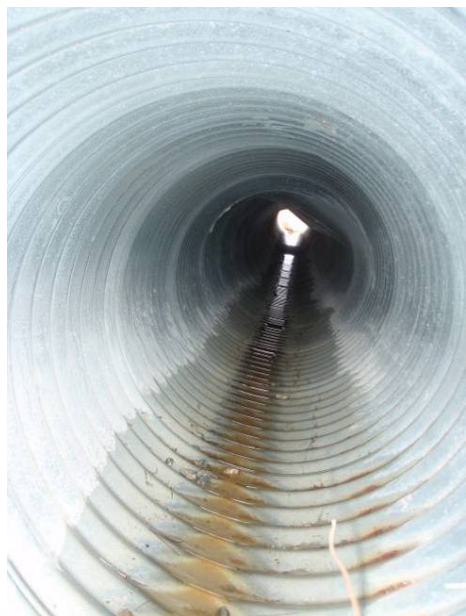
PHOTOGRAPH 25 – PC-13, km 12+745

Description: View through culvert from upstream to downstream. Crushing and dent on side and haunch near upstream end of culvert. Likely damaged during installation, continue to monitor as road bed consists of gravel and some larger cobbles (angular), potential for condition to worsen. Uniform grade, no blockage evident.

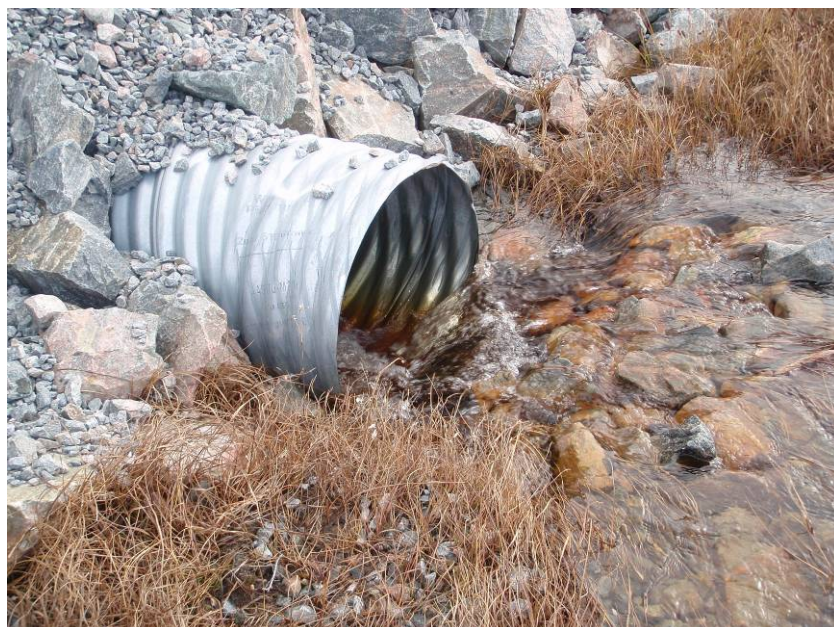
PHOTOGRAPH 28 – PC-3, km 13+685

Description: Side view of culvert inlet looking towards Baker Lake. Culvert is in good condition, uniform grade, and no obstructions. Potential for erosion at mouth of culvert as set below streambed. Streambed consists of cobbles.

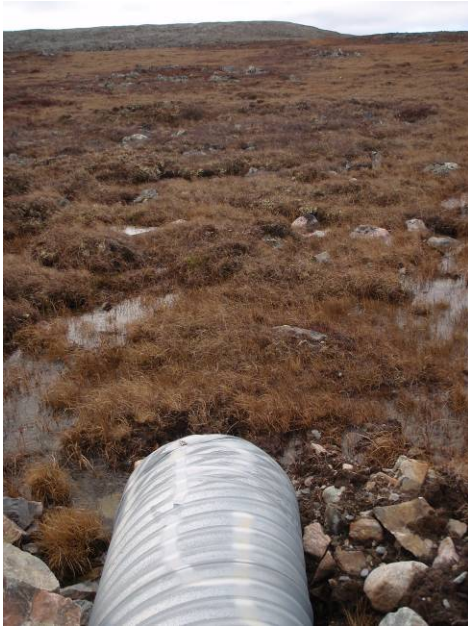
PHOTOGRAPH 31 – PC-4, km 14+910

Description: Upstream view of culvert, in good condition, uniform grade, no obstructions. Low flow observed through culvert at time of inspection.

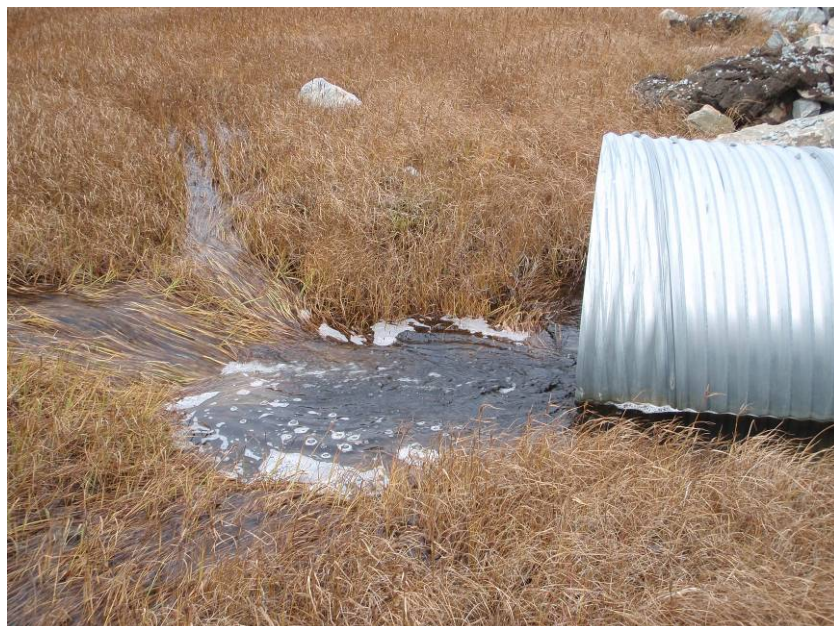
PHOTOGRAPH 33 – R-05A, km 15+645

Description: Upstream view of culvert. Culvert is in good condition, uniform grade, and no obstructions. Upstream end of culvert is set above bottom of stream or concentrated flow has eroded some material under the culvert. Stream bed consists of soil and grass. High flow was evident at the time of the inspection.

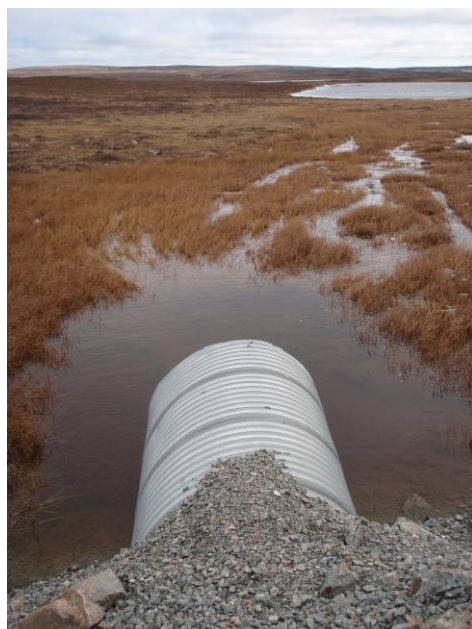
PHOTOGRAPH 36 – R-05A, km 15+645

Description: Downstream view of culvert. Concentrated flow. Adjacent to culvert, small flow evident passing through road, no visual evidence of turbidity observed.

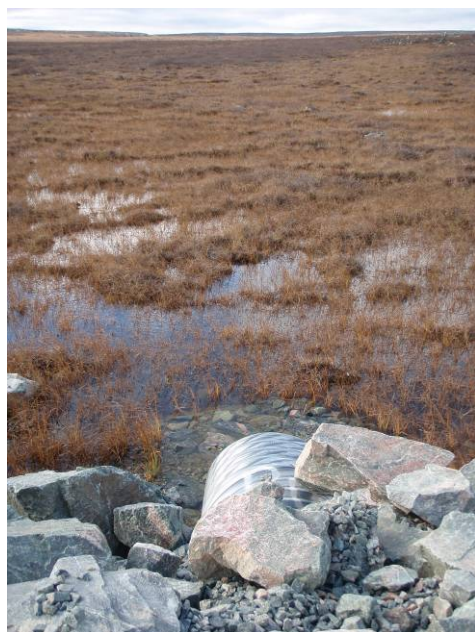
PHOTOGRAPH 38 – PC-5, km 18+280

Description: Upstream view of culvert. Culvert is in good condition, uniform grade, and no obstructions. Low gradient flow observed.

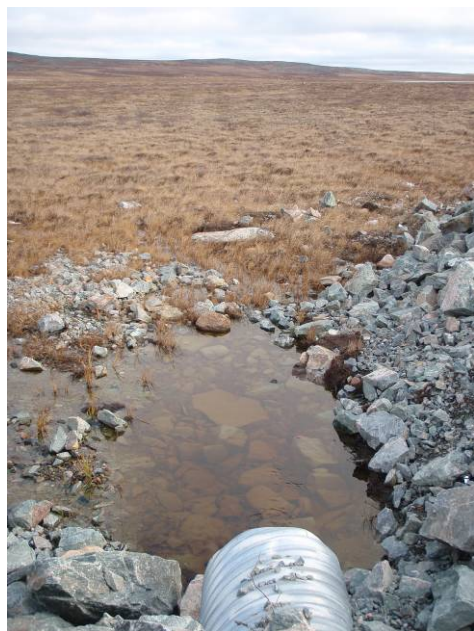
PHOTOGRAPH 39 – PC-5, km 18+280

Description: Downstream view of culvert. Broad valley, low gradient, no definitive channel observed.

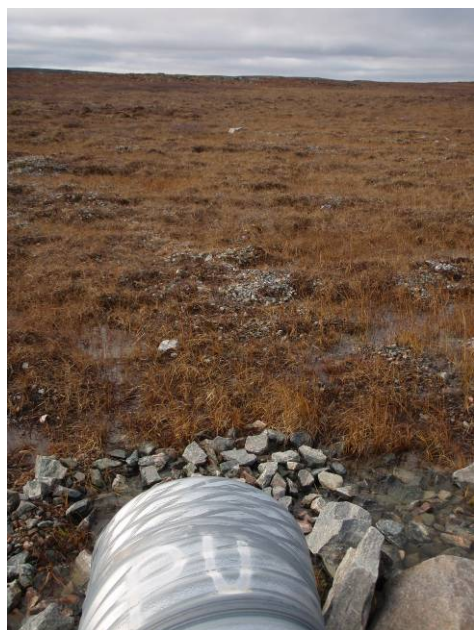
PHOTOGRAPH 40 – PC-6, km 19+075

Description: Upstream view of culvert. Culvert is in good condition, and uniform grade. Few cobbles in culvert but do not obstruct the flow. Low gradient flow, no definitive channel observed.

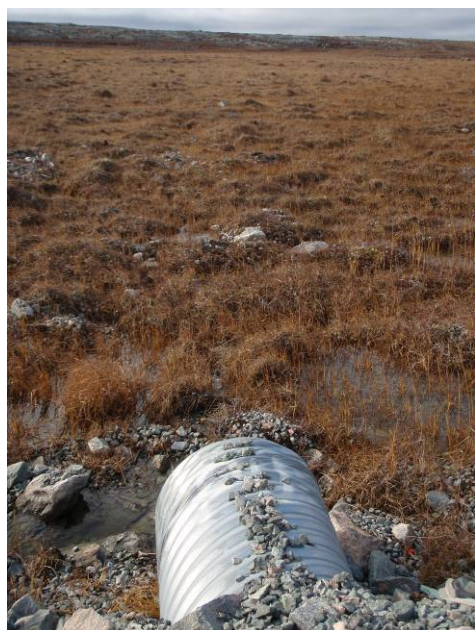
PHOTOGRAPH 42 – PC-7, km 20+505

Description: Upstream view of culvert. Culvert is in good condition, uniform grade, and no obstructions. Low gradient flow, very broad stream observed. Stream bed consists of cobbles, gravel and grass.

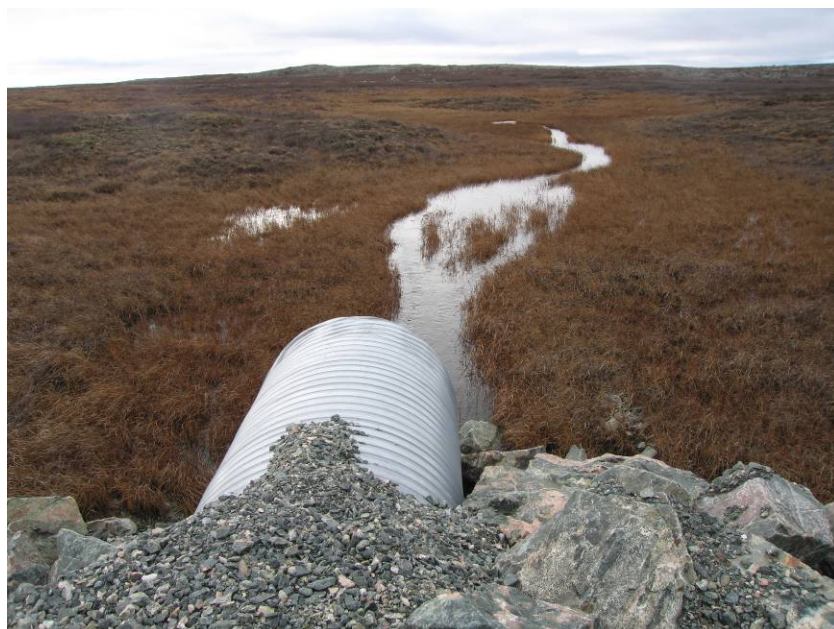
PHOTOGRAPH 44 – R-07, km 25+900

Description: Upstream view of culvert. Culvert is in good condition, uniform grade, and no obstructions. Low gradient flow observed. Stream bed consists of soil and grass, some gravel.

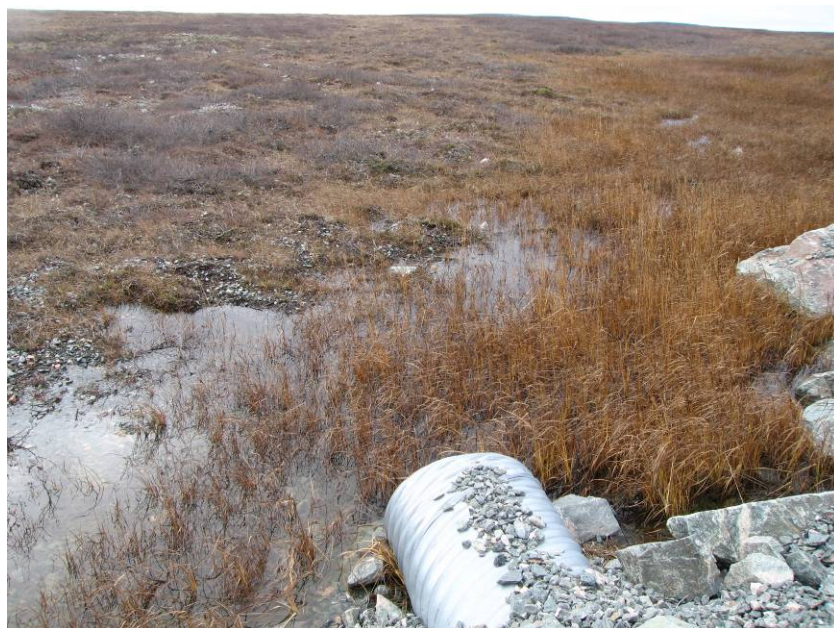
PHOTOGRAPH 46 – PC-8, km 29+785

Description: Upstream view of culvert. Culvert is in good condition, uniform grade, and no obstructions.

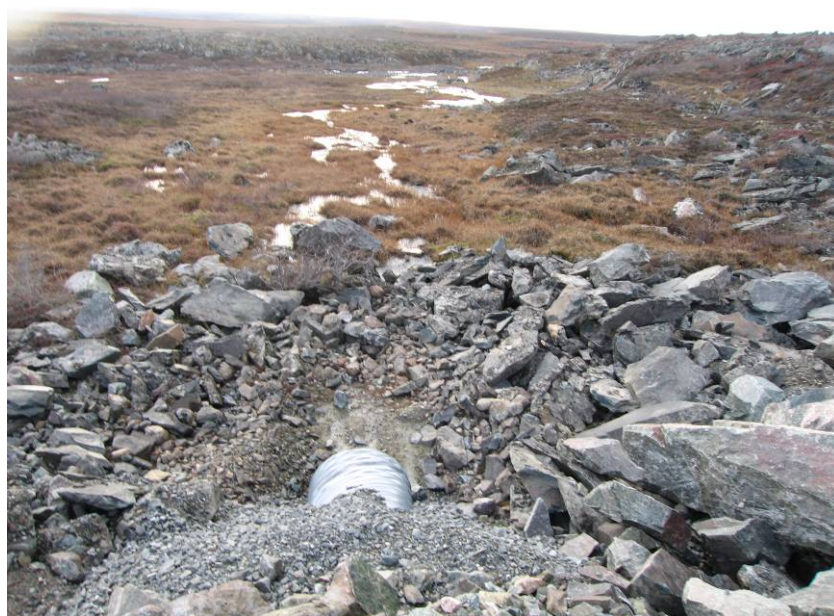
PHOTOGRAPH 48 – PC-9, km 35+690

Description: Downstream view of culvert and valley. Culvert is dry, flow is occurring through road and boulder field adjacent to culvert. No flow path, no turbidity evident. Culvert is in good condition, uniform grade, and no obstructions.

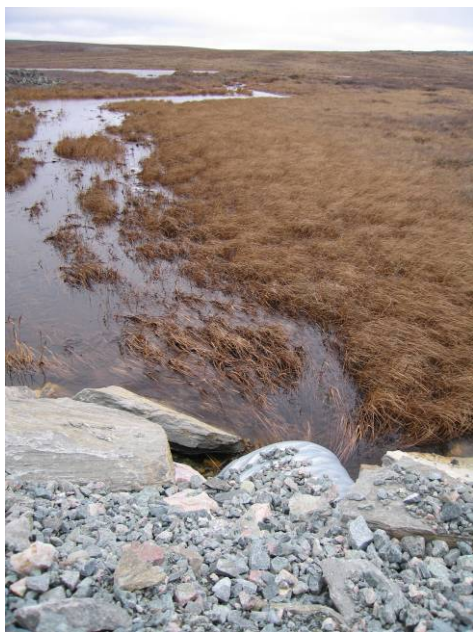
PHOTOGRAPH 50 – PC-10, km 36+865

Description: Upstream view of culvert (right side of road heading to Meadowbank). Culvert is in good condition, uniform grade, and no obstructions. Minor crushing along haunch of culvert observed. No sign of erosion and no turbidity. Stream bed consists of gravel and grass.

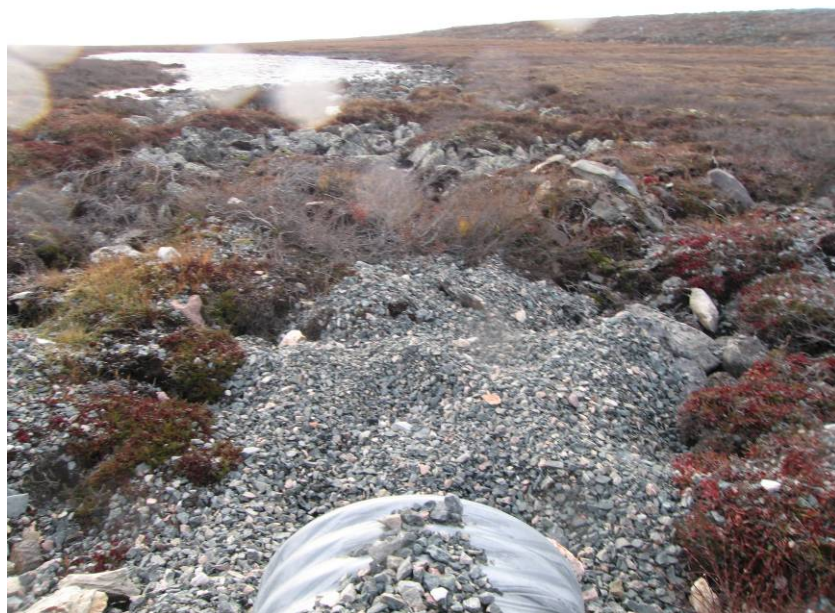
PHOTOGRAPH 52 – PC-11, km 39+552

Description: Upstream view of culvert. Culvert is generally in good condition, uniform grade, no obstructions, slight bow (crushing) in haunch.

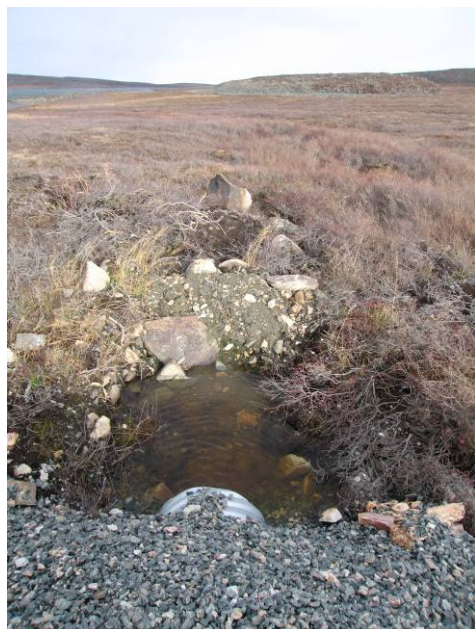
PHOTOGRAPH 53 – PC-11, km 39+552

Description: Downstream view of culvert. Water appears to be mostly ponded and not flowing, pool appears to have been created on downstream side during culvert installation.

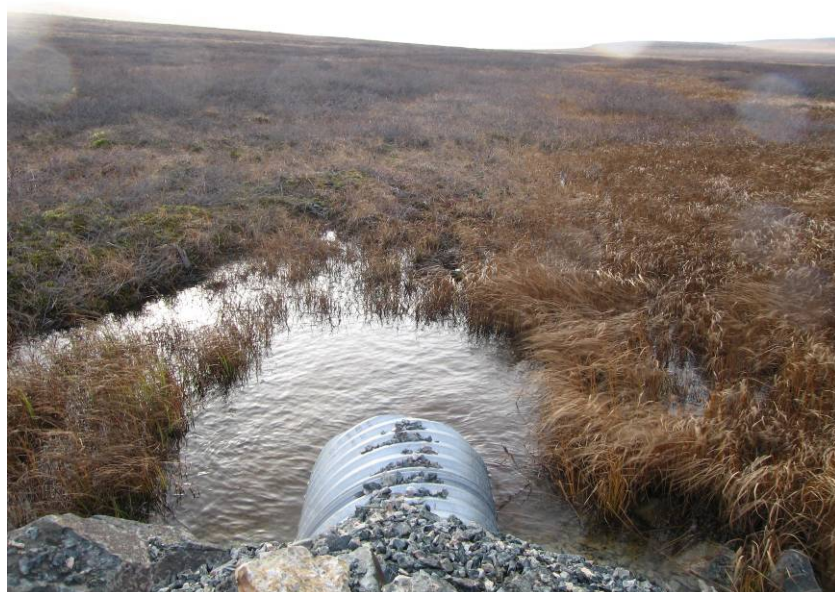
PHOTOGRAPH 54 – PC-12, km 41+410

Description: Upstream view of culvert. Culvert is half full; water appears to be mostly ponded and not flowing. Culvert has a uniform grade and is in good condition.
