2009 Annual Geotechnical Inspection, Meadowbank Gold Project, Nunavut

2009 Annual Geotechnical Inspection - Meadowbank Gold Project, Nunavut

Agnico-Eagle Mines Limited
Meadowbank Division
P.O. Box 540
Baker Lake, Nunavut
X0C 0A0

Project Number: 09-1428-0018
Doc. No. 969 Ver. 0

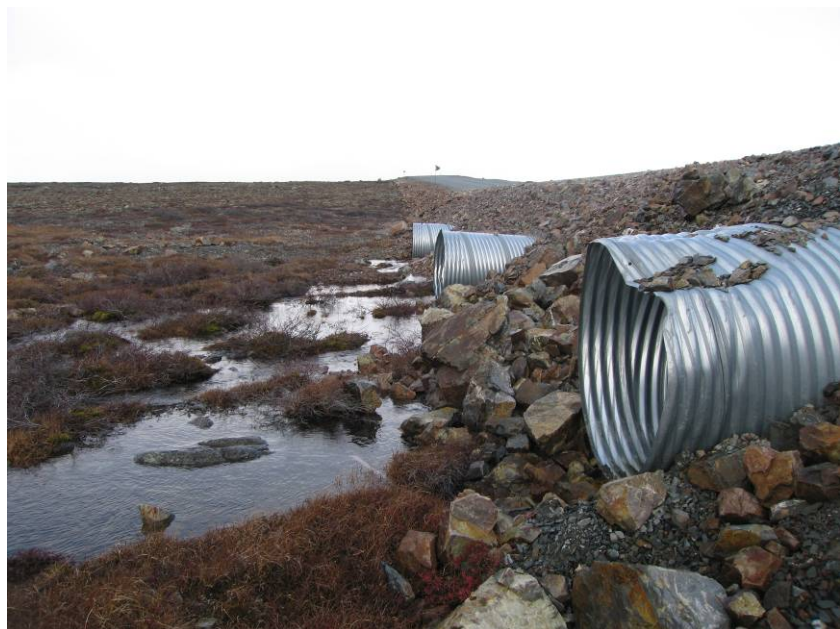
PHOTOGRAPH 59 – R-14, km 67+840

Description: View of culverts from upstream side. Culvert closer to Baker Lake (closer in photograph) is set at a slightly higher elevation.

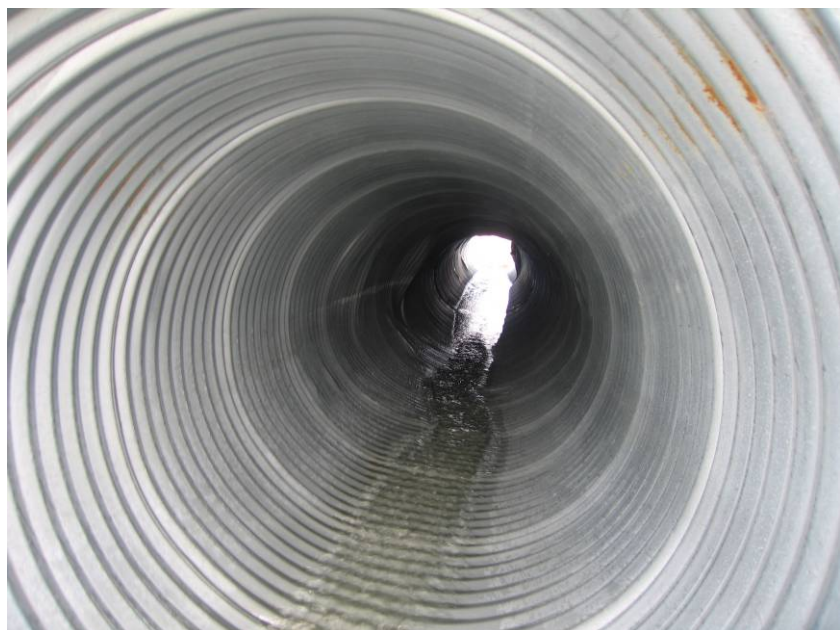
PHOTOGRAPH 60 – R-14, km 67+840

Description: View through central culverts from upstream to downstream. Culvert damaged on side and haunch crushing.

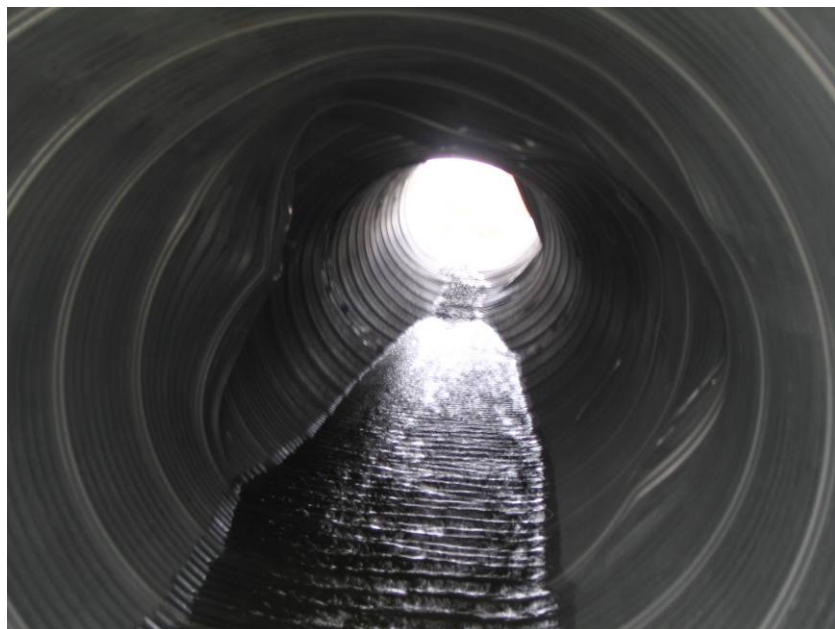
PHOTOGRAPH 63 – R-14, km 67+840

Description: View through central culverts from downstream to upstream. Culvert damaged on side and top, crushing is evident.

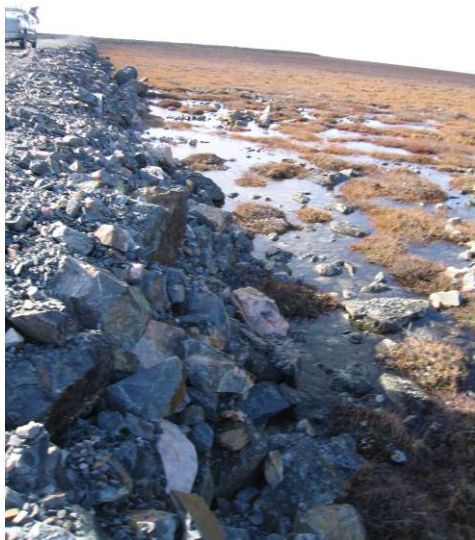
PHOTOGRAPH 65 – R-17, km 77+440

Description: Upstream side view of road. Flow through road, no turbidity.

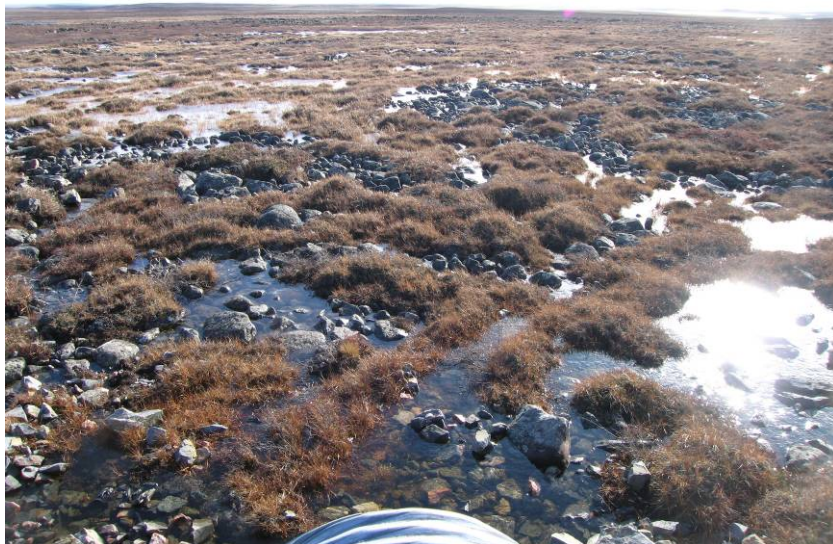
PHOTOGRAPH 66 – R-17, km 77+440

Description: Downstream view of culverts. Culvert is in good condition, uniform grade, no obstructions.

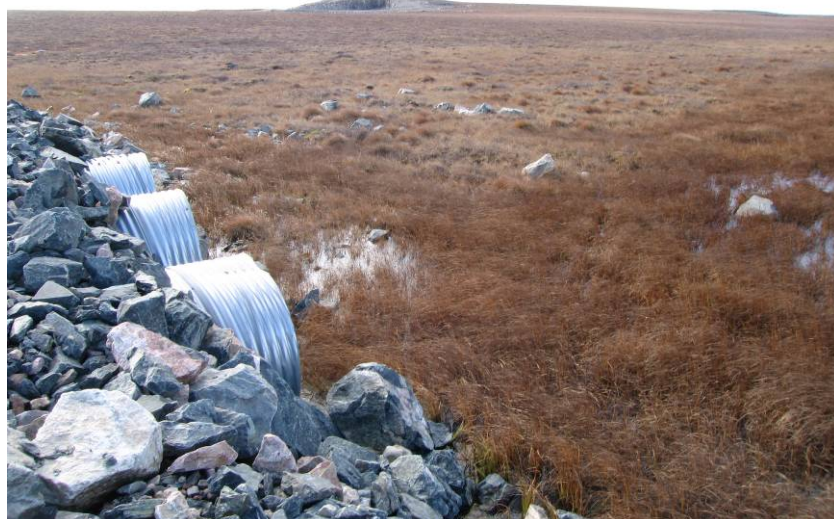
PHOTOGRAPH 67 – R-18A, km 81+045

Description: Upstream side view of culverts. Northern most culvert (closest to Meadowbank) observed to have some minor crushing along haunch. Central culvert shows minor crushing of top and dents in base and sides likely damaged during construction. Southern most culvert (closest to Baker Lake) is in the best condition. There is minimal road cover over culverts. All culverts observed to have a constant grade and no obstructions. Grass in stream base, no turbidity observed.

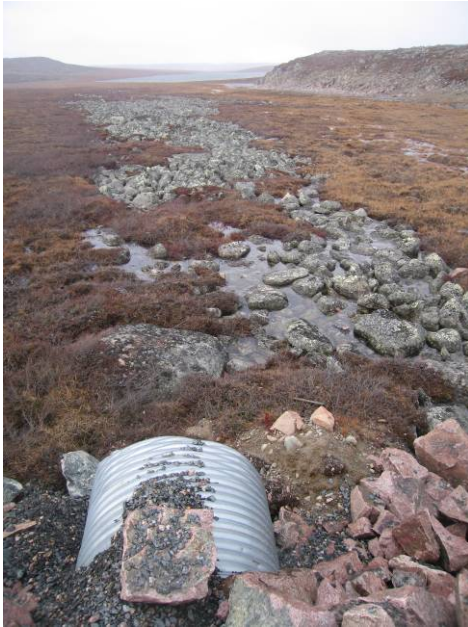
PHOTOGRAPH 69 – R-20, km 85+490

Description: Downstream view of culvert, looking west. Culvert is in good condition, uniform grade, and no obstructions.

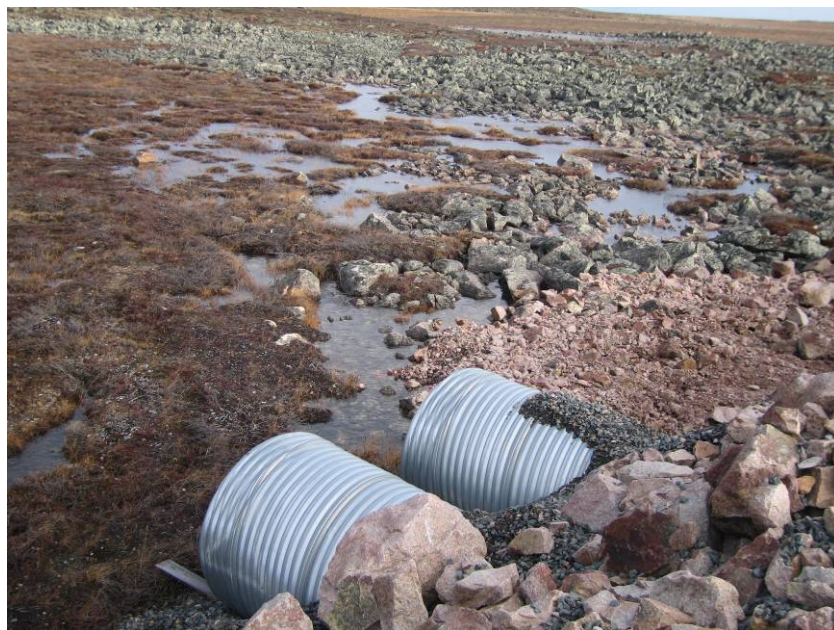
PHOTOGRAPH 72 – R-21, km 87+500

Description: Upstream view of culverts, looking north. Both culverts show some dents on base and sides likely damaged during installation. Minor crushing on crest of culverts also was evident. Uniform grade and no obstructions observed.

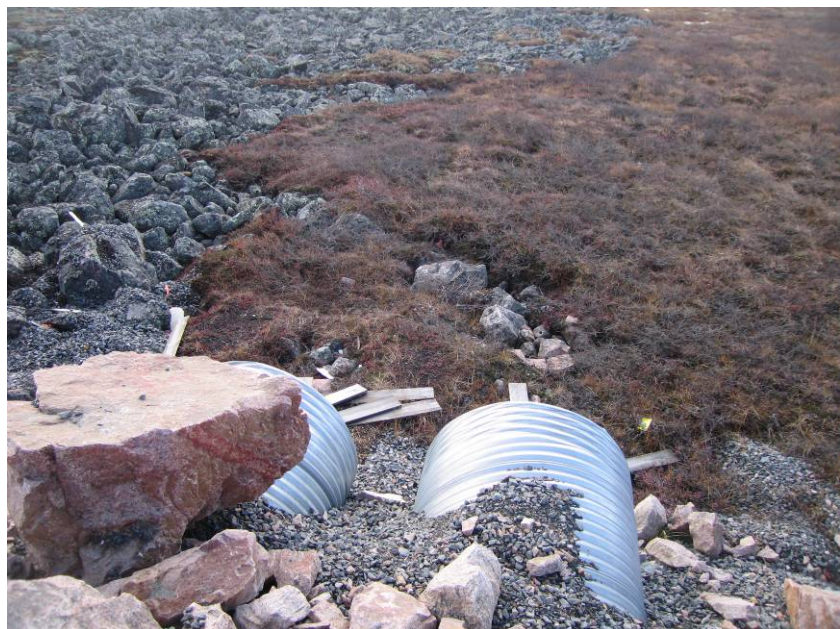
PHOTOGRAPH 75 – R-21, km 87+500

Description: Downstream view of culverts.

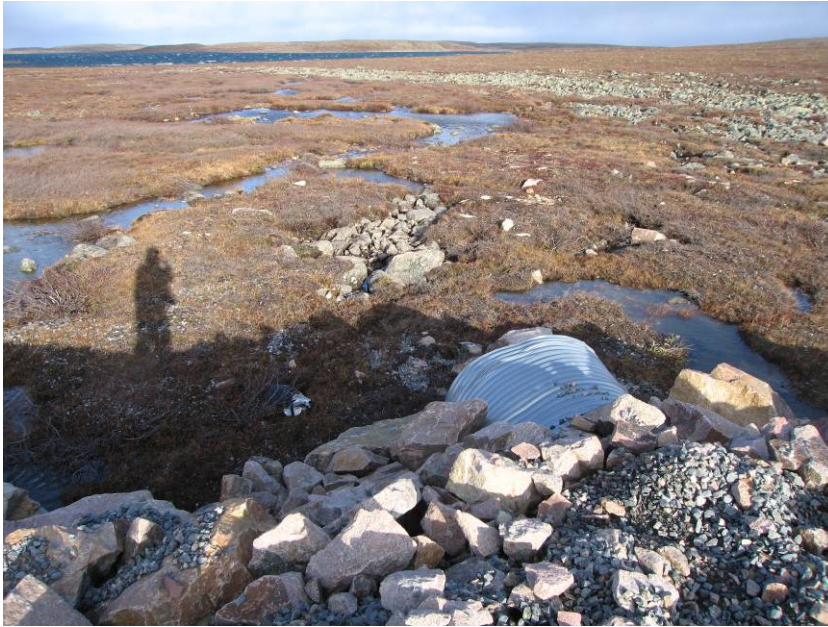
PHOTOGRAPH 77 – R-23, km 93+600

Description: Upstream view of culvert and valley, looking northwest.

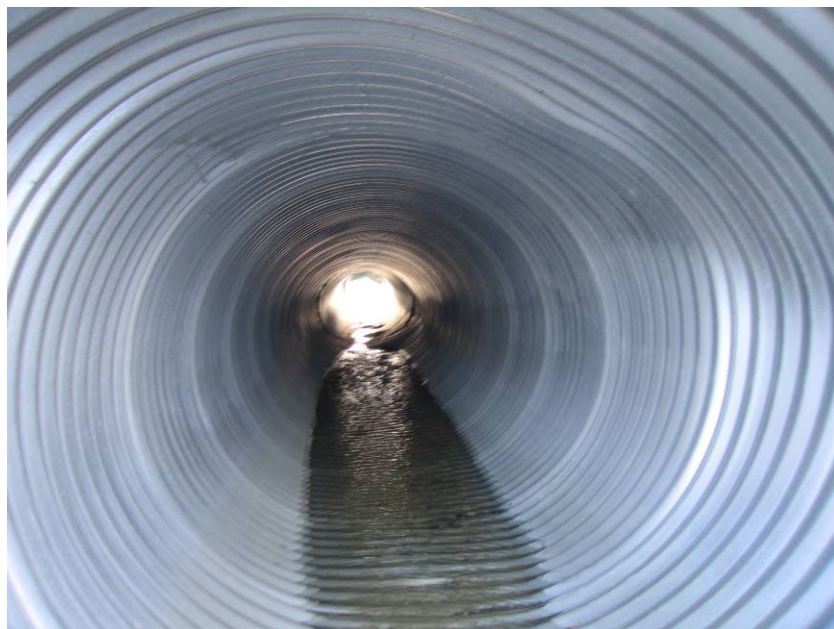
PHOTOGRAPH 79 – R-23, km 93+600

Description: Upstream to downstream view through culvert. Moderate crushing along haunch of culvert centerline, uniform grade, no blockages, and no sign of erosion observed.

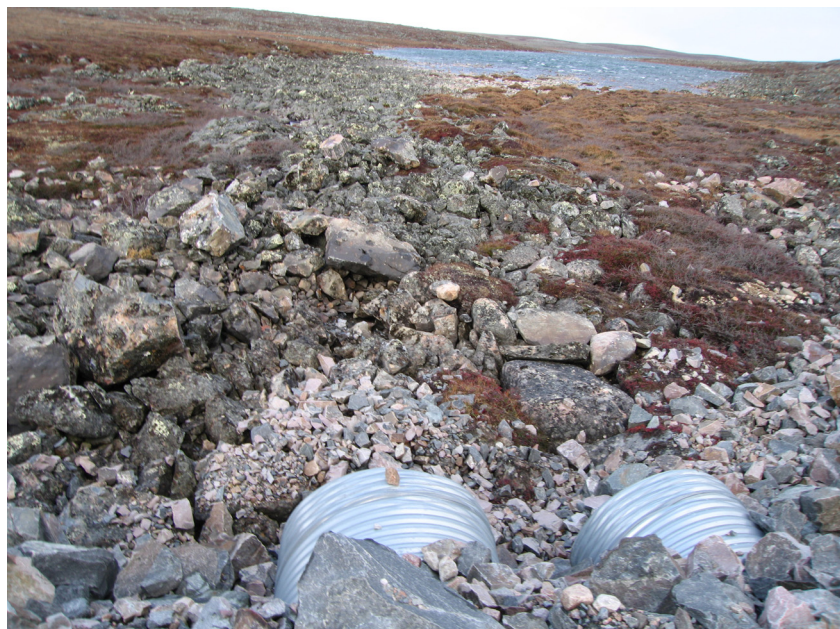
PHOTOGRAPH 81 – R-24, km 98+250

Description: Upstream view of culverts and valley, looking northwest. No sign of erosion.

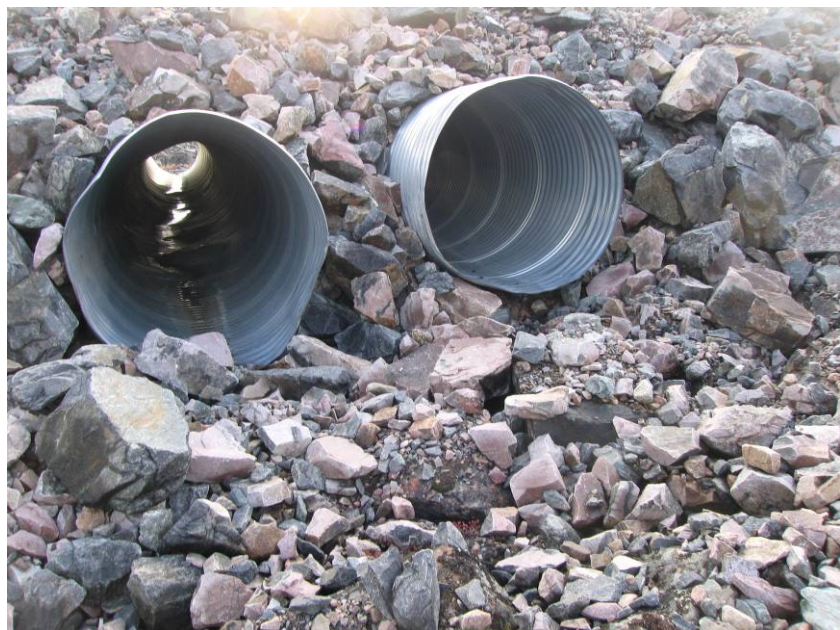
PHOTOGRAPH 82 – R-24, km 98+250

Description: Upstream to downstream view through culverts. Both culverts show some crushing along centerline (haunch) and some dents in base likely damaged during installation. Bedding appears to consist of larger diameter and sharper rocks.

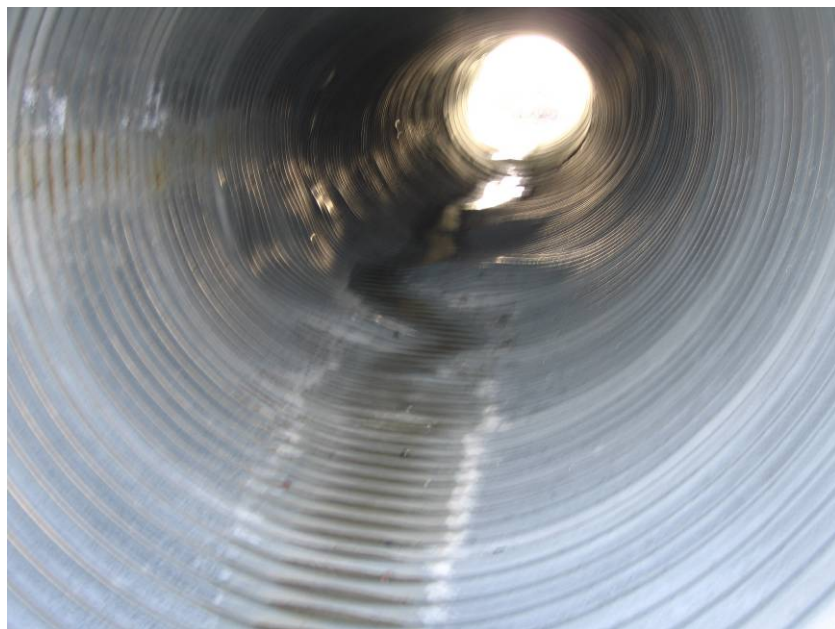
PHOTOGRAPH 83 – R-24, km 98+250

Description: Upstream to downstream view through northern most culvert (closest to Meadowbank – left side in Photograph 82).

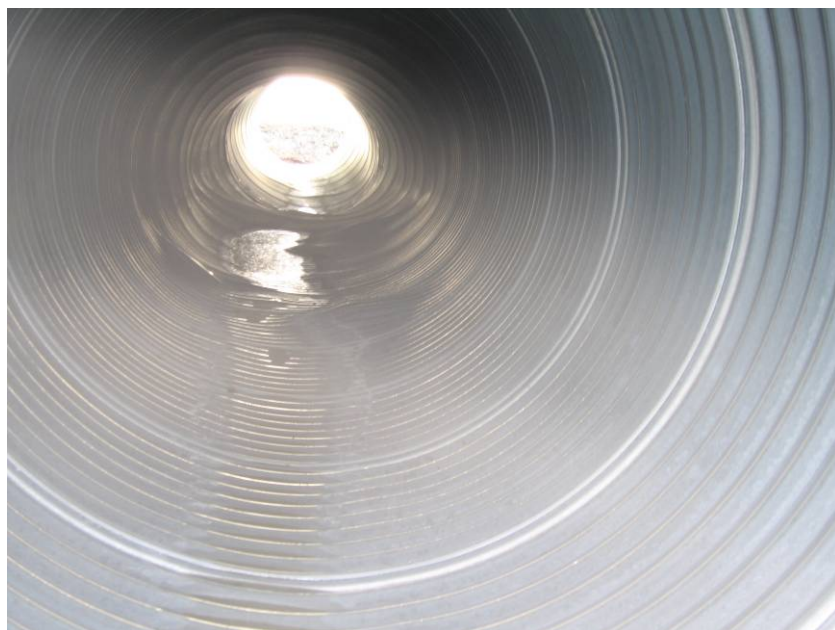
PHOTOGRAPH 84 – R-24, km 98+250

Description: Upstream to downstream view through right culvert on Photograph 82 (closest to Baker Lake).

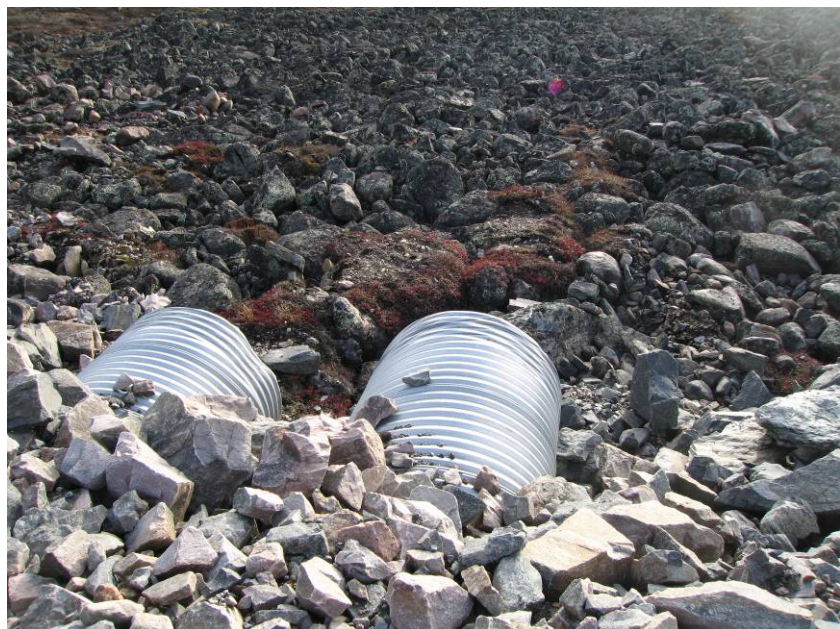
PHOTOGRAPH 85 – R-24, km 98+250

Description: Downstream view of culverts.

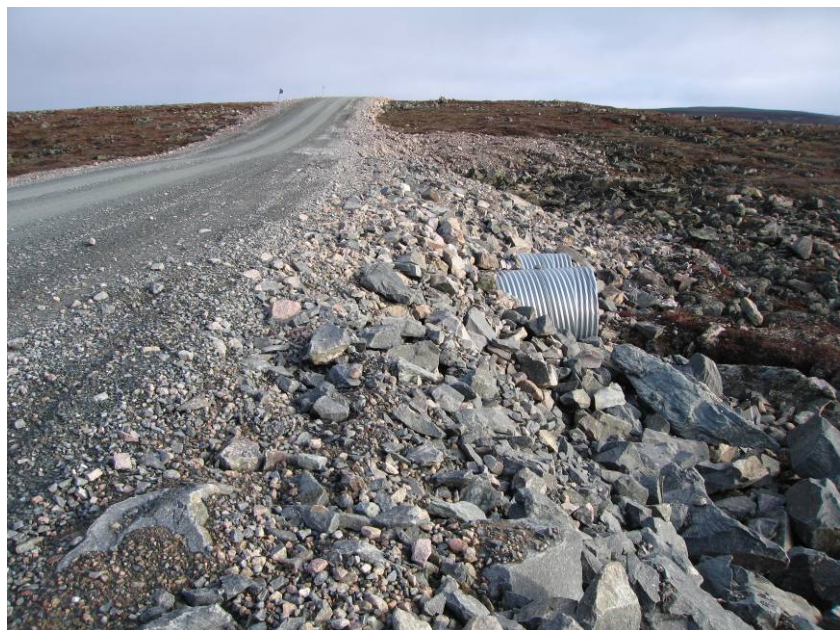
PHOTOGRAPH 86 – R-24, km 98+250

Description: Downstream view of culverts and road. Uniform grade and no blockages observed.

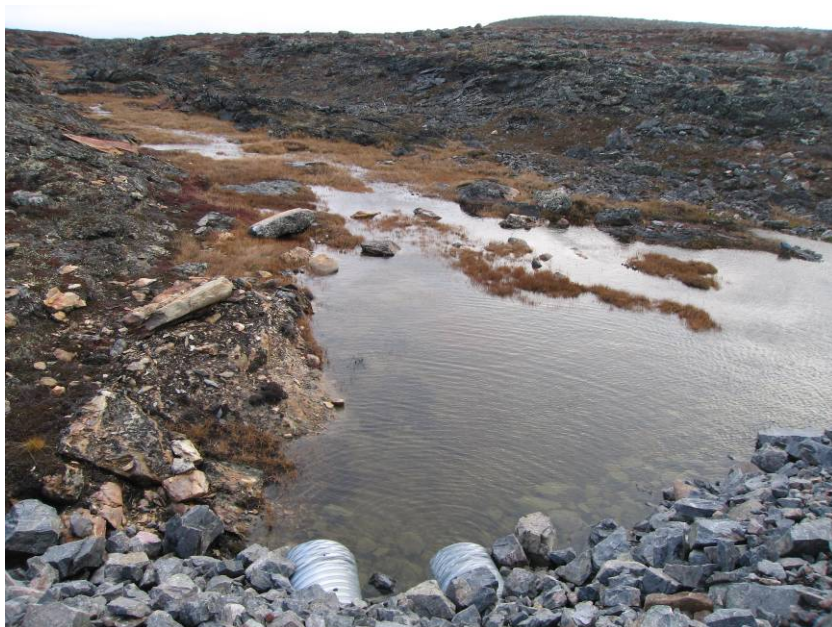
PHOTOGRAPH 87 – R-25, km 102+050

Description: Upstream view of culverts and valley, looking northeast.

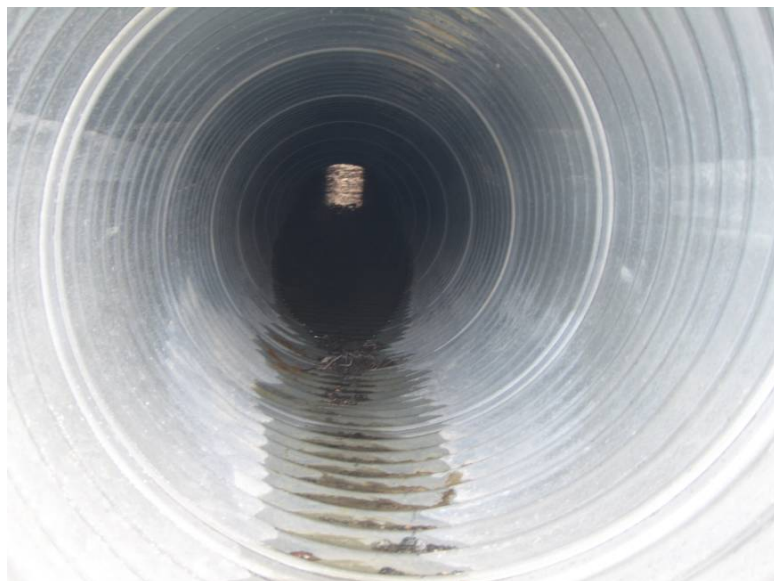
PHOTOGRAPH 89 – R-25, km 102+050

Description: Downstream to upstream view through right culvert in Photograph 88. Culvert is bent in central area, non-uniform grade. No outflow and three-quarters full on upstream side.

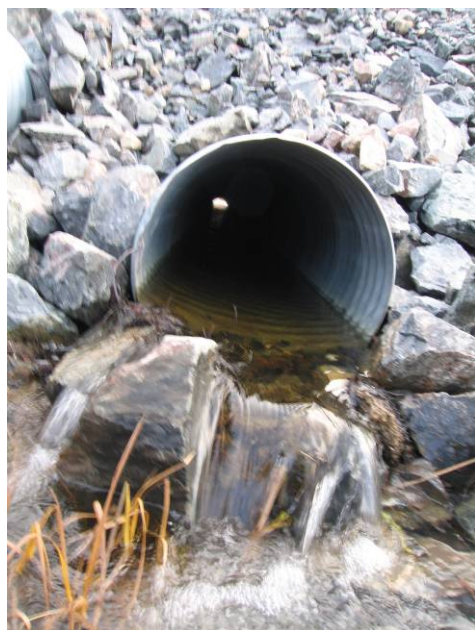
PHOTOGRAPH 90 – R-25, km 102+050

Description: Downstream to upstream view through left culvert in Photograph 88. No signs of erosion upstream or downstream. Culvert is in good condition, uniform grade, no obstructions, and was approximately flowing at one-quarter full.

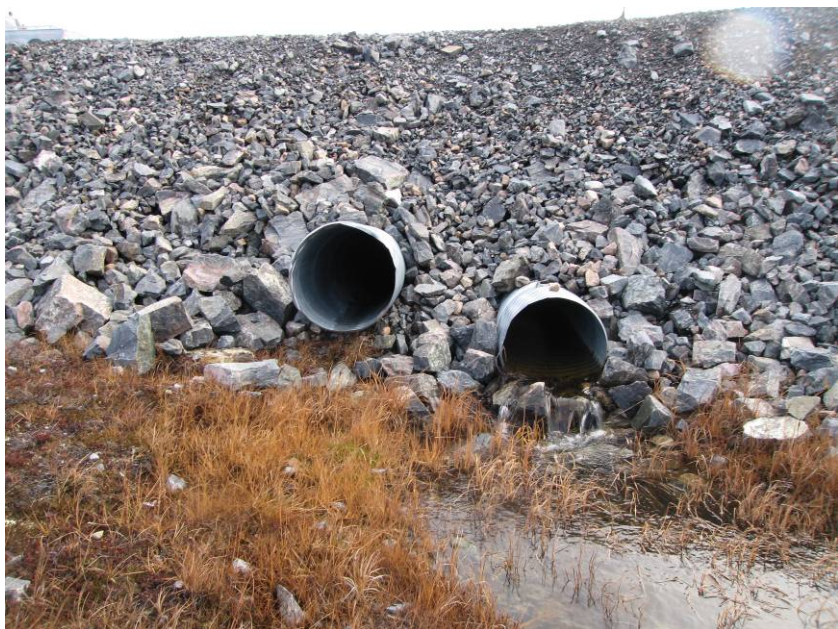
PHOTOGRAPH 91 – R-25, km 102+050

Description: Downstream view, culvert offset at discharge end.

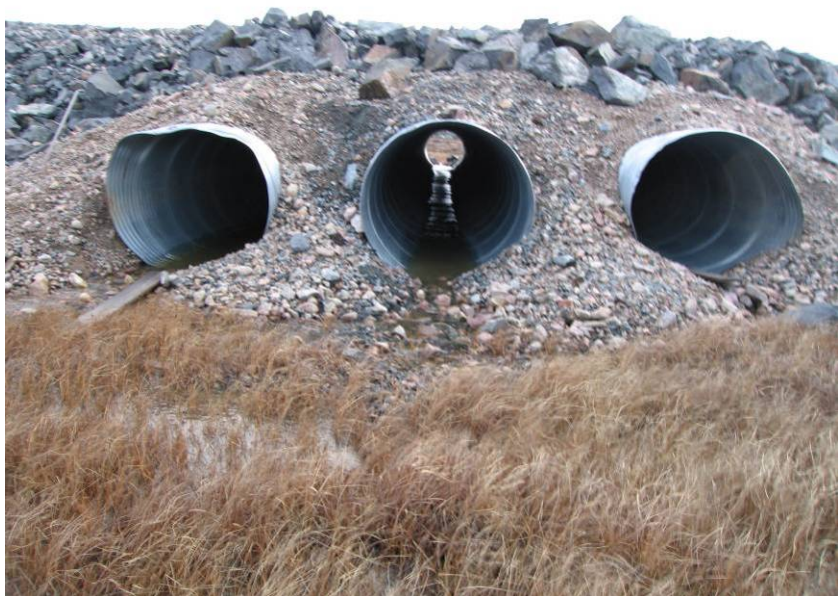
PHOTOGRAPH 92 – R-26, km 104+710

Description: Downstream to upstream view through culverts. All culverts are in good condition, a uniform grade, and no signs of erosion upstream or downstream were observed.

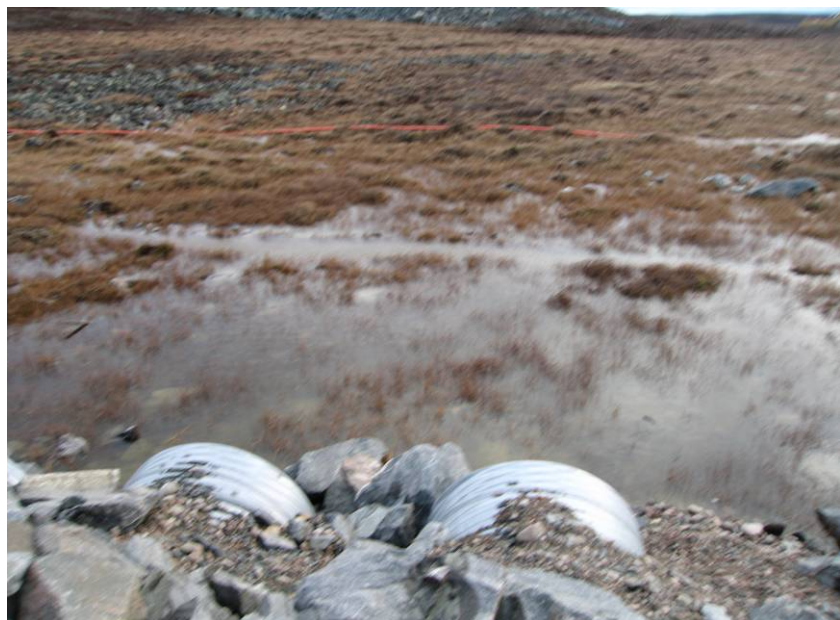
PHOTOGRAPH 93 – R-26, km 104+710

Description: Upstream view, looking east.

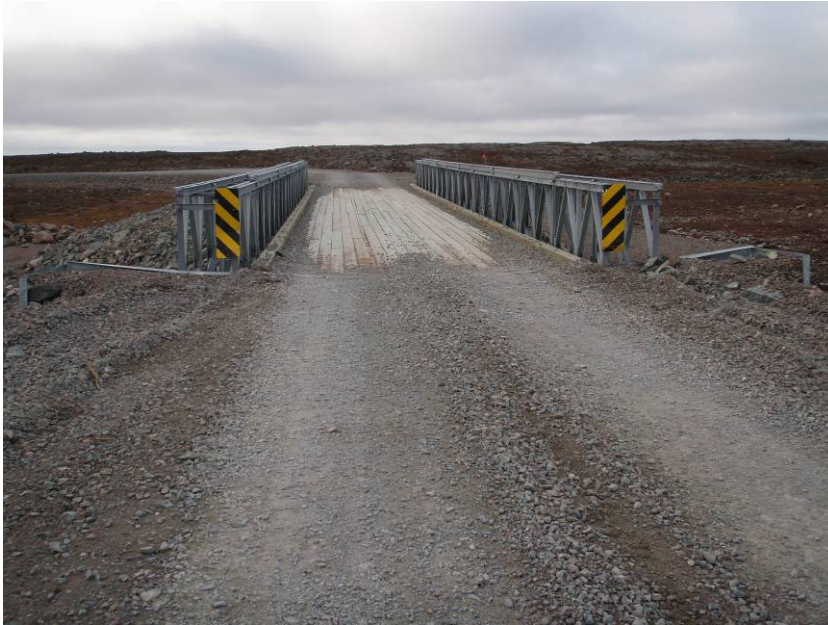
PHOTOGRAPH 1 – Bridge 1 - R02, km 8+750

Description: View of bridge looking across deck looking south west. Abutment supports slightly damaged, likely during construction.

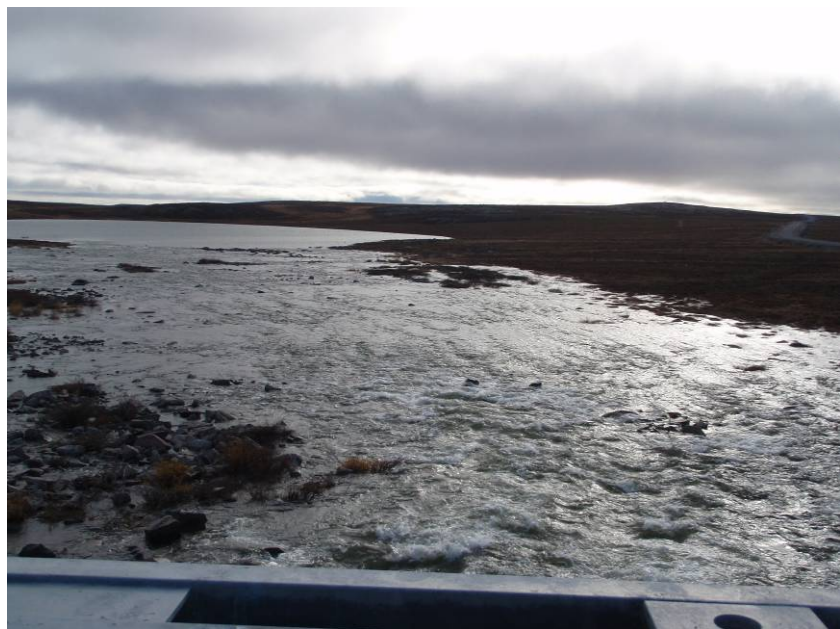
PHOTOGRAPH 3 – Bridge 1 - R02, km 8+750

Description: Downstream view from deck, looking southeast.

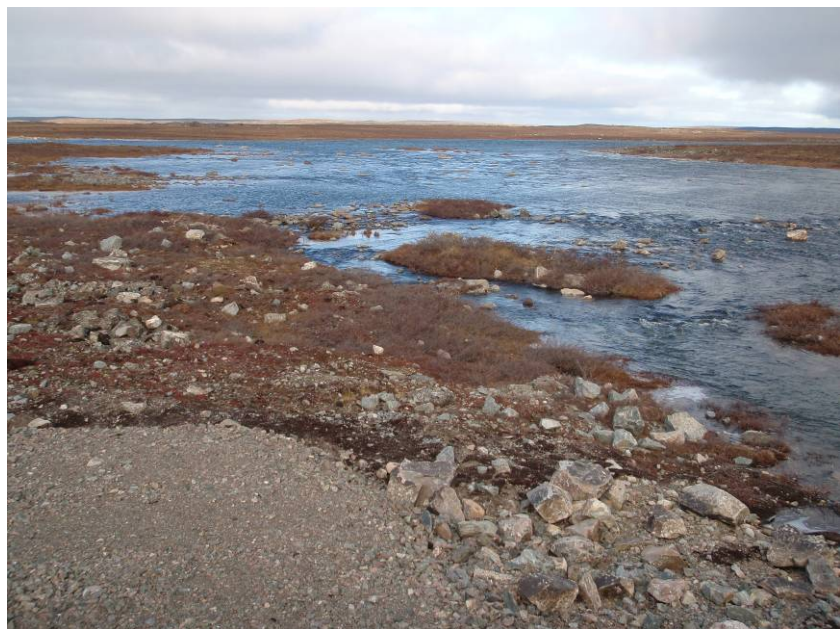
PHOTOGRAPH 5 – Bridge 1 - R02, km 8+750

Description: View of crossing and valley.

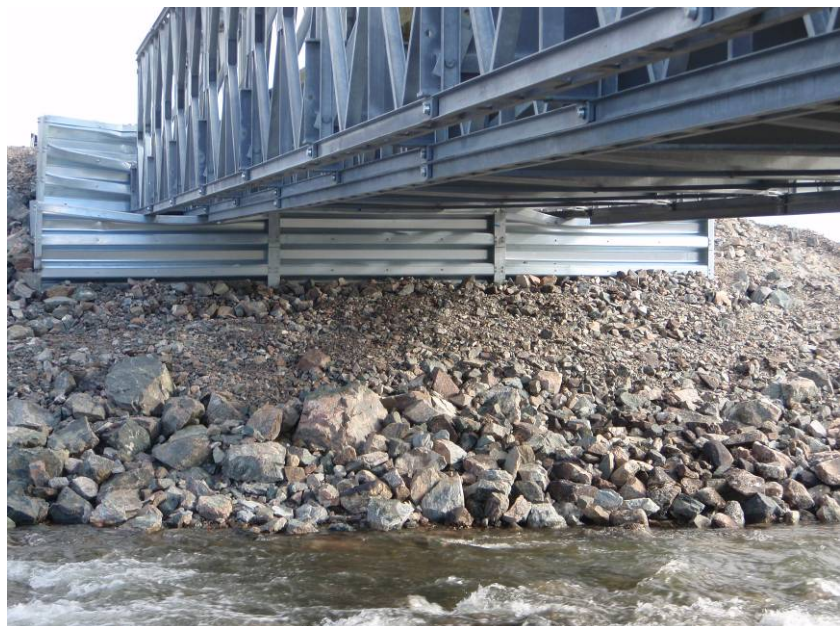
PHOTOGRAPH 7 – Bridge 1 - R02, km 8+750

Description: View of abutment on northeast side.

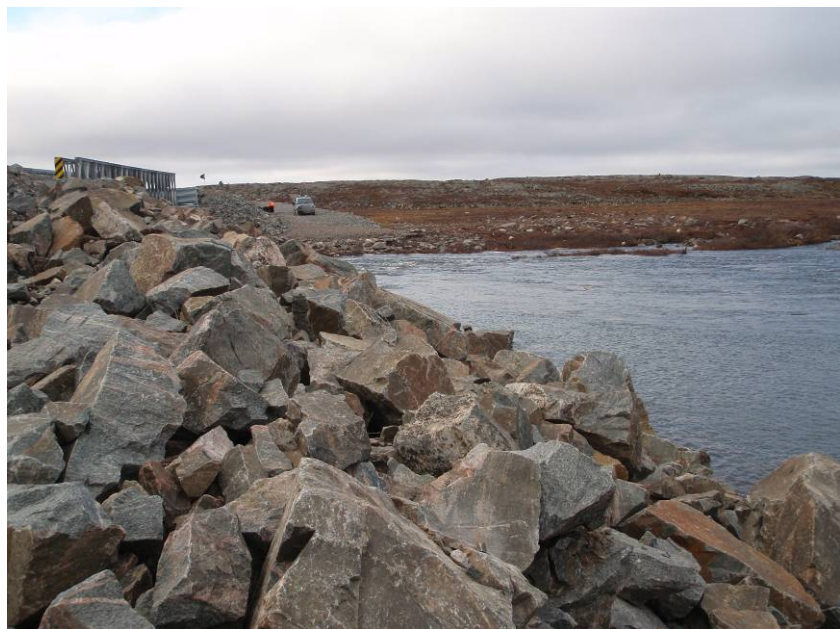
PHOTOGRAPH 9 – Bridge 1 - R02, km 8+750

Description: Upstream view, looking southwest.

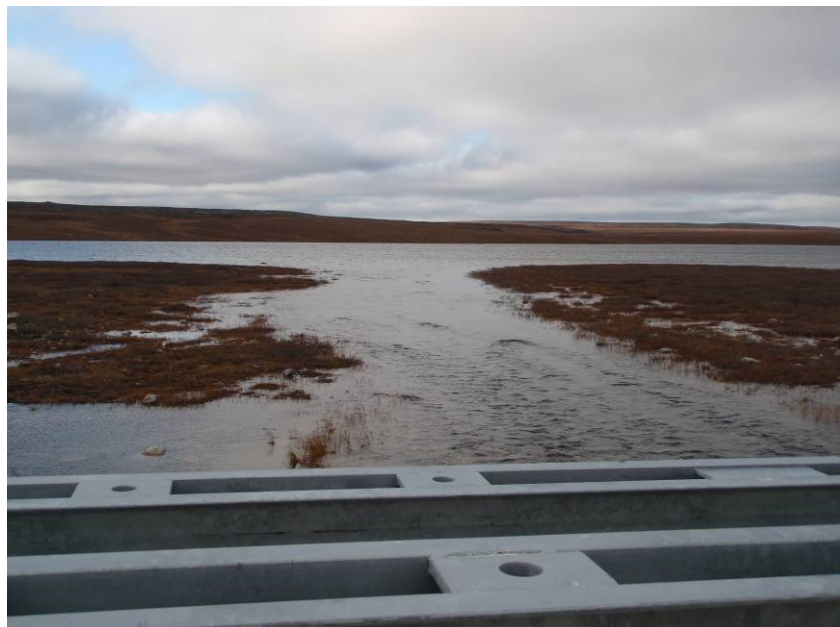
PHOTOGRAPH 10 – Bridge 2 - R05, km 17+600

Description: Upstream view from deck, looking west. Concentrated flow beneath bridge observed. Stream bed consists of cobbles, some gravel and a few boulders. Beyond main channel is primarily grass. The flow passes closer to abutment on left abutment (Meadowbank side).

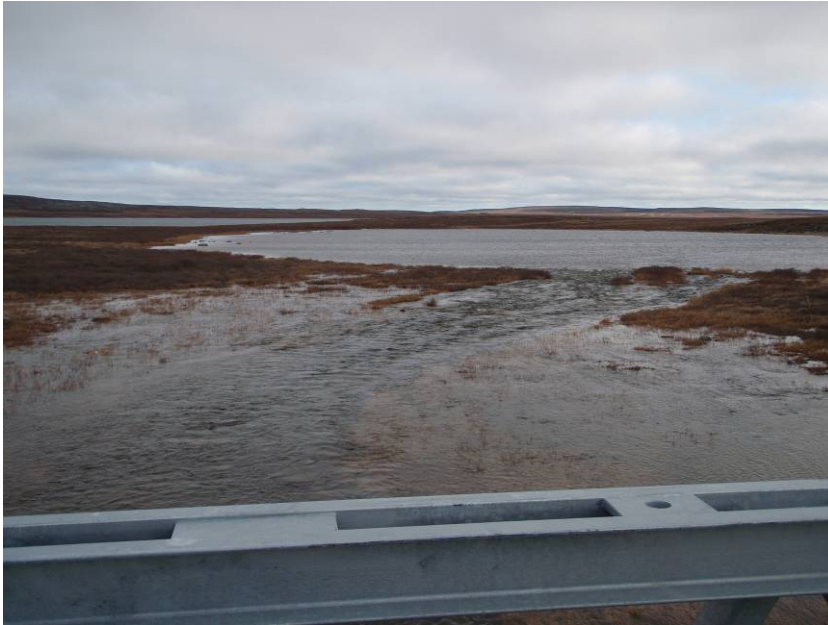
PHOTOGRAPH 11 – Bridge 2 - R05, km 17+600

Description: Downstream view from deck, looking east.

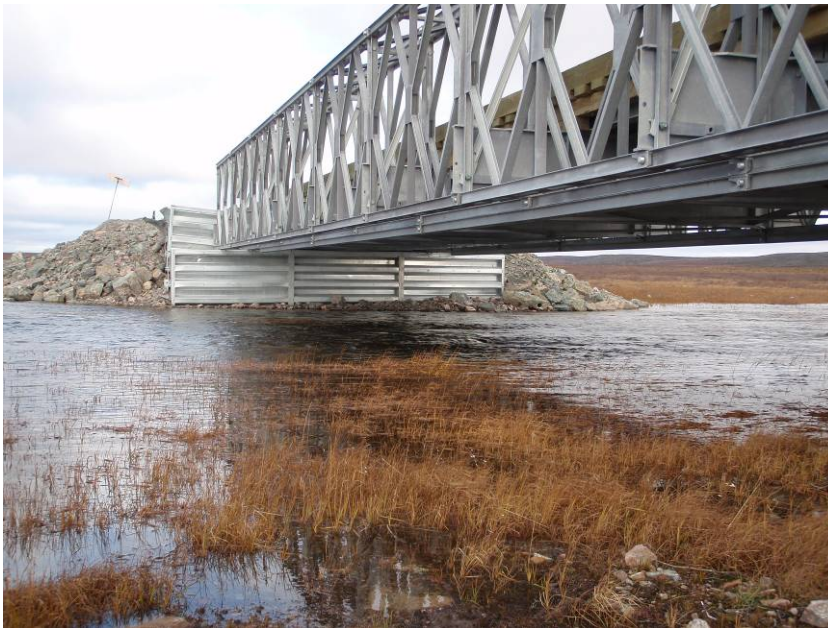
PHOTOGRAPH 12 – Bridge 2 - R05, km 17+600

Description: Upstream view of abutment on north side. Minor damage to abutment box, likely damaged during construction.

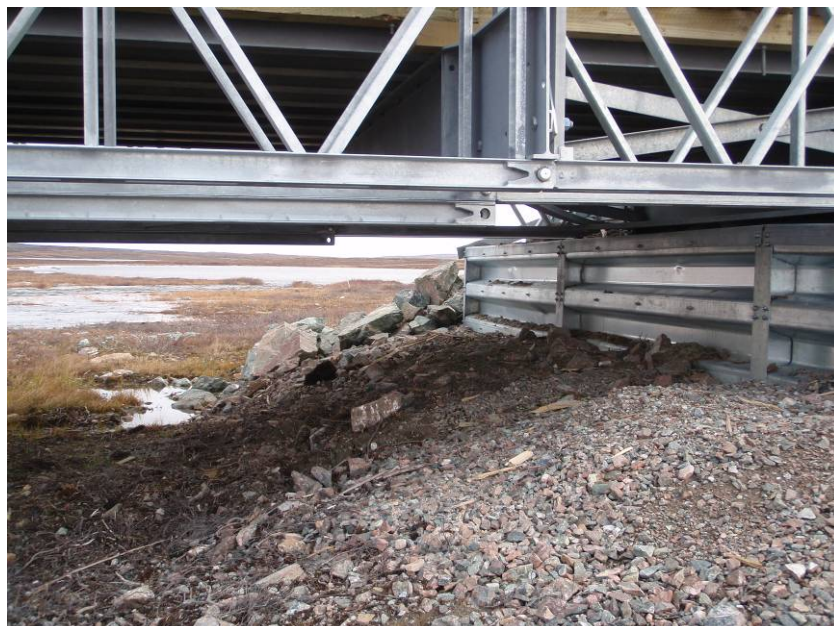
PHOTOGRAPH 13 – Bridge 2 - R05, km 17+600

Description: Upstream view of abutment on south side. Minor damage to abutment box, likely damaged during construction.

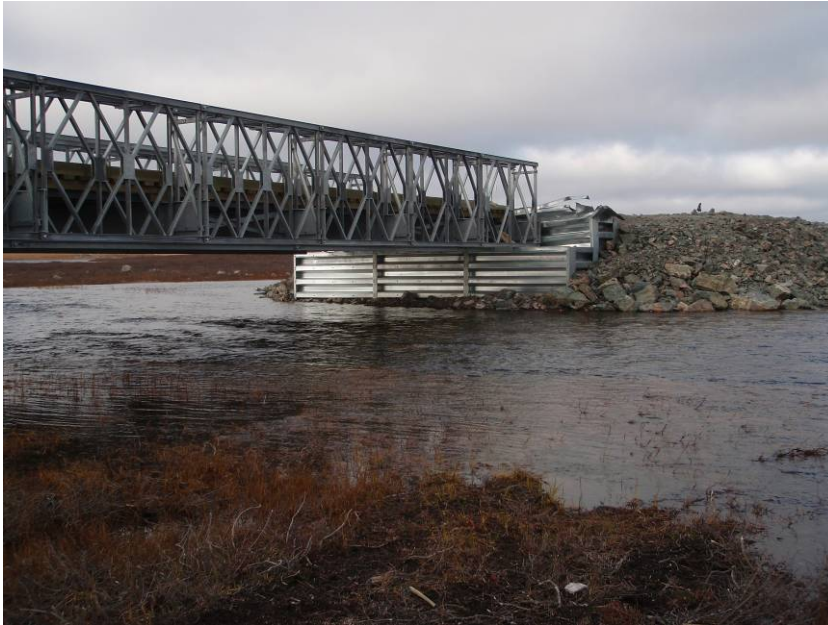
PHOTOGRAPH 15 – Bridge 2 - R05, km 17+600

Description: Upstream view of abutment on north side. Minor damage on deck, likely damaged when grading.

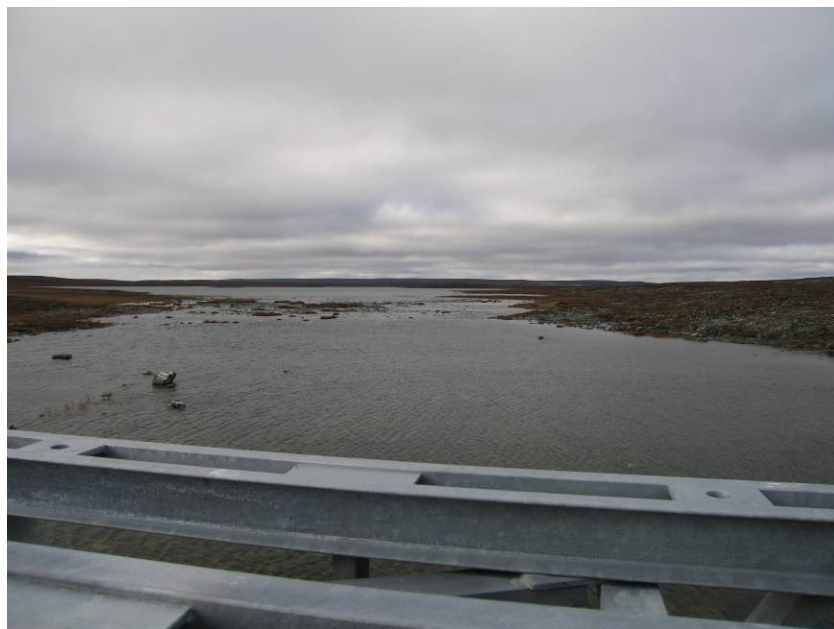
PHOTOGRAPH 17 – Bridge 3 - R06, km 23+100

Description: Upstream view from deck, looking west. Concentrated flow beneath the bridge. The flow passes equally beneath the bridge. No signs of erosion or turbidity.

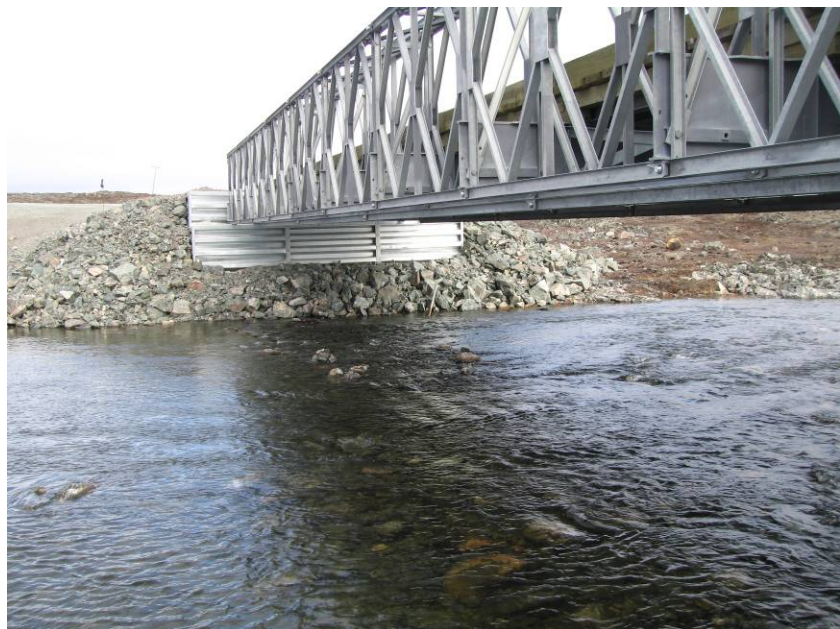
PHOTOGRAPH 19 – Bridge 3 - R06, km 23+100

Description: Upstream view of abutment on north side.

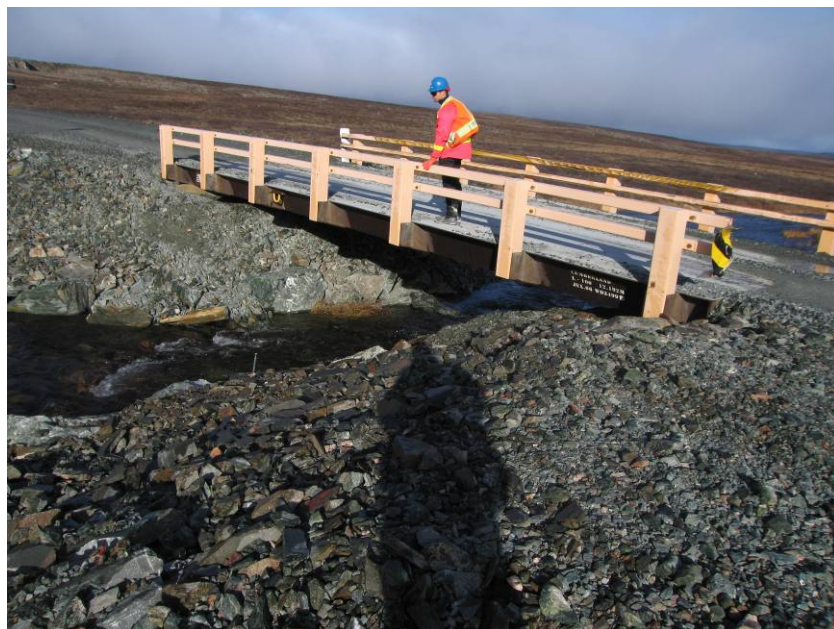
PHOTOGRAPH 21 – Bridge 4 - R09, km 48+500

Description: Upstream view of bridge from south side.

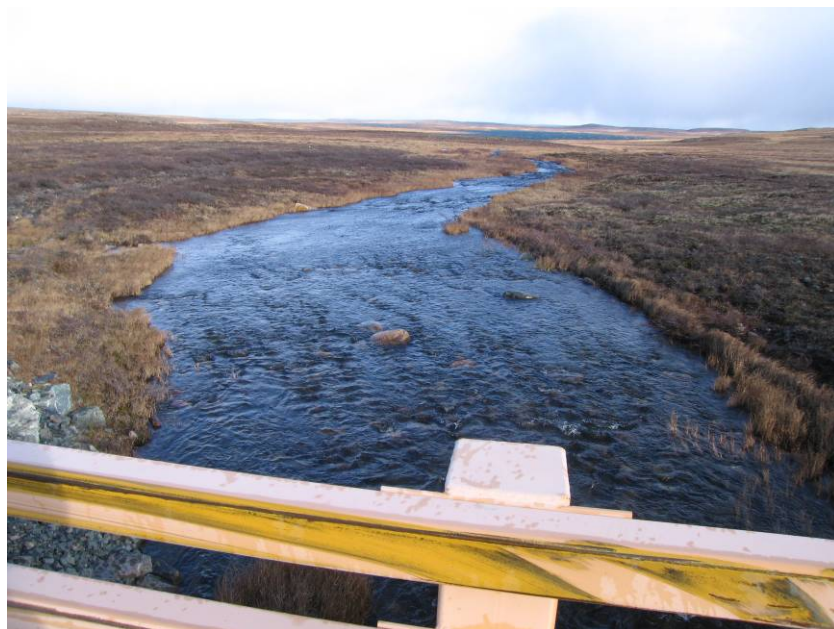
PHOTOGRAPH 23 – Bridge 4 - R09, km 48+500

Description: Downstream view from deck, looking east. Stream bed consists of cobbles and boulders with some grass.

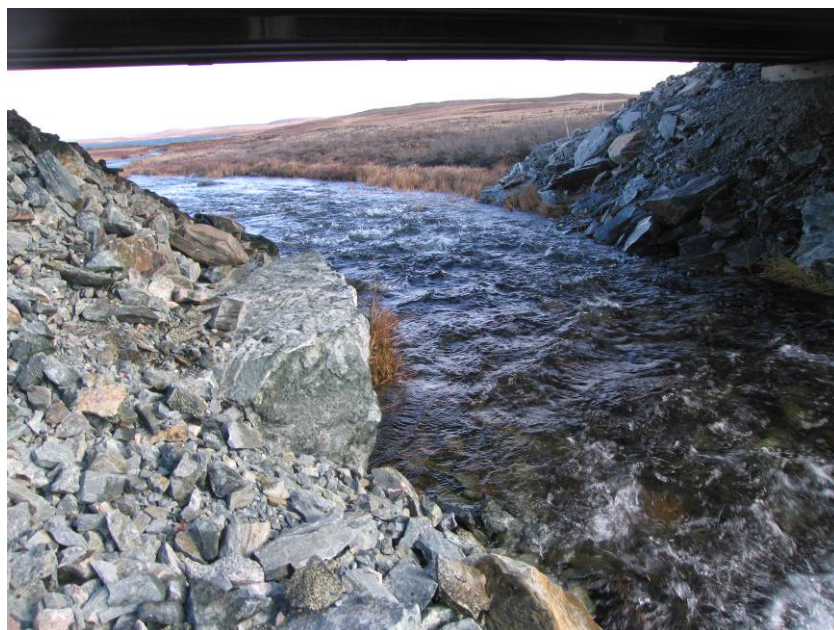
PHOTOGRAPH 24 – Bridge 4 - R09, km 48+500

Description: View from upstream under the bridge, looking east. Good condition, no sign of erosion of abutments or stream bed. No turbidity.

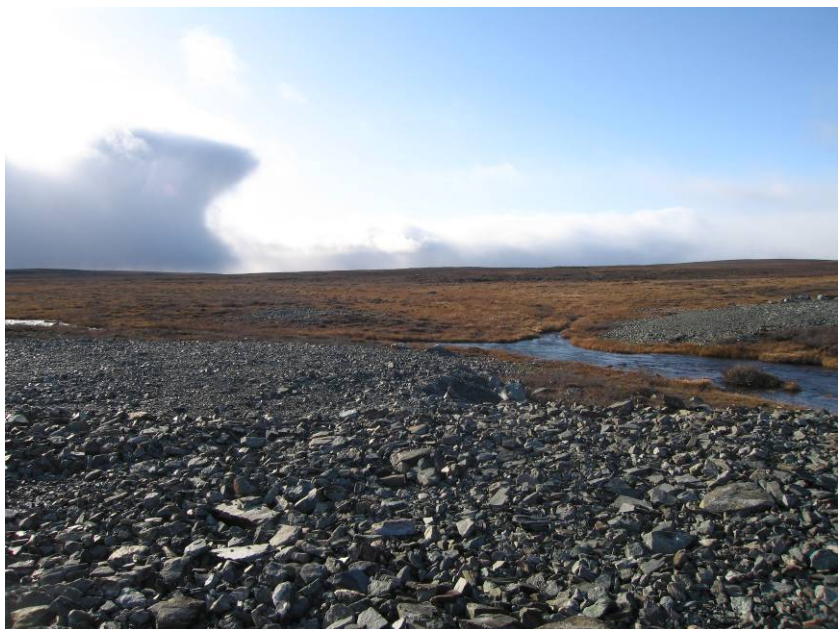
PHOTOGRAPH 25 – Bridge 4 - R09, km 48+500

Description: View of upstream flow channels and old road.

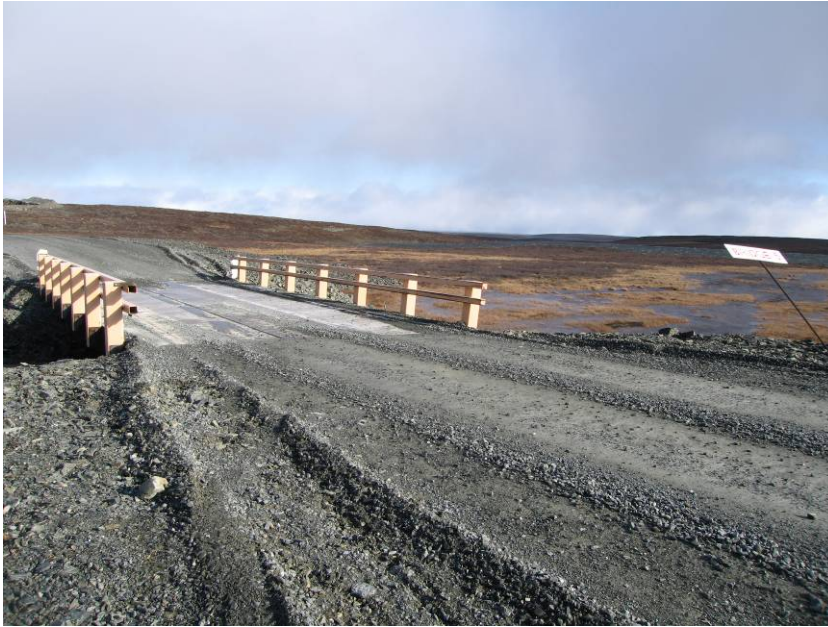
PHOTOGRAPH 27 – Bridge 5 - R13, km 62+060

Description: View of bridge deck, looking northeast.

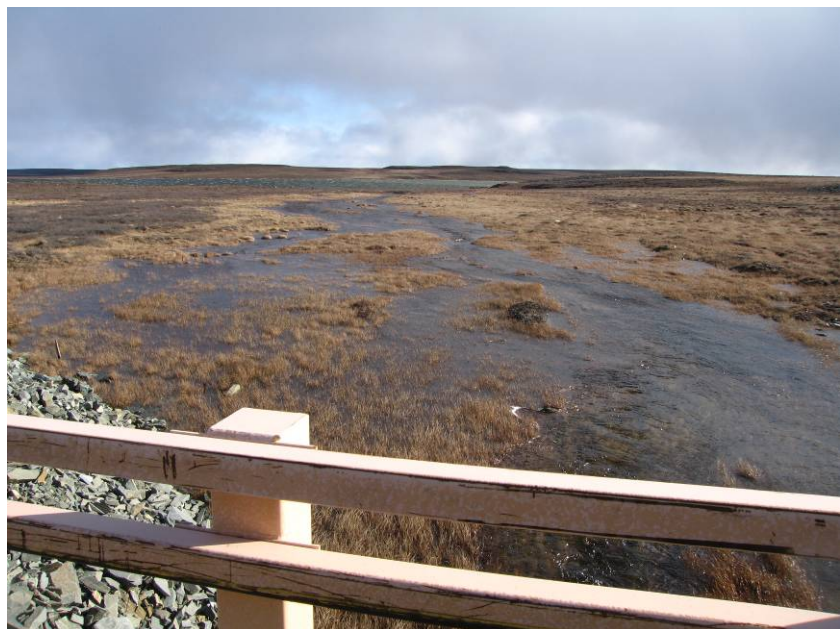
PHOTOGRAPH 29 – Bridge 5 - R13, km 62+060

Description: Downstream view from deck, looking southeast. On downstream side, “hole” or depression evident and is surrounded by larger cobbles. No signs of turbidity.

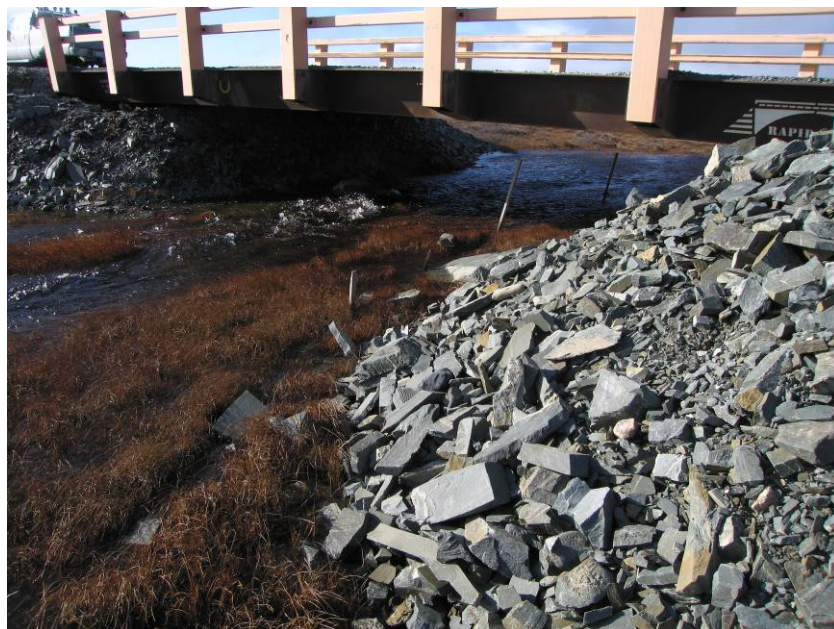
PHOTOGRAPH 30 – Bridge 5 - R13, km 62+060

Description: View of bridge and abutments from downstream, looking west. Abutments appeared to be in good condition.
