2009 Annual Geotechnical Inspection, Meadowbank Gold Project, Nunavut

2009 Annual Geotechnical Inspection - Meadowbank Gold Project, Nunavut

Agnico-Eagle Mines Limited
Meadowbank Division
P.O. Box 540
Baker Lake, Nunavut
X0C 0A0

Project Number: 09-1428-0018
Doc. No. 969 Ver. 0

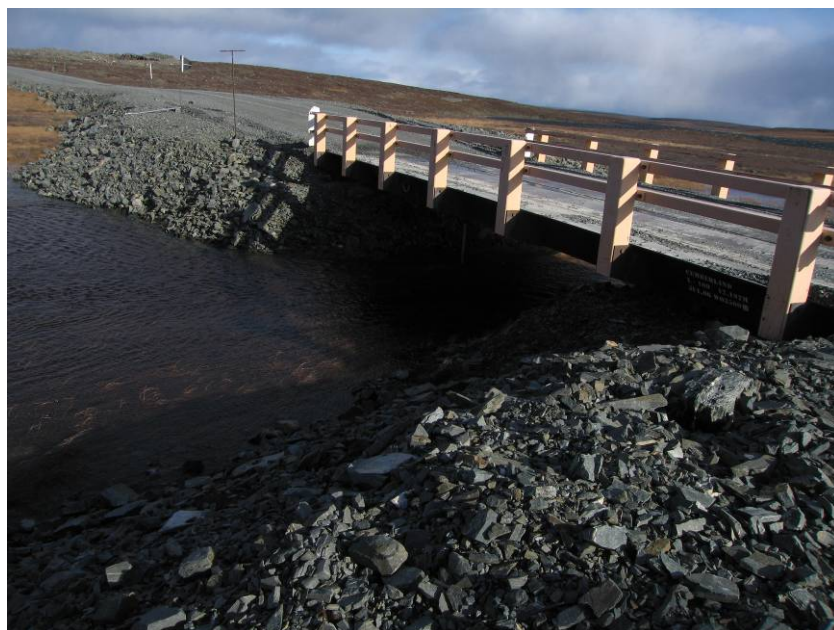
PHOTOGRAPH 31 – Bridge 5 - R13, km 62+060

Description: View of bridge and abutments from upstream, looking east. Abutments appeared to be in good condition.

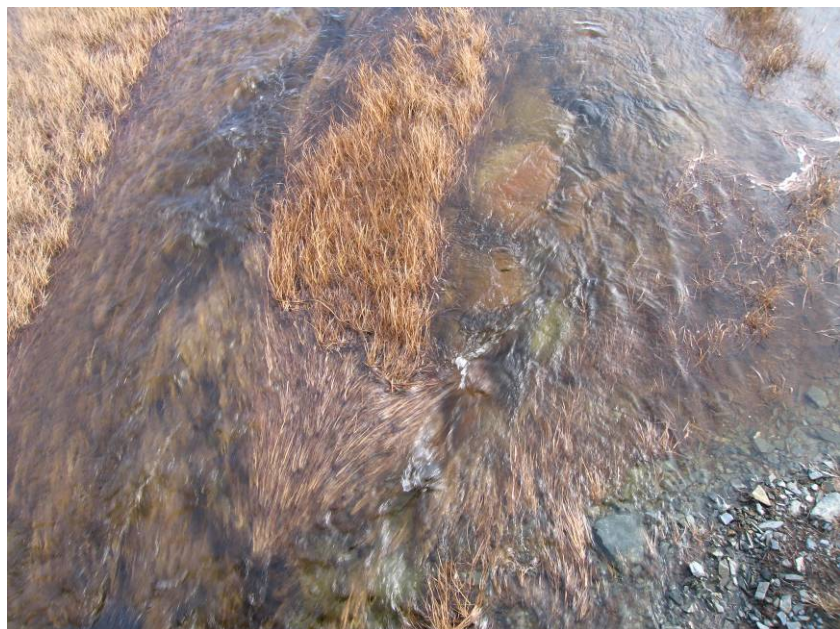
PHOTOGRAPH 32 – Bridge 5 - R13, km 62+060

Description: Photo of boulders and deeper pockets (depressions) in stream bed on downstream side of bridge.

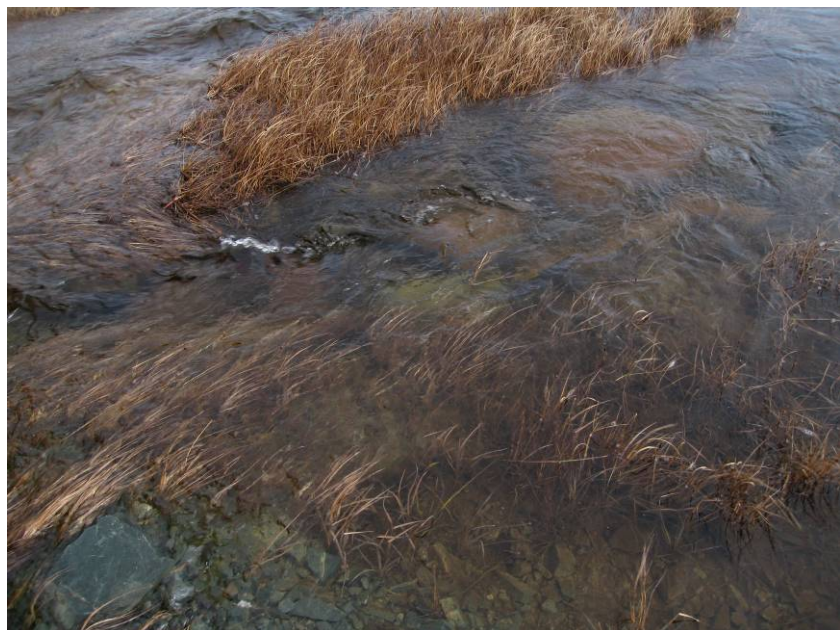
PHOTOGRAPH 33 – Bridge 5 - R13, km 62+060

Description: Photo of boulders and deeper pockets on downstream side of bridge.

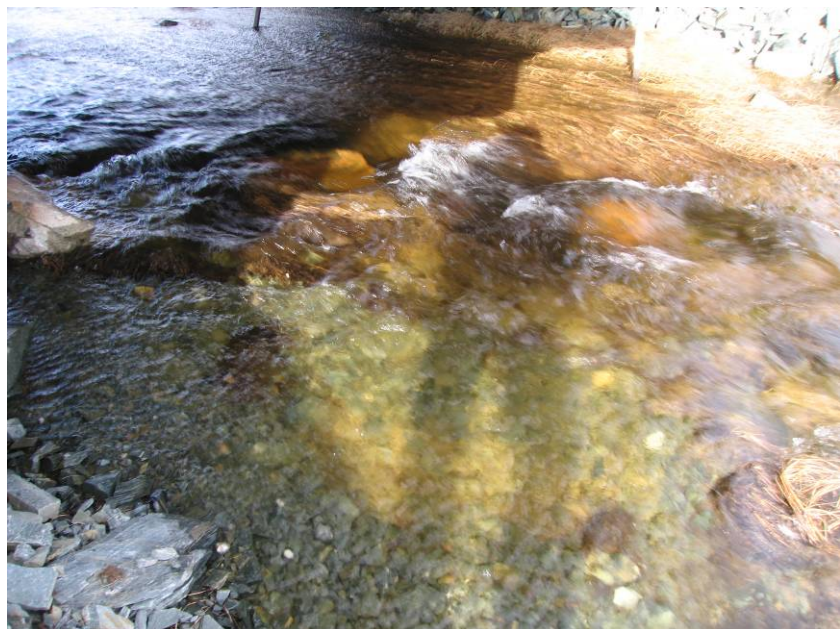
PHOTOGRAPH 34 – Bridge 5 - R13, km 62+060

Description: Photo of similar deeper pockets and boulders under bridge.

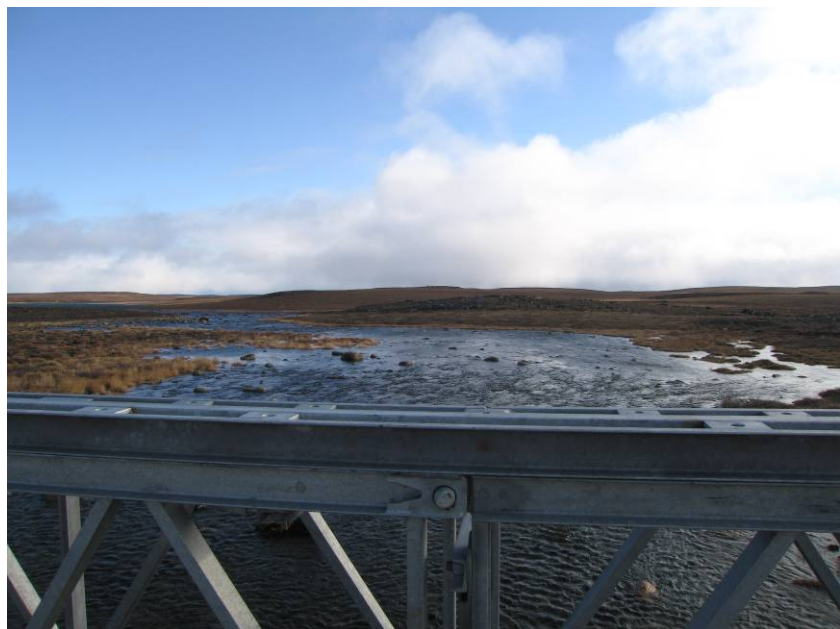
PHOTOGRAPH 36 – Bridge 6 - R15, km 69+200

Description: Downstream view from deck, looking east.

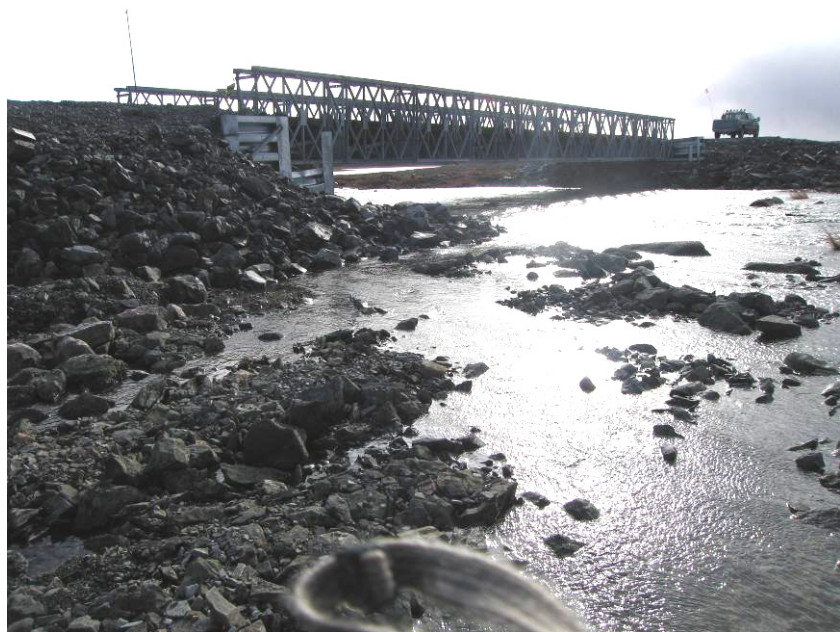
PHOTOGRAPH 37 – Bridge 6 - R15, km 69+200

Description: View of bridge from upstream, looking south. Flow beneath bridge, no evidence of flow through road fill material.

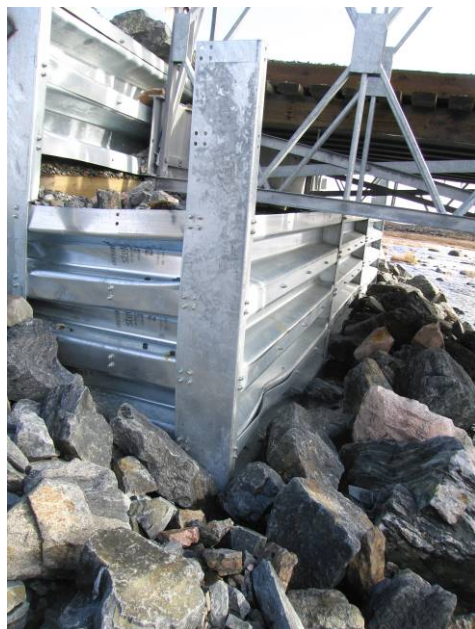
PHOTOGRAPH 39 – Bridge 6 - R15, km 69+200

Description: View of left abutment containment/reinforcement looking from upstream, in good condition.

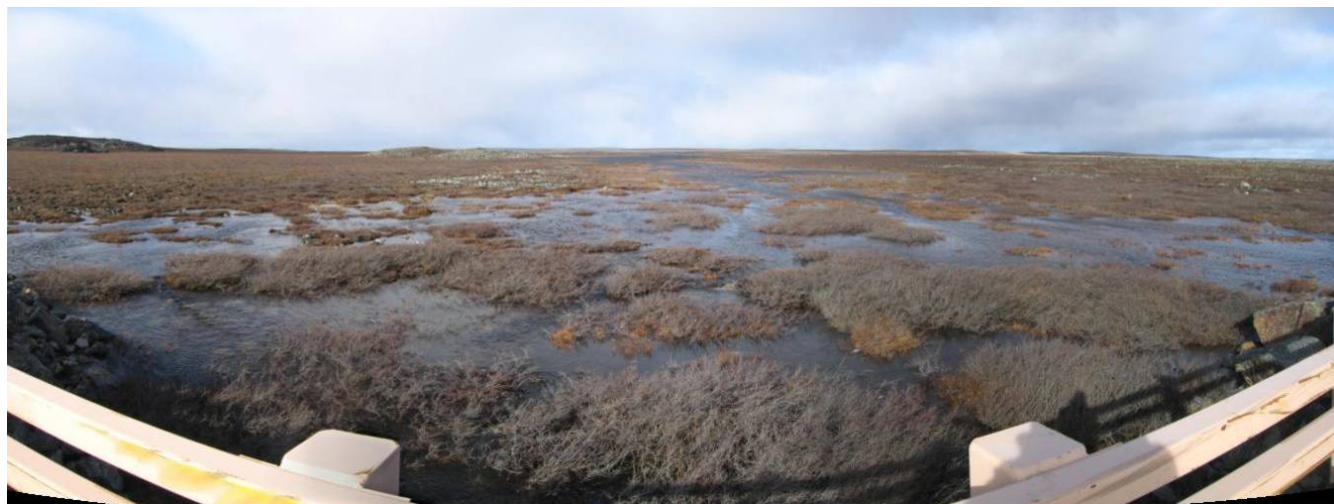
PHOTOGRAPH 39 – Bridge 7 - R16, km 73+800

Description: Upstream view from deck of Rapid Span Bridge. Broad valley, some flow through abutments and no sign of turbidity.

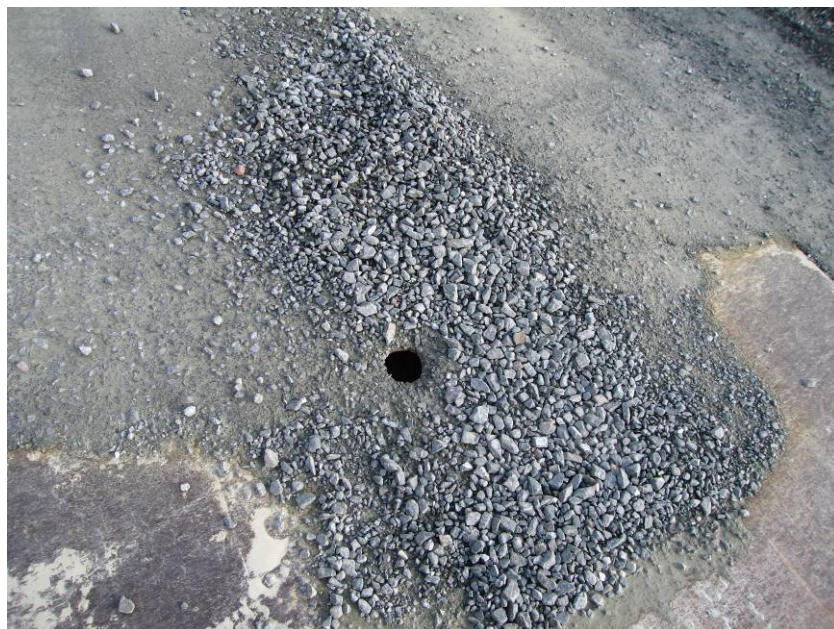
PHOTOGRAPH 41 – Bridge 7 - R16, km 73+800

Description: View of deck surface with hole.

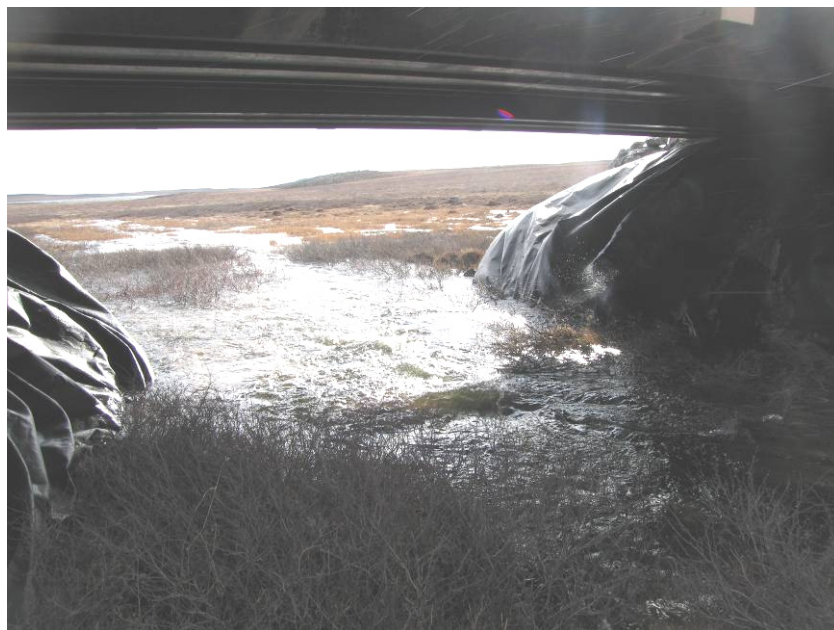
PHOTOGRAPH 42 – Bridge 7 - R16, km 73+800

Description: View beneath deck from upstream to downstream. Grass and cobbles in stream bed. Geotextile on abutments is damaged, some granular road bed falling below deck.

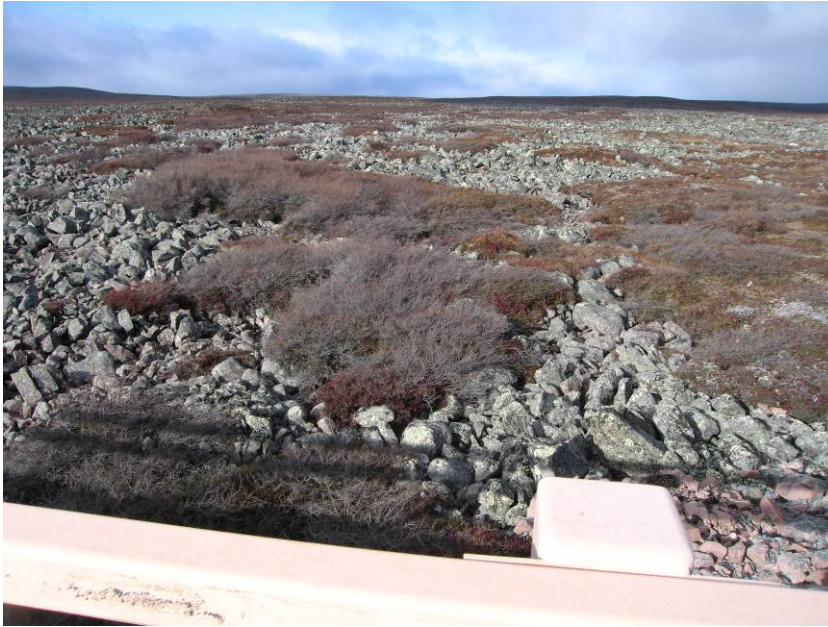
PHOTOGRAPH 45 – Bridge 8 - R18, km 79+500

Description: Upstream view from deck of bridge. Boulder field valley, boulder diameter typically about 0.5 m, and virtually no flow. Heavier vegetation of shrubs and moss observed.

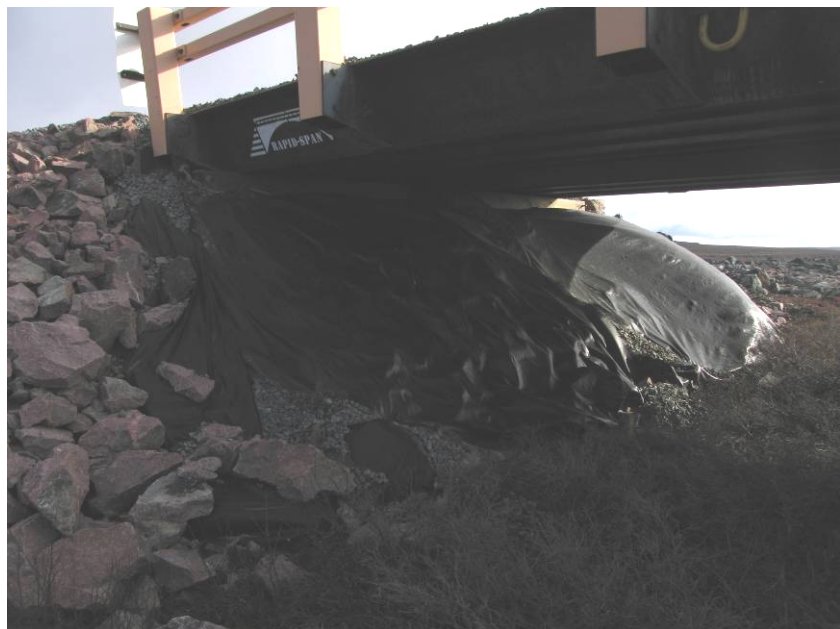
PHOTOGRAPH 47 – Bridge 8 - R18, km 79+500

Description: View of left abutment from upstream to downstream. Geotextile beneath abutment, small amount of road base observed to have fallen below the bridge deck.

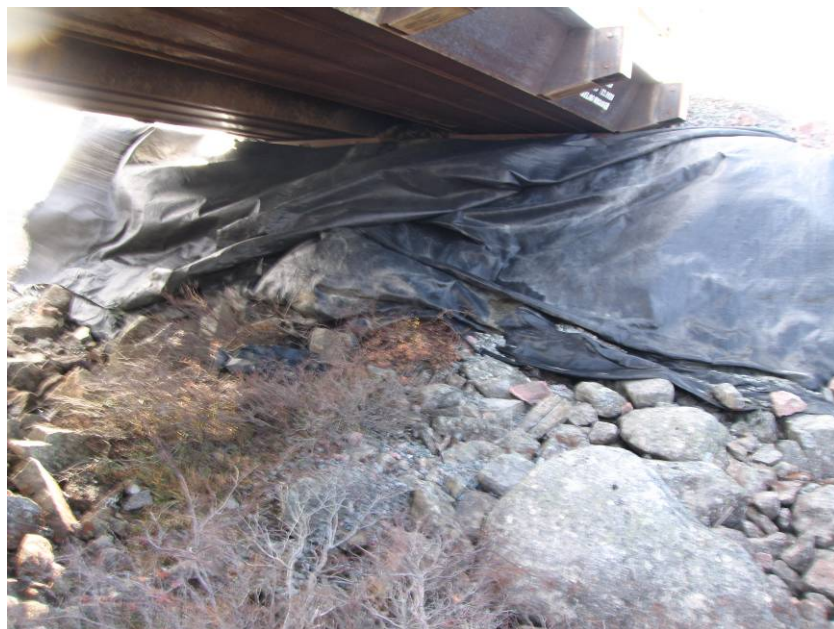
PHOTOGRAPH 49 – Bridge 8 - R18, km 79+500

Description: View of right abutment from upstream to downstream. Damaged geotextile beneath abutment, blowing in the wind.

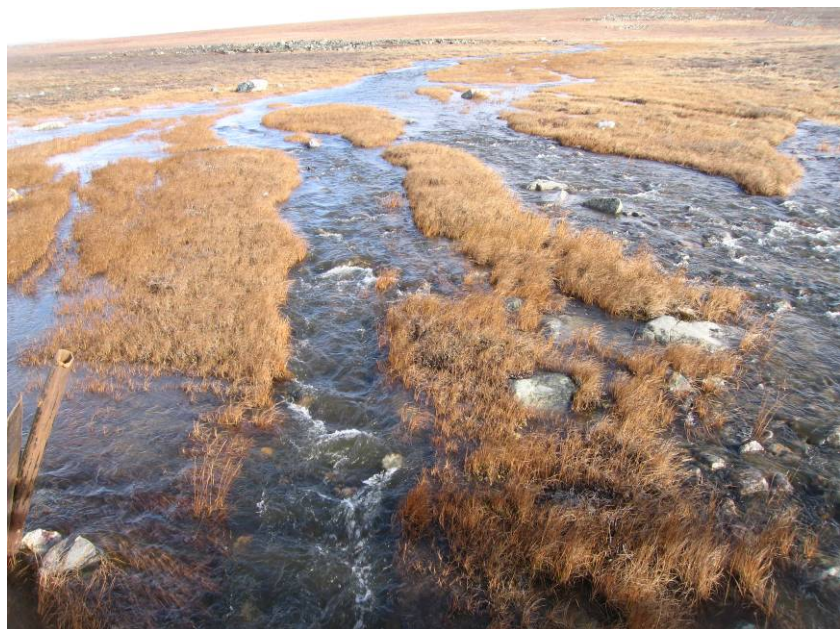
PHOTOGRAPH 51 – Bridge 9 - R19, km 83+100

Description: Upstream view from deck of Rapid Span Bridge, looking northeast.

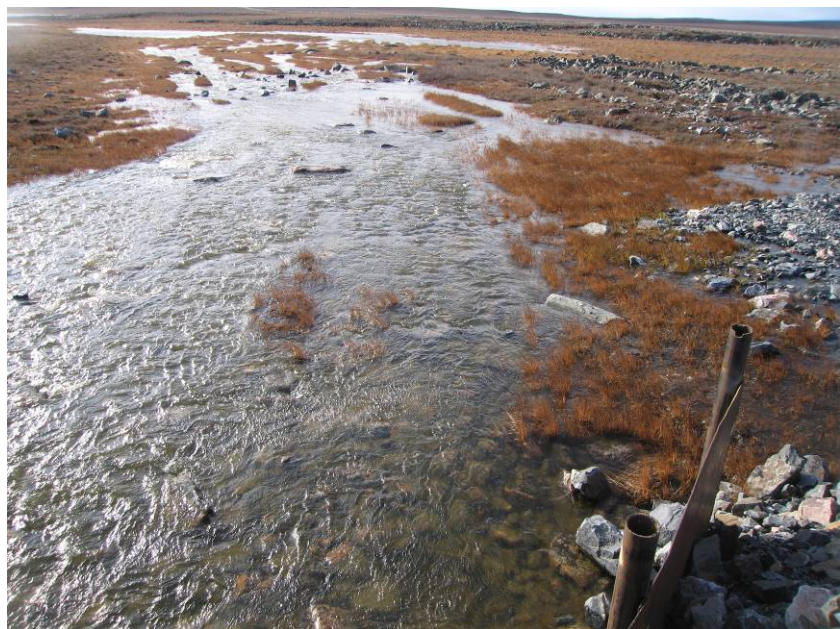
PHOTOGRAPH 53 – Bridge 9 - R19, km 83+100

Description: Downstream view from deck of Rapid Span Bridge, looking south.

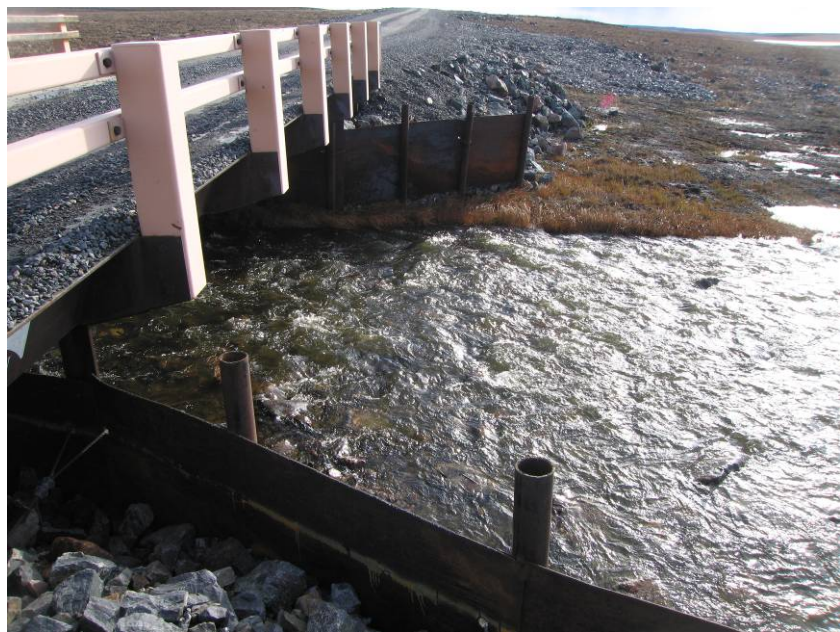
PHOTOGRAPH 54 – Bridge 9 - R19, km 83+100

Description: Downstream view of southeast abutment looking east. Sheet walls with steel pipes for anchors beneath bridge on both abutments observed.

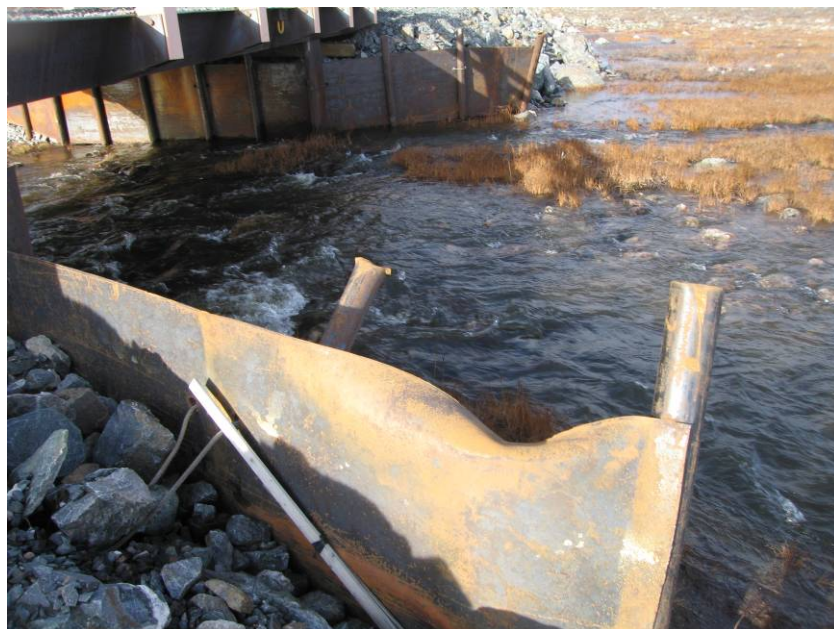
PHOTOGRAPH 55 – Bridge 9 - R19, km 83+100

Description: Upstream view from southeast abutment looking west. Steel pipes show some damage, bent.

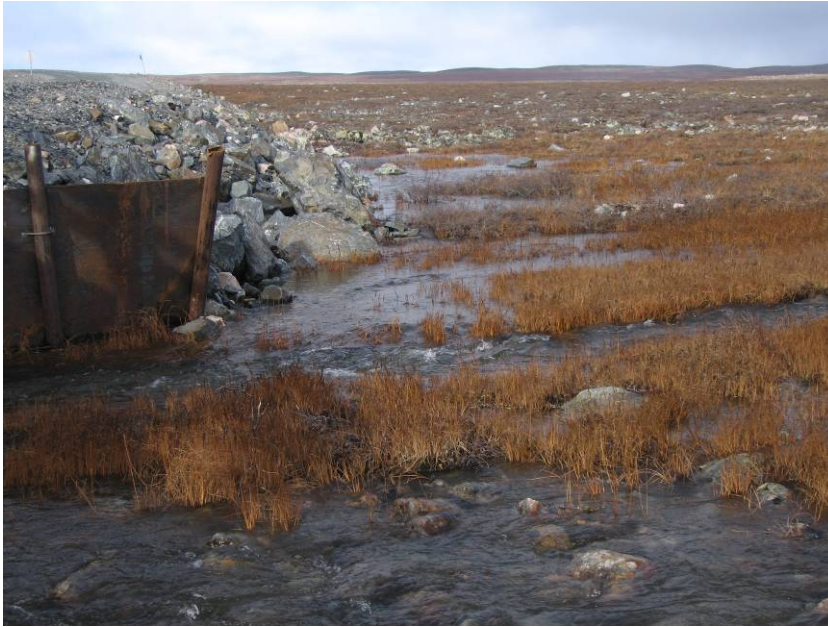
PHOTOGRAPH 59 – Bridge 9 - R19, km 83+100

Description: View of upstream side of northwest abutment. Flow passing through road.

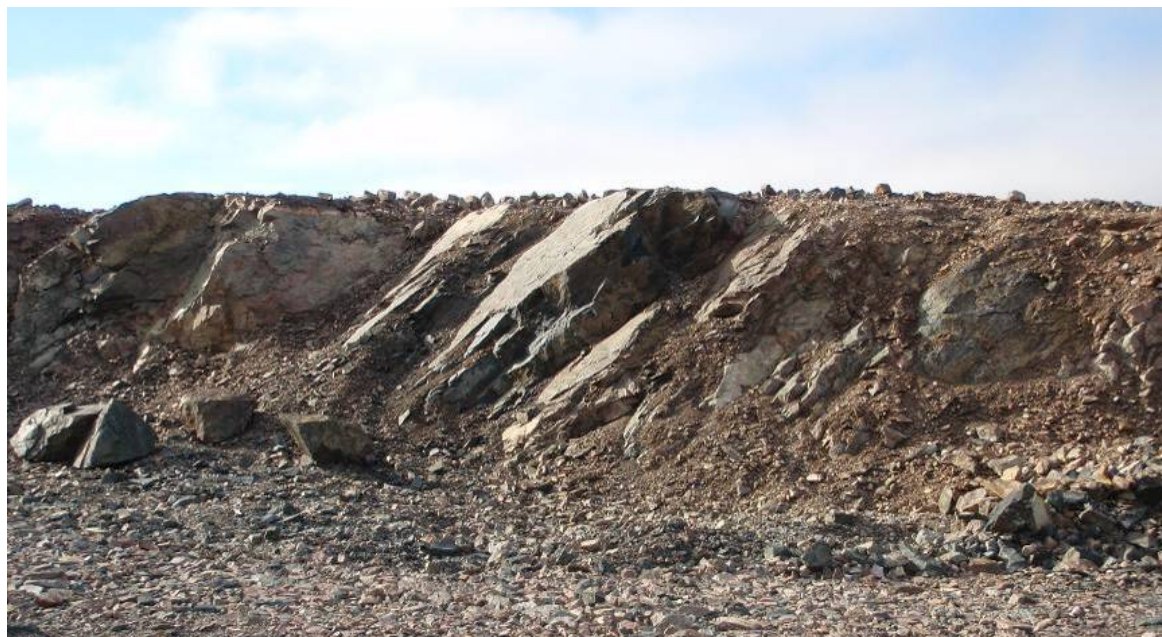
PHOTOGRAPH 1 – Quarry 1

Description: View of north wall of quarry, looking northwest. Walls about 6 to 7 m high.

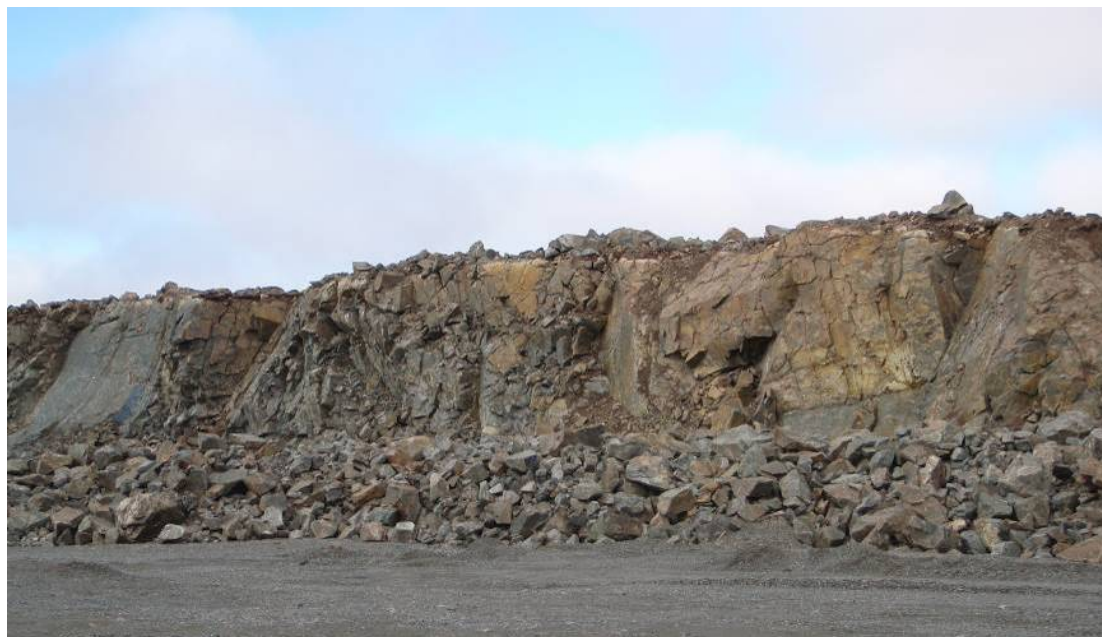
PHOTOGRAPH 3 – Quarry 2

Description: View of north wall, looking northwest. Pile of rocks, less than 1 m in diameter, typically.

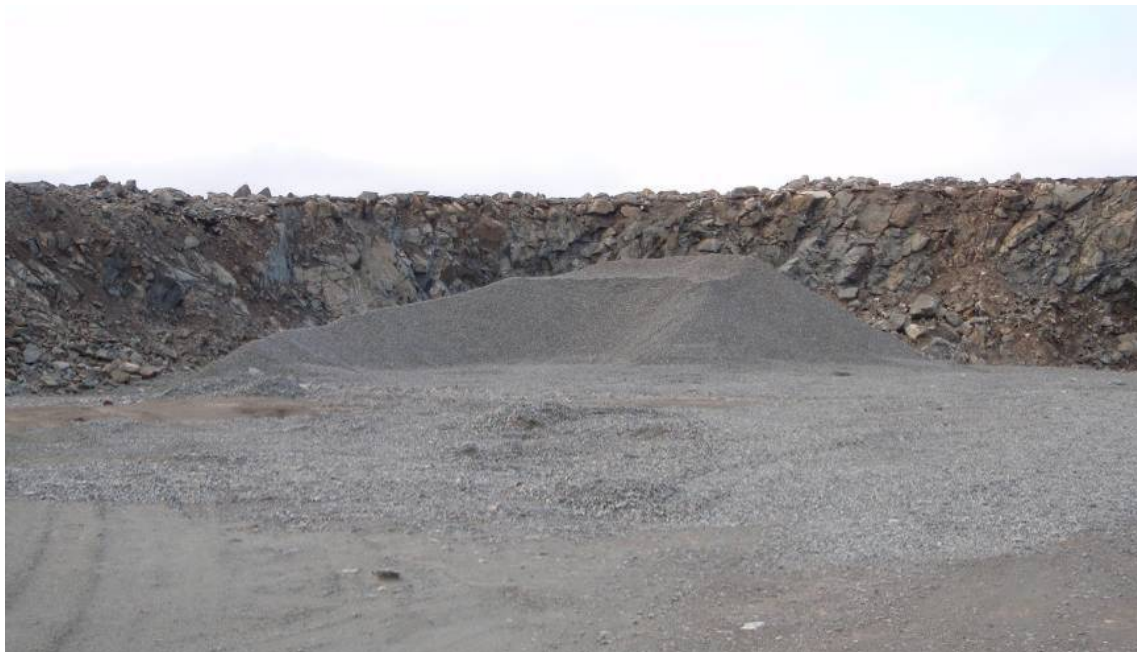
PHOTOGRAPH 5 – Quarry 2

Description: View of west wall and road base stockpile, looking southwest.

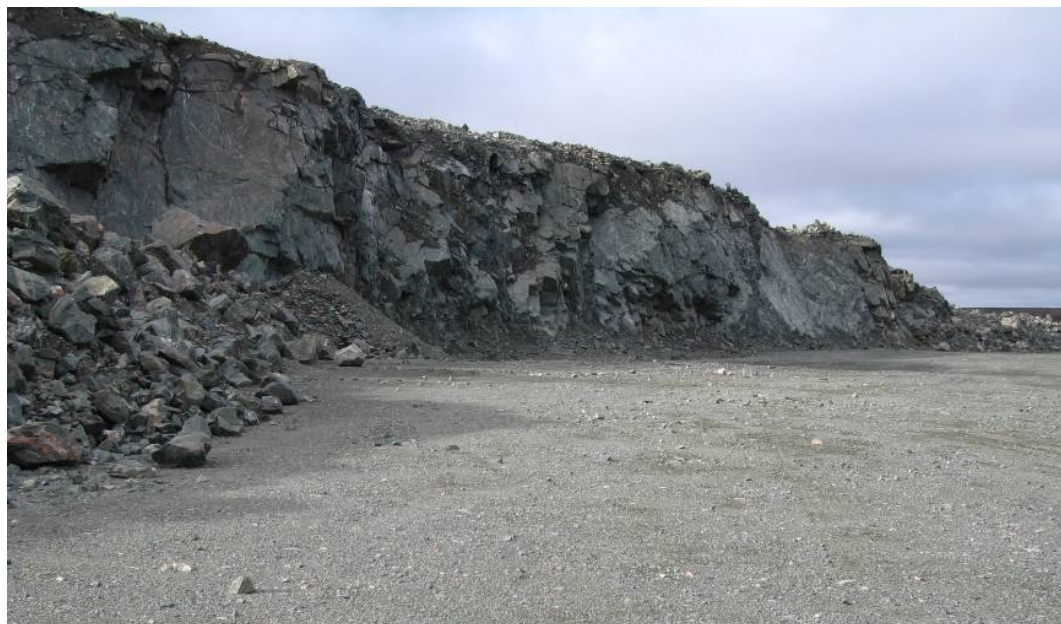
PHOTOGRAPH 7 – Quarry 3

Description: View of west wall. High cut wall, jointed and fractured, ravelling.

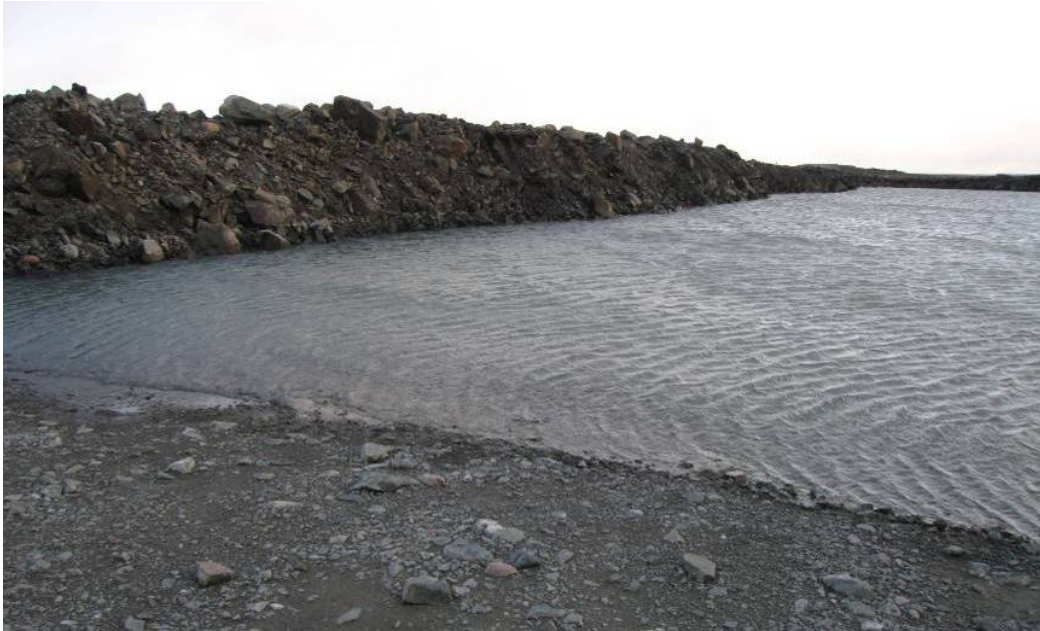
PHOTOGRAPH 11 – Quarry 4

Description: View of east and south side of the quarry. Quarry is flooded.

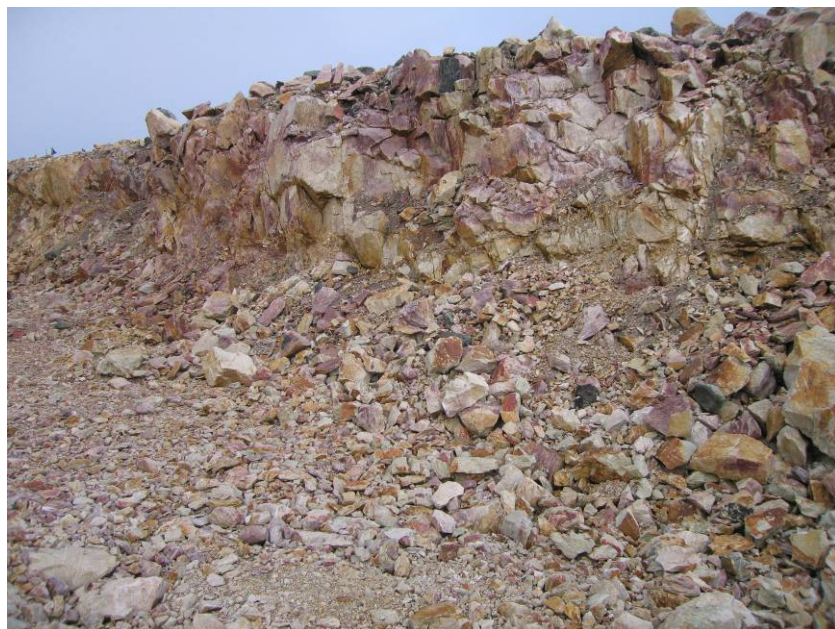
PHOTOGRAPH 13 – Quarry 5

Description: View of east wall, looking southeast. Near vertical wall about 8 m high, some ravelling.

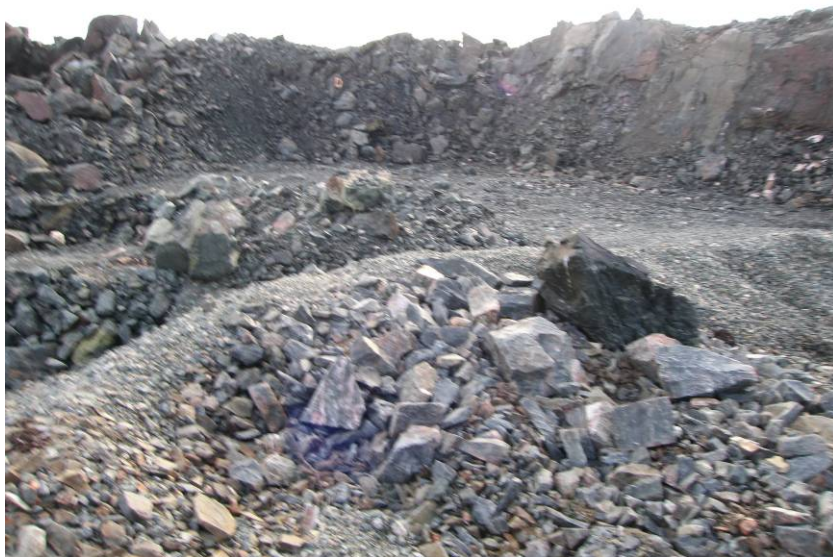
PHOTOGRAPH 17 – Quarry 6

Description: View of southwest wall. Drums of material noted in 2008 inspection have been removed. Center of quarry temporarily contains piles of contaminated soil.

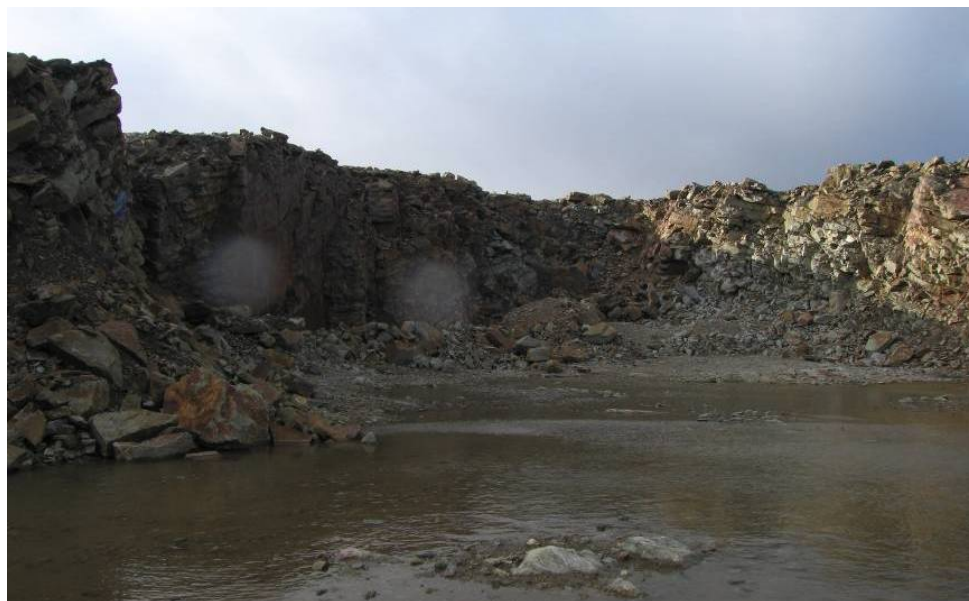
PHOTOGRAPH 199 – Quarry 7

Description: View of west wall. Near vertical wall, about 10 m high, majority fractured and jointed, block size pieces (0.2 to 0.5 m) and smaller ravelling. Some ponded water, less than 20 cm deep.

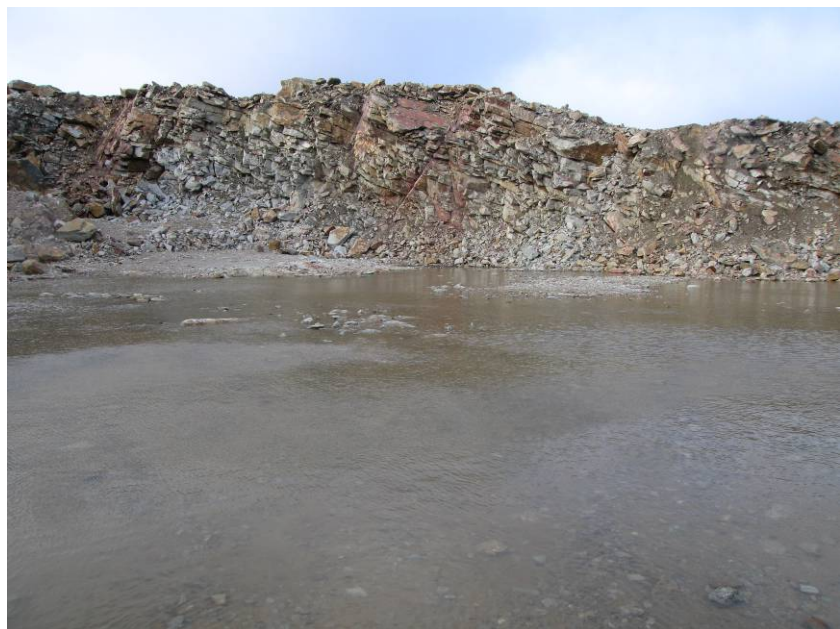
PHOTOGRAPH 21 – Quarry 7

Description: View of north wall, looking northwest. Some ponded water, about 20 cm deep.

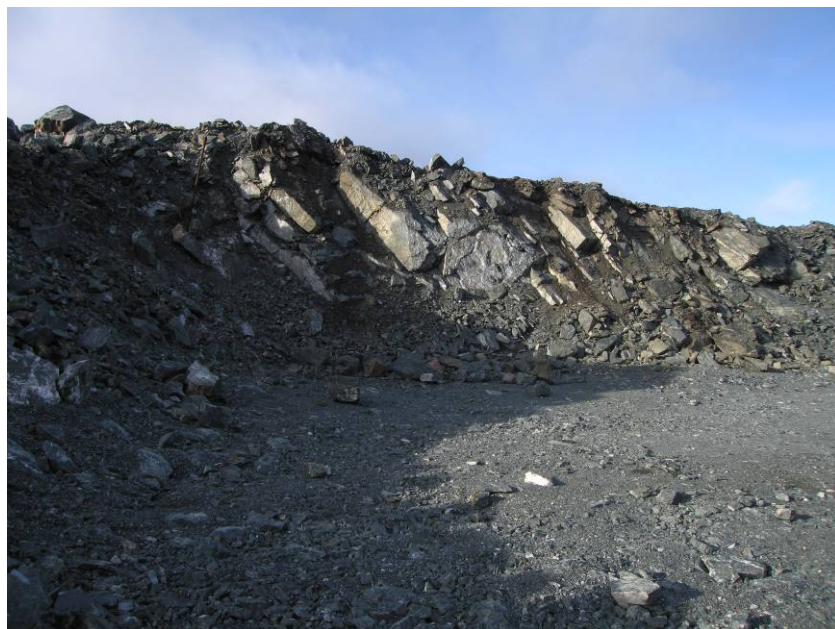
PHOTOGRAPH 23 – Quarry 8

Description: View of north wall, looking northwest. Wall about 8 to 10 m high, lightly fractured and jointed, raveling prevalent.

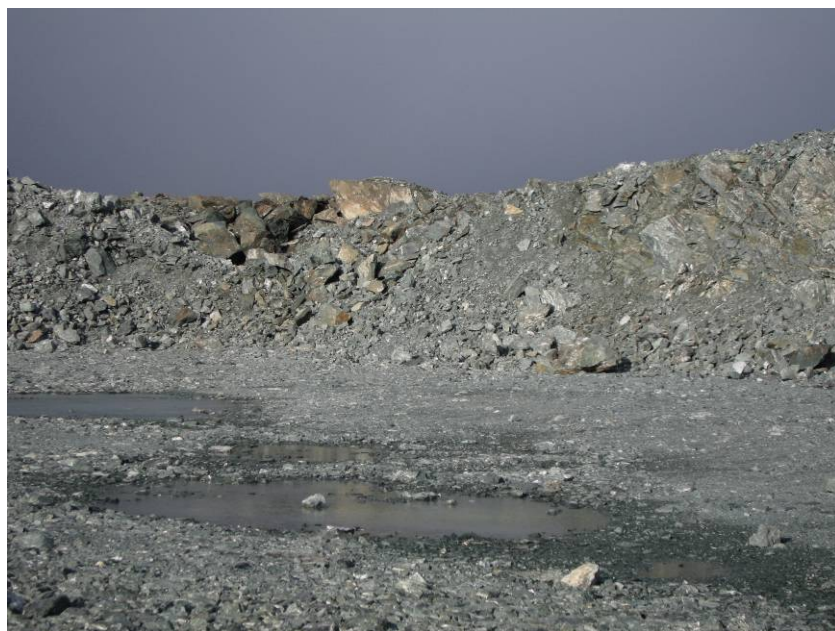
PHOTOGRAPH 26 – Quarry 9

Description: View of northeast wall of quarry, looking north. Wall 4 to 8 m high, highly fractured, raveling, some large blocks have fallen. Higher slopes are about 75°.

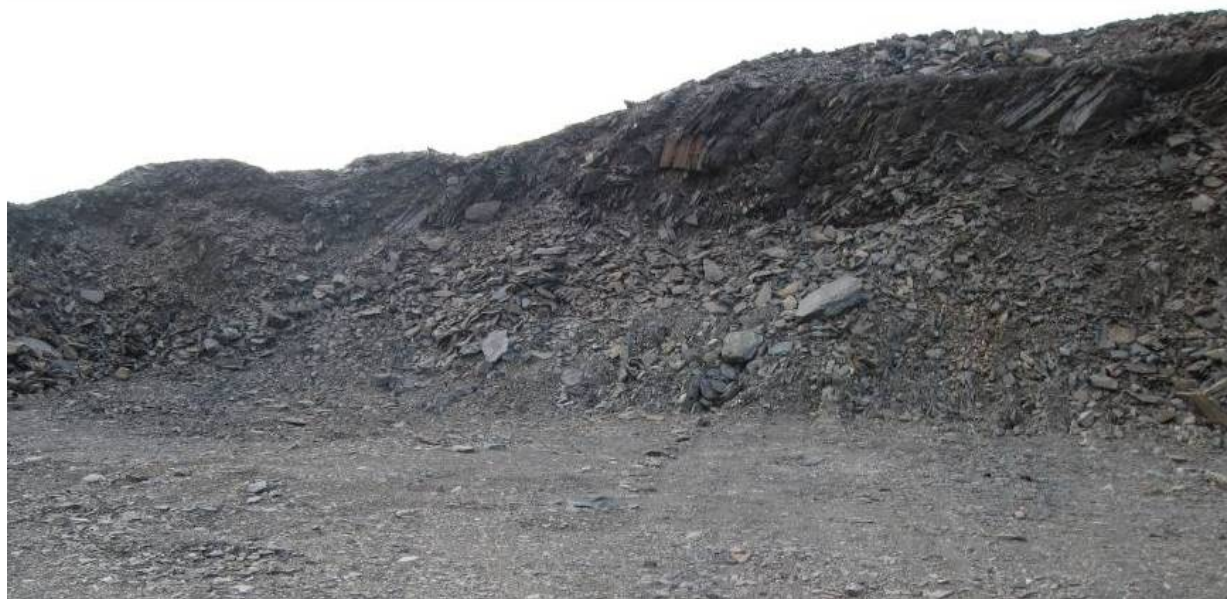
PHOTOGRAPH 30 – Quarry 10

Description: View of south wall. Wall highly fractured and ravelling.

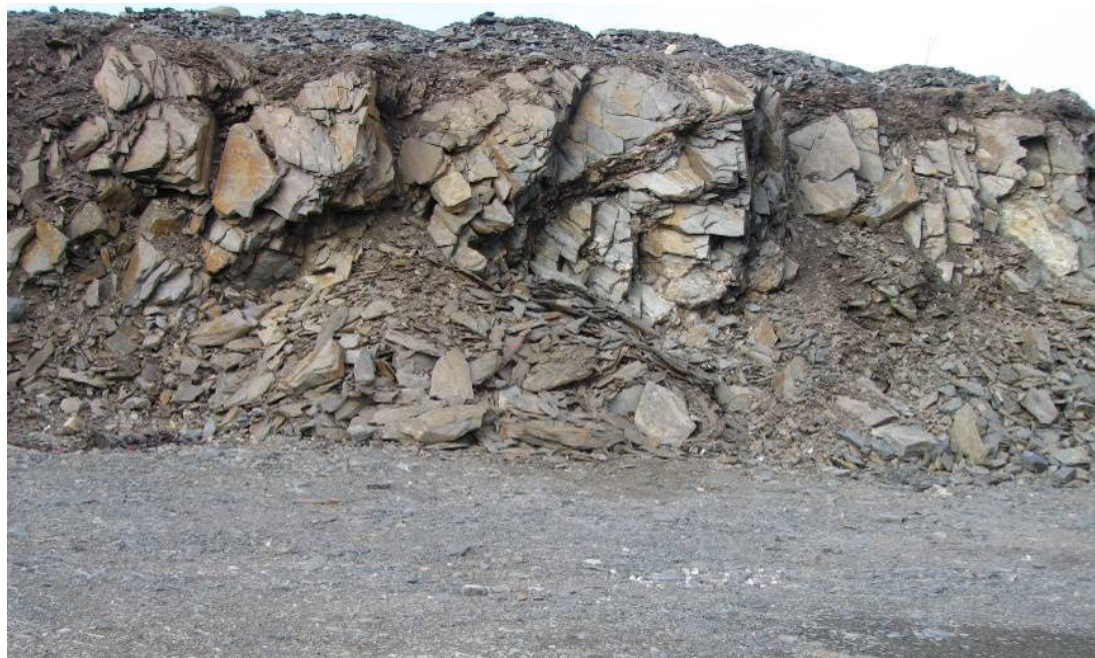
PHOTOGRAPH 31 – Quarry 10

Description: View of west wall. Wall highly fractured and ravelling.

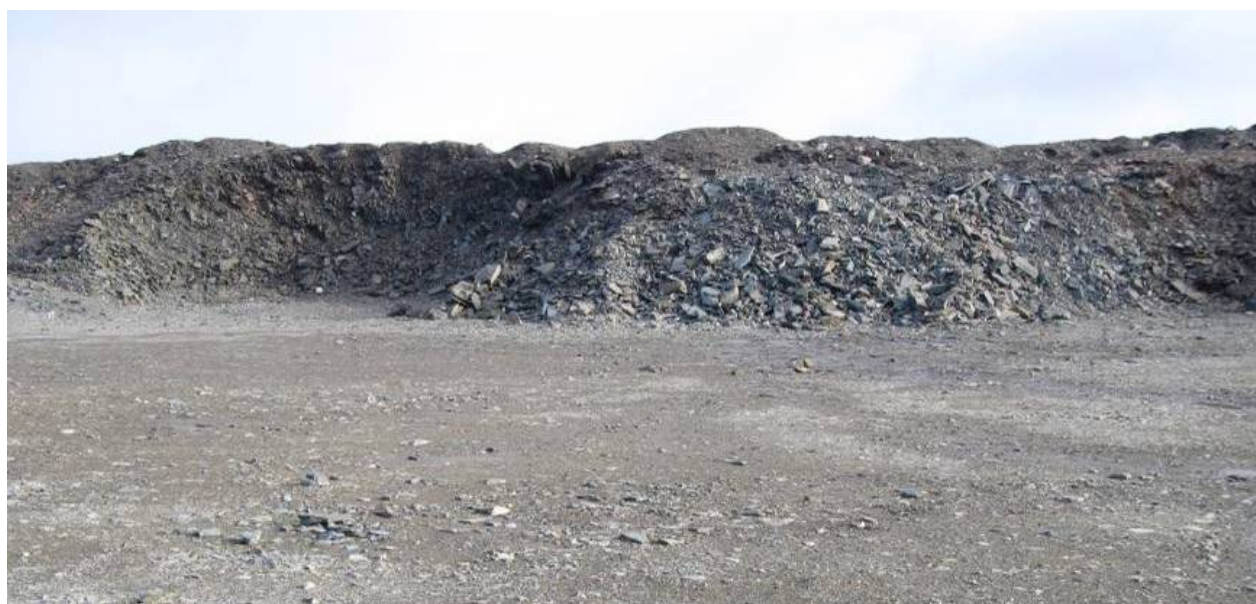
PHOTOGRAPH 34 – Quarry 10

Description: View of east wall. Wall highly fractured, ravelling, slope angle about 60°.

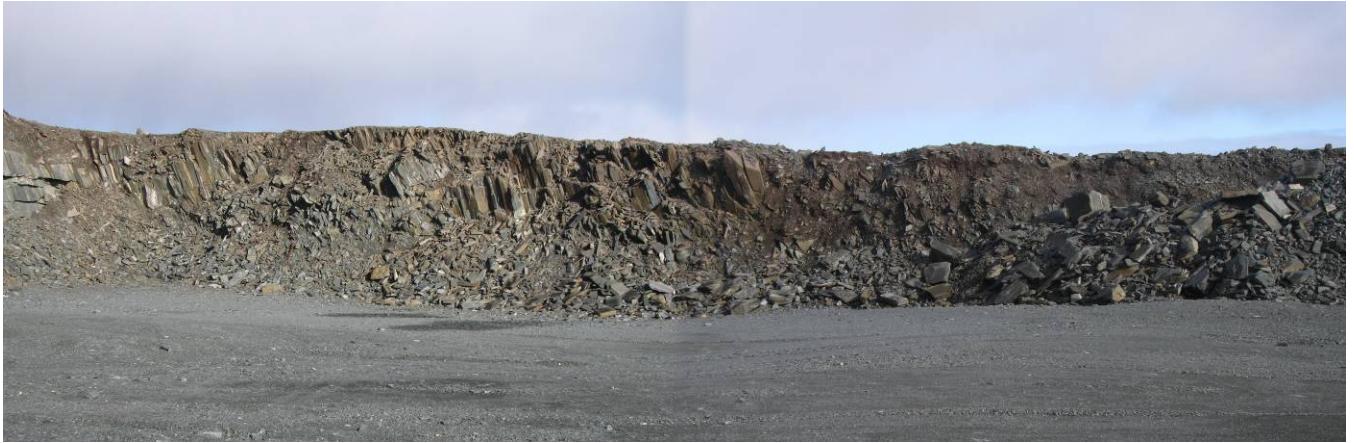
PHOTOGRAPH 35 – Quarry 11

Description: View of southern portion of the eastern wall. Stockpile of rock and crush in front of quarry wall. Vertical wall highly fractured, thin planar surfaces, ravelling.

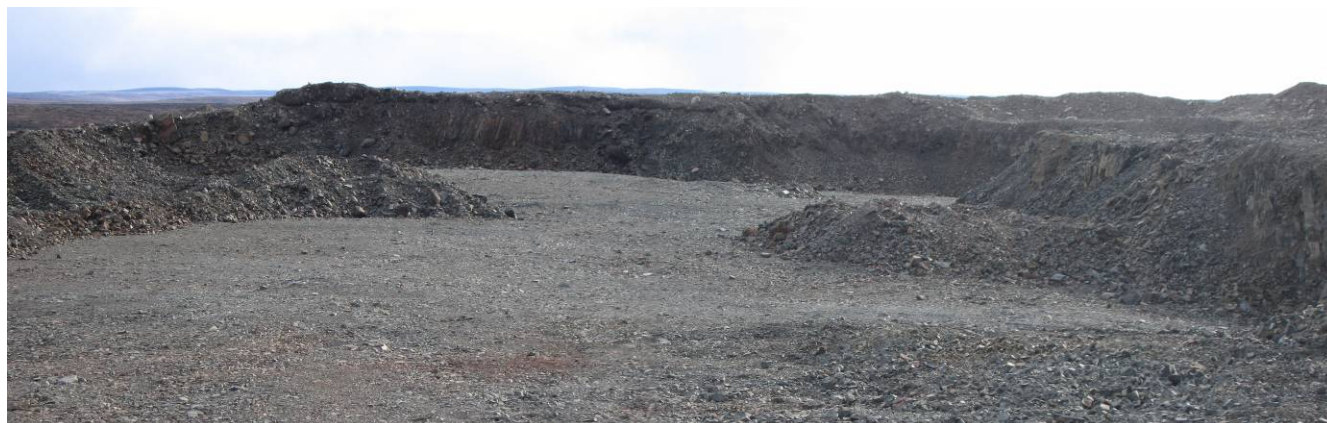
PHOTOGRAPH 39 – Quarry 12

Description: General view, looking southwest. Walls about 8 m high, highly jointed, ravelling.

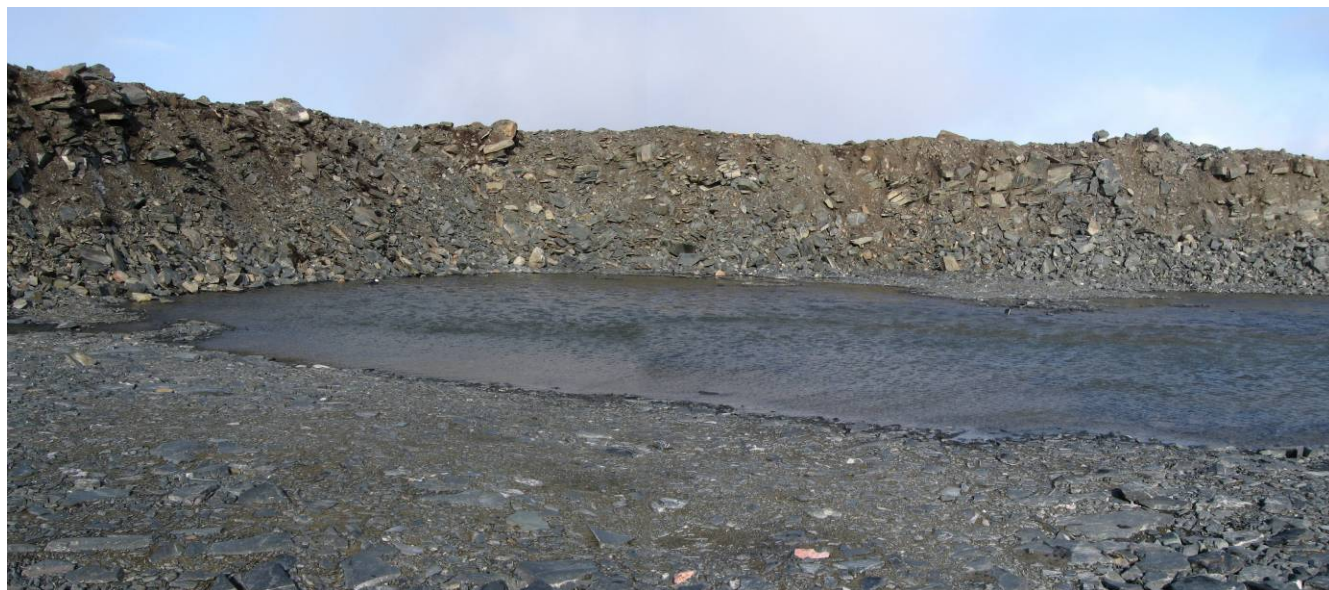
PHOTOGRAPH 42 – Quarry 13

Description: View of the northwest side of the quarry. Ravelling, about 60° slopes, and about 5 m high. Ponded water less than 0.3 m deep.

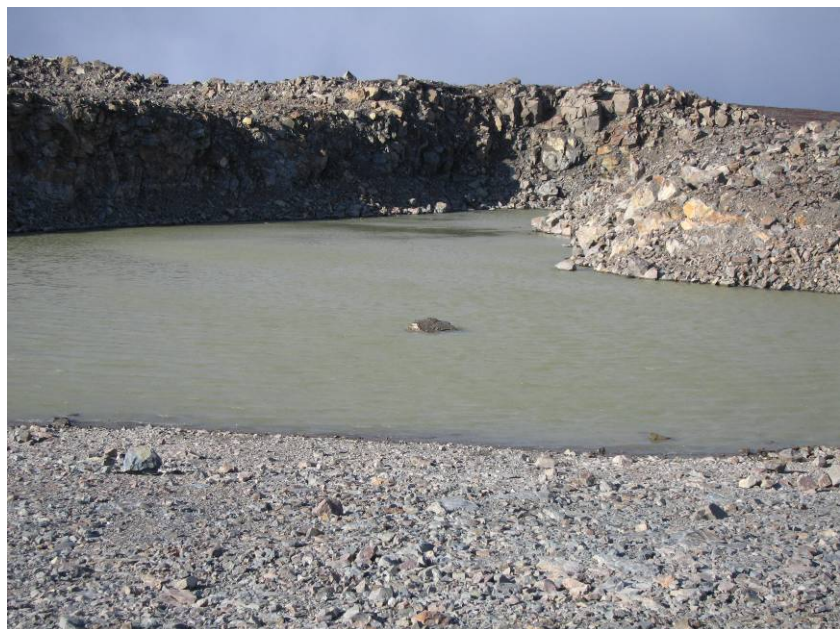
PHOTOGRAPH 48 – Quarry 14

Description: View looking northwest. Mostly vertical wall, less ravelling. Quarry is flooded.

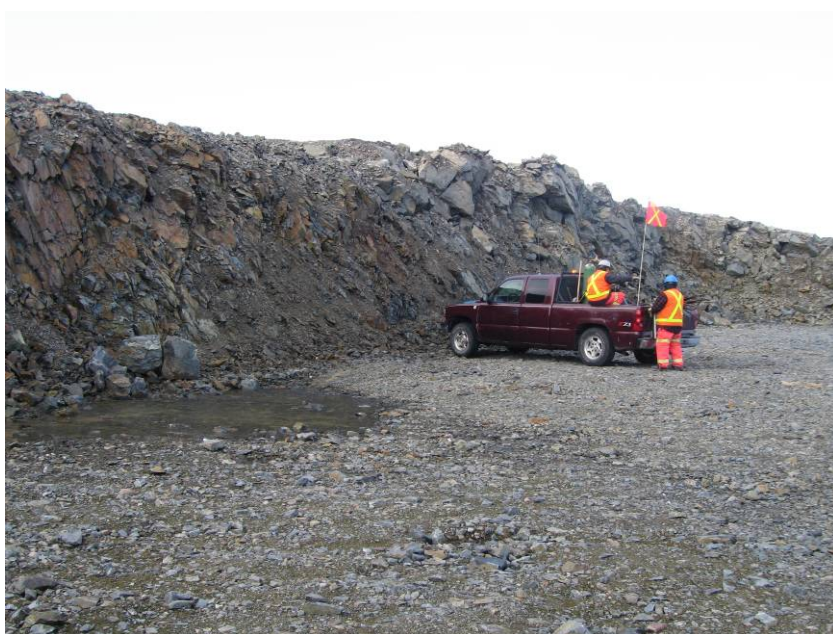
PHOTOGRAPH 50 – Quarry 15

Description: Looking southwest. Vertical wall 4 to 6 m high.
