2009 Annual Geotechnical Inspection, Meadowbank Gold Project, Nunavut

2009 Annual Geotechnical Inspection - Meadowbank Gold Project, Nunavut

Agnico-Eagle Mines Limited
Meadowbank Division
P.O. Box 540
Baker Lake, Nunavut
X0C 0A0

Project Number: 09-1428-0018
Doc. No. 969 Ver. 0

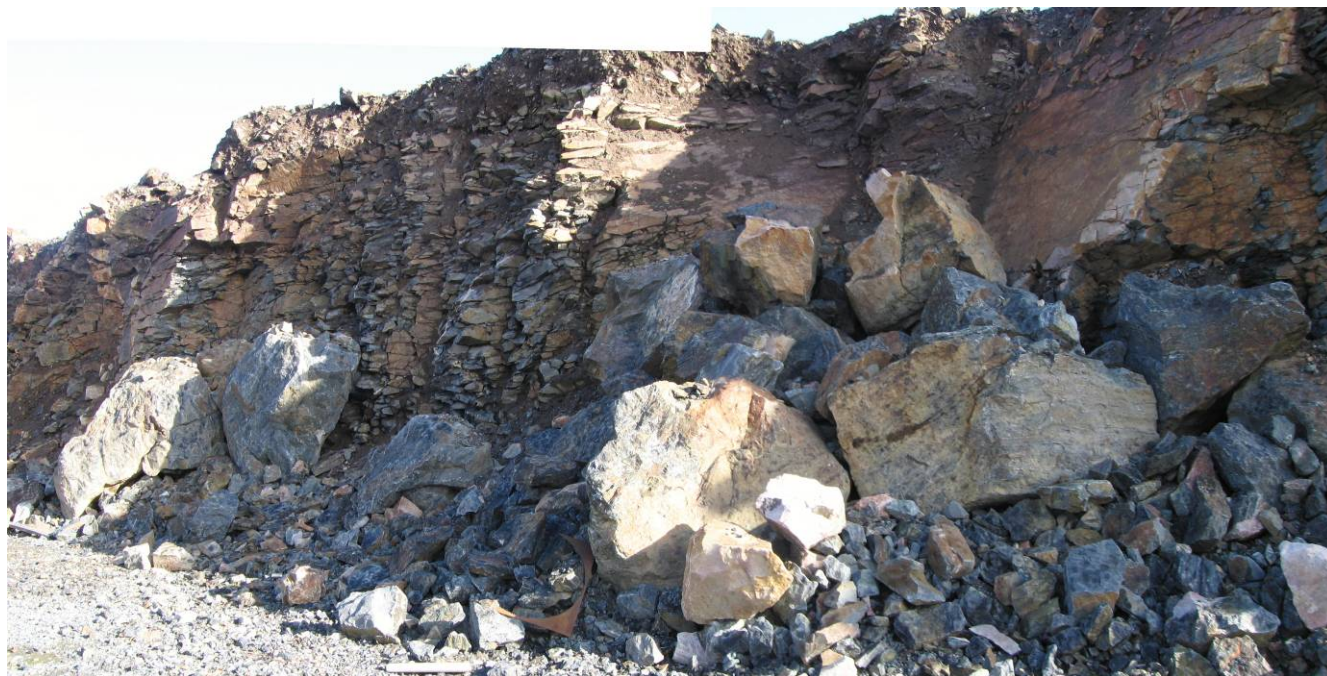
PHOTOGRAPH 53 – Quarry 16

Description: North view, with slide of large blocks. Vertical wall about 8 to 10 m high.

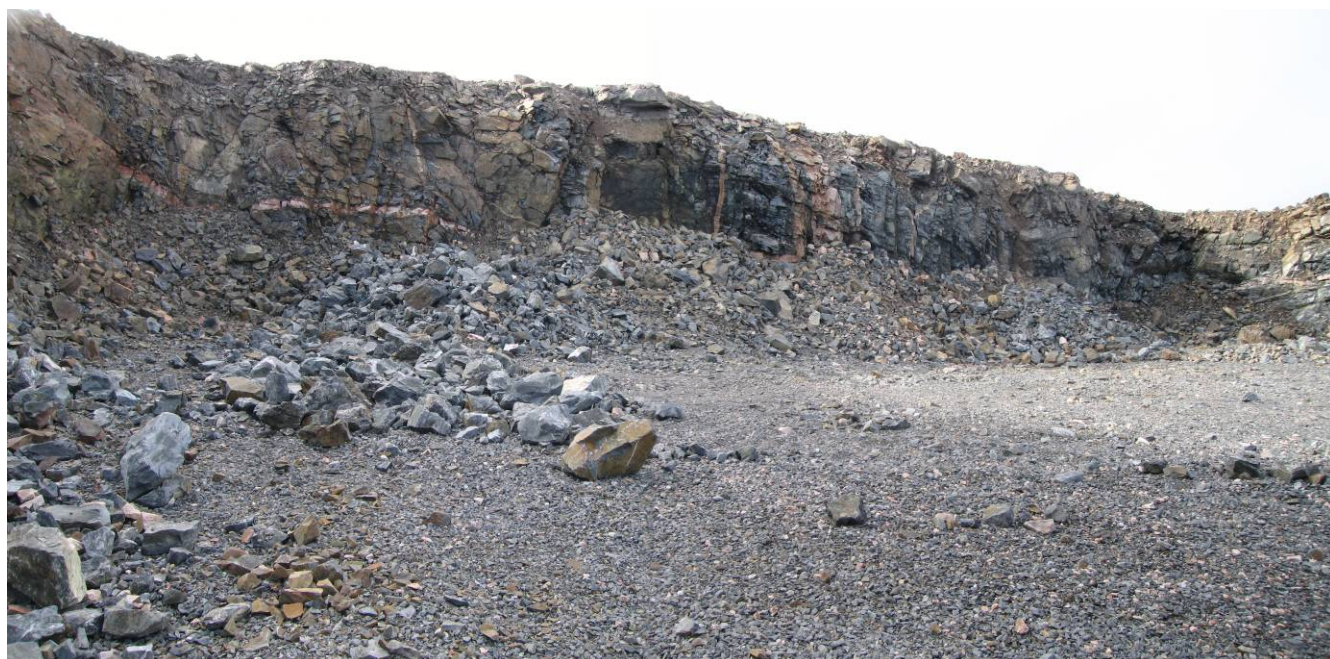
PHOTOGRAPH 55 – Quarry 16

Description: Looking south.

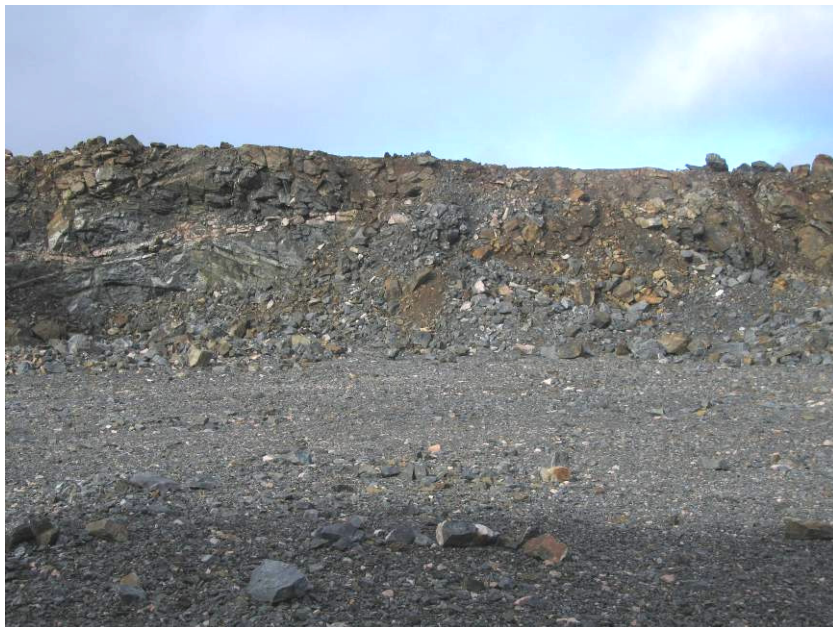
PHOTOGRAPH 56 – Quarry 16

Description: Looking north. Vertical wall about 8 to 10 m high, ravelling of small blocks.

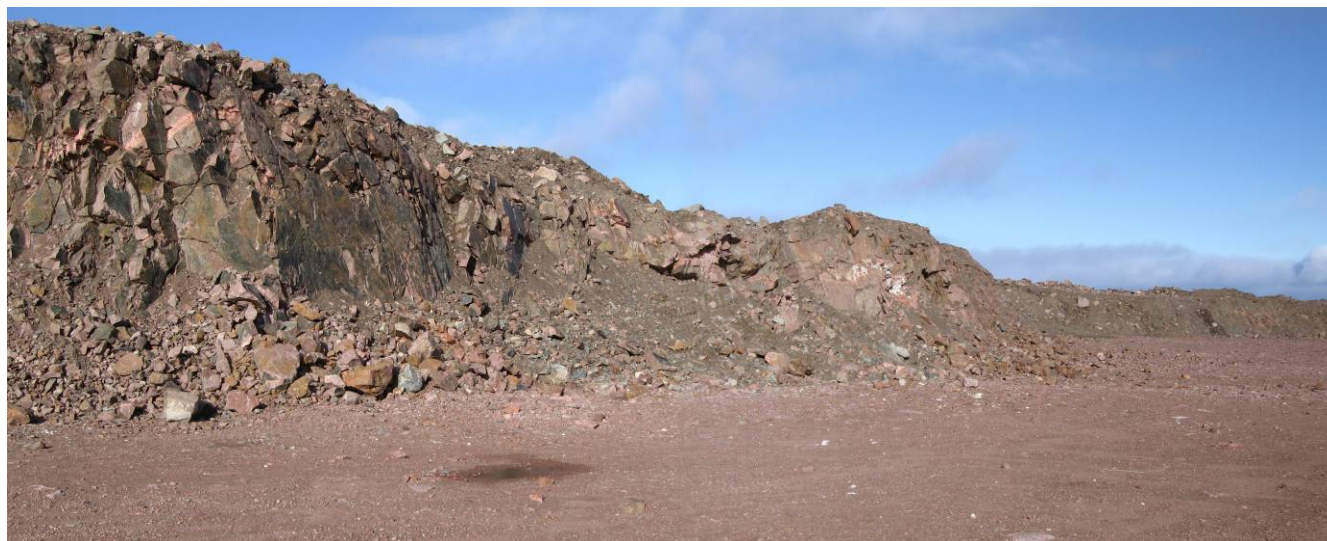
PHOTOGRAPH 58 – Quarry 17

Description: Looking northwest. Vertical wall 4 to 6 m high.

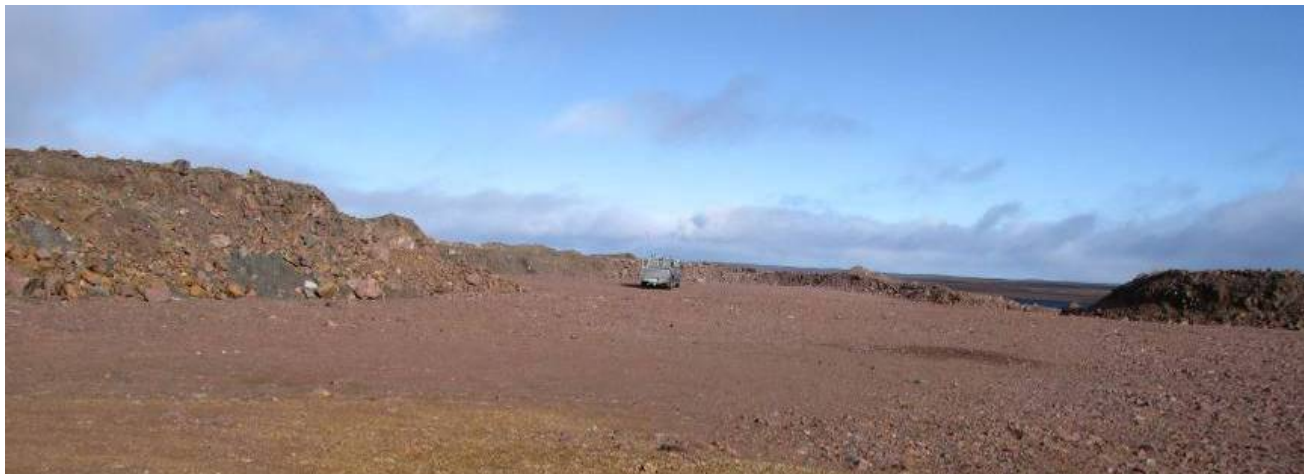
PHOTOGRAPH 60 – Quarry 17

Description: General view of quarry, looking north.

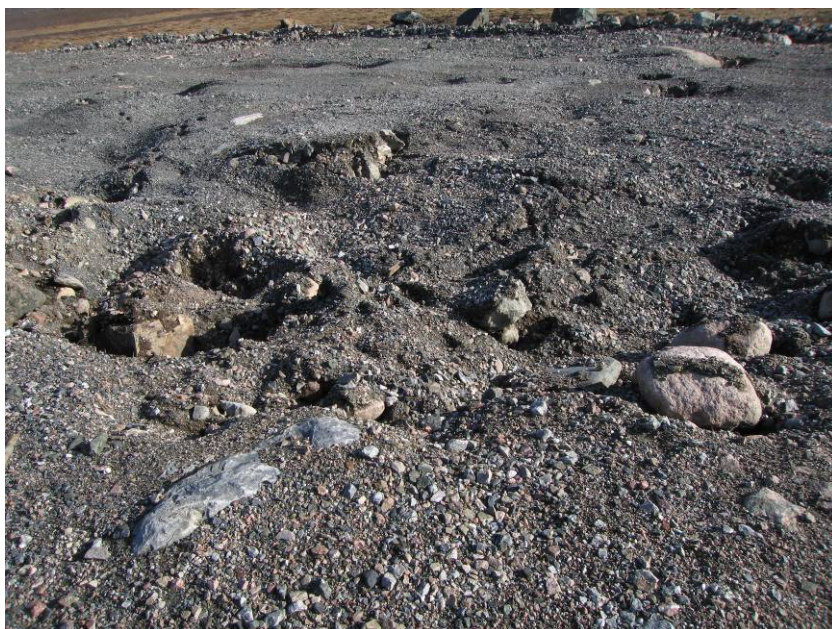
PHOTOGRAPH 612 – Quarry 18

Description: View of frost heave and thaw settlement at entrance of quarry.

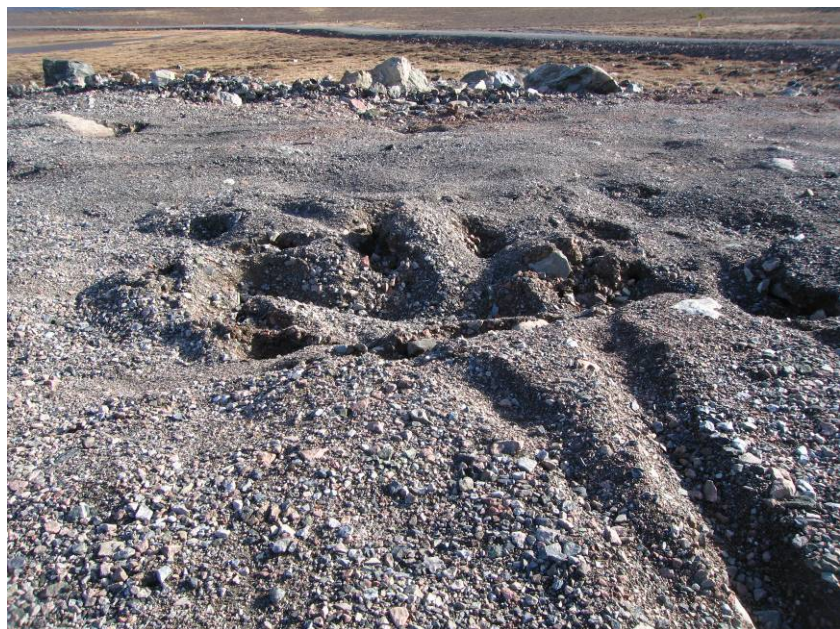
PHOTOGRAPH 62 – Quarry 18

Description: View of frost heave and thaw settlement at entrance of quarry, looking northeast.

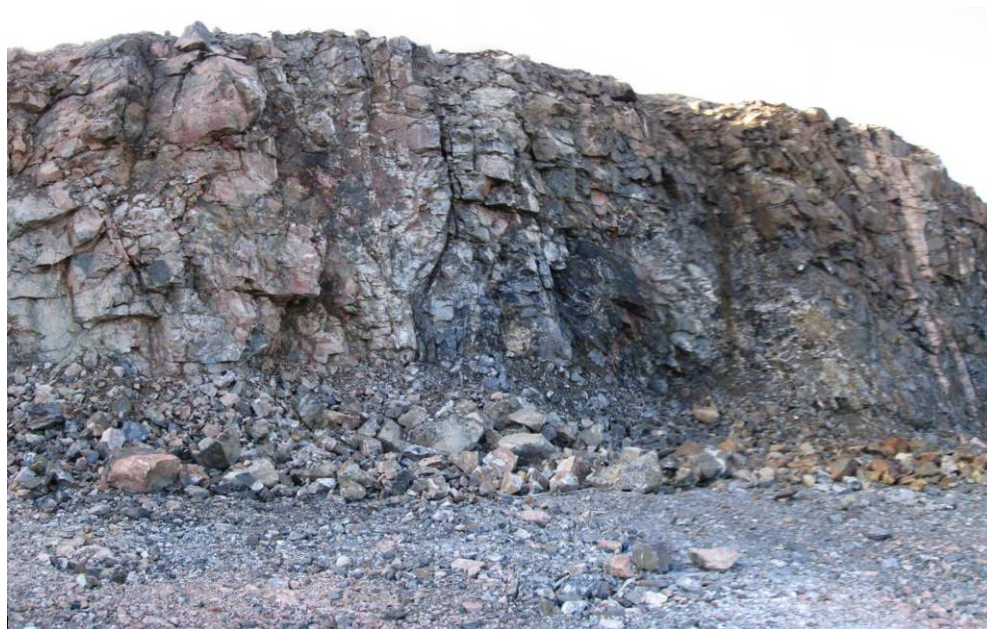
PHOTOGRAPH 64 – Quarry 18

Description: Panoramic view of central area of quarry, looking south. Vertical wall 10 to 12 m high. Some ravelling and blocking, larger unstable blocks near crest (top left corner of photograph).

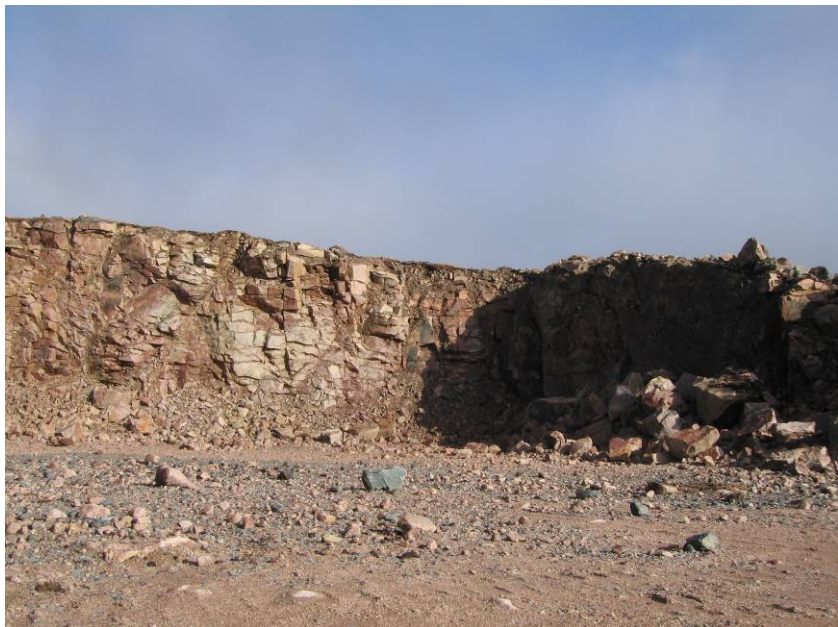
PHOTOGRAPH 66 – Quarry 19

Description: Looking north. Vertical wall, some ravelling of small blocks.

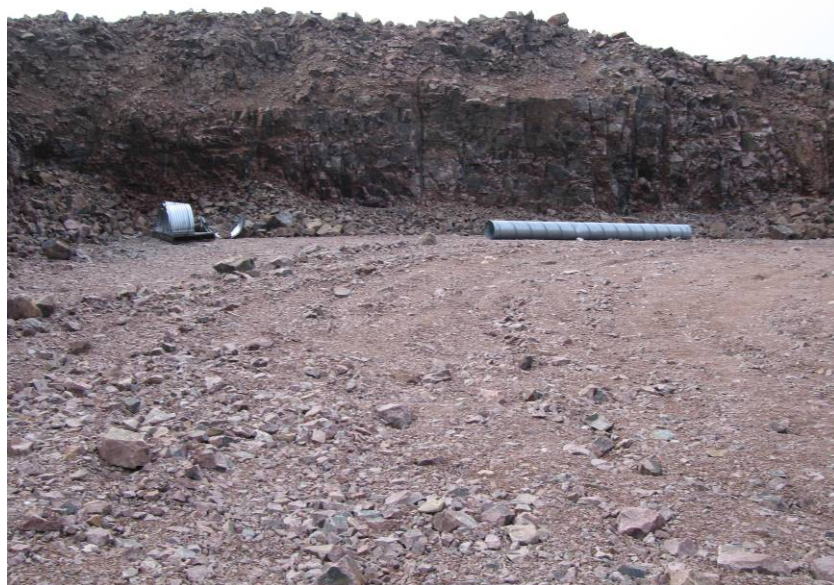
PHOTOGRAPH 70 – Quarry 21

Description: Looking south. Vertical walls 6 to 8 m high decreasing towards the AWPAP. Some ravelling of small blocks. Small inflow / seepage observed but no ponded water.

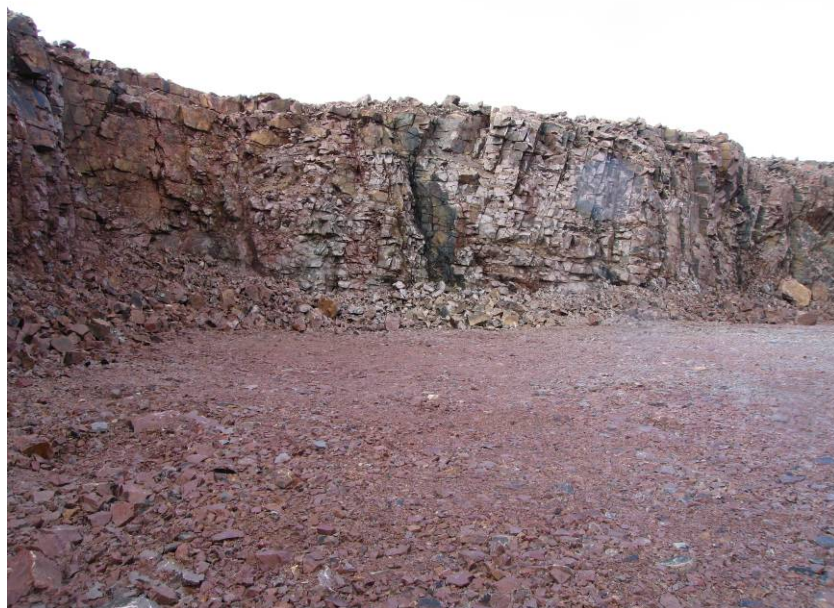
PHOTOGRAPH 723 – Quarry 21

Description: Looking south. Vertical walls 7 to 8 m high. Some ravelling of small blocks.

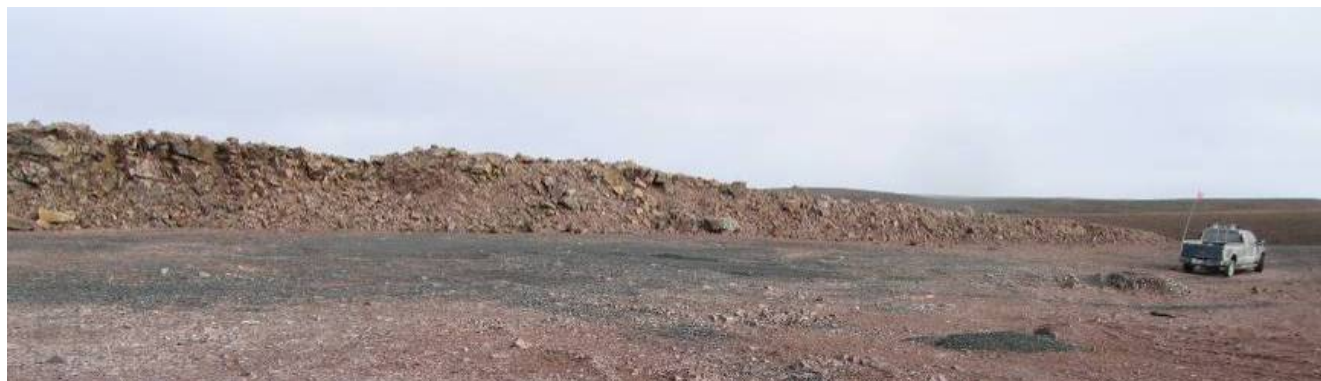
PHOTOGRAPH 74 – Quarry 21

Description: General view looking northeast. Wall sloped by natural processes, ravelling. Wall height decreases towards AWPAR.

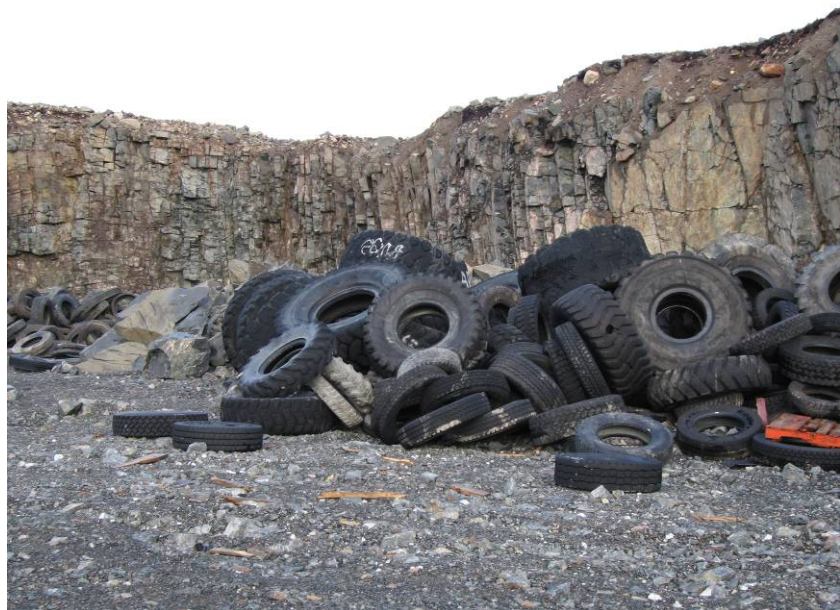
PHOTOGRAPH 76 – Quarry 22

Description: Pile of tires at right back corner of quarry. Vertical walls 8 to 10 m high.

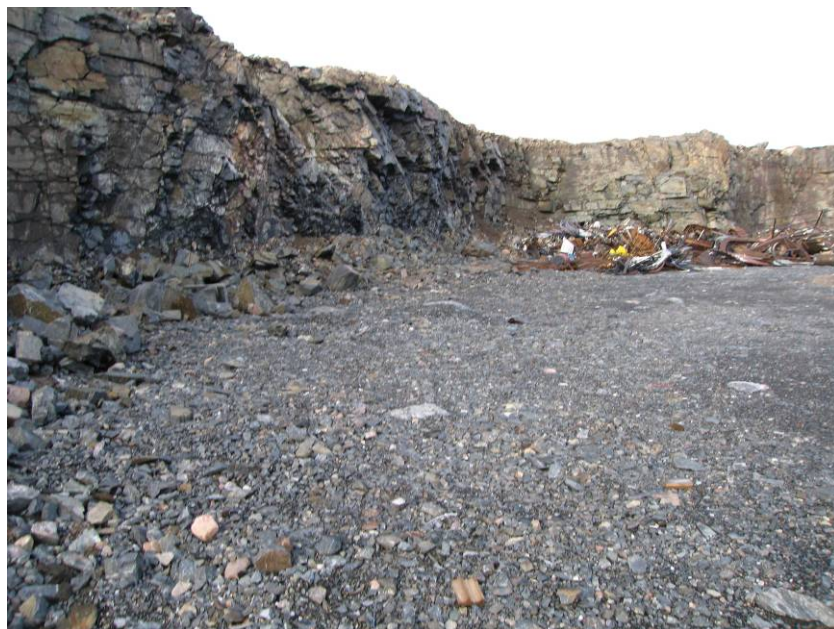
PHOTOGRAPH 78 – Quarry 22

Description: Miscellaneous refuse at left back corner of quarry, looking northwest.

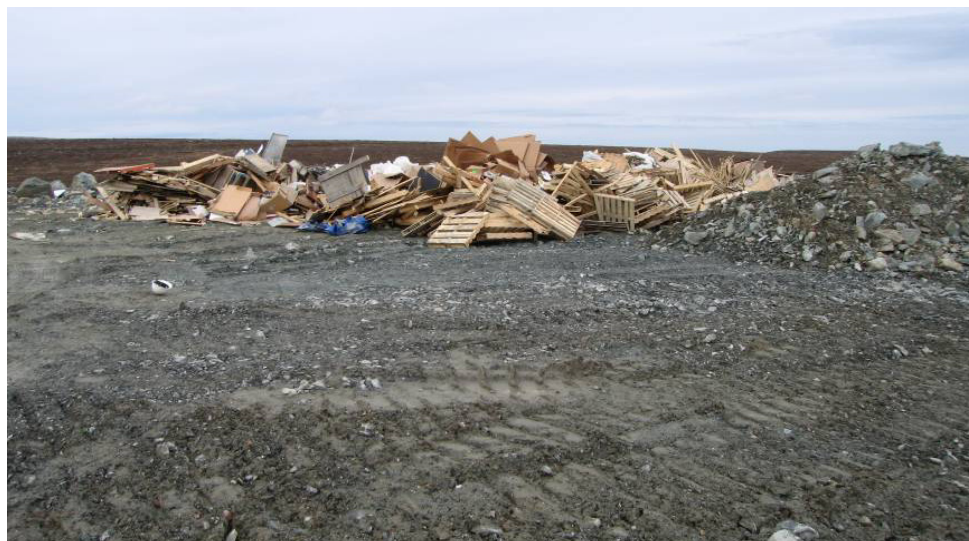
PHOTOGRAPH 1 – Landfill

Description: Looking north at waste in top of current cell.

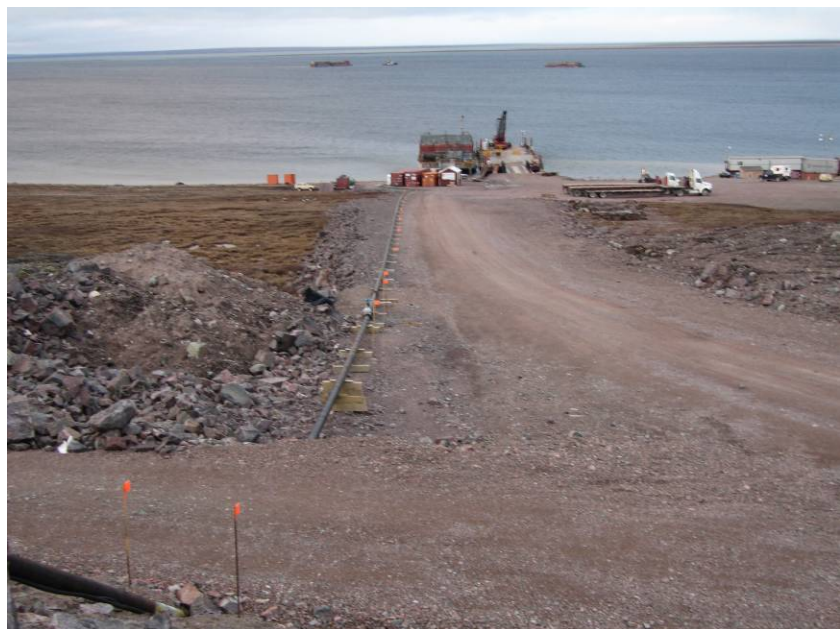
PHOTOGRAPH 1 – Baker Lake Tank Farm

Description: View of road and pipeline between the dock area and the tank farm, looking southwest.

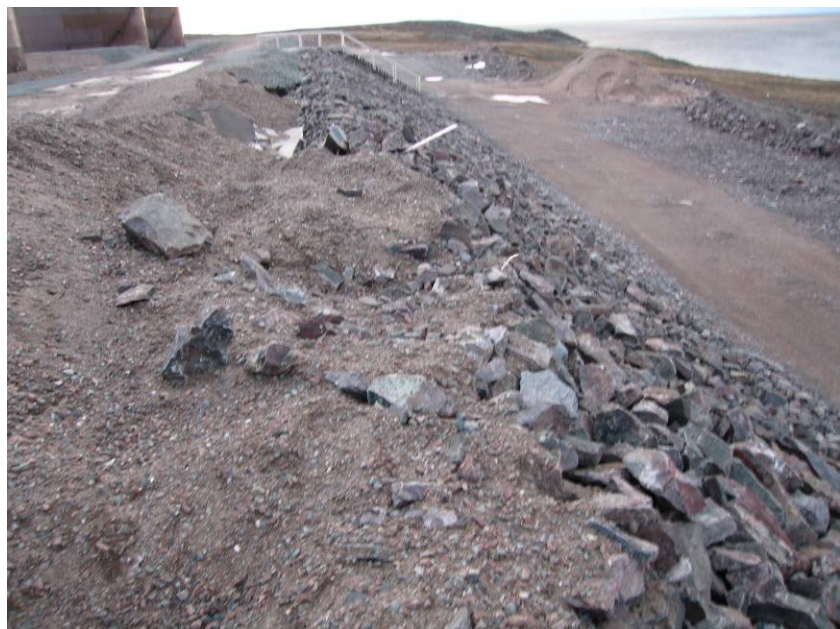
PHOTOGRAPH 3 – Baker Lake Tank Farm

Description: View of containment berm in front of Tank 1 and 2, looking southeast.

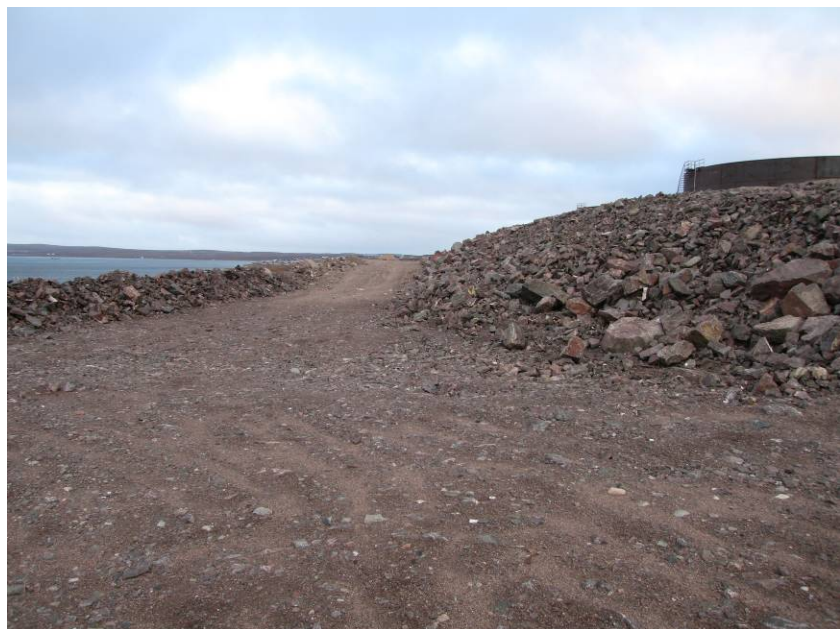
PHOTOGRAPH 5 – Baker Lake Tank Farm

Description: View of road and embankment of containment berm downstream of tanks, looking northwest.

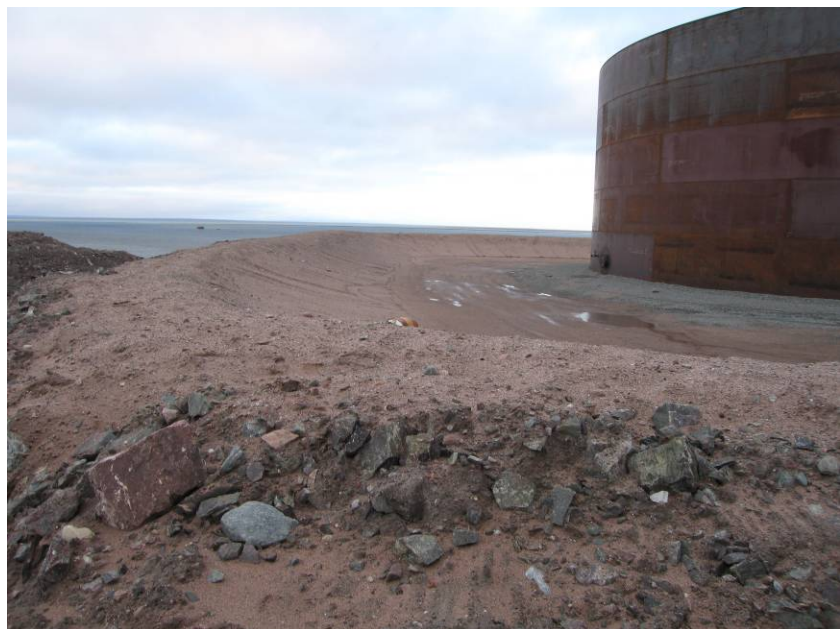
PHOTOGRAPH 7 – Baker Lake Tank Farm

Description: View of containment berm on the east side of Tank 4, looking southwest.

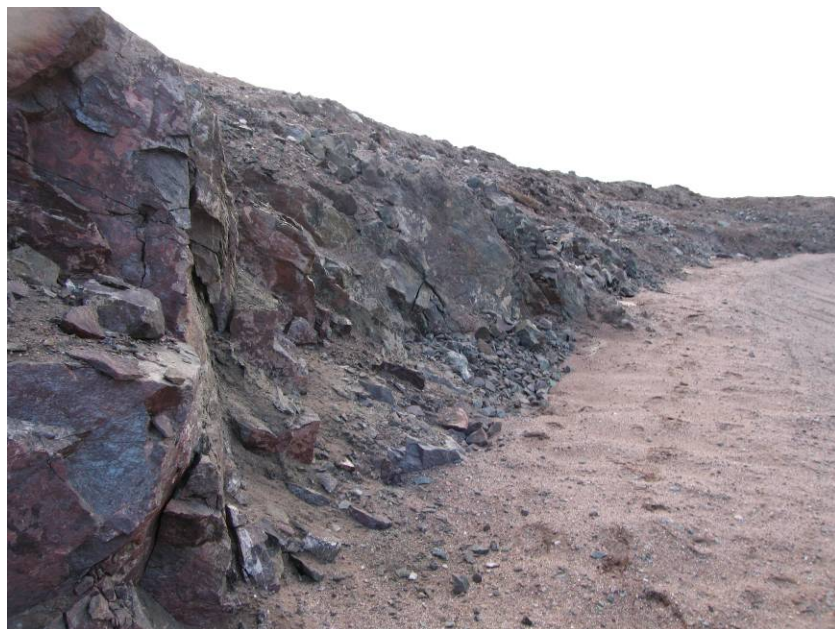
PHOTOGRAPH 5 – Baker Lake Tank Farm

Description: View of cut slope on the north side of Tank 4, looking northeast. Two benches used along northeast side, upper one is mainly soil, lower bench consists of more competent rock.

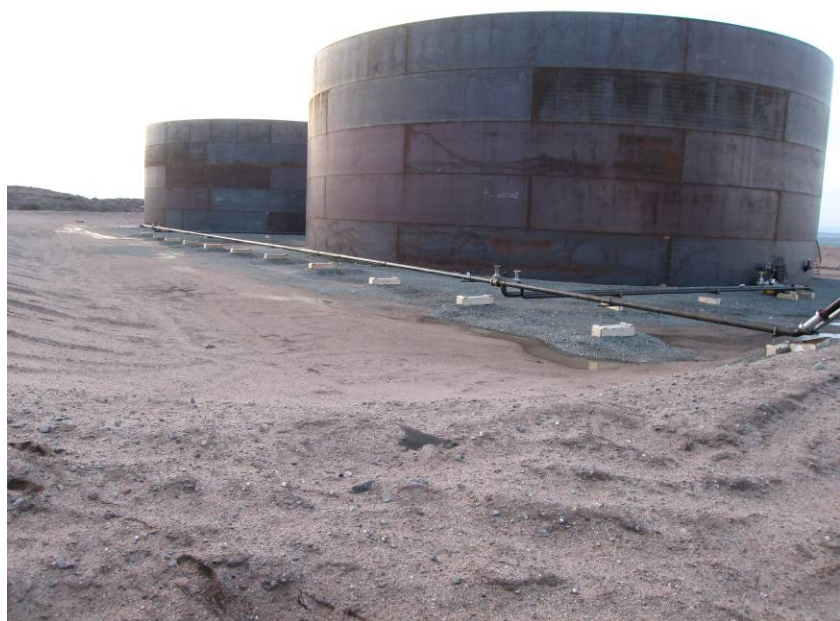
PHOTOGRAPH 7 – Baker Lake Tank Farm

Description: View of Tank 3 (foreground) and Tank 4, looking south.

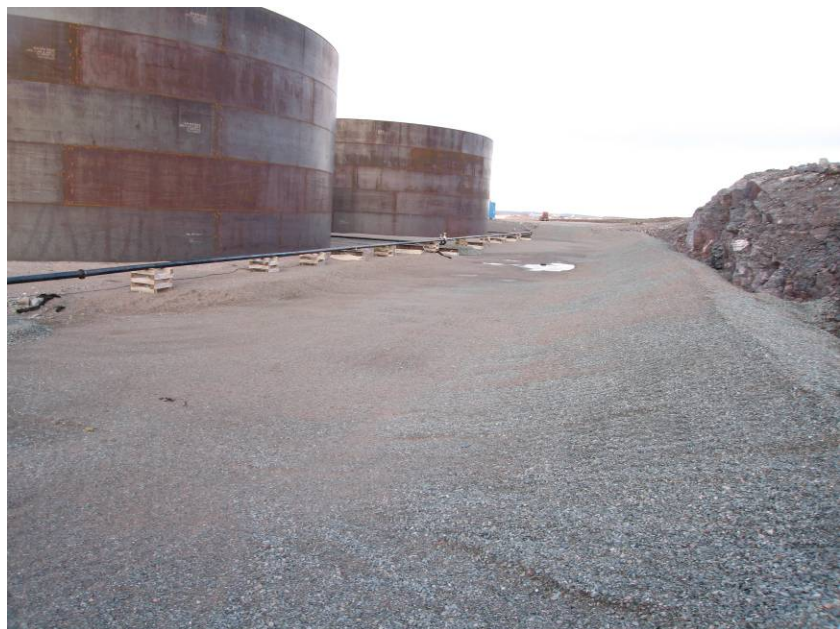
PHOTOGRAPH 9 – Baker Lake Tank Farm

Description: View of Tank 2 (foreground) and Tank 1, looking northwest.

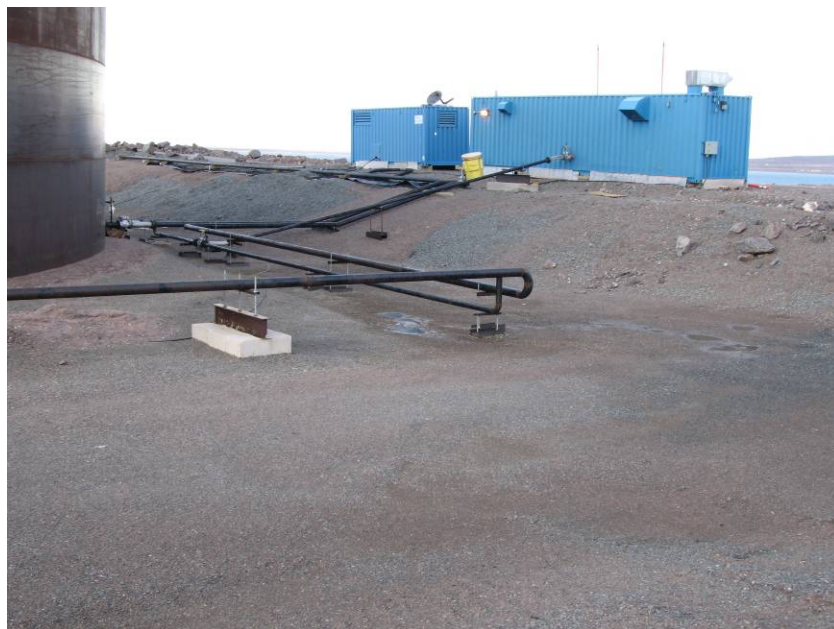
PHOTOGRAPH 11 – Baker Lake Tank Farm

Description: View of refuelling station adjacent to Tank 1, looking southwest.

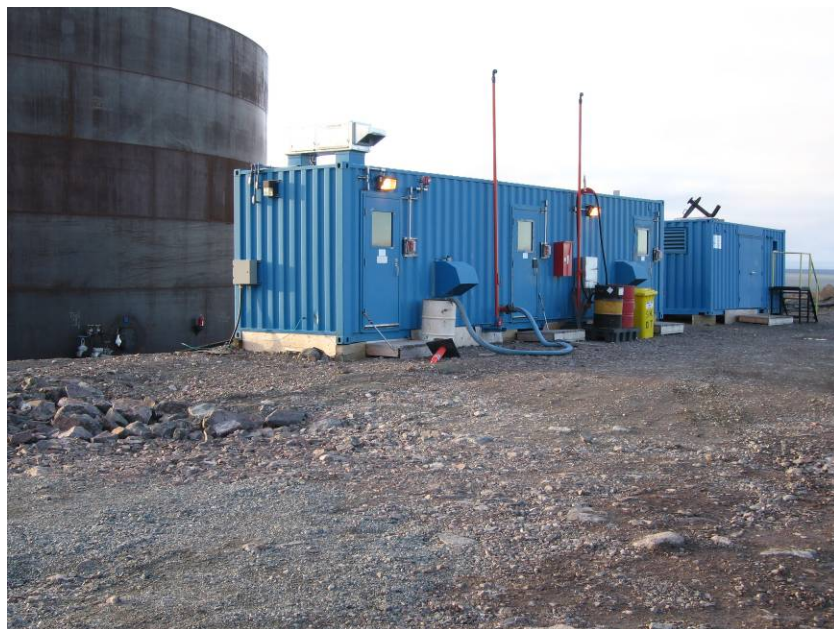
PHOTOGRAPH 13 – Baker Lake Tank Farm

Description: View of refuelling station, looking south.

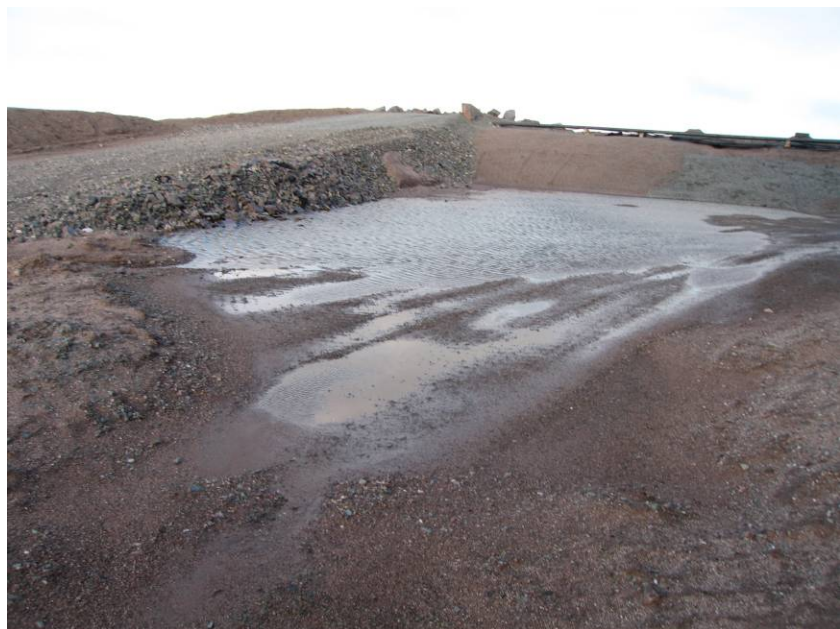
PHOTOGRAPH 15 – Baker Lake Tank Farm

Description: View of access ramp and ponded water in western corner on the south side of Tank 1, looking west.

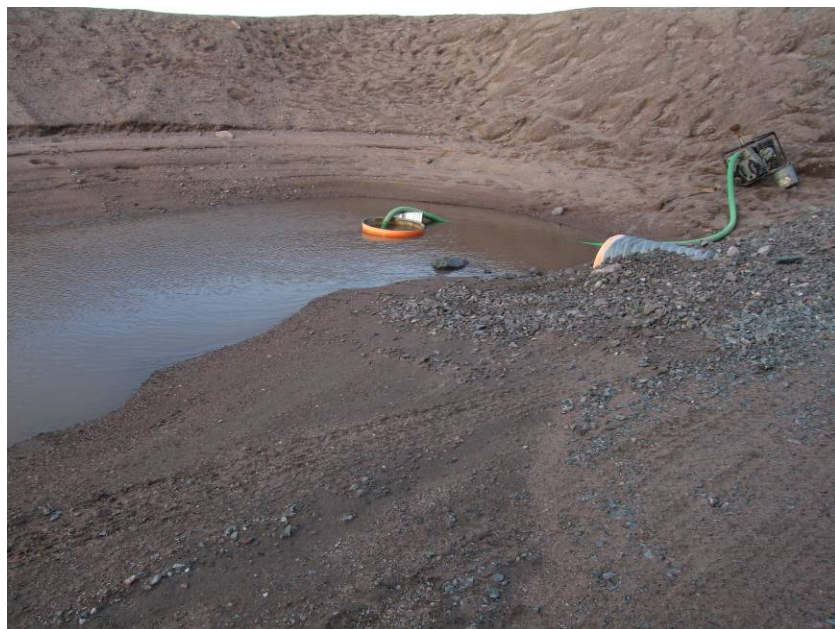
PHOTOGRAPH 17 – Baker Lake Tank Farm

Description: View of ponded water and sump in containment area in front of Tank 3, looking west.

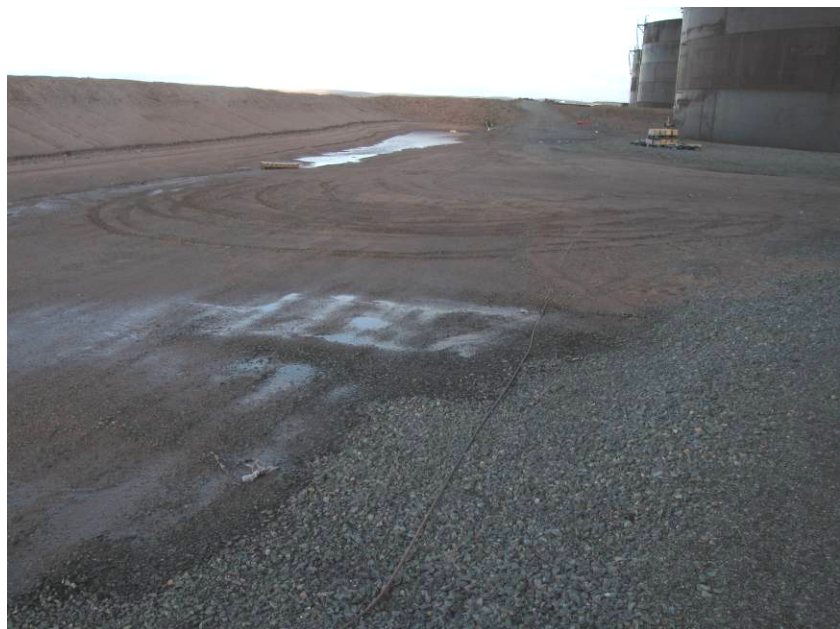
PHOTOGRAPH 19 – Baker Lake Tank Farm

Description: View of containment area in front of Tank 4 and Tank 3, looking west.

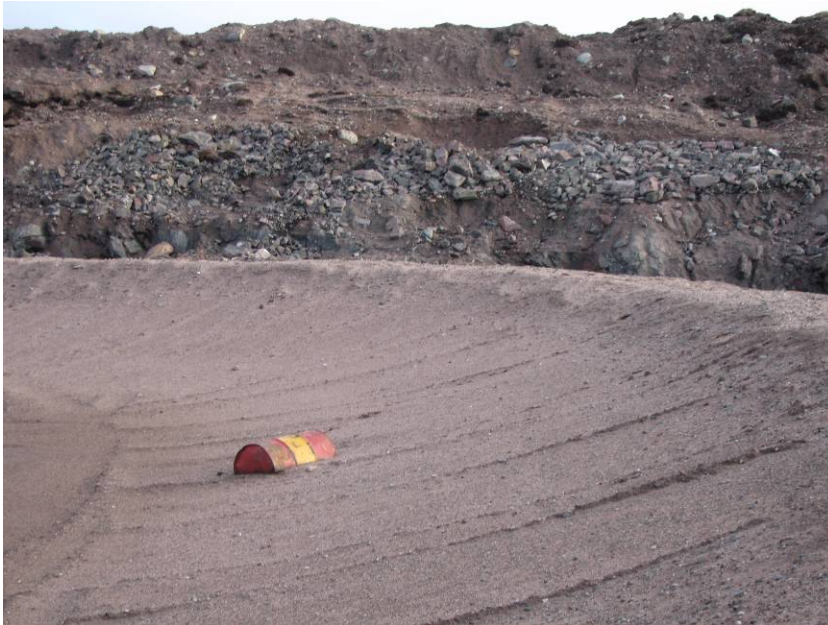
PHOTOGRAPH 21 – Baker Lake Tank Farm

Description: View of containment area east of Tank 4 and buried tank, looking north.

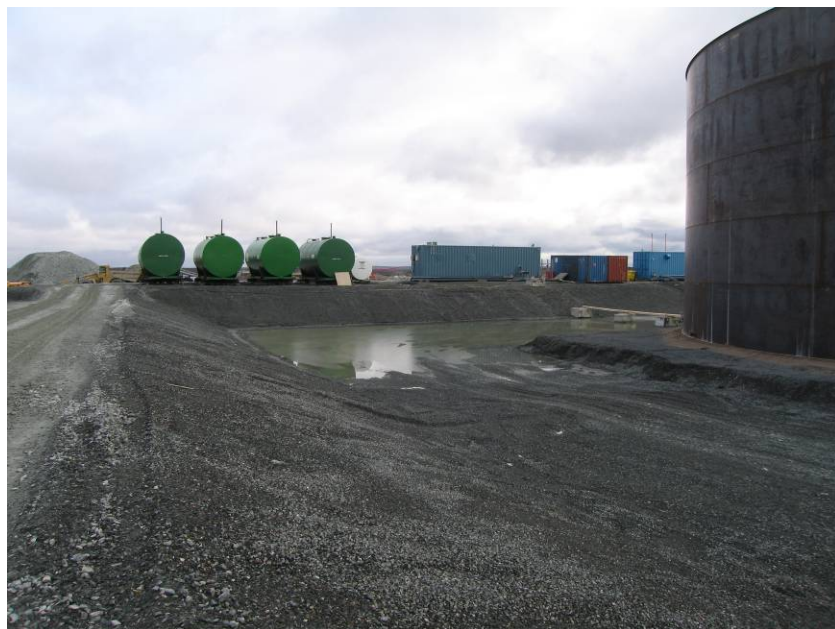
PHOTOGRAPH 1 – Meadowbank Tank Farm

Description: View of 4 diesel tanks (green), 1 gasoline tank (white), containment area and fuel storage tank, looking northeast. Sub-excavated area lined with 1.5mm HDPE (not inspected) and covered with approximately 25mm minus gravel and sand.

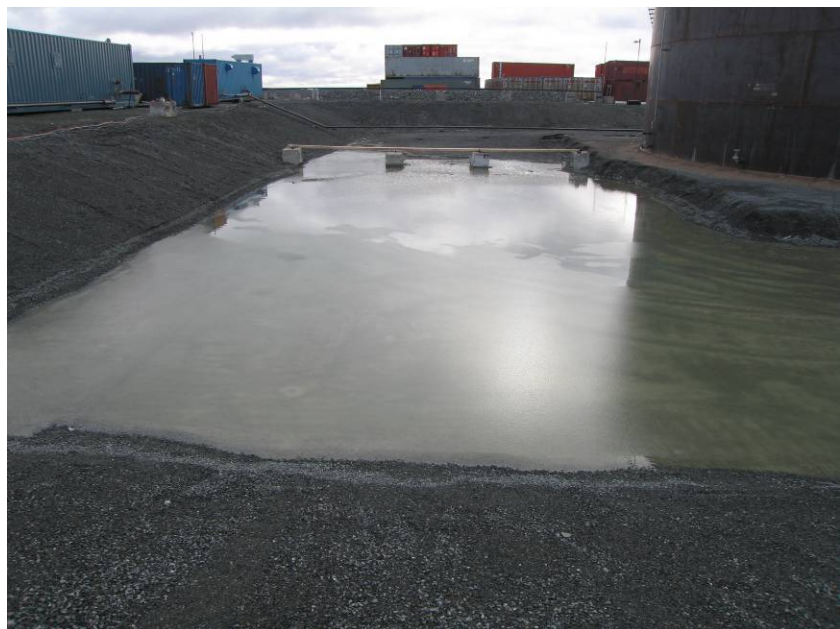
PHOTOGRAPH 3 – Meadowbank Tank Farm

Description: View of containment area and tank, looking southeast. Ponded fluid within the tank farm area.

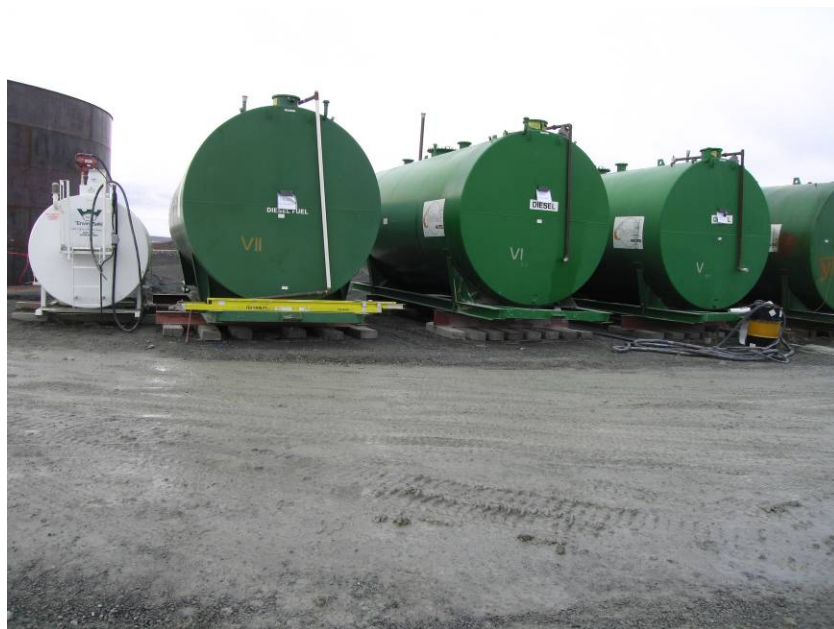
PHOTOGRAPH 5 – Meadowbank Tank Farm

Description: View of 4 diesel tanks and gasoline tank (white), looking southwest in the refuelling area.

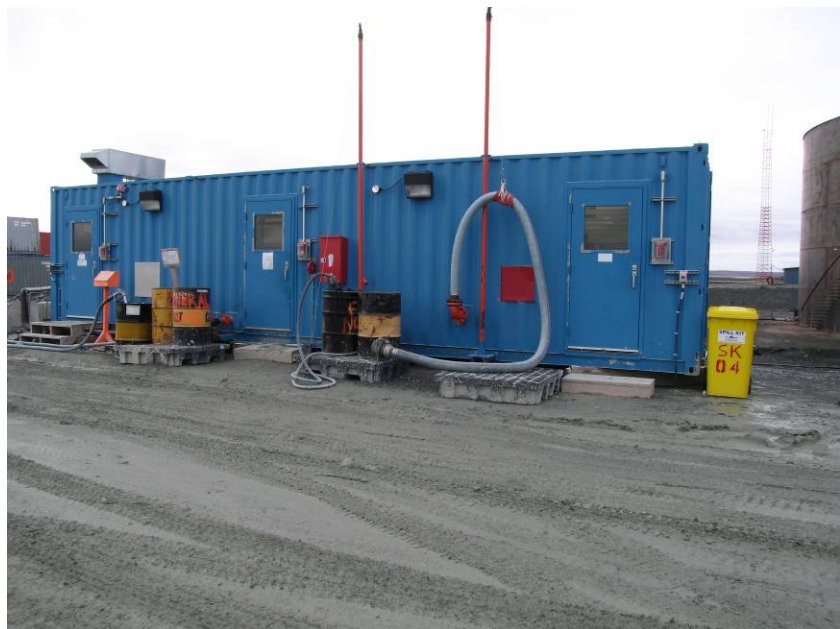
PHOTOGRAPH 7 – Meadowbank Tank Farm

Description: View of refuelling station, looking southwest.

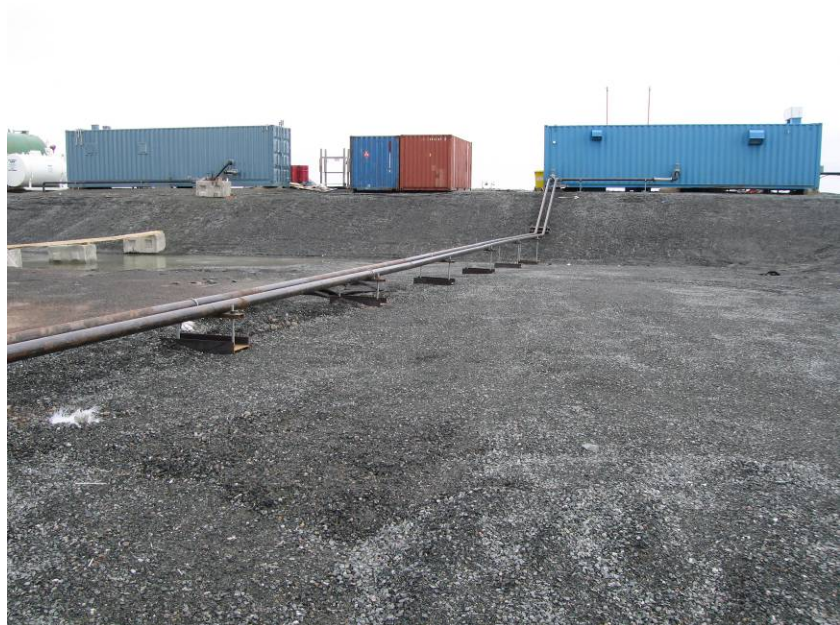
PHOTOGRAPH 7 – Meadowbank Tank Farm

Description: View from within the tank farm containment area looking at the piping and refuelling station.
Photograph taken looking northeast.

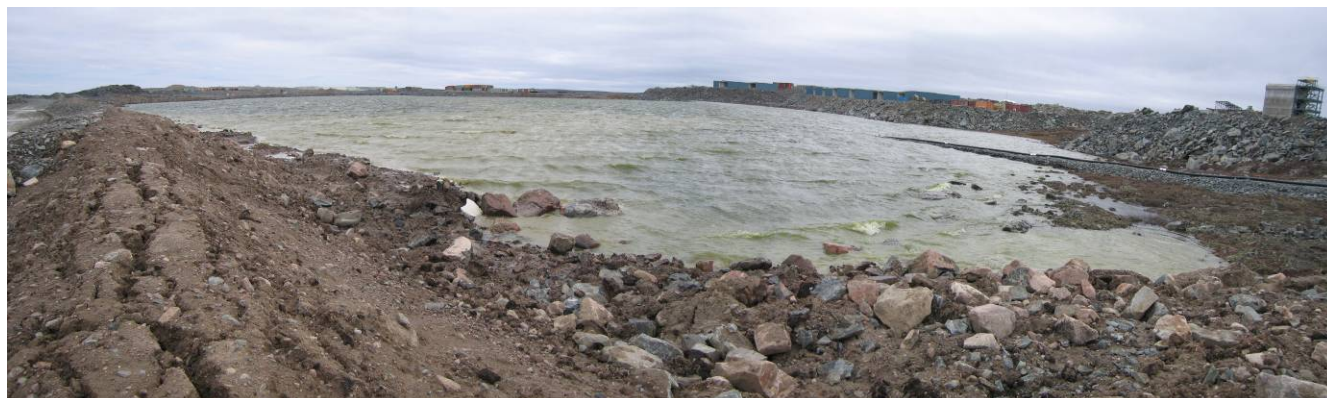
PHOTOGRAPH 1 – Stormwater Pond 1, Teardrop Lake

Description: View of Stormwater Pond 1, also referred to as Teardrop Lake, looking southeast.
