## **Appendix A3**

### **Independent Geotechnical Expert Review Panel 2009 Reports**

February 10, 2009

**Re: Meadowbank Dike Review Board (MDRB)**  
**Report No. 2**

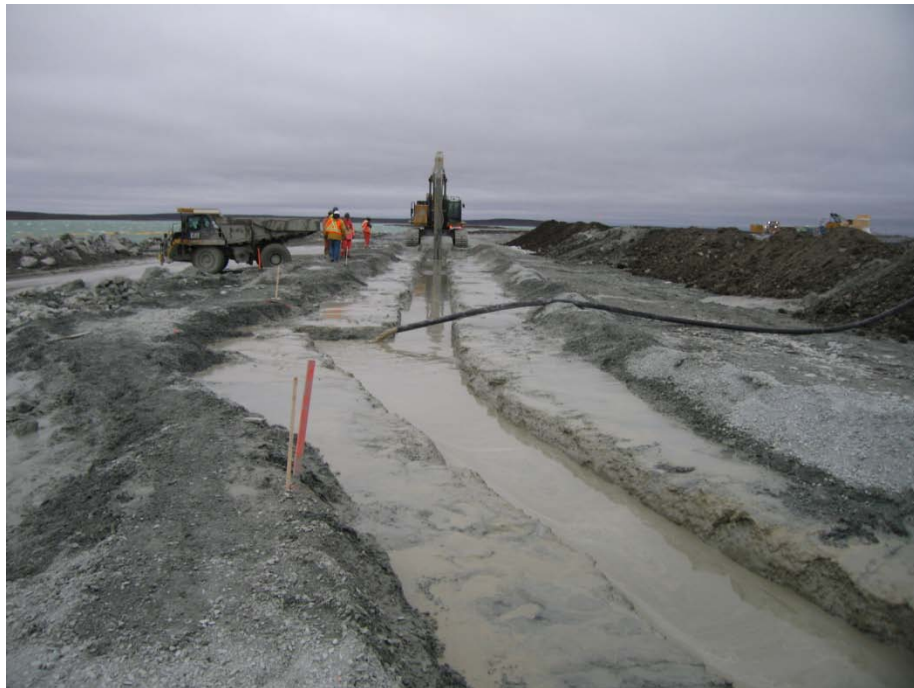
**Response:** Discussions were held between Golder, AEM, and the contractor prior to slurry wall construction. Turning points in the cutoff wall were successfully constructed by creating a small overlap in the two axes. The photograph below shows one such turning point in the cutoff wall alignment. The alignment was also slightly modified during the construction process near Goose Island.
