Appendix E1

Document: *2010 Spill Reports*

SUBJECT: January 16th Fuel Tanker Accident

SUBJECT: October 6th Fuel Tanker Accident

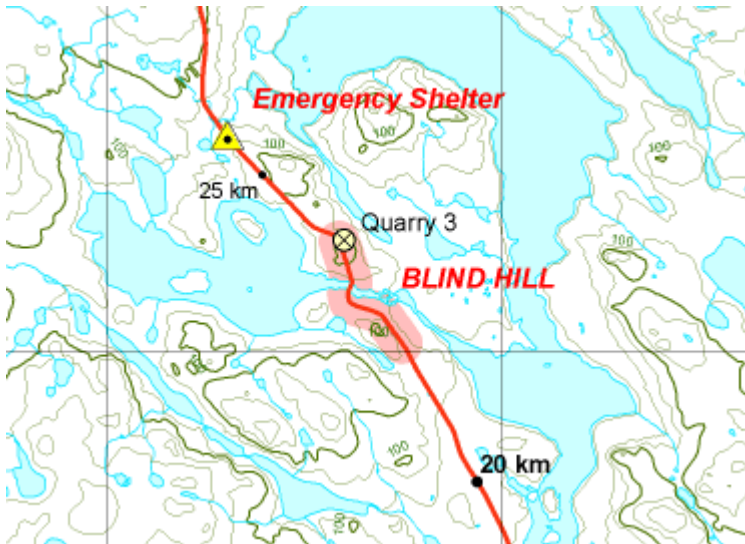
Wednesday, October 16 at 4:45 AM, due to slippery condition on the road, a tanker truck hauling fuel from Baker Lake to Meadowbank mine site rolled over off the road (Photo No 1) just after bridge #3 and just before Quarry 3 at KM 22 (N 64 30 019, W 096 07 451, IOL land parcel BL 18). The tanker truck was hauling 40,000L of diesel fuel to site. The vehicle is owned by AEM however the drivers are under contract with Arctic Fuels in Baker Lake. The tank was damaged on a rock and the fuel was leaking on the ground.

Spill occurred approximately 80 meters north of unnamed river on a hillside with a downward slope of 10-15% towards the river.
