Annual Review of Slope Performance

MEADOWBANK MINE

ANNUAL REVIEW OF PIT SLOPE PERFORMANCE (2015)

CJ Clayton Mine Geotechnical Services Ltd.
North Vancouver, BC

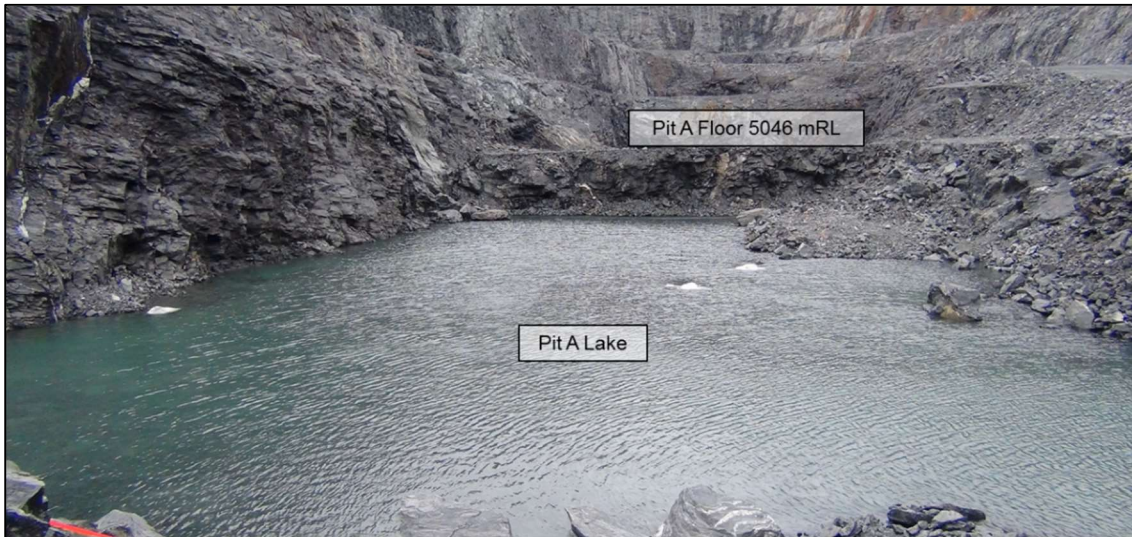
Photograph 4-3: Pit A Lake

Pit A is at the north end of the Portage Pit, and includes the northwest through northeast end walls of the pit. There are 15 benches remaining to be mined in Pit A to a final floor elevation of 5004 mRL, planned for Q1 2018. A portion of the west wall of Pit A will be mined as a push-back. At the time of the inspection, a small lake at the base of Pit A had formed and will be drained before mining commences again, shown in Photograph 4-3.

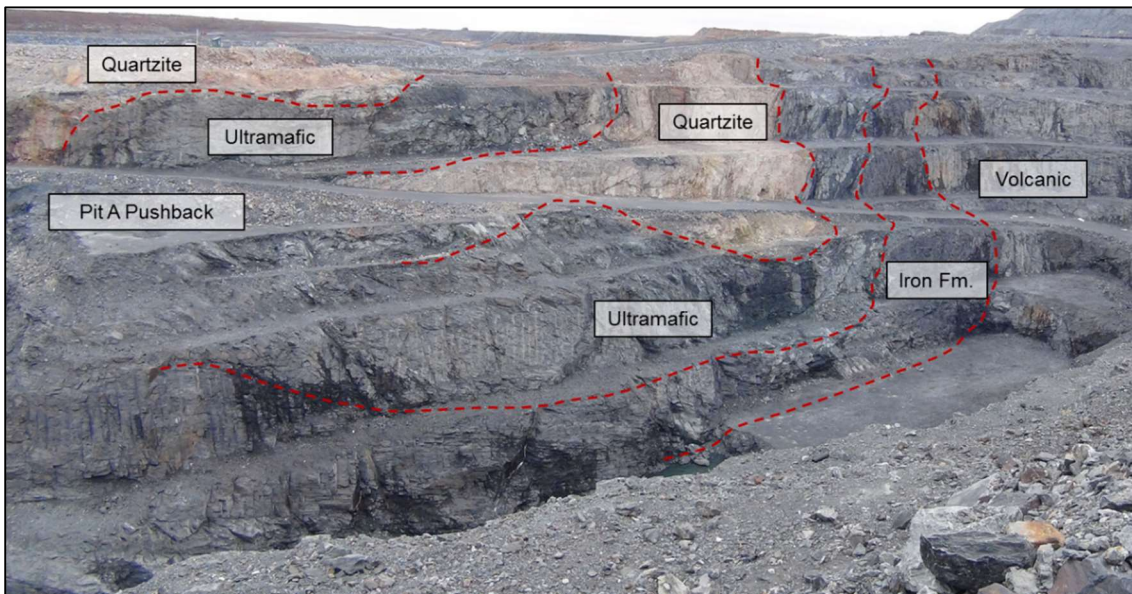
Photograph 4-4: Pit A west wall

The west wall bench face angles are excavated steeper than designed, however wide catch benches are used to manage the overall slope angle within the design criteria. The benches continue to perform well and as with the 2014 inspection there is very little accumulation of material on the catchment, and crest loss is minimal. An area of instability of the lower west wall identified during the 2014 inspection continues to ravel, and some new material has accumulated at the toe of the slope (shown in Photograph 4-5). A hard toe in iron formation remains at the

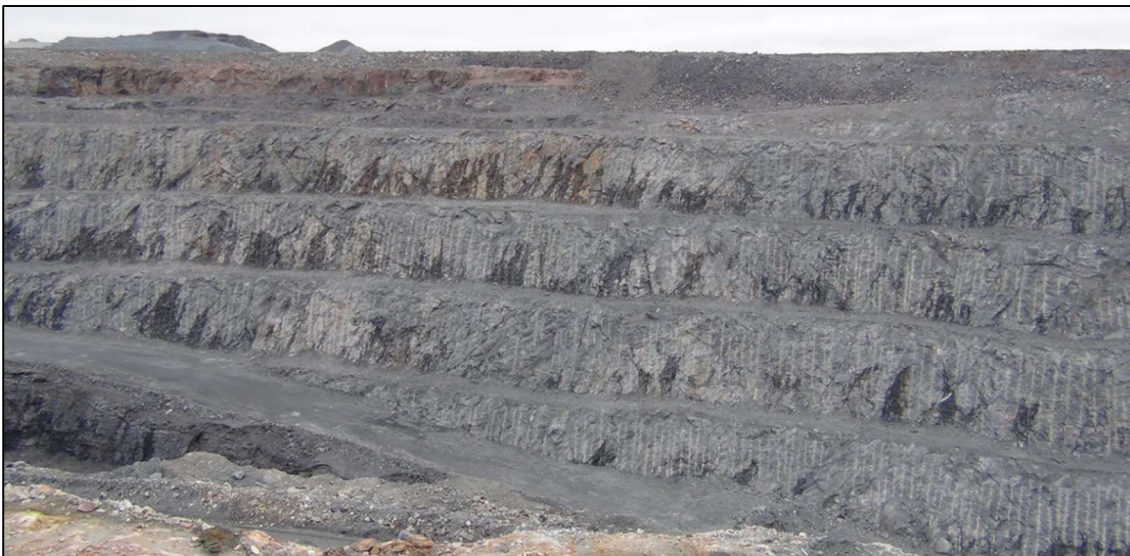
Photograph 4-9: Pit A east wall performance

The east wall of Pit A continues to perform adequately. It is well scaled, with steep bench face angles, and minimal accumulations of material on the catch benches.

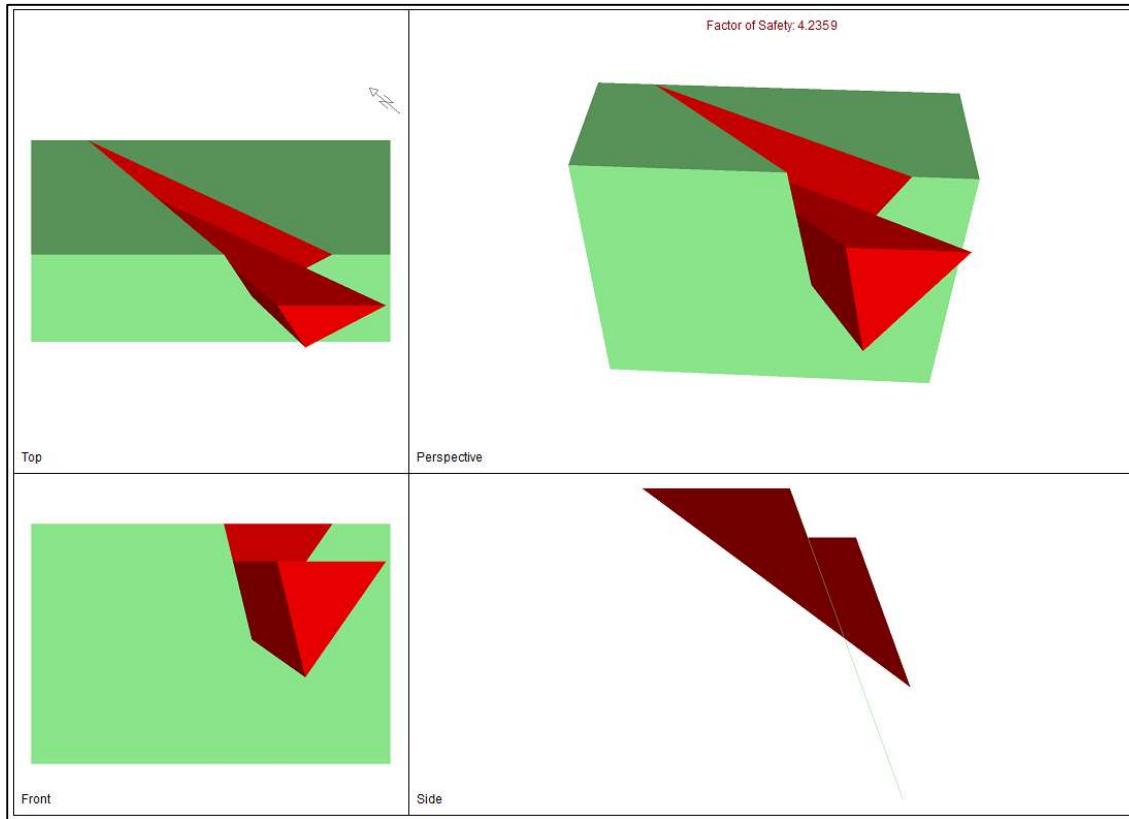
Figure 4-1: Pit A SWEDGE analysis

The weight of the wedge is estimated by SWEDGE to be 418 tonnes. There is no seepage noted on the wall, and so the analysis was carried out appropriately without water pressure, and using frictional strength of 30 degrees with no cohesive strength. Based on the analysis the factor of safety associated with this wedge is greater than 4. Since Pit A will be re-opened this area should continue to be visually monitored as part of regular inspections.

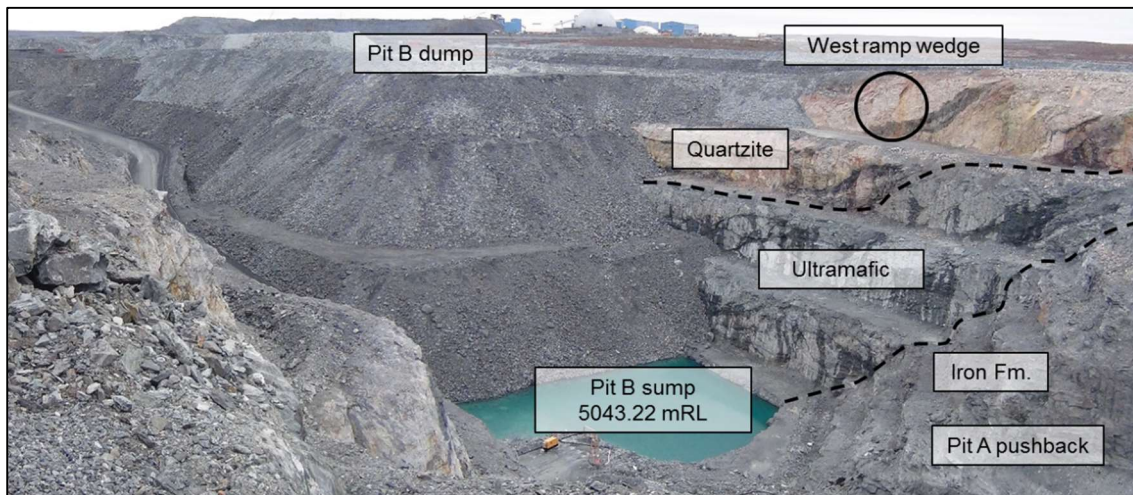
Photograph 4-12: Pit B west wall performance

The west wall of Pit B is performing adequately, exposing quartzite in the upper benches overlying ultramafic rock, and iron formation. There is no access to the west wall of the pit, and access to the base of the pit is gained by the east ramp which also provides access to Pit A.

There is no evidence of large-scale instability for the west wall of Pit B.

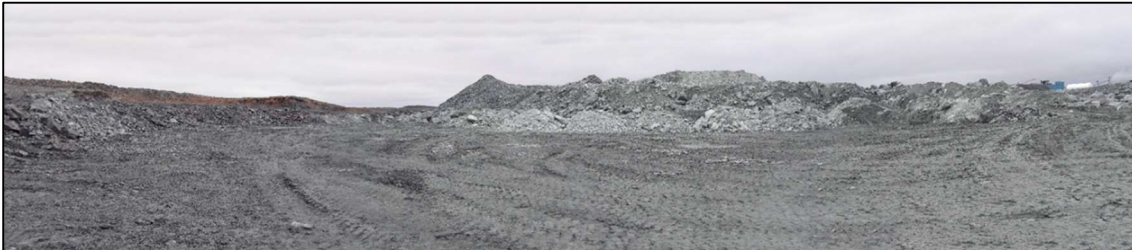
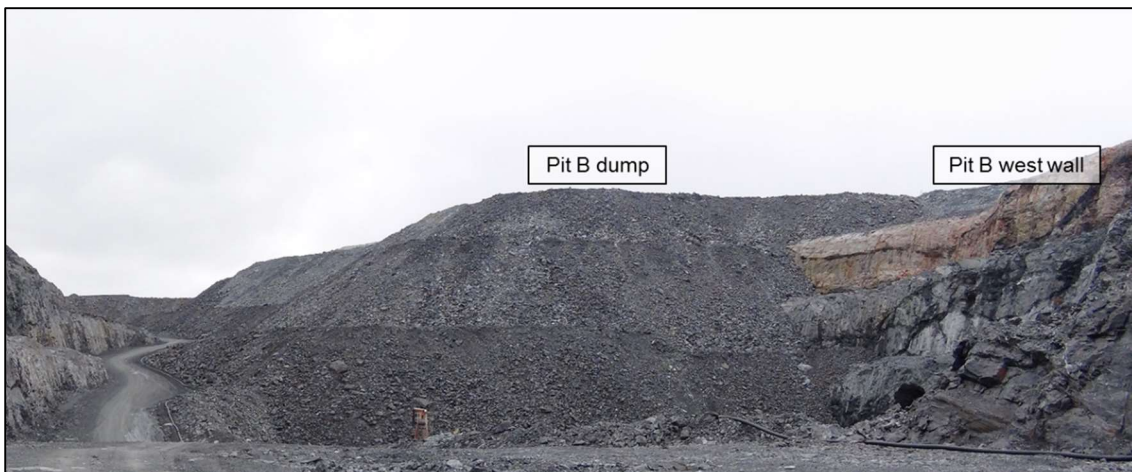
Photograph 4-15: Pit B dump platform

Photograph 4-16: Pit B dump

Only limited areas of the crest were accessible, but no tension cracks or indications of subsidence or settlement were noted during the inspection; no bulging of the dump toe or dump face was observed.

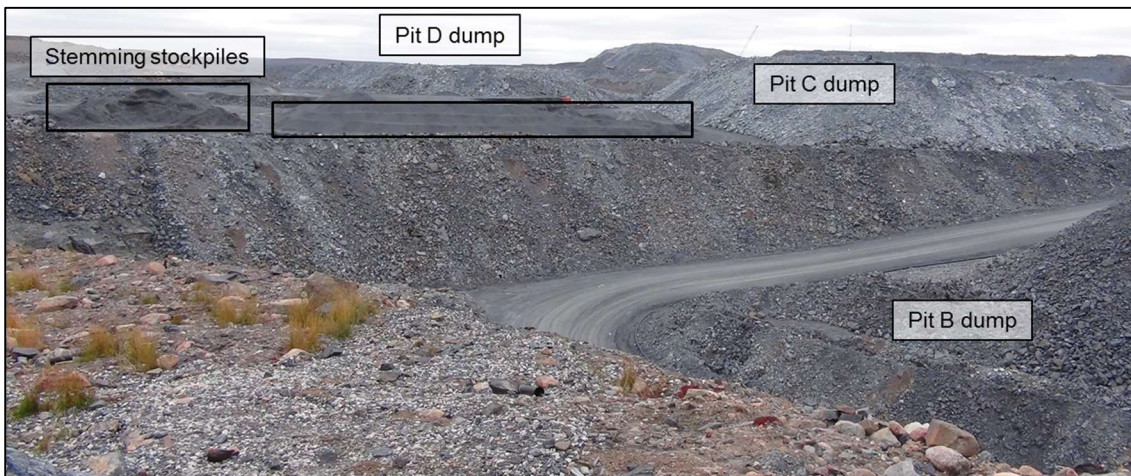
Photograph 5-1: Pit C and Pit D waste rock dumps looking south

The west and east pit walls of Pit C are buttressed by waste rock and no longer present any significant geotechnical hazard. The main dump platform for Pit C is used for storing stockpiles of stemming material. The Pit C dump is performing adequately. There were no tension cracks observed in the crest area, and no bulging of the face or toe areas was noted at the time of the inspection.

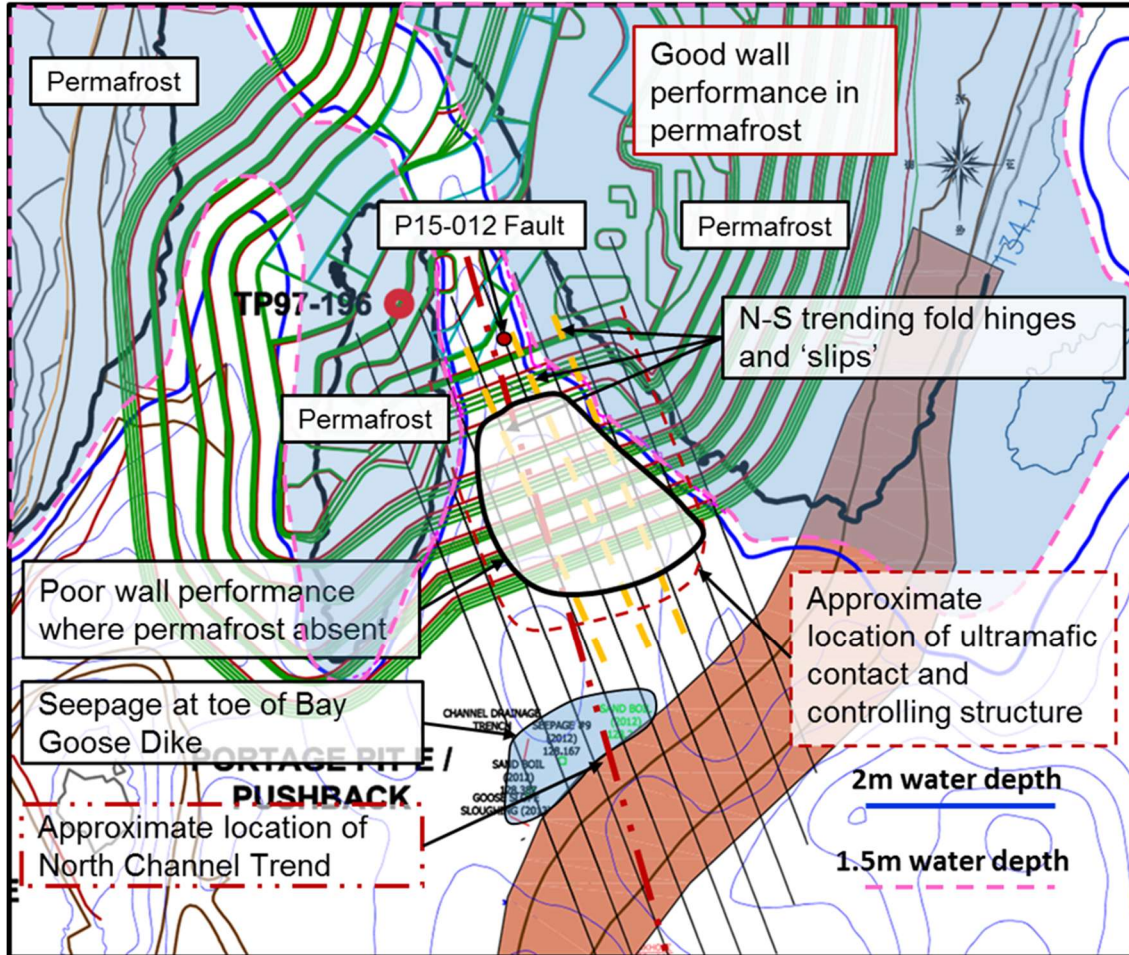
Figure 6-3: Pit E3 south wall performance relative to permafrost location

The orientation of the main stratigraphic boundaries, and the layer-parallel foliation developed as part of the major fold events, are the primary controls on bench-scale and overall slope stability, and so an understanding of the fold patterns relative to the south wall is of primary importance in assessing the slope stability. Previous studies (2007) identified that the foliation and stratigraphy at the south end of the Portage Pit is reoriented to an east-west direction, dipping to the north.

There are two potential scales of failure to be addressed in relation to the stability of the south wall: the first is bench, or multi-bench kinematic instability associated with the tight isoclinal folding forming large wedges; the second is larger scale deep-seated circular type failure associated with the geometry and orientation of the ultramafic rock and shear zone.

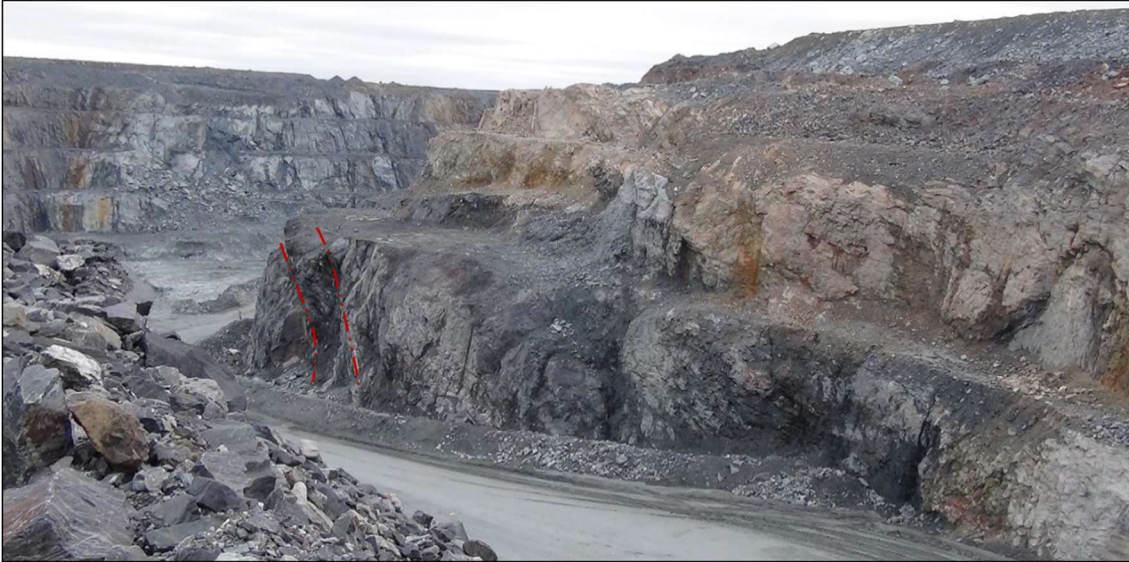
Photograph 6-6: Pit E3 Ramp Area 1 above ramp - Bay Fault or splay

The ramp passes beneath an area of wall that was problematic during the 2014 site visit (Area 1 and Area 2). The area of wall is associated with a fault zone – possibly the Bay Fault or a splay off that fault trend - trending through this area of the pit. This fault, or shear, is several metres wide, and steeply dipping to the west.

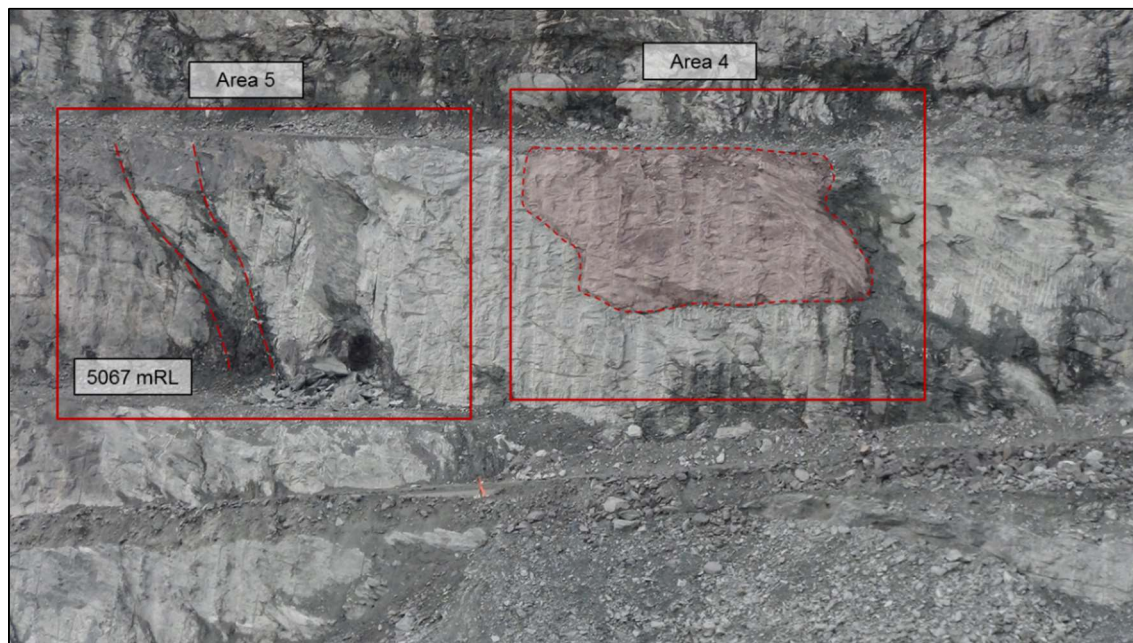
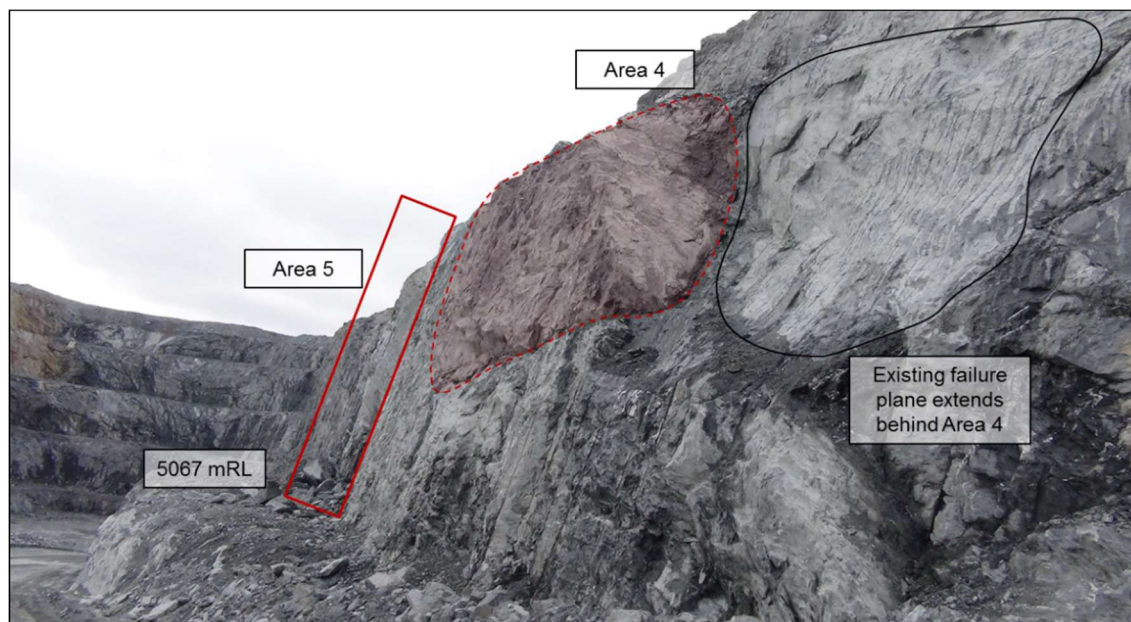
Area 5 is defined by a series of closely spaced bench-scale joints trending into the wall, and forming steeply plunging wedges. Some material has already failed on to the 5067 mRL bench. On-going raveling of material can be expected from this area. However, the steeply plunging orientation of the wedges will result in relatively small volume of material which will be managed by the 5067 mRL catch bench.

Photograph 6-9: Pit E3 Ramp Areas 4 and 5

Photograph 6-10: Pit E3 Ramp Areas 4 and 5 viewed from the ramp

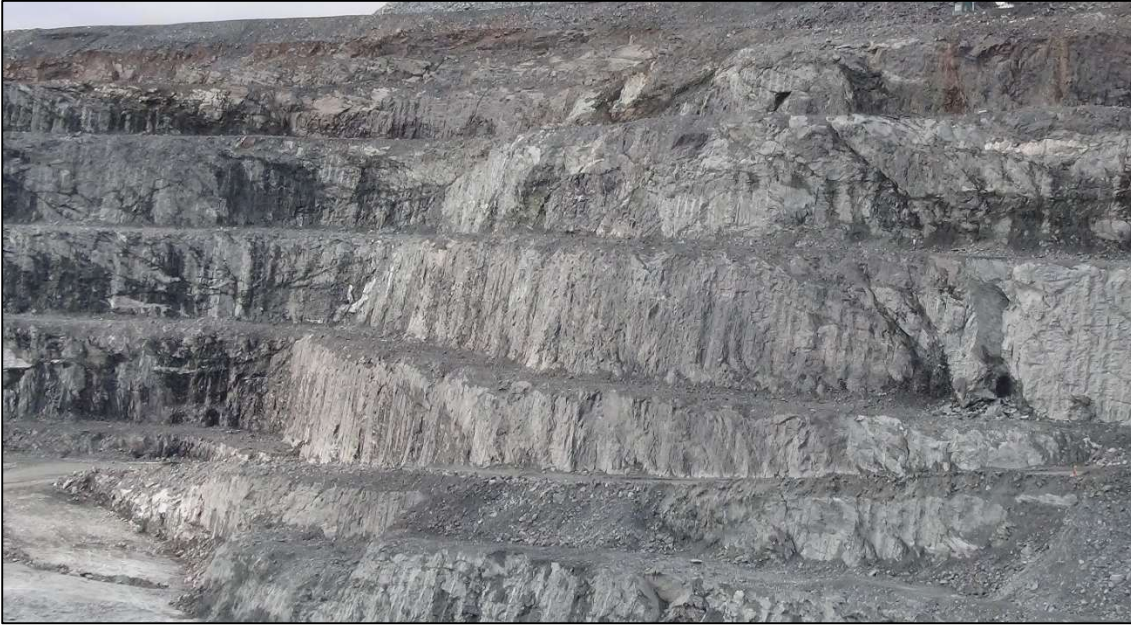
Photograph 6-12: Pit E3 west wall ramp south end

As the West Wall Ramp continues to descend into the pit to the south past Areas 5 and 6, the quality of the ultramafic rock improves as does the bench performance. This is seen in the following photograph.

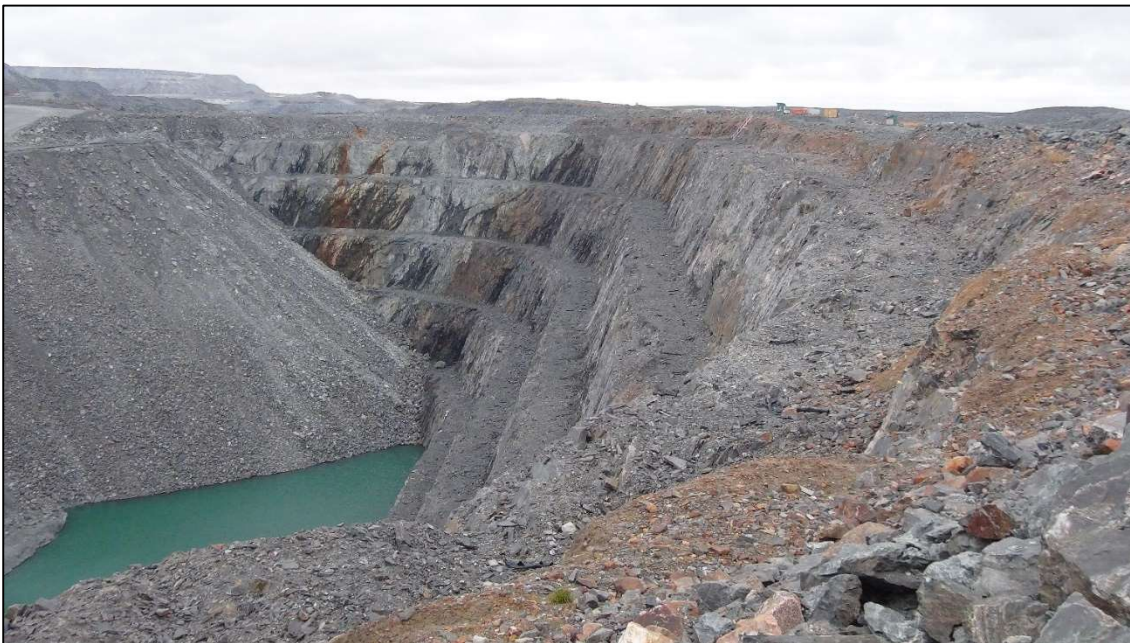
Photograph 7-1: Goose Pit east wall performance looking north

The following photograph shows the east pit wall looking north. There has been very little loss of catchment over time, and very little accumulation of material on the benches.

The east wall continues to perform satisfactorily and there are no immediate geotechnical concerns.

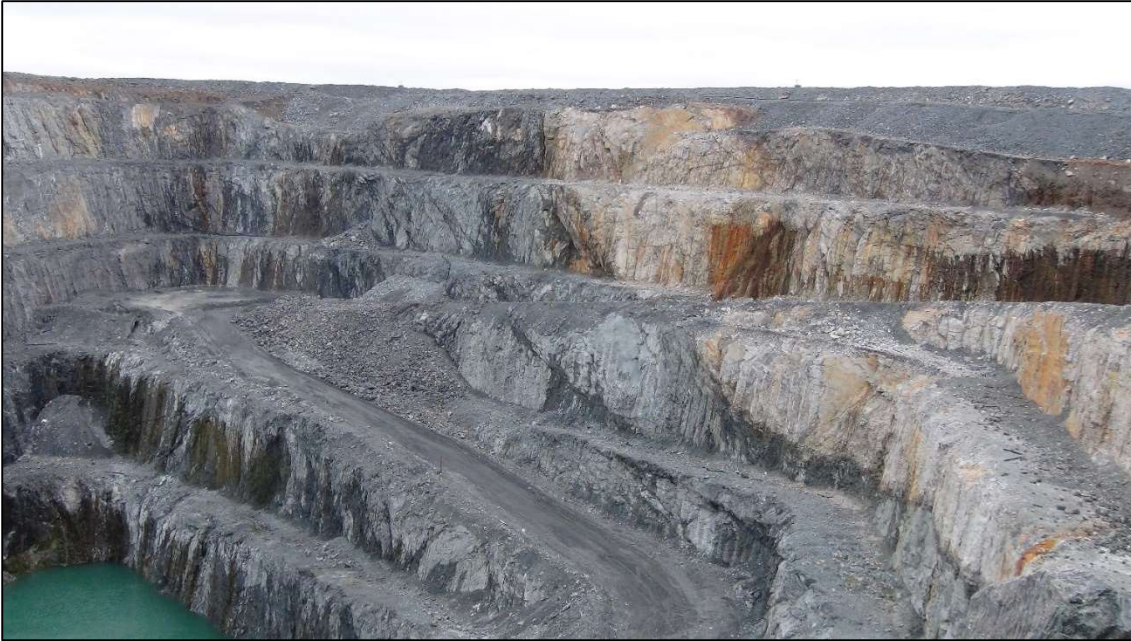
Photograph 7-2: Goose Pit south wall performance

The south wall of the Goose pit is comprised of iron formation and intermediate volcanic rock in the east, transitioning through a sequence of ultramafic rock, quartzite, and iron formation. The most prominent structural feature is the Bay Fault which intersects the south wall of the pit, within the ultramafic rock. The various lithological units are shown in the following photographs.

The bench-scale and overall wall performance of the south wall continue to be satisfactory. There is no evidence of additional instability from the 2014 inspection.

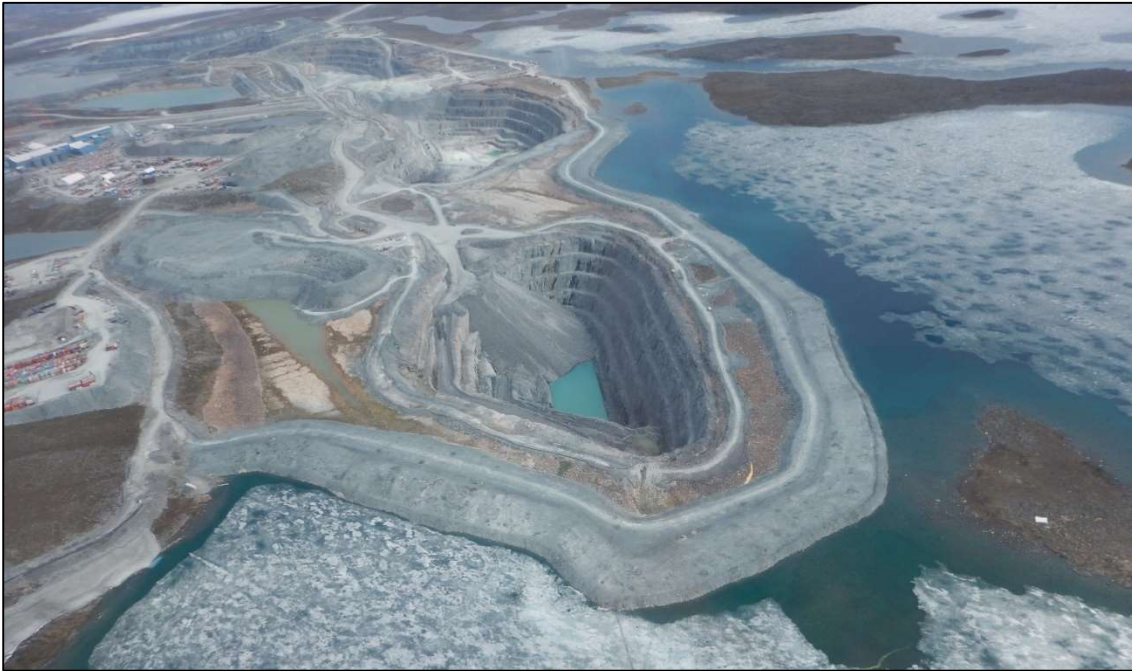
Photograph 7-4: Goose Pit waste rock dump (photograph courtesy of AEM)

The Goose Pit has been used as a short-haul waste rock dump. Waste rock has been dumped from the crest area and ramp entry at the northwest end of the pit. The dump platform is at elevation 5125 mRL; the dump toe extends into the pit lake, and across the pit floor to the east wall, at the north end of the pit. Currently, there is no active dumping.

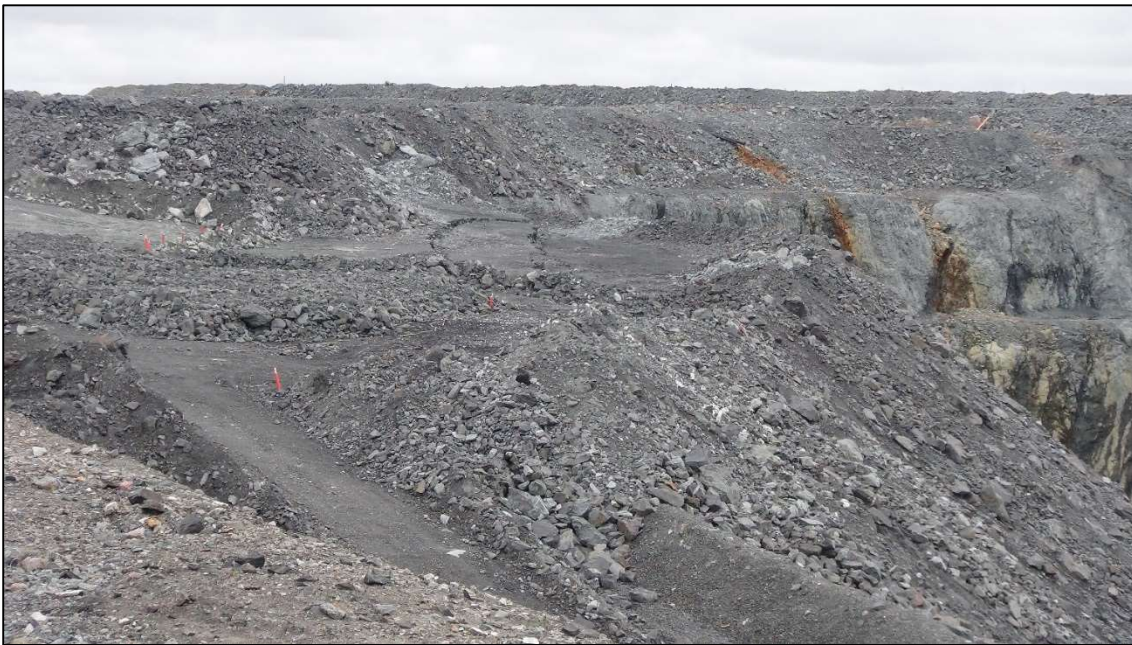
Photograph 7-5: Goose Pit dump crest

A series of large tension cracks were noted on the dump platform, between 10 m and 20 m back from the dump crest. The tension cracks are curvilinear and extend the full width of the dump platform. There is up to approximately 30 cm of vertical displacement across the cracks and lateral separation, or opening.

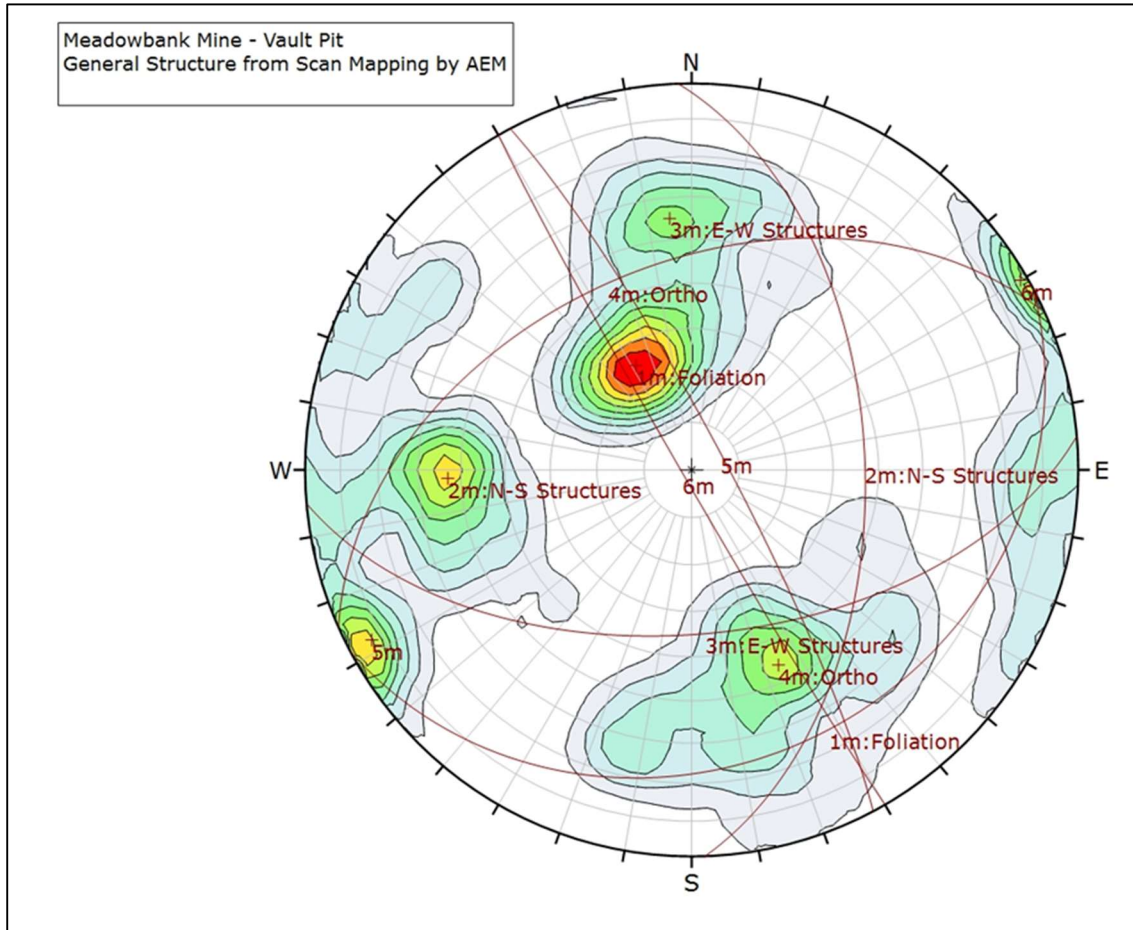
Stereonet 1: Vault general structure based on AEM scan

AEM carried out additional structural mapping using a Lidar scanner and compared the data to the orientation data used in the feasibility design. The general structure is consistent with structural orientation data used in the feasibility design, and is shown below based on the scan data provided by AEM.

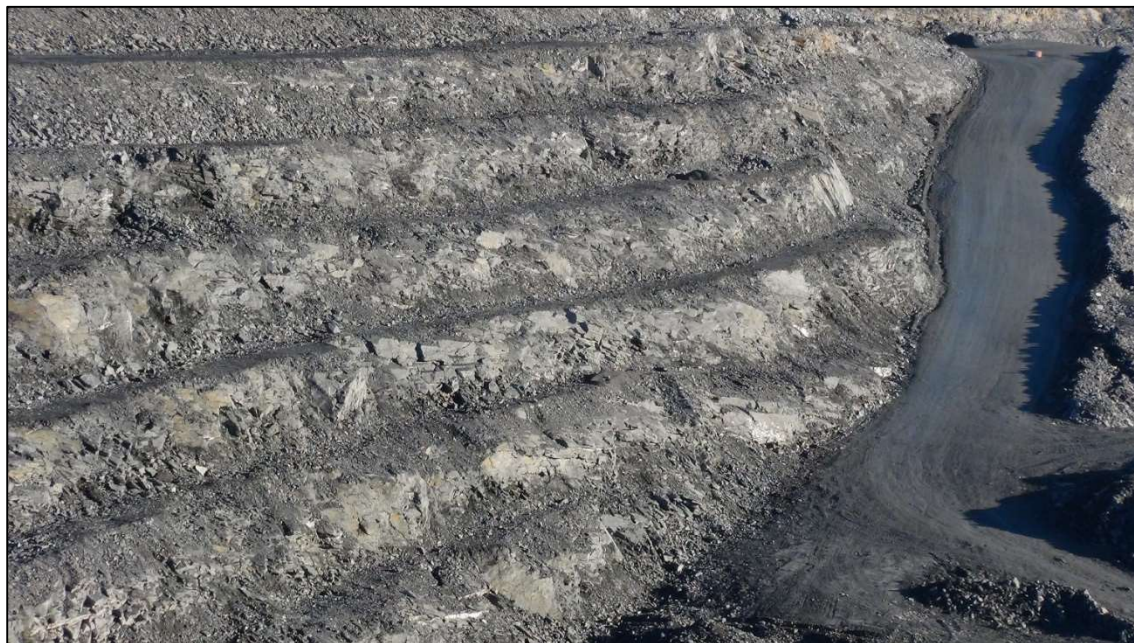
Photograph 8-1: Vault Pit grid west footwall slope

The inter-ramp slope angle is shallow at 33 degrees, and so the likelihood of larger scale multiple bench failures of significant volume is low. While there is catchment loss resulting from crest break-back, the benches are performing well. AEM report that operators have been instructed not to over-dig in order to minimize catchment loss.

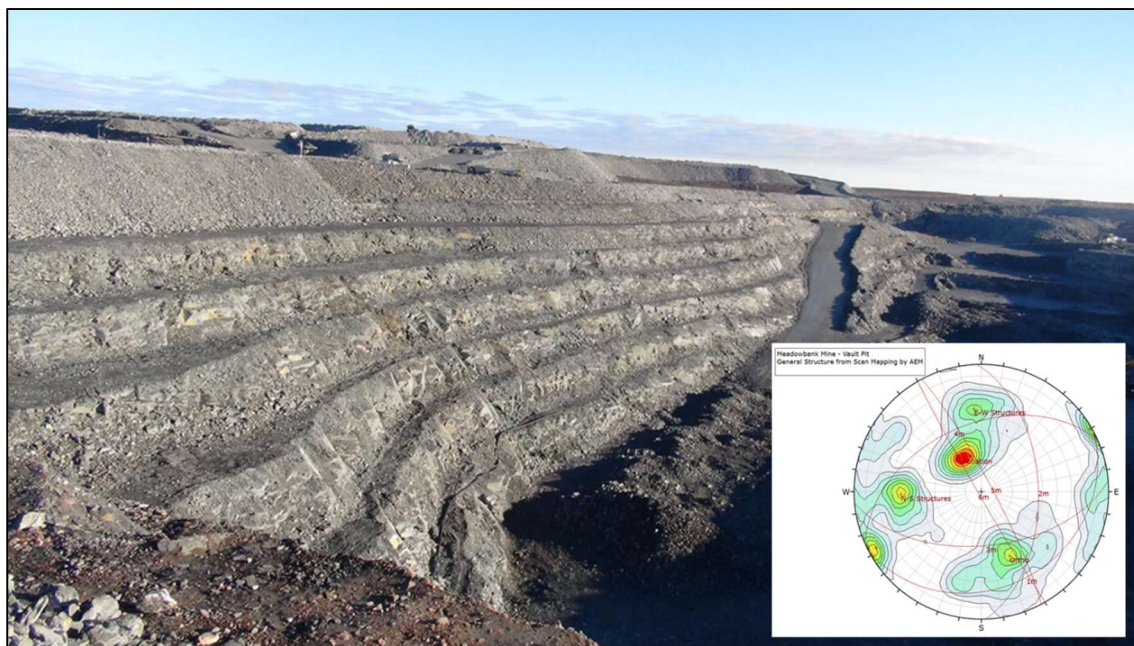
Photograph 8-2: Vault Pit grid west footwall slope, south end

At the south end of the wall a series of closely spaced continuous fault structures trend into the wall at high angles. These are part of the east-west trending family of faults and sub-parallel joints which dip to the south at about 55

degrees. These features form narrow wedges with north-south trending faults and sub-parallel joints. The plunge of these wedges ranges from about 30 degrees to about 60 degrees, and where undercut by the inter-ramp angle have formed multiple bench features. These features are narrow and widely spaced, and because of the shallow inter-ramp angle result in only raveling of limited extent is observed.

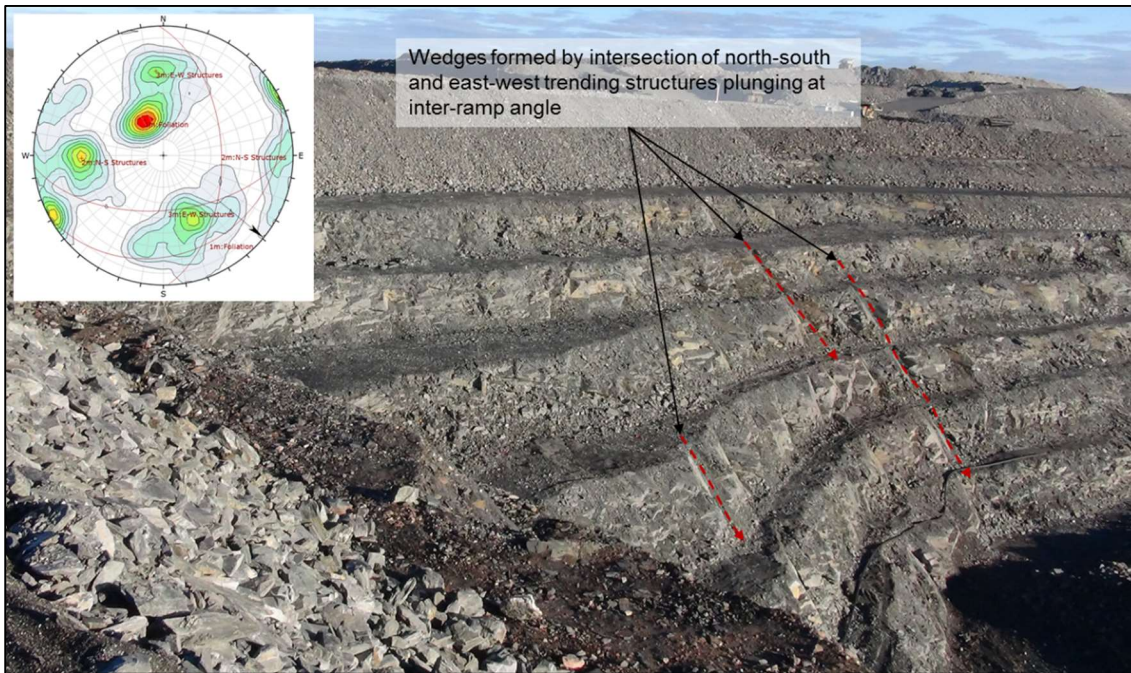
Photograph 8-3: Vault Pit grid west footwall slope south end wedges

There are no significant geotechnical concerns noted, and no evidence of large scale (overall slope) instability for the footwall slope.

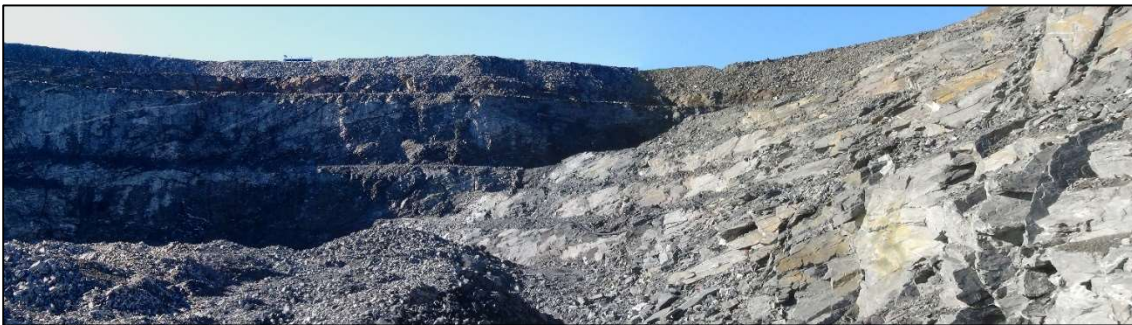
The southwest wall (grid south) intersects the stratigraphy and foliation perpendicular to their trend. The gently dipping structure can be seen clearly in the wall, as shown in the following photographs.

Photograph 8-5: Vault Pit grid south wall transition

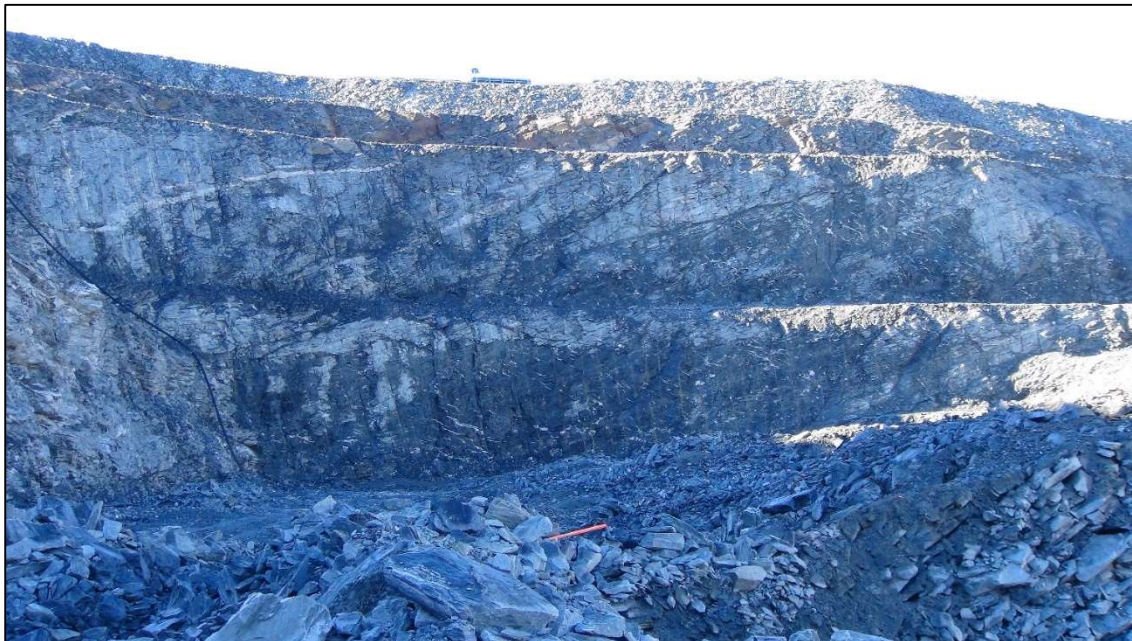
Photograph 8-6: Vault Pit grid south wall structure

Pre-shearing of the walls has been effective for developing steep and final bench face angles. Although the bench faces are blocky in appearance, half-barrels from the drill holes are visible, and there is little accumulation of debris on the benches. While it was not possible to gain access for a bench traverse, observations of the two upper benches shown in the photograph below indicate these to have been cleaned well.

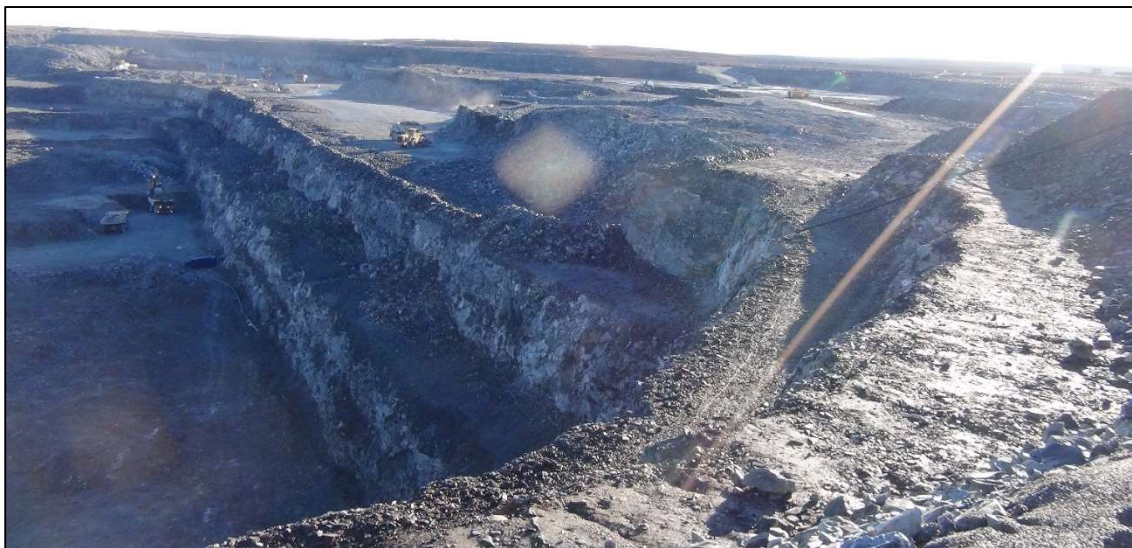
Photograph 8-7: Vault Pit grid south wall upper catch benches

There are no significant bench-scale geotechnical concerns noted for the grid south wall, and no evidence of large scale (overall slope) instability.

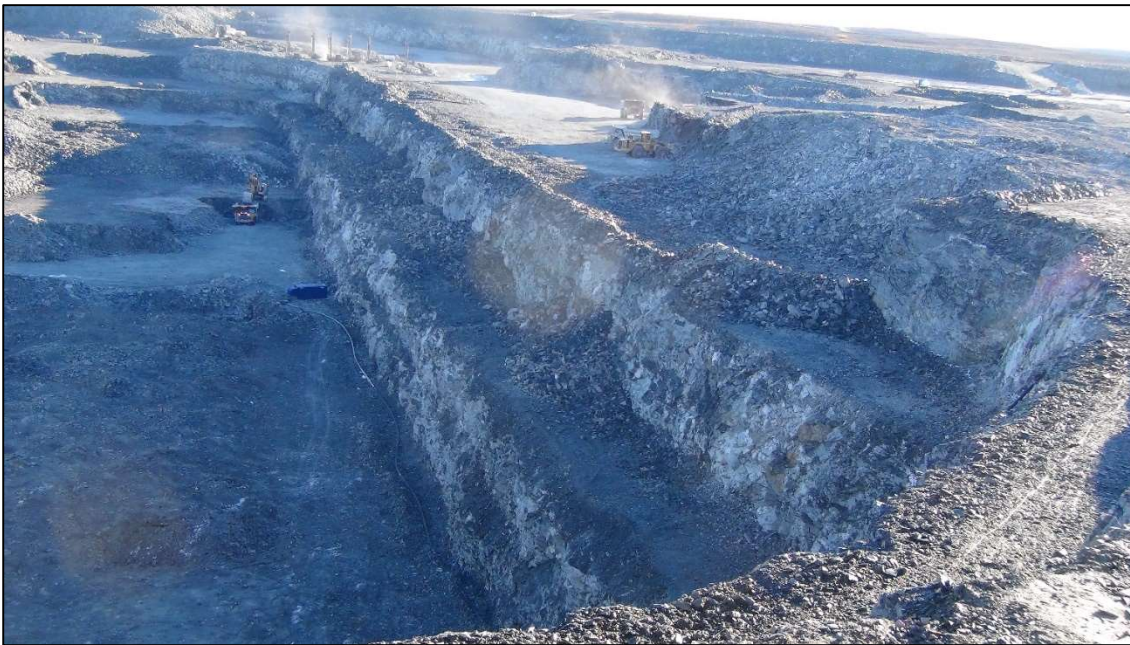
Photograph 8-8: Vault Pit Phase 1 east wall performance

Although bulk blasting has been used to develop these walls, the bench face performance is relatively good, but blocky in appearance. There is very little crest loss and very little accumulation of debris on the benches. The debris that is observed on the benches in Photograph 8-8 is from spill-over of windrowed material along the crest of the bench above to develop a temporary safety berm.

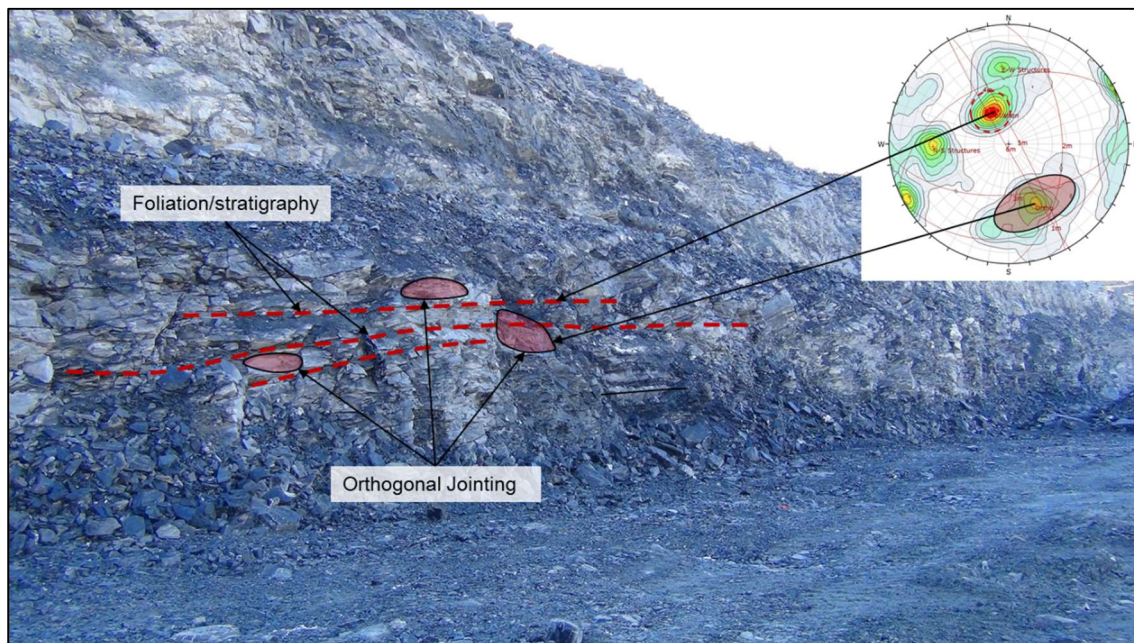
The blocky nature of the benches results from the closely spaced foliation dipping into the wall, joint surfaces inclined out of the wall, and northwest-southeast trending joint sets. These are shown in the following photograph.

Photograph 8-9: Vault Pit Phase 1 east wall structure

The temporary benches are being scaled appropriately. In some instances over-excavation of the bench face has resulted in the creation of overhangs. Care should be exercised while operating beneath the temporary bench faces, and there should be no access to the face by personnel or light vehicles.

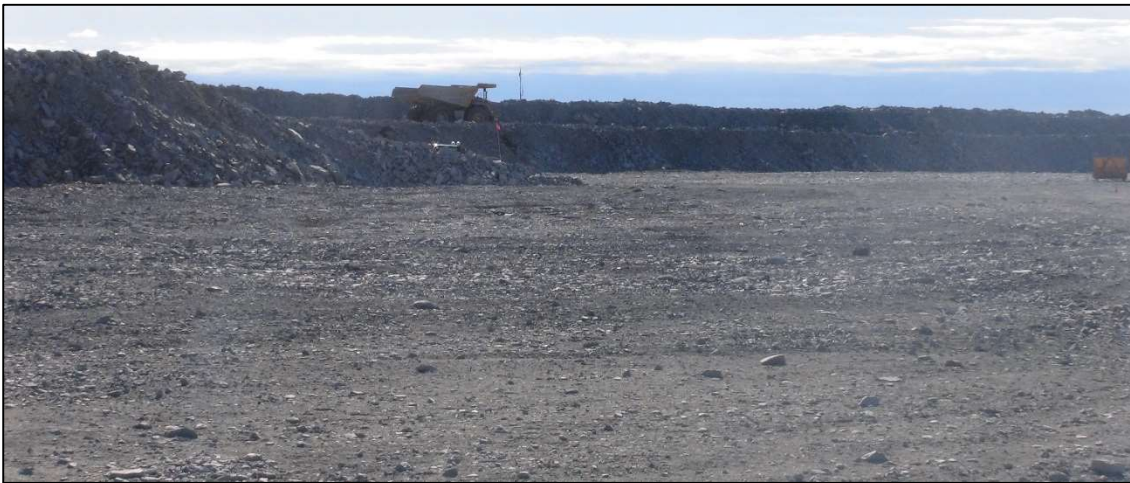
At the time of the site visit the Phase 2 pit had not been advanced significantly from the 2014 inspection, and much of the exposed pit area consisted of bench cut in till, the ring road and thermal capping. Rock outcrop that is exposed is strongly fractured, and the till/bedrock interface forms an undulating and uneven surface around the edge of the pit.

Photograph 8-11: Vault Pit Phase 2 5130 platform looking southeast

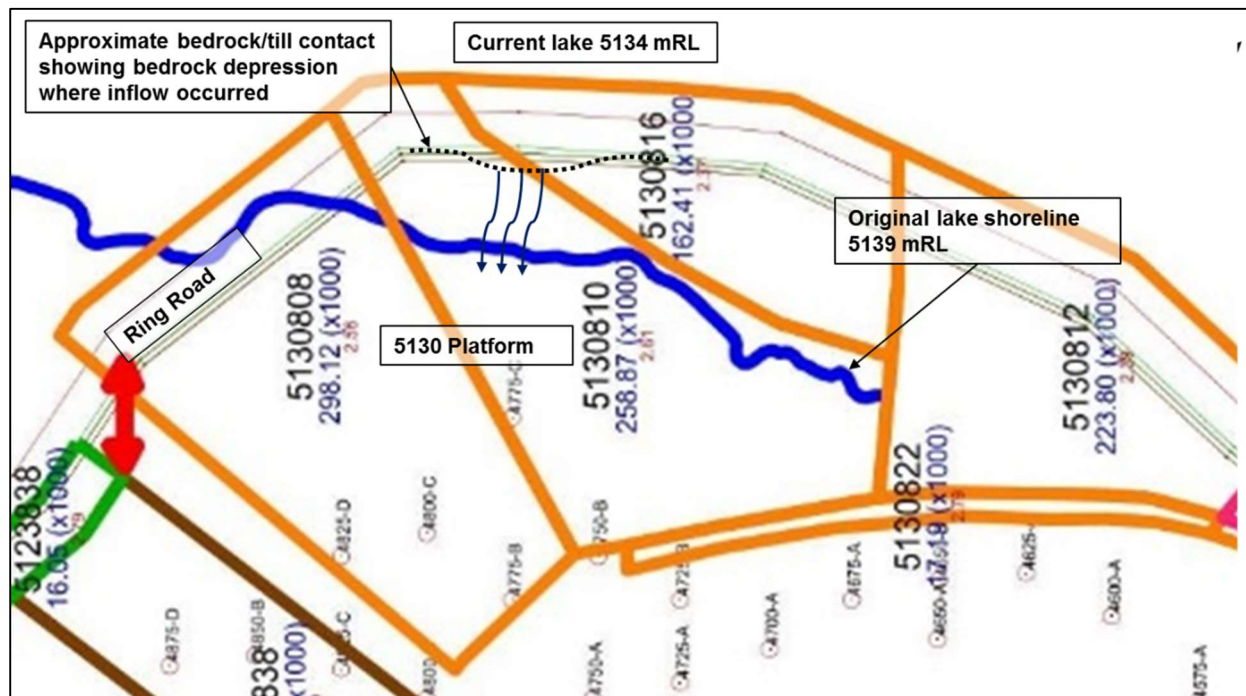
Figure 8-4: Vault Pit inflow location on 5130 bench, grid east wall

- Lower the water level in Vault Lake to reduce inflows through the ring road.
- If settlement of the ring road is noted, use road rock fill material to bring back to grade. Monitor for the development of tension cracks within the road surface. Restrict access on the downstream side of the ring road in the immediate area of the seepage.
