Annual Review of Slope Performance

MEADOWBANK MINE

ANNUAL REVIEW OF PIT SLOPE PERFORMANCE (2015)

CJ Clayton Mine Geotechnical Services Ltd.
North Vancouver, BC

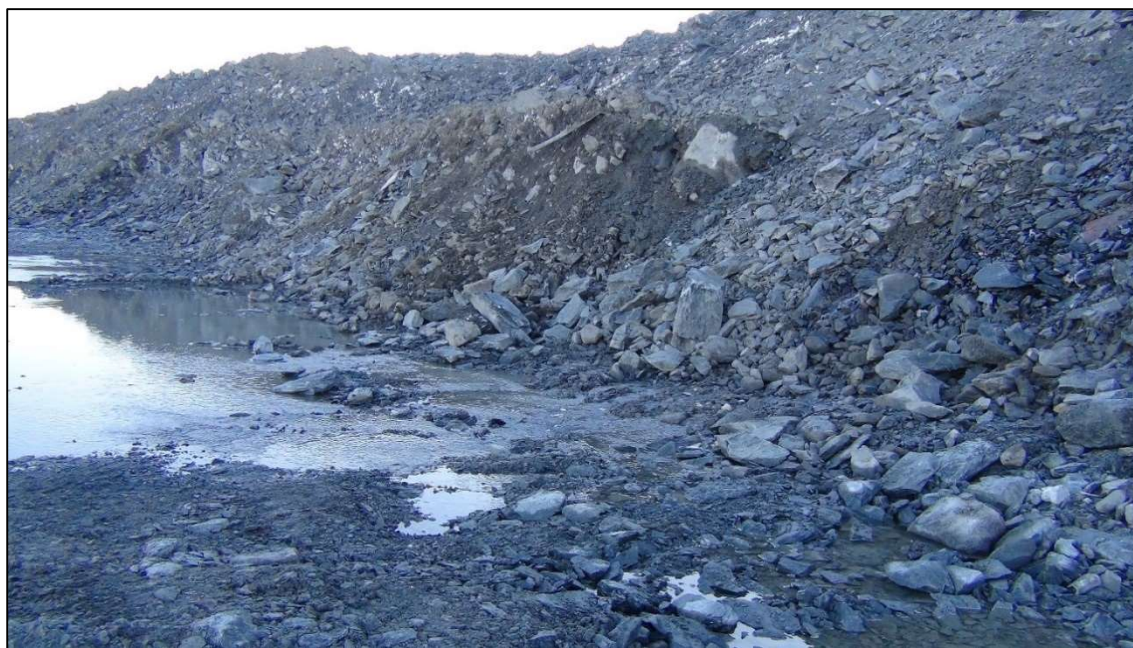
Photograph 8-12: Vault Pit flowing water from seepage face on downstream side of ring road (5130 mRL)

A review of the area indicated that the seepage was associated with a bedrock depression exposed in the till material of the ring road. The bedrock depression allowed a hydraulic connection to be formed with the partially dewatered Vault Lake so that water could flow through the depression and through the coarse rock fill used for construction of the ring road. Water flowing through the rock fill was clear, and so there was no indication that till material underlying the ring road was being eroded, which could potentially lead to instability. The rock fill overlying the till is relatively thin, as is the till. Even if erosion of the till were to occur, overall instability of the ring road is unlikely due to the relatively thin till profile. Some settlement of the ring road in this area was noted, and this can be remedied by hauling and dumping additional rock fill material to bring the ring road back up to grade.

- Lower the water level in Vault Lake to reduce inflows through the ring road.
- If settlement of the ring road is noted, use road rock fill material to bring back to grade. Monitor for the development of tension cracks within the road surface. Restrict access on the downstream side of the ring road in the immediate area of the seepage.

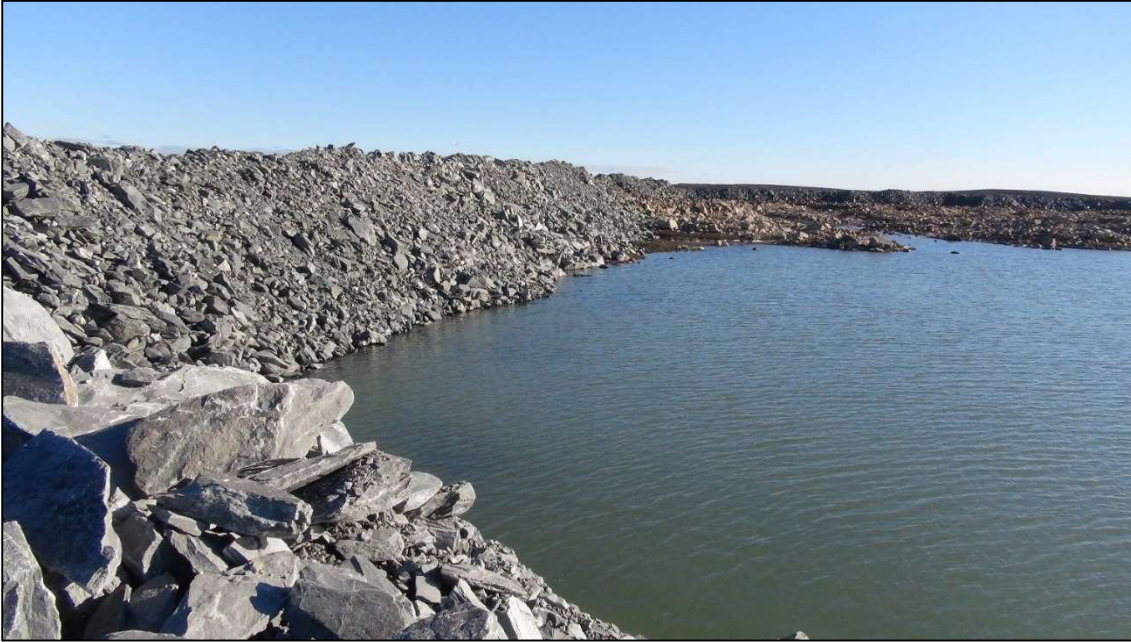
Photograph 8-13: Vault Lake on upstream side of ring road (5134 mRL)

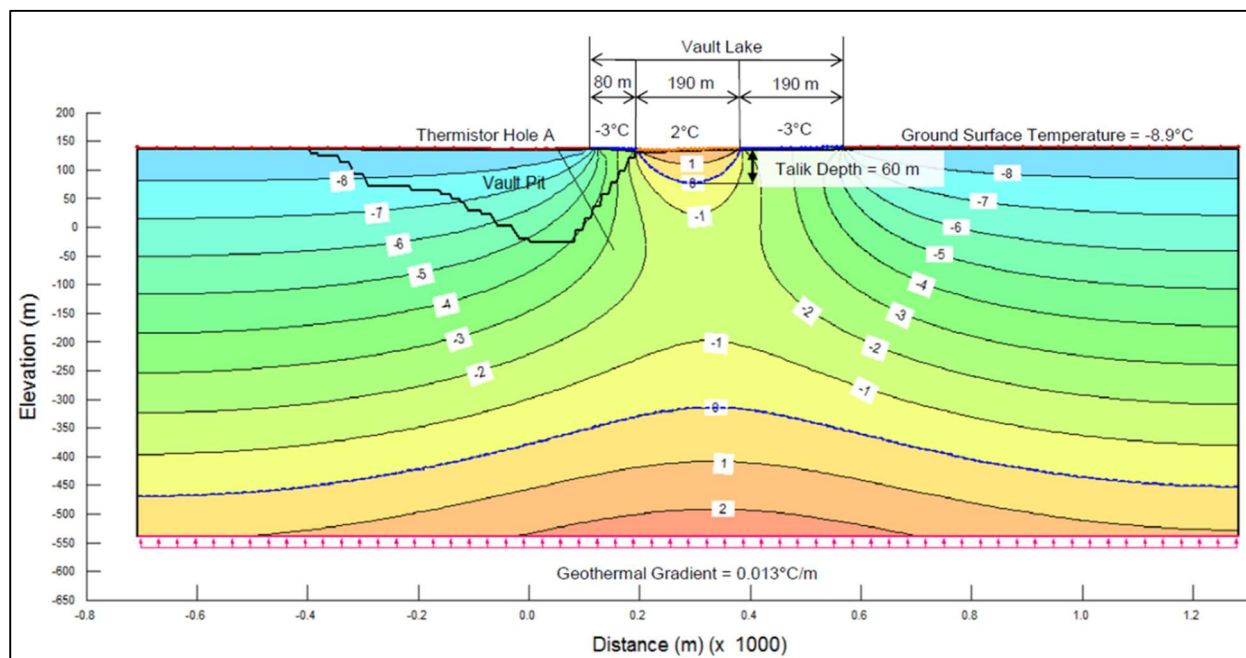
Thermal modeling carried out during the 2013 optimization study noted that if this part of the pit were pushed back to intersect the talik beneath Vault Lake, then inflows to the pit are to be expected (Golder 2013). This is shown by the following steady state thermal figure from the 2013 report, which shows the east pit crest intersecting the talik beneath Vault Lake during initial mining of the pit in this area. Currently, the inflows to the pit that occurred on 16 September 2015 are consistent with the predictions of the thermal modeling.

Figure 8-5: Vault Pit steady state thermal model (Ref: Golder 2013)

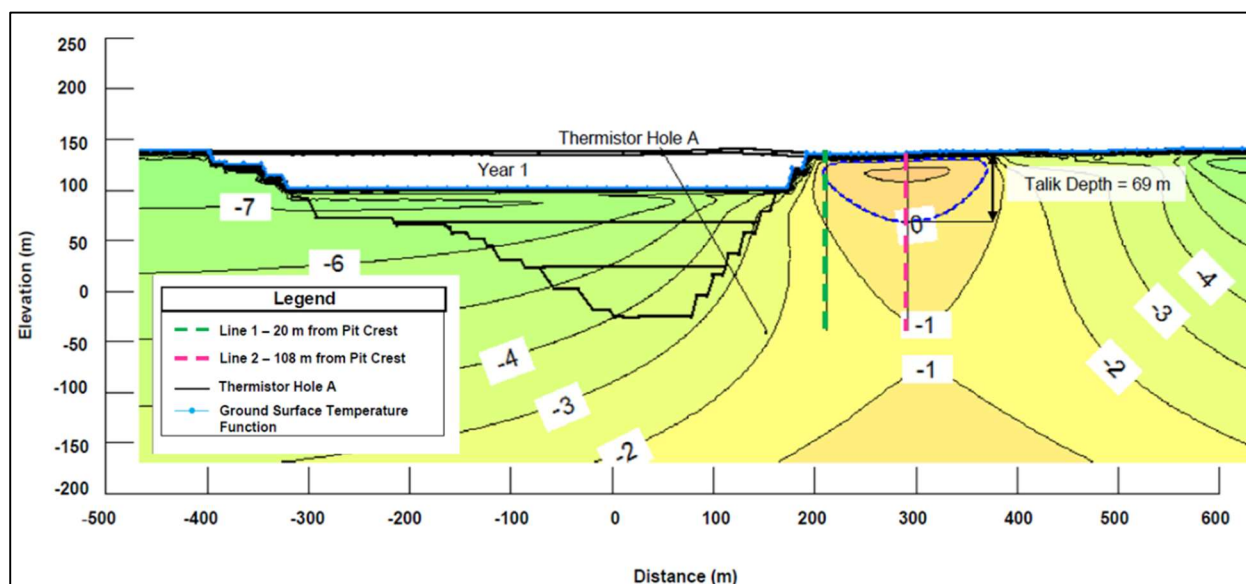
The thermal modeling also predicts that over time, permafrost will develop into the talik area, eventually preventing further inflows (after the first full bench has been excavated). It is important that AEM monitor this condition next year to confirm the observed seepage behaviour remains consistent with the predictions of the thermal model. The optimized slope design criteria and the slope stability relies on the predictions that the development of permafrost and continued isolation of the talik will act as a barrier to groundwater, so that no groundwater pressures will exist behind the wall.

Figure 8-6: Vault Pit transient thermal model, Year 1 (Ref: Golder 2013)

The wall should be observed generally to be dry. If significant seepage is observed from the wall at various bench levels during next year's thaw period, combined thermistor and piezometer tips should be installed behind the wall to define the thermal and groundwater pressure conditions, and compare these to model predictions.

- If significant inflows continue to be observed during 2016 summer thaw period, install piezometers and thermistor behind the wall, record observed conditions, and compare with predicted conditions.

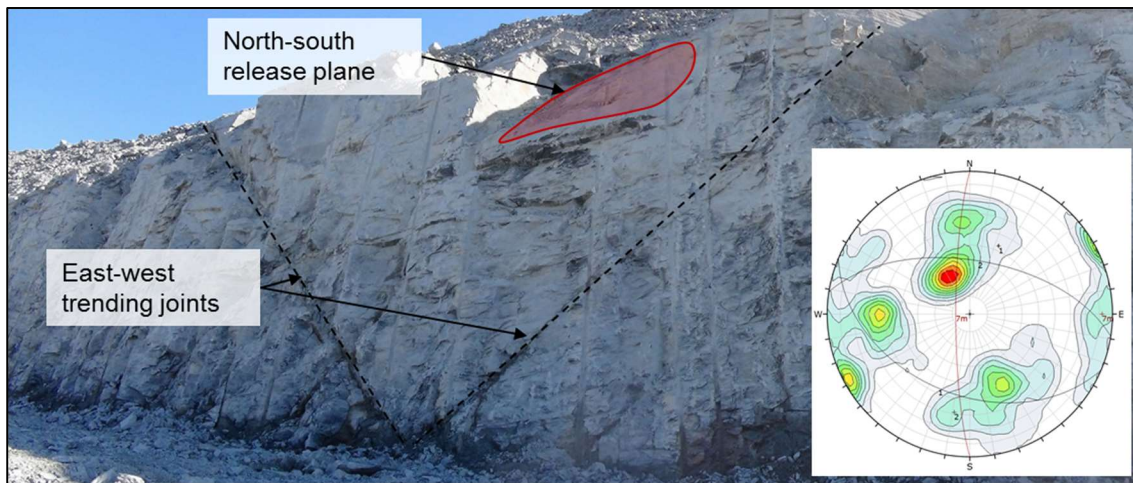
A large wedge was observed at the north end of the east wall on the 5109 platform. The wedge is formed by intersecting east-west trending structures which are inclined to the north and south, as shown in the following photograph.

Photograph 8-14: Vault Pit Phase 2 grid east wall wedge

The plunge of these wedges is shallow, less than 10 degrees. Consequently it is not anticipated that these will present bench-scale or multiple bench scale stability issues as the pit is developed. Nevertheless, as the pit continues to be mined, these should continue to be monitored for changes in orientation. The presence of steeply west dipping back release planes could also present the risk of smaller scale planar failures and so light vehicle traffic and personnel should maintain a safe setback distance from the bench faces.

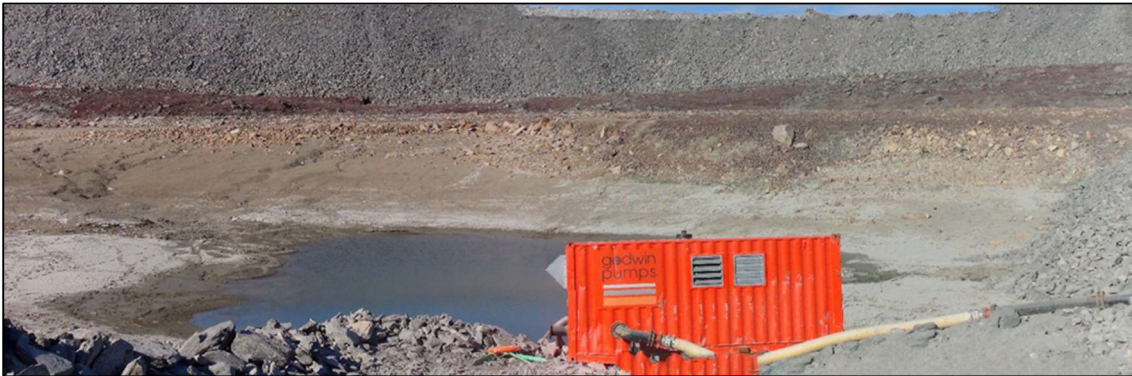
Photograph 8-17: Vault Pit Pond A water management pond

It is possible the seepage source is release of water stored in the talik beneath Vault Lake, or potentially seepage from Pond A. However, flows are low and are not likely to result in the formation of significant ice.

The geometry of the back release plane is such that this wedge could be supported by bolting, and this should be considered. In the interim, a bumper berm should be placed at the base of the wedge to maintain traffic or personnel at a safe setback distance. Water lines from the sump should be moved so that if failure were to occur it would not compromise the effectiveness of the water management system.
