Appendix F1

GN Spill Report

NT-NU SPILL REPORT

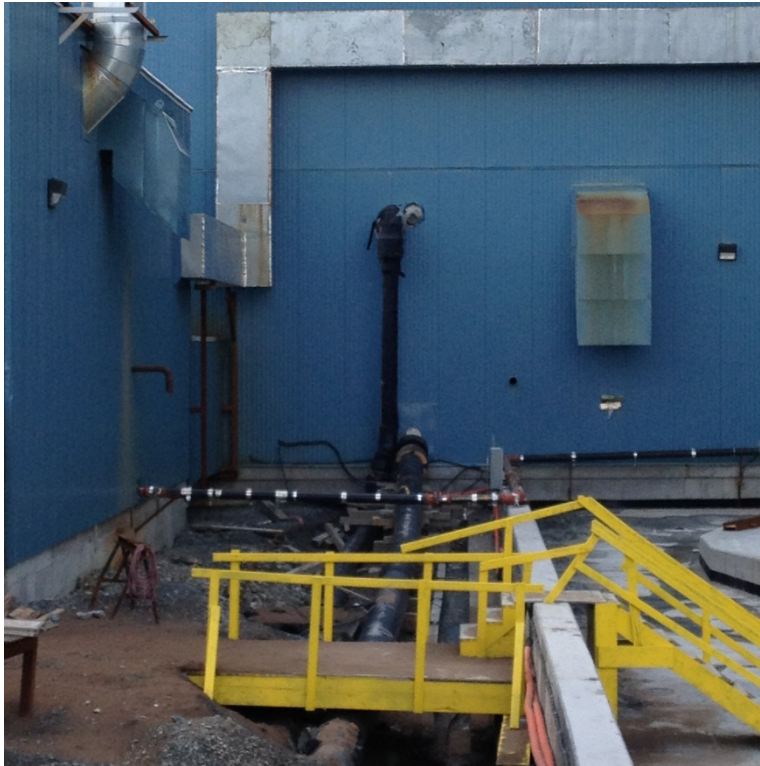
Clean up was immediately initiated by shovelling and pumping the slurry back into the leach pad containment. The “Y” that broke was replaced, and tailings deposition recommenced.

The Mill maintenance group has added a better support to the location in which the “Y” is located. In addition, as part of the preventative maintenance program, the “Y” will be inspected annually and changed if any irregularities are noted.

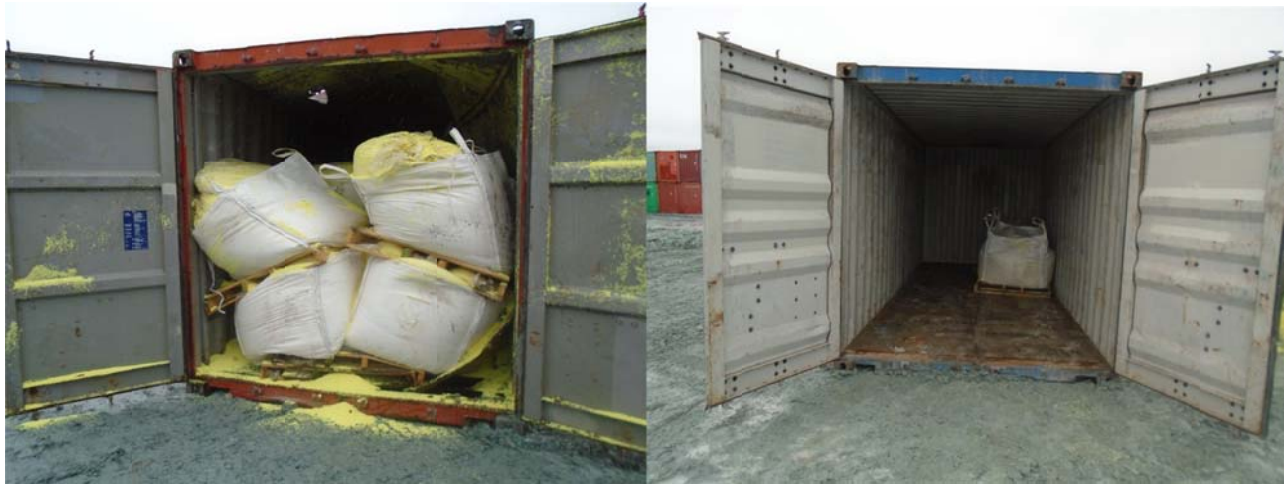
After investigation it was found that the bottom of the container was rusted and could not withstand the weight of the load during transfer. It was also found to be slippery because of ice accumulation underneath. Because of the aforementioned factors, the container handler could not hold it upright and it fell on its side. Spillage occurred when the container was put back upright, exposing gaps and openings.

Clean up was immediately started by collecting fallen prills around area. Upon opening the door of the container, salvageable bags and products were put into an empty container and brought to the Mill for process use.

Short term : containers that are stored at ground level over winter will be inspected before handling. This includes also an assessment of the bottom portion for any signs of damage and/or rust.

Mid/long term : storage/placement of containers on site, especially related to chemicals, will be re-evaluated to see if minimizing the possibility of corrosion is possible. This could include, for example and not necessarily : storing selected containers on second/third row, putting block under them so they are not in contact with the ground, and so forth.

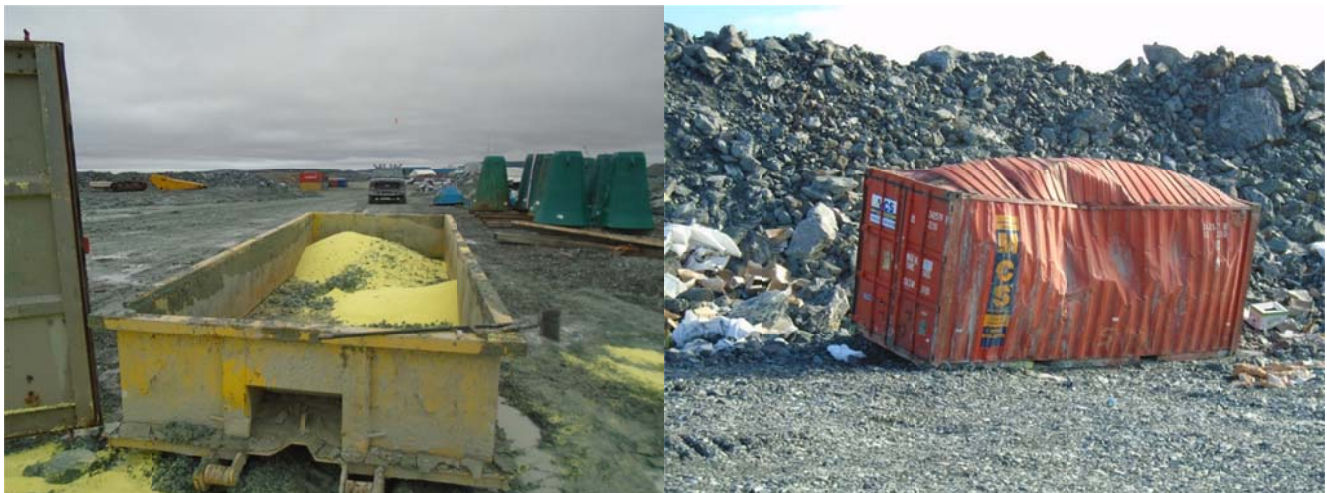
All products lost in the process of removing bags and the original spilled material was then put in a roll-off to be disposed of at the landfill. Soil was added on top of the material to ensure that nothing gets windblown during transport. Roll-off was cleaned once emptied at disposal location. Everything was then covered with NPAG material to prevent further exposure to the product. The damaged container was brushed clean and also brought to the landfill.

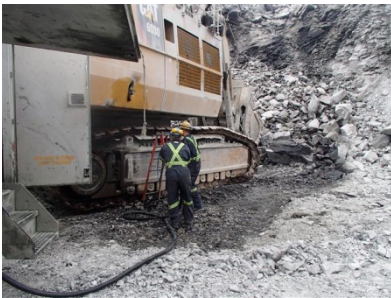
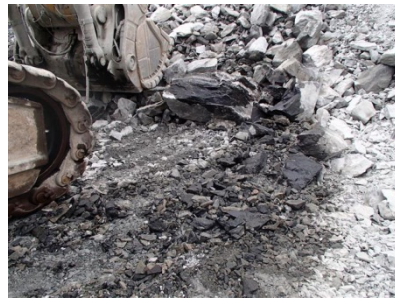
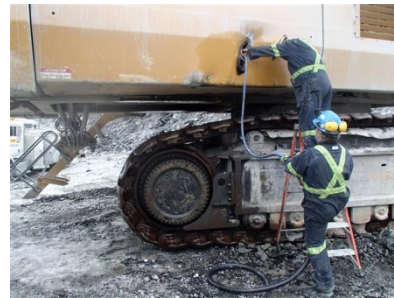
July 30, 2015 Spill

H	PRODUCT SPILLED Diesel Fuel	QUANTITY IN LITRES, KILOGRAMS OR CUBIC METRES 300 Litres	U.N. NUMBER 1202		
	SECOND PRODUCT SPILLED (IF APPLICABLE)	QUANTITY IN LITRES, KILOGRAMS OR CUBIC METRES	U.N. NUMBER		
I	SPILL SOURCE Excavator Fuel Tank	SPILL CAUSE Equipment Damage	AREA OF CONTAMINATION IN SQUARE METRES 10m2		
J	FACTORS AFFECTING SPILL OR RECOVERY	DESCRIBE ANY ASSISTANCE REQUIRED	HAZARDS TO PERSONS, PROPERTY OR EQUIPMENT		
K	ADDITIONAL INFORMATION, COMMENTS, ACTIONS PROPOSED OR TAKEN TO CONTAIN, RECOVER OR DISPOSE OF SPILLED PRODUCT AND CONTAMINATED MATERIALS While performing regular excavation in Vault Pit, a piece of loose rock fell from the pit wall and struck the large excavator on the track and then hit the fuel tank, puncturing it. The fuel spilled out of the punctured hole onto the ground inside the pit. All fueled spilled was contained inside the pit with no effect to any waterways. The contaminated area was excavated to remove all contaminated material. This contaminated material will be taken to the Meadowbank landfarm for remediation. Photos attached. Spill Location - 14W 0640816 7219910 Contact information: Jeffrey Pratt 819-759-3555 ext 6728

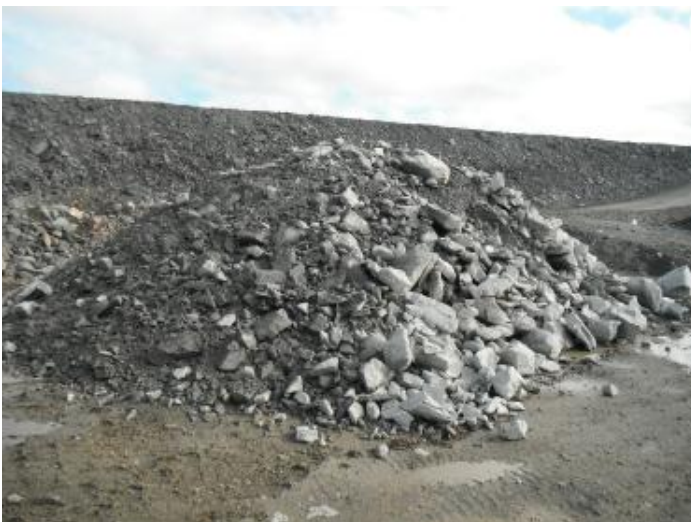
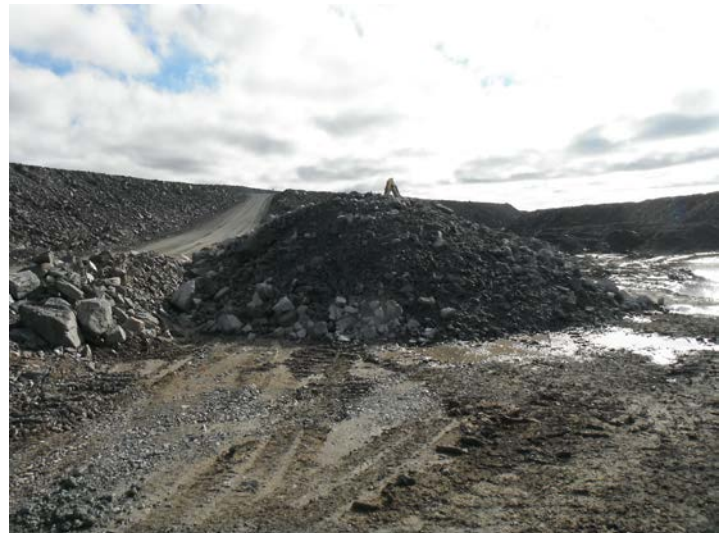
Clean-up – July 31st

After the excavator was repaired and deemed fit to work, the mine crew went forward to remove the contaminated material from the area of the spill. The material was all gathered into one pile prior to transport. All material was transported to the Meadowbank Landfarm for remediation.

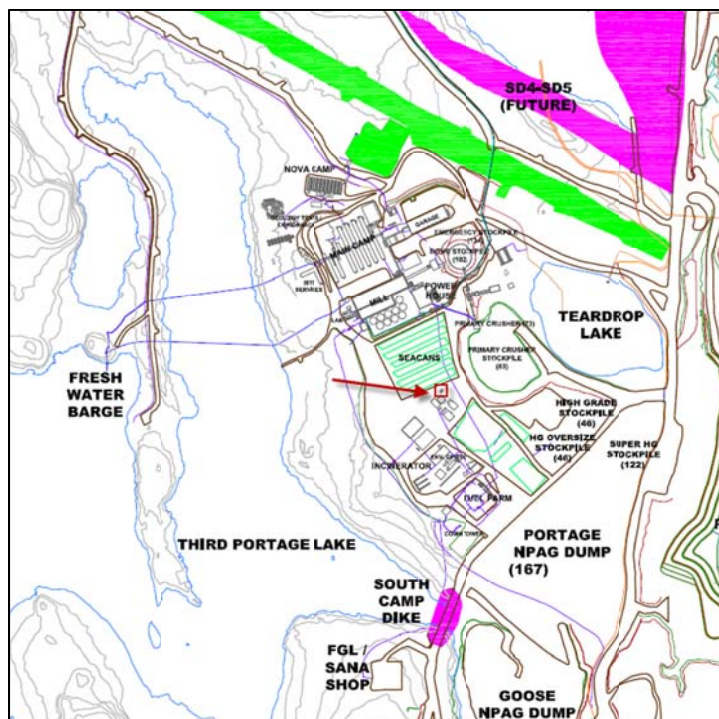
Figure 1 – Approximate location of the spill, September 4th 2015

On September 4th 2015, in the area of the oil filtering station, during the process of moving totes of waste oil from a container, the forks of the loader hit the outlet valve of a tote behind the one being moved. Upon noticing the spill of waste oil, the employee on the ground signaled the operator to stop moving the tote. They then proceeded to flip the tote on its side to prevent further spillage. See Figure 1 for the approximate location of the spill. Approximately 160 liters of waste oil was spilled and the area of contamination was approximately 20 m².
