Report: 2017 Annual Geotechnical Inspection

February 2018

2017 Annual Geotechnical Inspection Meadowbank Gold Mine, Nunavut

Report Number: 1784282-1574-RPT-Rev0

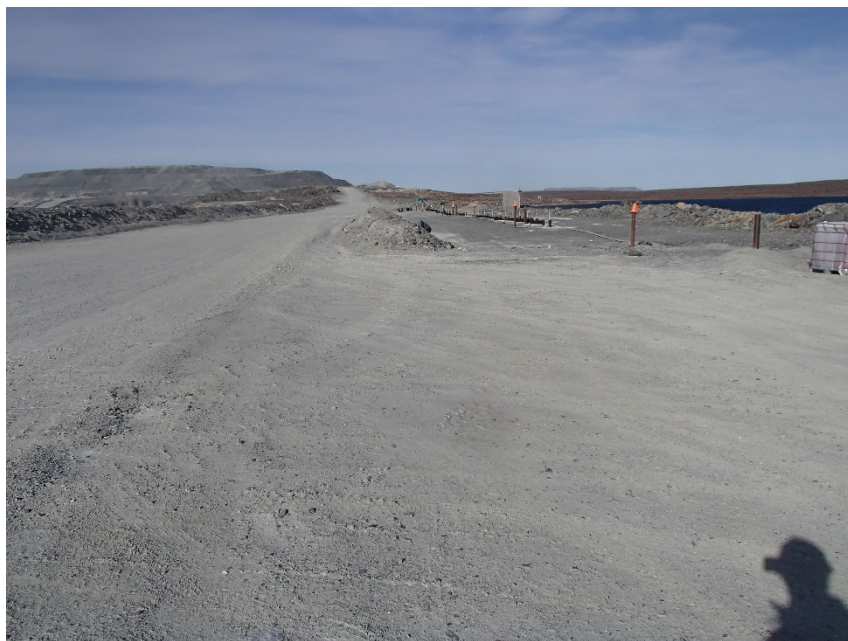
Photograph A1-2 East Dike

Description: From approximately Sta. 60+375, looking south at the crest.

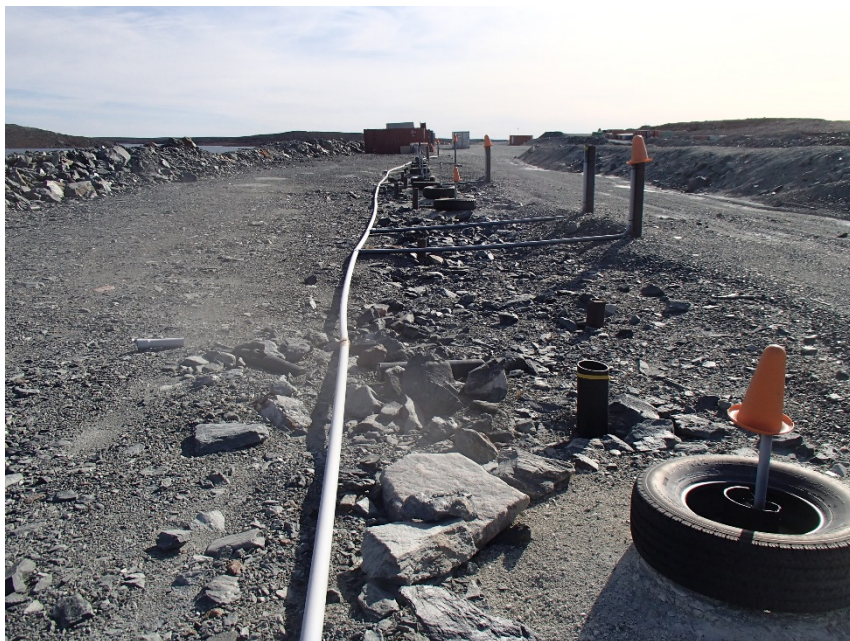
Photograph A1-4 East Dike

Description: From approximately Sta. 60+560, looking north at the crest.

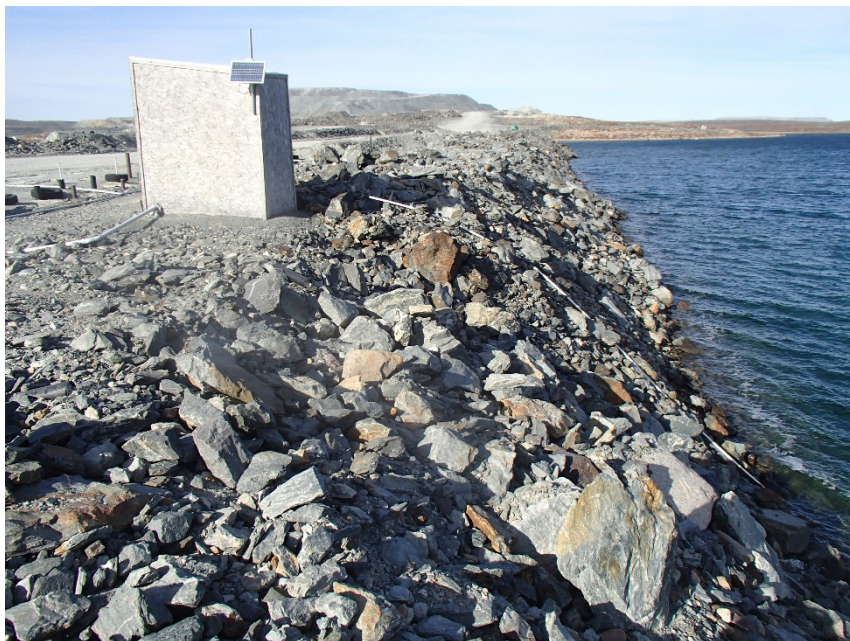
Photograph A1-6 East Dike

Description: From approximately Sta. 60+540 upstream, looking south at the crest and the upstream slope.

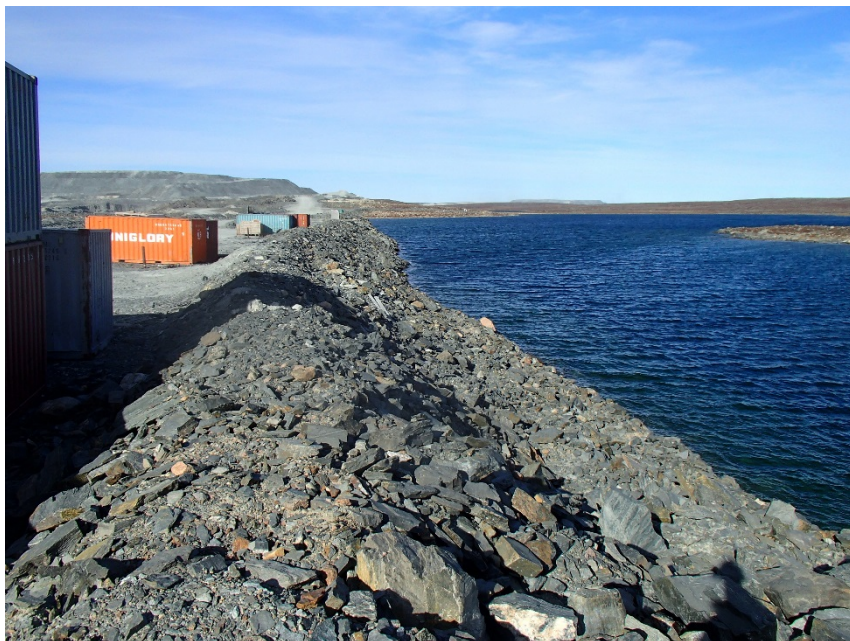
Photograph A1-8 East Dike

Description: From approximately Sta. 60+810, looking south at the crest.

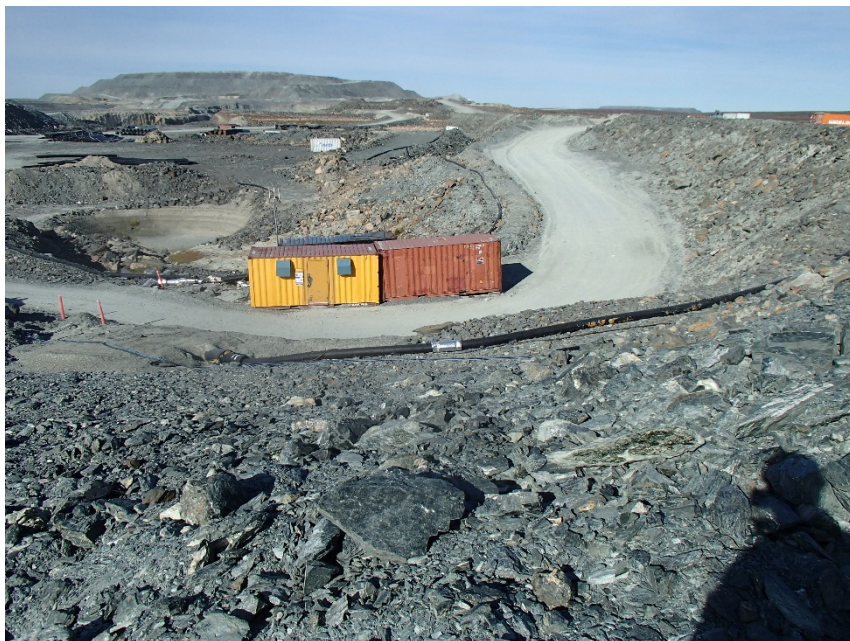
Photograph A1-10 East Dike

Description: From approximately Sta. 60+250 upstream, looking south at the crest and the upstream slope.

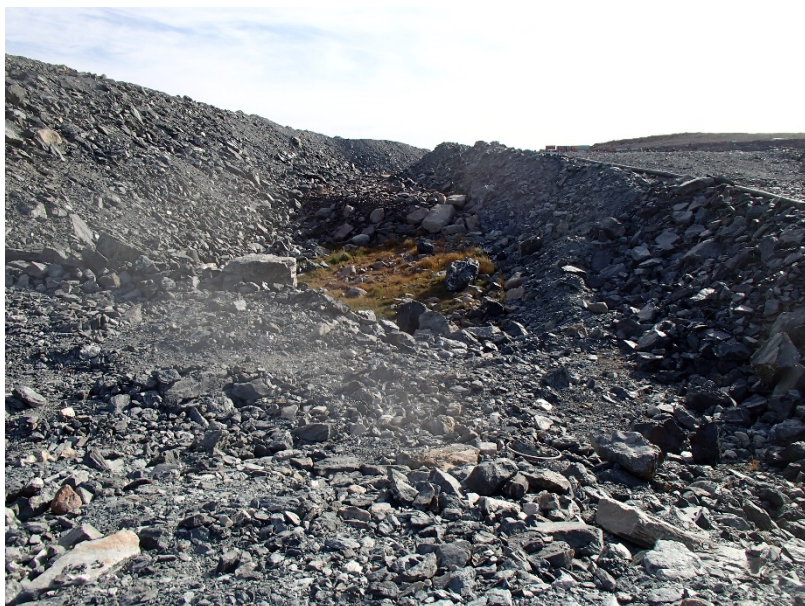
Photograph A1-14 East Dike

3.7 Other unusual conditions	None		
4. DOWNSTREAM TOE AREA		520, 523, 531, 532, 533	
4.1 Seepage from dam	Yes, presence of 3 zones		Zone of seepage downstream near Sta. 60+247. A sump is installed (pumping system located in container on the photo). No additional seepage observed at the surface of the ground. Pumping collection system started on April 4, 2012. Flow is being monitored since July 2013.
			Zone of seepage downstream near Sta. 60+498. A sump is installed (pumping system located in container on the photo). Ponded water nearby. No additional seepage observed at the surface of the ground during the inspection. Pumping collection system started on April 4, 2012. Flow is being monitored since July 2013.
			Seepage zone near Sta. 60+575. According to AEM, this zone was practically dry all year. Water ponding was observed during inspection but no flow was noticed.

Description: From approximately Sta. 60+570 downstream, looking north at the downstream toe.

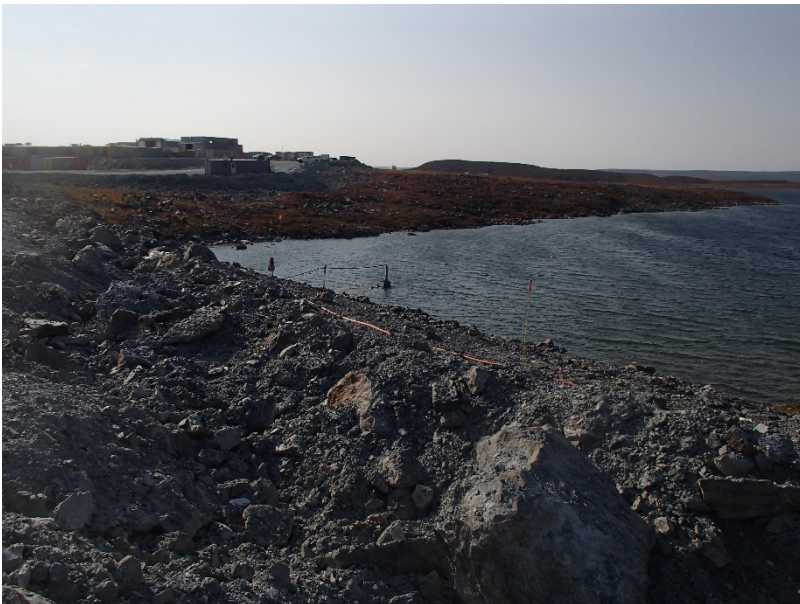
Photograph A2-2 South Camp Dike

2.4 Cracks	None observed		
2.5 Face liner condition (if applicable)	Liner not visible at the time of the inspection		Bituminous geomembrane liner. Compacted granular material mixed with bentonite was placed above the liner, followed by a thermal cap layer covering the entire liner face.

Description: From the south abutment, looking north at the upstream slope and the thermistors instrumentation set-up.

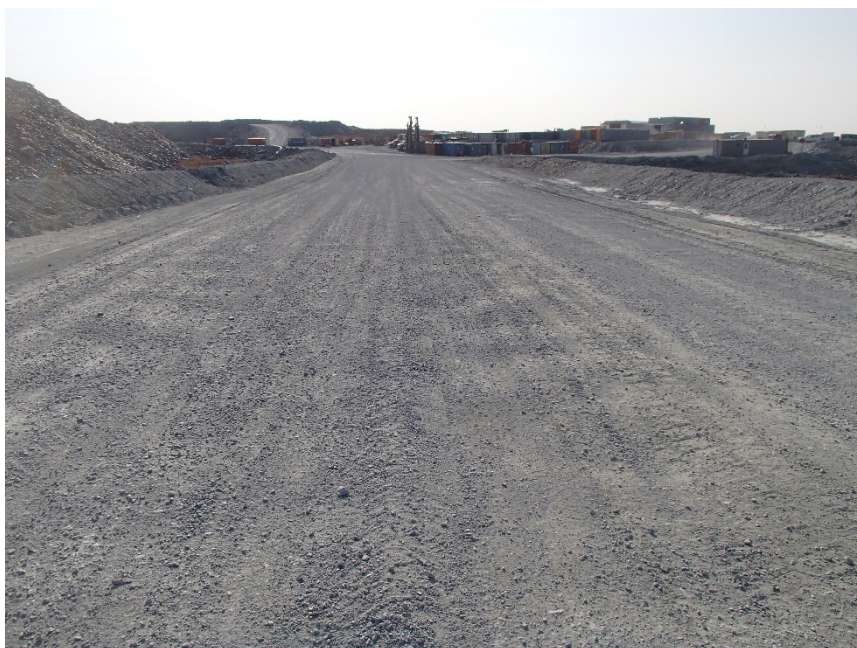
Photograph A2-4 South Camp Dike

Description: From the south abutment, looking north at the crest.
