Bay-Goose Dike Photographic Log and Record of Inspection

**2017 ANNUAL GEOTECHNICAL INSPECTION
MEADOWBANK GOLD MINE, NUNAVUT**

APPENDIX A3 RECORD OF DAM INSPECTION

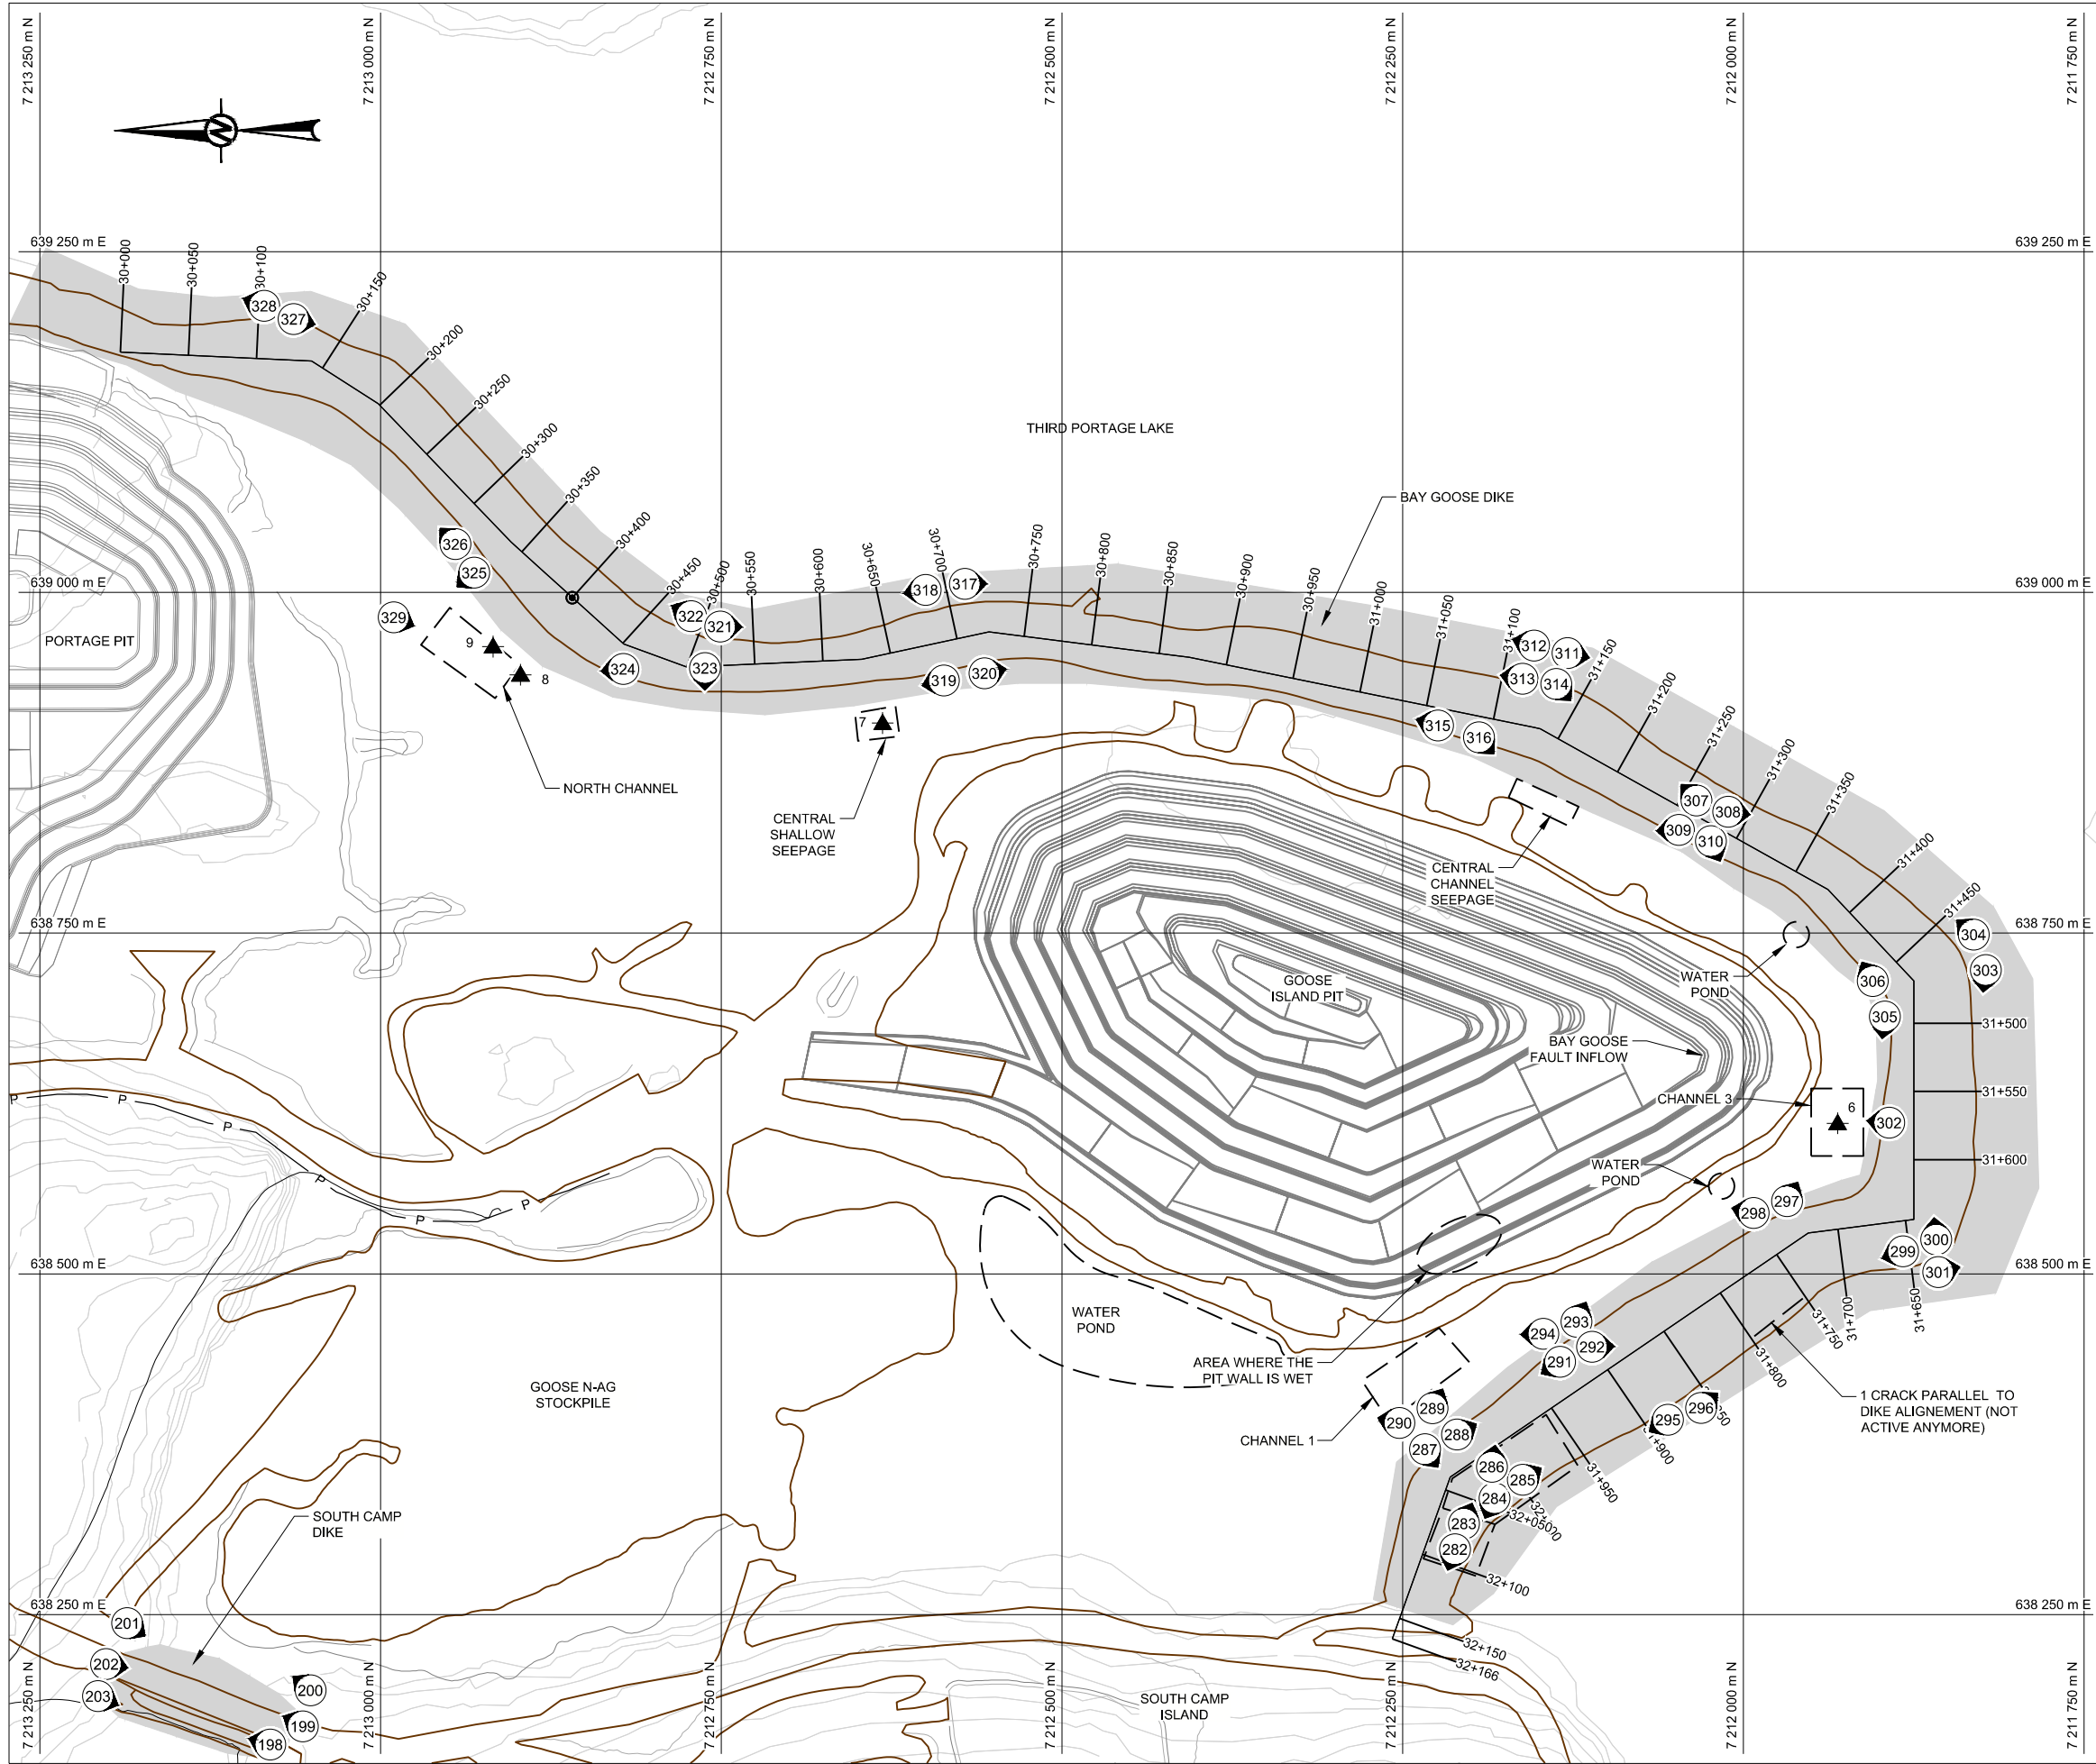
4.1 Seepage from dike	Yes		Seepage zone observed as well as water pond. The seepage is being monitored by the mine and does not show signs of aggravation.
	North Channel	325, 329	Monitored by stations 8 (30+420) and 9 (30+380). Water flowing was observed during the inspection.
	Central Shallow	319	Presence of 2 seepage channels at 30+650 and 30+625. Flow was observed during inspection at 30+650. Monitored by station 7.

INSPECTION ITEM	OBSERVATIONS DATA	PHOTO	COMMENTS & OTHER DATA
	Central Channel	316	Presence of a seepage channel at Sta. 31+165. Water ponding was observed at the time of the inspection. It was pumped once after freshet only.
	Channel 3	297, 302, 305	Light flow observed during inspection. Monitored by station 6.
	Channel 1	289, 290	This seepage channel was not flowing at the time of the inspection.
	Water Ponds	298	Presence of water pond with no sign of seepage. Located at 31+750. Water was observed downstream of Channel 1 ponding against the ring rod of Goose Pit.

4.6 Other unusual conditions	Yes		Inflow of water on pit wall. Probably due to the Bay-Goose fault and rock quality. In the vicinity of Channels 1, 2 and 3. Not monitored anymore.
