SADDLE DAM 1 PHOTOGRAPHIC LOG

Saddle Dam 2 Photographic Log and Record of Inspection

Stormwater Dike Photographic Log and Record of Inspection

2017 ANNUAL GEOTECHNICAL INSPECTION
MEADOWBANK GOLD MINE, NUNAVUT

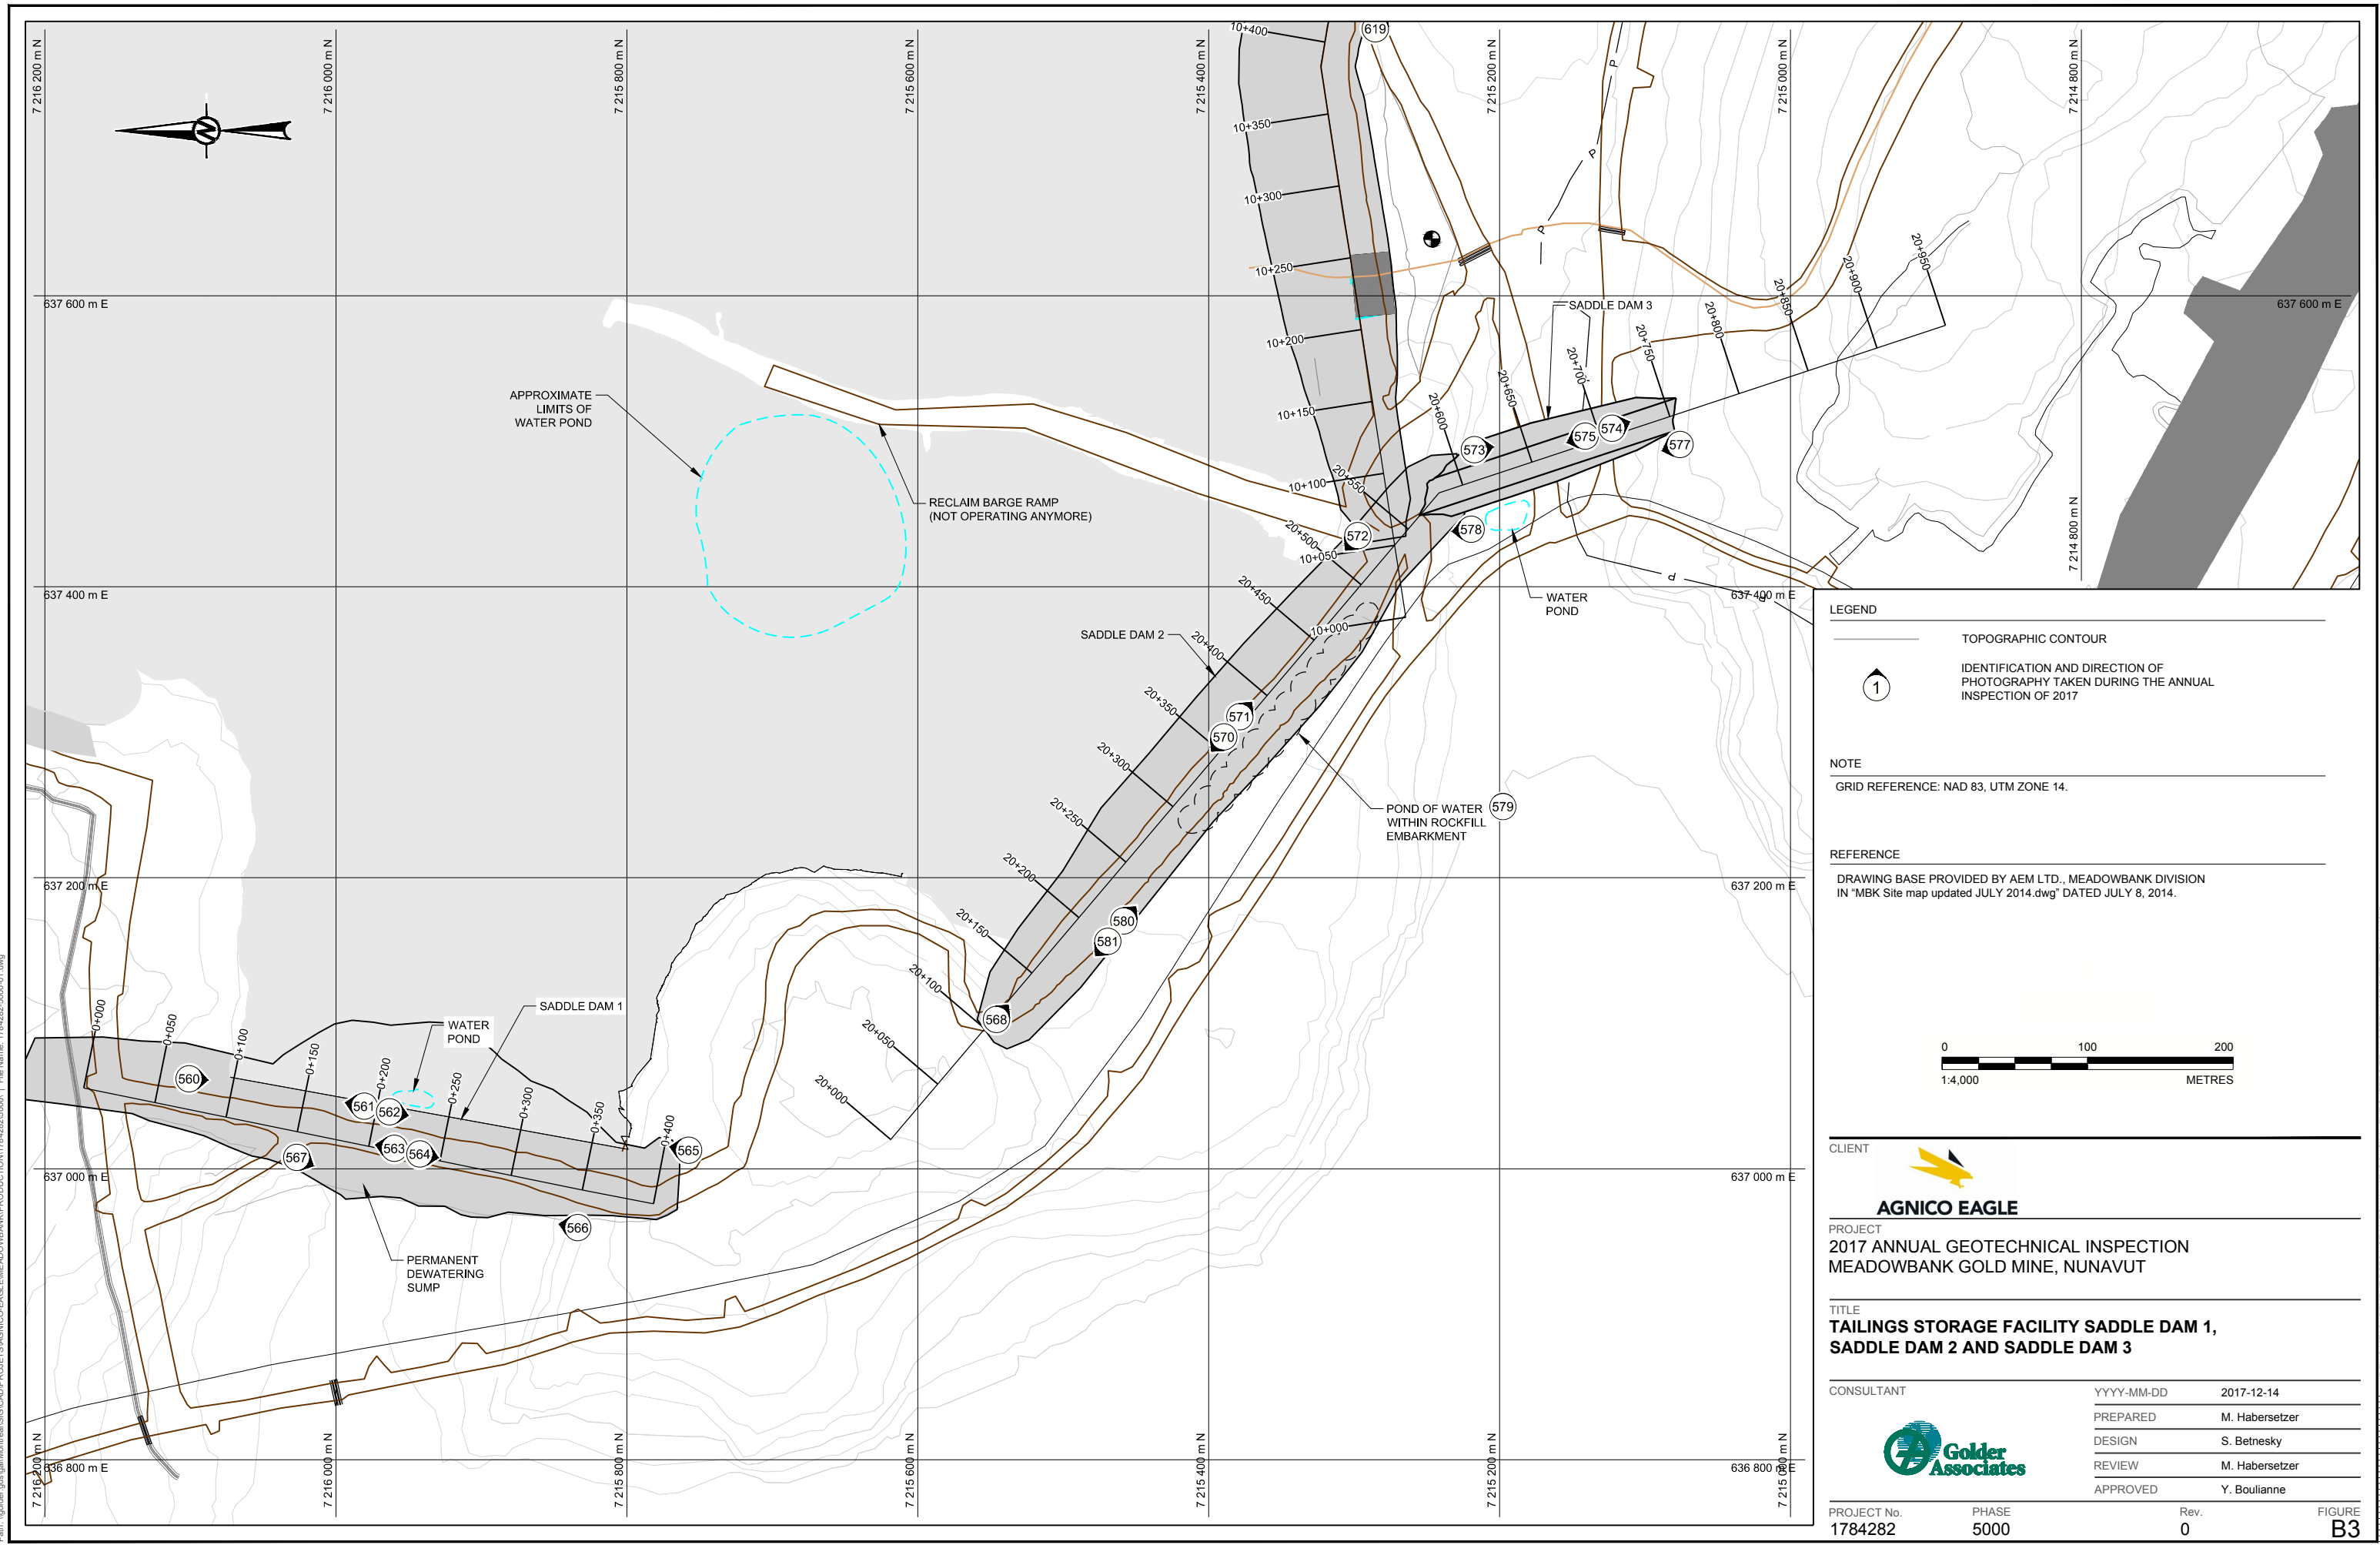
4.6 Other unusual conditions	Yes		Water is still ponding within the rockfill embankment between 20+275 to 20+475 approximately.
5. ABUTMENTS			
5.1 Seepage at contact zone (abutment/embankment)	None observed

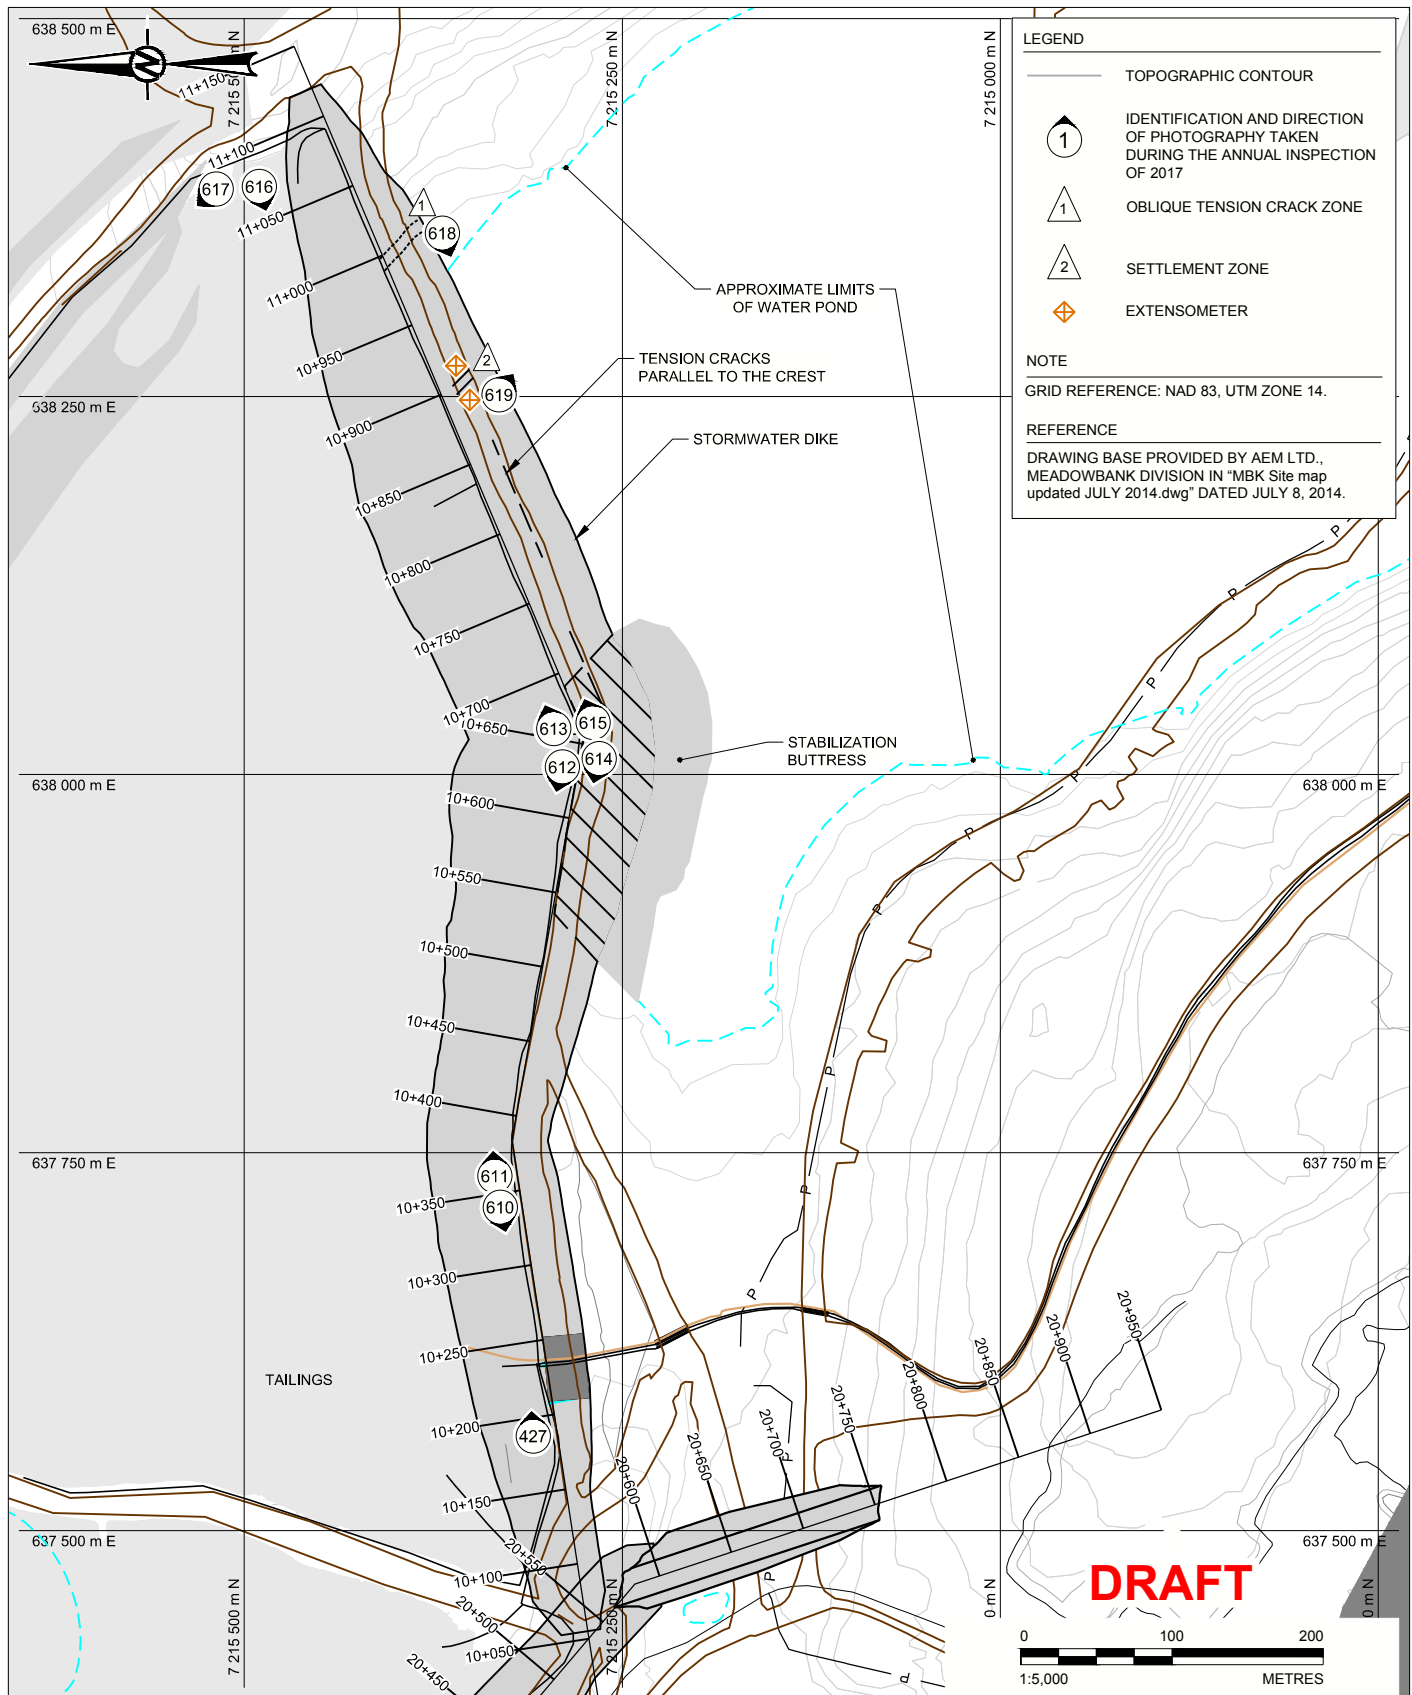
1.4 Surface cracking	Yes	619	Tension cracks and unexpected movement were observed (oblique tension cracks extending side to side). They are concentrated from 10+850 to 11+025 and appeared in late June after the freshet. No movement has been observed in the zone where a buttress was constructed at the toe in the South Cell. The buttress is covered by the pond.

1.5 Unexpected settlement	Yes (approx. 300 mm)		
1.6 Lateral movement	Yes		
1.7 Other unusual conditions			
2. UPSTREAM SLOPE		610, 611, 612, 613, 616	
2.1 Slope angle	Approx. 3H:1V		Rockfill
