APPENDIX B6

Saddle Dam 4 Photographic Log and Record of Inspection

APPENDIX B6 RECORD OF DAM INSPECTION

Client: AEM **By:** Yves Boulianne
Project: Meadowbank **Date:** September 13, 2017
Location: Saddle Dam 4 **Reviewed:** Yves Boulianne

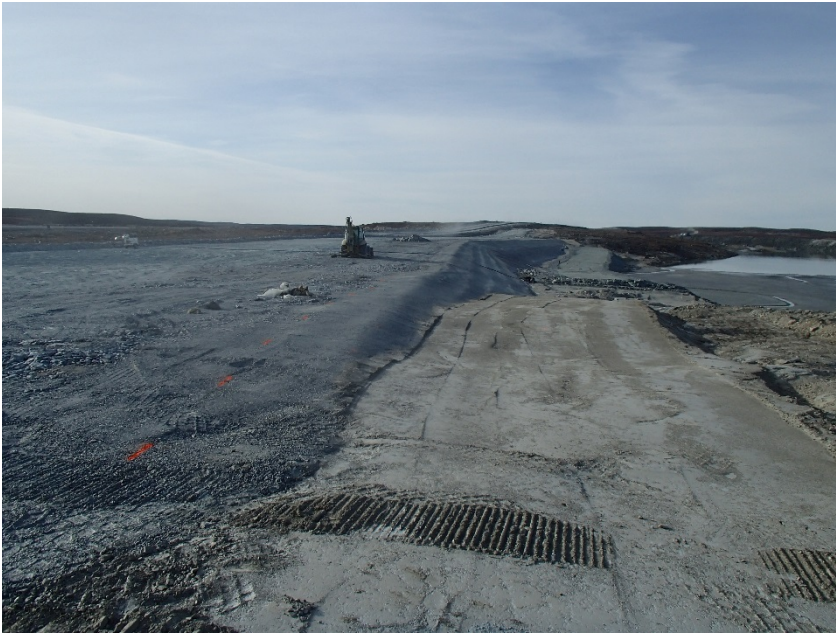
Photograph B6-1 Saddle Dam 4

Description: From 40+200 approximately, looking northwest at the upstream slope.

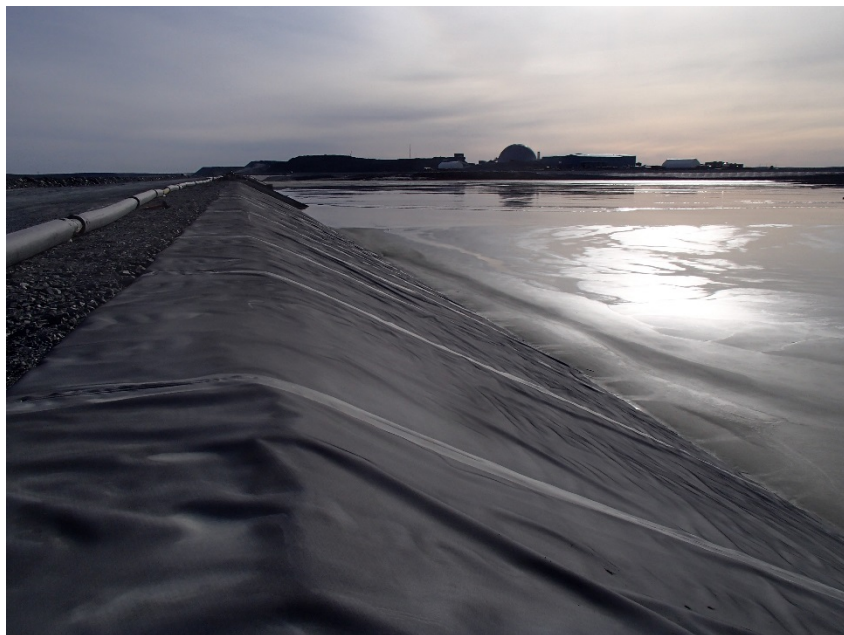
Photograph B7-1 Central Dike and Saddle Dam 5

Description: From approximately Sta. 0+325 looking southwest. View of the upstream slope of Central Dike.
