THERMISTOR 545-P1

MDRB # 22 P3 – STORMWATER DIKE UPDATE

Patrice Gagnon
September 4th 2017

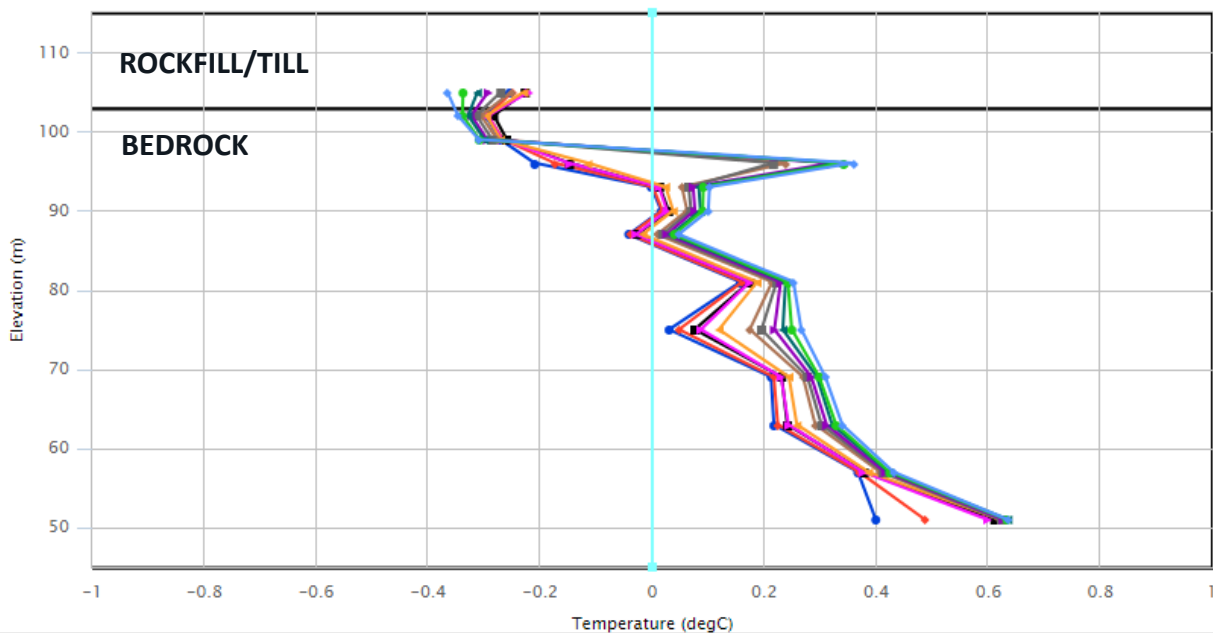
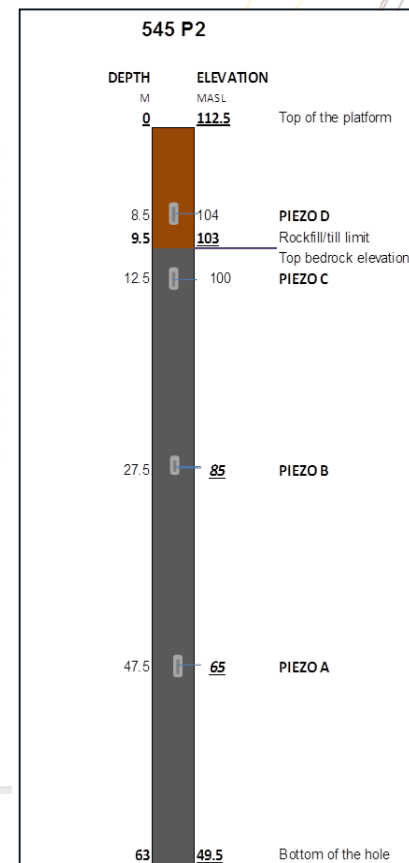
12 - CD - 545 - P2

- Temperature peak observed on the bead located at El. 96m from January 2015 to March 2017;
- In January 2015 readings was switched from manual to automatic;
- In March 2017, AVW multiplexer was changed and temperature profile was back to its original profile;
- Investigation still on going – interpretation of data must be done with precaution.

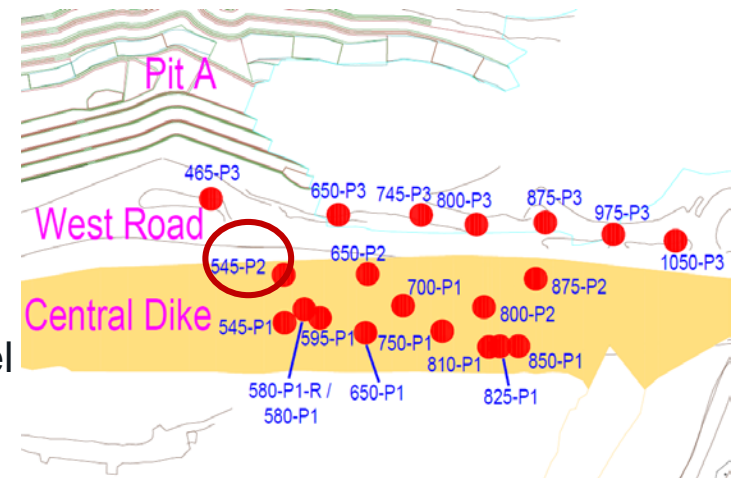
545-P2 Hole - Piezometrics Elevation and Attenuation Pond Elevation vs Time

- ➔ Piezometer A reading is increasing with South Cell level
- ➔ Other piezometers are recording suction

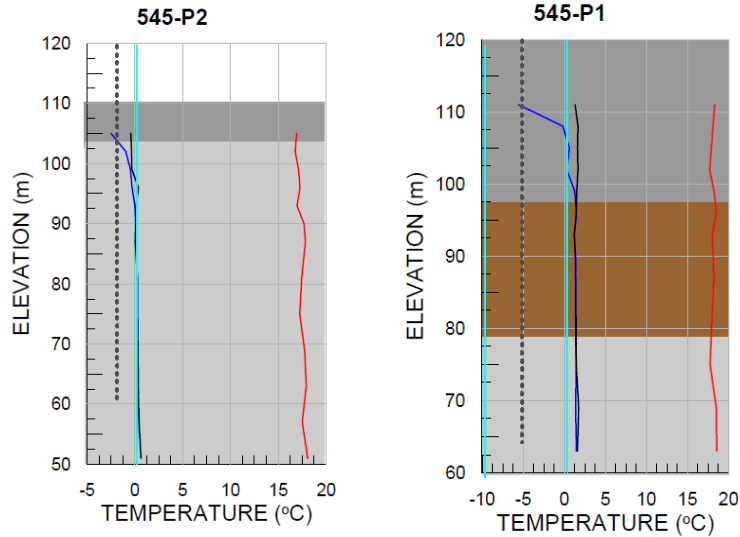
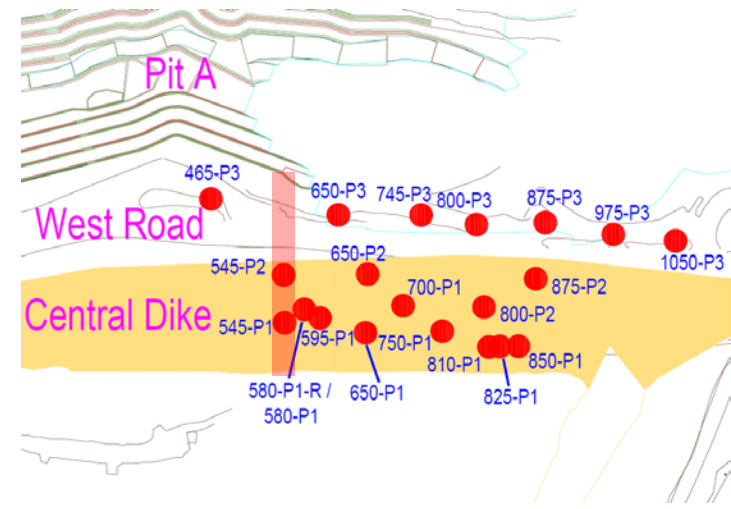
THERMISTOR READINGS FROM AUGUST 2015 - 2016

Max temperature in 2015-2016 was more around 2°C

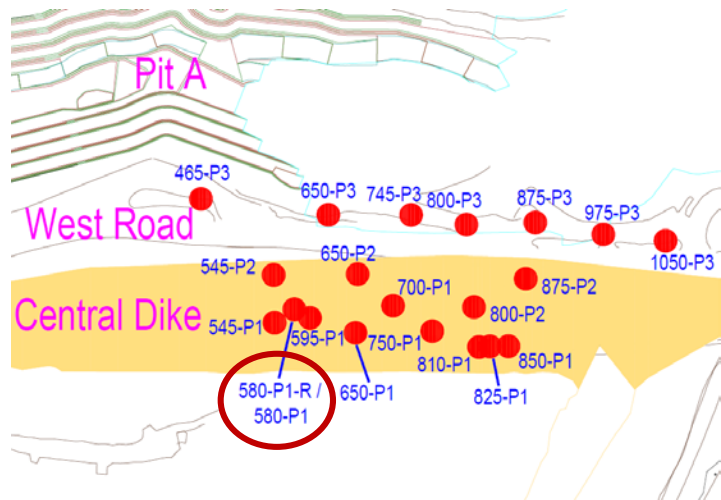
DH 580-P1-R Instrumentation

- Stabilisation in progress
- Temperature readings above 0°C
- Similar temperature readings range than 580-P1

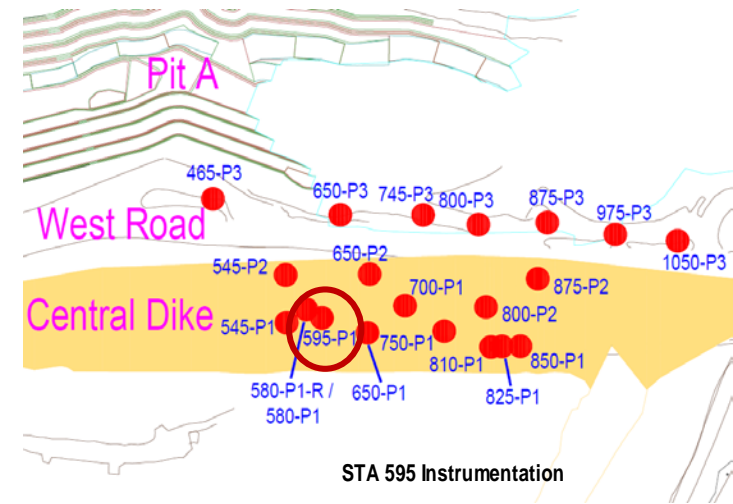
➔ Piezometric readings are fluctuating around D/S pond elevation since the installation.

➔ **Piezo C to E was installed in casing**

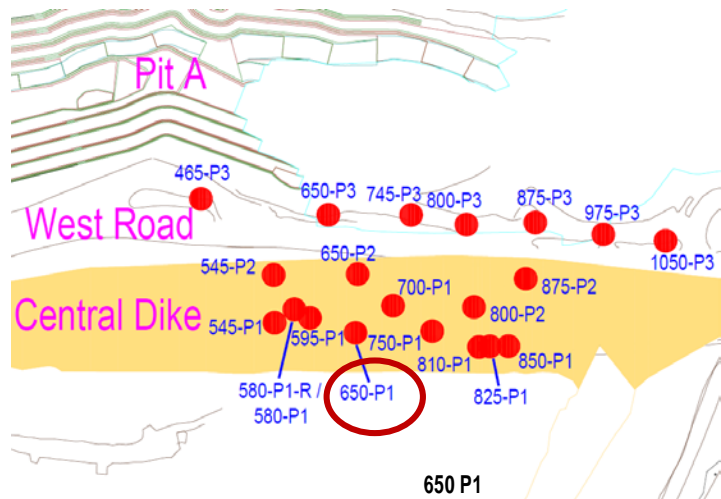
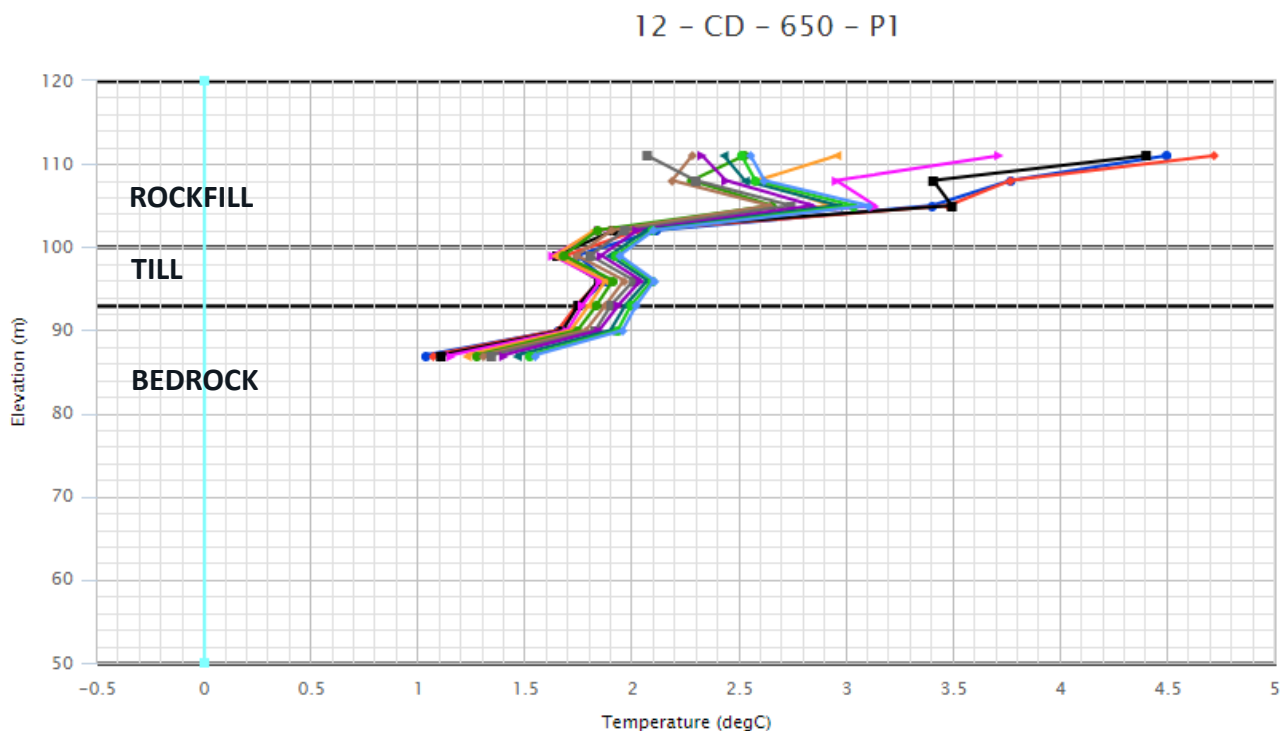
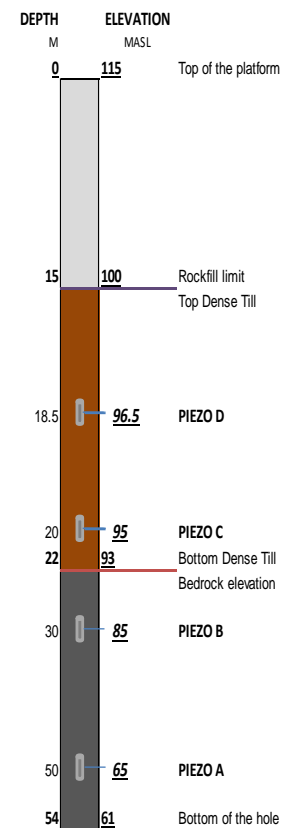
650 P1

- Thermistance reading not functional since January 2017
- Beads 10 to 12 are not fonctionning since August 2016
- Temperature of the bedrock/till units were in between 1.0 and 2.1° C.

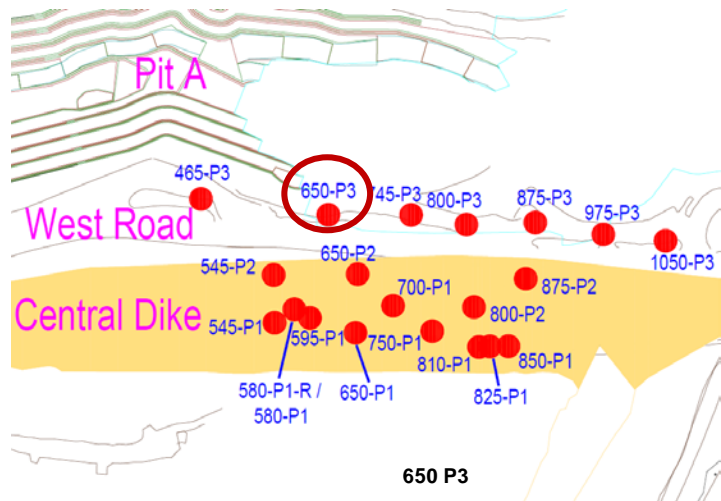
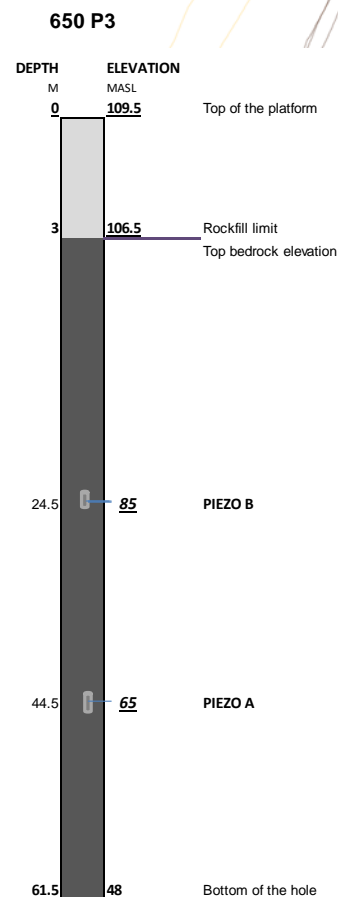
- Bedrock Below 0° C at 650-P3
- Temperature spike at El. 75 m is related to capacitance effect on this specific bead.

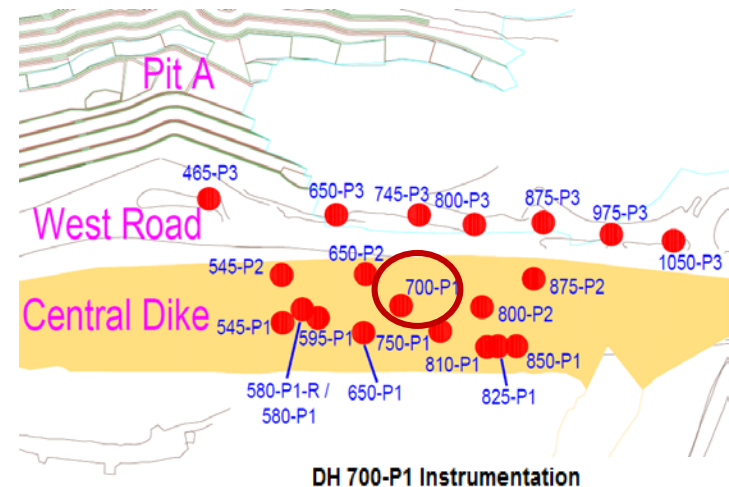
THERMISTOR 700-P1

- New instrument installed in 2017
- Stabilisation of temperature ongoing
- Till and bedrock temperature readings above 0° C

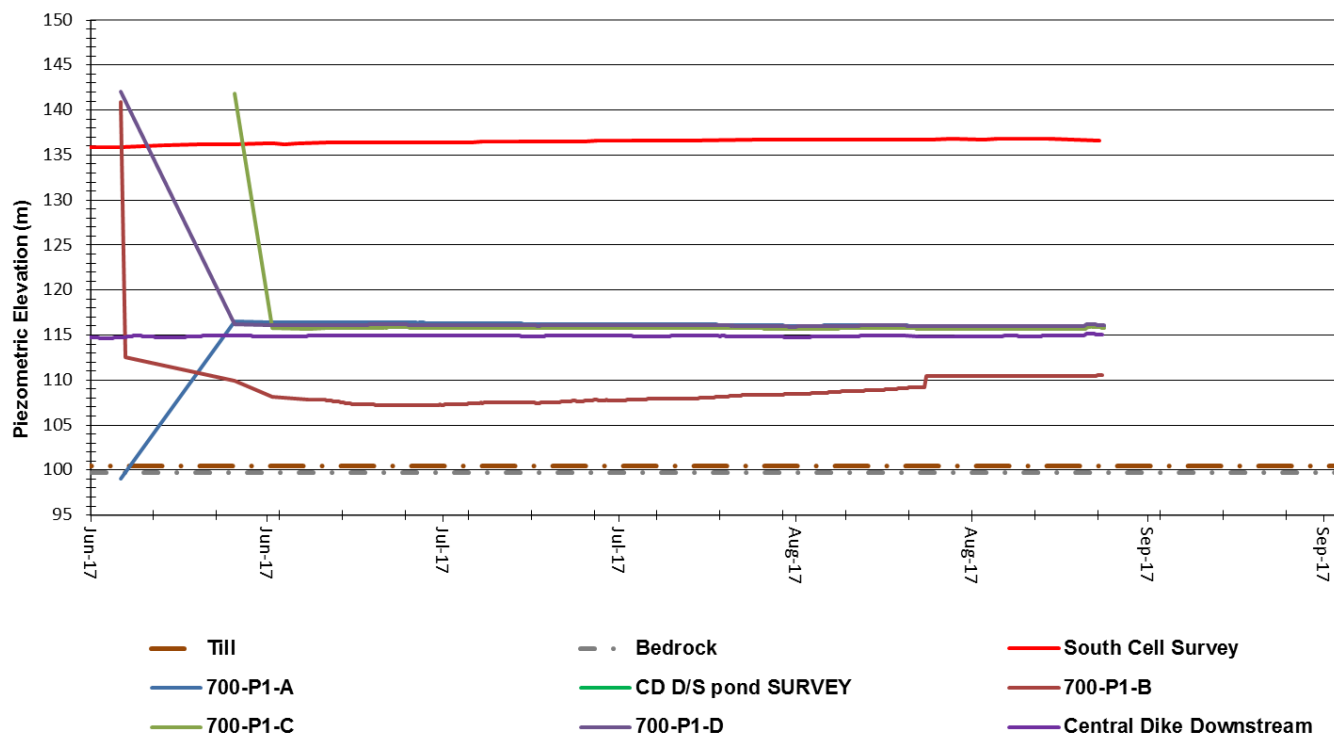
700-P1 Hole - Piezometrics Elevation and Attenuation Pond Elevation vs Time

- New instrument installed in 2017
- Stabilization of temperature ongoing
- Reading automatization occurred on the date of the small bump observed on the piezo B
- Piezo A.C and D are showing reading similar to the D/S pond.

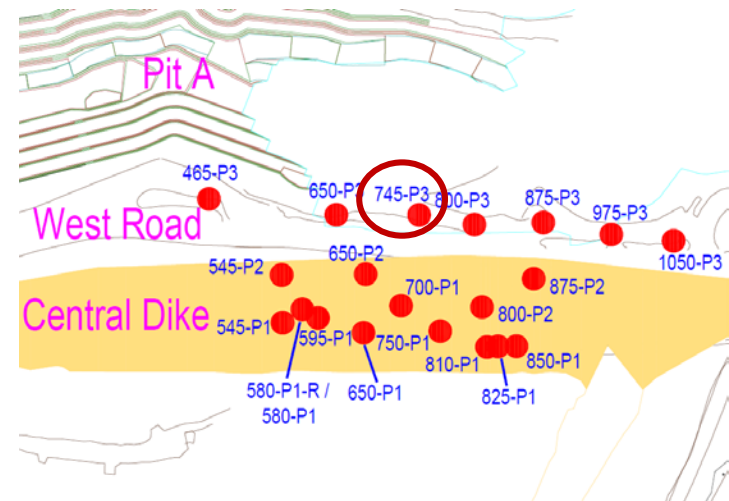
THERMISTOR 745-P3

- Thermistor installed to monitor freeze back of the West Road. This thermistor do not reach bedrock
- Rockfill and till below 0° C at 745-P3
- Frozen limit of the northern section of the P3 line

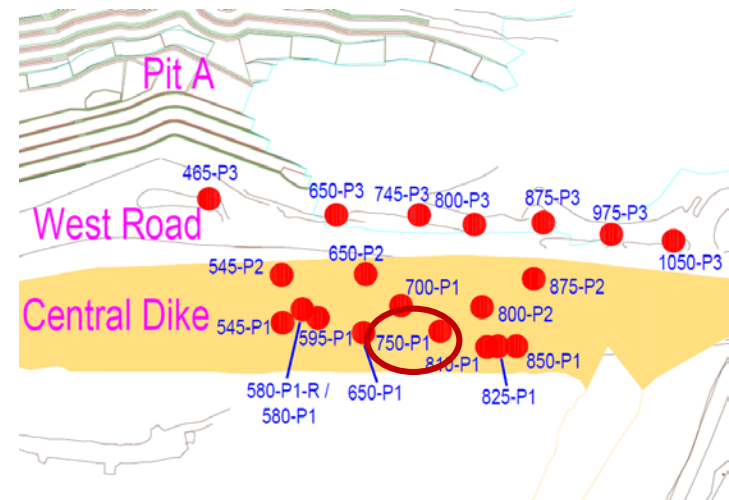
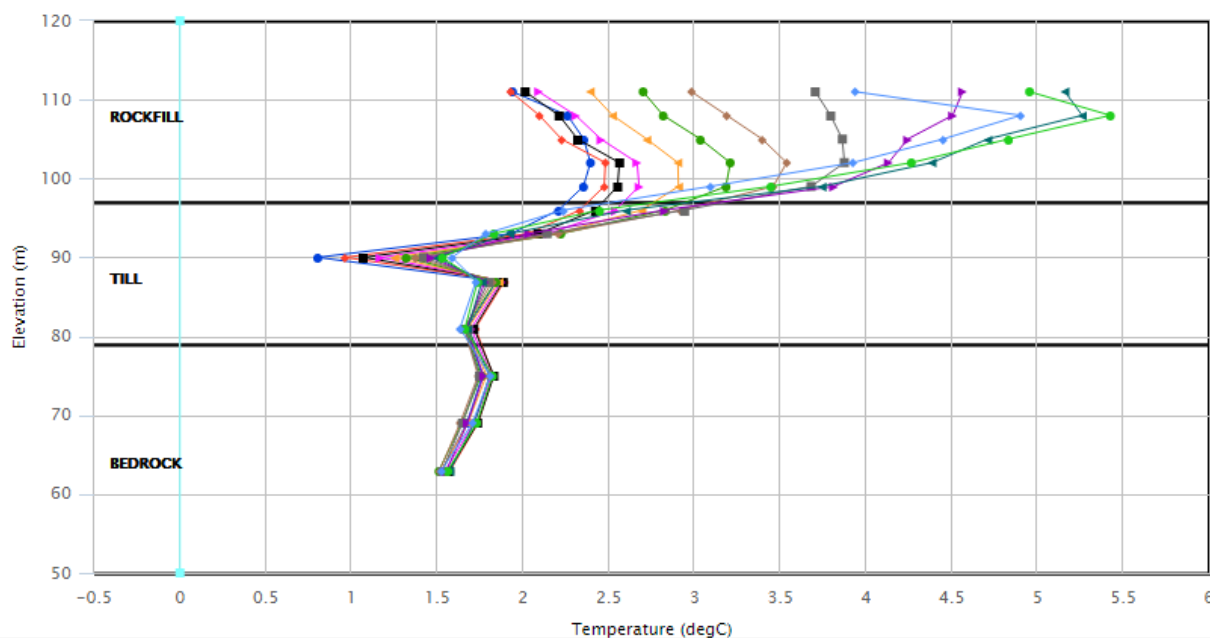
12 - CD - 750 - P1

- ➔ Cooling trend in till layer. The bead located at elevation 90m is in average 1° C cooler than in 2016.

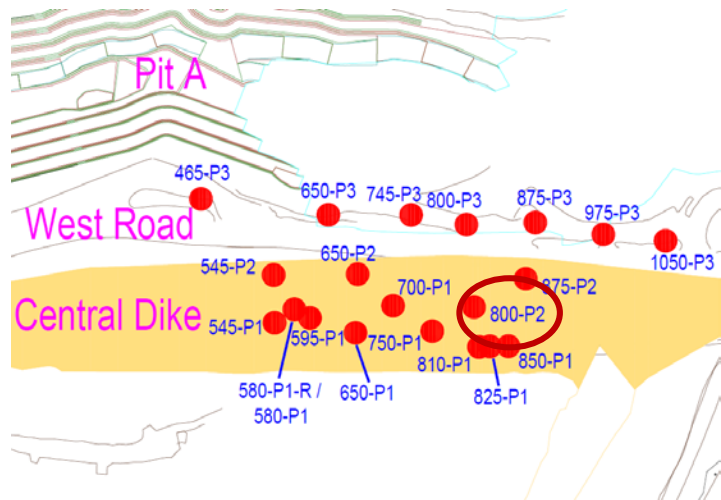
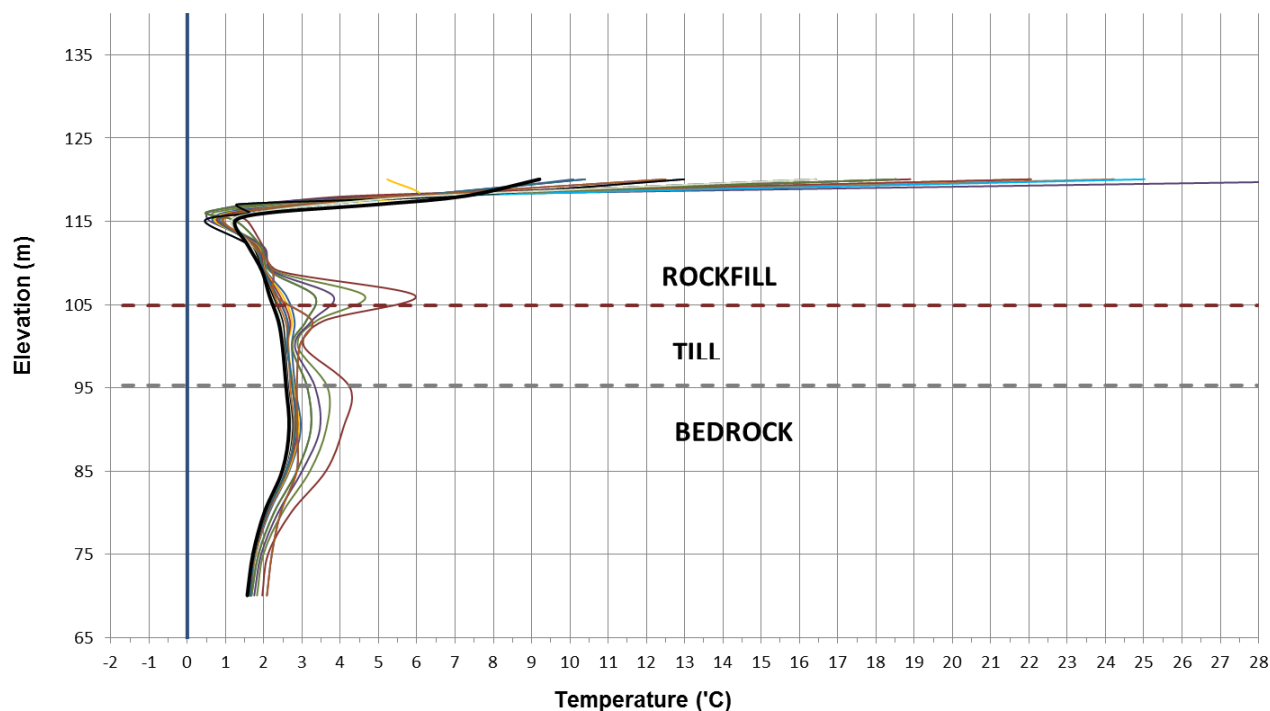
TH-800-P2 Central Dike - Bead Temperature vs. Elevation - 2017

- New instrument installed in 2017
- Stabilisation of temperature ongoing
- Temperature above 0 °C

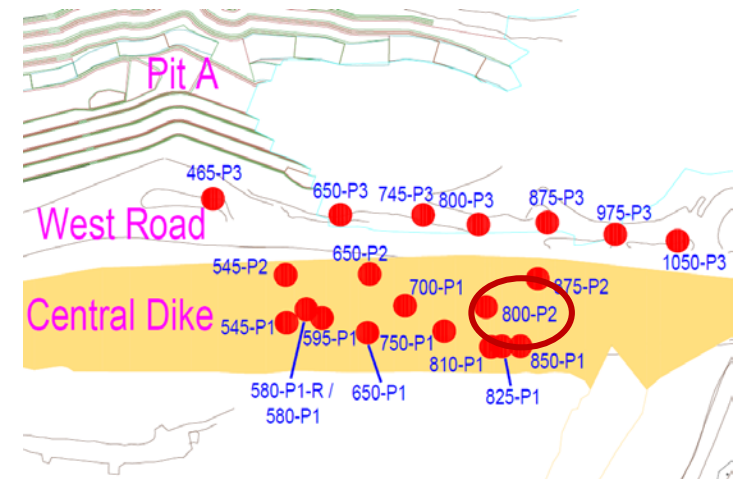
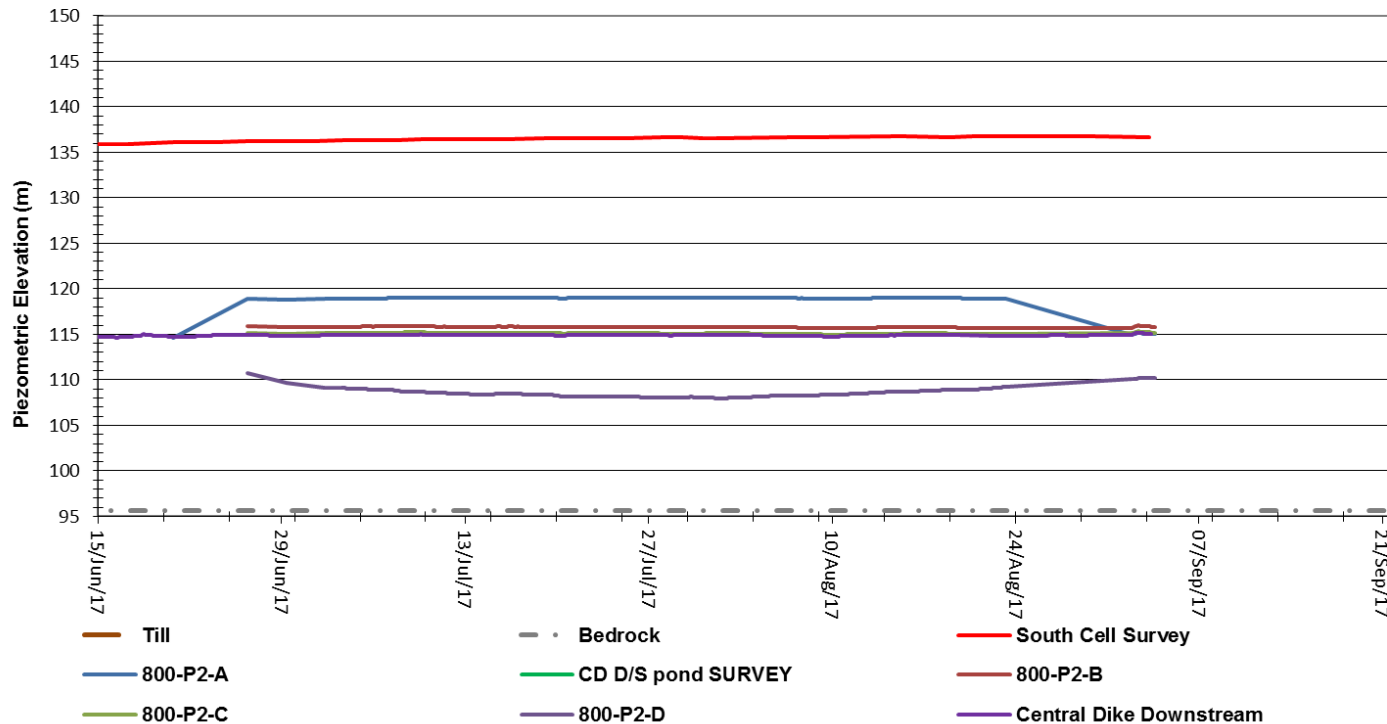
800-P2 Hole - Piezometrics Elevation and Attenuation Pond Elevation vs Time

- New instrument installed in 2017
- Stabilisation ongoing
- Piezo A,B and C are showing pressure readings similar to the elevation of the D/S pond.

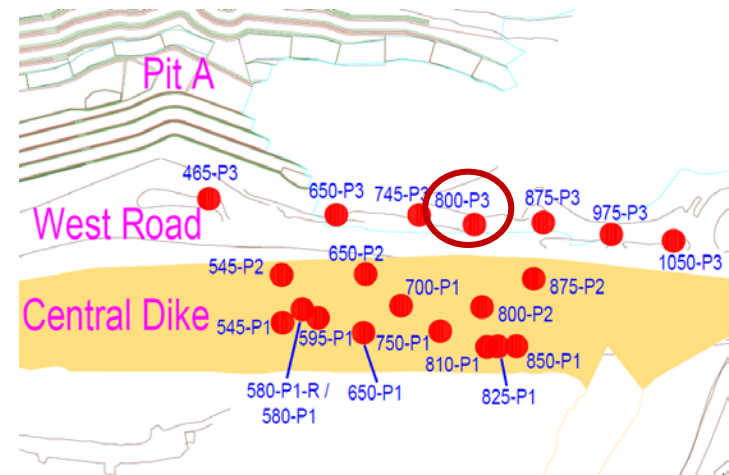
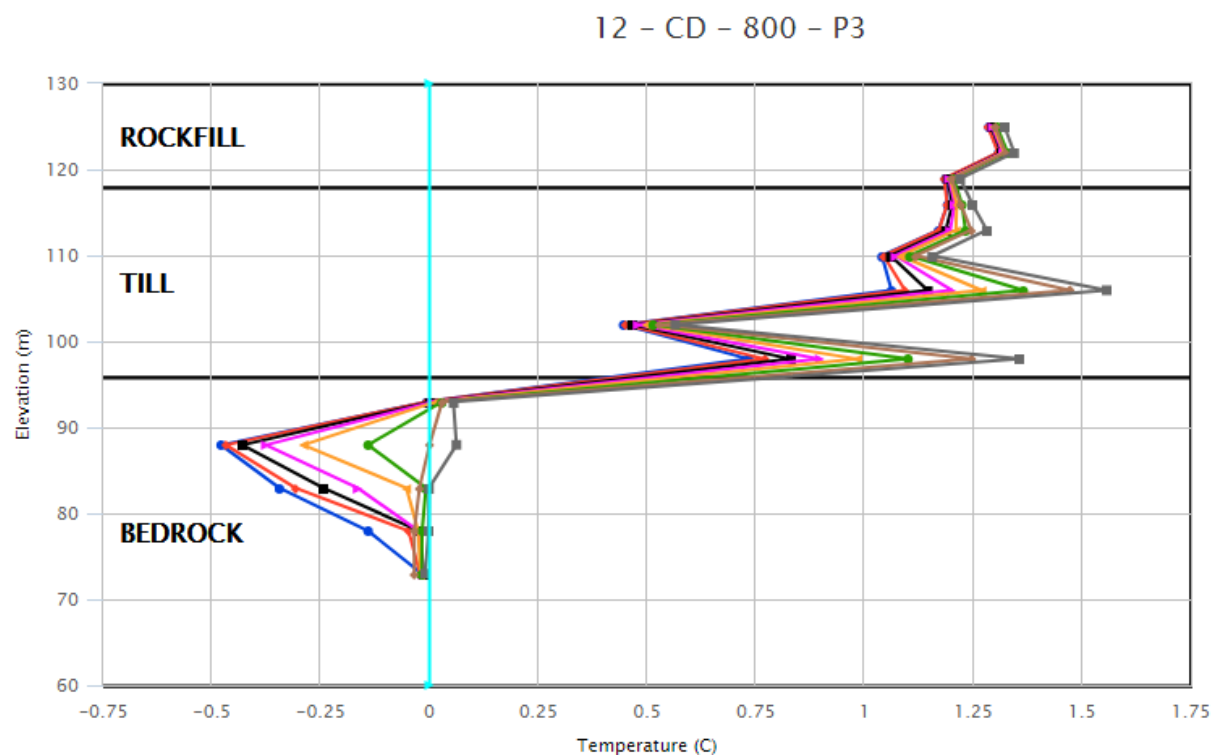
DH 800-P3 Instrumentation

- New instrument installed in 2017
- Stabilisation in progress
- Temperature under 0° C below El. 93 m

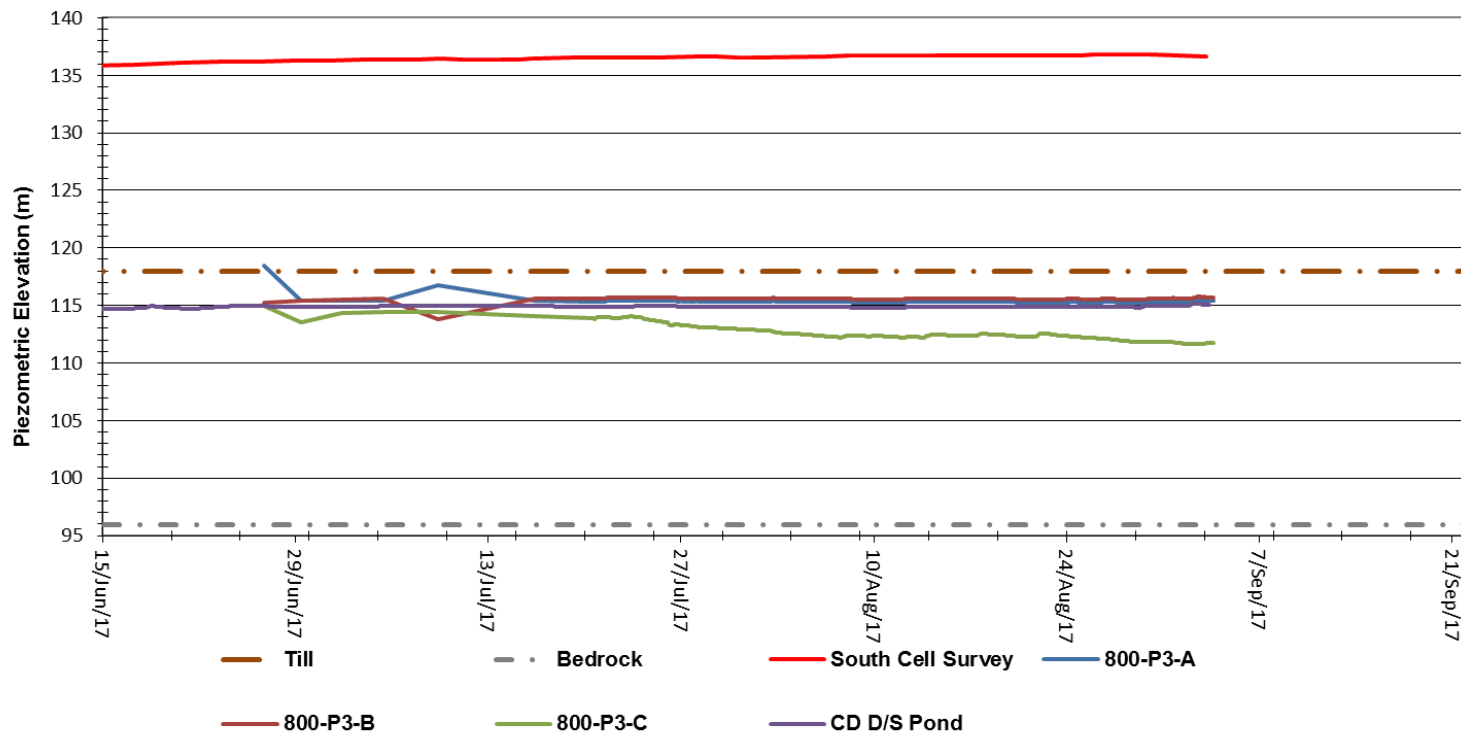
800-P3 Hole - Piezometrics Elevation and Attenuation Pond Elevation vs Time

- New instrument installed in 2017
- Stabilization in progress
- Piezo A & B readings are similar to the D/S pond elevation readings
- Piezo C readings is slowly decreasing

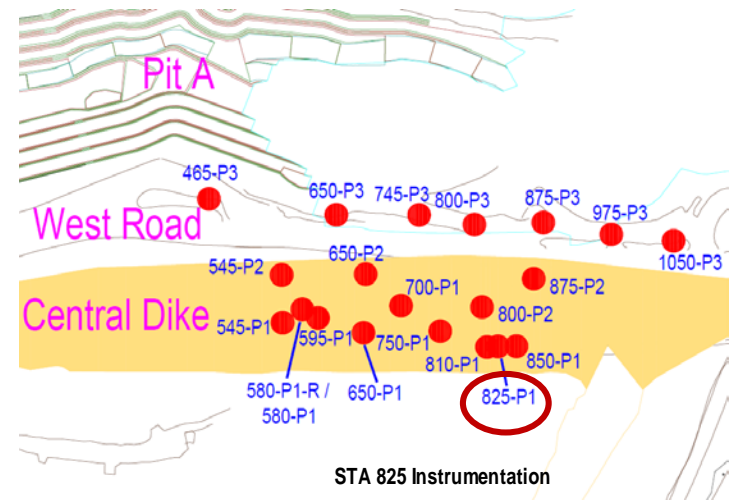
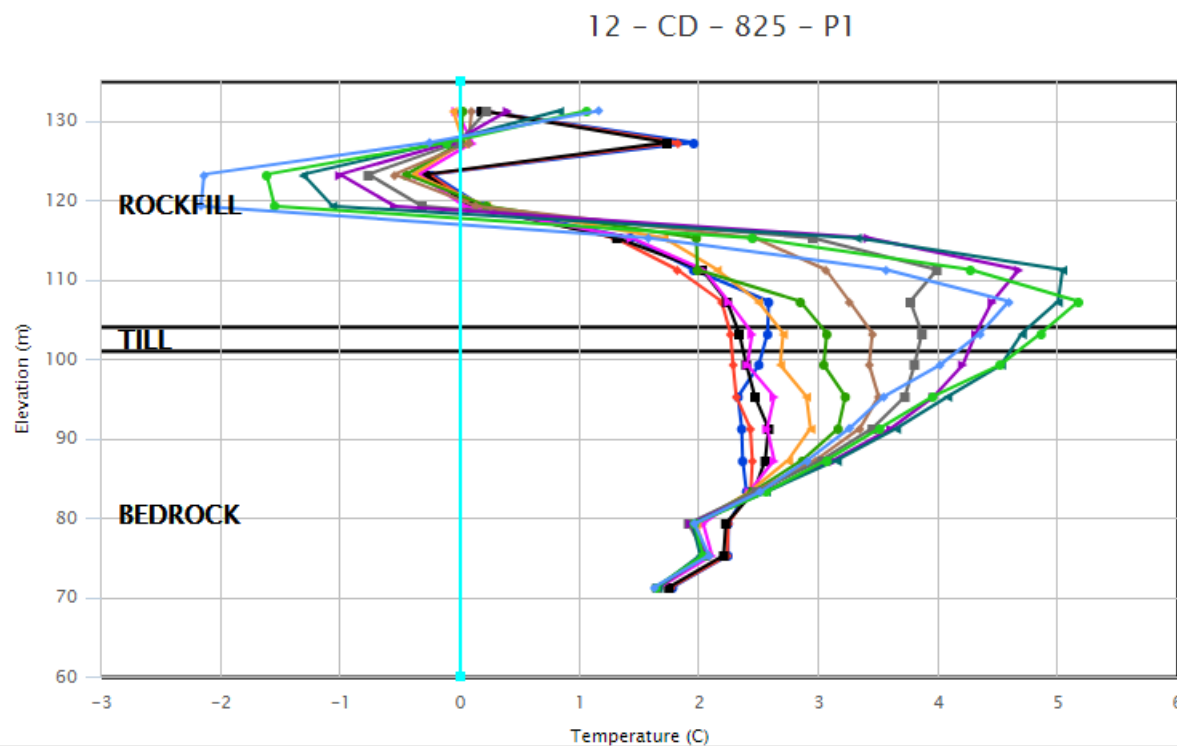
THERMISTOR 825-P1

- Temperature variation over the year inside the bedrock/till units is higher than in the previous year:
- 2016: [1.5, 3.2]
- 2017: [1.6, 4.5]
- Generally warmer readings recorded over the last year.

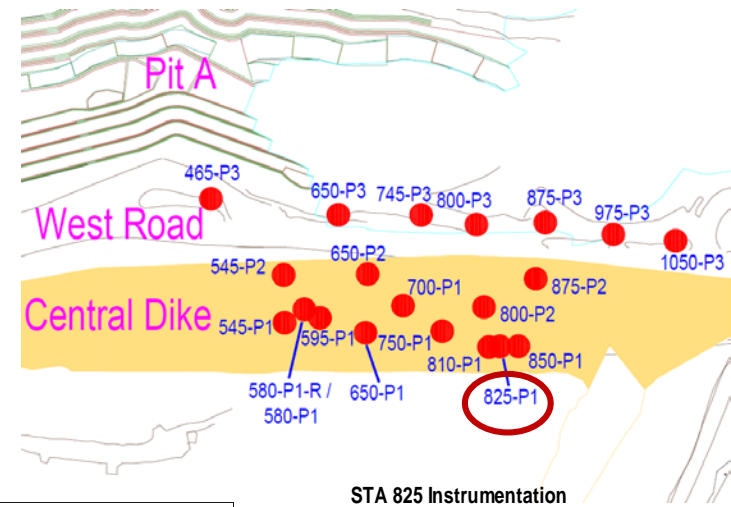
PIEZOMETER 825-P1

- Increased in piezometric elevation of Piezo E since April 2017. Seem to be connected now with South Cell.
- Piezo A and B showing readings similar to the D/S pond and are reacting directly with elevation change.

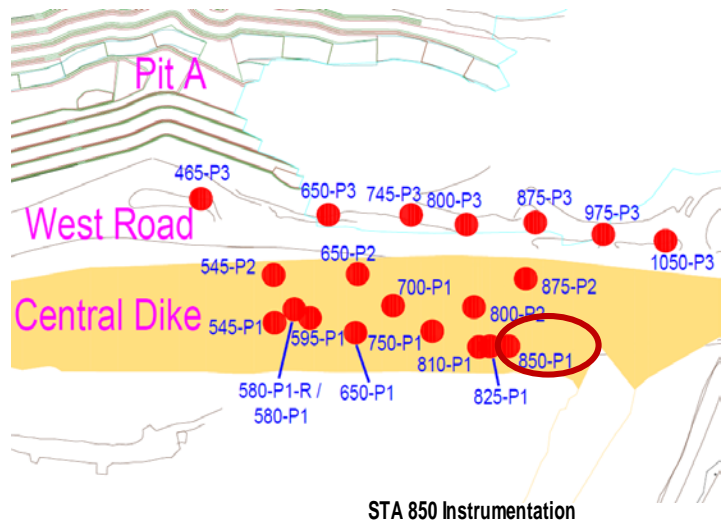
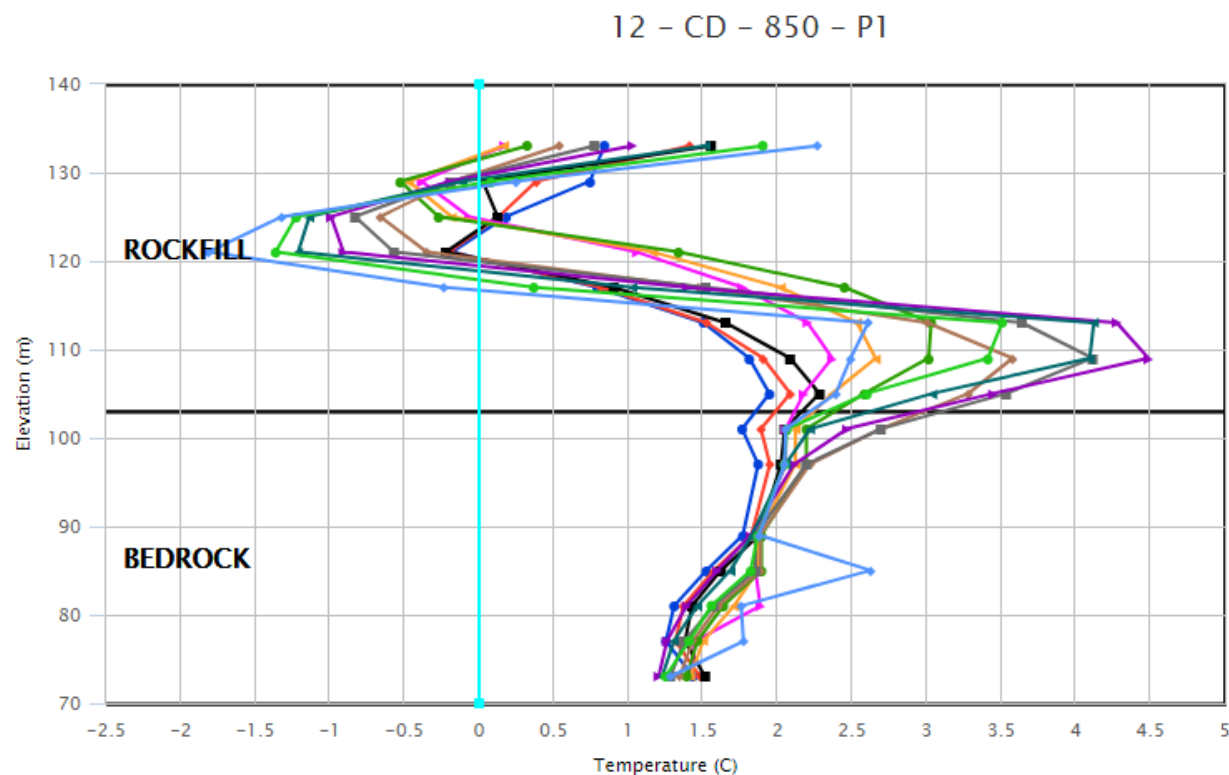
THERMISTOR 850-P1

- Temperature above 0° C in bedrock at 850-P1
- Similar profile than in 2016

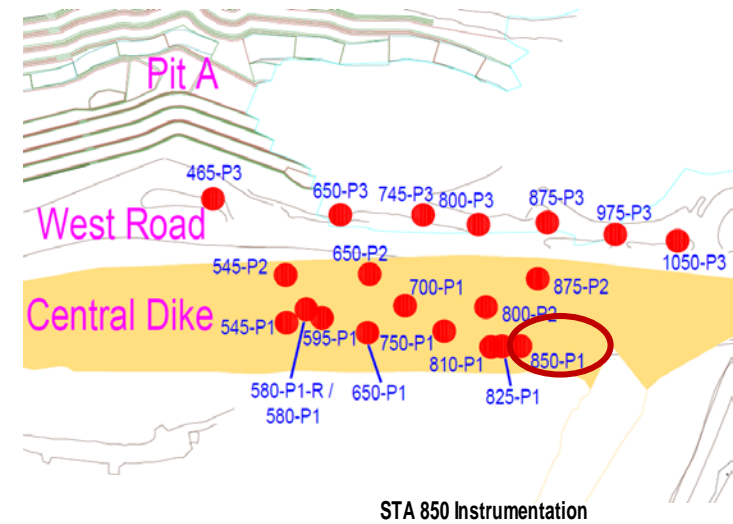
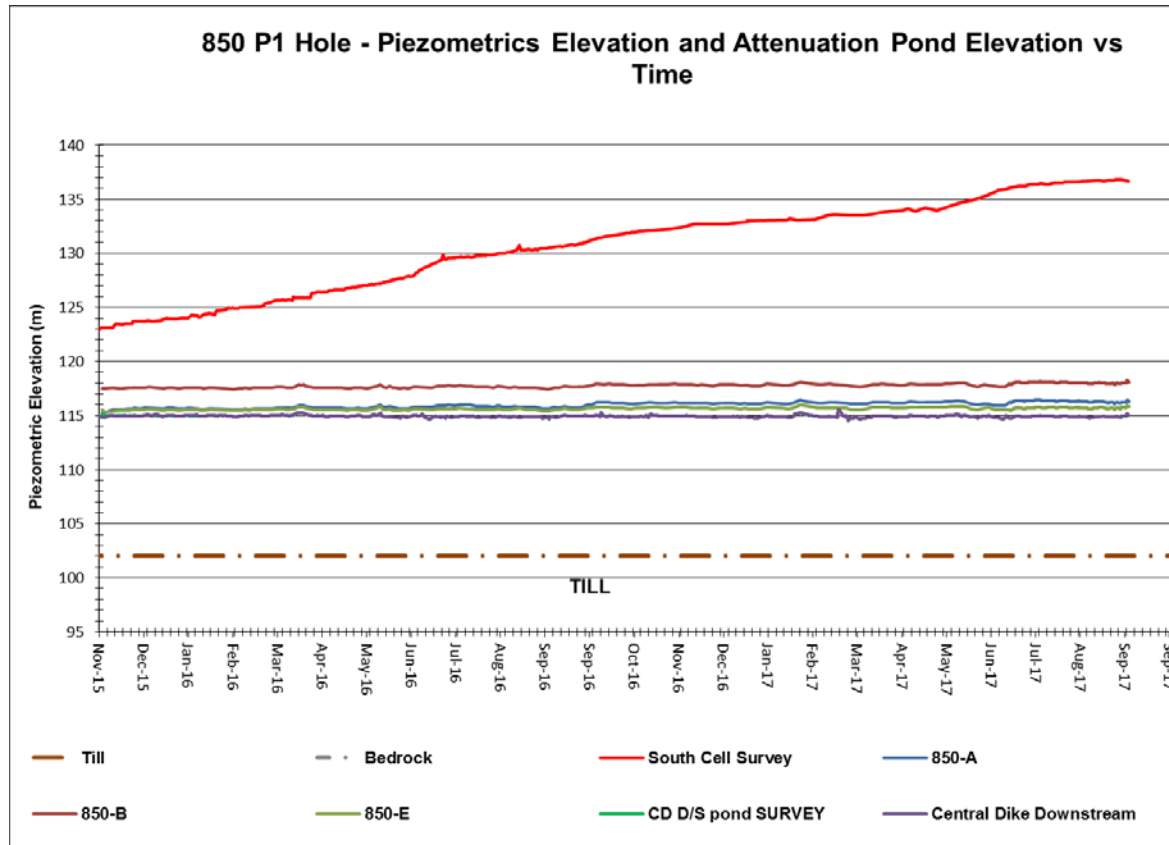
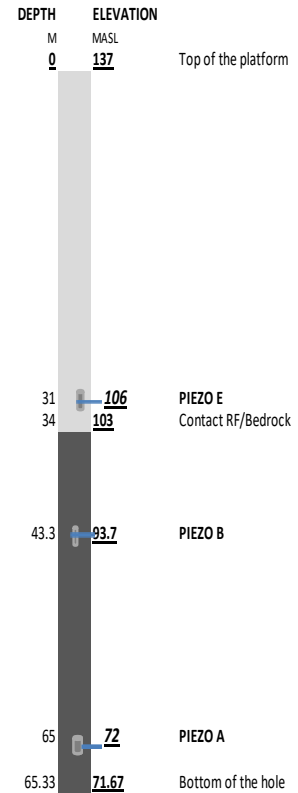
PIEZOMETER 850-P1

- All piezometer are following the trend of the D/S pond regime
- However piezo B is one of the highest in the piezometer readings that have stable reading (117.5m)

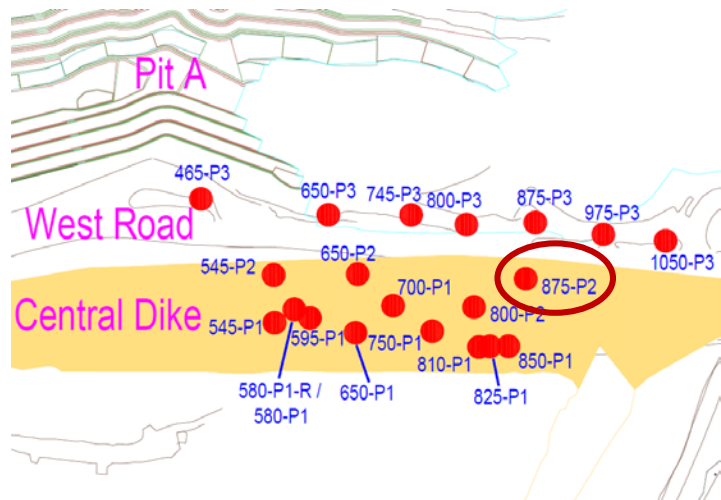
DH 875-P2 Instrumentation

- New thermistor installed in 2017
- Stabilisation of temperature ongoing
- Bedrock temperature above 0° C

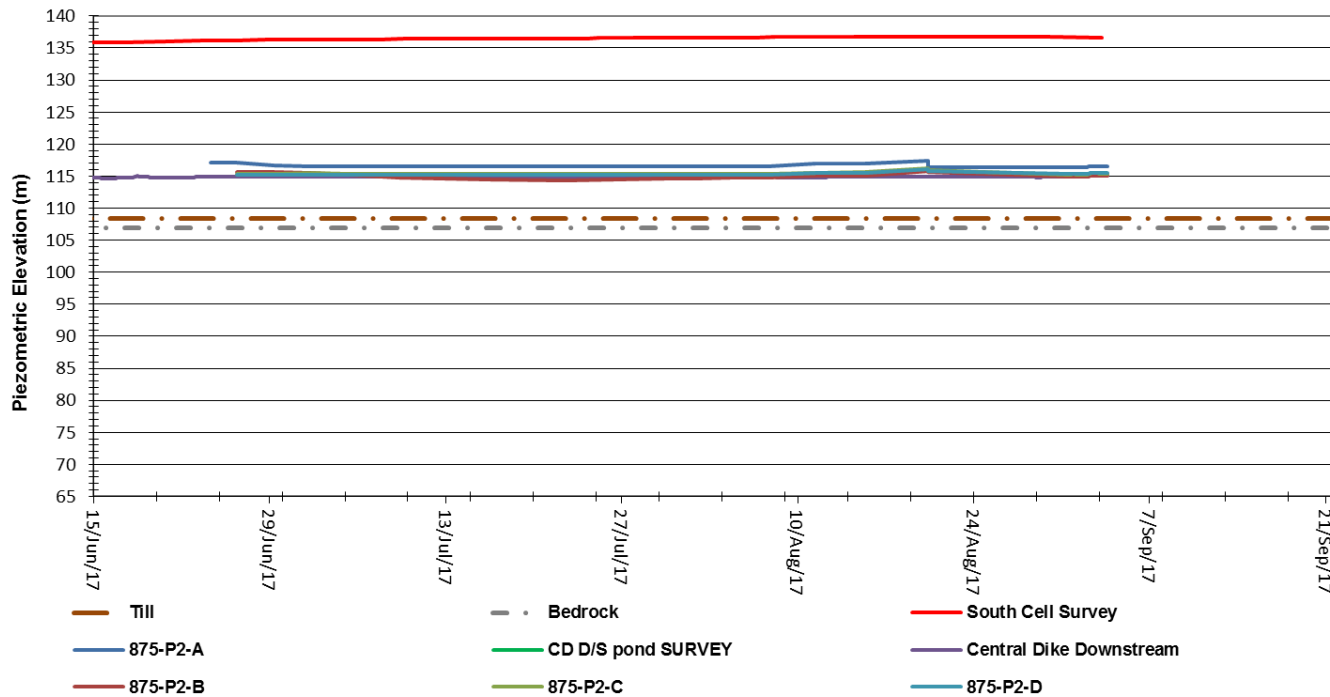
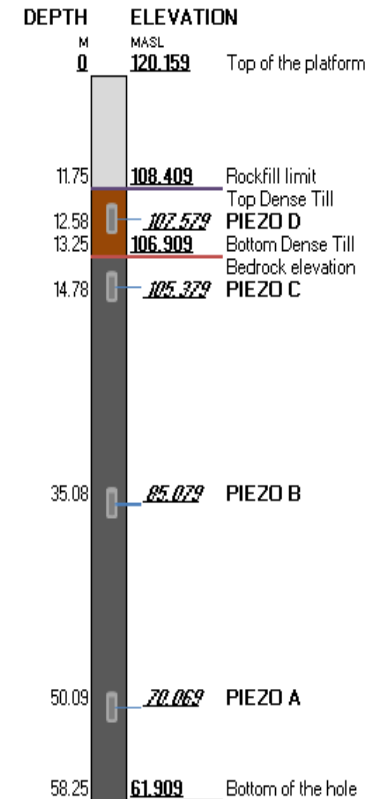
DH 875-P2 Instrumentation

- All piezometer are following the trend of the D/S pond regime
- Small glitch in the data was observed when automatization of the system was completed

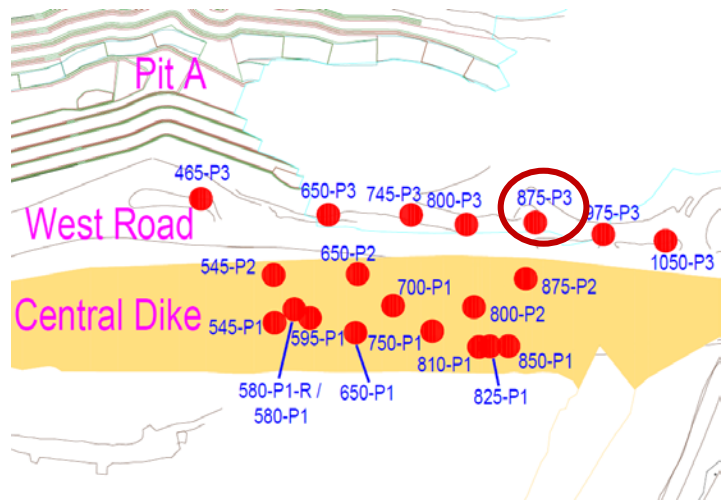
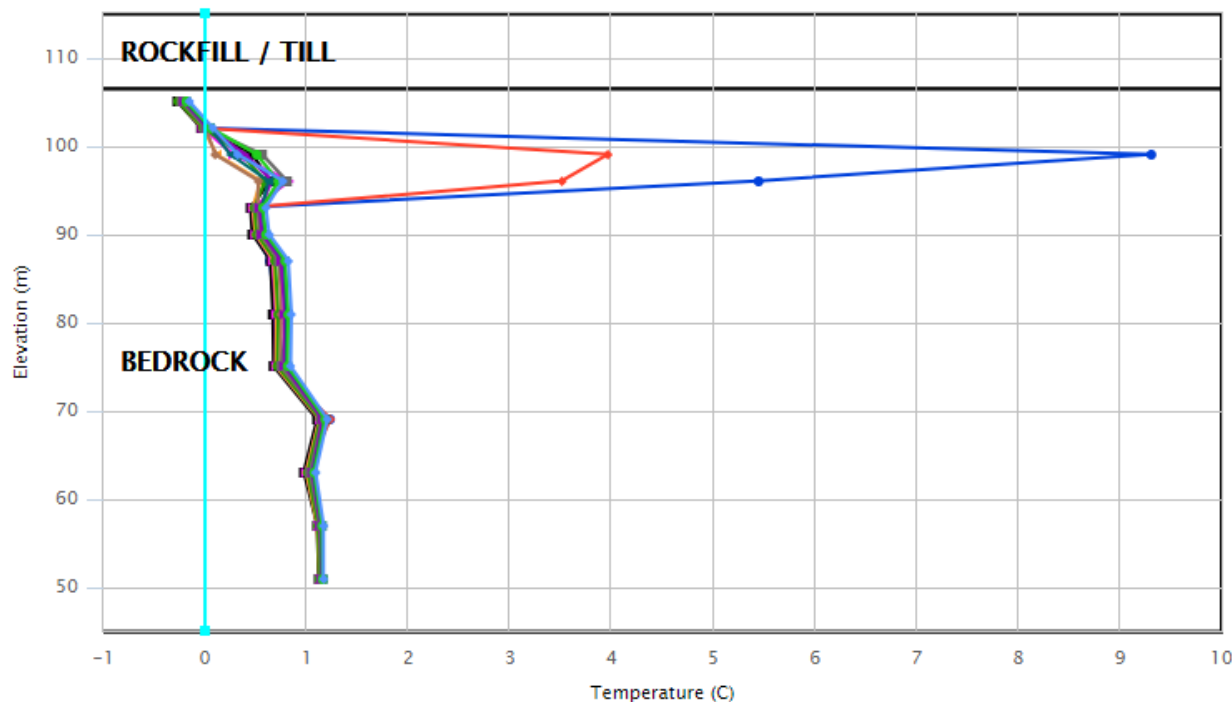
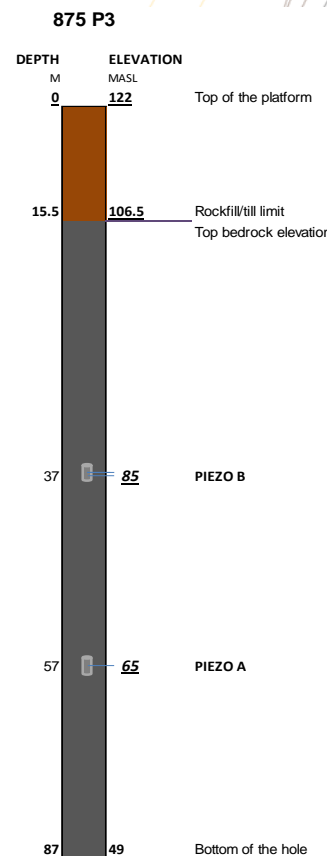
12 - CD - 875 - P3

- Temperature above 0° C in bedrock at 875-P3
- Temperature spike at El.96 m and 99 m are related to capacitance effect.

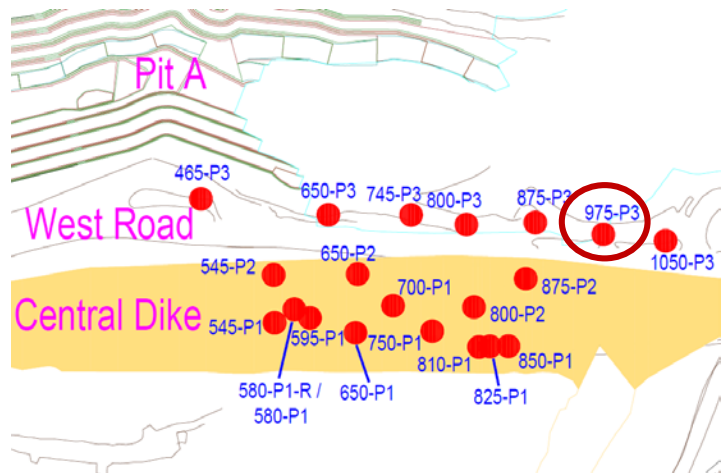
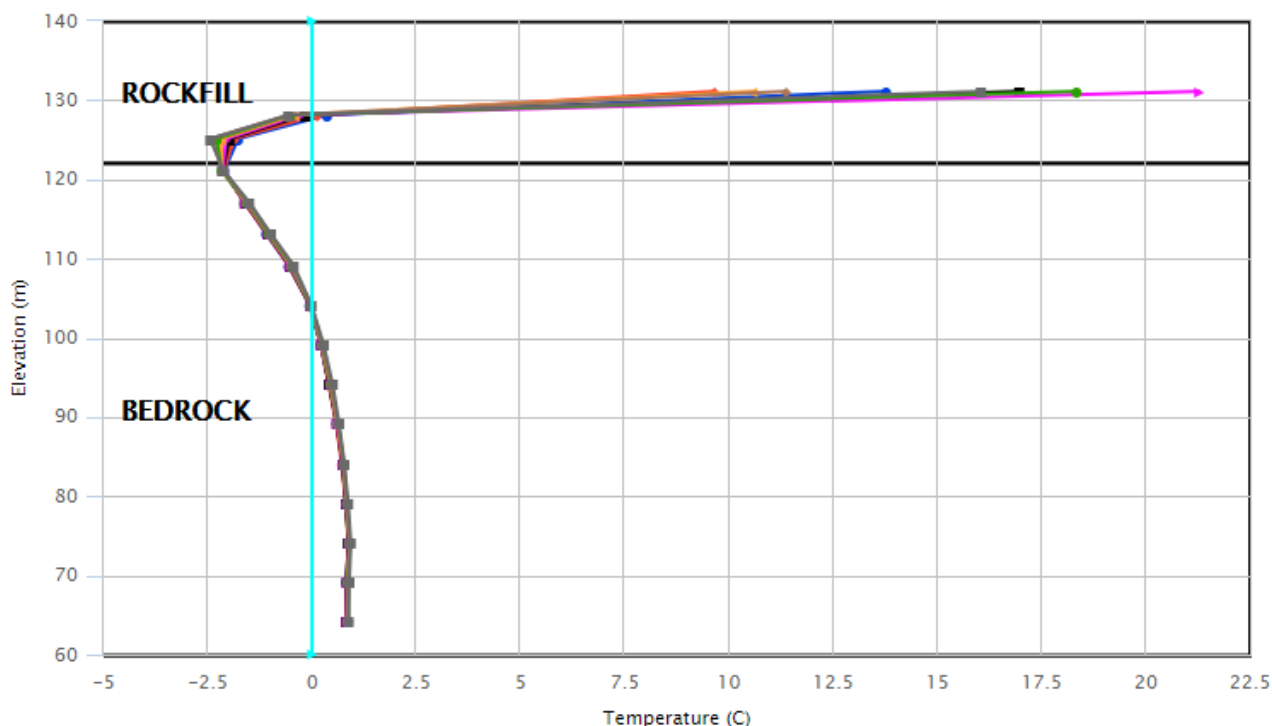
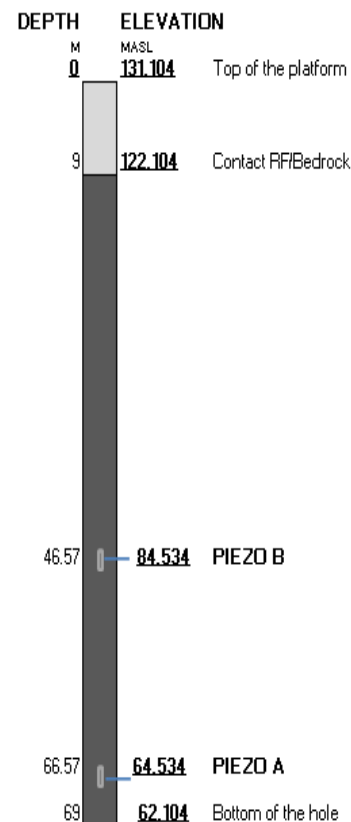
DH 975-P3 Instrumentation

- New instrument installed in 2017
- Stabilization of the thermistor mostly done
- Temperature above 0° C in bedrock below El. 105 m
