THERMISTOR 545-P1

MDRB # 22 P3 – STORMWATER DIKE UPDATE

Patrice Gagnon
September 4th 2017

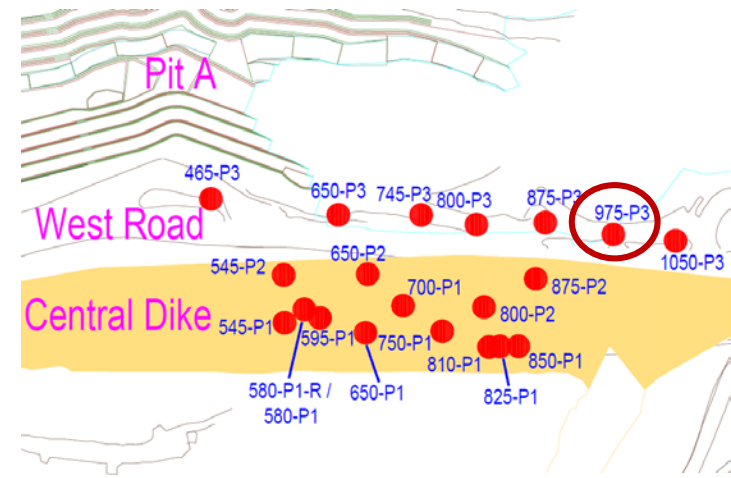
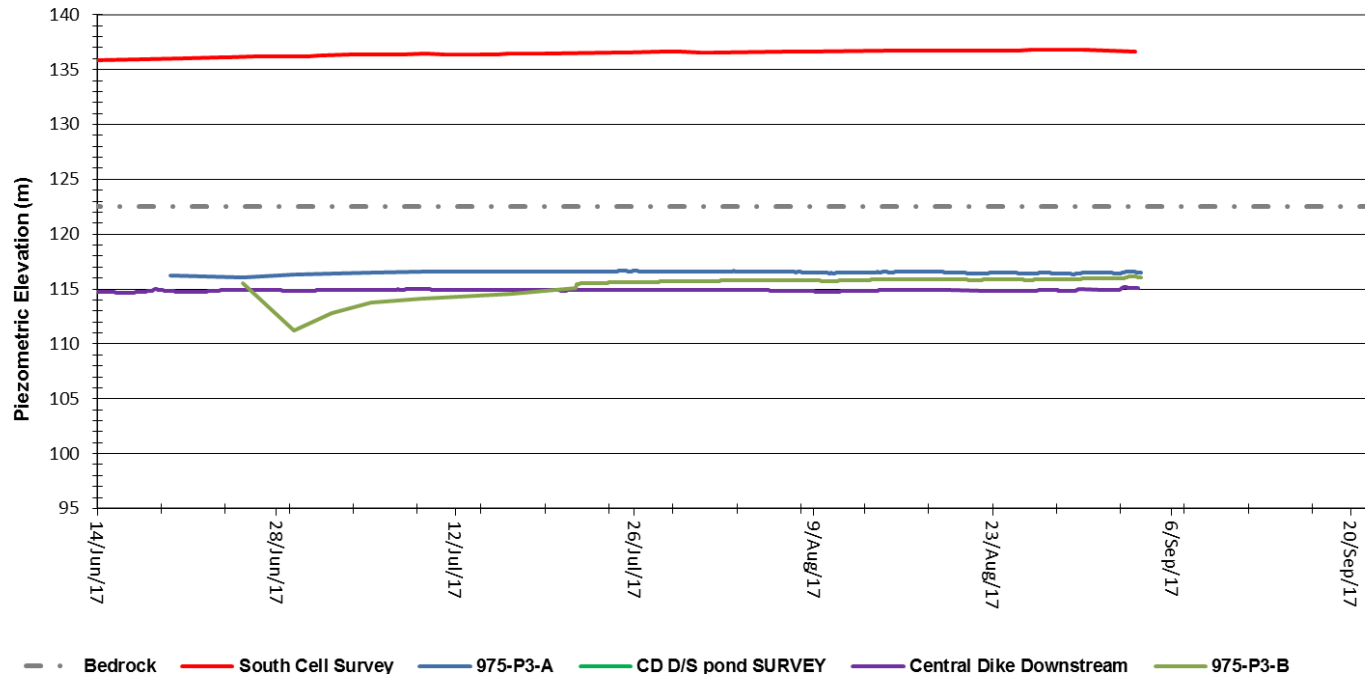
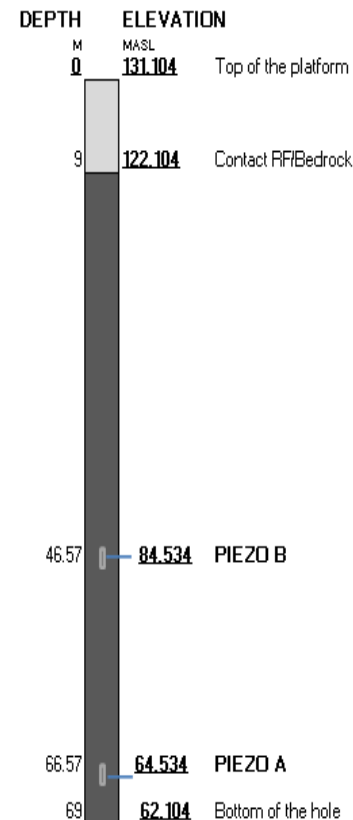
975-P3 Hole - Piezometrics Elevation and Attenuation Pond Elevation vs Time

- New instrument installed in 2017
- All piezometer are following the trend of the D/S pond regime

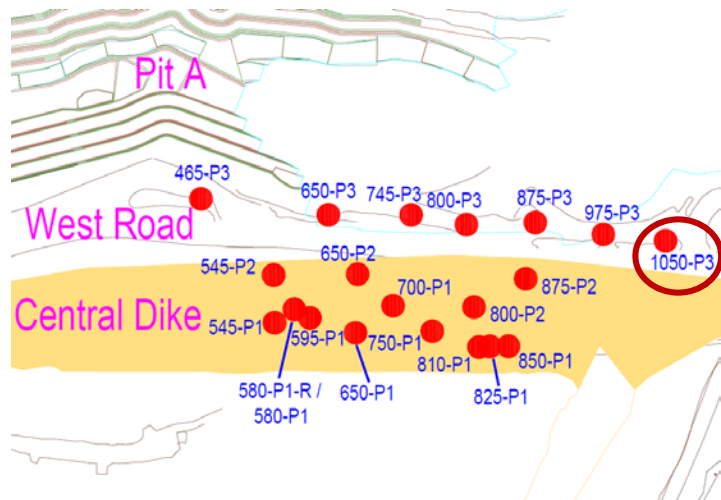
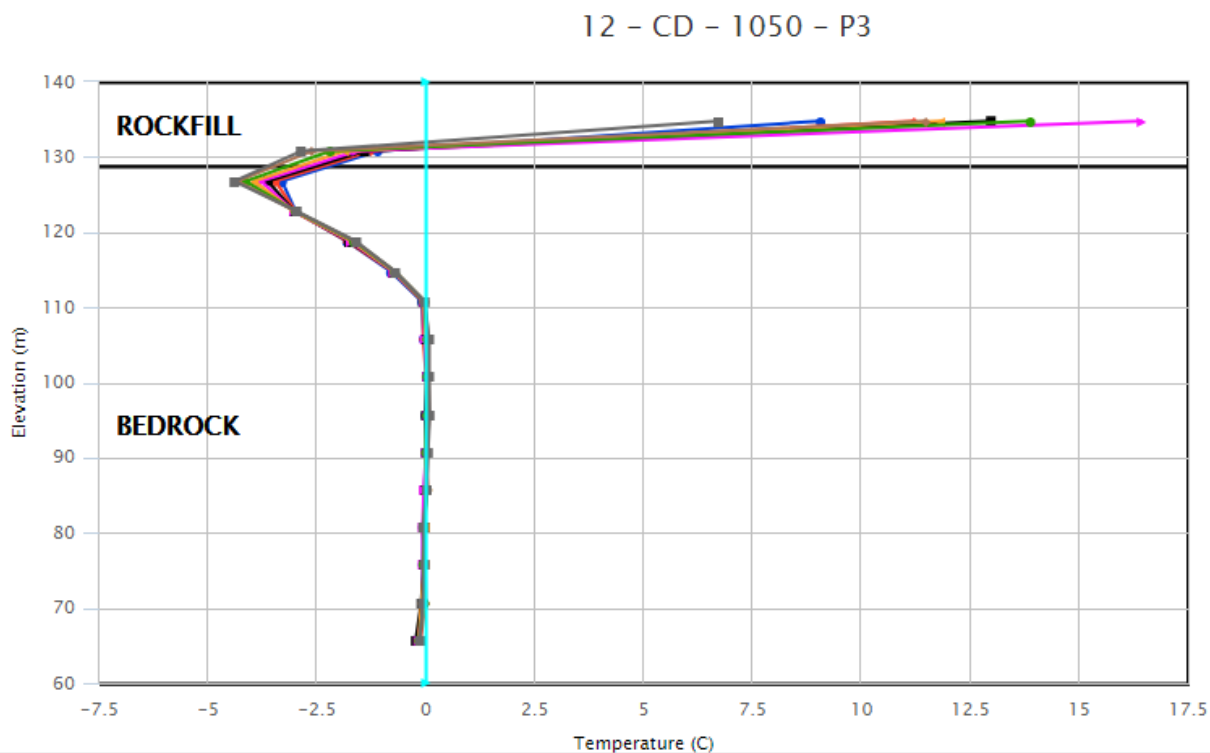
DH 1050-P3 Instrumentation

➡ Temperature at 0° C in bedrock

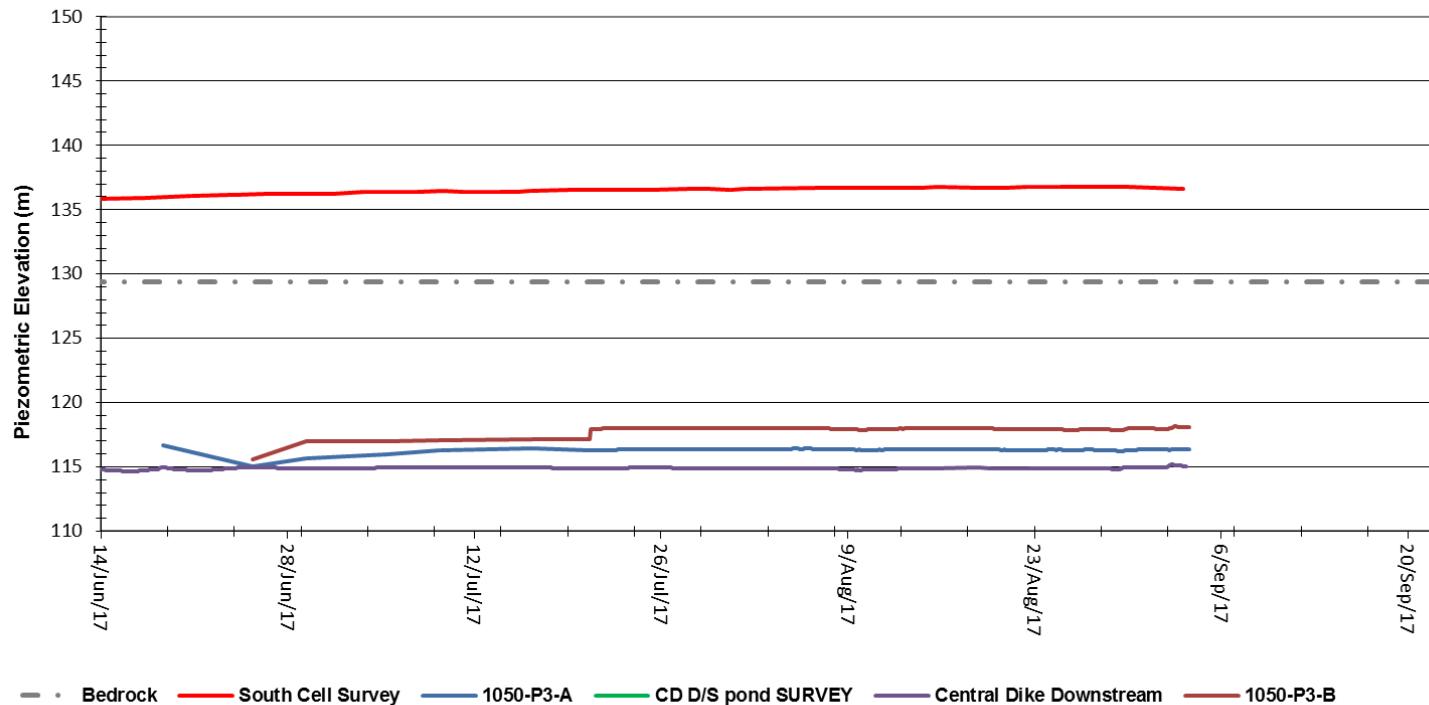
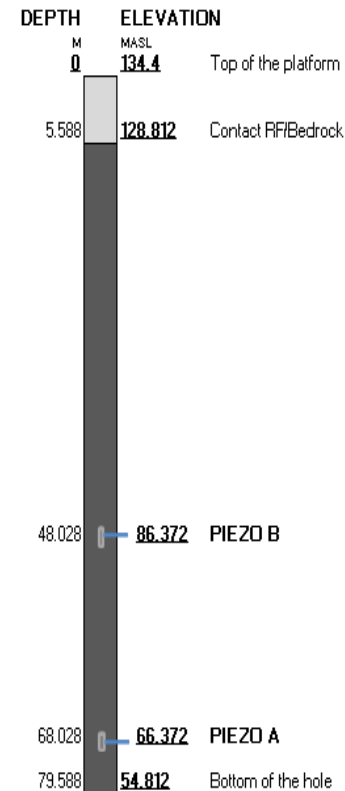
1050-P3 Hole - Piezometrics Elevation and Attenuation Pond Elevation vs Time

- Piezometers temperature just below the freezing point
- Piezometers are following the trend of the D/S pond elevation.

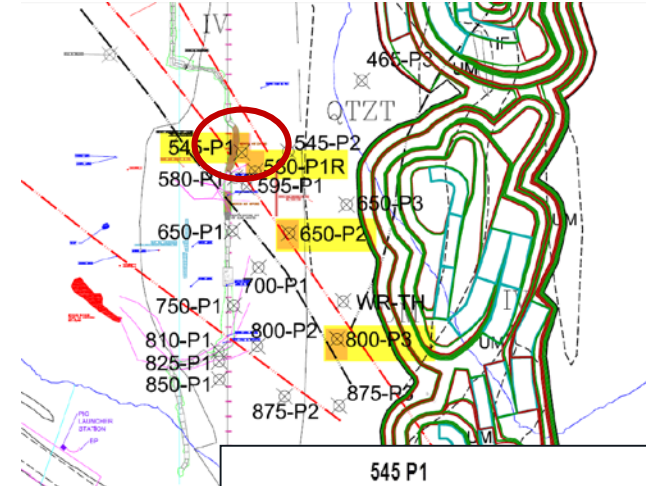
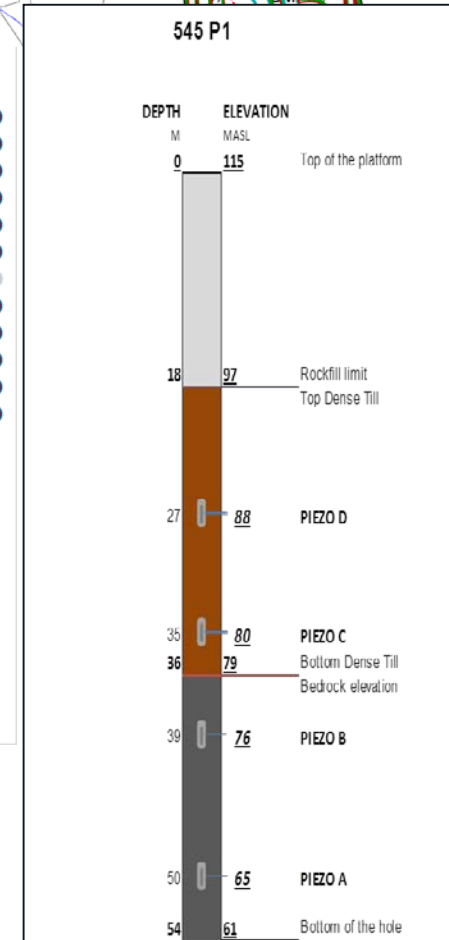
THERMISTOR 545-P1

- 545-P1 thermistor is showing the same temperature profile than last year. Warmer peak observed at elevation 70m since the installation.
- Temperature in the bedrock/till unit is in between 1.1 and 1.75° C.

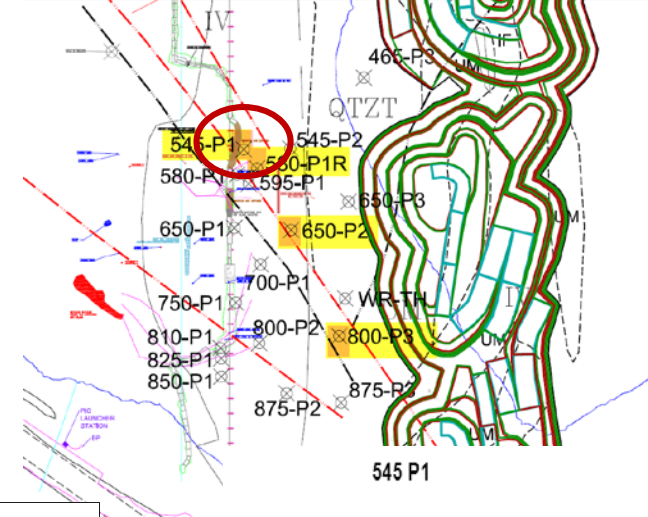
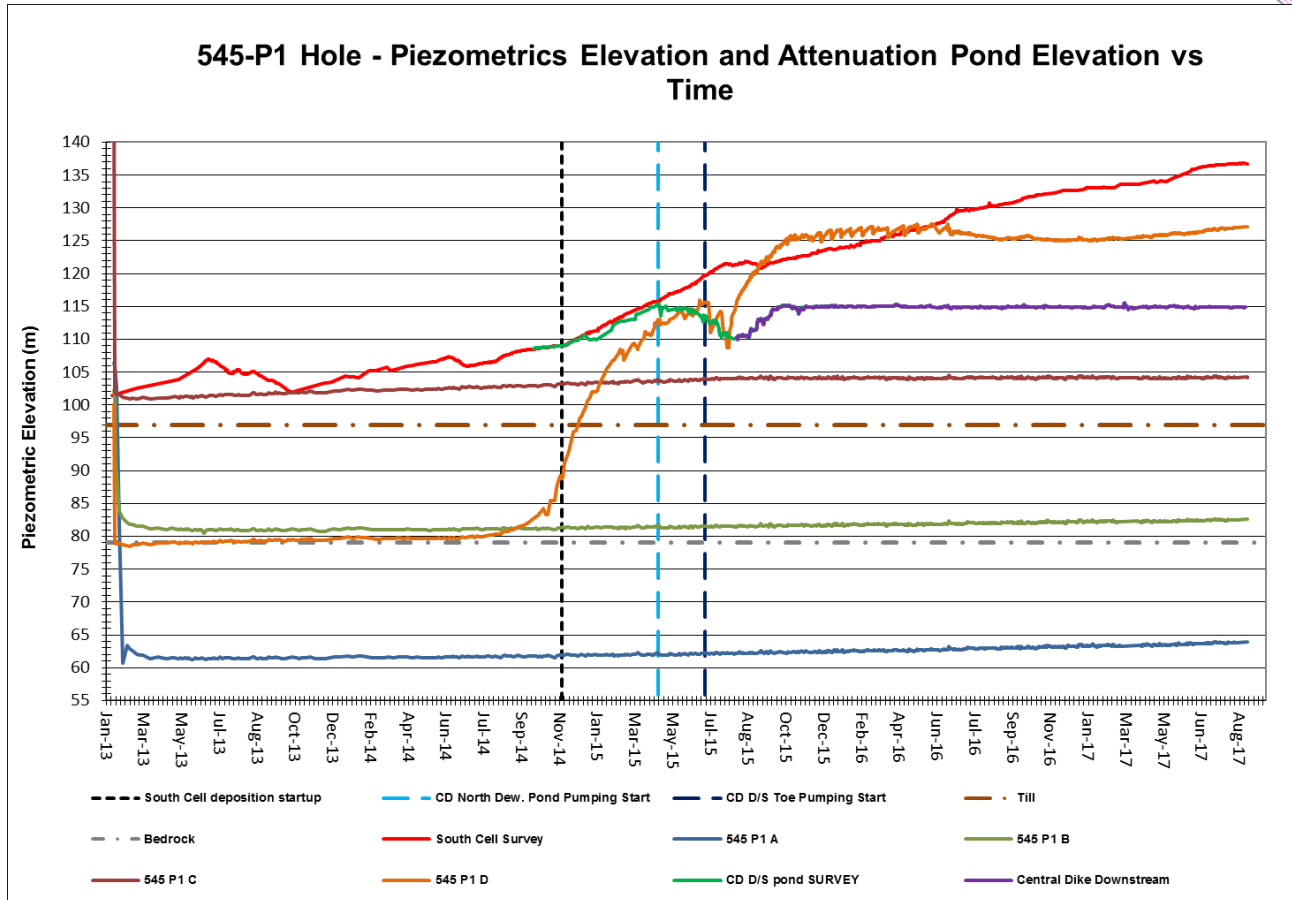
PIEZOMETER 545-P1

- Piezometer D still constant, no change since August 2015
- Piezometer A is recording suction since its installation
- Identification of the piezo on the field is confusing. Interpretation of the readings must be done with precaution.

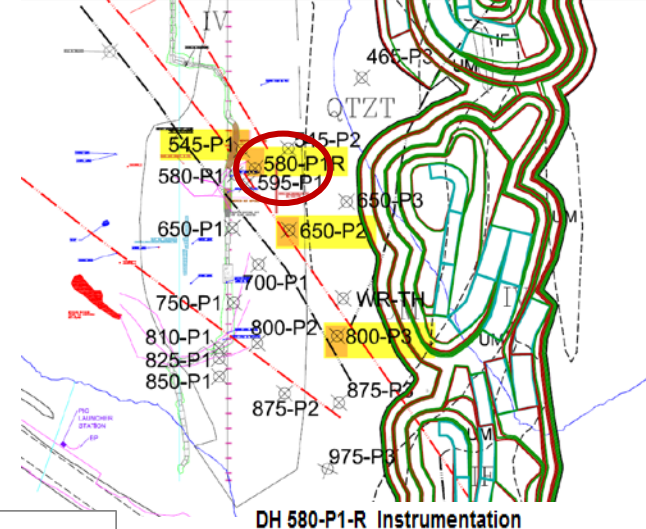
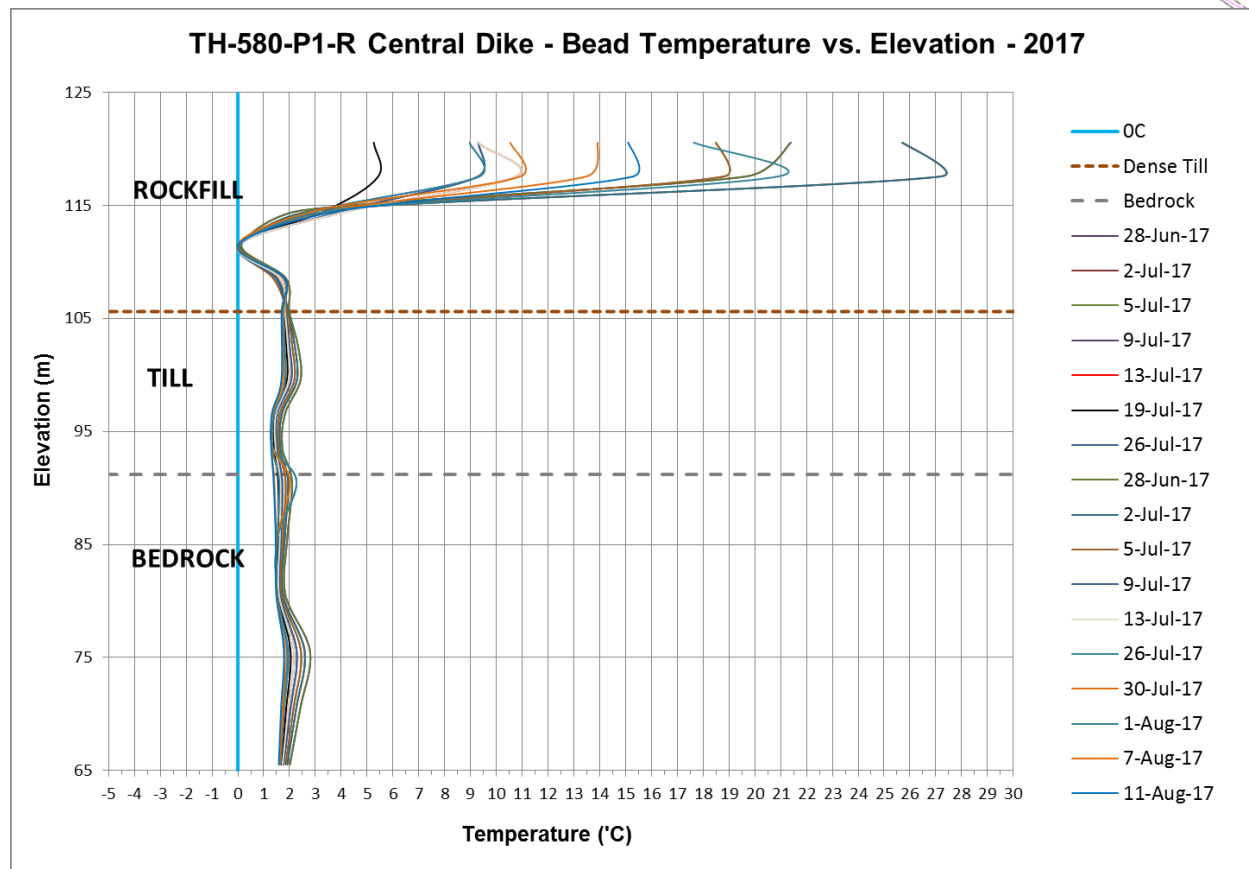
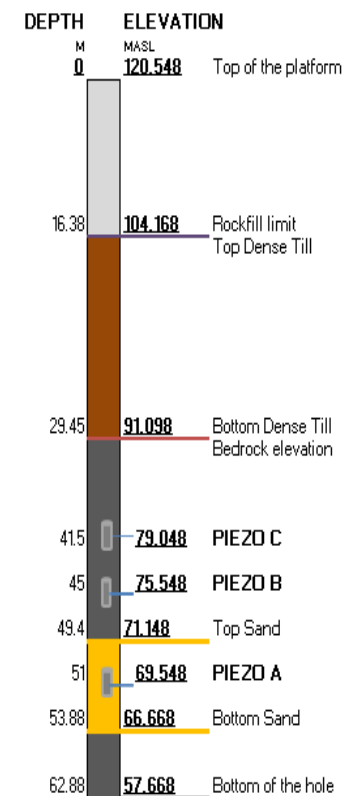
THERMISTOR 580-P1R

- Stabilisation in progress
- Temperature readings above 0°C
- Similar temperature readings range than 580-P1

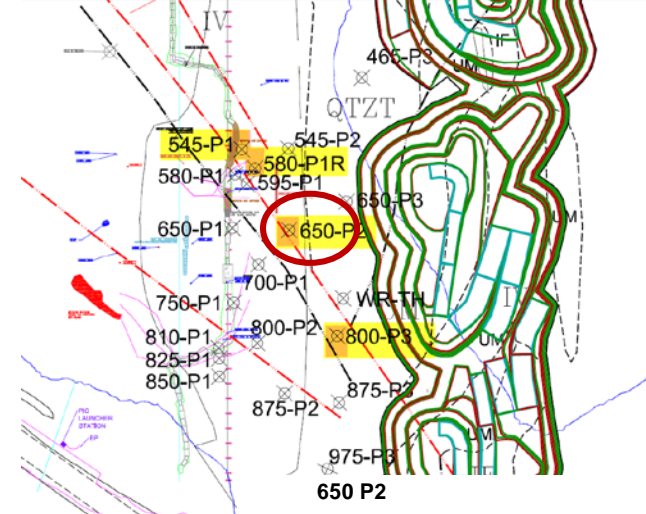
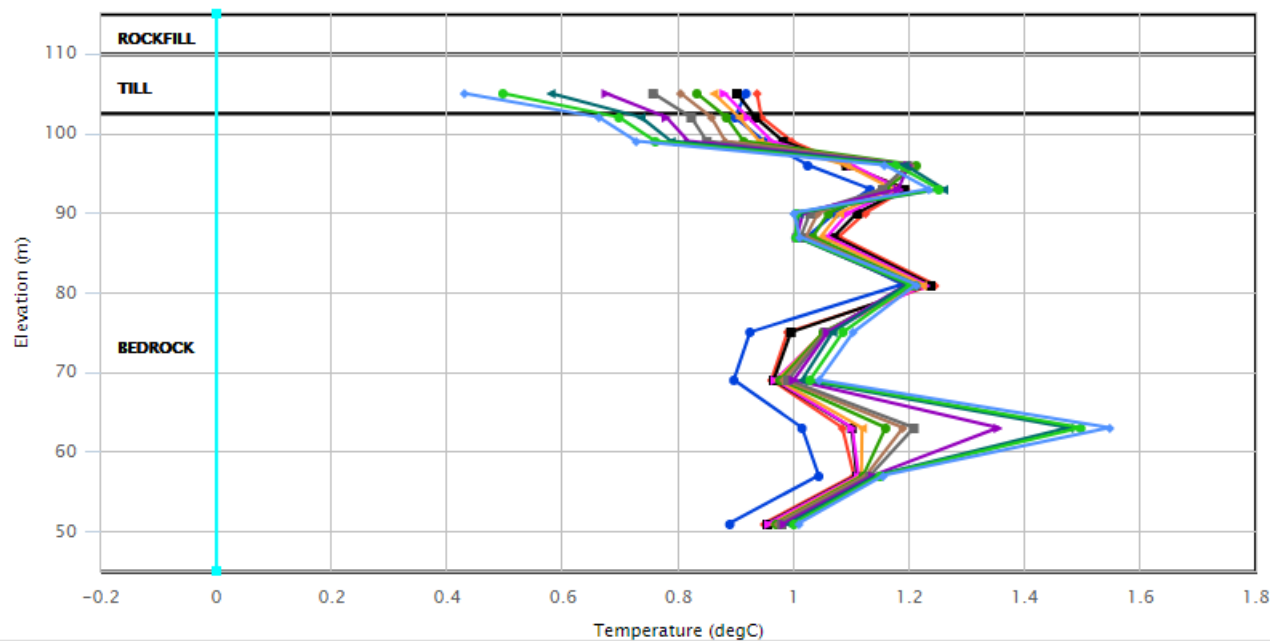
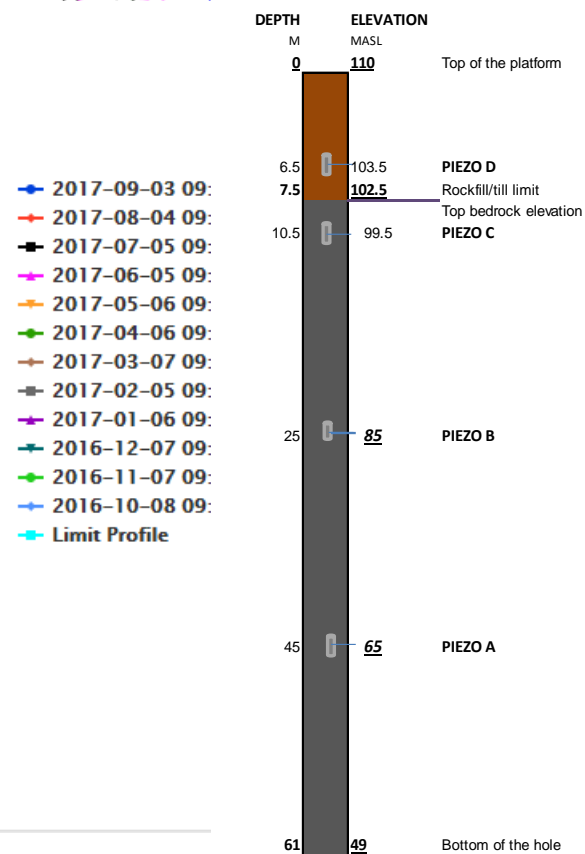
THERMISTOR 650-P2

- Cooling trend observed below El. 80 similar to 2016 readings.

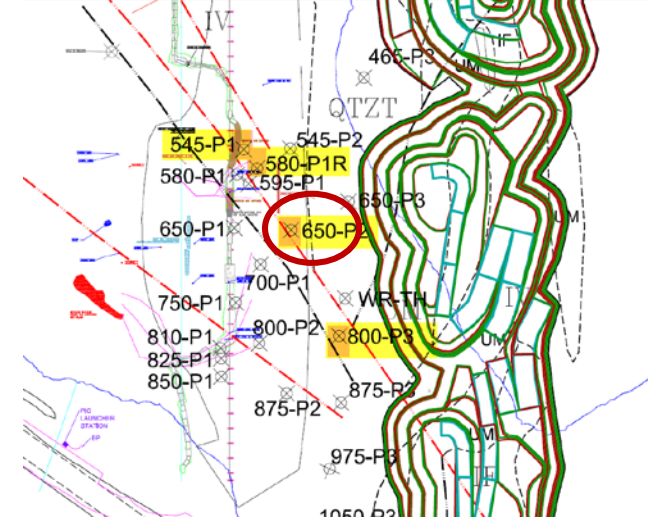
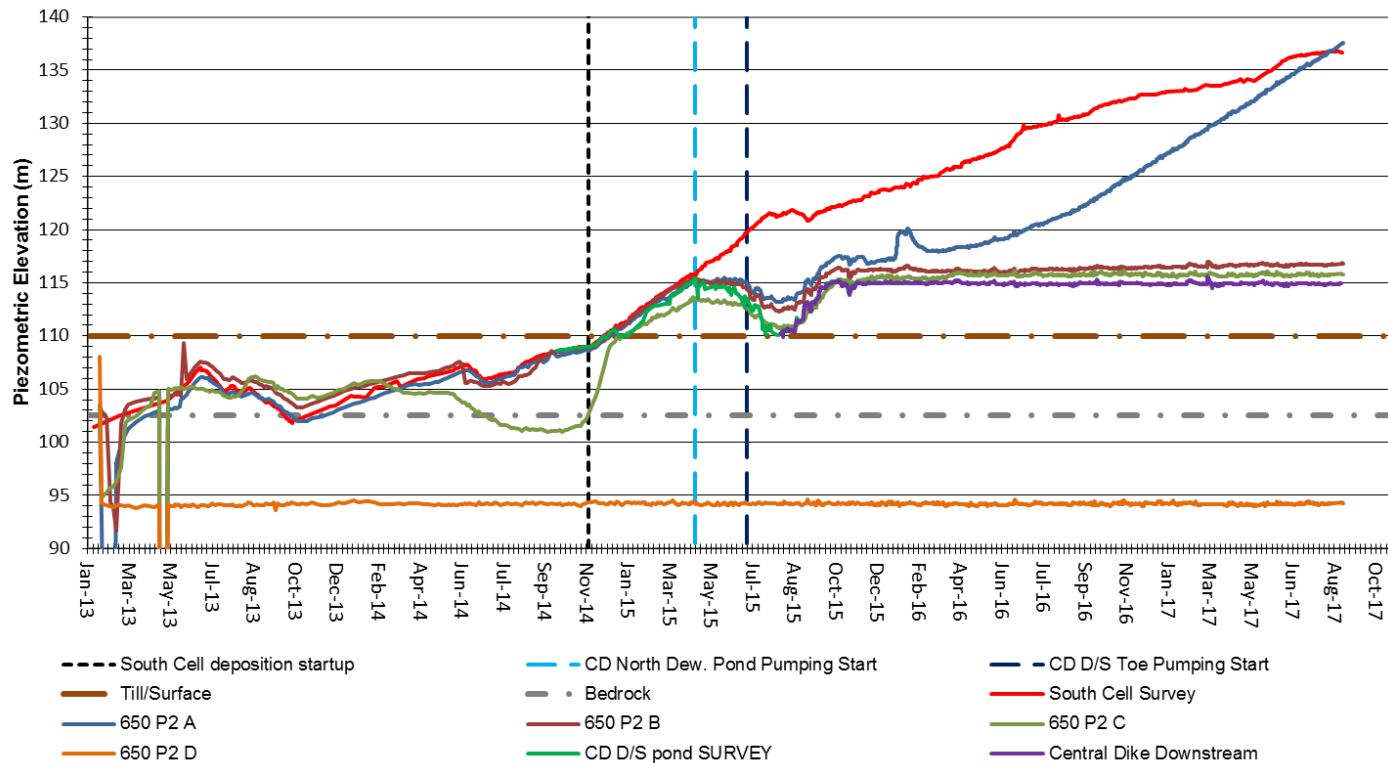
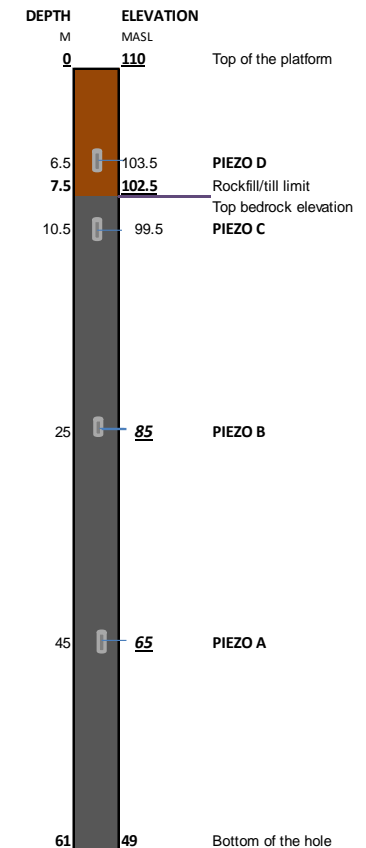
PIEZOMETER 650-P2

- Piezometer A in bedrock continue its rise and is now over the elevation of the South Cell
- Piezo B-C are following the piezometric regime of the D/S pond
- Piezo D is in suction

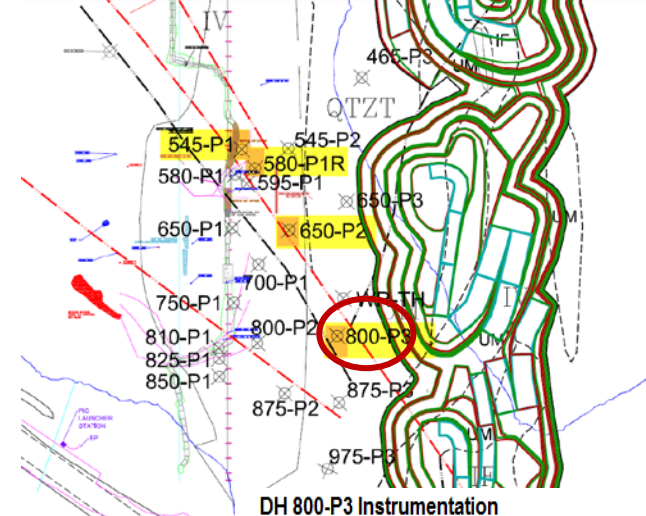
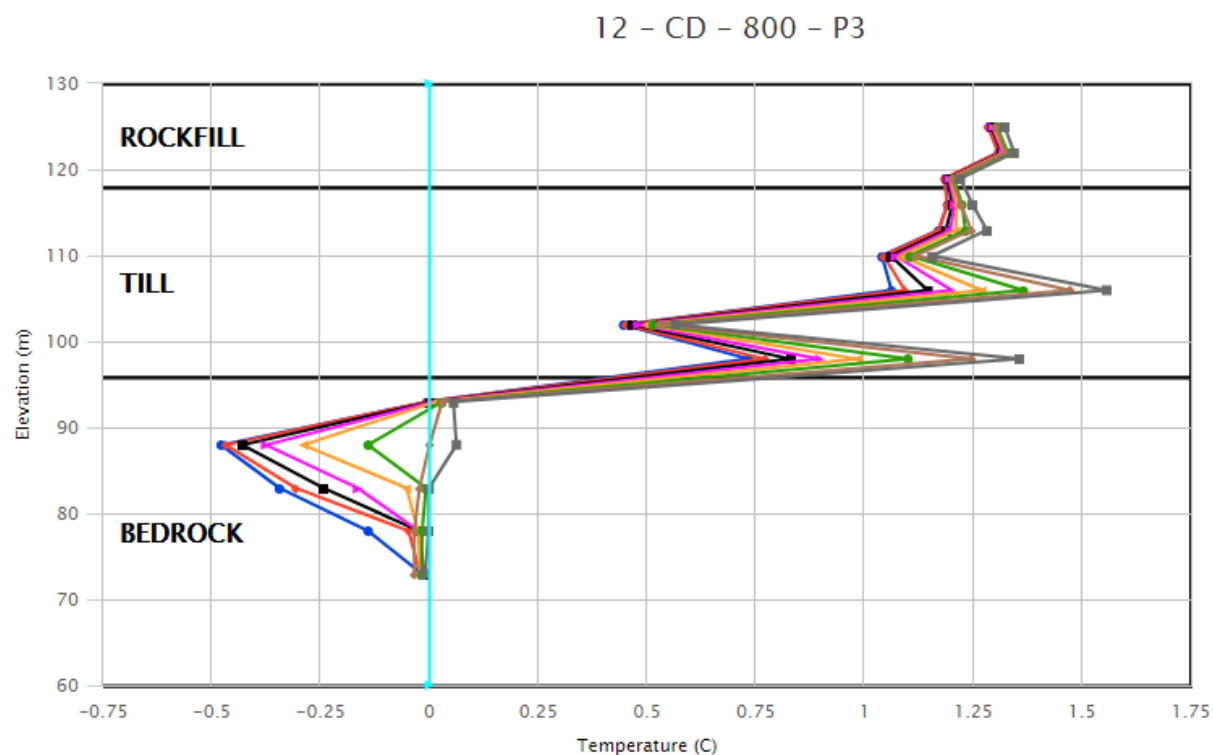
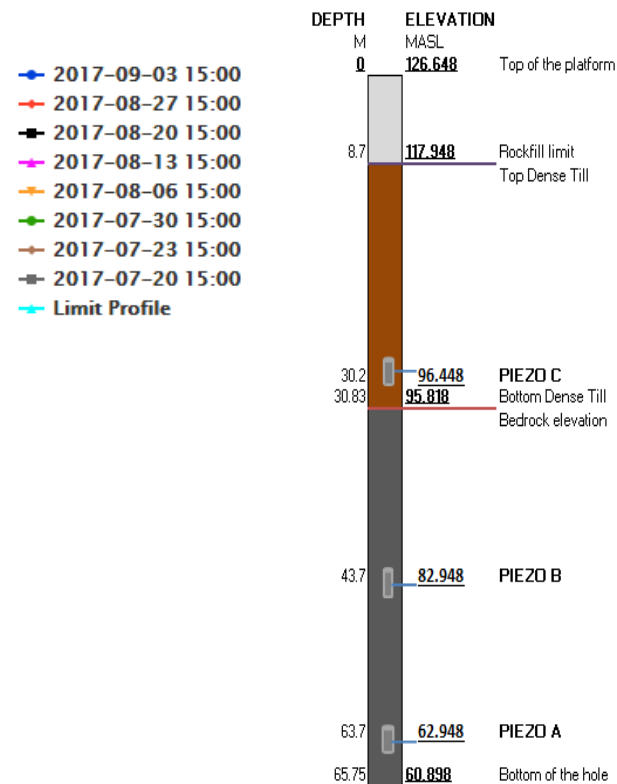
THERMISTOR 800-P3

- New instrument installed in 2017
- Stabilisation in progress
- Temperature under 0° C below El. 93 m

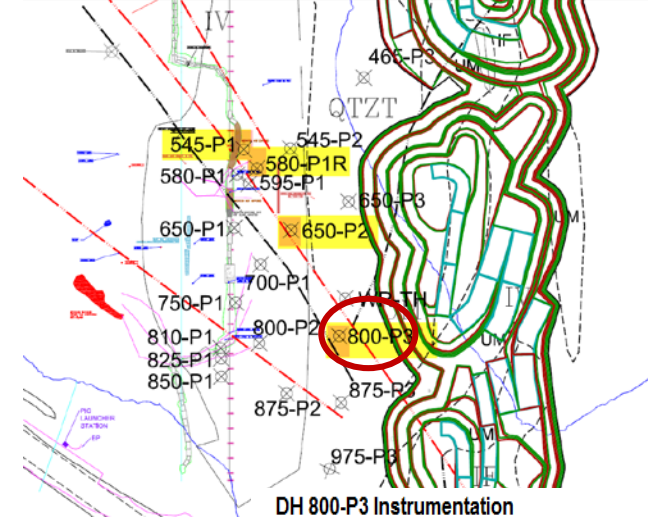
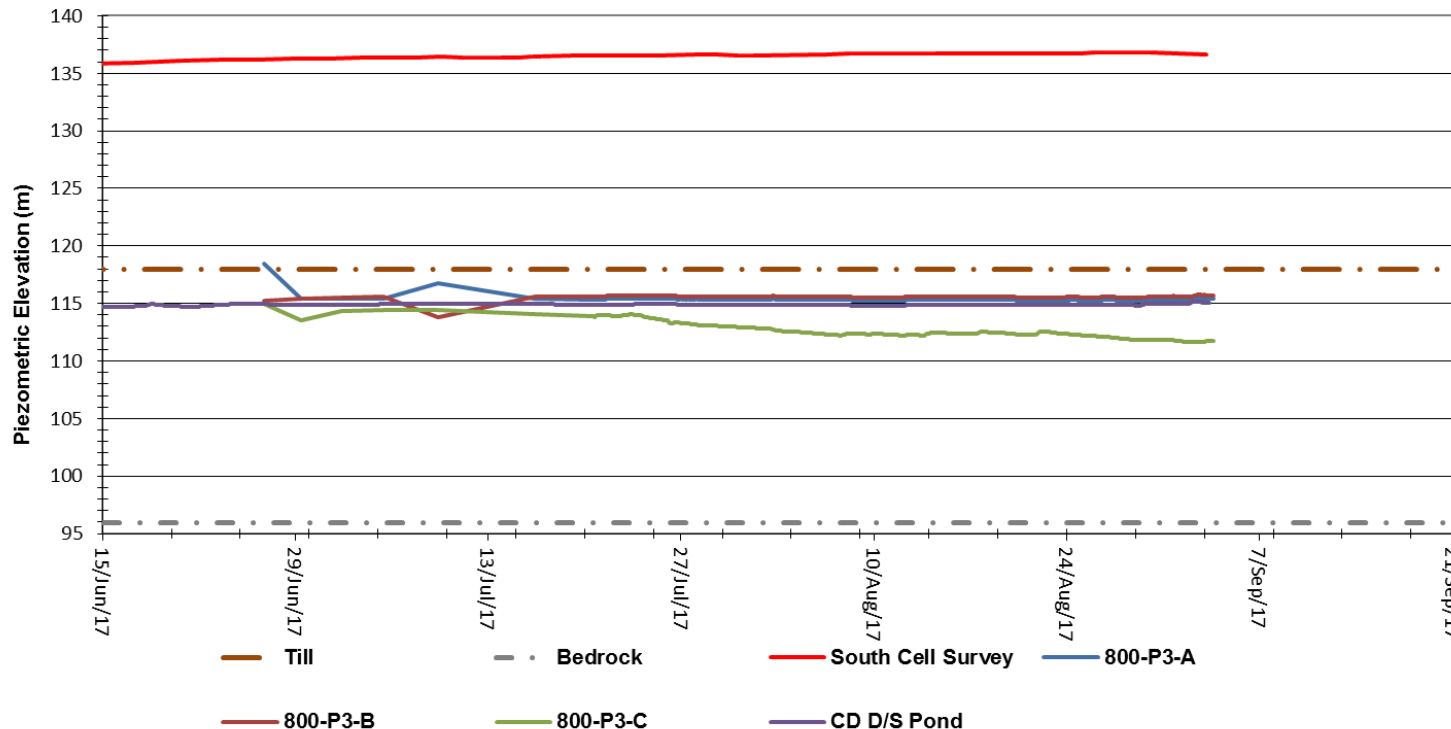
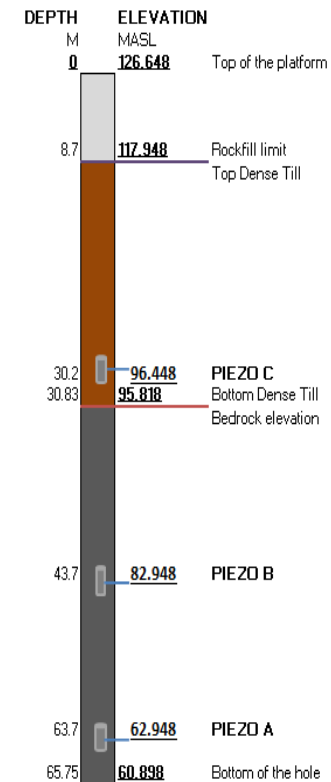
PIEZOMETERS 800-P3

- New instrument installed in 2017
- Stabilization in progress
- Piezo A & B readings are similar to the D/S pond elevation readings
- Piezo C readings is slowly decreasing

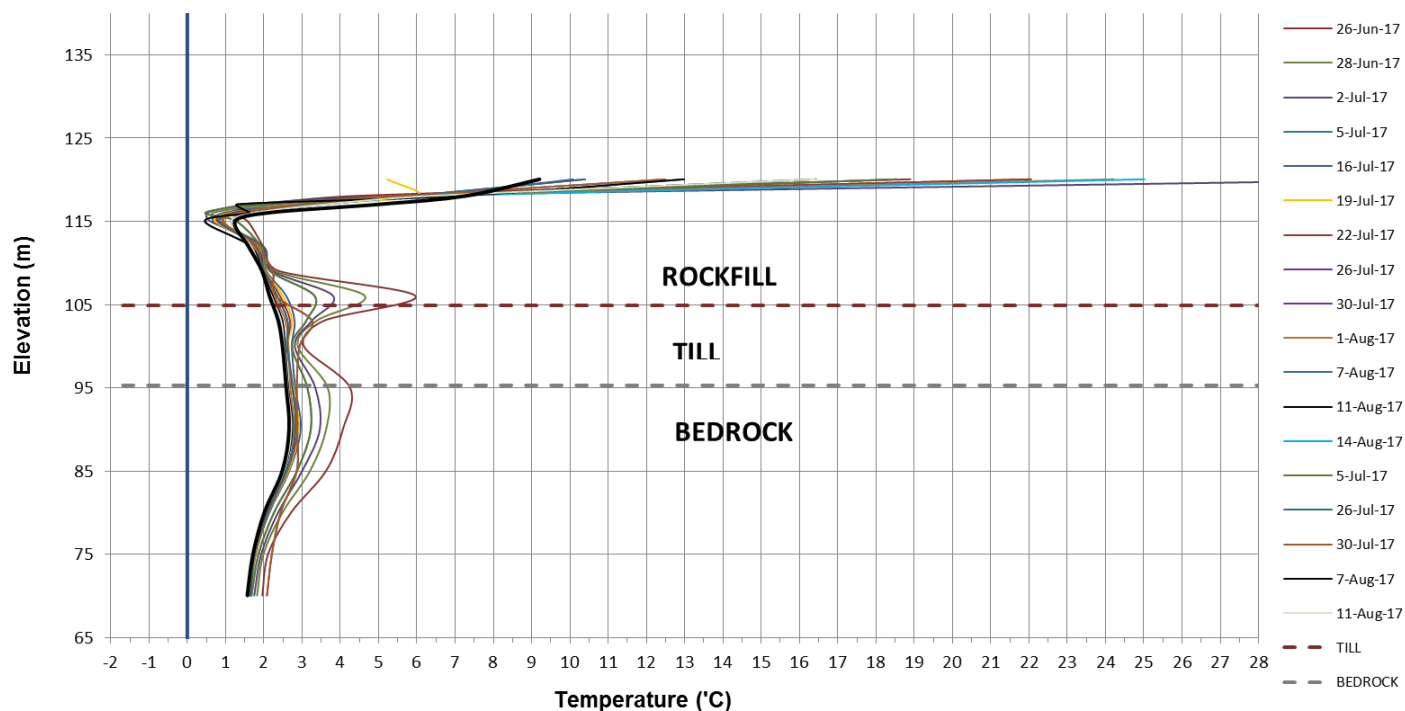
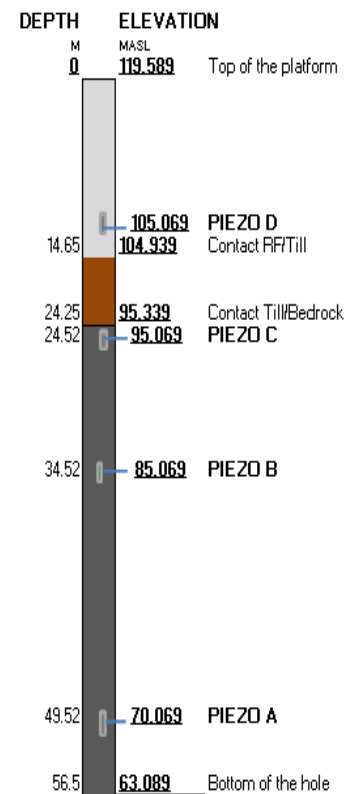
THERMISTOR 800-P2

- New instrument installed in 2017
- Stabilisation of temperature ongoing
- Temperature above 0 °C

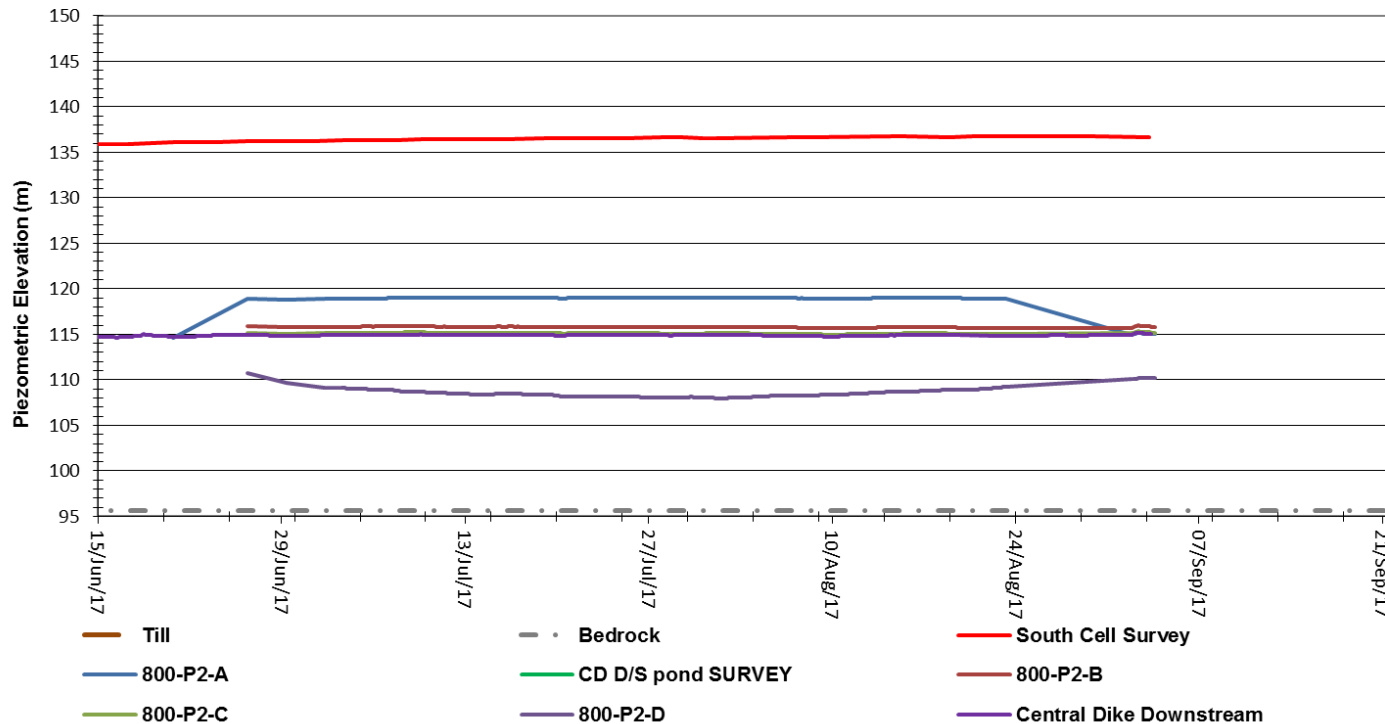
PIEZOMETER 800-P2

- New instrument installed in 2017
- Stabilisation ongoing
- Piezo A,B and C are showing pressure readings similar to the elevation of the D/S pond.

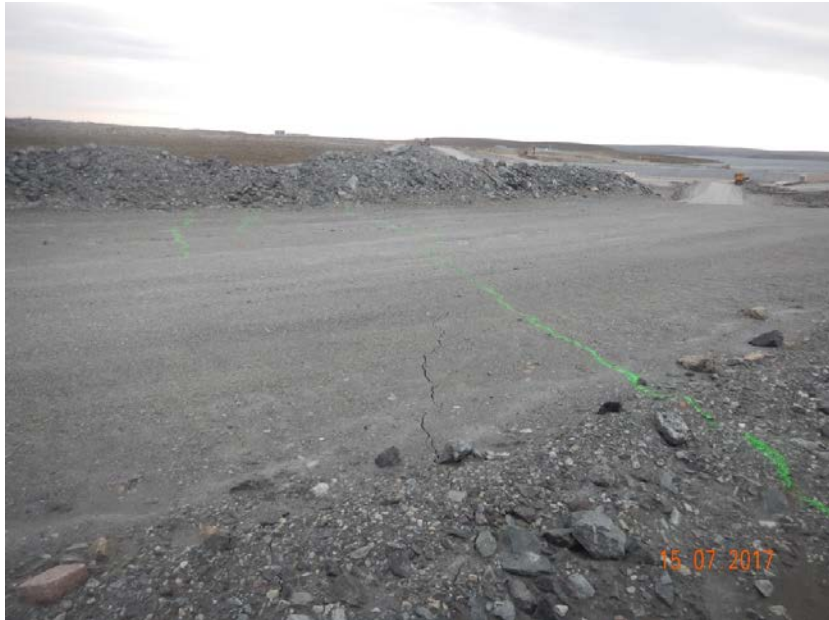
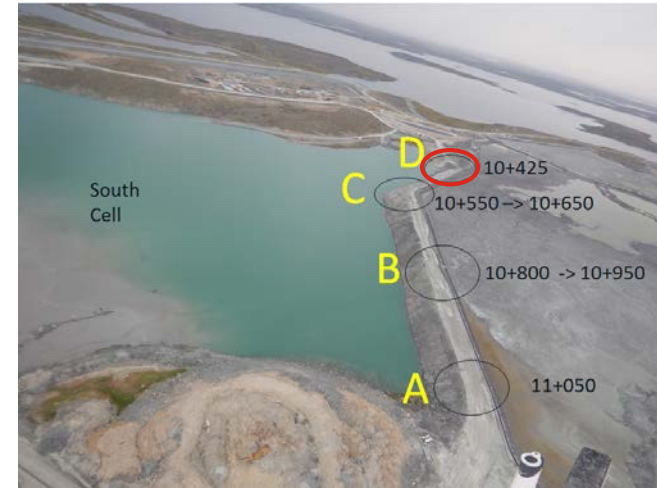
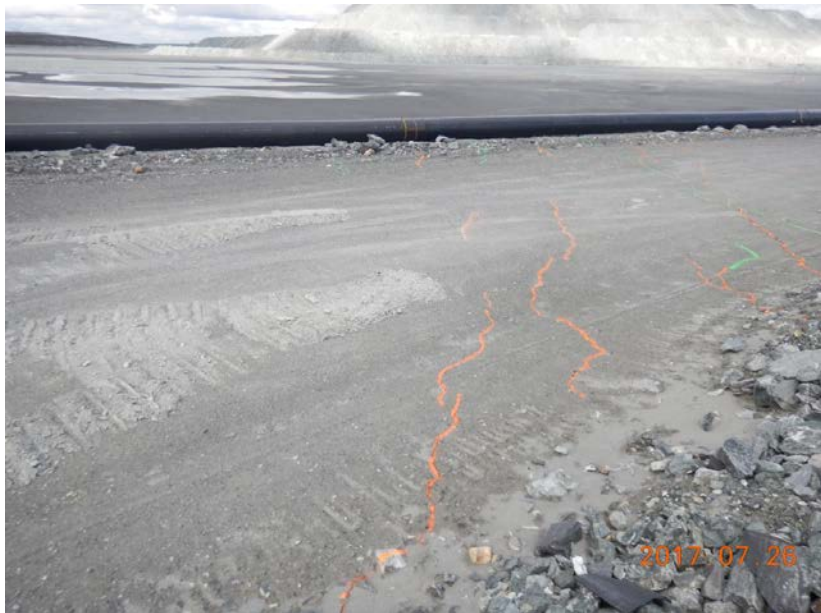
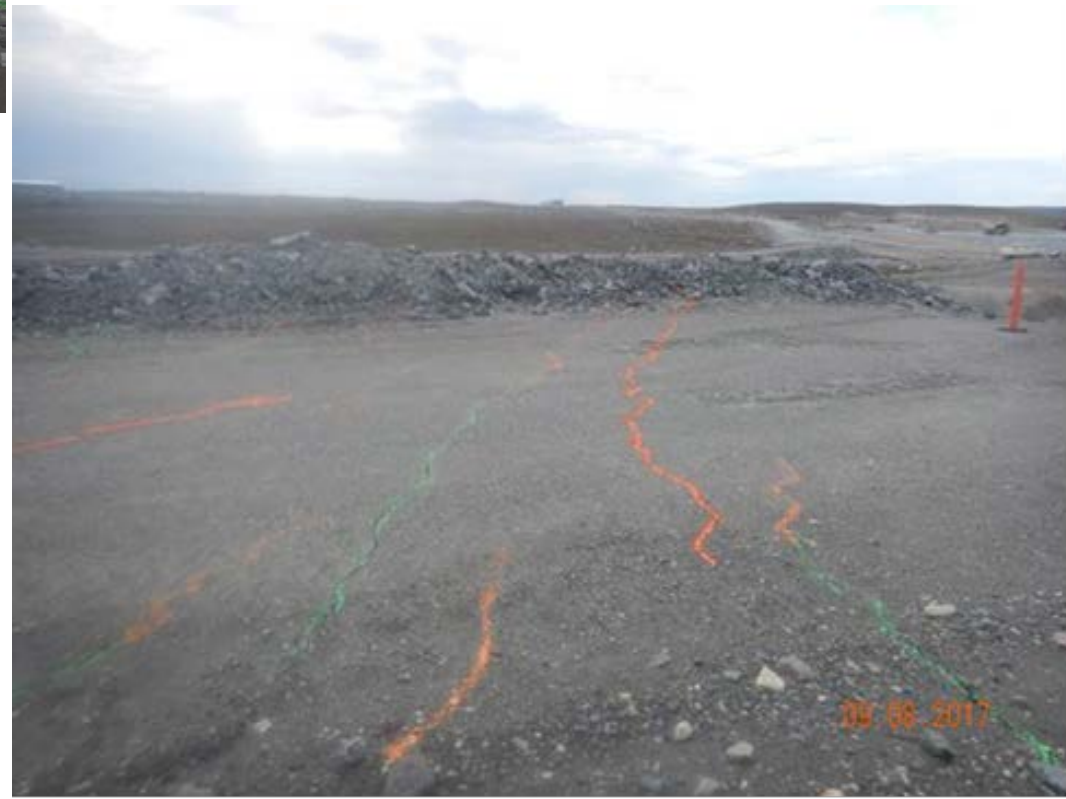
PICTURE OF MOVEMENT – 10+425

- Observed initially on July 15th 2017
- Appeared when water reached the toe in the area
- Crack width relatively small (<1cm)
- Cracks did not progressed
