Meadowbank 2018 TSF As-built report

2018 CONSTRUCTION SEASON AS-BUILT REPORT TAILINGS STORAGE FACILITY MEADOWBANK GOLD PROJECT, NUNAVUT

1897439-1578-R-Rev0

November 2018

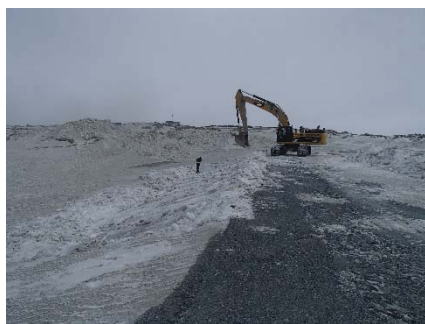
SD3-297 (2018-05-14), looking SE from Sta. 20+730/-10 m. Removal of snow on the upstream slope of SD3 with an excavator, from Sta. 20+640 to 20+760 m.

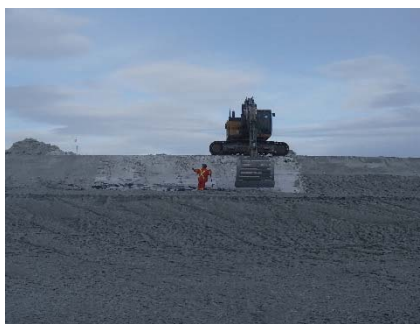
SD3-298 (2018-05-16), looking S from Sta. 20+680/-88 m. Removal of snow on the upstream slope of SD3 above El. 142 m, from Sta. 20+620 m to 20+780 m.

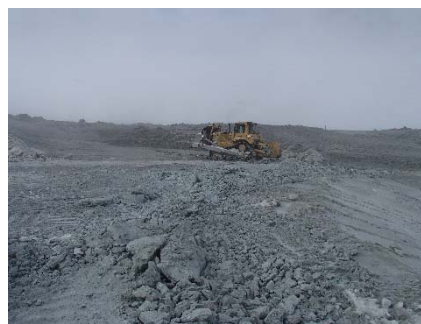
SD3-299 (2018-05-16), looking NW from Sta. 20+620/-26 m. Scarification of the frozen ultramafic volcanic (UM) rockfill on the crest with a dozer for the anchoring trench excavation between Sta. 20+605 m and 20+780 m.

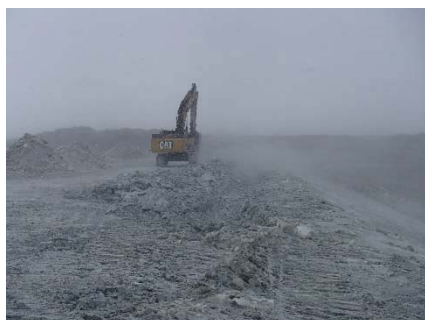
SD3-300 (2018-05-16), looking NW from Sta. 20+790/-33 m. Excavation of the LLDPE geomembrane crest anchoring trench with an excavator from Sta. 20+675 m to 20+780 m.

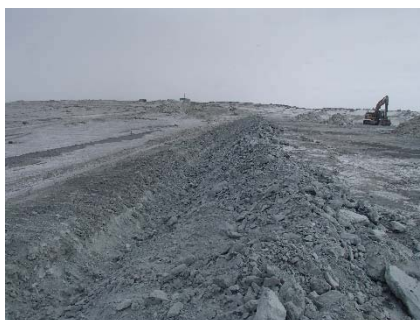
SD3-301 (2018-05-17), looking SE from Sta. 20+660/-22 m. Excavation of the LLDPE geomembrane crest anchoring trench with an excavator from Sta. 20+655 m to 20+675 m.

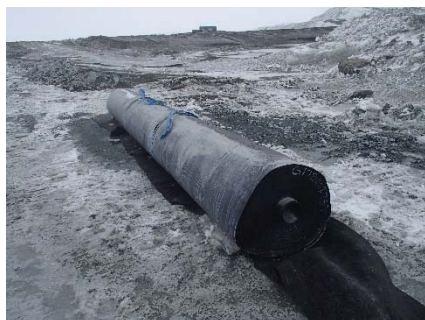
SD3-303 (2018-05-21), looking N from Sta. 20+780/-15 m. View of a LLDPE liner roll stored on geotextile.

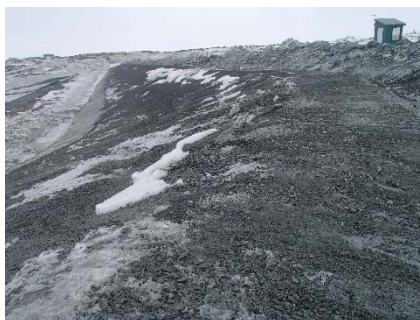
SD3-304 (2018-05-21), looking SE from Sta. 20+620/-36 m. Smoothing of the surface of the fine filter with an excavator on top of the upstream slope from Sta. 20+600 m to 20+780 m.

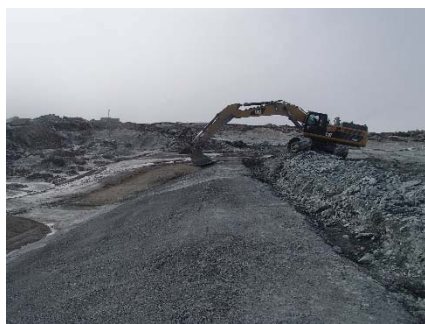
SD3-306 (2018-06-06), looking S from Sta. 20+780/-25 m. Correction of the surface of the fine filter in the upstream slope and the top of the first class compacted sieved till layer with an excavator from Sta. 20+803 m to 20+793 m.

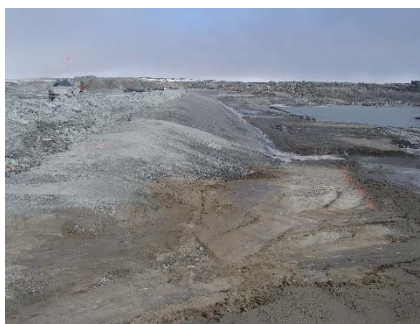
SD3-307 (2018-06-06), looking N from Sta. 20+800/-25 m. View of the liner bedding ready for geosynthetics installation.

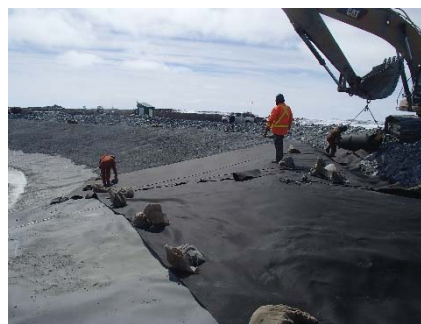
SD3-308 (2018-06-06), looking SW from Sta. 20+620/-48 m. Installation of the geotextile on the upstream slope 3H:1V between El. 143 m and 145 m from Sta. 20+620 m to 20+630 m.

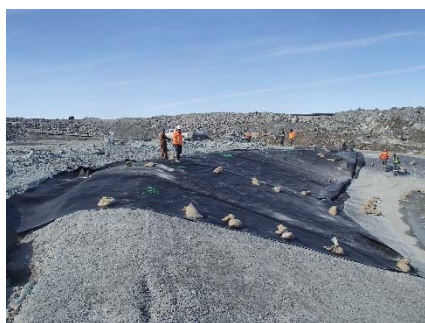
SD3-309 (2018-06-06), looking N from Sta. 20+640/-26 m. Installation of the LLDPE liner on the upstream slope 3H:1V between El. 143 m and 145 m from Sta. 20+620 m to 20+630 m (panel numbers 934 to 939).

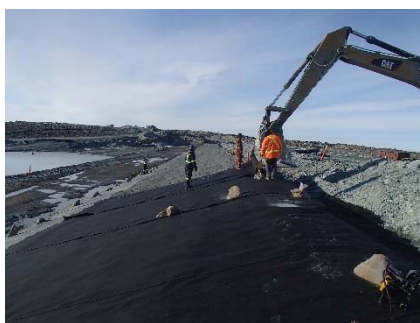
SD3-310 (2018-06-07), looking S from Sta. 20+635/-24 m. Installation of the geotextile on the upstream slope 3H:1V between El. 143 m and 145 m from Sta. 20+630 m to 20+800 m.

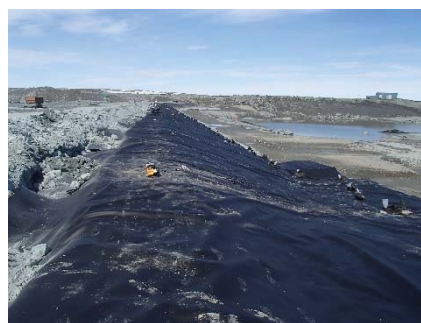
SD3-311 (2018-06-07), looking N from Sta. 20+810/-26 m. Installation of the LLDPE liner on the upstream slope 3H:1V between El. 143 m and 145 m from Sta. 20+630 m to 20+800 m (panel numbers 939 to 964).

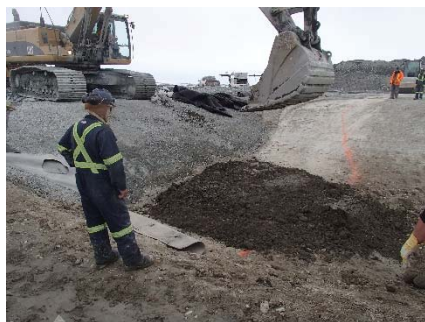
SD3-312 (2018-06-08), looking W from Sta. 20+610/-48 m. Placement of a 0.15 m thick lift of compacted sieved till from Sta. 20+596.4 m to 20+601.6 m (o.s. -42.6 to -46.3 m) to fill the depression in the compacted sieved till layer.

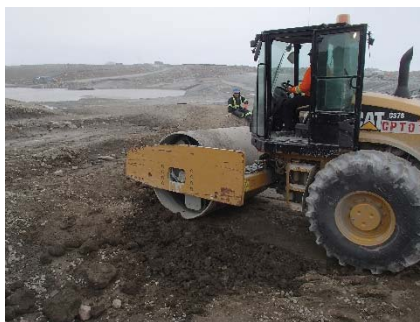
SD3-313 (2018-06-08), looking S from Sta. 20+600/-52 m. Compaction of the 0.15 m-thick lift of compacted sieved till with a 10-tonne smooth-drum compactor without vibration (4 passes) from Sta. 20+596 m to 20+601 m.

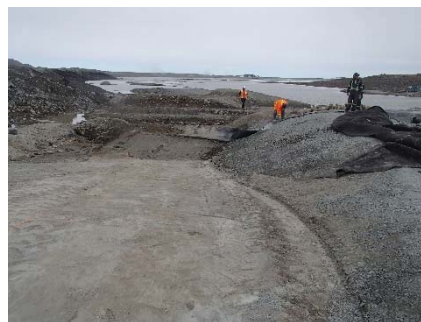
SD3-314 (2018-06-08), looking E from Sta. 20+590/-32 m. View of the liner bedding ready for geosynthetics installation.

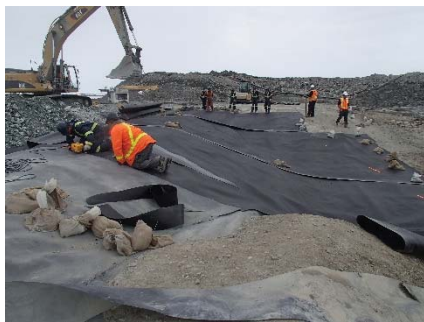
SD3-315 (2018-06-08), looking W from Sta. 20+615/-46 m. Installation of the geotextile on the upstream slope 3H:1V between El. 143 m and 145 m from Sta. 20+593 m to 20+610 m and installation of the LLDPE liner on the upstream slope 3H:1V between El. 143 m and 145 m from Sta. 20+593 m to 20+610 m (panel numbers 965 to 967).

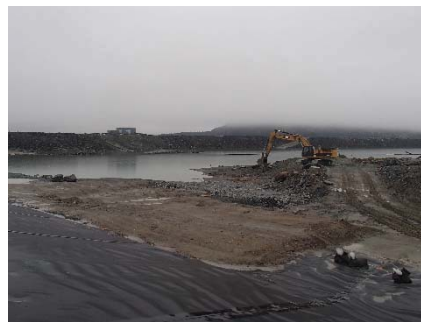
SD3-317 (2018-07-07), looking E from Sta. 20+800/-22 m. Reworking of the access to SD3.

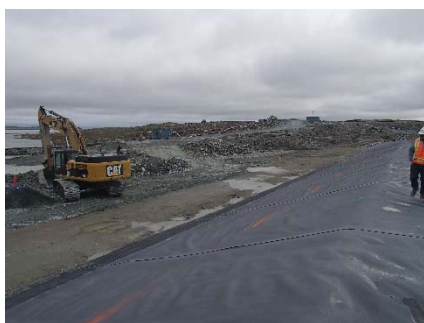
SD3-318 (2018-07-07), looking SE from Sta. 20+710/-24 m. Placement of IV rockfill in the water up to El. 142m with an excavator from Sta. 20+785 m to 20+730 m, at the bottom of the upstream slope of SD3 to widen the rockfill layer and allow access to the erosion protection.

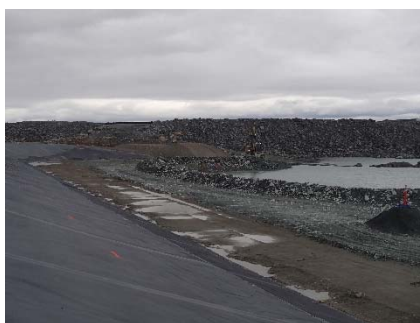
SD3-319 (2018-07-08), looking NE from Sta. 20+740/-31 m. Placement of IV rockfill in the water up to El. 142m with an excavator from Sta. 20+730 m to 20+610 m, at the bottom of the upstream slope of SD3 to widen the rockfill layer and allow access to the erosion protection.

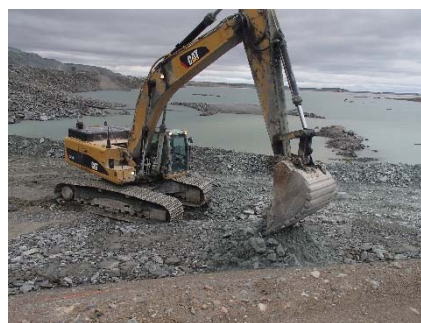
SD3-320 (2018-07-08), looking E from Sta. 20+620/-67 m. Placement of a 1 m thick (approx.) lift of fine IV rockfill over the compacted till in the upstream slope from El. 142 m to 144 m with an excavator from Sta. 20+600 m to 20+610 m.

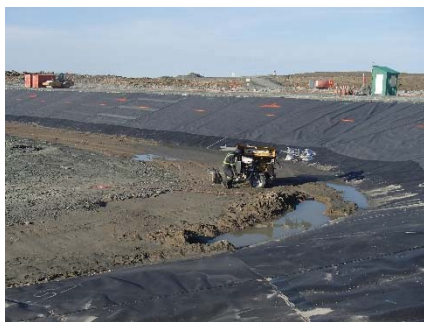
SD3-321 (2018-07-09), looking SW from Sta. 20+610/-56 m. Water ponding at El. 142m on the compacted sieved till layer of the upstream toe liner tie-in at approx. Sta. 20+620 m to 20+630 m was pumped.

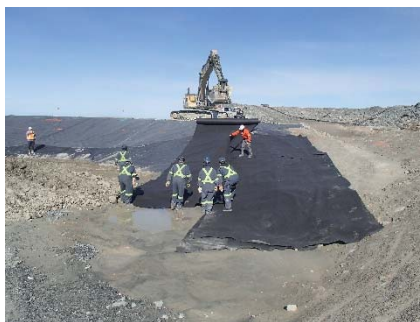
SD3-322 (2018-07-09), looking W from Sta. 20+625/-63 m. Installation of two layers of geotextile on the upstream slope 3H:1V between El. 142 m and 143 m (approx.) from Sta. 20+610 m to 20+800 m.

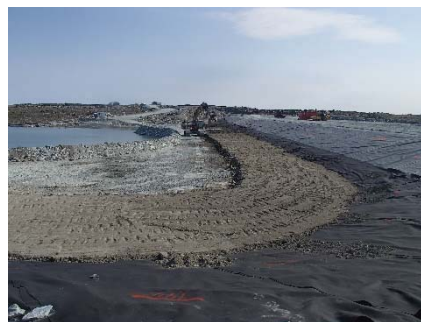
SD3-323 (2018-07-09), looking S from Sta. 20+610/-43 m. Placement of the first 0.5 m thick lift of low quality till (0-150 mm) from El. 142 m to 142.5 m from Sta. 20+610 m to 20+715 m.

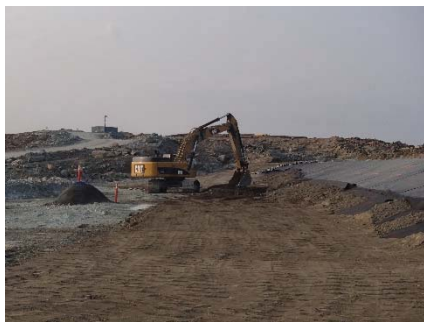
SD3-324 (2018-07-10), looking S from Sta. 20+680/-39 m. Placement of a 0.5 m thick lift of low quality till (0-150 mm) from El. 142 m to 142.5 m from Sta. 20+715 m to 20+760 m.

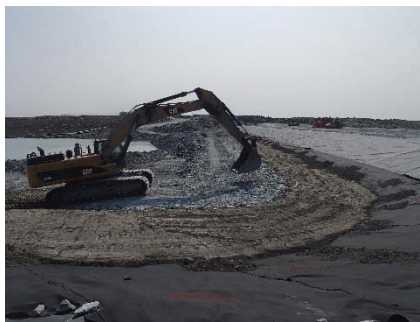
SD3-325 (2018-07-10), looking S from Sta. 20+610/-43 m. Placement of a first 0.5 m thick lift of fine rockfill (0-500 mm) upstream of the low quality till from El. 142 m to 142.5 m from Sta. 20+610 m to 20+760 m.

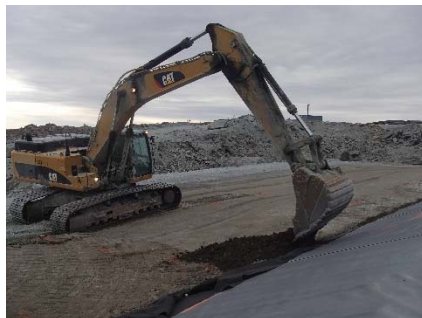
SD3-348 (2018-07-18), looking E from Sta. 20+760/-25 m. Placement of a 0.5 m thick layer of compacted sieved till on the upstream slope of SD3 with an LLDPE liner from Sta. 20+777 m to 20+807 m. No large rock was allowed to be placed against the LLDPE liner.

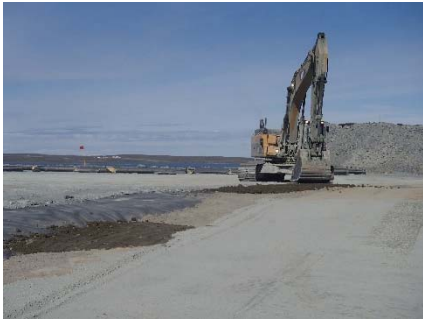
SD3-353 (2018-07-22), looking SW from Sta. 20+580/-49 m. View of SD3 at the end of the 2018 construction phase.

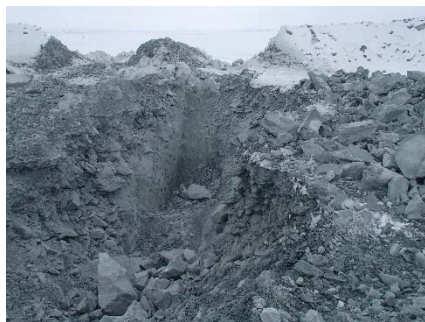
NCIS-001 (2018-05-19). View of a test pit in the UM rockfill lift at El. 152 m: a thick layer of snow (2 m) underlies the rockfill.

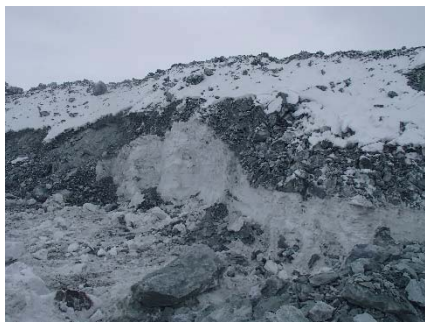
NCIS-002 (2018-05-19). View of the scraped upstream side of the UM rockfill lift at El. 152 m: a thick layer of snow (1.5 m) underlies the rockfill.

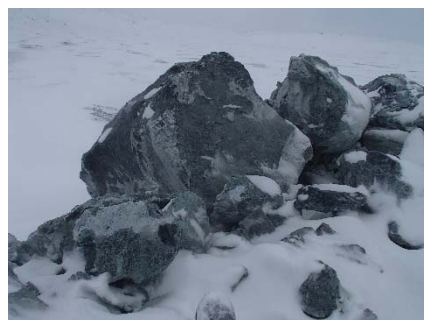
NCIS-006 (2018-05-19). View of oversize boulders on the UM rockfill lift at El. 152 m.

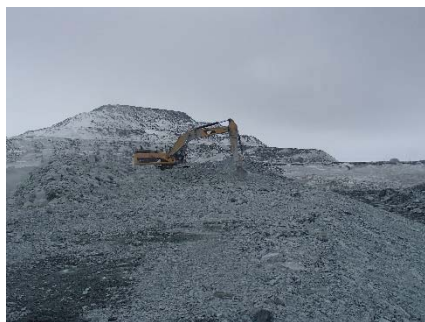
NCIS-013 (2018-05-22), looking NE from Sta. 2+600 m. Correction of the crest elevation with an excavator to achieve a closer elevation to 152 m around Sta. 2+650 m.

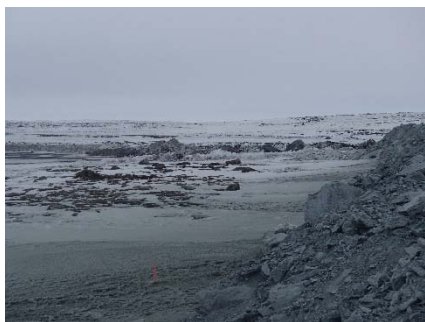
NCIS-014 (2018-05-22), looking SE from Sta. 1+900 m. View of the natural soil on which the 2015 capping is built.

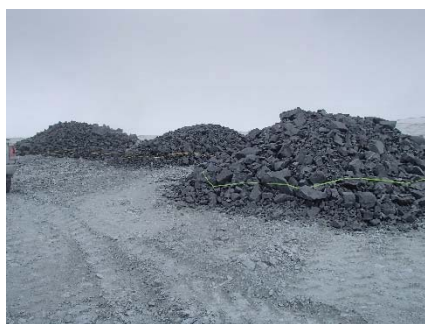
NCIS-016 (2018-05-23), looking SE from Sta. 1+750 m. View of the Iron Formation rockfill (PAG material) piles on the North Cell Internal Structure.

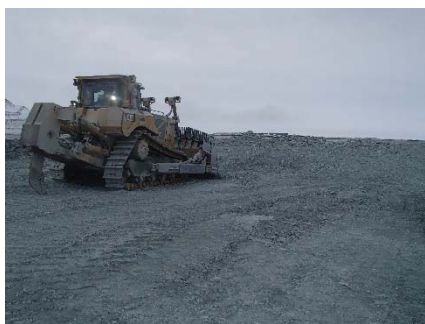
NCIS-020 (2018-05-27), looking S from Sta. 1+570 m. Placement a 2 m thick (approx.) lift of UM rockfill from El. 150 m to El. 152 m (approx.) with a dozer from Sta. 1+564 m to 1+535 m (o.s. unavailable).

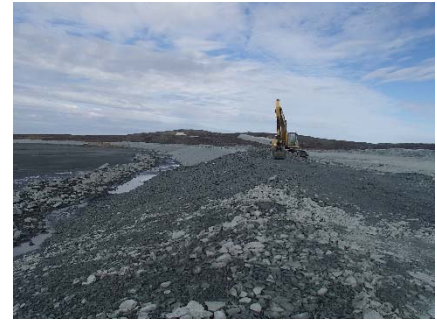
NCIS-030 (2018-06-20), looking W from Sta. 2+140/-29 m. Placement of a 0.5 m thick lift of coarse filter in the upstream slope from El. 150 m to 152 m with an excavator from Sta. 2+105 m to 1+930 m. Notice the presence of water ponding at the bottom of the slope.

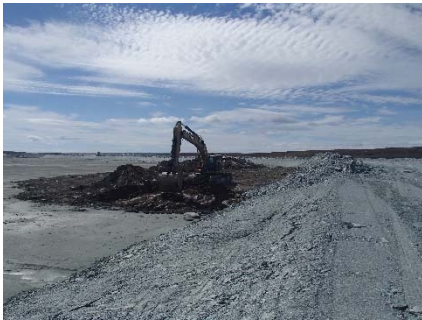
NCIS-031 (2018-06-20), looking SW from Sta. 1+880/-21 m. Final clean-up of the dike footprint with an excavator to reach a good quality bedrock from Sta. 1+800 to 1+850 m (o.s. -42 to -33 m).

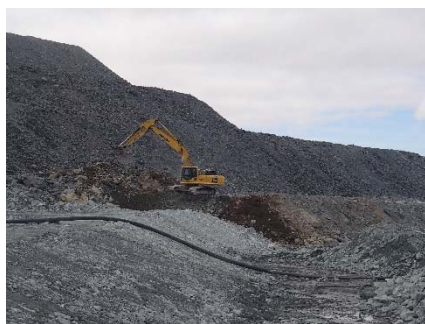
NCIS-046 (2018-06-26), looking SE from Sta. 2+680/-18 m. Removal of till material mixed with the UM rockfill of the capping (about 1 to 2 m thick along the slope) with an excavator from Sta. 2+760 m to 2+850 m (o.s. -35 to -17 m).

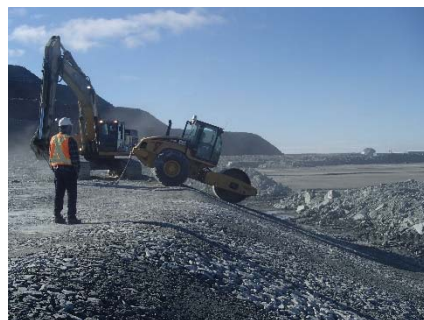
NCIS-054 (2018-06-28), looking SE from Sta. 2+580/-31 m. Compaction of the 0.5 m lift (approx.) of coarse filter between El. 150 and 152 m with a 10-tonne smooth-drum compactor with vibration (4 passes) in the upstream slope from Sta. 2+560 m to 2+815 m.

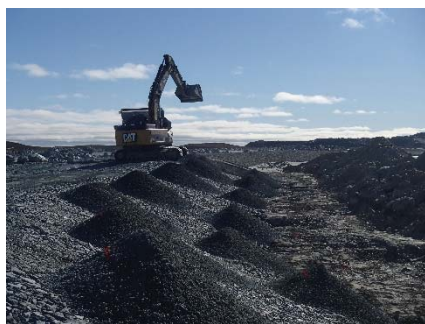
NCIS-055 (2018-06-28), looking NE from Sta. 1+730/-42 m. Placement of a 0.5 m thick lift of fine filter over the coarse filter in the upstream slope from El. 150 m to 152 m with an excavator from Sta. 1+820 m to 1+595 m.

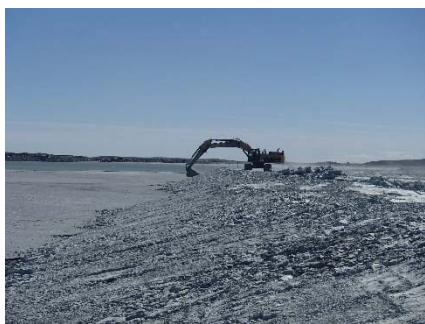
NCIS-056 (2018-06-28), looking S from Sta. 1+290/-39 m. Profiling of the upstream slope (3H:1V) from El. 148 to 150 m with an excavator from Sta. 1+340 m to 1+130 m.

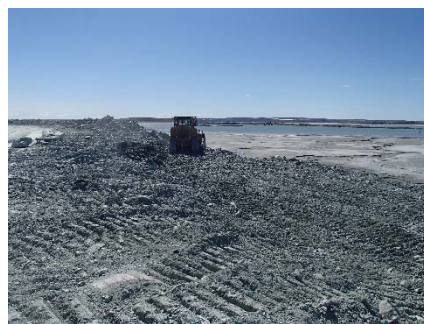
NCIS-057 (2018-06-28), looking SW from Sta. 3+010/-15 m. Removing of UM rockfill material from the capping with a dozer to level the surface to El. 152 m from Sta. 2+980 m to 3+050 m (o.s. -30 to -20 m).

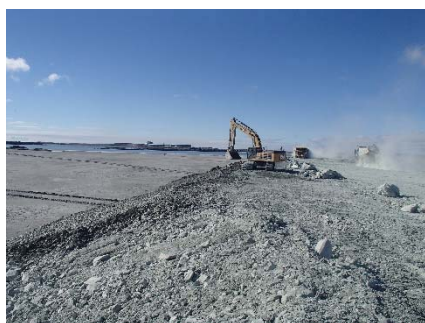
NCIS-058 (2018-06-29), looking S from Sta. 1+340/-34 m. Placement of a 0.5 m thick lift of coarse filter in the upstream slope from El. 148 m to 152 m with an excavator from Sta. 1+340 m to 1+270 m.

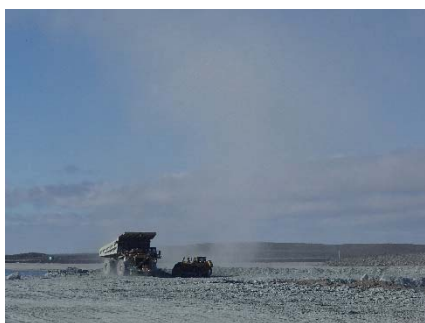
NCIS-059 (2018-06-29), looking S from Sta. 1+330/-34 m. Placement of a 1.5 to 2 m thick (approx.) lift of UM rockfill from El. 148 m to El. 150 m (approx.) with a dozer from Sta. 1+120 m to 1+100 m (-96 m to -60 m). The material is of good quality and is well graded.

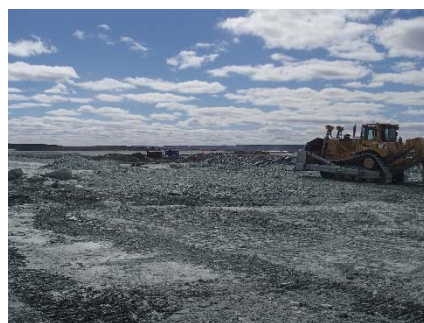
NCIS-060 (2018-06-29), looking SW from Sta. 1+365/-35 m. Placement of a 2 m thick (approx.) lift of UM rockfill from El. 150 m to El. 152 m (approx.) with a dozer from Sta. 1+340 m to 1+320 m (-19 m to +16 m). The material is of good quality and is well graded.

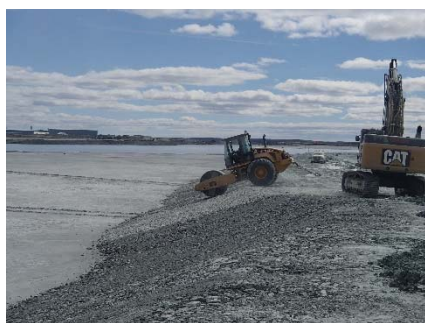
NCIS-061 (2018-06-29), looking S from Sta. 1+365/-35 m. Compaction of the 0.5 m lift of coarse filter between El. 148 and 152 m with a 10-tonne smooth-drum compactor with vibration (4 passes) in the upstream slope from Sta. 1+340 m to 1+270 m.

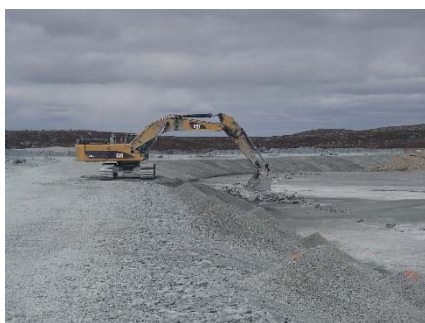
NCIS-062 (2018-06-29), looking N from Sta. 1+525/-33 m. Placement of a 0.5 m thick lift of fine filter over the coarse filter in the upstream slope from El. 150 m to 152 m with an excavator from Sta. 1+330 m to 1+260 m and from Sta. 1+595 m to 1+550 m.

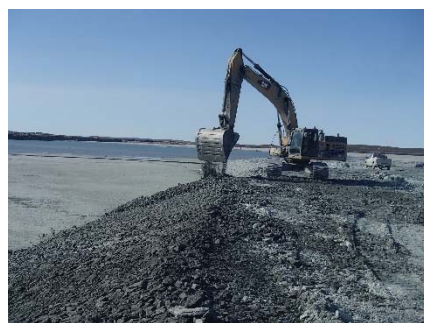
NCIS-063 (2018-06-30), looking SW from Sta. 1+200/-65 m. Placement of a 0.5 m thick lift of coarse filter in the upstream slope from El. 148 m to 150 m with an excavator from Sta. 1+270 m to 1+100 m.

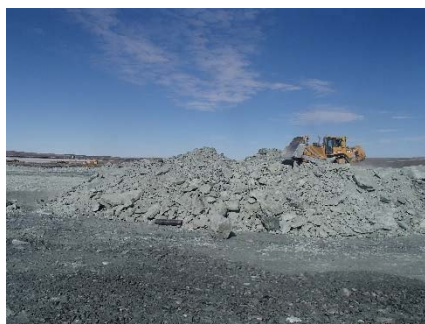
NCIS-064 (2018-06-30), looking W from Sta. 1+200/-65 m. Placement of a 2 m thick (approx.) lift of UM rockfill from El. 150 m to El. 152 m (approx.) with a dozer from Sta. 1+320 m to 1+235 m (-65 m to -45 m). The material is of good quality and is well graded.

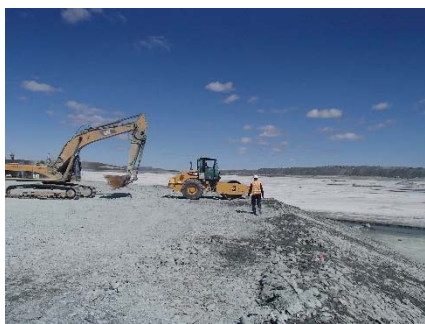
NCIS-065 (2018-06-30), looking NE from Sta. 1+140/-96 m. Compaction of the 0.5 m lift of coarse filter between El. 148 and 150 m with a 10-tonne smooth-drum compactor with vibration (4 passes) in the upstream slope from Sta. 1+270 m to 1+100 m.

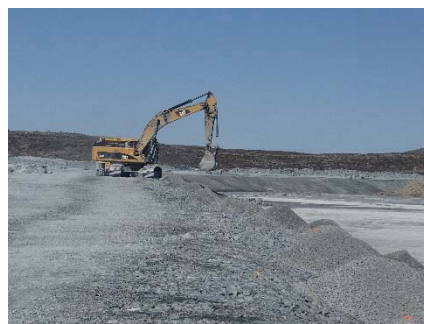
NCIS-066 (2018-06-30), looking N from Sta. 1+400/-34 m. Placement of a 0.5 m thick lift of fine filter over the coarse filter in the upstream slope from El. 150 m to 152 m with an excavator from Sta. 1+595 m to 1+550 m.

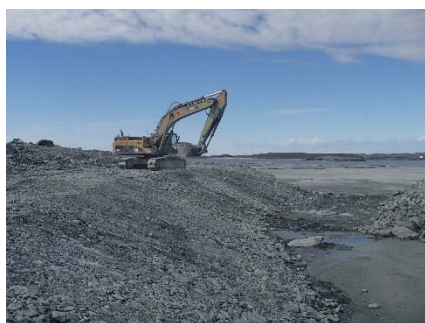
NCIS-067 (2018-07-01), looking N from Sta. 2+880/-26 m. Profiling of the upstream slope (3H:1V) from El. 150 to 152 m with an excavator from Sta. 2+860 m to 2+975 m.

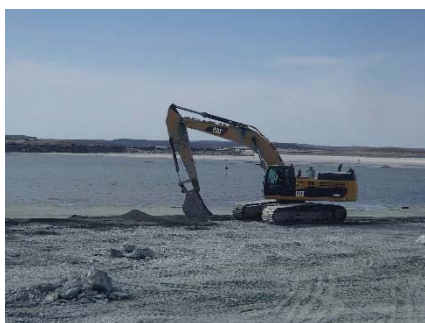
NCIS-068 (2018-07-01), looking S from Sta. 1+150/-62 m. Placement of a 0.5 m thick lift of fine filter over the coarse filter in the upstream slope from El. 148 m to 150 m with an excavator from Sta. 1+180 m to 1+100 m.

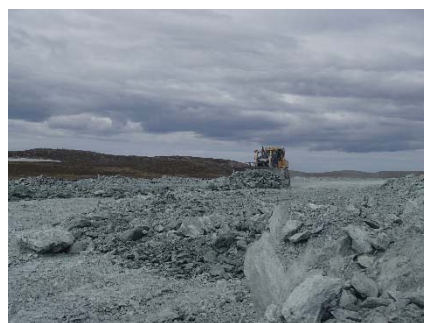
NCIS-069 (2018-07-01), looking NW from Sta. 1+180/-56 m. Placement of a 2 m thick (approx.) lift of UM rockfill from El. 150 m to El. 152 m (approx.) with a dozer from Sta. 1+235 m to 1+160 m (-60 m to -44 m). The material is of good quality and is well graded.

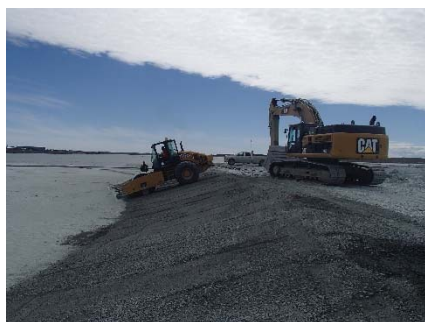
NCIS-070 (2018-07-01), looking S from Sta. 1+160/-89 m. Compaction of the 0.5 m lift of fine filter between El. 150 and 152 m with a 10-tonne smooth-drum compactor with vibration (4 passes) in the upstream slope from Sta. 1+335 m to 1+100 m.

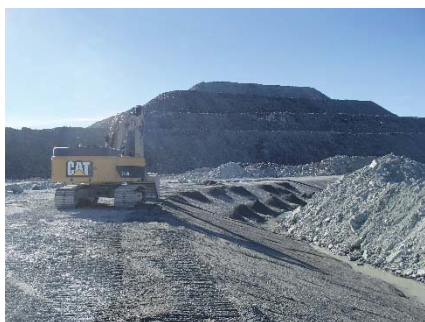
NCIS-071 (2018-07-02), looking SE from Sta. 2+670/-28 m. Placement of a 0.5 m thick lift of fine filter over the coarse filter in the upstream slope from El. 150 m to 152 m with an excavator from Sta. 1+550 m to 1+320 m and 1+630 m to 1+610 m.

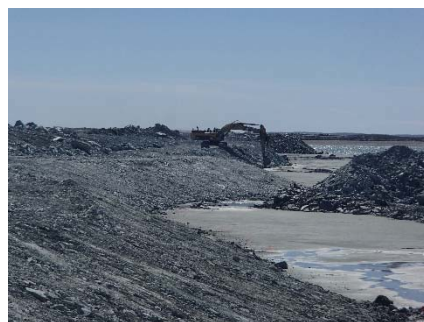
NCIS-072 (2018-07-02), looking W from Sta. 2+790/-38 m. Profiling of the upstream slope (3H:1V) from El. 150 to 152 m with an excavator from Sta. 2+975 m to 3+070 m.

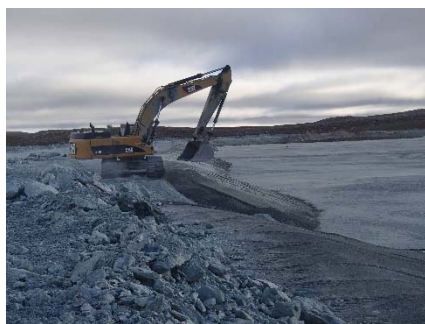
NCIS-073 (2018-07-03), looking N from Sta. 1+300/-33 m. Placement of a 0.5 m thick lift of fine filter over the coarse filter in the upstream slope from El. 150 m to 152 m with an excavator from Sta. 1+320 m to 1+300 m.

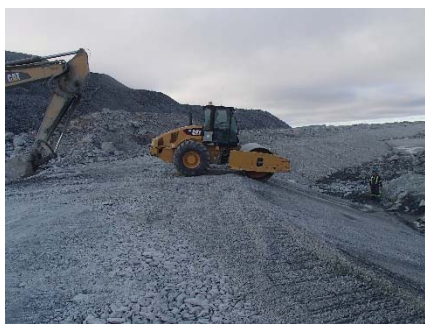
NCIS-074 (2018-07-03), looking SE from Sta. 2+750/-37 m. Compaction of the 0.5 m lift (approx.) of fine filter between El. 150 and 152 m with a 10-tonne smooth-drum compactor (4 passes) in the upstream slope from Sta. 2+810 m to 2+095 m.

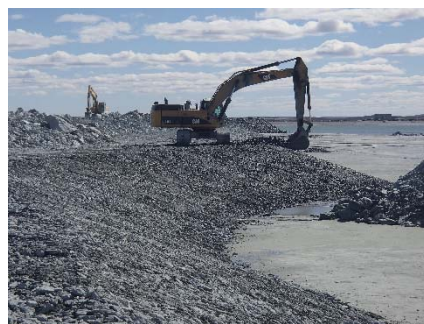
NCIS-075 (2018-07-03), looking S from Sta. 2+860/-36 m. Placement of a 0.5 m thick lift of coarse filter in the upstream slope from El. 150 m to 152 m with an excavator from Sta. 2+815 m to 2+980 m.

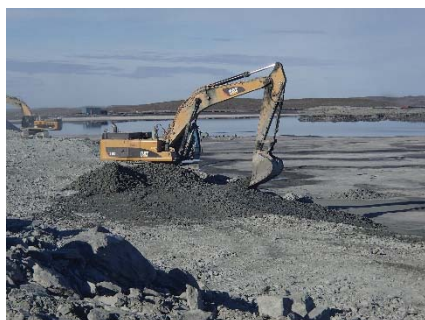
NCIS-076 (2018-07-04), looking SW from Sta. 2+940/-15 m. Placement of a 0.5 m thick lift of coarse filter in the upstream slope from El. 150 m to 152 m with an excavator from Sta. 2+980 m to 3+160 m.

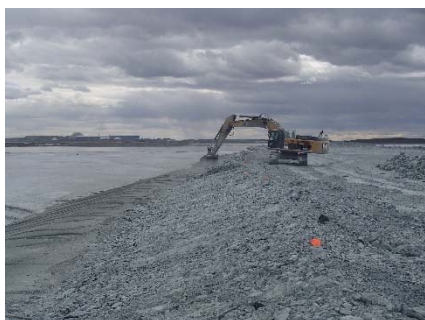
NCIS-077 (2018-07-04), looking S from Sta. 1+310/-32 m. Profiling of the upstream slope (3H:1V) from El. 150 m to 152 m with an excavator from Sta. 1+300 m to 1+175 m and from 3+070 m to 3+160 m.

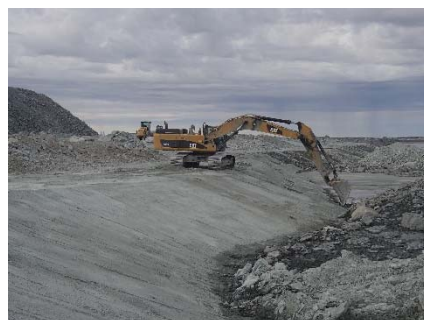
NCIS-078 (2018-07-05), looking S from Sta. 2+760/-39 m. Placement of a 0.5 m thick lift of fine filter over the coarse filter in the upstream slope from El. 150 m to 152 m with an excavator from Sta. 2+800 m to 2+980 m.

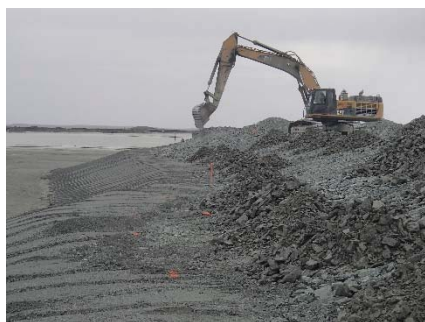
NCIS-079 (2018-07-05), looking SW from Sta. 1+280/-39 m. Placement of a 0.5 m thick lift of coarse filter in the upstream slope from El. 150 m to 152 m with an excavator from Sta. 1+300 m to 1+200 m.

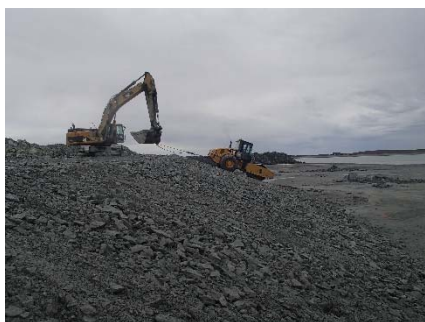
NCIS-080 (2018-07-05), looking S from Sta. 2+800/-38 m. Compaction of the 0.5 m lift (approx.) of coarse filter between El. 150 and 152 m with a 10-tonne smooth-drum compactor (4 passes) in the upstream slope from Sta. 2+925 m to 3+160 m and from Sta. 1+300 m to 1+200 m.

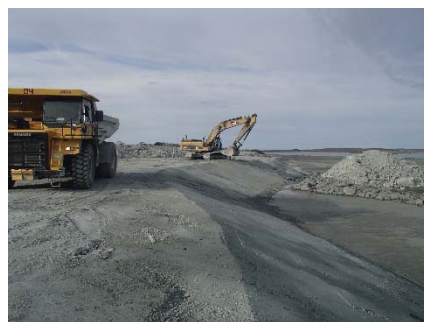
NCIS-081 (2018-07-06), looking SE from Sta. 2+975/-37 m (approx.). Placement of a 0.5 m thick lift of fine filter over the coarse filter in the upstream slope from El. 150 m to 152 m with an excavator from Sta. 1+300 m to 1+210 m and from Sta. 2+940 m to 3+120 m.

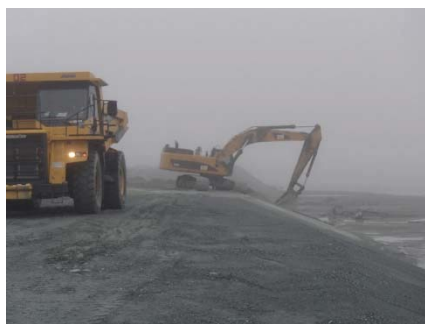
NCIS-082 (2018-07-07), looking S from Sta. 3+060/-33 m. Placement of a 0.5 m thick lift of fine filter over the coarse filter in the upstream slope from El. 150 m to 152 m with an excavator from Sta. 3+120 m to 3+160 m.

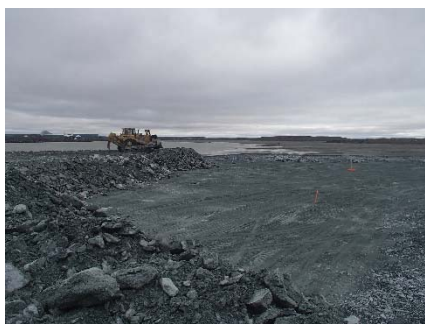
NCIS-083 (2018-07-07), looking SW from Sta. 1+140/52 m. Placement of a 2 m thick (approx.) lift of IV rockfill from El. 150 m to El. 152 m (approx.) with a dozer from Sta. 1+160 m to 1+170 m (-64 m to -111 m).

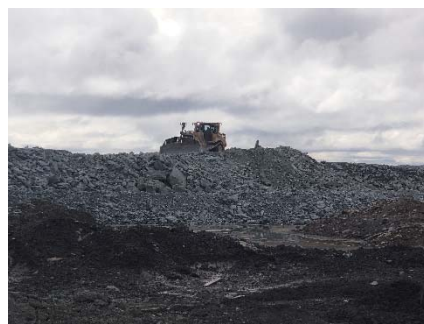
NCIS-084 (2018-07-08), looking E from Sta. 1+080/+47 m (approx.). Placement of a 2 m thick (approx.) lift of UM rockfill from El. 150 m to El. 152 m (approx.) with a dozer from Sta. 1+160 m to 1+130 m (-55 m to -102 m).

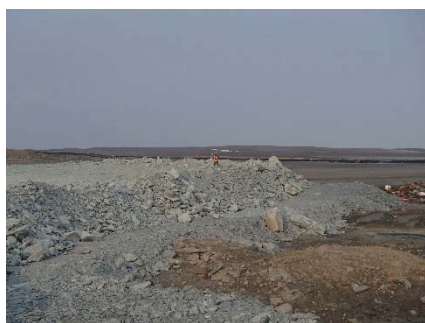
NCIS-085 (2018-07-09), looking SW from Sta. 1+150/-67 m (approx.). Placement of a 2 m thick (approx.) lift of UM rockfill from El. 150 m to El. 152 m (approx.) with a dozer from Sta. 1+130 m to 1+100 m (-55 m to -78 m).

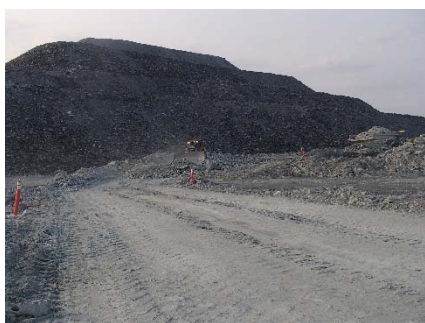
NCIS-086 (2018-07-10), looking E from Sta. 2+750/+14 m (approx.). Placement of a 2 m thick (approx.) lift of UM rockfill from El. 152 m to El. 154 m (approx.) with a dozer from Sta. 2+780 m to 2+760 m (-60 m to -44 m).

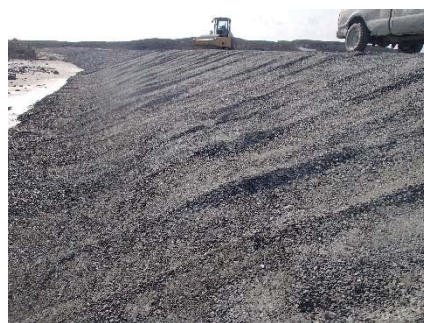
NCIS-087 (2018-07-11), looking W from Sta. 1+950/-34 m (approx.). Compaction of the 0.5 m lift (approx.) of fine filter between El. 150 and 152 m with a 10-tonne smooth-drum compactor (4 passes) in the upstream slope from Sta. 2+000 m to 1+930 m.

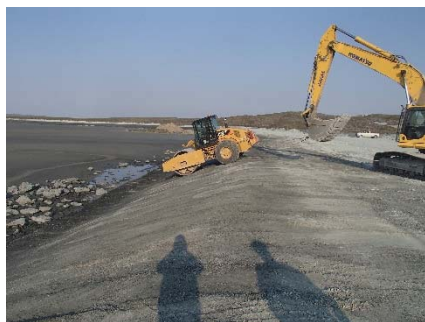
NCIS-088 (2018-07-12), looking W from Sta. 2+000/-35 m (approx.). Compaction of the 0.5 m lift (approx.) of fine filter between El. 150 m and 152 m with a 10-tonne smooth-drum compactor (4 passes) in the upstream slope from Sta. 2+028 m to 1+650 m.

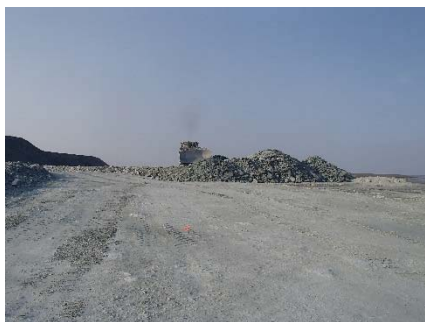
NCIS-089 (2018-07-12), looking S from Sta. 2+525/+4 m (approx.). Placement of a 2 m thick (approx.) lift of UM rockfill from El. 152 m to El. 154 m (approx.) with a dozer from Sta. 2+605 m to 2+455 m (+3 m to -23 m).

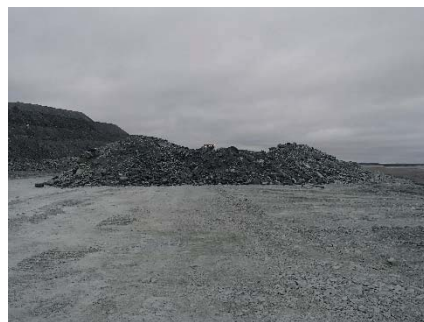
NCIS-090 (2018-07-13), looking SE from Sta. 2+440/-1 m (approx.). Placement of a 2 m thick (approx.) lift of UM rockfill from El. 152 m to El. 154 m (approx.) with a dozer from Sta. 2+455 m to 2+370 m (+4 m to -24 m).

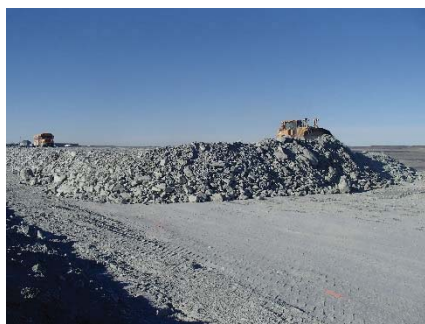
NCIS-091 (2018-07-14), looking S from Sta. 2+330/+13 m (approx.). Placement of a 2 m thick (approx.) lift of UM rockfill from El. 152 m to El. 154 m (approx.) with a dozer from Sta. 2+370 m to 2+290 m (+9 m to -22 m).

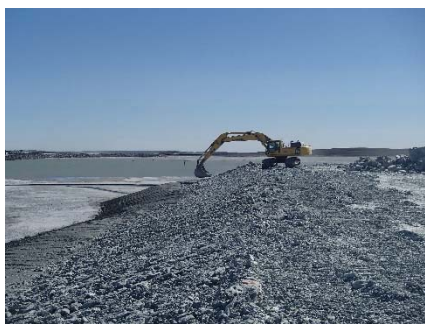
NCIS-092 (2018-07-14), looking S from Sta. 1+160/-77 m (approx.). Profiling of the upstream slope (3H:1V) from El. 150 to 152 m with an excavator from Sta. 1+185 m to 1+135 m.

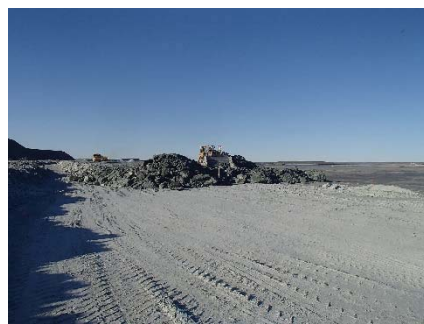
NCIS-093 (2018-07-15), looking S from Sta. 2+260/+12 m (approx.). Placement of a 2 m thick (approx.) lift of UM rockfill from El. 152 m to El. 154 m (approx.) with a dozer from Sta. 2+290 m to 2+280 m (+9 m to -22 m).

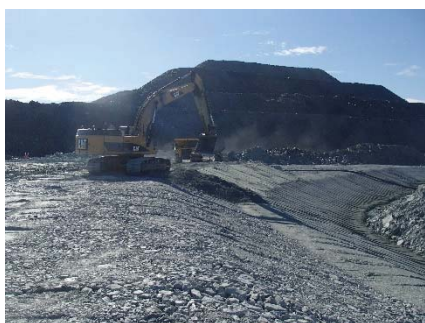
NCIS-103 (2018-07-20), looking NE from Sta. 2+420/-27 m (approx.). Profiling of the upstream slope (3H:1V) from El. 152 to 154 m with an excavator from Sta. 2+400 m to 2+410 m. Oversize boulders were removed.

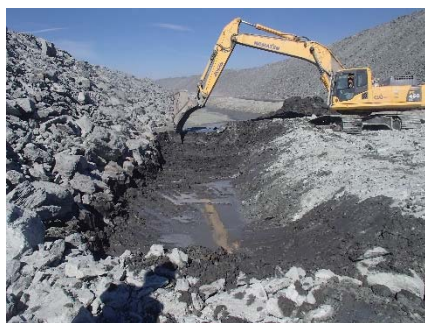
NCIS-114 (2018-07-24), looking N from Sta. 1+700/-34 m (approx.). Excavation of a 0.8 m (approx.) deep, 1 m wide shallow ditch in the rockfill capping with an excavator from Sta. 1+500 m to 1+650 m.

The decision was made to excavate a shallow unlined ditch (at least 1 m wide and 0.5 m deep) in the rockfill cover and tailings on the downstream side of the dike, in order to collect and redirect possible seepage which could occur through the dike toward the North Cell (see Figure 3). The ditch will start from the northwestern extremity of the North Cell Internal Structure, cross the Cyanide Burning Pad area (the pad will ultimately be relocated) and extend beyond the southwestern extremity of the dike to ensure that water is redirected toward the North Cell pond. A layer of rockfill was placed on the surfaces of the ditch excavated within the tailings to prevent erosion of the tailings. A temporary sump was excavated at the south extremity of the ditch.

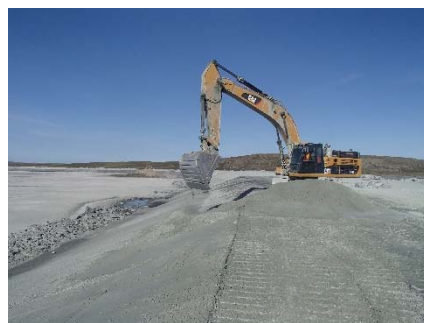
NCIS-116 (2018-07-25), looking SE from Sta. 1+700/+37 m (approx.). Excavation of a 0.8 m (approx.) deep, 1 m wide shallow ditch in the rockfill capping with an excavator from Sta. 1+500 m to 1+455 m.

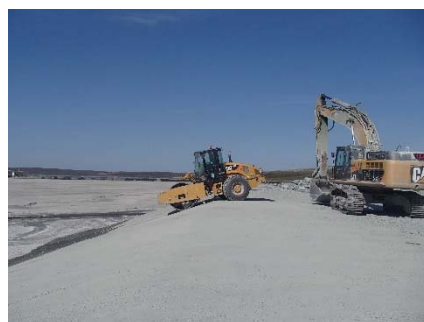
NCIS-125 (2018-07-27), looking NE from Sta. 3+050/+26 m (approx.). Corrections to the north sump: removal of approx. 0.5 m of tailing and till sieving reject material on the bottom of the excavation. The erosion protection material was replaced.

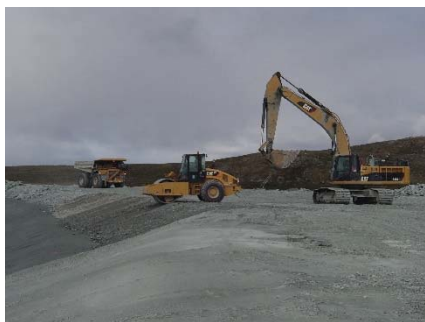
NCIS-130 (2018-07-28), looking S from Sta. 1+445/+16 m (approx.). Excavation of a 0.8 m (approx.) deep, 1 m wide shallow ditch in the rockfill capping with an excavator from Sta. 1+380 m to 1+300 m.

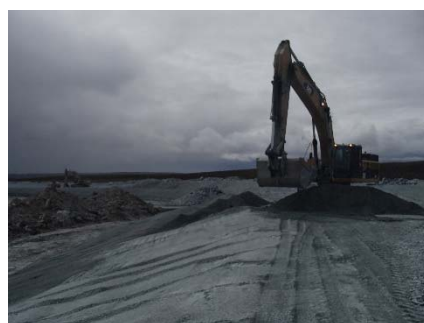
NCIS-135 (2018-07-30), looking SW from Sta. 1+860/-12 m (approx.). Placement of a 0.5 m thick lift of fine filter in the upstream slope from El. 152 m to 154 m with an excavator from Sta. 1+830 m to 1+700 m.

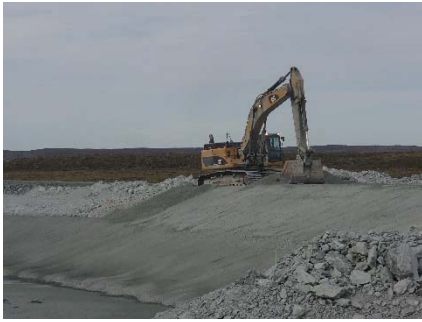
NCIS-136 (2018-07-31), looking SW from Sta. 1+800/-33 m (approx.). Placement of a 0.5 m thick lift of fine filter in the upstream slope from El. 152 m to 154 m with an excavator from Sta. 1+700 m to 1+660 m.

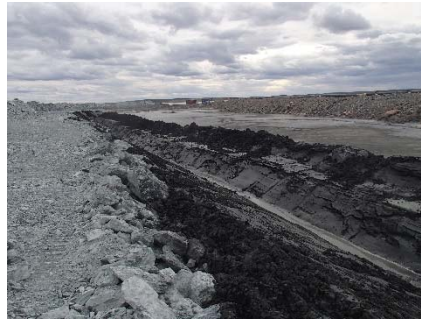
NCIS-137 (2018-07-31), looking SW from Sta. 1+380/+14 m (approx.). Excavation of a 0.8 m (approx.) deep, 1 m wide shallow ditch in the tailings with an excavator from Sta. 1+300 m to 1+200 m.

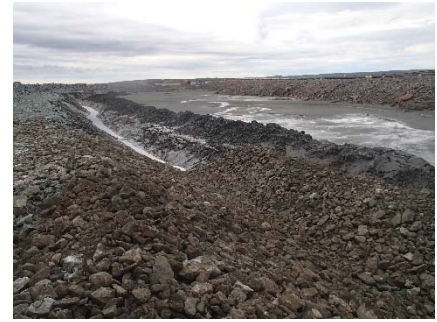
NCIS-138 (2018-08-01), looking SW from Sta. 1+365/+15 m (approx.). Excavation of a 0.8 m (approx.) deep, 1 m wide shallow ditch in the tailings and placement of a 0.3 m thick (approx.) layer of till sieving reject material on the bottom and on the slopes of the ditch from Sta. 1+200 m to 1+100 m.

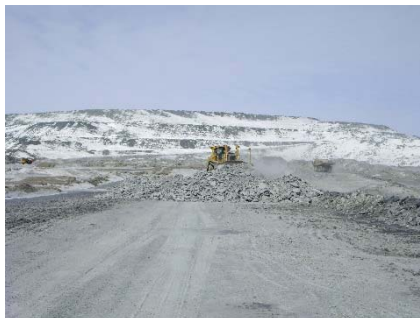
CD-1797 (2018-04-23), looking N from Sta. 0+380/-20 m. Placement a 2 m thick (approx.) lift of intermediate volcanic rockfill from El. 143 m to El. 145 m from 0+250 to 0+400 m (o.s. -28 to -18 m).

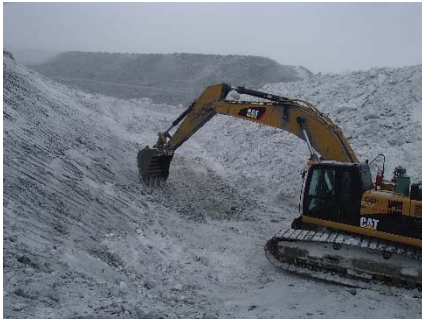
CD-1805 (2018-04-28), looking NE from Sta. 40+780/+2 m. Placement a 1.5 m thick (approx.) lift of intermediate volcanic (IV) rockfill from approx. Sta. 40+780 to 40+805 m (o.s. -6 to 9 m).

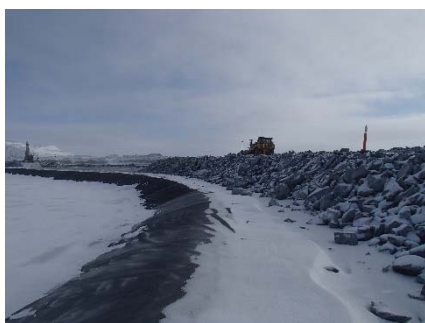
CD-1818 (2018-05-03), looking NE from Sta. 40+770/-25 m. Placement of a 2 m thick (approx.) lift of intermediate volcanic (IV) rockfill from El. 143 m to El. 145 m from approx. Sta. 0+980 m to 0+880 m (o.s. -28 to -11 m).

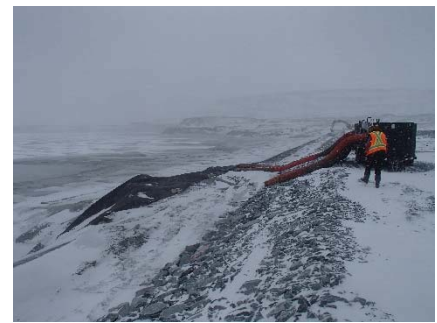
CD-1829 (2018-05-06), looking N from Sta. 0+340/-24 m. Placement of a 0.5 m thick lift of coarse filter from El. 143 m to 143.5 m with an excavator from Sta. 0+170 m to 0+460 m and placement of a 0.5 m thick lift of fine filter from Sta. 0+170 m to 0+380 m.

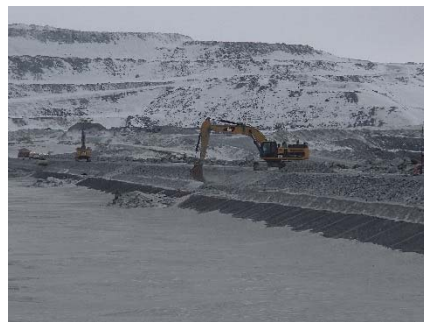
CD-1834 (2018-05-08), looking NE from Sta. 40+760/-23 m. Placement of a first 0.5 m thick lift of coarse filter from El. 143 m to 143.5 m on length of approx. 5 m with an excavator at the location of the deposition finger at Sta 0+520 m and 0+660 m.

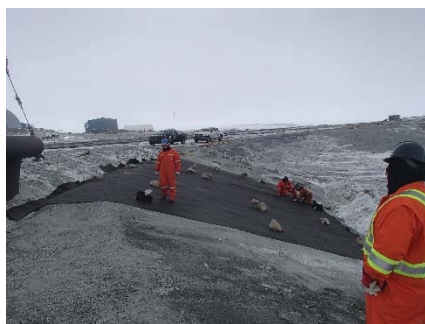
CD-1858 (2018-05-21), looking S from Sta. 0+970/-45 m. View of the bottom of the fine filter upstream slope. Some material is missing to achieve a smooth slope.

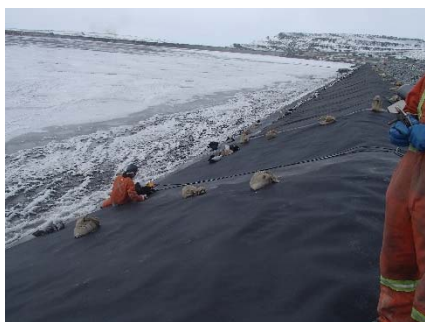
CD-1865 (2018-05-25), looking NW from Sta. 40+740/-35 m. Repairs on the extrusion fillet seam at the bottom of the LLDPE liner panels between Sta. 40+680 m and 0+950 m, on panels 802 to 807, and 811 to 813.

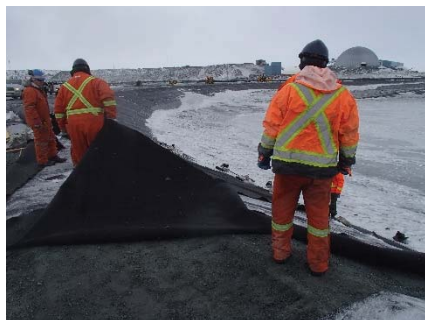
CD-1867 (2018-05-25), looking E from Sta. 40+680/-37 m. View of repair patches on the extrusion weld at the bottom of the panels.

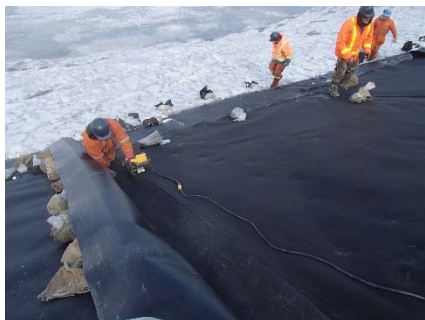
CD-1868 (2018-05-27), looking S from Sta. 0+915/-24 m. Removal of the wet geotextile in place from Sta. 0+935 m to 0+900 m.

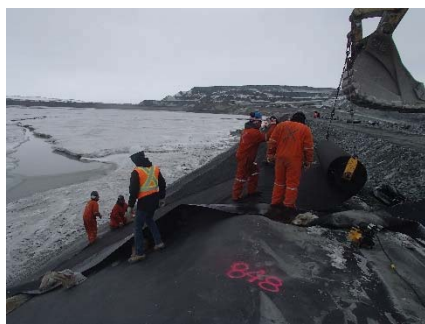
CD-1876 (2018-05-30), looking N from Sta. 0+820/-26 m. View of repair patches on the extrusion weld at the bottom of the panel 838.

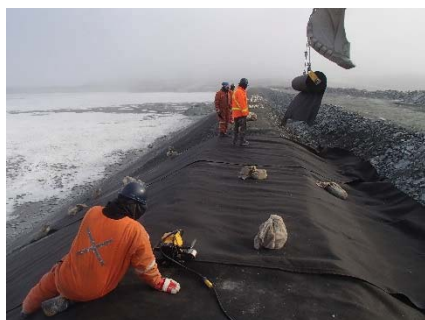
CD-1879 (2018-06-01), looking N from Sta. 0+735/-28 m. View of the repaired holes on panel 850.

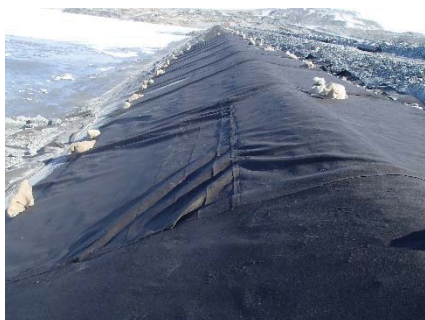
CD-1881 (2018-06-02), looking N from Sta. 0+530/-27 m. View of a geotextile panel with a horizontal weld in the slope at Sta. 0+520 m before its removal.

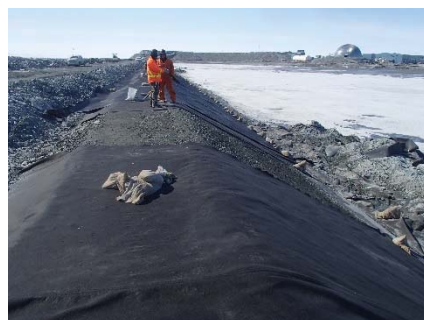
CD-1882 (2018-06-02), looking S from Sta. 0+510/-25 m. View of the emplacement of the geotextile panel with a horizontal weld in the slope at Sta. 0+520 following its removal.

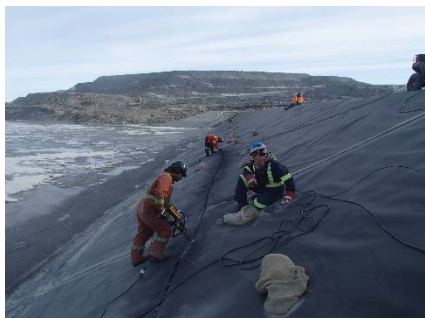
CD-1891 (2018-06-05), looking NE from Sta. 0+960/-28 m. View of leaking extrusion fillet seams before their repair on panel 816 and 818.

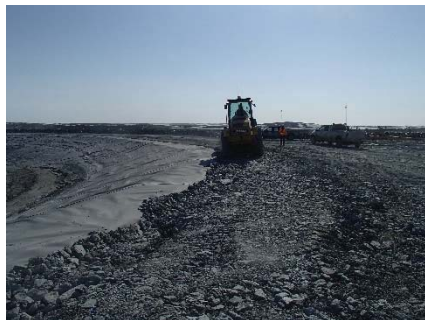
CD-1894 (2018-06-10), looking W from Sta. 0+800/-28 m. View of a block in direct contact with the LLDPE liner following the construction of the deposition fingers on Central Dike.

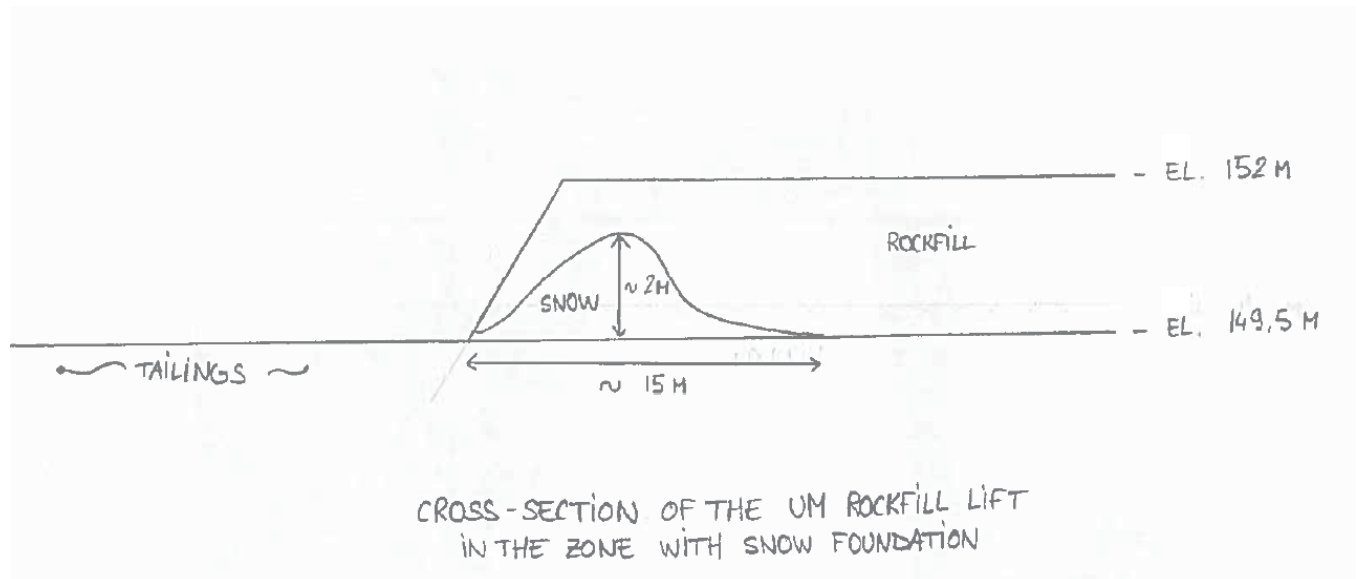
- It was noticed that the 2-m thick UM rockfill at El. 152 m (approx.) was placed on an important layer of hard snow (up to 2 m thick) without QA/QC supervision earlier in the season (see photographs and sketch below), over a distance of approx. 100 m along the dike. It is required to remove this rockfill and clear the snow before placing rockfill again, as the presence of an underlying snow layer will cause excessive settlement in the structure. It was reiterated that per the design, the foundation of the structure must be snow-free, compacted rockfill material constituting the capping of the North Cell.

- Test pits were excavated to identify the extent of the snow layer. Since snow was not observed in the northern part of the UM rockfill lift, which appears to be built directly on the North Cell capping, it was decided to move the operations there and progress towards the north. The excavator removes the snow-rich toe of the UM rockfill lift until snow is no longer observed (a 2-3 m wide zone in average), and a dozer pushes the excavated material (UM rockfill mixed with snow) toward the center of the North Cell to clear the upstream toe.

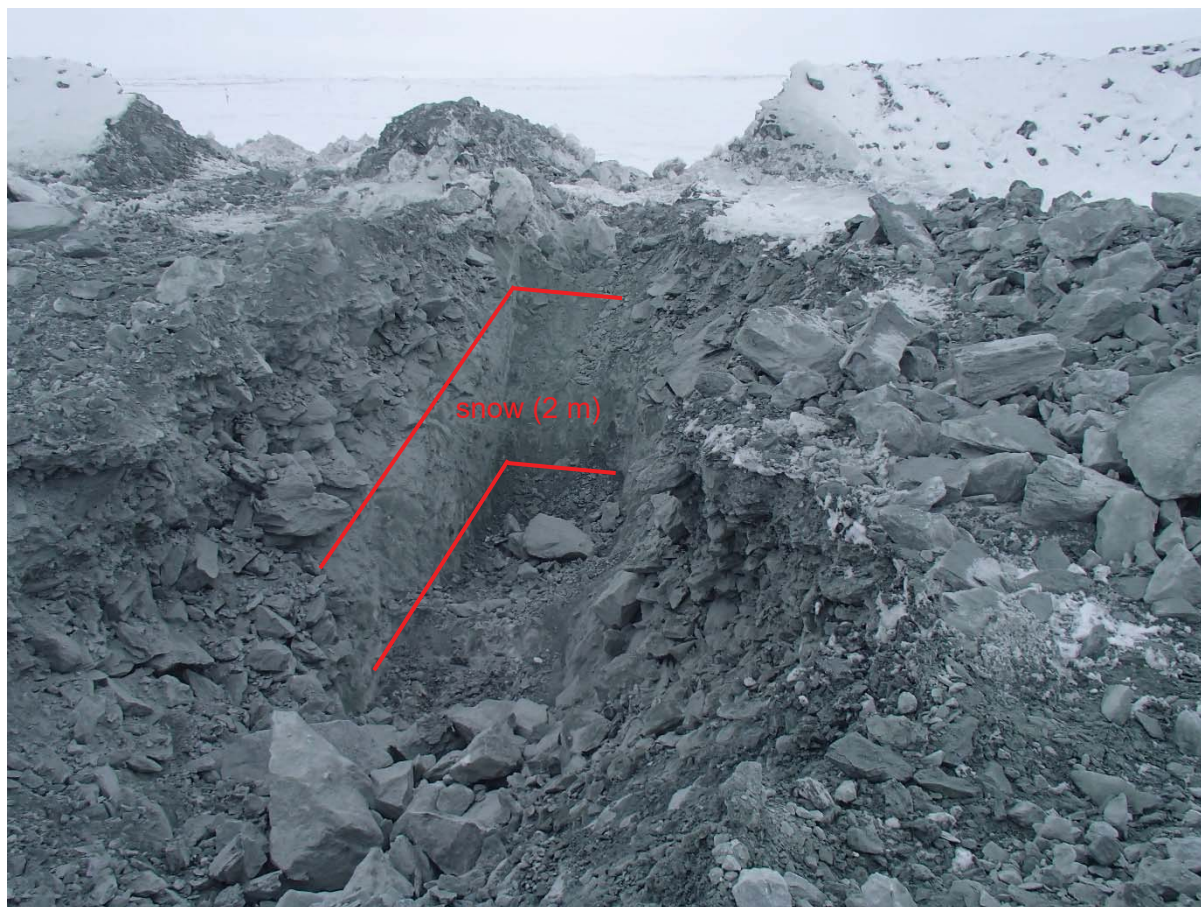
Photograph NCIS-001: View of a test pit in the UM rockfill lift at El. 152 m: a thick layer (2 m) of snow underlies the rockfill.

- Ensure that the layer of hard snow (up to 2 m thick) under the 2 m thick UM rockfill at El. 152 m (approx.) is not within the footprint of the dike, or that it is removed during the profiling of the slope. The foundation of the structure must be snow-free, compacted rockfill material constituting the capping of the North Cell.
