Meadowbank 2018 TSF As-built report

2018 CONSTRUCTION SEASON AS-BUILT REPORT TAILINGS STORAGE FACILITY MEADOWBANK GOLD PROJECT, NUNAVUT

1897439-1578-R-Rev0

November 2018

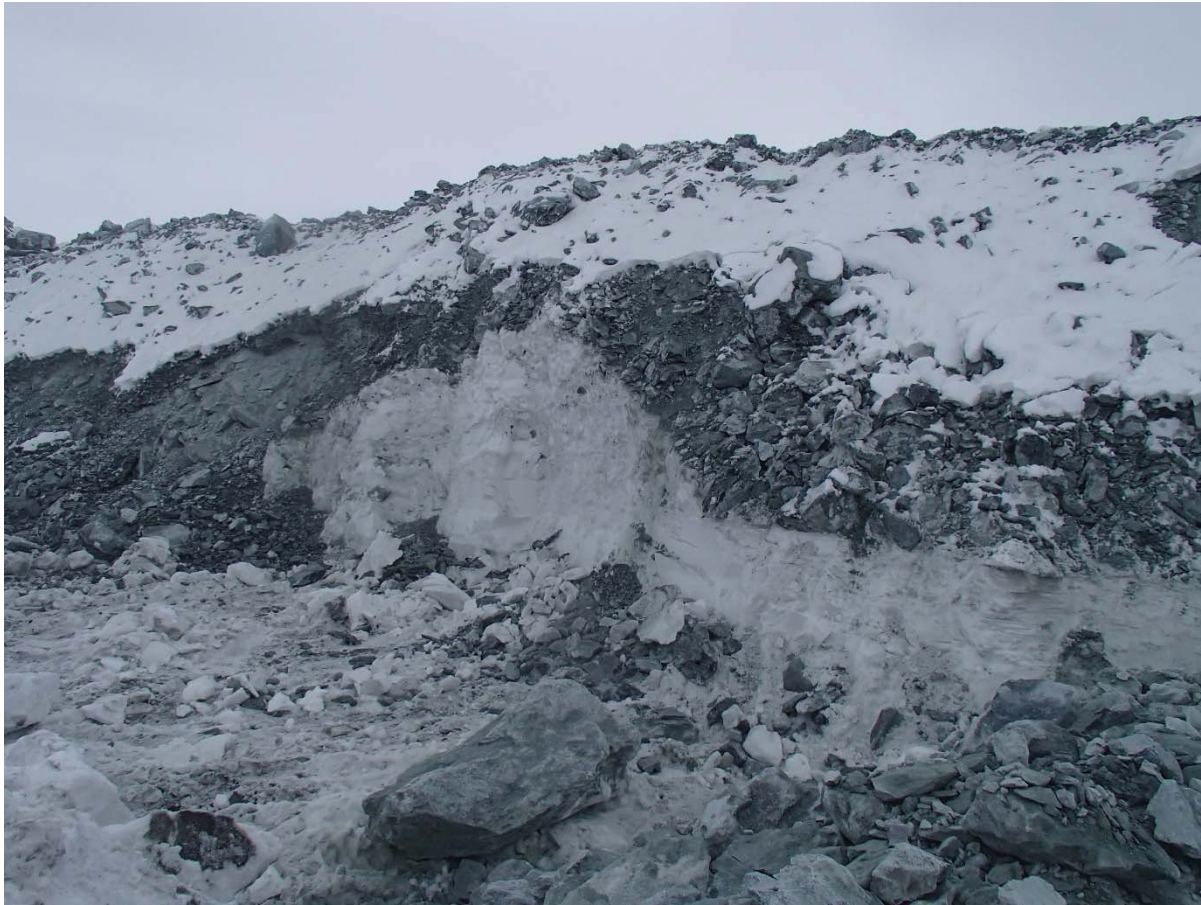
Photograph NCIS-002: View of the scraped upstream side of the UM rockfill lift at El. 152 m: a thick layer of snow (1.5 m) underlies the rockfill.

- Ensure that the layer of hard snow (up to 2 m thick) under the 2 m thick UM rockfill at El. 152 m (approx.) is not within the footprint of the dike, or that it is removed during the profiling of the slope. The foundation of the structure must be snow-free, compacted rockfill material constituting the capping of the North Cell.

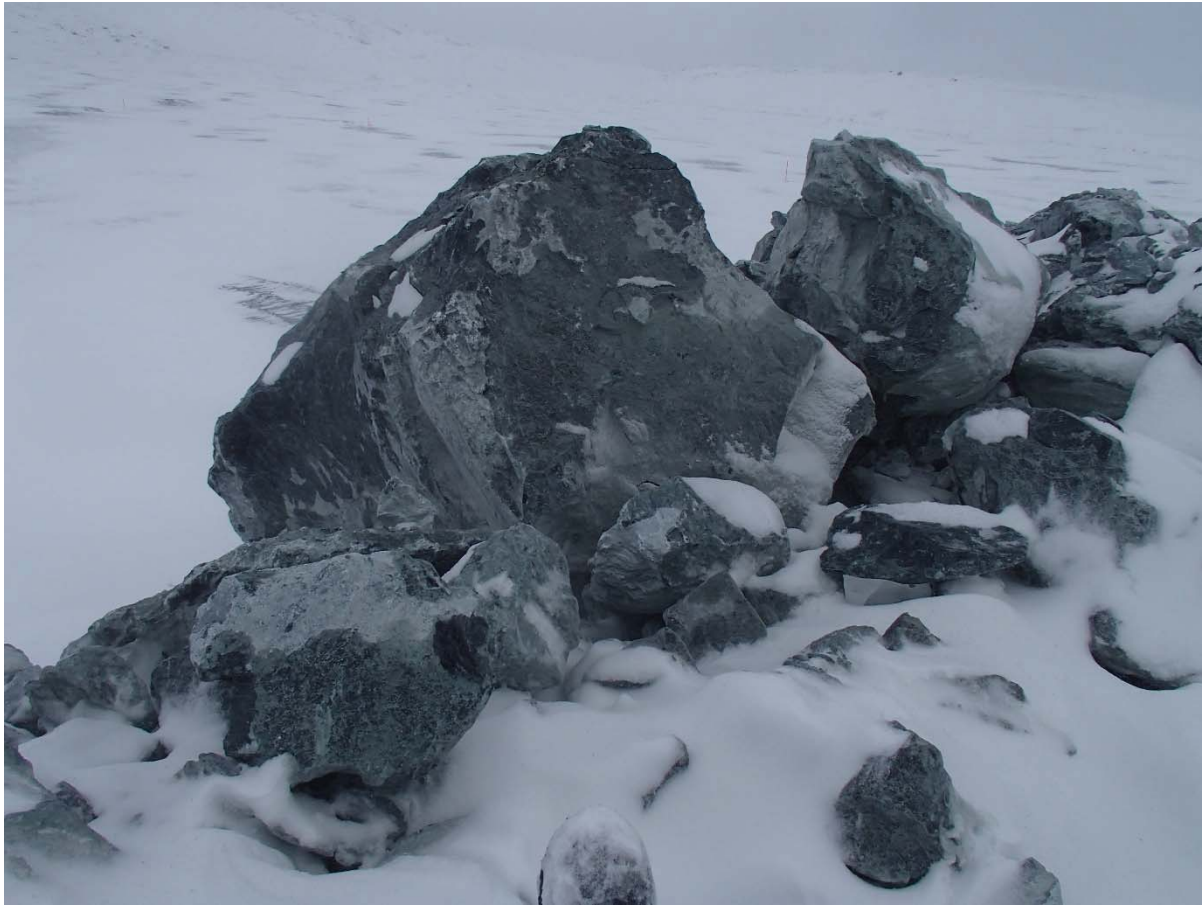
- The QA Manager noticed several oversize boulders on the UM rockfill lift at El. 152 m and reiterated that the maximum allowable size on the dikes is 1.3 m. AEM forwarded the information to the operators in the pit and on the dikes. If an oversize boulder is delivered on the dikes, it will be pushed aside in the downstream slope by the dozer during placement. The QA Manager reiterated that oversize boulders already in place in the upstream slope of the structure must be removed during sloping operations. The boulders will be moved into the tailings of the North Cell.

Photograph NCIS-006: View of oversize boulders on the UM rockfill lift at El. 152 m.

- The QC representative marked some oversize boulders on the upstream slope with paint. The boulders need to be removed during sloping operations.
- The UM rockfill lift at El. 152 m included a portion where the 2015 North Cell rockfill capping is built on the natural soil (thin layer of organic soil overlying till), between Sta. 1+800 m and 1+900 m approximately. The toe of the UM rockfill lift reaches beyond the toe of the capping, meaning the dike is partially founded on unprepared natural soil. The filter zone is also expected to extend on the natural soil. A test pit has been excavated to estimate the thickness of the soil layer; however, the frozen conditions prevented the excavator from reaching deeper than about 200 mm (see photograph below). The QA Manager asked that the surveyor estimate the width of the lift that lies beyond the capping. The upstream slope in this section was not profiled and further discussions will follow regarding actions to take.

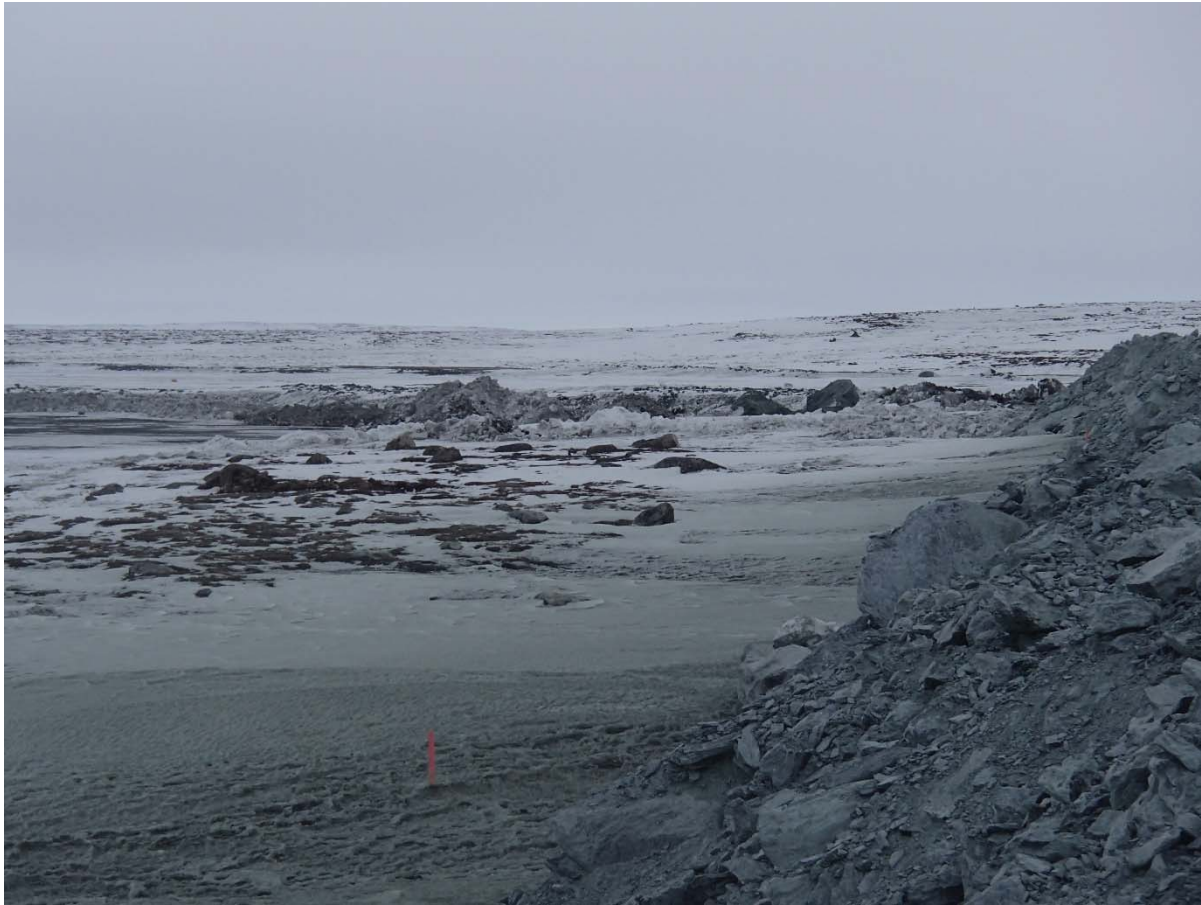
- The quality and gradation of the UM rockfill placed on the structure is now satisfactory.
- The alignment of the Internal Structure has been reviewed (see plan enclosed).
- Centerline to be obtained from SANA for QA follow-up of activities using the portable GPS.
- Decision to make with AEM about the foundation of the section of the structure between Sta. 1+800 m and 1+900 m, built on unprepared natural soil.

Photograph NCIS-014: From Sta. 1+900 m (approx.), looking SE. View of the natural soil on which the 2015 capping is built.

- Updated material quantities were issued with the new alignment of the North Cell Internal Structure.
- Regarding the rockfill lift founded on unprepared natural soil (Sta. 1+800 m to 1+900 m, approx.), AEM decided that the rockfill will be removed and the natural soils excavated within the footprint to reach a good quality bedrock. The frozen natural soil material will need to be exposed and excavated as it thaws.

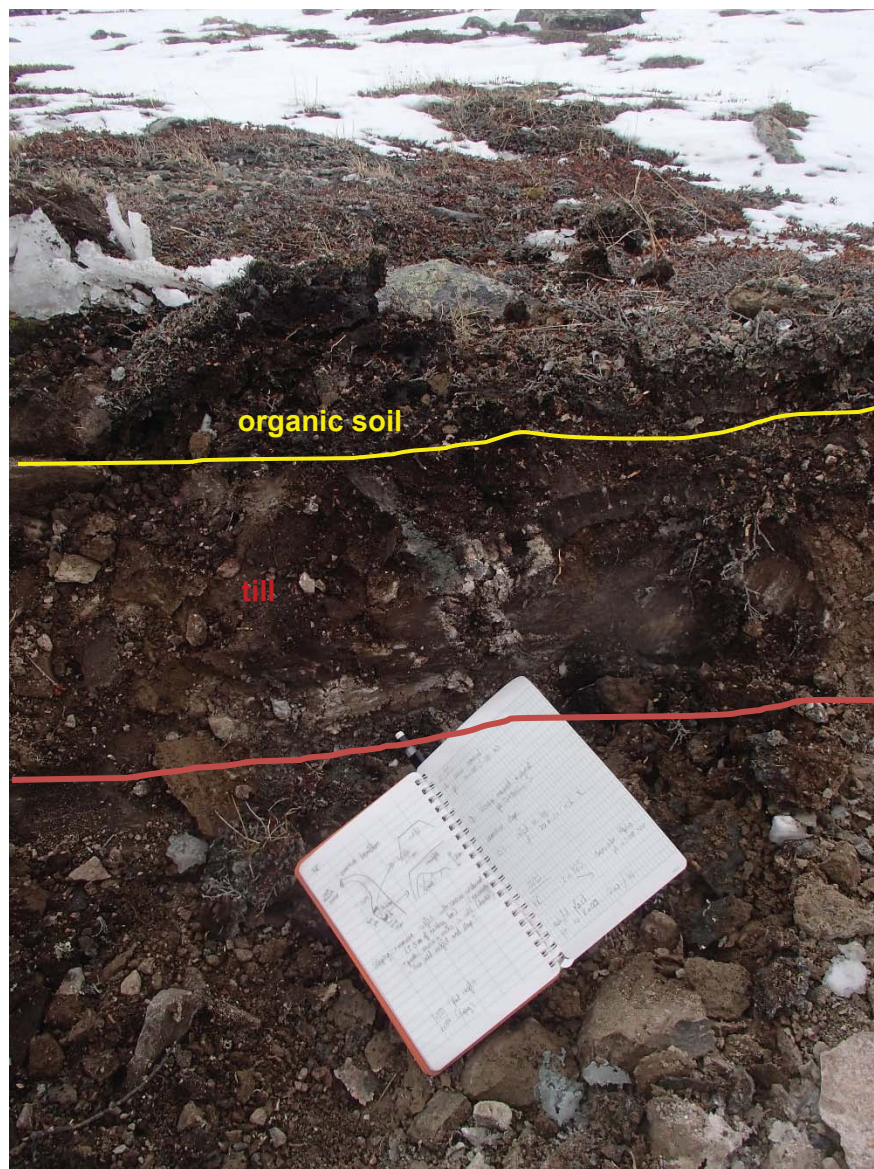
Photograph NCIS-015: From Sta. 1+850 m (approx.), looking S. View of the 200 mm deep test pit excavated into the natural soil. A thin layer or organic soil overlies frozen till.

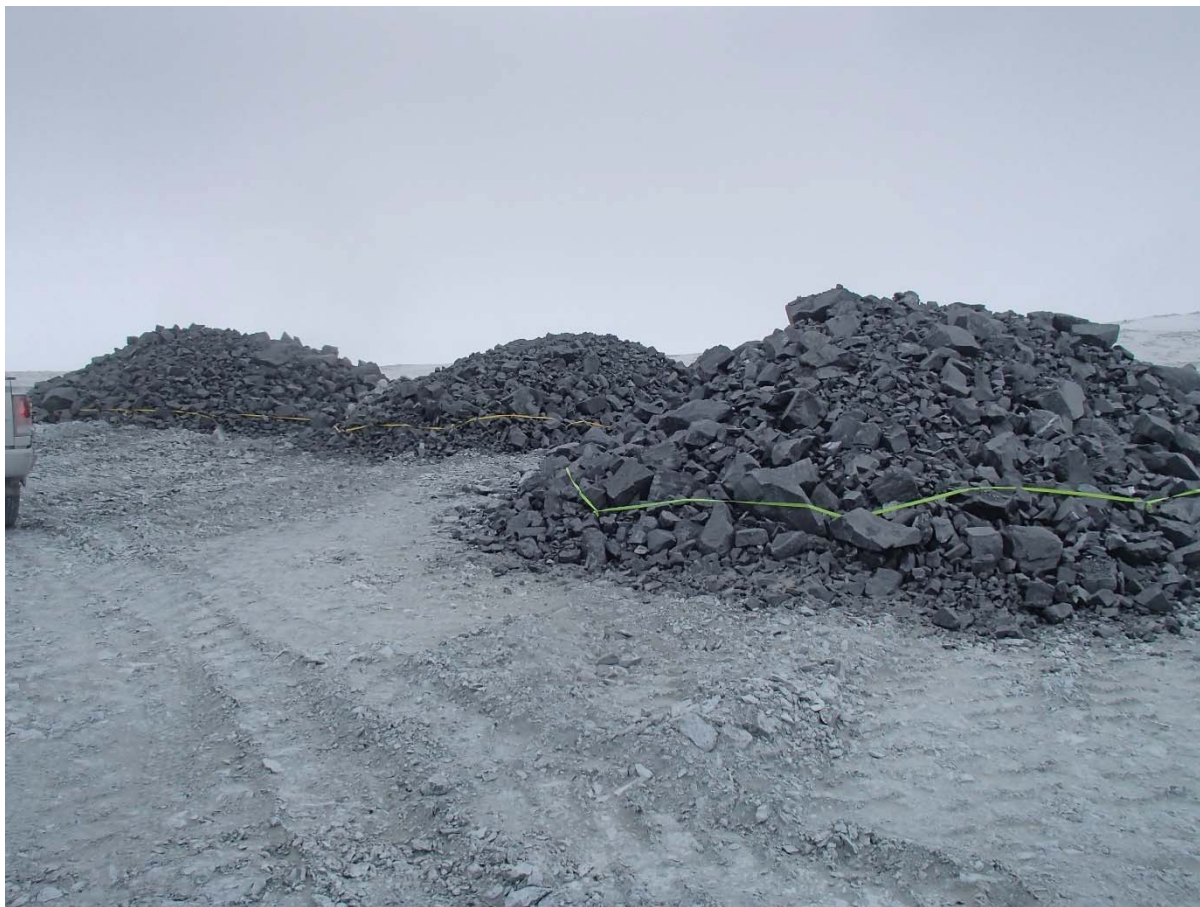
Photograph NCIS-016: From Sta. 1+750 m (approx.), looking SE. View of the Iron Formation rockfill (PAG material) piles on the North Cell Internal Structure to be cleaned from the structure embankment.

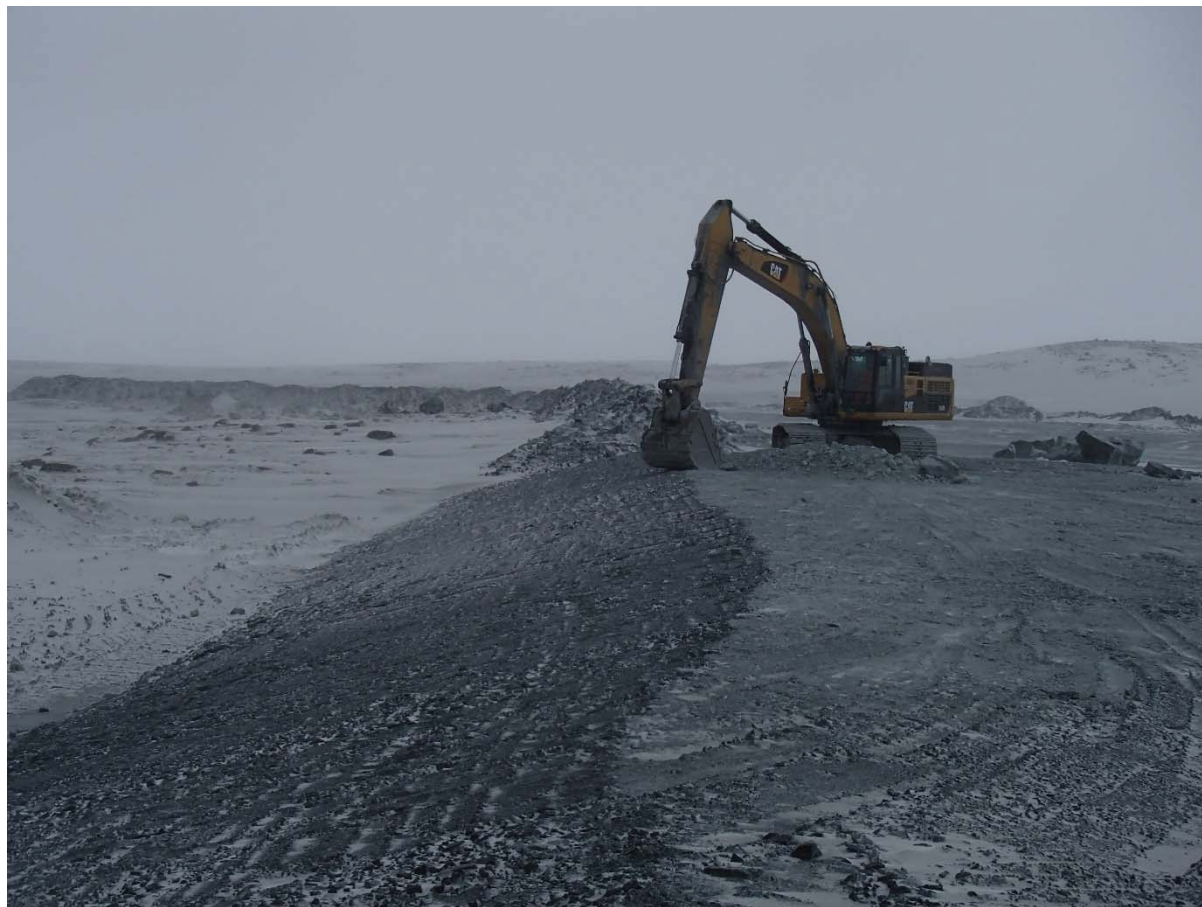
Photograph NCIS-019: From Sta. 2+100 m (approx.), looking SW. Profiling of the upstream slope (3H:1V) from El. 150 to 152 m with an excavator from Sta. 1+860 m to 1+678 m. The portion between Sta. 1+900 m and 1+800 m, where the structure is built on the natural ground, was not profiled.

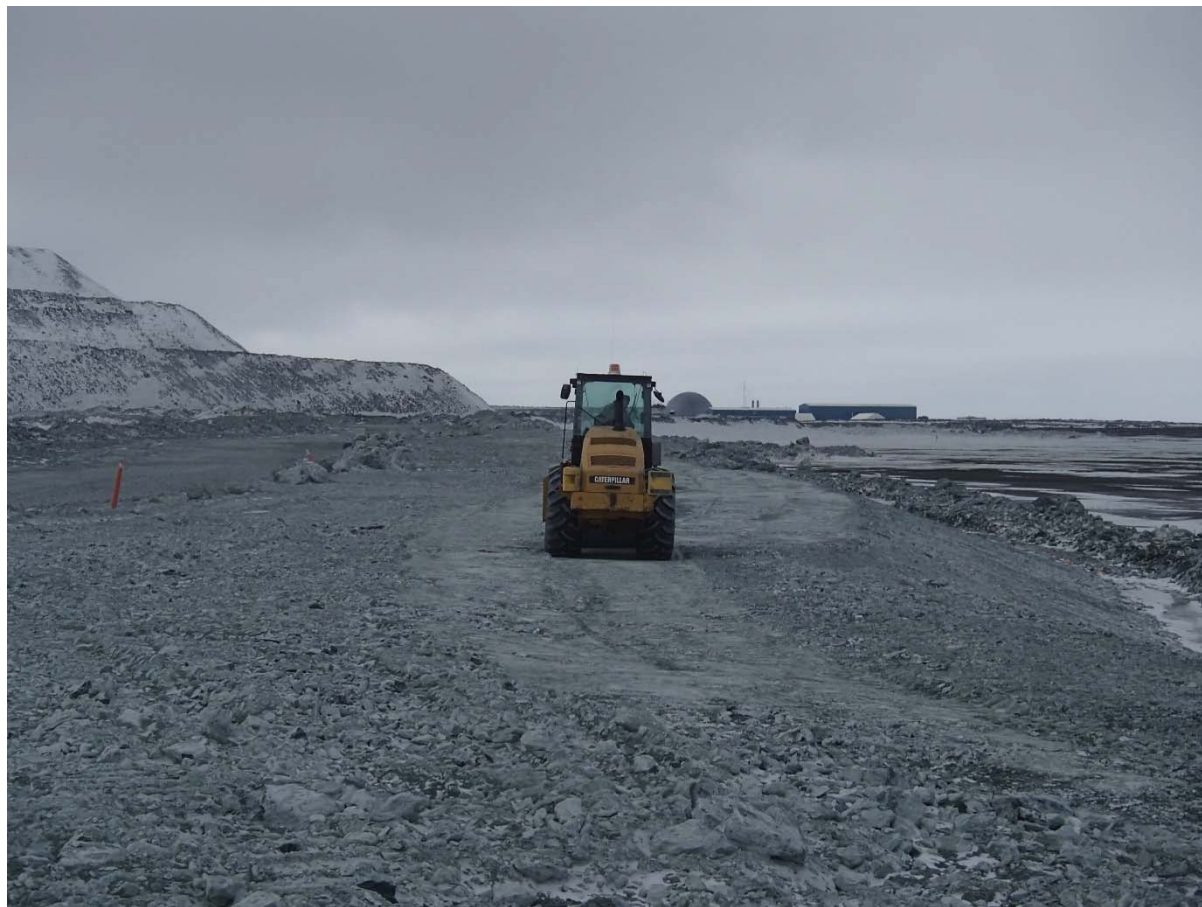
Photograph NCIS-022: From Sta. 2+245 m (approx.), looking SE. Compaction of the 2 m lift (approx.) of ultramafic (UM) rockfill at El. 152 m with a 10-tonne smooth-drum compactor with vibration (6 passes) between the haul truck traffic lane and the upstream slope from Sta. 2+625 to 1+625 m (offset unavailable).

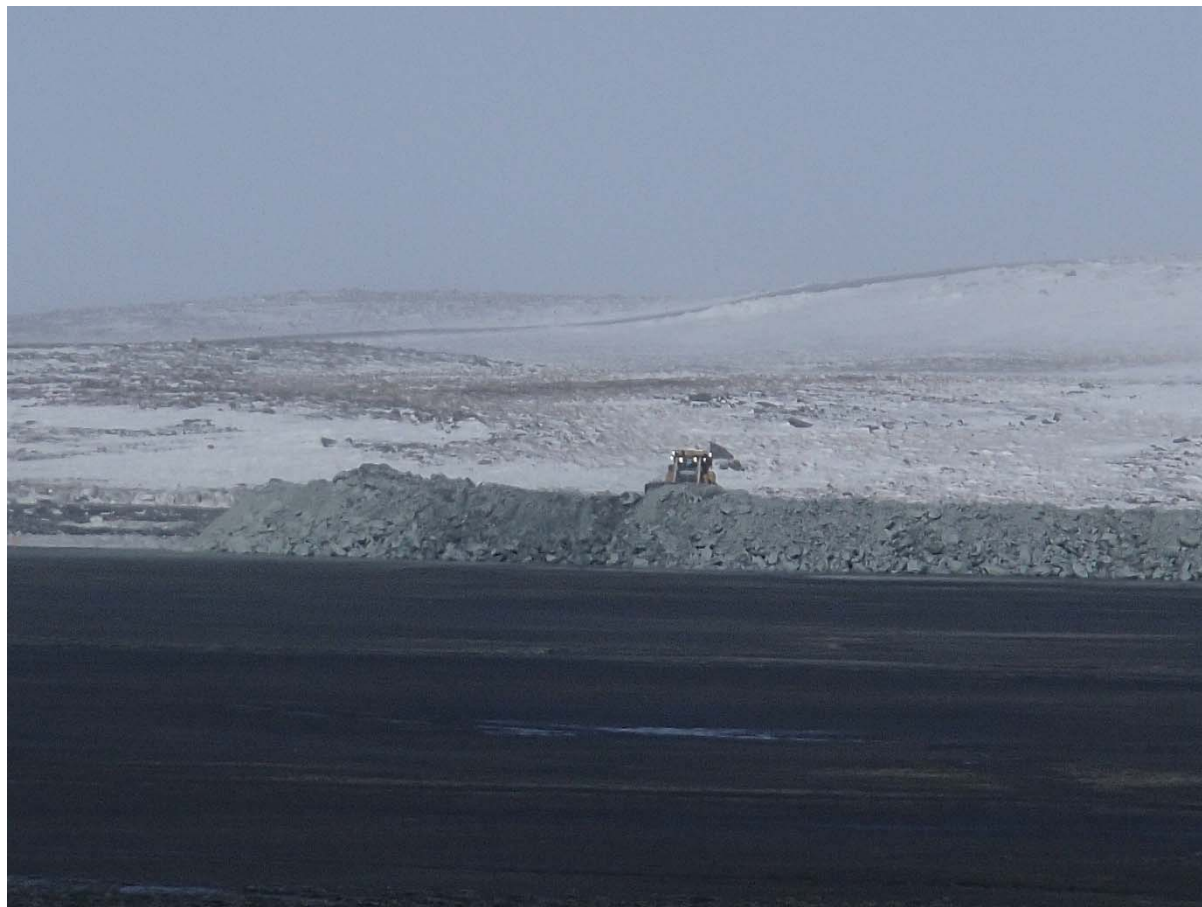
Photograph NCIS-023: From Sta. 2+570 m (approx.), looking W. Placement of a 2 m thick (approx.) lift of UM rockfill from El. 150 m to El. 152 m (approx.) with a dozer from Sta. 1+500 m to 1+450 m (offset unavailable). The material is of good quality and is well graded.

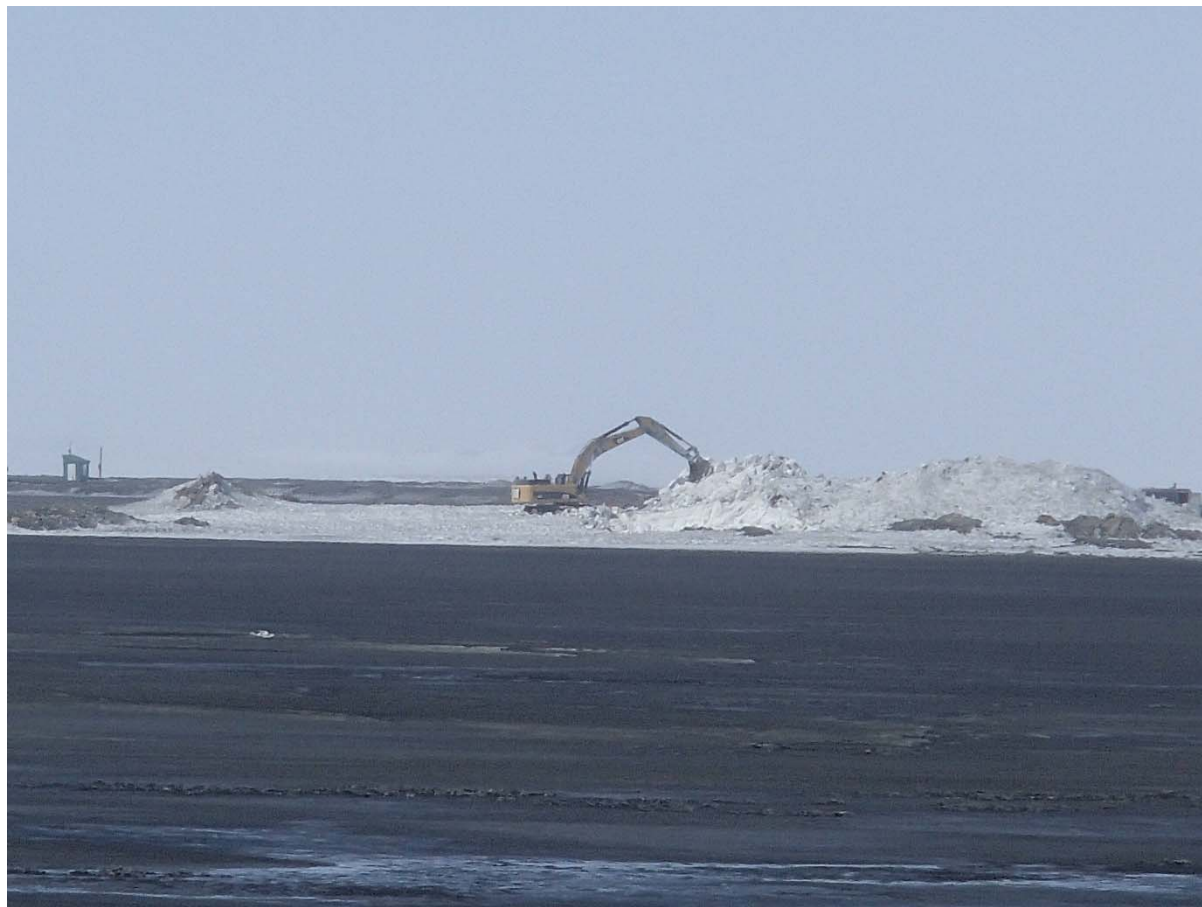
Photograph NCIS-024: From Sta. 2+570 m (approx.), looking SW. Removal of the snow bank in the footprint with an excavator from Sta. 1+160 m to 1+120 m (approx.).

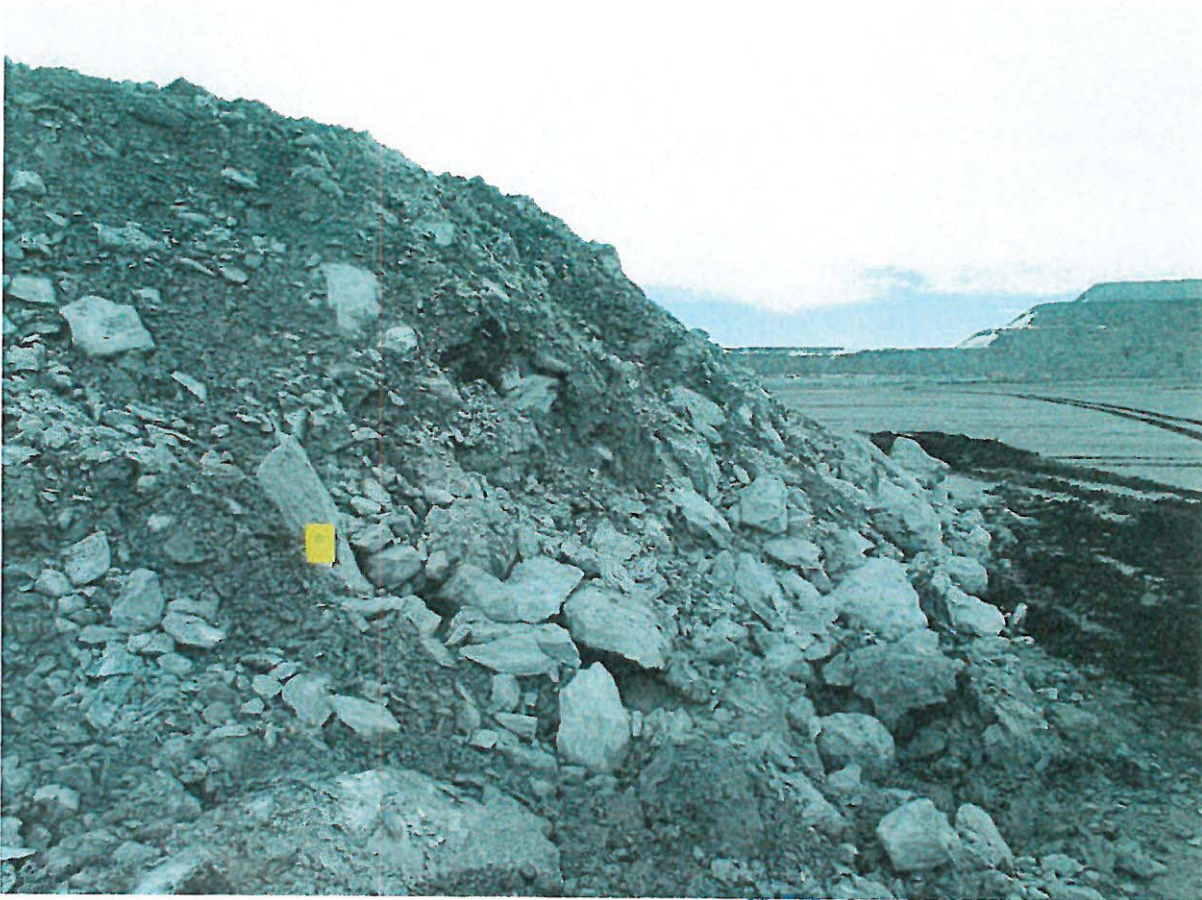
- The QA Manager observed that the UM rockfill lift was about 3.2 m thick around Sta. 1+340 m and asked for the elevation of the tailings ahead of the UM rockfill lift advancement front. AEM consulted the LIDAR survey and reported a 148.8 m elevation (approx.) that is declining towards the direction of the rockfill lift advancement and reaches 148 m around Sta. 1+200 m. Based on the 152 m elevation of the rockfill lift, the lift thickness is of 3.2 m around Sta. 1+340 m and would increase to 4 m around Sta. 1+200 m. Furthermore, as the tailings are thawing at the surface, the expected settling of soft tailings below the rockfill will increase the lift thickness. Considering that the lift maximum thickness was 2 m per design, it is not recommended to continue placement of UM rockfill in a single lift thicker than 2 m, as the compaction quality will be compromised. A maximum lift thickness of 2.8 m had previously been agreed by the Designer. AEM will have a meeting regarding this situation.

Photograph NCIS-028: From Sta. 1+340/+3 m, looking E. View of the LM rockfill lift approximately 3.2 m thick.

- Ensure that the layer of hard snow (up to 2 m thick) under the 2 m thick UM rockfill at El. 152 m (approx.) is not in the footprint of the dike, or that it is removed during the profiling of the slope. The foundation of the structure must be snow-free, compacted rockfill material constituting the capping of the North Cell.
- Thickness of the UM rockfill lift to be limited to 2.8 m.

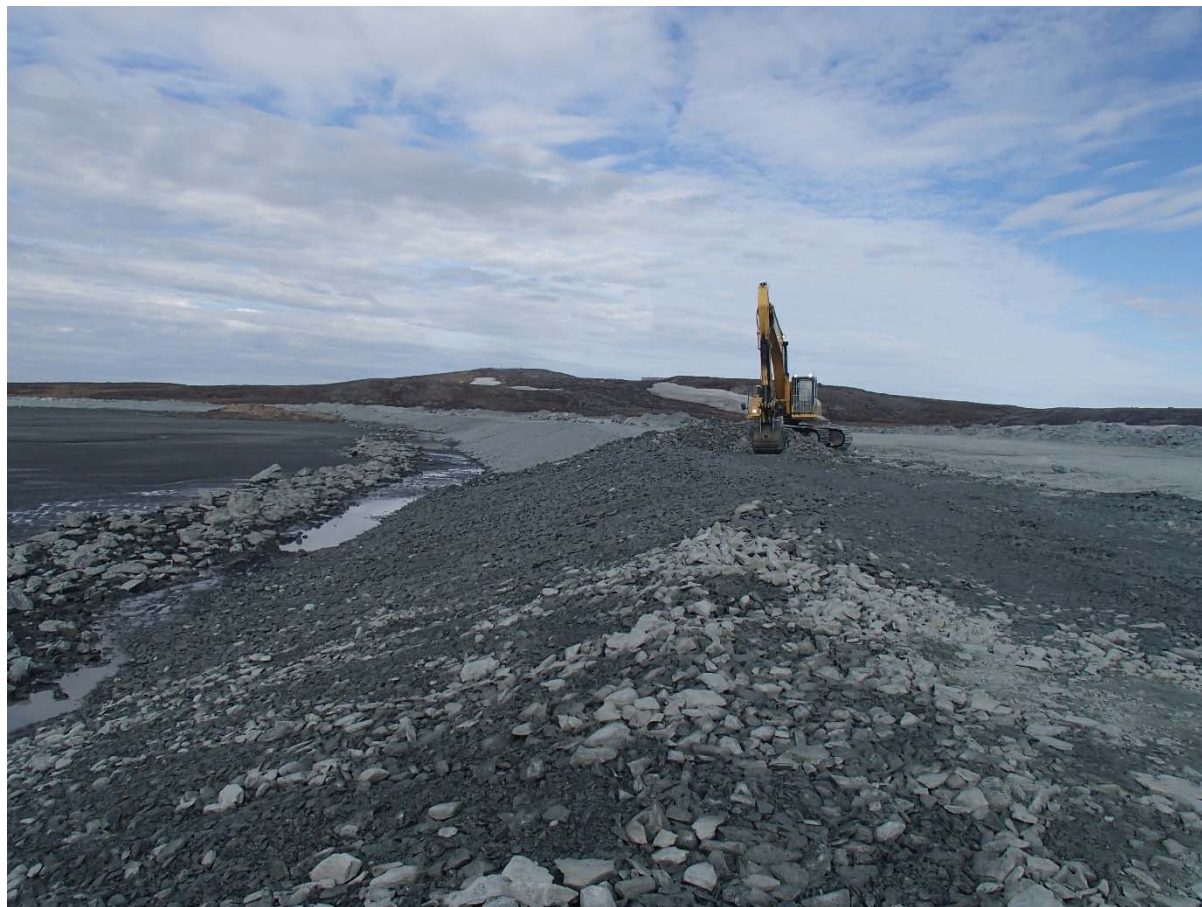
Photograph NCIS-030: From Sta. 2+140/-29 m (approx.), looking W. Placement of a 0.5 m thick lift of coarse filter in the upstream slope from El. 150 m to 152 m with an excavator from Sta. 2+105 m to 1+930 m. Notice the presence of water ponding at the bottom of the slope.

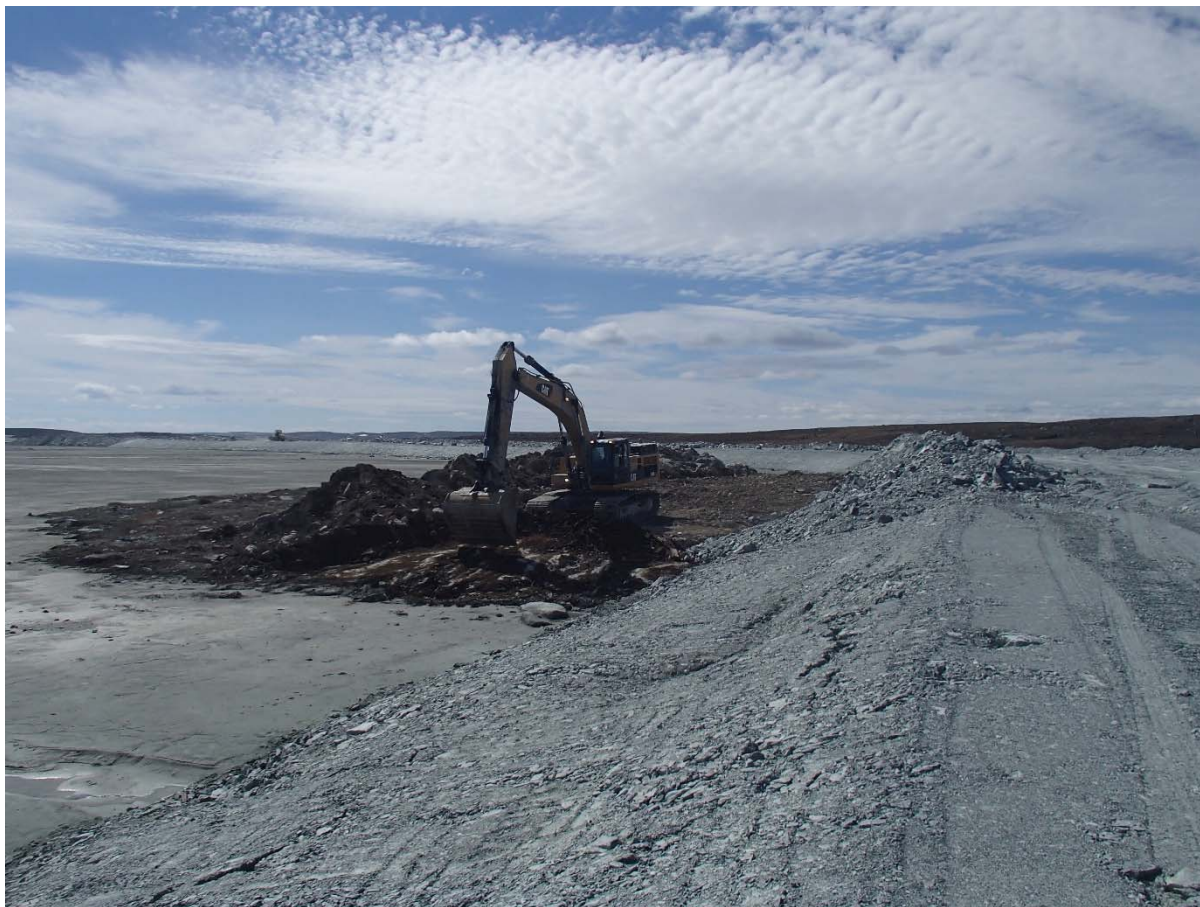
- The foundation has been exposed in the section where the structure is built on natural ground (approx. Sta. 1+800 to 1+900 m). The natural soil was constituted of a shallow layer of till and organic soil overlying bedrock. Till removal down to the bedrock with an excavator was done to ensure a sound foundation for the filters and reduce the risk of settlement. The foundation was approved by the QA Manager. No foundation approval forms are required for the North Cell Internal Structure.

Photograph NCIS-031: From Sta. 1+880/-21 m (approx.), looking SW. Final clean-up of the dike footprint with an excavator to reach a good quality bedrock from Sta. 1+800 to 1+850 m (offset -42 to -33 m).

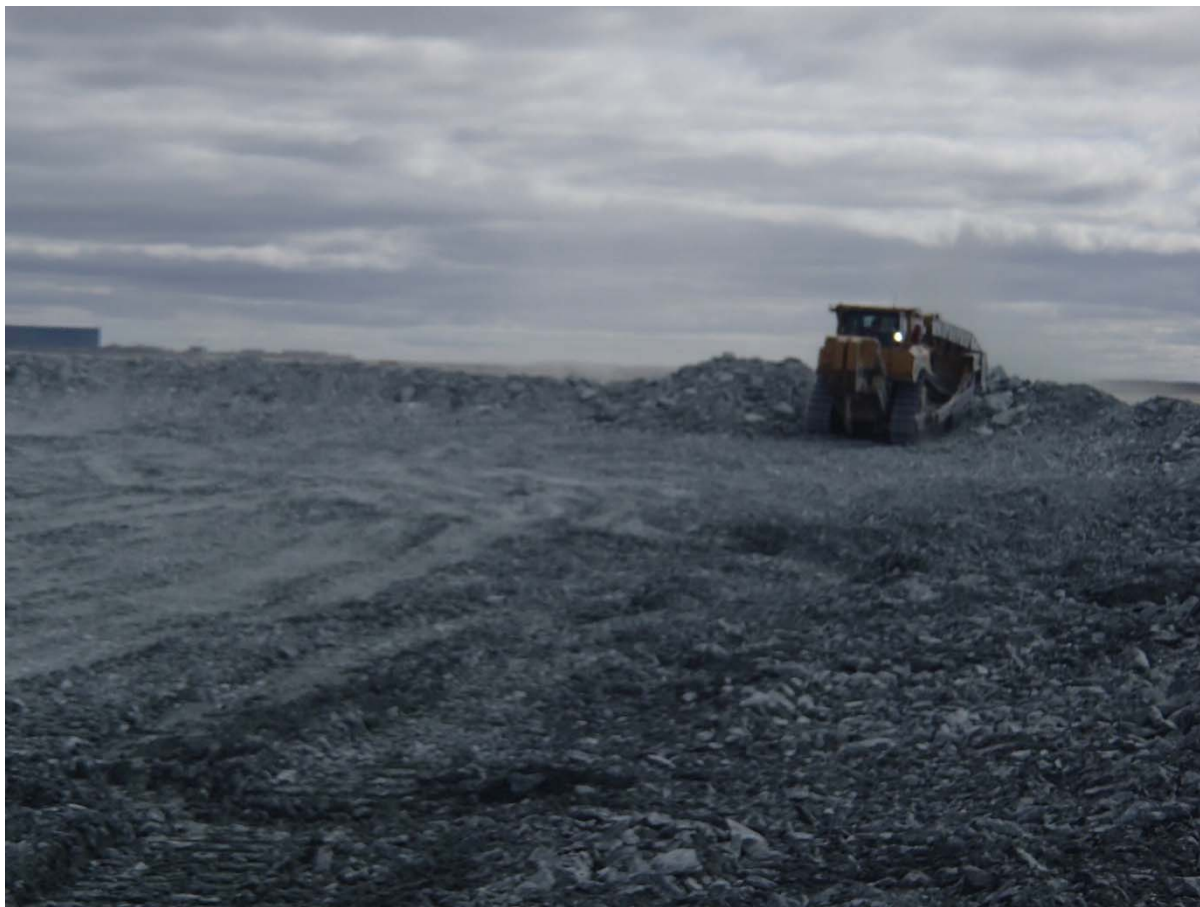
Photograph NCIS-044: From Sta. 1+200/-19 m (approx.), looking S. Placement of a 1.5 to 2 m thick (approx.) lift of UM rockfill from El. 148 m to El. 150 m (approx.) with a dozer from Sta. 1+150 m to 1+120 m (-92 m to +10 m). The material is of good quality and is well graded.

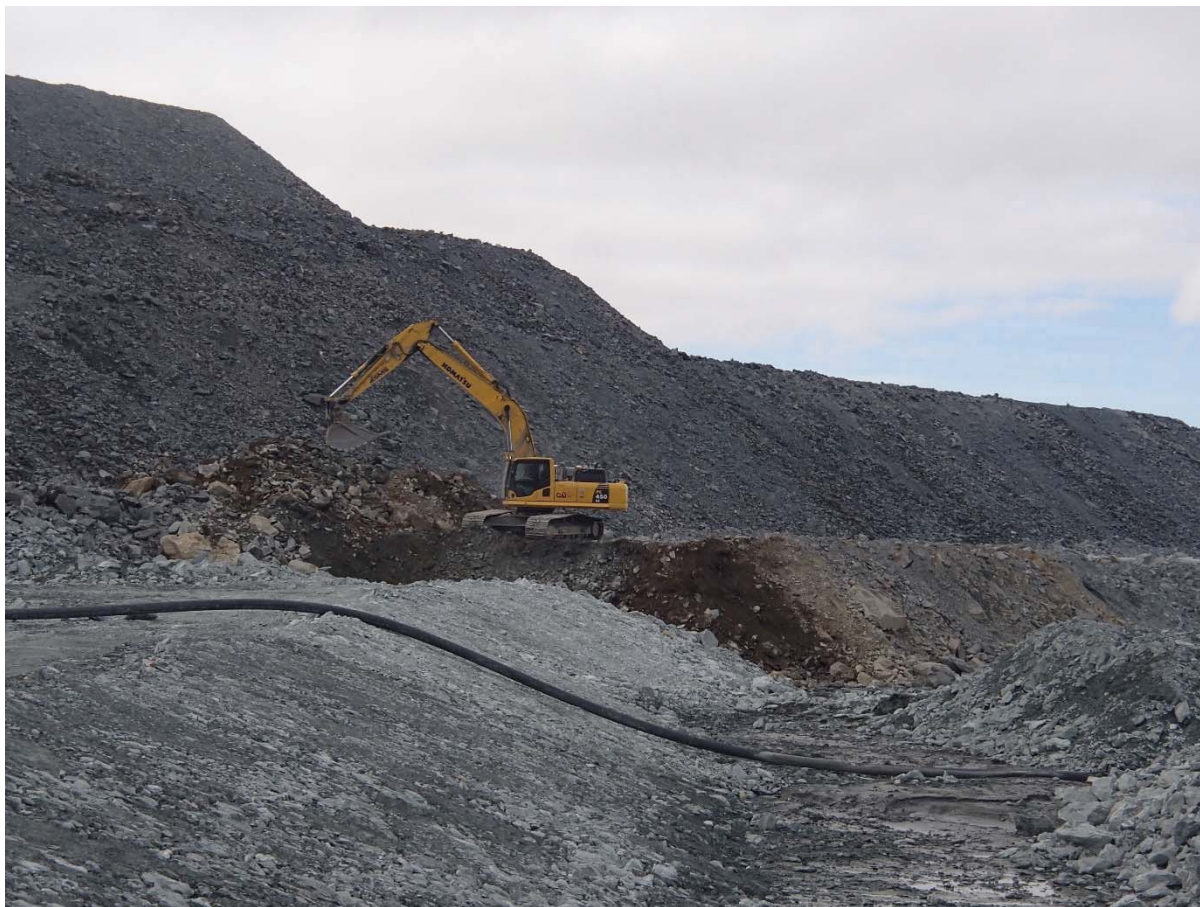
Photograph NCIS-046: From Sta. 2+680/-18 m (approx.), looking SE. Removal of till material mixed with the UM rockfill of the capping (about 1 to 2 m thick along the slope) with an excavator from Sta. 2+760 m to 2+850 m (offset -35 to -17 m).

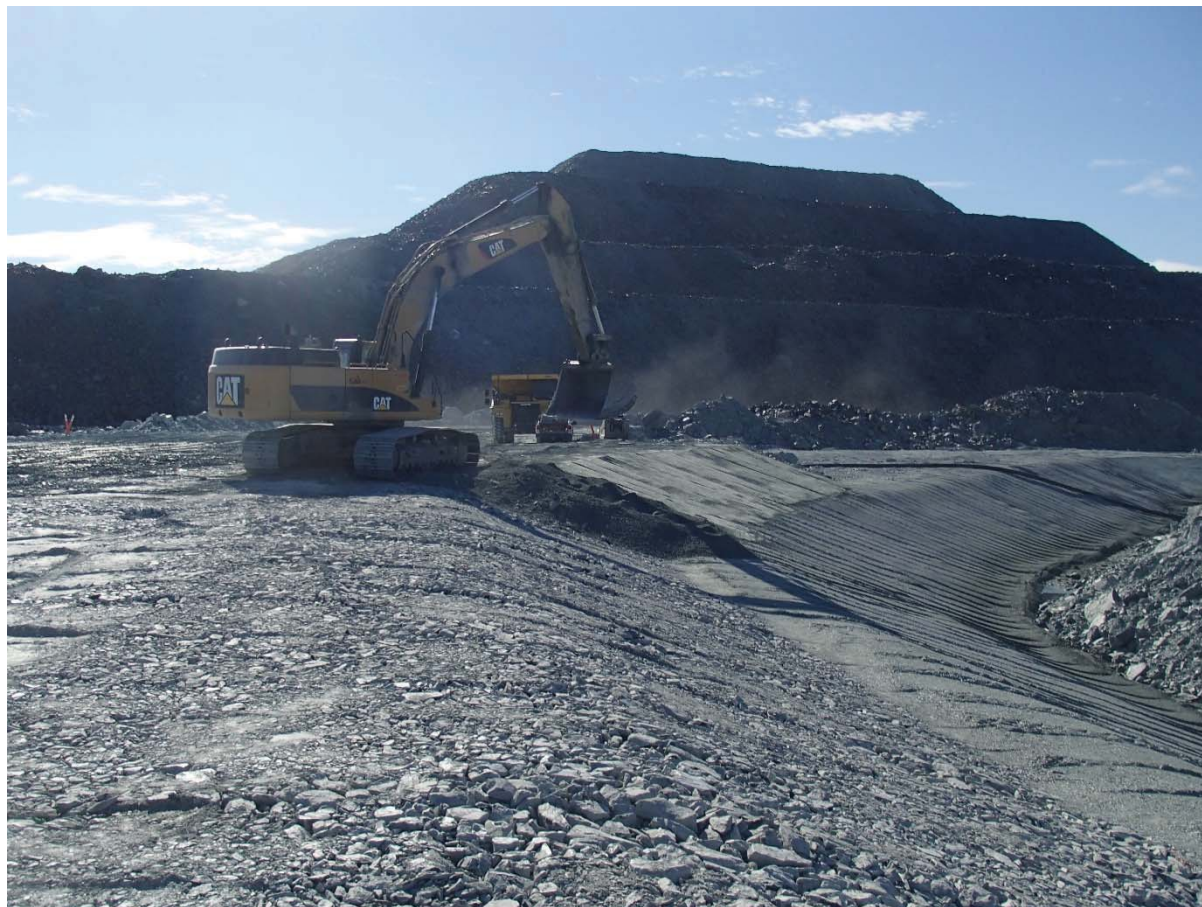
Photograph NCIS-103: From Sta. 2+420/-27 m (approx.), looking NE. Profiling of the upstream slope (3H:1V) from El. 152 to 154 m with an excavator from Sta. 2+400 m to 2+410 m. Oversize boulders were removed.

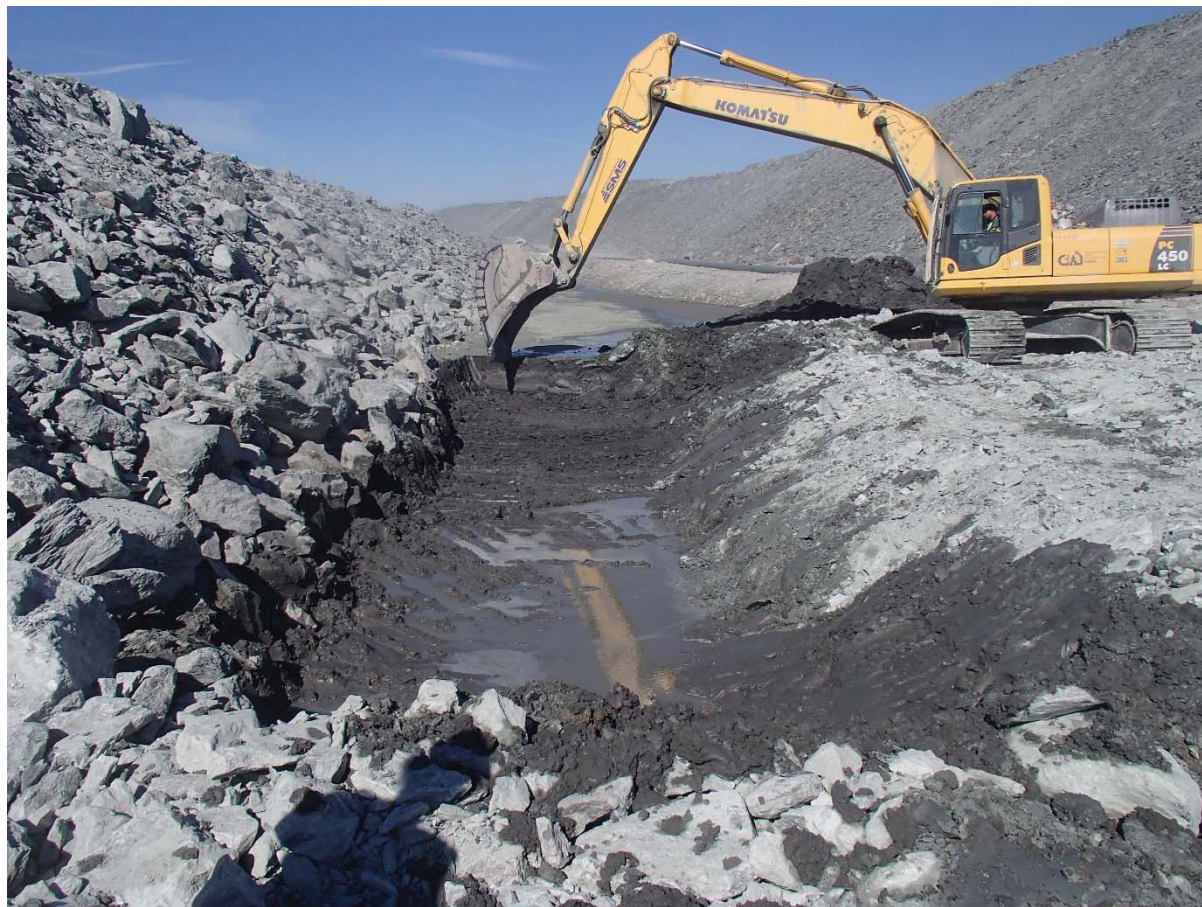
Photograph NCIS-115: From Sta. 3+040/-33 m (approx.), looking NE. Excavation of a 1 m (approx.) sump in the tailings with an excavator from Sta. 3+010 m to 3+030 m (o.s. +27 to +30 m). The bottom of the excavation was frozen.

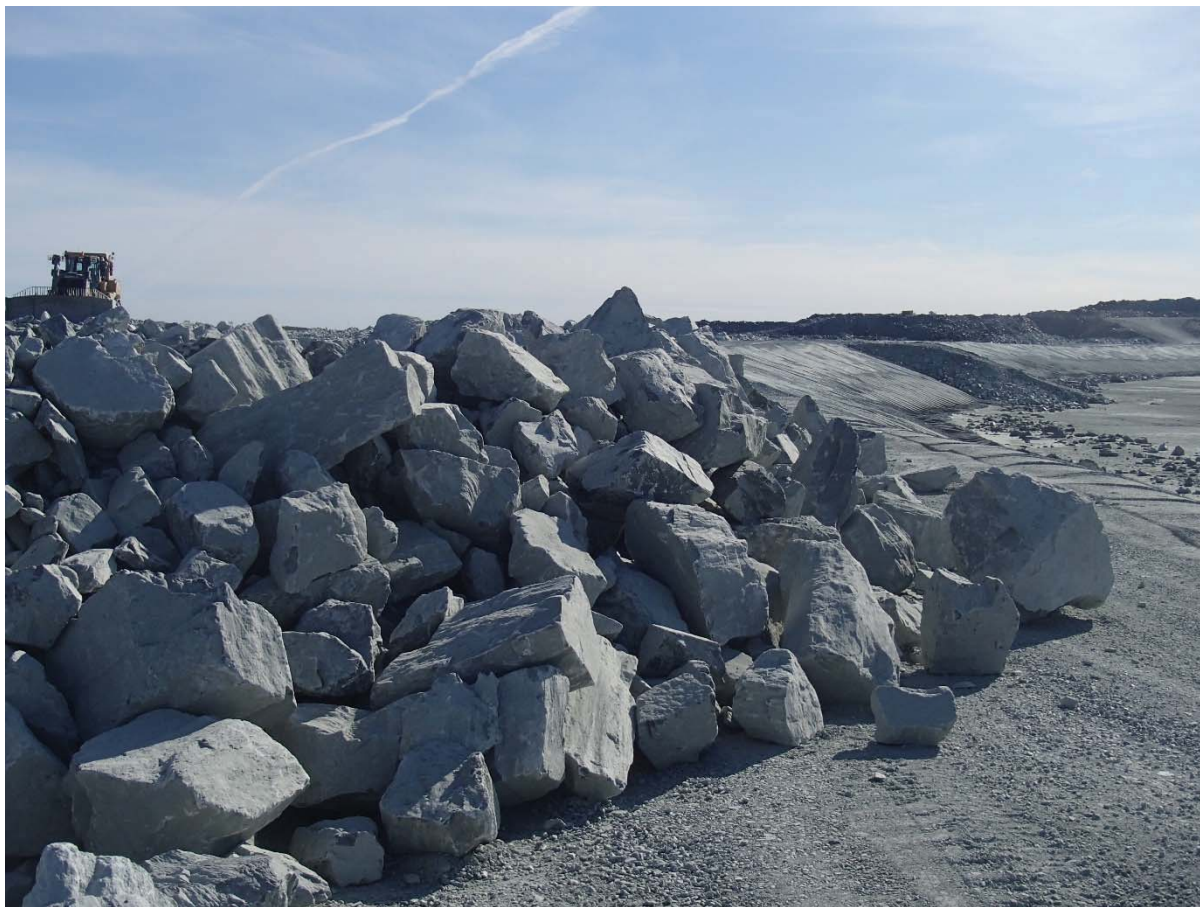
Photograph NCIS-120: From Sta. 1+830/-27 m (approx.), looking NE. View of an accumulation of boulders on the upstream slope of the NCIS.

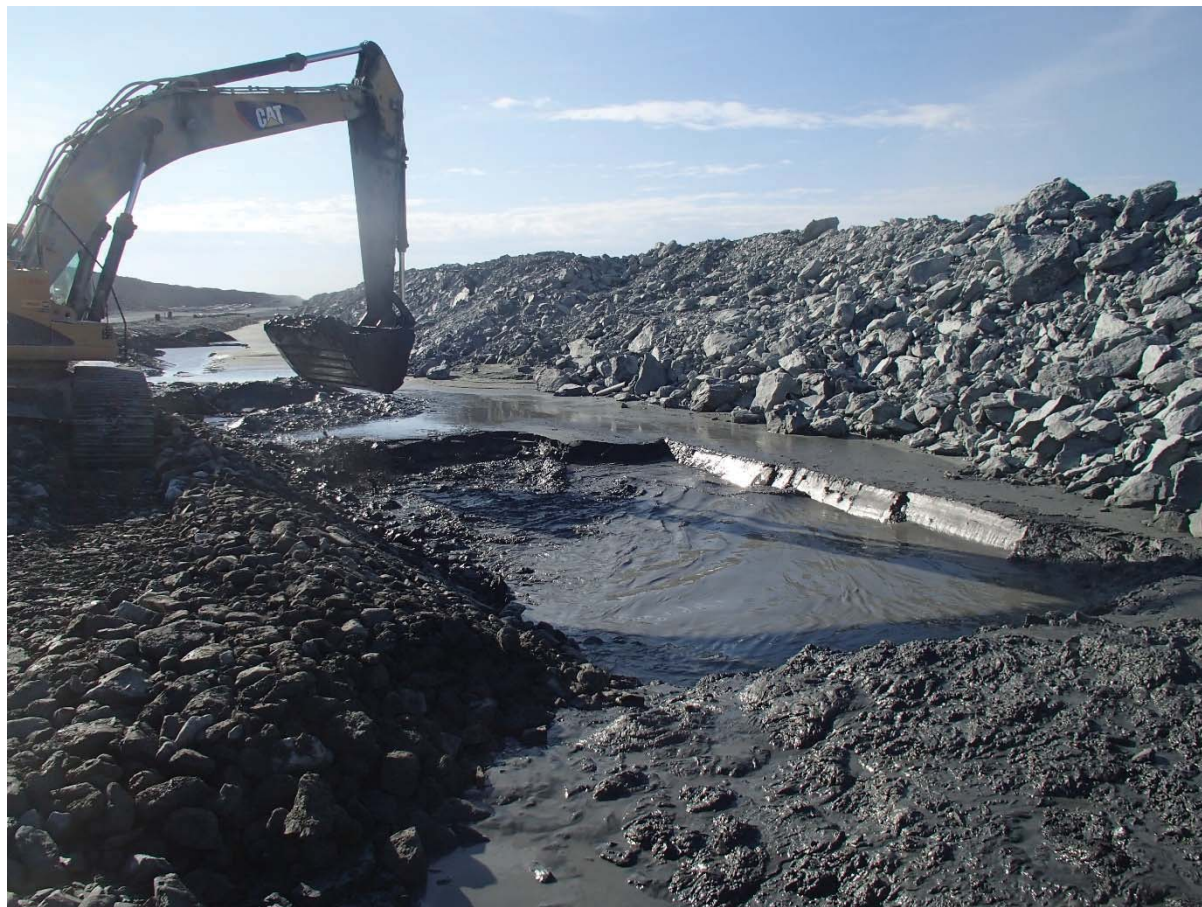
Photograph NCIS-123: From Sta. 3+340/+33 m (approx.), looking S. Excavation of a 1 m (approx.) deep sump (south sump) in the tailings with an excavator from Sta. 3+345 m to 3+365 m (o.s. +24 to +32 m). The bottom of the excavation was frozen.

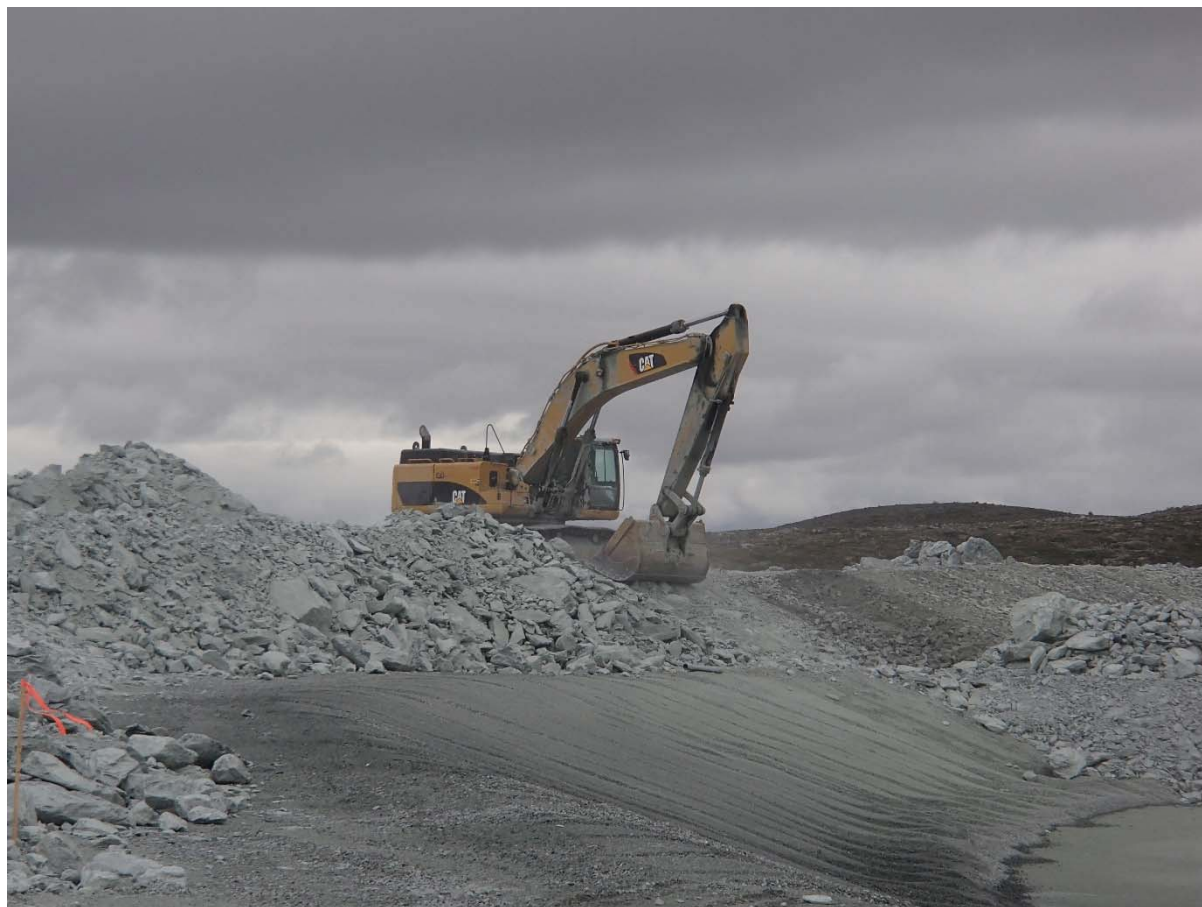
Photograph NCIS-134: From Sta. 1+630/-32 m (approx.), looking NE. Completion of the profiling of the upstream slope (3H:1V) from El. 152 to 154 m with an excavator from Sta. 1+700 m to 1+660 m.
