Meadowbank 2018 TSF As-built report

2018 CONSTRUCTION SEASON AS-BUILT REPORT TAILINGS STORAGE FACILITY MEADOWBANK GOLD PROJECT, NUNAVUT

1897439-1578-R-Rev0

November 2018

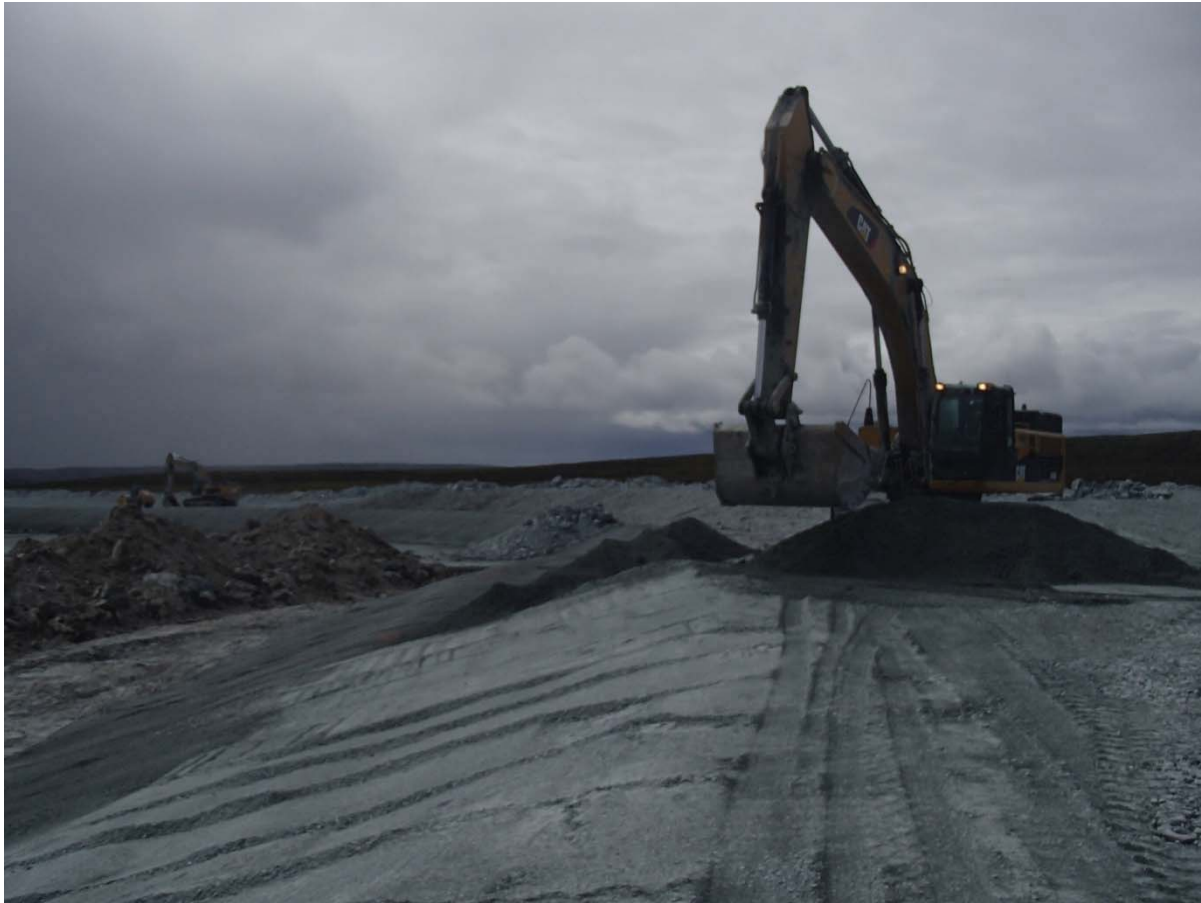
Photograph NCIS-135: From Sta. 1+860/-12 m (approx.), looking SW. Placement of a 0.5 m thick lift of fine filter in the upstream slope from El. 152 m to 154 m with an excavator from Sta. 1+830 m to 1+700 m.

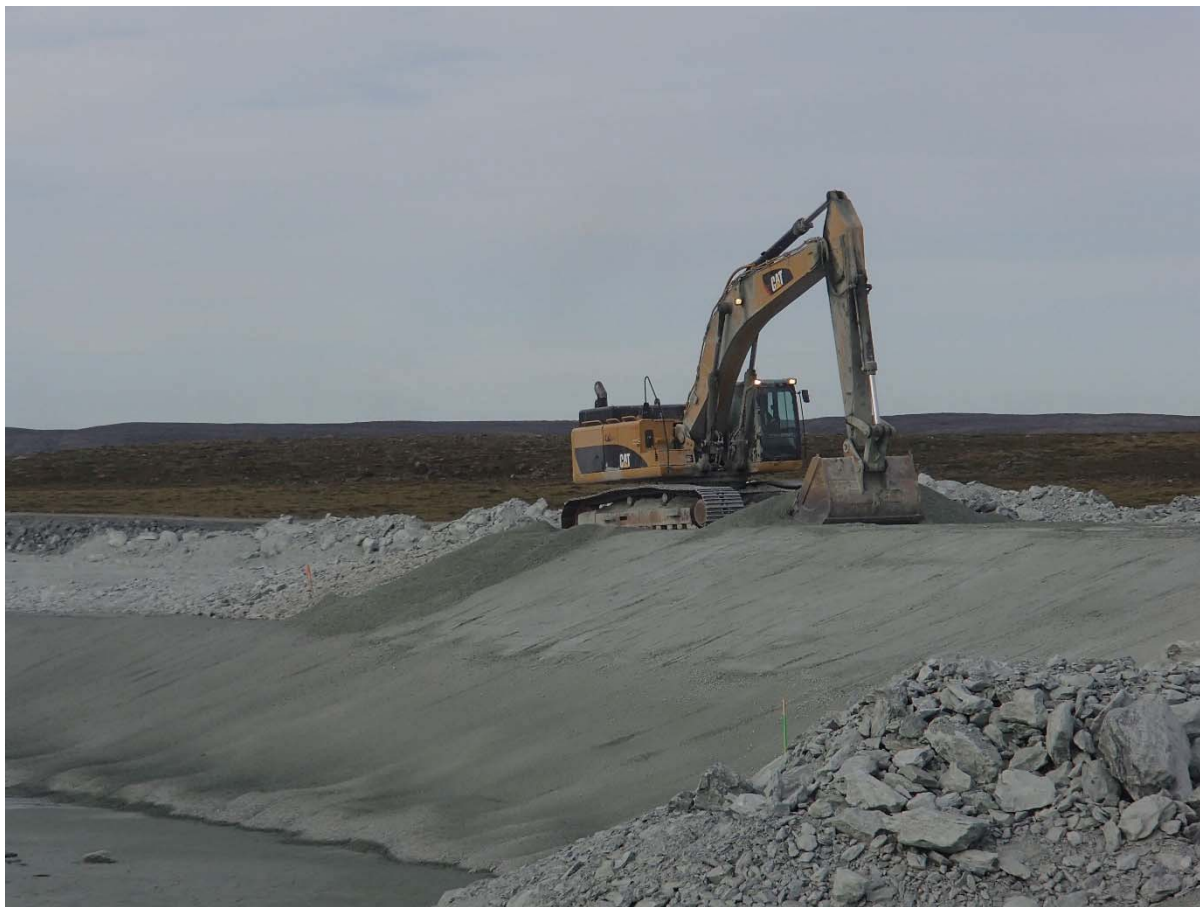
Photograph NCIS-136: From Sta. 1+800/-33 m (approx.), looking SW. Placement of a 0.5 m thick lift of fine filter in the upstream slope from El. 152 m to 154 m with an excavator from Sta. 1+700 m to 1+660 m.

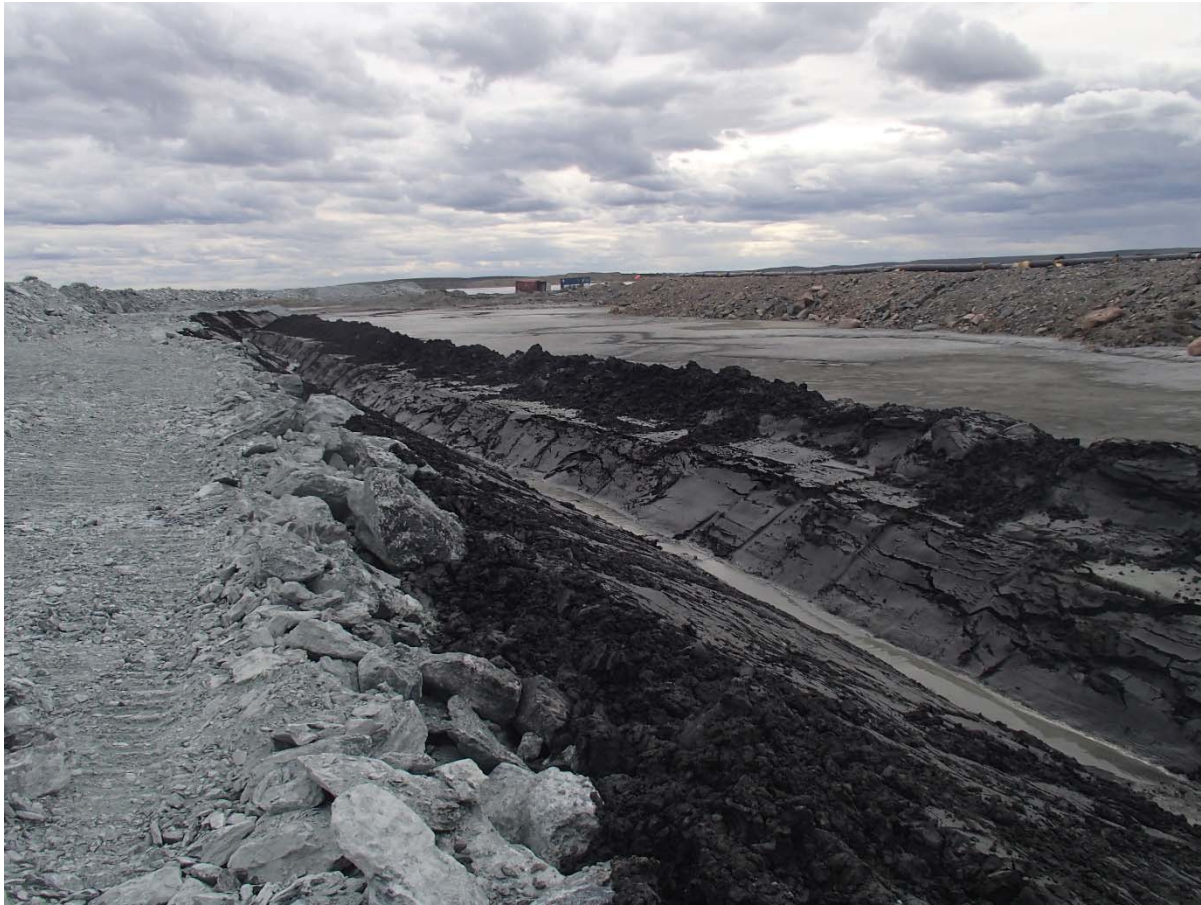
Photograph NCIS-137: From Sta. 1+380/+14 m (approx.), looking SW. Excavation of a 0.8 m (approx.) deep, 1 m wide shallow ditch in the tailings with an excavator from Sta. 1+300 m to 1+200 m.

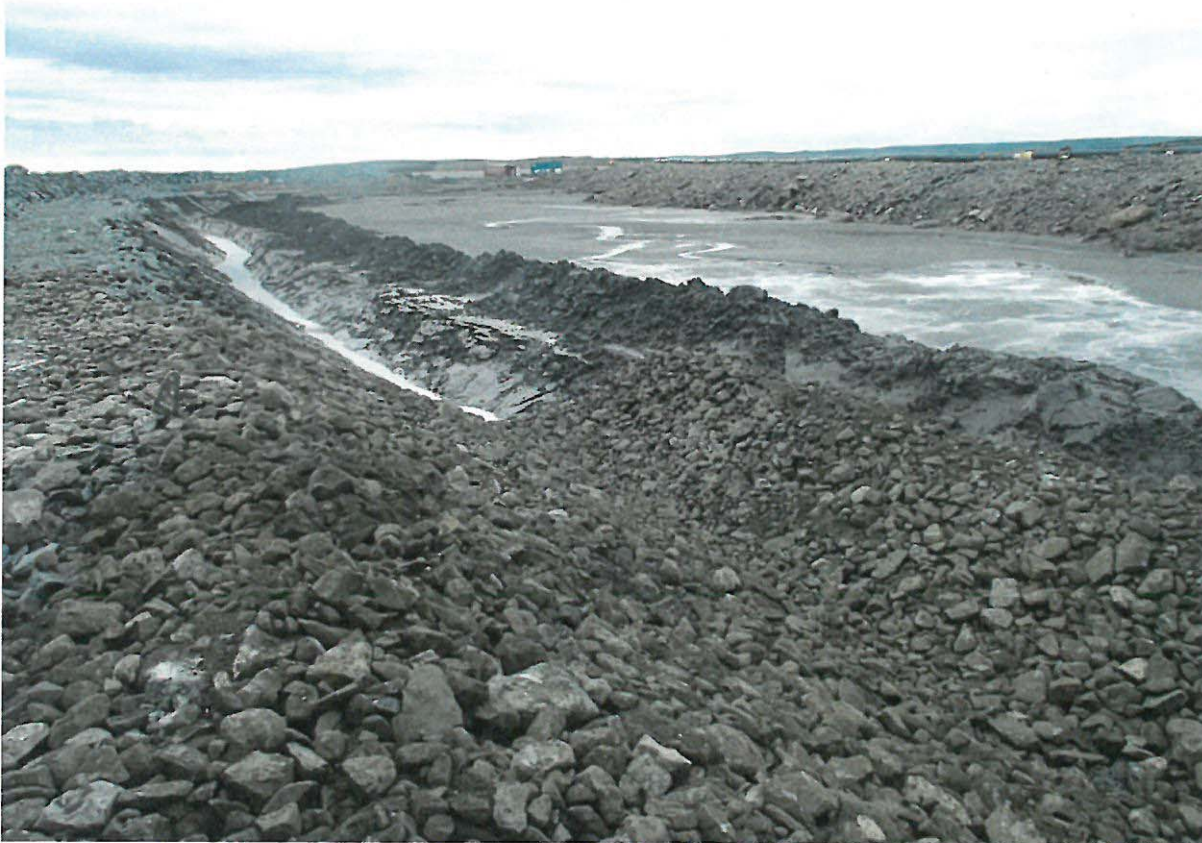
Photograph NCIS-138: From Sta. 1+365/+15 m (approx.), looking SW. Excavation of a 0.8 m (approx.) deep, 1 m wide shallow ditch in the tailings and placement of a 0.3 m thick (approx.) layer of till sieving reject material on the bottom and on the slopes of the ditch from Sta. 1+200 m to 1+100 m.

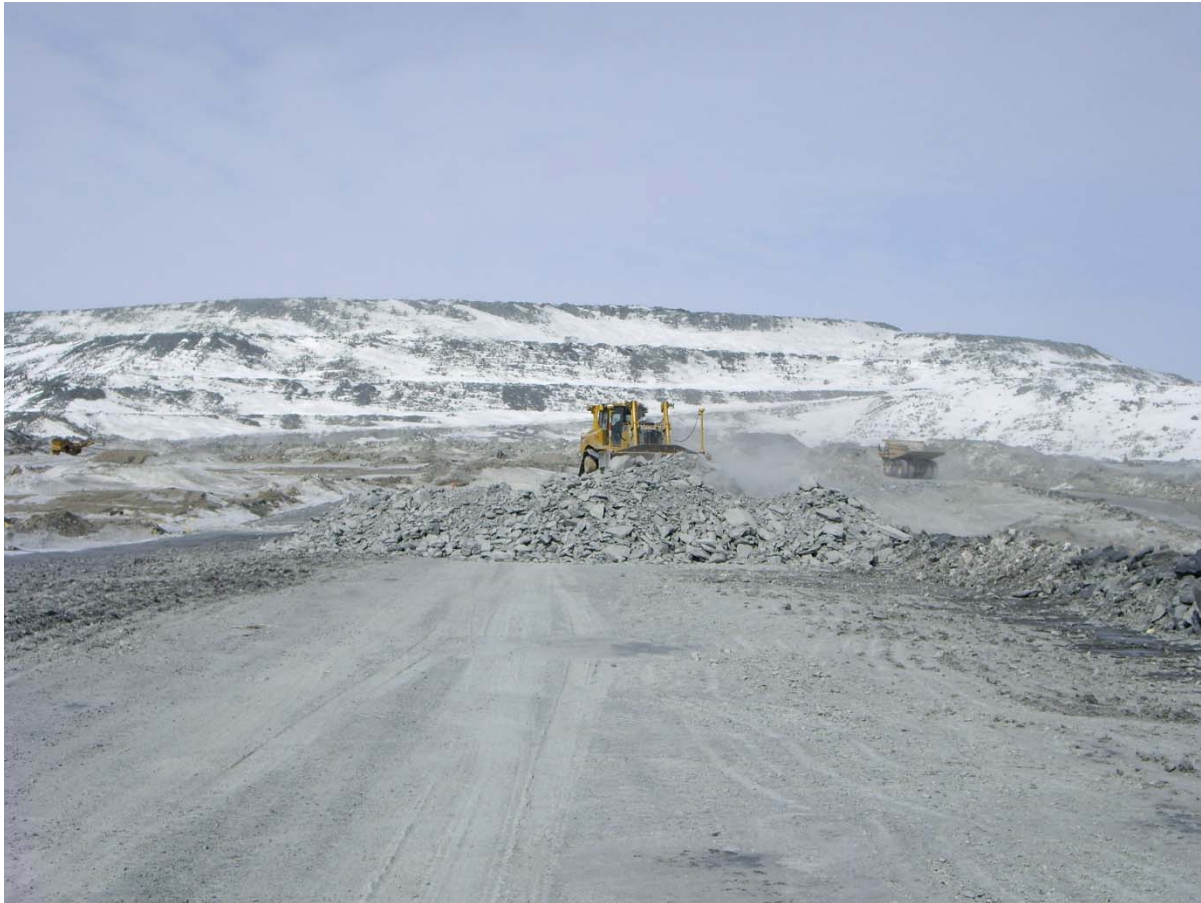
Photograph CD-1798: From Sta. 0+500/-15 m looking N. Placement of a 2 m thick (approx.) lift of intermediate volcanic (IV) rockfill from El. 143 m to El. 145 m from 0+340 to 0+435 m (o.s. -28 to -18 m).

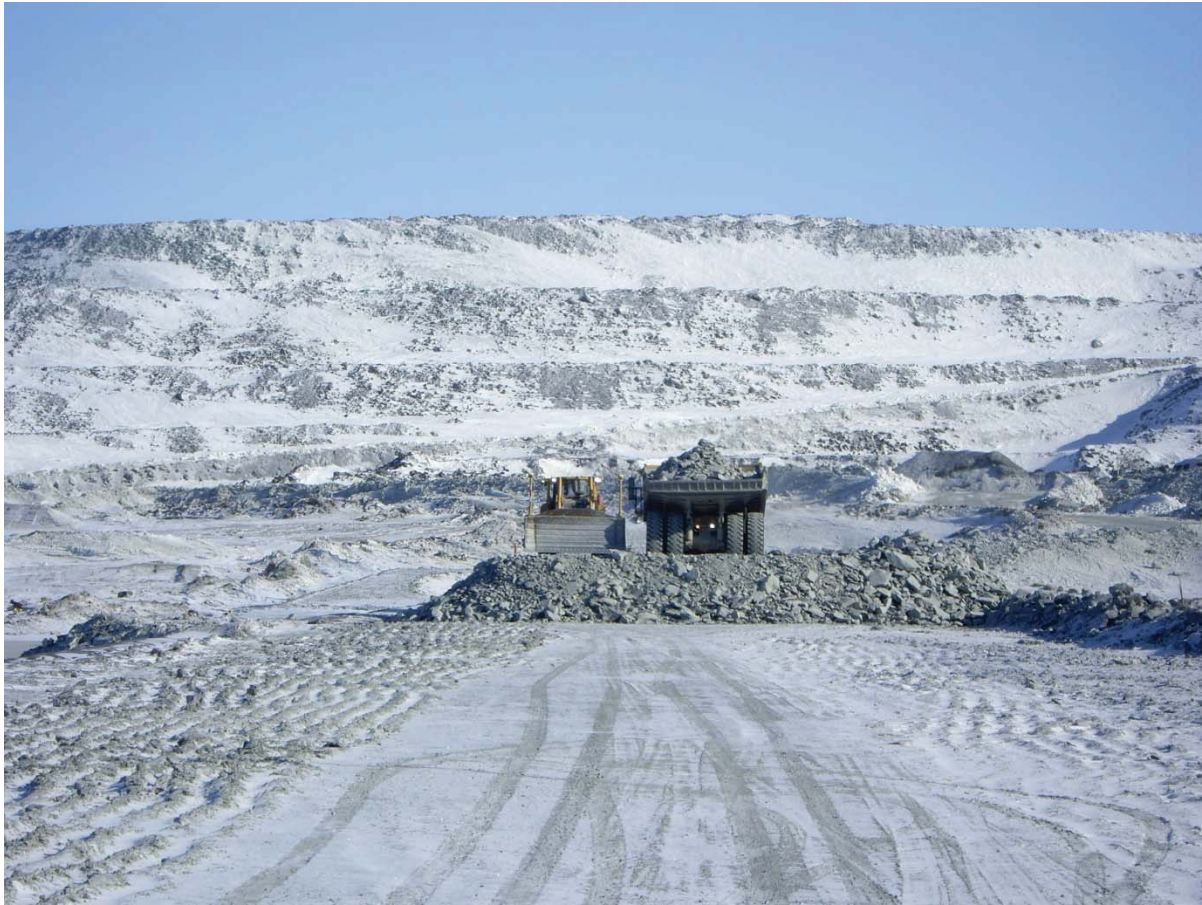
Photograph CD-1799: From Sta. 0+080/-25 m looking S. Placement of a 2 m thick (approx.) lift of intermediate volcanic (IV) rockfill from El. 143 m to El. 145 m from 0+340 to 0+435 m (o.s. -28 to -18 m).

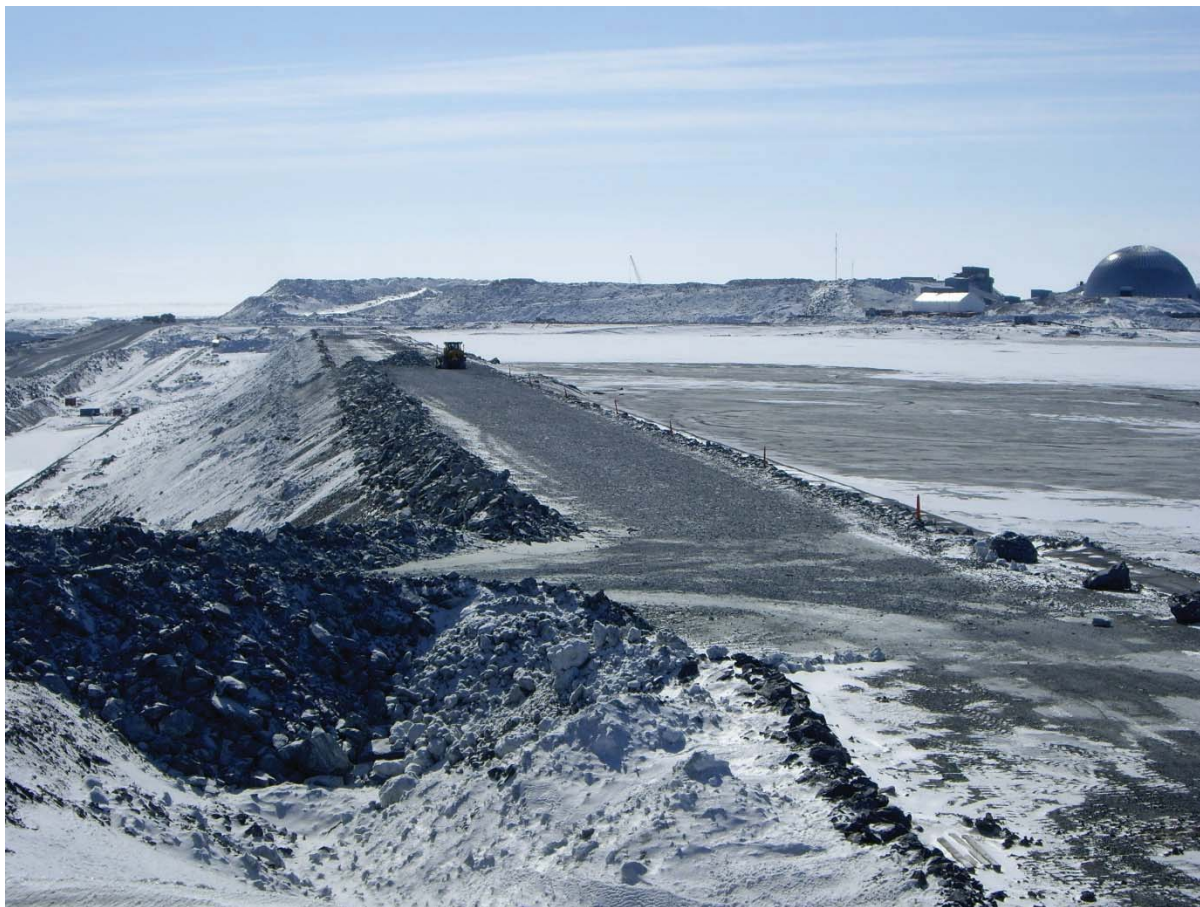
Photograph CD-1800: From Sta. 0+500/-14 m looking N. Placement of a 2 m thick (approx.) lift of intermediate volcanic (IV) rockfill from El. 143 m to El. 145 m from 0+435 to 0+535m (o.s. -28 to -18 m).

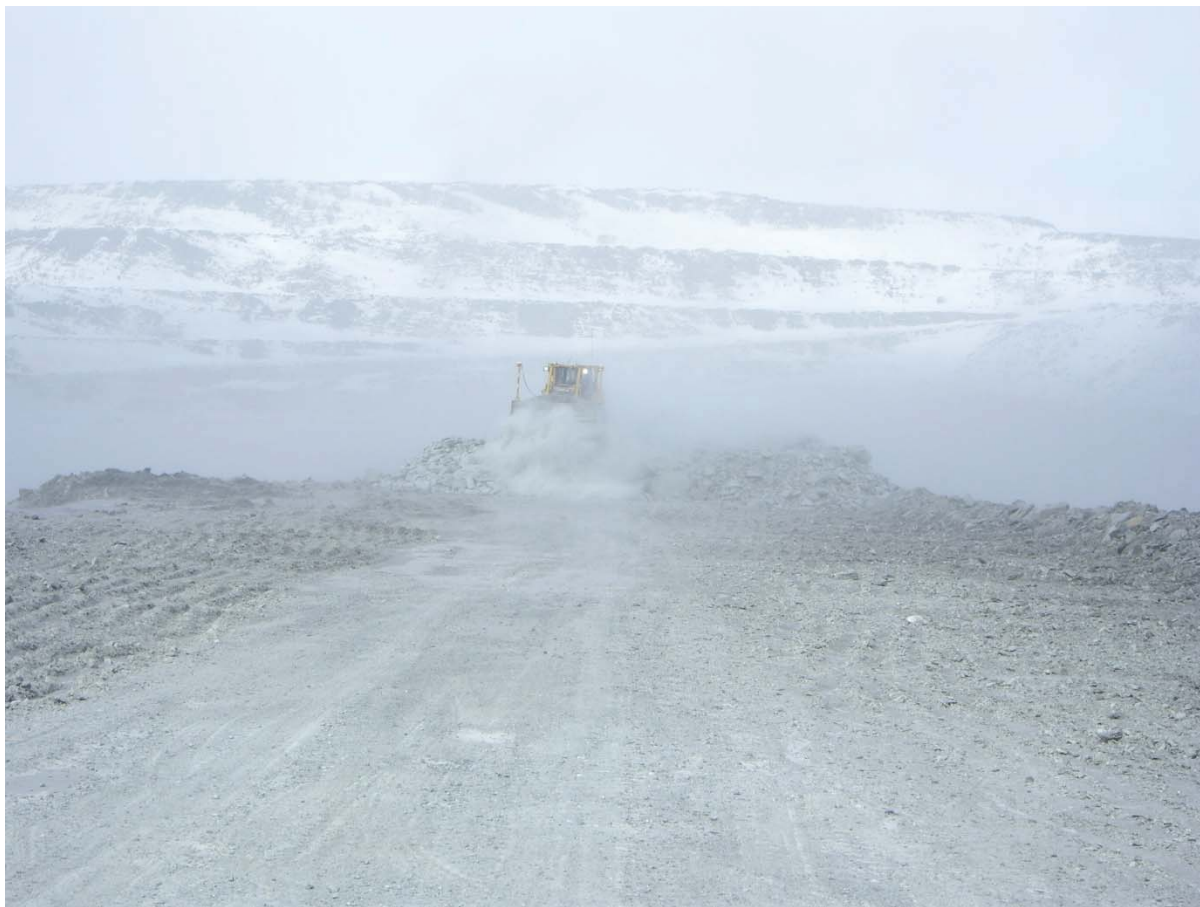
Photograph CD-1801: From Sta. 0+650/-10 m looking N. Placement of a 2 m thick (approx.) lift of intermediate volcanic (IV) rockfill from El. 143 m to El. 145 m from 0+535 to 0+625m (o.s. -28 to -18 m).

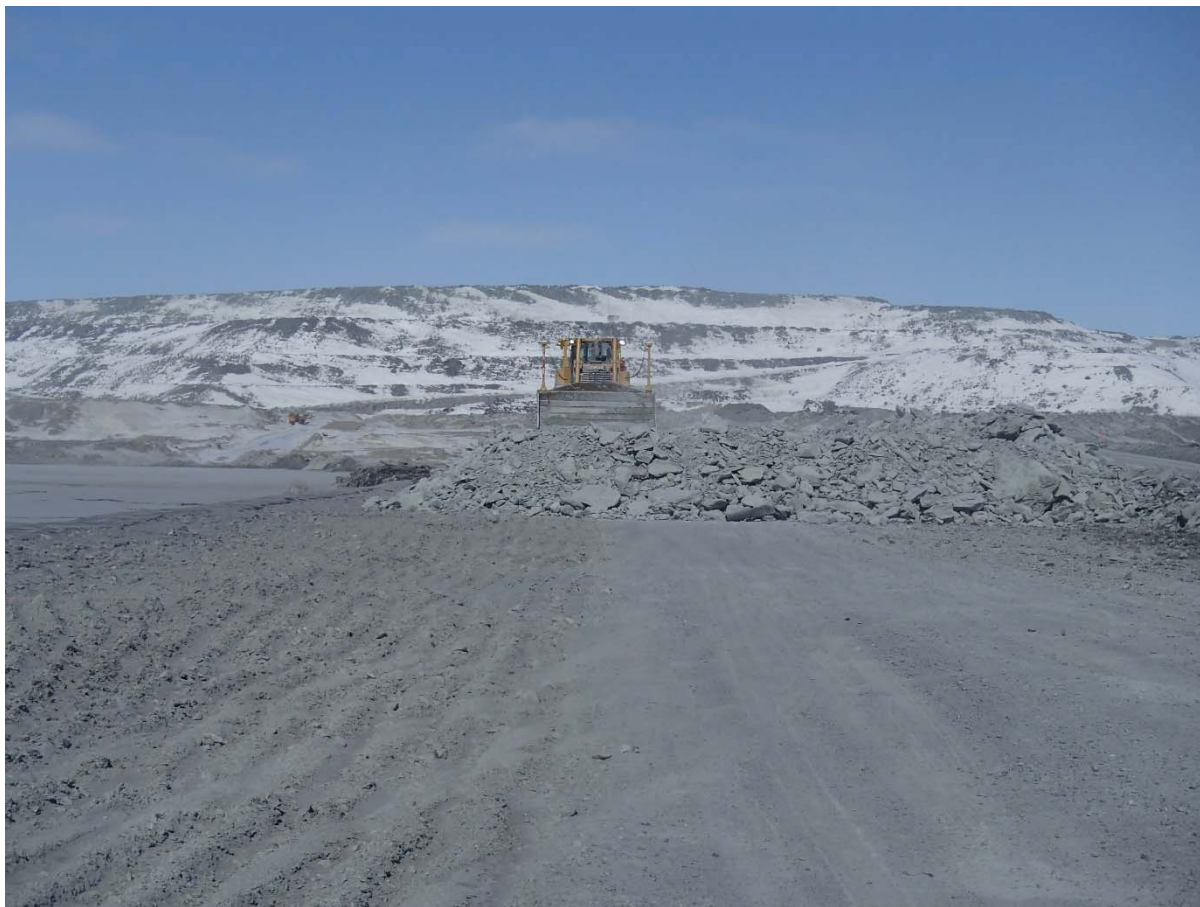
Photograph CD-1802: From Sta. 0+770/-16 m looking N. Placement of a 2 m thick (approx.) lift of intermediate volcanic (IV) rockfill from El. 143 m to El. 145 m from approx. Sta. 0+525 to 0+710 m (o.s. -28 to -18 m).

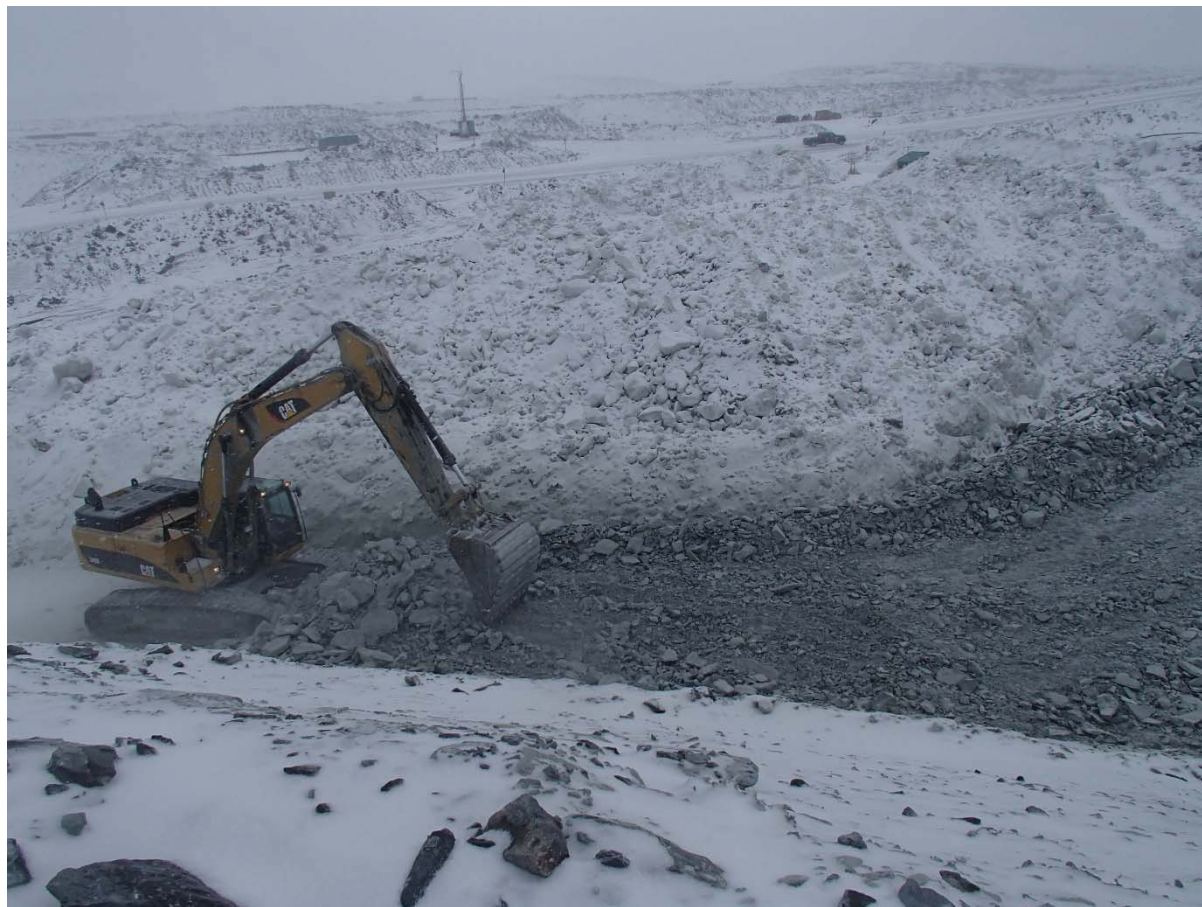
Photograph CD-1809: From Sta. 0+870/-16 m looking N. Placement of a 2 m thick (approx.) lift of intermediate volcanic (IV) rockfill from El. 143 m to El. 145 m from approx. Sta. 0+760 to 0+835 m (o.s. -28 to 3 m).

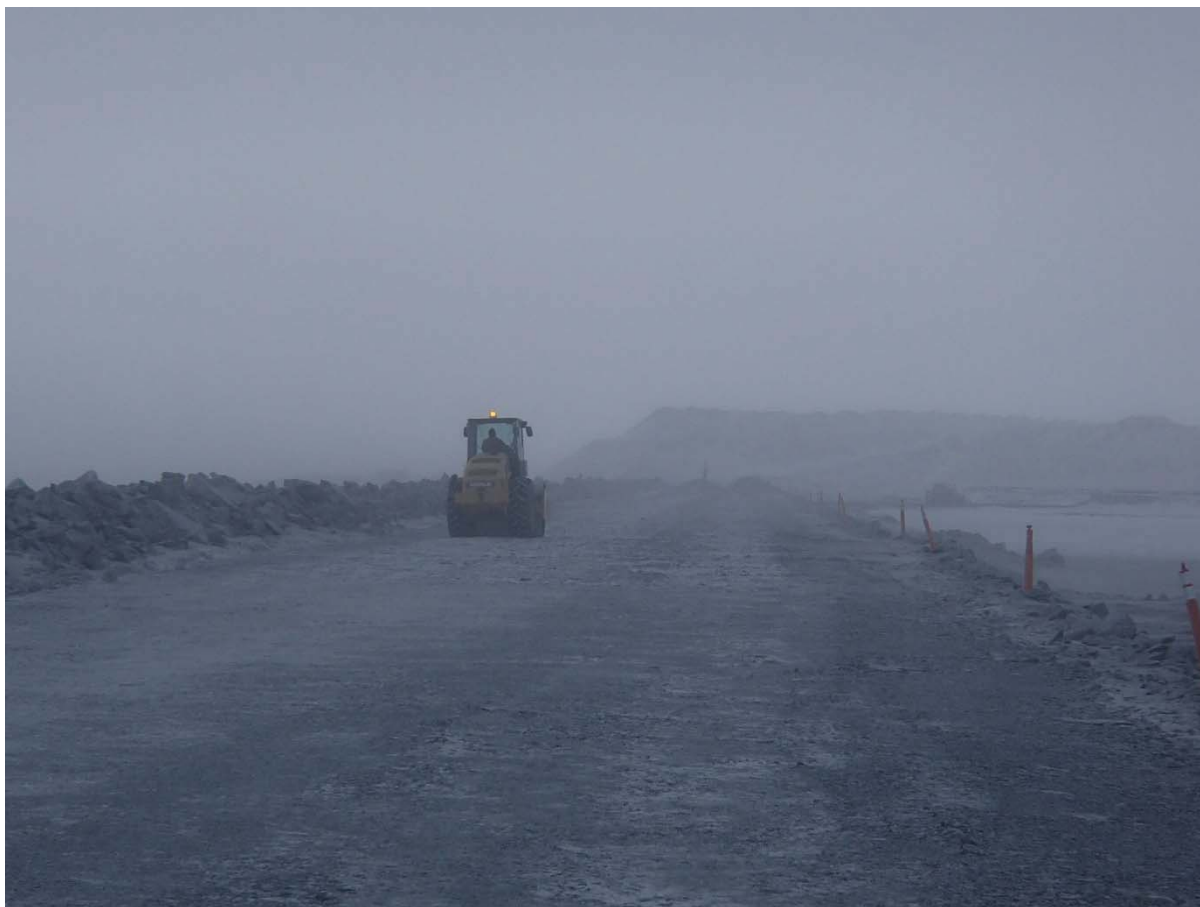
Photograph CD-1811: From Sta. 0+985/-11 m looking SE. Placement the second, third, fourth and fifth 1 m thick (approx.) lifts of intermediate volcanic (IV) rockfill from approx. Sta. 0+985 to 40+780 m (o.s. -8 to 8 m) with the excavator.

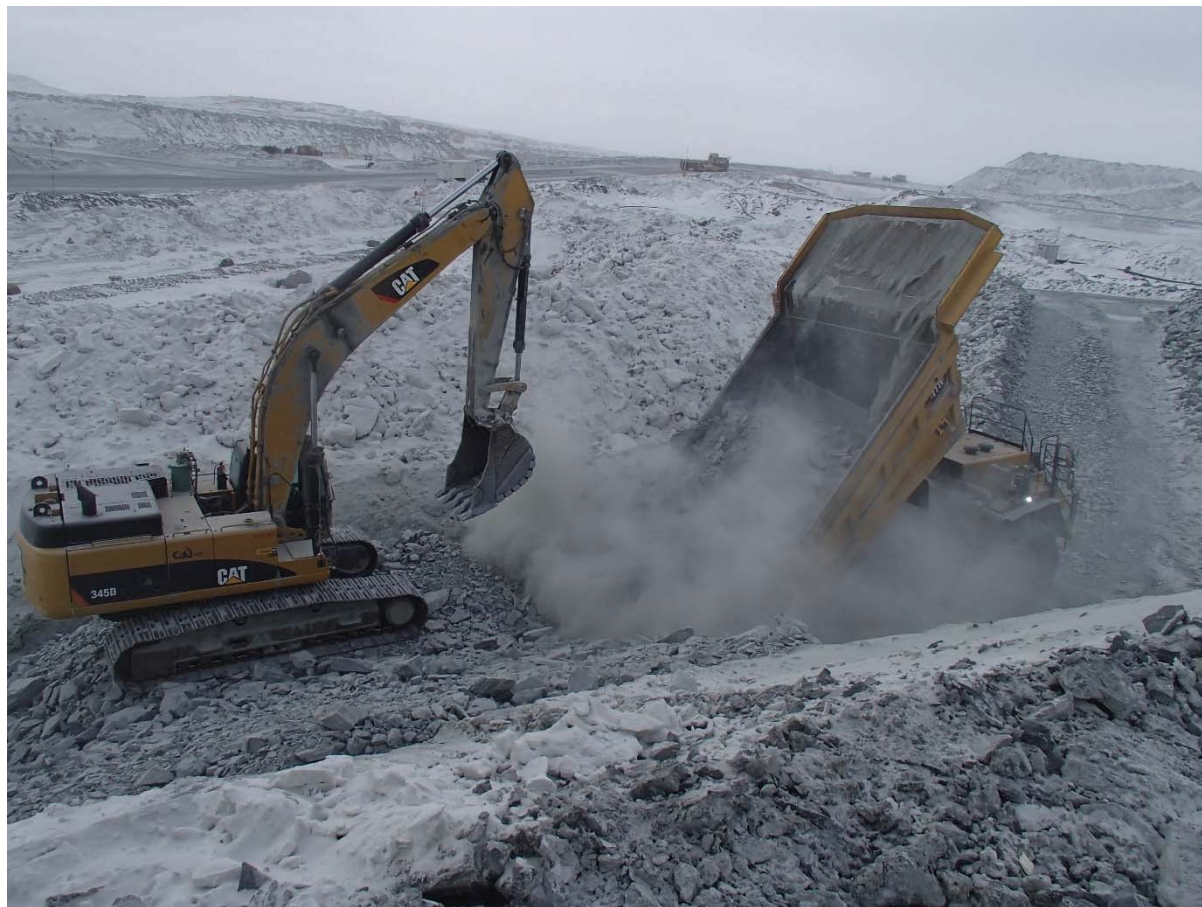
Photograph CD-1812: From Sta. 0+985/-11 m looking SE. Placement of intermediate volcanic (IV) rockfill on the existing downstream slope up to approx. El. 140 m, from approx. Sta. 0+985 to 40+780 m.

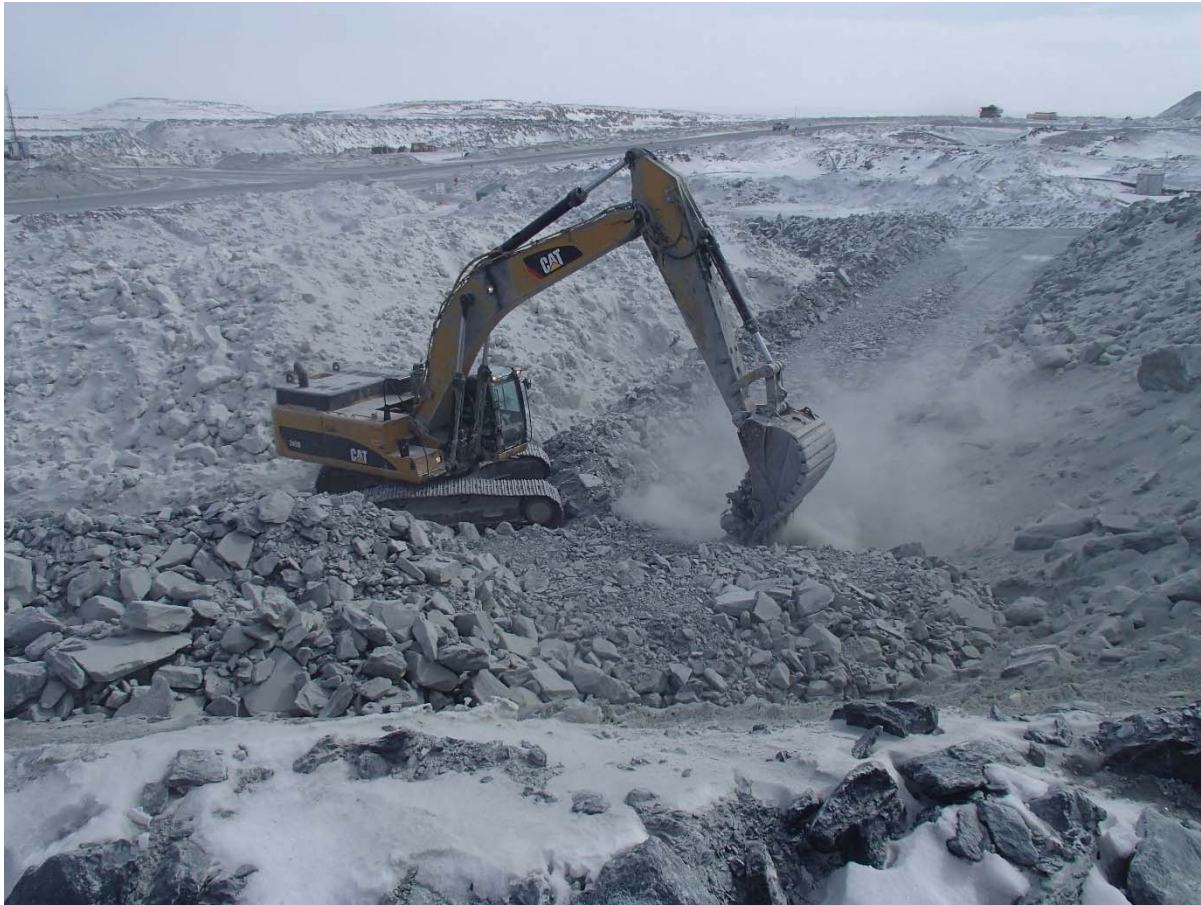
Photograph CD-1813: From Sta. 0+980/-2, looking S. Placement of intermediate volcanic (IV) rockfill on the existing downstream slope up to approx. El. 143 m, from approx. Sta. 0+980 to 40+780 m.

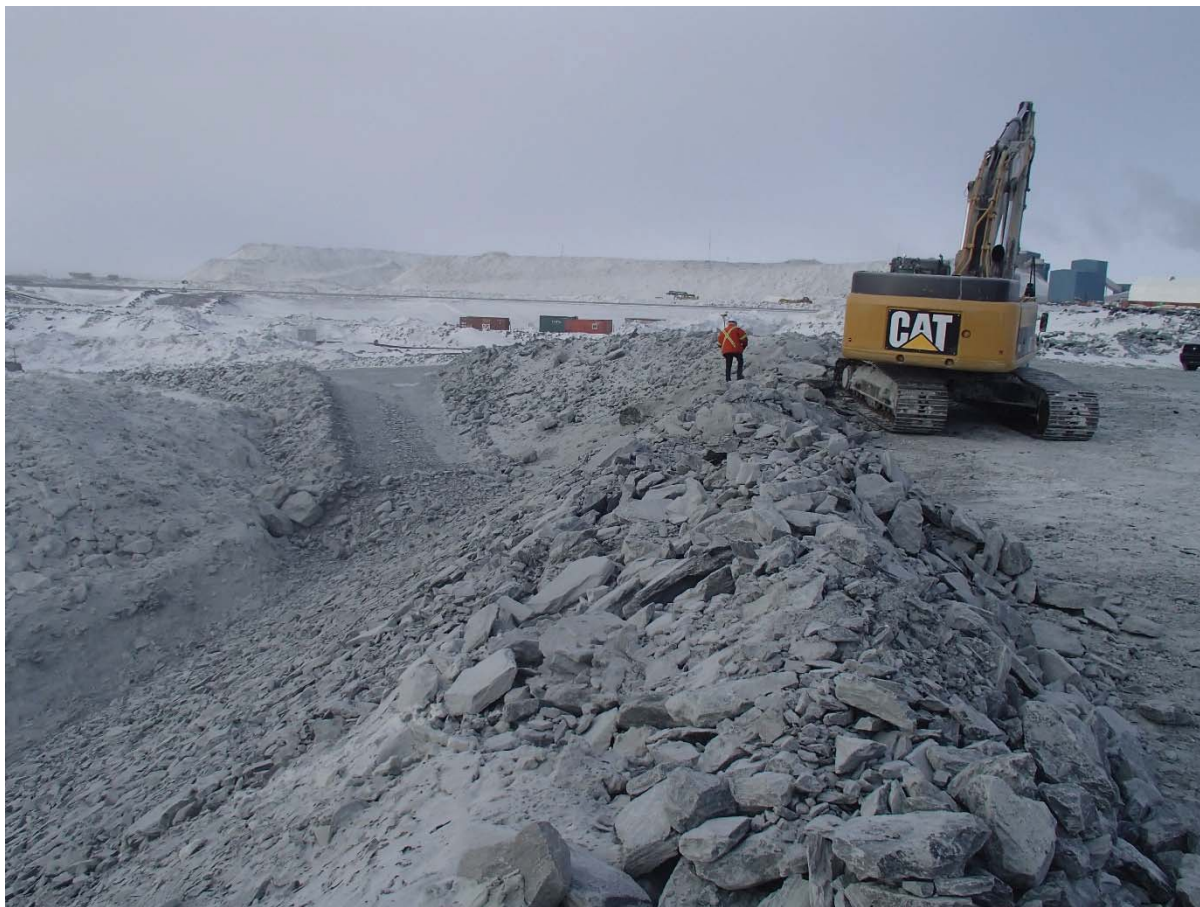
Photograph CD-1814: From Sta. 0+970/-10, looking NE. Placement of intermediate volcanic (IV) rockfill around the instruments at approx. Sta. 0+830 m with the excavator.

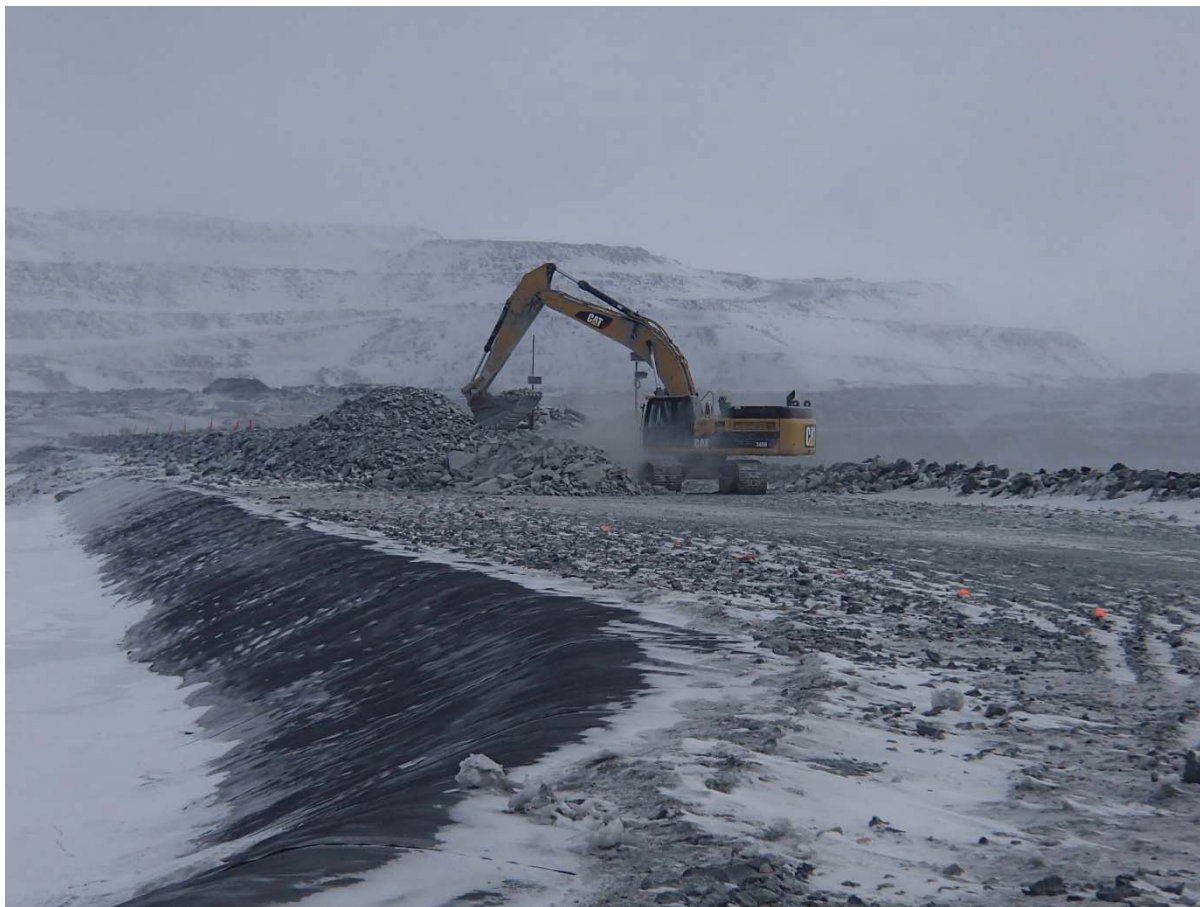
Photograph CD-1815: From Sta. 0+920/-25, looking S. Placement of a 2 m thick (approx.) lift of intermediate volcanic (IV) rockfill from El. 143 m to El. 145 m from approx. Sta. 40+740 to 0+980 m (o.s. -28 to -11 m).

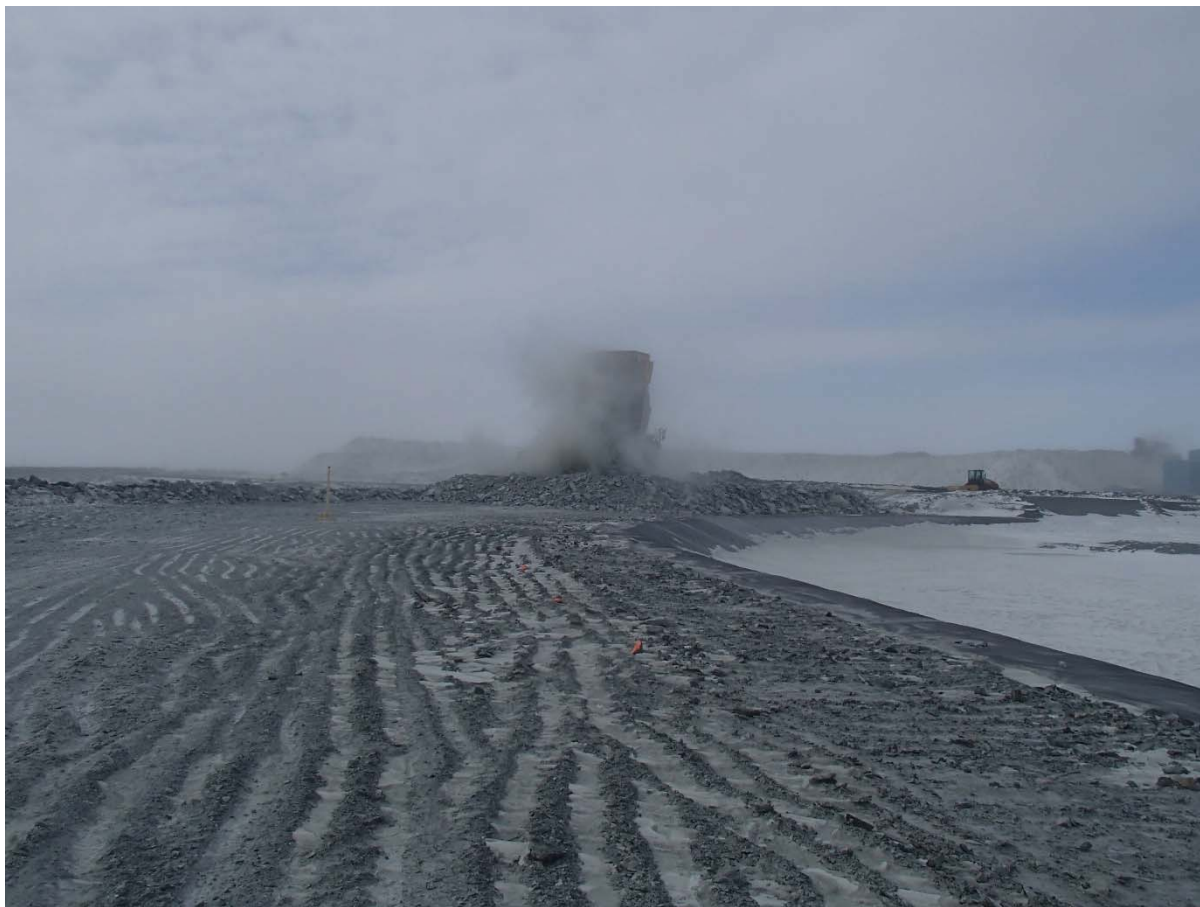
Photograph CD-1816: From Sta. 0+175/-27, looking S. Profiling of the upstream slope (2H:1V) from El. 143 to 145 m with an excavator between Sta. 0+175 and 0+560 m.

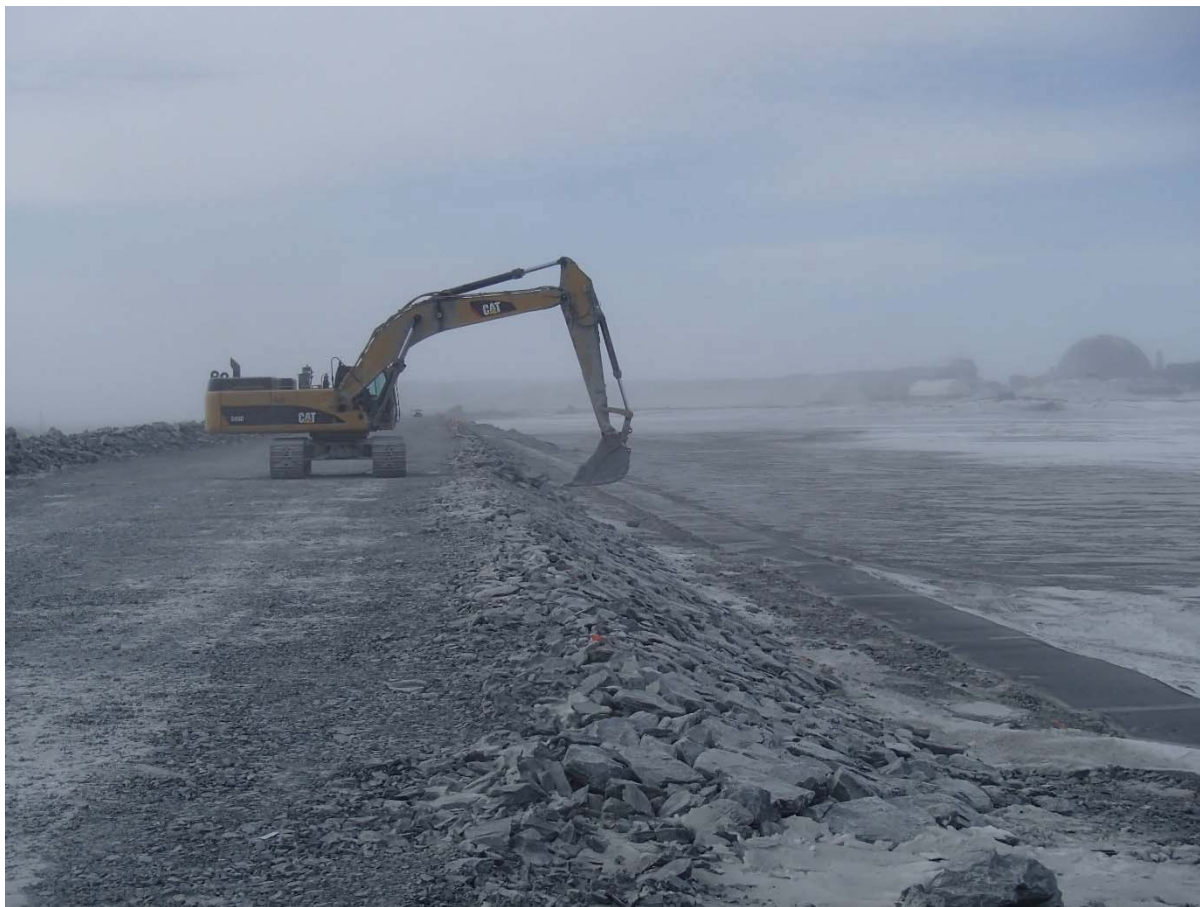
- It was observed that when using the D9 bulldozer, which does not have a GPS to monitor elevation, the intermediate volcanic (IV) rockfill lift thickness was slightly in excess of 2 m (approx. 2.5 m) on Central Dike, at the junction with Saddle Dam 5. The bulldozer was replaced with the GPS-equipped D8 bulldozer used in the previous days, which ensured that the elevation of the lift was at 145m.

Photograph CD-1817: From Sta. 40+700/-10, looking NE. View of the rockfill lift thickness at the junction of Saddle Dam 5 and Central Dike, approx. 2.5 m thick.

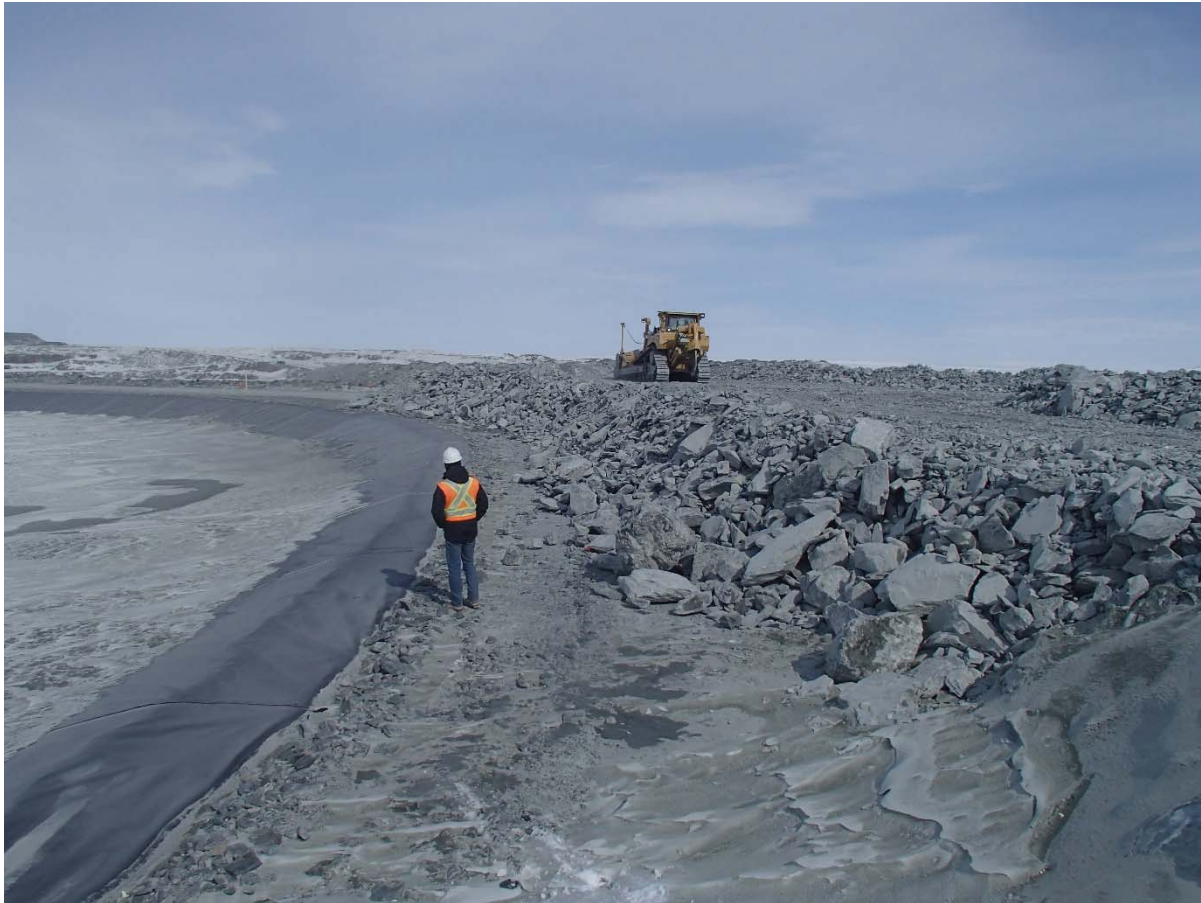
Photograph CD-1818: From Sta. 40+770/-25, looking NE. Placement of a 2 m thick (approx.) lift of intermediate volcanic (IV) rockfill from El. 143 m to El. 145 m from approx. Sta. 0+980 m to 0+880 m (o.s. -28 to -11 m).

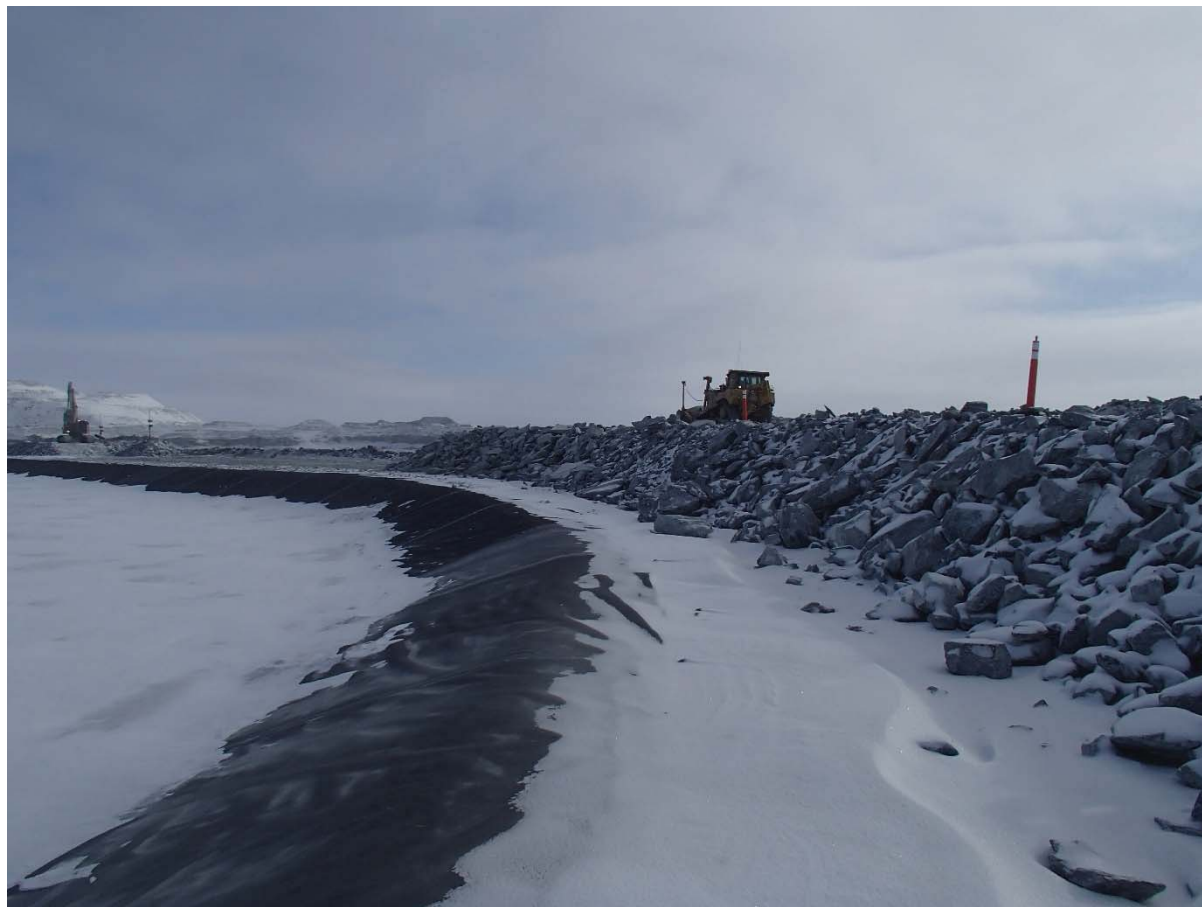
Photograph CD-1819: From Sta. 0+560/-21, looking S. Profiling of the upstream slope (2H:1V) from El. 143 to 145 m with an excavator between Sta. 0+560 m and 0+830 m.

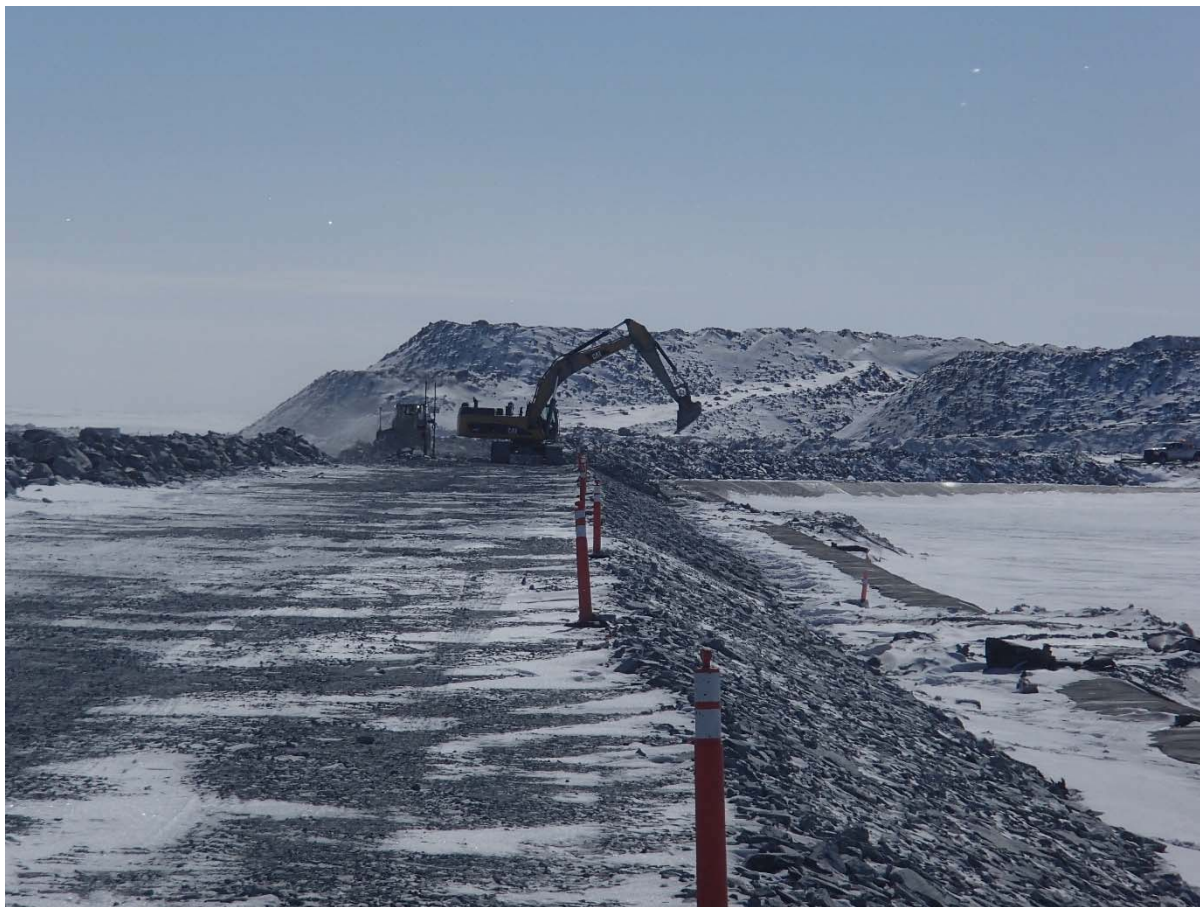
Photograph CD-1820: From Sta. 0+790/-7, looking S. Placement of a 2 m thick (approx.) lift of intermediate volcanic (IV) rockfill from El. 143 m to El. 145 m from approx. Sta. 0+880 m to 0+830 m (o.s. -28 to -11 m).
