Meadowbank 2018 TSF As-built report

2018 CONSTRUCTION SEASON AS-BUILT REPORT TAILINGS STORAGE FACILITY MEADOWBANK GOLD PROJECT, NUNAVUT

1897439-1578-R-Rev0

November 2018

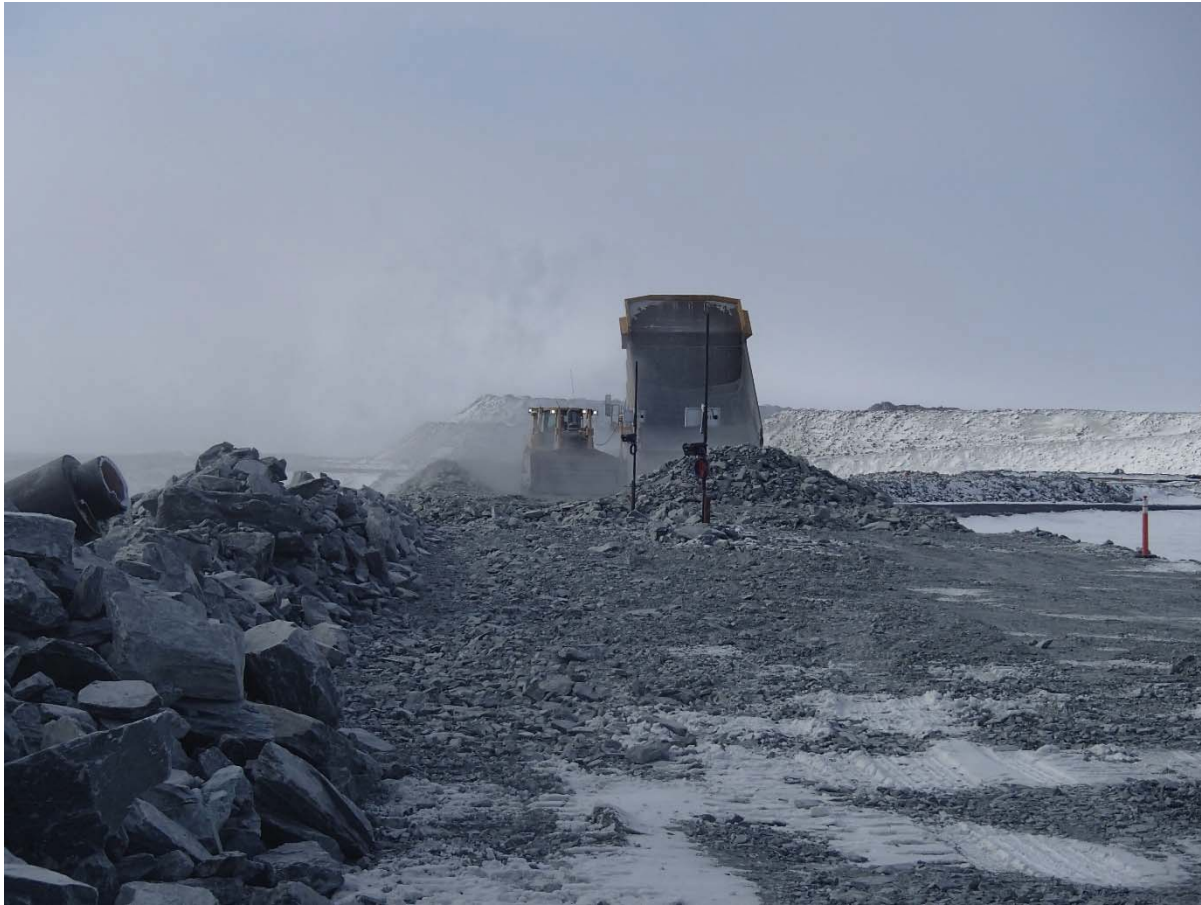
Photograph CD-1821: From Sta. 0+175/+3, looking S. Profiling of the downstream slope (1.5H:1V) from El. 143 to 145 m with an excavator between Sta. 0+250 m and 0+330 m.

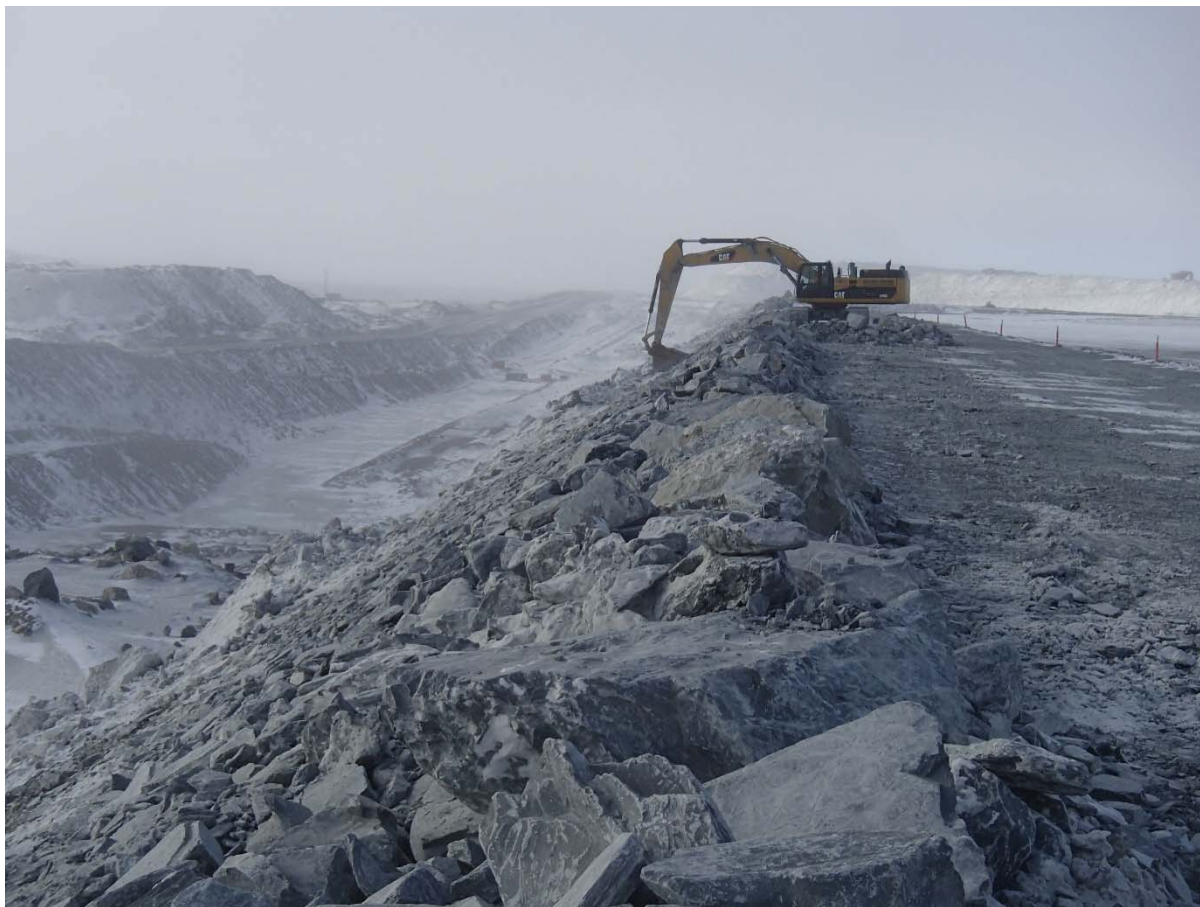
Photograph CD-1822: From Sta. 40+725/+7, looking N. Placement of two 2 m thick (approx.) lifts of intermediate volcanic (IV) rockfill from El. 141 m to El. 145 m from approx. Sta. 40+720 m to 40+750 m (o.s. -10 to +10 m) and profiling of the upstream slope (2H:1V) from El. 143 to 145 m with an excavator between Sta. 0+830 m and 0+980 m.

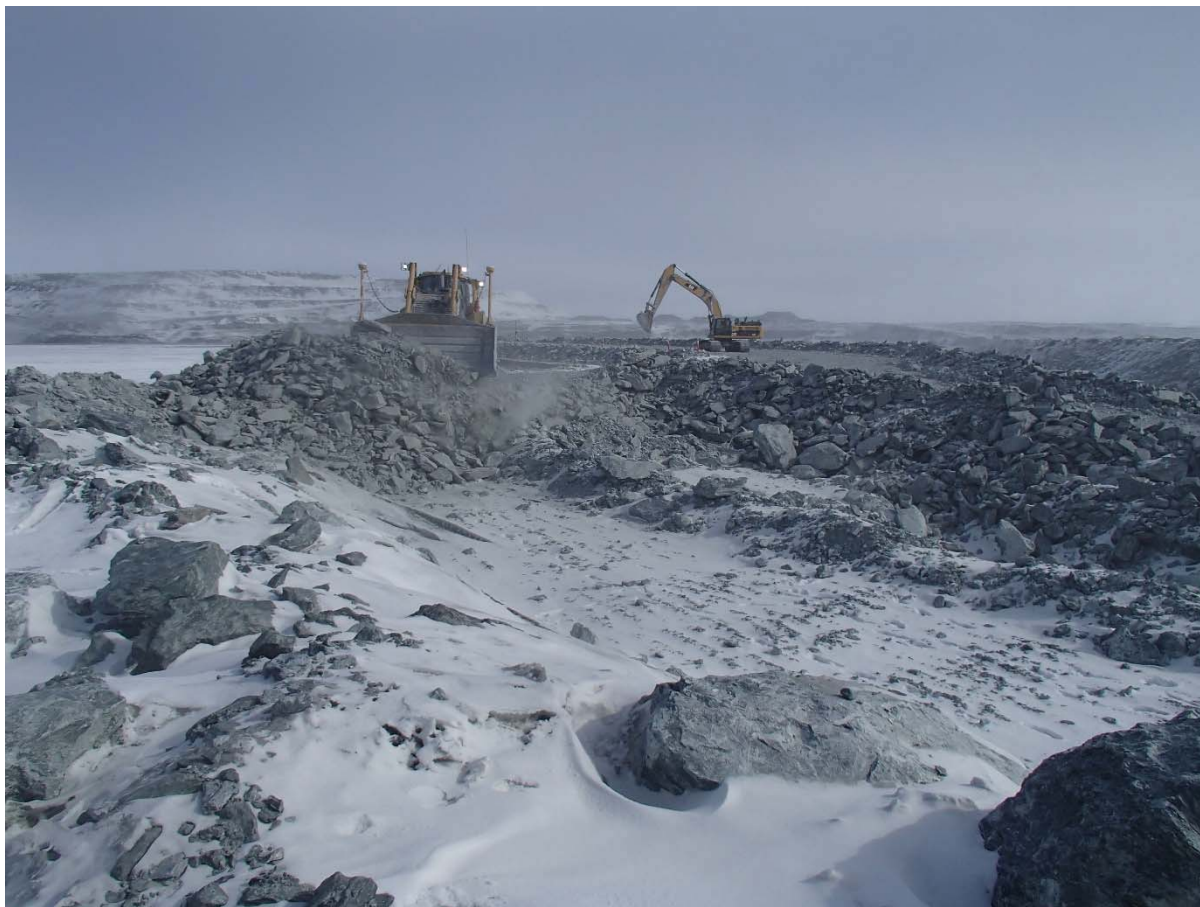
Photograph CD-1823: From Sta. 0+175/+8, looking NE. Compaction of the two 2 m lifts (approx.) of intermediate volcanic (IV) rockfill at El. 143 and at El. 145 m with a 10-tonne smooth-drum compactor with vibration (6 passes) from Sta. 40+720 m to 40+750 m (o.s. -10 to +10 m).

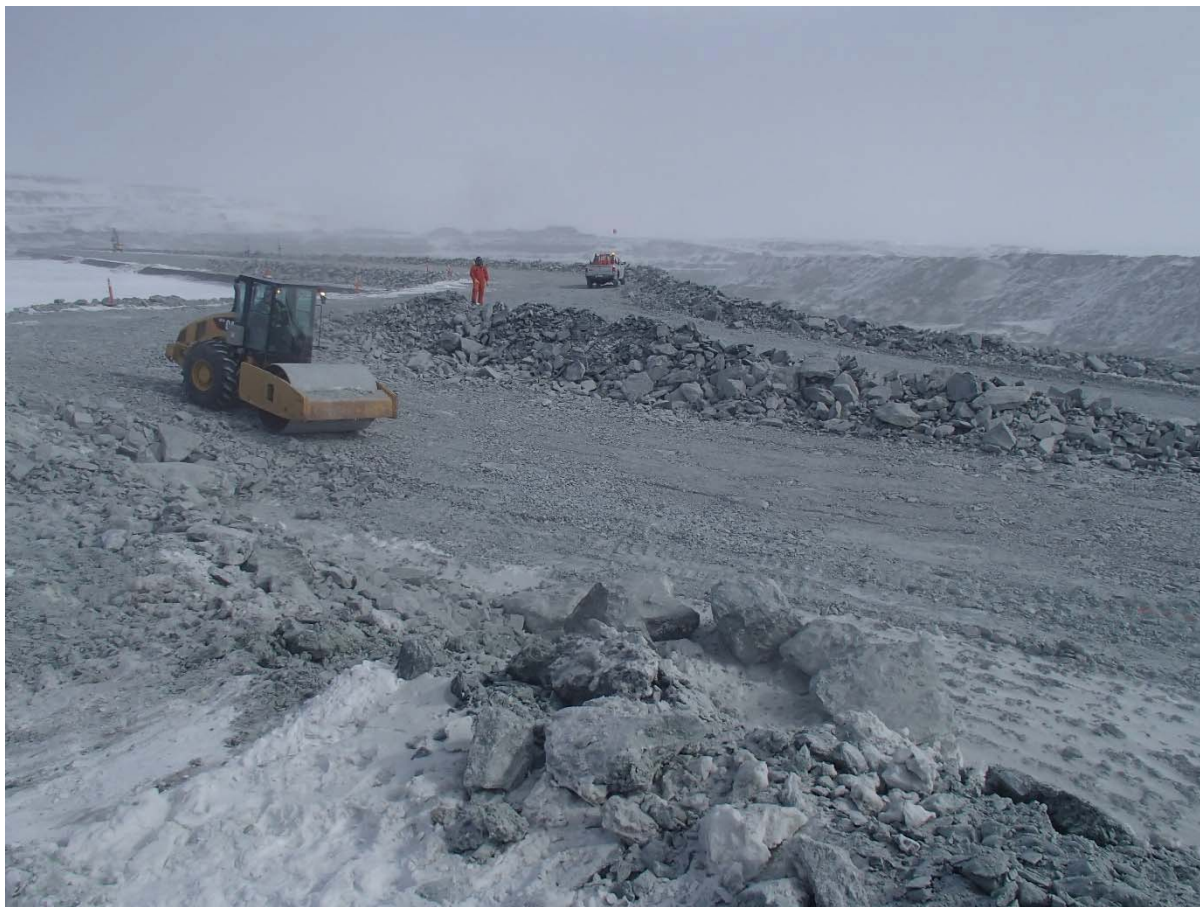
Photograph CD-1824: From Sta 40+760/-25 m, looking NE. Profiling of the upstream slope (2H:1V) from El. 143 to 145 m with an excavator between Sta. 0+830 m and 40+730 m.

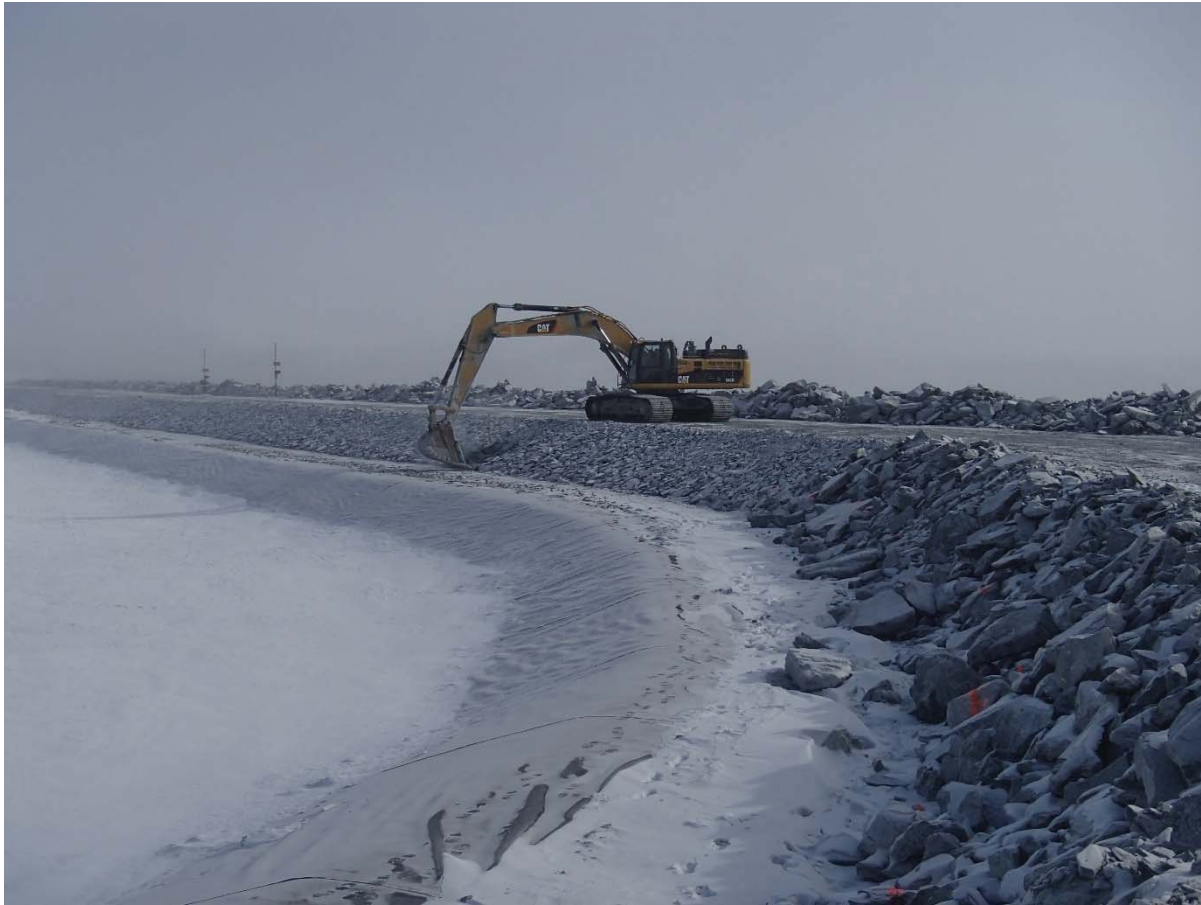
Photograph CD-1825: From Sta 0+430/+9 m, looking S. Profiling of the downstream slope (1.5H:1V) from El. 143 to 145 m with an excavator between Sta. 0+330 m and 0+440 m and between Sta. 0+530 m and 0+745 m.

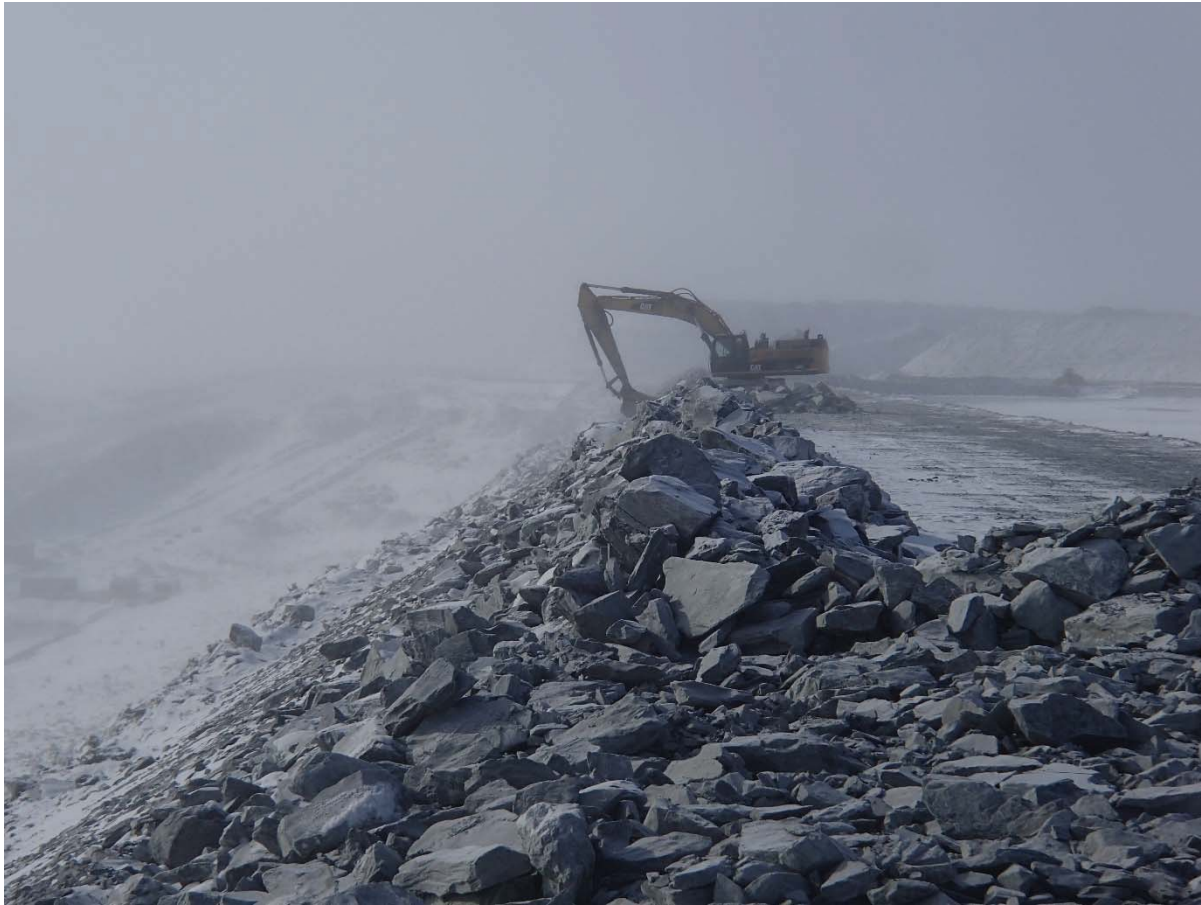
Photograph CD-1826: From Sta 40+770/-27 m, looking NE. Placement of a 0.5 m thick lift of coarse filter from El. 143 m to 143.5 m with an excavator from Sta. 40+730 m to 0+ 775 m.

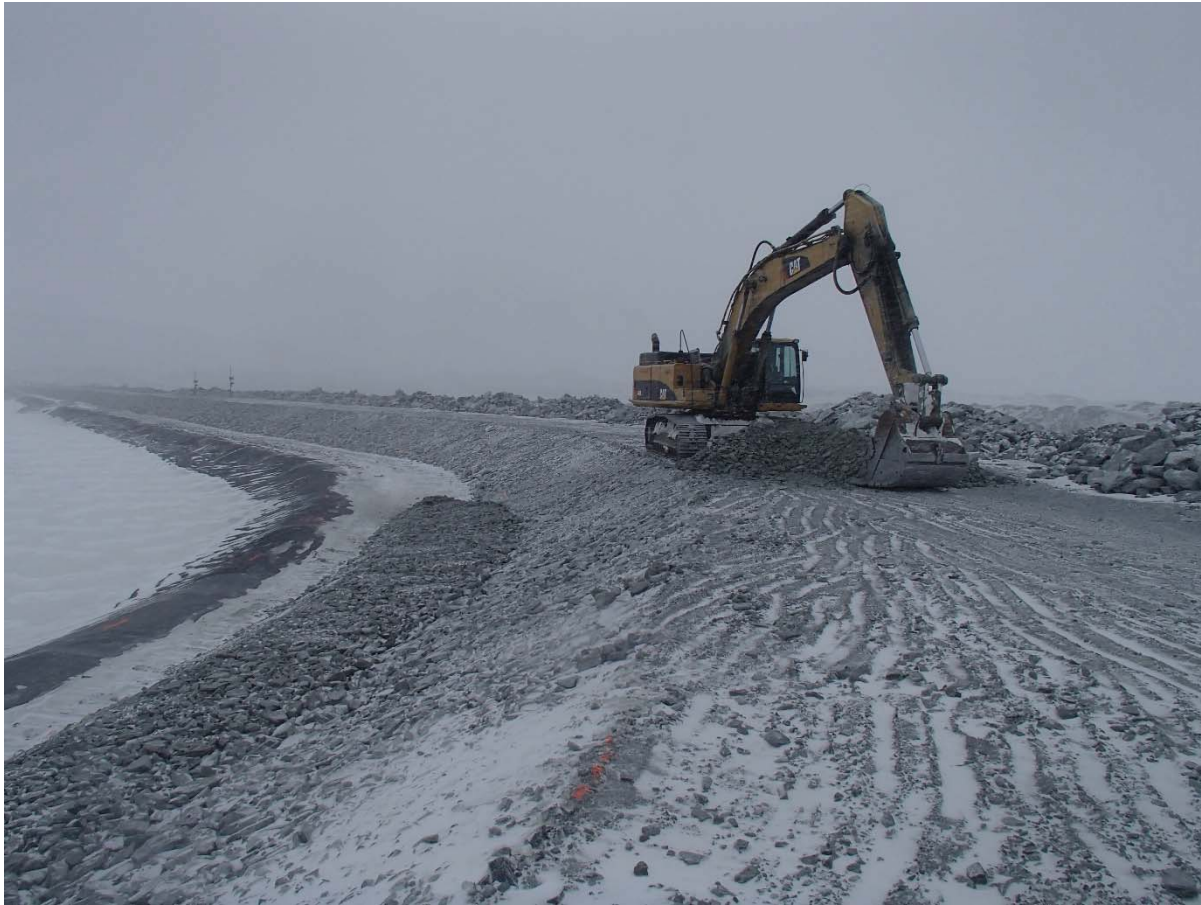
Photograph CD-1827: From Sta 0+940/-16 m, looking SW. Placement of a 0.5 m thick lift of fine filter from El. 143 m to 143.5 m with an excavator from Sta. 40+730 m to 0+ 835 m.

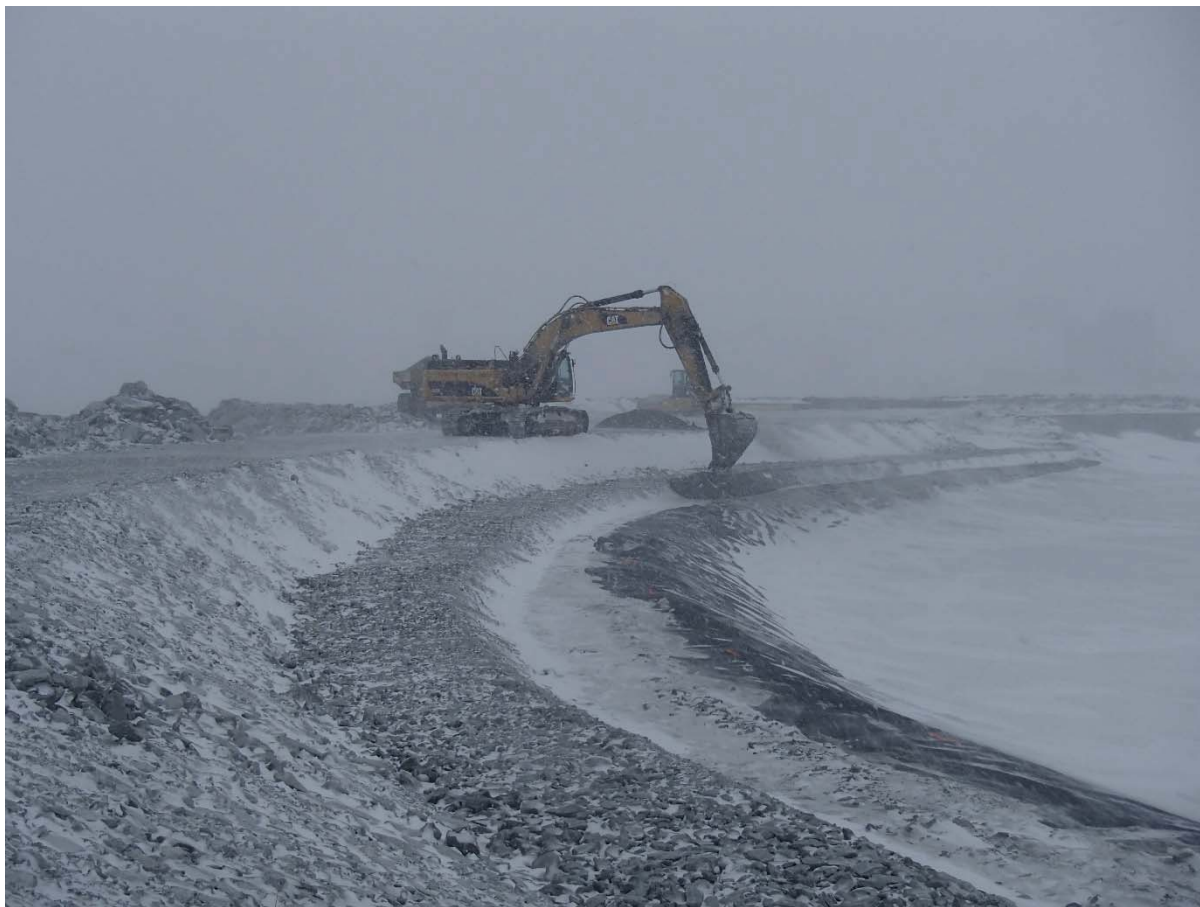
Photograph CD-1828: From Sta 0+410/-22 m, looking N. Defrosting of the deposition finger materials with two Frost Fighters at Sta. 0+390 m.

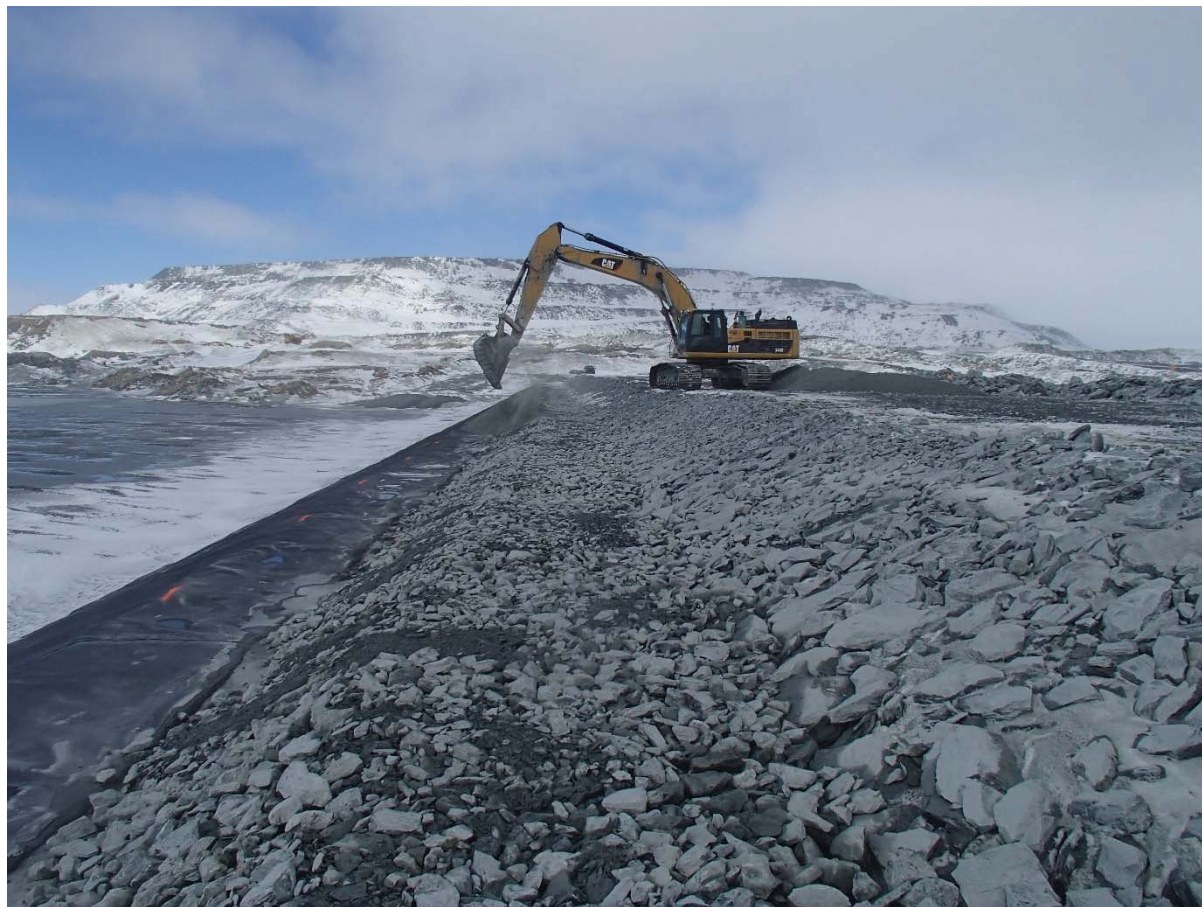
Photograph CD-1829: From Sta 0+410/-22 m, looking N. Placement of a 0.5 m thick lift of coarse filter from El. 143 m to 143.5 m with an excavator from Sta. 0+170 m to 0+460 m and placement of a 0.5 m thick lift of fine filter from Sta. 0+170 m to 0+380 m.

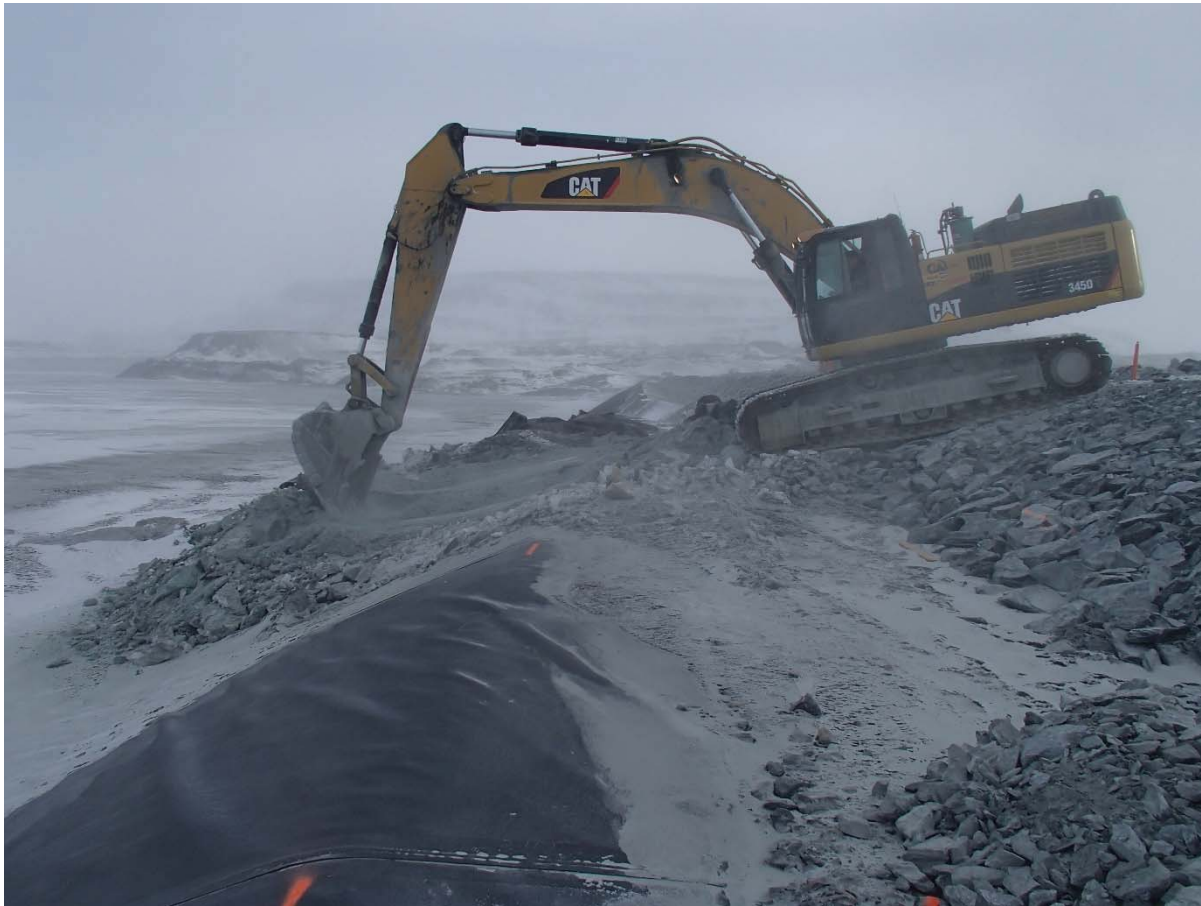
- Punctures were noticed on the top of the LLDPE liner around the four deposition fingers which were removed with the excavator. The holes all seem to be located above El. 142 m, where the horizontal extrusion weld for the raise of the liner is planned to be done. An inspection to assess the damages to the LLDPE liner on the upstream slope of Central Dike will be performed by the QA Manager.

Photograph CD-1830: From Sta. 0+420/-26 m, looking N. Removal of the deposition point finger materials with an excavator at Sta. 0+390 m.

- Evaluate the LLDPE liner damages on the upstream slope of Central Dike.
- Inspect the LLDPE rolls stored on trailers outside once the snow has melted.
- Make a decision regarding the design changes to apply to the SD3 LLDPE liner protection cover.

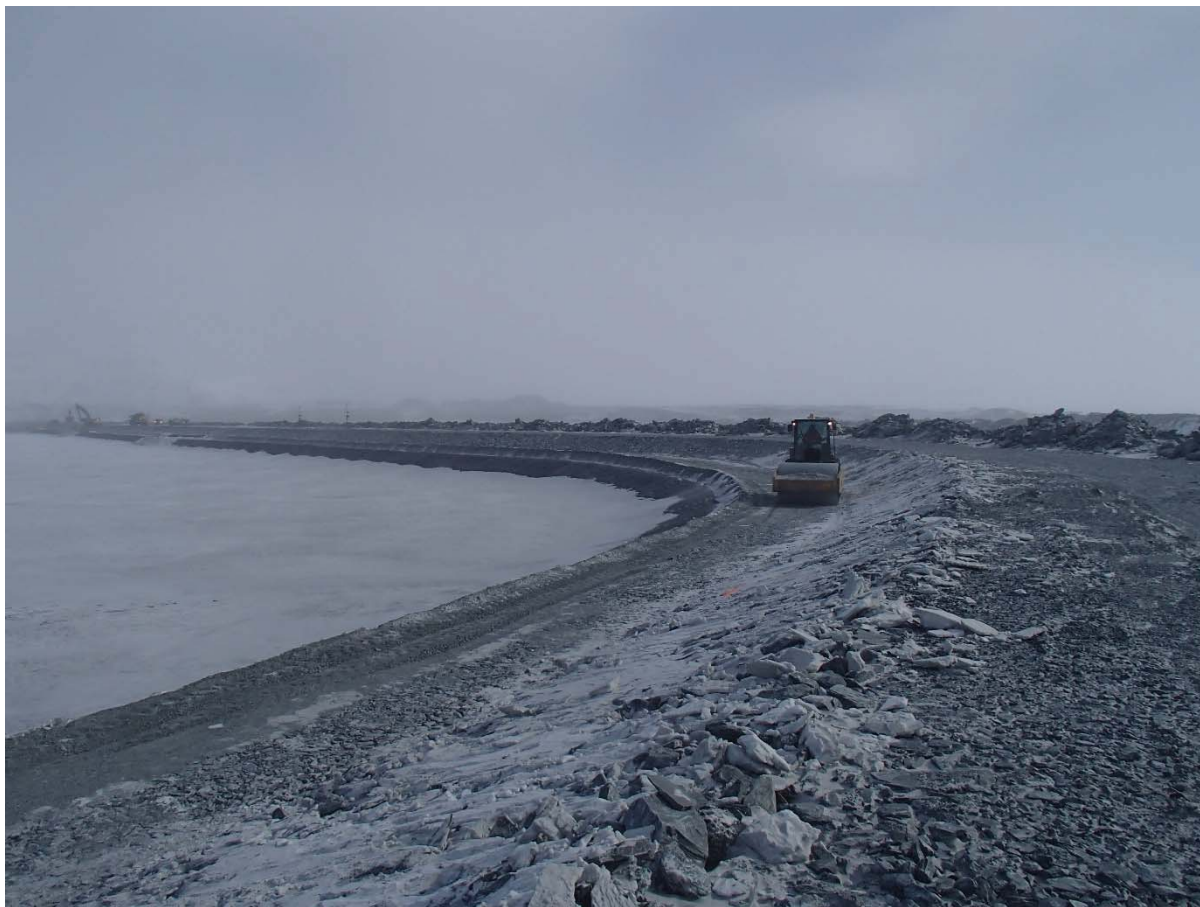
- Six passes of compactor were needed for the compaction of the first lift of coarse and fine filters at El. 143.5 m on Central Dike to achieve the maximum compaction (assessed visually). No watering of the filter materials was possible as water would have frozen inside the lift. The compaction was followed closely by the QC and QA personnel. Compaction of the filters is not optimal. However, the placed filter materials are not expected to settle significantly and will provide a good foundation for the geosynthetics.

Photograph CD-1831: From Sta. 40+730/-24 m, looking NE. Compaction of the first 0.5 m lift (approx.) of fine and coarse filters material at El. 143.5 m with a 10-tonne smooth-drum compactor with vibration (6 passes) from Sta. 40+730 m to 0+830 m and from Sta. 0+175 m to 0+490 m.

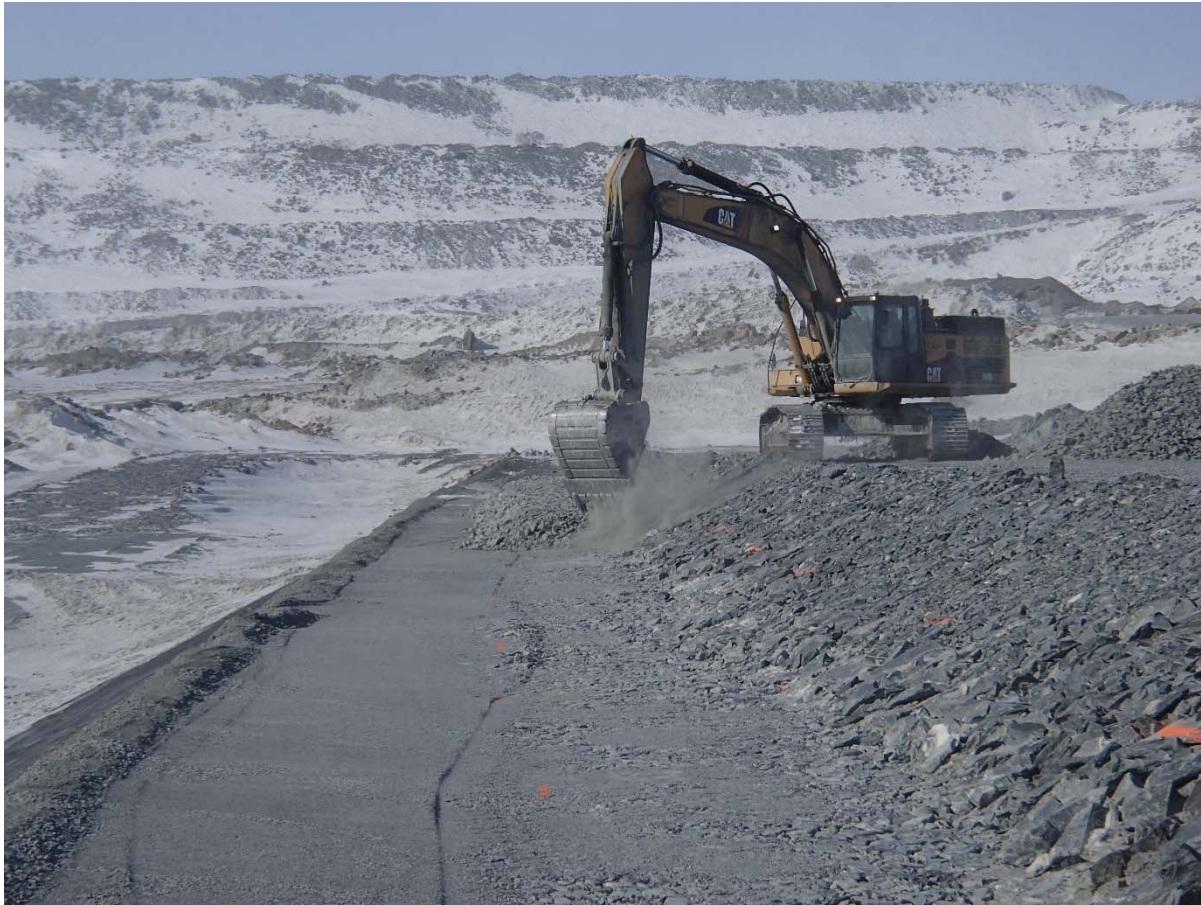
Photograph CD-1832: From Sta. 0+280/-25 m, looking N. Placement of a second 0.5 m thick lift of coarse filter from El. 143.5 m to 144 m with an excavator from Sta. 0+175 m to 0+280 m.

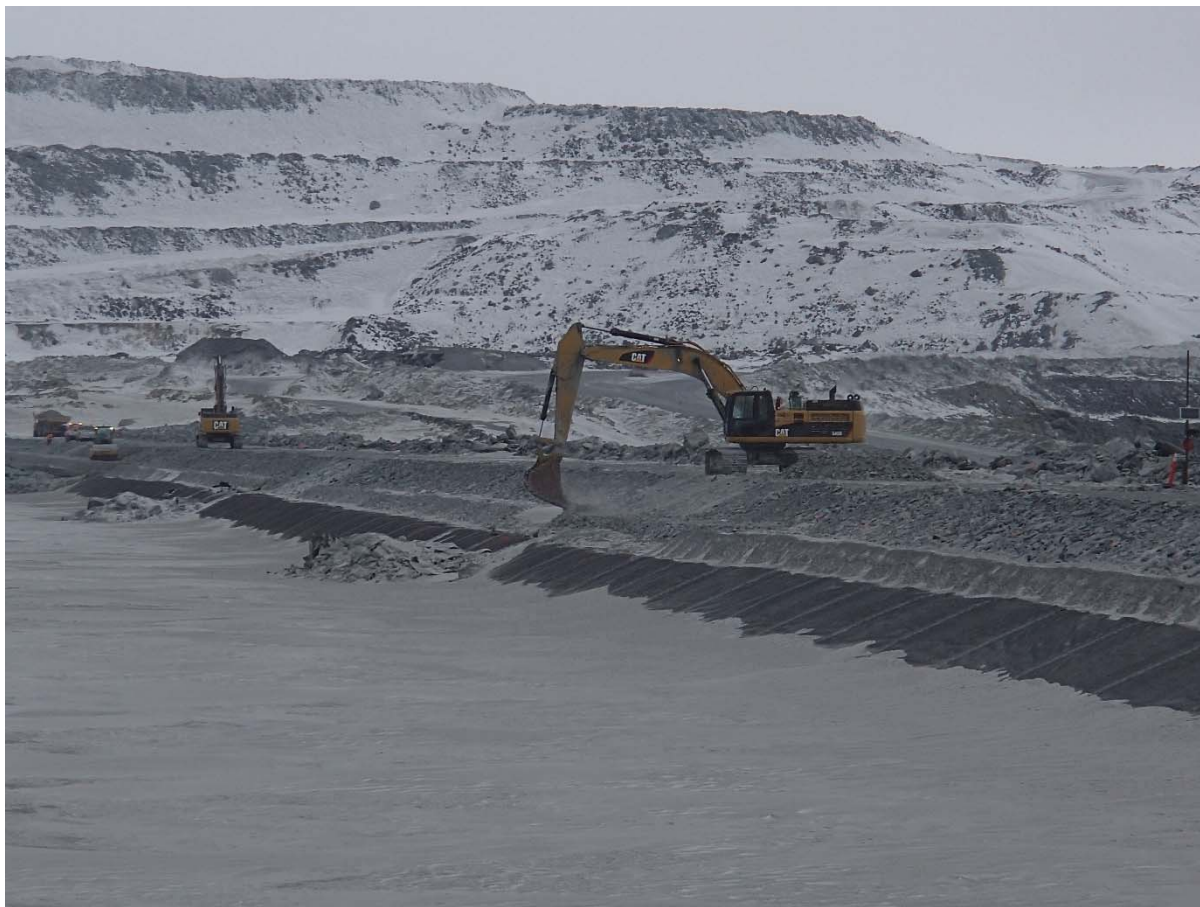
Photograph CD-1834: From Sta. 40+760/-23 m, looking NE. Placement of a first 0.5 m thick lift of coarse filter from El. 143 m to 143.5 m on length of approx. 5 m with an excavator at the location of the deposition finger at Sta. 0+520 m and 0+660 m.

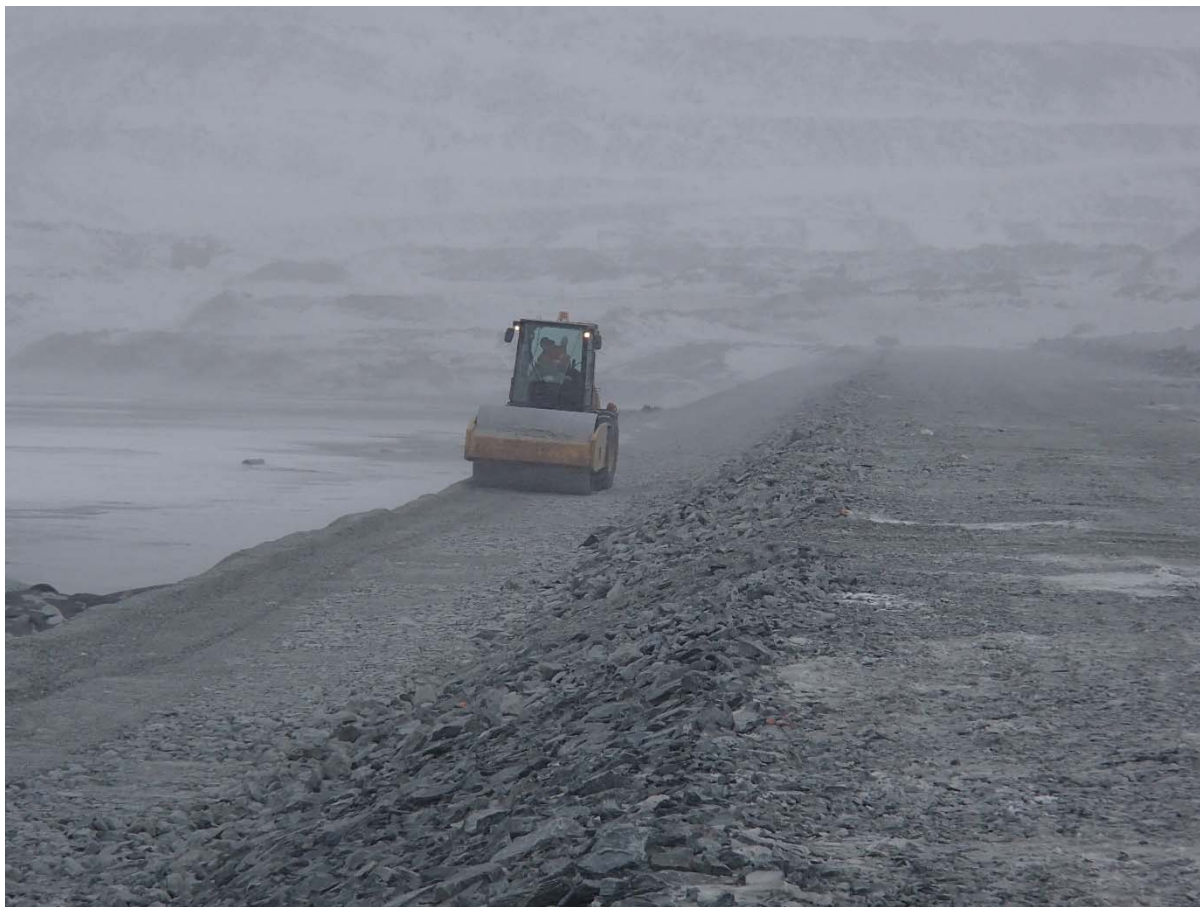
Photograph CD-1835: From Sta. 0+830/-20 m, looking N. Compaction of the first 0.5 m lift (approx.) of fine and coarse filters material at El. 143.5 m with a 10-tonne smooth-drum compactor with vibration (6 passes) from Sta. 0+490 to 0+835 m.

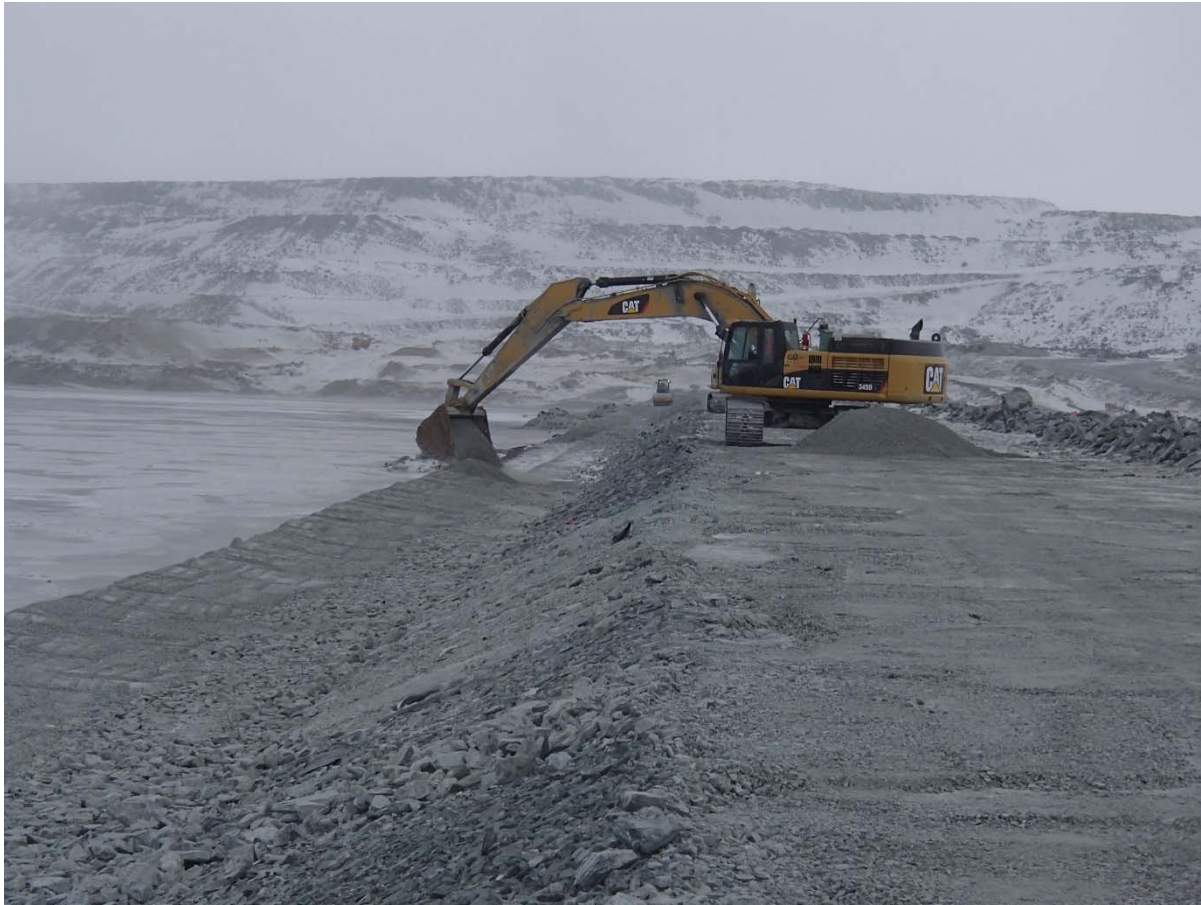
Photograph CD-1836: From Sta. 0+830/-20 m, looking N. Placement of a first 0.5 m thick lift of fine filter from El. 143 m to 143.5 m upstream of the coarse filter with an excavator from Sta. 0+490 to 0+835 m.

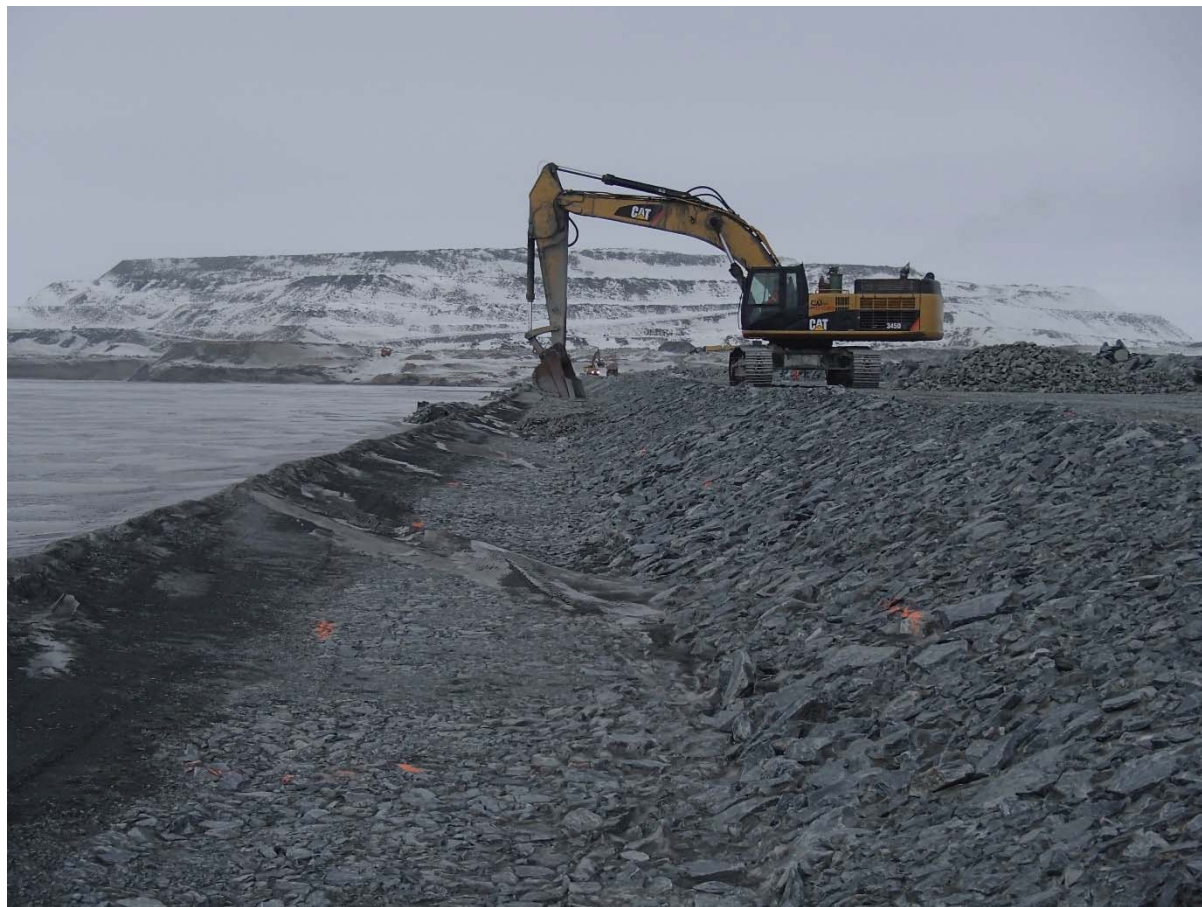
Photograph CD-1837: From Sta. 0+940/-25 m, looking N. Placement of a second 0.5 m thick lift of coarse filter from El. 143.5 m to 144 m with an excavator from Sta. 0+290 to 0+500 m and from Sta. 0+835 to 0+930 m.

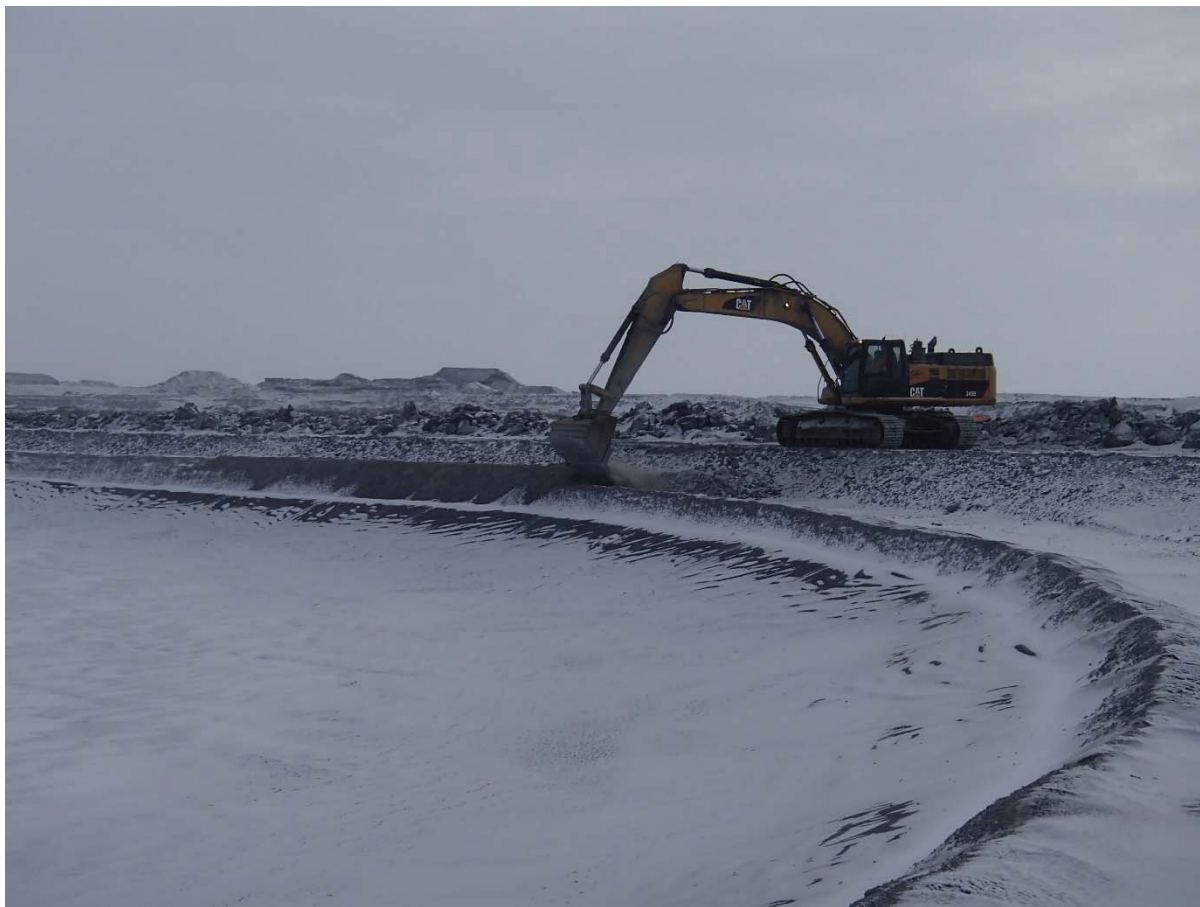
Photograph CD-1838: From Sta. 40+750/-31 m, looking NE. Placement of a second 0.5 m thick lift of fine filter from El. 143.5 m to 144 m upstream of the coarse filter with an excavator from Sta. 0+500 m to 0+835 m and from Sta. 0+930 to 40+730 m.
