Meadowbank and Whale Tail 2022 Annual Geotechnical Inspection

REPORT**2022 Annual Geotechnical Inspection***Meadowbank Complex, Nunavut*

1617-2146800622-5000-RA-Rev0

16 December 2022

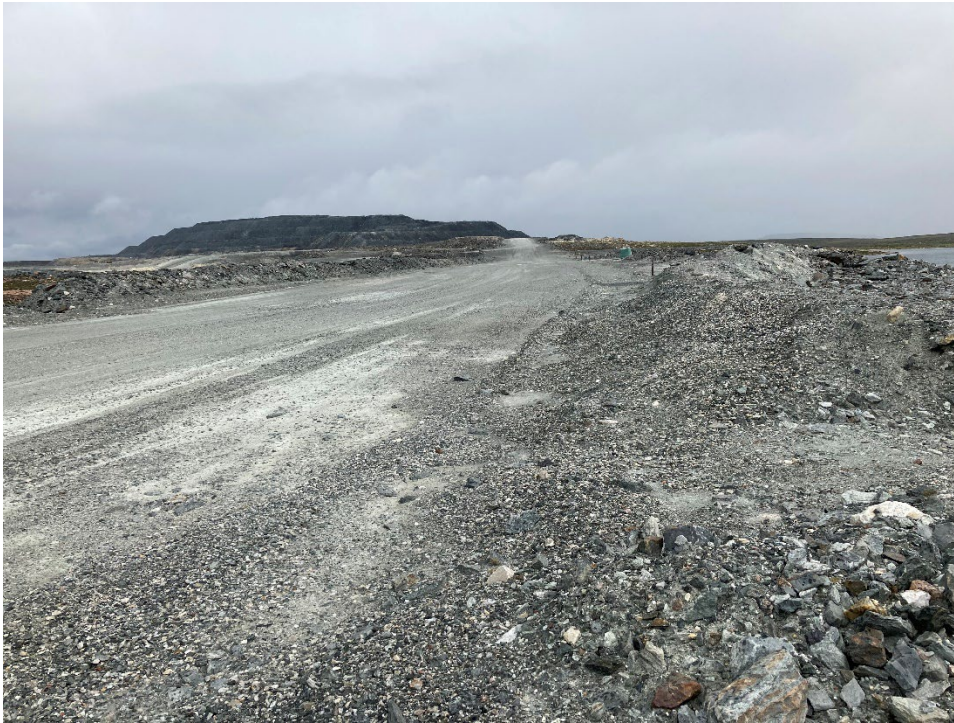
Photograph A1-1 East Dike

Description: From approximately Sta. 60+500, looking north at the crest.

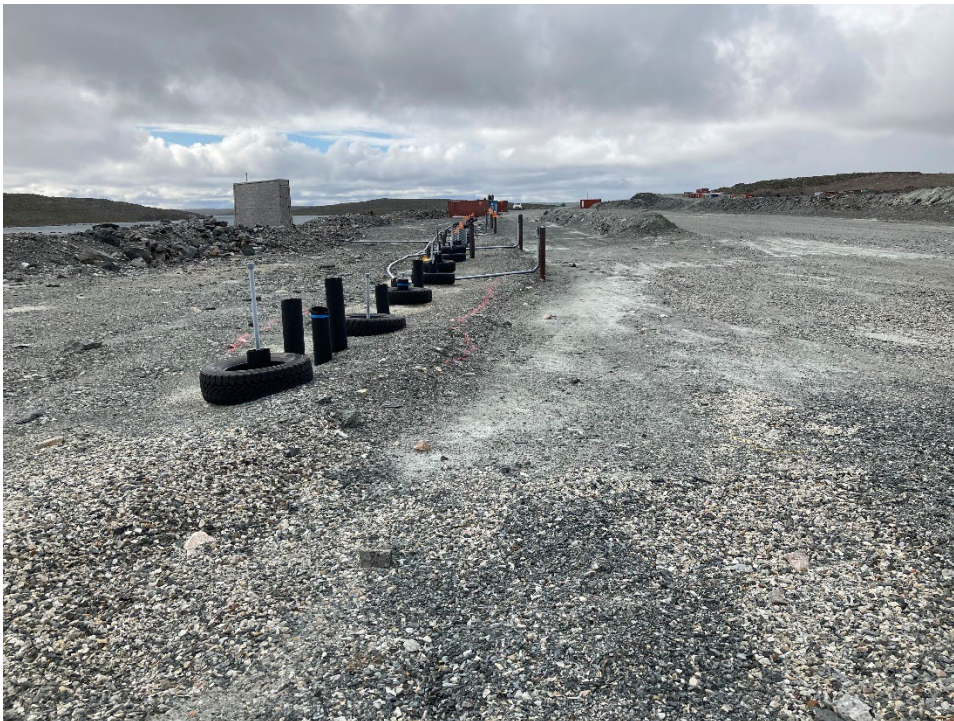
Photograph A1-2 East Dike

Description: From approximately Sta. 60+500, looking south at the crest.

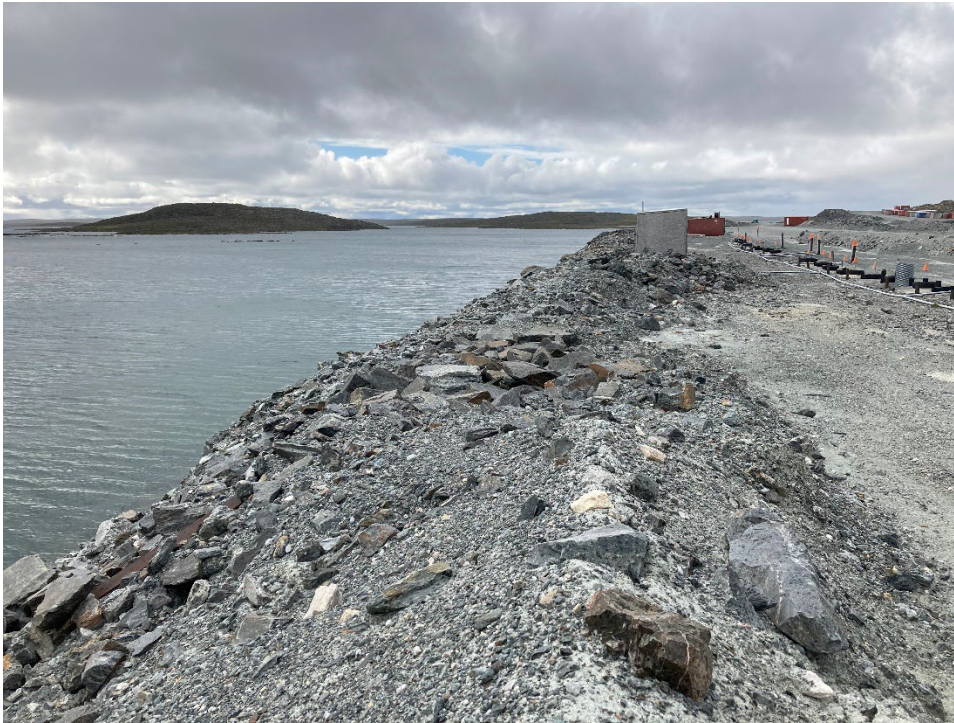
Photograph A1-3 East Dike

Description: From approximately Sta. 60+500 upstream, looking south at the crest.

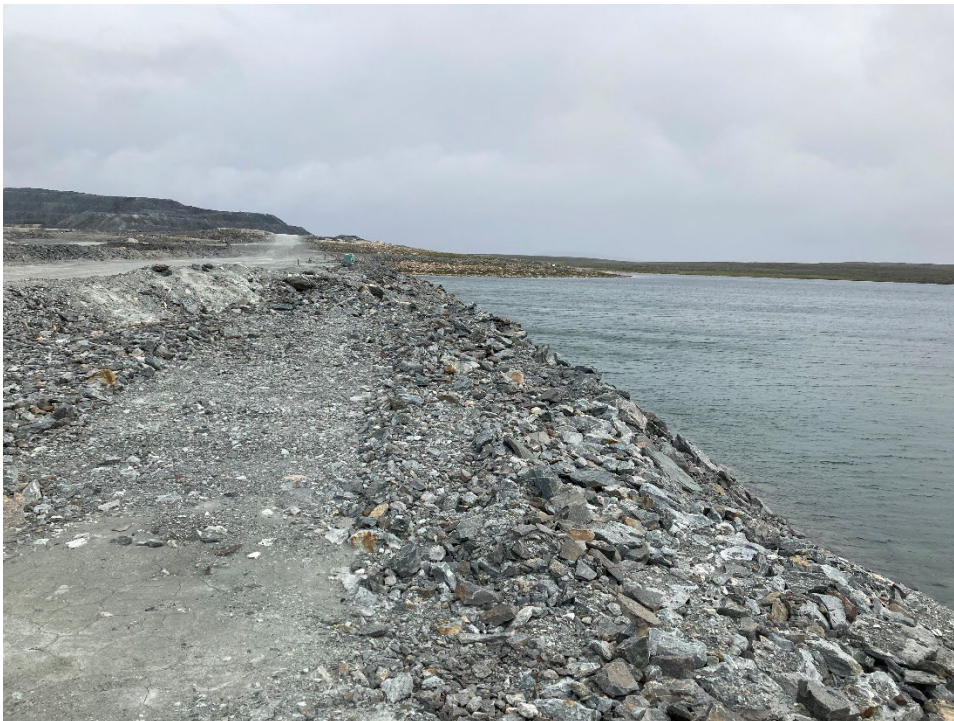
Photograph A1-4 East Dike

Description: From approximately Sta. 60+500 upstream, looking north at the crest.

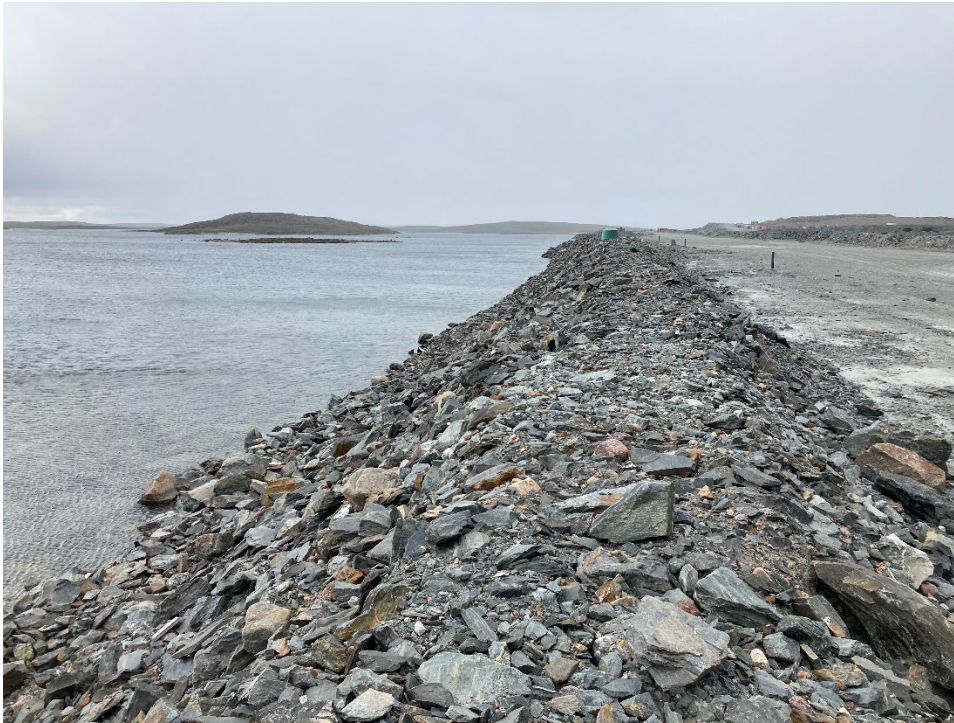
Photograph A1-5 East Di

Description: From approximately Sta. 60+810, looking south at the crest and upstream slope.

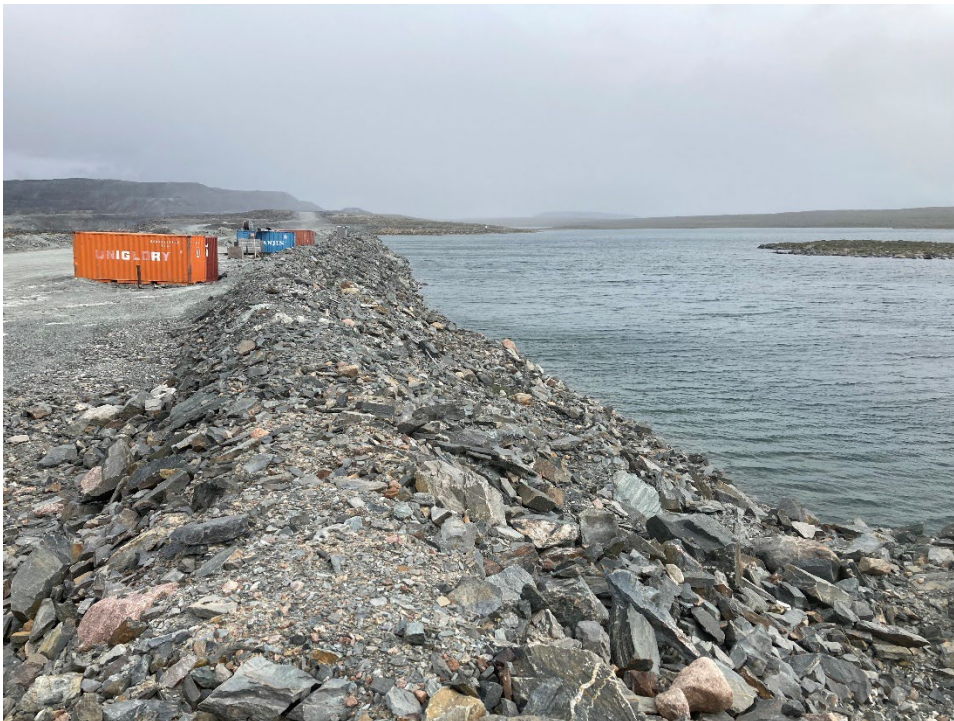
Photograph A1-6 East Di

Description: From Sta. 60+300 upstream, looking north at the crest and upstream slope.

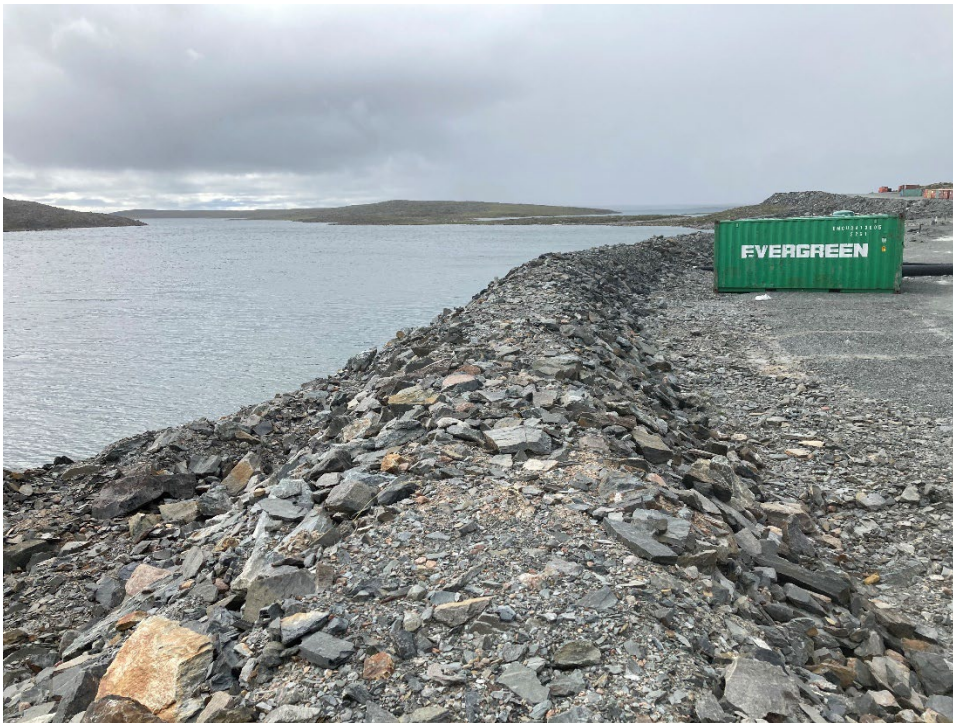
Photograph A1-7 East Dike

Description: From approximately Sta. 60+250 upstream, looking south at the upstream slope.

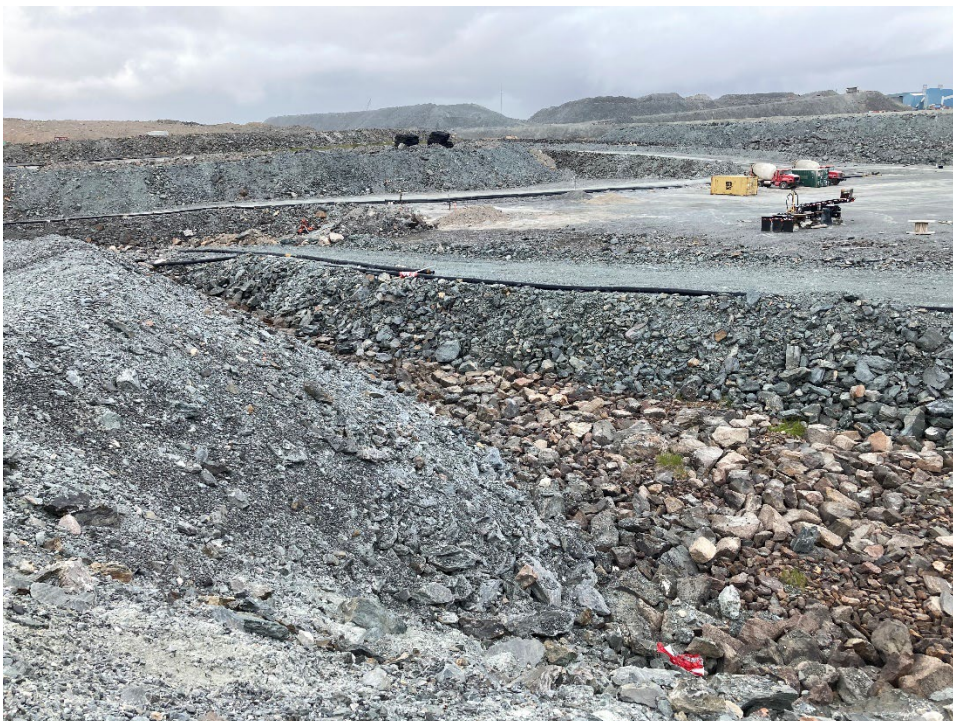
Photograph A1-8 East Dike

Description: From approximately Sta. 60+250, looking west at the downstream side and toe.

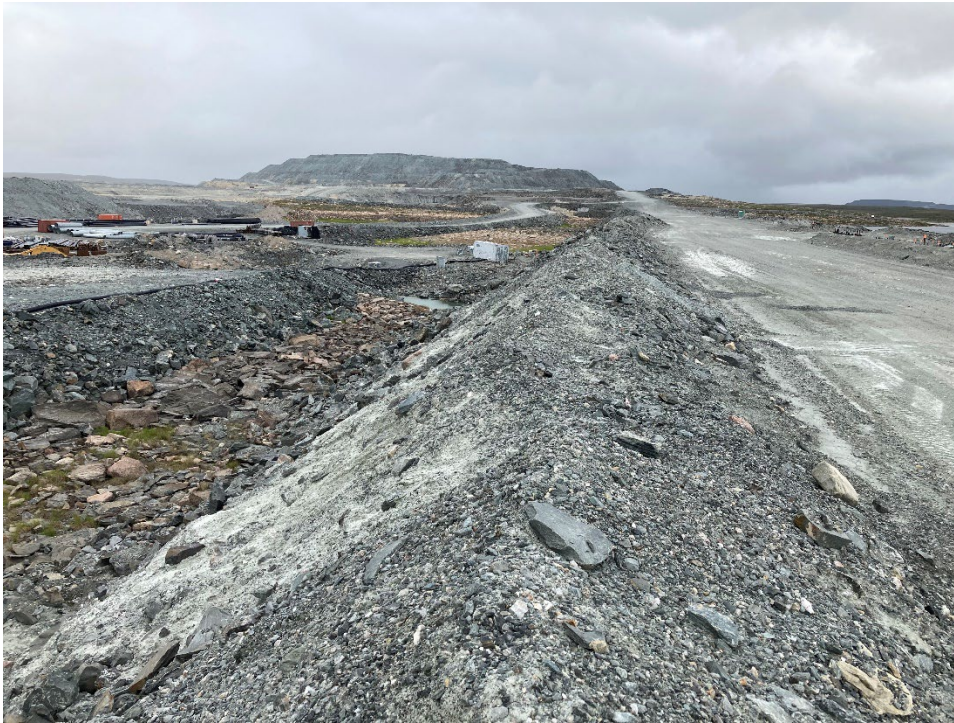
Photograph A1-9 East Dike

Description: From approximately Sta. 60+300, looking north at the downstream side and toe.

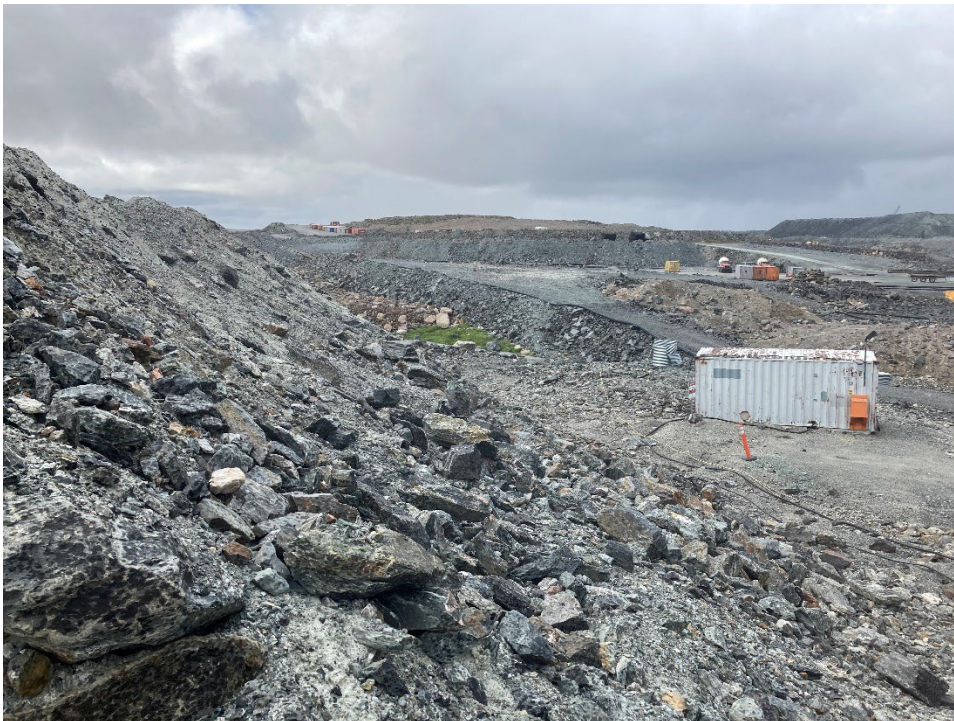
Photograph A1-10 East Dike

Description: From approximately Sta. 60+475, looking south at the downstream toe.

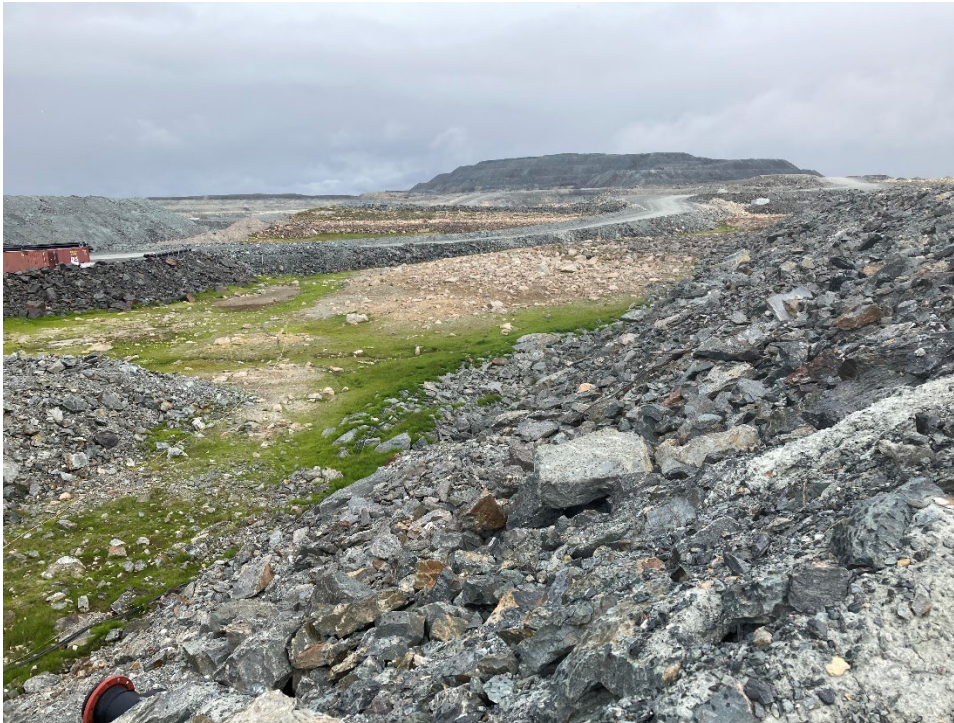
Photograph A1-11 East Dike

Description: From approximately Sta. 60+500, looking north at the downstream toe.

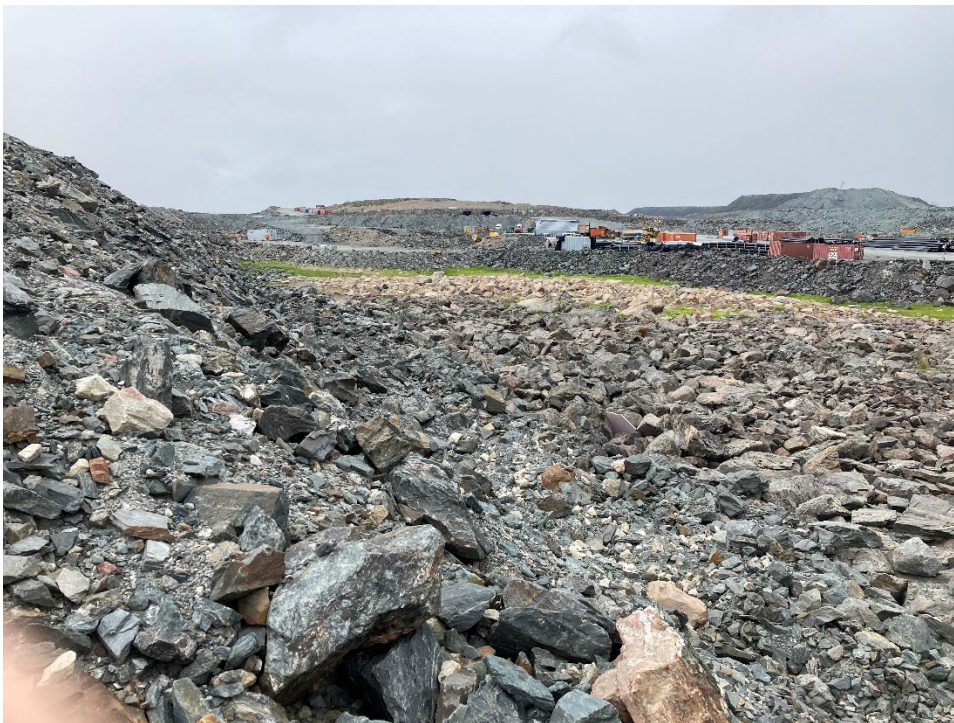
Photograph A1-12 East Dike

Description: From approximately Sta. 60+560, looking south at the downstream toe.

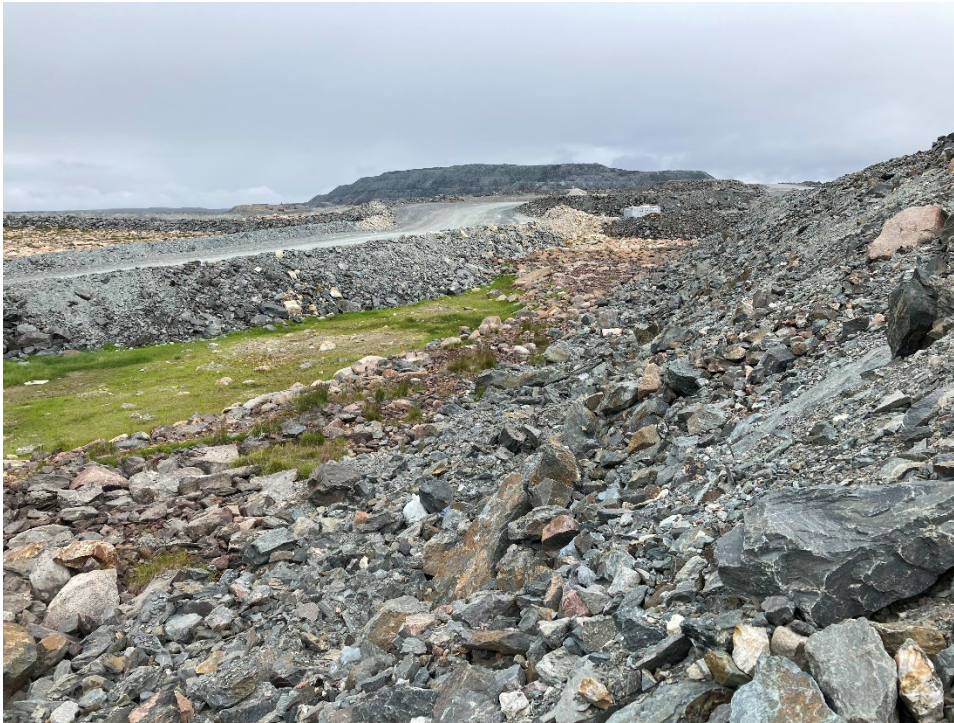
Photograph A1-13 East Dike

Description: From approximately Sta. 60+560, looking north at the downstream slope and toe.

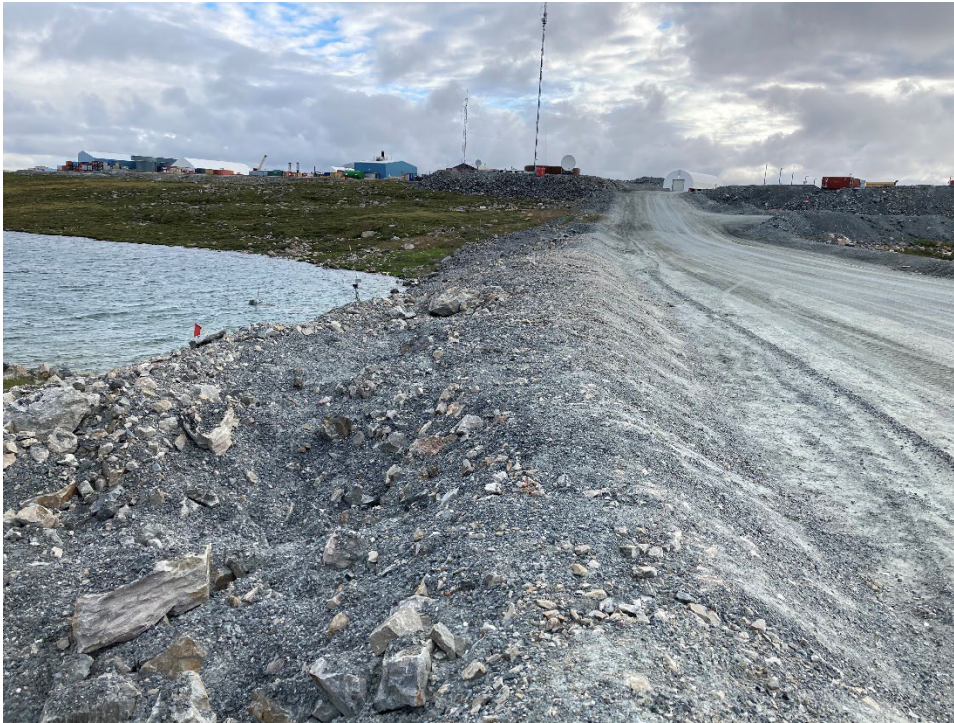
Photograph A2-1 South Camp Dike

Description: From the south abutment, looking north at the upstream slope and the thermistors instrumentation set-up.

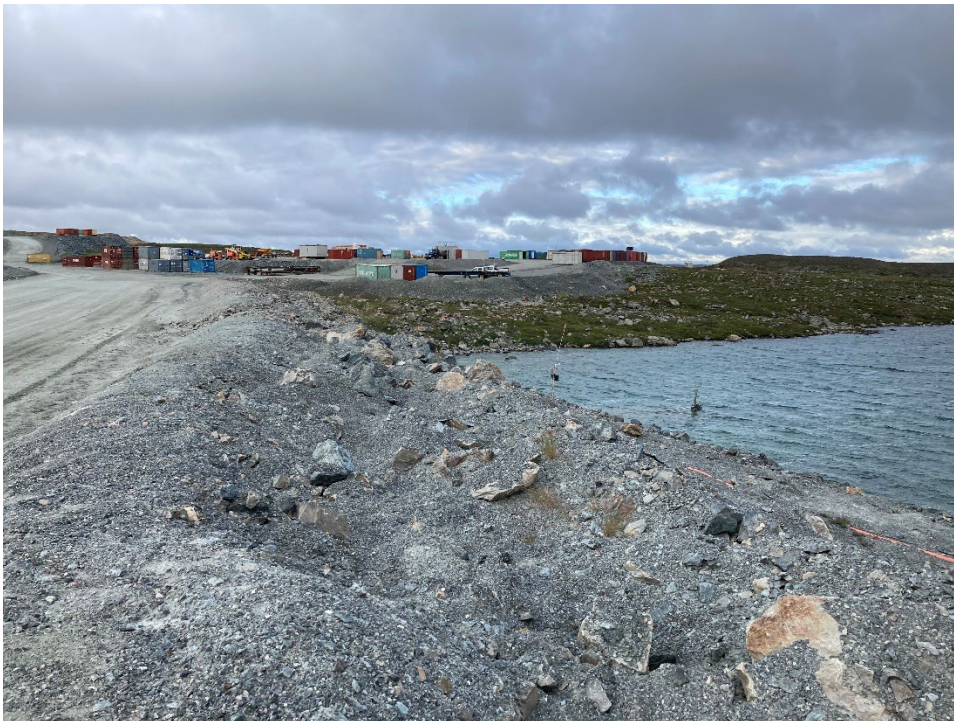
Photograph A2-2 South Camp Dike

Description: From the north abutment, looking south at the upstream slope and thermistors instrumentation set-up.

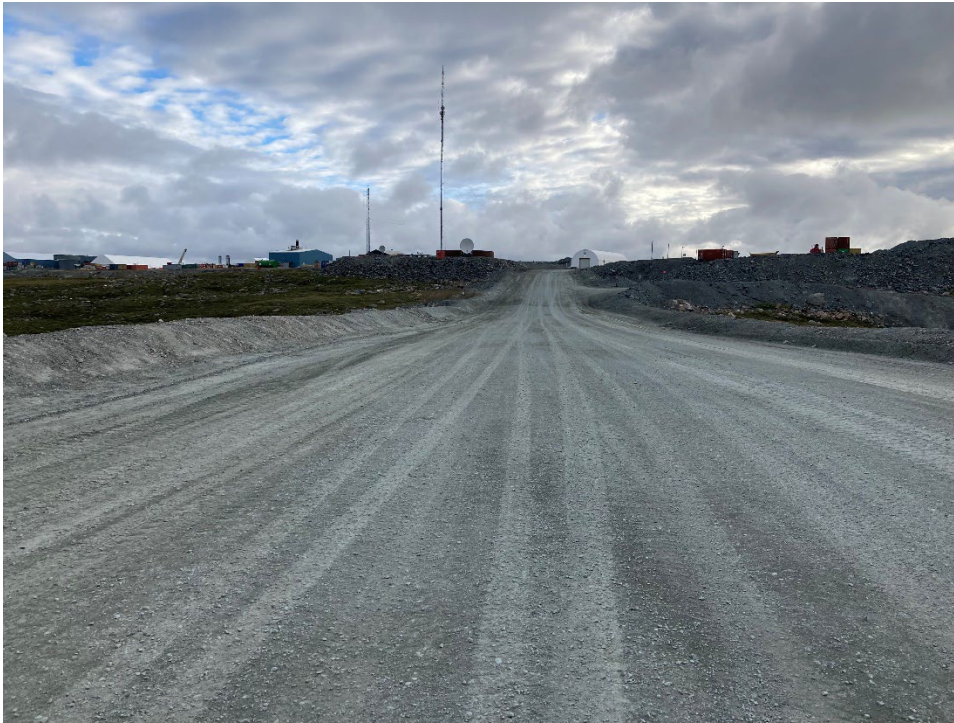
Photograph A2-3 South Camp Dike

Description: From the south abutment, looking north at the crest.

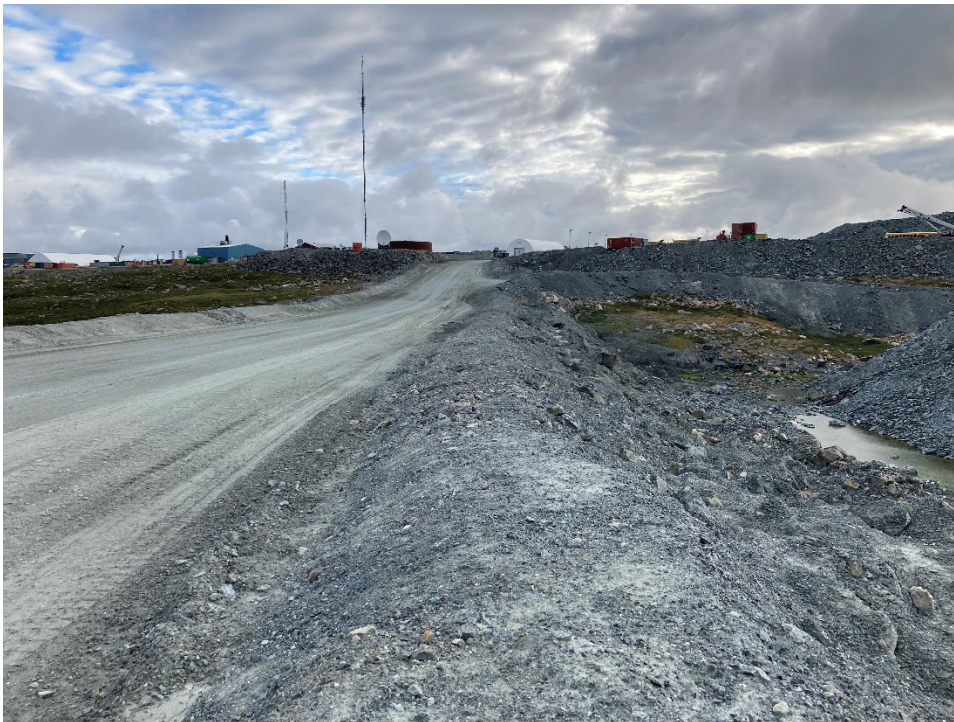
Photograph A2-6 South Camp Dike

Description: From the north abutment, looking south at the downstream slope. There is some water ponding, from run-off.

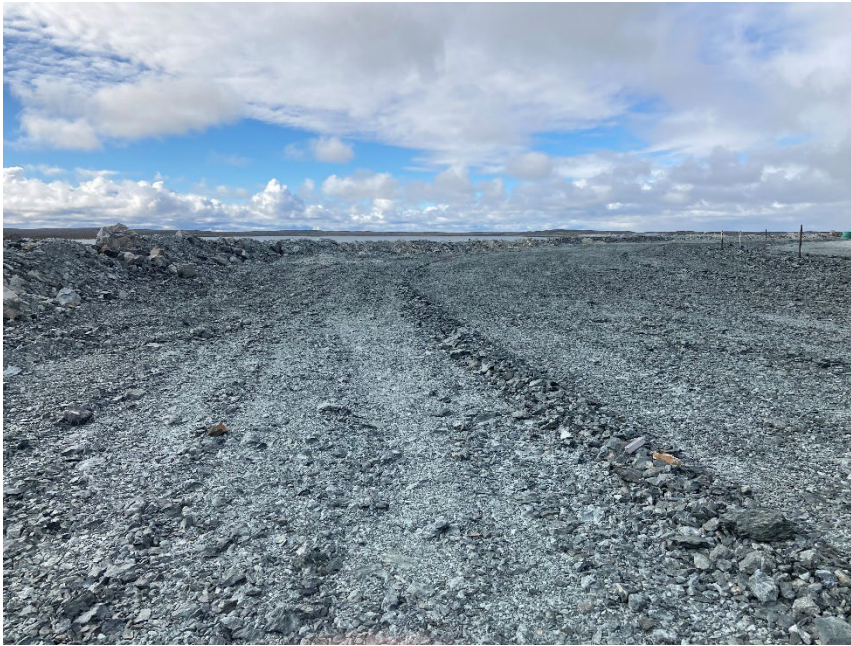
Photograph A3-1 Bay Goose Dike

Description: From approximately Sta. 30+142 (north abutment) looking southwest at the crest and upstream slope.

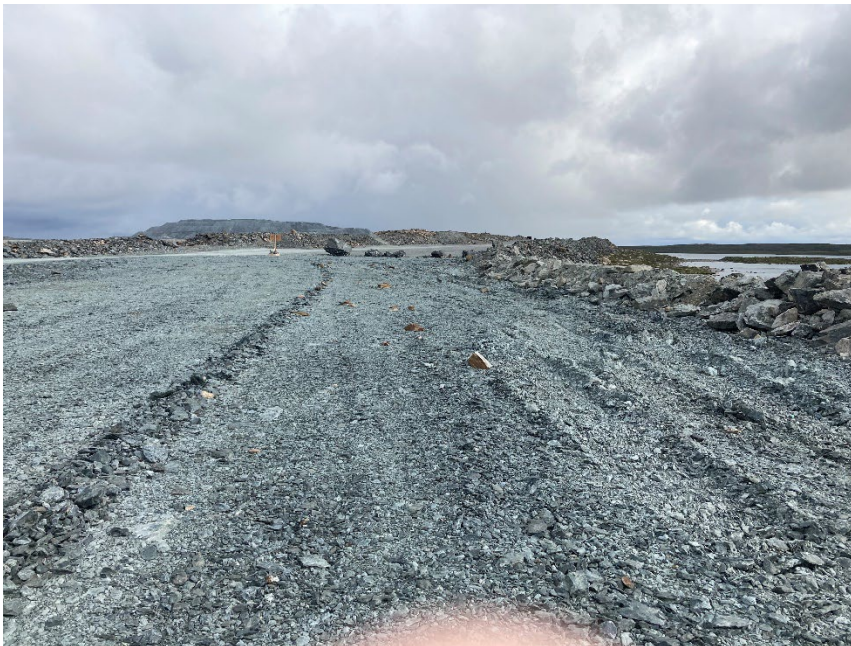
Photograph A3-2 Bay Goose Dike

Description: From approximately Sta. 30+130 (north abutment), looking north at the crest and upstream slope.

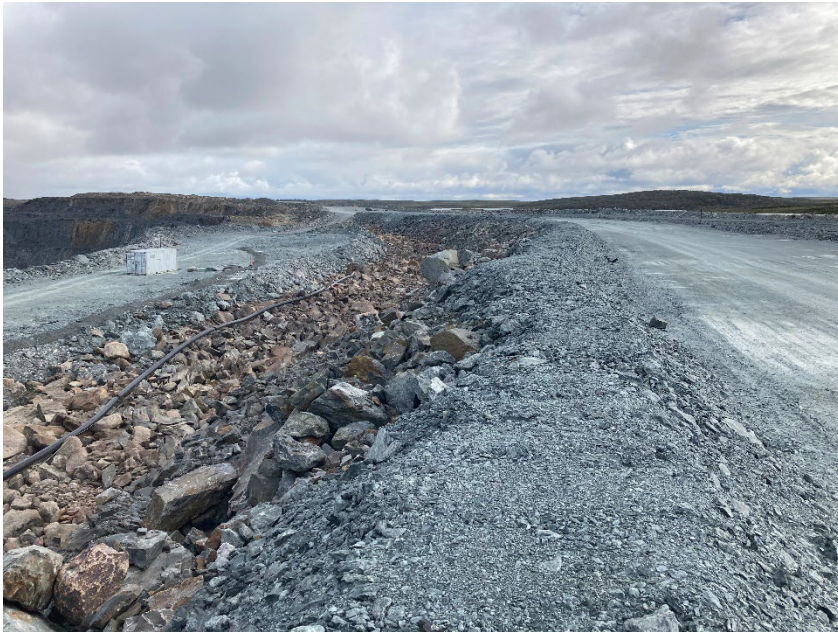
Photograph A3-3 Bay Goose Dike

Description: From approximately Sta. 30+340 on the crest, looking northeast at the dam crest and downstream slope

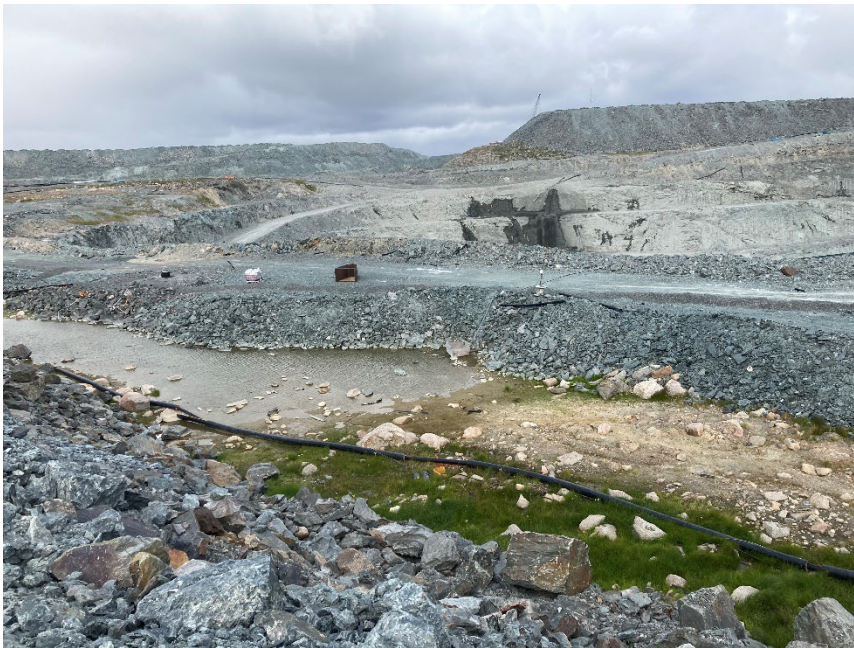
Photograph A3-4 Bay Goose Dike

Description: From approximately Sta. 30+340, looking northwest at the north seepage channel.

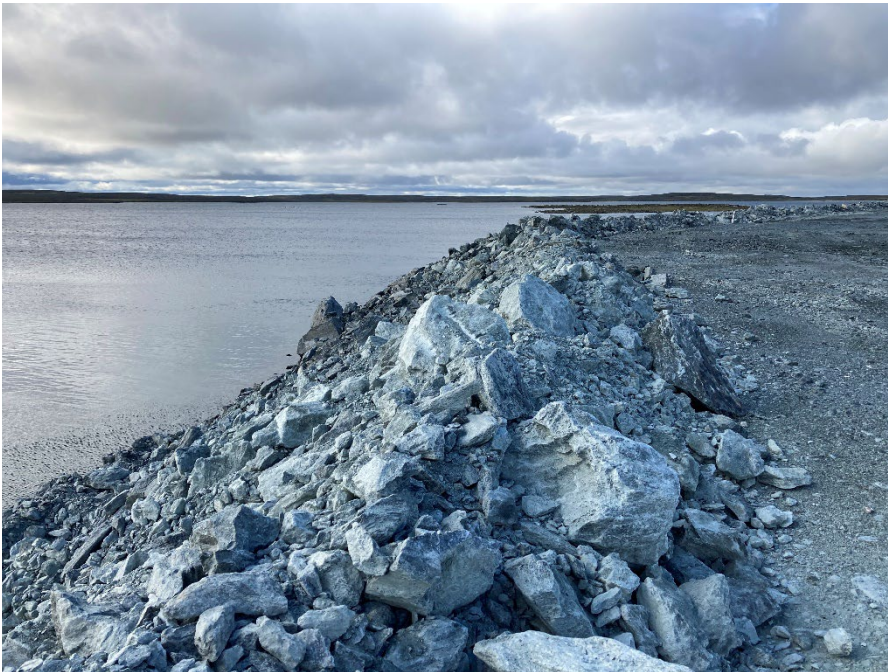
Photograph A3-8 Bay Goose Dike

Description: From approximately Sta. 31+130, looking south at the upstream slope.

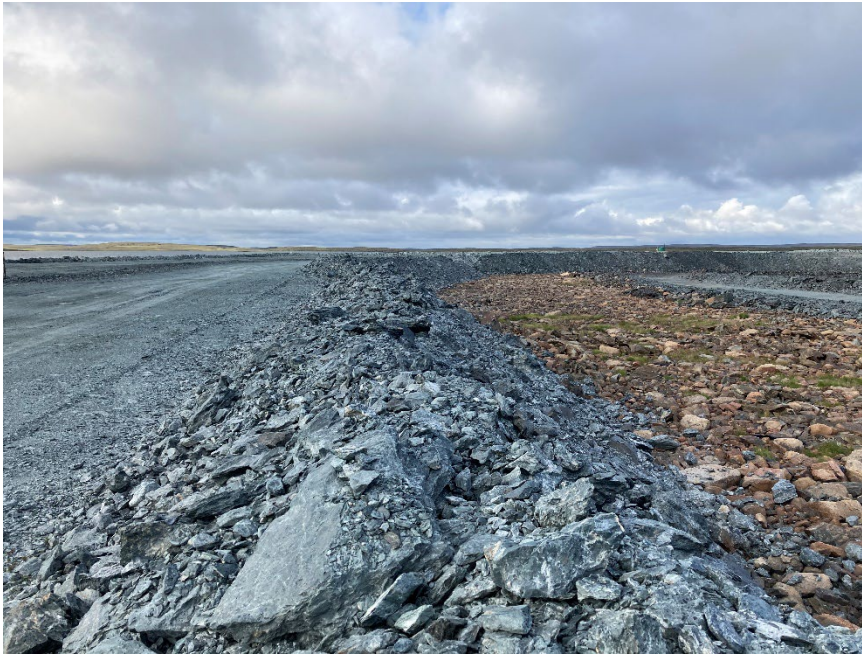
Photograph A3-15 Bay Goose Dike

Description: From approximately Sta. 31+280 on the crest, looking southwest at the downstream slope and the water pond at the downstream toe at Sta. 31+350.

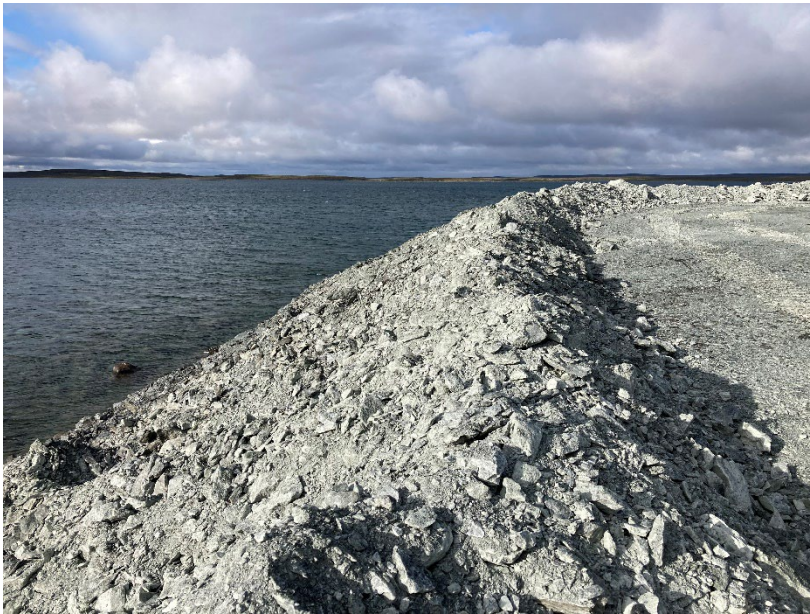
Photograph A3-18 Bay Goose Dike

Description: From approximately Sta. 31+475, looking west at the crest. Old cracks are disappearing.

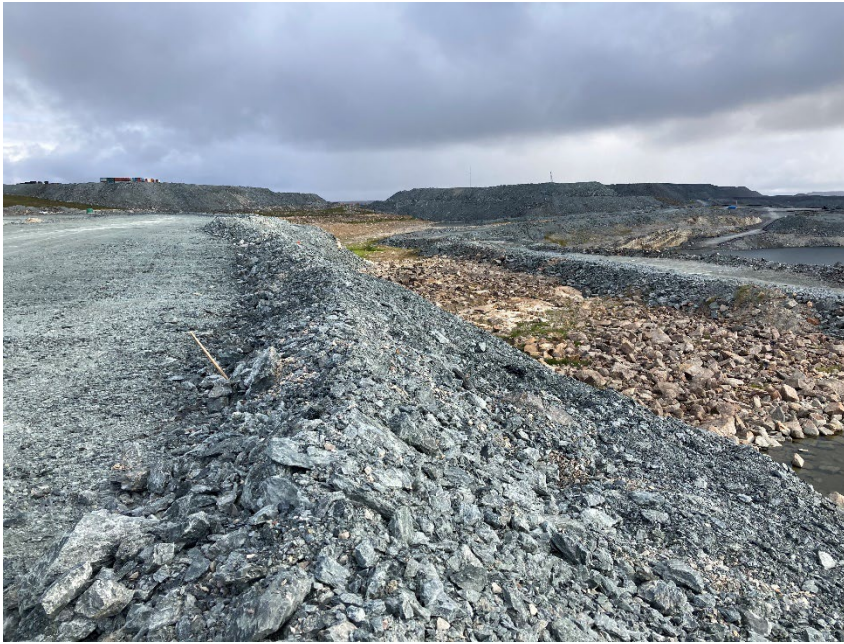
Photograph A3-27 Bay Goose Dike

Description: From the crest at approximately Sta. 31+740, looking north downstream at the water pond at Sta. 31+750.

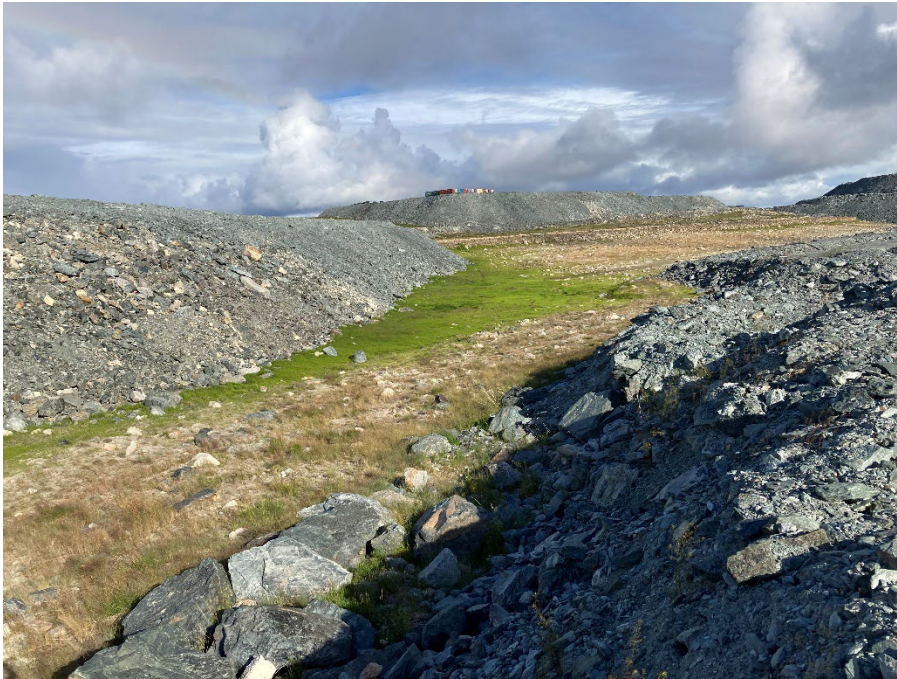
Photograph A3-33 Bay Goose Dike

Description: From about Sta. 31+920, looking northwest at the downstream toe toward Channel 1 monitoring station.

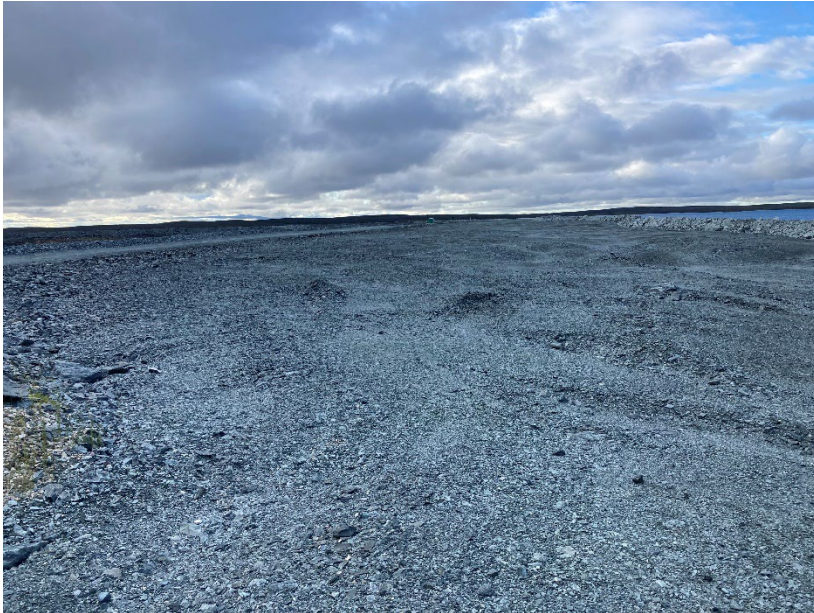
Photograph A3-36 Bay Goose Dike

Description: From approximately Sta. 32+025 (south abutment) looking east at the crest and upstream slope. Zone of high magnitude settlement in the ultramafic cap. The tension cracks seem no longer active.

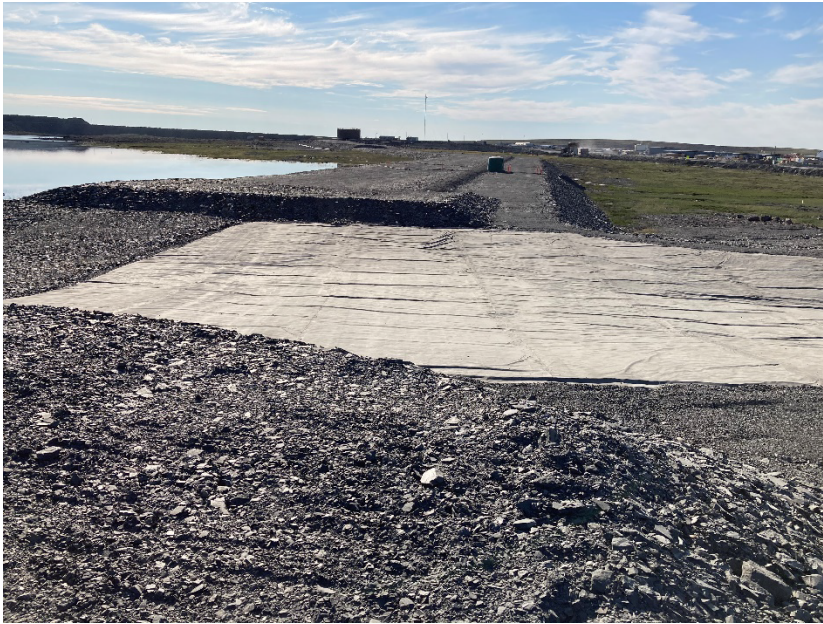
Photograph A6-17 IVR Dike D-1

Description: From approx. Sta. 0+050, looking south at the spillway. Presence of piping at the outlet of the spillway.

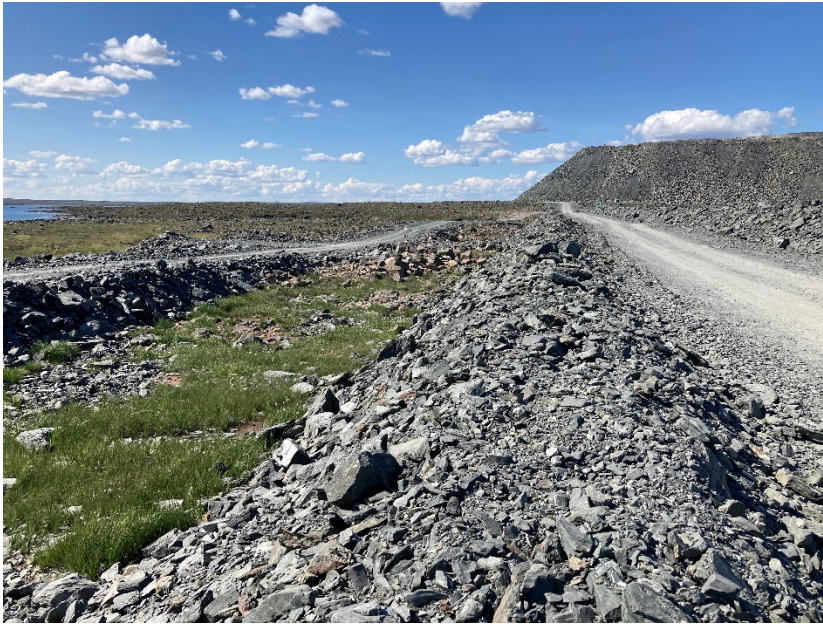
Photograph A7-1 WRSF Dike

Description: From approx. Sta. 0+350 (east abutment), looking west at the dike crest and downstream slope. Presence of water ponding at the toe.

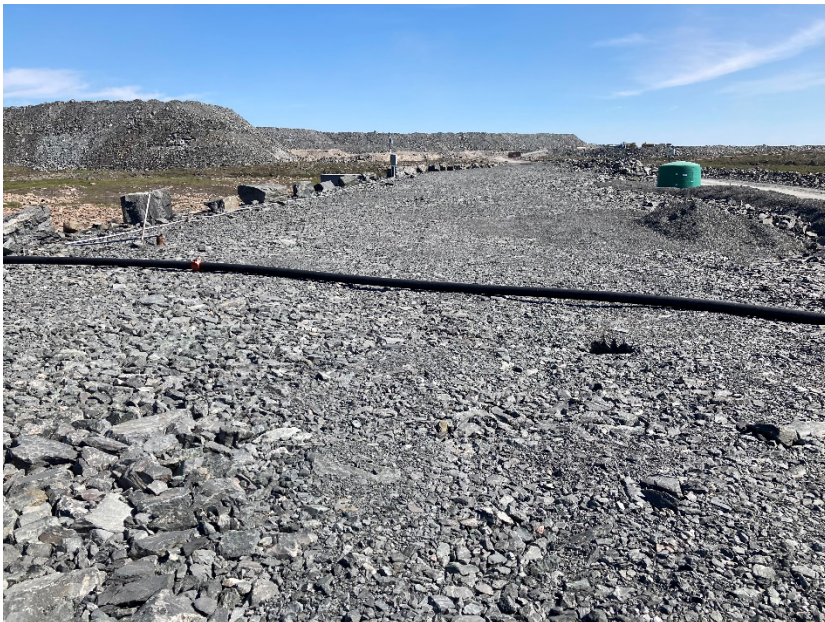
Photograph A7-8 WRSF Dike

Description: From approx. Sta. 0+080 (west abutment), looking east at the upstream thermal berm crest. Presence of holes (approx. 300mm)

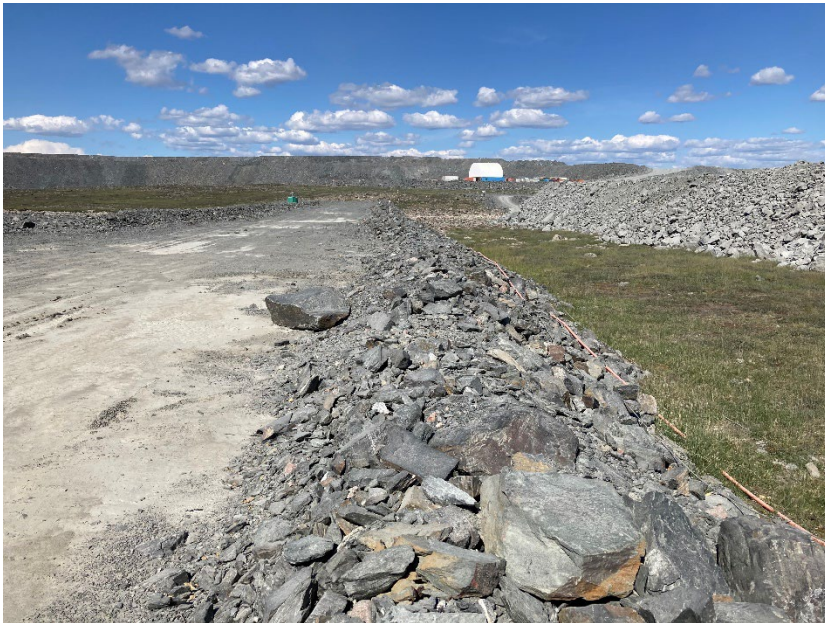
Photograph A8-2 Mammoth Dike

4.1 Seepage from dam	None observed		Water ponding some distance from the toe. No flow observed. The pond was being pumped out at the time of the inspection.

Description: From approx. Sta. 0+300 (south abutment), looking north to the crest and downstream slope.

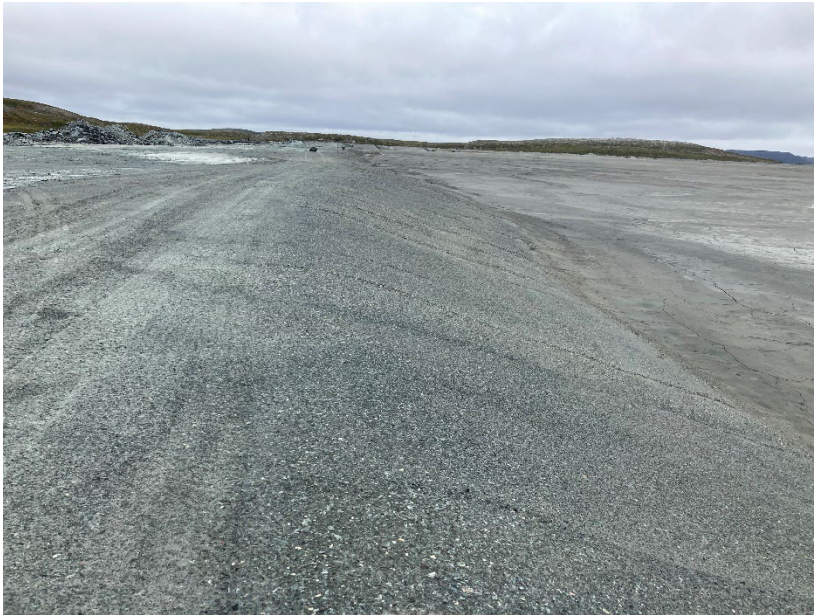
Photograph B1-1 Tailings Storage Facility

Description: From the North Cell Internal Structure, looking northeast toward the upstream slope and the North Cell.

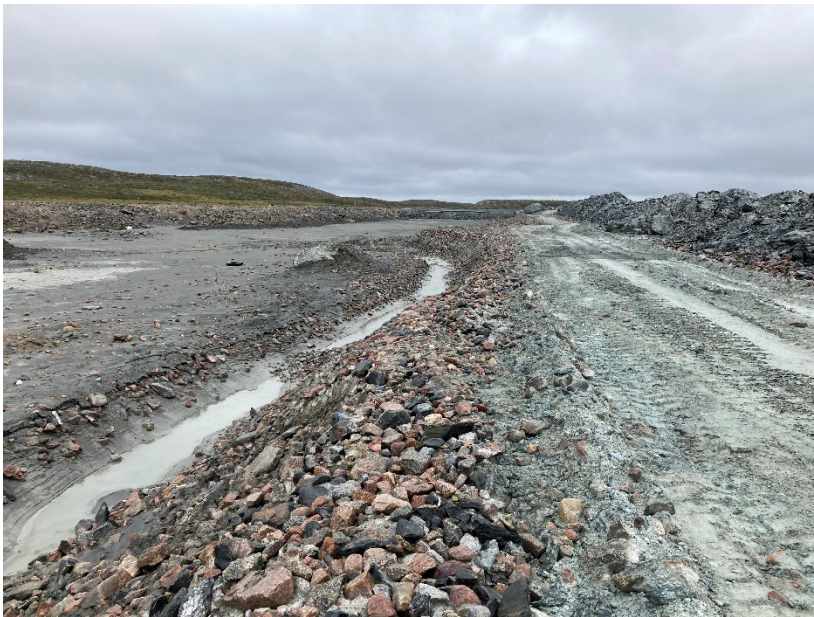
Photograph B1-3 Tailings Storage Facility

INSPECTION ITEM	OBSERVATIONS DATA	PHOTO	COMMENTS & OTHER DATA
4. DOWNSTREAM TOE AREA		356	
4.1 Seepage from dam	Yes		Pumping stations are in place downstream of the structure and in operation as needed.
4.2 Signs of erosion	None observed		
4.3 Signs of turbidity in seepage water	Not applicable		
4.4 Discoloration/staining	No		
4.5 Outlet operating problem (if applicable)	Not applicable		
4.6 Other unusual conditions			
5. ABUTMENTS			
5.1 Seepage at contact zone (abutment/embankment)	None observed		
5.2 Signs of erosion	None observed		
5.3 Excessive vegetation	No		
5.4 Presence of rodent burrows	None observed		
5.5 Other unusual conditions	None		
6. RESERVOIR			
6.1 Stability of slopes	Stable		
6.2 Distance to nearest slide	None observed		
6.3 Estimate of slide volume (if applicable)	Not applicable		
6.4 Floating debris	None observed

Description: From the North Cell Internal Structure, looking north toward the diversion ditch.

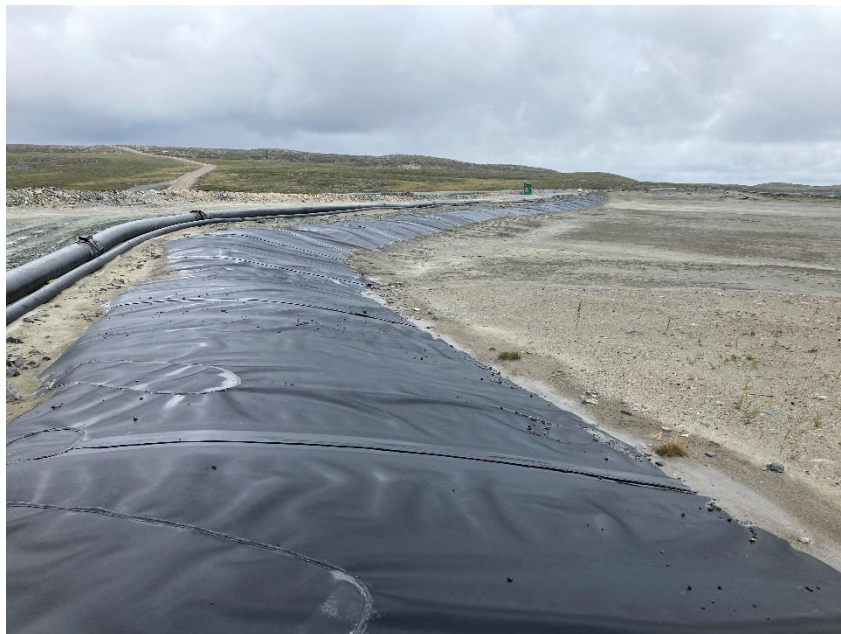
Photograph B2-6 Saddle Dam 1

Description: From the south abutment looking north at the upstream slope. Adequate tailings beach against SD1.

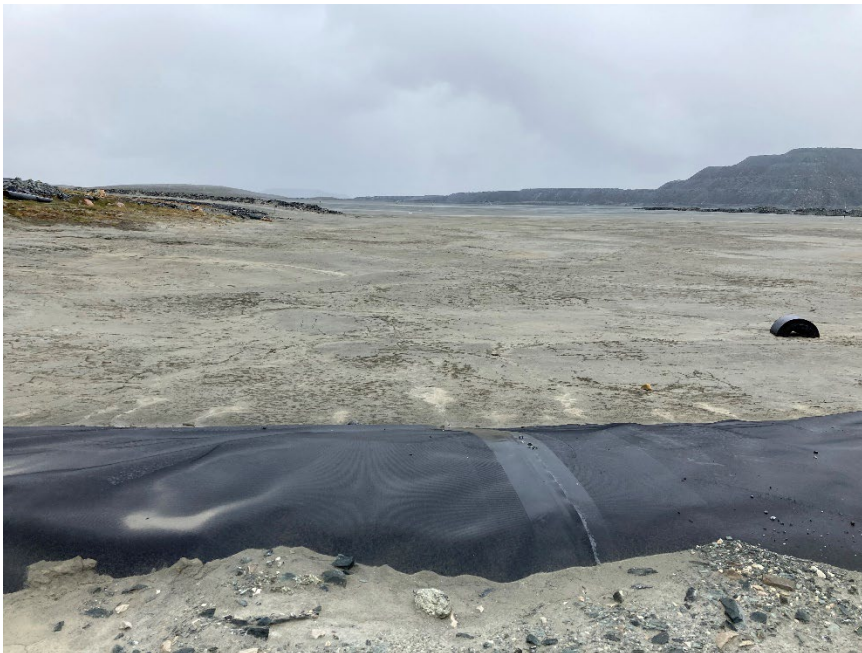
Photograph B3-2 Saddle Dam 2

Description: From Saddle Dam 2 (approximately Sta. 20+110) upstream, looking southeast at the North Cell. The tailings beach against SD2 is adequate.
