Meadowbank and Whale Tail 2022 Annual Geotechnical Inspection

REPORT**2022 Annual Geotechnical Inspection***Meadowbank Complex, Nunavut*

1617-2146800622-5000-RA-Rev0

16 December 2022

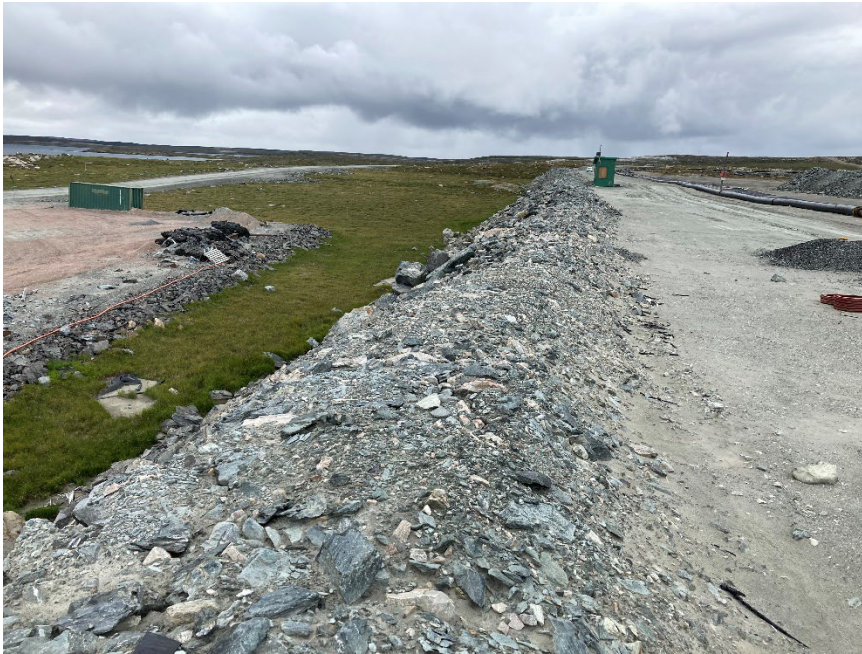
Photograph B3-7 Saddle Dam 2

4.4 Discoloration/staining	No		
4.5 Outlet operating problem (if applicable)	Not applicable		
4.6 Other unusual conditions	Yes		Limited water is still ponding within the rockfill embankment between 20+275 to 20+475 approximately.

Description: From Saddle Dam 2 (approximately Sta. 20+500) downstream, looking northwest at the downstream toe and slope of Saddle Dam 2.

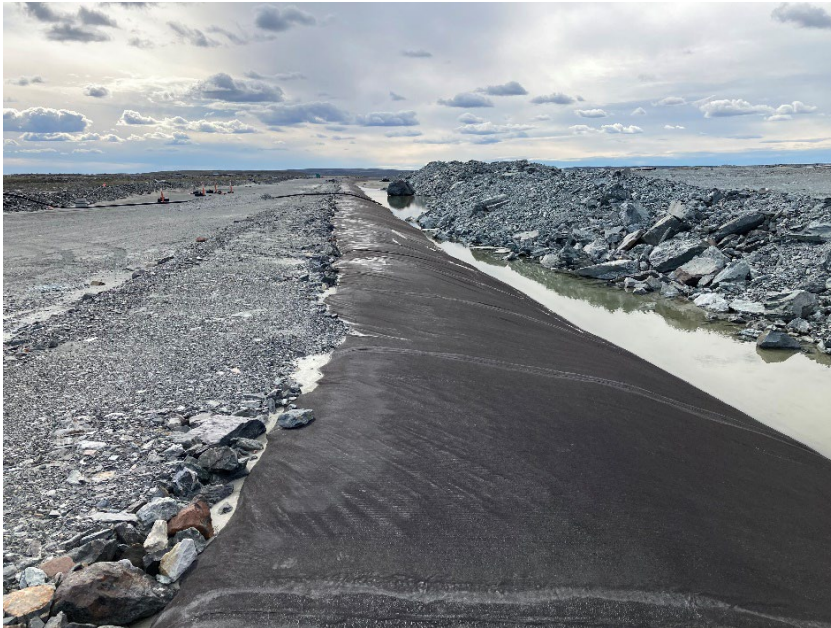
Photograph B4-1 Stormwater Dike

Description: From the east abutment (11+100 approximately), looking west at the upstream face and the rockfill cover of the North Cell. Shallow water ponding against portion of the dike (less than 30 cm deep). Large rocks are present near the liner.

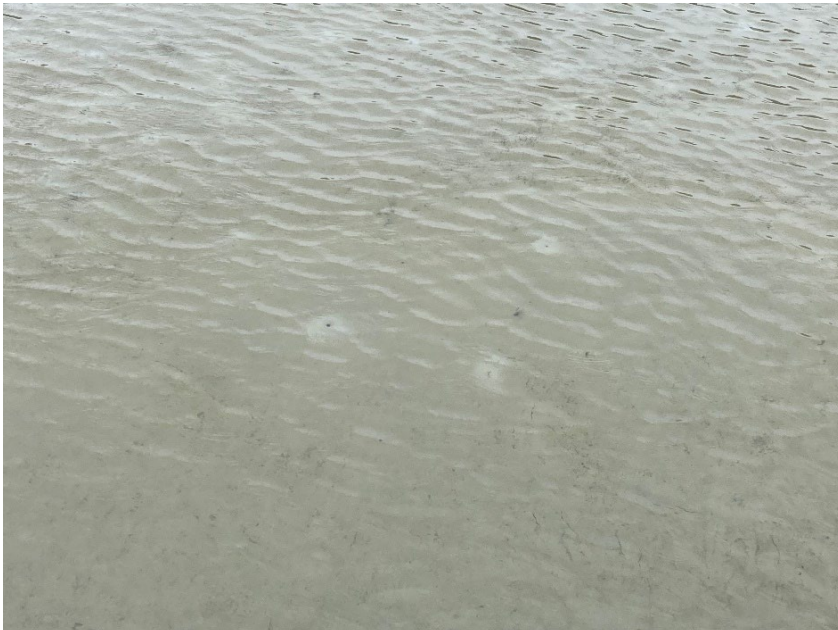
Photograph B4-2 Stormwater Dike

Description: From the east abutment (11+100 approximately), looking northwest at the upstream tailings in the North Cell. Presence of small sandboil-looking features under the water.

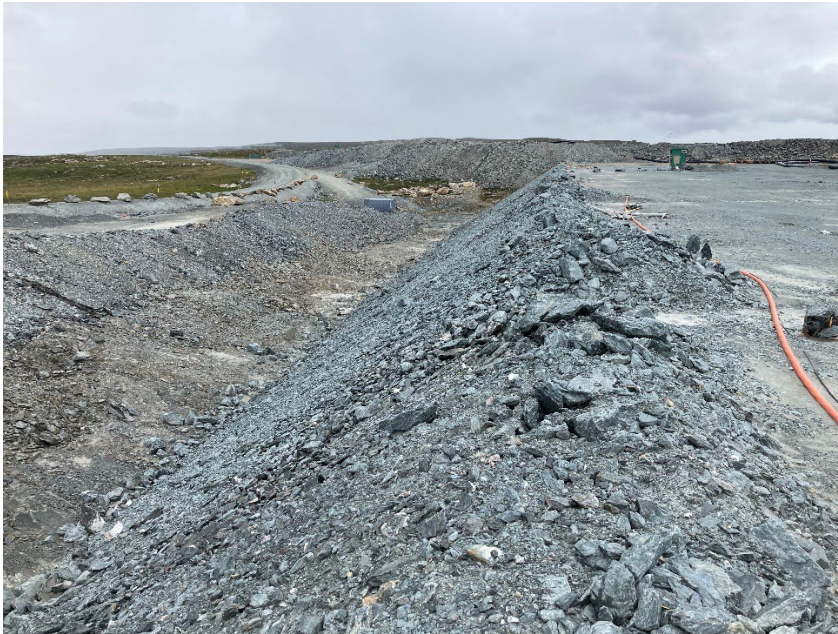
Photograph B5-1 Saddle Dam 3

Description: From Sta. 20+750, looking northwest at the downstream slope and toe.

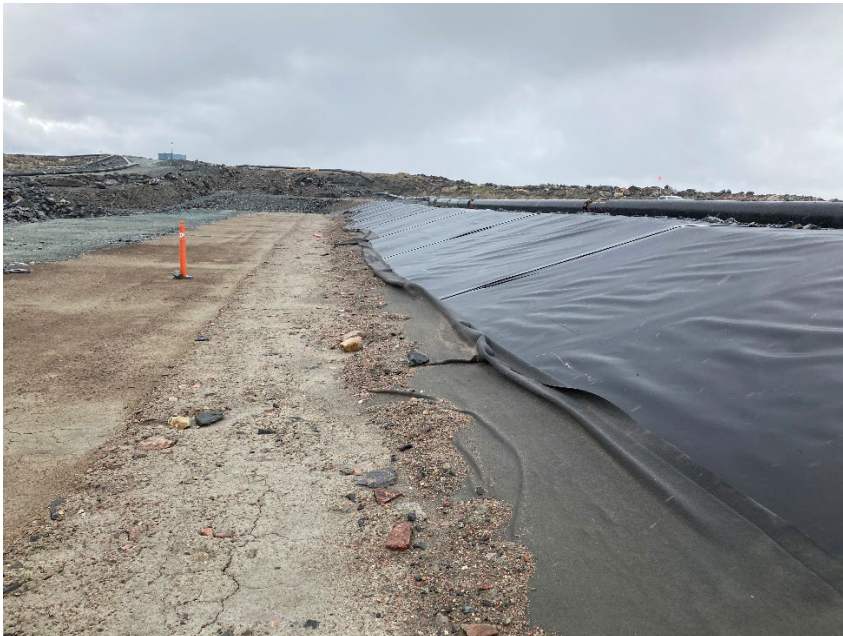
Photograph B5-2 Saddle Dam 3

Description: From Sta. 20+700, looking southeast at the crest.

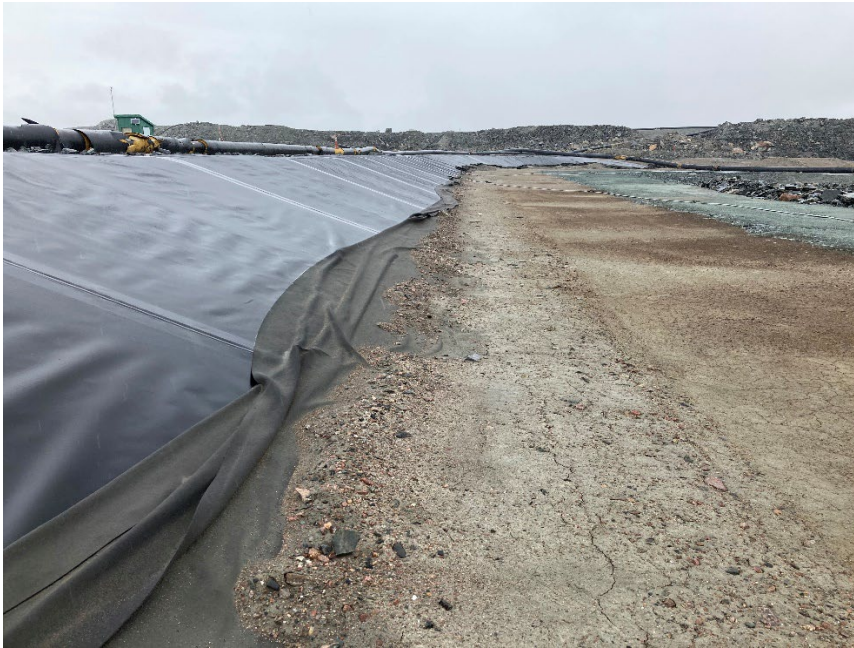
Photograph B5-3 Saddle Dam 3

Description: From Sta. 20+700, looking northwest at the crest.

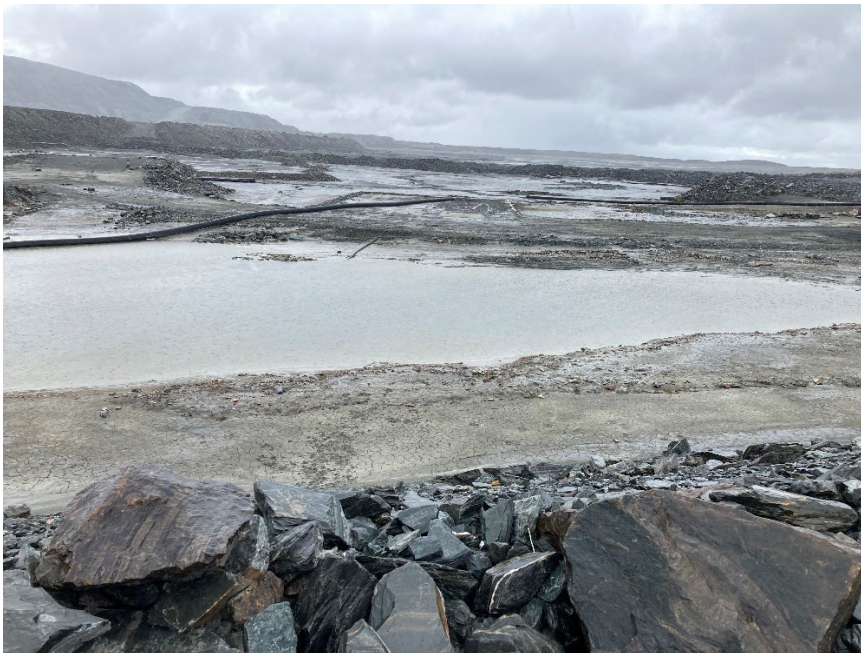
Photograph B5-4 Saddle Dam 3

Description: From Sta. 20+610, looking south at the upstream slope.

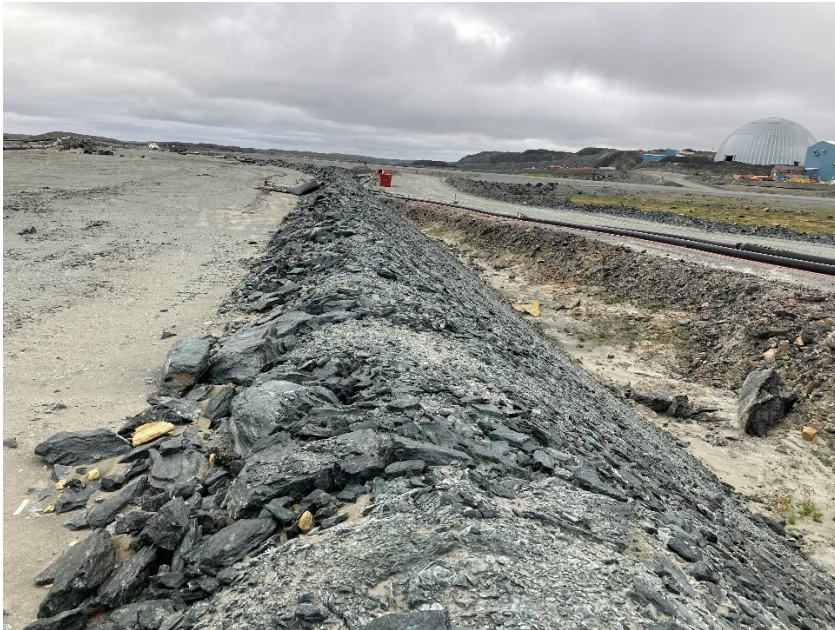
Photograph B6-1 Saddle Dam 4

Description: From 40+200 approximately, looking southeast at the crest and the downstream slope and toe.

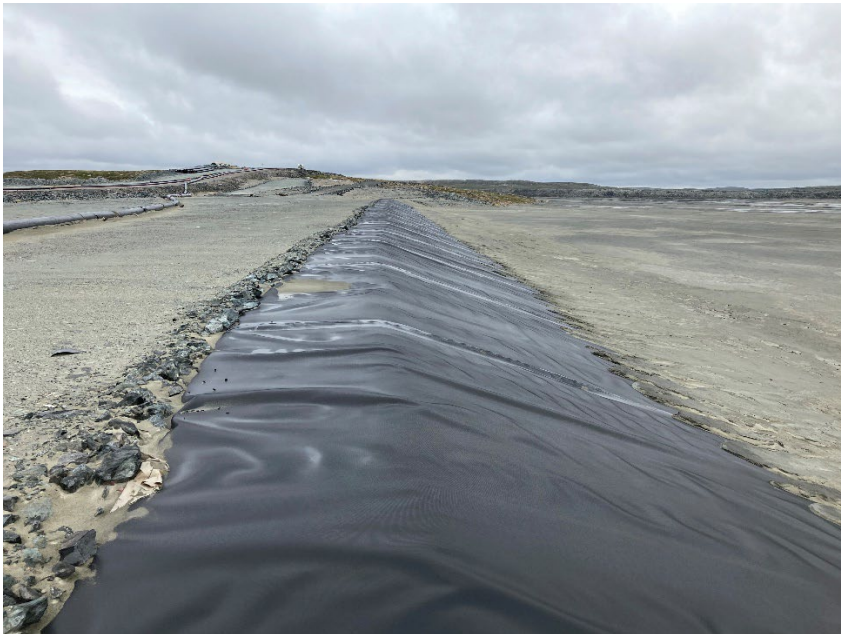
Photograph B6-2 Saddle Dam 4

Description: From 40+150 approximately, looking northeast at the upstream slope and the South Cell.

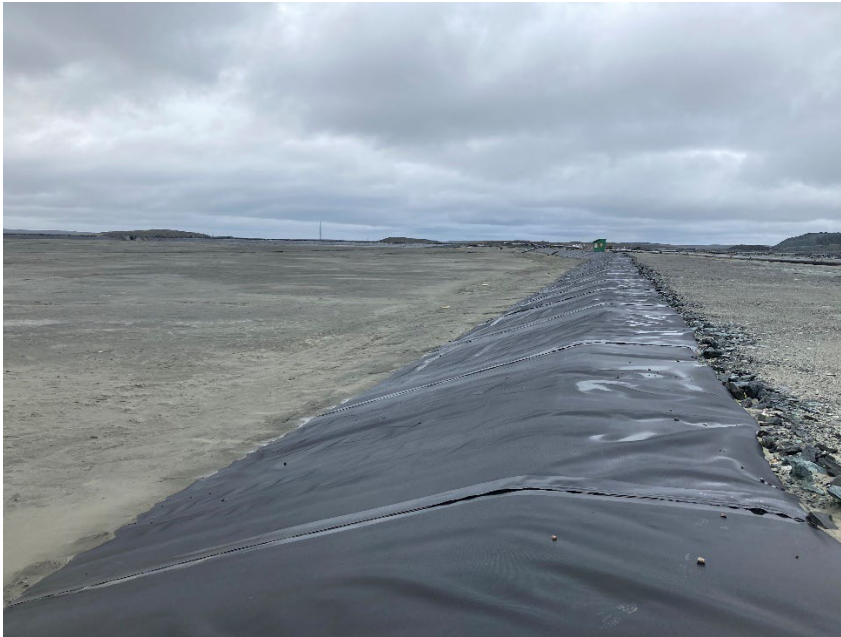
Photograph B6-3 Saddle Dam 4

Description: From 40+150 approximately, looking southeast at the crest and the upstream slope.

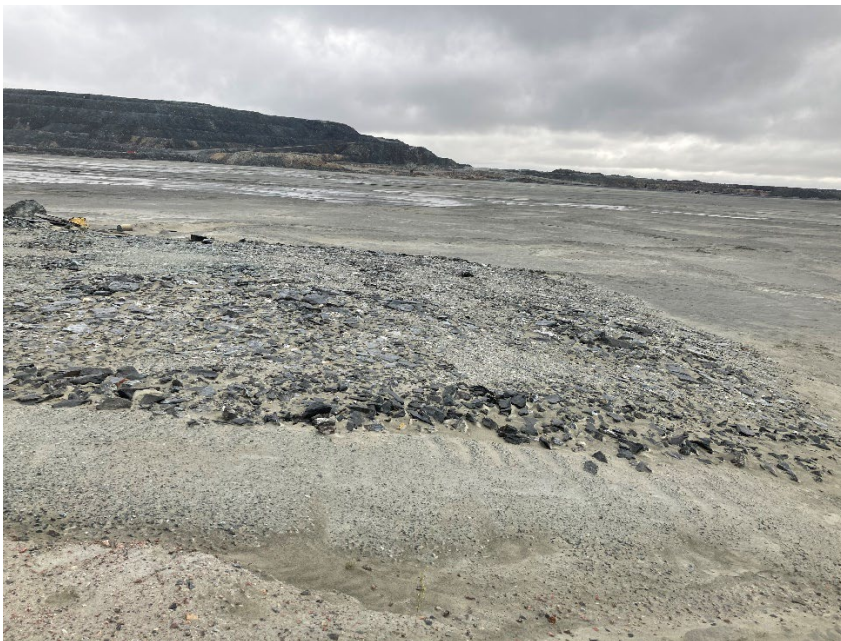
Photograph B6-4 Saddle Dam 4

Description: From 40+250 approximately, looking northwest at the crest and the upstream slope.

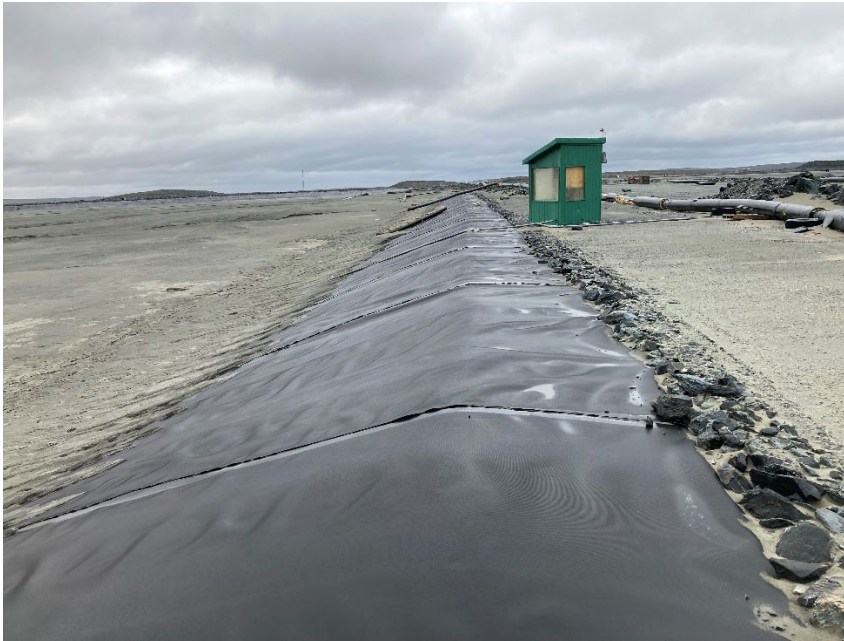
Photograph B6-5 Saddle Dam 4

Description: From 40+250 approximately, looking southeast at the crest and the upstream slope.

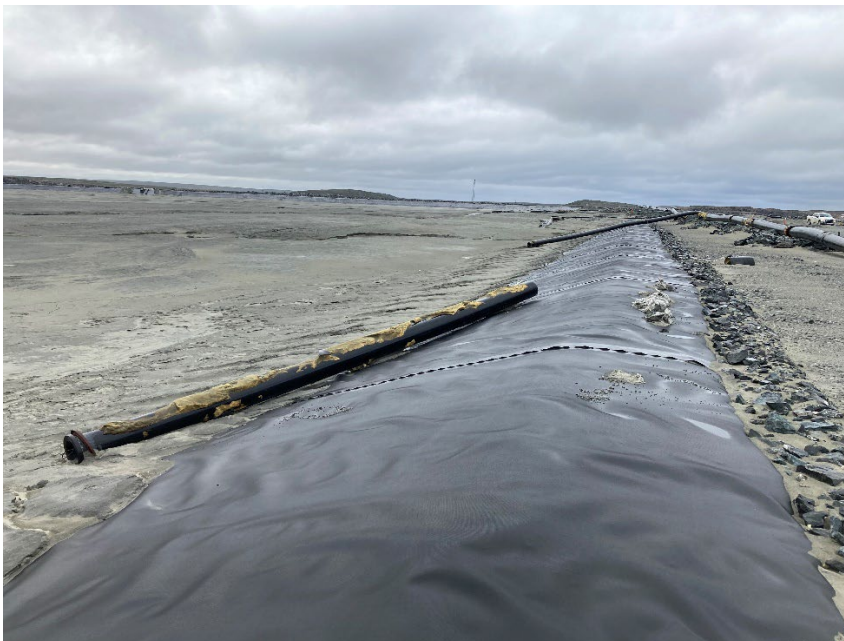
Photograph B6-6 Saddle Dam 4

Description: From 40+300 approximately, looking southeast at the crest and the upstream slope. Presence of a pipe on the liner.

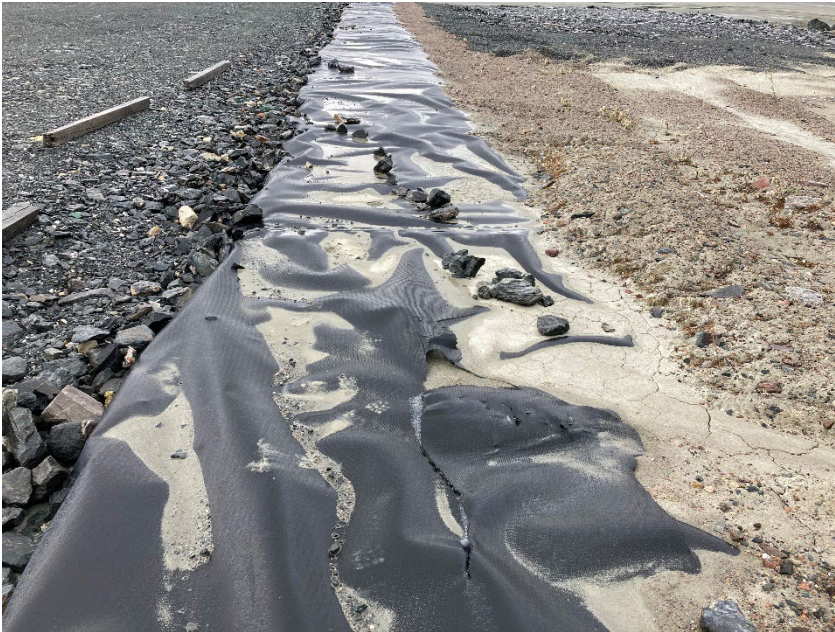
Photograph B7-1 Central Dike and Saddle Dam 5

Description: From the north abutment, looking south. Rips in the liner at the top of the upstream slope.

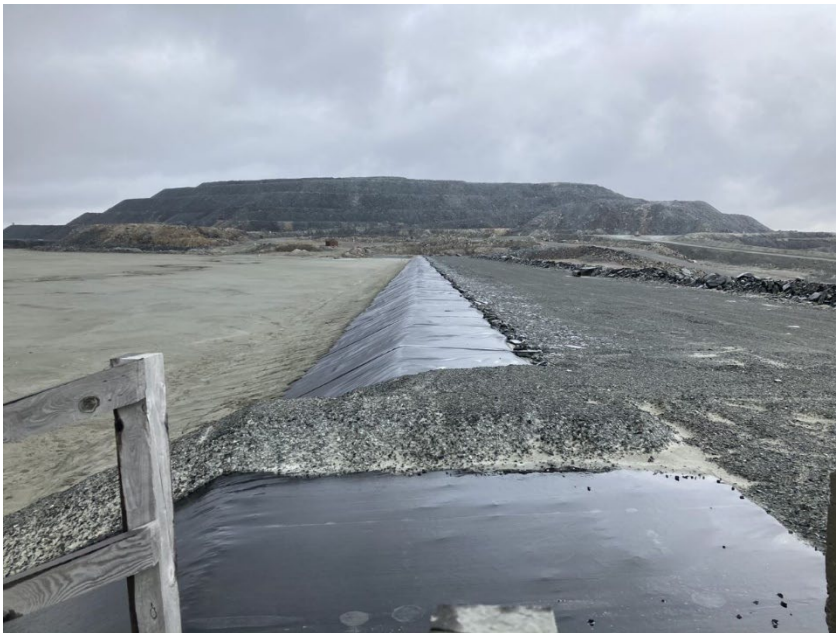
Photograph B7-2 Central Dike and Saddle Dam 5

Description: From approximately Sta. 0+400 (deposition point) looking west at the South Cell. Adequate tailings beach against the south section of the structure.

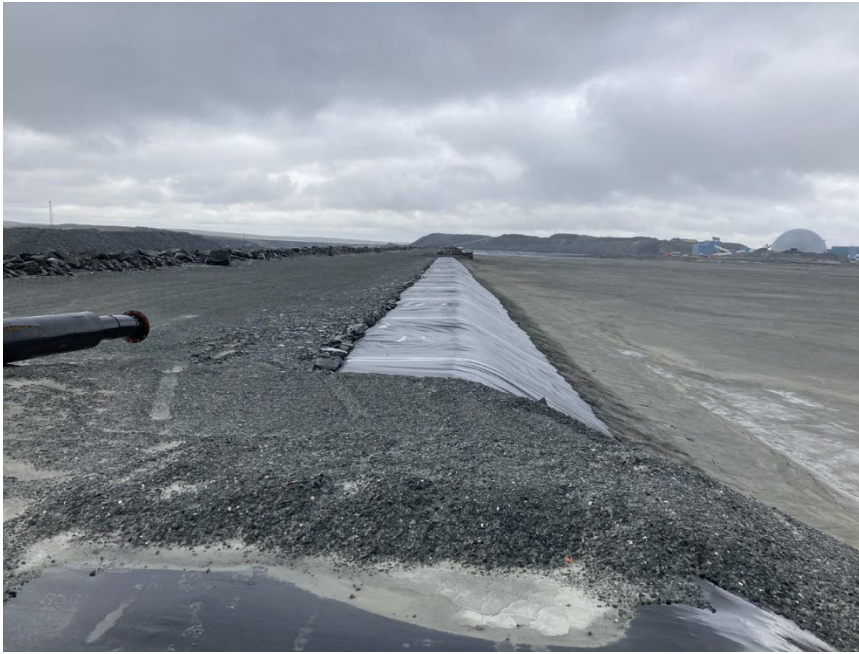
Photograph B7-3 Central Dike and Saddle Dam 5

Description: From approximately Sta. 0+400 (deposition point) looking south at the upstream slope. Adequate tailings beach against the south section of the structure.

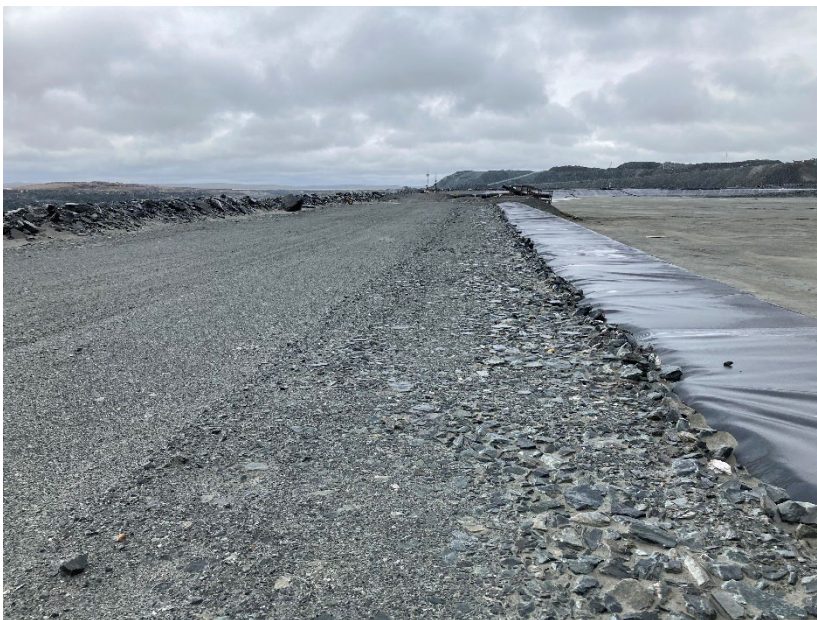
Photograph B7-4 Central Dike and Saddle Dam 5

Description: From approximately Sta. 0+720 looking south at the crest.

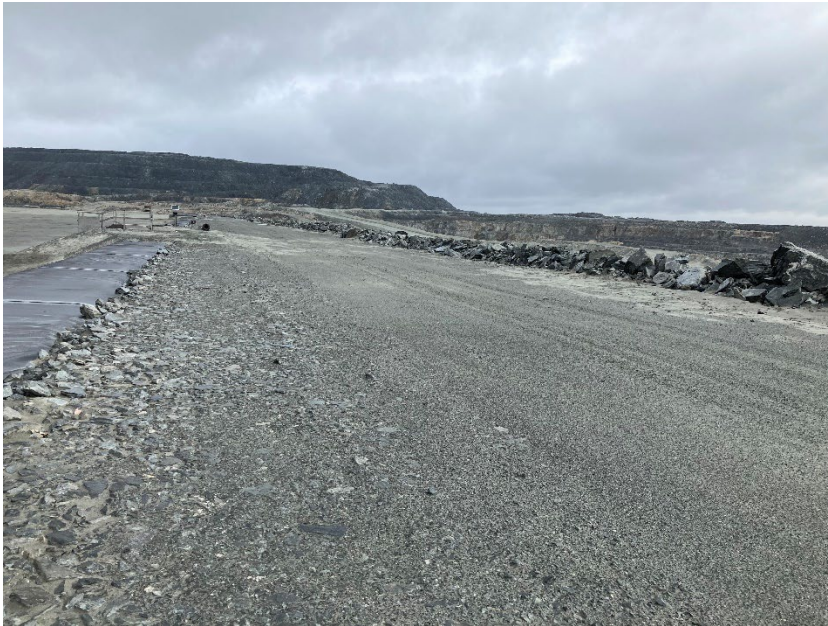
Photograph B7-5 Central Dike and Saddle Dam 5

Description: From approximately Sta. 0+720 looking north at the crest.

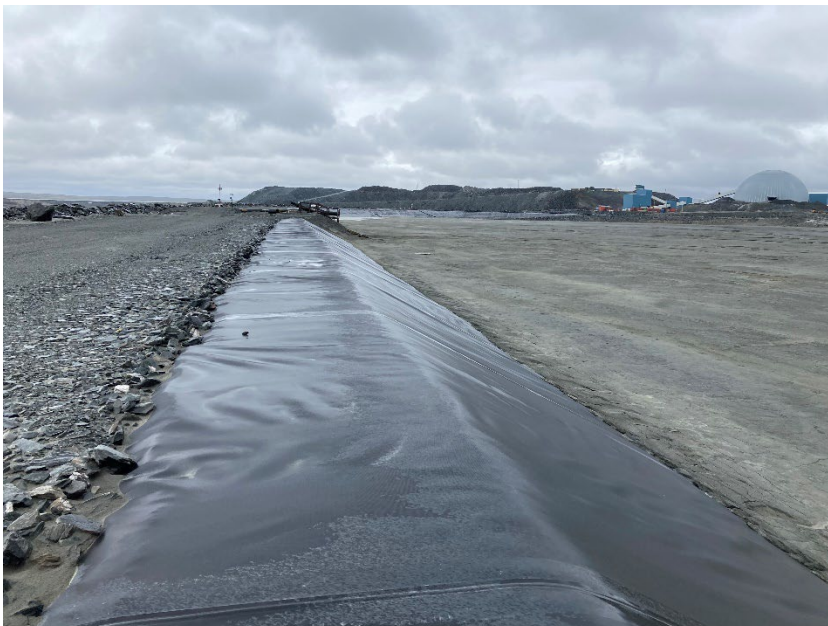
Photograph B7-6 Central Dike and Saddle Dam 5

Description: From approximately Sta. 0+720 looking south at the crest and the upstream slope.

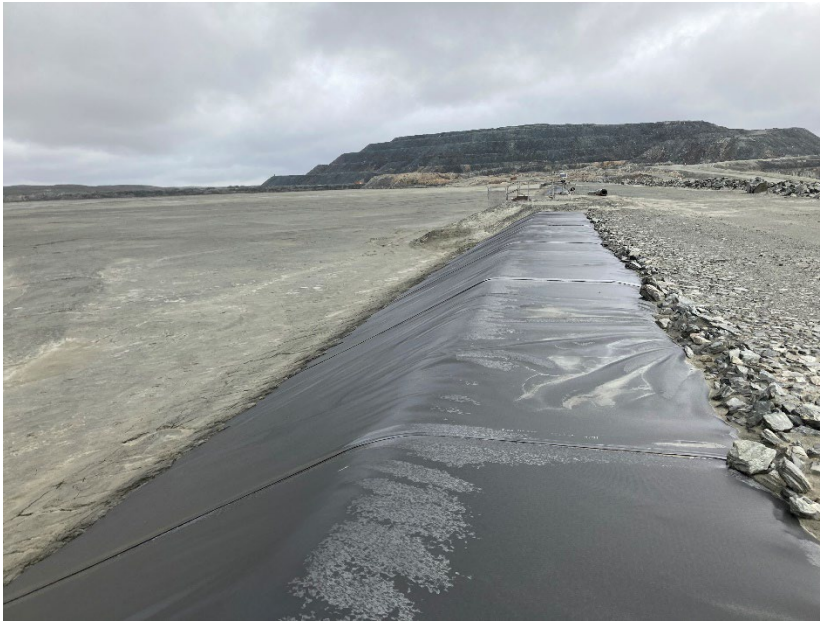
Photograph B7-7 Central Dike and Saddle Dam 5

Description: From approximately Sta. 0+720 looking north at the crest and the upstream slope.

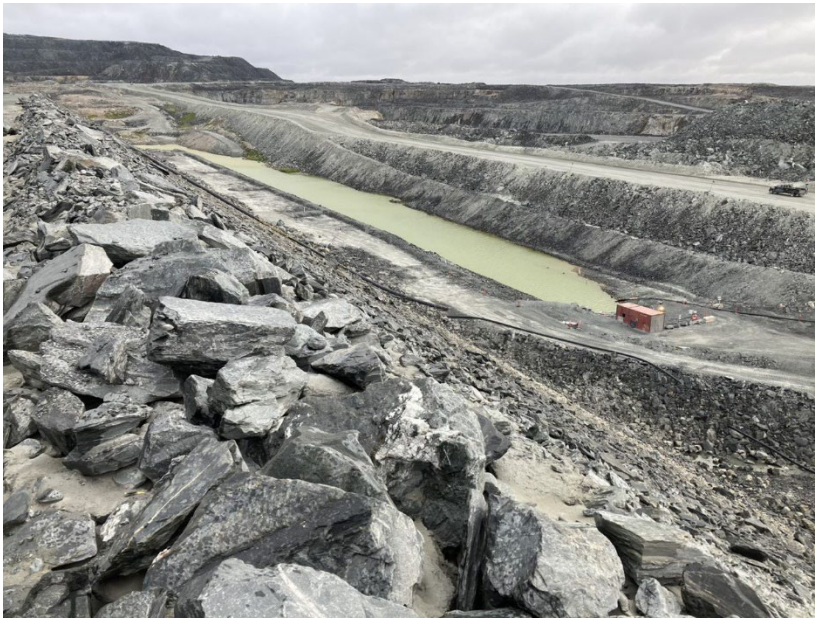
Photograph B7-8 Central Dike and Saddle Dam 5

Description: From approximately Sta. 0+875, looking north at the downstream slope and toe.

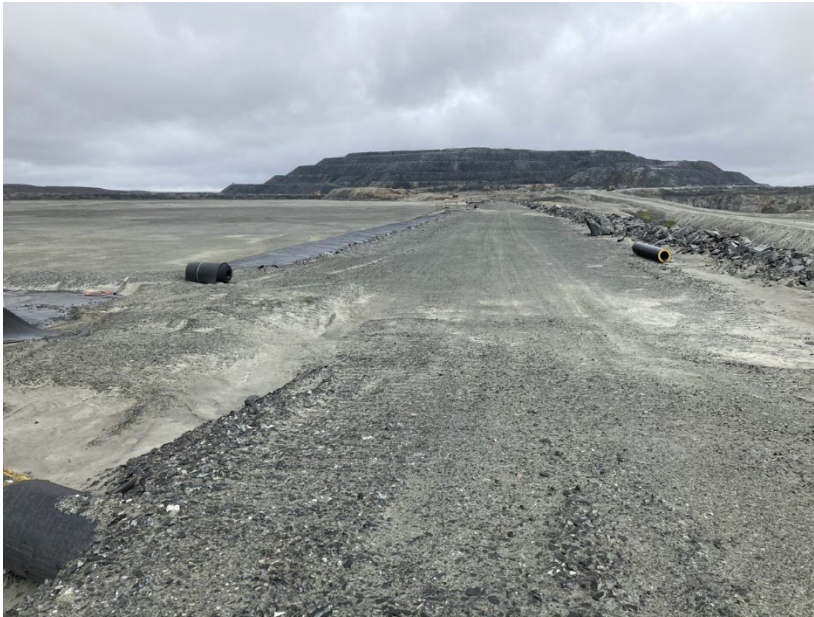
Photograph B7-9 Central Dike and Saddle Dam 5

Description: From approximately Sta. 0+800, looking north at the crest.

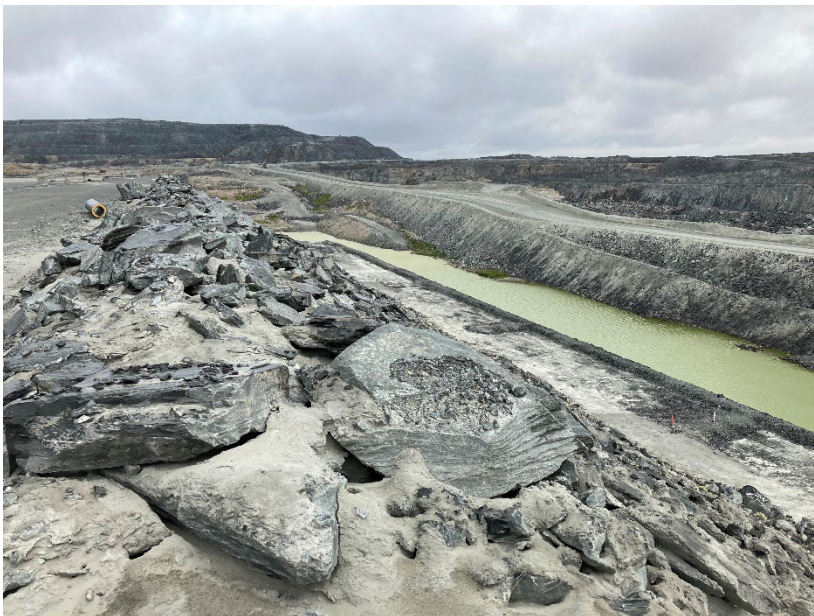
Photograph B7-10 Central Dike and Saddle Dam 5

Description: From approximately Sta. 0+800, looking north at the crest, downstream slope and toe.

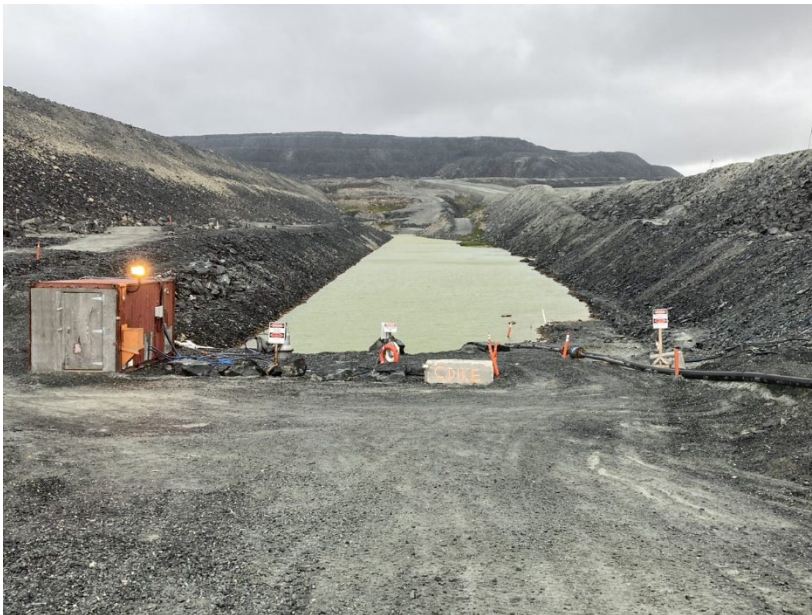
Photograph B7-11 Central Dike and Saddle Dam 5

Description: From approximately Sta. 0+900 downstream, looking north at the downstream pond.

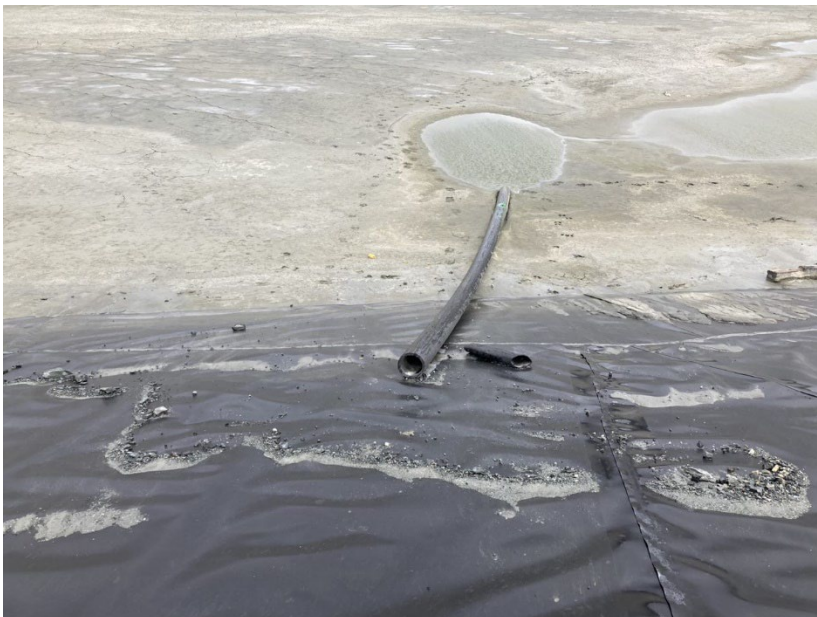
Photograph B7-12 Central Dike and Saddle Dam 5

Description: From approximately Sta. 0+950, looking west at the upstream slope. Presence of gravel on the liner.

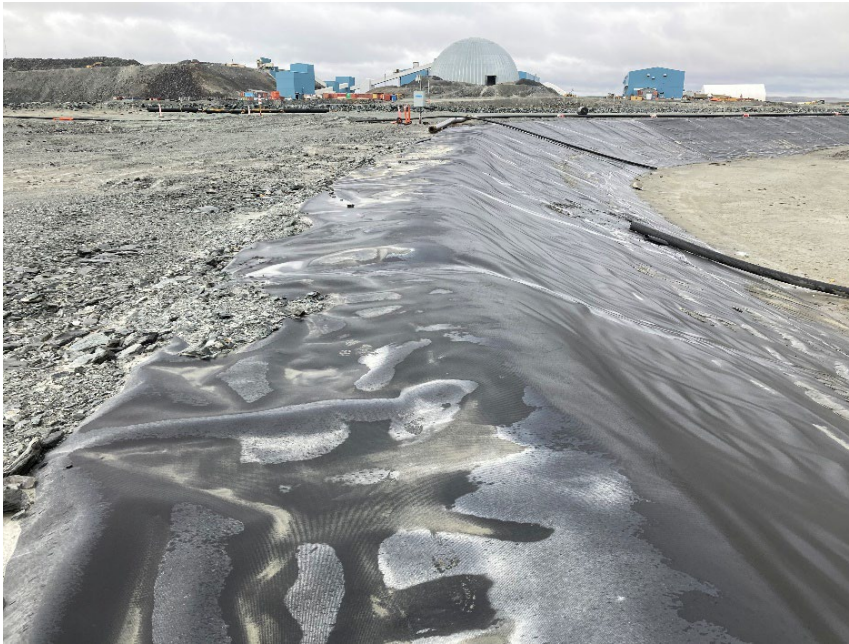
Photograph B7-13 Central Dike and Saddle Dam 5

Description: From approximately Sta. 0+950, looking south at the upstream slope. Presence of rips in the liner.

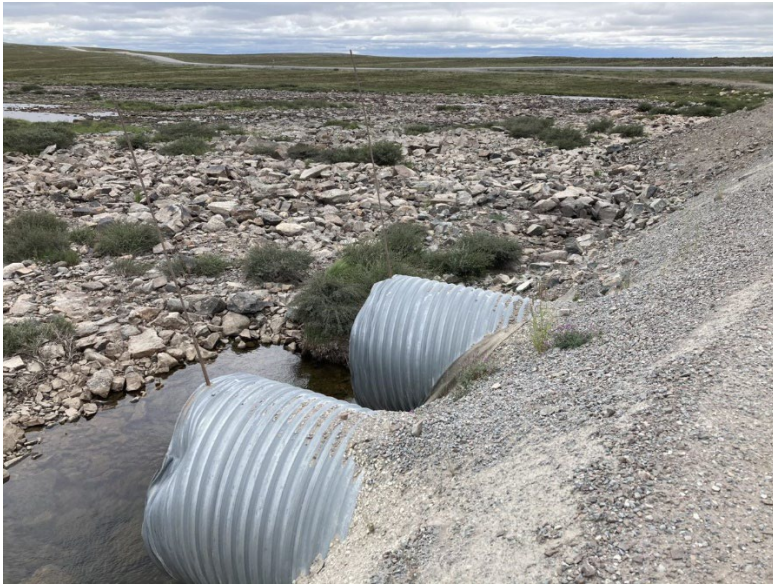
Photograph D2-1: PC-17A km 8+830

8+830	PC-17A	2X1800 mm CSP	Sign of erosion beneath the inlet and flow of water occurring beneath the culvert. The 1800 CSP were installed too high. While conditions are not perfect, they have proven stable over the past years. No sign of degradation from last year on both the inlet and outlet sides. Flow was observed beneath the culvert in the past, but in 2019 the flow moved further south (5-10 m from culvert). Stable, to keep monitoring for evolution.
8+850	PC-17	2x1200 mm CSP	In good condition

Description: View of the culvert outlets. No sign of degradation and the flow is stable south of the culverts (5-10 m away).

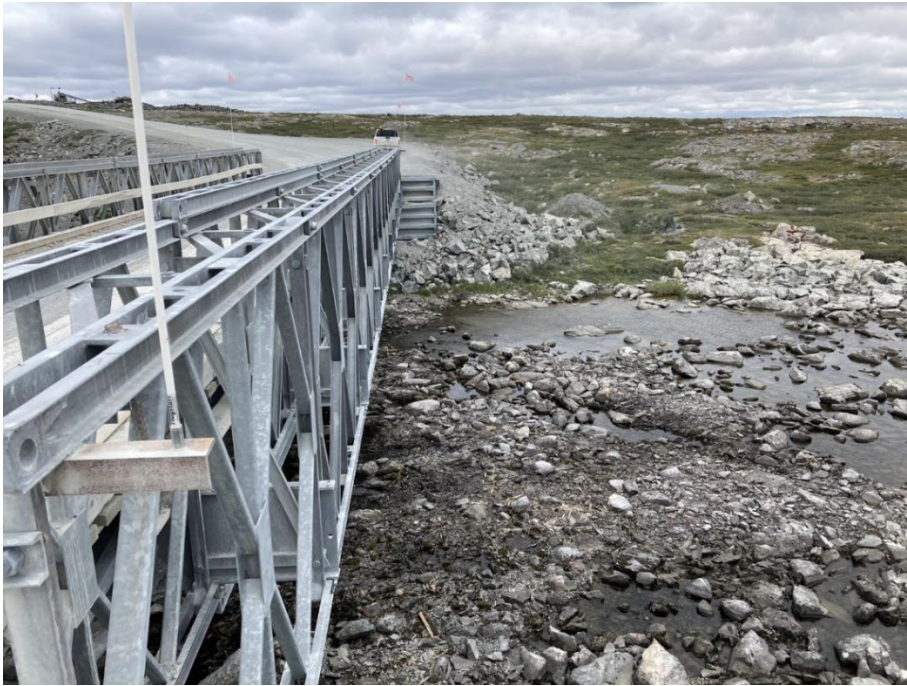
Photograph D3-5 Bridges 3 – R06 km 23+100

Description: Looking at the north abutment.

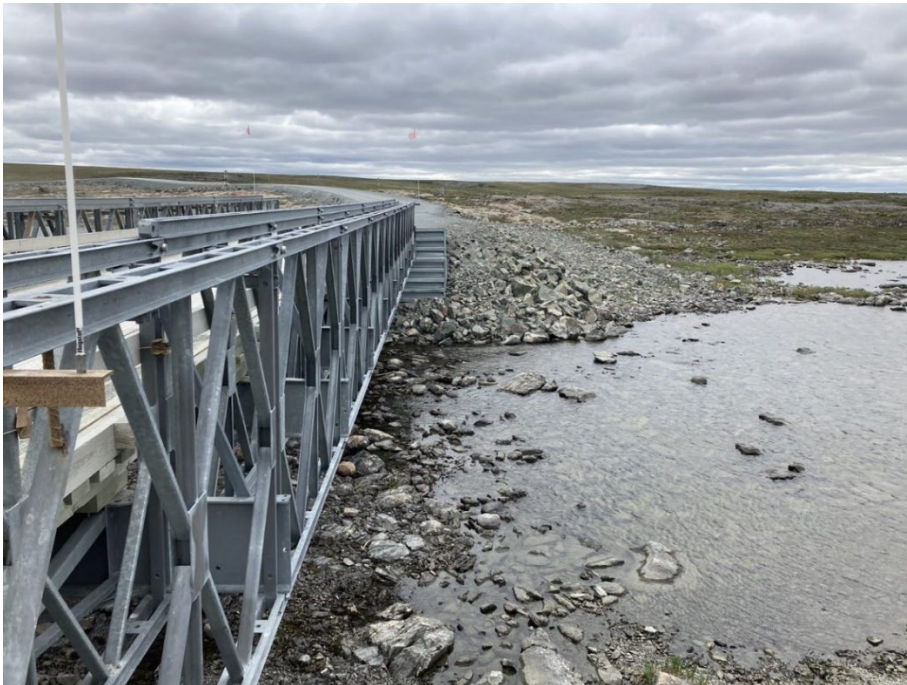
Photograph D3-6 Bridges 3 – R06 km 23+100

Description: Looking at the south abutment.

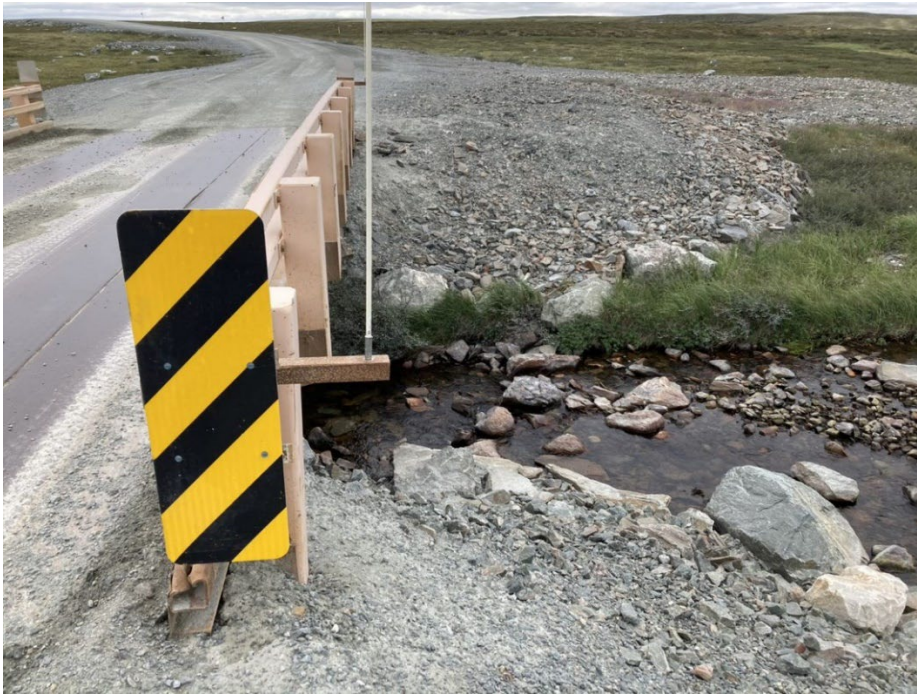
Photograph D3-9 Bridges 4 – R09 km 48+500

Description: Looking at the south abutment.

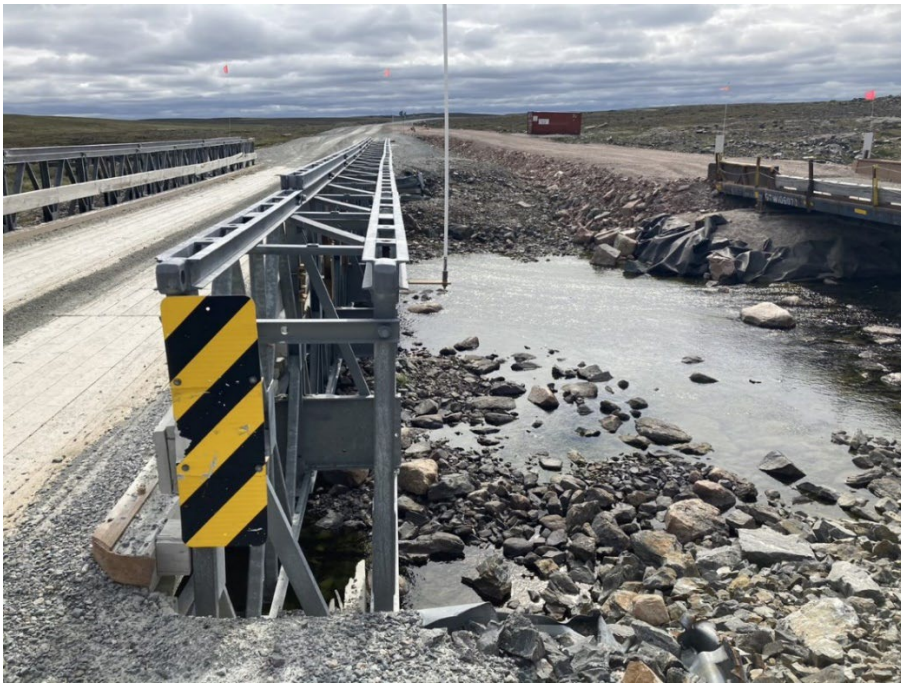
Photograph D3-13 Bridges 6 – R15 km 69+200

Description: Looking at the south abutment. Damage to the bin wall likely caused during snow removal activities. Bridge is tipping toward the west side on the abutment.

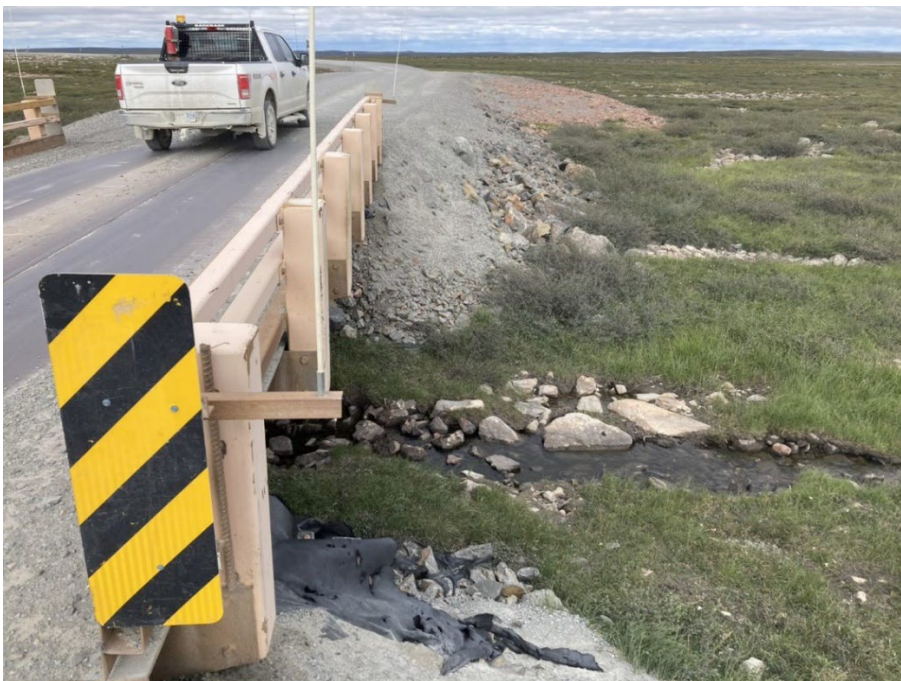
Photograph D3-14 Bridges 7 – R16 km 73+800

Description: Looking at the north abutment. In good condition.

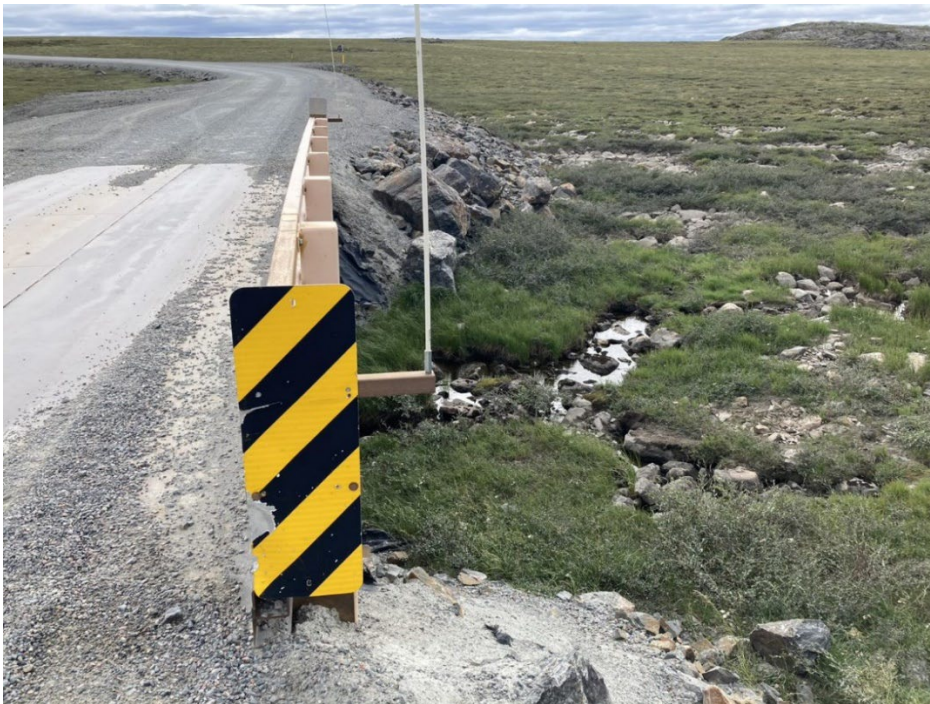
Photograph D3-15 Bridges 7 – R16 km 73+800

Description: Looking at the south abutment. In good condition.

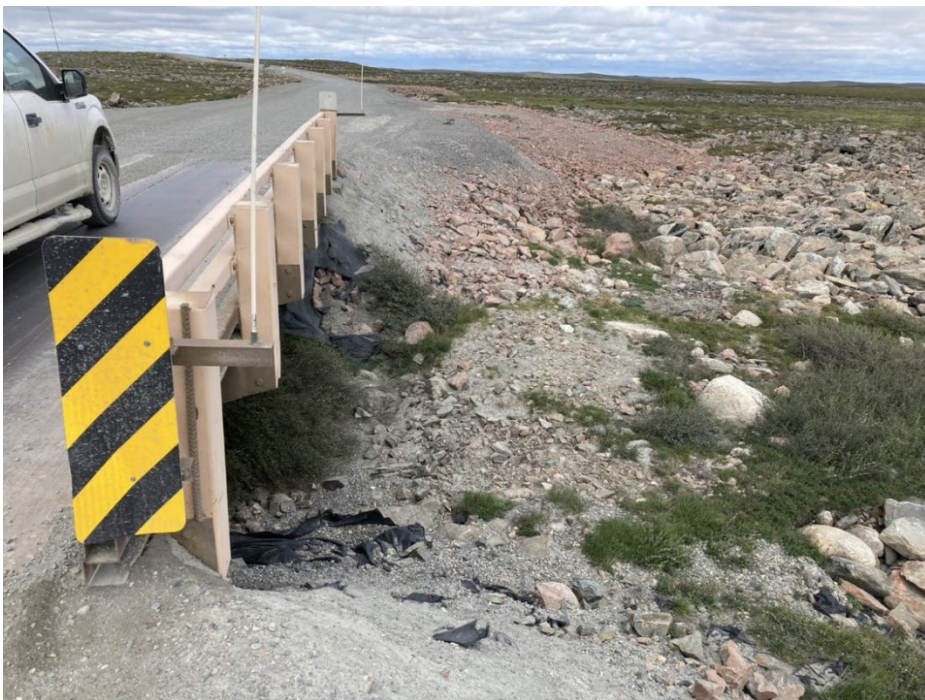
Photograph D3-16 Bridges 8 – R18 km 79+500

Description: Looking at the north abutment. In good condition.

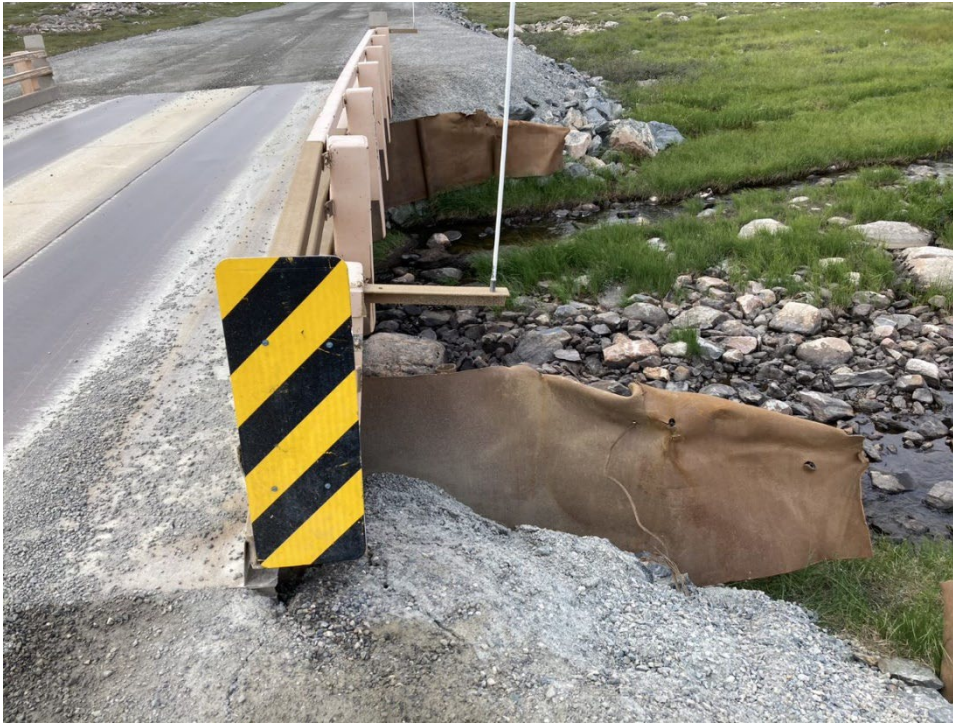
Photograph D3-19 Bridges 9 – R19 km 83+150

Description: Looking at the south abutment. Minor damage to steel plate due to snow removal activity. Minor tension cracks, seem inactive.

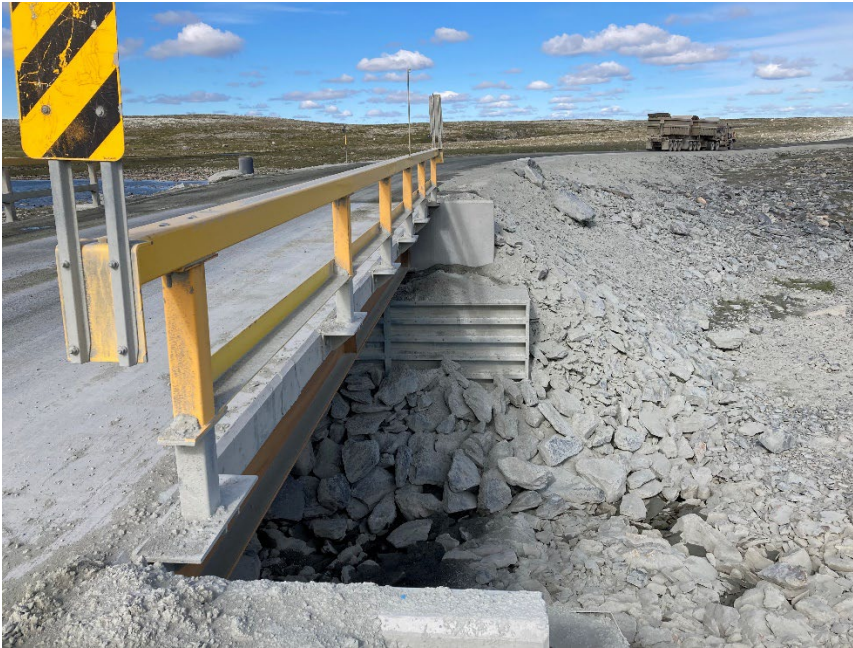
Photograph E2-1 Bridges 1 – km 119+400

Description: Looking at the north abutment.

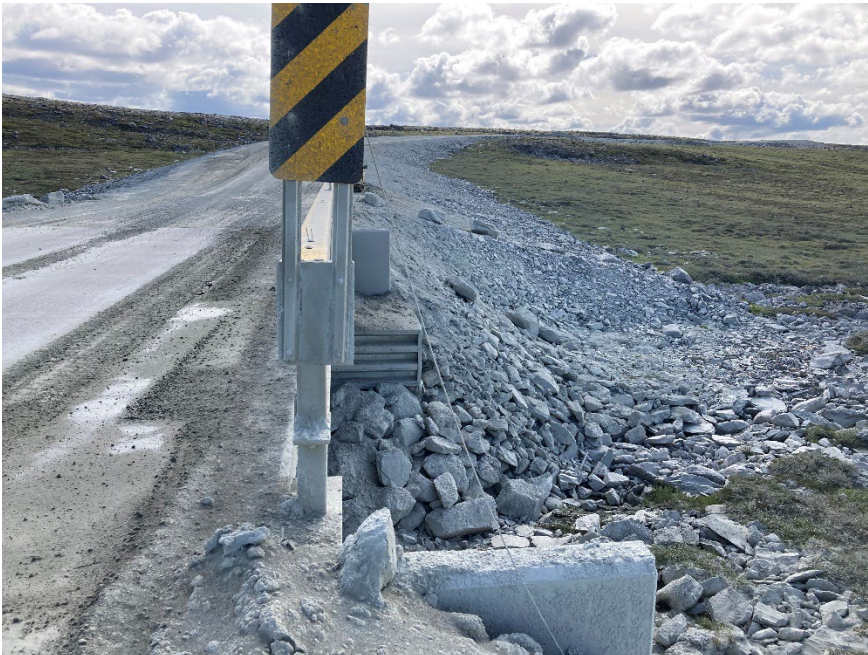
Photograph E2-2 Bridges 1 – km 119+400

Description: Looking at the south abutment.

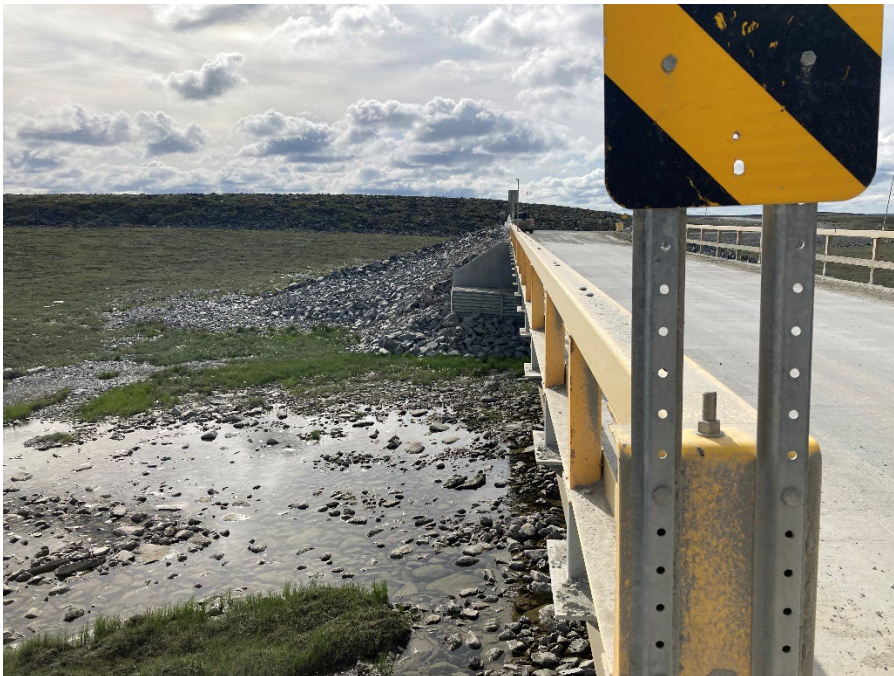
Photograph E2-6 Bridges 3 – km 132+000

Description: Looking at the southeast abutment.
