Meadowbank and Whale Tail 2022 Annual Geotechnical Inspection

REPORT**2022 Annual Geotechnical Inspection***Meadowbank Complex, Nunavut*

1617-2146800622-5000-RA-Rev0

16 December 2022

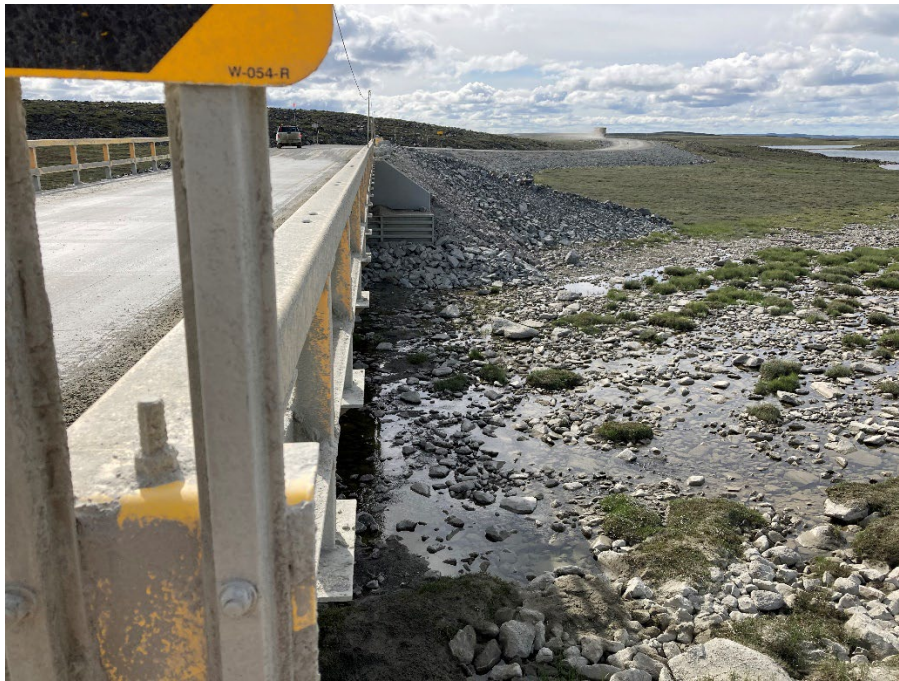
Photograph E2-7 Bridges 3 – km 132+000

Description: Looking at the southwest abutment.

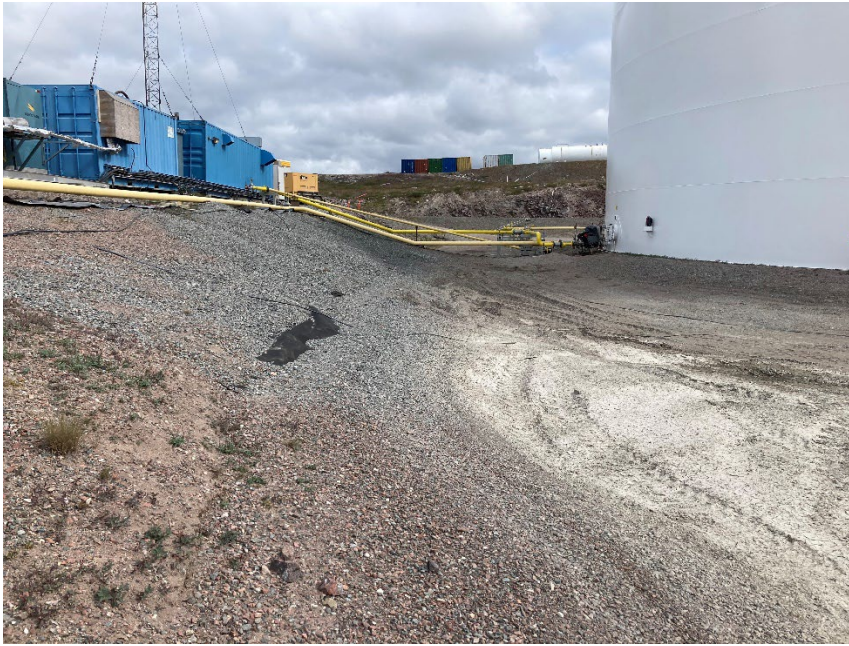
Photograph G1-1 Baker Lake Tank Farm

Description: From the south side of Tank 1, looking southeast at Tanks 1, 2, 3, and 4.

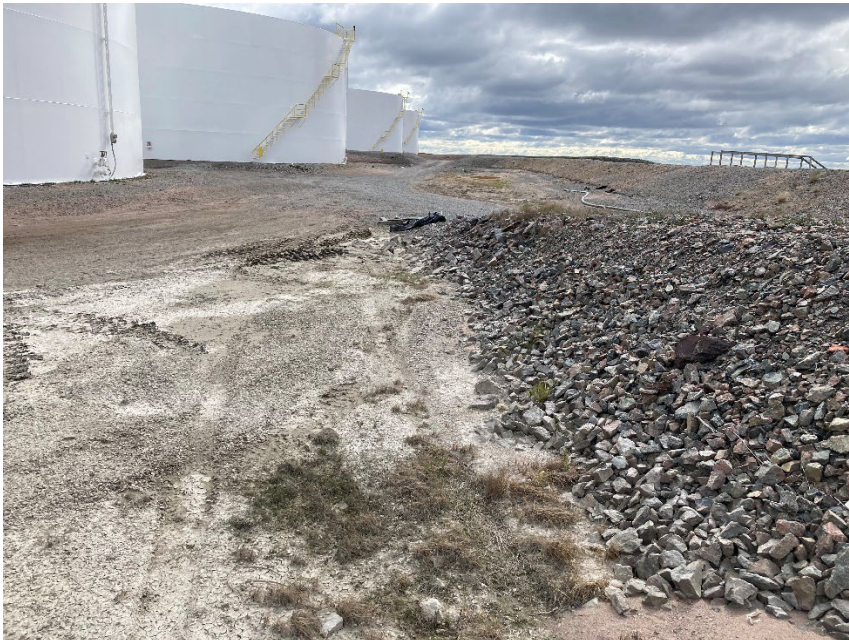
Photograph G1-2 Baker Lake Tank Farm

Description: Looking at the southwestern corner of Tank 1.

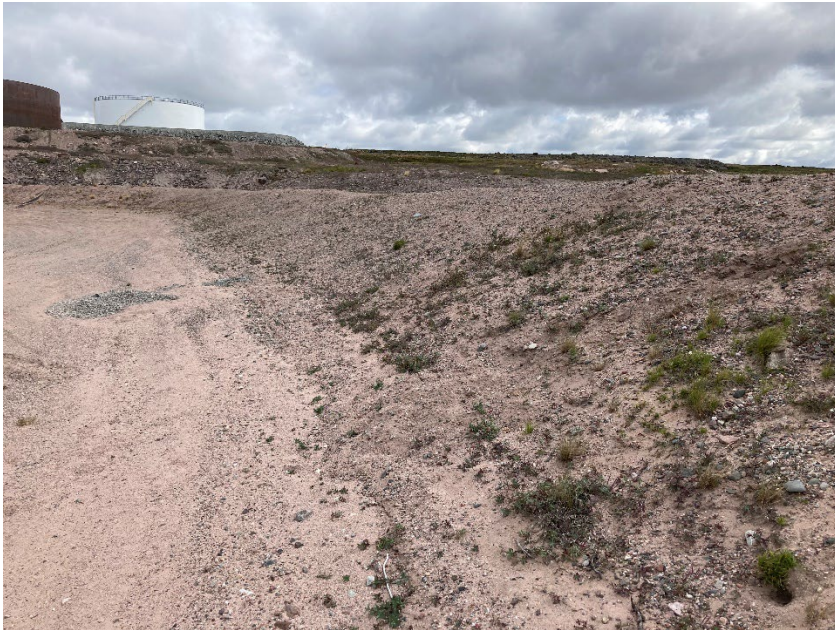
Photograph G1-9 Baker Lake Tank Farm

Description: From the south portion of the site looking northeast.

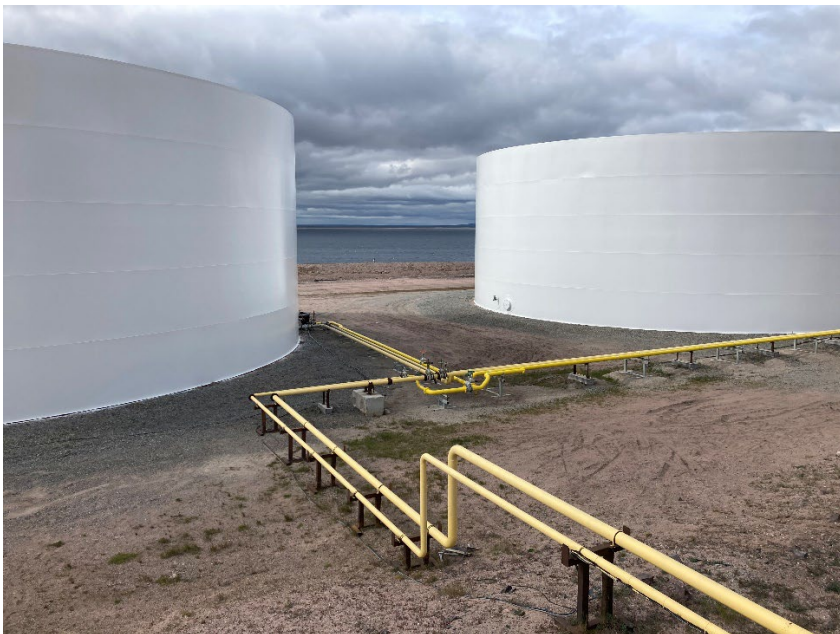
Photograph G1-12 Baker Lake Tank Farm

Description: From the northern side of Tank 4, looking southwest toward Tanks 3 and 4.

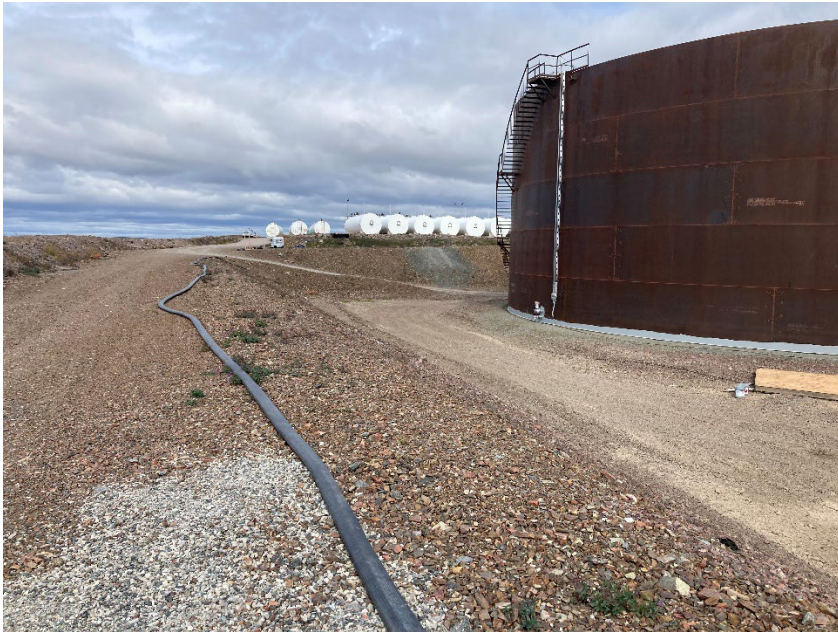
Photograph G1-13 Baker Lake Tank Farm

Description: Looking northwest at the southern and western sides of Tank 5.

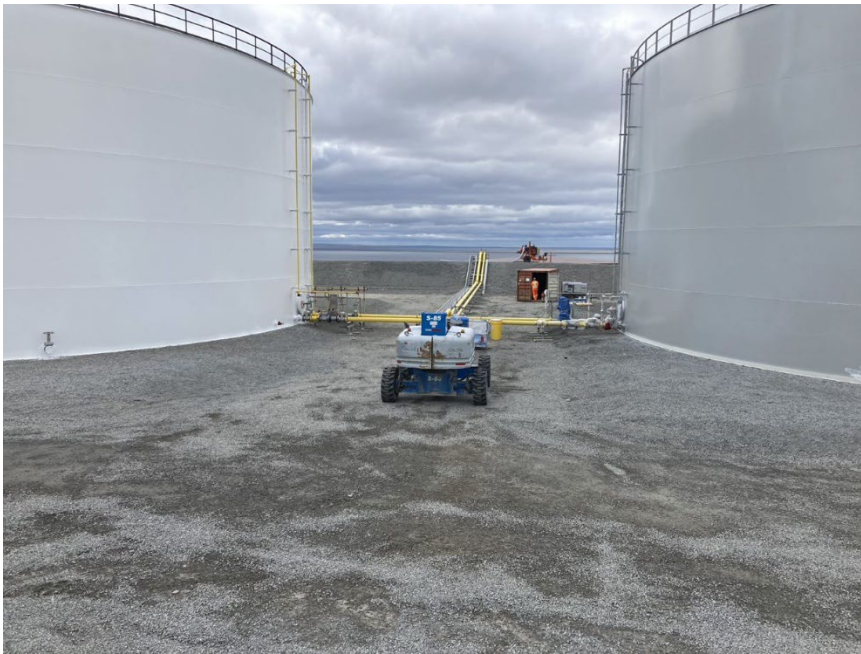
Photograph G1-19 Baker Lake Tank Farm

Description: Looking southwest at the crest on the northeast corner of Tank 8.

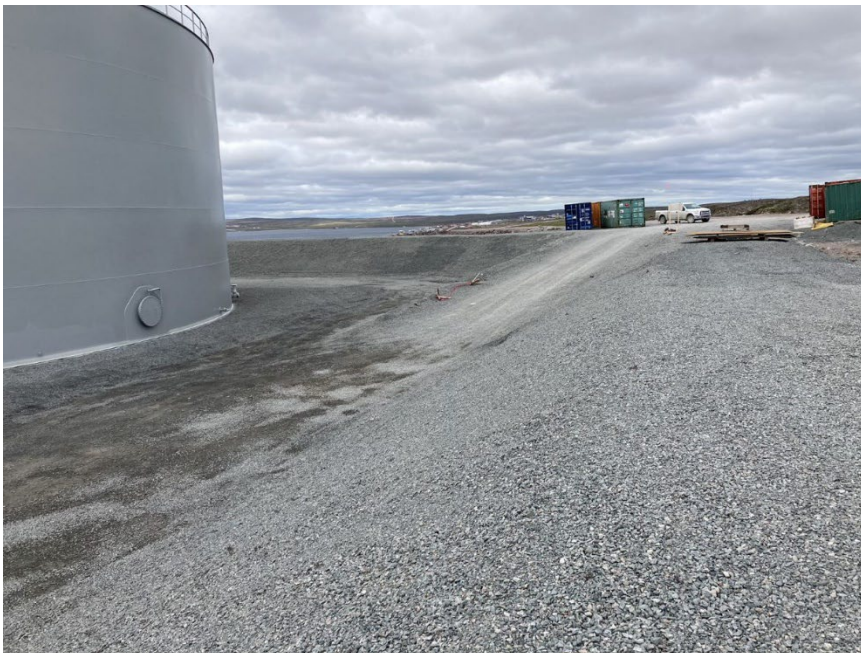
Photograph G1-20 Baker Lake Tank Farm

Description: Looking southwest between Tank 8 and Tank 7.

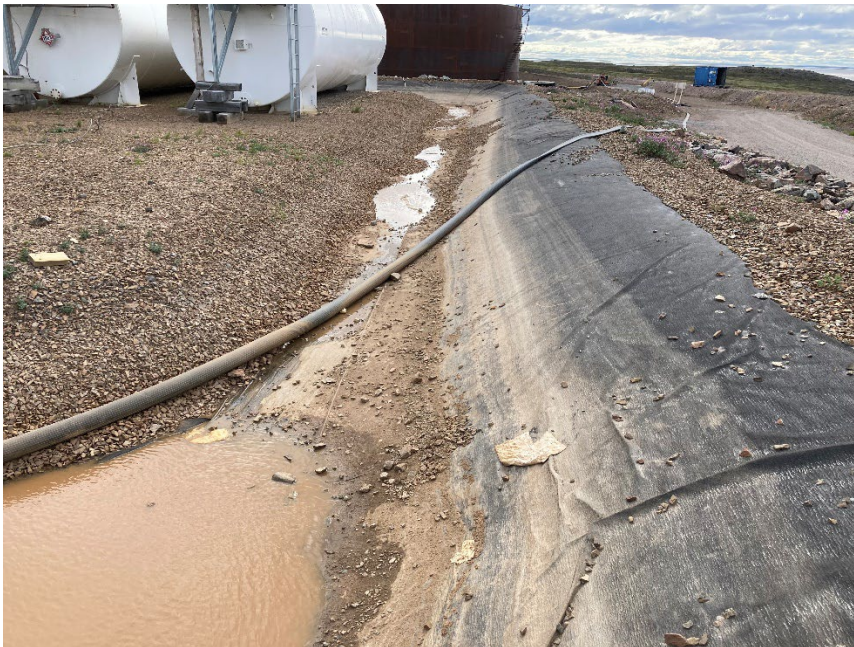
Photograph G1-22 Baker Lake Tank Farm

Description: From the southwestern corner of the Jet A fuel tanks looking northeast. Presence of exposed geomembrane with holes and water ponding.

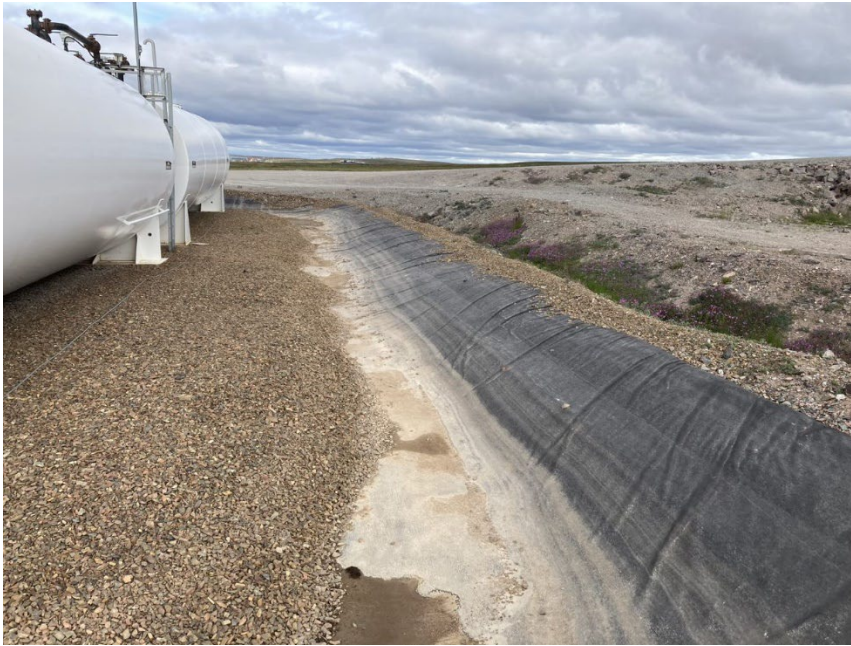
Photograph G1-23 Baker Lake Tank Farm

Description: From the southwestern corner of the Jet A fuel tanks looking east. Presence of exposed geomembrane and water ponding.

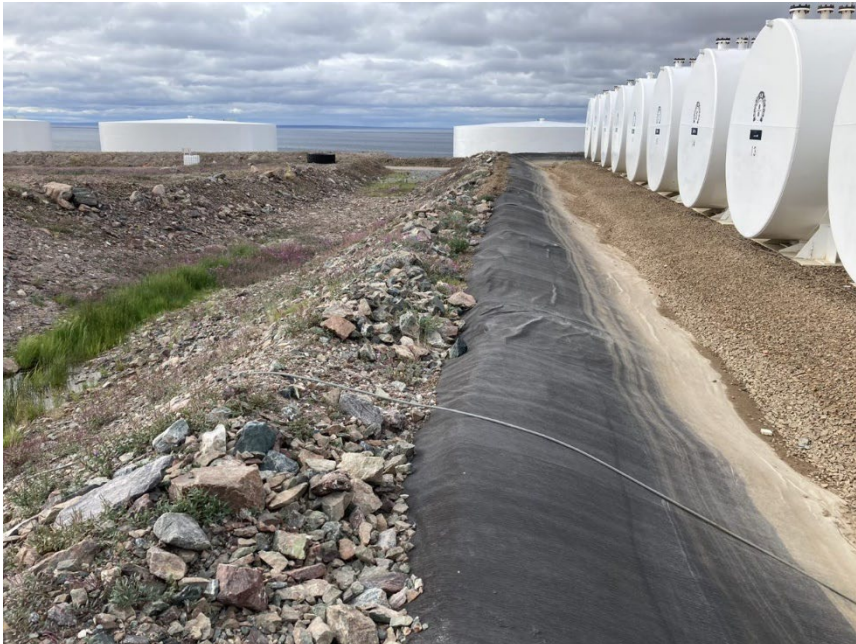
Photograph G1-24 Baker Lake Tank Farm

Description: From the northeastern corner of the Jet A fuel tanks looking west.

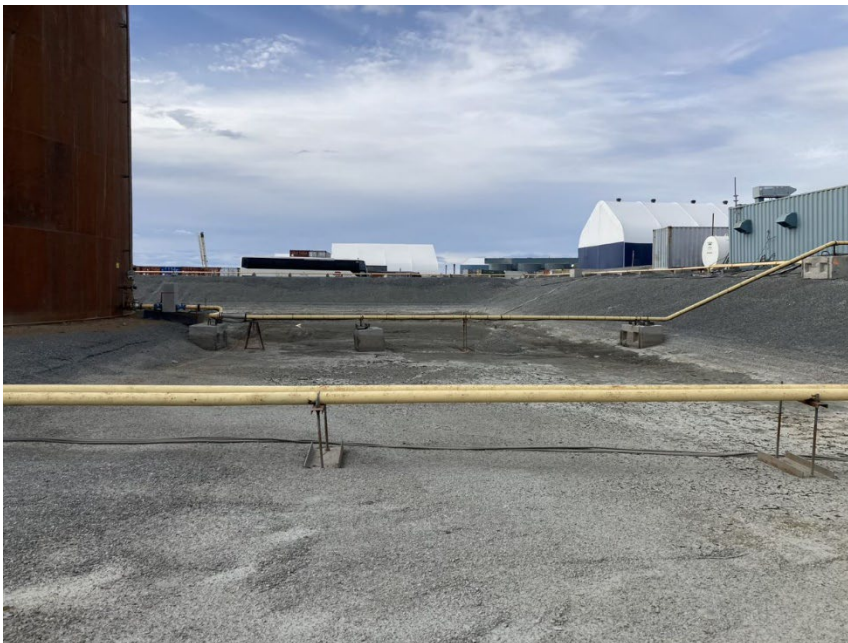
Photograph G2-6 Meadowbank Tank Farm

Description: Looking southeast from the northeastern side of the tank. Presence of water ponding.

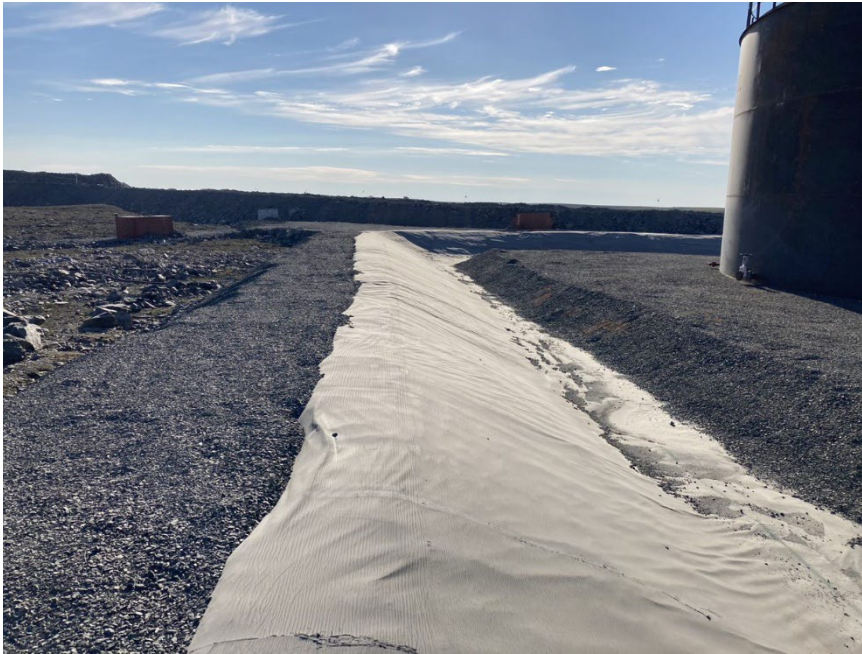
Photograph G3-3 Whale Tail Project Site Tank Farm

Description: From the fuelling pad, looking north at the Tank Farm. Presence of water ponding.

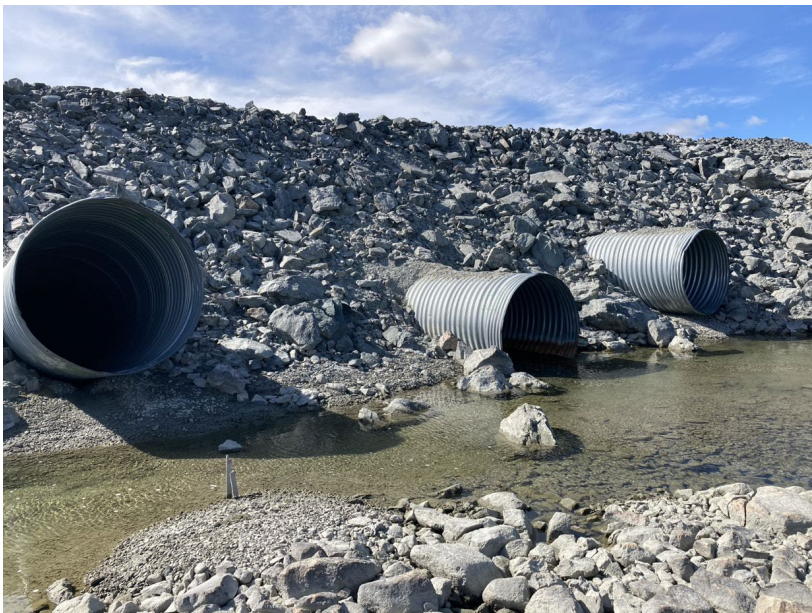
Photograph H1-2 Vault Road Culverts

Description: Looking at the outlet of the three culverts located on Vault Road at 640964E/7217466N. All of them are deformed in the middle.

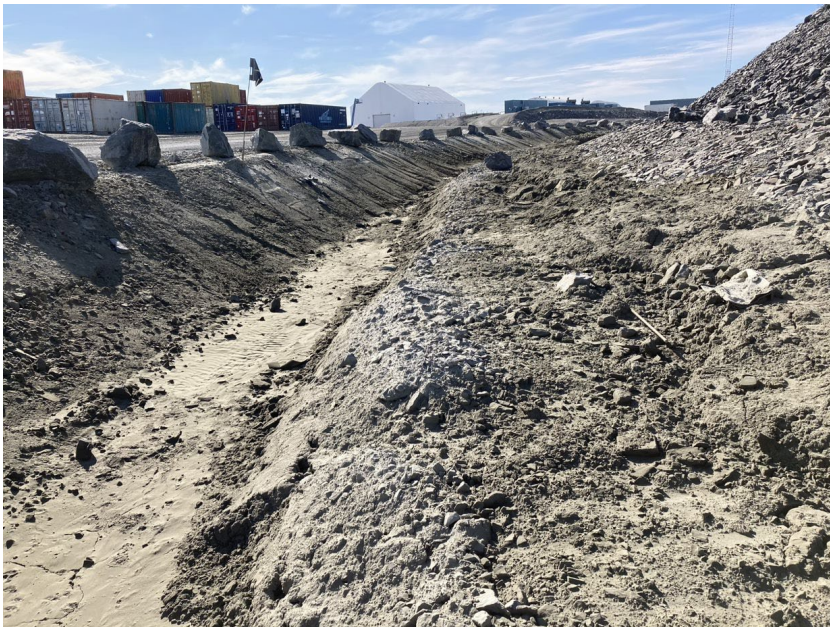
Photograph H11-4 Saline Ditch

Description: From approx. Sta. 0+140, looking southeast. Presence of mud and gravel in the ditch.

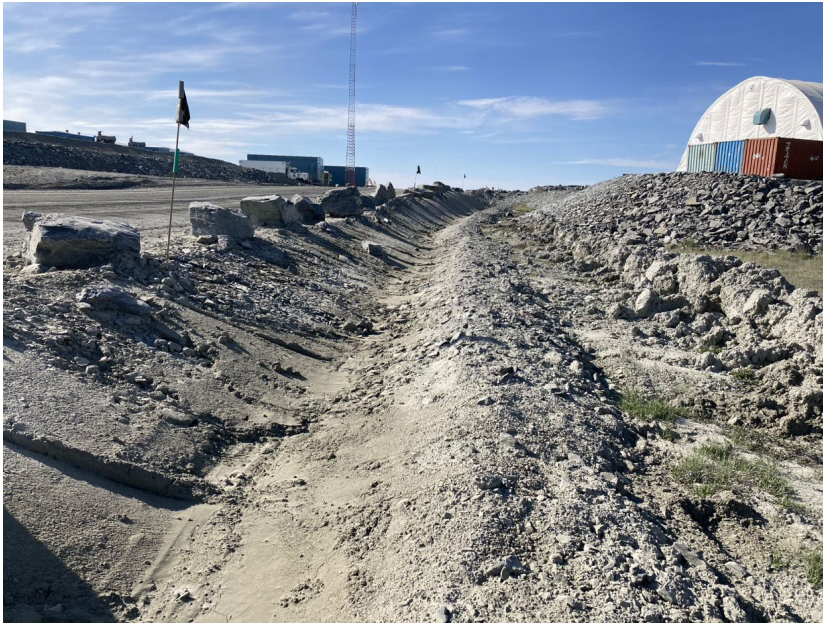
Photograph H11-5 Saline Ditch

Description: From approx. Sta. 0+140, looking southeast. Presence of gravel in the ditch.

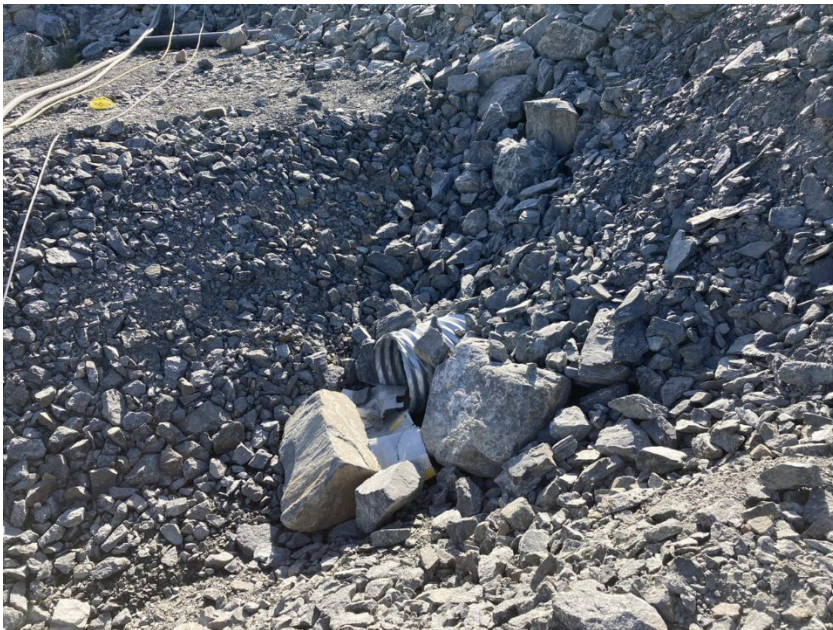
Photograph H11-10 Saline Ditch

Description: From approx. Sta. 0+560. Culvert obstructed by blocks and debris.

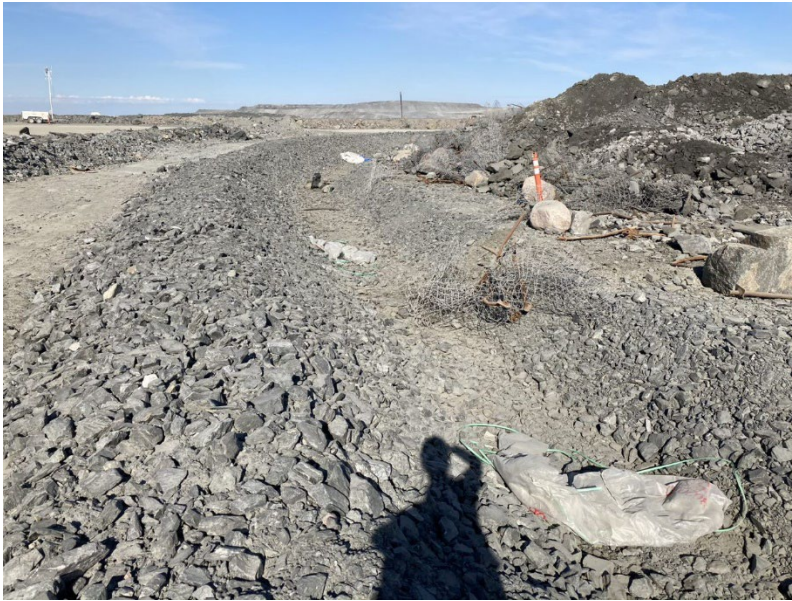
Photograph H12-3 UG Ore Stockpile Saline Ditch

Description: From approx. Sta. 0+050, looking southwest. Presence of debris in the ditch.

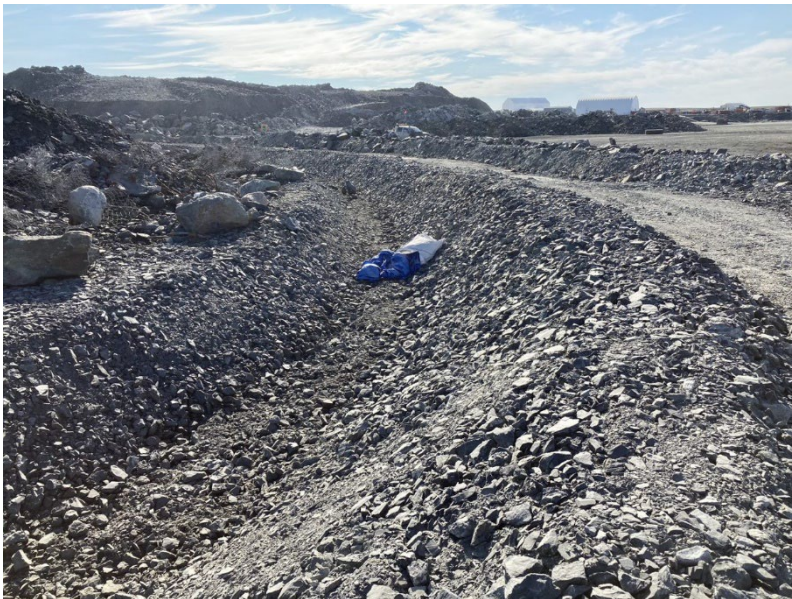
Photograph H12-4 UG Ore Stockpile Saline Ditch

Description: From approx. Sta. 0+150, looking southeast. Presence of debris in the ditch

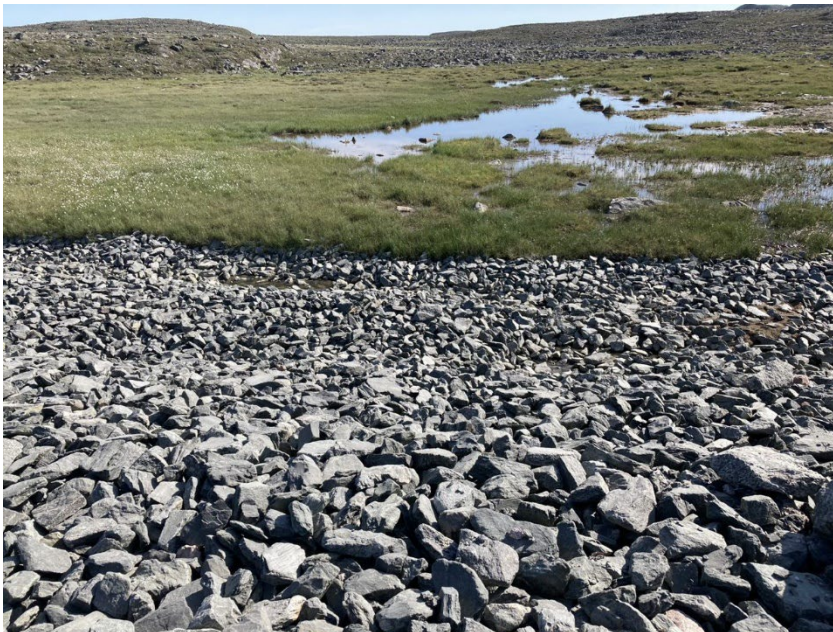
Photograph H13-2 IVR Diversion Channel

Description: From around Sta. 0+020, looking northeast. Water is entering the channel from the natural topography.

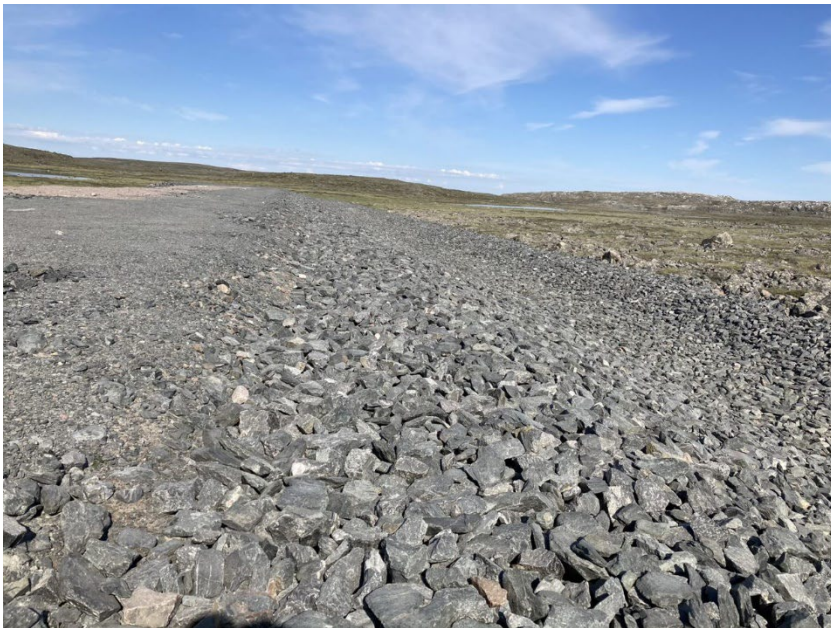
Photograph H13-4 IVR Diversion Channel

Description: From around Sta. 0+130, looking northwest.

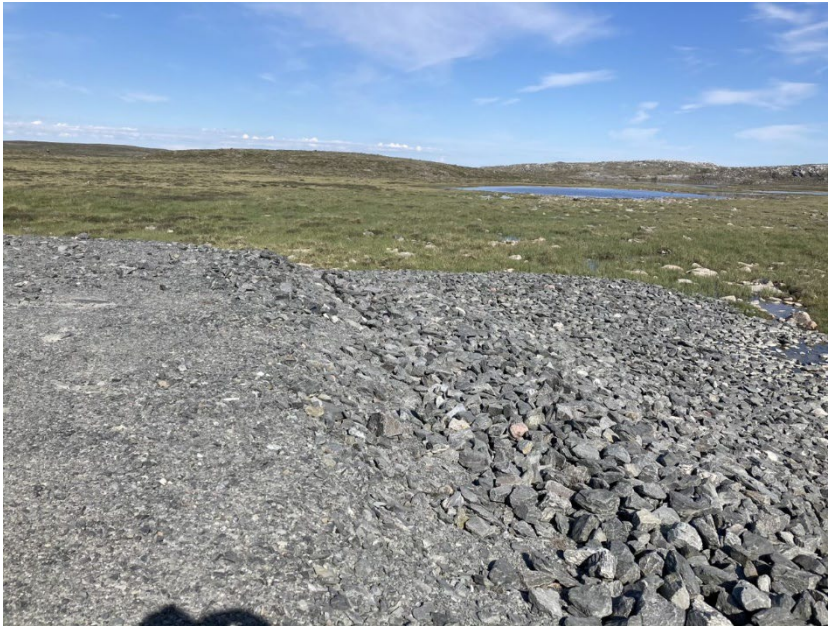
Photograph H13-5 IVR Diversion Channel

Description: From around Sta. 0+270, looking north at the outlet. Water is flowing well towards the lake.

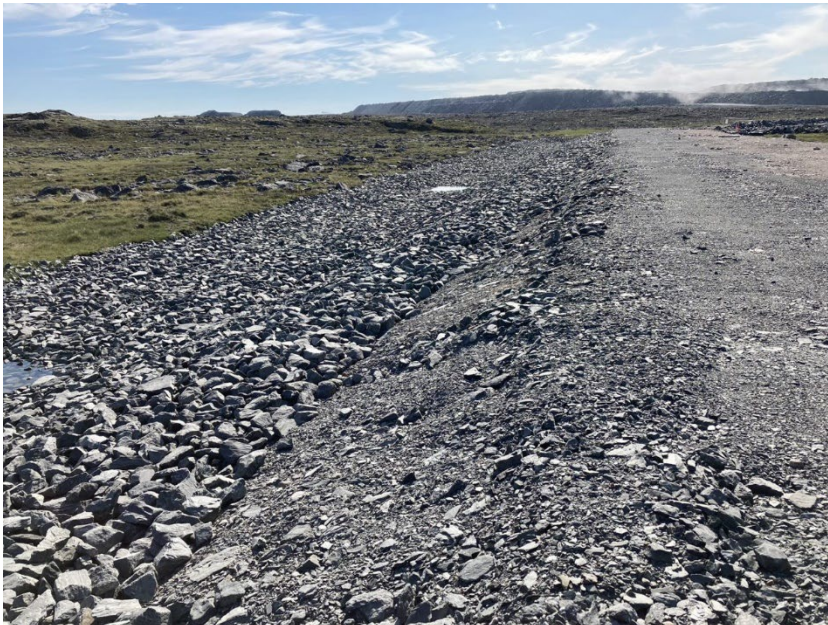
Photograph H13-6 IVR Diversion Channel

Description: From around Sta. 0+270, looking southeast.

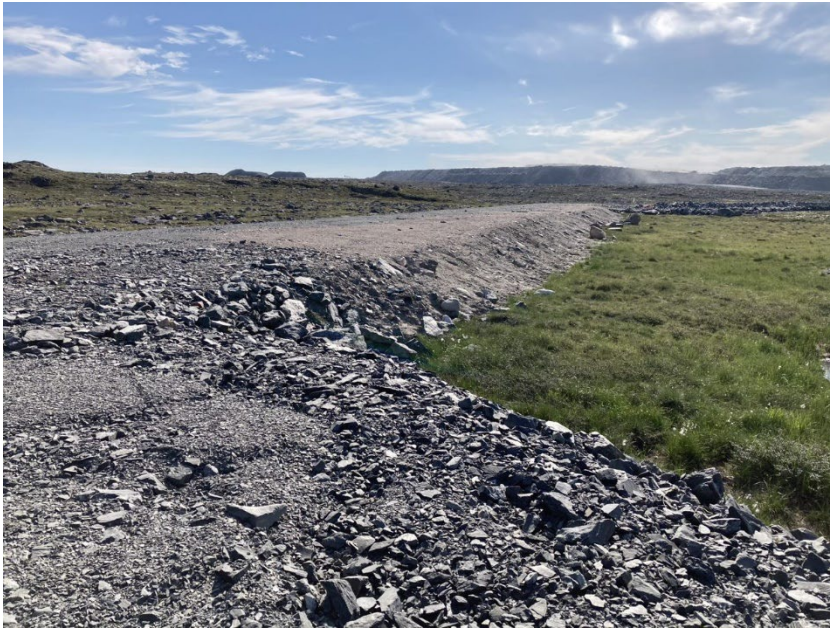
Photograph H13-7 IVR Diversion Channel

Description: From around the access road Sta. 0+270, looking southeast. Tension cracks in the side slope of the road.

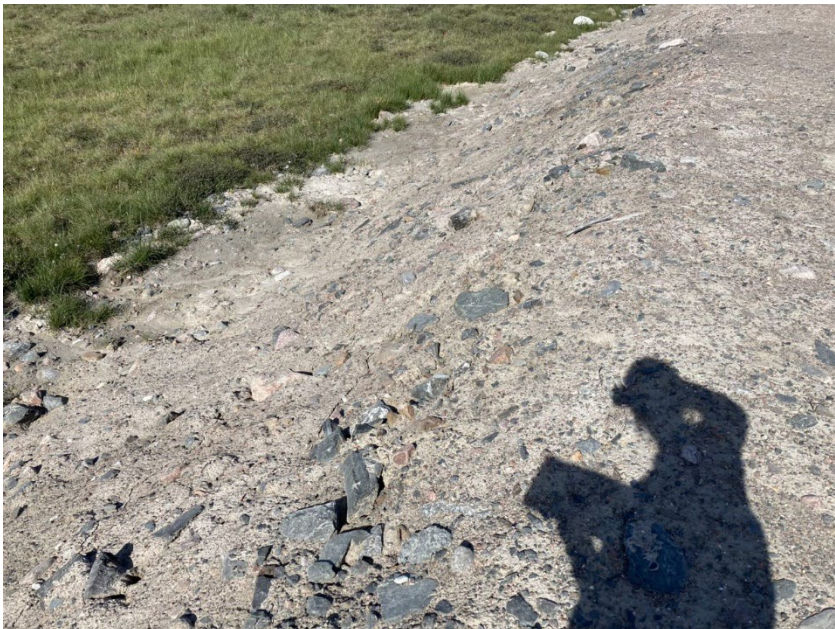
Photograph H13-8 IVR Diversion Channel

Description: From around the access road Sta. 0+110, looking northwest. Tension cracks in the side slope of the road.
