Whale Tail 2022 Annual Open Pit Geomechanical Inspection

March 17, 2023

**RE: Meadowbank Complex - Amaruq Site - 2022 Annual Open Pit
Geomechanical Inspection**

Meadowbank Complex - Amaruq Site - 2022 Annual Open Pit Geomechanical Inspection

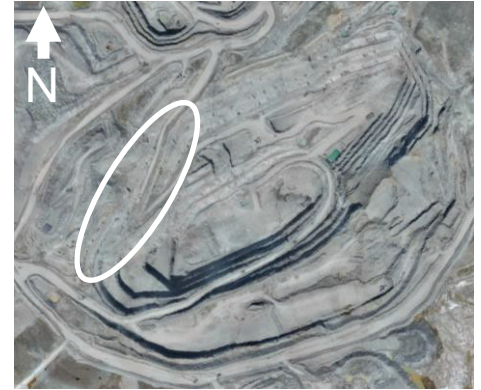
Observations - Northwest Wall

BFA: 65°
Bench Width: 10 m
Bench Height: 21 m
IRA: 47°

- Final wall in Design Sector A1/A1K.
- No mining has occurred in this area and there have been no slope failures since the last annual inspection.
- The benches are generally performing well.
- The Oxidized Greywacke is thought to be associated with a talik zone below what was the western end of Whale Tail Lake. It is of lower rock mass quality than the Greywacke and prone to ravelling. The exposures along the ramp are limited in height and rockfall has not been a concern to date. If ravelling increases, a rockfall berm could be constructed along the inside of the ramp through this unit.

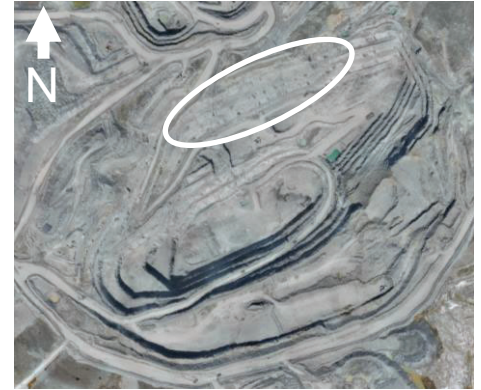
Observations - North Wall

BFA: 65°
Bench Width: 10 m
Bench Height: 21 m
IRA: 47°

- Final wall in Design Sector B1.
- Limited mining has occurred in this area and there have been no slope failures since the last annual inspection.
- The benches are performing better than expected, with the bench face often standing steeper than the foliation.
- The 2021/2022 design review found that many of the pre-shear drillholes have been drilled at an angle shallower than the planned 60°, reducing the effective bench width. Comments on drill and blast quality control are provided later in this presentation.

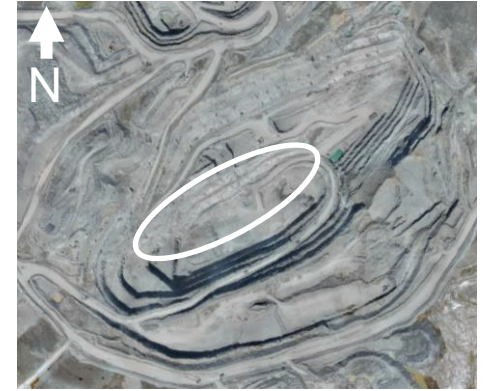
Observations - Phase 1 North Wall

- Interim wall in Phase 1. Phase 1 has been the focus of production over the past year.
- The wall was established in the Komatiite, parallel to the foliation. As expected, a series of bench-scale failures have occurred in areas where the foliation locally dips at a shallower angle than the bench face.

- The implementation of a 55° pre-shear has improved slope performance and half barrels are visible in many areas. Bench-scale failures have and will continue to occur. AEM continues to complete extensive scaling in this sector in order to remove potential hazards and reduce the likelihood of a failure. This is endorsed.

- The bench failures almost always occur during freshet or the summer months.
- As a result, the development of the ramp along the this wall was prioritized during the 2021-2022 winter in order to minimize the rockfall risk to personnel. A berm was installed along the inside of the ramp prior to freshet.

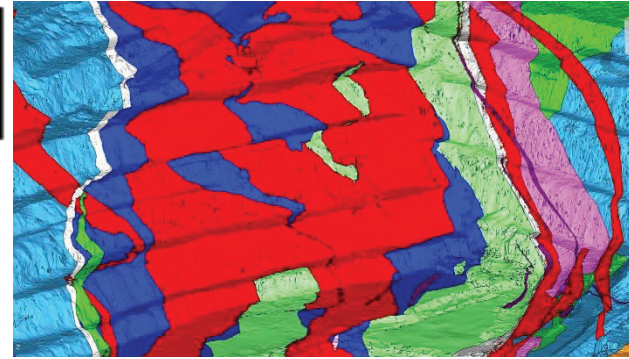
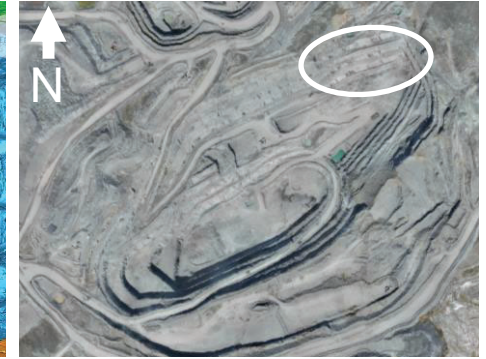
Observations - Northeast Wall

BFA: 55°
Bench Width: 11 m
Bench Height: 14 m
IRA: 34°

- Final wall in Design Sector D4K.
- This sector is within the Komatiite and has been characterized by a series of bench scale failures. The failures are currently understood to be a hybrid of failure on the foliation and failure of the weak rock mass, influenced by water (i.e., a combination of seepage within the talik and surface runoff) and the Brittle Structures.

- A revised slope design was developed in December 2021 and a pushback of the upper two benches completed to re-establish the slope. The pushback will eventually form part of the planned Whale Tail Extension to the northeast.

- The performance of the benches has improved with the revised slope design. Several bench-scale failures have occurred and will continue to occur.
- A series of bench-scale failures have occurred at the eastern end of the sector (outlined at right). The failures have almost, but not yet, linked up. This area is discussed on the following slide.

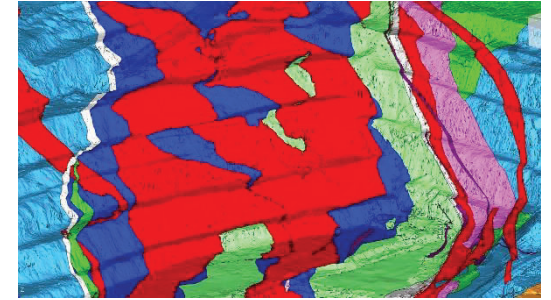
Observations - Northeast Wall (2)

- Seven rockfalls and bench scale failures have been reported in this sector in 2022, ranging in tonnage between approx. 150 and 1500 tonnes. All but one are associated with a series of progressive failures associated with the area outlined in the left photo.

- The failures occurred during freshet, between May 28 and July 17, with most occurring in June. Failures were expected and a rockfall berm was constructed below this area prior to freshet.

- The middle photo shows the outlined area at the time of many of the initial failures in June. These failures were relatively small and several appear to be associated with surface water or erosion of the face (see next slide). The rock mass quality was noted to reduce as the rock mass thawed and these failures progressed over time. The failures on the two benches have almost linked up.

- The western limit of the failures appears to be defined by the foliation. The eastern limit of the failures appears to have a structural control (see right photo). This may be one of the brittle structures (see image at upper right, with brittle structures in red).

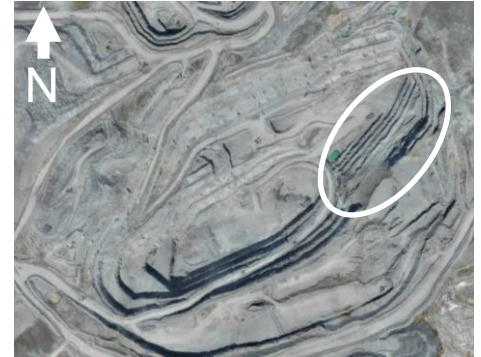
Observations - Phase 2 Southeast Wall

KOMATIITE
BFA: 75°
Bench Width: 10.5 m
Bench Height: 21 m
IRA: 52°

- Interim wall approximately within Design Sector G5. Also referred to as Phase 2 South (G5).
 - The lower portion of the wall has been developed with single benches. This was initiated due to the rockfall hazard at the transition with the East Wall.

- The wall is in the process of being mined out as part of the Phase 3 pushback. Spillover from the pushback is accumulating on the uppermost catch benches. The single benches have been effective and material has not yet reached the lower benches or the pit floor. This should continue to be monitored.

- Specific areas of note are listed below and outlined on the photo.
1. A bench-scale failure occurred along a sub-vertical contact between the Komatiite and the Greywacke in 2021. The failure will be mined out by the pushback. It is likely that localized bench-scale failures will occur on adversely oriented contacts as mining progresses.

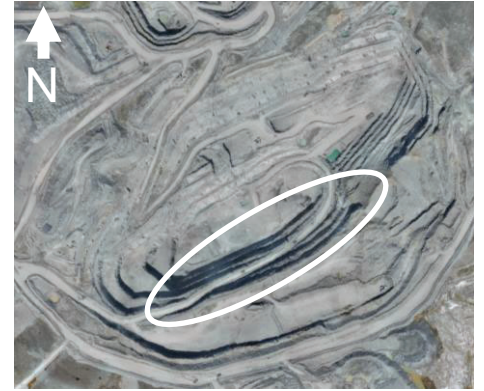
Observations - Phase 2 South Wall

- Interim wall approximately within Design Sector H5. Also referred to as Phase 2 South (H5).
- The wall is generally performing well. Specific areas of note are listed below and discussed on the following slides.
 1. Spillover from the Phase 3 pushback has created a rockfall hazard along the Phase 1 ramp (not numbered below as it occurs throughout).
 2. Seepage within the talik associated with Whale Tail Lake.
 3. A possible unstable block was previously identified below the ramp.
 4. Poor scaling of the lowermost bench has created a rockfall hazard.

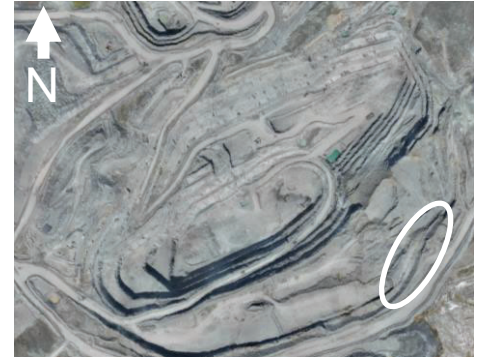
Observations - Phase 3 South Wall (4)

- A prominent fault, believed to be the Ramp Fault, has been exposed in the southeast wall of the Phase 3 Pushback.
- The fault is associated with a zone of reduced rock mass quality 1 to 2 m thick and 10 to 20 cm of gouge.
- A considerable amount of loose was present on the wall. It is understood that the wall had not yet been approved and that additional scaling will be recommended. This is endorsed.

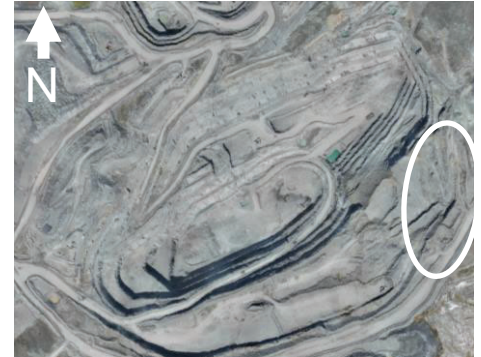
Observations - Phase 3 Southeast Wall

BFA: 75°
Bench Width: 16 m
Bench Height: 21 m
IRA: 44°

- Final wall in Design Sector F6.
- The slope geometry recommendations for this sector were adjusted in late 2021 as the strike of the sector had changed, increasing the potential for planar failure on Joint Set C.
- The achievable bench geometry is sensitive to both the persistence of Joint Set C and blasting and scaling practices. With careful blasting and scaling, a BFA of 75° and IRA of 44° could be achievable if the persistence is limited to 10 m or less, though with backbreak in the order of 8 m. However, if these practices are not used or are not effective, a BFA of 50° and IRA of 39° will be required.
- Geotechnical inspections and Bench Approvals were identified as a critical control for managing potential crest loss, rockfall and bench-scale failures.
- These are the first benches established in this sector and it is important to validate the bench design and implementation.
