IVR V1 Open Pit

Observations - Northeast Wall

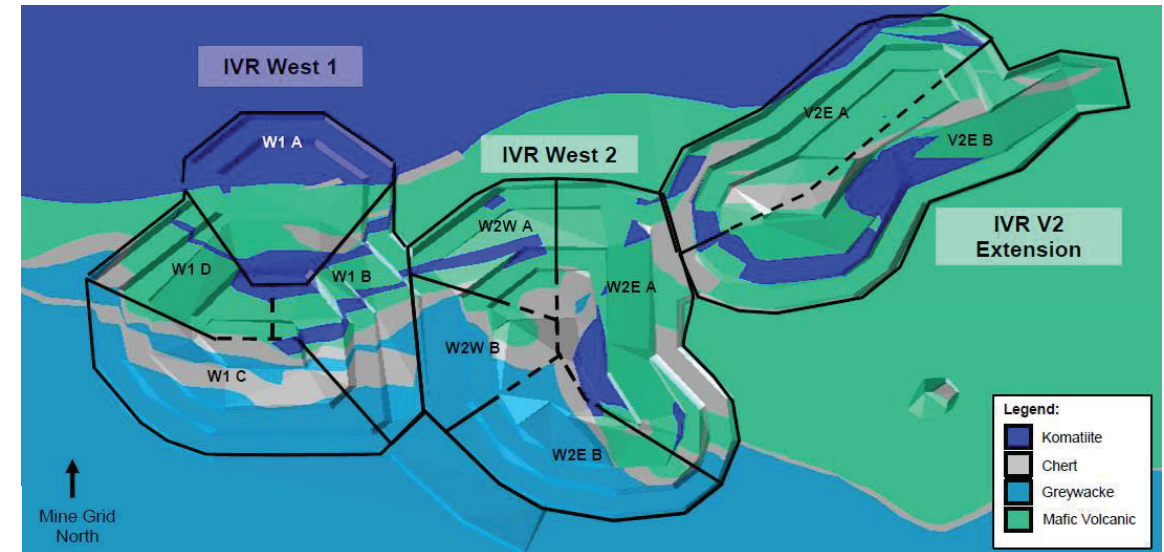
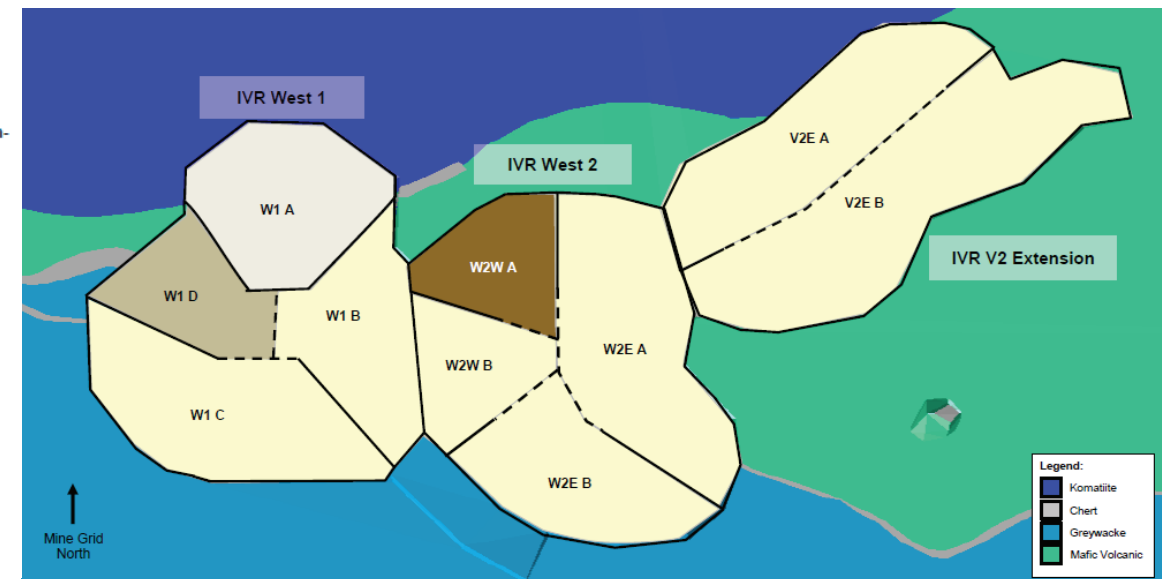
Bench Geometry Controlled by Bench-Scale Failures

W1 D
BFA: 65°
Bench Width: 10 m
Bench Height: 21 m
IRA: 47°

W2W A
BFA: 55°
Bench Width: 11 m
Bench Height: 21 m
IRA: 39°

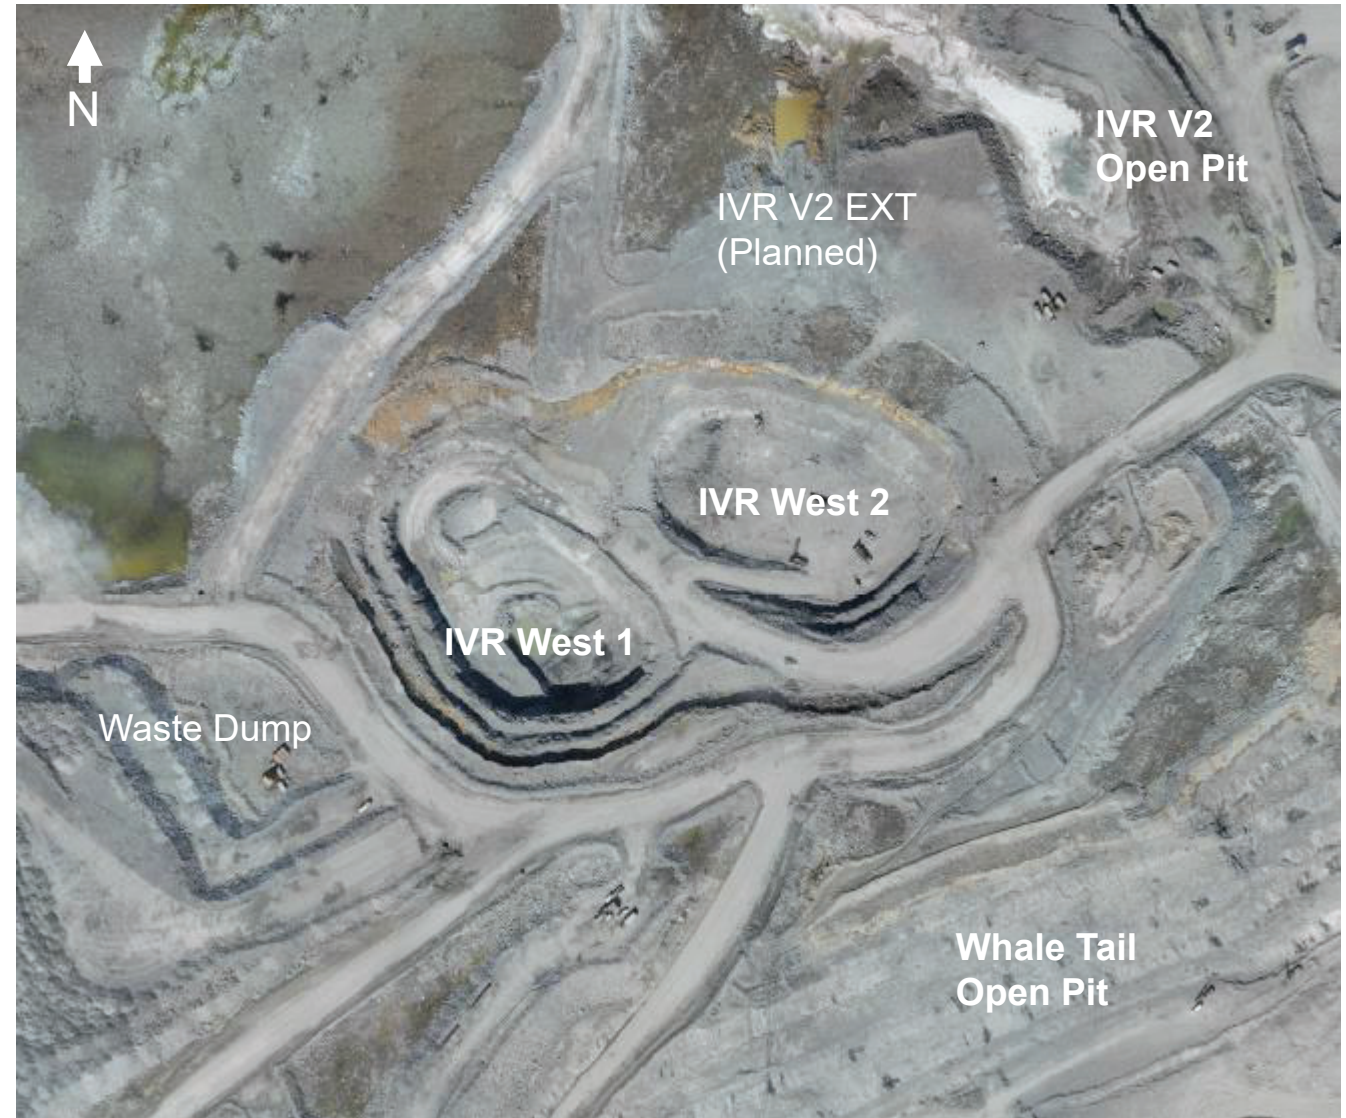
- The IVR West 1 and IVR West 2 open pits were inspected on August 14 and 15, 2022. Observations made during the inspection are summarized on the following slides.
- The approximate current pit geometry is shown at right.
- Mining of IVR West 1 was recently completed and the open pit is being partially backfilled with waste rock. The drone imagery shown at right was taken prior to the start of backfilling.
- Mining of IVR West 2 will be completed in August 2022 at which point the open pit will be used for water management before being backfilled in 2033.
- Mining of IVR V2 Extension has not yet started.

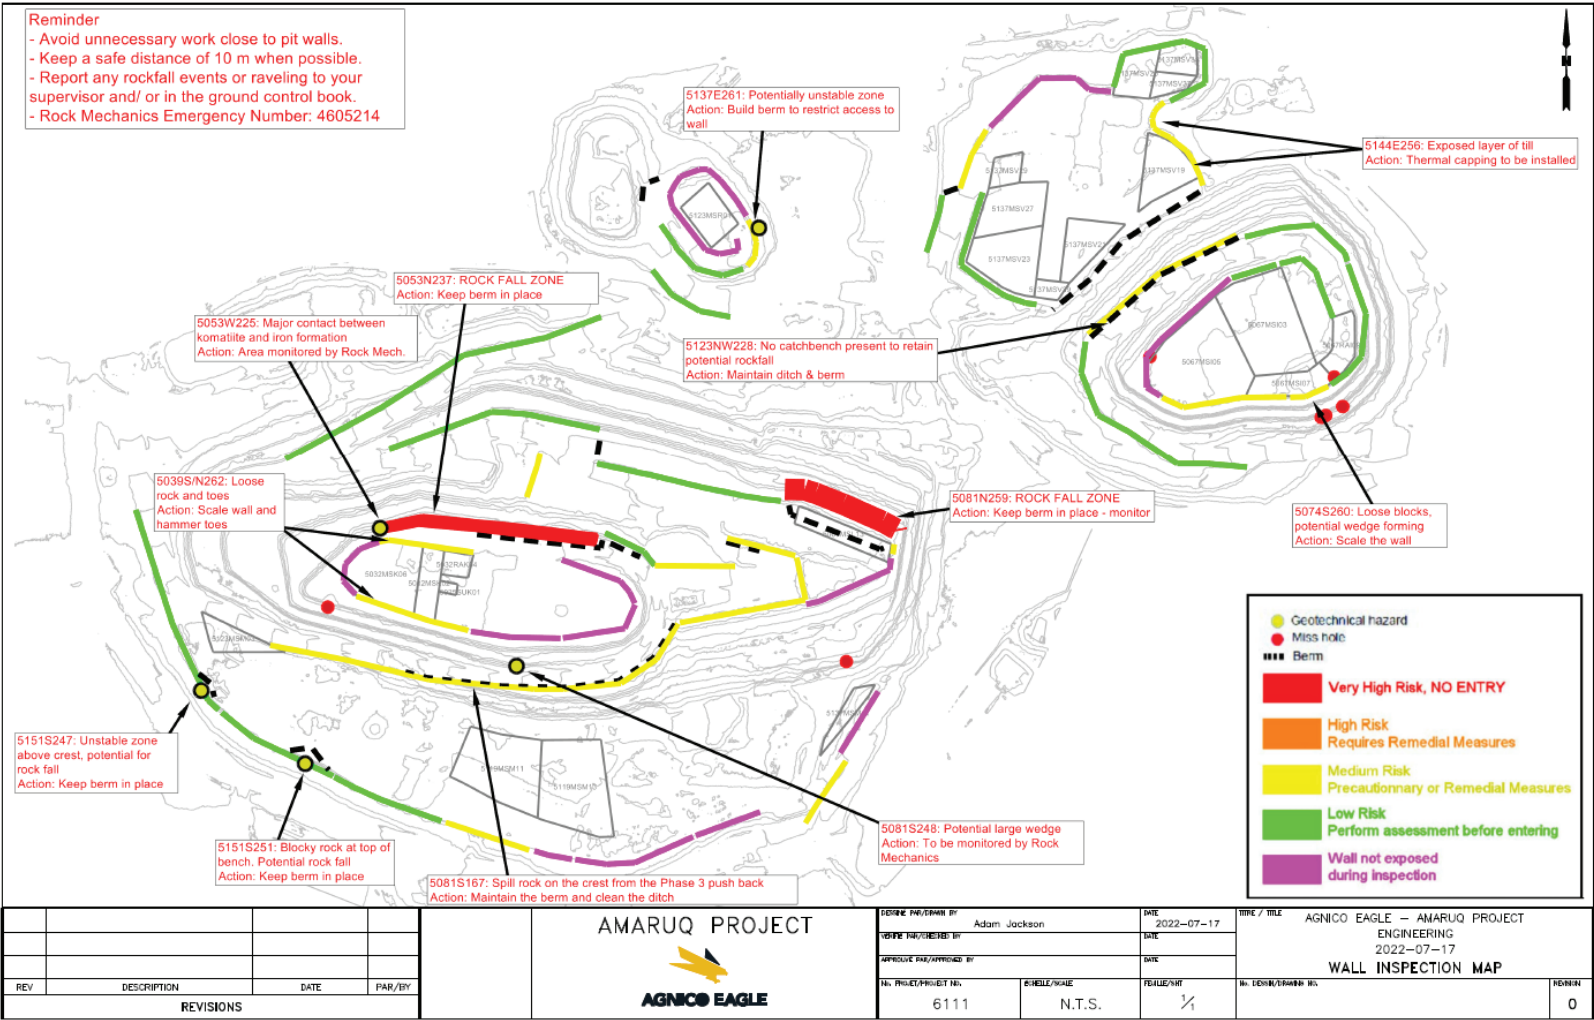
- Identified hazards and the required mitigation work are tracked on a Hazard Map available to the workforce. The map is an effective tool.
- There continues to be limited guidance on how to select the risk ratings. Recommend providing detailed guidance, including examples, on how to determine these ratings. The goal is to ensure that each member of the Rock Mechanics team can perform the assessment in a consistent and reliable manner.
- The map is updated every two weeks. However, with multiple pits in progress it is often rapidly out of date. Recommend issuing an update weekly (or more frequently) if there are notable changes. One possibility would be to issue a brief supplement that focuses solely on what has changed.

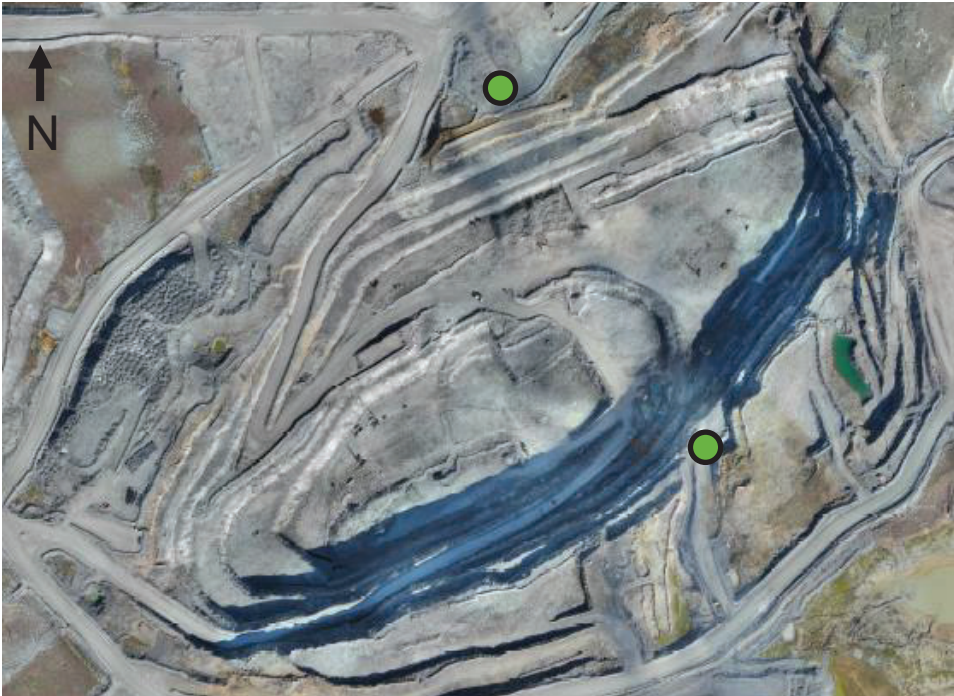
- The actions to be taken by Dispatch in the event of a Grey or Orange alarm specifically state that operations are not to be stopped. This is often at odds with the guidance provided by Rock Mechanics and creates room for confusion. Recommend modifying the response, so that the first action is to contact Rock Mechanics (or the Pit Supervisor).

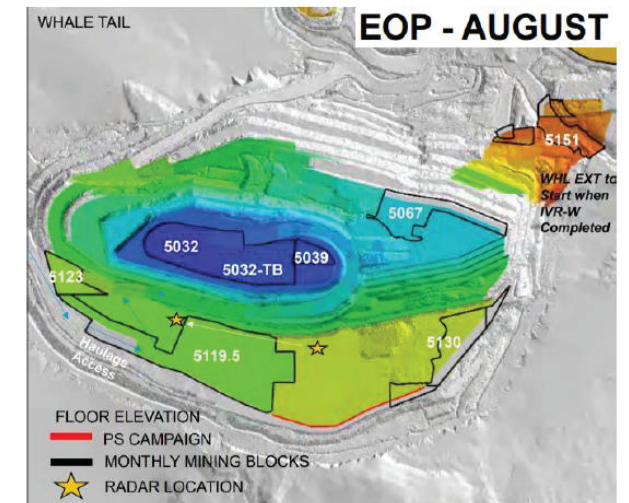
MONITORING OF NORTH WALL

Exact location for the radar to be determined. It will be critical to monitor the NE wall once activities resume in Phase 2, however it may interfere with mining of 5130 bench in Phase 3. Blasts are typically directed to the west. Moving the radar out for each blast may be required.
