### **Meadowbank and Whale Tail 2022 Annual Geotechnical Inspection**

**REPORT****2022 Annual Geotechnical Inspection***Meadowbank Complex, Nunavut*

**Golder Associés Ltée**

1617-2146800622-5000-RA-Rev0

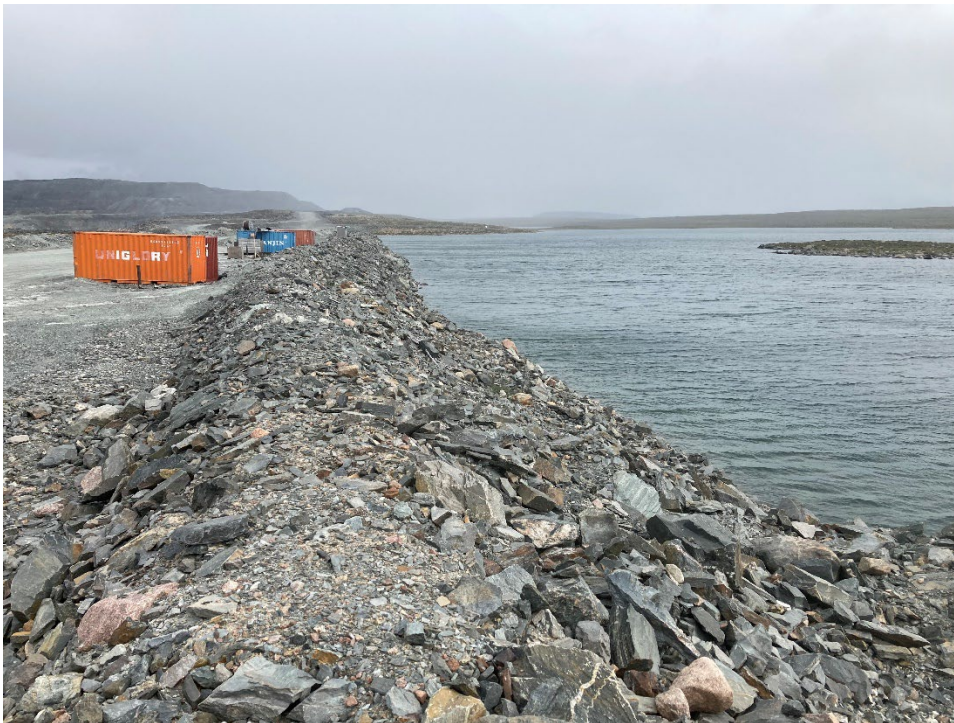
**Photograph A1-6 East Di**

**Description:** From Sta. 60+300 upstream, looking north at the crest and upstream slope.

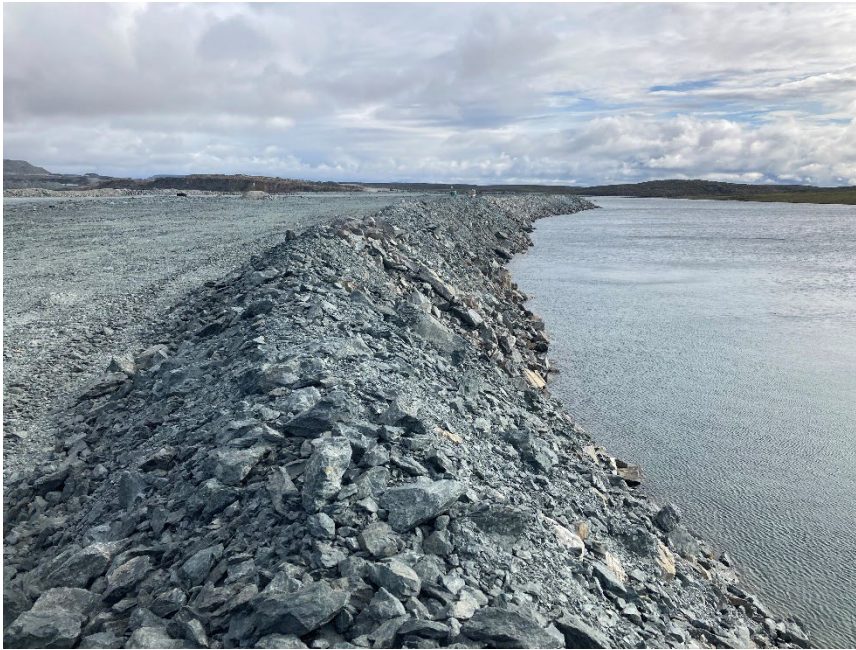
**Photograph A3-5 Bay Goose Dike**

**Description:** From Sta. 30+500, looking northeast at the crest and the upstream slope.

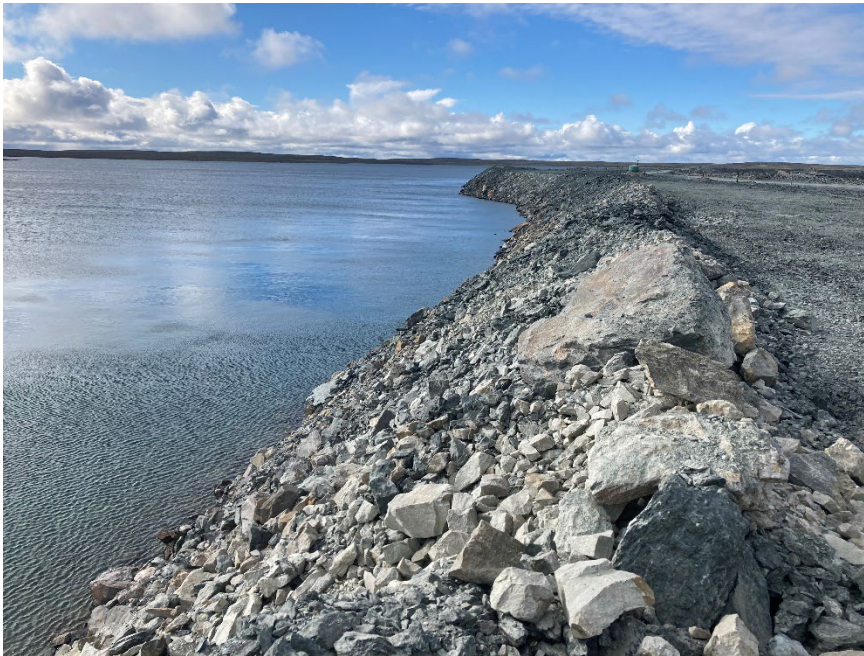
**Photograph A3-6 Bay Goose Dike**

**Description:** From Sta. 30+500, looking south at the crest and the upstream slope.

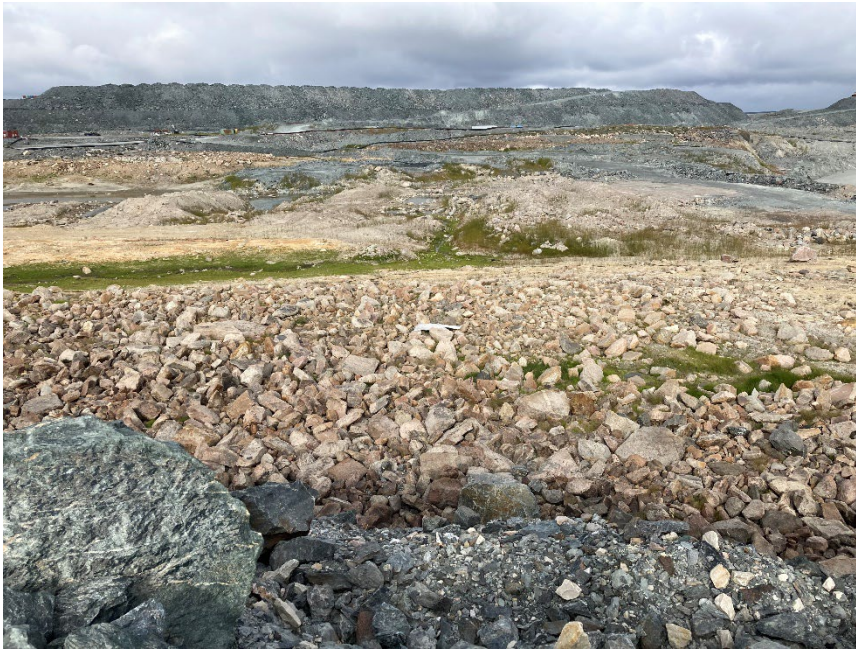
**Photograph A3-7 Bay Goose Dike**

**Description:** From Sta. 30+500, looking west at the downstream slope and toe.

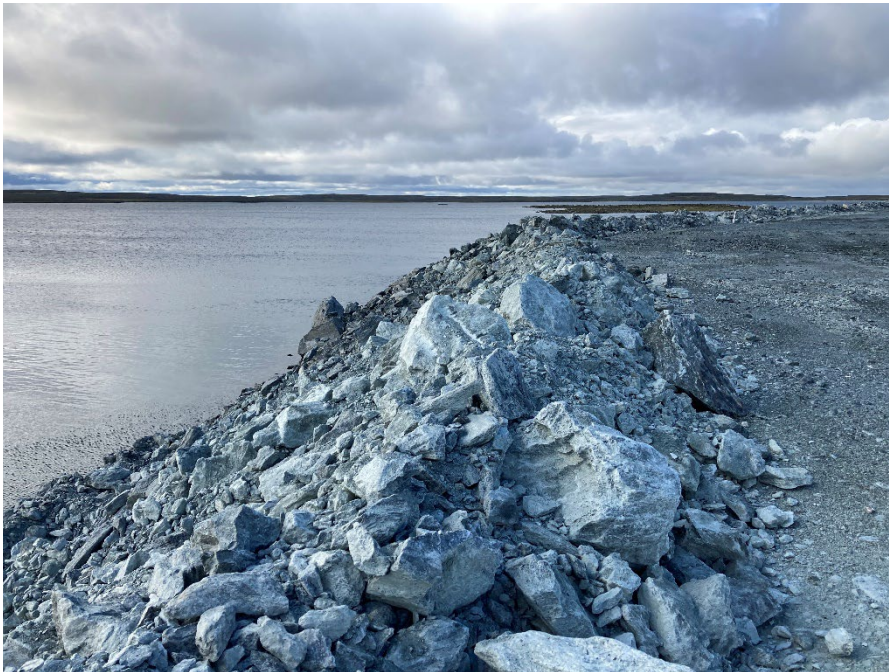
**Photograph A3-8 Bay Goose Dike**

**Description:** From approximately Sta. 31+130, looking south at the upstream slope.

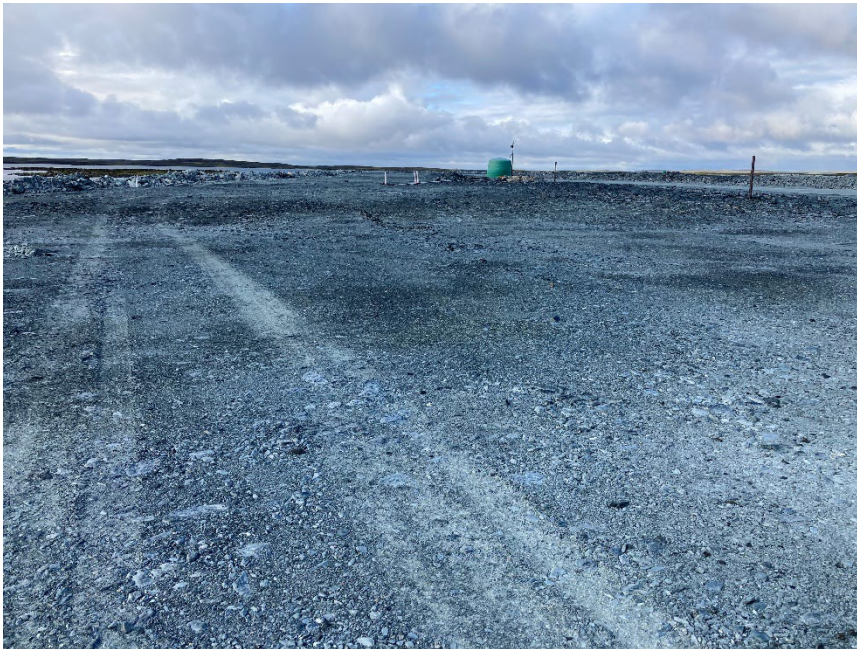
**Photograph A3-12 Bay Goose Dike**

**Description:** From approximately Sta. 31+130, looking southwest at the crest.

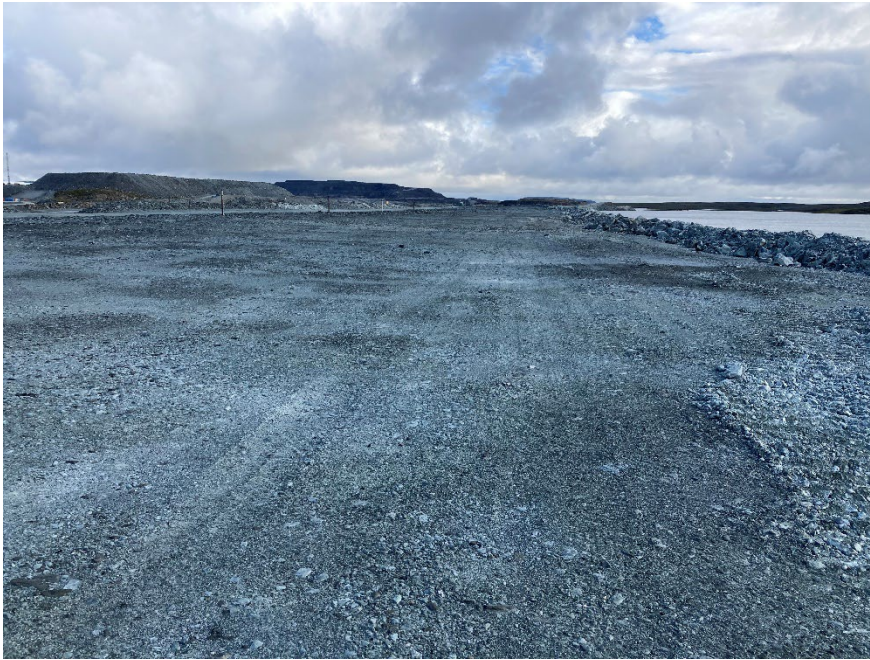
**Photograph A3-13 Bay Goose Dike**

**Description:** From approximately Sta. 31+130, looking north at the crest.

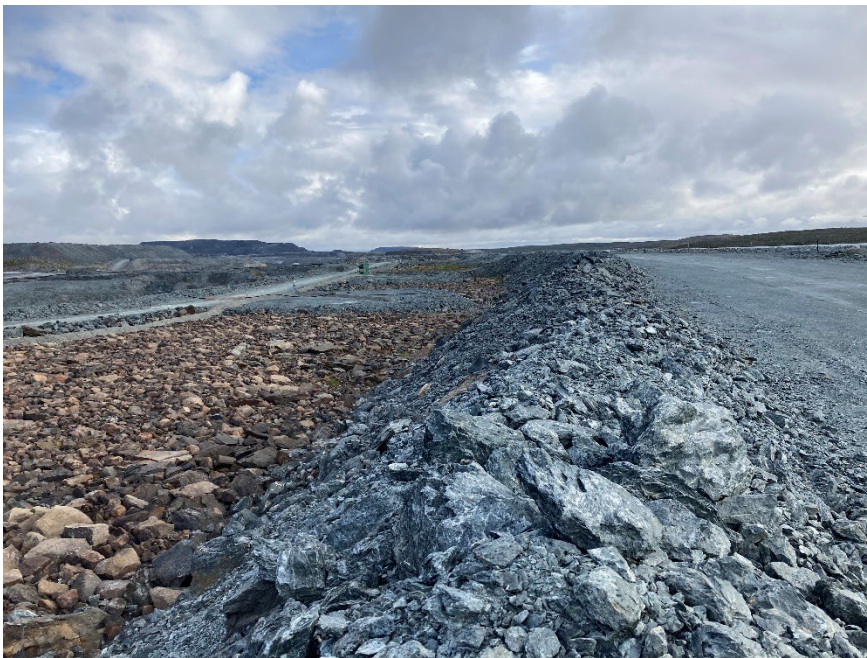
**Photograph A3-14 Bay Goose Dike**

**Description:** From approximately Sta. 31+280 on the crest, looking north at the downstream slope and toe area.

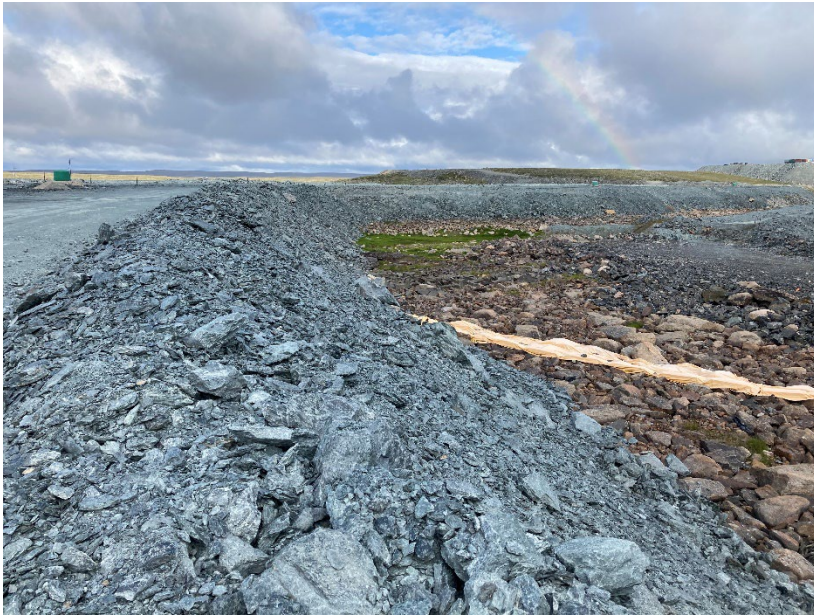
**Photograph A3-21 Bay Goose Dike**

**Description:** From approximately Sta. 31+475, looking west at the crest and the downstream slope toward Channel 3.

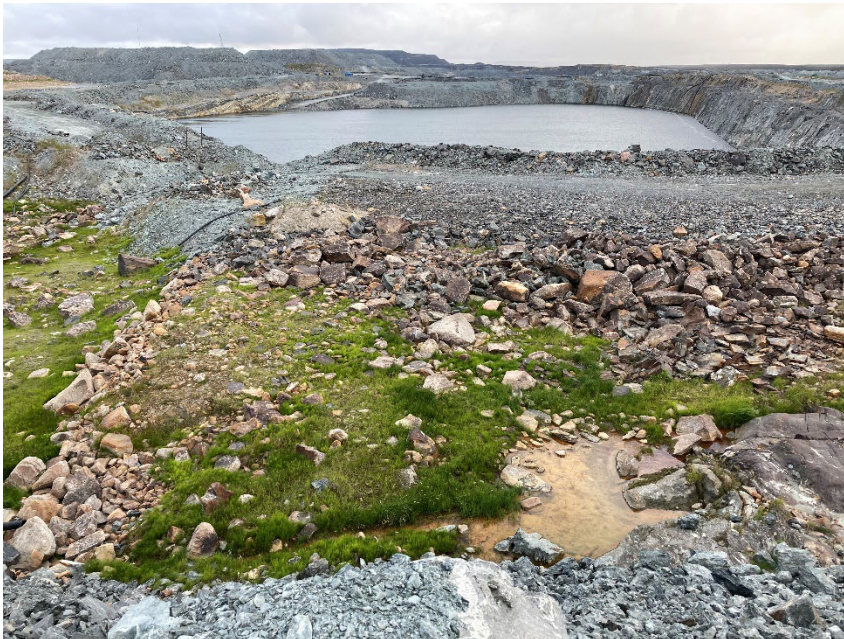
**Photograph A3-22 Bay Goose Dike**

| INSPECTION ITEM | OBSERVATIONS DATA | PHOTO | COMMENTS & OTHER DATA |
|---|---|---|---|
| | Channel 3 | | Light flow observed during inspection. Monitored by station 6. |

**Description:** From approximately Sta. 31+570, looking north toward Channel 3.

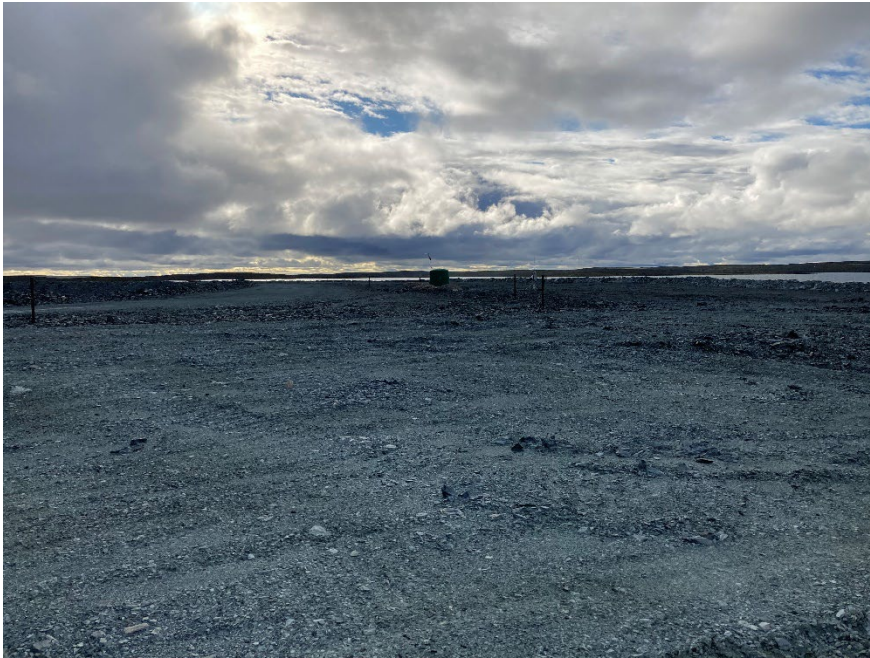
**Photograph A3-23 Bay Goose Dike**

**Description:** From approximately Sta. 31+645, looking east at the crest.

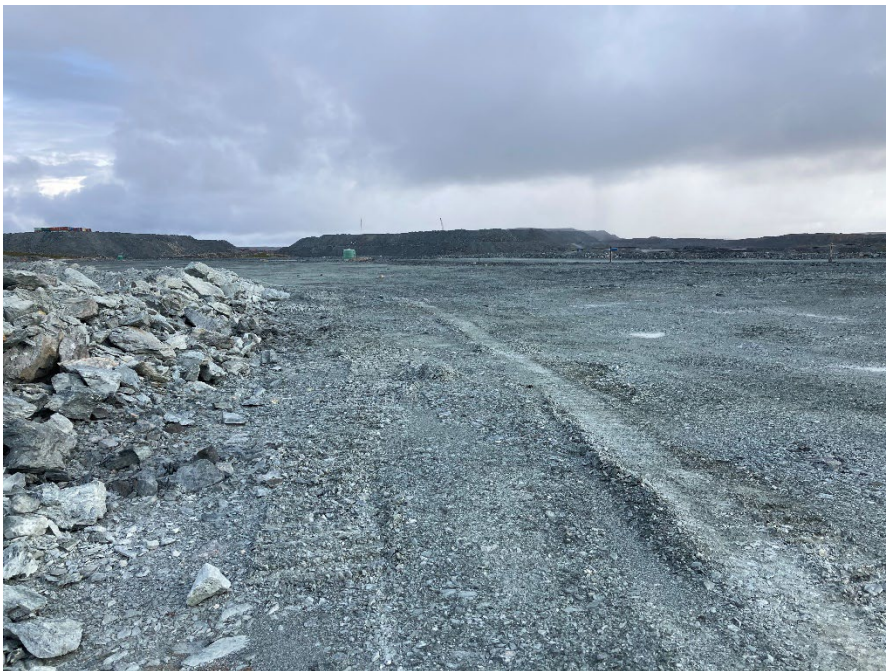
**Photograph A3-24 Bay Goose Dike**

**Description:** From approximately Sta. 31+645, looking northwest at the crest and upstream slope.

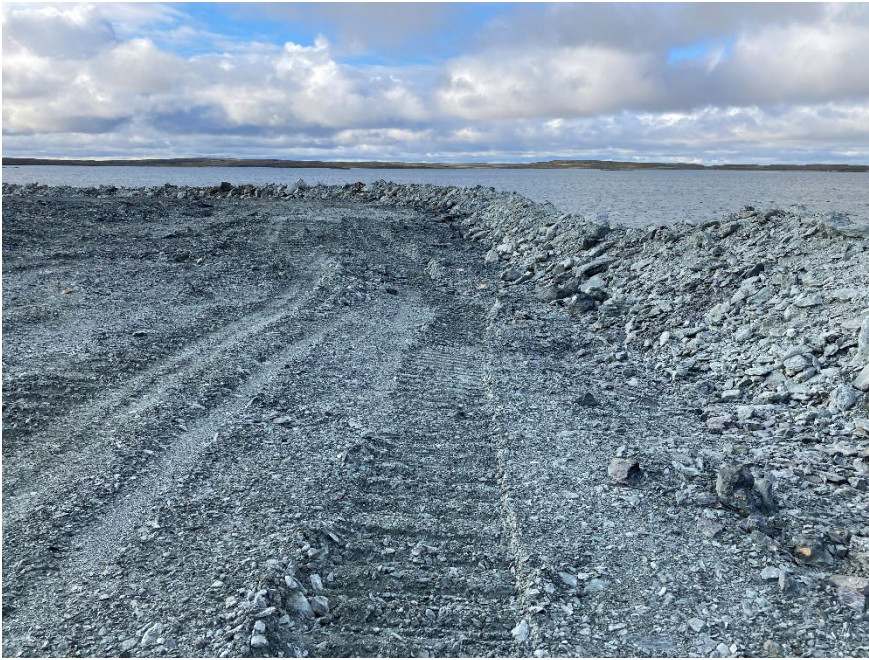
**Photograph A3-25 Bay Goose Dike**

**Description:** From approximately Sta. 31+640, looking southeast at the upstream slope.

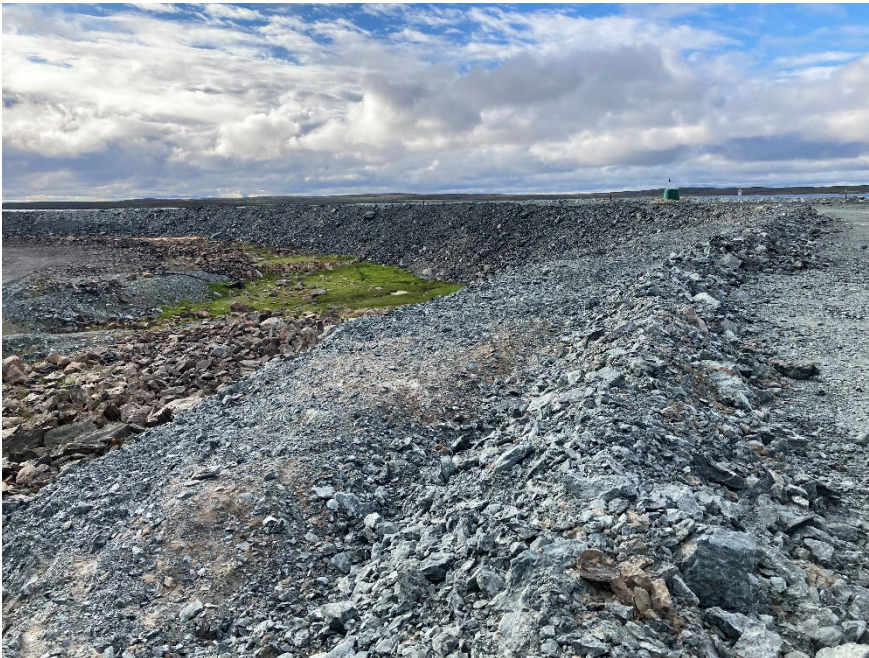
**Photograph A3-26 Bay Goose Dike**

**Description:** From the crest at approximately Sta. 31+740. Looking southeast downstream toward Channel 3.

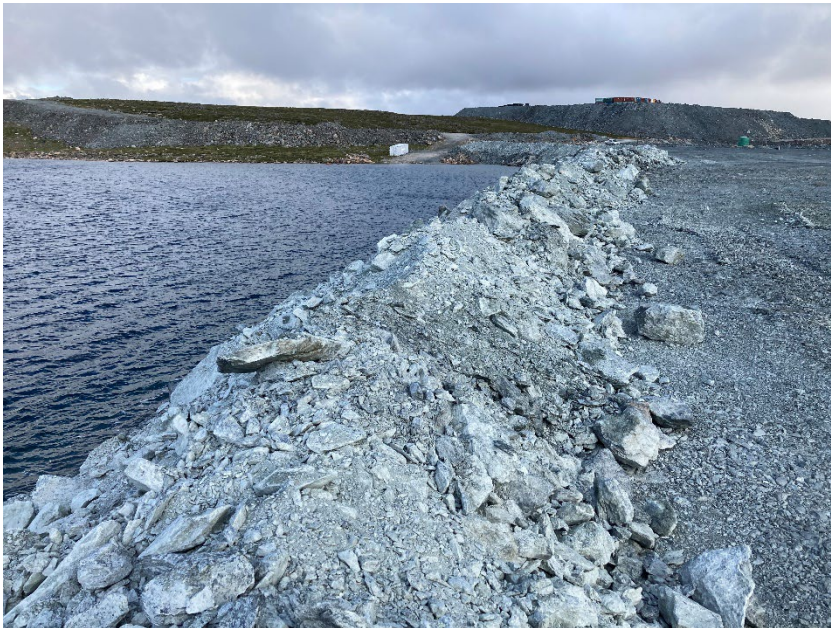
**Photograph A3-28 Bay Goose Dike**

**Description:** From approximately Sta. 31+870, looking northwest at the crest and upstream slope.

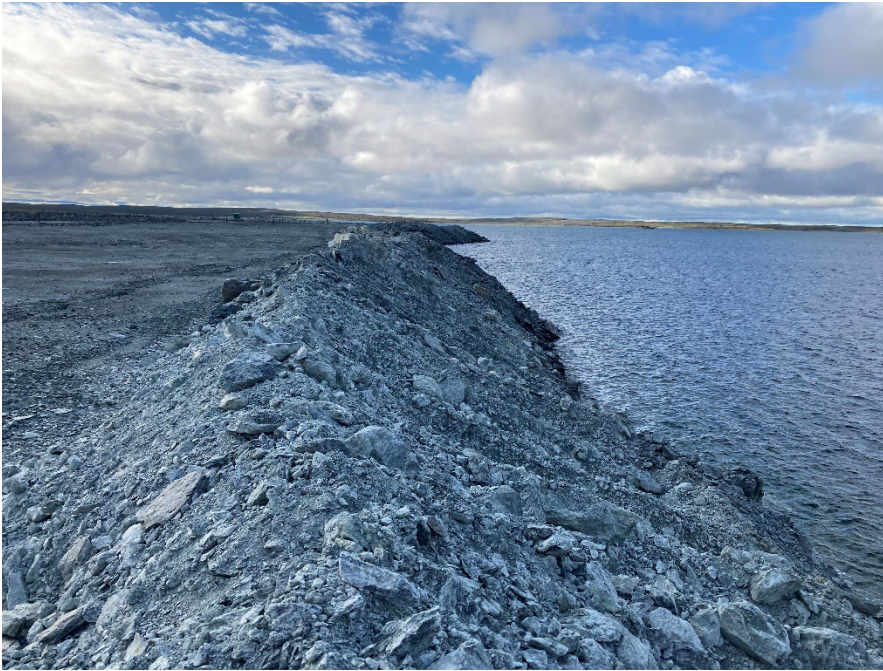
**Photograph A3-29 Bay Goose Dike**

**Description:** From approximately Sta. 31+870, looking southeast at the crest and upstream slope.

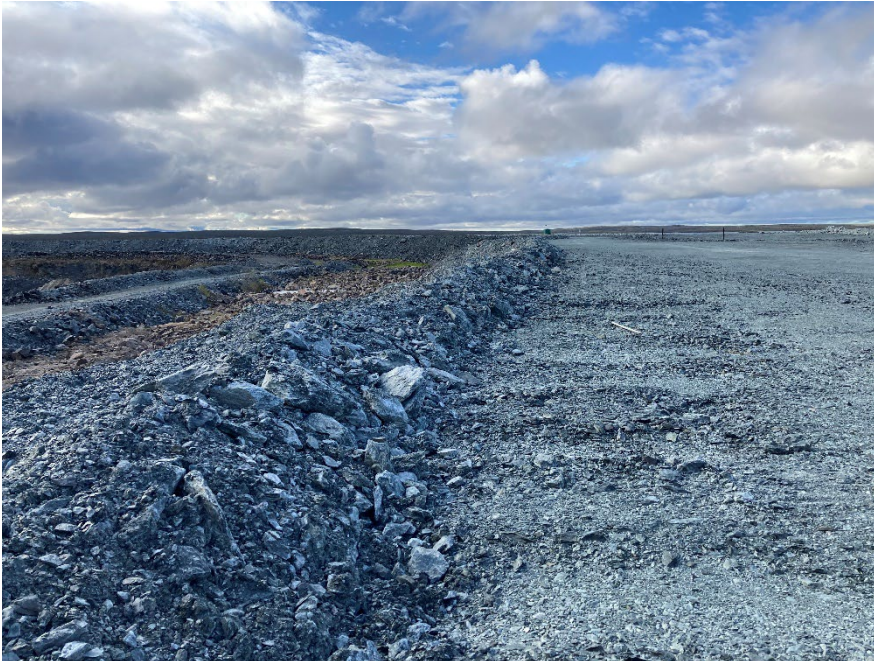
**Photograph A3-30 Bay Goose Dike**

**Description:** From approximately Sta. 31+920, looking south at the crest.

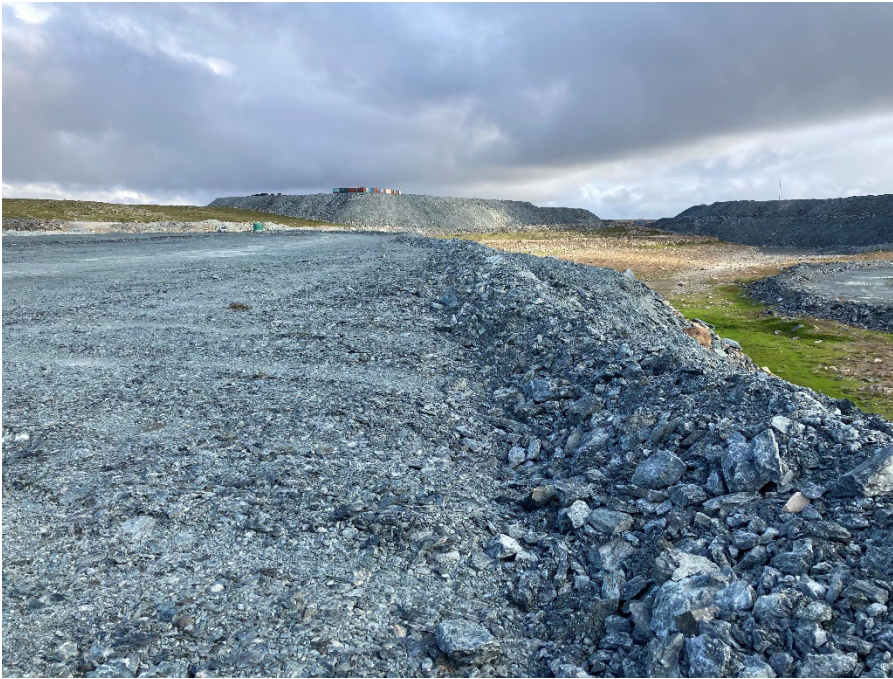
**Photograph A3-31 Bay Goose Dike**

**Description:** From approximately Sta. 31+920, looking northwest at the crest.

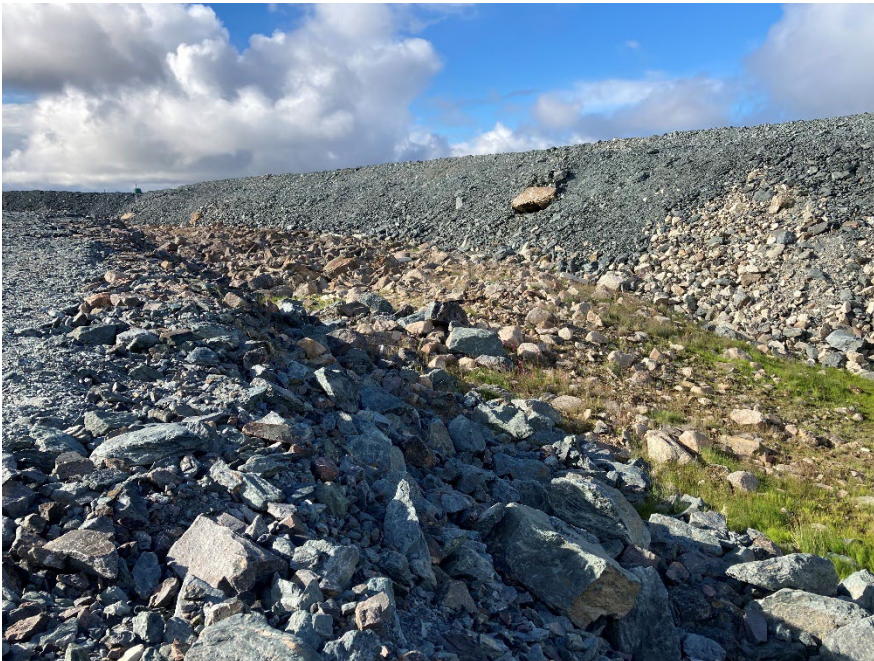
**Photograph A3-32 Bay Goose Dike**

**Description:** From approximately Sta. 31+920, looking southeast at the downstream toe.

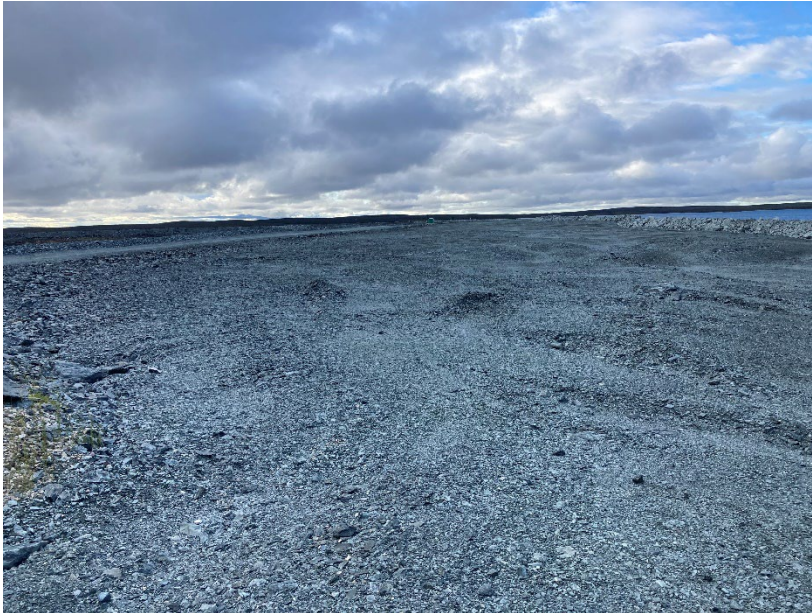
**Photograph A3-36 Bay Goose Dike**

**Description:** From approximately Sta. 32+025 (south abutment) looking east at the crest and upstream slope. Zone of high magnitude settlement in the ultramafic cap. The tension cracks seem no longer active.

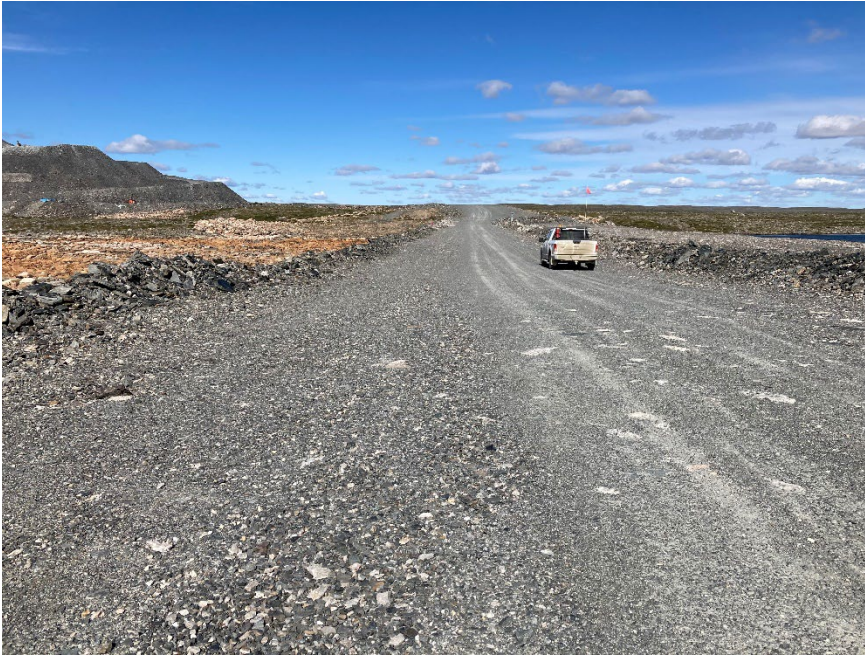
**Photograph A4-1 Vault Dike**

**Description:** From the east abutment, looking northwest at the crest.
