**Appendix A-7**

# Waste Rock Storage Facility I Dike

| <b>Project:</b> | Whale Tail Project | <b>Date:</b> | July 26, 2022 |

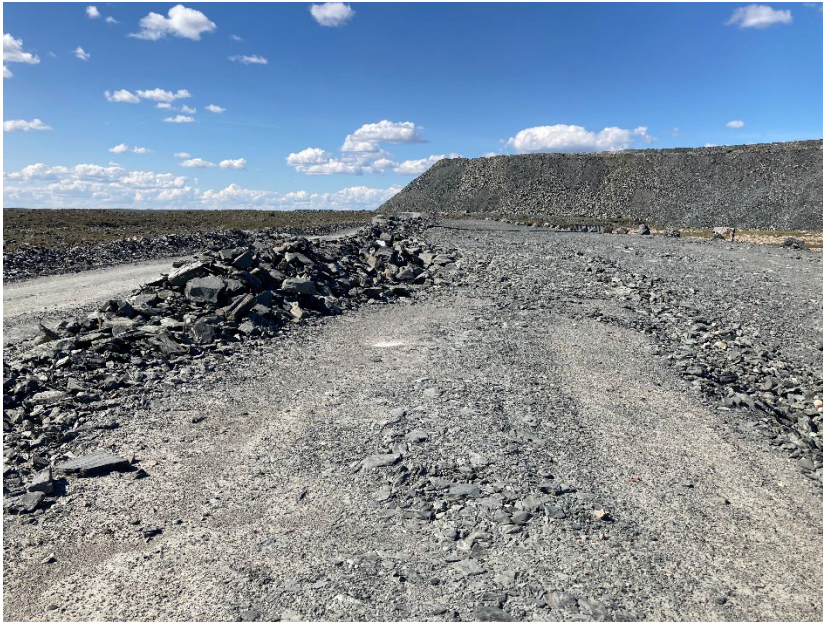
**Photograph A7-3 WRSF Dike**

**Description:** From approx. Sta. 0+350 (east abutment), looking west at the upstream thermal berm crest.

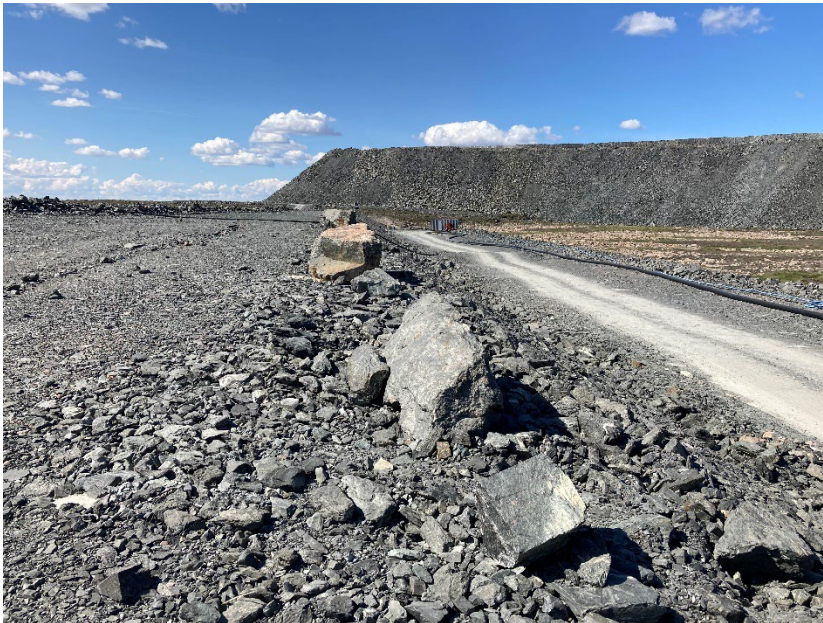
**Photograph A7-4 WRSF Dike**

**Description:** From approx. Sta. 0+350 (east abutment), looking west at the upstream thermal berm slope and dewatering ramp.
