**APPENDIX B-3**

**Saddle Dam 2**

<b>Client:</b>	AEM	<b>By:</b>	Marion Habersetzer
<b>Project:</b>	Meadowbank	<b>Date:</b>	July 29, 2022
<b>Location:</b>	Saddle Dam 2	<b>Reviewed:</b>	Yves Boulianne

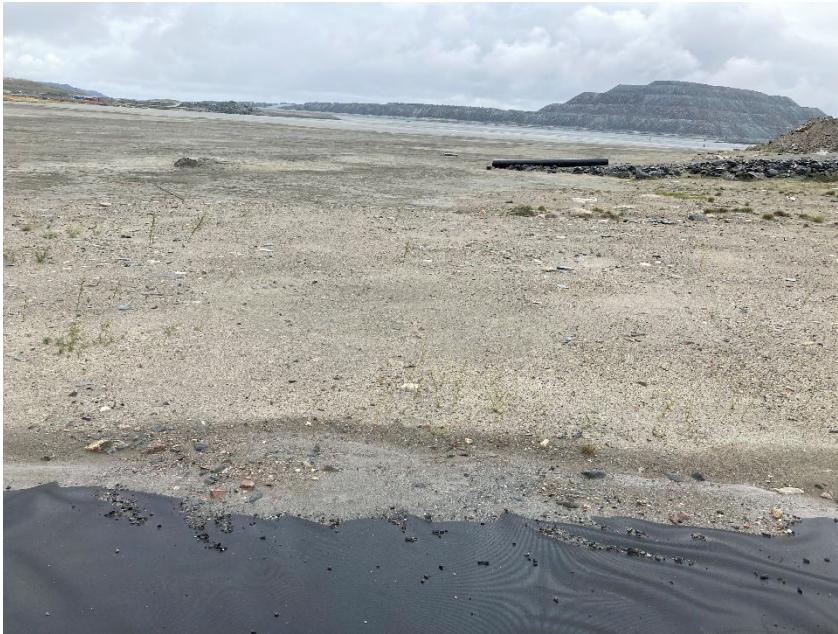
**Photograph B2-7 Saddle Dam 1**

**Description:** From the south abutment looking east at the upstream slope and the North Cell.

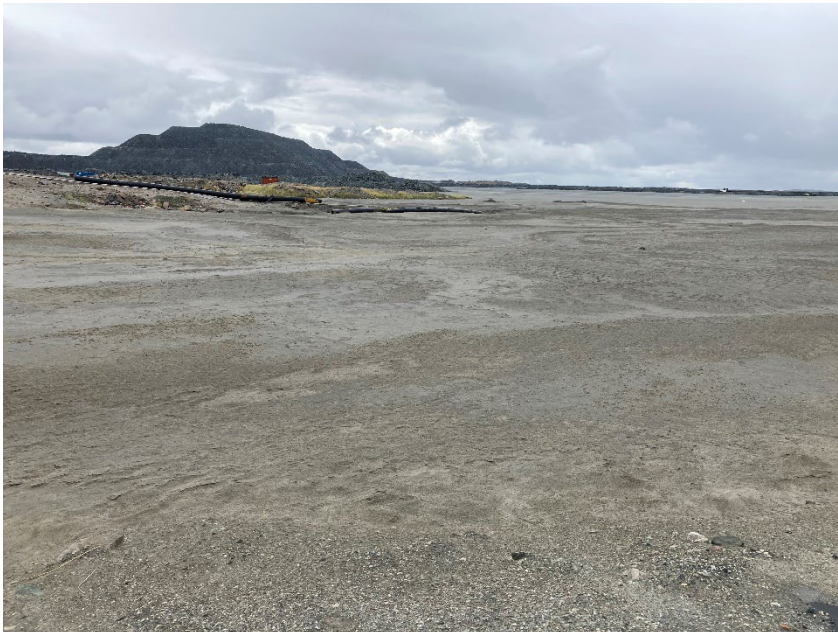
**Photograph B2-8 Saddle Dam 1**

**Description:** From approximately Sta. 0+050 upstream, looking east at the North Cell.

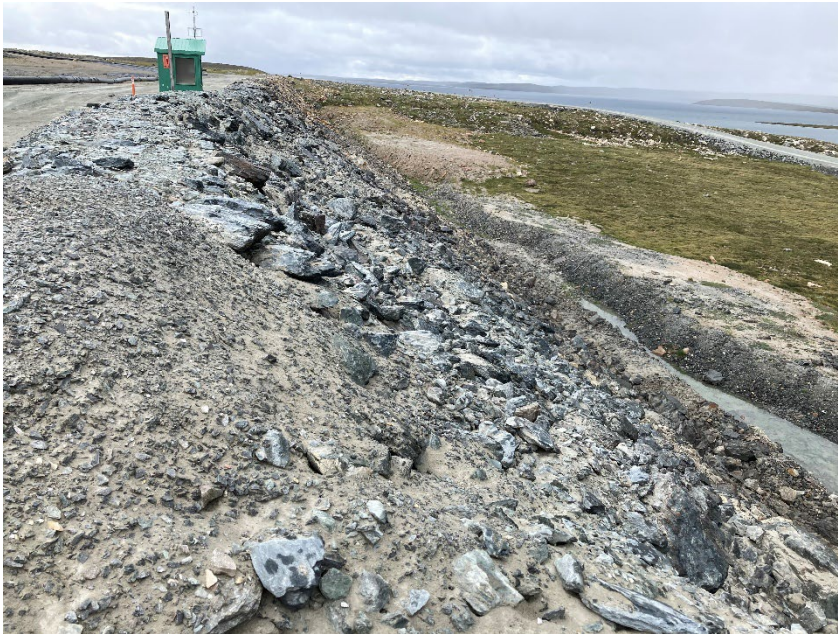
**Photograph B2-9 Saddle Dam 1**

**Description:** From approximately Sta. 0+175 downstream, looking west at the crest and downstream slope.

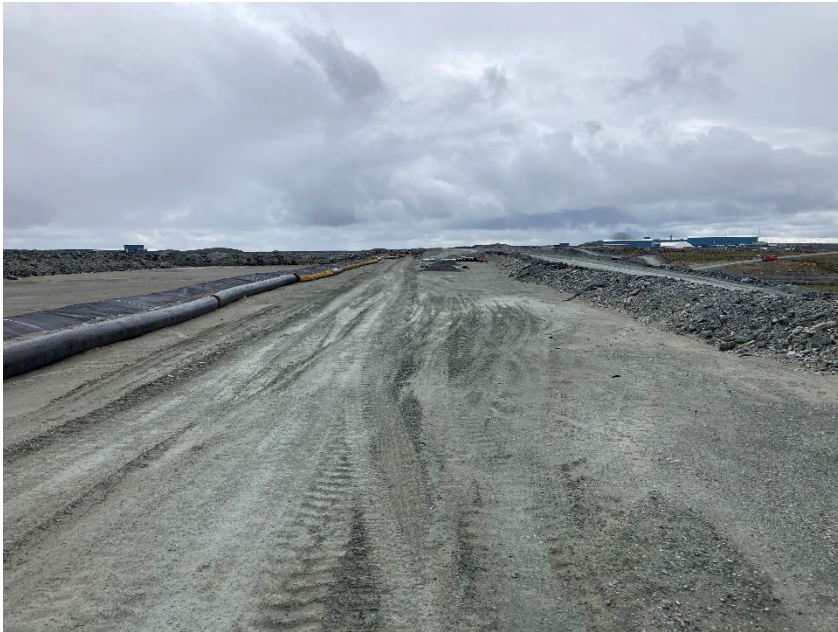
**Photograph B3-3 Saddle Dam 2**

**Description:** From approximately Sta. 20+370 looking southeast at the crest.

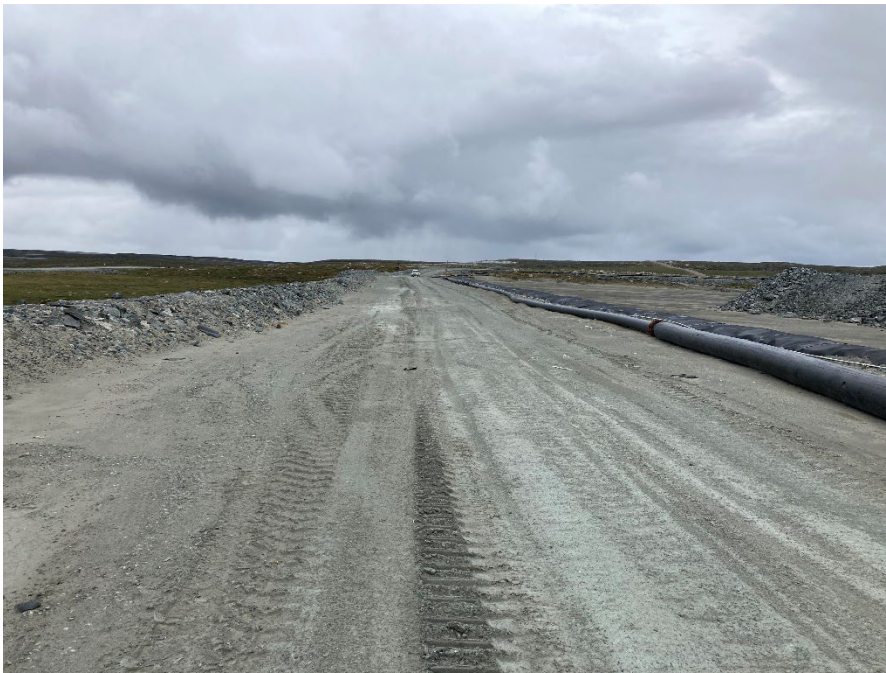
**Photograph B3-4 Saddle Dam 2**

**Description:** From approximately Sta. 20+370 looking northwest at the crest.

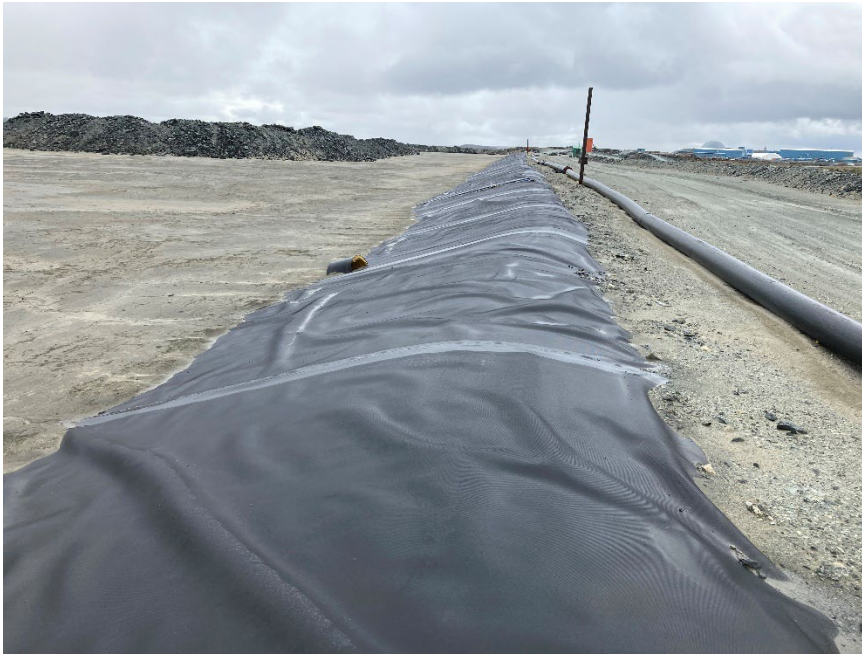
**Photograph B3-5 Saddle Dam 2**

**Description:** From approximately Sta. 20+525, looking northwest at the crest and upstream slope.

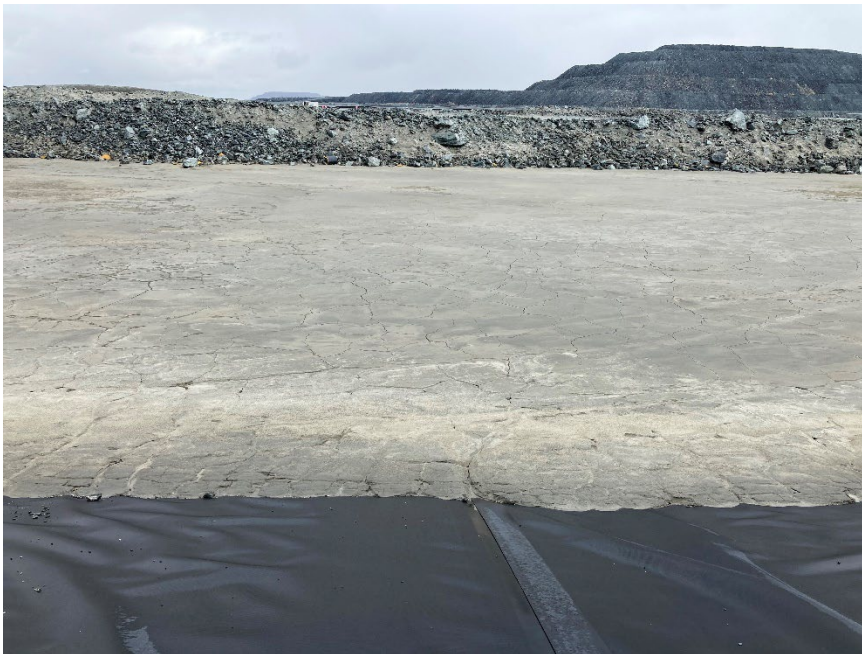
**Photograph B3-6 Saddle Dam 2**

INSPECTION ITEM	OBSERVATIONS DATA	PHOTO	COMMENTS & OTHER DATA
2.3 Signs of movement (deformation)	None observed		
2.4 Cracks	None observed		
2.5 Face liner condition (if applicable)	Good		Wooden pallet on liner at 20+475 to remove.

**Description:** From approximately Sta. 20+475, looking northeast at the upstream slope.

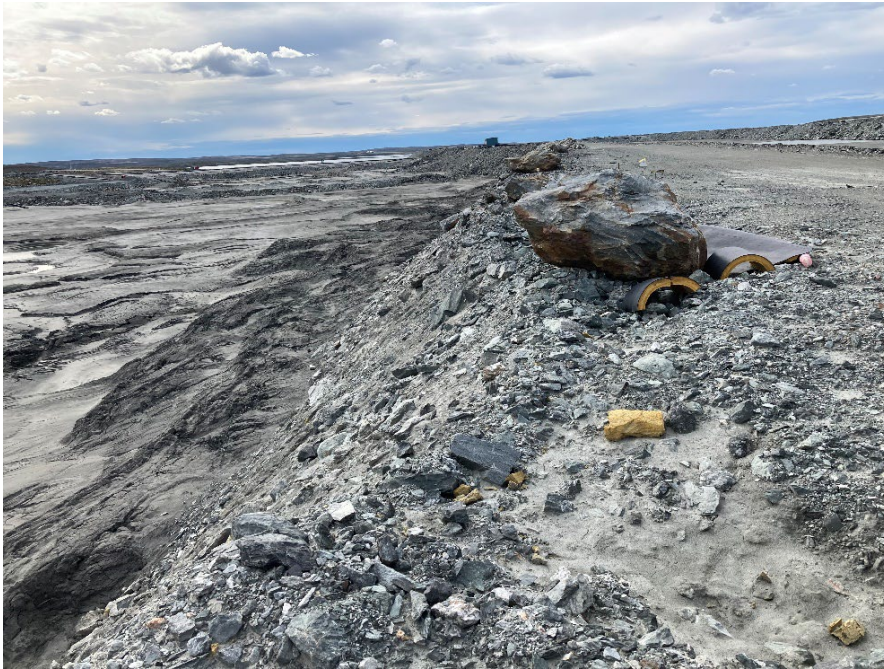
**Photograph B4-7 Stormwater Dike**

**Description:** From approximately Sta. 10+650 looking west at the crest.

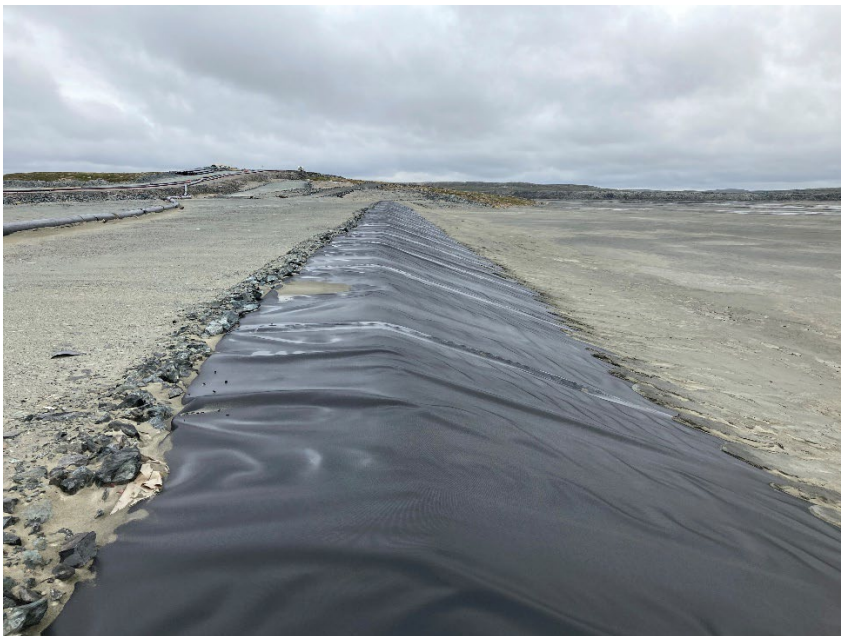
**Photograph B6-2 Saddle Dam 4**

**Description:** From 40+150 approximately, looking northeast at the upstream slope and the South Cell.

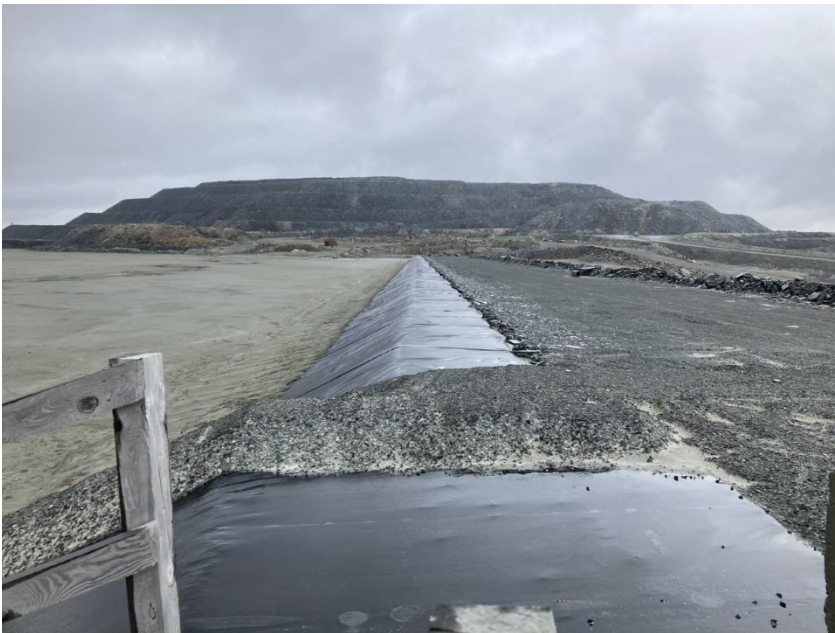
**Photograph B7-2 Central Dike and Saddle Dam 5**

**Description:** From approximately Sta. 0+400 (deposition point) looking west at the South Cell. Adequate tailings beach against the south section of the structure.

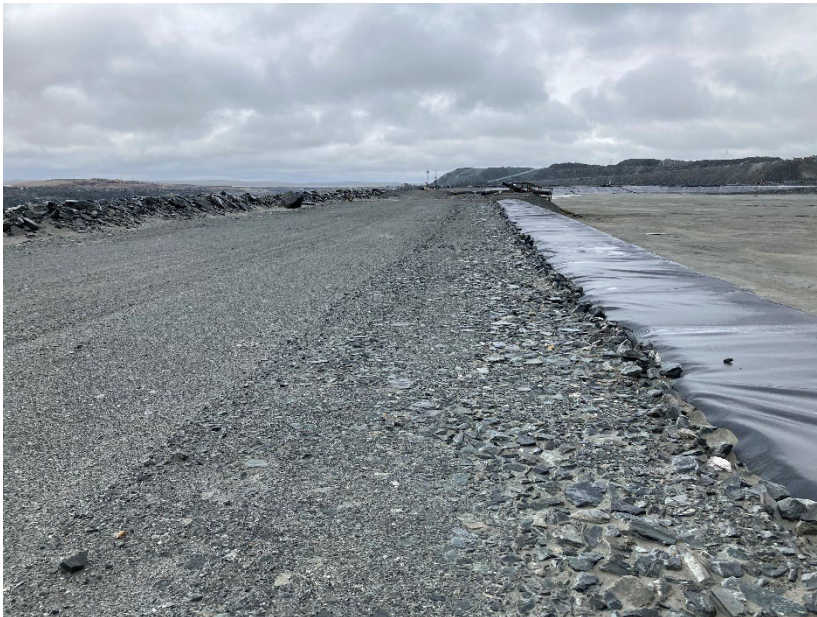
**Photograph B7-4 Central Dike and Saddle Dam 5**

**Description:** From approximately Sta. 0+720 looking south at the crest.

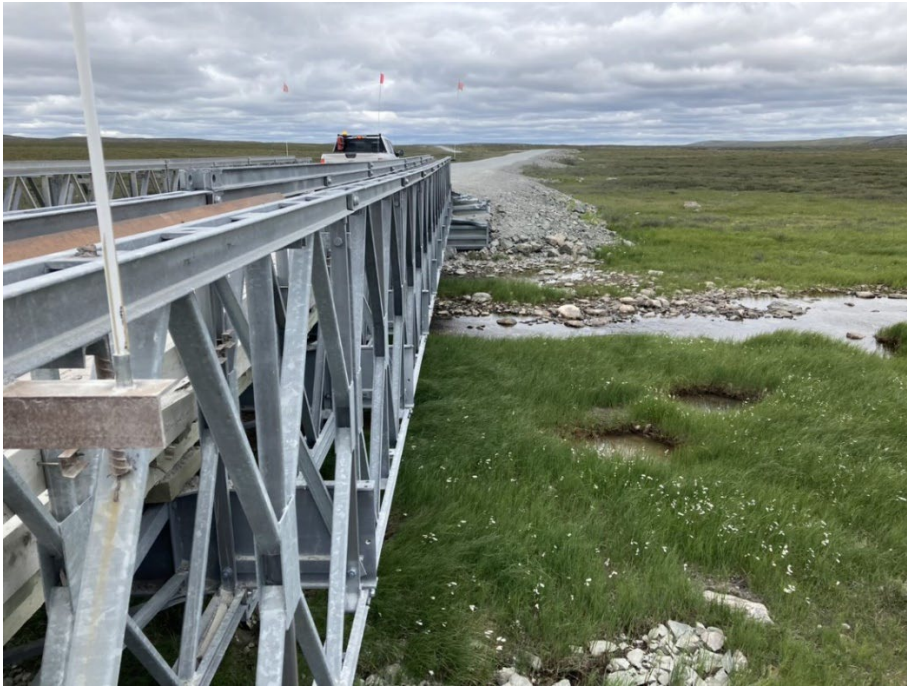
**Photograph D3-3 Bridges 2 – R05 km 17+600**

**Description:** Looking at the south abutment. Minor damage to the bin wall.

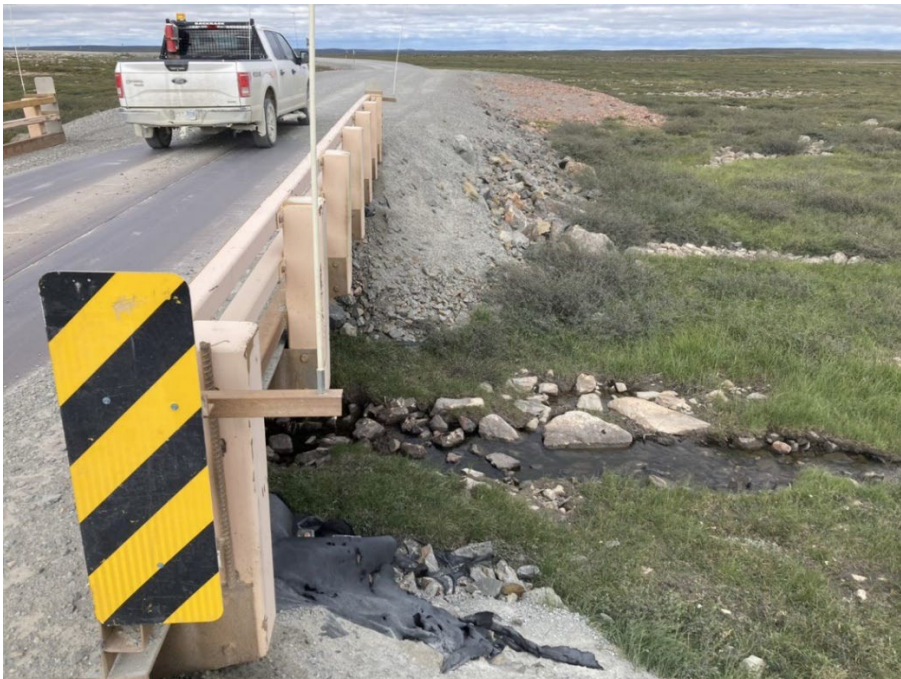
**Photograph D3-14 Bridges 7 – R16 km 73+800**

**Description:** Looking at the north abutment. In good condition.

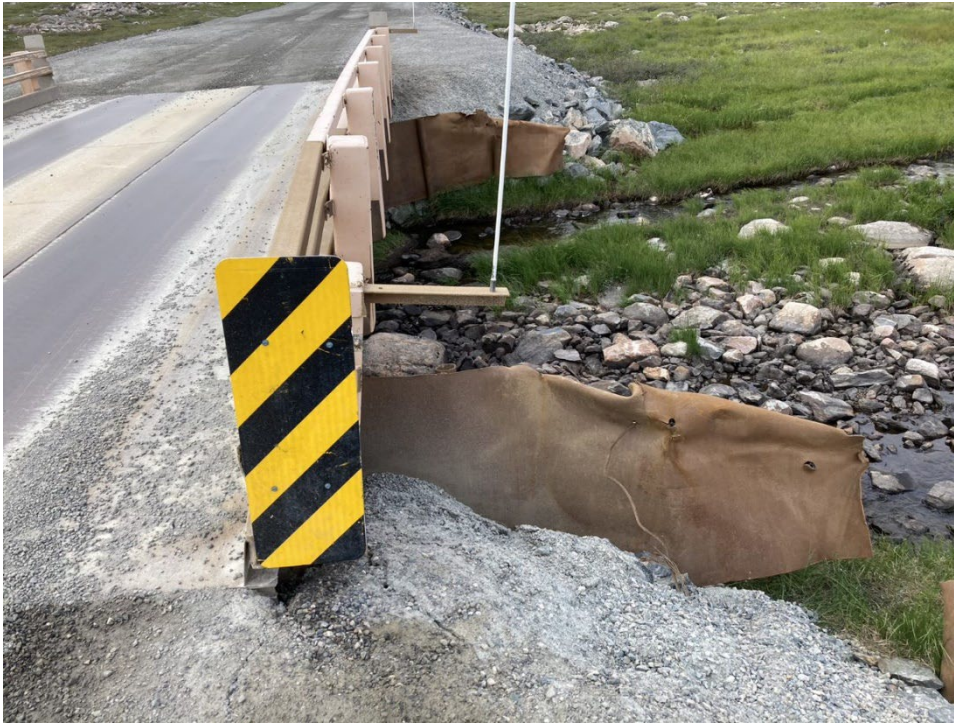
**Photograph D3-19 Bridges 9 – R19 km 83+150**

**Description:** Looking at the south abutment. Minor damage to steel plate due to snow removal activity. Minor tension cracks, seem inactive.
