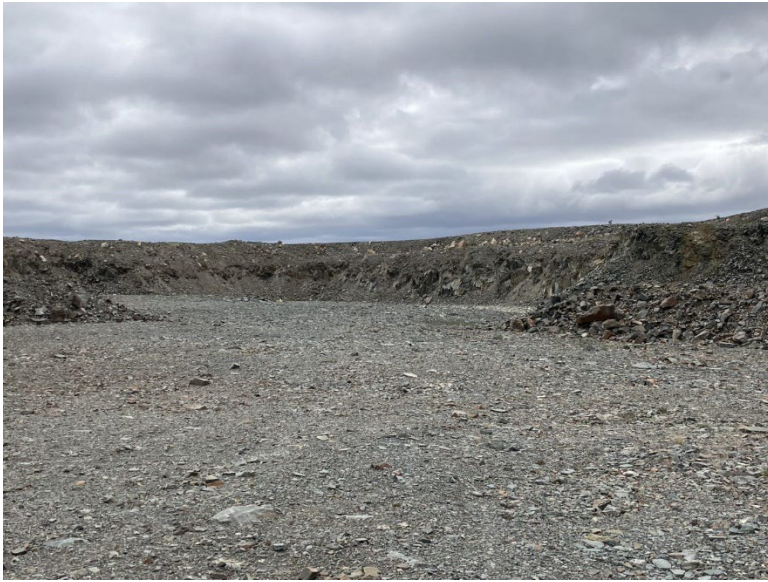
Photograph F-1: Quarry 12 – km 58+300

Description: View of north wall. Presence of loose blocks at the base of the wall.

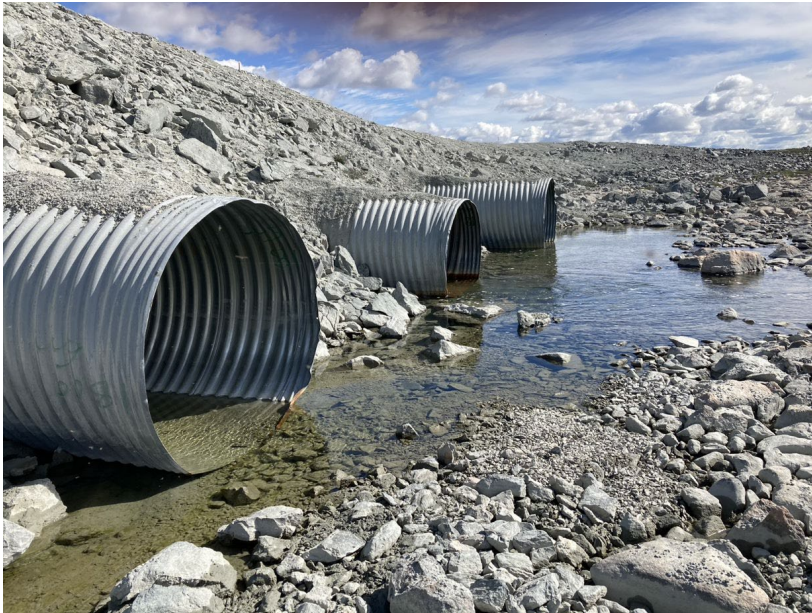
Photograph H1-1 Vault Road Culverts

Description: Looking at the outlet of the three culverts located on Vault Road at 640964E/7217466N. All of them are deformed in the middle.

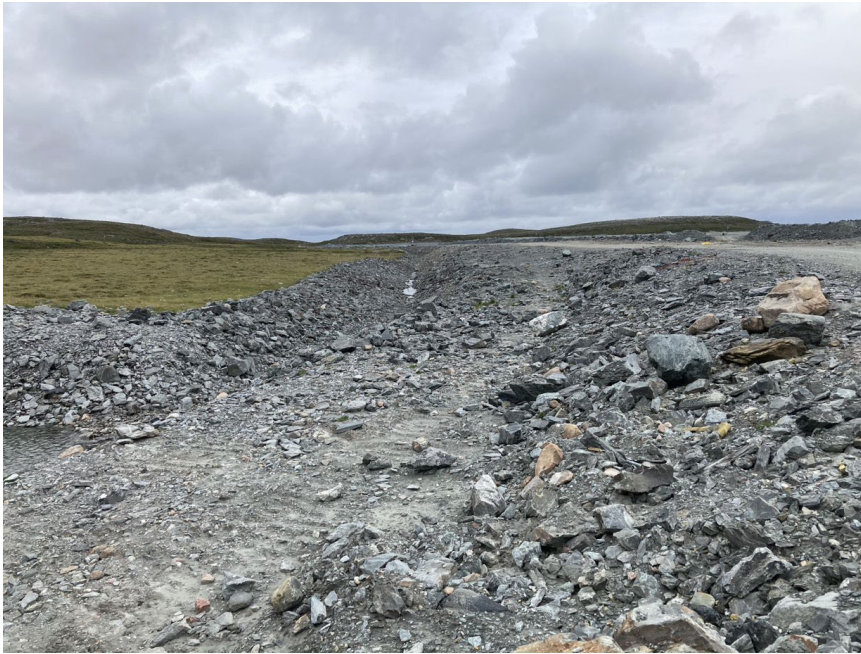
Photograph H2-15 Diversion Ditch and its Sediment and Erosion Protection Structure

Description: From 637251E/7216171N, looking north at the western diversion ditch.

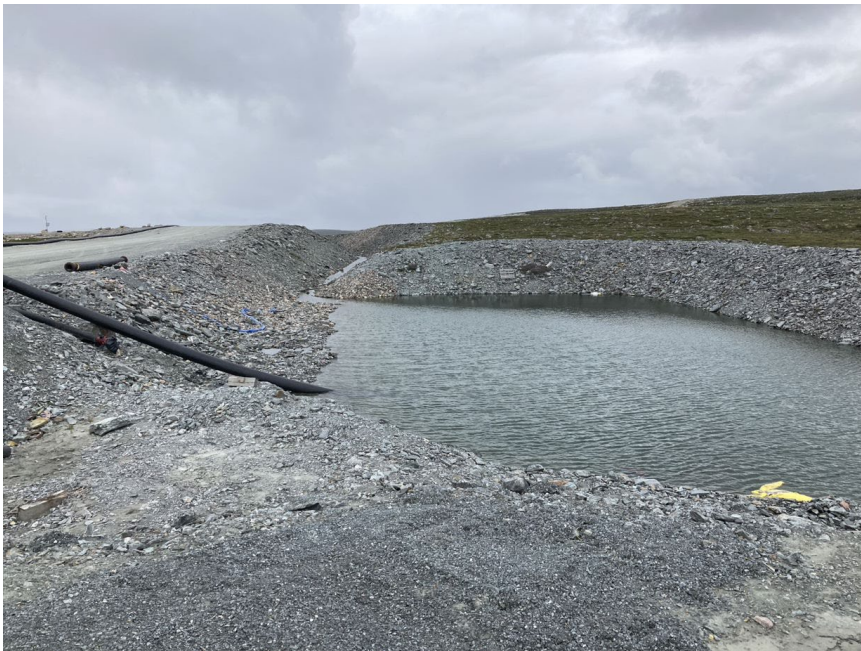
Photograph H2-16 Diversion Ditch and its Sediment and Erosion Protection Structure

Description: From 637251E/7216171N, looking southwest at the western diversion ditch and its retention basin.

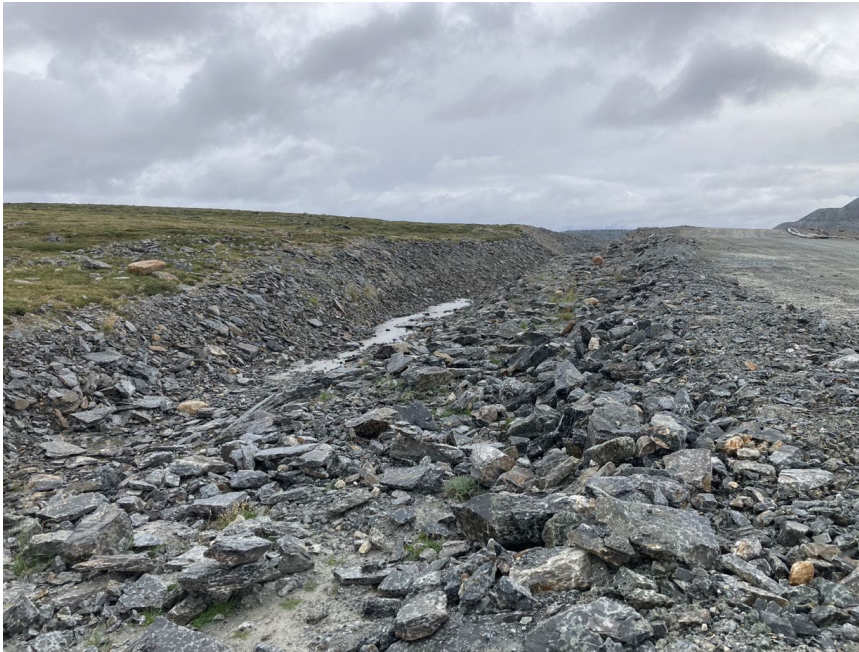
Photograph H2-17 Diversion Ditch and its Sediment and Erosion Protection Structure

Description: From 637074E/7216157N, looking east at the western diversion ditch.

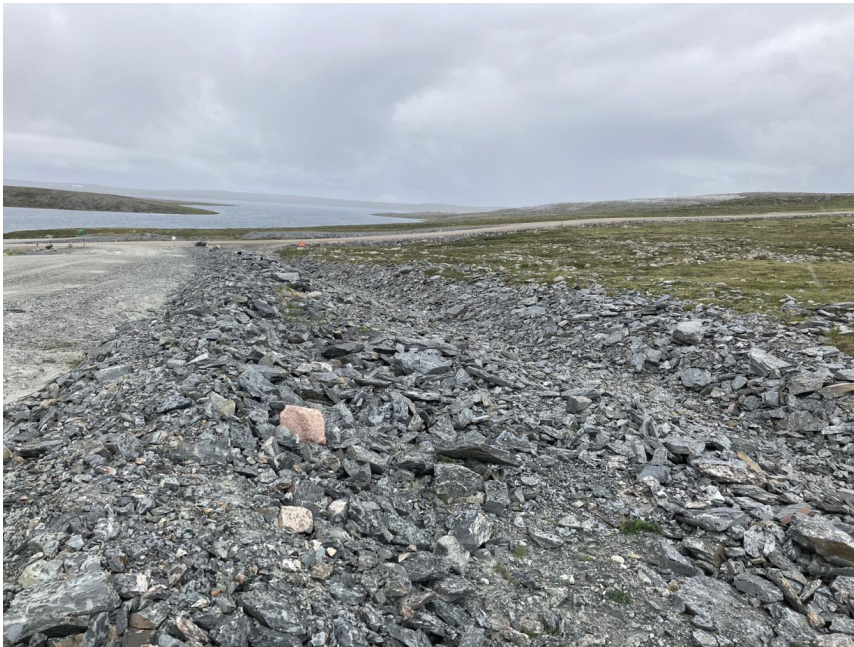
Photograph H2-18 Diversion Ditch and its Sediment and Erosion Protection Structure

Description: From 637074E/7216157N, looking west at the western diversion ditch.

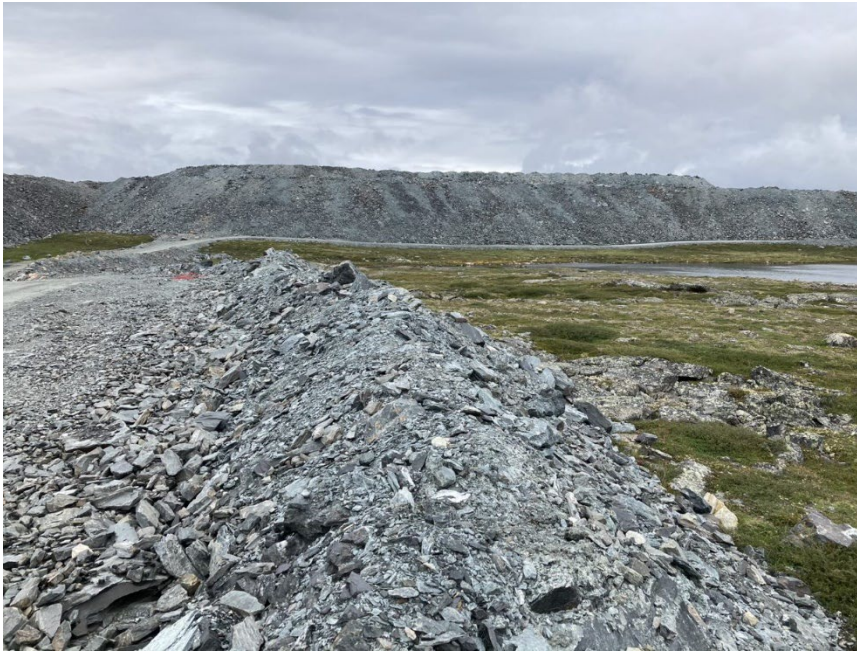
Photograph H3-1 RSF Till Plug

Description: From the south side of NP2 Lake (north of the diversion ditch) looking west at the RSF till plug.

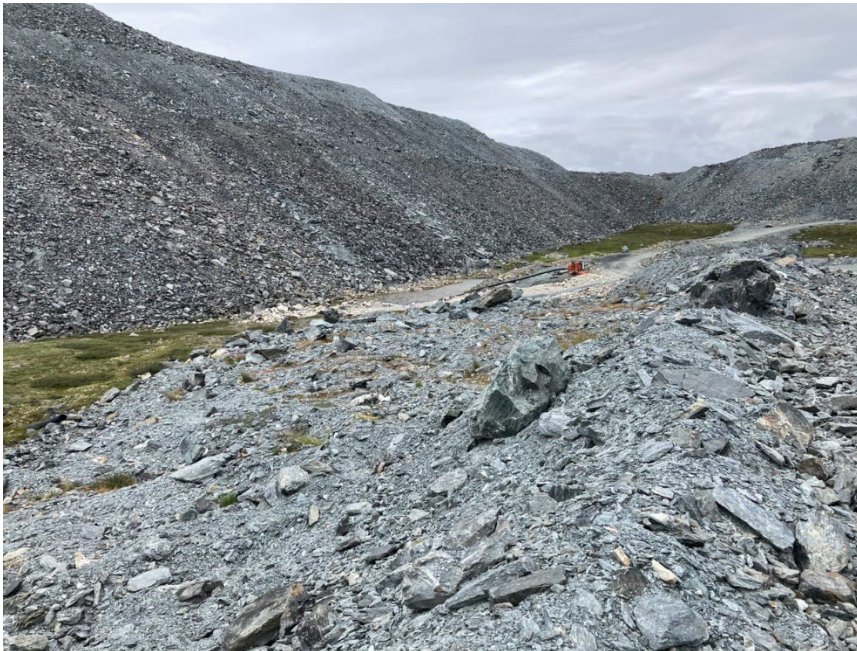
Photograph H3-2 RSF Till Plug

Description: From the south side of NP2 Lake (south of the diversion ditch) looking west at the RSF till plug.

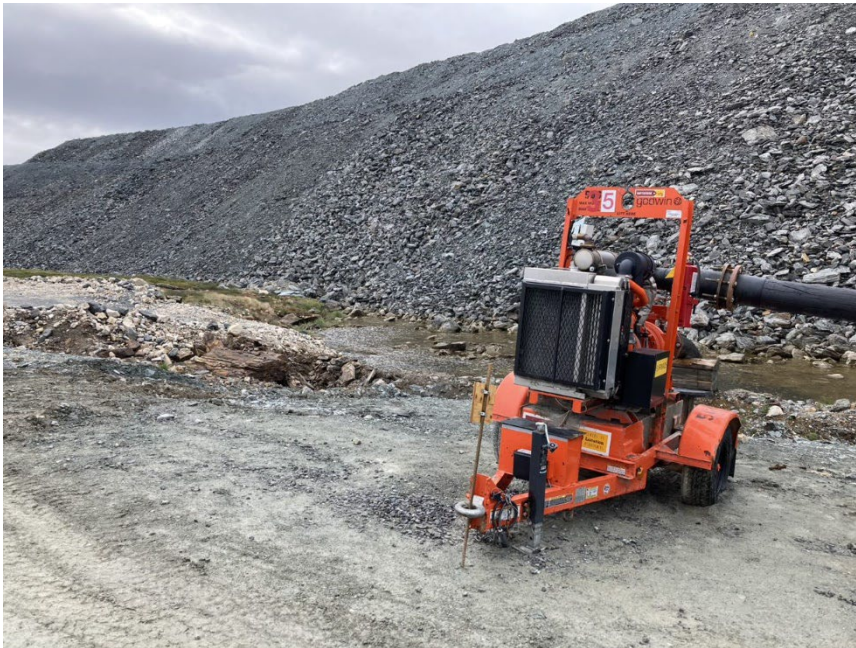
Photograph H3-3 RSF Till Plug

Description: From the south side of NP2 Lake (south of the diversion ditch) looking southeast at the RSF till plug.

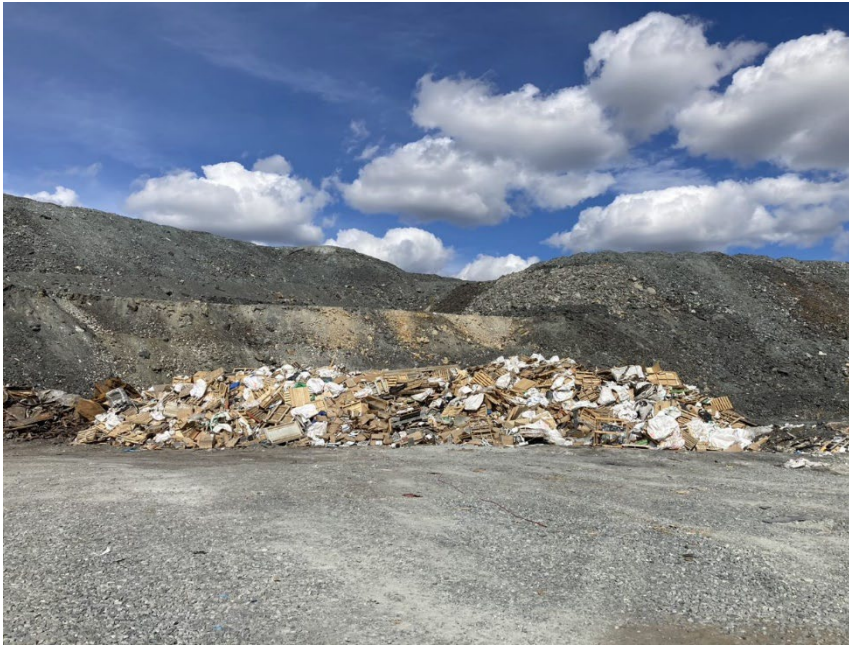
Photograph H4-1 Meadowbank Landfill

Description: From the 2020 landfill location within the Rock Storage Facility, looking southeast.

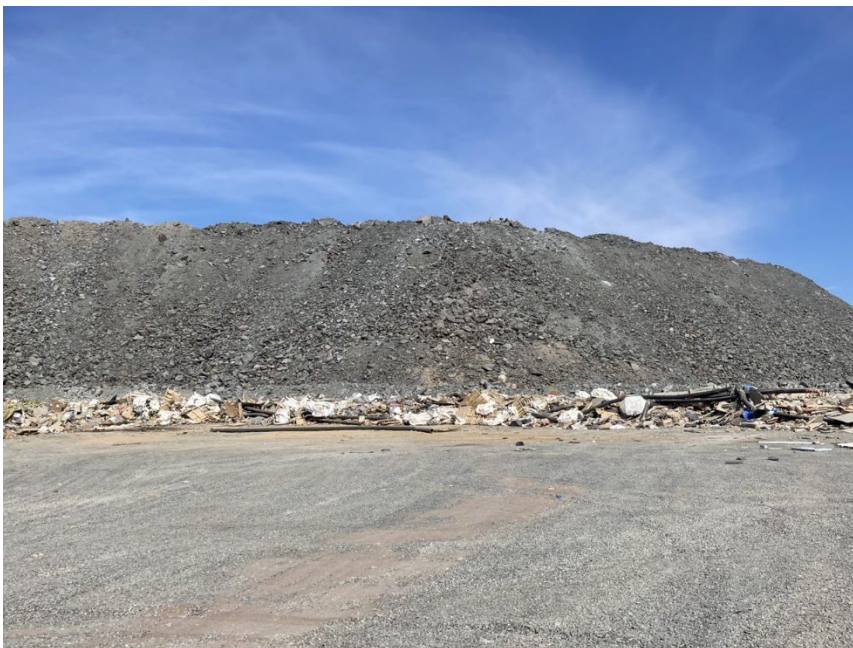
Photograph H4-2 Whale Tail Project Landfill

Description: From the new landfill location within the Whale Tail WRSF, looking north.

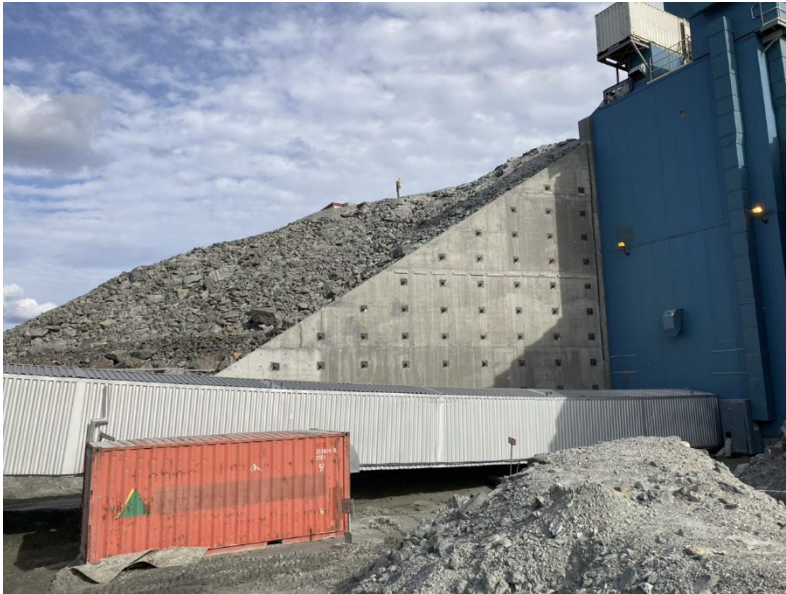
Photograph H6-1 Meadowbank Crusher Retaining Wall

Description: From the base of the wall, looking southeast.

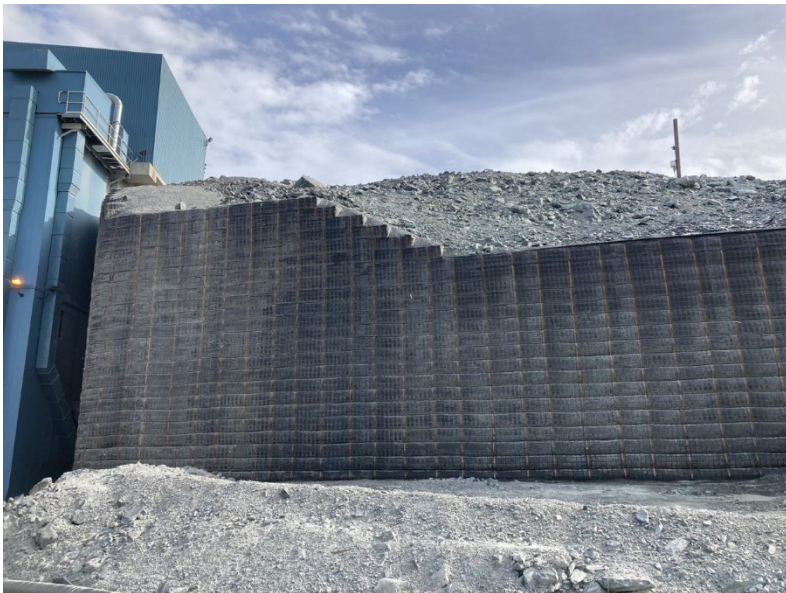
Photograph H6-2 Meadowbank Crusher Retaining Wall

Description: From the base of the wall, looking southeast.

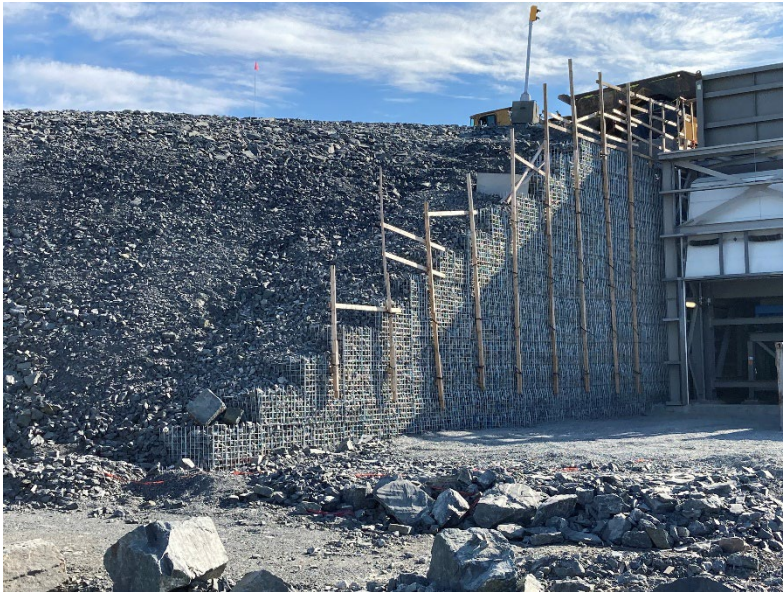
Photograph H6-3 Whale Tail Project Tramp Metal Removal Facility Retaining Wall

Description: From the base of the wall, looking north.

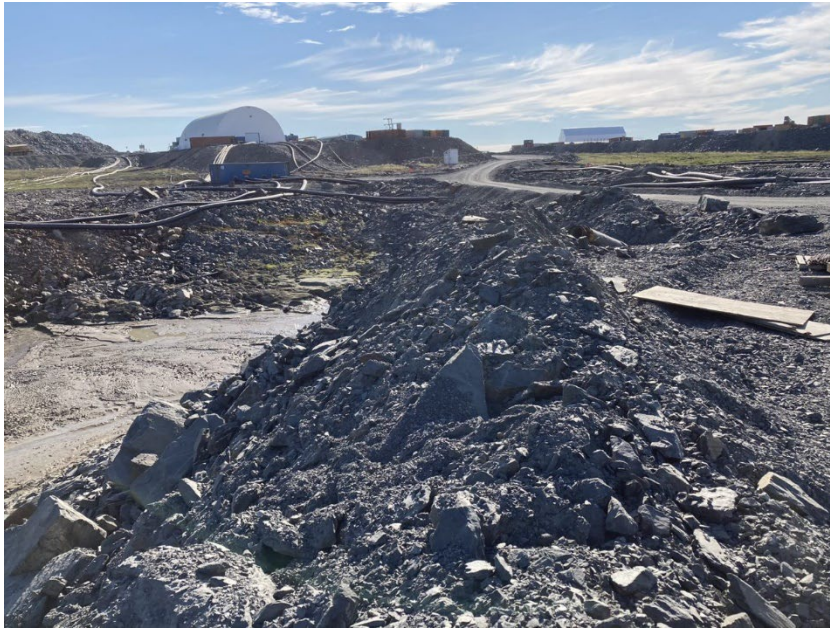
Photograph H7-1 Whale Tail Project Site Attenuation Pond Ramp

Description: From the pump pad, looking east at the ramp.

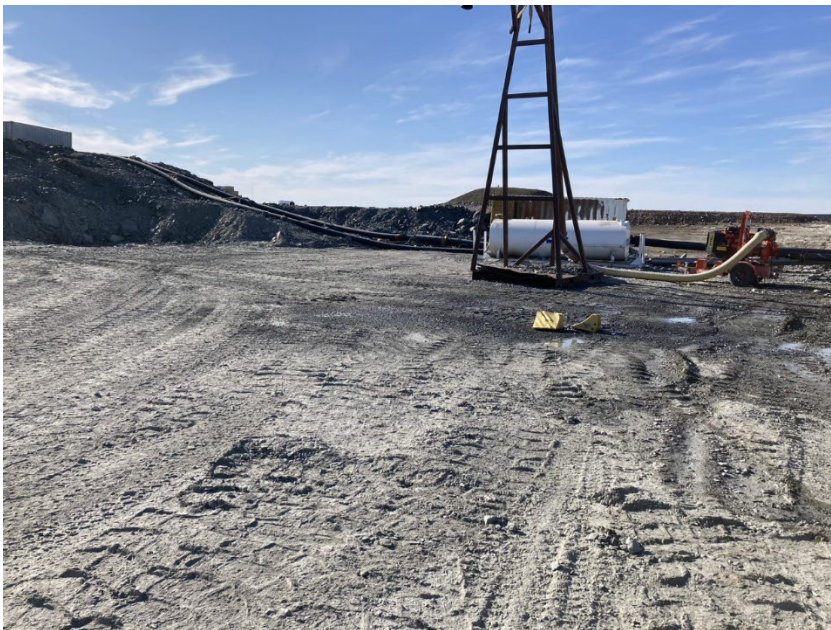
Photograph H7-2 Whale Tail Project Site Attenuation Pond Ramp

Description: From the pump pad, looking south at the pump pad.

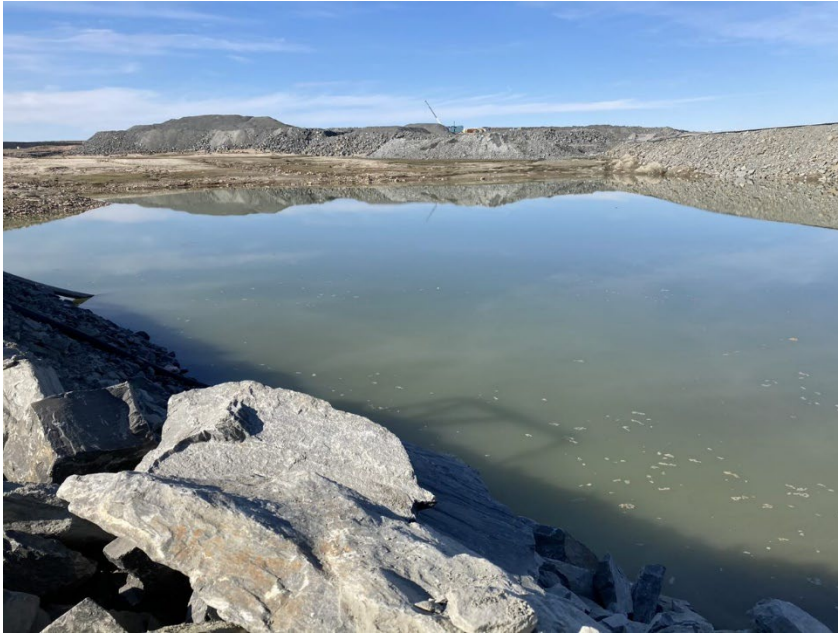
Photograph H7-3 Whale Tail Project Site Attenuation Pond Ramp

Description: From the pump pad, looking west at the Attenuation Pond.

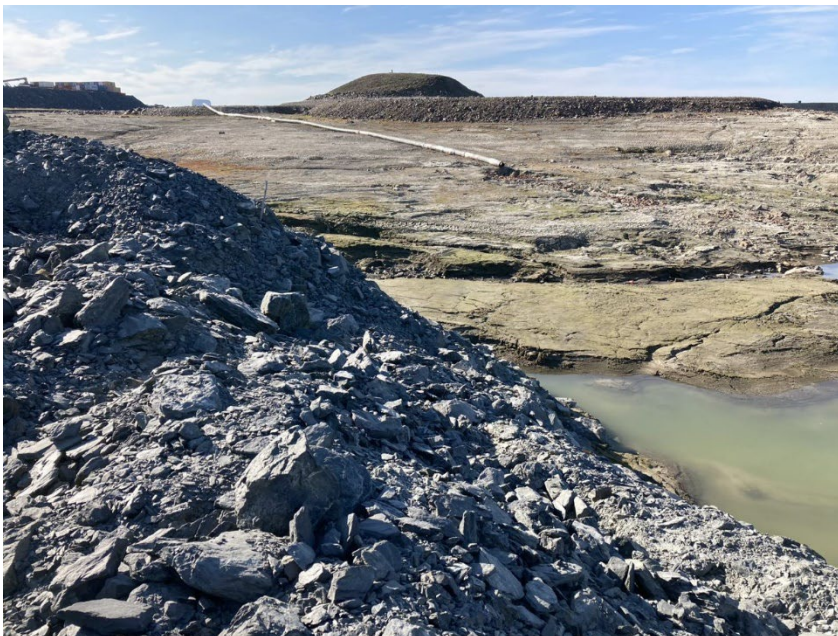
Photograph H7-4 Whale Tail Project Site Attenuation Pond Ramp

Description: From the pump pad, looking south at the Attenuation Pond.

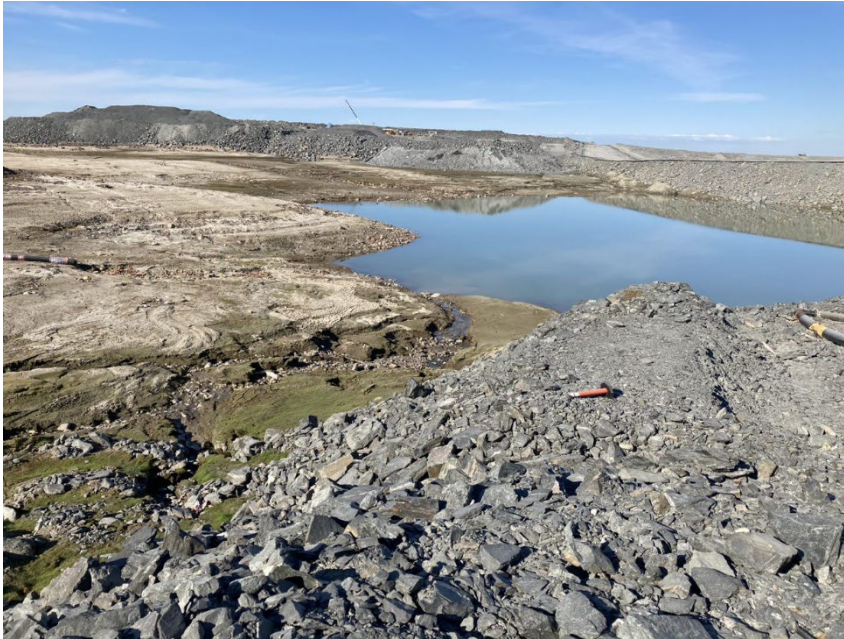
Photograph H7-5 Whale Tail Project Site Attenuation Pond Ramp

Description: From the pump pad, looking west at the primary attenuation pond ramp.

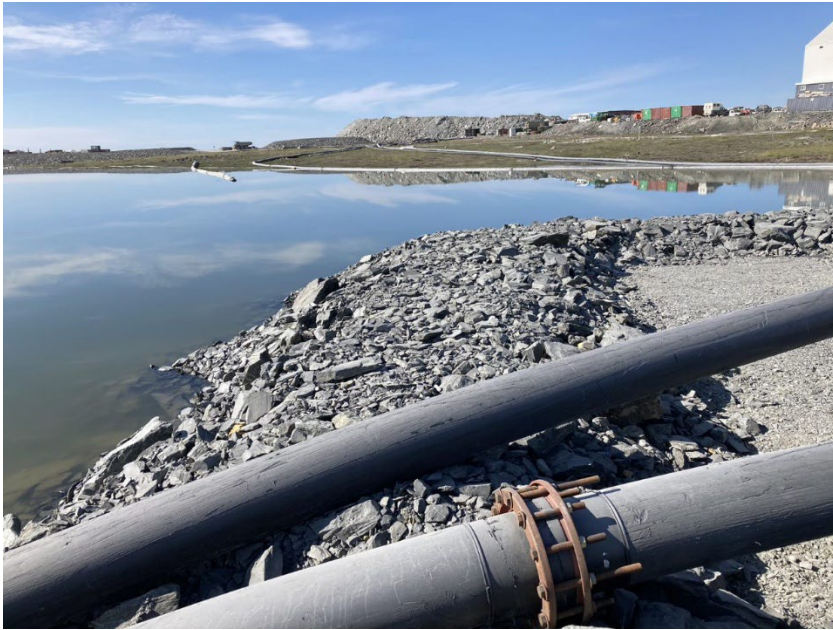
Photograph H8-1 Attenuation Pond Ramp

Description: From the pump pad, looking southwest at the Attenuation Pond.

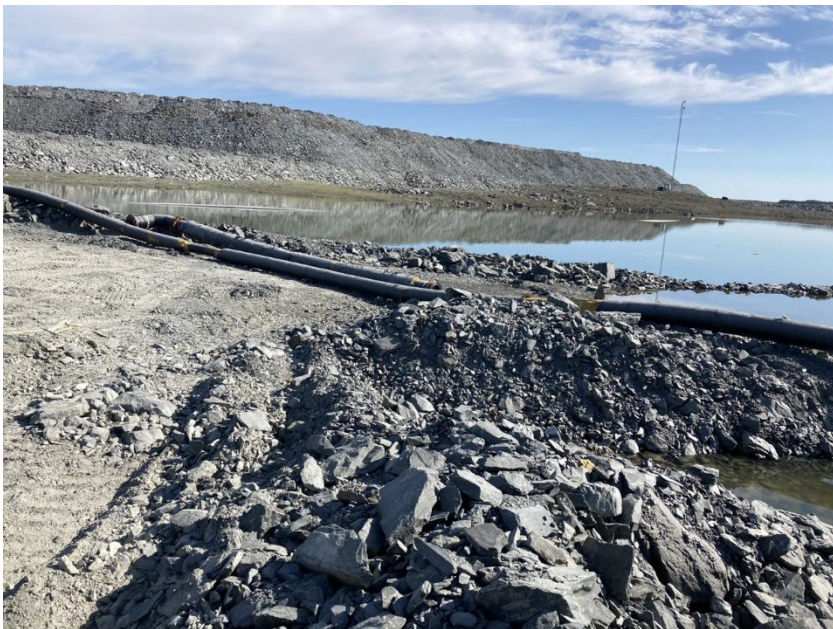
Photograph H8-2 IVR Attenuation Pond Ramp

Description: From the pump pad, looking northeast at the Attenuation Pond.

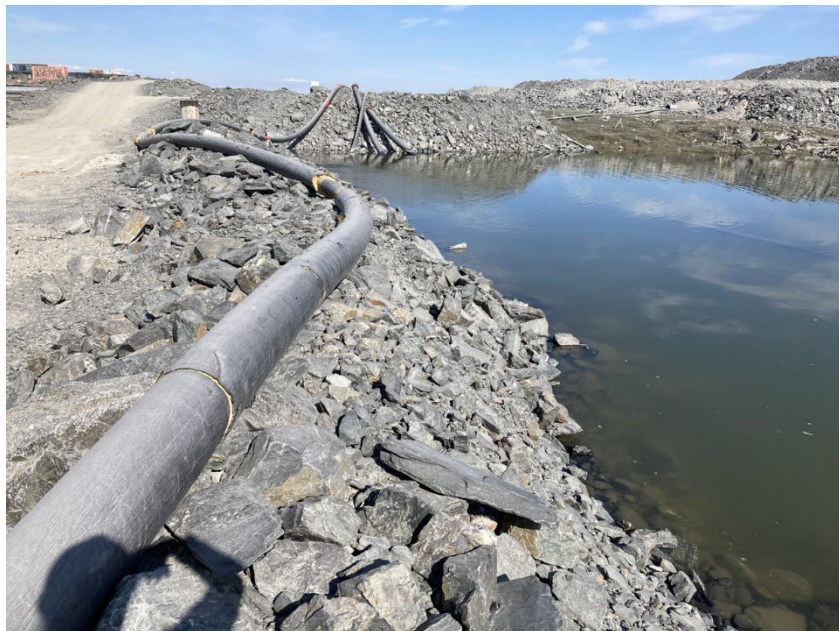
Photograph H8-3 IVR Attenuation Pond Ramp

Description: From the pump pad, looking northwest at the southern slope of the pump pad.

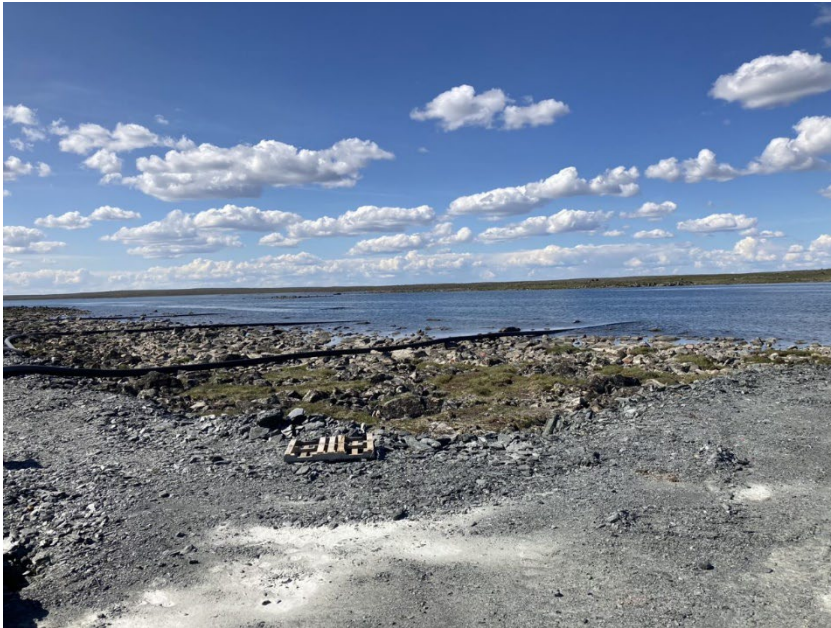
Photograph H9-1 Mammoth Lake Diffuser

Description: From the access road, looking west. Three diffusers are present and working normally.

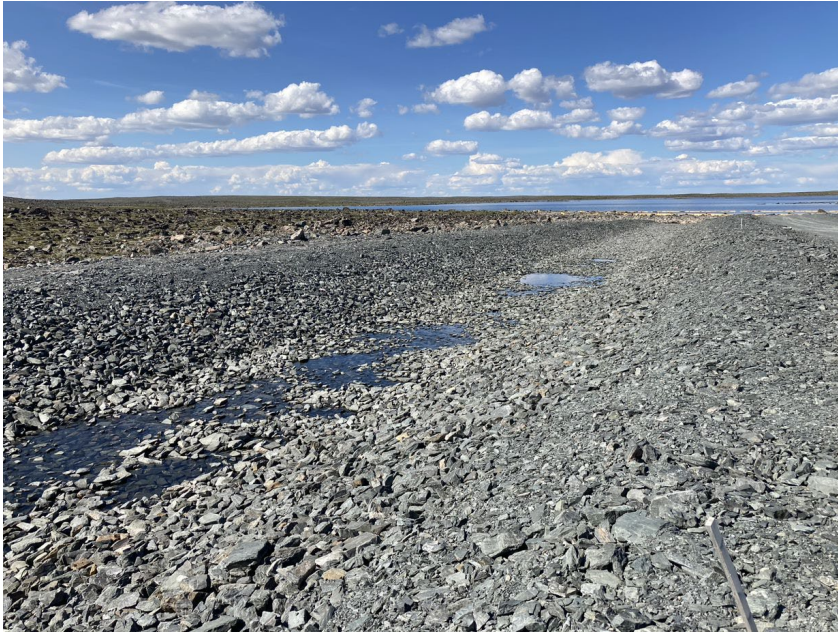
Photograph H10-3 South Whale Tail Channel

Description: From approx. Sta. 0+800, looking northwest.

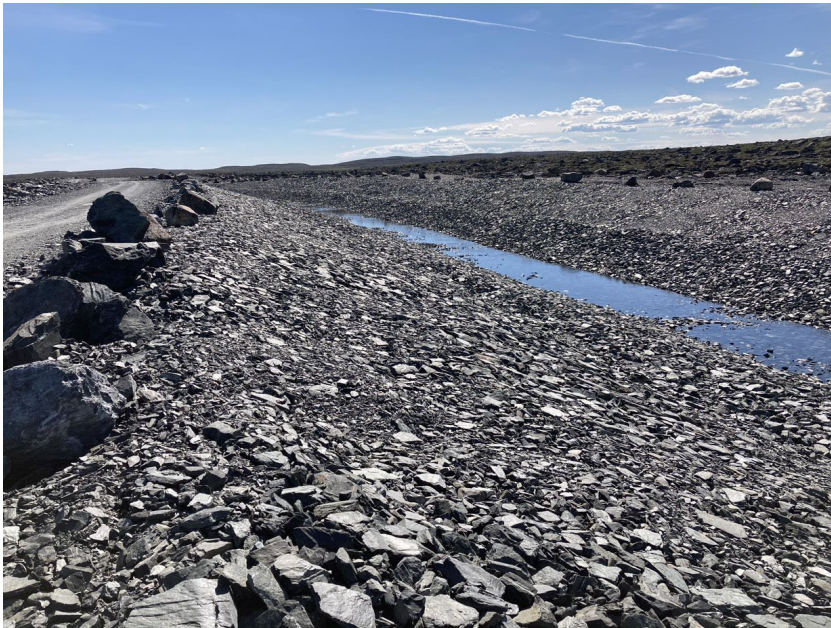
Photograph H10-4 South Whale Tail Channel

Description: From approx. Sta. 0+675, looking southeast.

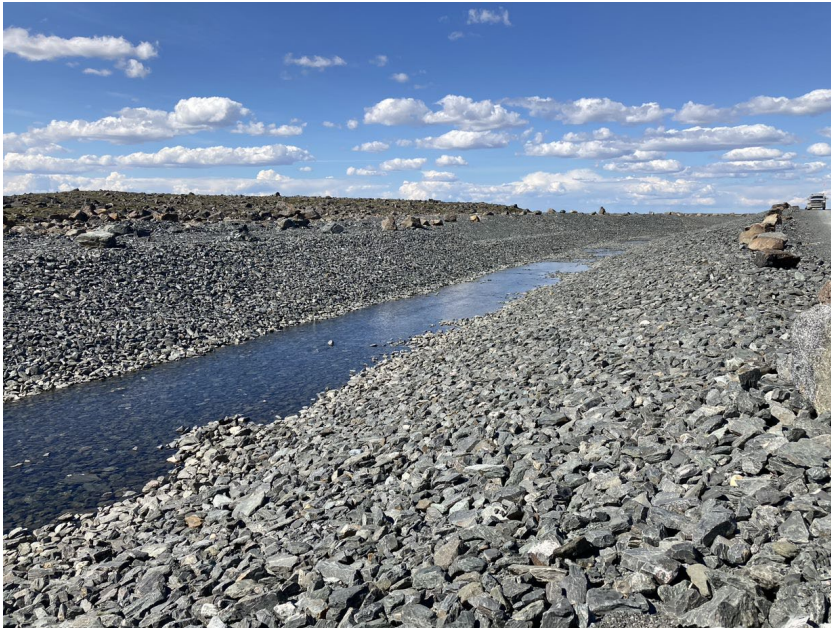
Photograph H10-5 South Whale Tail Channel

Description: From approx. Sta. 0+450 (Lake A45 area), looking northwest.

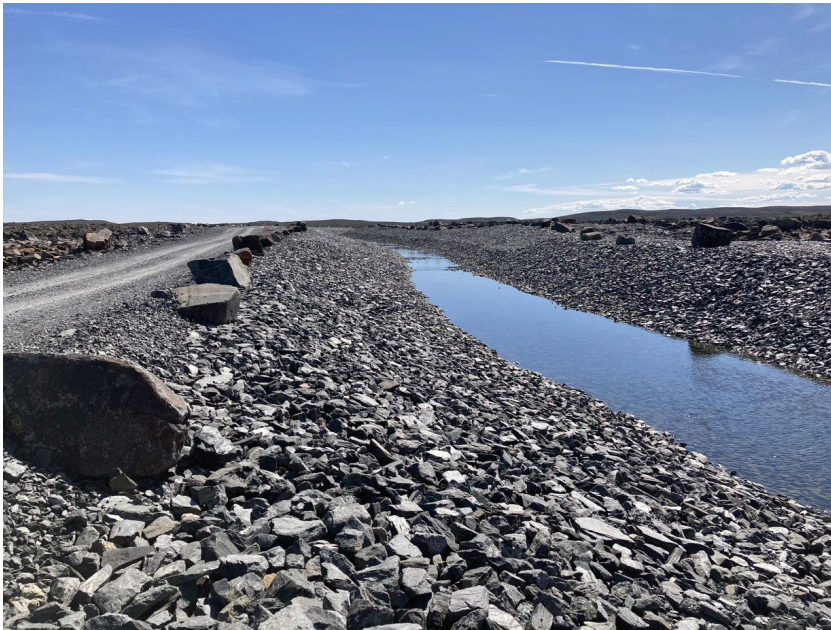
Photograph H10-6 South Whale Tail Channel

Description: From approx. Sta. 0+450 (Lake A45 area), looking southeast.

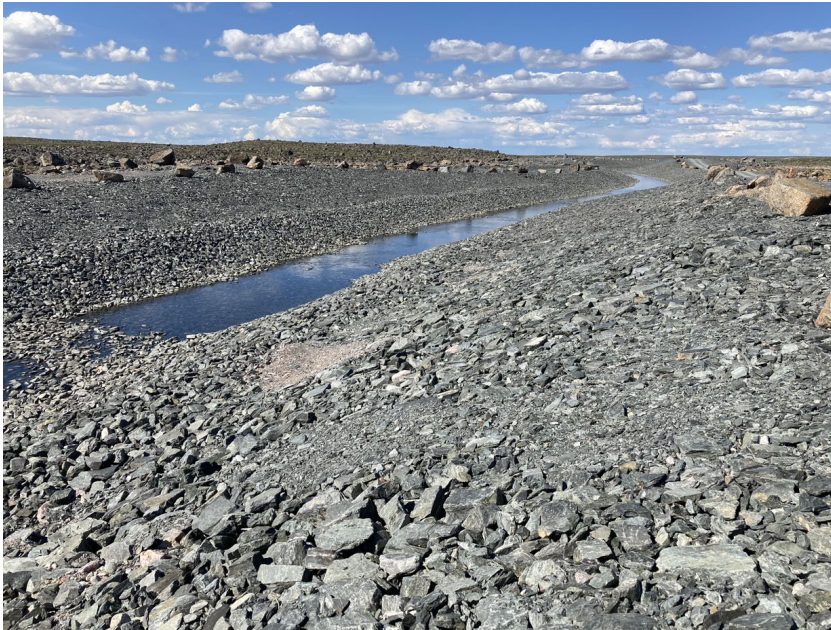
Photograph H10-7 South Whale Tail Channel

Description: From approx. Sta. 0+200, looking northwest.

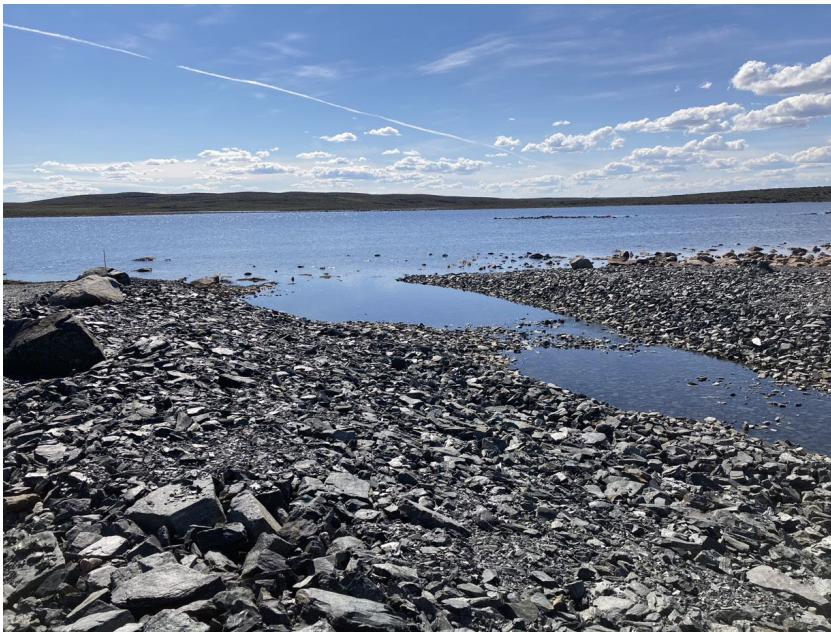
Photograph H10-8 South Whale Tail Channel

Description: From the Whale Tail South Lake inlet, looking southwest.

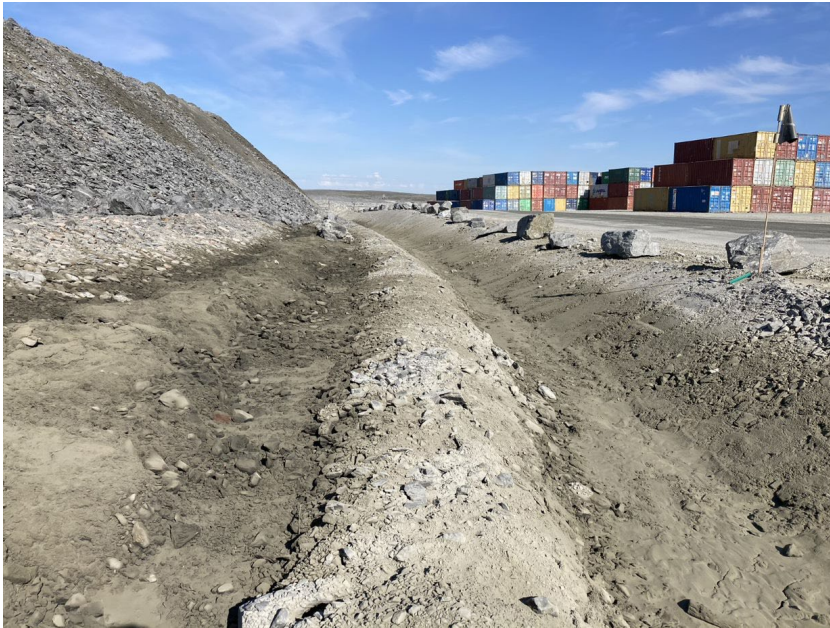
Photograph H11-3 Saline Ditch

Description: From approx. Sta. 0+530, looking east.
