Whale Tail 2025 Annual Open Pit Geomechanical Inspection Report

March 10, 2026

RE: Meadowbank Complex - Amaruq Site - 2025 Annual Open Pit Geomechanical Inspection

2025 Annual Open Pit Geomechanical Inspection

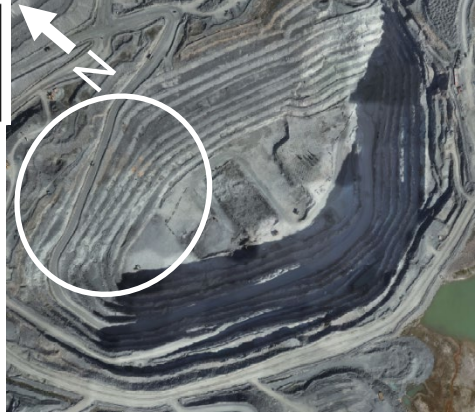
Observations - Northwest Wall

BFA: 65°
Bench Width: 10.5 m
Bench Height: 21 m
IRA: 46°

- Final wall in Design Sector A1/A1K.
- The benches in the Greywacke and Oxidized Greywacke are generally performing well.
- A series of bench-scale failures have occurred in the Komatiite along three High-Strain / Brittle Structures since September 2023, including 11 failures between August 2024 and August 2025. This is discussed further on the next slide. Elsewhere in the sector the Komatiite has performed well.
- A potential wedge is present above the ramp (white box). The wedge is discussed further on a subsequent slide.

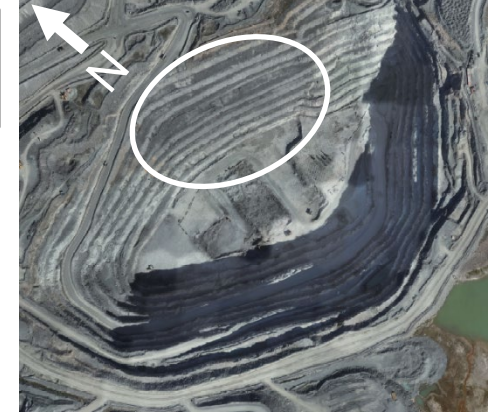
Observations - North Wall

BFA: 65°
Bench Width: 10.5 m
Bench Height: 21 m
IRA: 46°

- Final wall in Design Sector B1.
- Approximately two benches have been mined on this wall since the last annual inspection.
- There have been no slope failures since the last annual inspection.
- To date, the benches have performed better than expected, with the bench face often standing steeper than the foliation in the Greywacke. As the wall transitions into Design Sectors B1K and B2K with depth, the bench faces are expected to more consistently break to the foliation. This is evident in the increased crest loss experienced at the eastern end of the most recent bench (circled below)
- There is a potential for localized wedge failures along the contact between the Greywacke and the Komatiite in the next few benches.

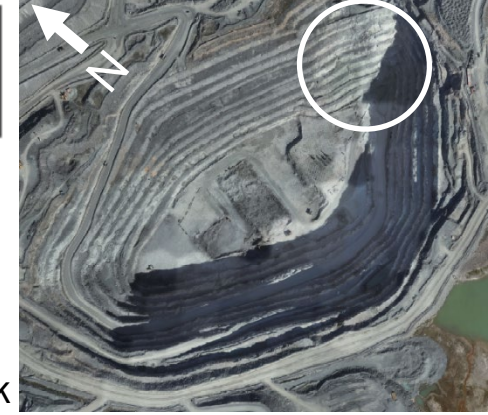
Observations - Northeast Wall

BFA: 55°
Bench Width: 11 m
Bench Height: 14 m
IRA: 34°

- Final wall in Design Sector D4K.
- This sector is within the Komatiite and has been characterized by a series of bench scale failures associated with the weak rock mass and the High-Strain / Brittle Structures (select structures are shown in red below). The slope design was revised in December 2021 and has been successful in managing the performance of the slope.

- Two rockfalls have occurred in this sector since the last annual inspection, ranging in size from 500 to 900 tonnes (circled below). Both of the failures occurred in the fall, above the active bench and in an area where berms were in place due to the Working with Komatiite Procedure. The failure mechanism is a hybrid wedge failure along the foliation, consistent with previous failures in this sector.

- The buttress should be designed in detail and included in the LOM and Budget mine plans. Ensure that the benches will remain frozen between development and buttressing prior to freshet. If this is not possible, a revised mining strategy will be required for this area.

- It is important that the orientation of the foliation and HSB Structures be confirmed through mapping as these benches are established.

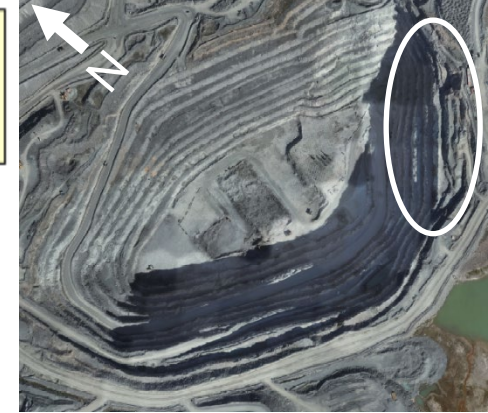
Observations - East Wall

BASE CASE
BFA: 75°
Bench Width: 10 m
Bench Height: 21 m
IRA: 53°

- Final wall in Design Sector E4, transitioning into G5.
- Note that the southern portion of this wall, in Design Sectors F6 and G5, is discussed on the next slide.

- The benches have generally performed well. Increased crest loss occurred on the upper benches where adverse structure (Joint Set B or C) is present. The foliation strikes roughly perpendicular to the wall, which is favourable for bench stability.

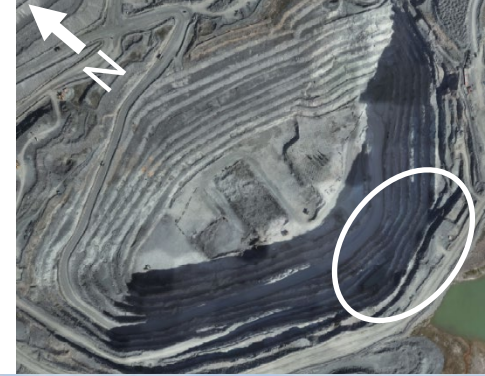
Observations - Southeast Wall

BFA: 75°
Bench Width: 16 m
Bench Height: 21 m
IRA: 44°

- Final wall in Design Sector F6, transitioning to G5.
- The slope geometry recommendations for this sector were adjusted in early 2023 by AEM to reduce the catch bench width from 16 m to 13 m based on the observed slope performance.

- Subsequently, the 5046 bench experienced > 6 m of crest loss over significant intervals of the catch bench. An additional catch bench was added above the ramp as a rockfall protection measure and a rockfall fence was installed in November 2024 (circled in black at right).

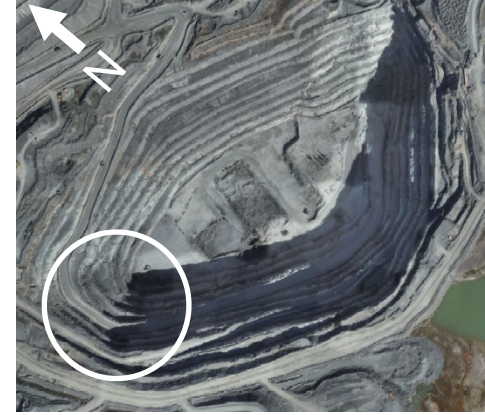
Observations - Southwest Wall

BASE CASE
BFA: 75°
Bench Width: 10 m
Bench Height: 21 m
IRA: 53°

- Final wall in Design Sectors I6 (Diorite) and I1 (predominantly Greywacke).
- The wall is generally performing well. However, there continue to be challenges with drilling and blasting practices resulting in crest loss or hard toes on the benches.

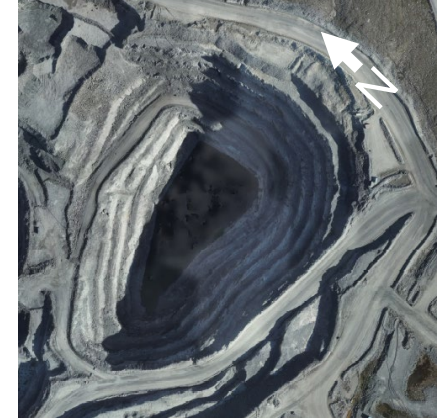
Observations - General

- The Northwest Wall is the footwall of the deposit and was established primarily within the Komatiite.
- Several bench scale failures and rockfalls have occurred over time on this wall, primarily associated with planar or wedge failures along the foliation. A progressive failure impacted the ramp in 2023 (circled in black below) and further failures are possible in this area.

- No rockfalls have occurred since the 2024 annual inspection. Minor ravelling continues to occur along the high-strain / brittle structure in the west wall (circled in white below).

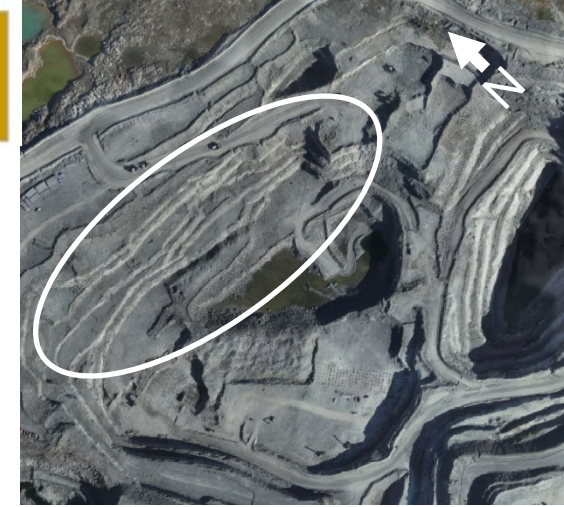
Observations - North Wall

V2 A & V2 E
BFA: 75°
Bench Width: 10 m
Bench Height: 14 m
IRA: 40°

- Final wall established in the footwall of the deposit, primarily within the Mafic Volcanics. This wall has been extended due to the push backs of the East and West walls since the 2025 inspection but has not been advanced to depth.

- The observed slope behaviour continues to be consistent with expectations. While crest loss occurs along the foliation, most of the bench face is typically held at a steeper angle than the dip of the foliation.

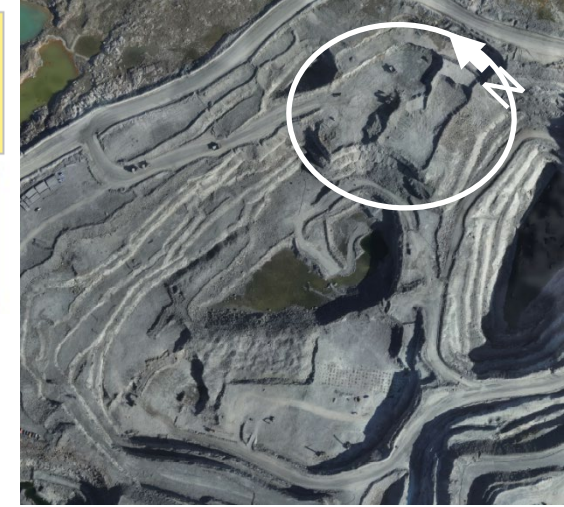
- The East Wall is being pushed back in anticipation of joining the IVR V2 and V1 open pits.
- At the time of the 2025 inspection, only a short interval of the East Wall was established and it had not yet been scaled. The East Wall below the pushback has not been advanced since the 2024 annual inspection and was largely obscured by overspill at the time of the 2025 inspection.
- The eastern extension of the North Wall has been exposed to a height of single bench and is shown below. The bench face is breaking back to the foliation, as expected. The orientation of the foliation and the lithologies forming the benches should be verified through mapping.
- The noses formed with the Turtlehead and with the IVR V1 open pit represent potential rockfall hazards. These will be mined out by the pushback, which is a favourable development from a geomechanical perspective.

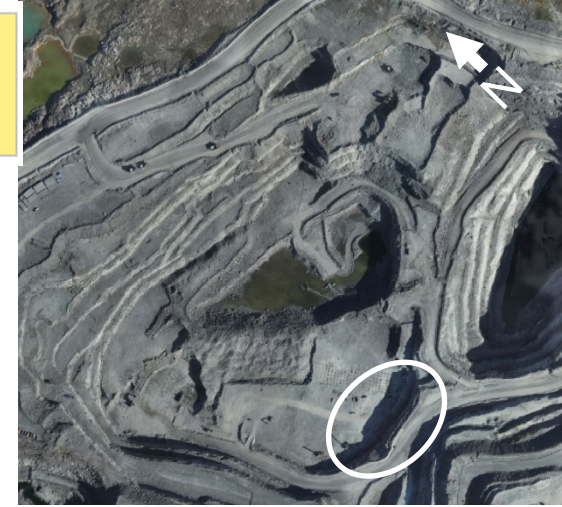
Observations - South Wall

BFA: 75°
Bench Width: 10.5 m
Bench Height: 21 m
IRA: 52°

- The rock mass quality and rock mass structure in this wall are generally favourable and the performance of the initial bench has largely been consistent with expectations.
- However, a large potential wedge was identified in the initial flitch during mining and was proactively scaled out. Several smaller wedges formed by the same structures are present directly to the east of this area, at the crest.
- The joint sets that formed the wedge have not yet been confirmed. The sub-vertical set forming the eastern limit of the wedge may be Joint Set D while the shallower dipping set forming the western limit of the wedge may be Joint Set B. This should be confirmed and compared relative to the results of the stability analyses completed for this wall. If these features are more prominent than originally thought, the bench design may need to be adjusted.

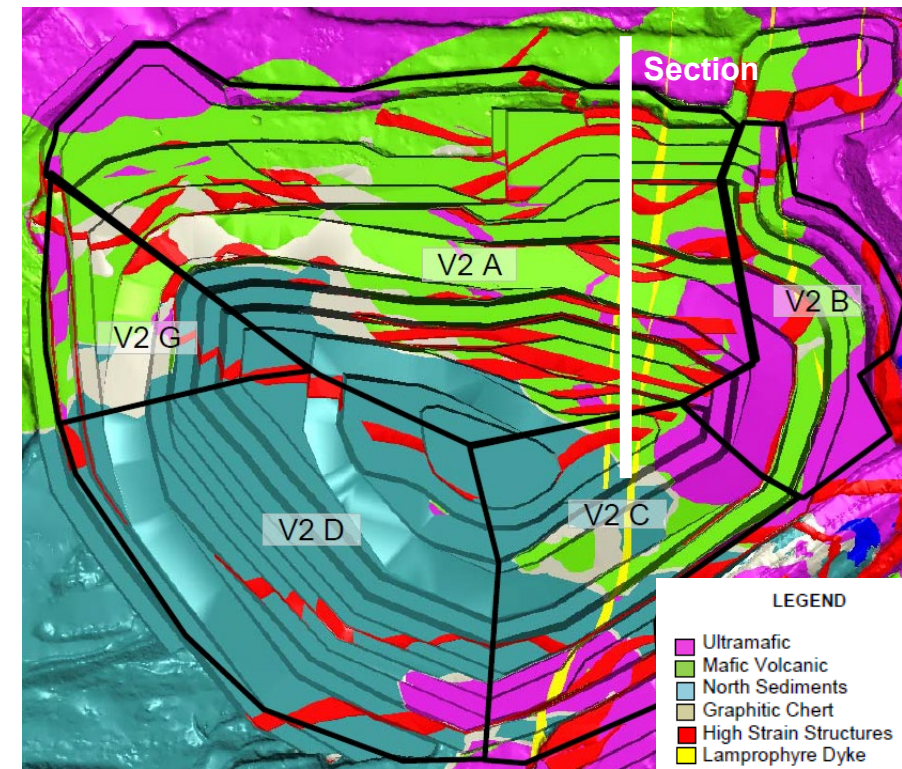
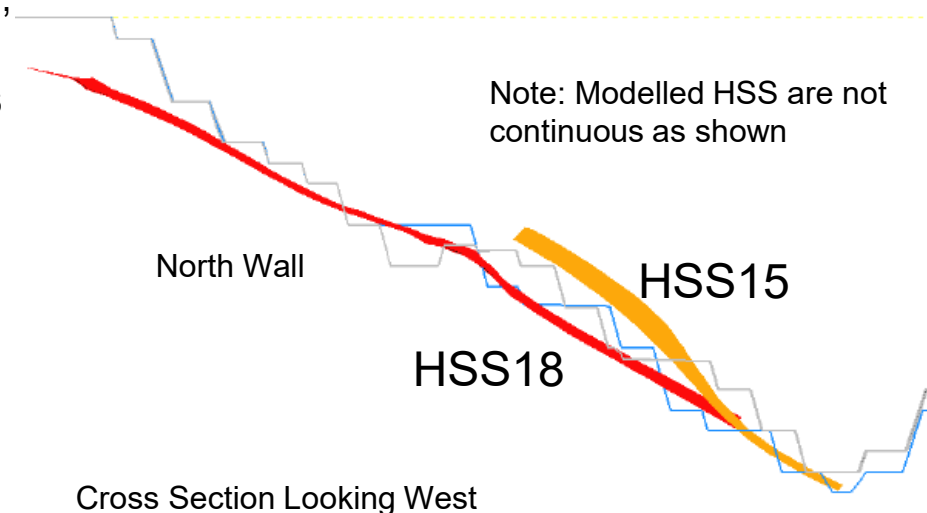
- Several High-Strain / Brittle Structures are located behind or in proximity to the North Wall, including HSS #14, #15 and #18. The slope design is sensitive to the position and continuity of these structures, especially HSS #18. The slope geometry recommendations are based on the current understanding that HSS #18 is not continuous at an inter-ramp scale. However, multi-bench scale failures could occur depending on the position and persistence of the weak intervals along this structure.

- There continues to be a need for on-going geological and geomechanical mapping to confirm the lithology and rock mass structure exposed in the pit walls. If there are significant changes to the interpretation of the Komatiite or High-Strain / Brittle Structures, the potential impact on the open pit slope performance and design should be assessed.

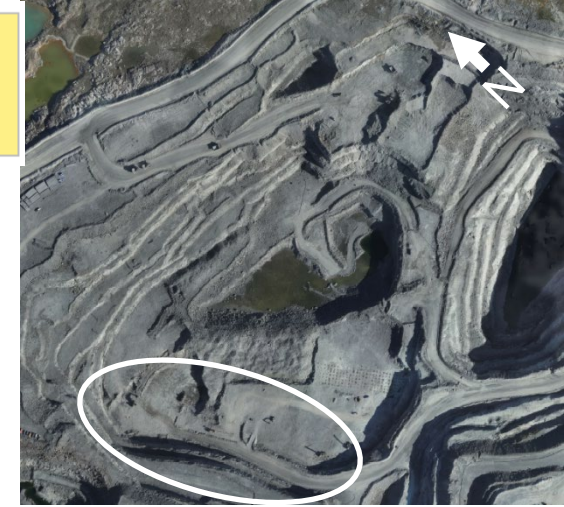
Observations - West Wall

BFA: 75°
Bench Width: 10.5 m
Bench Height: 21 m
IRA: 52°

- The pushback of the west wall is complete and it has reached the current pit floor.
- The rock mass structure is favourable in this sector and the benches have performed well. The wall continues to benefit from the improvements to drilling and blasting practices in 2024. Half-barrels are regularly observed.

- Several shallow-dipping HSB structures are exposed in the wall. The structures dip to the south and their impact has been limited to locally increased crest loss. However, this is a good opportunity to validate the HSB model.

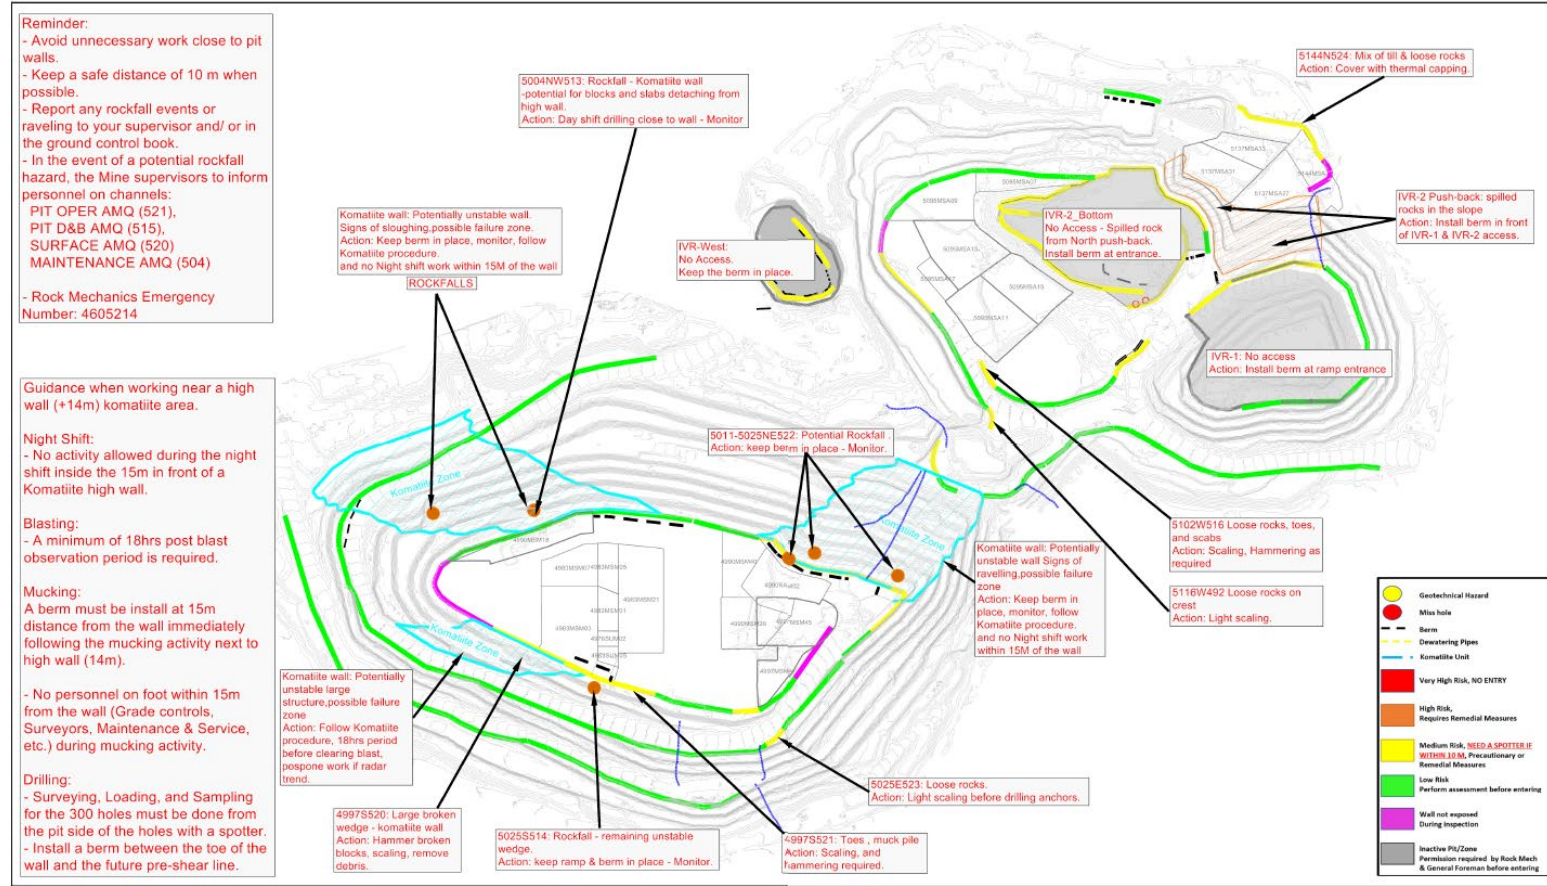
- Identified hazards and the required mitigation work are tracked on a Hazard Map available to the workforce that is updated every two weeks.
- Comments on the maps and their integration with work near the pit walls is provided on the next slide.
- There continues to be limited guidance on how to select the risk ratings. However, only two AEM personnel complete the maps and they feel that they use a similar approach. Recommend developing more detailed guidance in the event of a change in personnel.
- The hazard map has been updated to show the location of the Komatiite Zones (which trigger the Working With Komatiite procedure) and the position of berms. Green Candles are also used in the pit to demarcate geotechnical hazards. These are positive developments.

- Recommend reviewing the integration between the Work Close to Pit Wall procedure and the hazard maps to ensure that the procedure can be consistently implemented as intended.

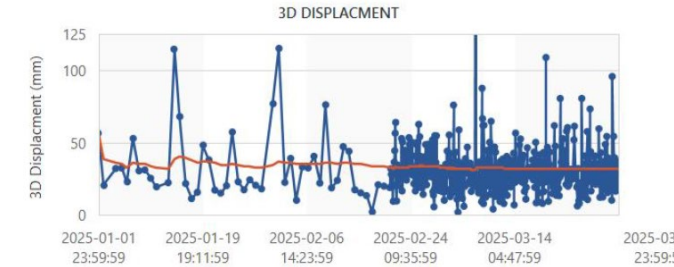
Data
from #5039

- The mine has installed GNSS beacons to complement the SSR data, provide a long-term deformation baseline, and to allow the true displacement vector of the slope to be measured. Four beacons were installed in 2023 and early 2024 in the Northeast and Northwest walls of the WHL open pit.

- Since the 2024 annual inspection, one additional GNSS/GPS (#5025) was installed in the Greywacke in the North Wall. The Greywacke is initially expected to experience less displacement than the Komatiite in the Northeast and Northwest walls and thus should be a useful point of comparison. The Greywacke is predicted to start to deform during the recovery of the crown pillar.

- The beacon installed on the ramp in the northwest wall is no longer functional as the battery has drained. The battery should be replaced.
- The beacon data are imprecise and are reviewed using moving averages. The displacement has averaged 5 to 10 mm over a 3 month period.

- The GNSS beacons are now fully integrated into the mine's monitoring system (e.g., MonitorIQ) and an alarm has been defined at 10 mm/hr. Due to the precision of the beacons, recommend defining the alarm over a longer time period (e.g. a week). A TARP still needs to be developed.

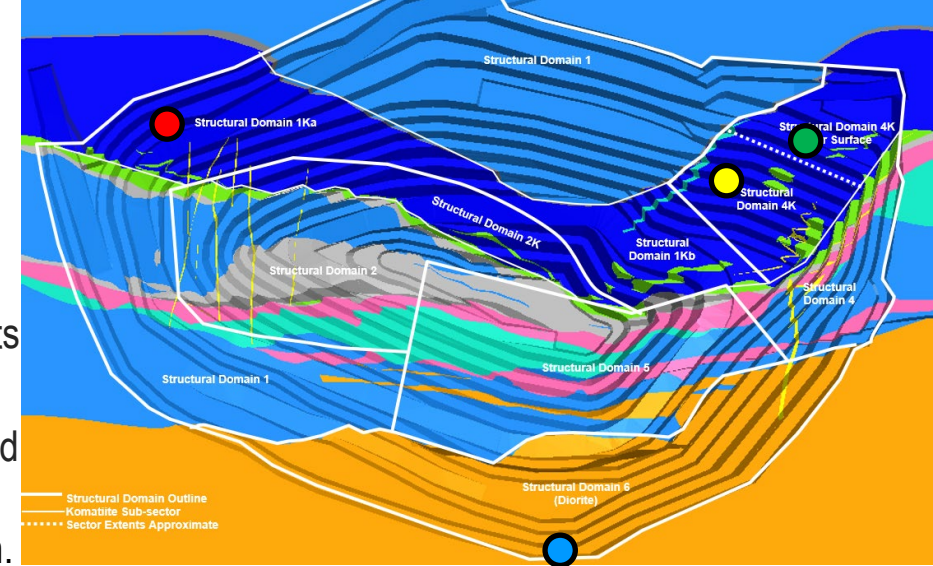
- A thermistor string, five vibrating wire piezometers, and a TDR cable installed in a single drillhole in the South Wall (blue dot at right) in order to monitor the hydrogeological conditions within the talik exposed in the south wall. The data have largely stabilized, with limited changes due to recent mining. The TDR is available but is not currently being monitored.

- An SAA inclinometer and VWP installed in the upper Northeast wall (green dot). This area was originally in a closed talik associated with Whale Tail lake but the instrumentation indicates that the rock mass is now frozen. The SAA has reported consisted displacement (8 mm since November 2023) towards the open pit and this is discussed further on the next slide.

- A second SAA inclinometer and VWP were installed in the lower Northeast Wall (yellow dot) in Q1 2024. The SAA was damaged during installation and only the VWP is functional.

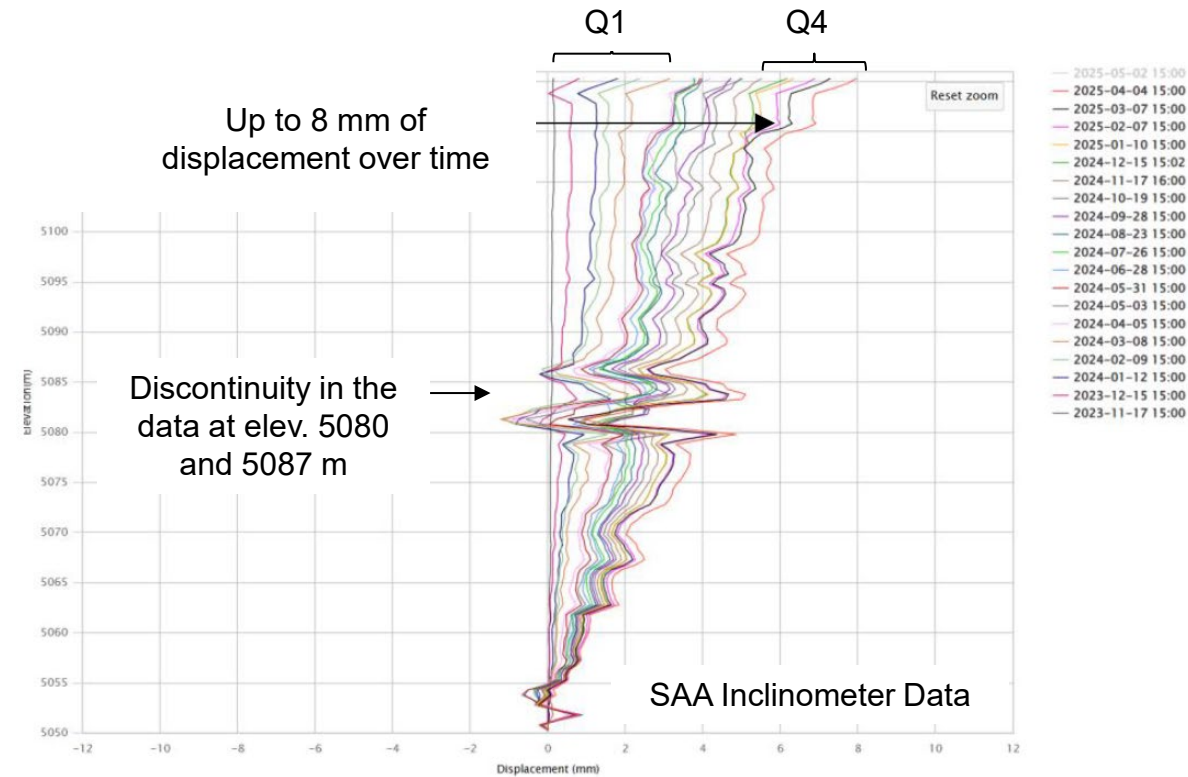
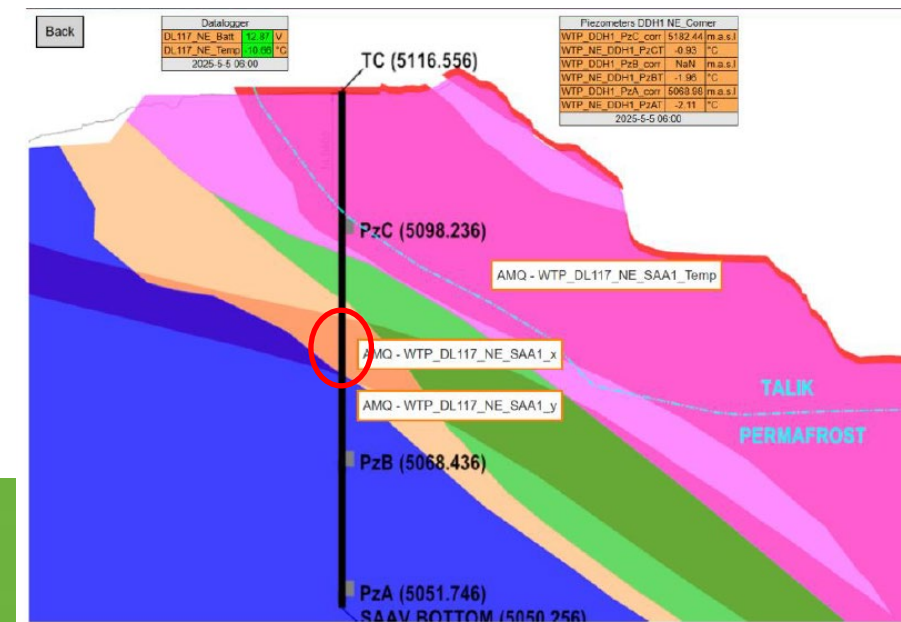
- The data from the SAA installed in the upper Northeast Wall of the WHL open pit are shown at upper right.
 - There are peaks in the data at elevation 5080 and 5087 (roughly the area circled in red at bottom right). These correspond to a contact between the Greywacke (blue) and the Chert (orange).
 - A high-level review of the data suggests that the displacement increased when mining was occurring at the toe of the slope in Q1 and Q4 2024. Recommend plotting the data relative to mining activities in this sector.
-
- All of the instruments are integrated into the mine's monitoring system (e.g., MonitorIQ). Trigger thresholds, alarms, and a TARP need to be developed for the SAA to govern the management and interpretation of the data.
 - Additional instrumentation should be installed as mining progresses (e.g., Design Sector A1K and IVR V2 Design Sector V2A).

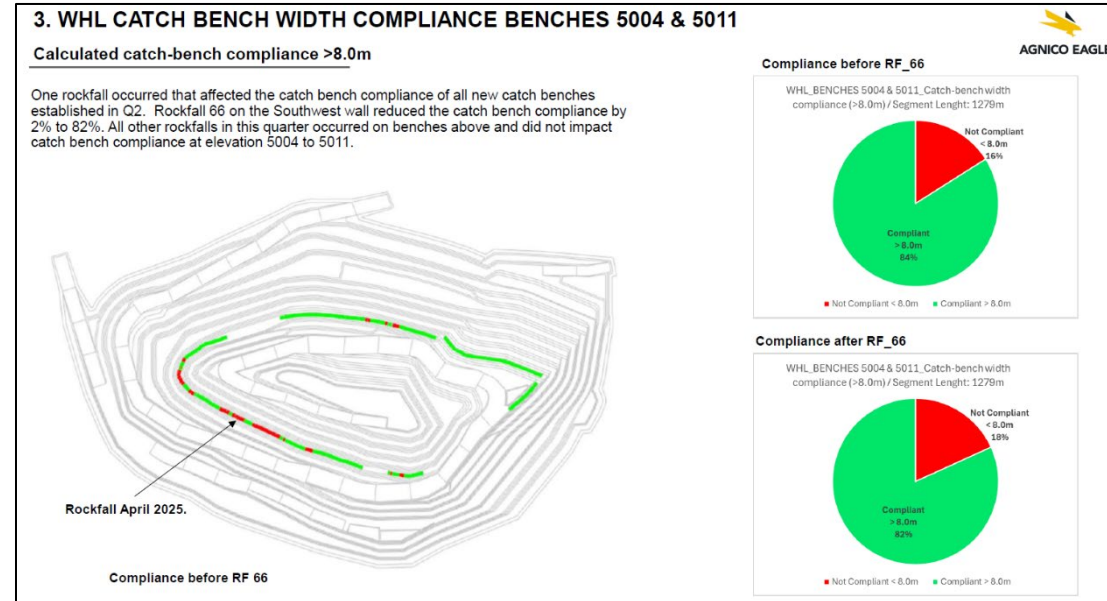
- Back break of the crests was measured for the IVR V2 open pit for Q3-Q4 of 2024. The backbreak averaged 1.6 to 2 m (excluding the first bench which is influenced by surface effects). However, whether or not this complied with the design basis was not assessed. Catch bench width compliance was subsequently assessed in Q2 2025 for the pre-sheared benches. The catch benches evaluated achieved the required width of 8 m with 79% reliability. This is consistent with the design basis.

- The catch bench performance needs to be consistently compared to the design basis. Recommend continuing to complete this as part of the quarterly reports.
