MEADOWBANK GOLD MINE

FRESHET ACTION AND INCIDENT RESPONSE PLAN

OCTOBER 2015

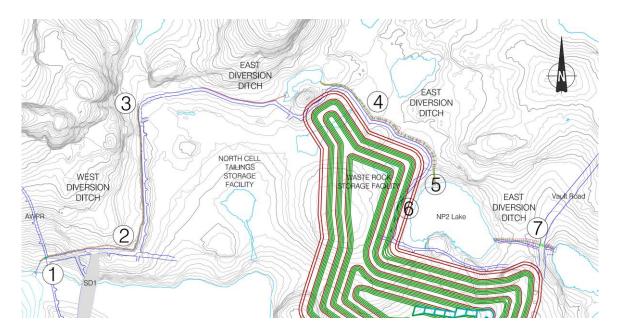
Figure 2-3: Location of the areas of interest for the 2015 diversion ditches freshet Action plan

Ditch outflows are important to ensure proper flow of freshet drainage. The culvert under the AWAR (Figure 2-3 #1) is a critical section of the West Diversion Ditch. Snow removal must be performed to avoid ponding and damage to the ditch/trench structure as well as to maintain the integrity of the AWAR which, in turn, is critical to transportation at the Meadowbank mine site.

One of the deepest sections of the West Diversion ditch is located in the corner next to the Saddle Dam 1 – see Figure 2-4 and Figure 2-3 #2 above. In 2013 a large accumulation of snow blocked the flow through this ditch at a location denoted by the red square. Water accumulated behind the blockage and raised upstream creating channels through the rockfill and into the North Cell TSF. In early May of each year, AEM will remove the snow accumulation to allow the water to flow freely preventing the water upstream from increasing in level and hydraulic head pressure. In addition, large flows can scour the ditch system causing sediment migration through the ditches which could impact Third Portage Lake. To prevent this, snow must be removed from the corner area with a long reach excavator in early May.

The construction access road at the Northwest corner of the North Cell TSF (see Figure 2-6 and Figure 2-3 #3) is vulnerable to damage from the freshet water flow from the northern watershed (see watercourse flow in Figure 2-6 denoted by light blue dotted line). The start of the West Diversion ditch is also located in this area and is designed to collect most of the freshet flow – note arrows in Figure 2-6. In order to prevent the water from accumulating against the access construction road and possible overflow to the tailings pond, the snow and ice must be removed in early May from the areas indicated by the red circle in Figure 2-6. This is very important as the start of the West ditch is shallow, must manage a high initial flow rate and can plug easily (with snow). Also, note in the Figure 2-6 two areas where water ponded during the 2013 and 2014 freshet. As a contingency, a pump can be utilized to transfer this water to the North Cell TSF or the West Diversion ditch (non-contact water only). In addition, to prevent any contamination of Third Portage Lake, daily inspections will be completed and samples will be taken if AEM suspects that any seepage contamination is migrating out of the TSF (analysis for CN and metals). If water is contaminated with tailings, the water will pumped back to the TSF.

This area of the East Diversion ditch, seen in Figure 2-8 and Figure 2-3 #5, is critical as it acts as the outflow of the North part of the East Diversion ditch into NP-2 Lake. This outlet must be cleared of obstructions – snow and ice in early May to promote drainage through the ditch and into NP-2 Lake. The presence of ice blocks will be mitigated using the steam machine to melt away the obstruction. Daily inspections will commence in early May and sample monitoring will be conducted monthly during open water in accordance with the Water License (location ST-5). Sampling frequency of ST-5 may be increased if TSS results are near 30 mg/L (grab) and 15 mg/L (monthly average), or visually elevated. Turbidity barriers have been installed at the ditch outlet into NP-2 in 2013 to mitigate elevated TSS. If a discharge of TSS occurs, the Environmental Department will notify DFO.

This area of the East Diversion ditch is critical as it acts as the outflow of NP-2 Lake through the Vault Road culvert (see Figure 2-3 #7). The culvert seen in Figure 2-9 connects the East Diversion ditch from Lake NP-2 to NP-1. Snow and ice must be removed from the area, including upstream at the exit of NP-2 Lake in early May to ensure that the outlet of NP-2 flows freely to NP-1 and ultimately to Dogleg Lake. Back up could cause upstream water raises in Lake NP-2 which could cause overflow into the RSF at ST-16. First, snow from the ditch between NP1 and the road (1) would be removed in early May. Next, any obstruction between the road and NP2 Lake (2) would be removed. If needed, the steam machine would be used to remove the ice and snow from inside the culvert (3) and ensure that any other ice obstructions were removed from the outlet of NP2 Lake (4) to allow free flow of melt water. Daily inspections will commence in early May and TSS sample monitoring will be conducted monthly. Sampling frequency may be increased if TSS results are near 30 mg/L (grab) and 15 mg/L (monthly average), or visually elevated. A turbidity barrier (orange barrier #1) was installed in 2014 at the ditch outlet into NP-1 to mitigate the risk of elevated TSS (Figure 2-10). If a discharge of TSS occurs, the Environmental Department will notify DFO.

The northwestern area of the RSF, which consists entirely of NPAG material, extends towards the East Diversion ditch as shown in Figure 2-3 #6. Runoff from this area, while not anticipated to be contaminated could, if significant, discharge to NP-2 lake after crossing the tundra. A natural depression should capture most of the NPAG runoff. Daily inspections will be conducted by the Environmental Department. Sample monitoring will be undertaken when water is observed in order to determine water quality. Contaminated water must be kept from reaching NP-2 Lake. Ditching can be undertaken as a mitigation measure if required.

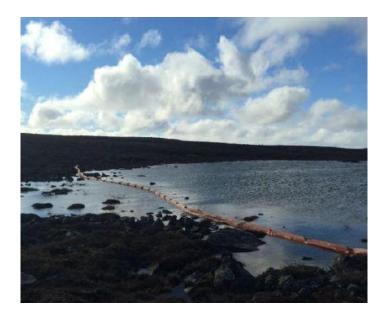
Figure 2-11: Turbidity barriers at the inlet of Dogleg Lake

In June 2015, while conducting regular inspections as per the Freshet Action Plan, AEM staff observed elevated TSS in the water running under Vault Road (culvert) toward Lake NP-1. The flow was largely localized due to a large accumulation of snow in this area, significant snowmelt occurring due to spring freshet and recent heavy rain. After some additional melting of ice and snow it was clear that water with elevated TSS was flowing past the turbidity and silt barrier that

was in place from last year, onto the lake ice. A second turbidity barrier (yellow barrier #2) was installed just outside of the first barrier. Two additional barriers were also installed as a precautionary measure at the outlet of NP-1 (barrier #3) and at the inlet of Dogleg Lake (barrier #4) (Figure 2-11). The incident was of short duration and the turbidity barriers prevented migration of TSS to Dogleg Lake which is fish bearing. AEM also proceeded to raise the Vault road near NP-1 culverts (Figure 2-12). A different source of aggregate — NPAG from Vault was used (harder material) which will prevent an accumulation of fine material and will allow for water to runoff instead of accumulating or percolating through the road. For the next winter season there will be no additional snow from ploughing placed in this area.

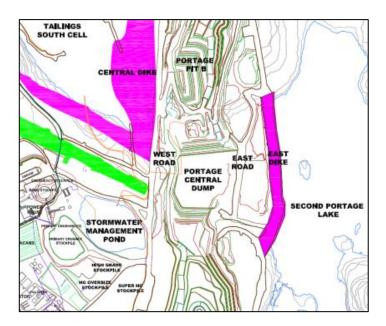
Figure 2-13: Portage Pit area with the Stormwater Management Pond

The Stormwater Management Pond is a small shallow and fishless water body that can be seen in Figure 2-13 adjacent to Portage Pit. Treated sewage is discharged into this pond before being transferred to the active TSF. The quantity of water transferred each year is recorded. Weekly inspections will be undertaken to determine the commencement of pumping.
