DATE May 21st 2018

1897439-1577-TM-Rev0

QA WEEKLY REPORT FROM MAY 14TH TO MAY 20TH – TSF SOUTH CELL CONSTRUCTION MEADOWBANK (1897439)

QA WEEKLY REPORT FROM MAY 21ST TO MAY 27TH – TSF SOUTH CELL CONSTRUCTION MEADOWBANK (1897439)

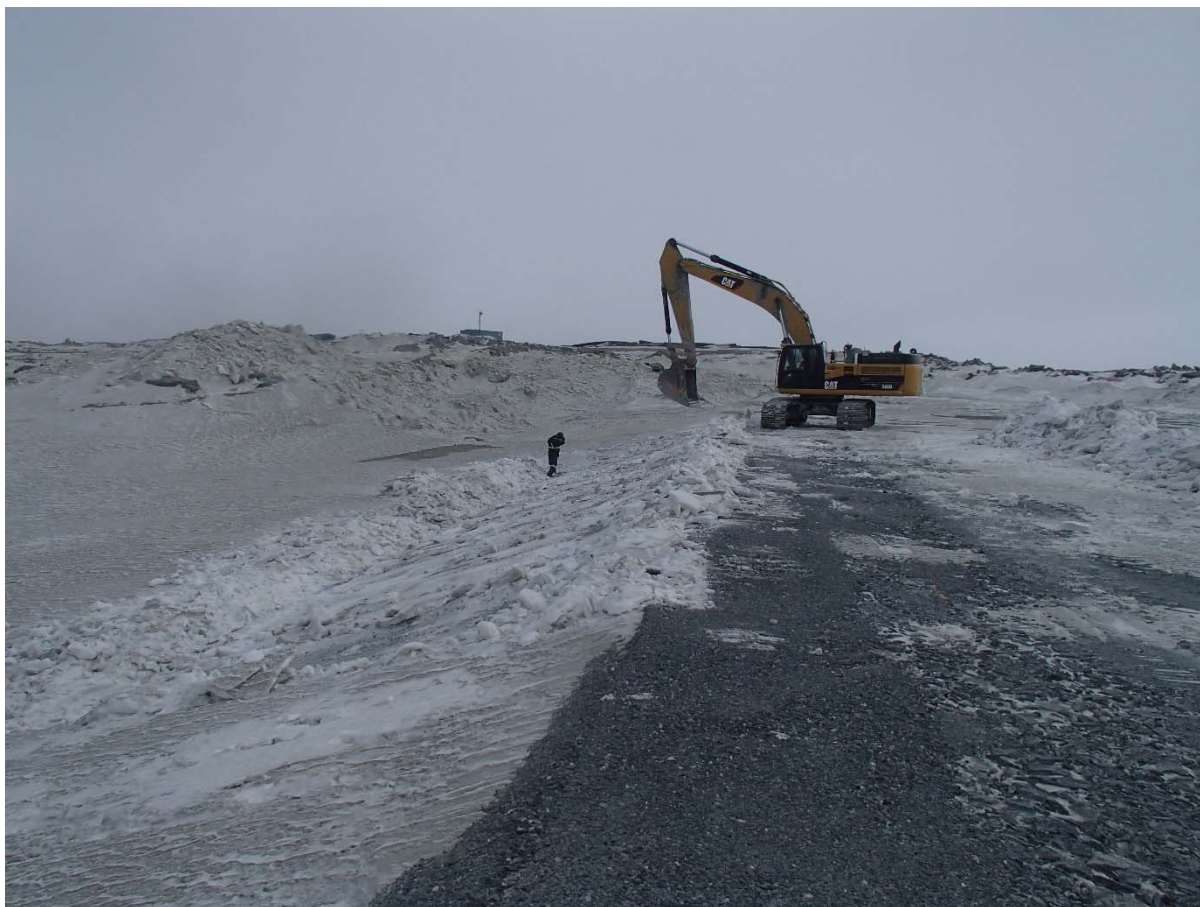
Photograph SD3-297: From Sta. 20+730/-10 m, looking SE. Removal of snow on the upstream slope of SD3 with an excavator, from Sta. 20+640 to 20+760 m.

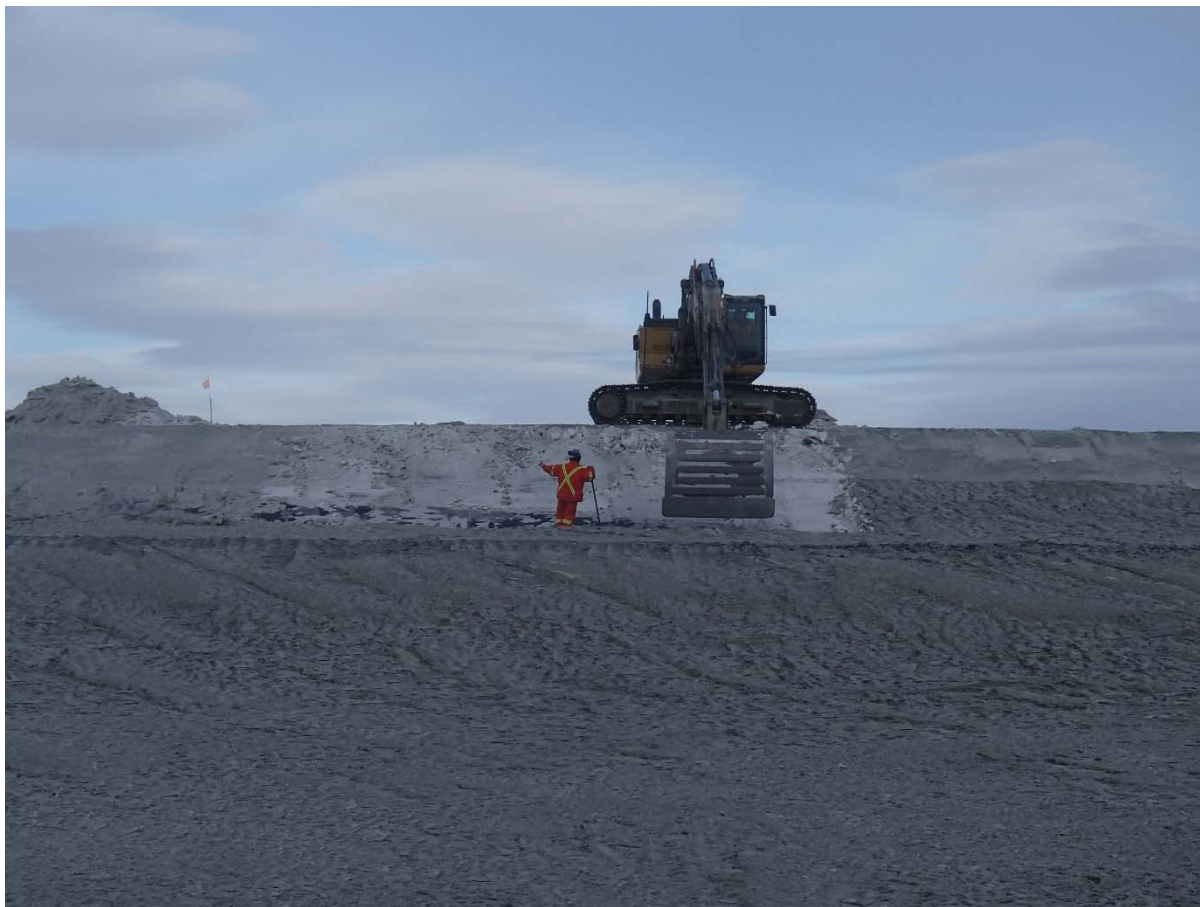
Photograph SD3-298: From Sta. 20+680/-88 m, looking S. Removal of snow on the upstream slope of SD3 above El. 142 m, from Sta. 20+620 m to 20+780 m.

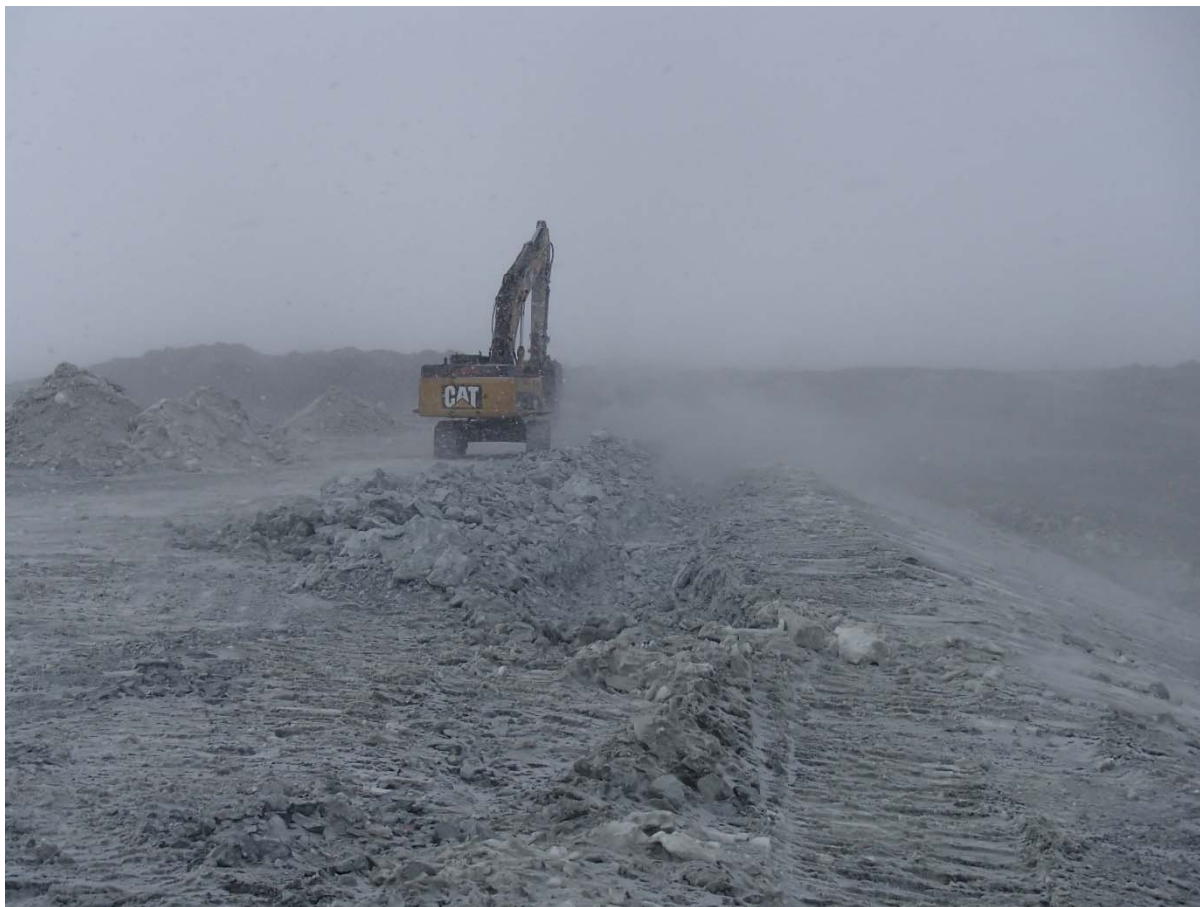
Photograph SD3-300: From Sta. 20+790/-33 m, looking NW. Excavation of the LLDPE geomembrane crest anchoring trench with an excavator from Sta. 20+675 m to 20+780 m.

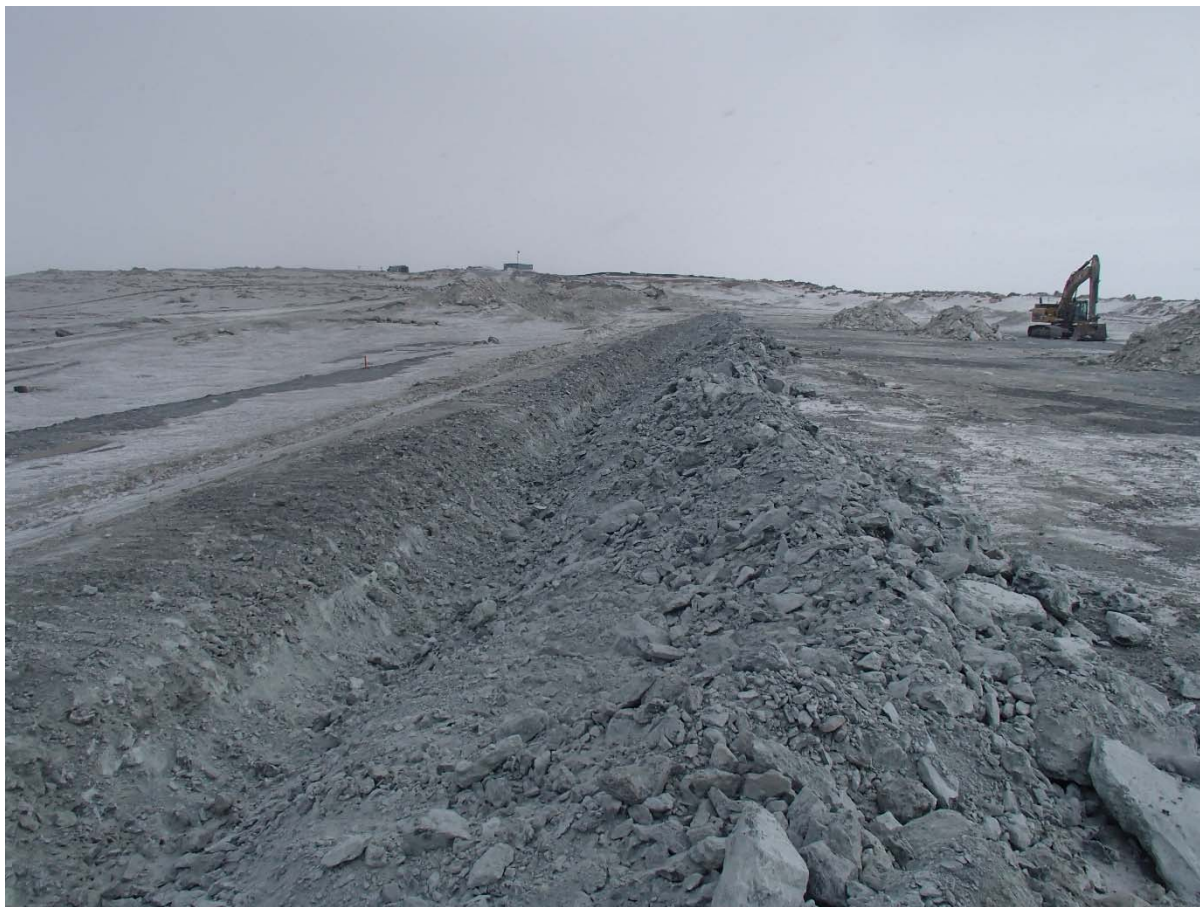
Photograph SD3-301: From Sta. 20+660/-22 m, looking SE. Excavation of the LLDPE geomembrane crest anchoring trench with an excavator from Sta. 20+655 m to 20+675 m.

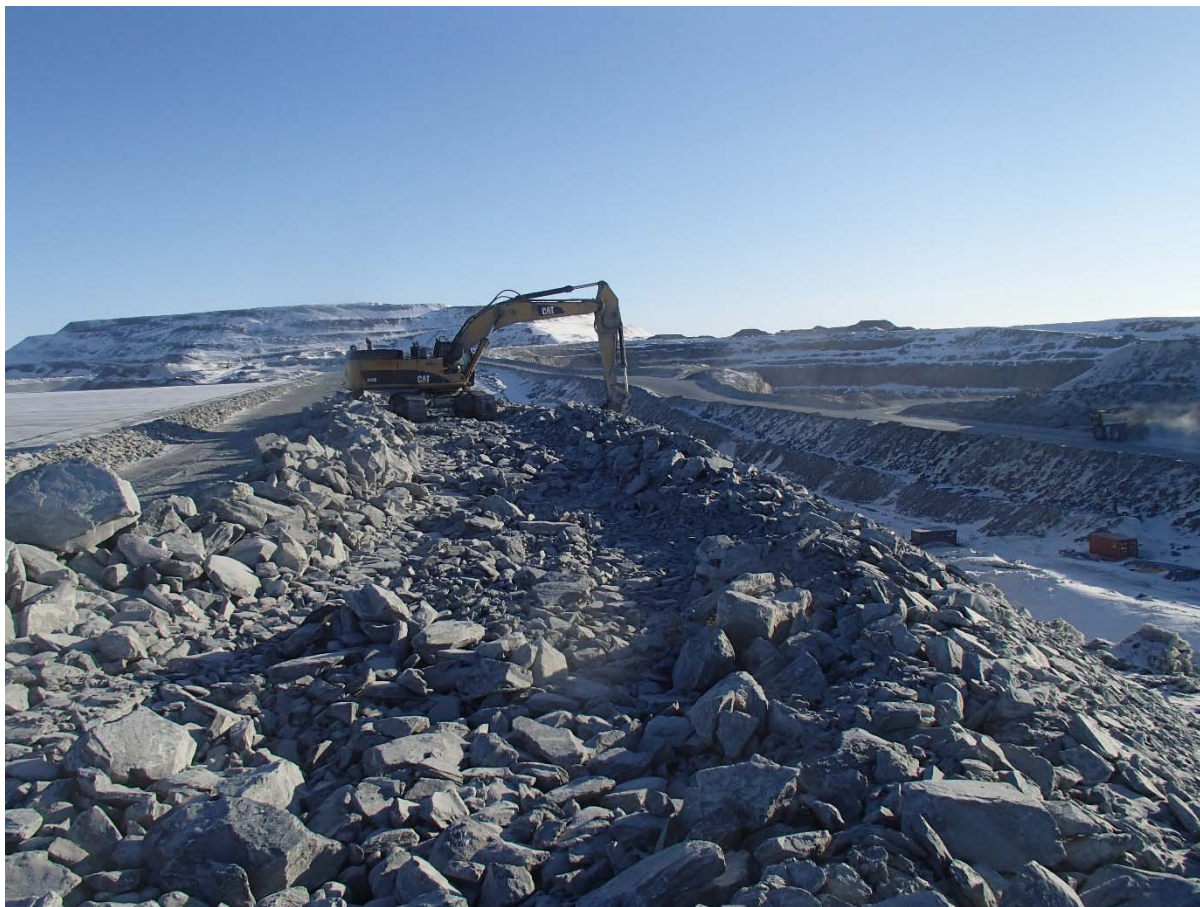
Photograph CD-1854: From Sta. 0+960/-13 m, looking N. Profiling of the downstream slope (1.5H:1V) from El. 143 to 145 m with an excavator between Sta. 0+940 m and 0+990 m.

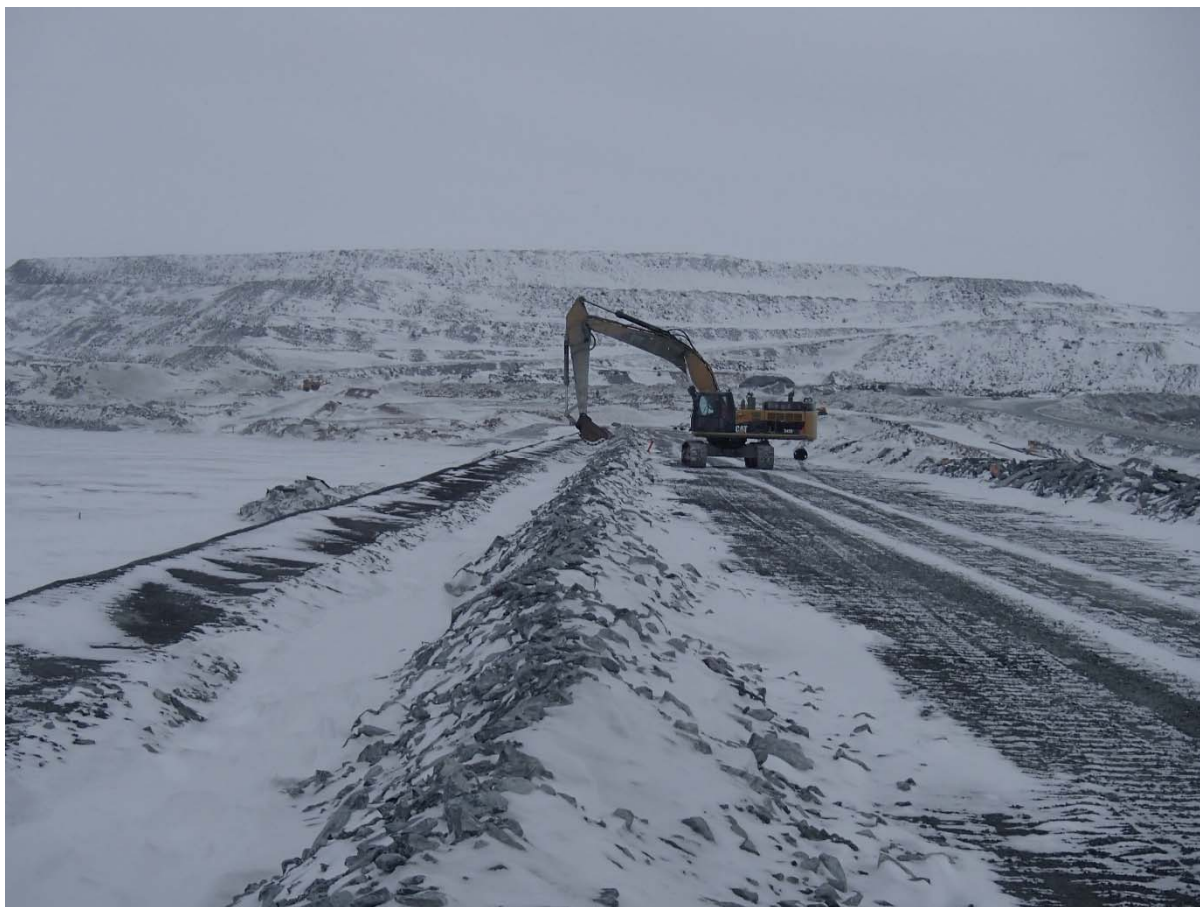
Photograph CD-1857: From Sta. 0+700/-20 m, looking N. Snow removal in the anchoring trench with an excavator between Sta. 0+170 m and 40+780 m.

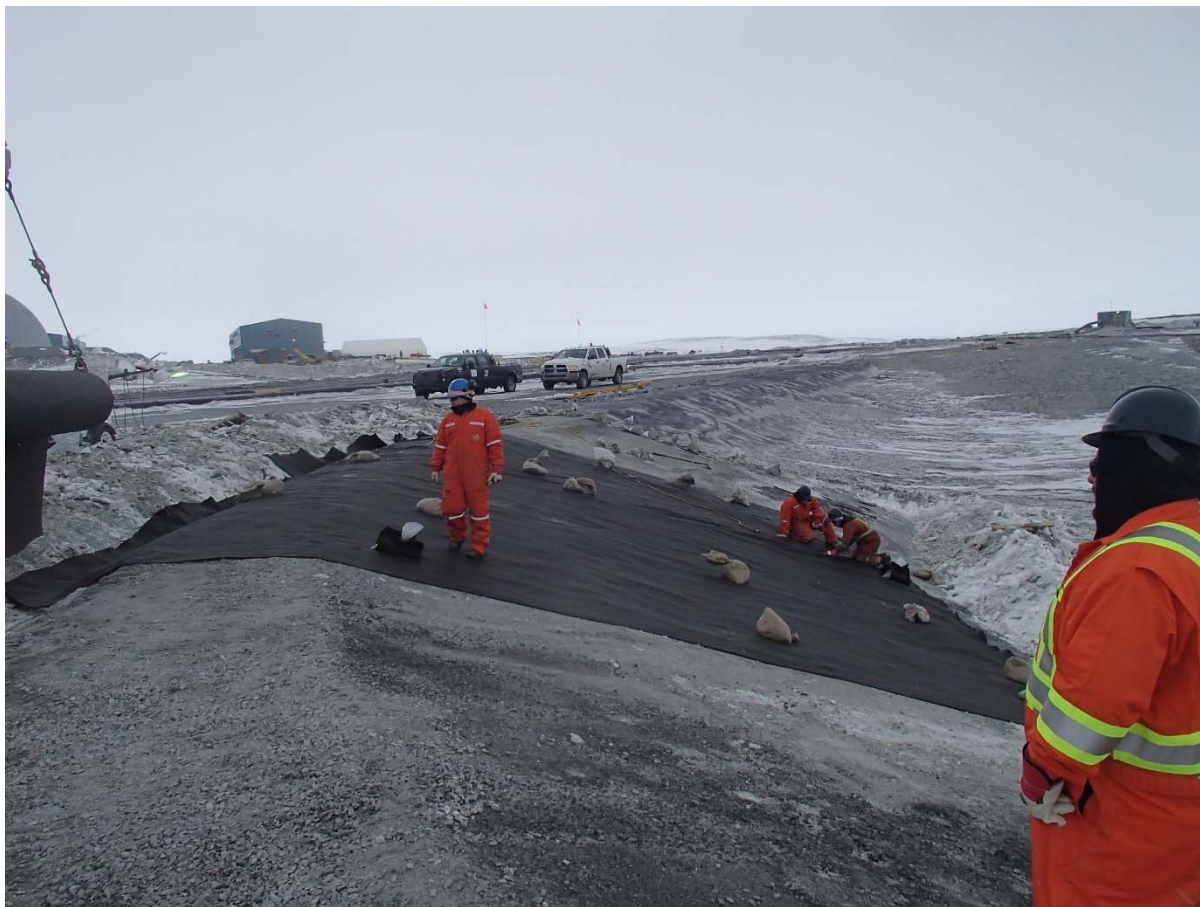
Photograph CD-1859: From Sta. 40+780/-38 m, looking SW. Installation of the geotextile on the upstream slope 3H:1V (SD5 side) to 2H:1V (Central Dike side) between El. 143 m and 145 m from Sta. 40+640 m to 0+830 m.

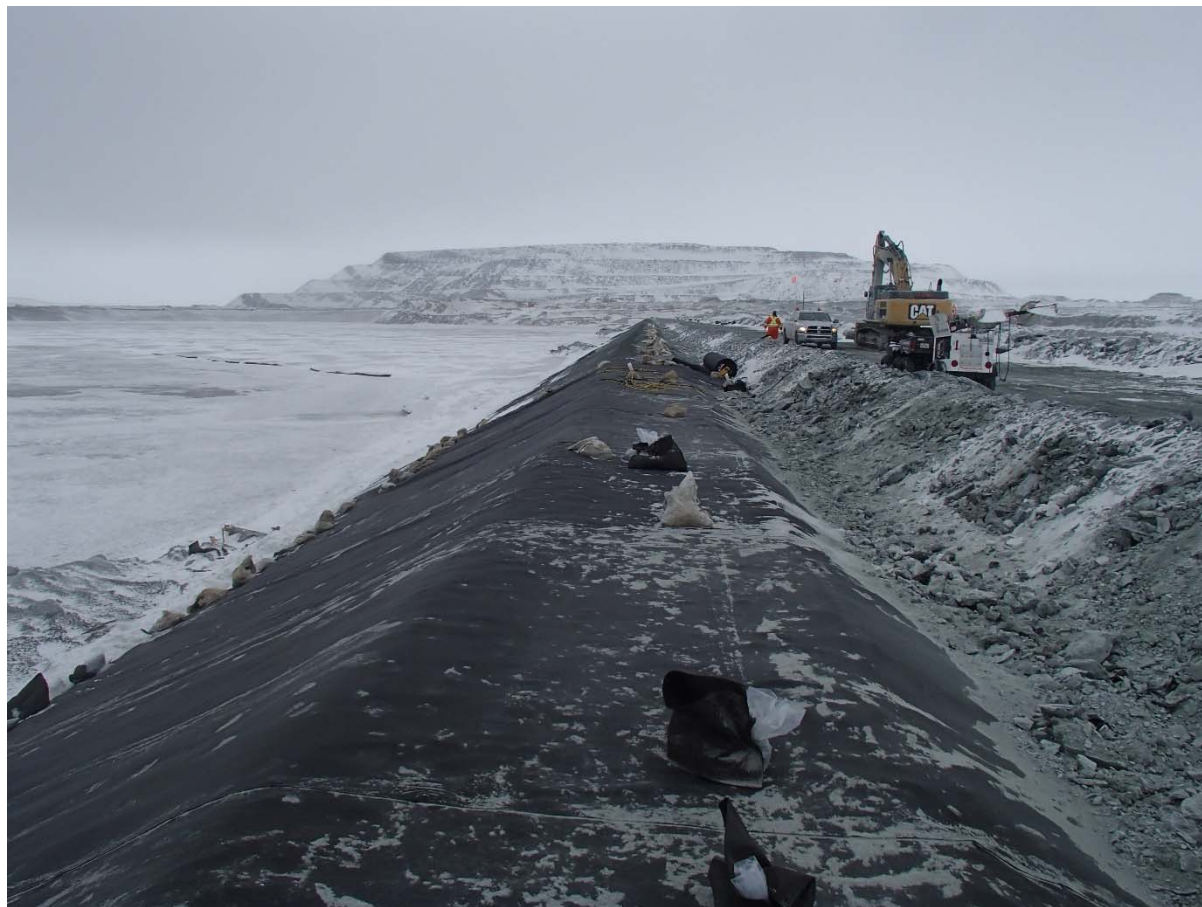
Photograph CD-1860: From Sta. 0+790/-26 m, looking N. Installation of the geotextile on the upstream slope 2H:1V between El. 143 m and 145 m from Sta. 0+830 m to 0+750 m.

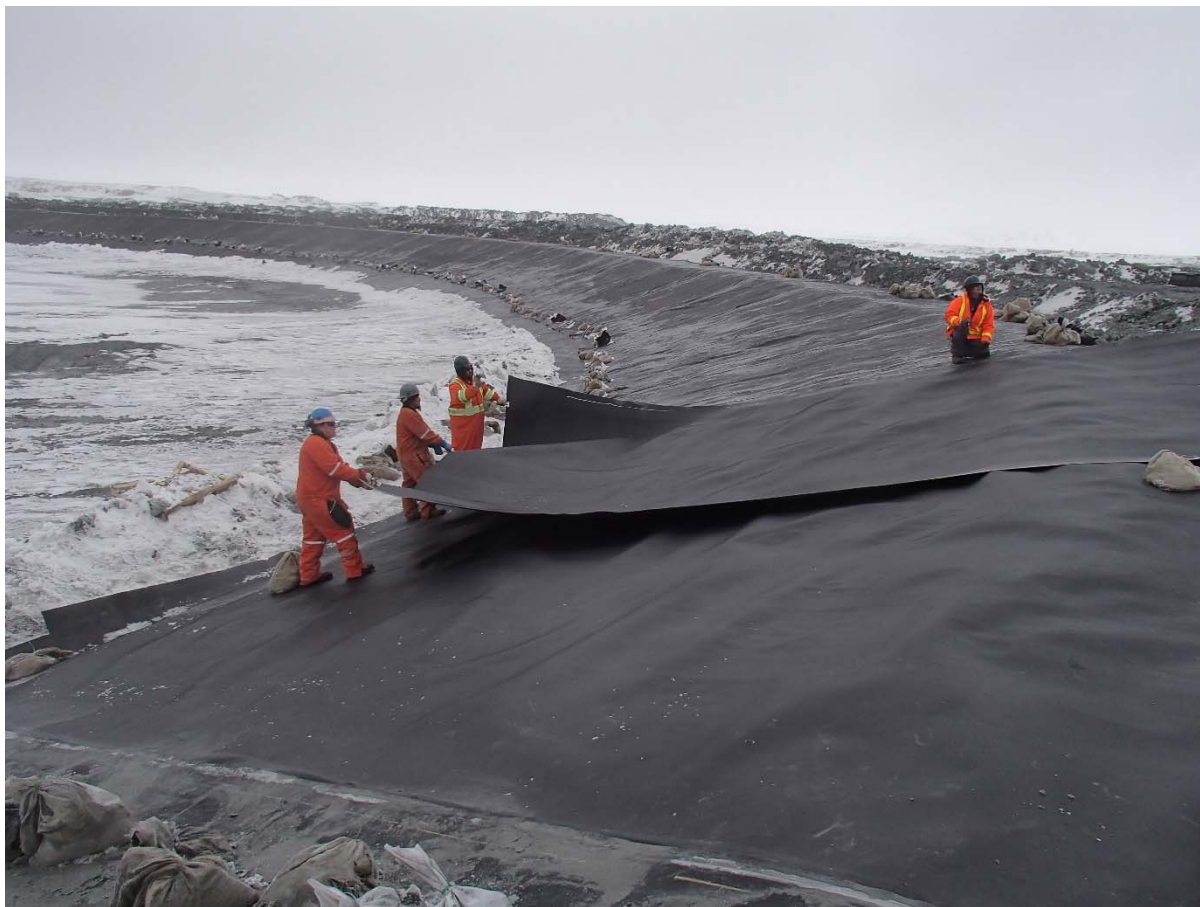
Photograph CD-1861: From Sta. 40+680/-28 m, looking NE. Installation of the LLDPE liner on the upstream slope 3H:1V (SD5 side) to 2H:1V (Central Dike side) between El. 143 m and 145 m from Sta. 40+680 m to 0+950 m (panel numbers 802 to 817).

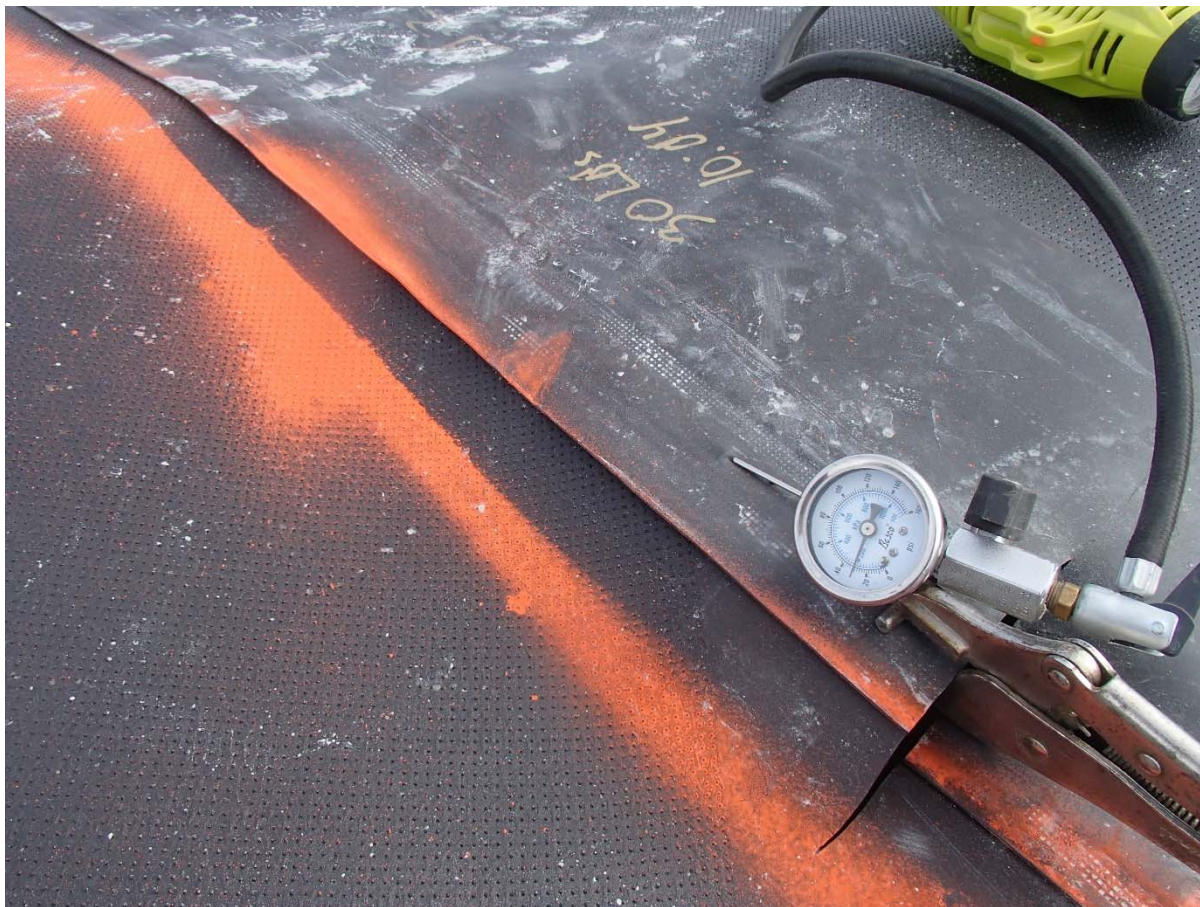
Photograph CD-1862: From Sta. 40+960/-24 m. View of an air channel test.

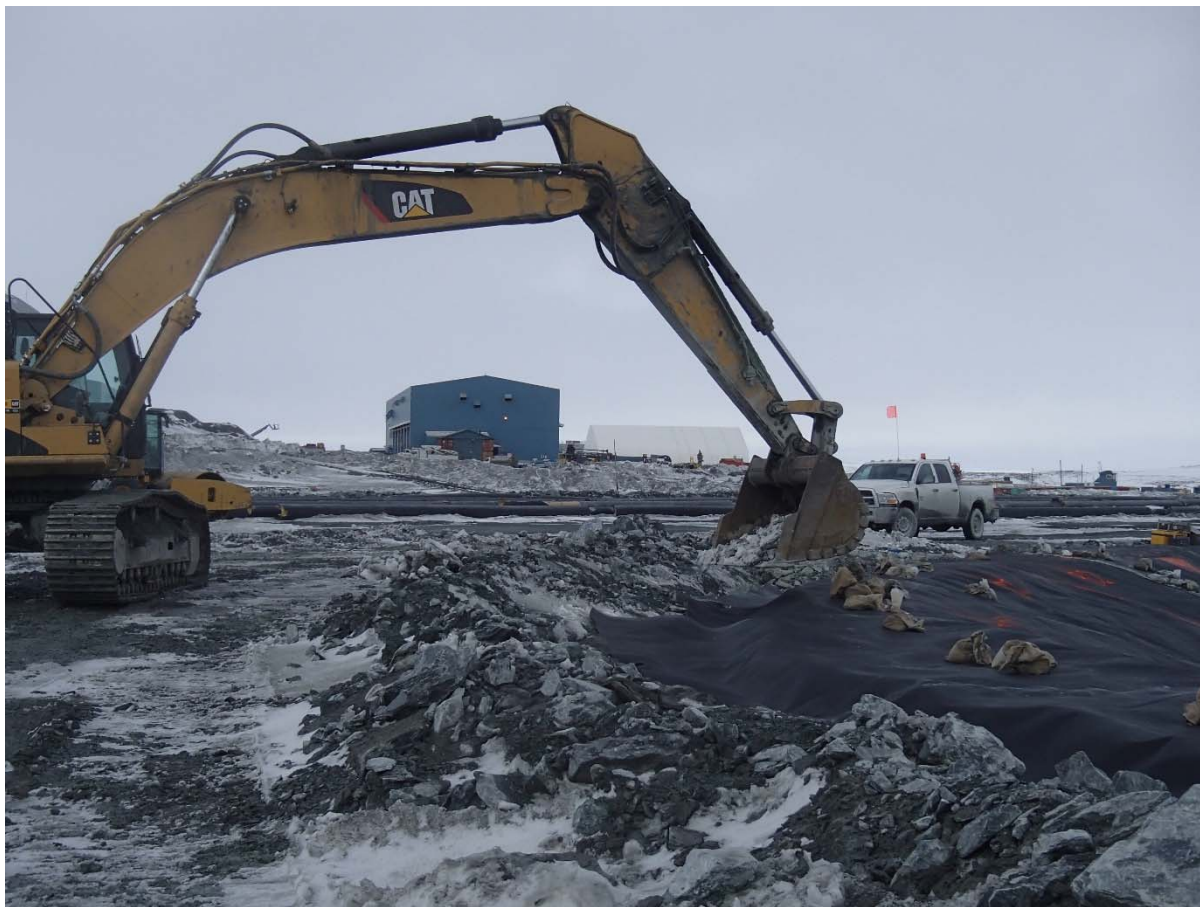
Photograph CD-1863: From Sta. 40+750/-18 m, looking SW. Backfilling of the geosynthetics tie-in from Sta. 40+680 m to 0+950 m.
