QA WEEKLY REPORT

1897439-1577-TM-Rev0

QA WEEKLY REPORT FROM MAY 28TH TO JUNE 3RD – TSF SOUTH CELL CONSTRUCTION MEADOWBANK (1897439)

QA WEEKLY REPORT FROM JUNE 4TH TO JUNE 11TH – TSF SOUTH CELL CONSTRUCTION MEADOWBANK (1897439)

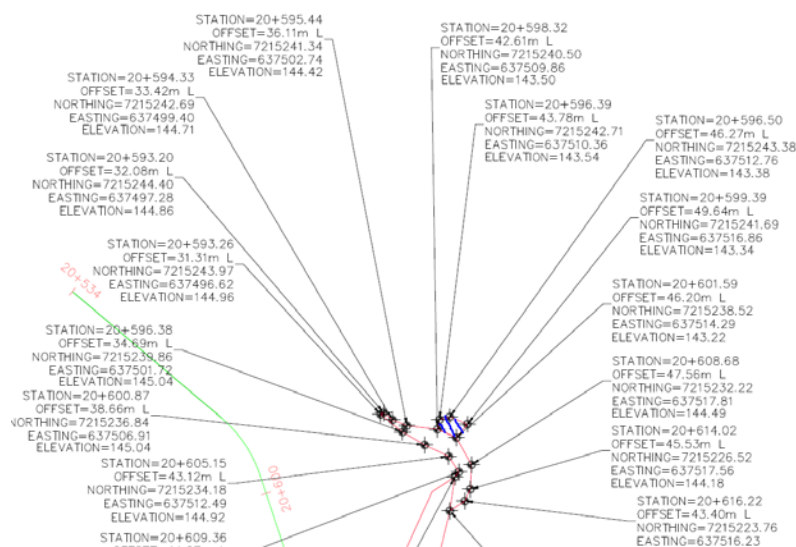
Figure 1: Sketch of the area to test with the portable nuclear gauge

- The QA Manager observed a depression on the compacted sieved till layer of the upstream toe liner tie-in at approx. Sta. 20+595 m where the pump evacuated the water for three days. The depression is approximately 3 m wide by 5 m long and 0.15 m deep. It was filled with compacted sieved till. As no portable nuclear gauge was present on site, a sample was taken for water content analysis and gradation, and no compaction test could be done. Compaction tests will be required on the compacted sieved till before the next phase of construction for the installation of the LLDPE liner protection cover on SD3.

- Calibration certificate of the tensiometer to be provided by ZTG.
- An alternative solution needs to be found for the TenCate Mirafi S1600 geotextile that is not equivalent to Texel 34.
- Portable nuclear gauge compaction tests will be required on the compacted sieved till around Sta. 20+595 m, El. 143.3 m, identified on the blue hatched area in Figure 1, before the next phase of construction for the installation of the LLDPE liner protection cover on SD3.
