QA WEEKLY REPORT

QA WEEKLY REPORT FROM JULY 16TH TO JULY 22ND – TSF SOUTH CELL CONSTRUCTION MEADOWBANK (1897439)

QA DAILY REPORT FOR APRIL 23RD, 2018 – TSF SOUTH CELL CONSTRUCTION - MEADOWBANK (1897439)

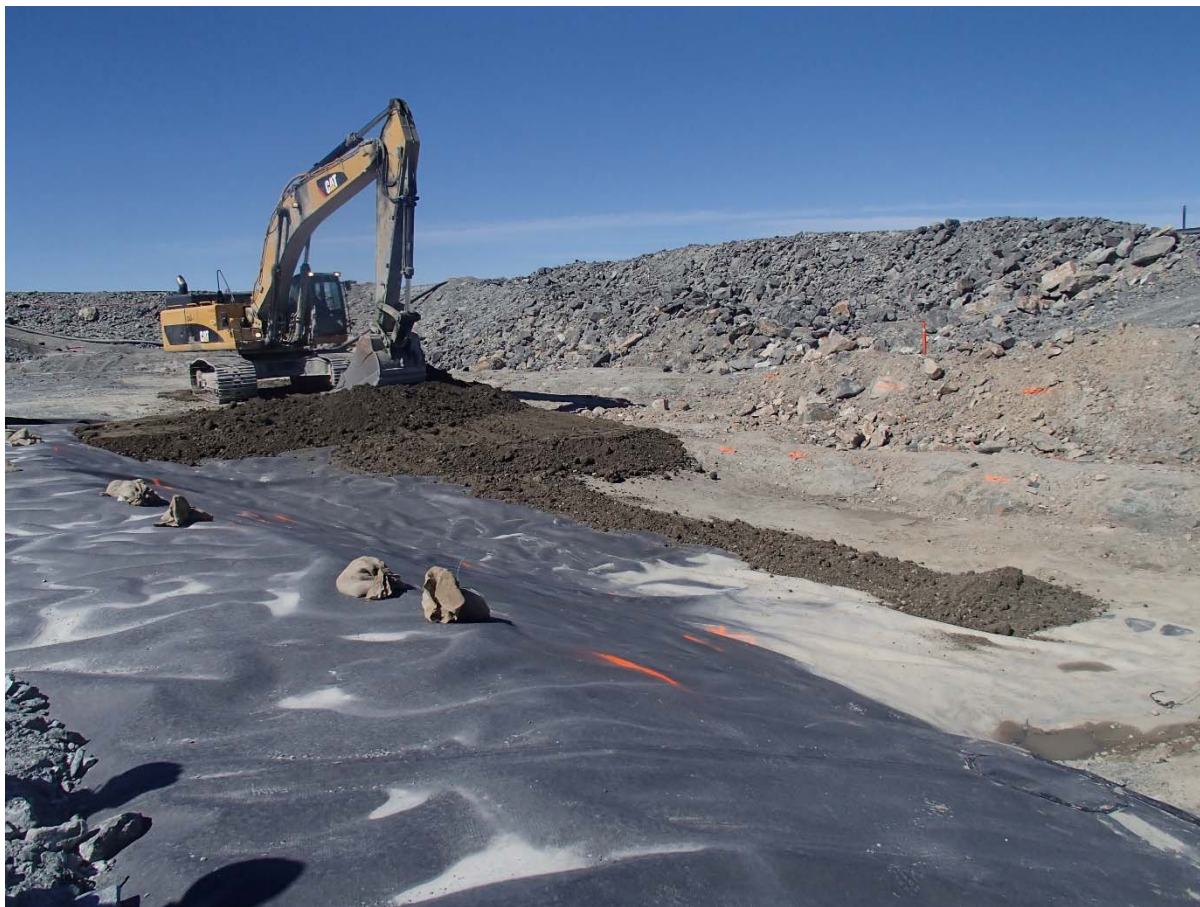
Photograph SD3-338: From Sta. 20+610/-43 m, looking NW. Placement of a first 0.5 m thick lift of compacted sieved till over the LLDPE geomembrane on the upstream toe liner tie-in with an excavator from Sta. 20+588 m to 20+599 m.

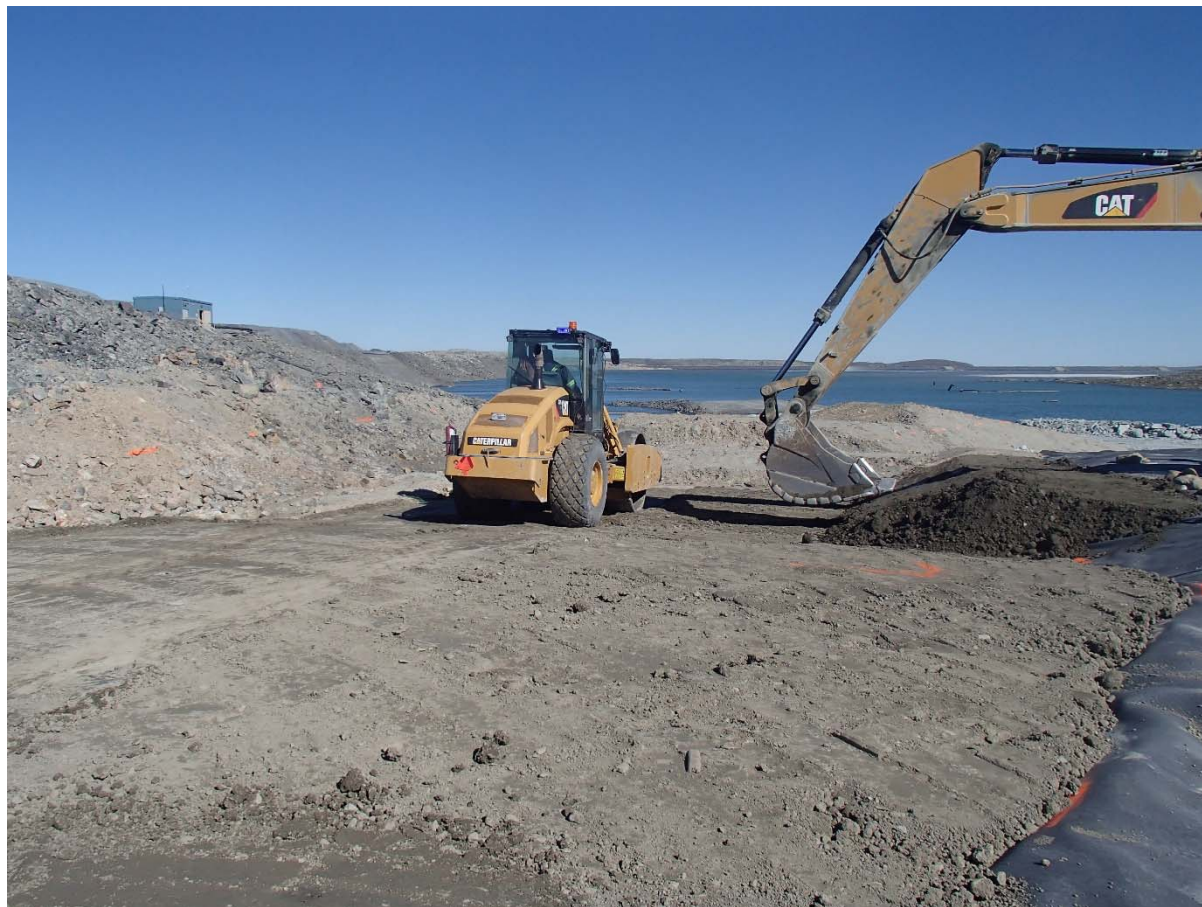
Photograph SD3-339: From Sta. 20+600/-29 m, looking E. Compaction of a first 0.5 m thick lift of compacted sieved till on the upstream toe liner tie-in with an excavator from Sta. 20+588 m to 20+599 m.

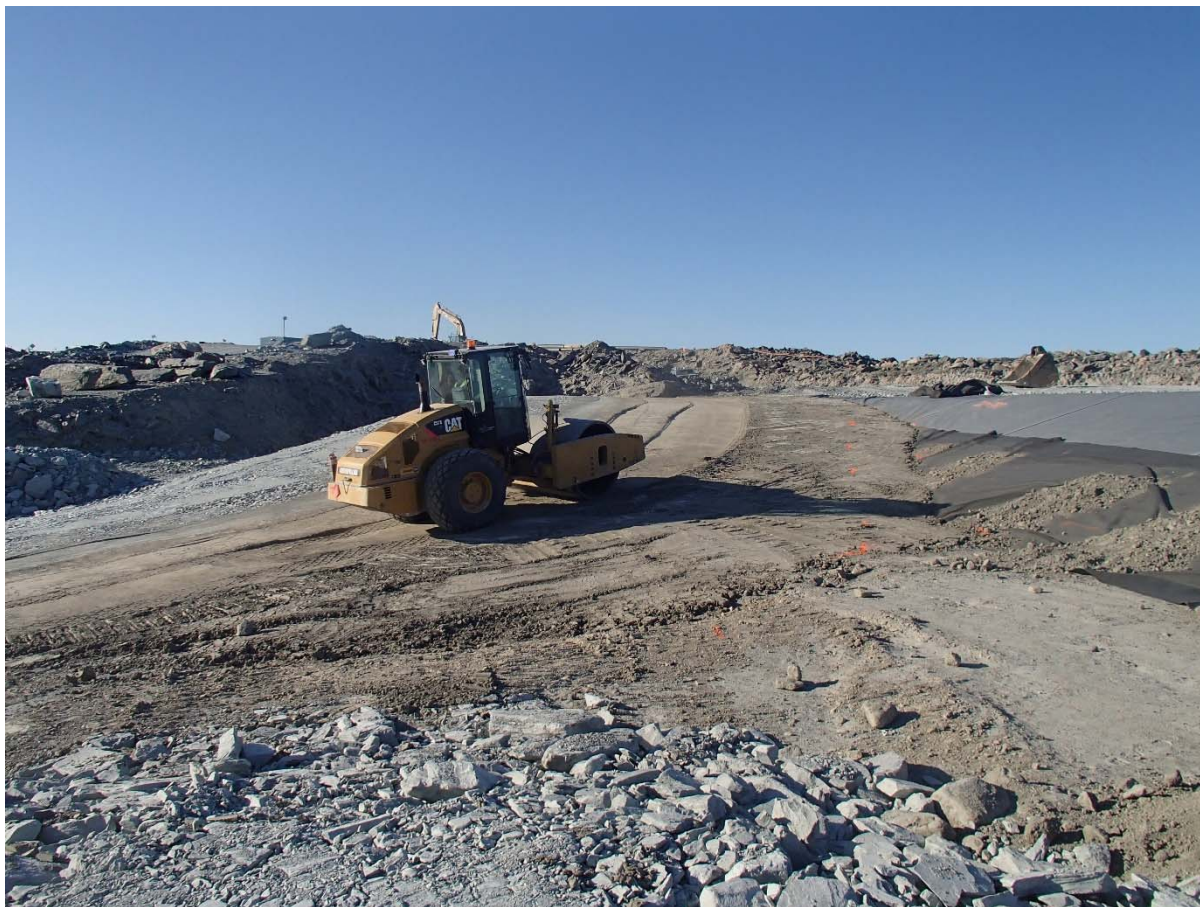
Photograph SD3-340: From Sta. 20+750/-40 m, looking S. Compaction of the third 0.5 m thick lift of compacted sieved till on the upstream toe liner tie-in with an excavator from Sta. 20+760 m to 20+820 m.

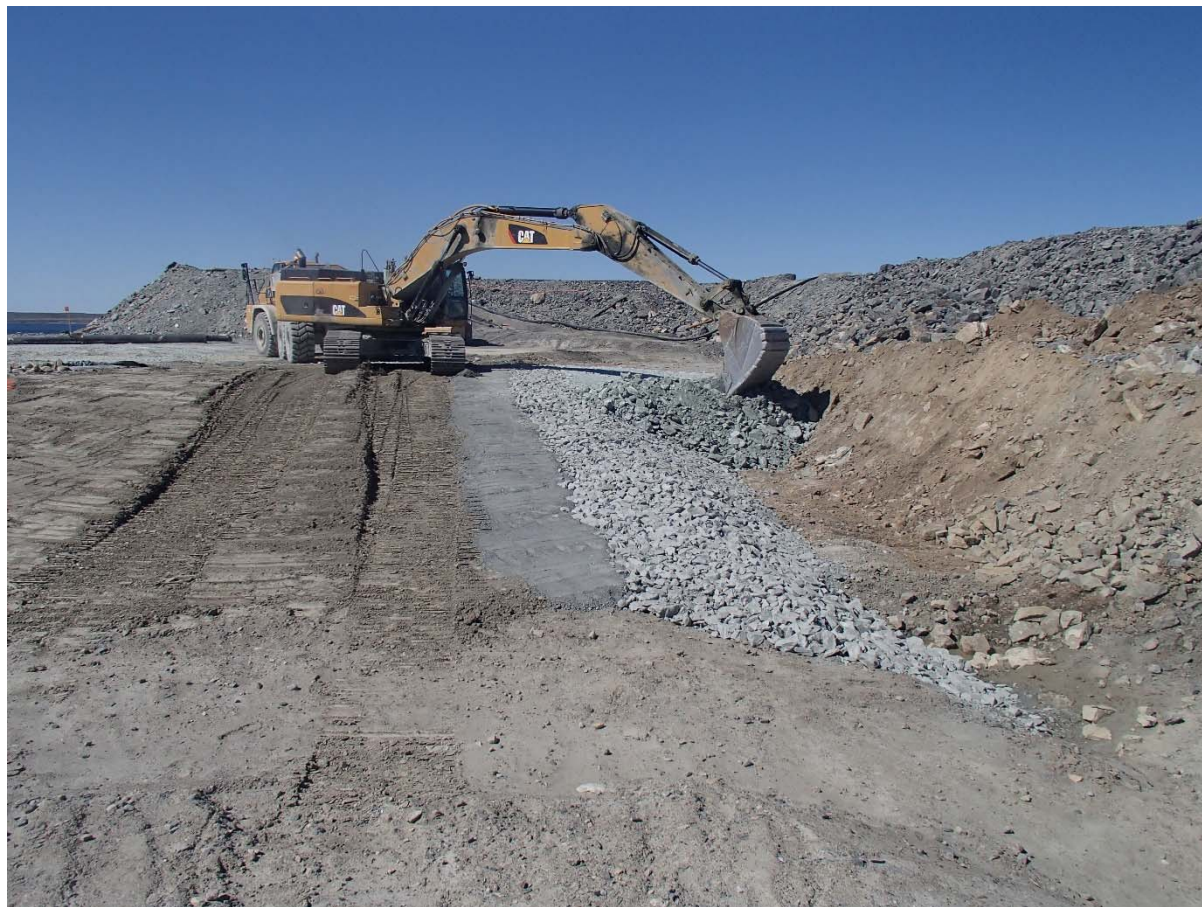
Photograph SD3-341: From Sta. 20+600/-58 m, looking W. Placement of a first 0.5 m thick lift of fine rockfill on the upstream slope of the upstream toe liner tie-in with an excavator from Sta. 20+588 m to 20+599 m.

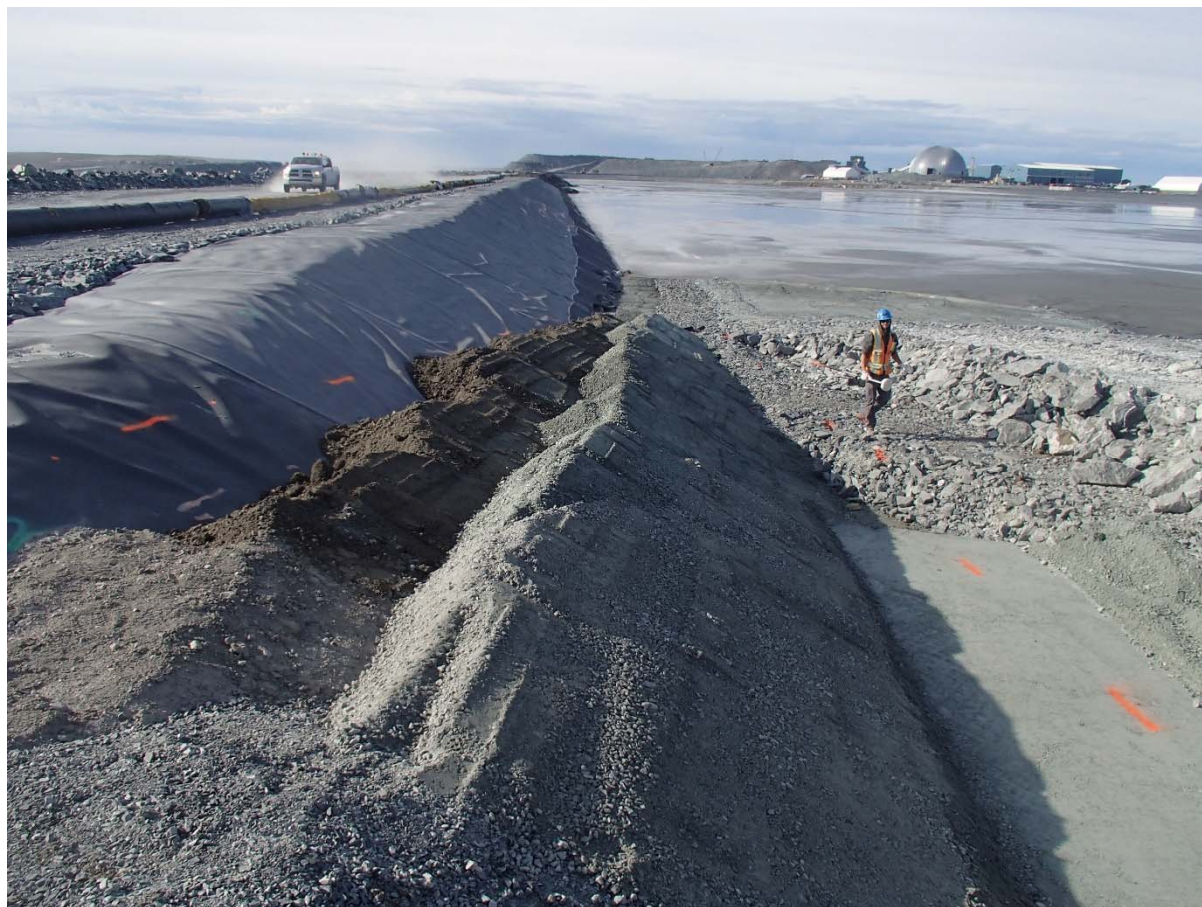
Photograph CD-1896: From Sta. 0+140/-30 m, looking S. Placement of 0.5 m thick layers of compacted sieved till and fine filter on the upstream slope of Central Dike with an excavator from Sta. 0+147 m to 0+177 m.

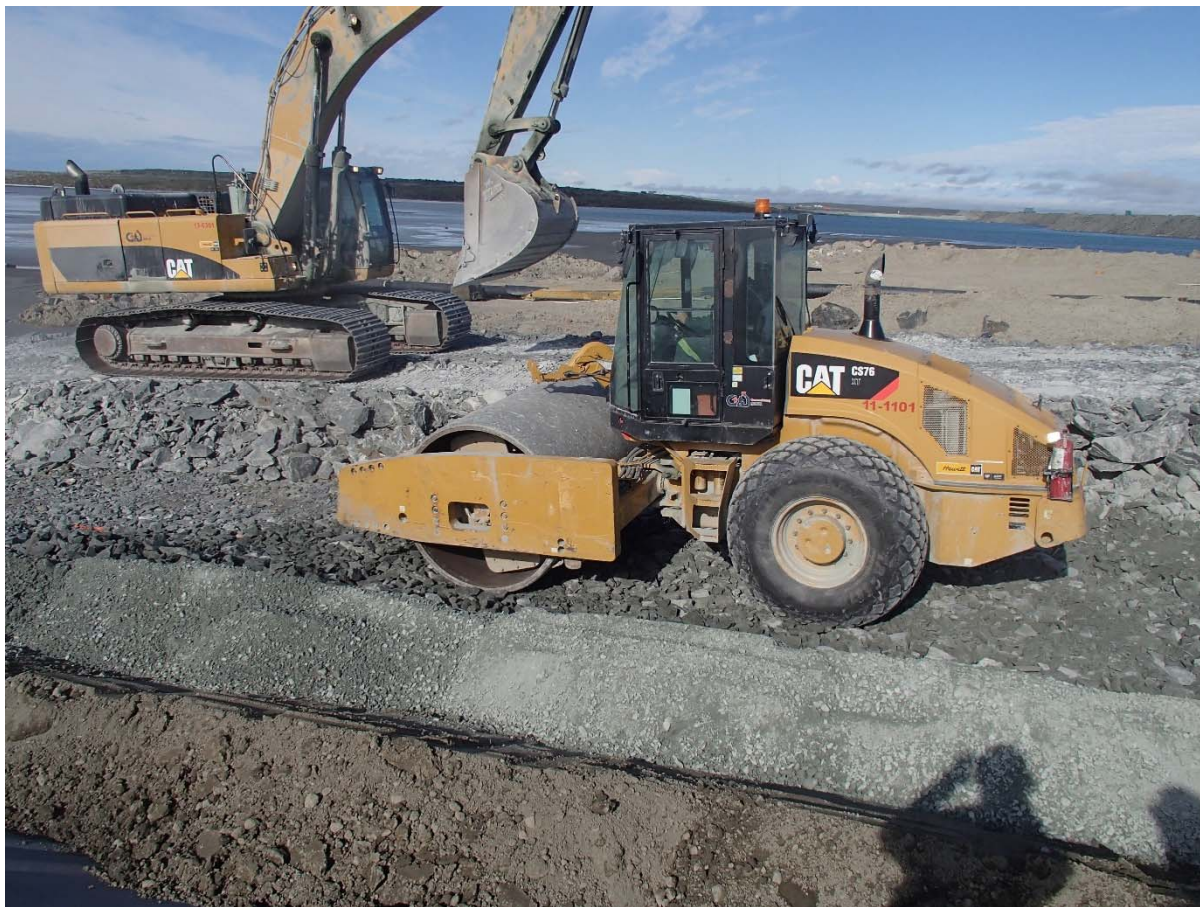
Photograph CD-1898: From Sta. 0+145/-30 m, looking W. Compaction of the 0.5 m thick lift of coarse filter on the top of the fine filter on the top of the upstream toe liner tie-in and on the upstream slope with a 10-tonne smooth-drum compactor with vibration (4 passes) from Sta. 0+147 m to 0+177 m.

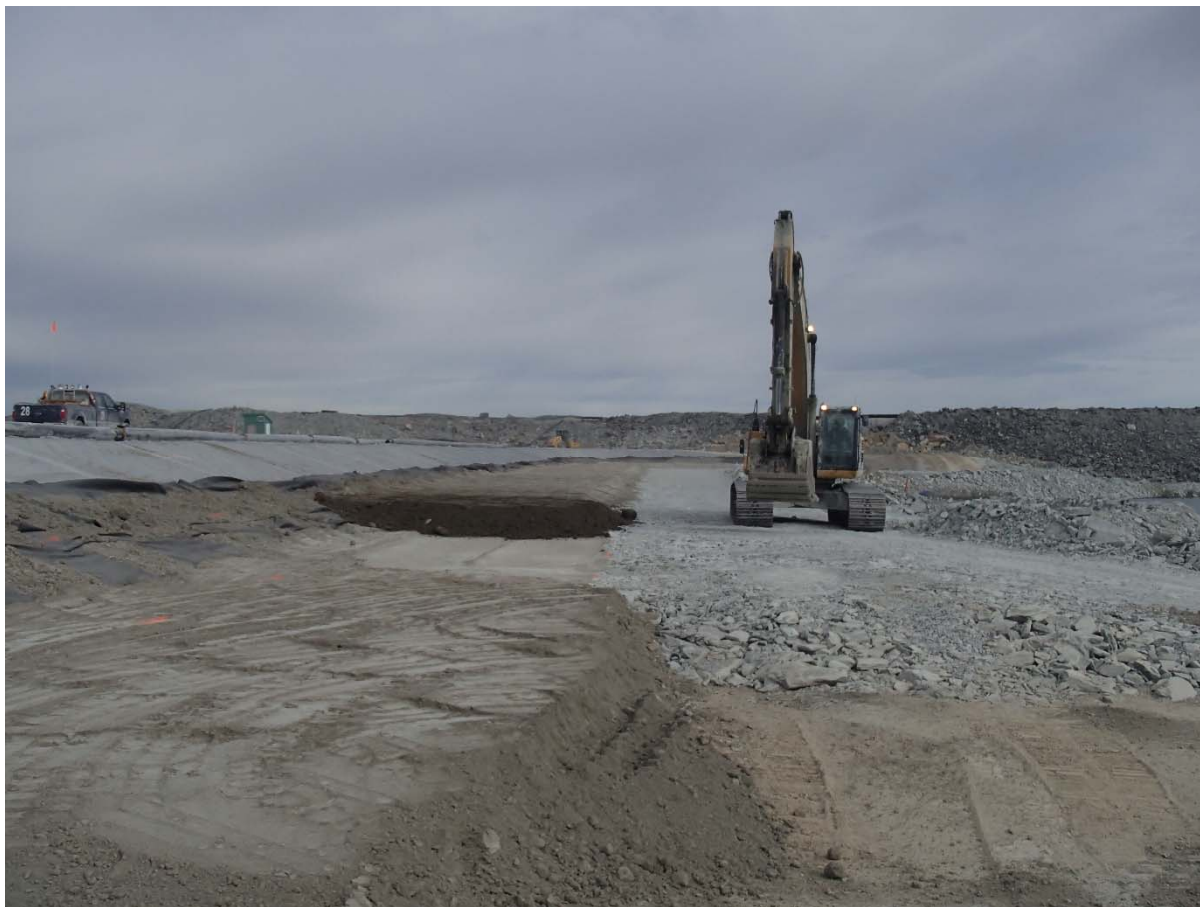
Photograph SD3-345: From Sta. 20+760/-42 m, looking NW. Placement of a fourth 0.5 m thick lift of low quality till (0-150 mm) from El. 143 m to 143.5 m from Sta. 20+619 m to 20+777 m.

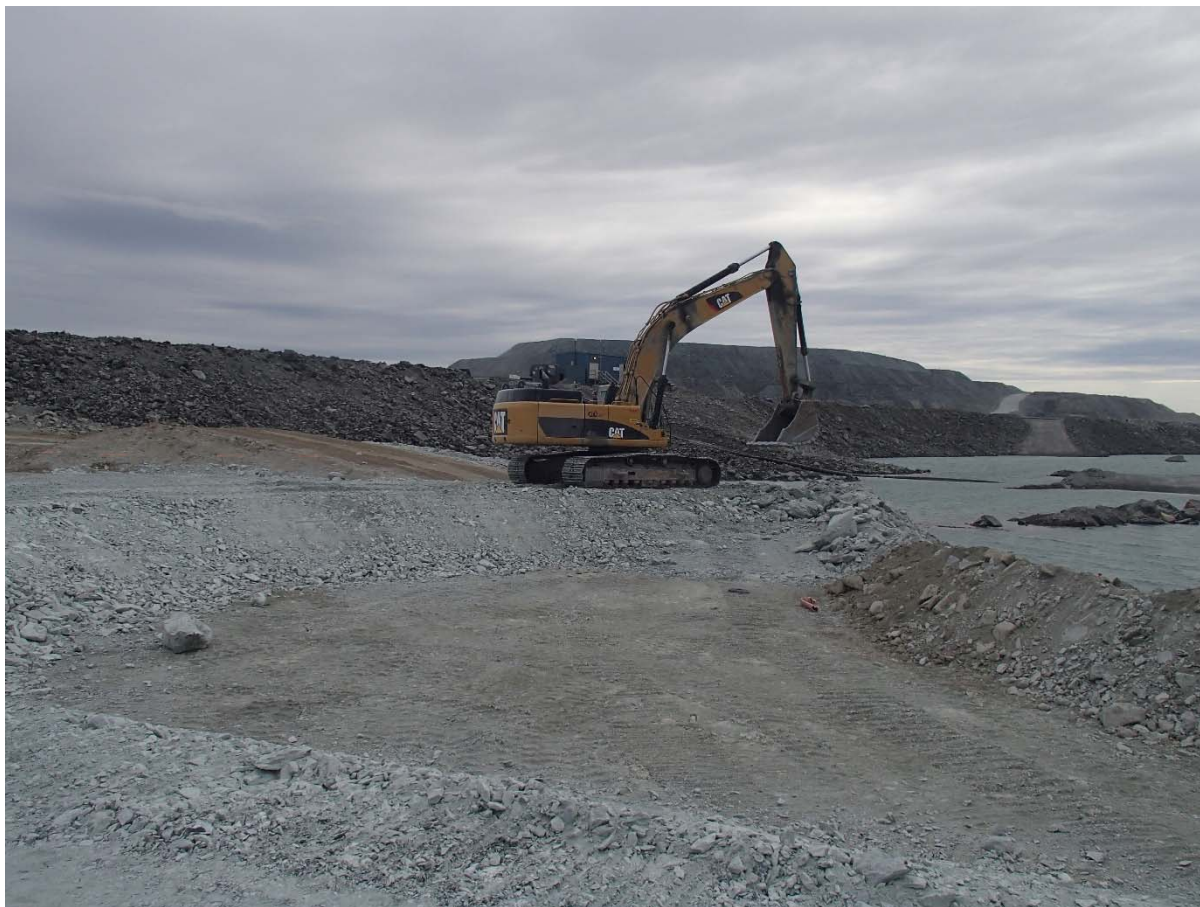
Photograph SD3-347: From Sta. 20+640/-41 m, looking W. Placement of a third 0.5 m thick lift of fine UM rockfill (0-500 mm) upstream of the low quality till (0-150mm) from El. 143 m to 143.5 m from Sta. 20+688 m to 20+619 m.

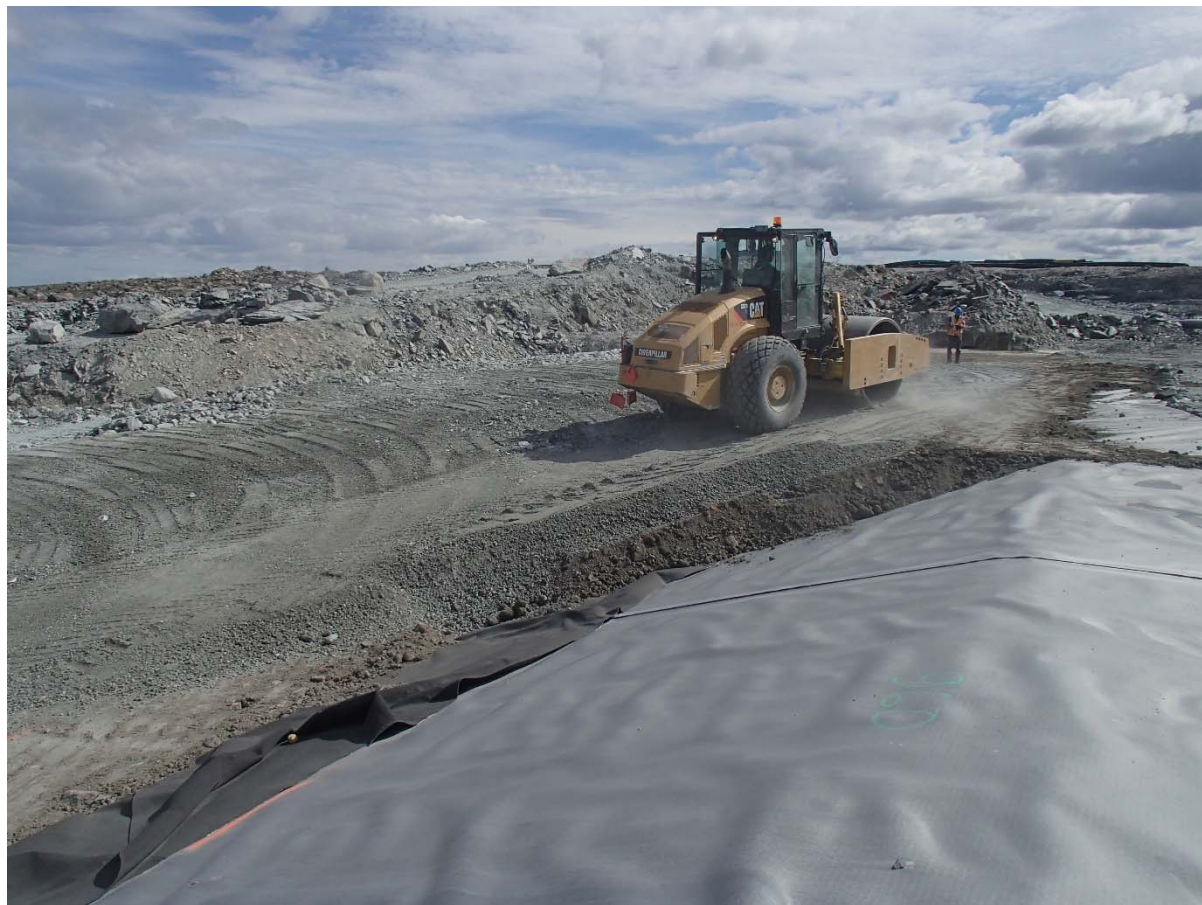
Photograph SD3-349: From Sta. 20+765/-29 m, looking SE. Compaction of the 0.5 m thick lift of fine filter on the top of the upstream toe liner tie-in with a 10-tonne smooth-drum compactor with vibration (4 passes) from Sta. 20+777 m to 20+807 m.

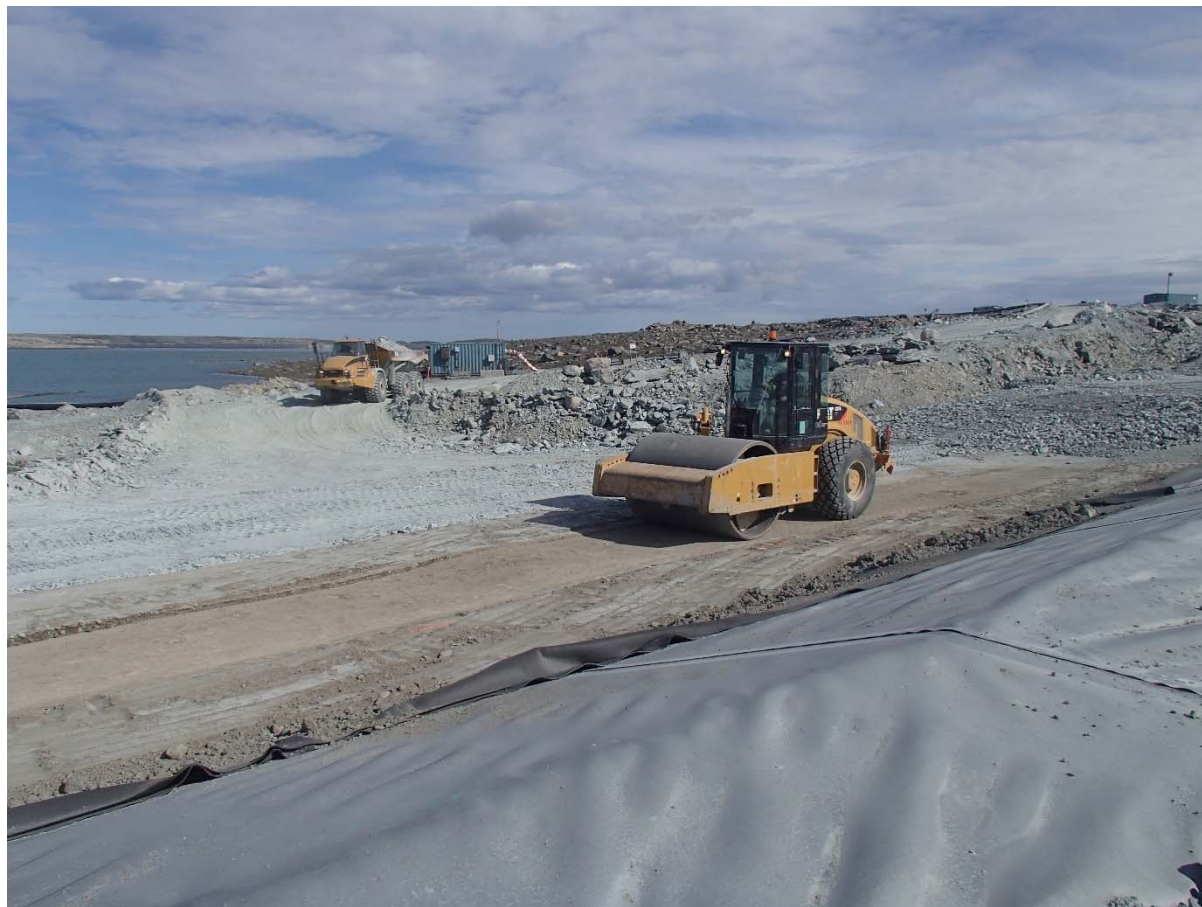
Photograph SD3-351: From Sta. 20+740/-24 m, looking SE. Compaction of the 0.5 m lift of low quality till (0-150 mm) at El. 143.5 m with a 10-tonne smooth-drum compactor with vibration (4 passes) from Sta. 20+619 m to 20+777 m.

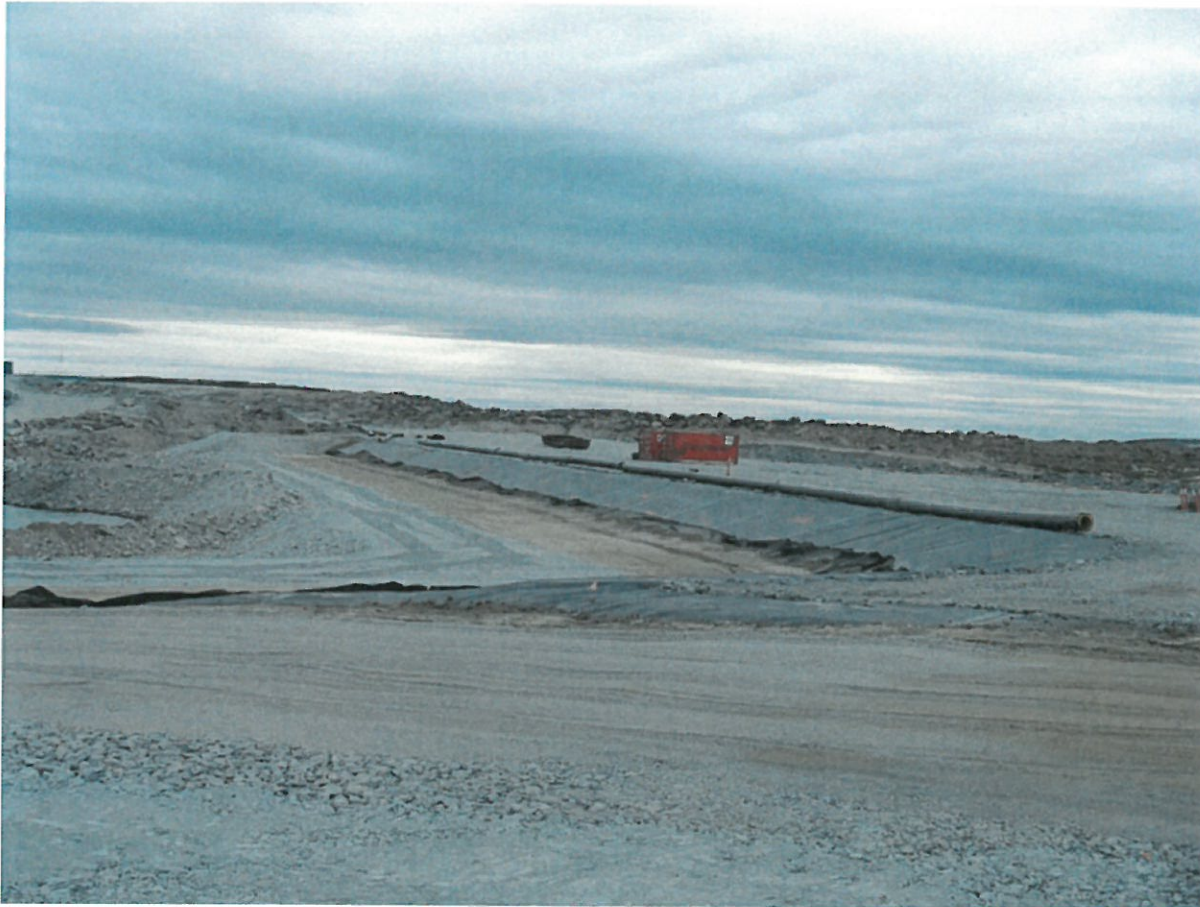
Photograph SD3-353: From Sta. 20+580/-49 m, looking SW. View of SD3 at the end of the 2018 construction phase.

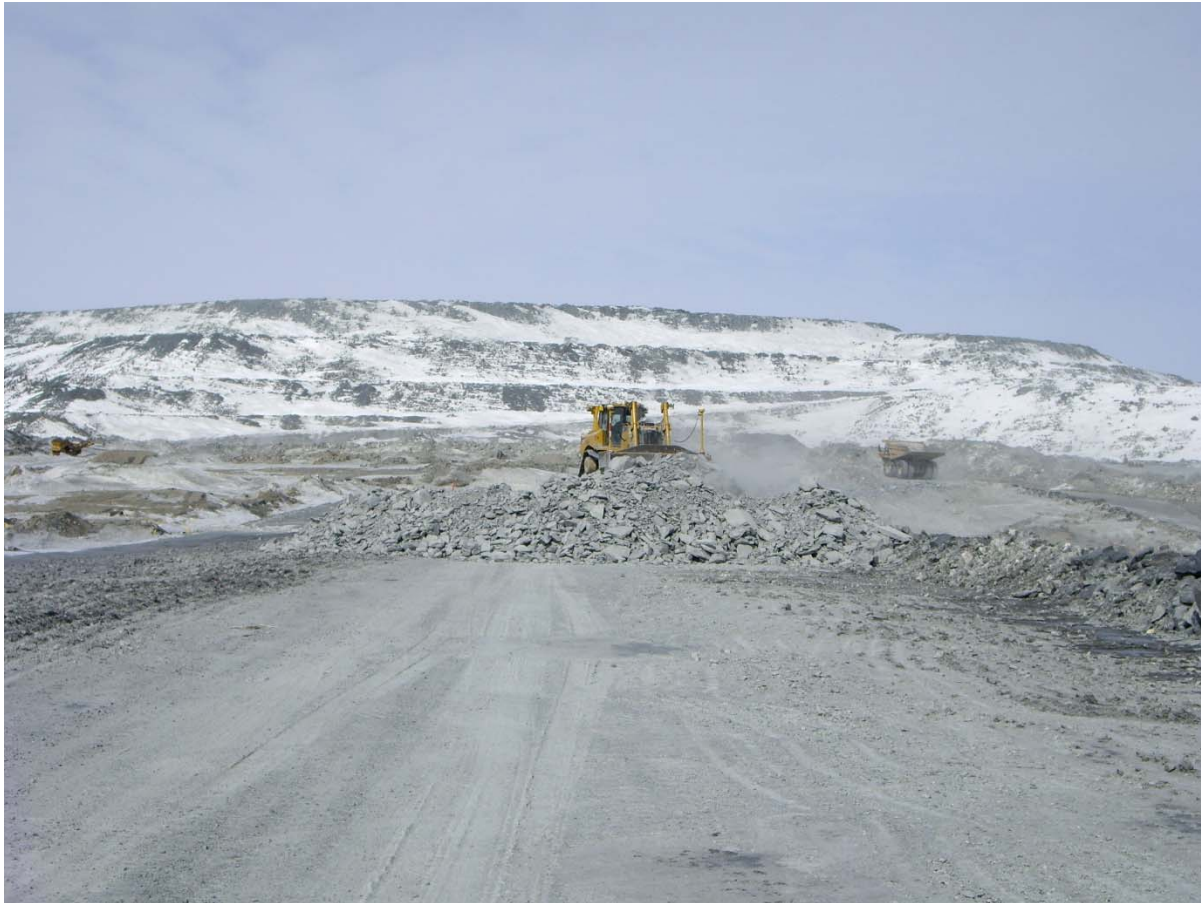
Photograph CD-1797: From Sta. 0+320/-20 m looking N. Placement a 2 m thick (approx.) lift of volcanic rockfill from El. 143 m to El. 145 m from 0+250 to 0+400 m (o.s. -28 to -18 m).

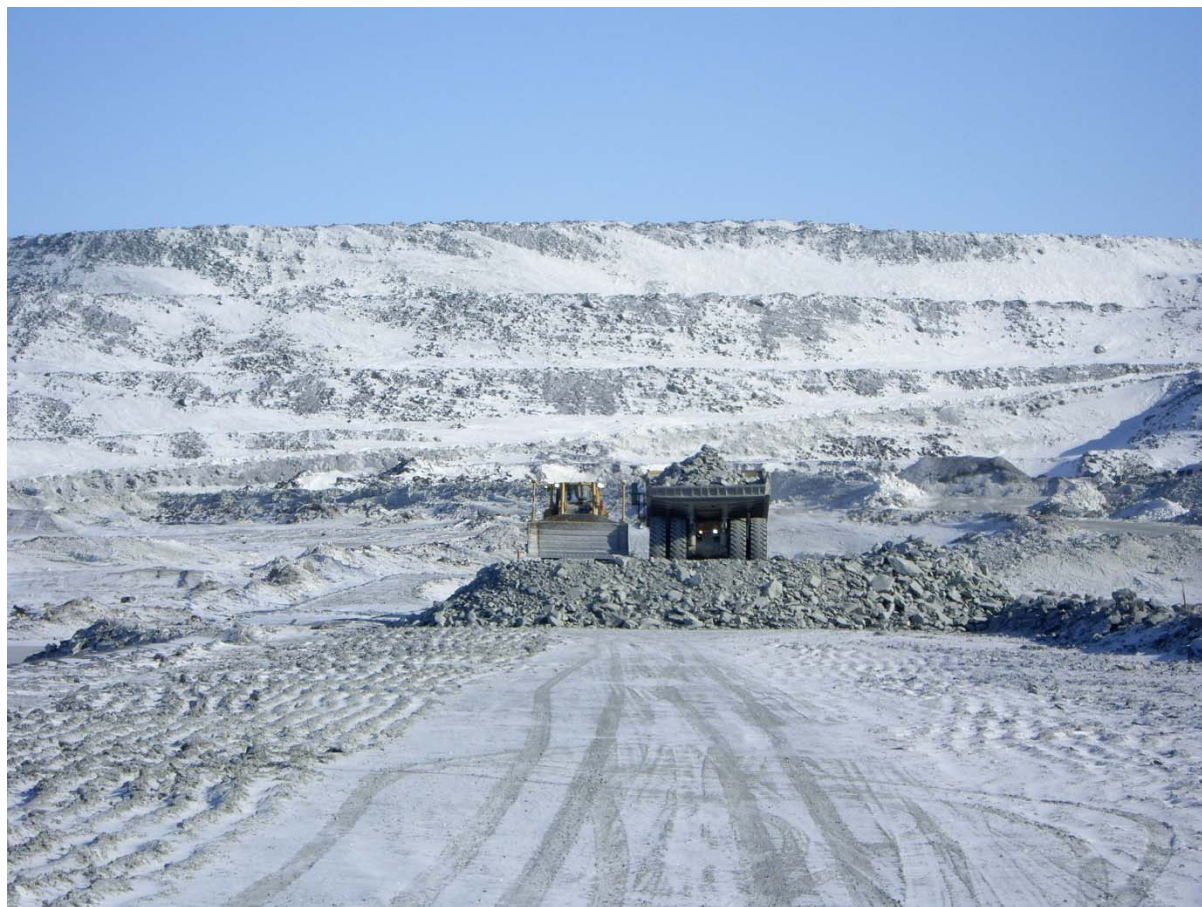
Photograph CD-1798: From Sta. 0+500/-15 m looking N. Placement a 2 m thick (approx.) lift of volcanic rockfill from El. 143 m to El. 145 m from 0+340 to 0+435 m (o.s. -28 to -18 m).

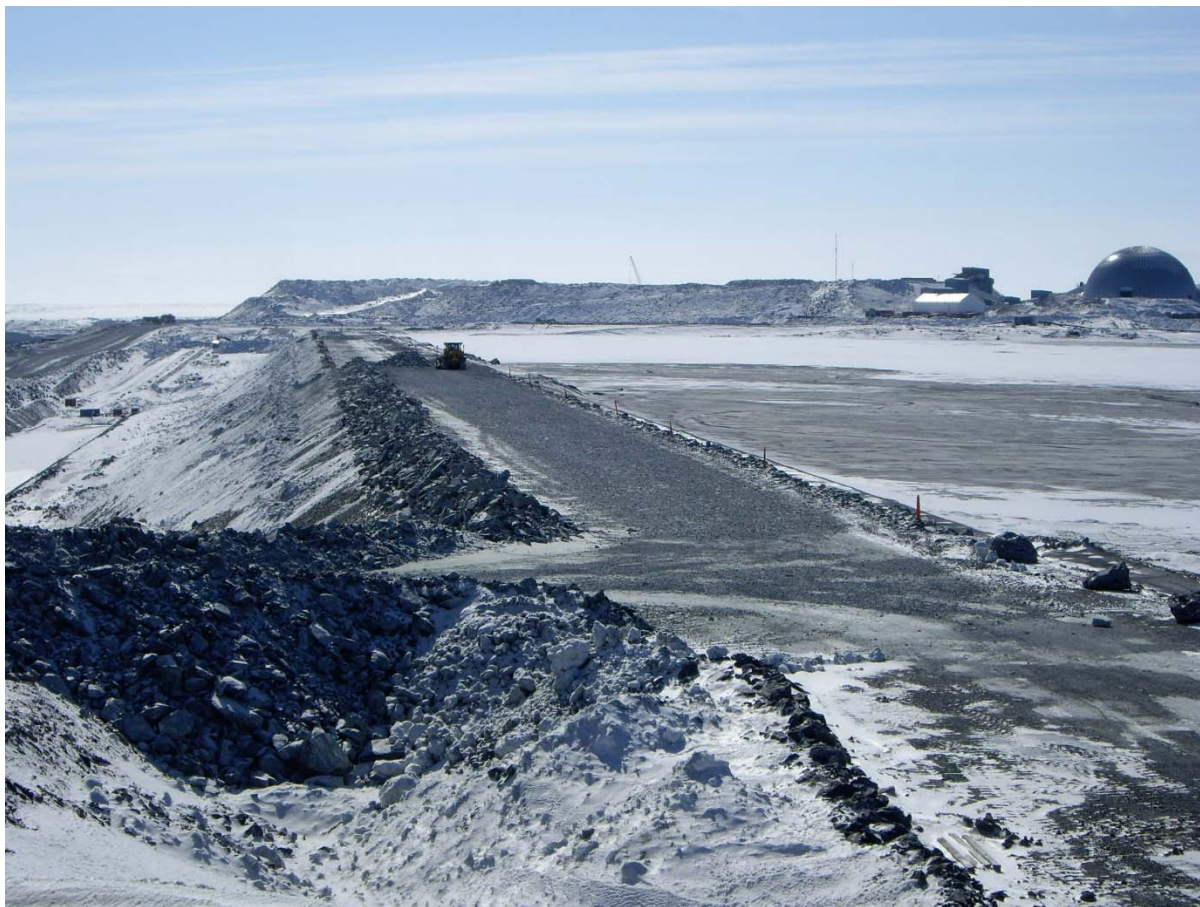
Photograph CD-1799: From Sta. 0+080/-25 m looking S. Placement a 2 m thick (approx.) lift of volcanic rockfill from El. 143 m to El. 145 m from 0+340 to 0+435 m (o.s. -28 to -18 m).

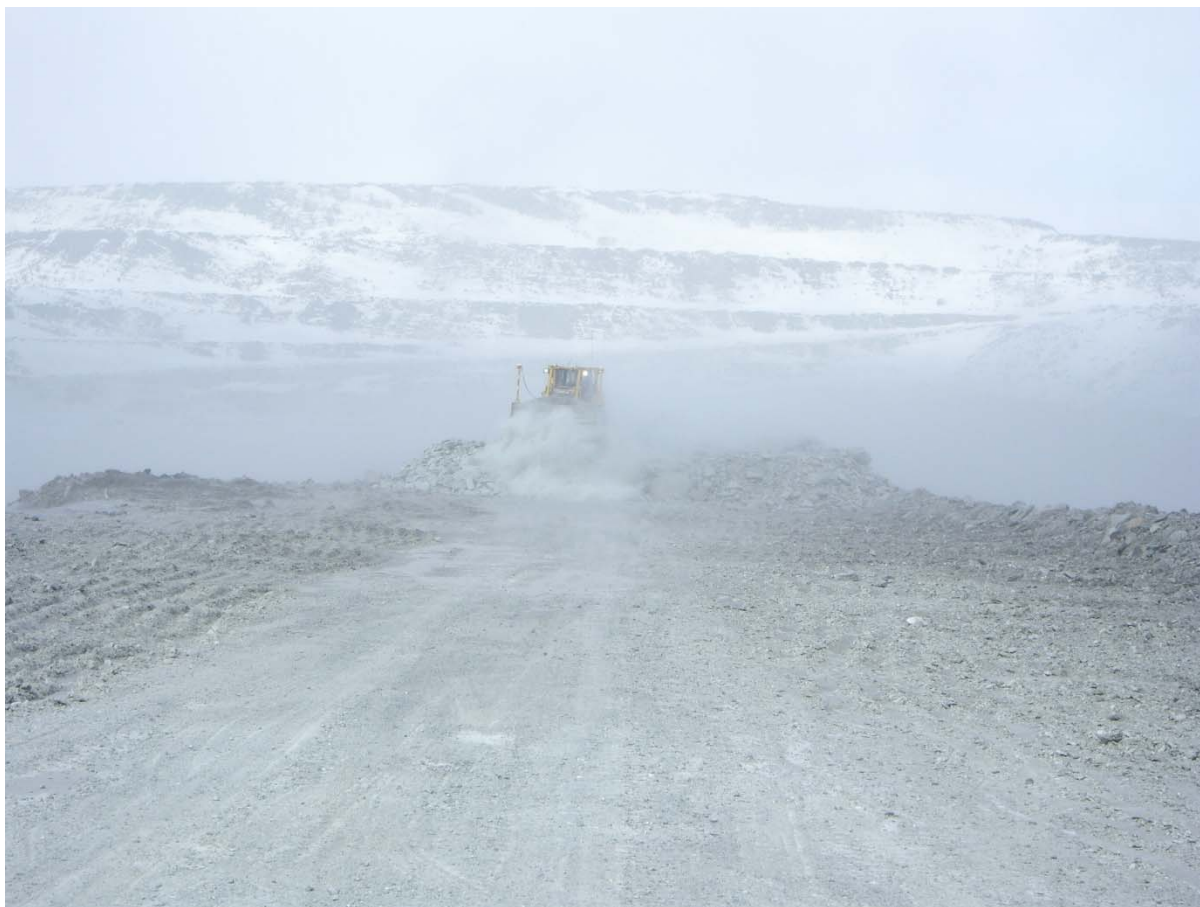
Photograph CD-1800: From Sta. 0+500/-14 m looking N. Placement a 2 m thick (approx.) lift of intermediate volcanic (IV) rockfill from El. 143 m to El. 145 m from 0+435 to 0+535m (o.s. -28 to -18 m).

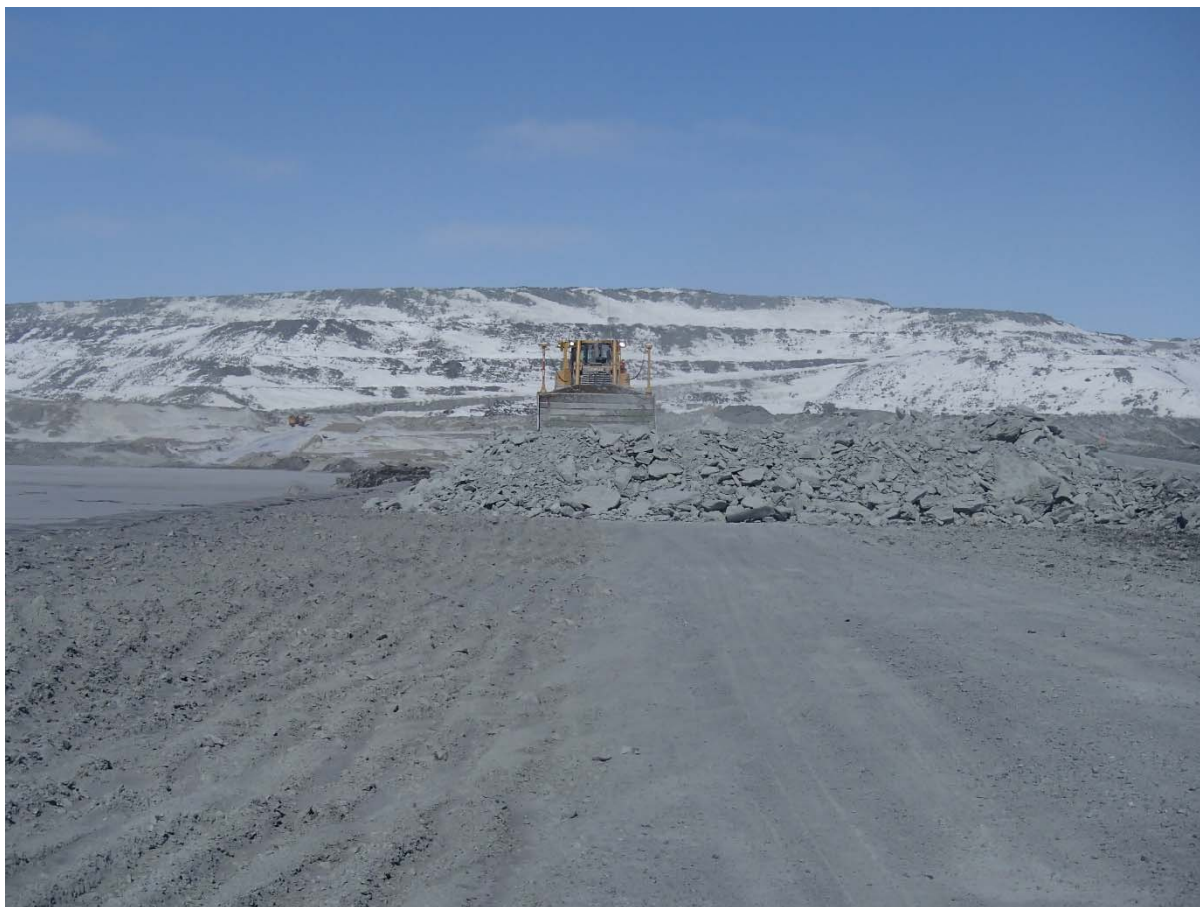
Photograph CD-1801: From Sta. 0+650/-10 m looking N. Placement a 2 m thick (approx.) lift of intermediate volcanic (IV) rockfill from El. 143 m to El. 145 m from 0+535 to 0+625m (o.s. -28 to -18 m).

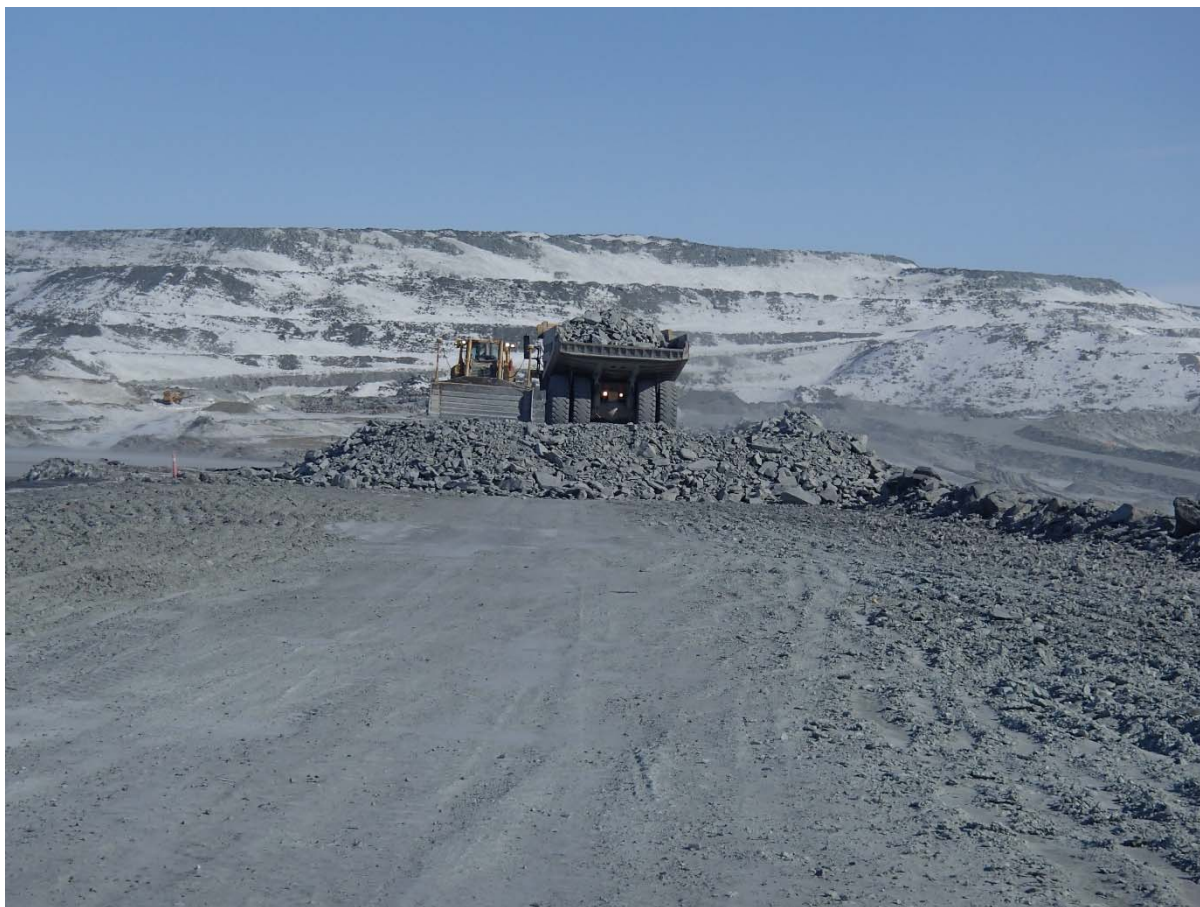
Photograph CD-1802: From Sta. 0+770/-16 m looking N. Placement a 2 m thick (approx.) lift of intermediate volcanic (IV) rockfill from El. 143 m to El. 145 m from approx. Sta. 0+525 to 0+710 m (o.s. -28 to -18 m).

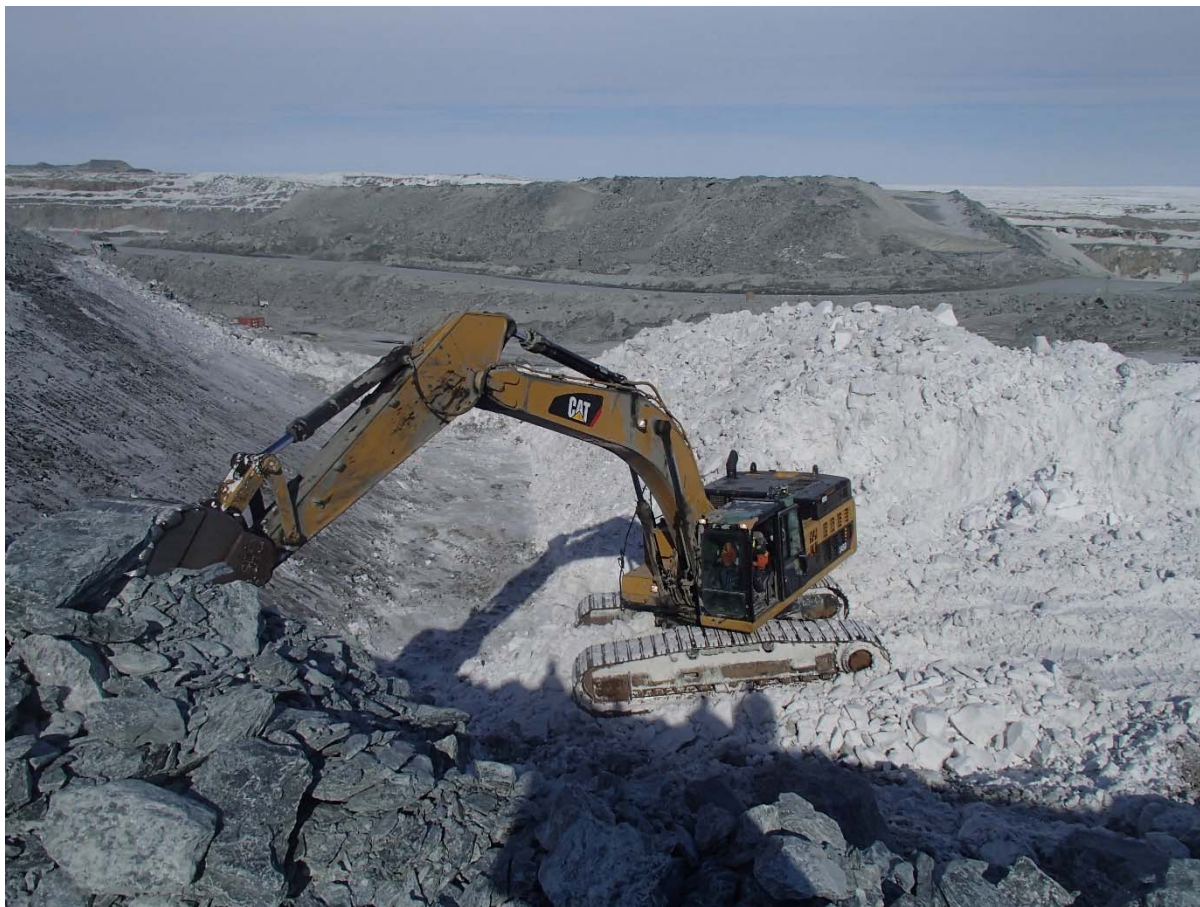
Photograph CD-1803: From Sta. 40+750/27 m looking NE. Removal of snow to expose the foundation bedrock with an excavator between approx. Sta. 40+780 and 40+800 m (o.s. 7 to 10 m).
