QA DAILY REPORT

QA DAILY REPORT FOR MAY 17TH, 2018 – TSF SOUTH CELL CONSTRUCTION - MEADOWBANK (1897439)

QA DAILY REPORT FOR MAY 18TH, 2018 – TSF SOUTH CELL CONSTRUCTION - MEADOWBANK (1897439)

QA DAILY REPORT FOR MAY 19TH, 2018 – TSF NORTH CELL CONSTRUCTION - MEADOWBANK (1897439)

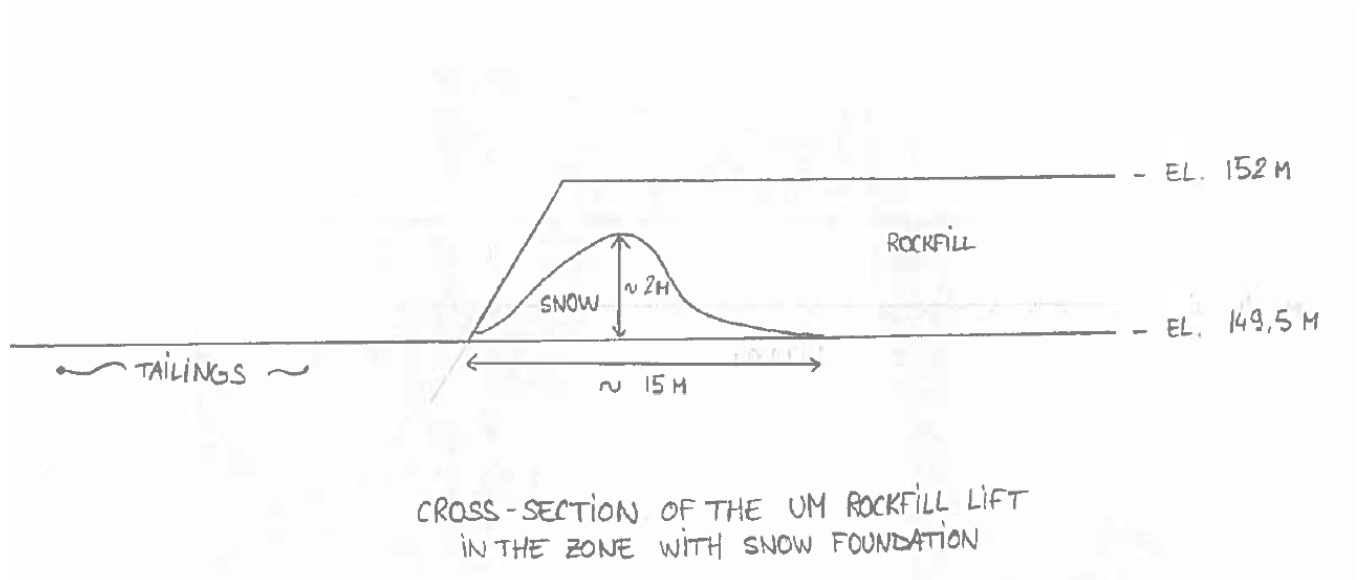
- It was pointed out that an elevation guide was required for the dozer operator for rockfill placement, as the D9 dozer is not equipped with a GPS to control the elevation of the rockfill lift. The current elevation of the lift is variable (approx. 152 m) and will be surveyed by SANA.
- It was noticed that the 2-m thick UM rockfill at El. 152 m (approx.) was placed on an important layer of hard snow (up to 2 m thick) without QA/QC supervision earlier in the season (see photographs and sketch below), over a distance of approx. 100 m along the dike. It is required to remove this rockfill and clear the snow before placing rockfill again, as the presence of an underlying snow layer will cause excessive settlement in the structure. It was reiterated that per the design, the foundation of the structure must be snow-free, compacted rockfill material constituting the capping of the North Cell.

- Test pits were excavated to identify the extent of the snow layer. Since snow was not observed in the northern part of the UM rockfill lift, which appears to be built directly on the North Cell capping, it was decided to move the operations there and progress towards the north. The excavator removes the snow-rich toe of the UM rockfill lift until snow is no longer observed (a 2-3 m wide zone in average), and a dozer pushes the excavated material (UM rockfill mixed with snow) toward the center of the North Cell to clear the upstream toe.
