QA DAILY REPORT

1897439-1576-TM-Rev0

QA DAILY REPORT FOR MAY 25TH, 2018 – TSF SOUTH CELL CONSTRUCTION - MEADOWBANK (1897439)

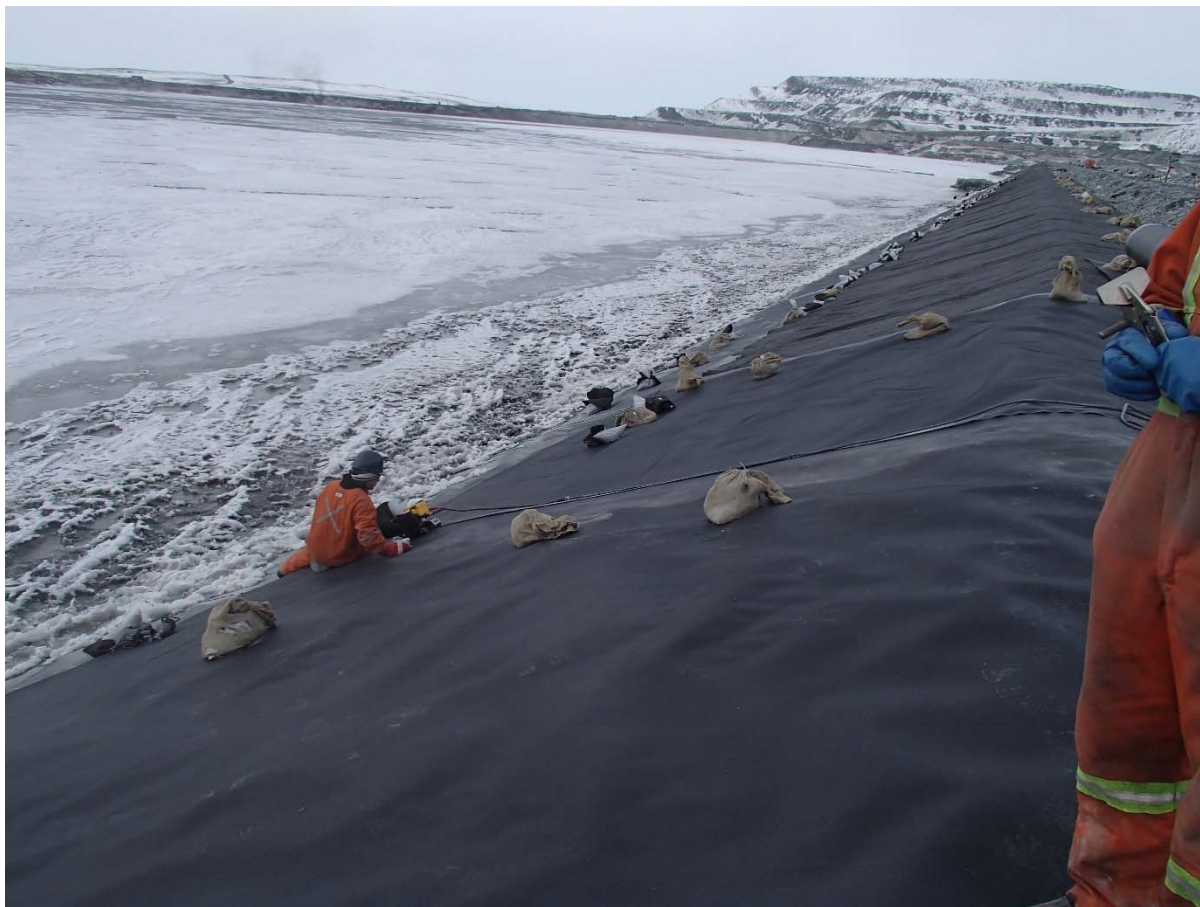
Photograph CD-1866: From Sta. 0+940/-25 m, looking NW. Installation of the LLDPE liner on the upstream slope 2H:1V between El. 143 m and 145 m from Sta. 0+950 m to 0+935 m (panel numbers 818 and 819).

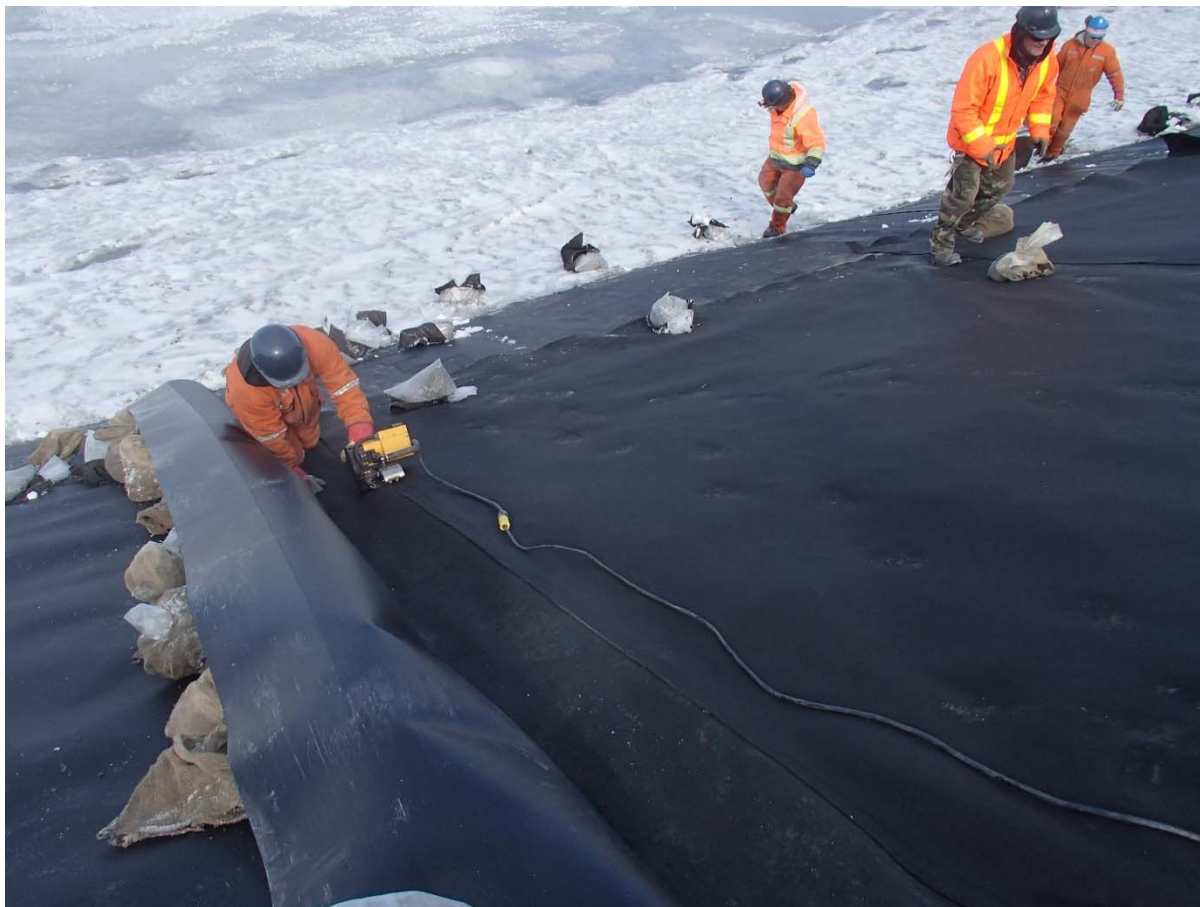
Photograph CD-1869: From Sta. 0+915/-30 m, looking W. Installation of the geotextile on the upstream slope 2H:1V between El. 143 m and 145 m from Sta. 0+935 m to 0+900 m.

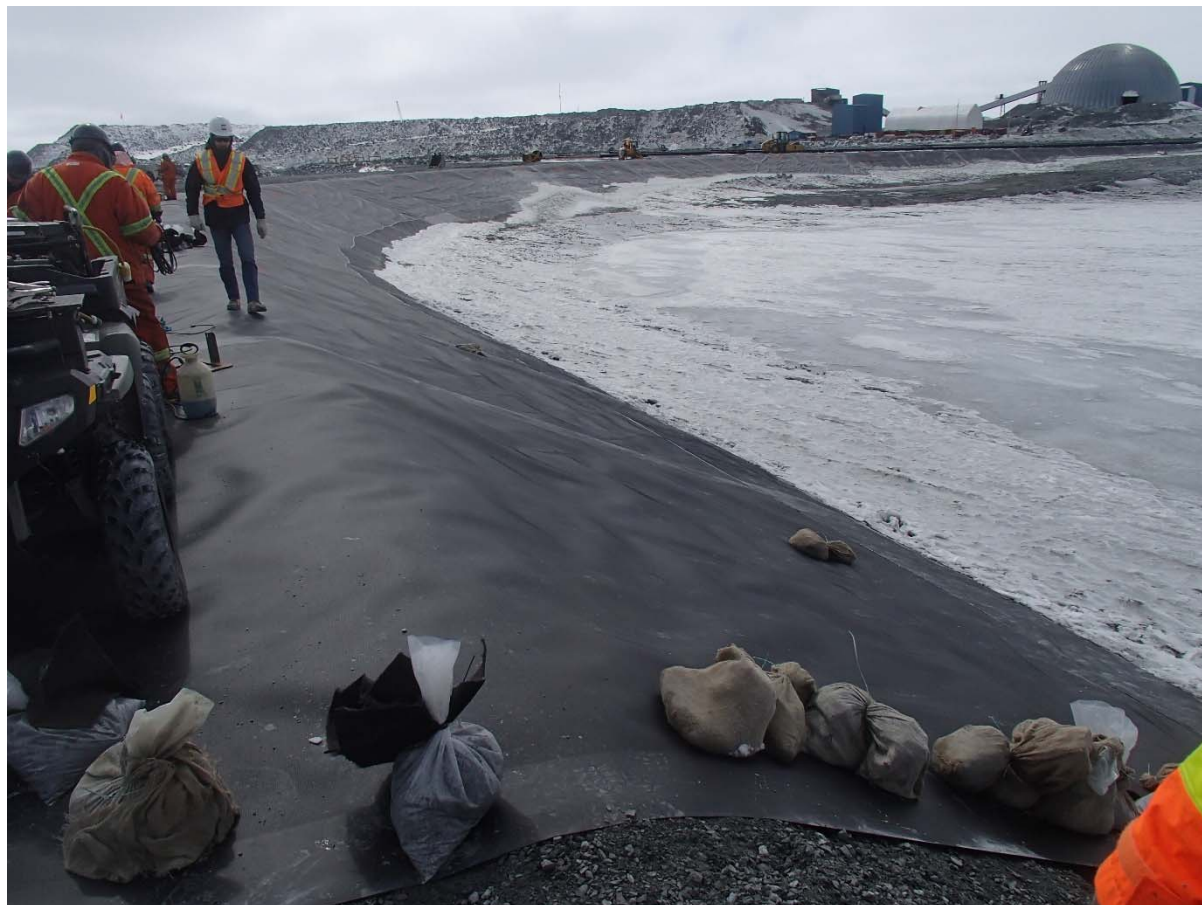
Photograph CD-1870: From Sta. 0+900/-26 m, looking S. Installation of the LLDPE liner on the upstream slope 2H:1V between El. 143 m and 145 m from Sta. 0+935 m to 0+900 m (panel numbers 820 to 823).

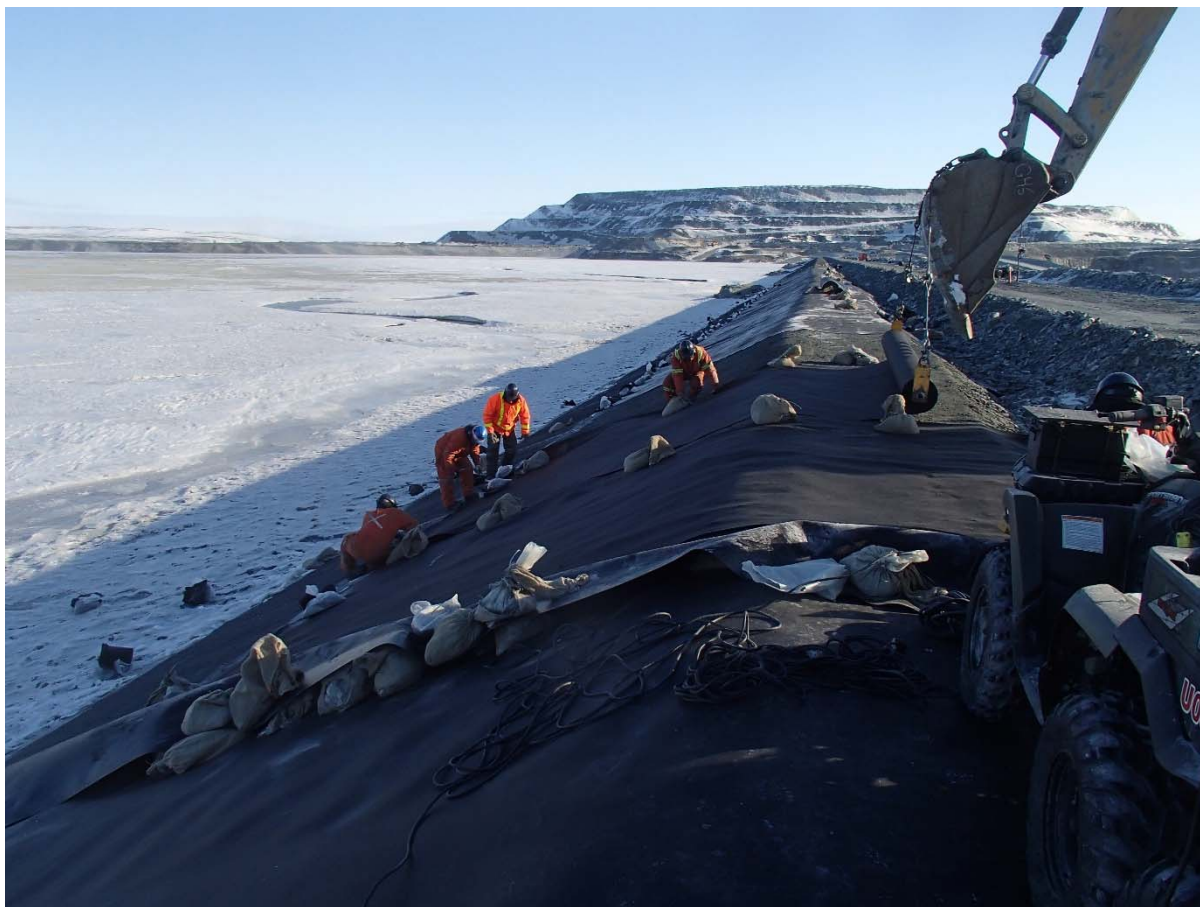
Photograph CD-1871: From Sta. 0+910/-25 m, looking N. Installation of the geotextile on the upstream slope 2H:1V between El. 143 m and 145 m from Sta. 0+900 m to 0+870 m.

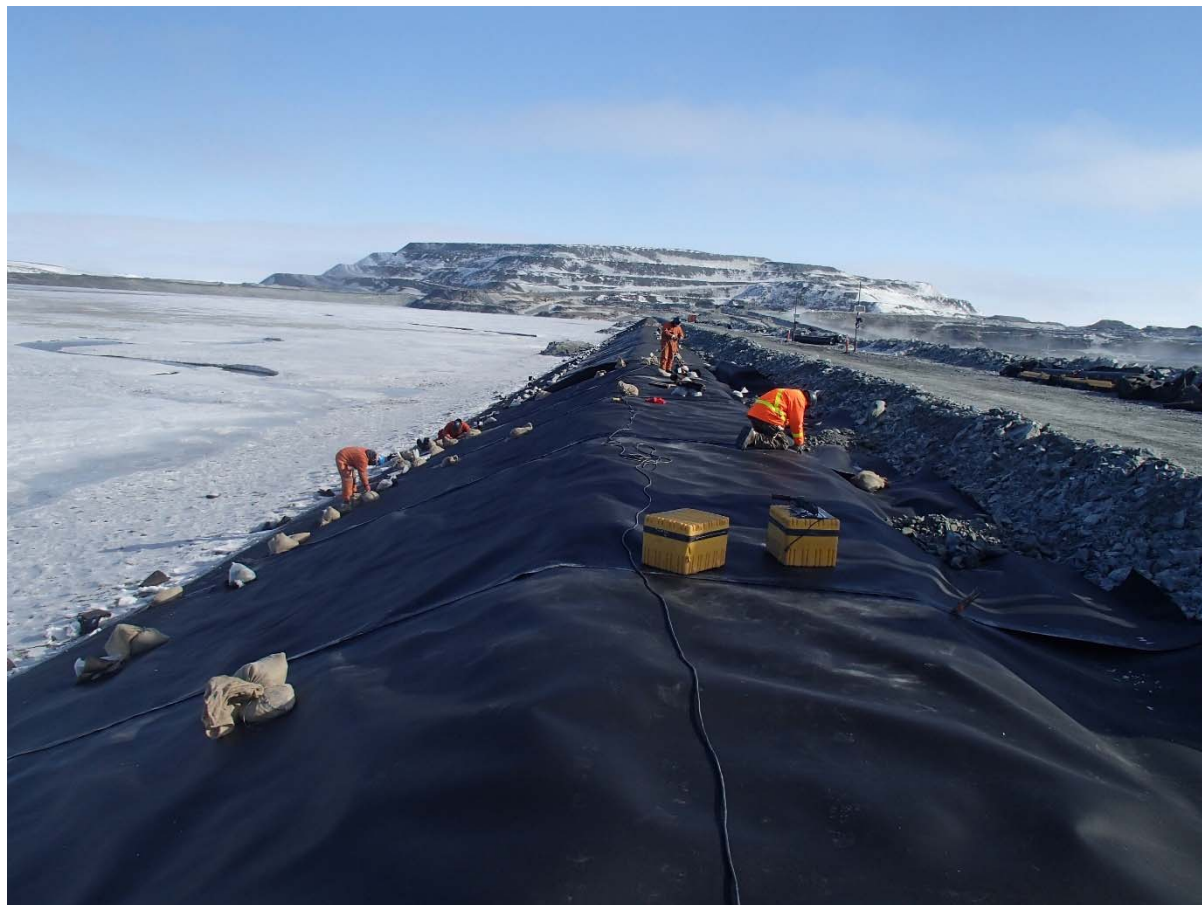
Photograph CD-1872: From Sta. 0+900/-24 m, looking N. Installation of the LLDPE liner on the upstream slope 2H:1V between El. 143 m and 145 m from Sta. 0+900 m to 0+760 m (panel numbers 824 to 844).

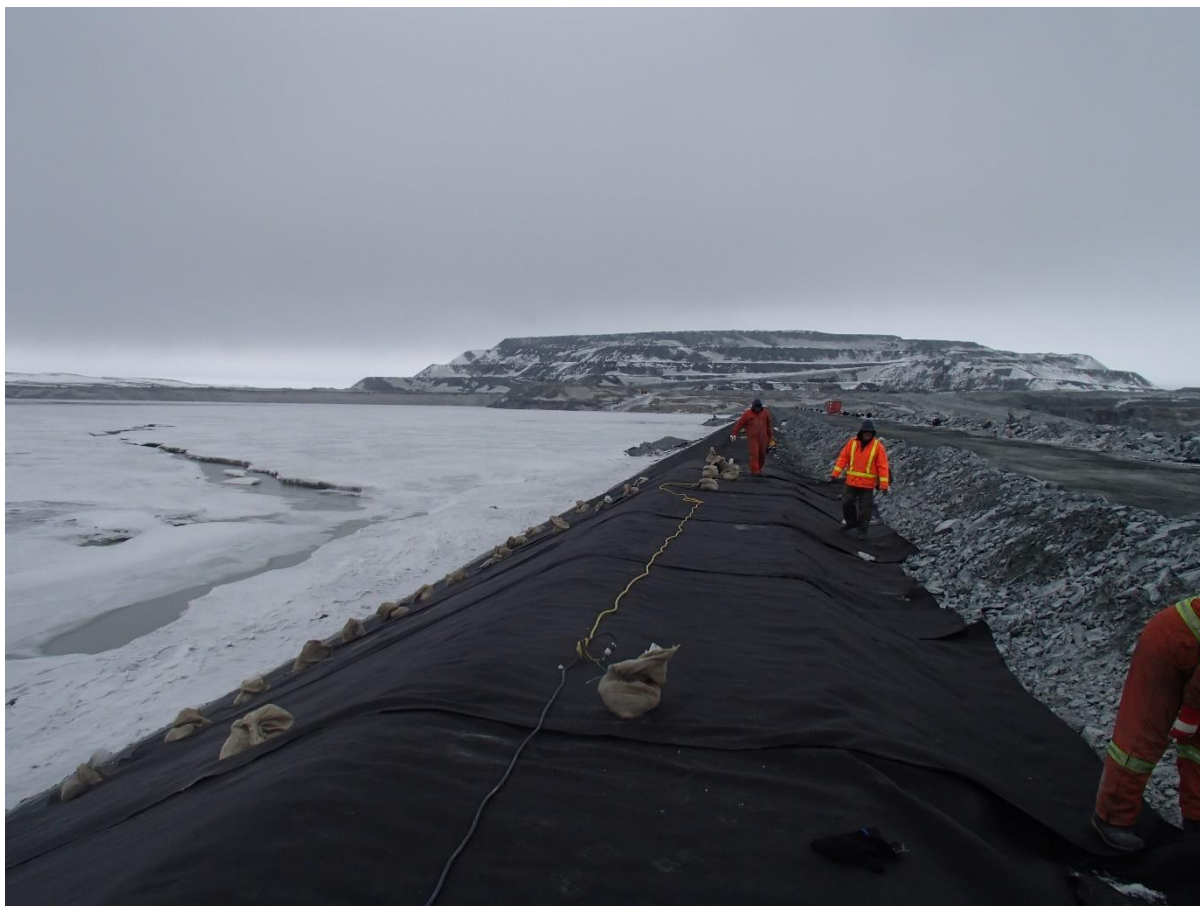
Photograph CD-1873: From Sta. 0+760/-26 m, looking N. Installation of the geotextile on the upstream slope 2H:1V between El. 143 m and 145 m from Sta. 0+760 m to 0+740 m.

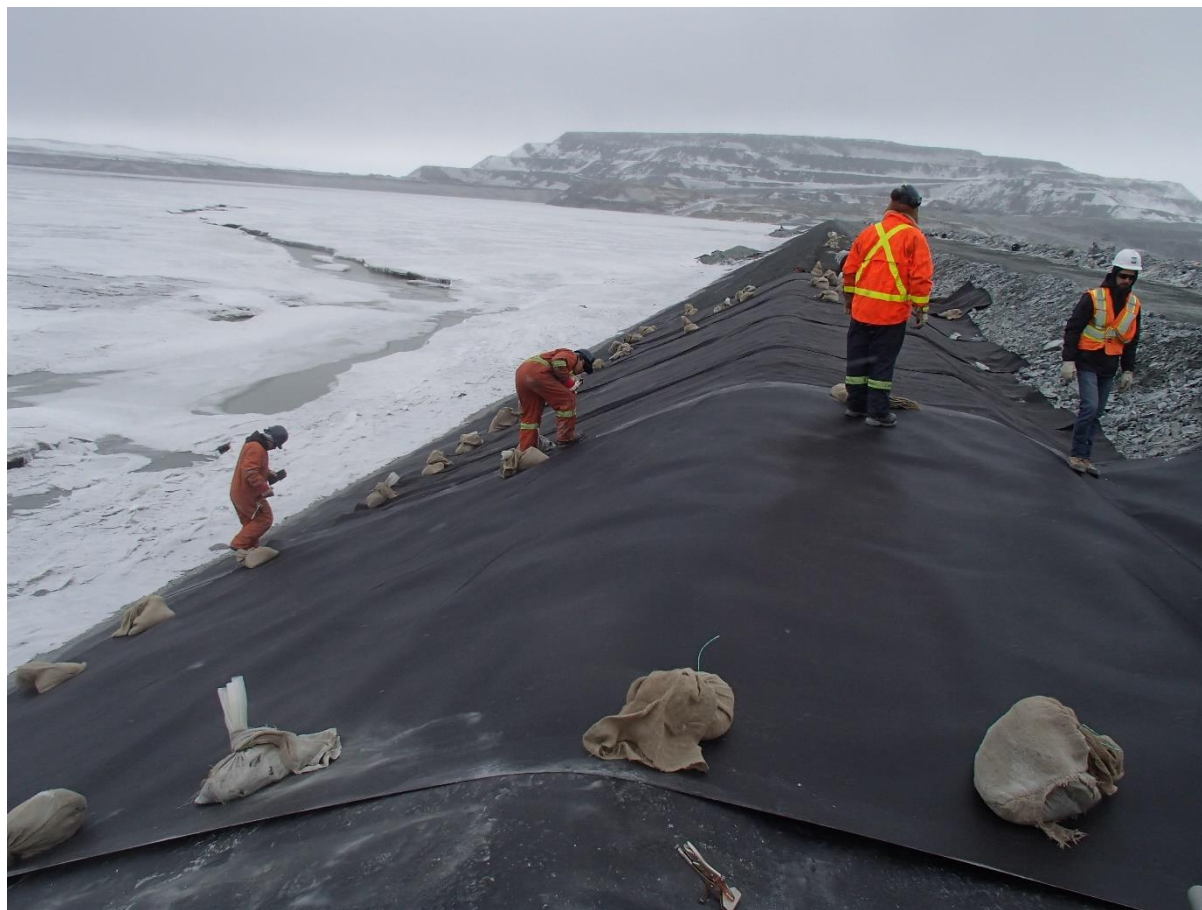
Photograph CD-1874: From Sta. 0+760/-26 m, looking N. Installation of the geotextile on the upstream slope 2H:1V between El. 143 m and 145 m from Sta. 0+760 m to 0+740 m.

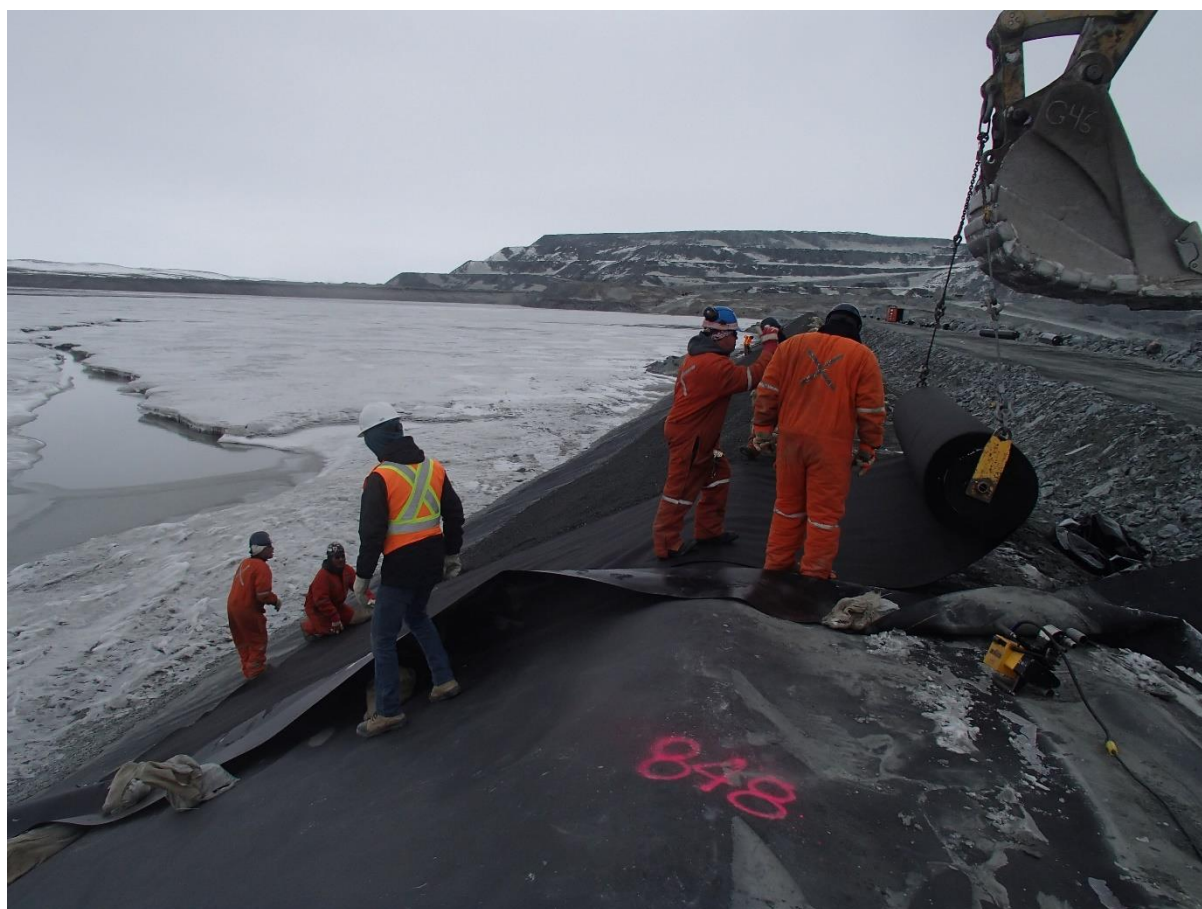
Photograph CD-1877: From Sta. 0+745/-26 m, looking N. Installation of the geotextile on the upstream slope 2H:1V between El. 143 m and 145 m from Sta. 0+740 m to 0+610 m.

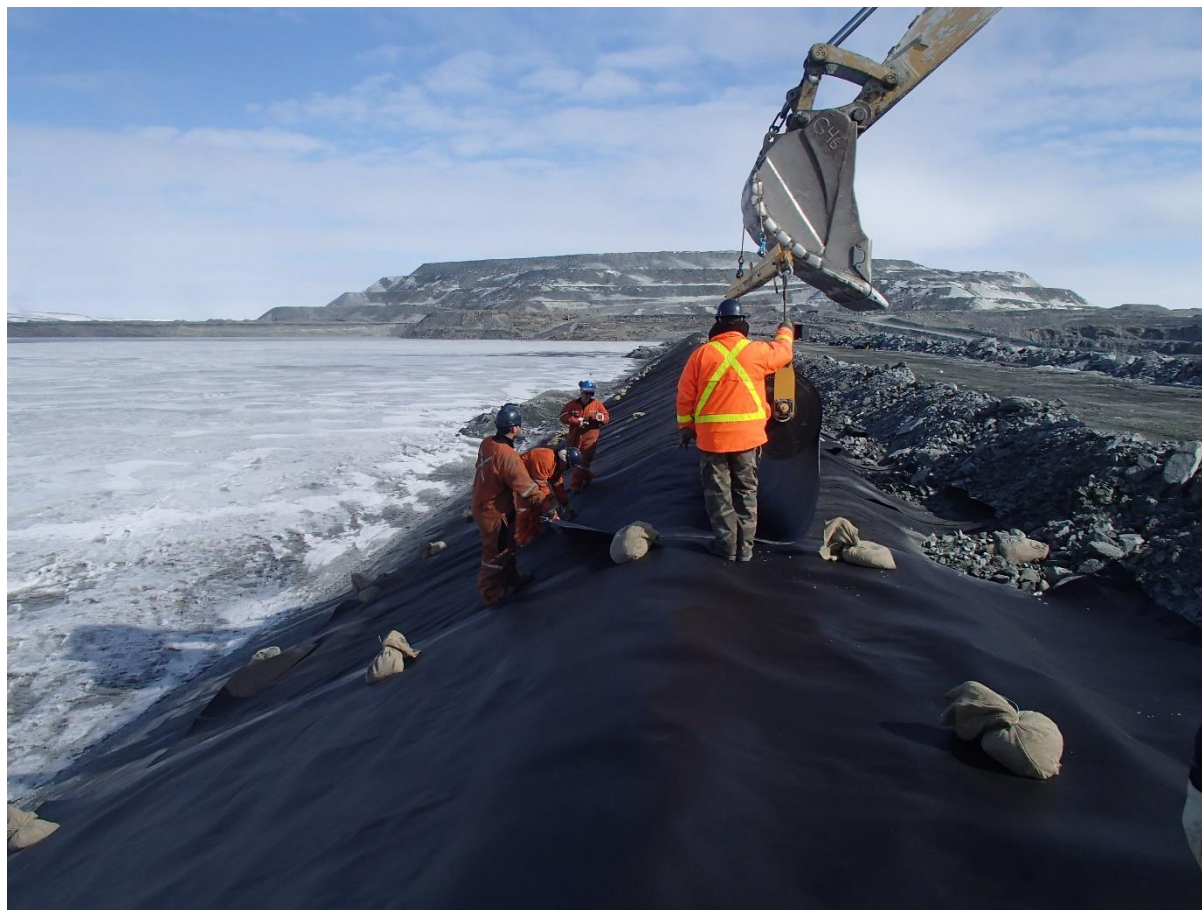
Photograph CD-1878: From Sta. 0+720/-24 m, looking N. Installation of the LLDPE liner on the upstream slope 2H:1V between El. 143 m and 145 m from Sta. 0+740 m to 0+610 m (panel numbers 849 to 867).

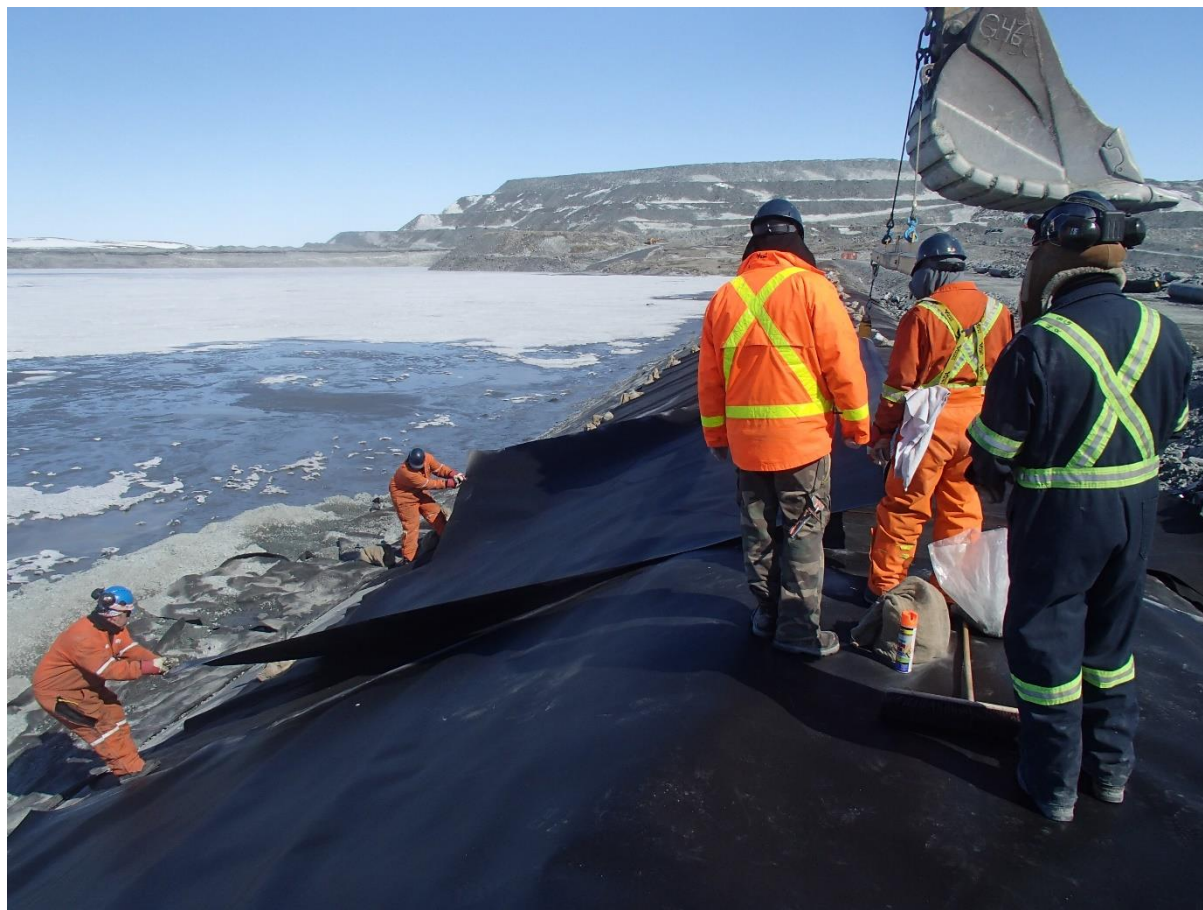
Photograph CD-1883: From Sta. 0+525/-26 m, looking N. Installation of the LLDPE liner on the upstream slope 2H:1V between El. 143 m and 145 m from Sta. 0+610 m to 0+480 m (panel numbers 868 to 886).

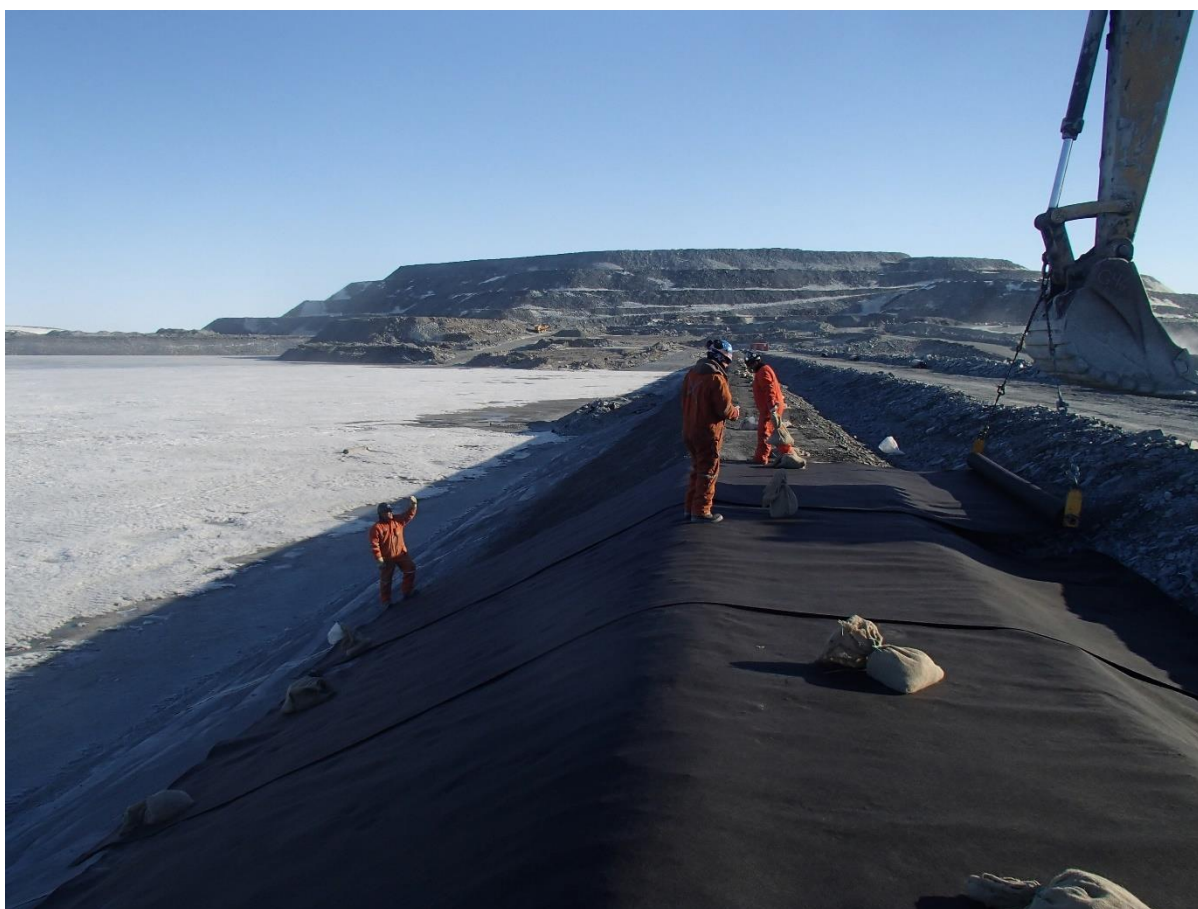
Photograph CD-1885: From Sta. 0+460/-26 m, looking N. Installation of the geotextile on the upstream slope 2H:1V between El. 143 m and 145 m from Sta. 0+480 m to 0+320 m.

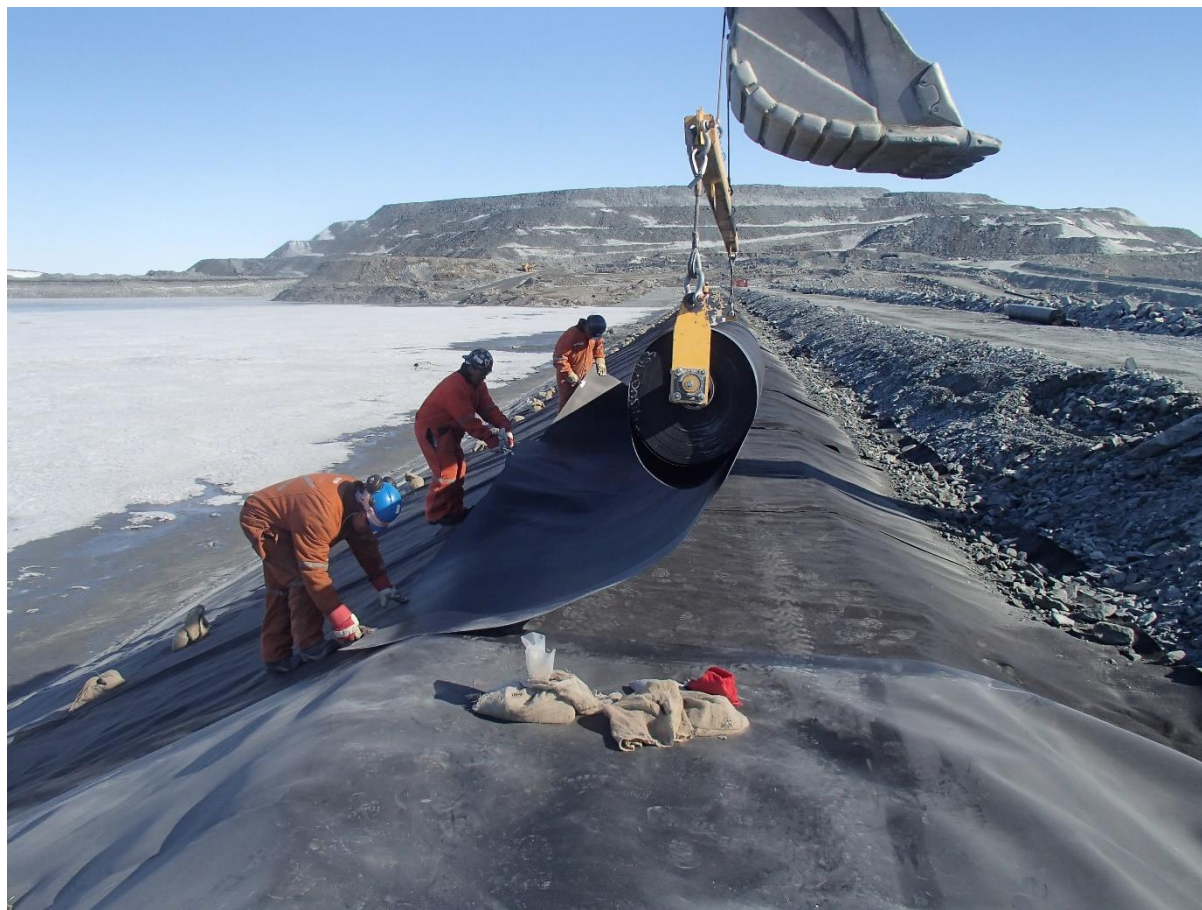
Photograph CD-1886: From Sta. 0+525/-26 m, looking N. Installation of the LLDPE liner on the upstream slope 2H:1V between El. 143 m and 145 m from Sta. 0+480 m to 0+320 m (panel numbers 887 to 910).
