PROJECT : Construction of Vault Dike  
PROJECT #: 6116/4 DATE: 2013-03-12  
DOCUMENT #: 2013 0312 - 01 CLIENT: OEM  
(YYYYMMDD-D1)

### CERTIFICATE OF ACCEPTANCE OF LINER CONDITION - VAULT DIKE

**AGNICO-EAGLE, MEADOWBANK VAULT DIKE  
ANICO-EAGLE MINE LIMITED  
Baker Lake, Nunavut  
Texel Geosol Project No. C12259**

**QUALITY CONTROL FINAL REPORT  
BY TEXEL GEOSOL INC.**

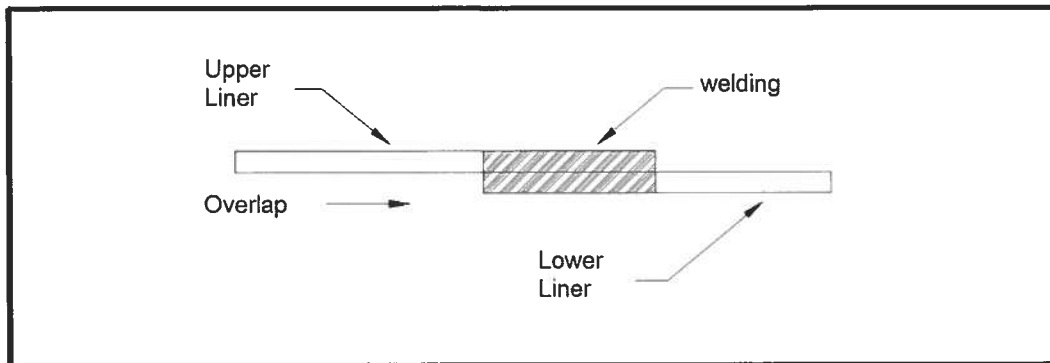
**Figure 1 – Bituminous Geomembrane Weld**

All seams between panels were made using a manual fusion process, the fusion being obtained using a propane torch and a roll pressure of 15 kg.

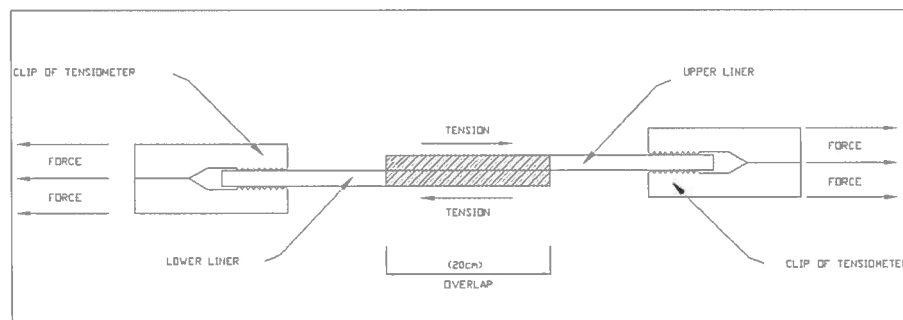
**Figure 2 - Shear Test**

Finally, a destructive testing program was applied, where seam samples taken from the installed geomembrane were tested for shear strength on a calibrated, portable tensiometer. On each sample, one shear tests were performed. All the results from these tests are included in Appendix I of this report.

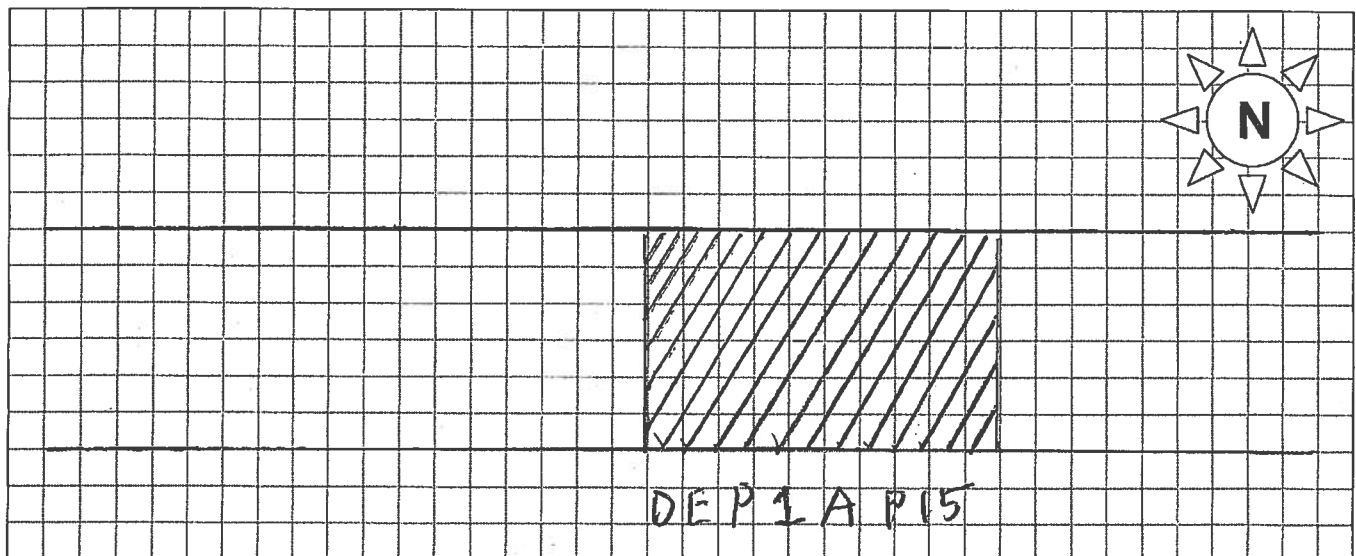
**CROQUIS / SKETCH**

Je, soussigné et représentant officiel de Texel Géosol, accepte et juge adéquat la préparation de la surface des assises telles que localisée au croquis ci-dessus. /  
I, the Texel Geosol's official representative, find acceptable for deployment the surface conditions of the area described above.

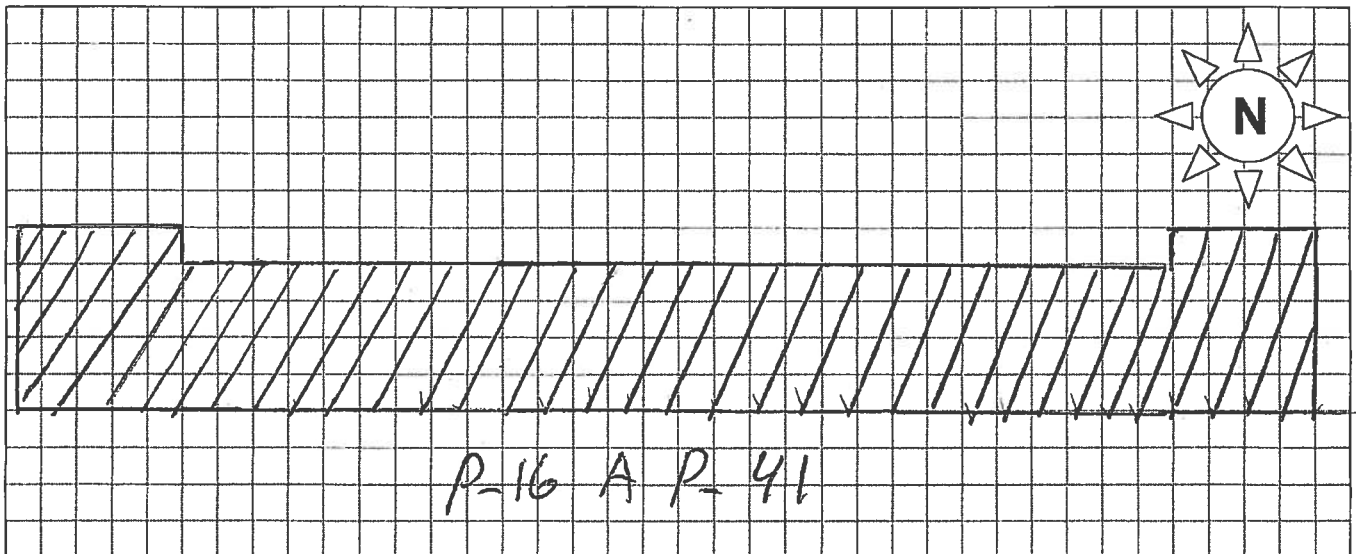
**CROQUIS / SKETCH**

Je, soussigné et représentant officiel de Texel Géosol, accepte et juge adéquat la préparation de la surface des assises telles que localisée au croquis ci-dessus. /  
I, the Texel Geosol's official representative, find acceptable for deployment the surface conditions of the area described above.

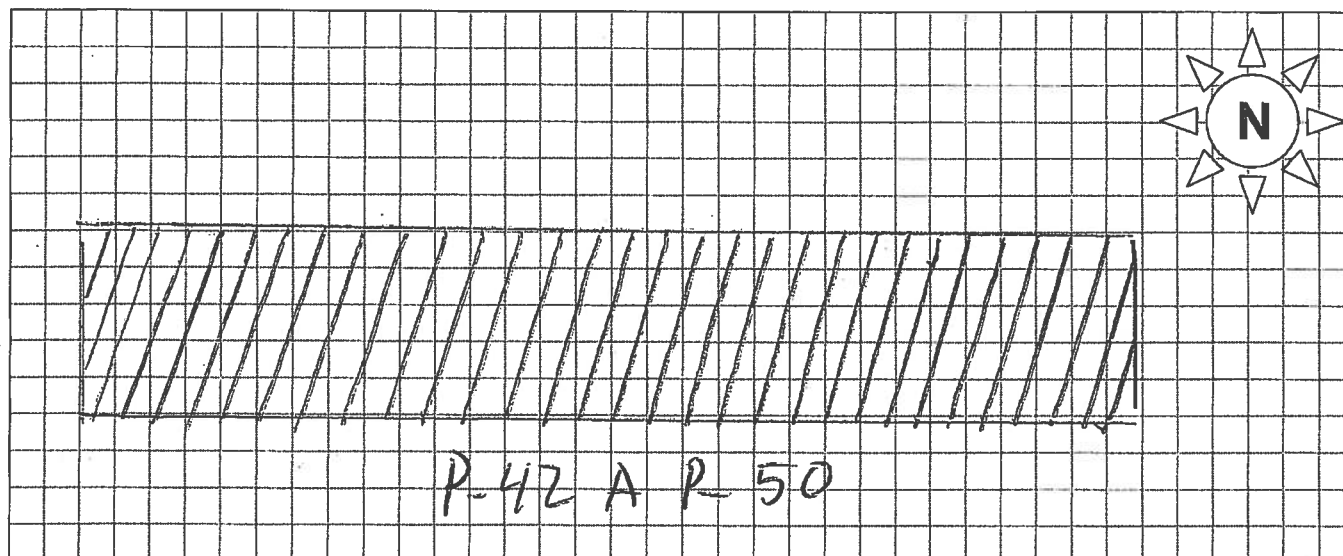
**CROQUIS / SKETCH**

Je, soussigné et représentant officiel de Texel Géosol, accepte et juge adéquat la préparation de la surface des assises telles que localisée au croquis ci-dessus. /  
I, the Texel Geosol's official representative, find acceptable for deployment the surface conditions of the area described above.
