**CONSTRUCTION SUMMARY REPORT
ROCK STORAGE FACILITY – INTERIM TILL PLUG**

**AGNICO-EAGLE MINES LIMITED
MEADOWBANK GOLD PROJECT**

OCTOBER 30TH, 2013

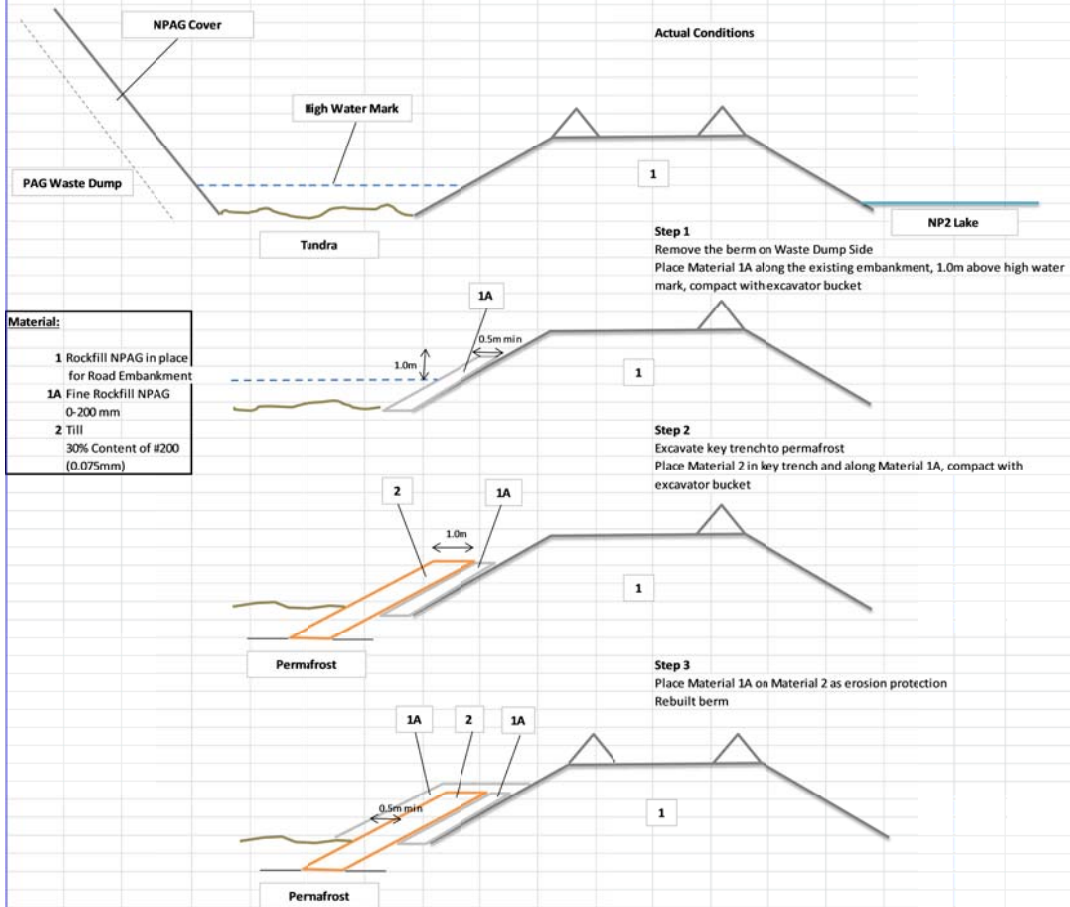
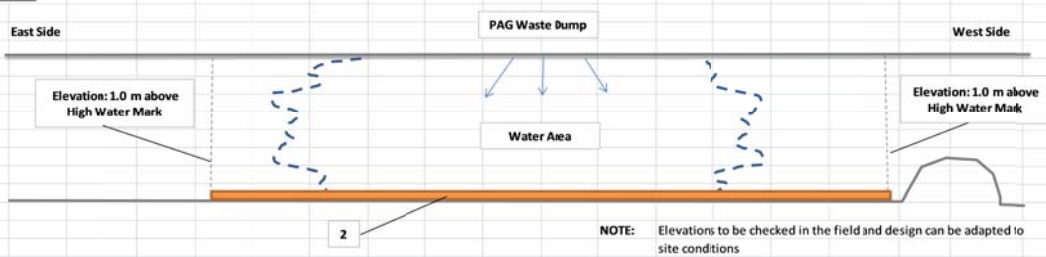
Figure 2 - Waste Rock Interim Till Plug

Figure 2: design drawings of the interim waste rock storage facility till plug to prevent seeping water from reaching NP-2 lake.
