Spill September 18th, 2015 – Follow Up Action Report

Please find the following information as a follow up to the Spill report submitted September 19th, 2015 by Agnico Eagle Meadowbank division. This detailed report is submitted to the Inspector in compliance with the conditions under the Nunavut Water Board License 2AM-MEA1525, Part H, Item 8c.

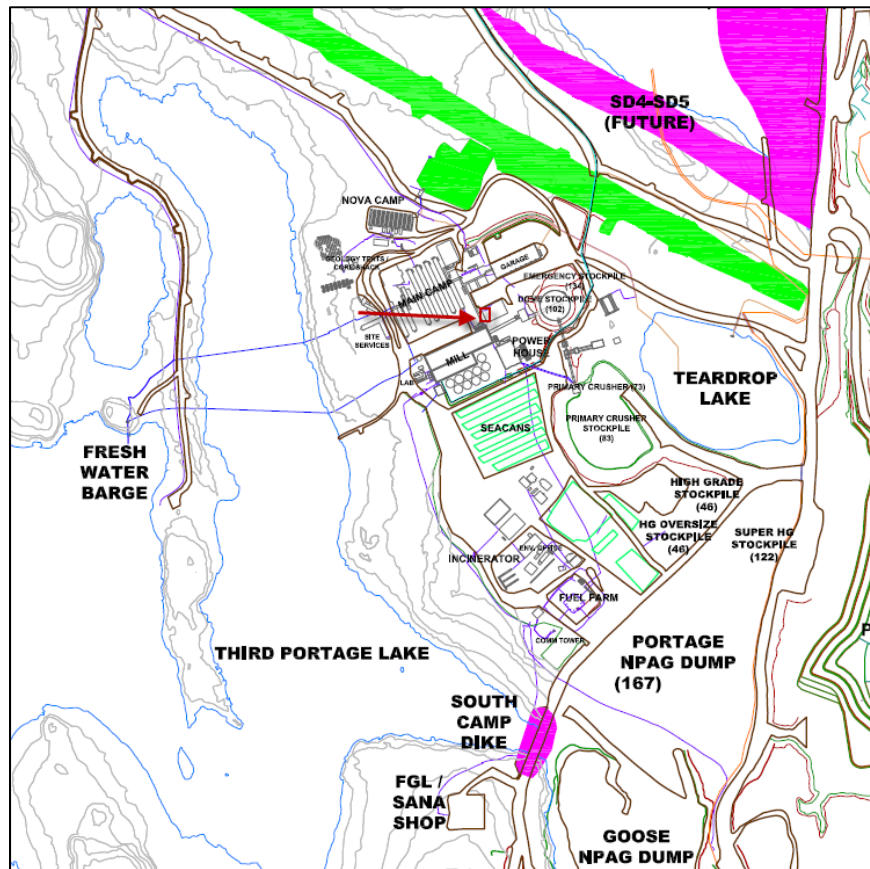
Figure 1 – Approximate location of the spill, September 18th 2015

On September 18th 2015, when moving a pallet of material between the Arctic Corridor (corridor between the Service Building and the Mill, see Figure 1) and the Warehouse Dome, a loader damaged the glycol pipe of the heating glycol system, resulting in a spill of glycol. Quickly the valve of the system was closed to prevent any more spillage. Absorbent pads were immediately put on the ground to absorb glycol. Approximately 900 liters of glycol were spilled on the ground and along the building. The quantity was determined based on the amount of glycol used to refill the heating system after the spill. The contaminated area is approximately 60 m² along the building. Photo 1 shows the contaminated area after the spill. The spill occurred in an area at approximately 375 meters from the closest watercourse and there is no threat to any receiving watercourse.

Spill location : Northing: 7214015 Easting: 638066
