<u>Spill September 4th, 2015 – Follow Up Action Report</u>

Please find the following information as a follow up to the Spill report submitted September 4th, 2015 by Agnico Eagle Meadowbank division. This detailed report is submitted to the Inspector in compliance with the conditions under the Nunavut Water Board License 2AM-MEA1525, Part H, Item 8c.

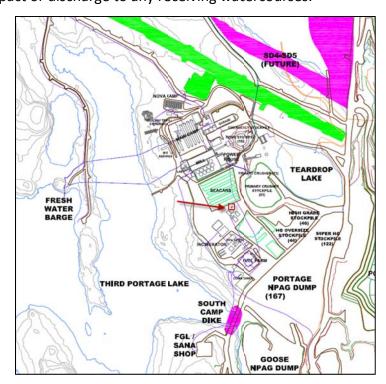
On September 4th 2015, in the area of the oil filtering station, during the process of moving totes of waste oil from a container, the forks of the loader hit the outlet valve of a tote behind the one being moved. Upon noticing the spill of waste oil, the employee on the ground signaled the operator to stop moving the tote. They then proceeded to flip the tote on its side to prevent further spillage. See Figure 1 for the approximate location of the spill. Approximately 160 liters of waste oil was spilled and the area of contamination was approximately 20 m².

Figure 1 – Approximate location of the spill, September 4th 2015
