## July 28<sup>th</sup>, 2017 Vault refuge genset spill

Please find the following information as a follow up to the Spill report submitted July 28<sup>th</sup> 2017 by Agnico Eagle Meadowbank division. This detailed report is submitted to the Inspector in compliance with the conditions under the Nunavut Water Board License 2AM-MEA1525, Part H, Item 8c.

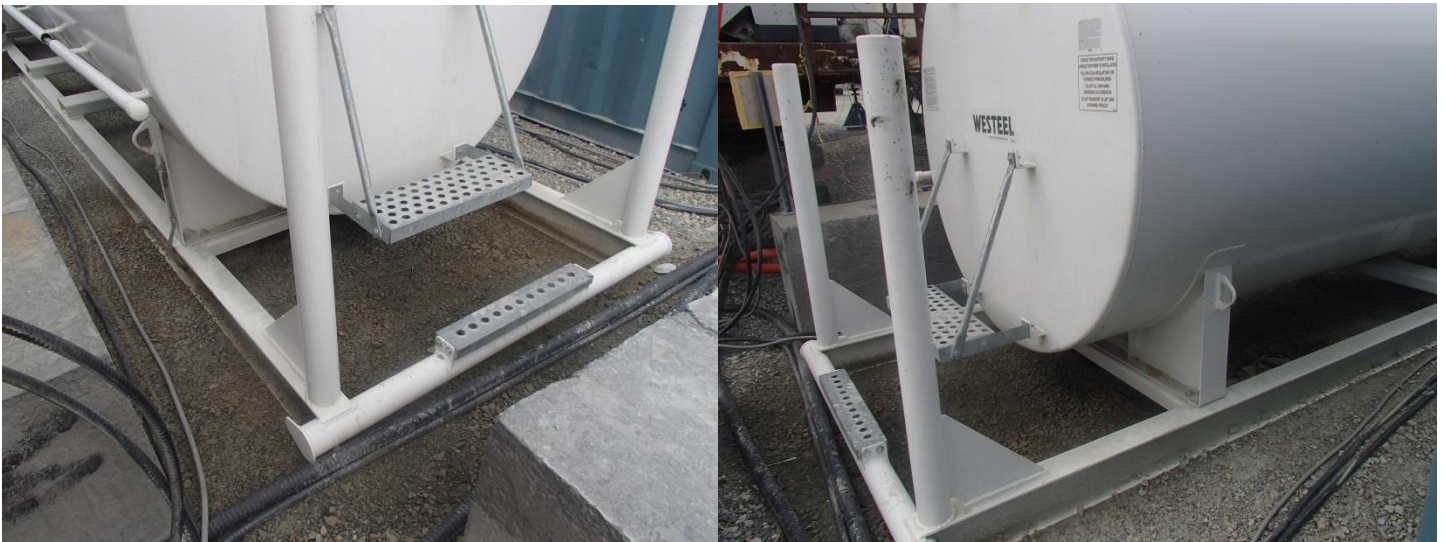
During regular maintenance work, a technician noticed a fuel smell from his work area. The worker notified immediately his supervisor and the Environmental department. Upon inspection it was determined that the source was from underneath the Vault refuge genset tank.

There were no off site impact or discharge to any receiving watercourses. The distance to the closest lake is estimated at 650 meters.

After investigation (see in appendix), it was assessed that the spill most probably originated from the refilling procedures of the tank. Consumption logs were verified and tabulated, pointing towards human error during refuelling.

Being underneath the tank, the recovery work had to be planned and assessed with the Energy and Infrastructure and Mine Departments. Level of the tank had to be lowered to safely lift and remove from the location. As well the area is part of the electrical feed of the Vault refuge station, thus electrical cables around the area had to be identified and taken away for the planned clean-up work. A complete shut-down of the refuge had to be planned, delaying recovery work. A PID meter was used to assist in locating contaminated area. To ensure stability of the ground for the tank reset, the whole area was dug to a stable and level depth. Thus, more material was removed from the recovery work. All material removed was considered contaminated and disposed at the approved Landfarm. The area was backfilled with proper material and the tank reinstalled at the same location.
