## 2023-12-15 MBK Seepage – Contaminated Water

GN reference #: 2023-524

Please find the following information as a follow up to the spill report, #2023-524 submitted December 15<sup>th</sup>, 2023, by Agnico Eagle Meadowbank division. This detailed report is submitted to the Inspector in compliance with the conditions under the Nunavut Water Board License 2AM-MEA1530, Part H, Item 8c.

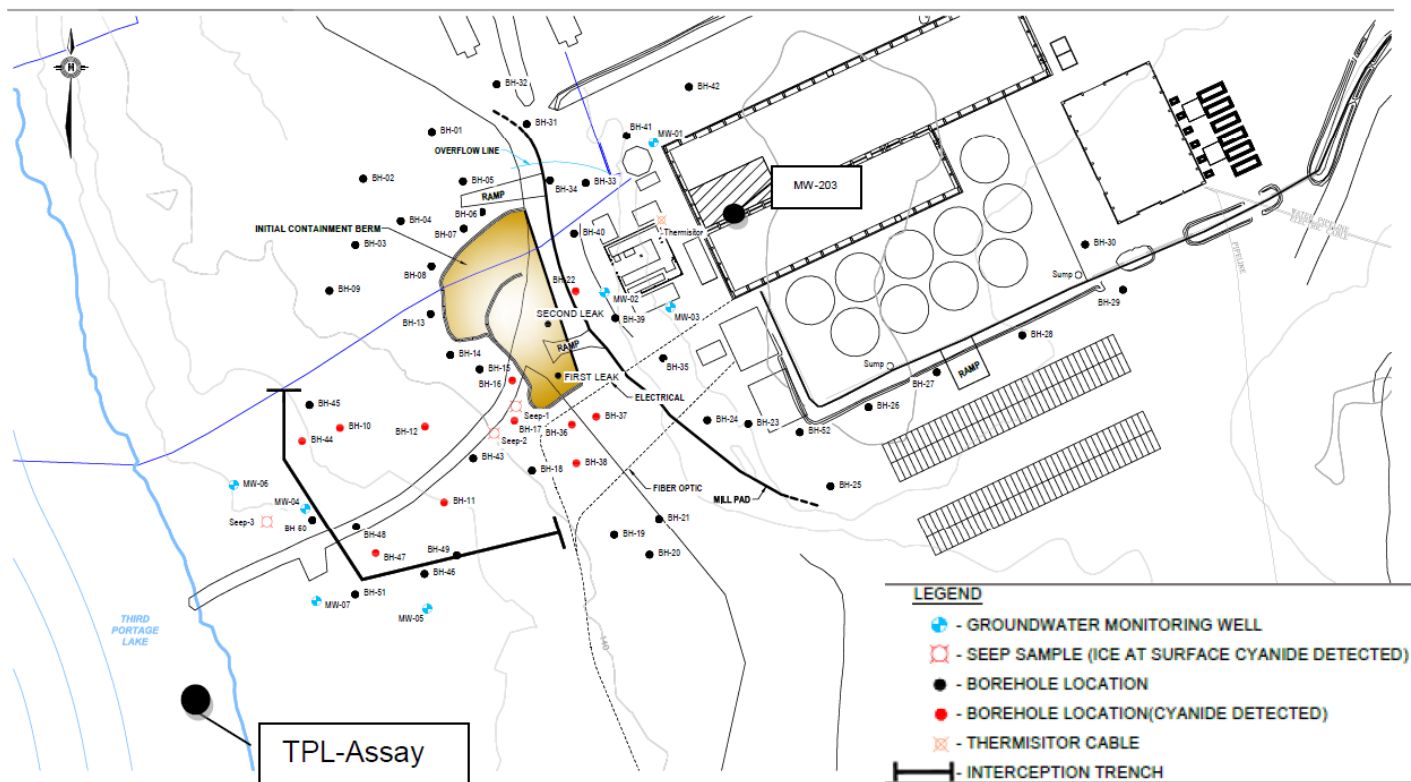
Figure 10. General Layout of the Assay Road Seepage monitoring wells as presented in the Meadowbank Complex's 2022 Annual Report

Continued monitoring of the area will continue a routine basis throughout Freshet. Continued investigation work within the Mill utilizing dye within different sumps, tanks, and containments to identify the seepage origin, should water inflow resume. As a precaution Agnico will be bringing in an expert to inspect and repair, if needed, all foundation sealants, within the mill sumps.
