November 30, 2009

# 2009 Annual Geotechnical Inspection - Meadowbank Gold Project, Nunavut

Agnico-Eagle Mines Limited  
Meadowbank Division  
P.O. Box 540  
Baker Lake, Nunavut  
X0C 0A0

**Project Number:** 09-1428-0018  
Doc. No. 969 Ver. 0

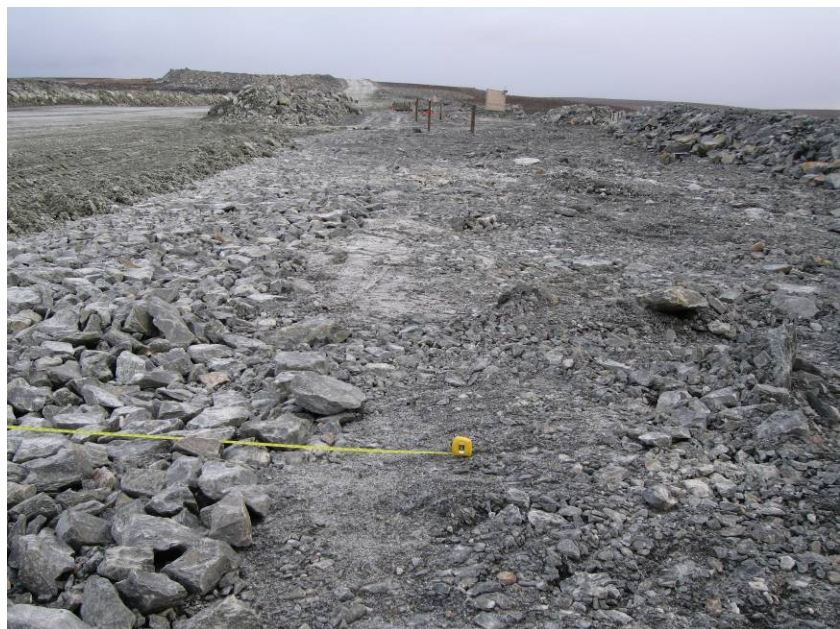
*PHOTOGRAPH 11 – East Dike*

**Description:** View of dike crest looking north from approximately Sta. 60+350.

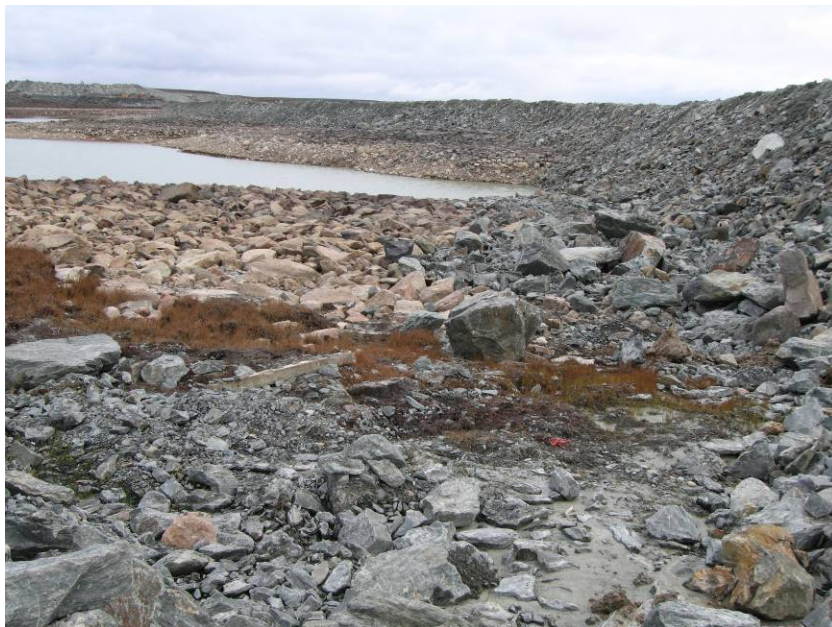
*PHOTOGRAPH 27 – East Dike*

**Description:** Downstream view of toe of dike from south abutment, looking north.

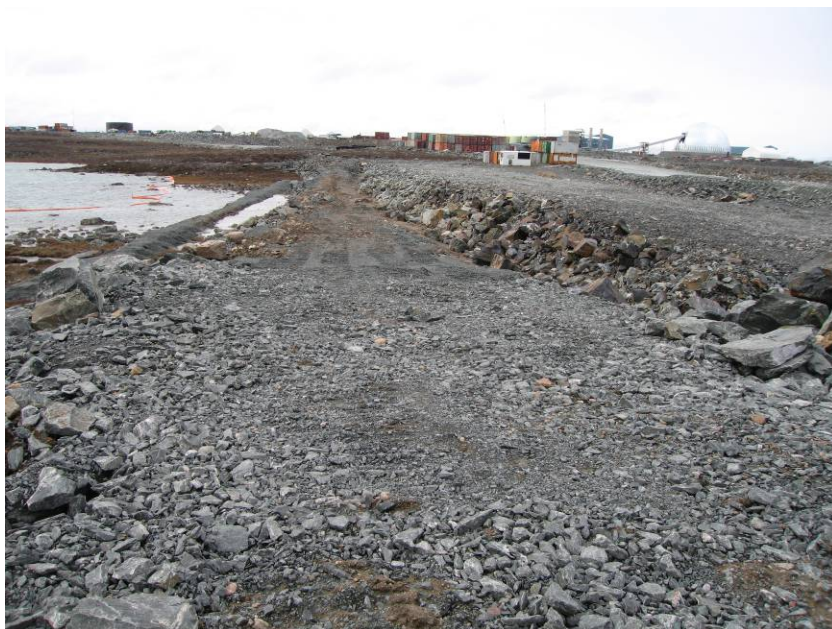
*PHOTOGRAPH 1 – West Channel Dike*

**Description:** From east abutment looking towards the west abutment along the upstream side of the dike. Surcharge load placed over the till core is evident.

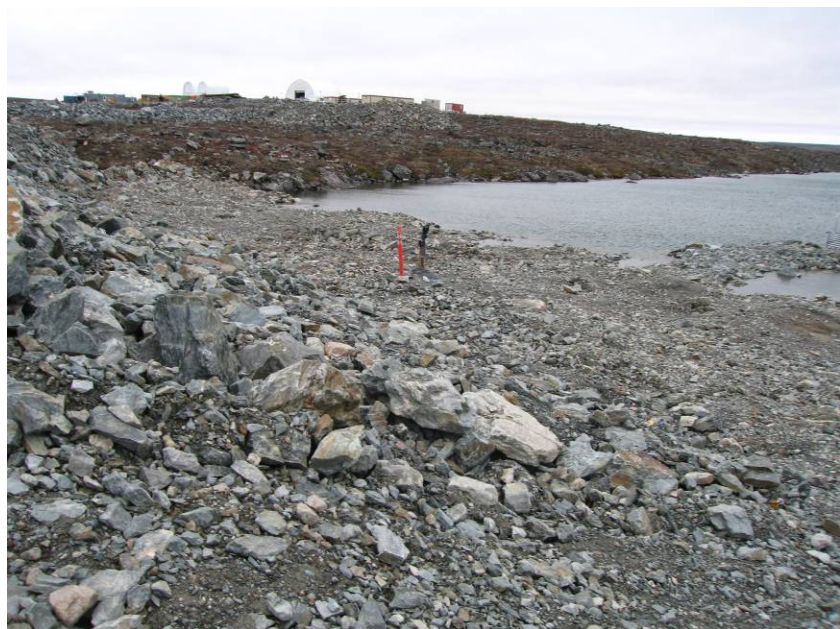
*PHOTOGRAPH 1 – South Camp Dike*

**Description:** Upstream side, looking towards the south abutment. Thermistor location evident.

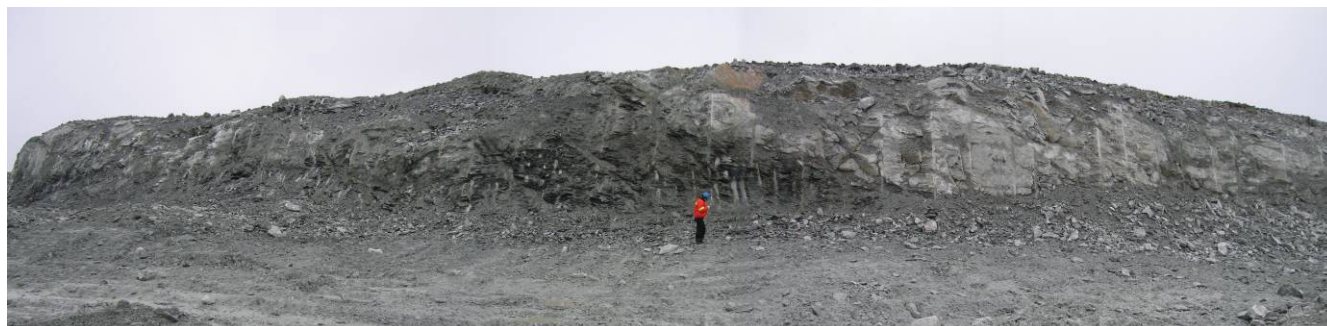
*PHOTOGRAPH 1 – North Portage Pit*

**Description:** Final northeast wall of North Portage Pit to first bench. Scaling has not been completed.

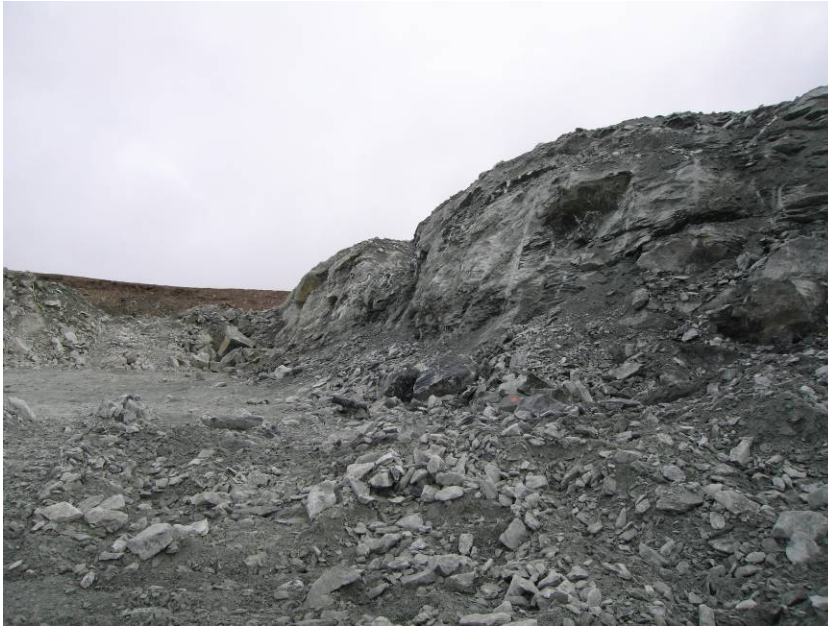
*PHOTOGRAPH 3 – North Portage Pit*

**Description:** Looking north along northeast final wall of North Portage Pit.

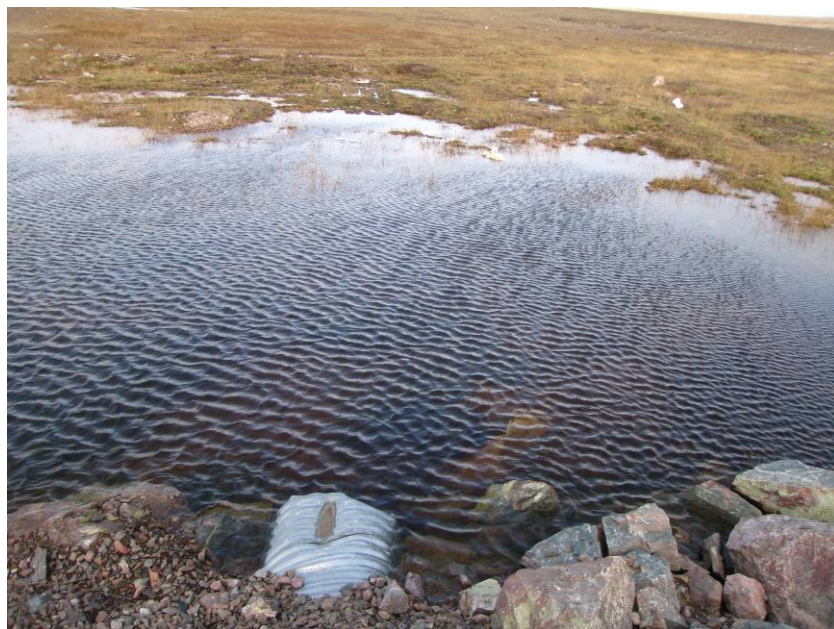
*PHOTOGRAPH 1 – PRC-1, km 0+430*

**Description:** Upstream view of culvert. Culvert is full, in good condition, uniform grade and no obstructions.

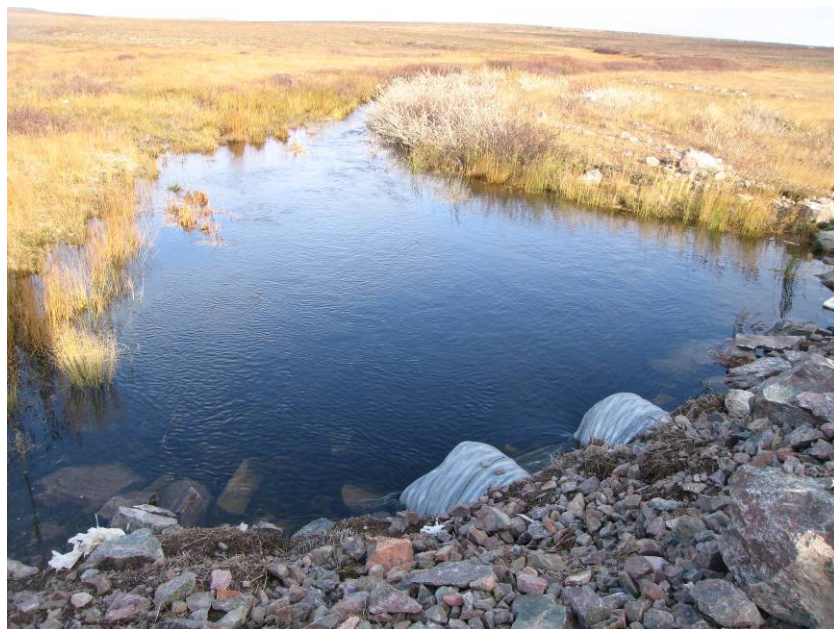
*PHOTOGRAPH 3 – PRC-2, km 0+470*

**Description:** Upstream view of culverts. Culverts are mostly full, in good condition, uniform grade, and no obstructions.

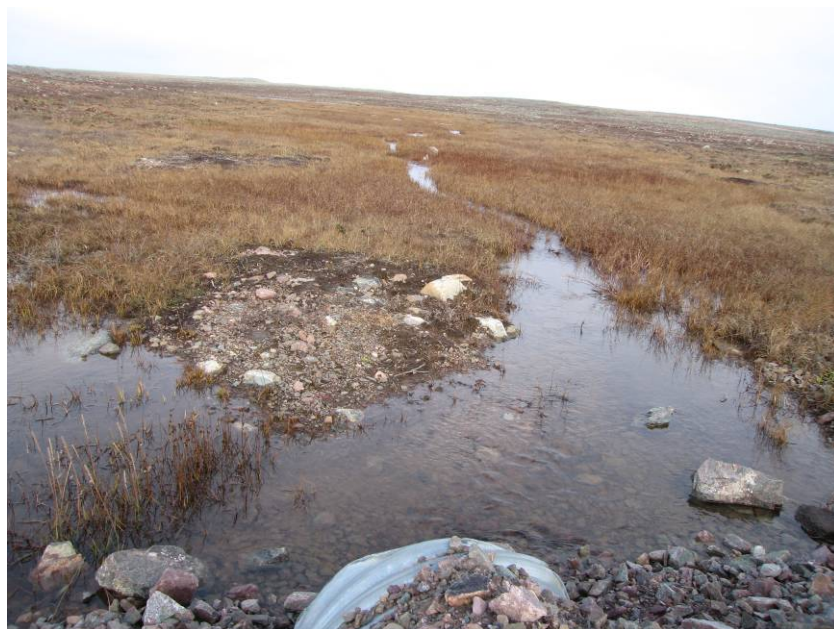
*PHOTOGRAPH 5 – PRC-3, km 1+380*

**Description:** Upstream view of culvert. Culvert is in good condition, uniform grade, and no obstructions.

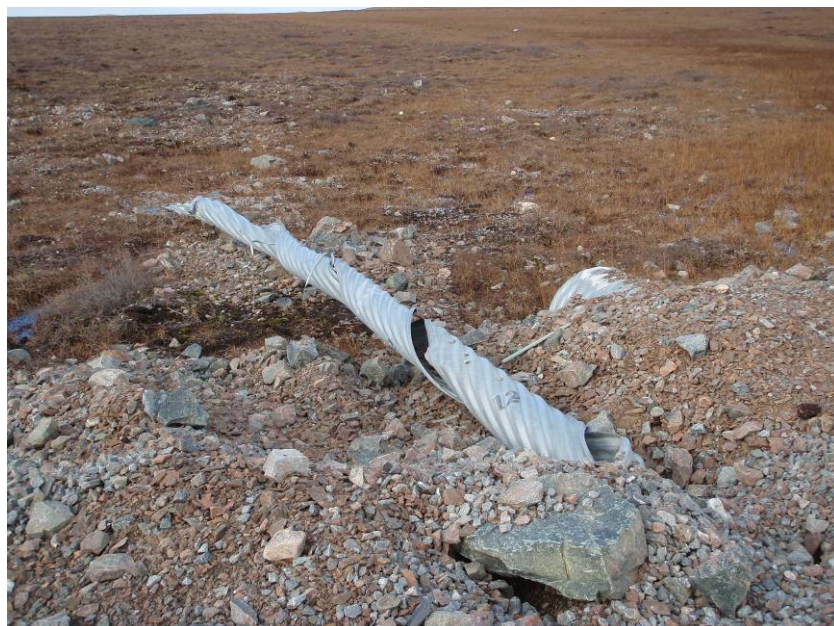
*PHOTOGRAPH 11 – PC-14, km 4+260*

**Description:** Upstream view of culverts. Culvert closer to Baker Lake is damaged on upstream side. Other culvert has minimal crushing on haunch of culvert near the center of the road. Uniform grade, no obstructions.

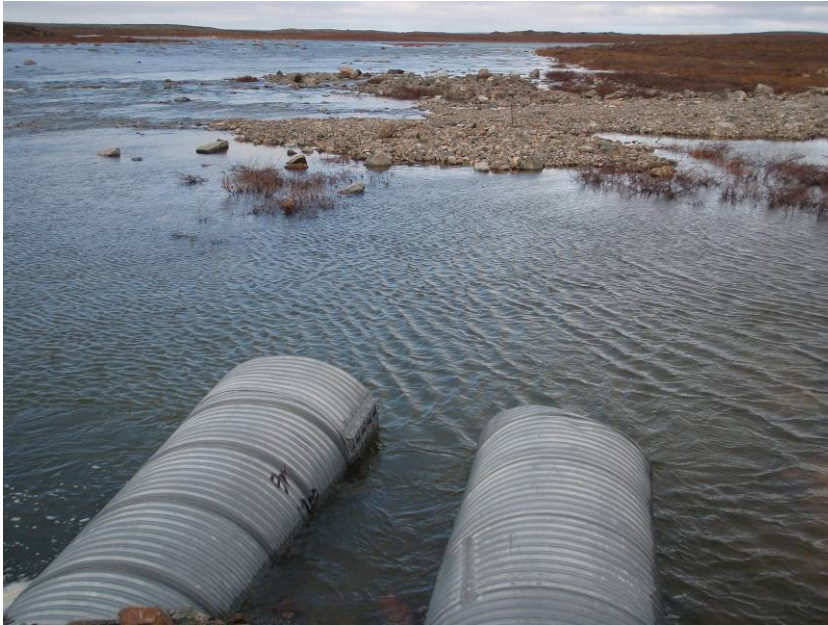
*PHOTOGRAPH 15 – PC-17, km 8+830*

**Description:** Upstream view of culverts. Culverts in good condition.

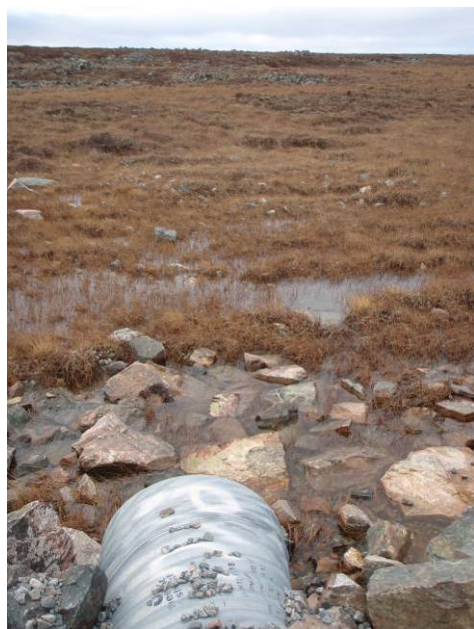
*PHOTOGRAPH 19 – R-03, km 10+580*

**Description:** Upstream view of culvert. Culvert is in good condition, uniform grade, and no obstructions. Water flowing through culvert is orange, oxidized.

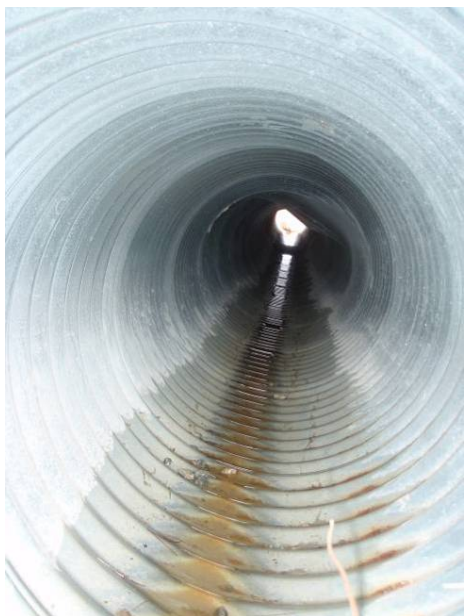
*PHOTOGRAPH 25 – PC-13, km 12+745*

**Description:** View through culvert from upstream to downstream. Crushing and dent on side and haunch near upstream end of culvert. Likely damaged during installation, continue to monitor as road bed consists of gravel and some larger cobbles (angular), potential for condition to worsen. Uniform grade, no blockage evident.

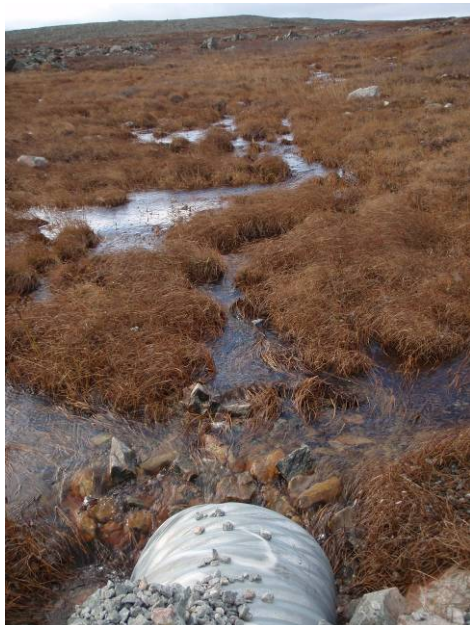
*PHOTOGRAPH 29 – PC-3, km 13+685*

**Description:** Upstream view of culvert.

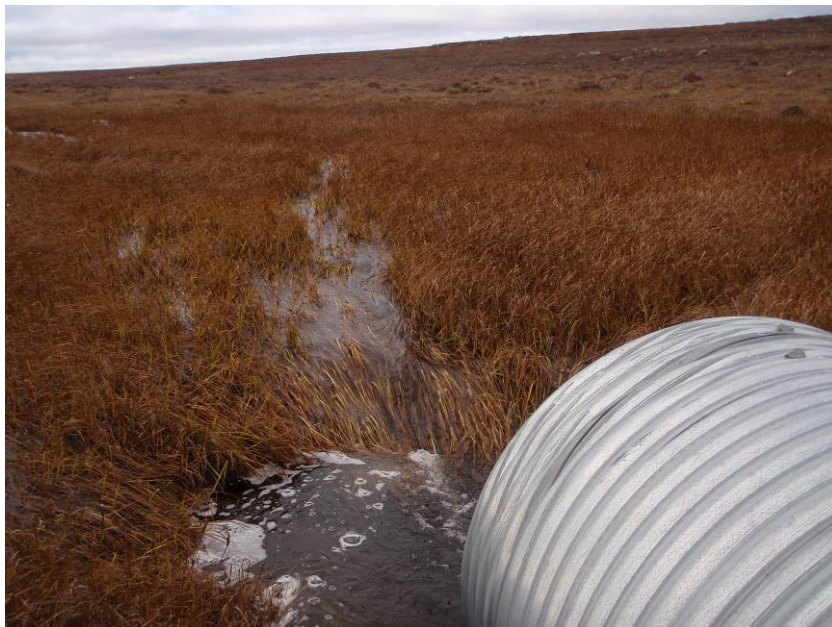
*PHOTOGRAPH 35 – R-05A, km 15+645*

**Description:** Upstream view of culvert.

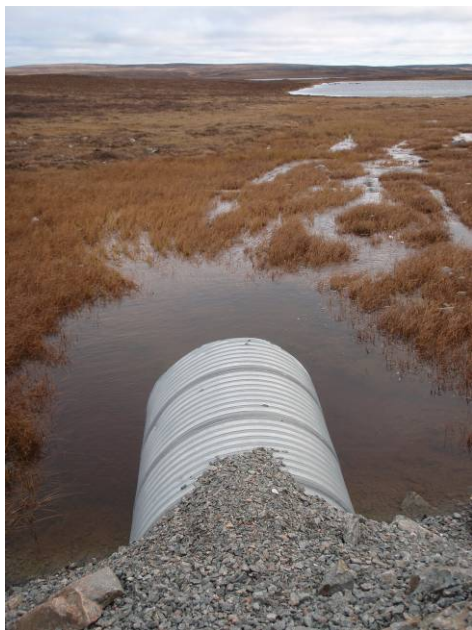
*PHOTOGRAPH 36 – R-05A, km 15+645*

**Description:** Downstream view of culvert. Concentrated flow. Adjacent to culvert, small flow evident passing through road, no visual evidence of turbidity observed.

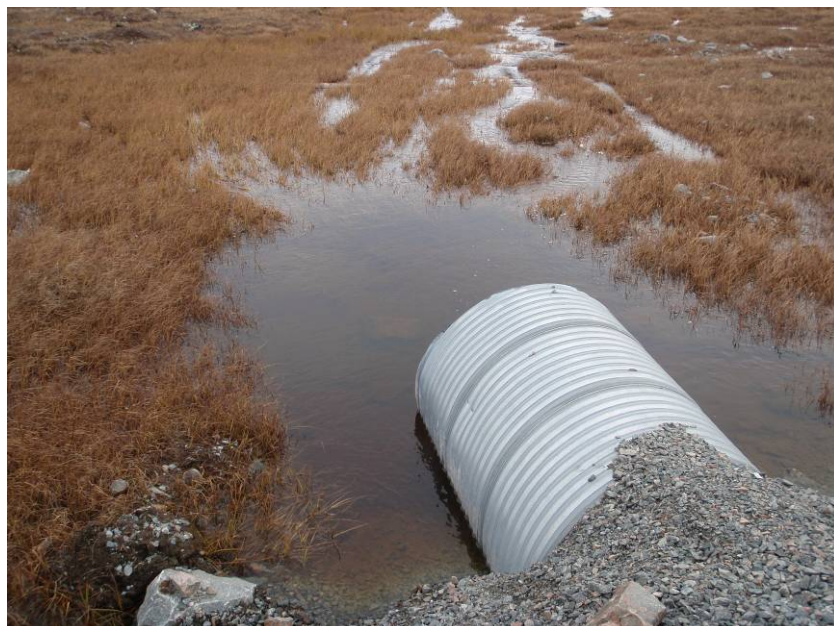
*PHOTOGRAPH 37 – R-05A, km 15+645*

**Description:** Downstream view of culvert.

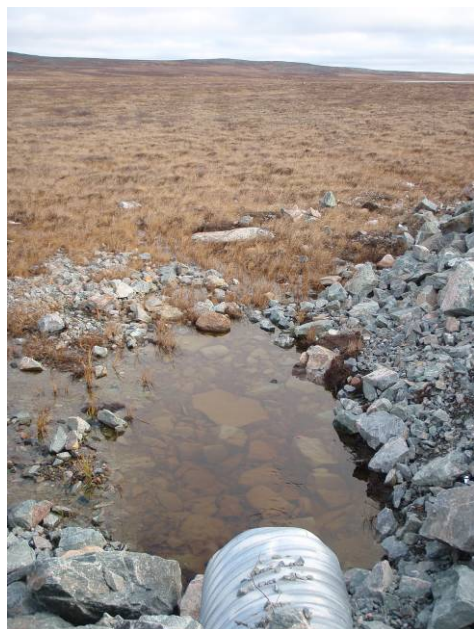
*PHOTOGRAPH 39 – PC-5, km 18+280*

**Description:** Downstream view of culvert. Broad valley, low gradient, no definitive channel observed.

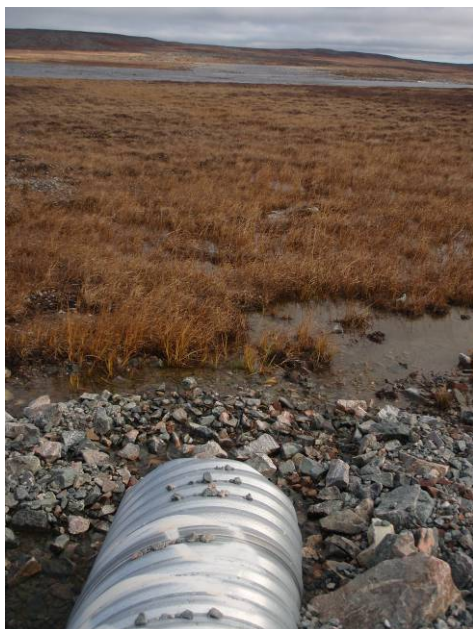
*PHOTOGRAPH 41 – PC-6, km 19+075*

**Description:** Downstream view of culvert.

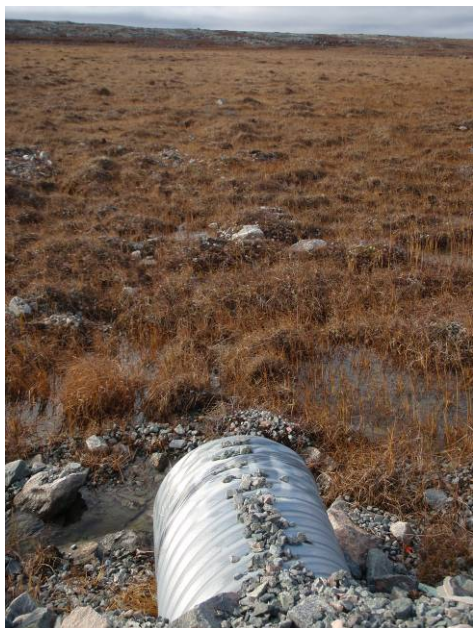
*PHOTOGRAPH 42 – PC-7, km 20+505*

**Description:** Upstream view of culvert. Culvert is in good condition, uniform grade, and no obstructions. Low gradient flow, very broad stream observed. Stream bed consists of cobbles, gravel and grass.

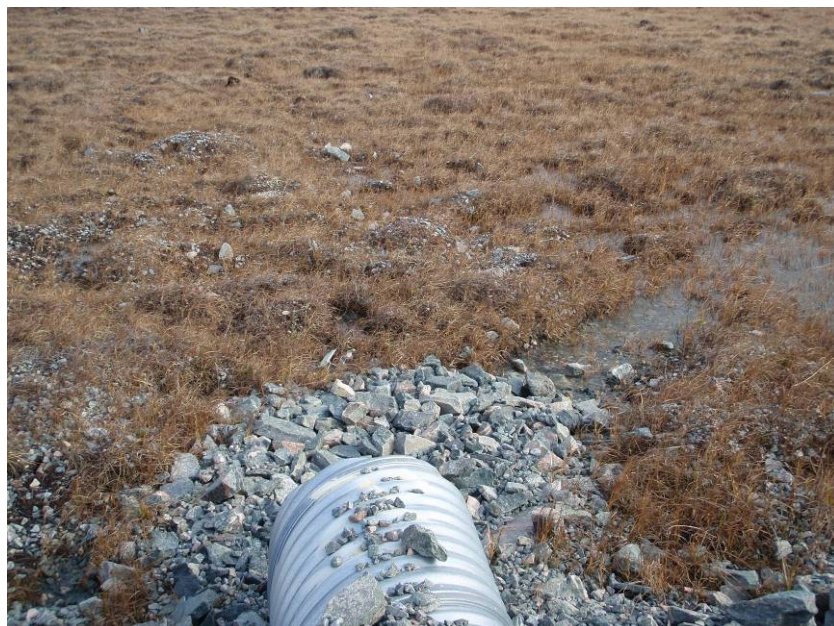
*PHOTOGRAPH 43 – PC-7, km 20+505*

**Description:** Downstream view of culvert.

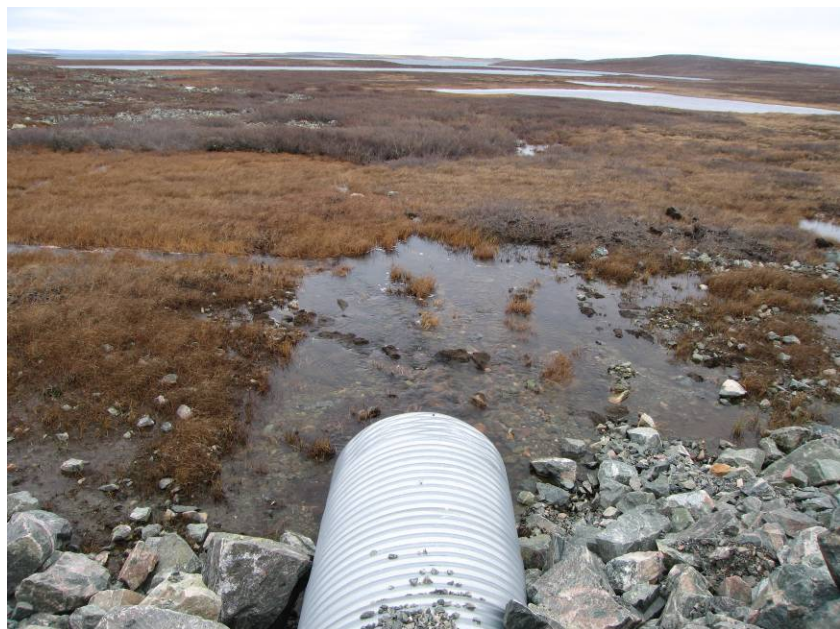
*PHOTOGRAPH 45 – R-07, km 25+900*

**Description:** Downstream view of culvert.

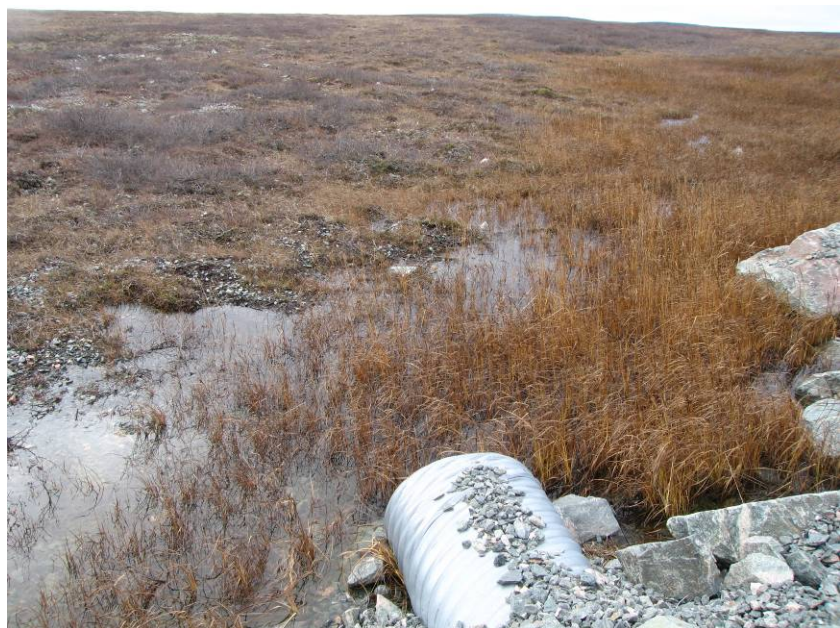
*PHOTOGRAPH 46 – PC-8, km 29+785*

**Description:** Upstream view of culvert. Culvert is in good condition, uniform grade, and no obstructions.

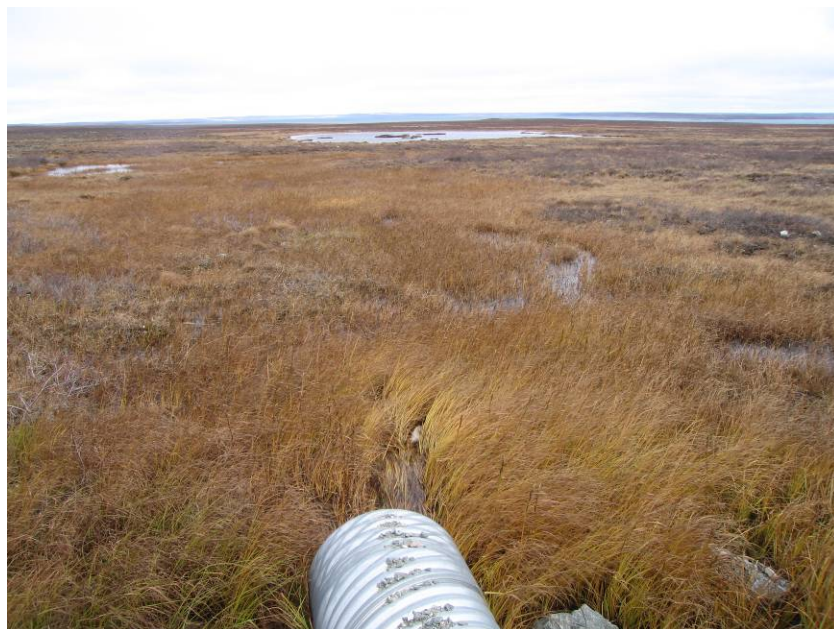
*PHOTOGRAPH 47 – PC-8, km 29+785*

**Description:** Downstream view of culvert.

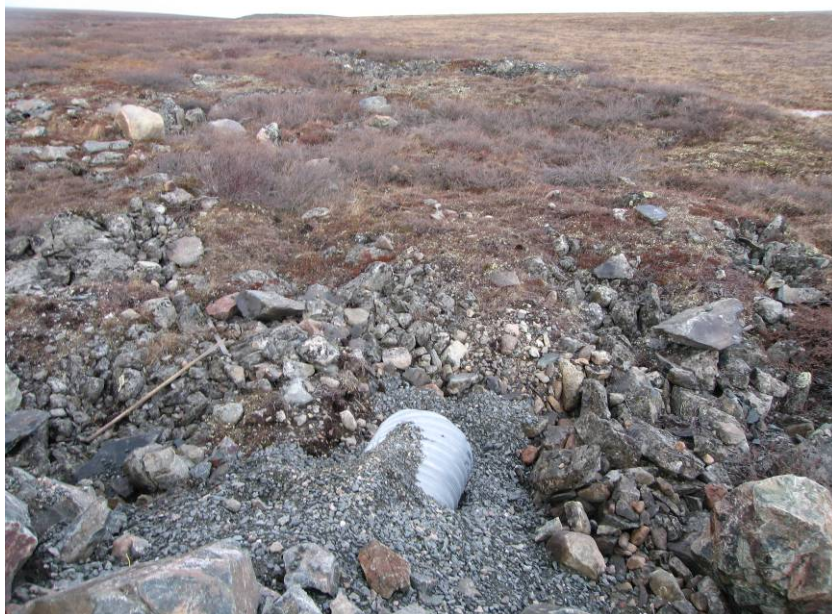
*PHOTOGRAPH 49 – PC-9, km 35+690*

**Description:** Upstream view of culvert and valley.

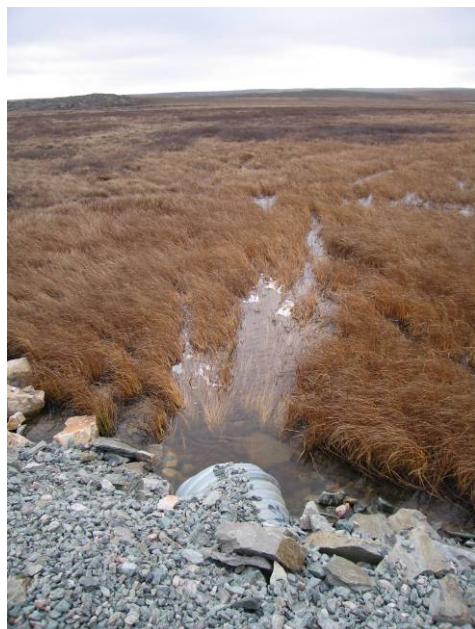
*PHOTOGRAPH 51 – PC-10, km 36+865*

**Description:** Downstream view of culvert.

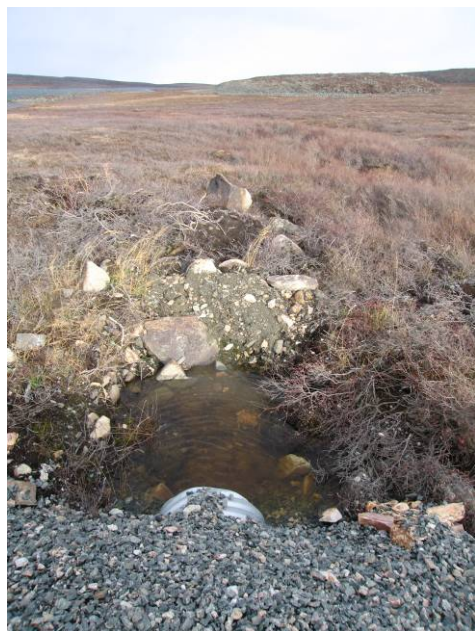
*PHOTOGRAPH 53 – PC-11, km 39+552*

**Description:** Downstream view of culvert. Water appears to be mostly ponded and not flowing, pool appears to have been created on downstream side during culvert installation.

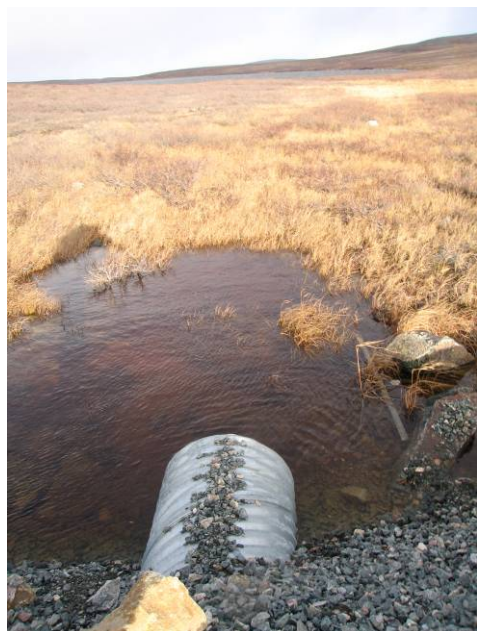
*PHOTOGRAPH 55 – PC-12, km 41+410*

**Description:** Downstream view of culvert.

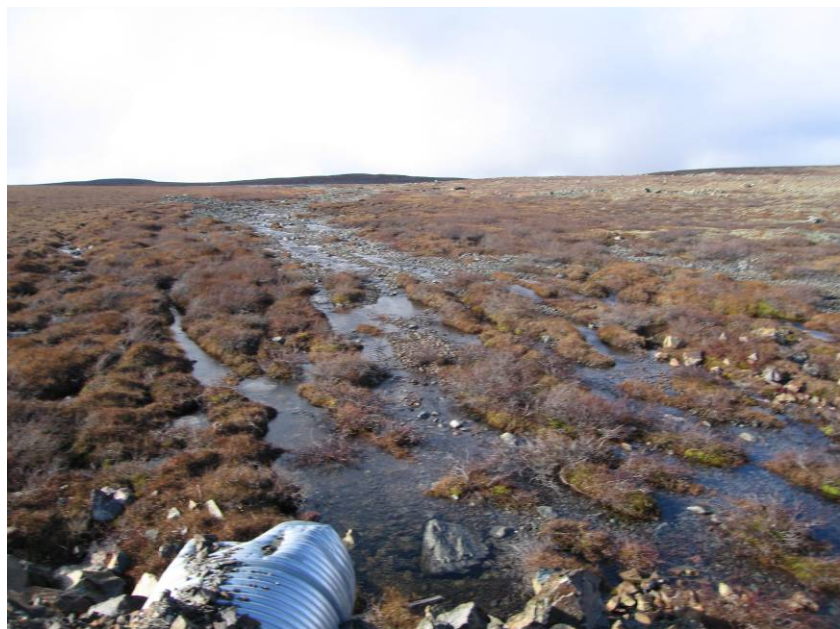
*PHOTOGRAPH 57 – R-14, km 67+840*

**Description:** Upstream view of culverts and valley.

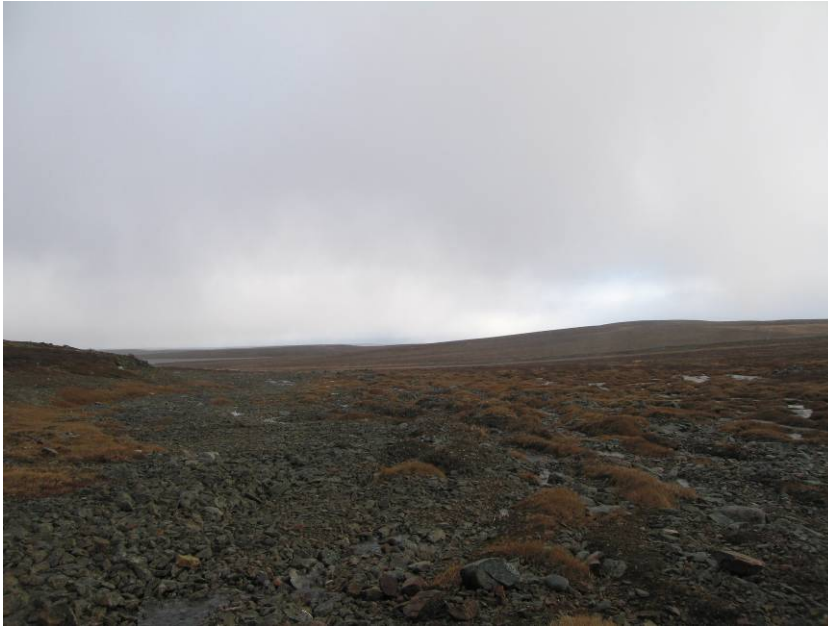
*PHOTOGRAPH 61 – R-14, km 67+840*

**Description:** View of downstream valley.

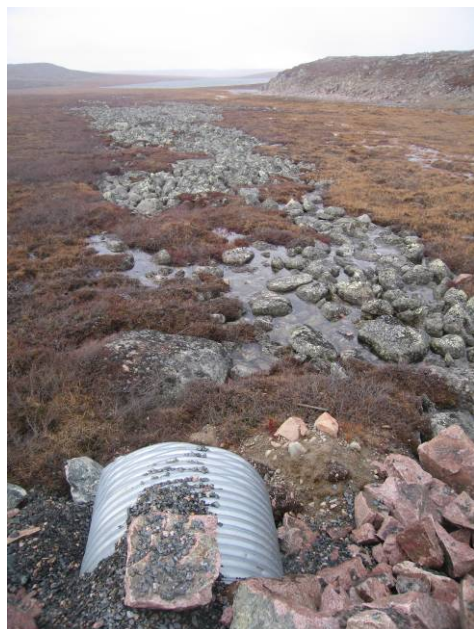
*PHOTOGRAPH 69 – R-20, km 85+490*

**Description:** Downstream view of culvert, looking west. Culvert is in good condition, uniform grade, and no obstructions.

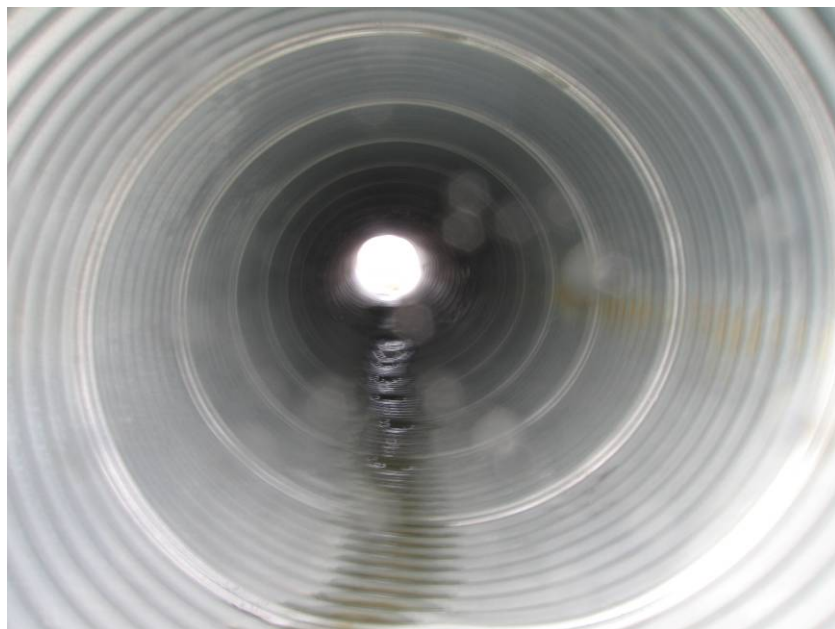
*PHOTOGRAPH 71 – R-20, km 85+490*

**Description:** Upstream to downstream view through culvert.

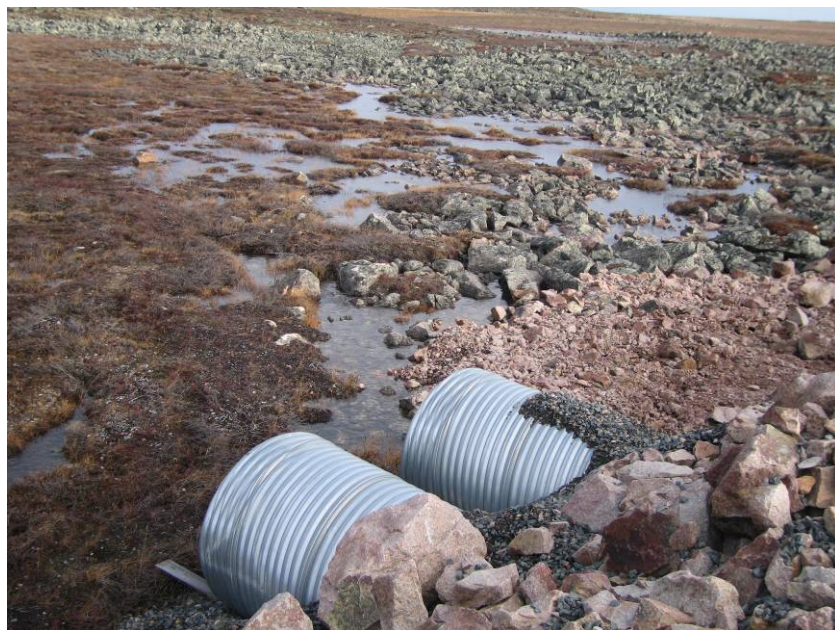
*PHOTOGRAPH 72 – R-21, km 87+500*

**Description:** Upstream view of culverts, looking north. Both culverts show some dents on base and sides likely damaged during installation. Minor crushing on crest of culverts also was evident. Uniform grade and no obstructions observed.

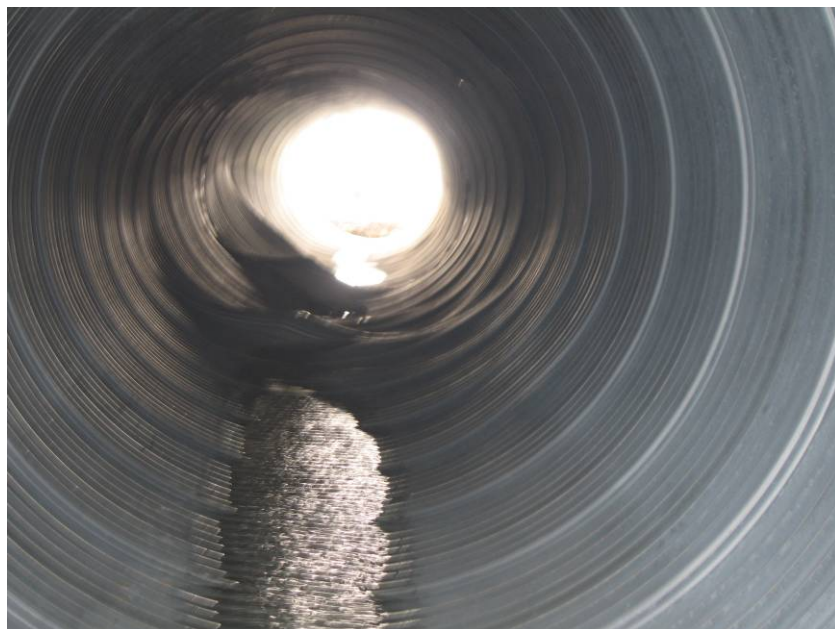
*PHOTOGRAPH 73 – R-21, km 87+500*

**Description:** View from upstream to downstream through eastern culvert (closest to Meadowbank) damage on base and sides evident. Grade is generally uniform and no blockages observed within culvert.

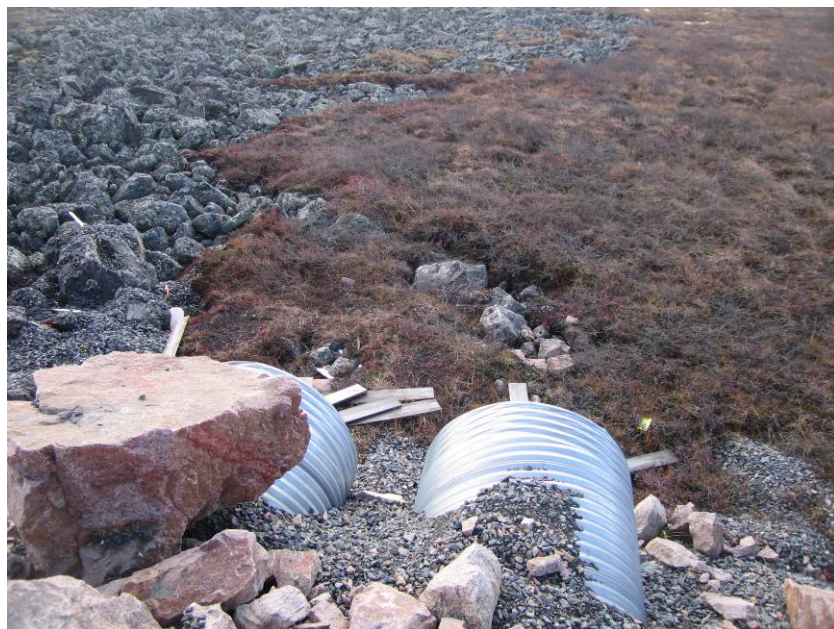
*PHOTOGRAPH 75 – R-21, km 87+500*

**Description:** Downstream view of culverts.

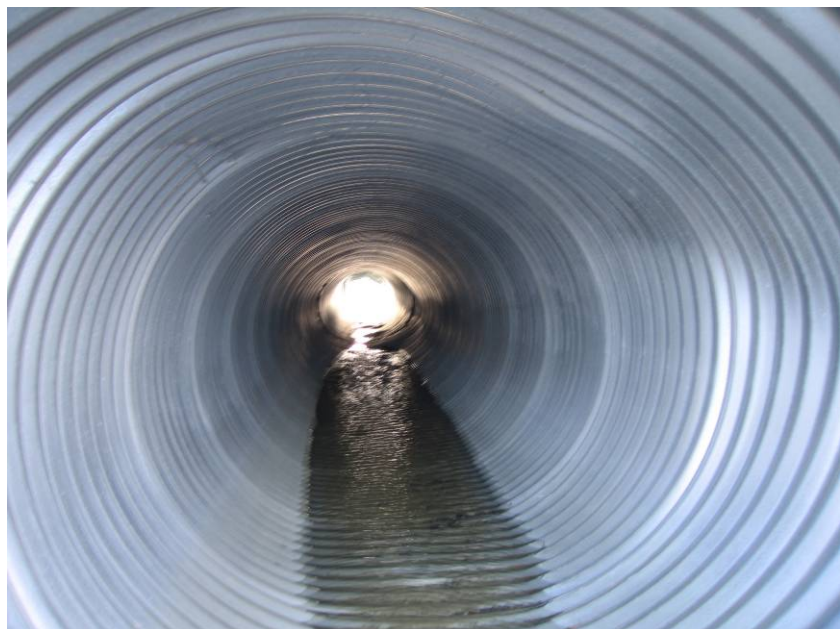
*PHOTOGRAPH 79 – R-23, km 93+600*

**Description:** Upstream to downstream view through culvert. Moderate crushing along haunch of culvert centerline, uniform grade, no blockages, and no sign of erosion observed.

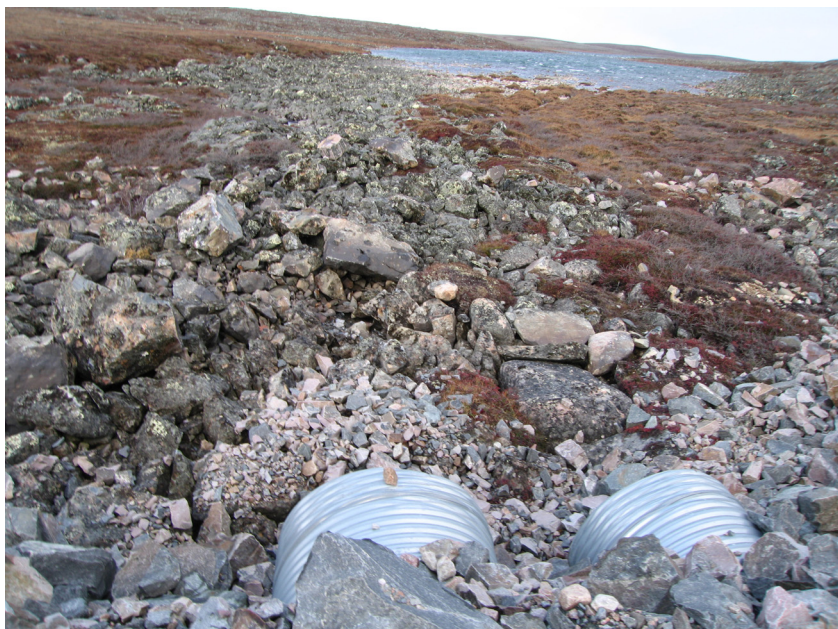
*PHOTOGRAPH 81 – R-24, km 98+250*

**Description:** Upstream view of culverts and valley, looking northwest. No sign of erosion.

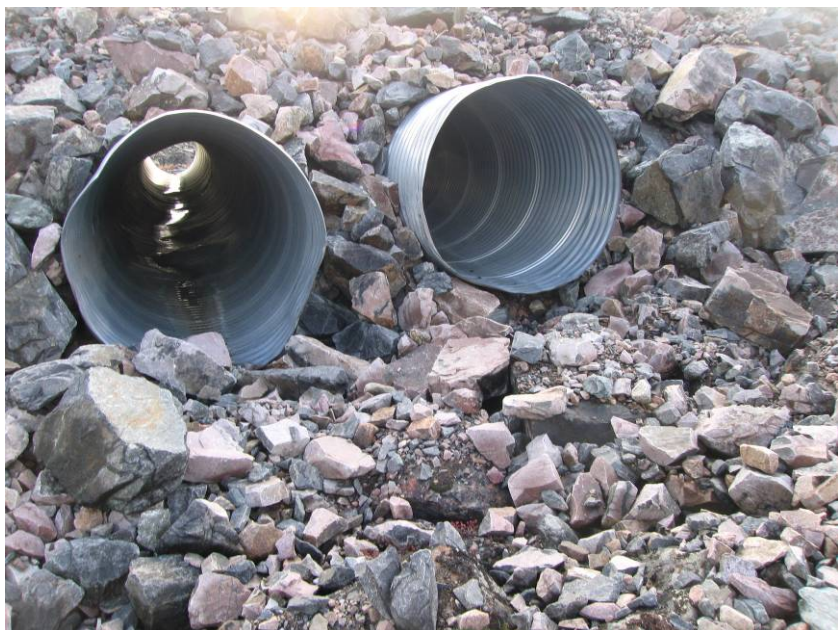
*PHOTOGRAPH 82 – R-24, km 98+250*

**Description:** Upstream to downstream view through culverts. Both culverts show some crushing along centerline (haunch) and some dents in base likely damaged during installation. Bedding appears to consist of larger diameter and sharper rocks.

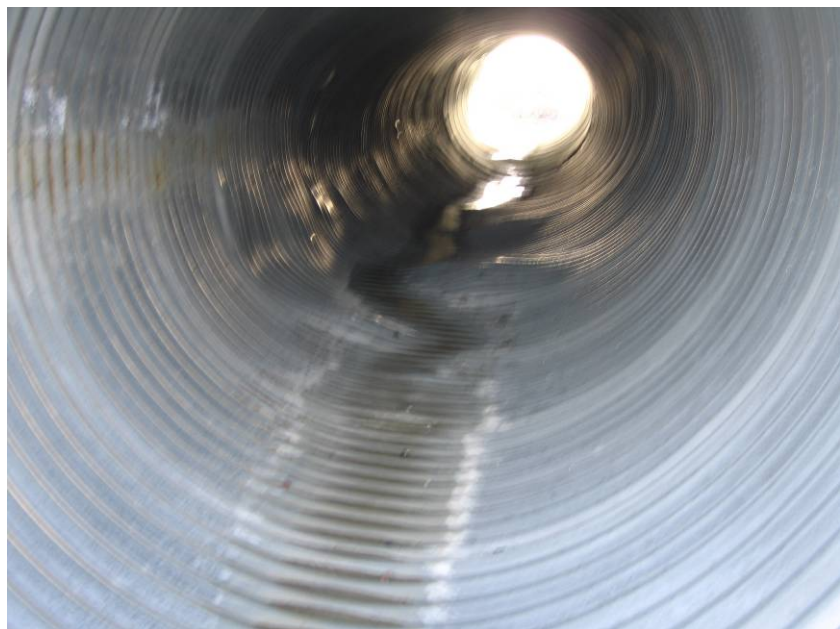
*PHOTOGRAPH 83 – R-24, km 98+250*

**Description:** Upstream to downstream view through northern most culvert (closest to Meadowbank – left side in Photograph 82).

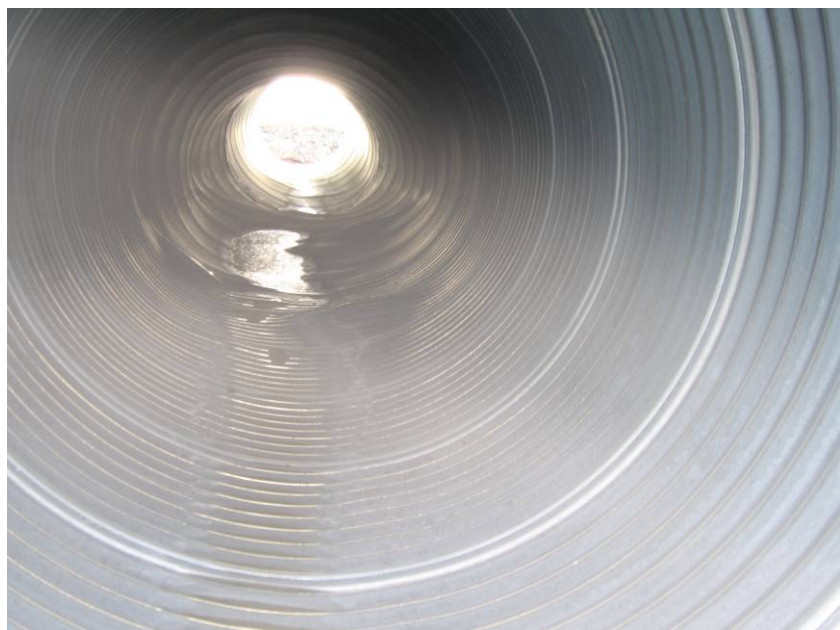
*PHOTOGRAPH 84 – R-24, km 98+250*

**Description:** Upstream to downstream view through right culvert on Photograph 82 (closest to Baker Lake).

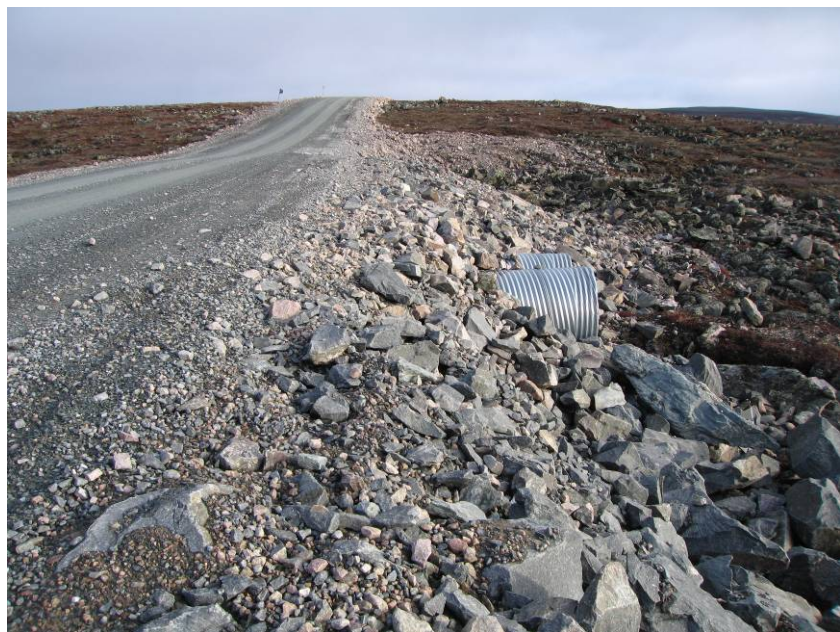
*PHOTOGRAPH 86 – R-24, km 98+250*

**Description:** Downstream view of culverts and road. Uniform grade and no blockages observed.

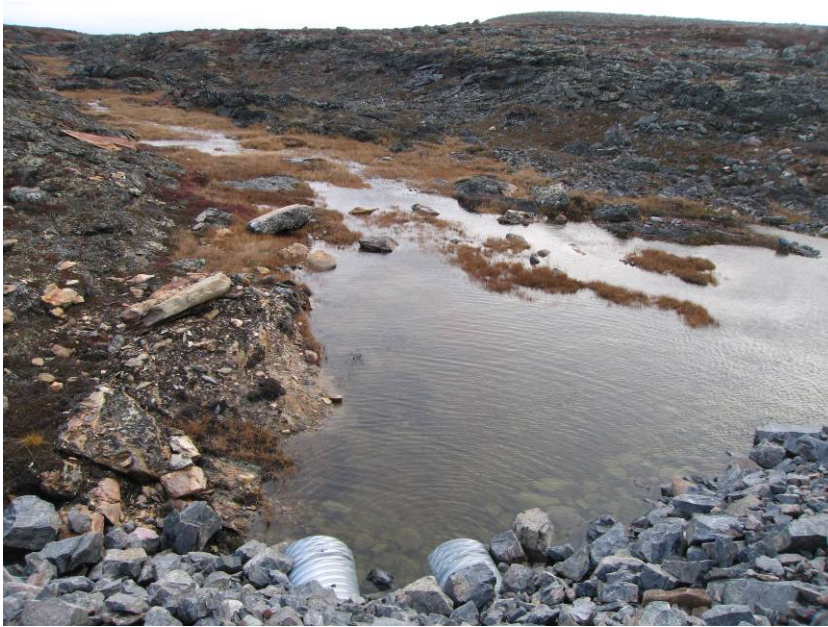
*PHOTOGRAPH 87 – R-25, km 102+050*

**Description:** Upstream view of culverts and valley, looking northeast.

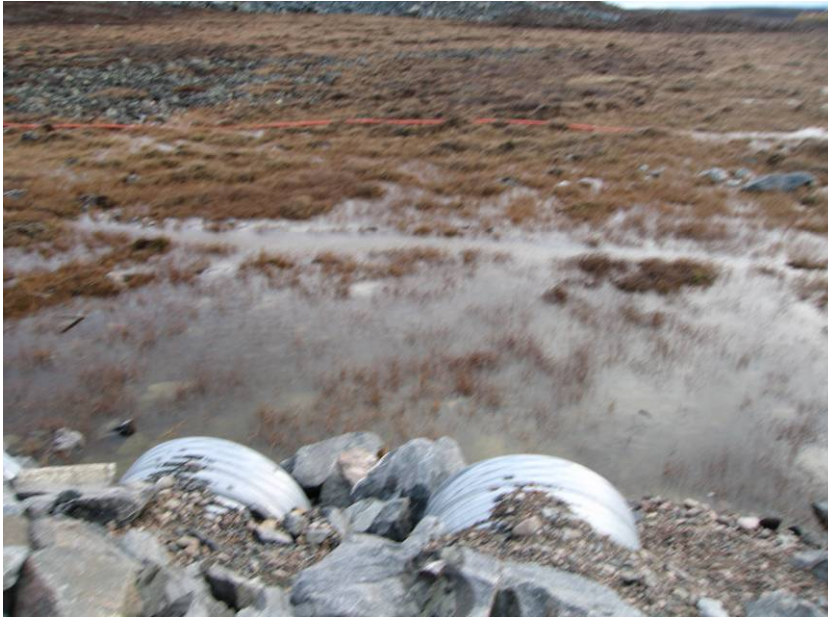
*PHOTOGRAPH 93 – R-26, km 104+710*

**Description:** Upstream view, looking east.

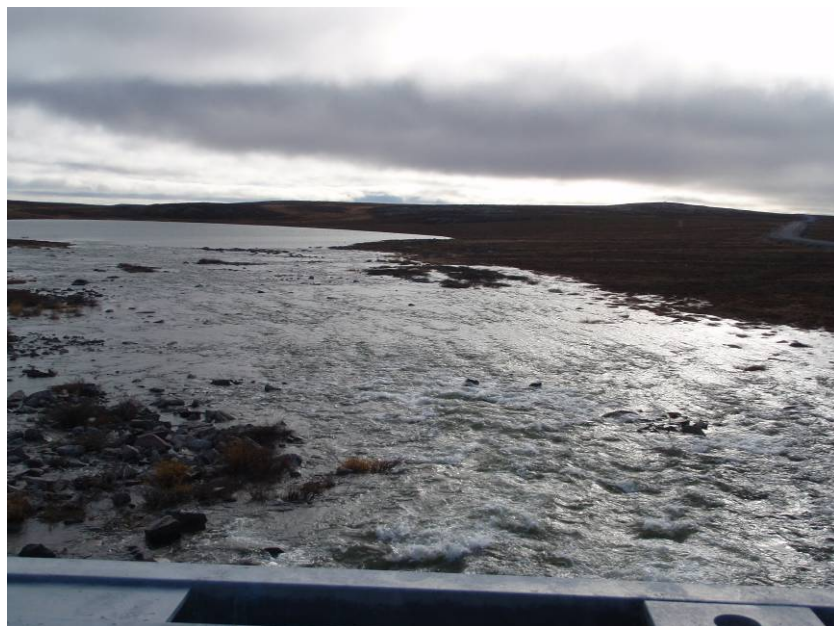
*PHOTOGRAPH 3 – Bridge 1 - R02, km 8+750*

**Description:** Downstream view from deck, looking southeast.

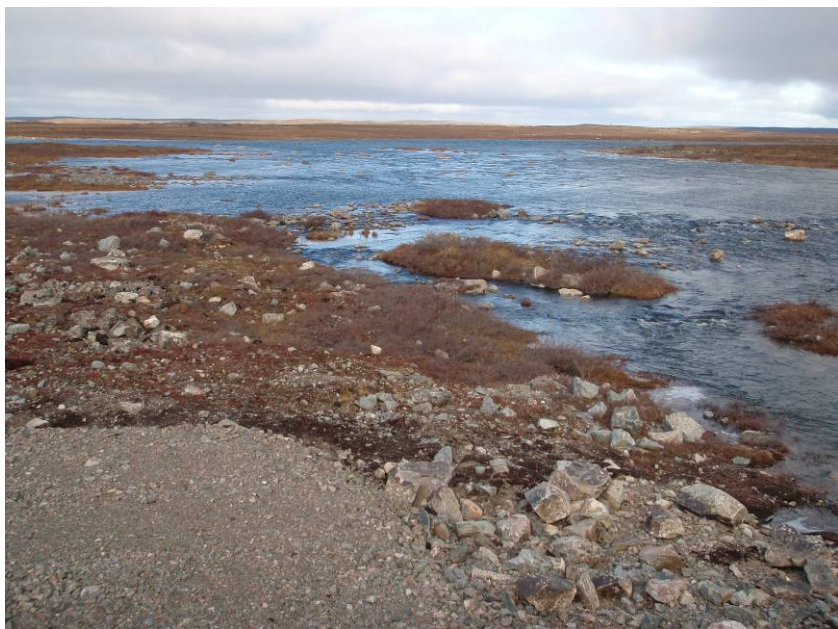
*PHOTOGRAPH 5 – Bridge 1 - R02, km 8+750*

**Description:** View of crossing and valley.
