November 30, 2009

# 2009 Annual Geotechnical Inspection - Meadowbank Gold Project, Nunavut

Agnico-Eagle Mines Limited  
Meadowbank Division  
P.O. Box 540  
Baker Lake, Nunavut  
X0C 0A0

**Project Number:** 09-1428-0018  
Doc. No. 969 Ver. 0

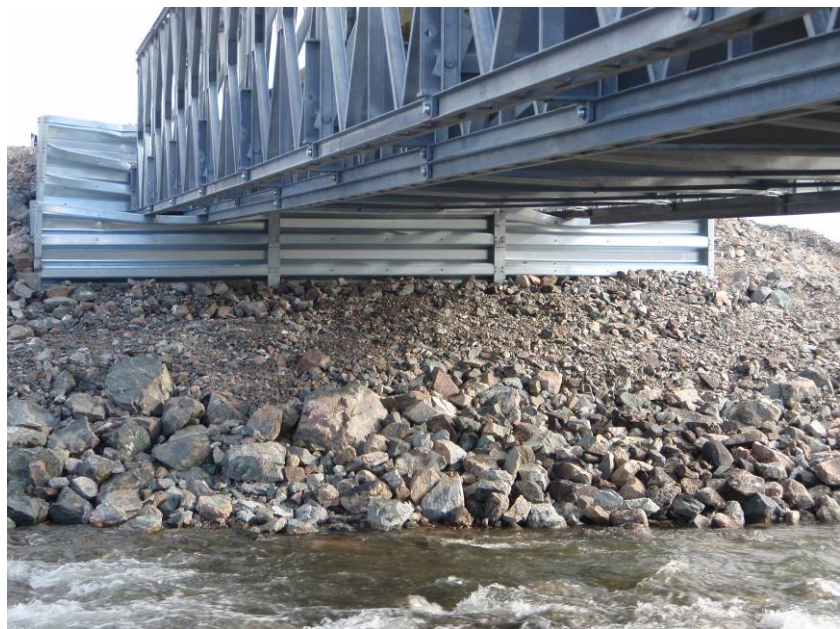
*PHOTOGRAPH 7 – Bridge 1 - R02, km 8+750*

**Description:** View of abutment on northeast side.

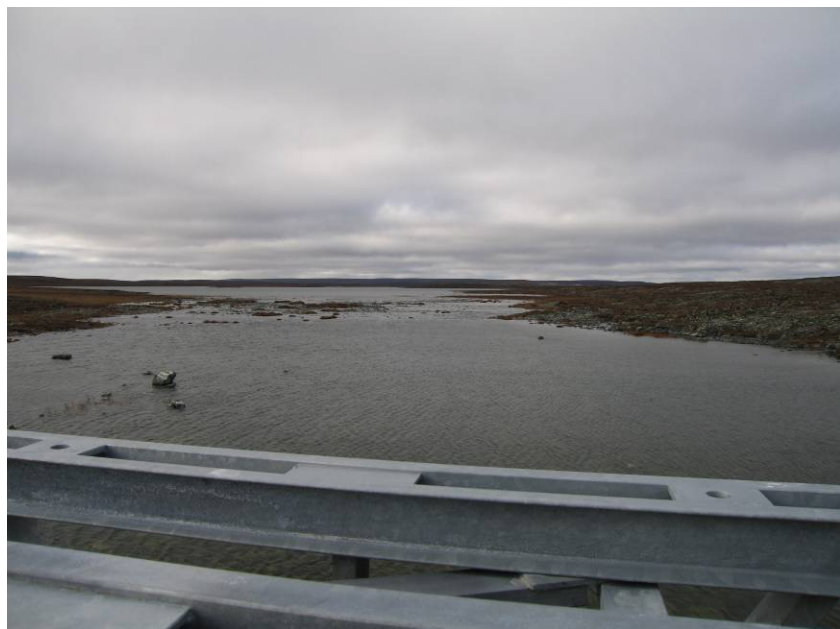
*PHOTOGRAPH 17 – Bridge 3 - R06, km 23+100*

**Description:** Upstream view from deck, looking west. Concentrated flow beneath the bridge. The flow passes equally beneath the bridge. No signs of erosion or turbidity.

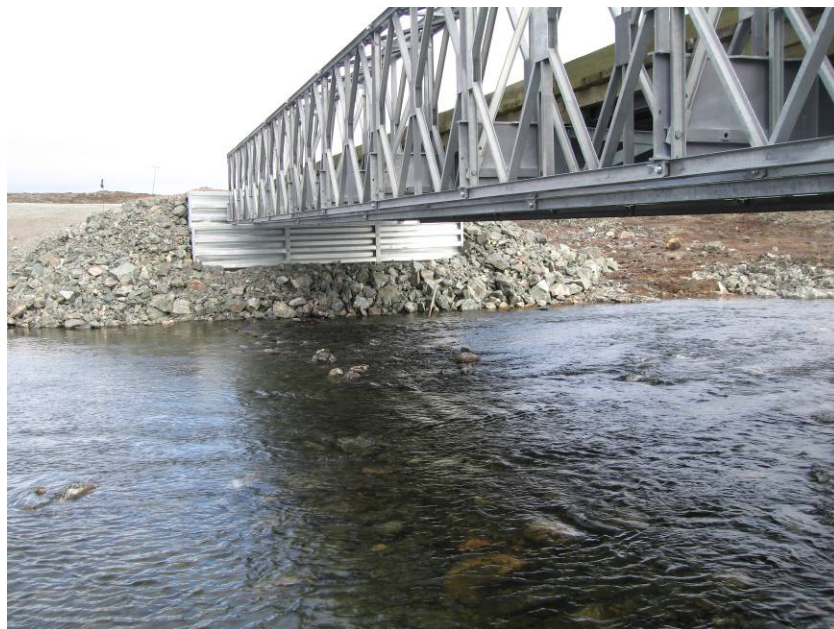
*PHOTOGRAPH 19 – Bridge 3 - R06, km 23+100*

**Description:** Upstream view of abutment on north side.

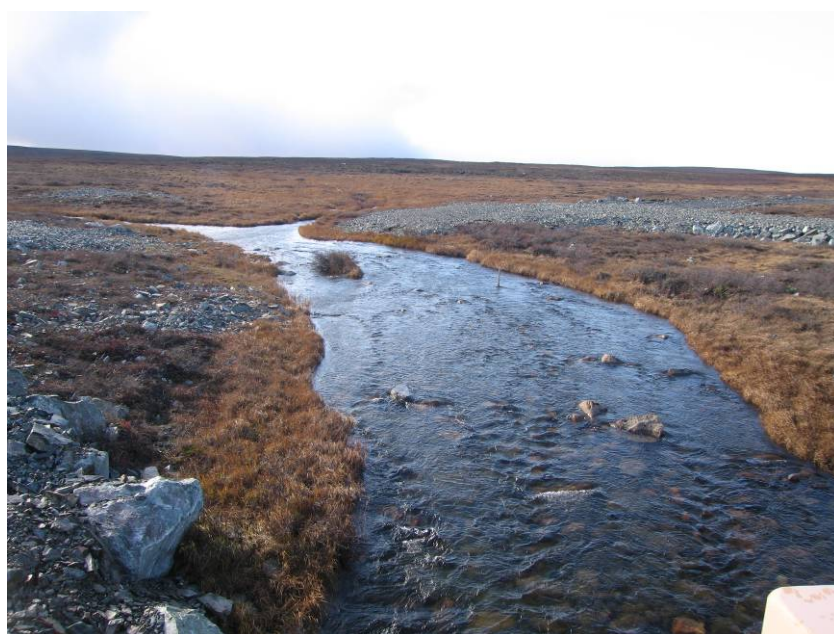
*PHOTOGRAPH 22 – Bridge 4 - R09, km 48+500*

**Description:** Upstream view of bridge from south side.

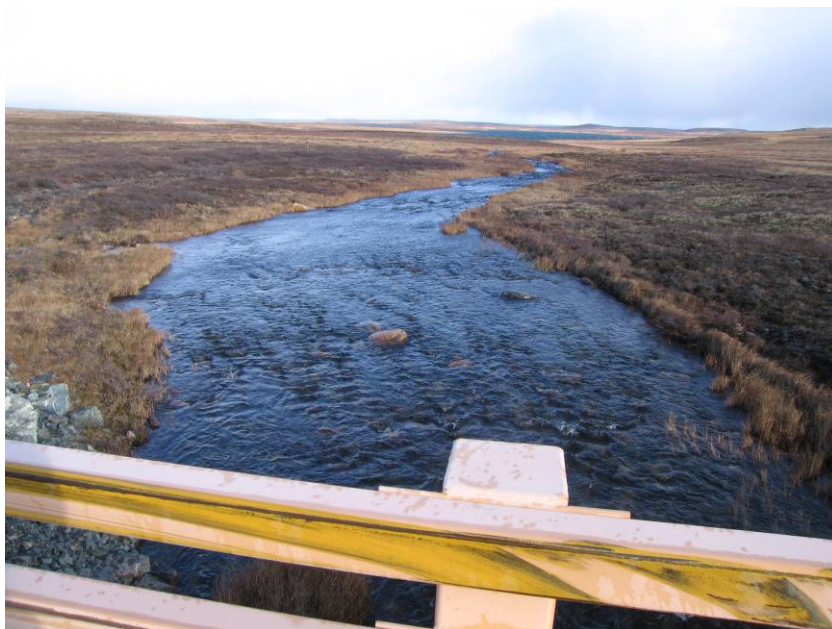
*PHOTOGRAPH 23 – Bridge 4 - R09, km 48+500*

**Description:** Downstream view from deck, looking east. Stream bed consists of cobbles and boulders with some grass.

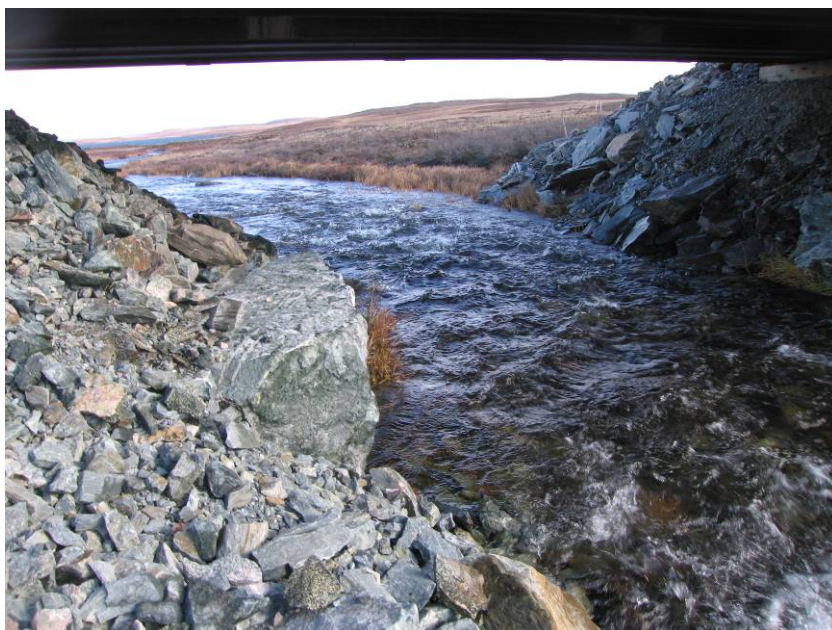
*PHOTOGRAPH 24 – Bridge 4 - R09, km 48+500*

**Description:** View from upstream under the bridge, looking east. Good condition, no sign of erosion of abutments or stream bed. No turbidity.

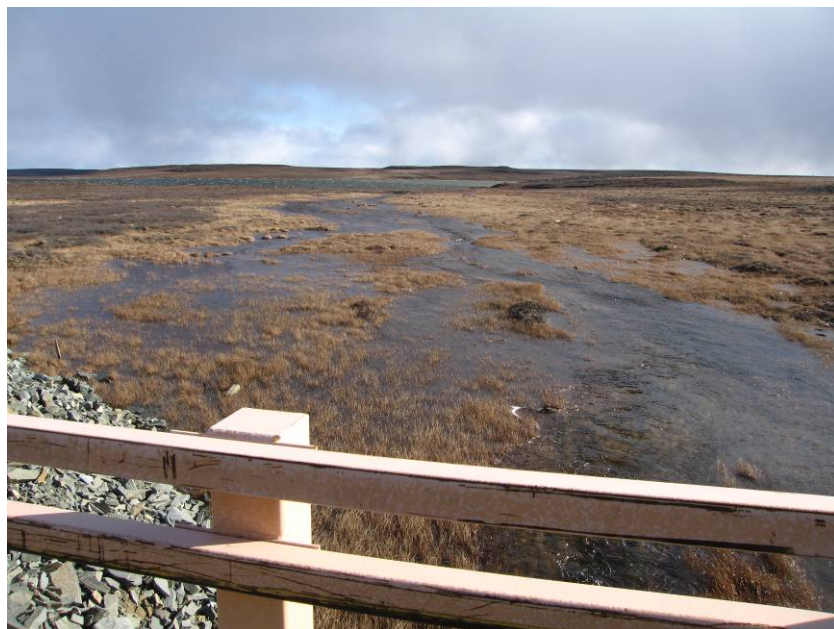
*PHOTOGRAPH 29 – Bridge 5 - R13, km 62+060*

**Description:** Downstream view from deck, looking southeast. On downstream side, “hole” or depression evident and is surrounded by larger cobbles. No signs of turbidity.

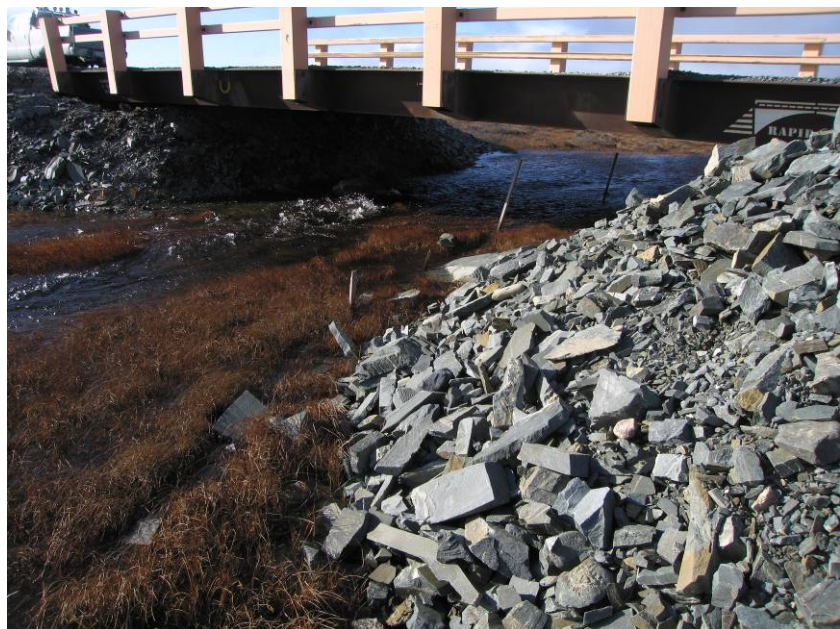
*PHOTOGRAPH 30 – Bridge 5 - R13, km 62+060*

**Description:** View of bridge and abutments from downstream, looking west. Abutments appeared to be in good condition.

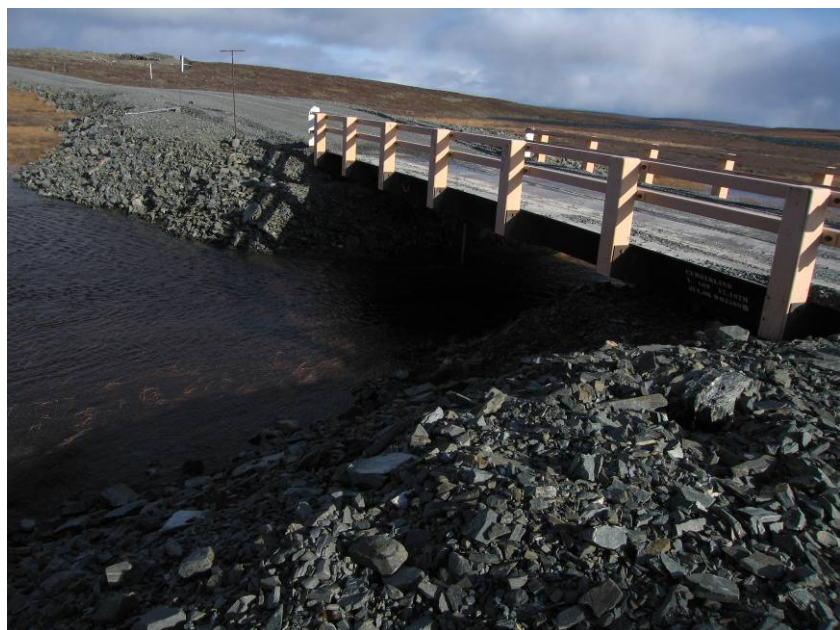
*PHOTOGRAPH 31 – Bridge 5 - R13, km 62+060*

**Description:** View of bridge and abutments from upstream, looking east. Abutments appeared to be in good condition.

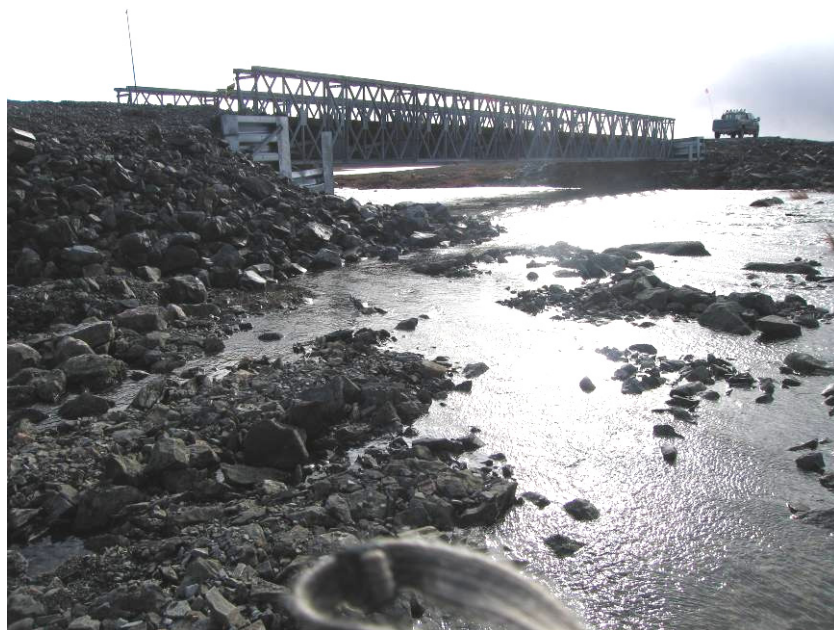
*PHOTOGRAPH 37 – Bridge 6 - R15, km 69+200*

**Description:** View of bridge from upstream, looking south. Flow beneath bridge, no evidence of flow through road fill material.

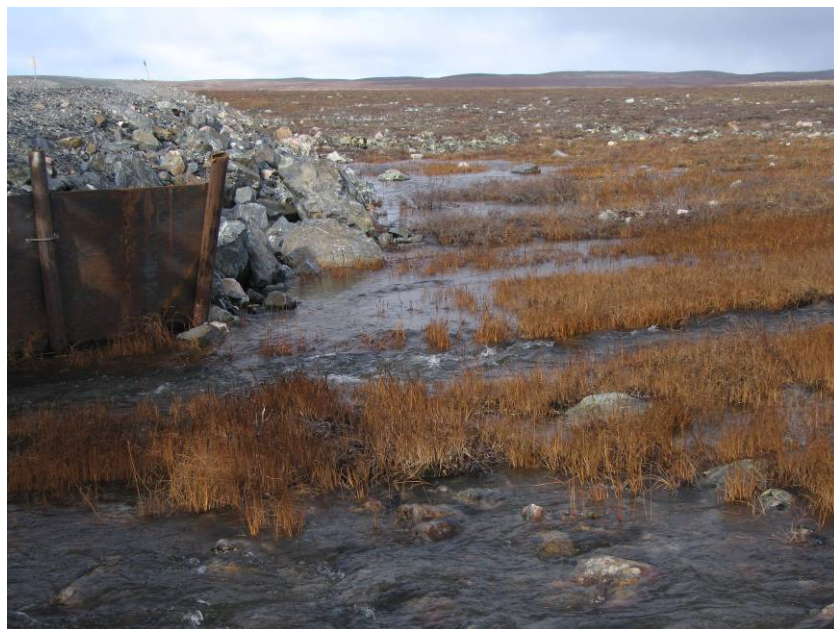
*PHOTOGRAPH 59 – Bridge 9 - R19, km 83+100*

**Description:** View of upstream side of northwest abutment. Flow passing through road.

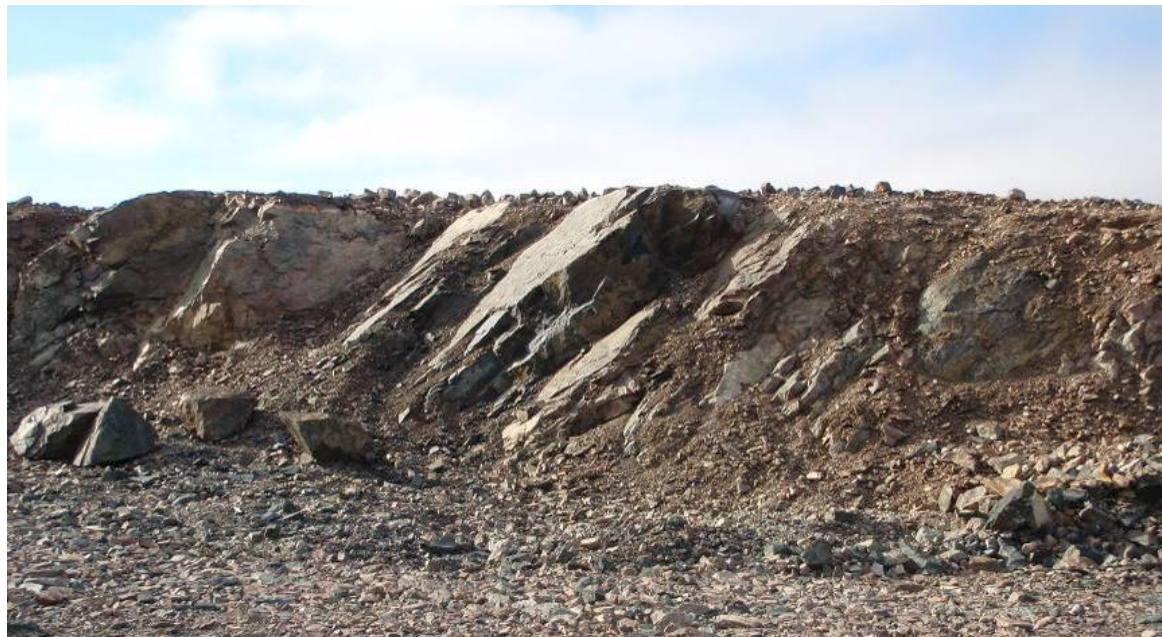
*PHOTOGRAPH 1 – Quarry 1*

**Description:** View of north wall of quarry, looking northwest. Walls about 6 to 7 m high.

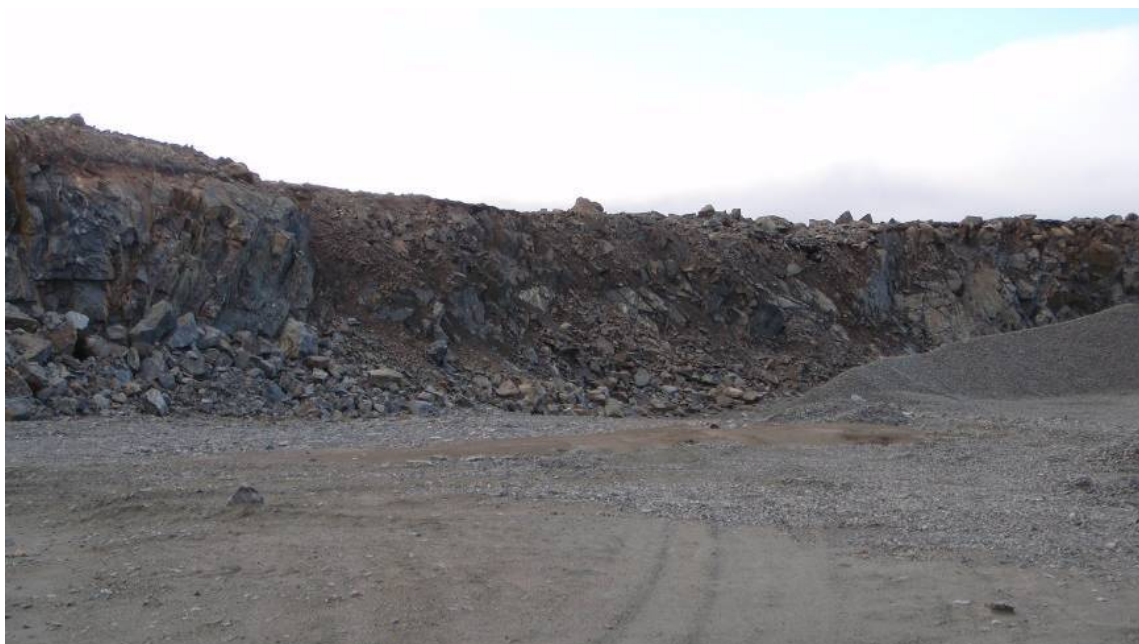
*PHOTOGRAPH 6 – Quarry 2*

**Description:** View of west wall and road base stockpile, looking southwest.

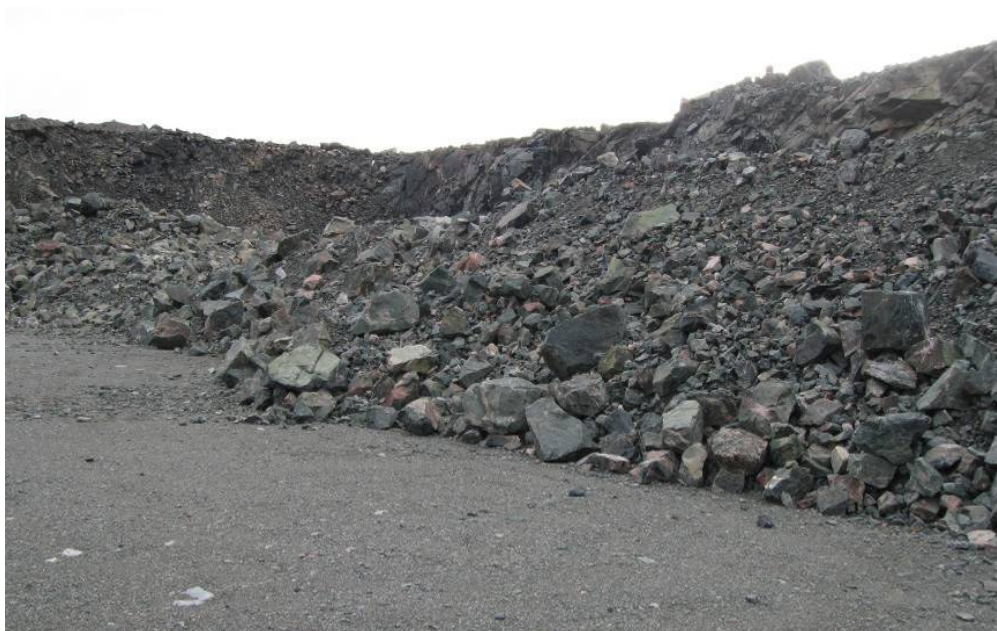
*PHOTOGRAPH 9 – Quarry 3*

**Description:** View of southeast wall quarry and pile of rock in front of cut wall.

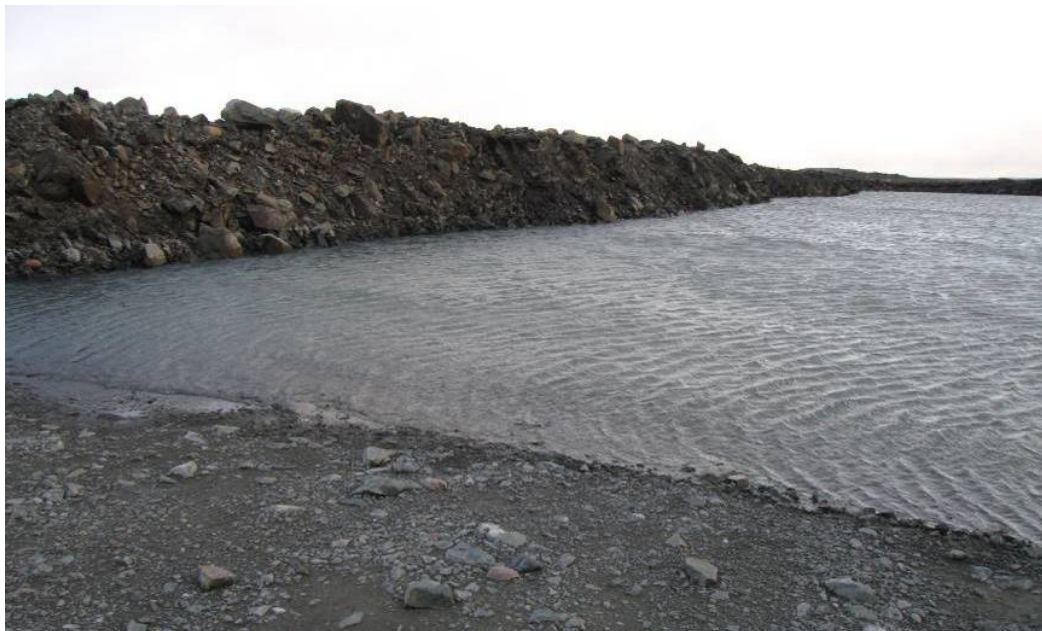
*PHOTOGRAPH 11 – Quarry 4*

**Description:** View of east and south side of the quarry. Quarry is flooded.

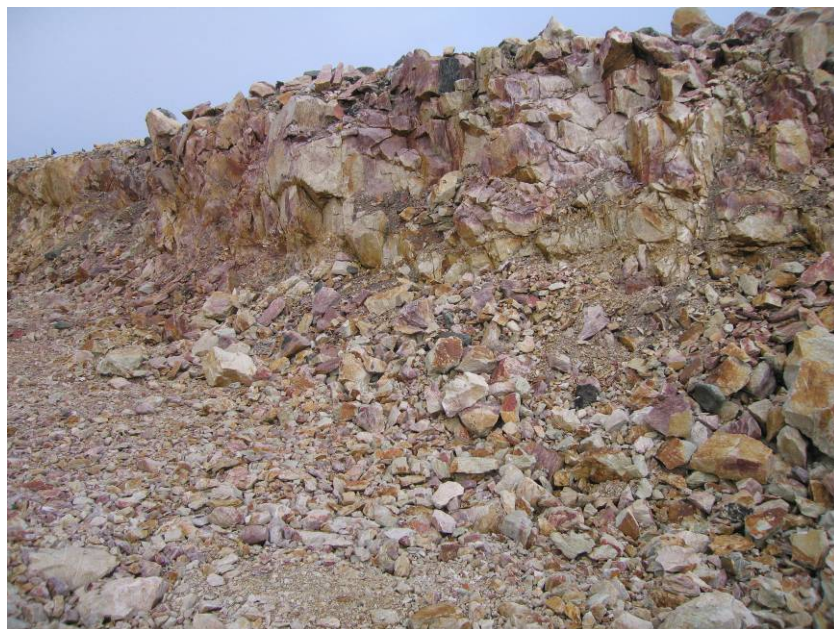
*PHOTOGRAPH 13 – Quarry 5*

**Description:** View of east wall, looking southeast. Near vertical wall about 8 m high, some ravelling.

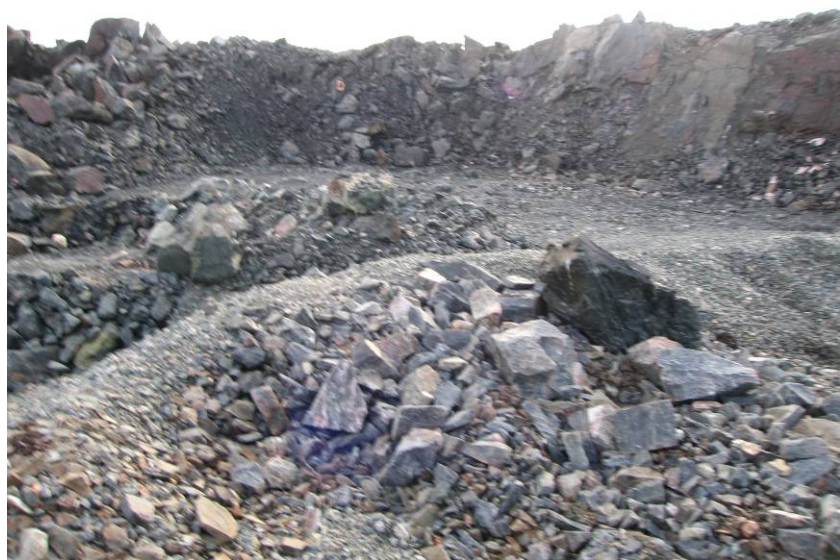
*PHOTOGRAPH 17 – Quarry 6*

**Description:** View of southwest wall. Drums of material noted in 2008 inspection have been removed. Center of quarry temporarily contains piles of contaminated soil.

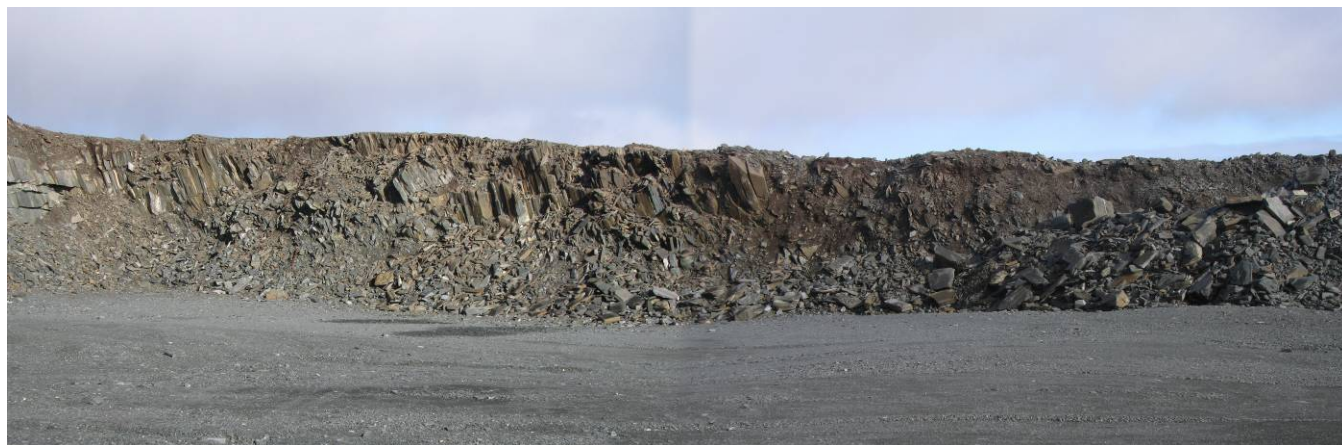
*PHOTOGRAPH 35 – Quarry 11*

**Description:** View of southern portion of the eastern wall. Stockpile of rock and crush in front of quarry wall. Vertical wall highly fractured, thin planar surfaces, ravelling.

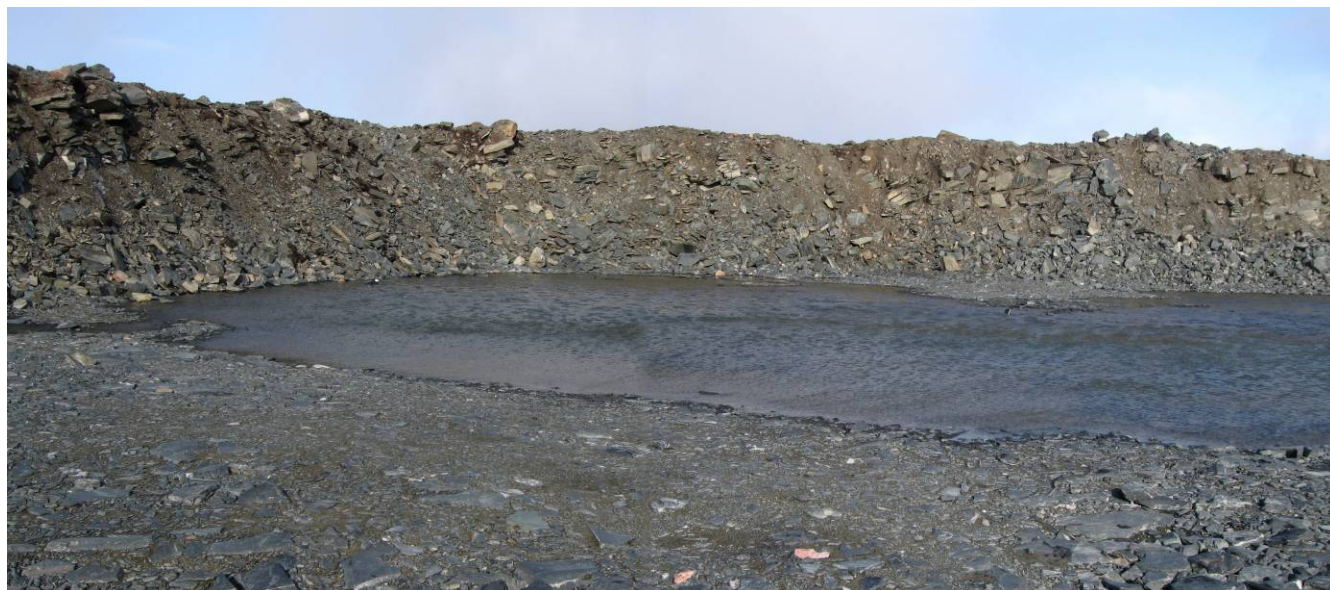
*PHOTOGRAPH 42 – Quarry 13*

**Description:** View of the northwest side of the quarry. Ravelling, about 60° slopes, and about 5 m high. Ponded water less than 0.3 m deep.

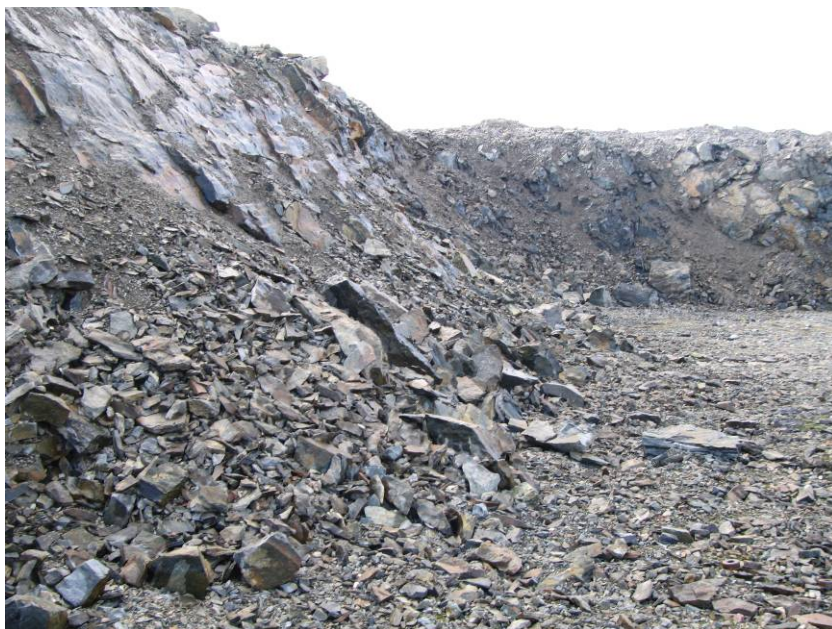
*PHOTOGRAPH 50 – Quarry 15*

**Description:** Looking southwest. Vertical wall 4 to 6 m high.

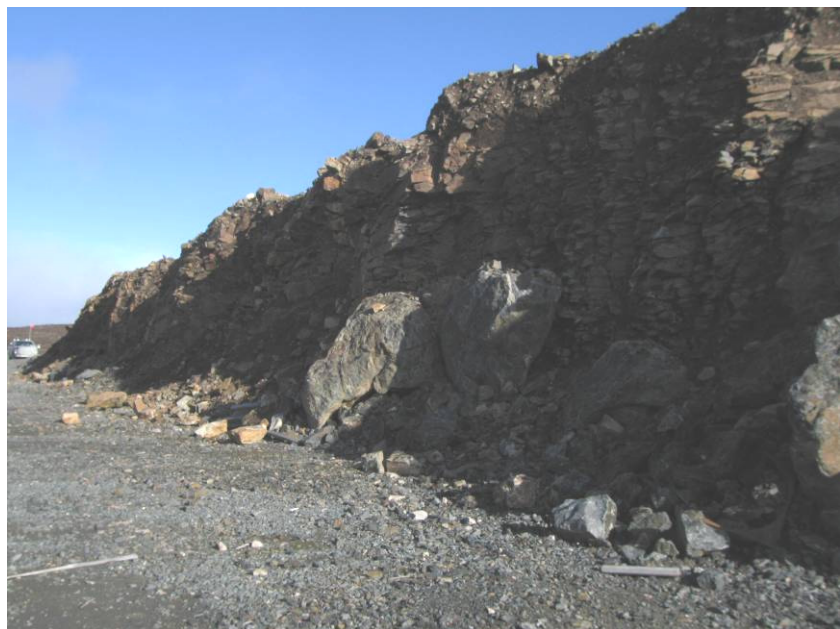
*PHOTOGRAPH 52 – Quarry 16*

**Description:** North view, with slide of large blocks. Vertical wall about 8 to 10 m high.

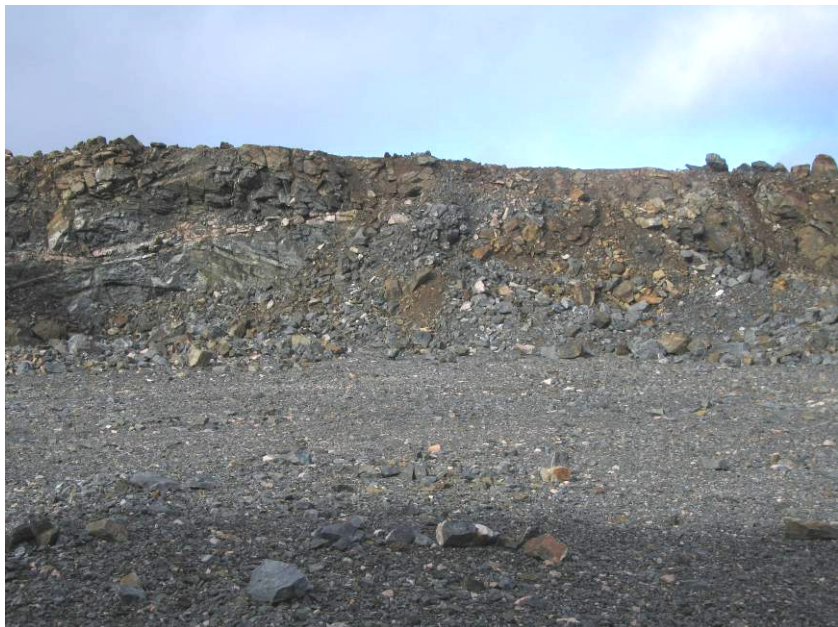
*PHOTOGRAPH 56 – Quarry 16*

**Description:** Looking north. Vertical wall about 8 to 10 m high, ravelling of small blocks.

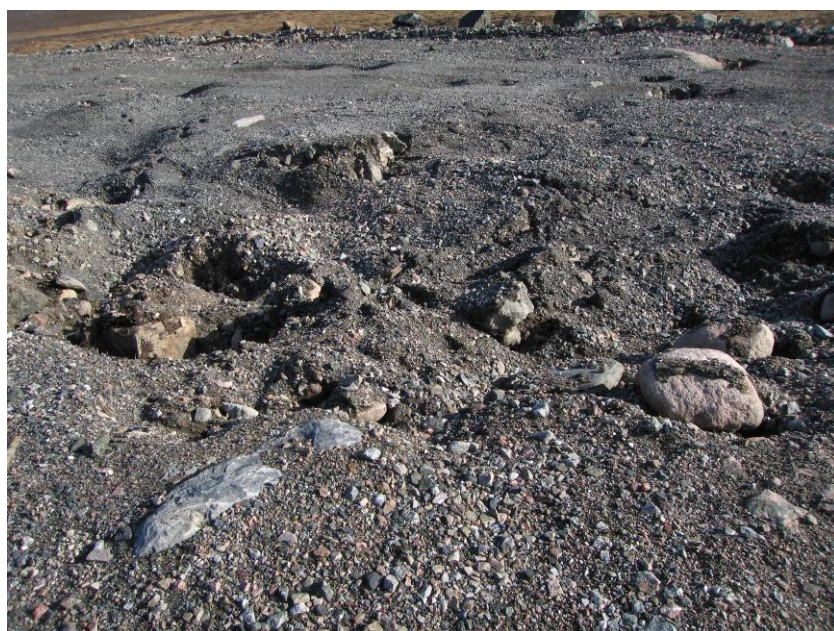
*PHOTOGRAPH 612 – Quarry 18*

**Description:** View of frost heave and thaw settlement at entrance of quarry.

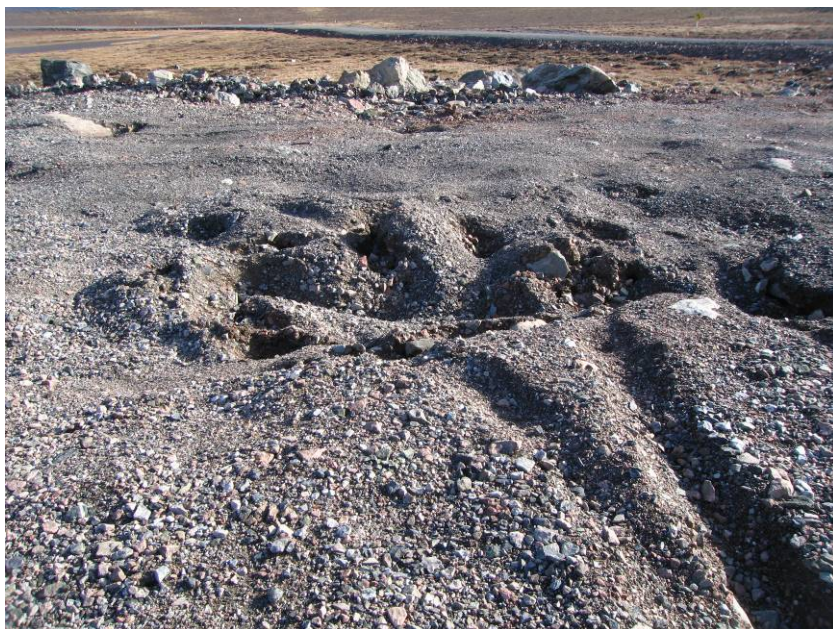
*PHOTOGRAPH 62 – Quarry 18*

**Description:** View of frost heave and thaw settlement at entrance of quarry, looking northeast.

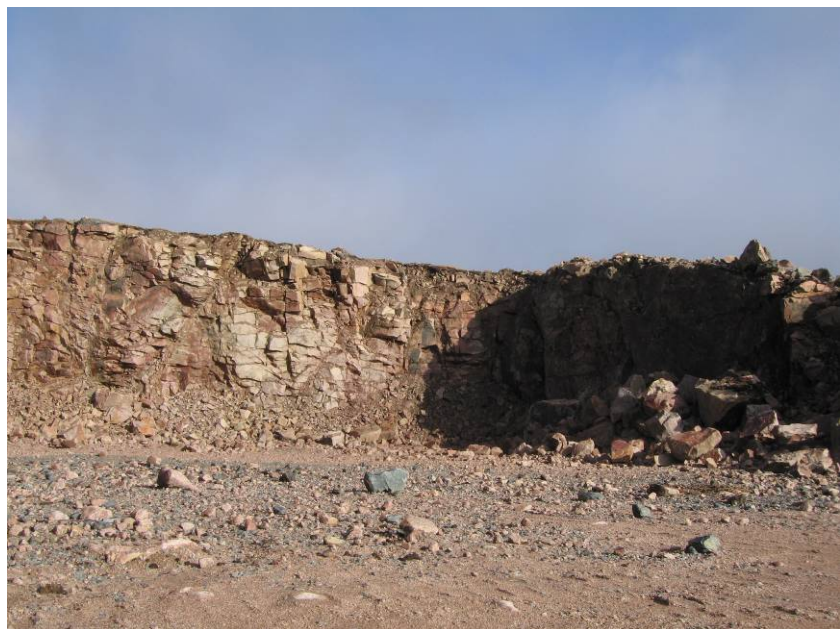
*PHOTOGRAPH 66 – Quarry 19*

**Description:** Looking north. Vertical wall, some ravelling of small blocks.

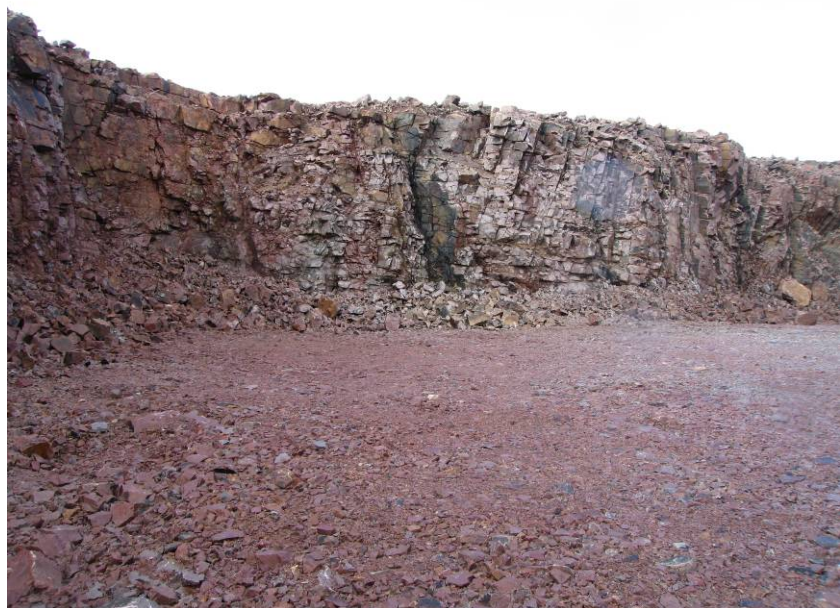
*PHOTOGRAPH 723 – Quarry 21*

**Description:** Looking south. Vertical walls 7 to 8 m high. Some raveling of small blocks.

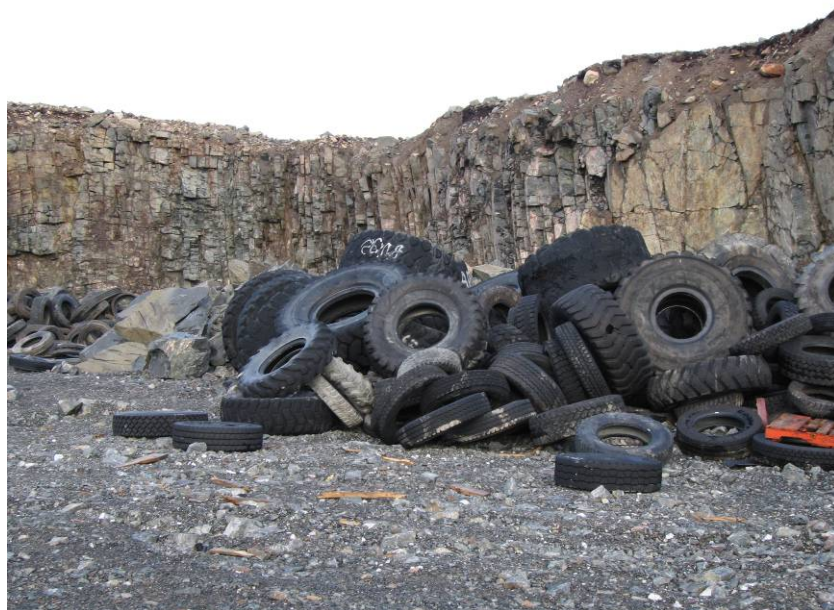
*PHOTOGRAPH 76 – Quarry 22*

**Description:** Pile of tires at right back corner of quarry. Vertical walls 8 to 10 m high.

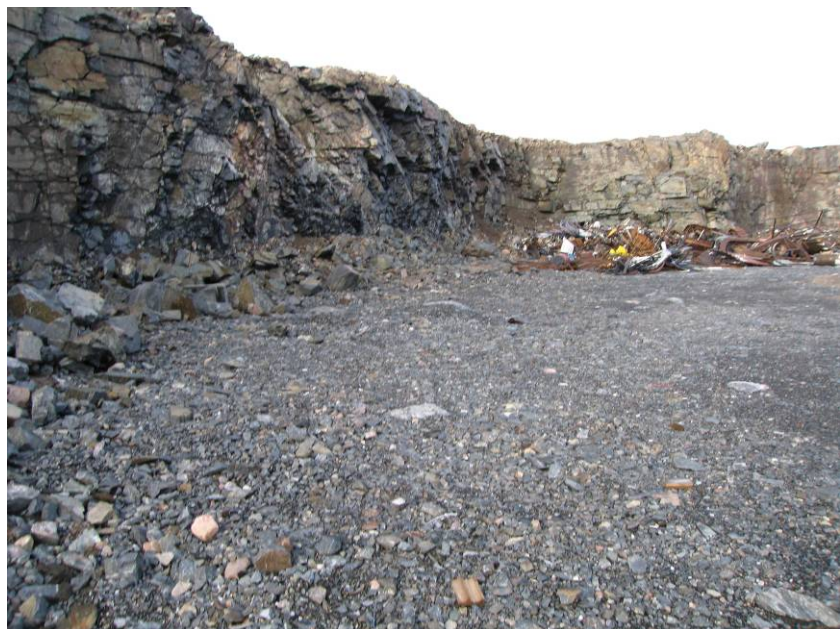
*PHOTOGRAPH 78 – Quarry 22*

**Description:** Miscellaneous refuse at left back corner of quarry, looking northwest.

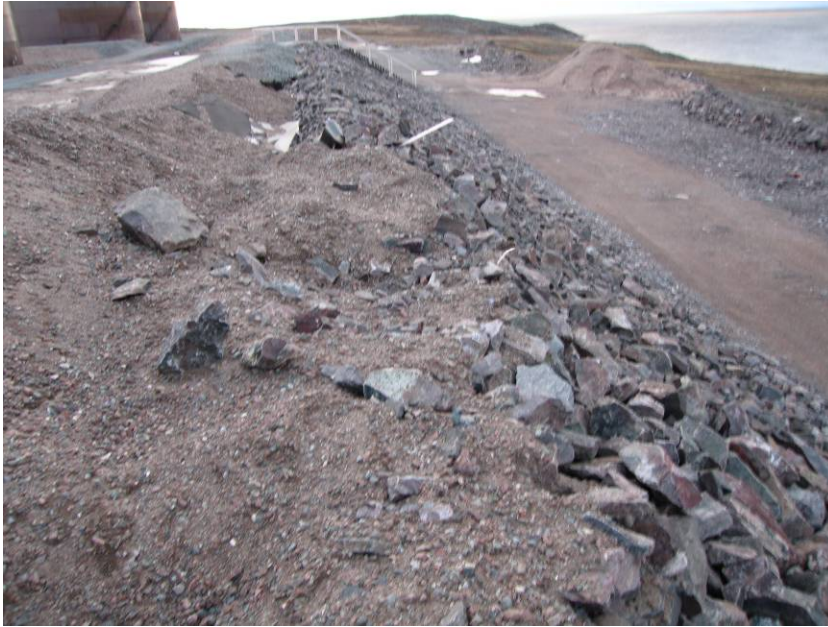
*PHOTOGRAPH 3 – Baker Lake Tank Farm*

**Description:** View of containment berm in front of Tank 1 and 2, looking southeast.

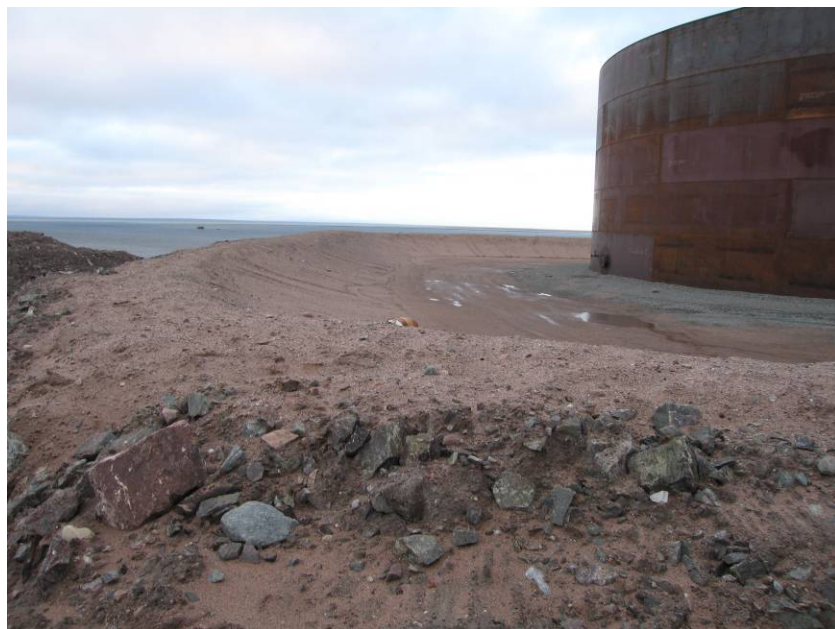
*PHOTOGRAPH 7 – Baker Lake Tank Farm*

**Description:** View of containment berm on the east side of Tank 4, looking southwest.

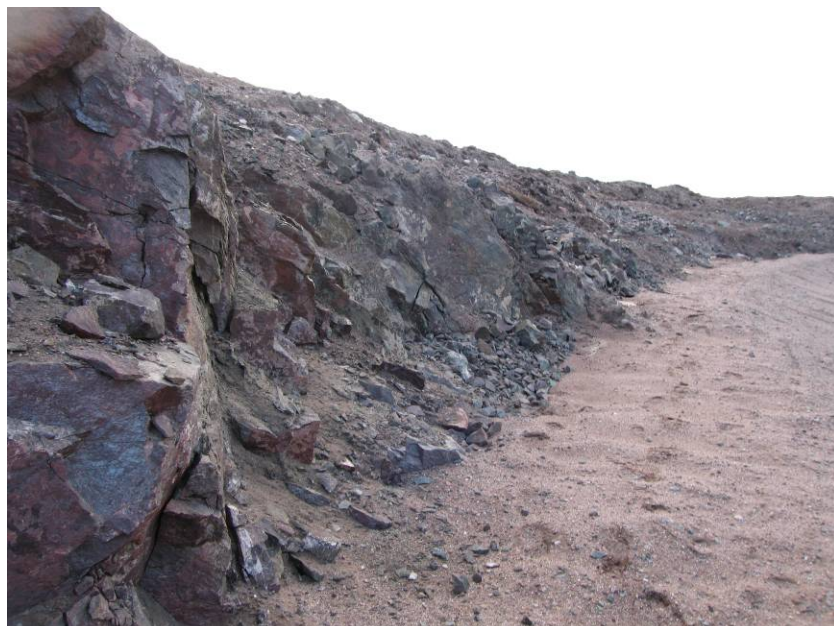
*PHOTOGRAPH 5 – Baker Lake Tank Farm*

**Description:** View of cut slope on the north side of Tank 4, looking northeast. Two benches used along northeast side, upper one is mainly soil, lower bench consists of more competent rock.

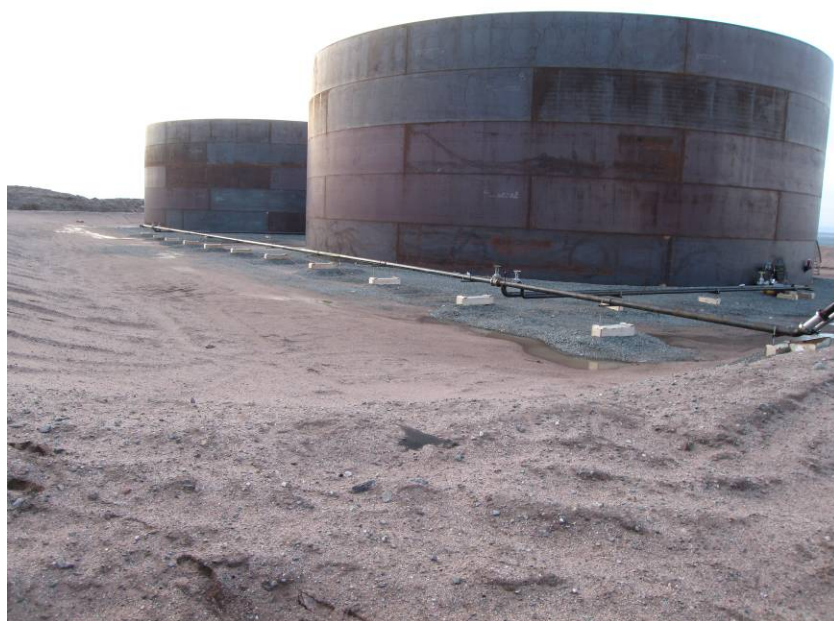
*PHOTOGRAPH 7 – Baker Lake Tank Farm*

**Description:** View of Tank 3 (foreground) and Tank 4, looking south.

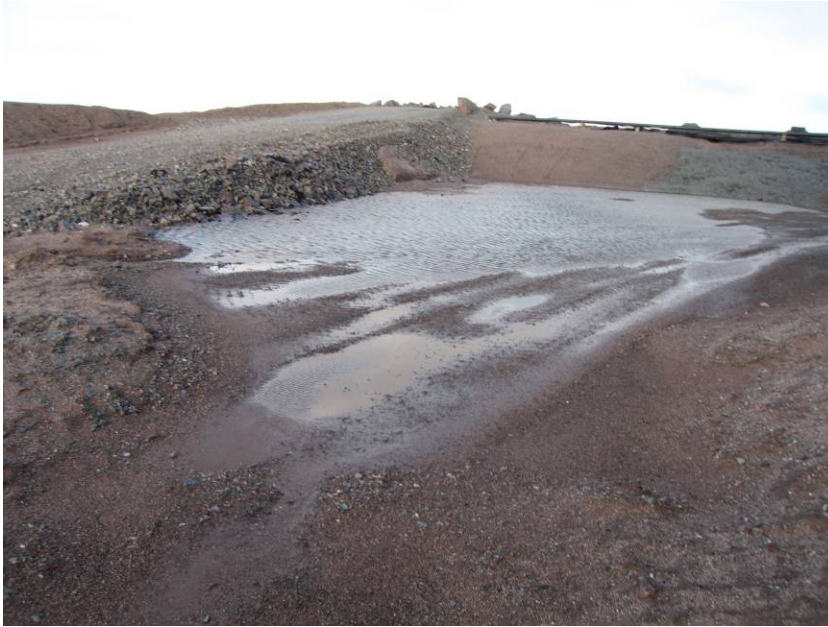
*PHOTOGRAPH 15 – Baker Lake Tank Farm*

**Description:** View of access ramp and ponded water in western corner on the south side of Tank 1, looking west.

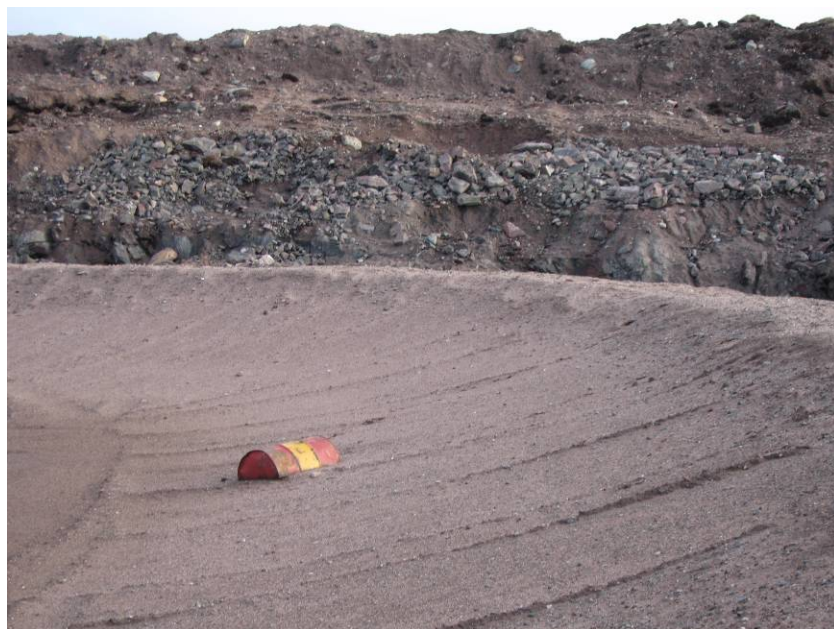
*PHOTOGRAPH 21 – Baker Lake Tank Farm*

**Description:** View of containment area east of Tank 4 and buried tank, looking north.

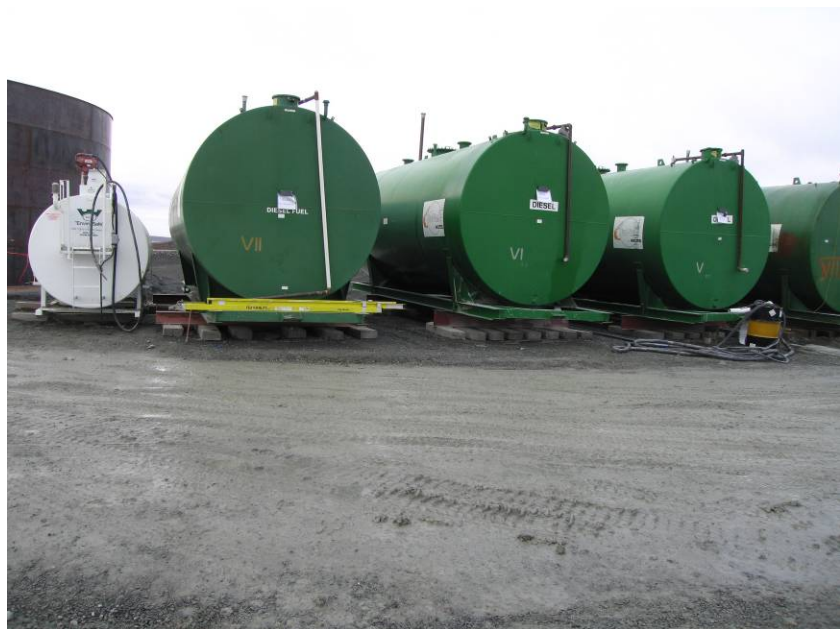
*PHOTOGRAPH 5 – Meadowbank Tank Farm*

**Description:** View of 4 diesel tanks and gasoline tank (white), looking southwest in the refuelling area.
