2010 Annual Geotechnical Inspection Meadowbank Gold Project, Nunavut

Submitted to:
Agnico-Eagle Mines Limited
Meadowbank Division
PO Box 540
Baker Lake, Nunavut
X0C 0A0

Project Number: 10-1428-0033/2000
Document Number: 1216 Ver. 0

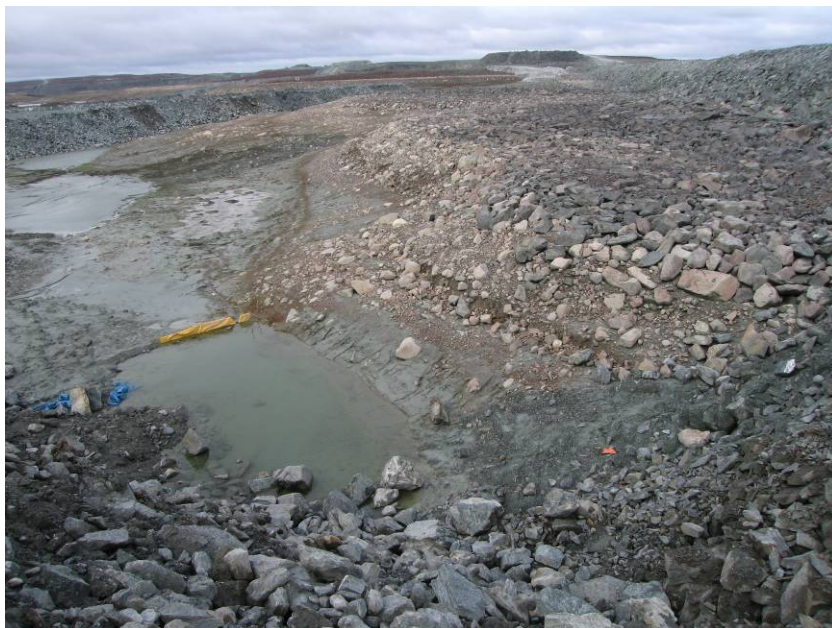
PHOTOGRAPH A1-1 – East Dike

Description: Panoramic view of downstream side from south abutment looking north.

4. DOWNSTREAM TOE AREA 4.1 Seepage from Dam	Yes	Appendix A1: North Weir Photos A1- 6 to 8 South Weir Photos A1-1 to 4	Seepage downstream of Sta. 60+450, where weir was installed in 2009, stable (about 8 l/s), clear flow "north weir". Seepage near 60+225 now measured by "south weir" installed in 2010, stable (about 4 l/s) clear flow. Additional small seepage zone #3 noted near 60+550, no weir

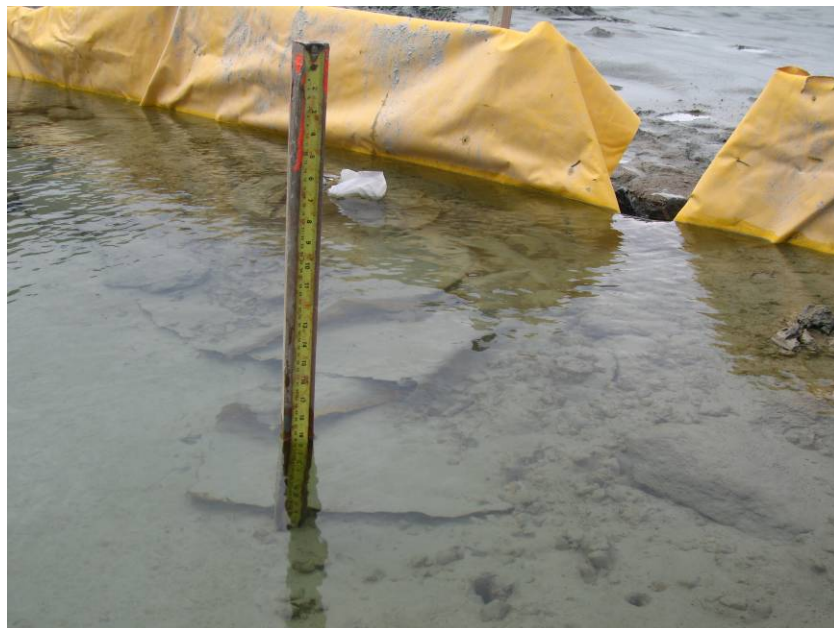
PHOTOGRAPH A1-3 – East Dike

Description: Staff gauge and upstream side of south weir.

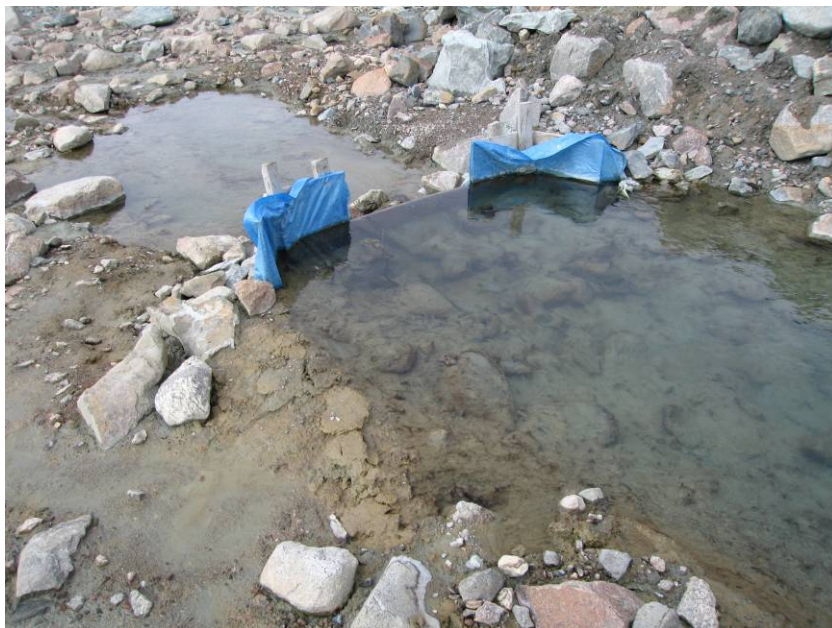
PHOTOGRAPH A1-7 – East Dike

Description: Looking west at north weir.

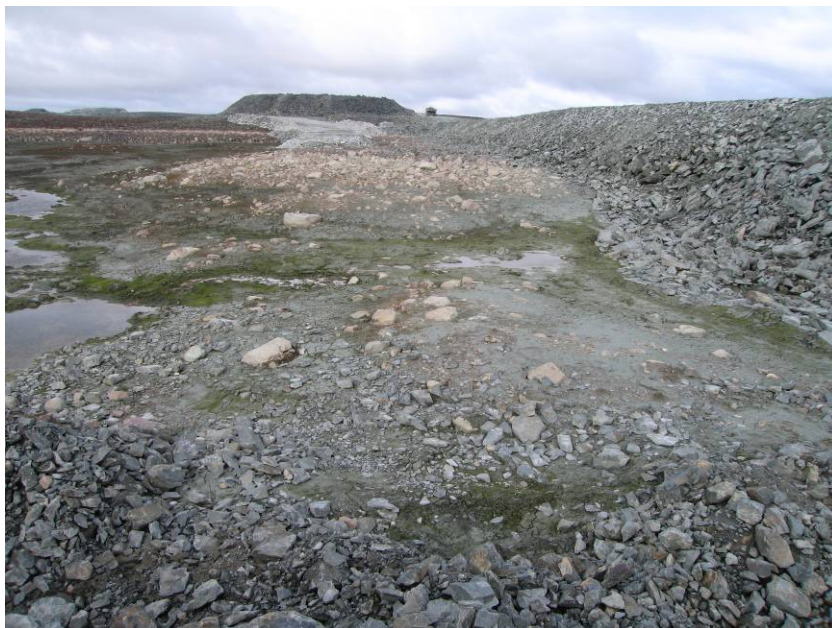
PHOTOGRAPH A1-9 – East Dike

Description: Looking north towards seepage zone #3 from approximately Sta. 60+480.

INSPECTION ITEM	OBSERVATIONS/ DATA	PHOTO	COMMENTS & OTHER DATA
4.2 Signs of Erosion	Not observed.	Seepage Zone #3 Photos A1-9 to 11	flow measurement, estimated 1 l/s, clear flow. Between 60+700 and 60+750 although no defined seepage noted, surface of lakebed soils is moist and has moss growing on it. Given dry weather this year, water source likely from seepage through the dike.

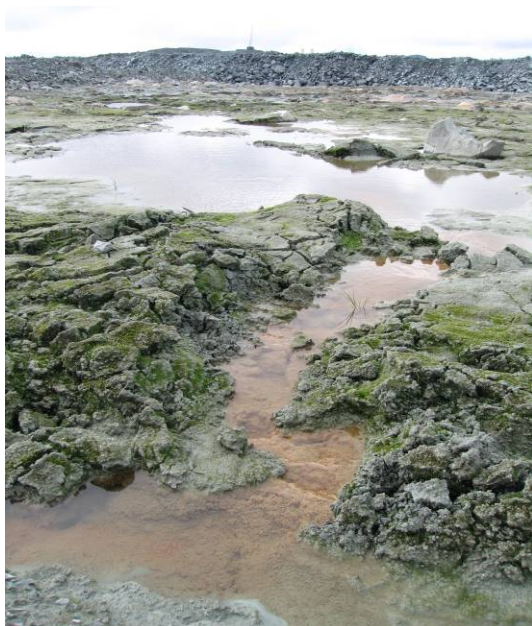
PHOTOGRAPH A1-11 – East Dike

Description: Looking west at seepage zone #3 approximately Sta. 60+550.

4.3 Signs of Turbidity in Seepage Water	No. Clear flow.	Moisture Photos A1-16 to 18.	
4.4 Discoloration/staining	Some.	Appendix A1: Photo A1-11	Near seepage Zone 3 (Sta. 60+550) some orange colouration was observed.

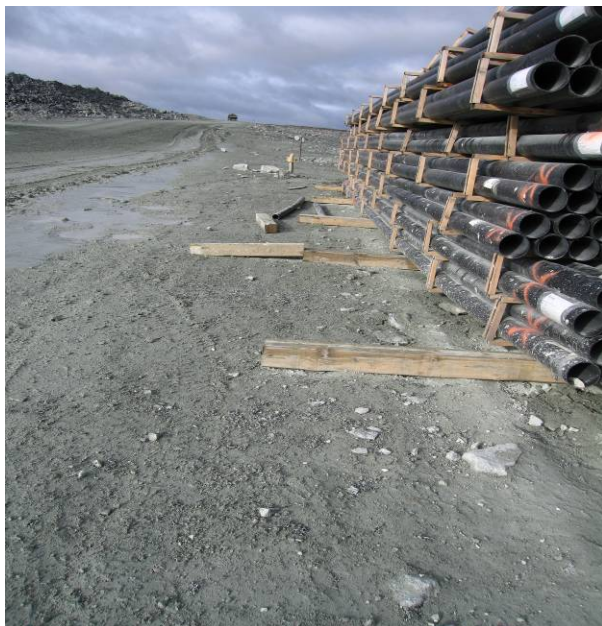
PHOTOGRAPH A1-21 – East Dike

Description: Piping stored on and near centreline of cutoff, on north abutment.

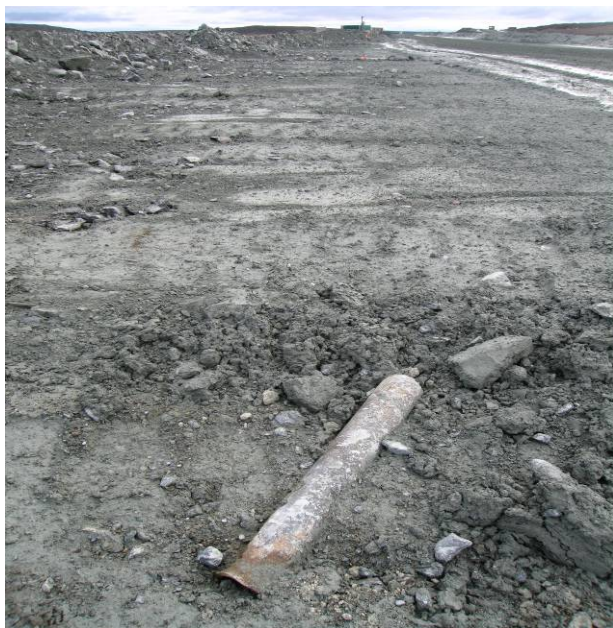
PHOTOGRAPH A1-23 – East Dike

Description: Settlement monitors destroyed foreground and in far ground too with orange cap on top.

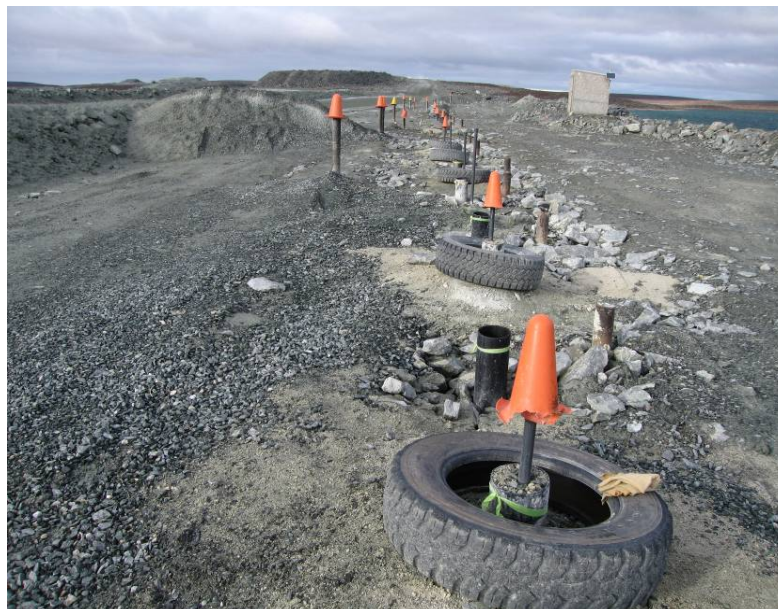
PHOTOGRAPH A1-29 – East Dike

Description: Sta. 60+400 from centreline of cutoff looking north at instrument installations being used to delineate seepage zone, downstream piezometers, centreline temporary thermistors, upstream emergency grout casings evident in photo.

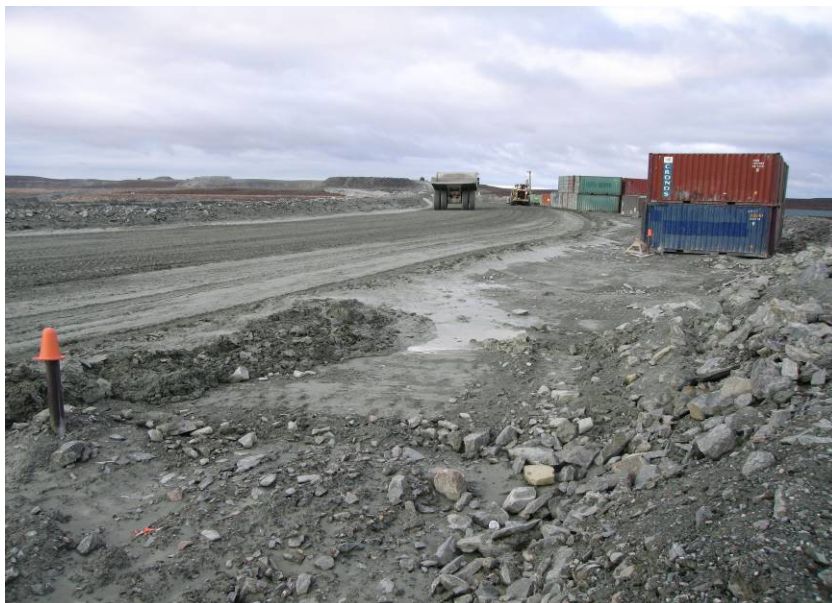
PHOTOGRAPH A1-33 – East Dike

Description: South abutment looking north along dike crest. Containers stored on/adjacent to cutoff wall alignment.

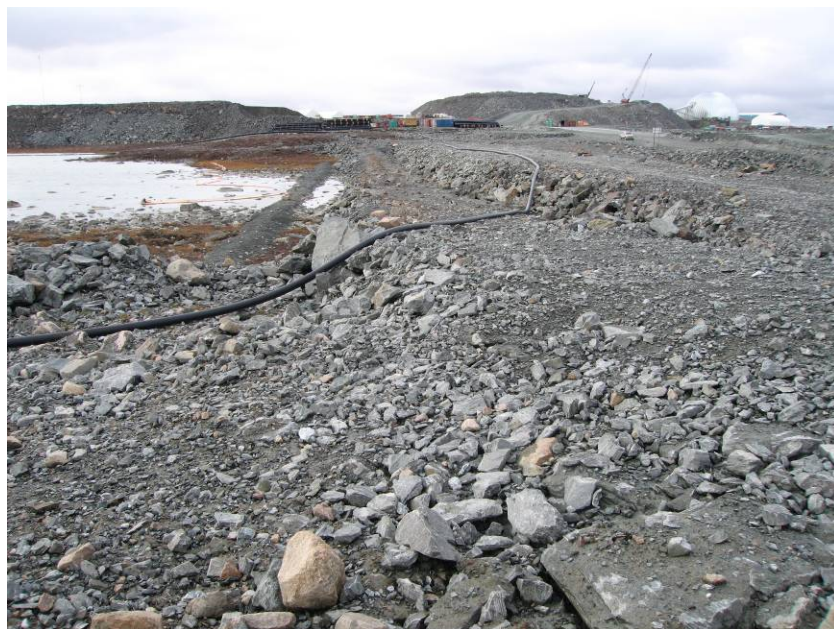
PHOTOGRAPH A2-1 – West Channel Dike

Description: Upstream side from east abutment looking west.

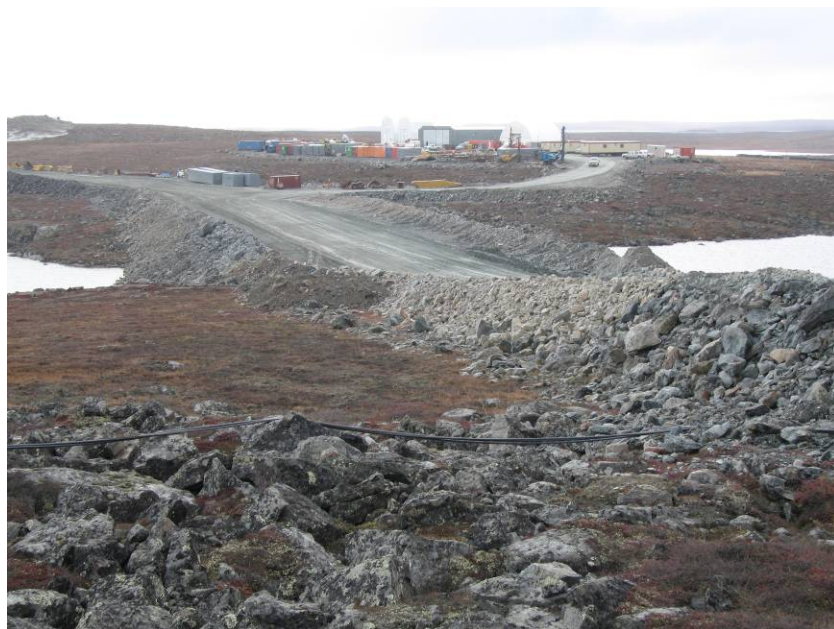
PHOTOGRAPH A3-1 – South Camp Dike

Description: Looking south at downstream side of dike and across crest.

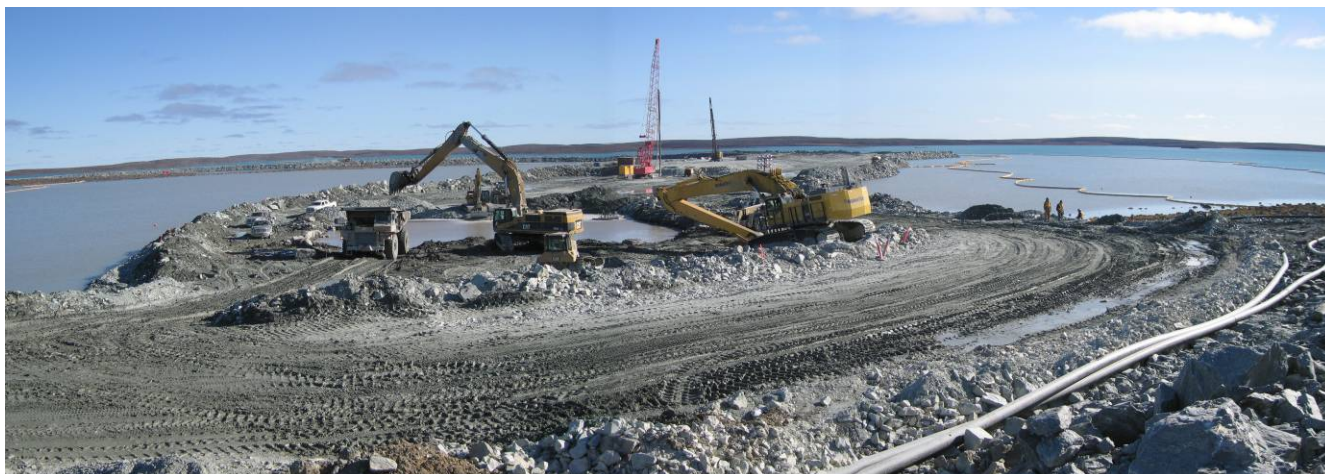
PHOTOGRAPH A4-1 – Bay Goose Dike

Description: From south abutment looking east at ongoing construction activities: initial trench excavation, trench backfilling, dynamic compaction and vibro densification. Note turbidity barriers within Third Portage Lake.

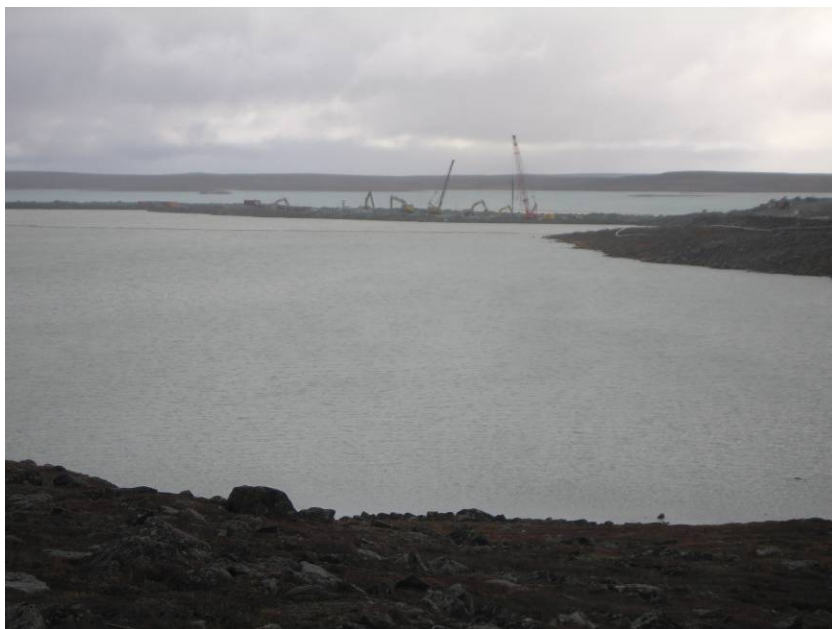
PHOTOGRAPH A4-3 – Bay Goose Dike

Description: View of Bay Goose Dike construction activities from plant site looking south.

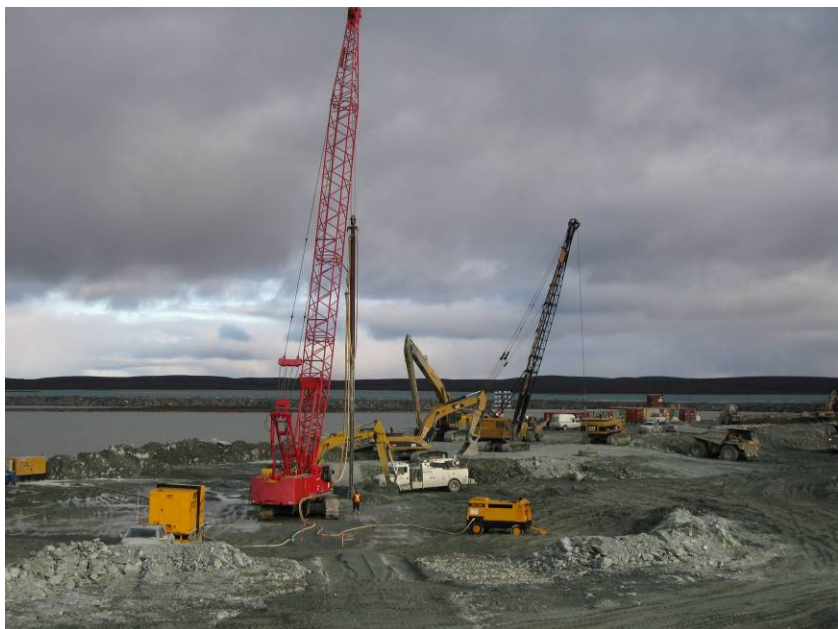
PHOTOGRAPH A4-5 – Bay Goose Dike

Description: Vibro densification near south abutment.

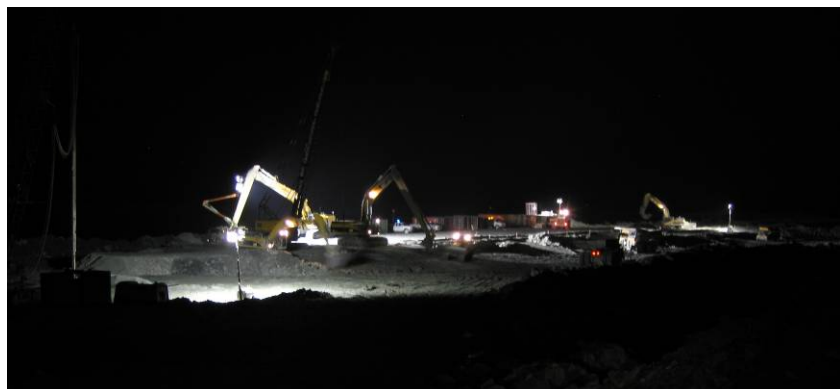
PHOTOGRAPH A4-7 – Bay Goose Dike

Description: Construction activities.

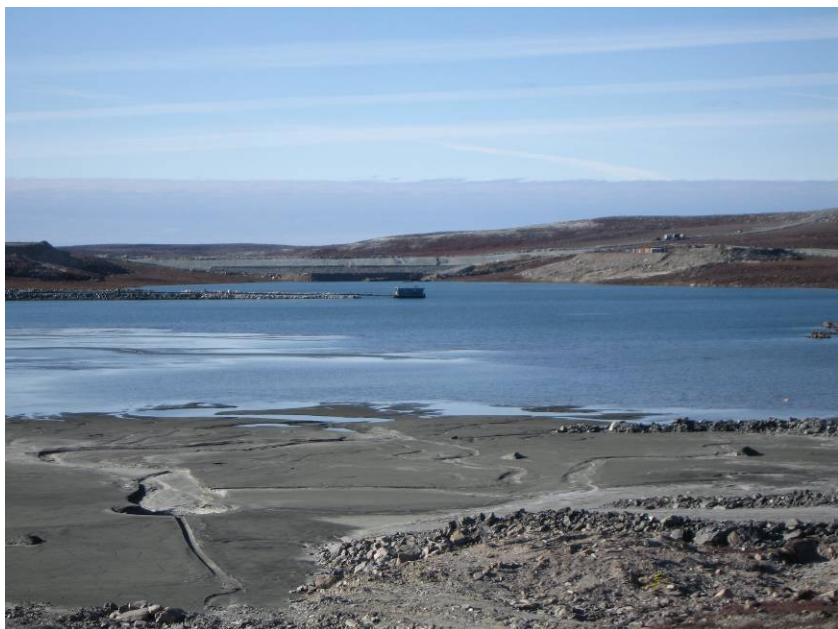
PHOTOGRAPH B1-1 – Tailings Storage Facility

Description: Beach upstream of Stormwater Dike, looking north at Reclaim Pond and Reclaim Barge.

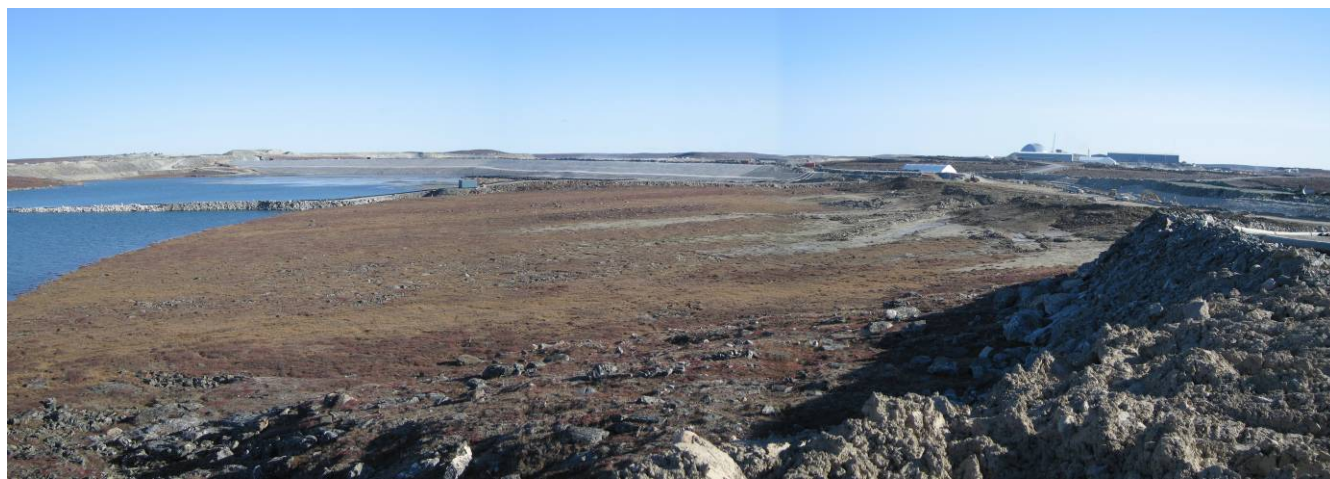
PHOTOGRAPH B1-3 – Tailings Storage Facility

Description: Looking southeast from hill between Saddle Dam 1 and Saddle Dam 2 at the north cell of the Tailings Storage Facility and in the far ground Stormwater Dike.

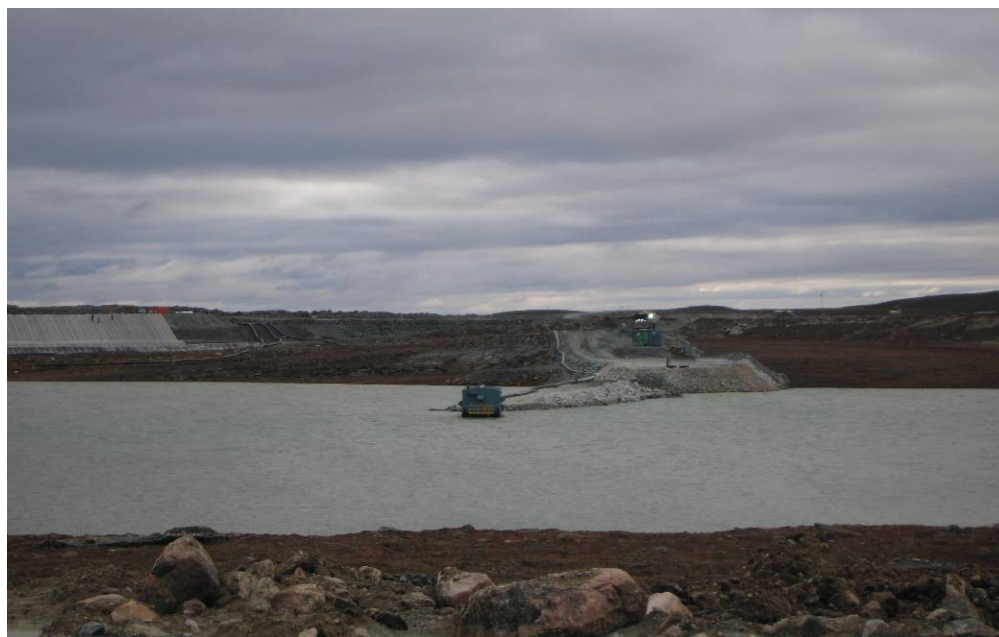
PHOTOGRAPH B1-4 – Tailings Storage Facility

Description: Looking south across Reclaim Pond towards the Reclaim Barge and Causeway, west abutment of Stormwater Dike evident on left side of the photo.

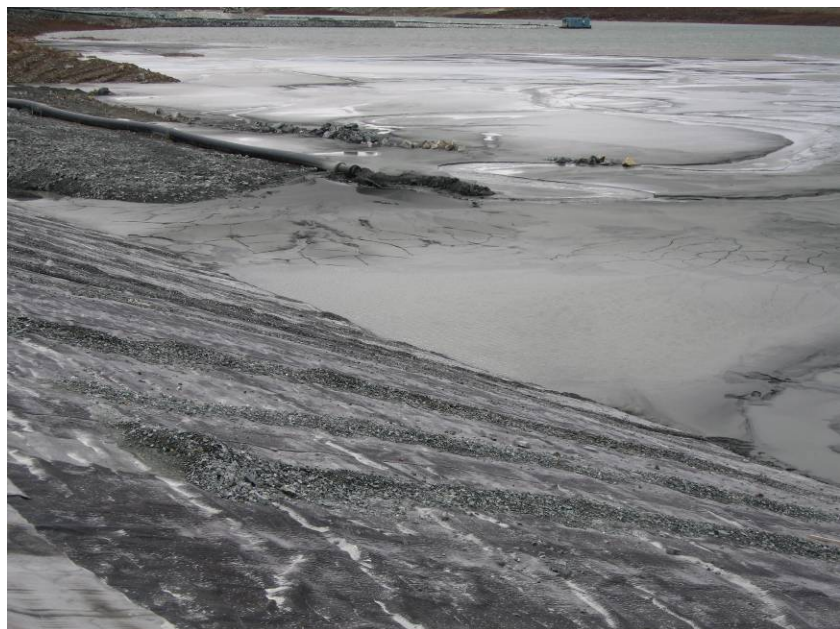
PHOTOGRAPH B1-5 – Tailings Storage Facility

Description: End of pipe discharge of tailings near the west abutment of Stormwater Dike.

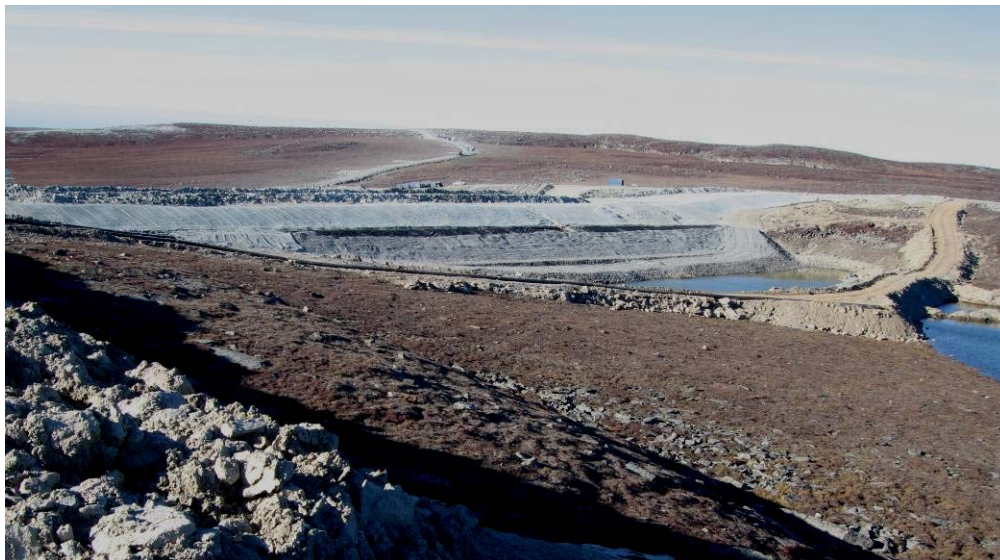
PHOTOGRAPH B2-1 – Saddle Dam 1

Description: Upstream view of Saddle Dam 1, looking north. Note soil berm upstream of dike.

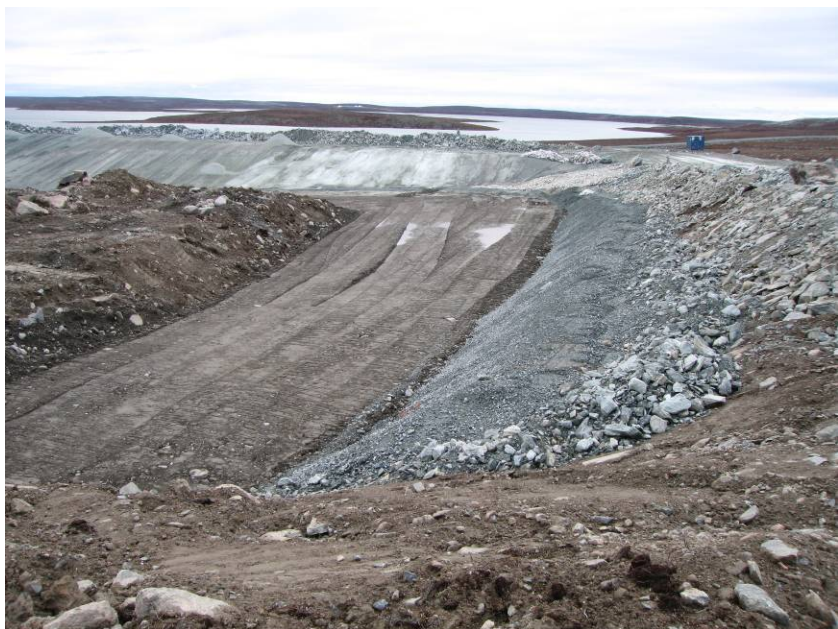
PHOTOGRAPH B2-3 – Saddle Dam 1

Description: Till placed at upstream toe of Stage 2 north abutment, looking west.

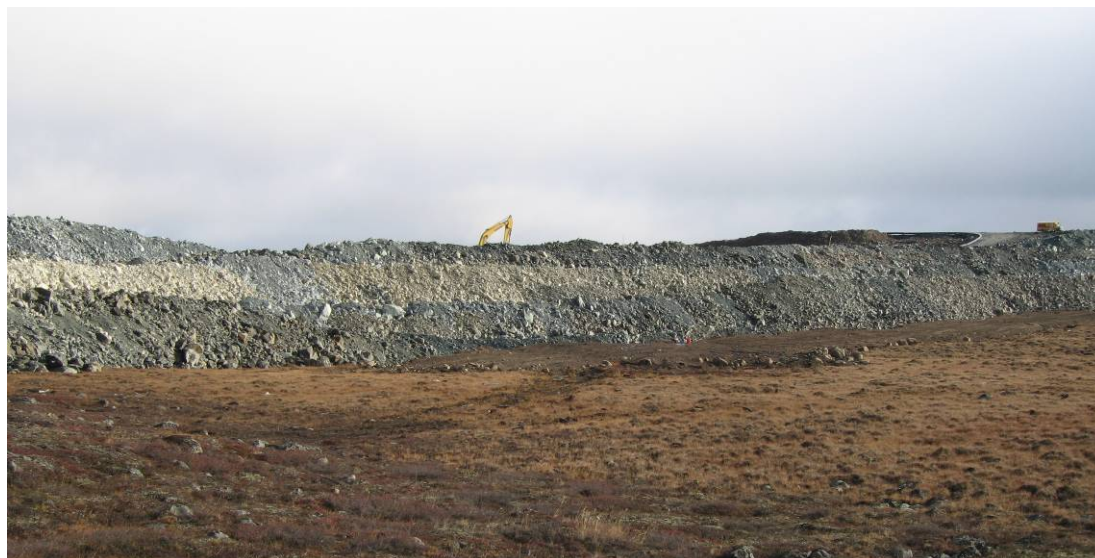
PHOTOGRAPH B2-5 – Saddle Dam 1

Description: Looking east at downstream rockfill slope of Saddle Dam 1.

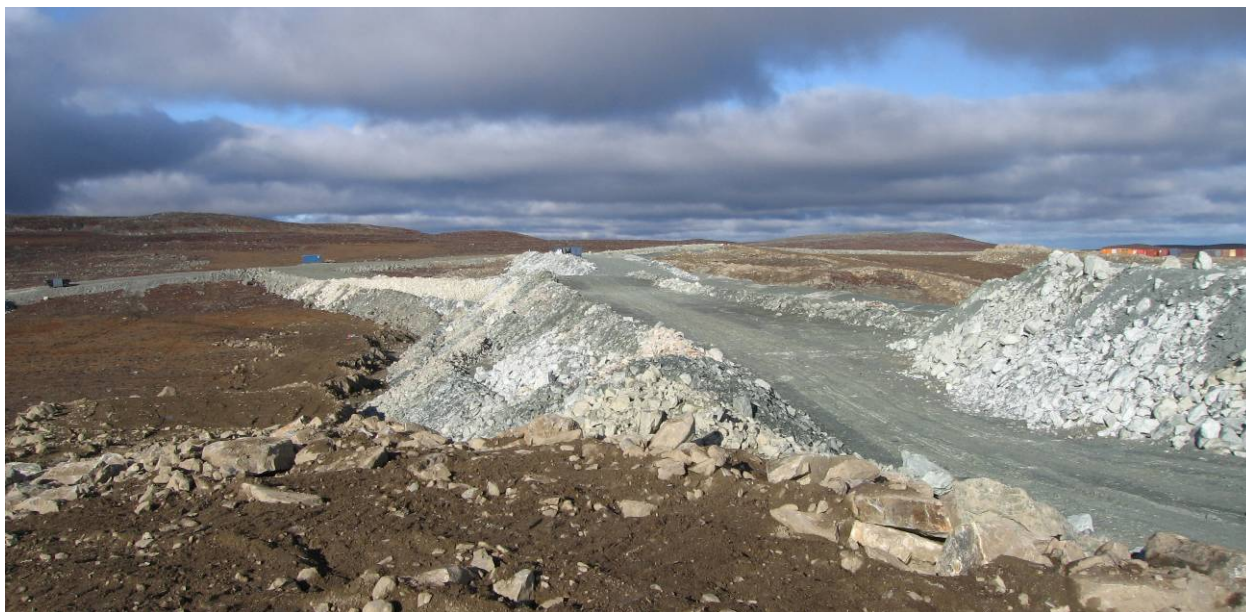
PHOTOGRAPH B2-7 – Saddle Dam 1

Description: Looking north from south abutment at downstream rockfill slope of Saddle Dam 1, Stage 2 rockfill placement in progress.

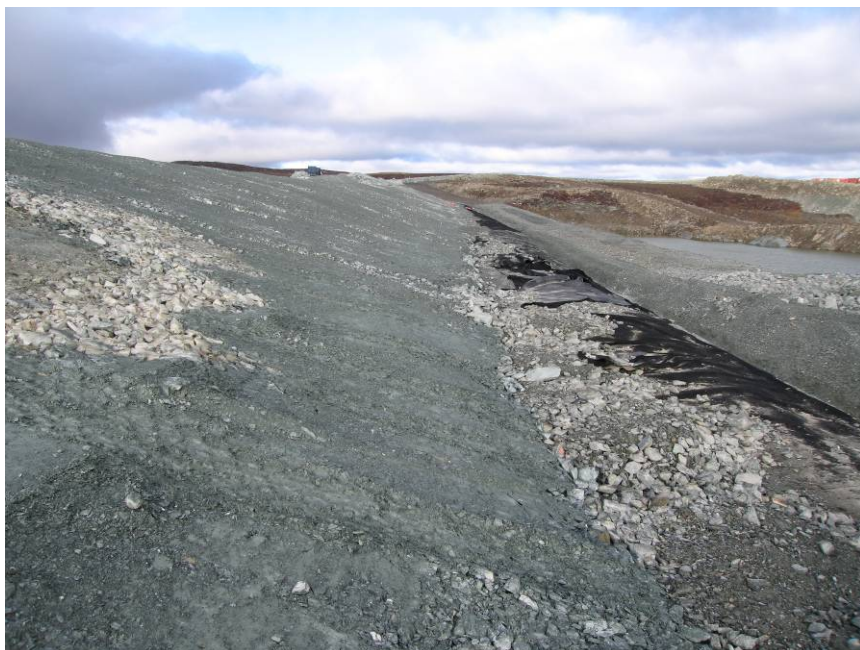
PHOTOGRAPH B2-9 – Saddle Dam 1

Description: Looking north from south abutment at upstream slope with fine and coarse filters evident.

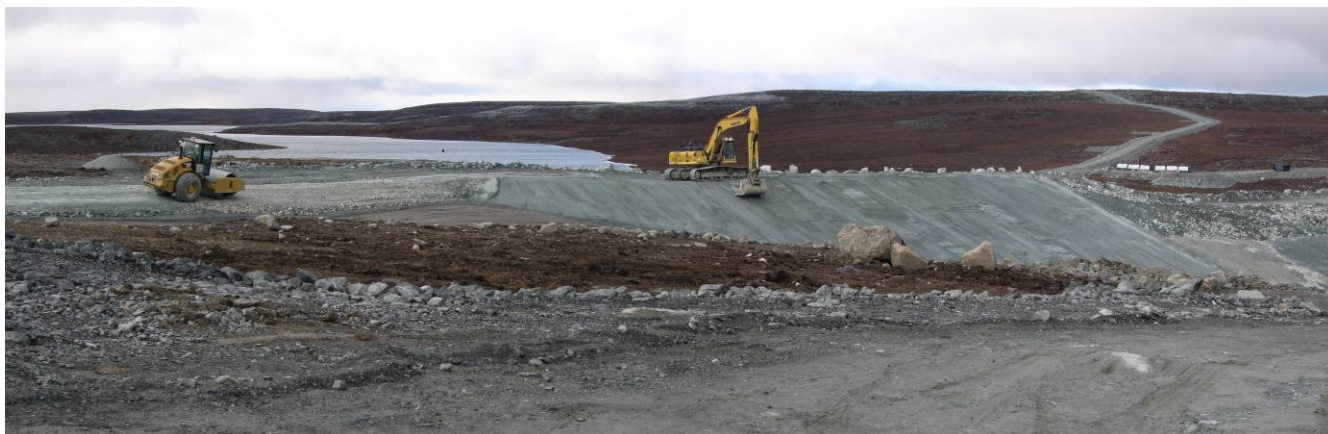
PHOTOGRAPH B2-11 – Saddle Dam 1

Description: Upstream side of dike, filter placement, compaction and trimming in preparation for liner installation on Stage 2 raise.

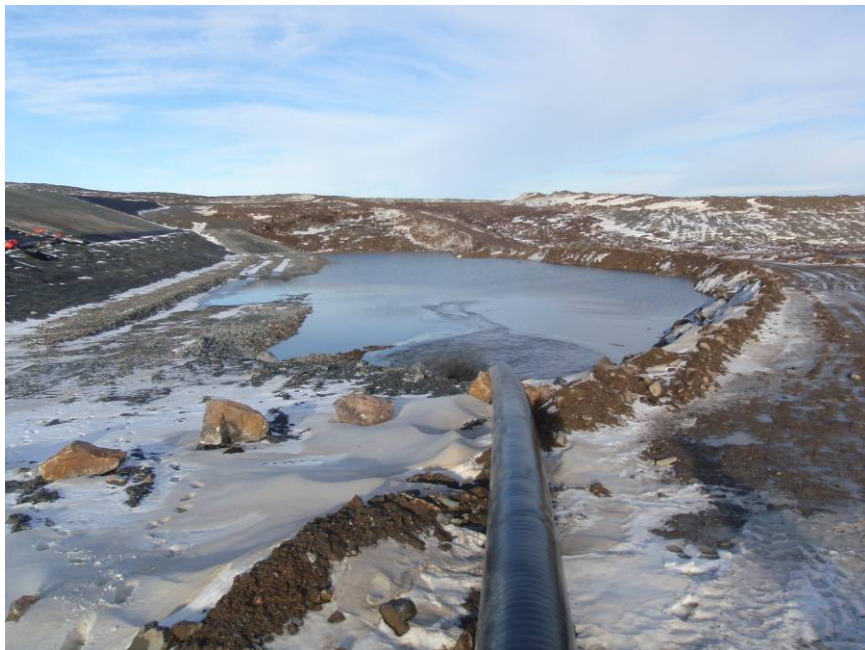
PHOTOGRAPH B2-13 – Saddle Dam 1

Description: View looking north at upstream side of dike, with tailings being discharged between the berm and dike toe.

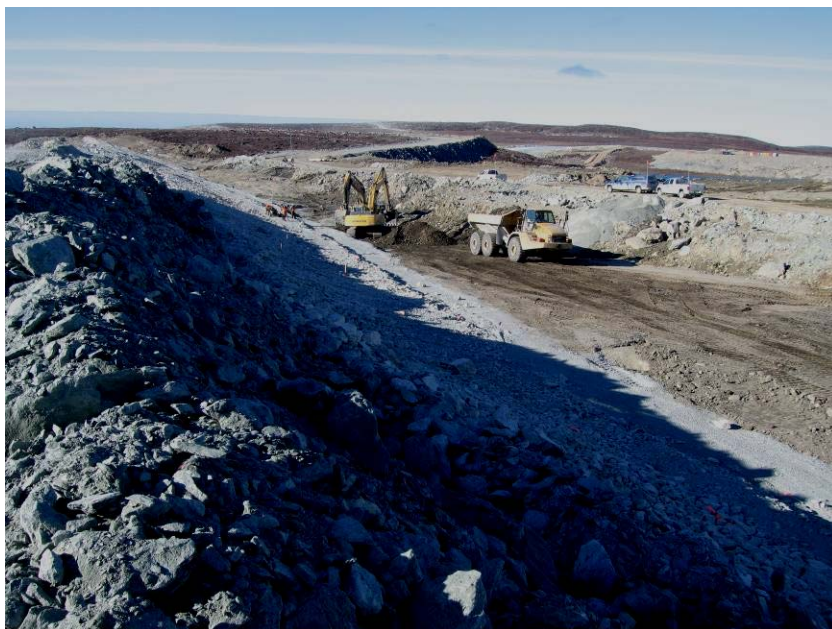
PHOTOGRAPH B3-1 – Saddle Dam 2

Description: Rockfill dam with till placement occurring at toe of dike. Photograph was taken near central portion of the dike crest looking northwest.

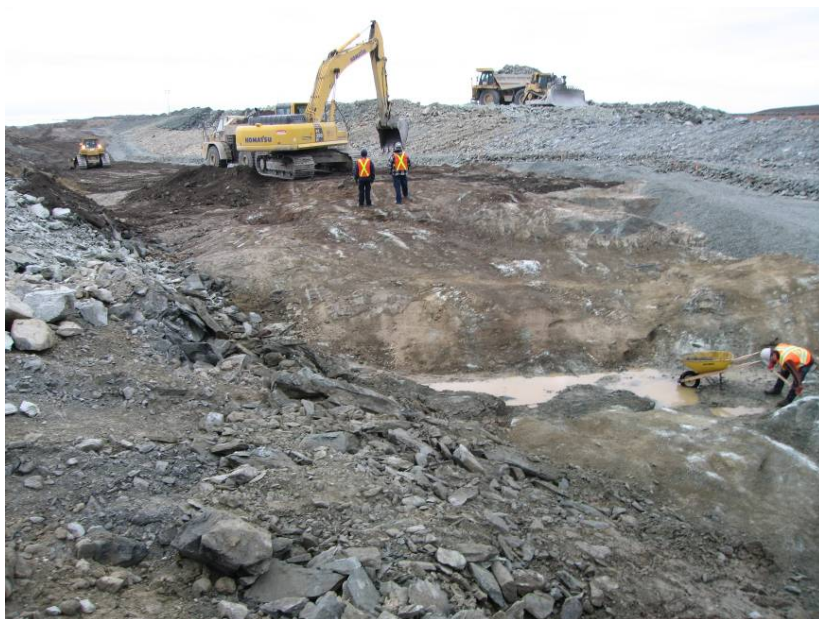
PHOTOGRAPH B3-3 – Saddle Dam 2

Description: Foundation preparation work of bedrock at toe of dike for liner connection. Note till placement above bedrock evident in far ground of photograph.

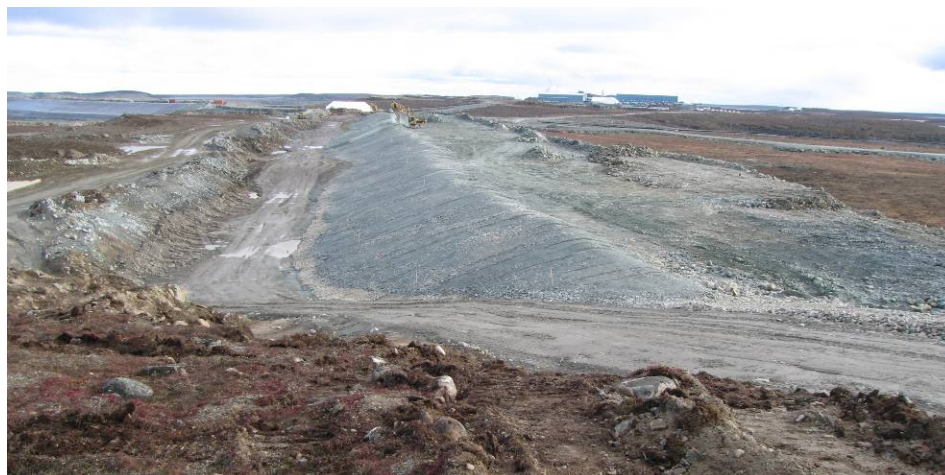
PHOTOGRAPH B3-5 – Saddle Dam 2

Description: From north abutment looking southeast along toe of dike and liner connection. Note construction was still in progress and crest height had not reached 150 m.

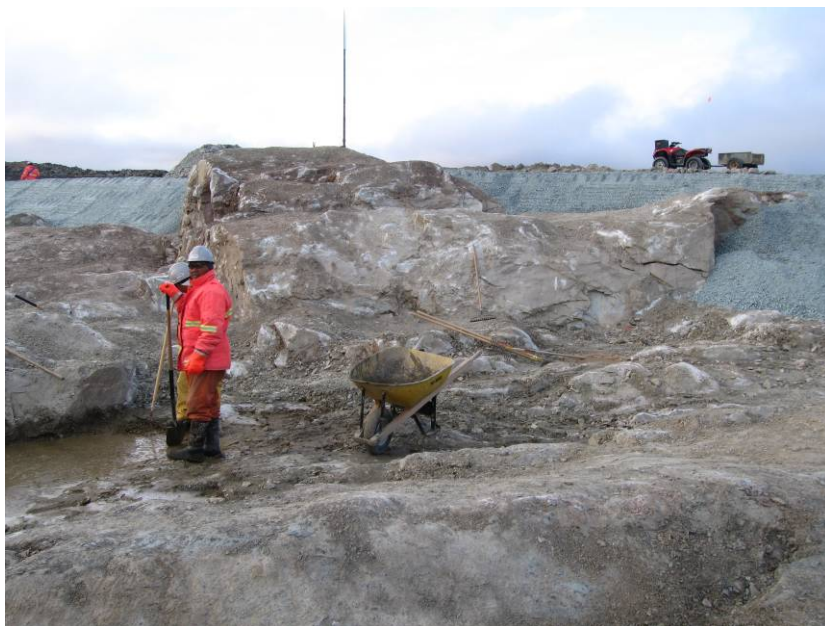
PHOTOGRAPH B3-11 – Saddle Dam 2

Description: Rock outcrop near south abutment, protruding through filter on upstream slope, looking southwest.

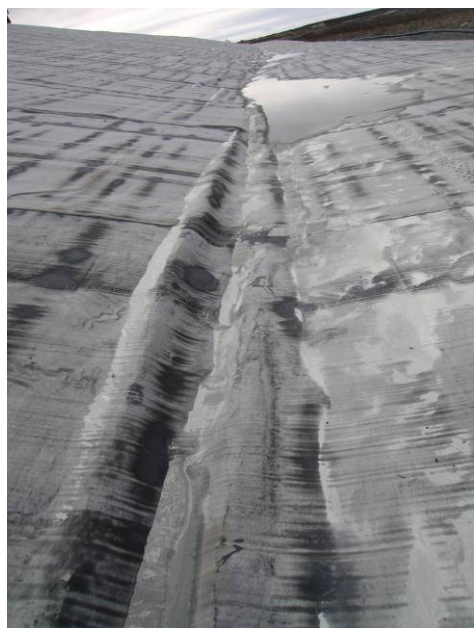
PHOTOGRAPH B4-10 – Stormwater Dike

Description: Some wrinkles observed in installed liner.

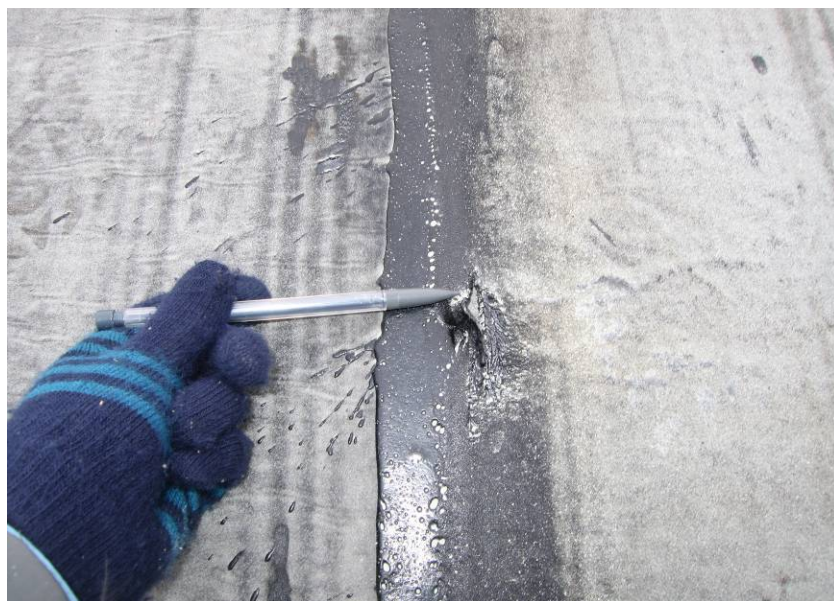
PHOTOGRAPH B4-12 – Stormwater Dike

Description: Repairs in 2010 liner remain to be made. Repairs in damaged 2009 liner also remain, example near 10+400.

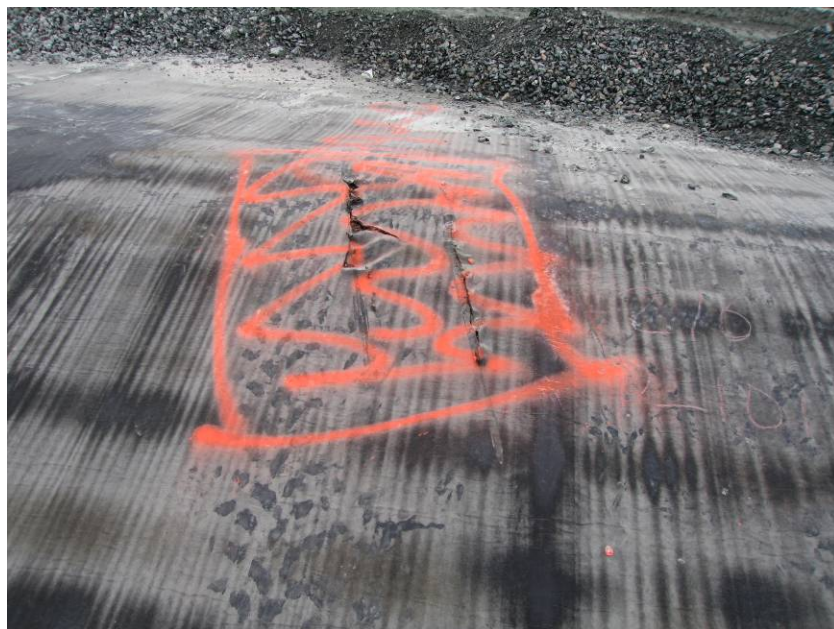
PHOTOGRAPH B4-13 – Stormwater Dike

Description: Damaged liner, still to be repaired, example near 10+650.

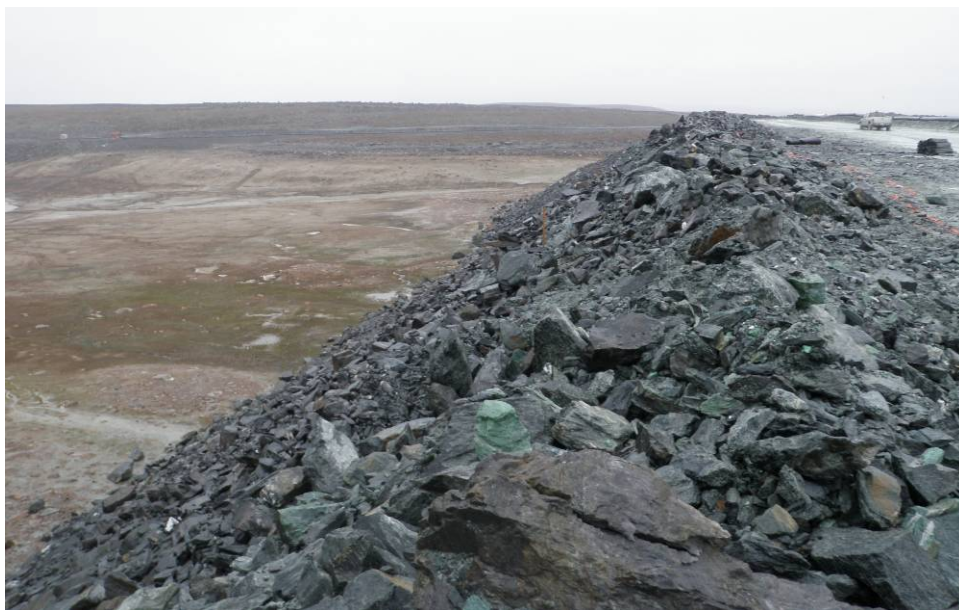
PHOTOGRAPH B4-17 – Stormwater Dike

Description: View near downstream crest between Sta. 10+849 and 10+940 showing tension cracks on the far right side of the photo and downstream rockfill slope, looking west.

3. DOWNSTREAM SLOPE 3.1 Slope angle 3.2 Signs of Erosion 3.3 Signs of Movement (Deformation) 3.4 Cracks 3.5 Seepage or Wet Areas	Approx. 1.2 or 1.3H:1V variable None observed. Tension cracks at crest between Sta. 10+849 and 10+940 near downstream. As mentioned above. Moss evident beyond downstream toe area and also softer areas of the foundation. None on downstream slope.		Rockfill. AEM is monitoring. Softer areas downstream may be attributed to the origin of the material "lakebed sediments".

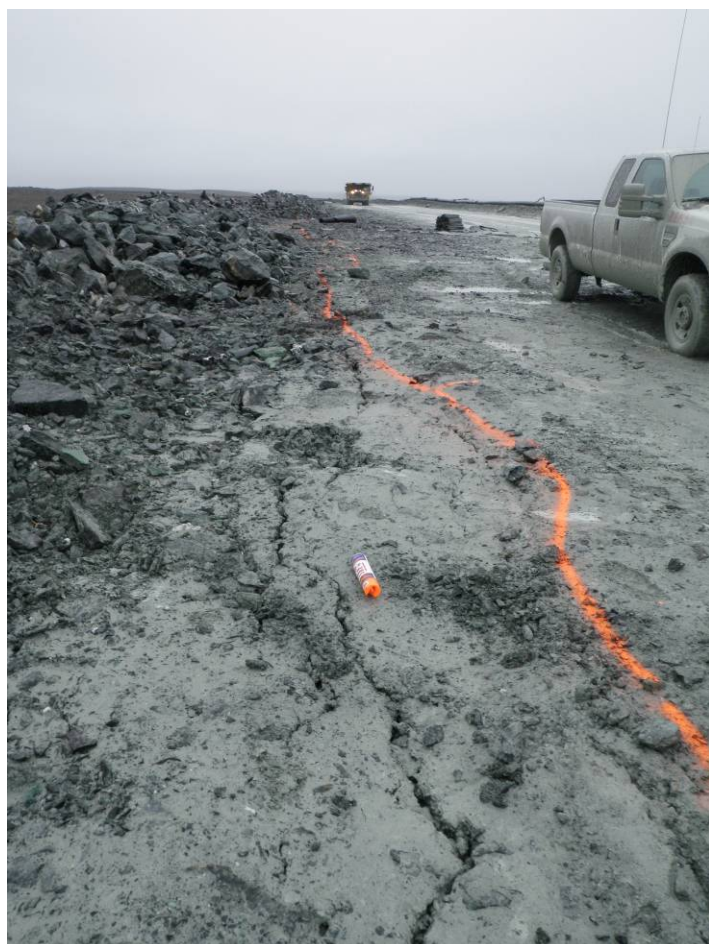
PHOTOGRAPH B4-19 – Stormwater Dike

Description: View near downstream crest between Sta. 10+849 and 10+940 showing tension cracks, looking west.

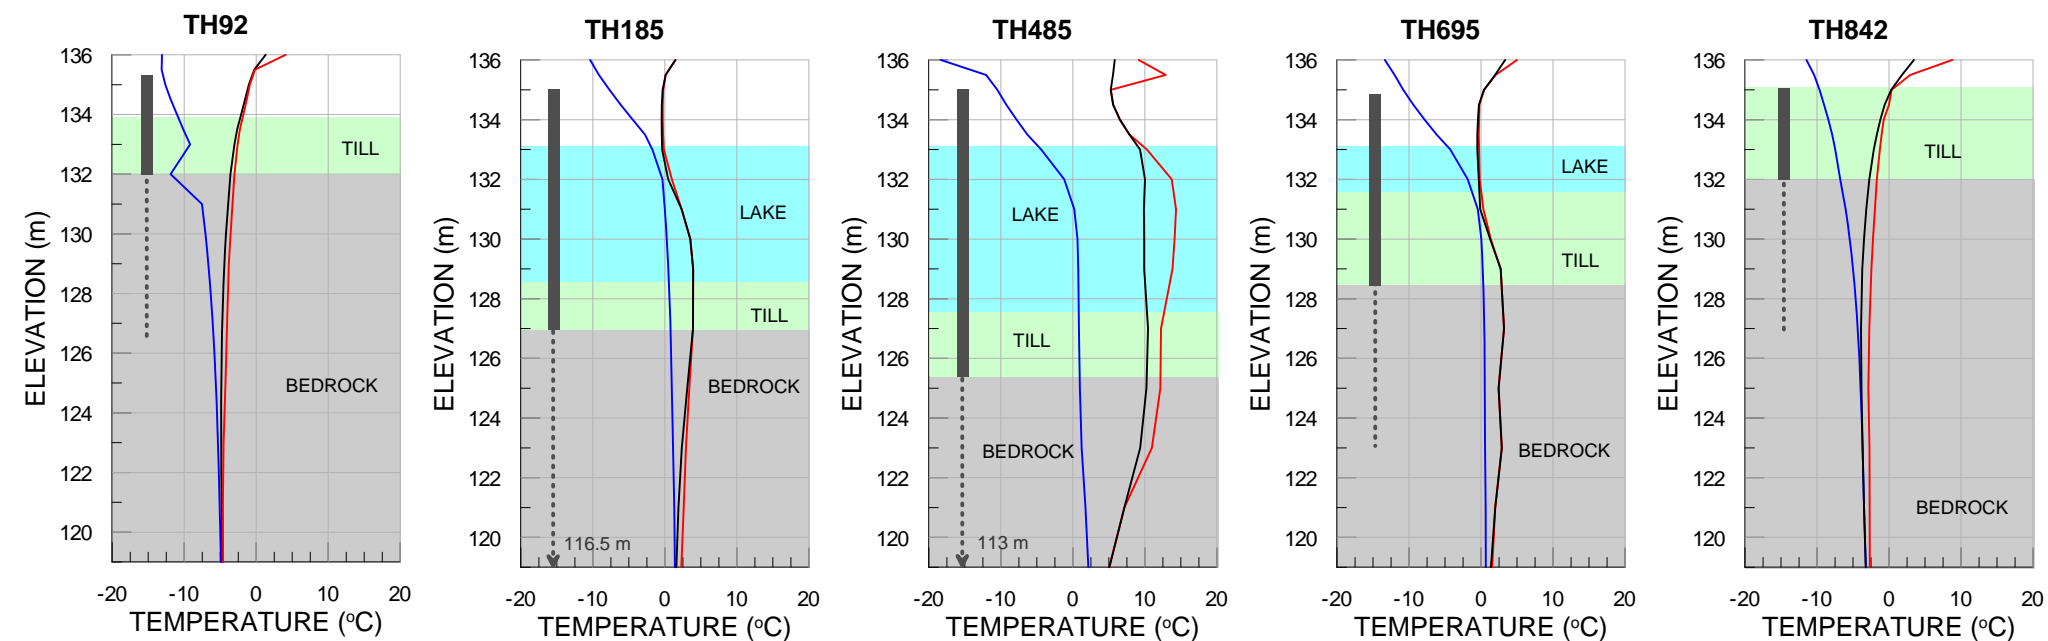
NOTE: TH92 node(9) at elevation 131, data not reported since May 1, 2010 as it appears not to be functioning.

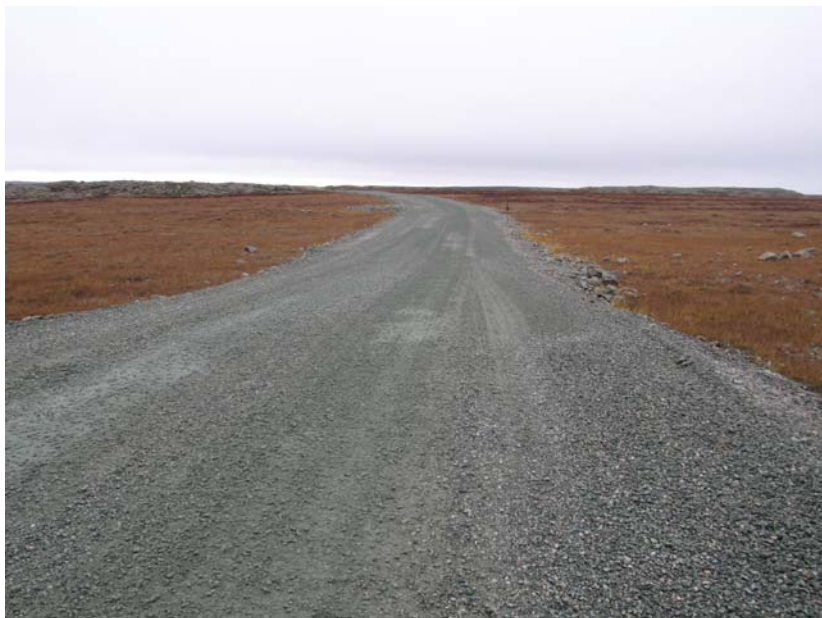
PHOTOGRAPH D1-1 – AWPR

Description: General view of road PC-7 (km 20+505) looking southeast towards Baker Lake.

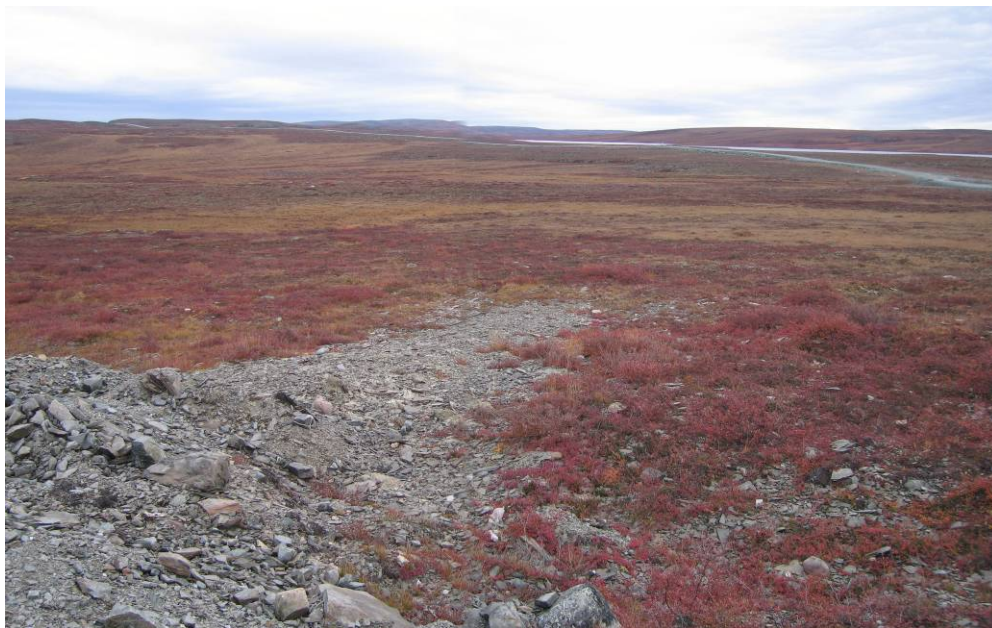
PHOTOGRAPH D1-3 – AWPR

Description: Panoramic view of road from Quarry 10 looking south towards RO9 bridge (Bridge 4) km 48.

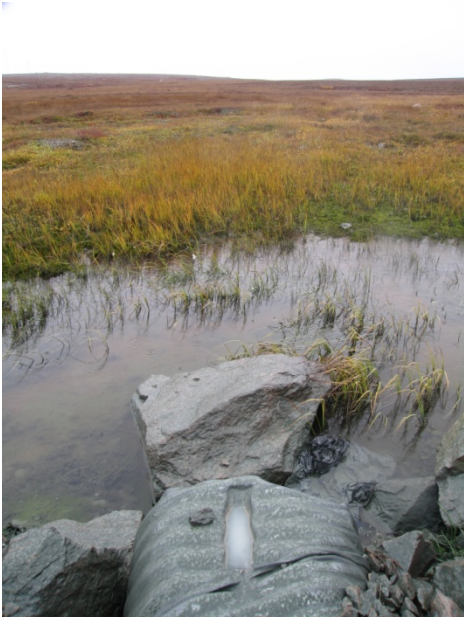
PHOTOGRAPH D2-1: PRC-1, km 0+430

Description: Upstream view of culvert. Large rock from road work has fallen in front of culvert. Rock is not blocking culvert. Uniform grade through culvert observed. Inlet should be cleaned.
