2010 Annual Geotechnical Inspection Meadowbank Gold Project, Nunavut

Submitted to:
Agnico-Eagle Mines Limited
Meadowbank Division
PO Box 540
Baker Lake, Nunavut
X0C 0A0

Project Number: 10-1428-0033/2000
Document Number: 1216 Ver. 0

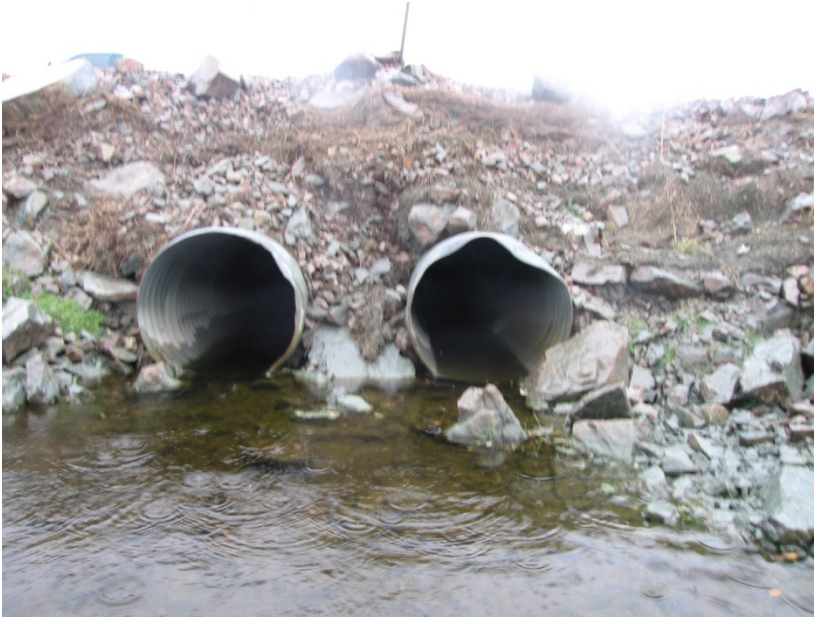
PHOTOGRAPH D2-3 – PRC-2, Km 0+470

Description: From upstream looking at culverts. Note both culverts have inflow.

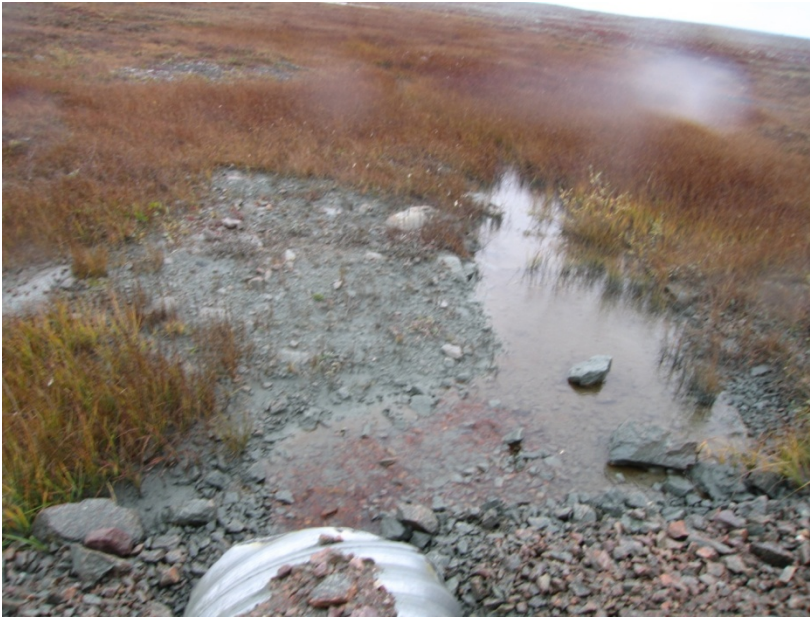
PHOTOGRAPH D2-5: PRC-3, km 1+380

Description: Upstream view of culvert and valley.

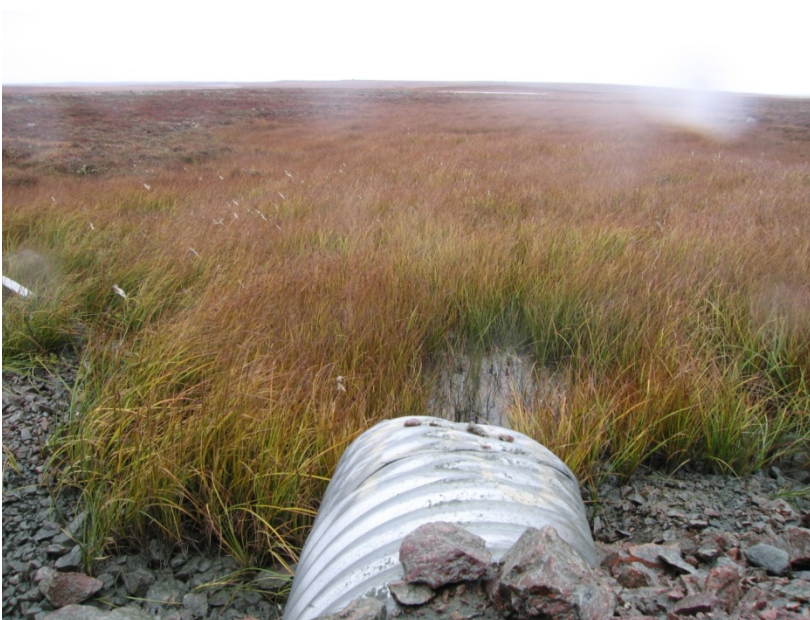
PHOTOGRAPH D2-6: PRC-3, km 1+380

Description: Downstream view of culvert. Good condition, uniform grade, no obstruction.

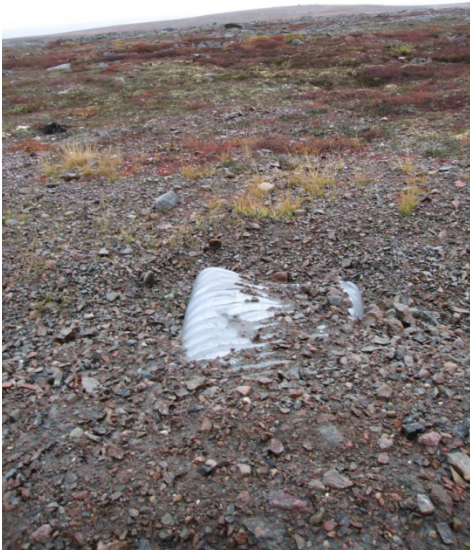
PHOTOGRAPH D2-7: R-00A, km 2+550

Description: Upstream view of culvert and valley. No defined channel.

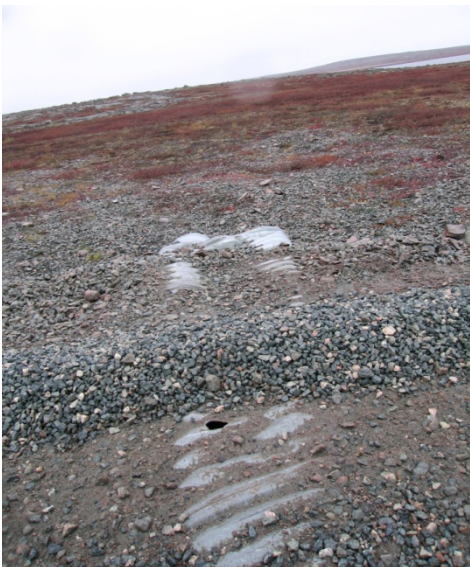
PHOTOGRAPH D2-8: R-00A, km 2+550

Description: Downstream view of culvert. Outlet is crushed and culvert has a hole on haunch, road bed cover is inadequate to protect the culvert.

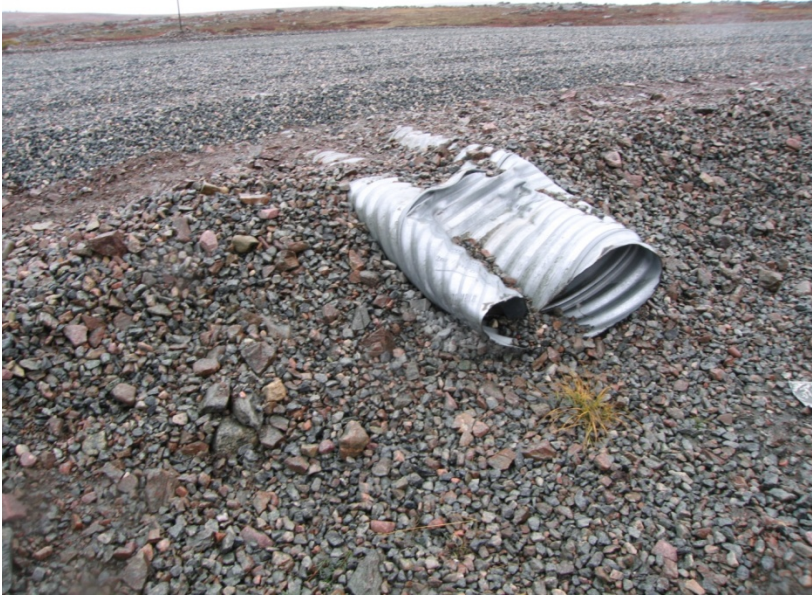
PHOTOGRAPH D2-9: R-00A, km 2+550

Description: Collapsed outlet. Road bed cover over culvert is too thin to provide protection. Uniform grade through culvert observed.

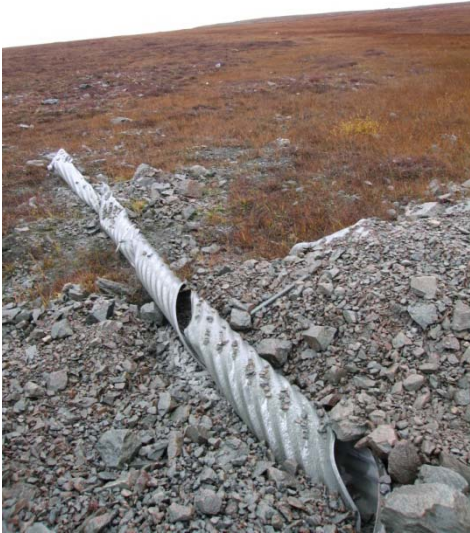
PHOTOGRAPHS D2-11: PC-14, km 4+260

Description: Upstream view of culverts and valley. Culvert on left in photo is filled with gravel, crushed / damaged. Culvert on right outlet partially crushed at inlet haunch, but still functions, uniform grade.

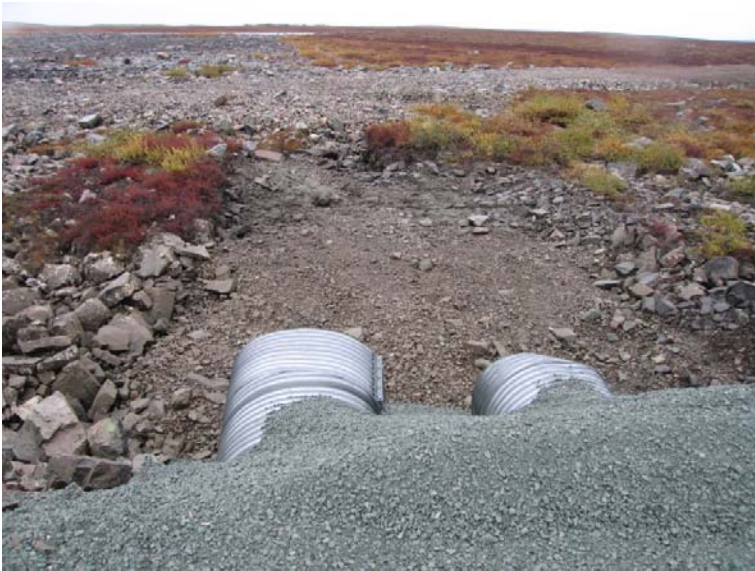
PHOTOGRAPH D2-13: PC-17, km 8+830

Description: Upstream view of culverts and valley. Note 3/4" to 1" diameter gravel placed around and on culverts. Scouring in front of culverts has occurred (note vegetation) streambed about 0.3 to 0.5 m lower.

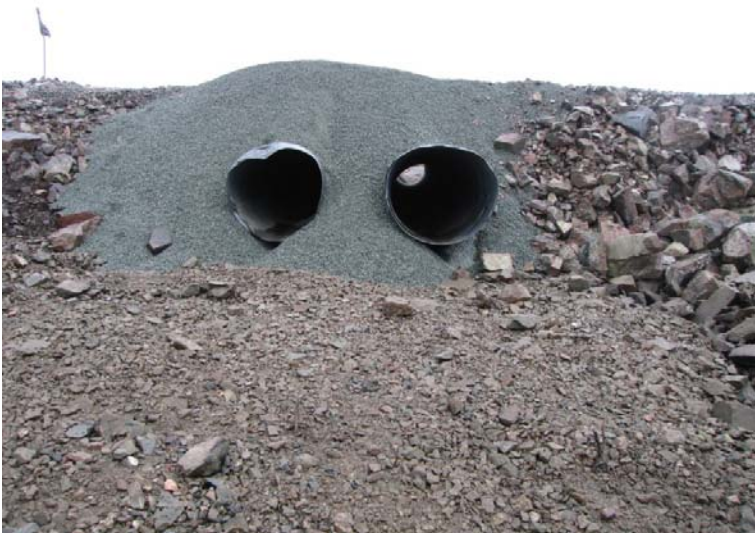
PHOTOGRAPH D2-14: PC-17, km 8+830

Description: From upstream looking at culvert inlets. Gravel placed around and on culverts. Flow beneath culvert has occurred; bedding material may have washed away. Note void on culvert closet to Baker Lake (right in photo). Uniform grade through both culverts, no obstructions observed. Streambed lower than culvert invert as a result of scouring.

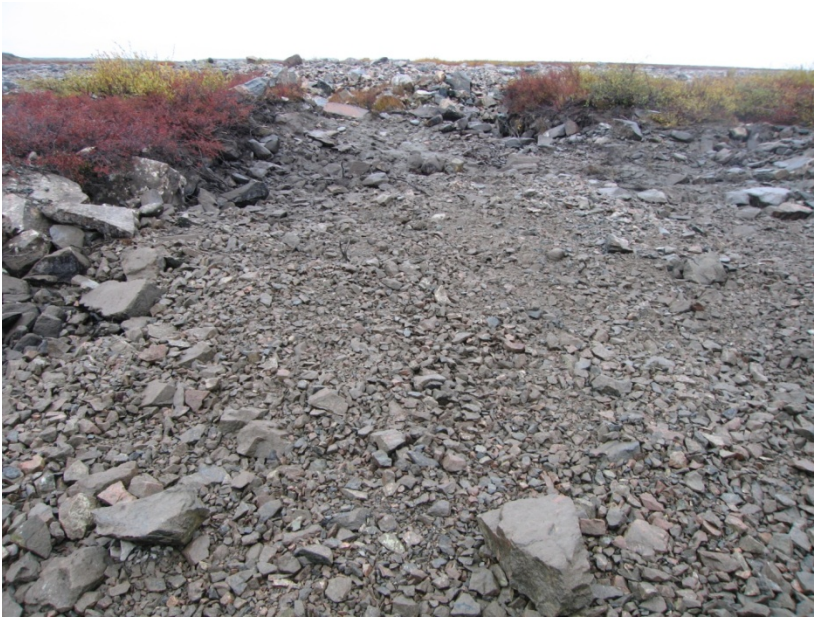
PHOTOGRAPH D2-15: PC-17, km 8+830

Description: Upstream view of stream bed. Note erosion / scouring.

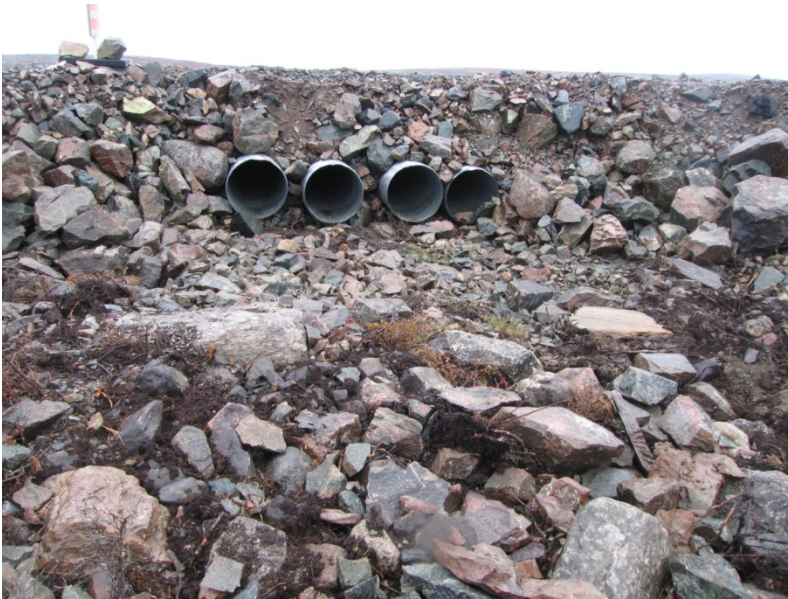
PHOTOGRAPH D2-17: 4 new culverts, approximately km 8+850

Description: From upstream looking at culverts. New culverts installed during 2010 freshet. Inverts not well bedded. Rocks 20 – 40 cm in mouth and several within culvert closest to Baker Lake (right on photo).

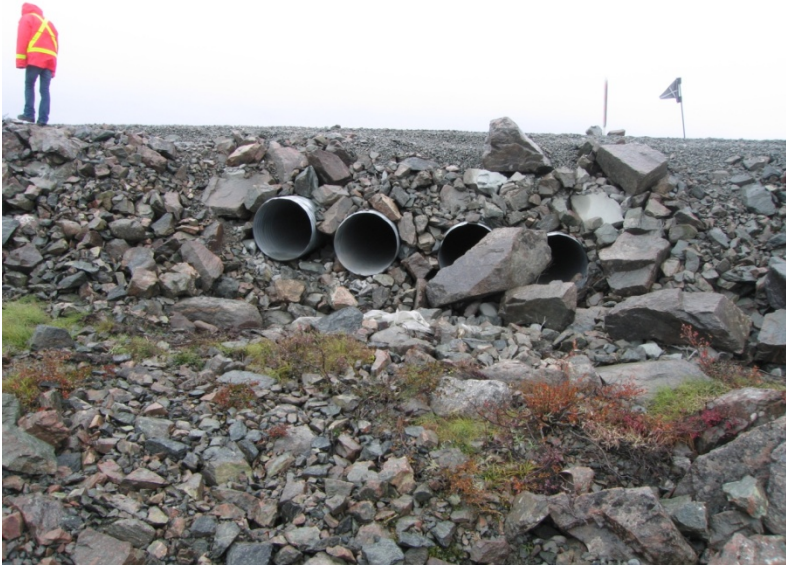
PHOTOGRAPH D2-19: 4 new culverts, approximately km 8+850

Description: From downstream looking at culverts. New culverts installed as an emergency action during 2010 freshet. Note rocks near outlet on right in photo.

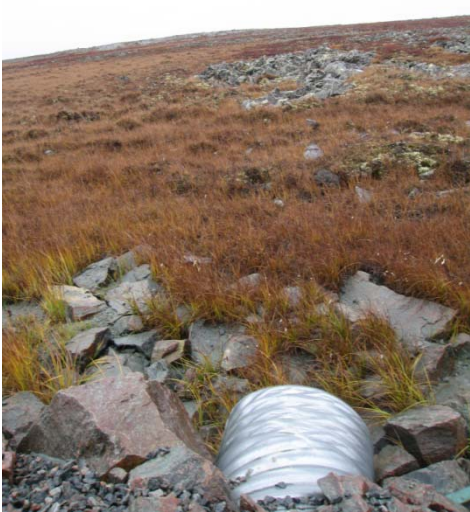
PHOTOGRAPH D2-21: PC-1, km 9+952

Description: Upstream view of culvert and valley. Good condition, uniform grade, no obstruction, no sign of erosion.

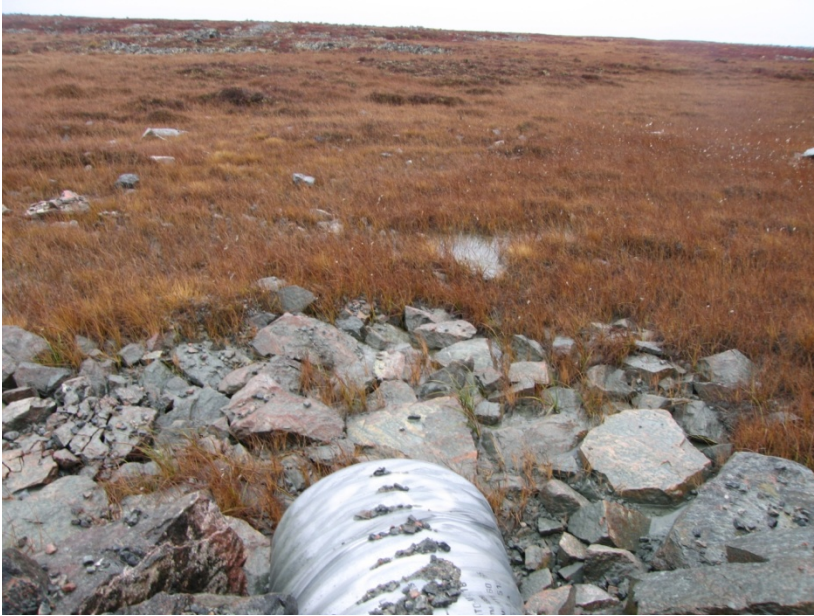
PHOTOGRAPH D2-23: R-03, km 10+580

Description: Upstream view of culvert and valley. Good condition, no obstruction, uniform grade, no sign of erosion.

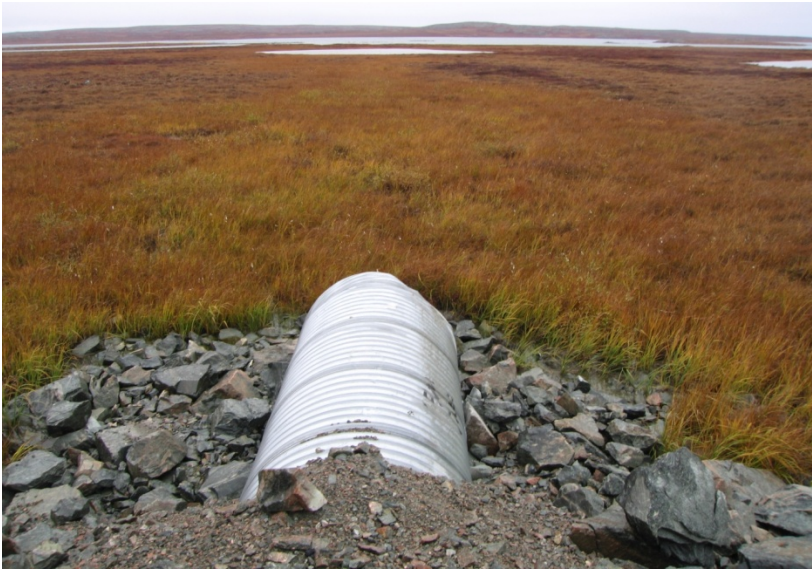
PHOTOGRAPH D2-27: R-04, km 12+050

Description: Downstream view of culvert and valley. Good condition, uniform grade, no sign of erosion.

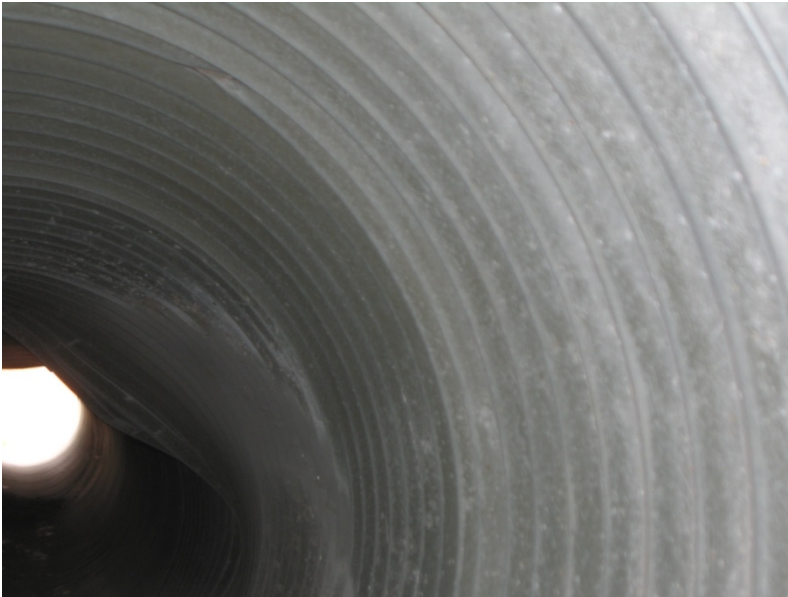
PHOTOGRAPH D2-29: PC-13, km 12+745

Description: From upstream to downstream view through culvert. Crushing on side of culvert. Capacity of culvert decreased.

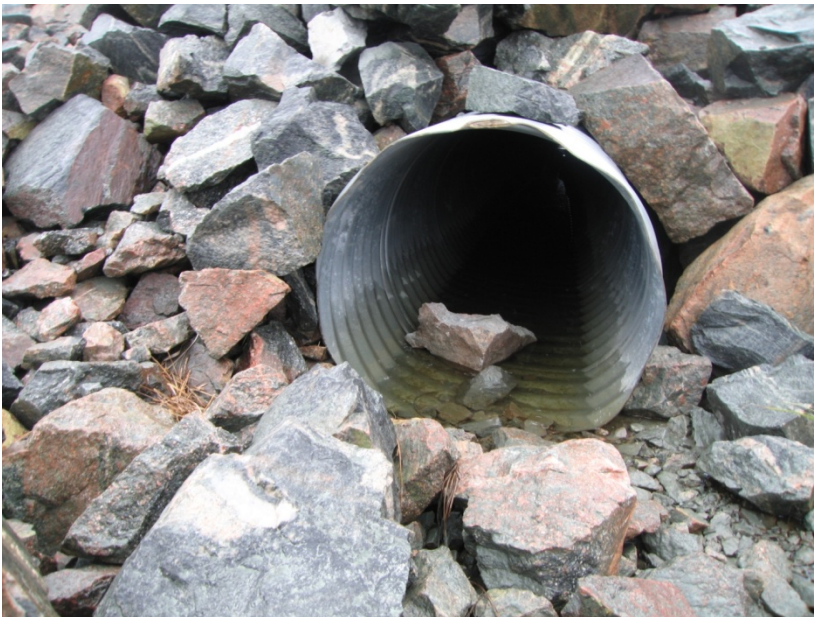
PHOTOGRAPH D2-32: PC-2, km 13+405

Description: From downstream looking at culvert. Uniform grade, good condition, and no sign of erosion evident. Cleanup at culvert inlet and outlet of culvert to remove cobbles from road construction is recommended.

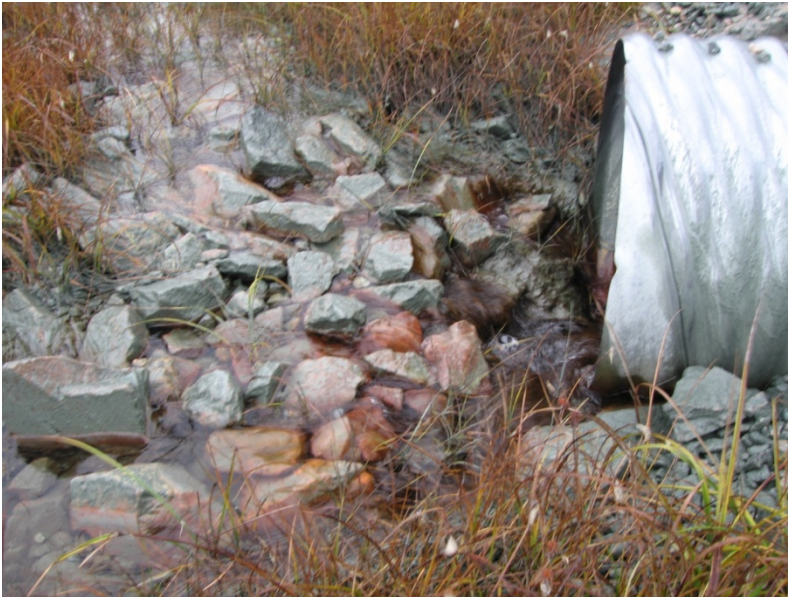
PHOTOGRAPH D2-33: PC-3, km 13+685

Description: Upstream view of inlet. Streambed slightly above culvert inlet, water flows down into culvert.

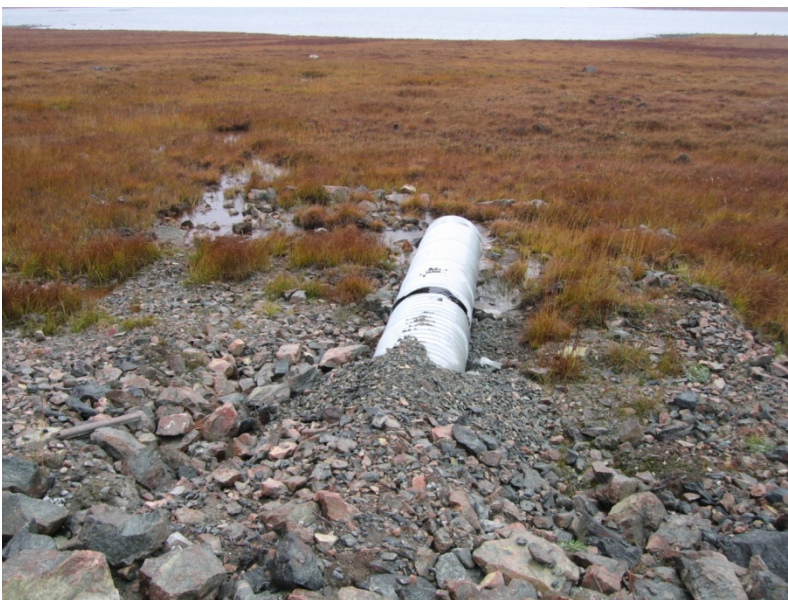
PHOTOGRAPH D2-34: PC-3, km 13+685

Description: Downstream view of culvert and valley. Good condition, uniform grade, no obstruction, no sign of erosion.

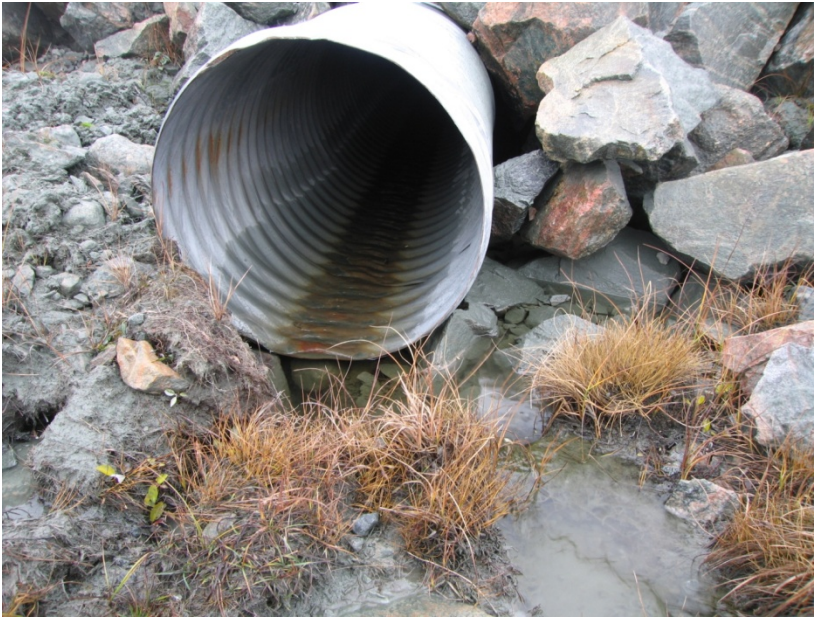
PHOTOGRAPH D2-35: PC-4, km 14+910

Description: From upstream looking at culvert inlet. Culvert set slightly above stream bed, water pools around base before flowing through. Good condition, uniform grade, no sign of erosion.

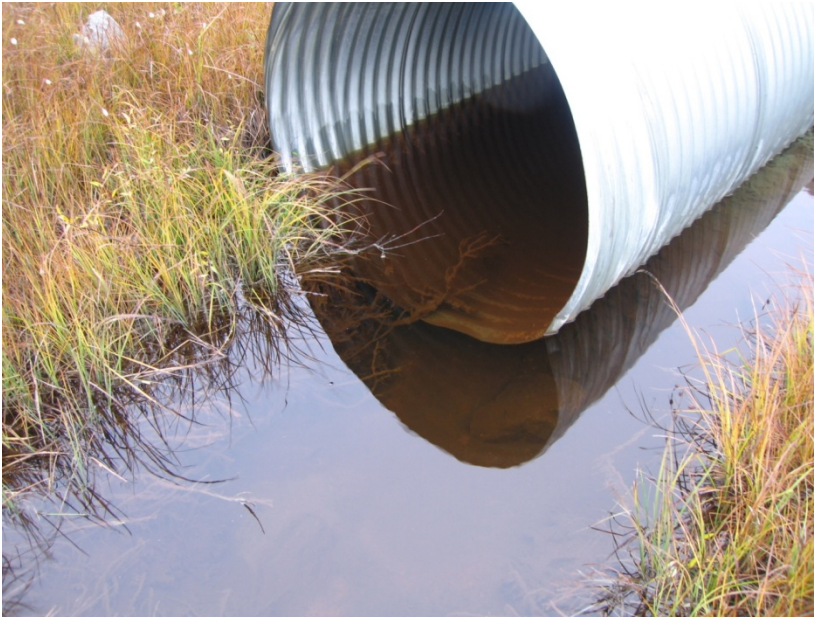
PHOTOGRAPH D2-37: R-05A, km 15+645

Description: From upstream looking at culvert inlet. Note culvert set above base. Pool 30-50cm deeper.

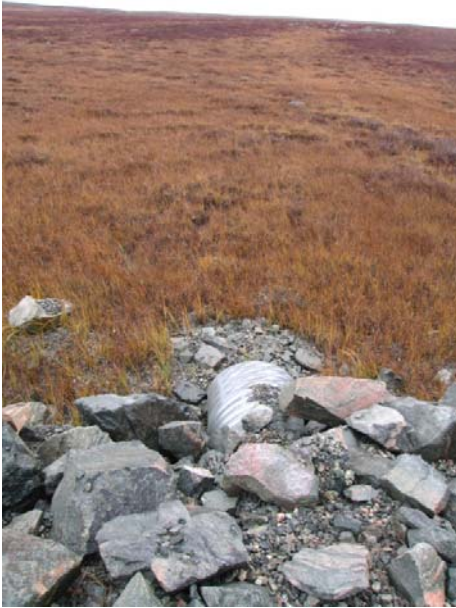
PHOTOGRAPH D2-39: PC-5, km 18+280

Description: Upstream view of culvert and valley. Good condition, uniform grade, no obstruction, no sign of erosion.

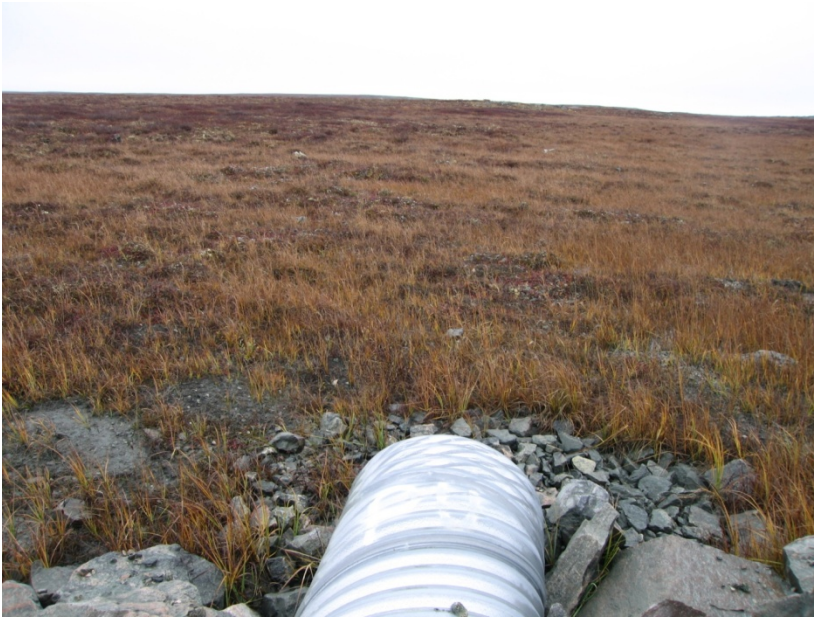
PHOTOGRAPH D2-41: PC-6, km 19+075

Description: Upstream view of culvert and valley. Good condition, uniform grade, no sign of erosion.

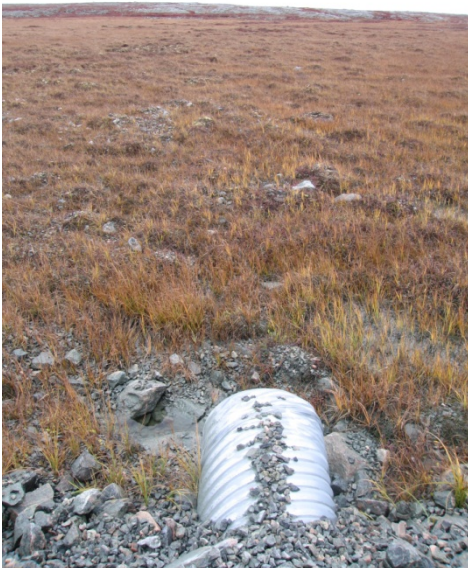
PHOTOGRAPH D2-44: PC-7, km 20+505

Description: Upstream view of culvert and valley. Good condition, uniform grade, no obstruction, no sign of erosion.

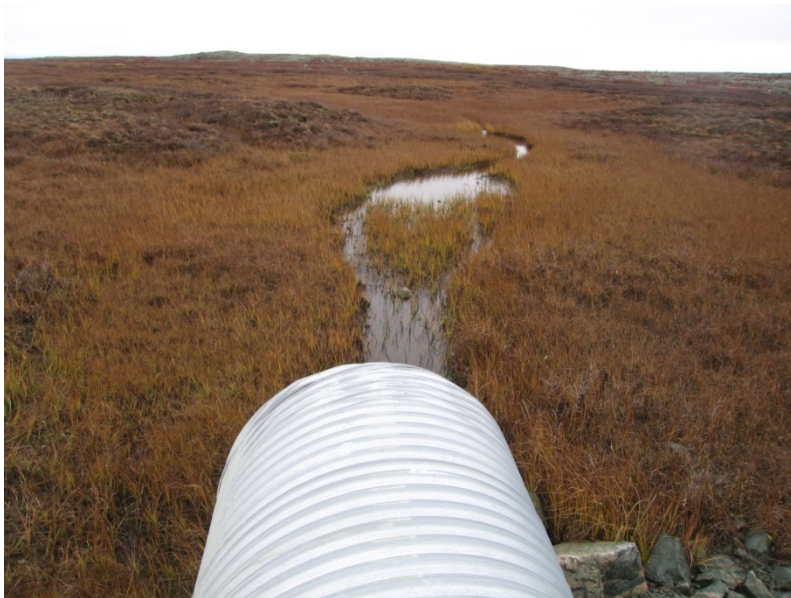
PHOTOGRAPH D2-46: R-07, km 25+900

Description: Upstream view of culvert and valley. Good condition, uniform grade, no obstruction, no sign of erosion.

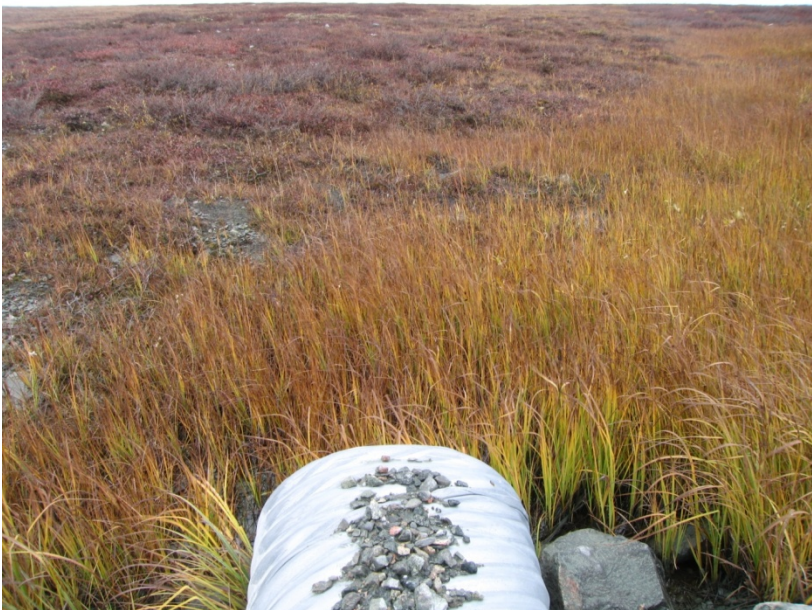
PHOTOGRAPH D2-48: PC-8, km 29+785

Description: Upstream view of culvert and valley. Good condition, uniform grade, no obstruction, no sign of erosion.

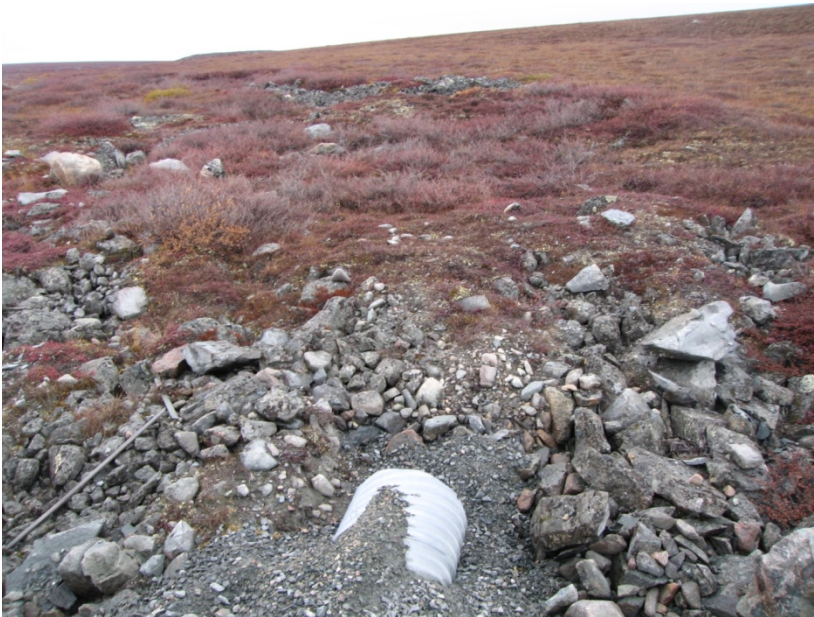
PHOTOGRAPHS D2-50: PC-9, km 35+690

Description: Upstream view of culvert and valley. Good condition, uniform grade, no obstruction, no sign of erosion.

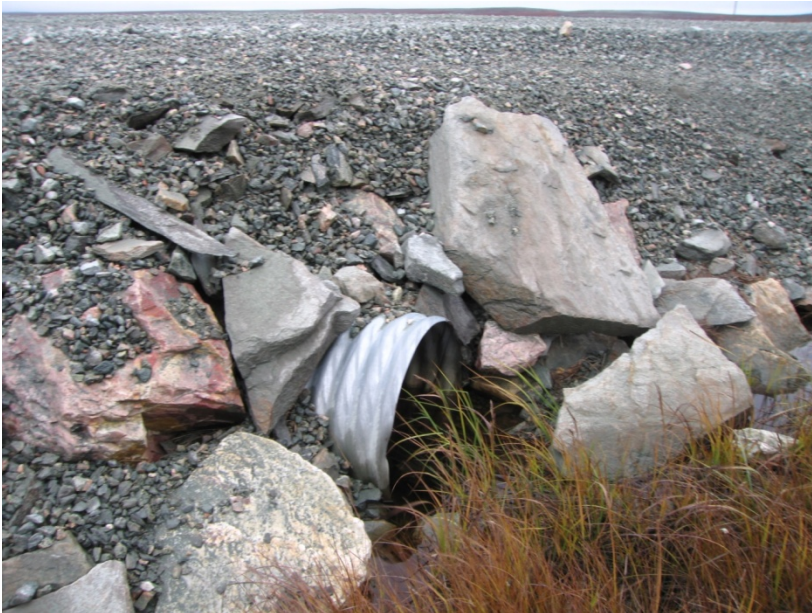
PHOTOGRAPH D2-52: PC-10, km 36+865

Description: Upstream view of culvert invert. Rocks from road work near mouth. Good condition, uniform grade, no obstruction, no sign of erosion.

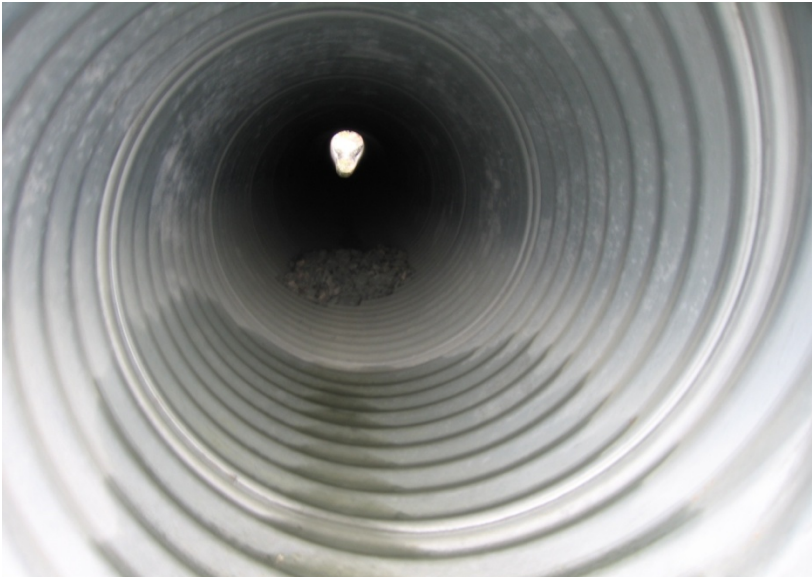
PHOTOGRAPH D2-55: PC-11, km 39+552

Description: From upstream to downstream view through culvert. Some gravel from road within culvert.

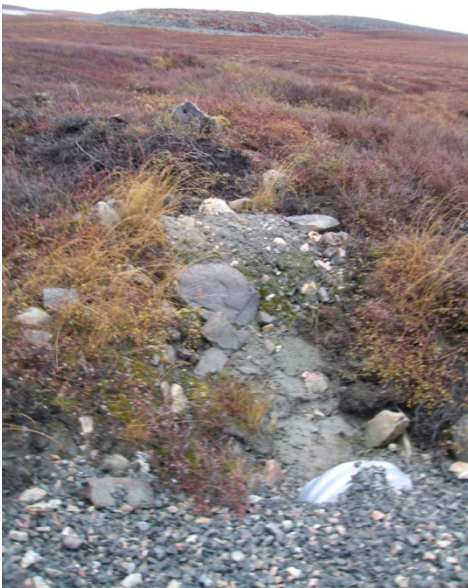
PHOTOGRAPH D2-56: PC-11, km 39+552

Description: Downstream view of culvert and valley. Note no channel, berm of material near outlet, water would pond and until it reaches a level close to that of the road, then it could overflow to the tundra. Recommend creating an outlet in the berm to prevent ponding.

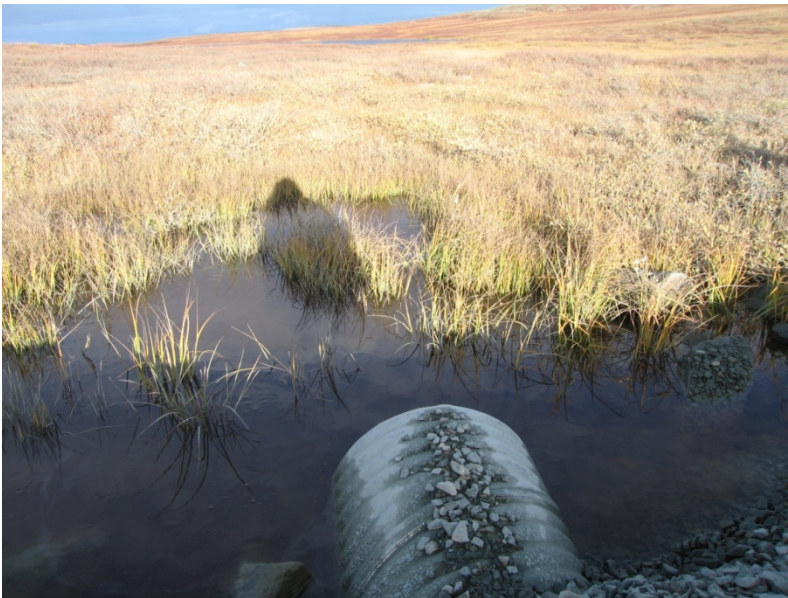
Description: Upstream view of culvert. Note ponded water.

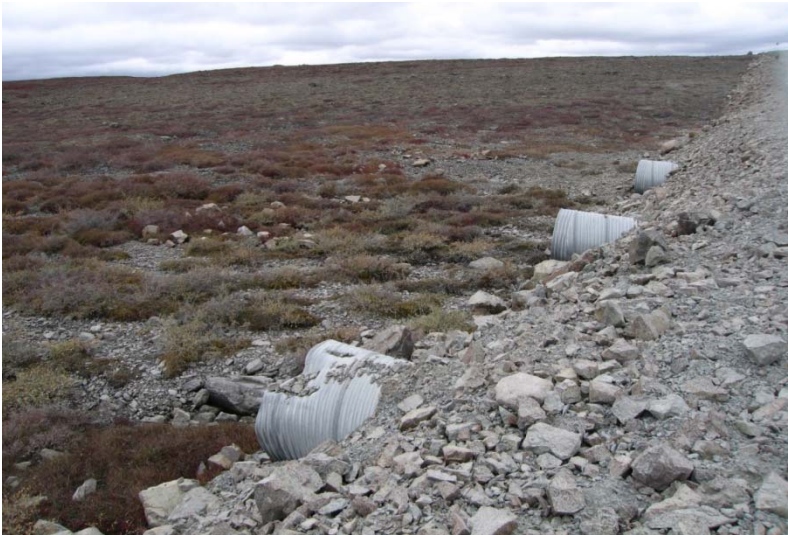
PHOTOGRAPH D2-59: R-14, km 67+840

Description: Upstream view of culverts. No visible flow entering culverts or in channel, however on downstream visible flow from middle culvert and flow appearing beyond and small flow beneath road rockfill between middle and side culvert. Good conditions with minor dents, uniform grade.

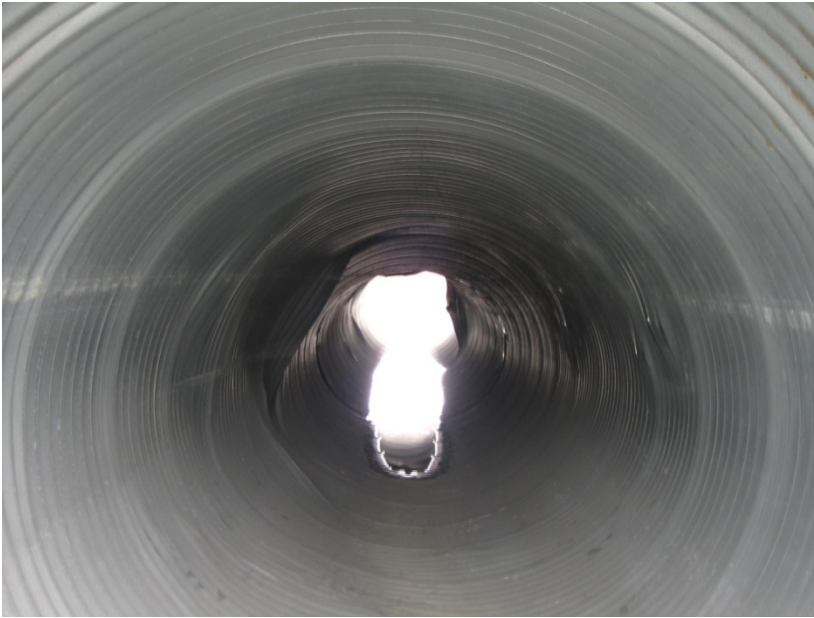
PHOTOGRAPH D2-61: R-14, km 67+840

Description: View through middle culvert. Note water in middle where water is entering through joint or hole and then flowing through the culvert. Initially flows through rockfill.

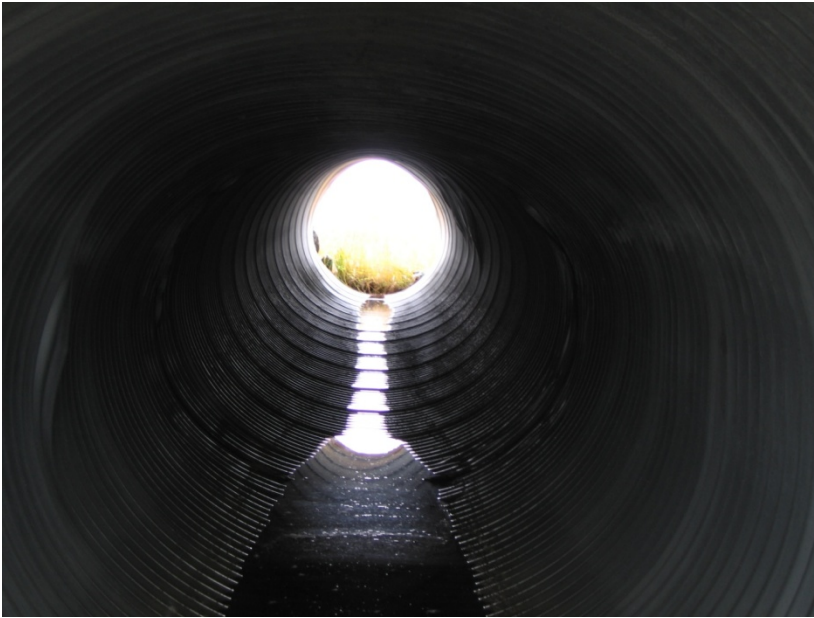
PHOTOGRAPH D2-67: R-18A, km 81+045

Description: View from upstream to downstream through middle culvert. Note dents in haunch near middle of the culvert.

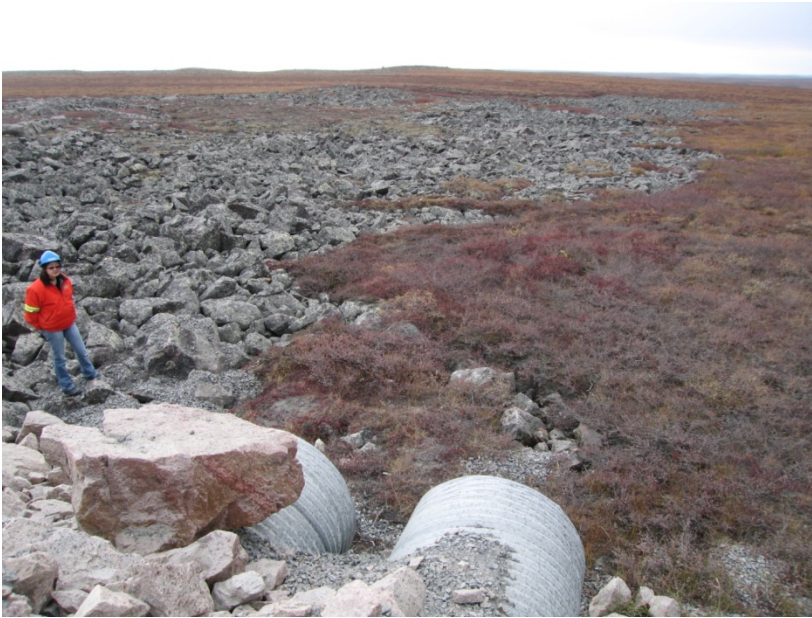
PHOTOGRAPH D2-73: R-21, km 87+500

Description: Downstream view of culverts and valley. Note large rock above culvert closest to Meadowbank (left side of photo).

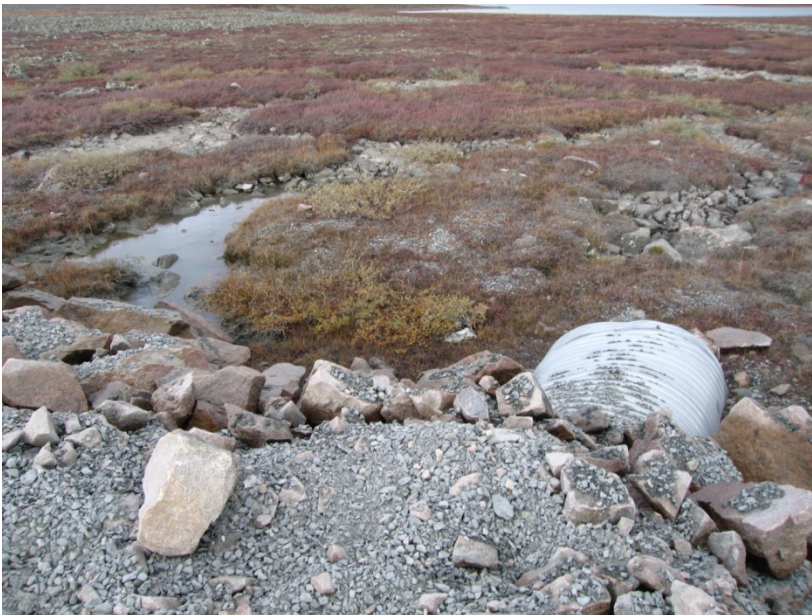
PHOTOGRAPH D2-74: R-23, km 93+600

Description: Upstream view of culvert and valley. Small dents in base and side of culvert, uniform grade, and no obstructions observed.

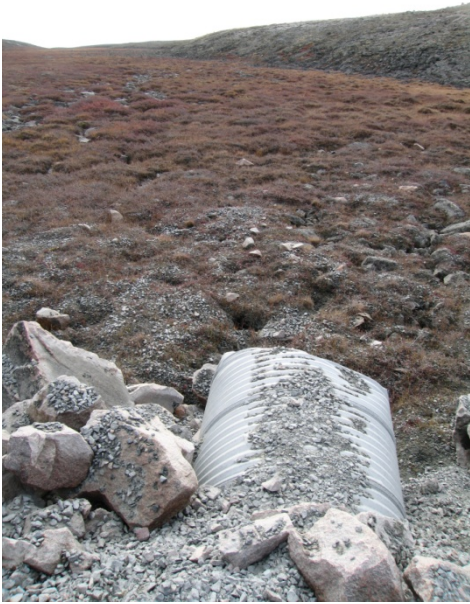
PHOTOGRAPH D2-75: R-23, km 93+600

Description: Upstream view of culvert and valley. Flow has occurred through road bed either side of culvert with some migration of fines. No narrow defined channel.

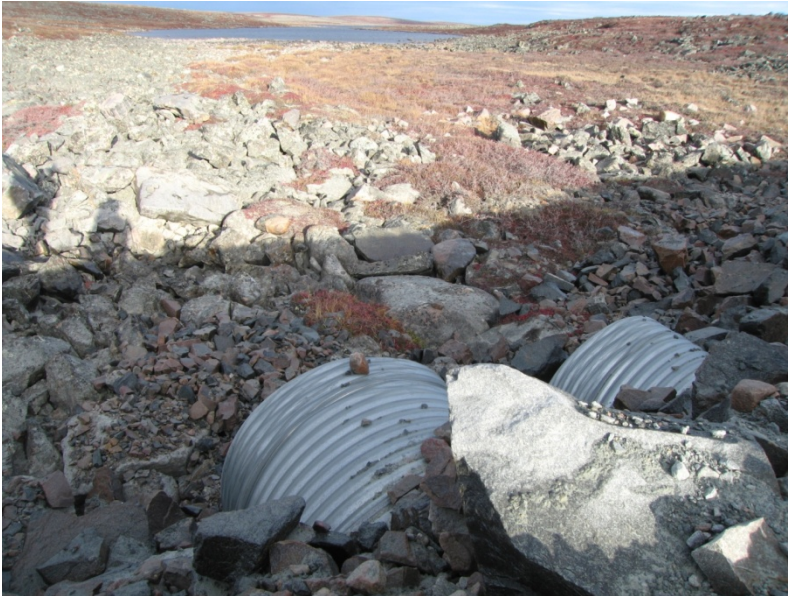
PHOTOGRAPH D2-78: R-24, km 98+250

Description: Downstream view of culverts. Some dents in base and haunch due to coarse road bed, observed in both culverts.

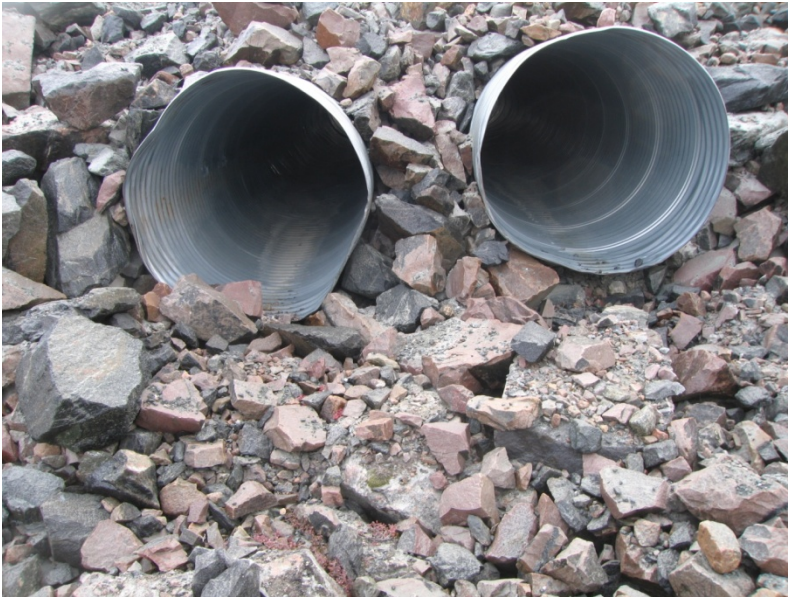
PHOTOGRAPH D2-79: R-24, km 98+250

Description: Downstream to upstream view of culverts. Culvert closest to Meadowbank (left culvert in photo) slightly lower outlet elevation compared to the culvert on the right. Left culvert may pool a little water near center.

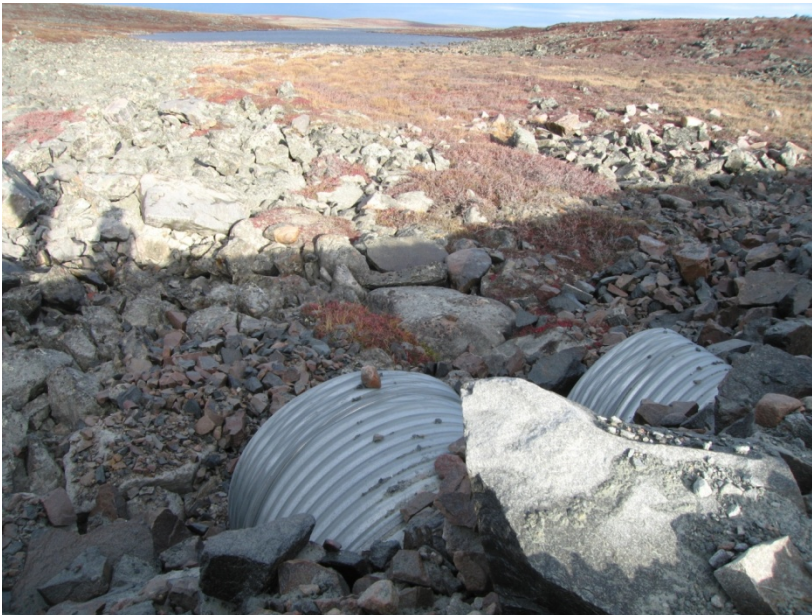
PHOTOGRAPH D2-80: R-24, km 98+250

Description: Downstream view of culverts. Some dents on base and haunch observed.

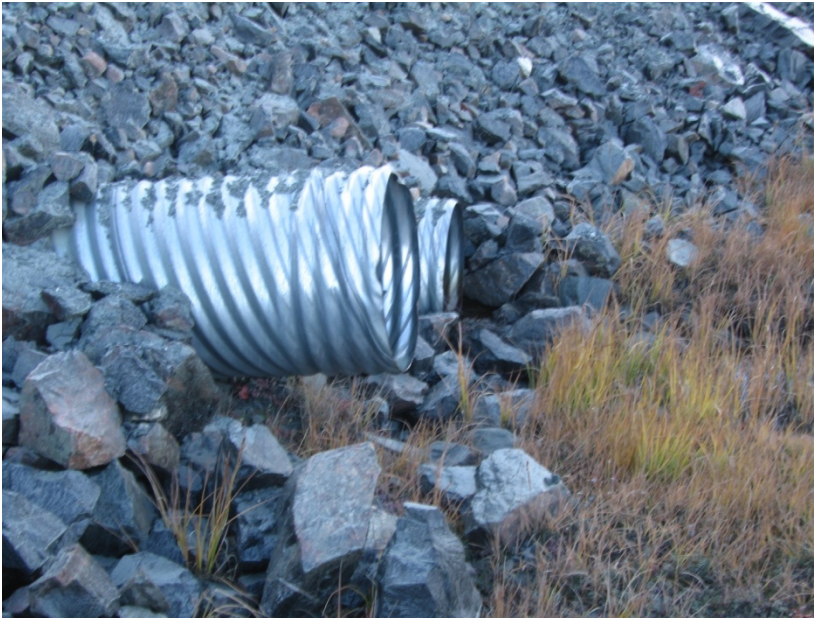
PHOTOGRAPH D2-83: R-25, km 102+050

Description: From downstream looking south. Culvert bent upwards.

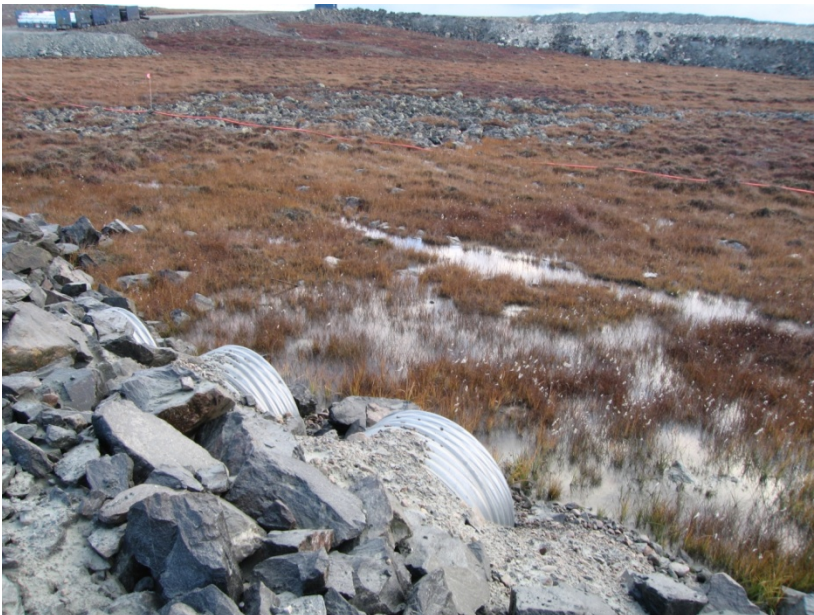
PHOTOGRAPH D2-84: R-26, km 104+710

Description: Upstream view of culverts. Some rocks from road have fallen down. Uniform grade, very minor dents, no obstructions. Very small flow observed in one culvert.

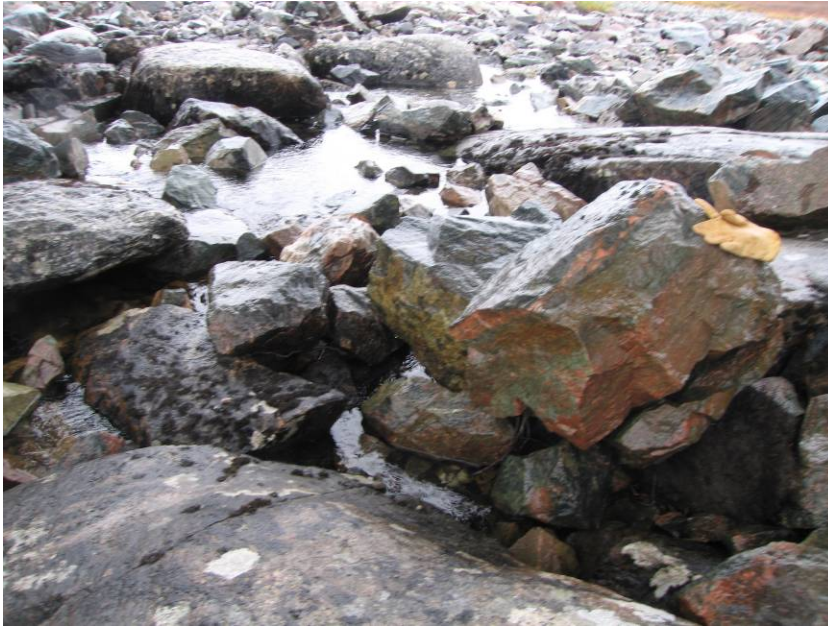
PHOTOGRAPH D3-7 – Bridge 1 - R02, km 8+750

Description: Right abutment near base in streambed, some of the rocks from the abutment have eroded / fallen down into the channel. Note rock glove is on is “fresher” looking than others.

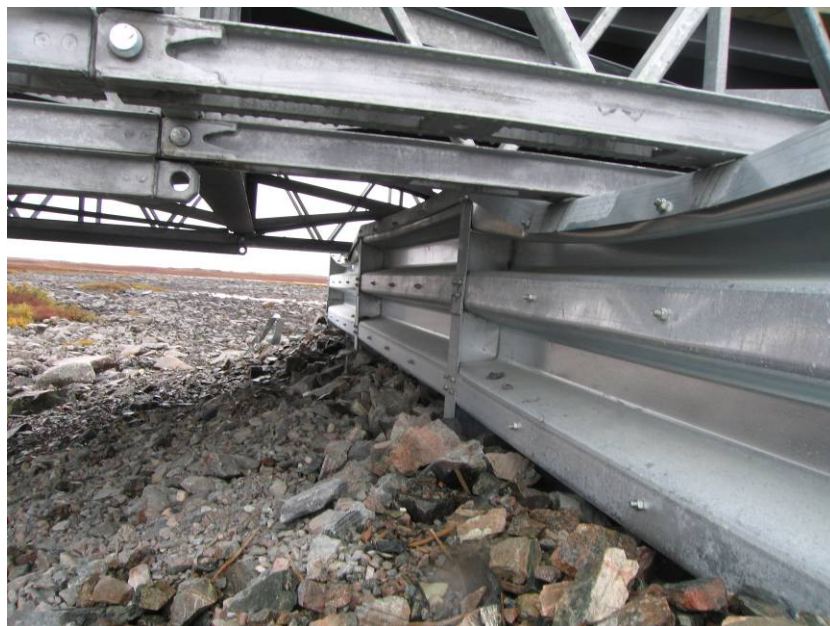
PHOTOGRAPH D3-9 – Bridge 1 - R02, km 8+750

Description: Downstream to upstream view, left abutment containment. Bent assumed during construction.

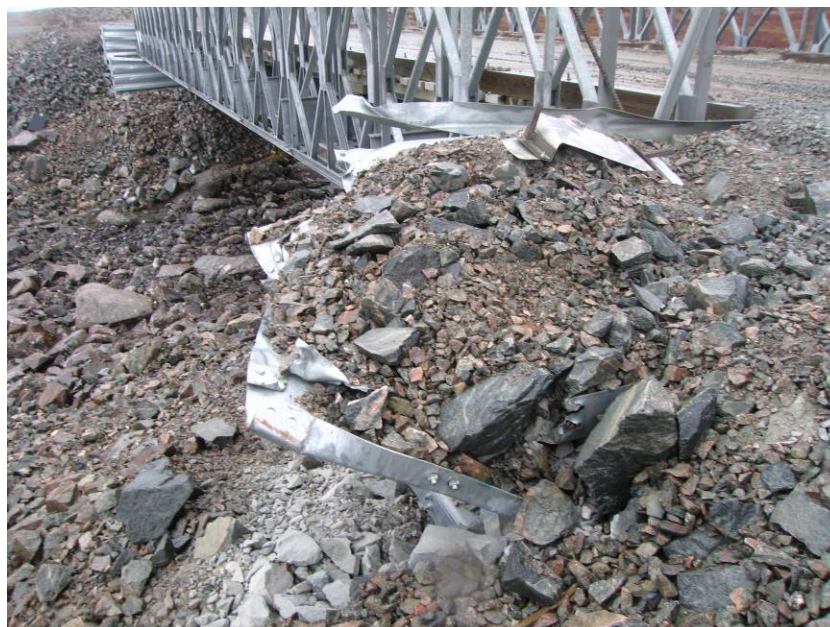
PHOTOGRAPH D3-10 – Bridge 1 - R02, km 8+750

Description: Downstream left abutment containment damaged likely occurred during snow removal activities.

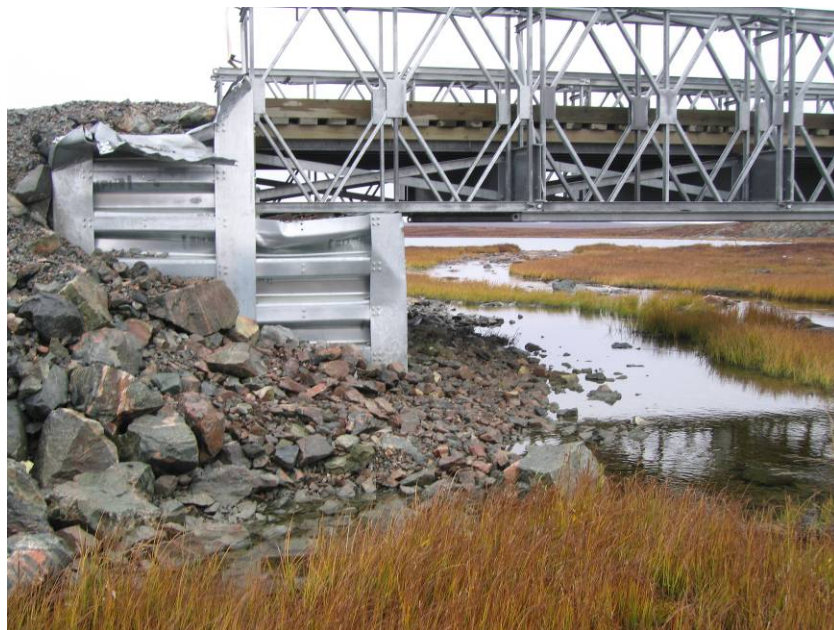
PHOTOGRAPH D3-14 – Bridge 2 - R05, km 17+600

Description: View from upstream to downstream of left abutment, note damage to containment but not a significant concern.
