2010 Annual Geotechnical Inspection Meadowbank Gold Project, Nunavut

Submitted to:
Agnico-Eagle Mines Limited
Meadowbank Division
PO Box 540
Baker Lake, Nunavut
X0C 0A0

Project Number: 10-1428-0033/2000
Document Number: 1216 Ver. 0

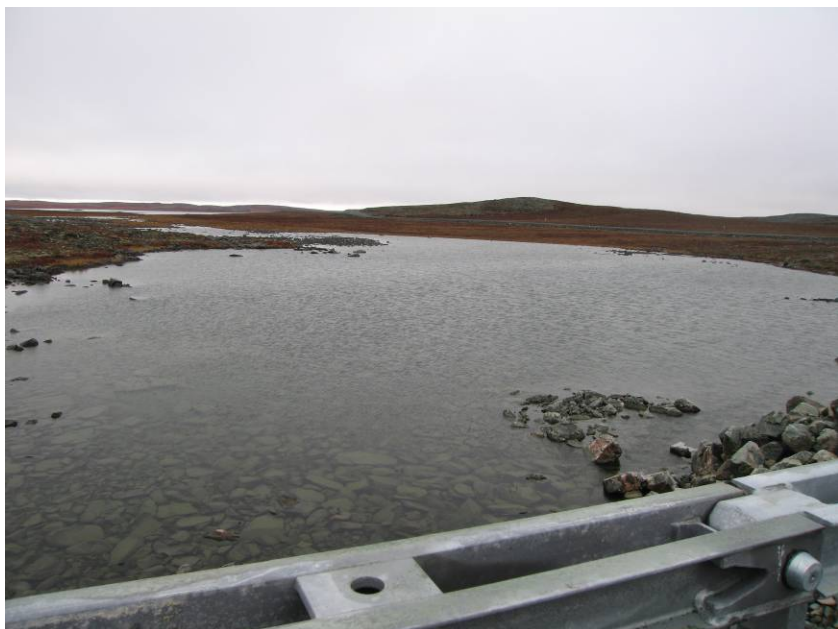
PHOTOGRAPH D3-17 – Bridge 3 - R06, km 23+100

Description: Downstream view from bridge deck.

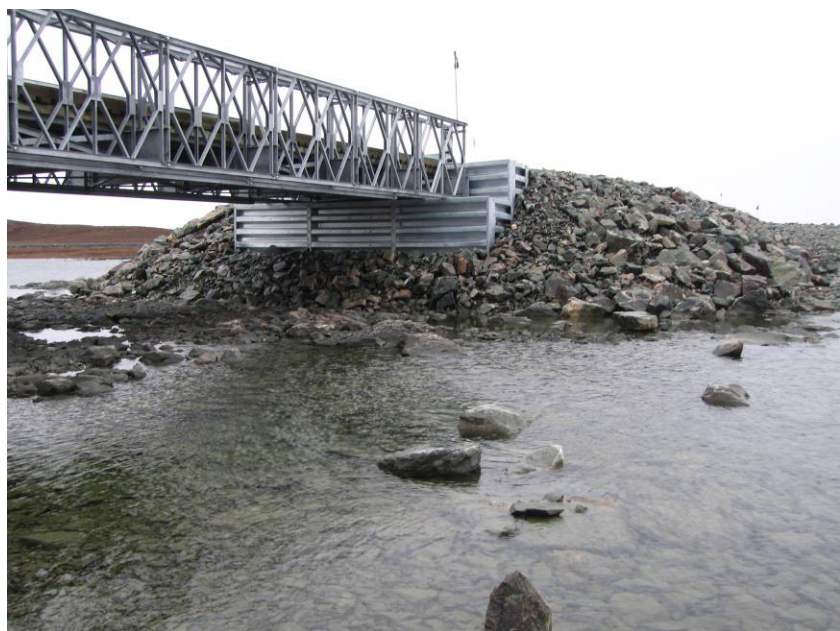
PHOTOGRAPH D3-19 – Bridge 3 - R06, km 23+100

Description: Standing on upstream side looking at right abutment.

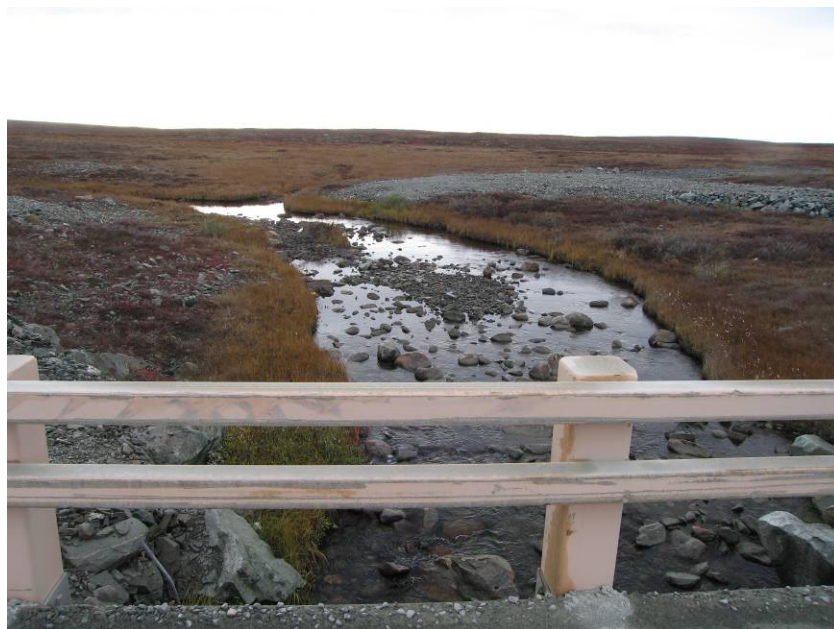
PHOTOGRAPH D3-21 – Bridge 4 - R09, km 48+500

Description: Upstream view from bridge deck, 12m Rapid Span Bridge. Upstream of bridge two streams join. Note gravel "access road" on right side of photo.

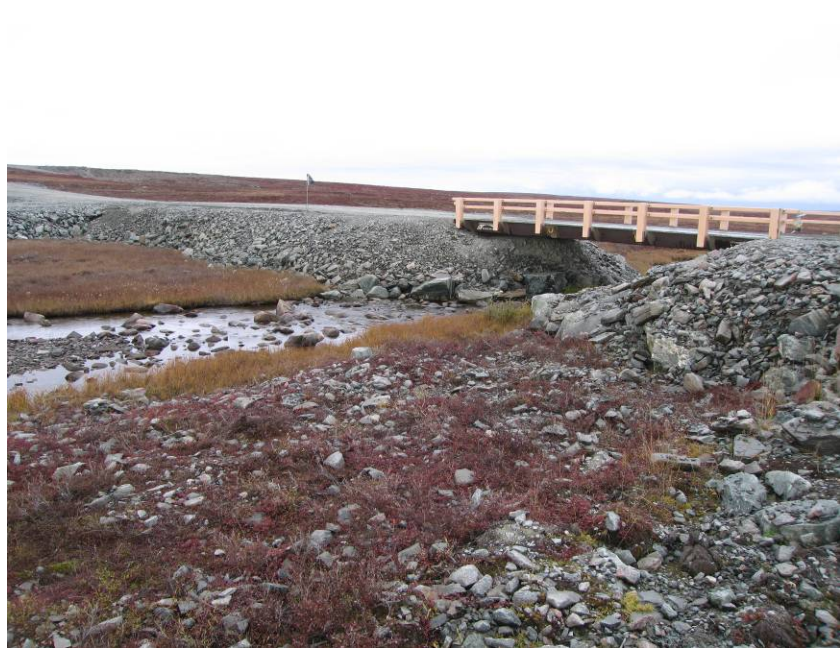
PHOTOGRAPH D3-23 – Bridge 4 - R09, km 48+500

Description: View of bridge from upstream.

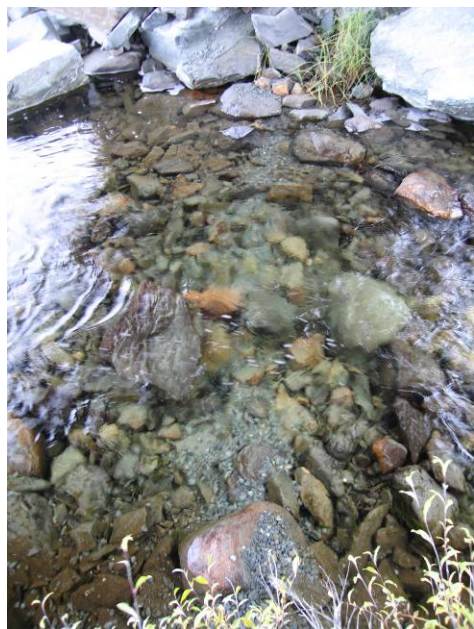
PHOTOGRAPH D3-25 – Bridge 4 - R09, km 48+500

Description: Deeper depression in streambed beneath bridge and gravel from road appears to have fallen through gap bridge deck into the stream.

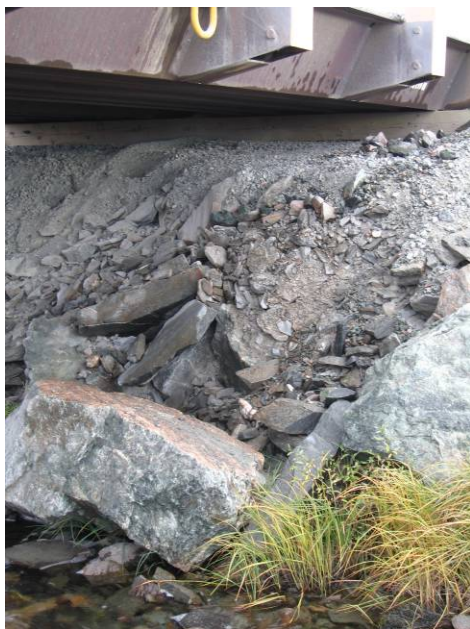
PHOTOGRAPH D3-27 – Bridge 4 - R09, km 48+060

Description: Right abutment. Some erosion of bank, larger boulder has fallen down.

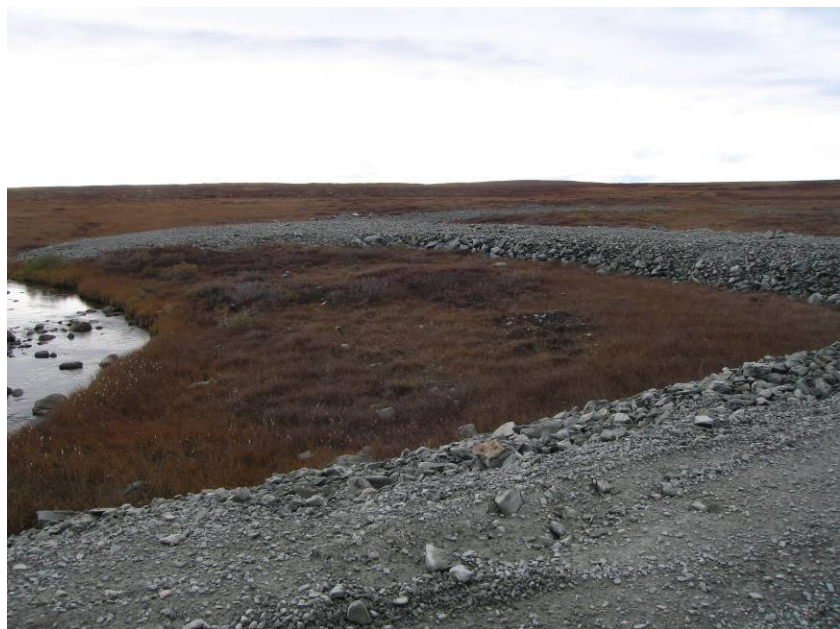
PHOTOGRAPH D3-29– Bridge 4 - R09, km 48+060

Description: From Meadowbank side of bridge looking upstream at turnaround loop near stream and tributary joining.

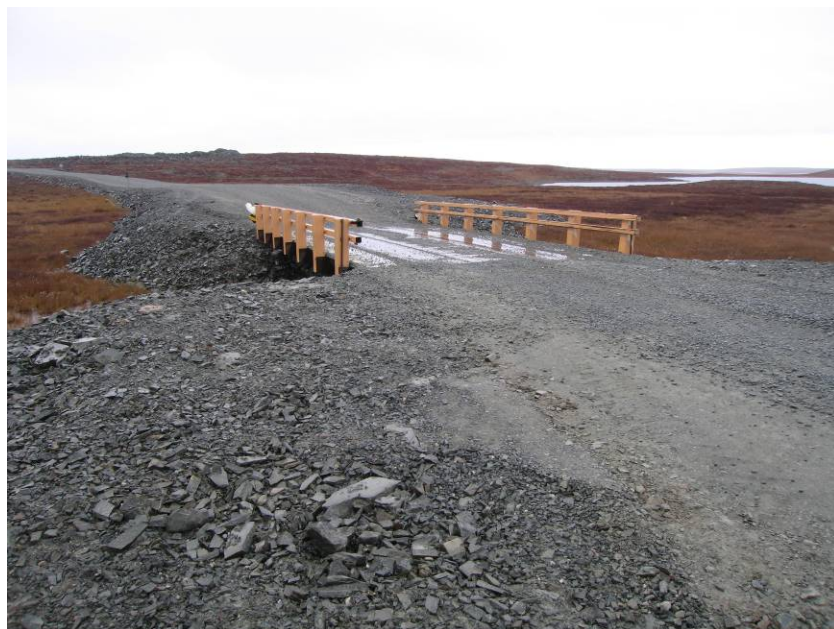
PHOTOGRAPH D3-31 – Bridge 5 - R13, km 62+060

Description: View of bridge from Baker Lake side looking towards Meadowbank at downstream side of bridge. 12m Rapid Span Bridge.

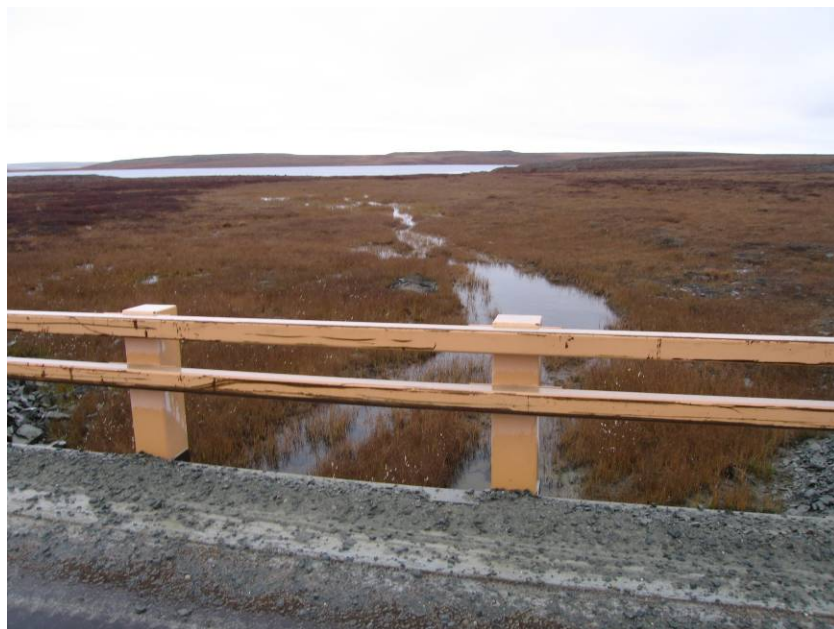
PHOTOGRAPH D3-33 – Bridge 5 - R13, km 62+060

Description: Downstream view from bridge deck. Bridge is channelizing flow increasing velocity.

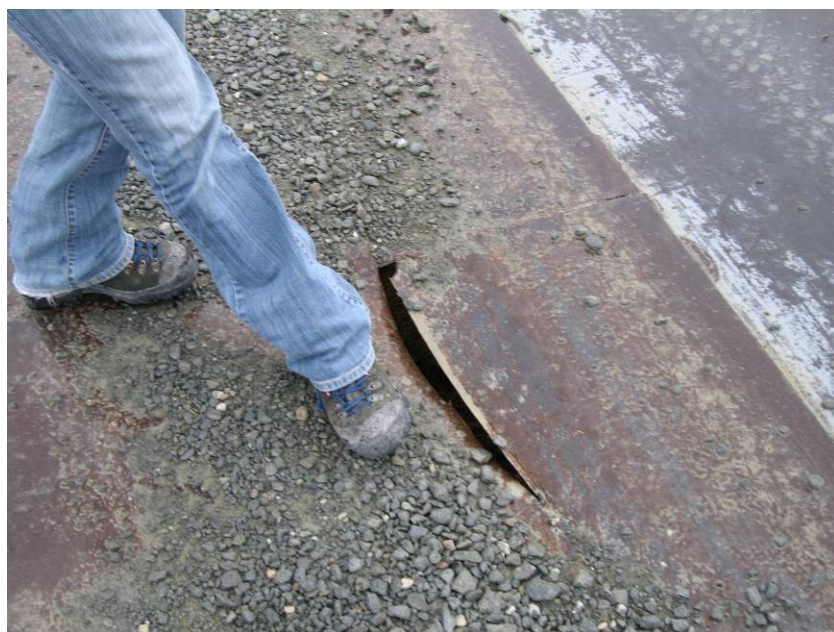
PHOTOGRAPH D3-34 – Bridge 5 - R13, km 62+060

Description: Looking at middle of bridge deck. Hole in steel decking, failed weld. Repairs have been made.

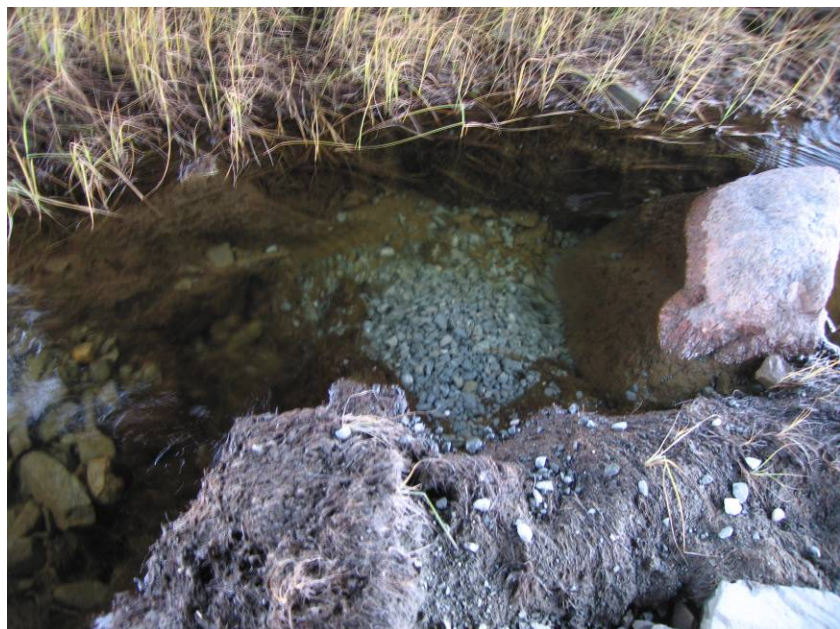
PHOTOGRAPH D3-35 – Bridge 5 - R13, km 62+060

Description: Beneath bridge. Road gravel has fallen down into water course through hole in deck.

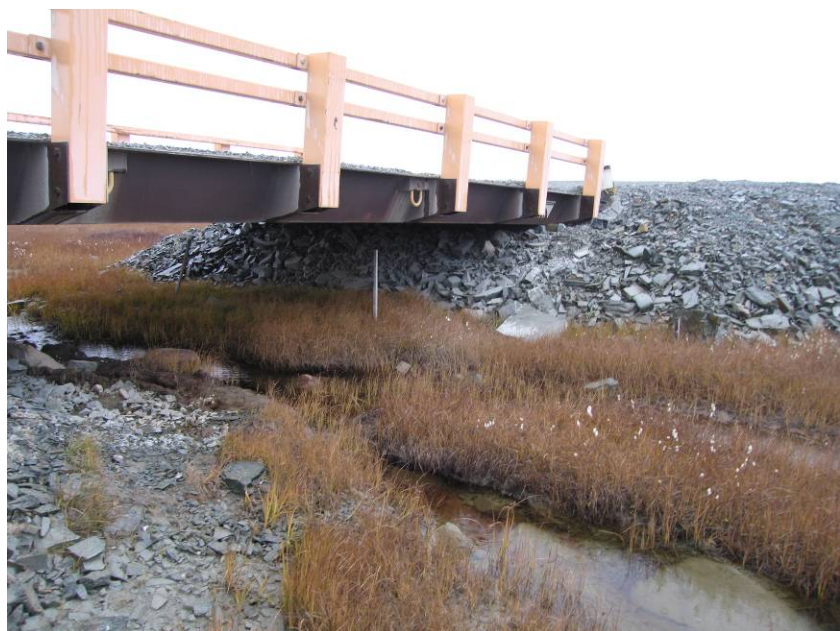
PHOTOGRAPH D3-37 – Bridge 5 - R13, km 62+060

Description: View of left abutment looking from downstream on right abutment.

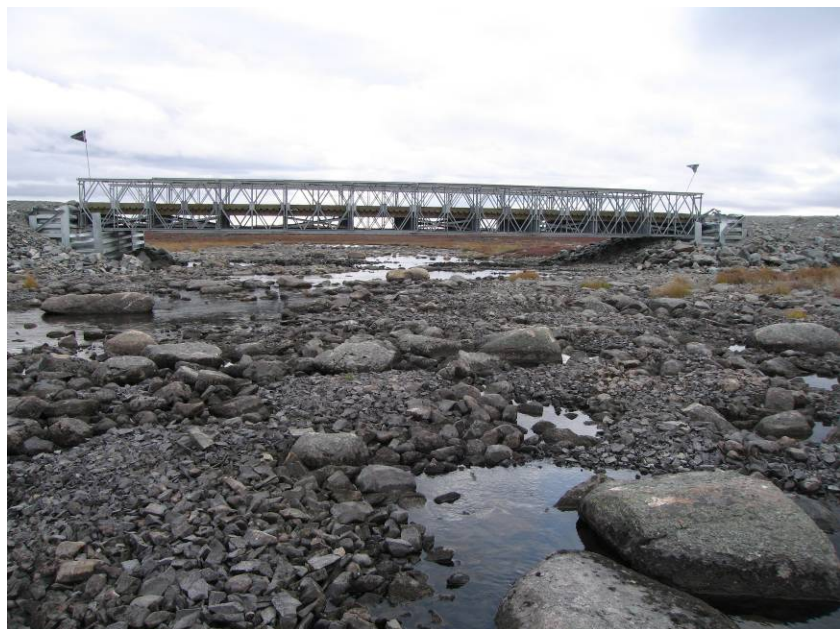
PHOTOGRAPH D3-39 – Bridge 6 - R15, km 69+200

Description: View of bridge from upstream looking downstream, 30m Acrow Panel Bridge.

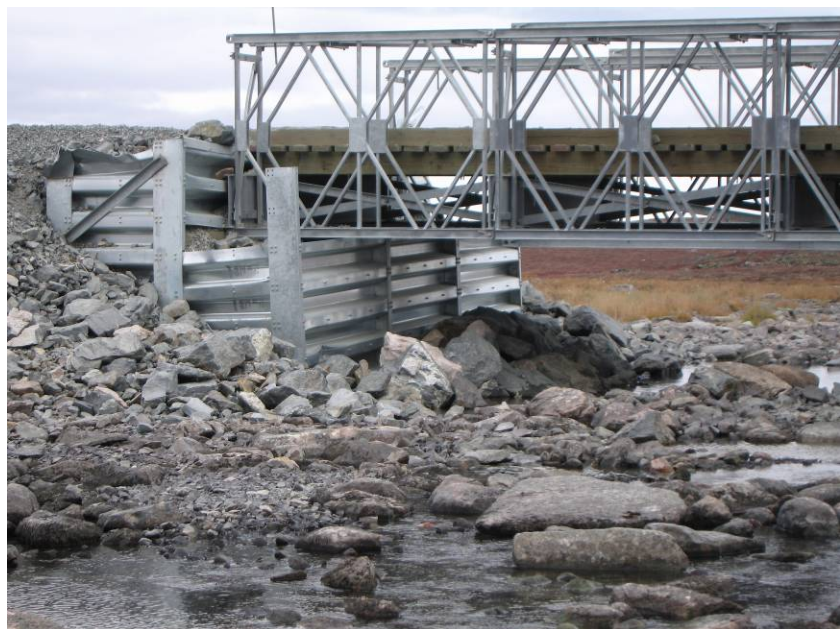
PHOTOGRAPH D3-41 – Bridge 6 - R15, km 69+200

Description: Left abutment. View from upstream to downstream.

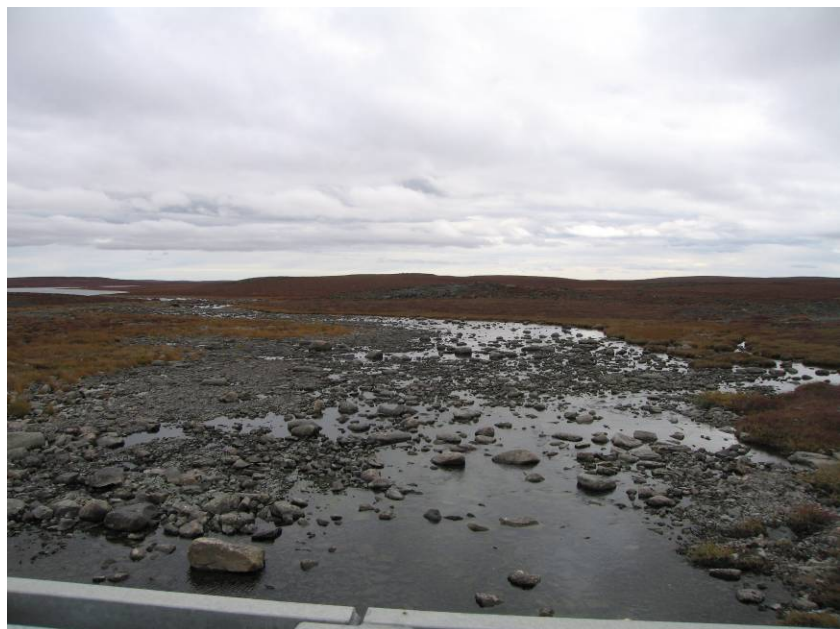
PHOTOGRAPH D3-43 – Bridge 6 - R15, km 69+200

Description: Downstream view from bridge deck.

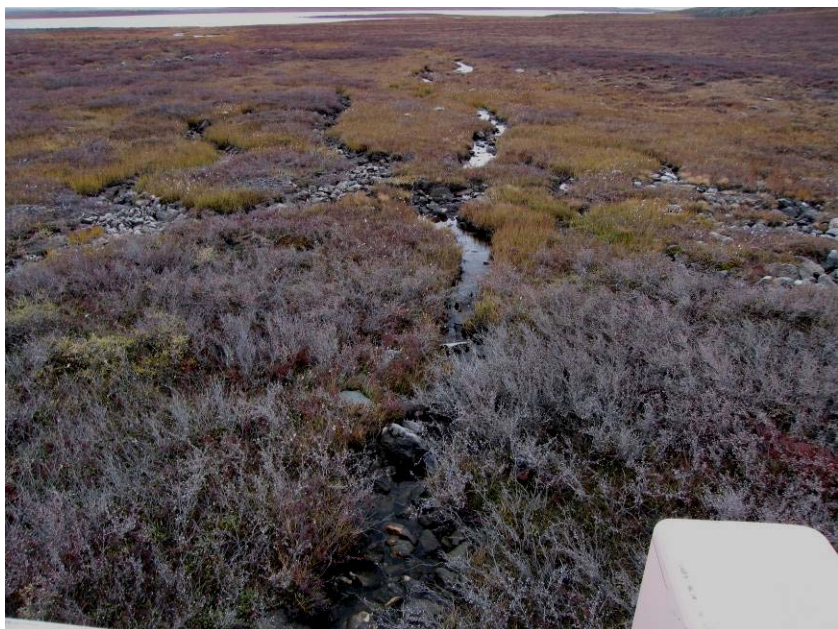
PHOTOGRAPH D3-45 – Bridge 7 - R16, km 73+800

Description: Downstream view from bridge deck. View of valley.

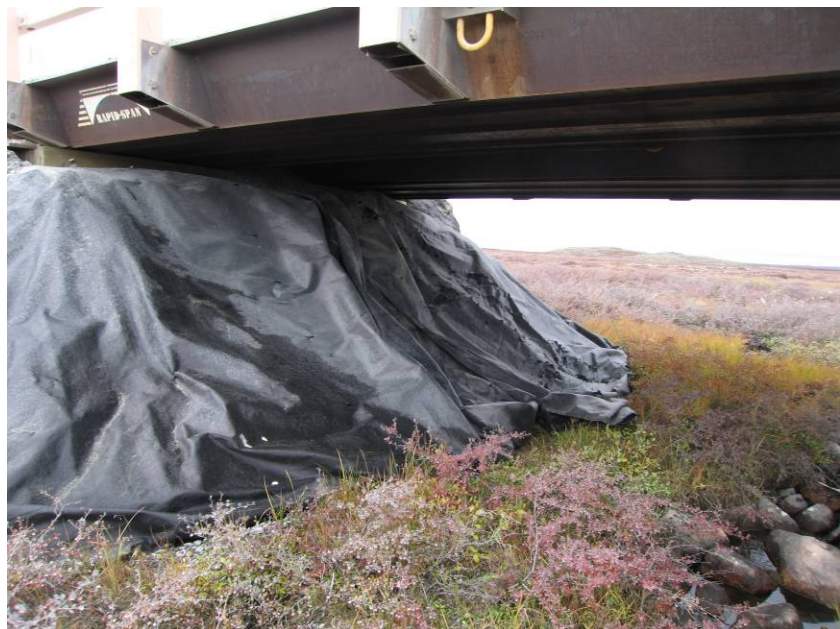
PHOTOGRAPH D3-47 – Bridge 7 - R16, km 73+800

Description: Right abutment. Downstream to upstream view.

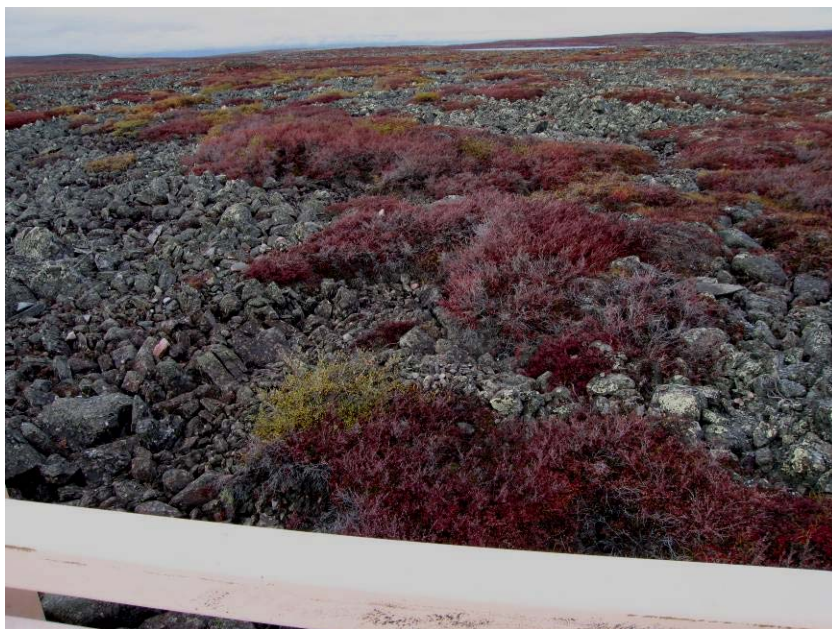
PHOTOGRAPH D3-49 – Bridge 8 - R18, km 79+500

Description: Upstream view from bridge deck, 12m Rapid Span Bridge. View of valley.

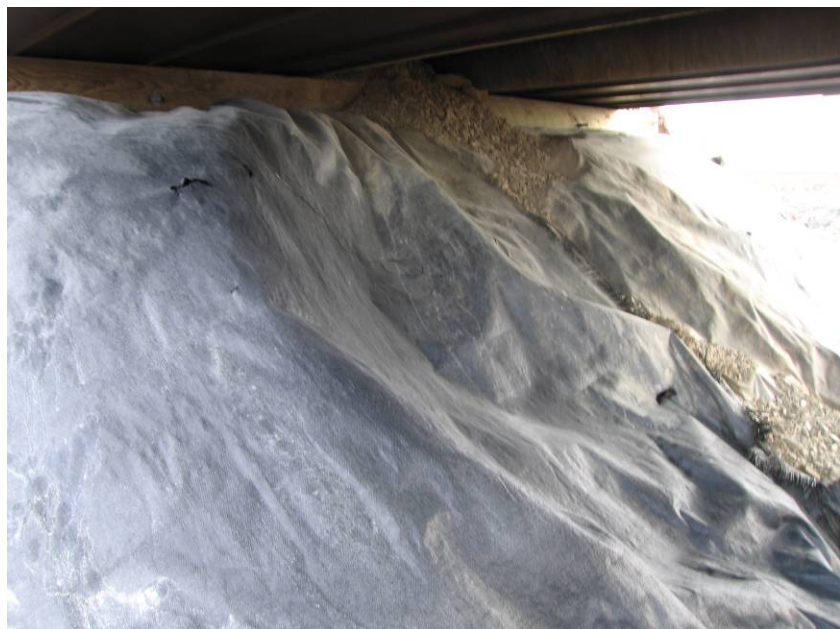
PHOTOGRAPH D3-51 – Bridge 8 - R18, km 79+500

Description: Left abutment. View from upstream to downstream. Note gravel from road bed that has fallen down onto geotextile.

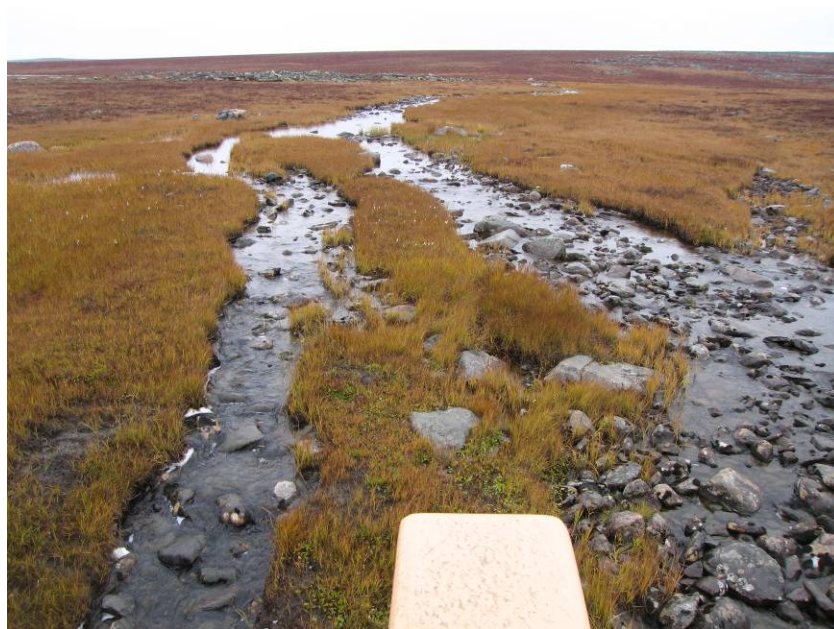
PHOTOGRAPH D3-53 – Bridge 9 - R19, km 83+100

Description: Upstream view from bridge deck, 12m Rapid Span Bridge.

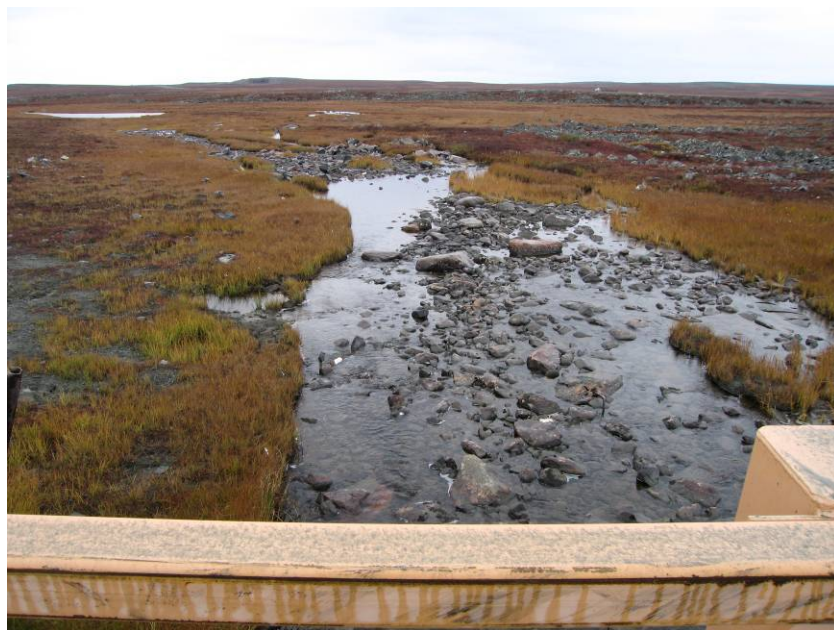
PHOTOGRAPH D3-54 – Bridge 9 - R19, km 83+100

Description: Downstream view from bridge deck. No sign of erosion, no sign of turbidity, good condition. Some bending of steel sheet walls on abutments.

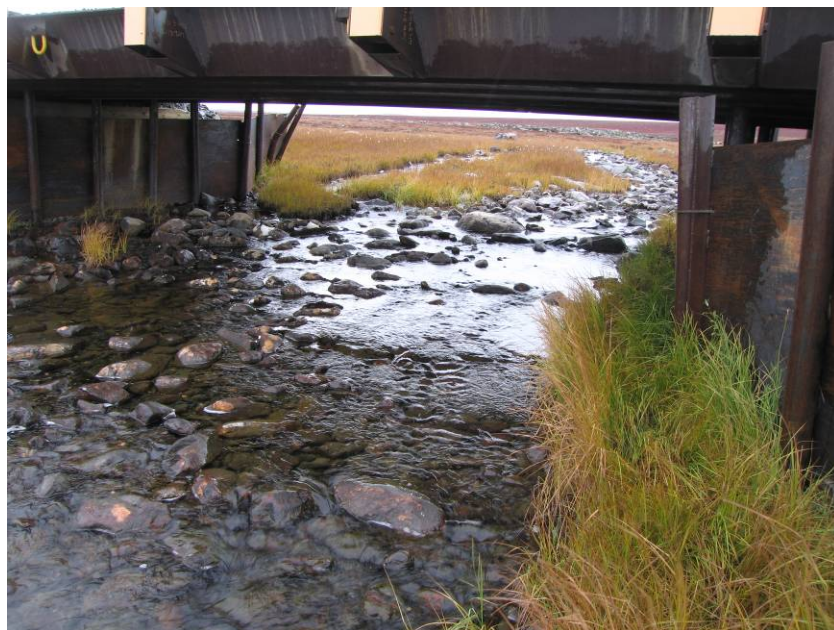
Description: View from upstream side of left abutment looking towards right abutment.

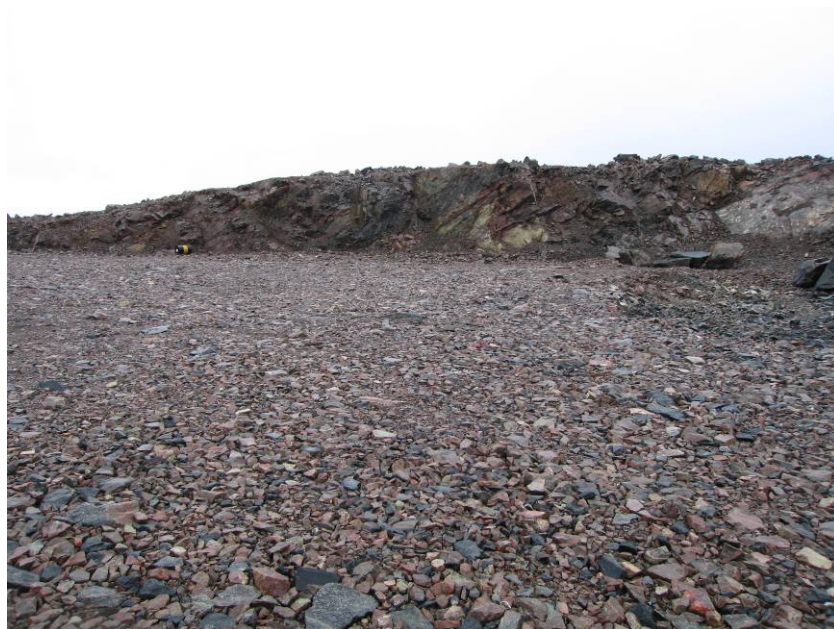
PHOTOGRAPH E-1 – Quarry 1

Description: View of south wall of quarry, looking south.

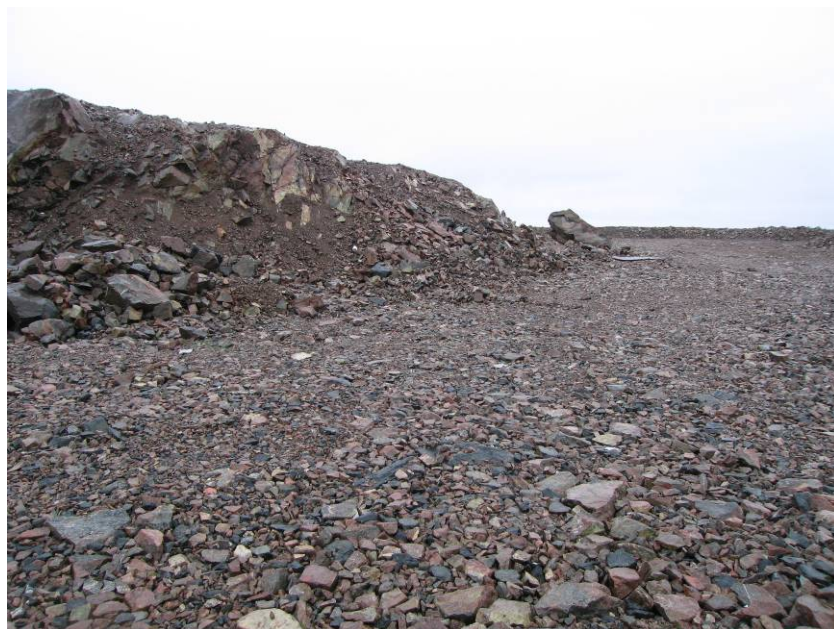
PHOTOGRAPH E-3 – Quarry 1

Description: View of north wall, looking northwest.

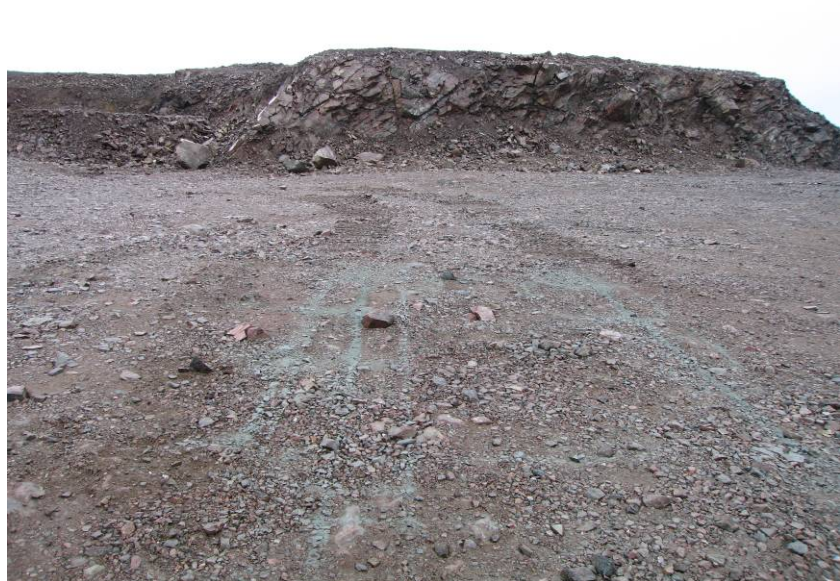
PHOTOGRAPH E-5 – Quarry 1

Description: View of south wall of 2010 expansion, looking south.

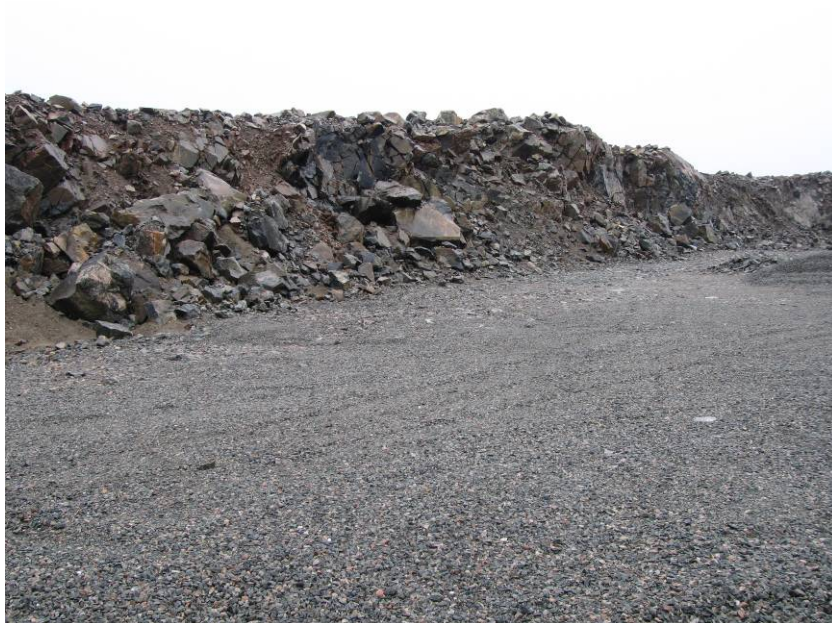
PHOTOGRAPH E-7 – Quarry 2

Description: View of south wall, looking southeast.

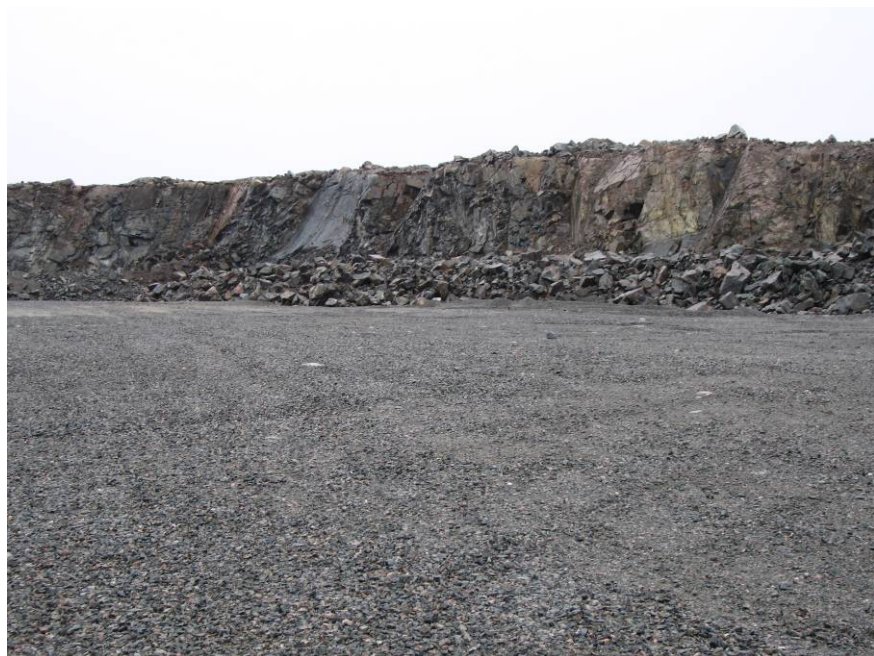
PHOTOGRAPH E-9 – Quarry 2

Description: View of north wall, looking north.

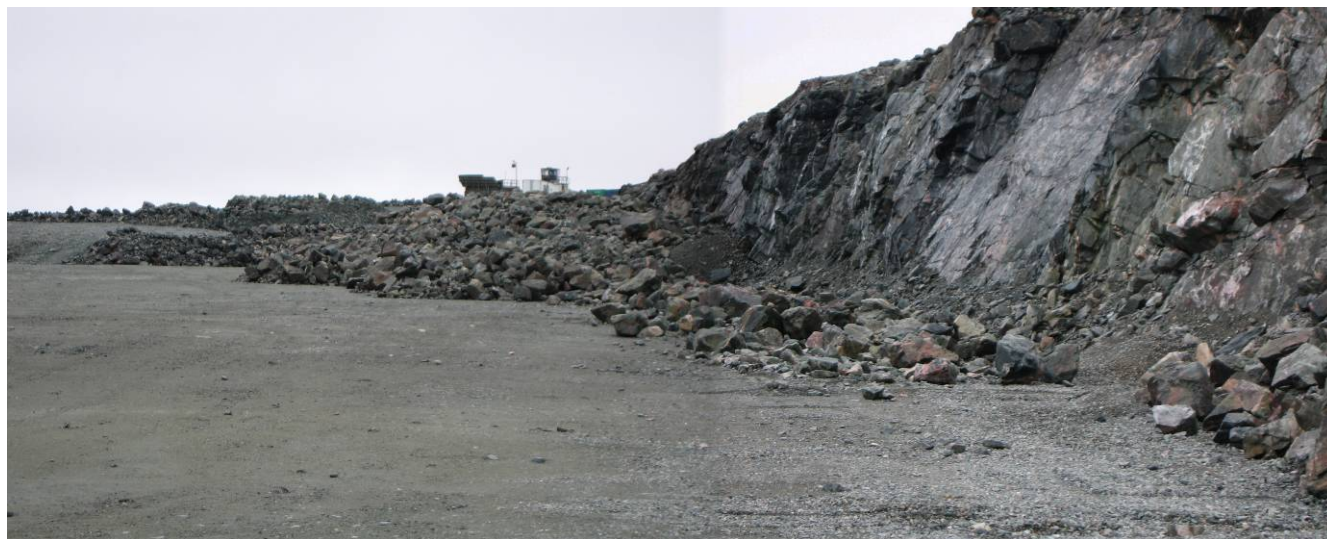
PHOTOGRAPH E-11 – Quarry 3

Description: Panoramic view of quarry, looking southwest.

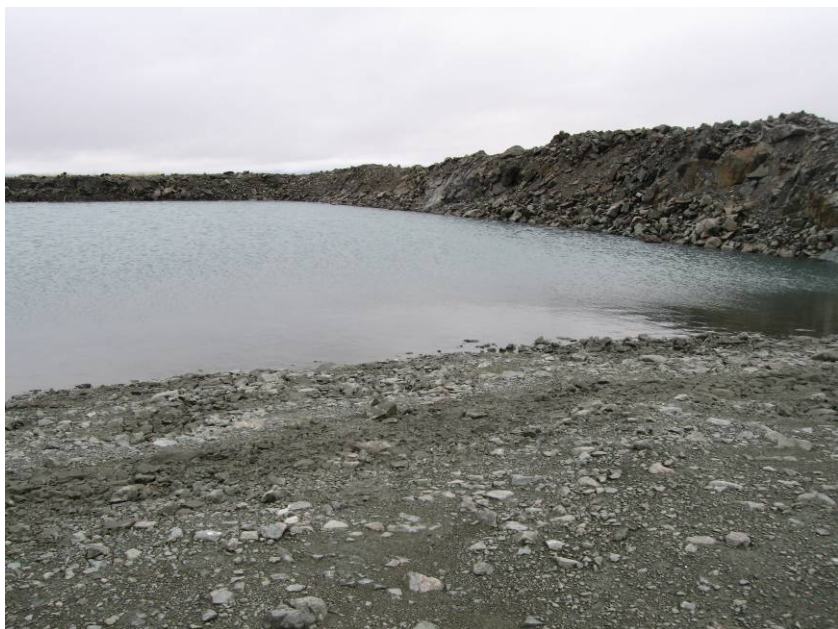
PHOTOGRAPH E-13 – Quarry 4

Description: View of south and west wall, looking southwest.

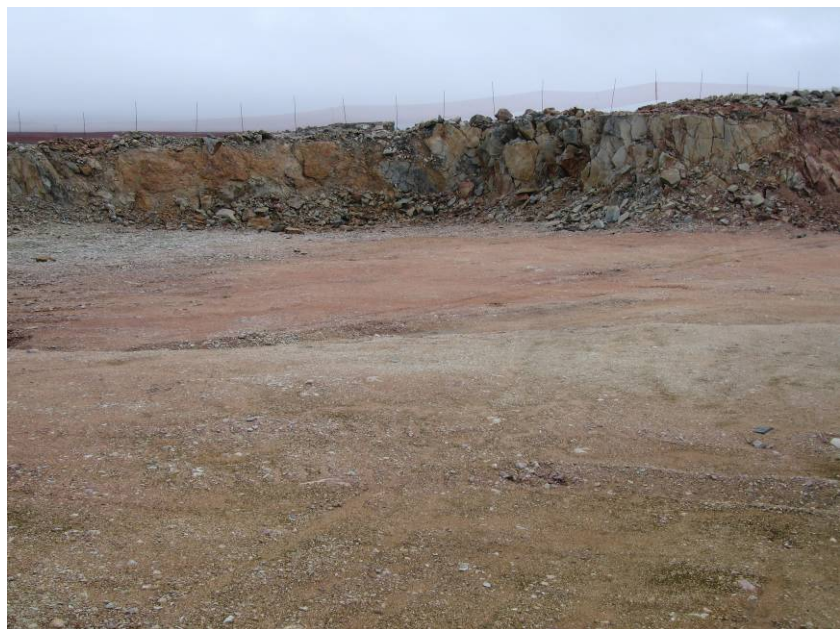
PHOTOGRAPH E-15 – Quarry 5

Description: View of north wall, looking northwest.

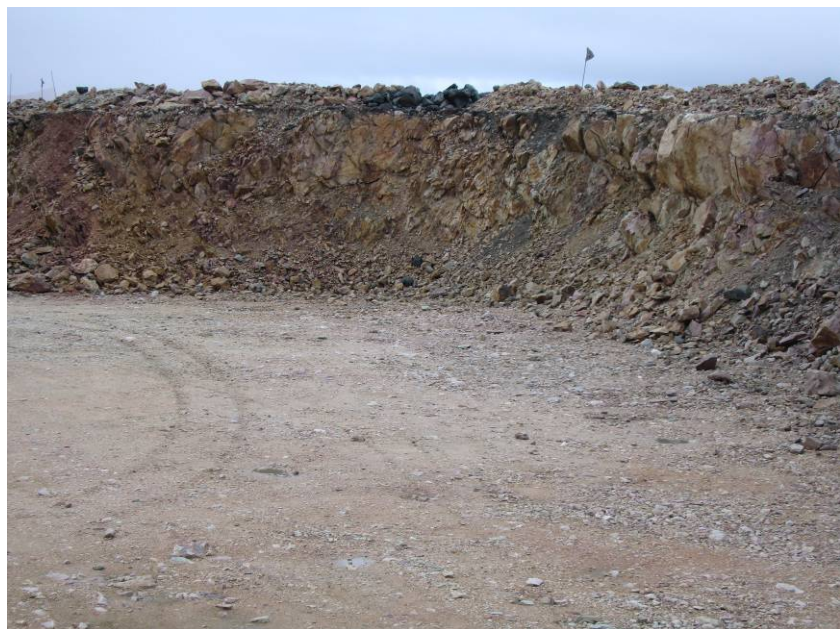
PHOTOGRAPH E-17 – Quarry 5

Description: View of east wall, looking east.

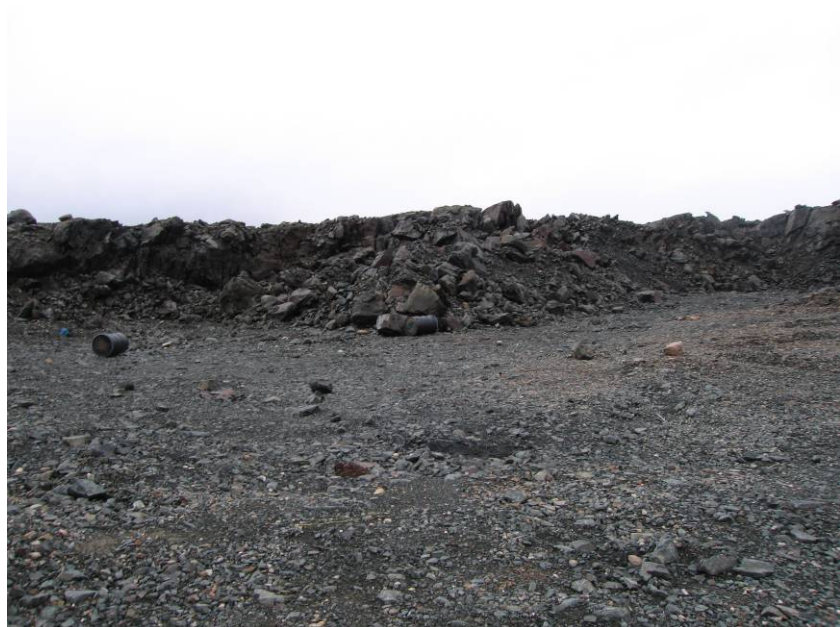
PHOTOGRAPH E-19 – Quarry 6

Description: View of west wall, looking west.

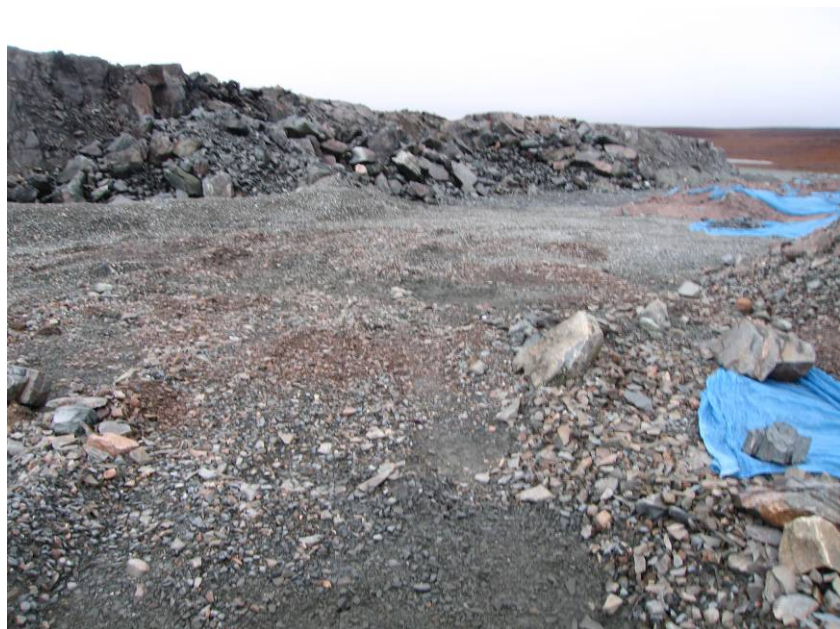
PHOTOGRAPH E-21 – Quarry 6

Description: View of east wall, looking east.

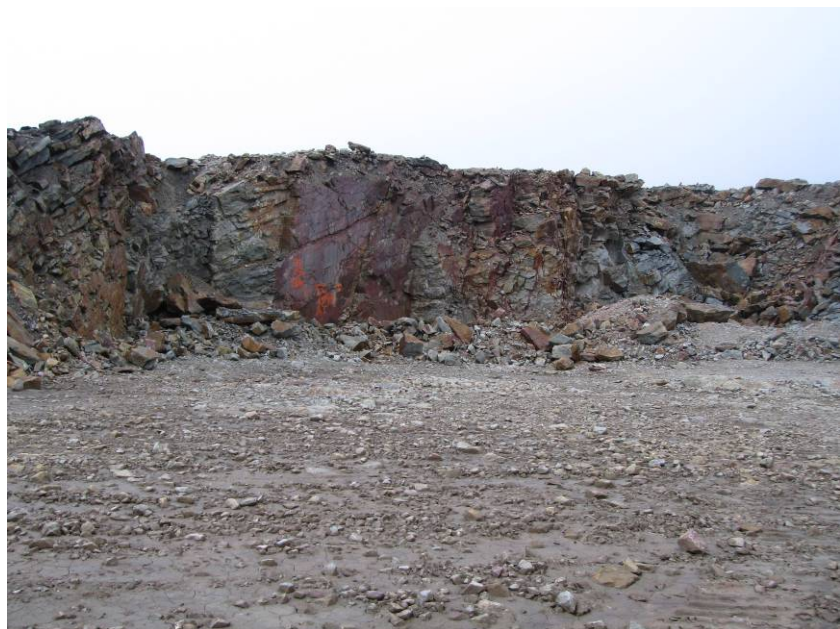
PHOTOGRAPH E-23 – Quarry 7

Description: View of west wall, looking northwest.

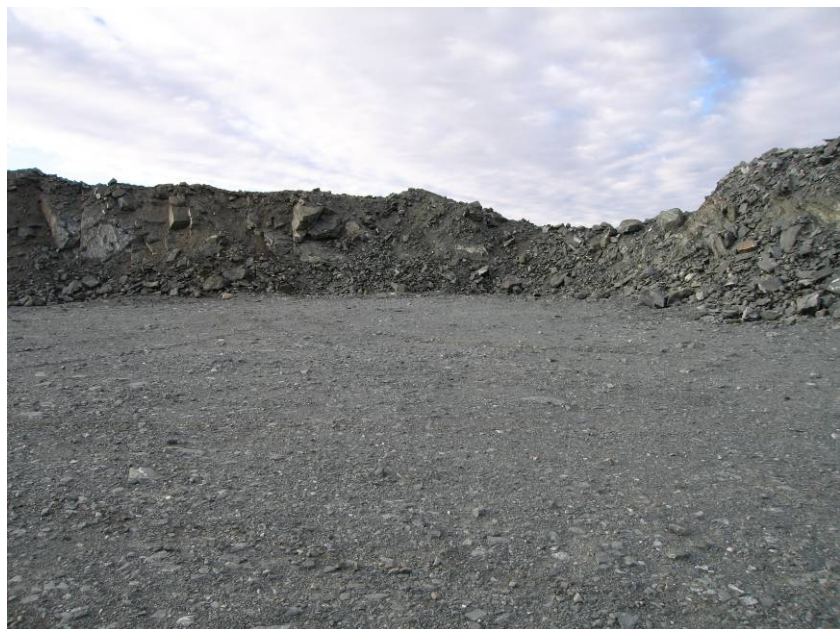
PHOTOGRAPH E-25 – Quarry 8

Description: View of west wall, looking west.

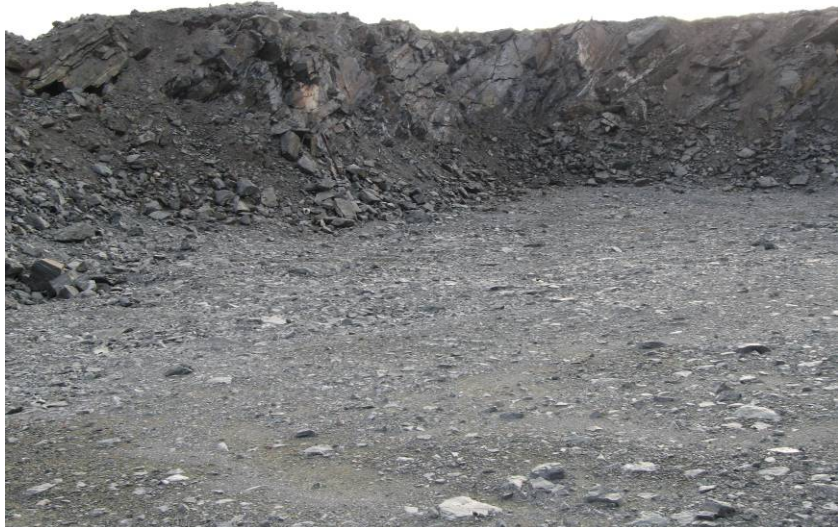
PHOTOGRAPH E-27 – Quarry 8

Description: View of southeast wall, looking south.

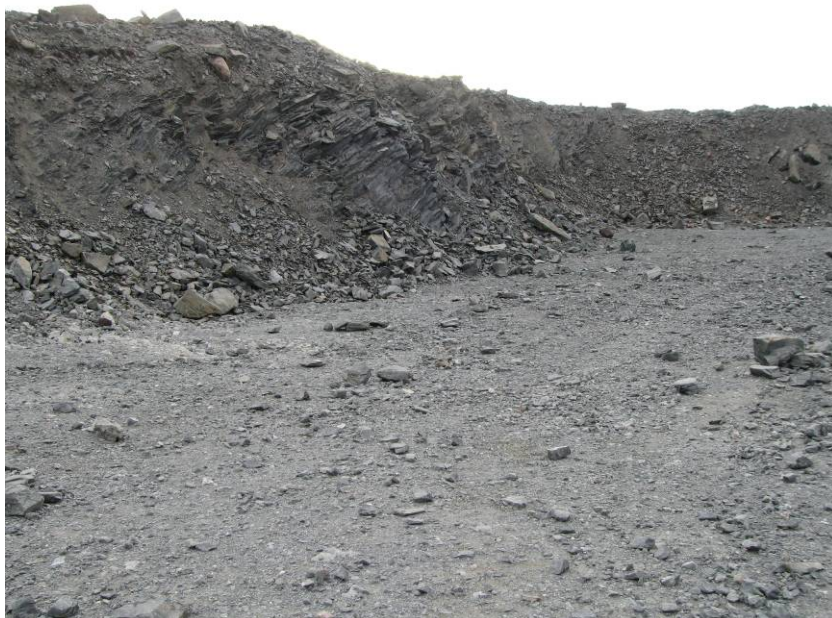
PHOTOGRAPH E-29 – Quarry 9

Description: View of southwest wall, looking southwest.

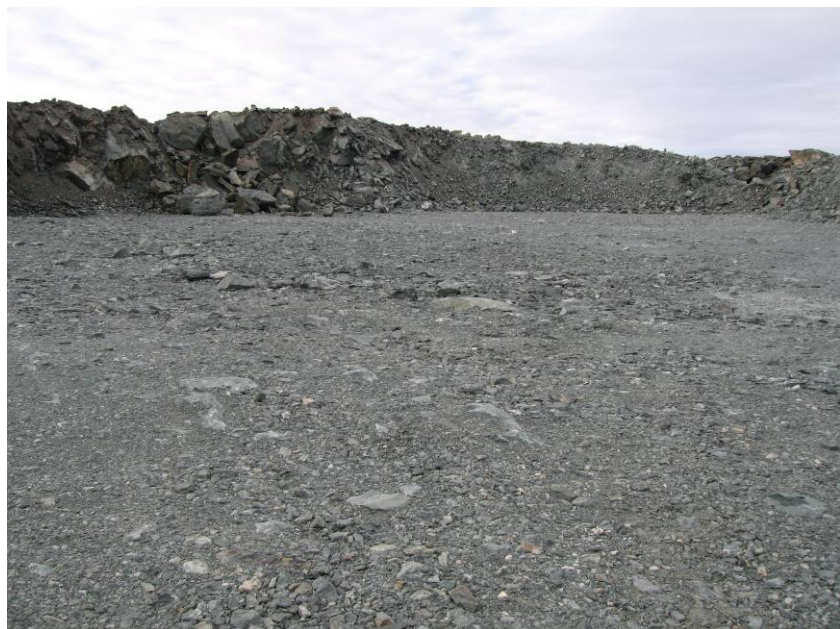
PHOTOGRAPH E-31 – Quarry 9

Description: View of north wall, looking north.

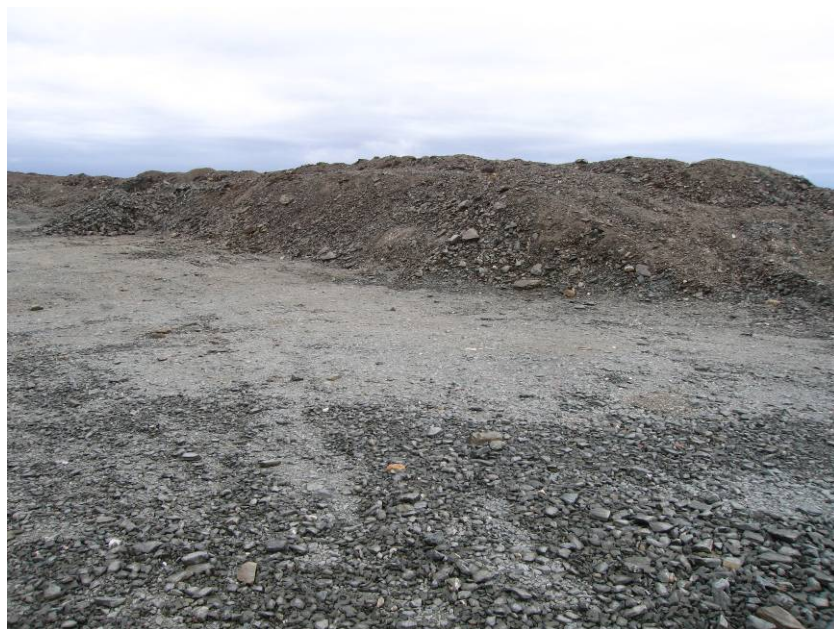
PHOTOGRAPH E-33 – Quarry 10

Description: View of east wall, looking northeast.

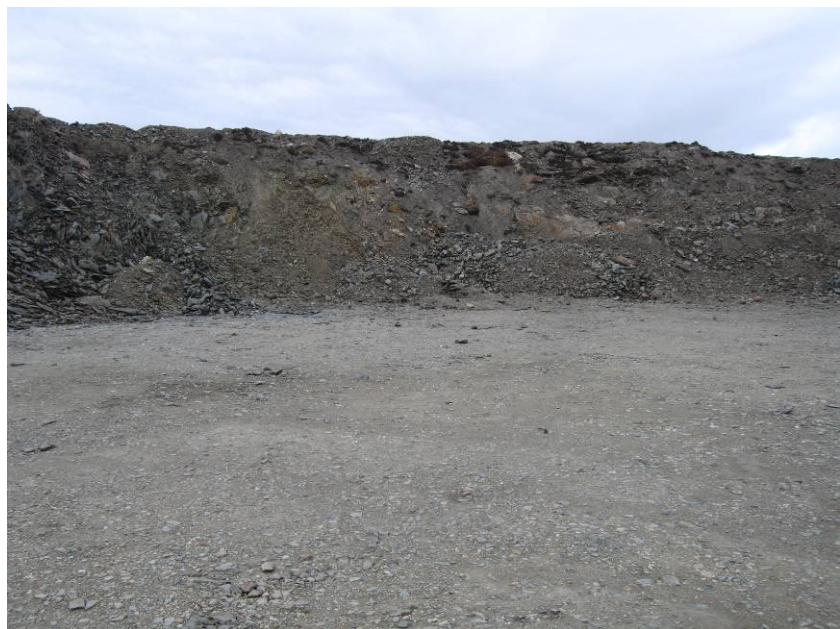
PHOTOGRAPH E-35 – Quarry 10

Description: View of west wall, looking northwest.

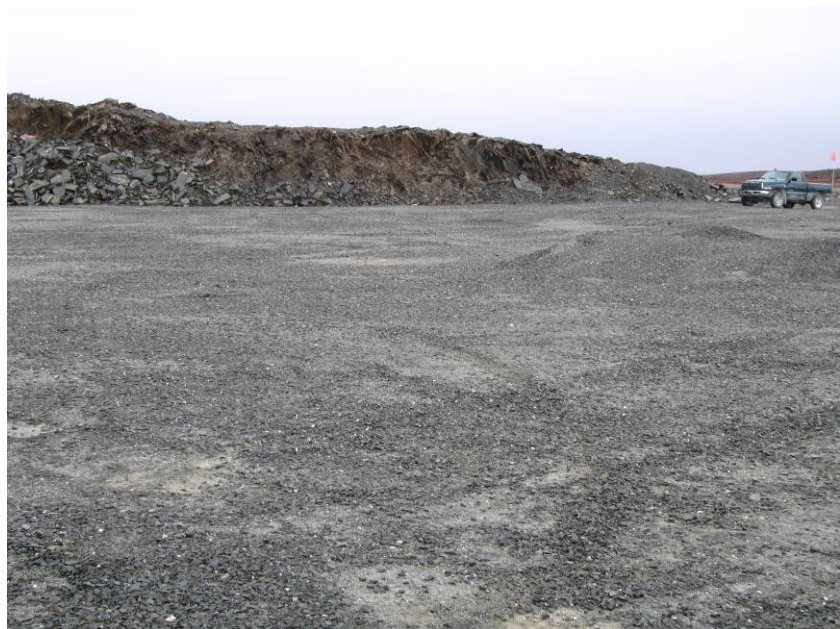
PHOTOGRAPH E-37 – Quarry 11

Description: View of the southeastern portion of the quarry, looking south.

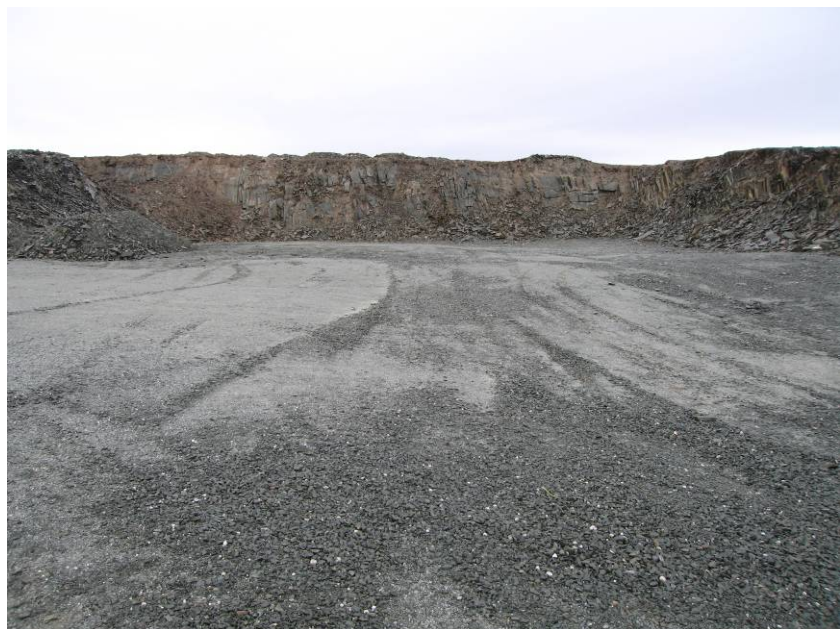
PHOTOGRAPH E-39 – Quarry 11

Description: View of north wall, looking north.
