2010 Annual Geotechnical Inspection Meadowbank Gold Project, Nunavut

Submitted to:
Agnico-Eagle Mines Limited
Meadowbank Division
PO Box 540
Baker Lake, Nunavut
X0C 0A0

Project Number: 10-1428-0033/2000
Document Number: 1216 Ver. 0

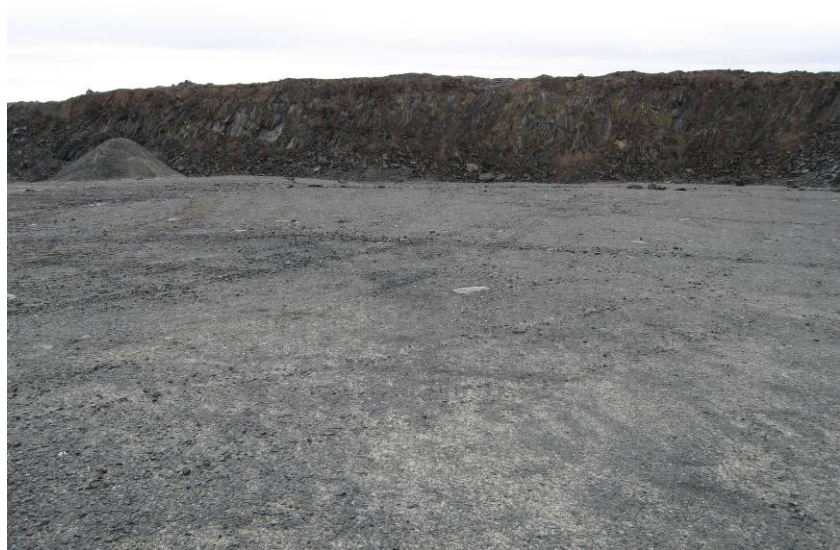
PHOTOGRAPH E-41 – Quarry 11

Description: View of west wall, looking west.

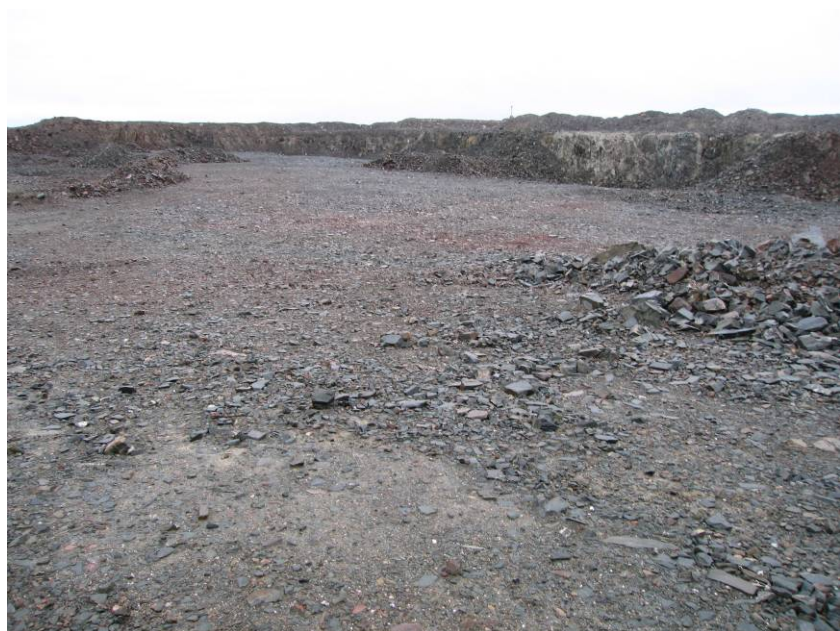
PHOTOGRAPH E-43 – Quarry 12

Description: General view looking south.

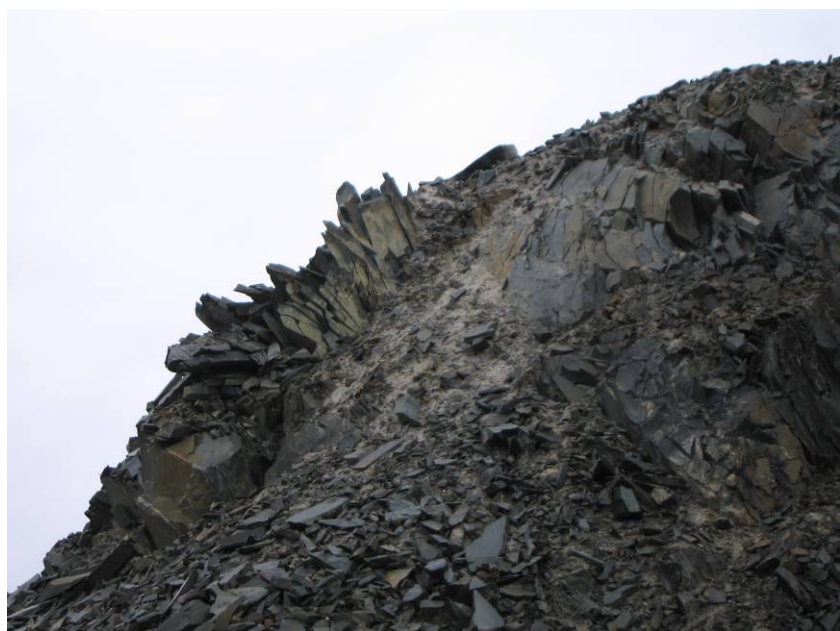
PHOTOGRAPH E-45 – Quarry 12

Description: View looking southwest.

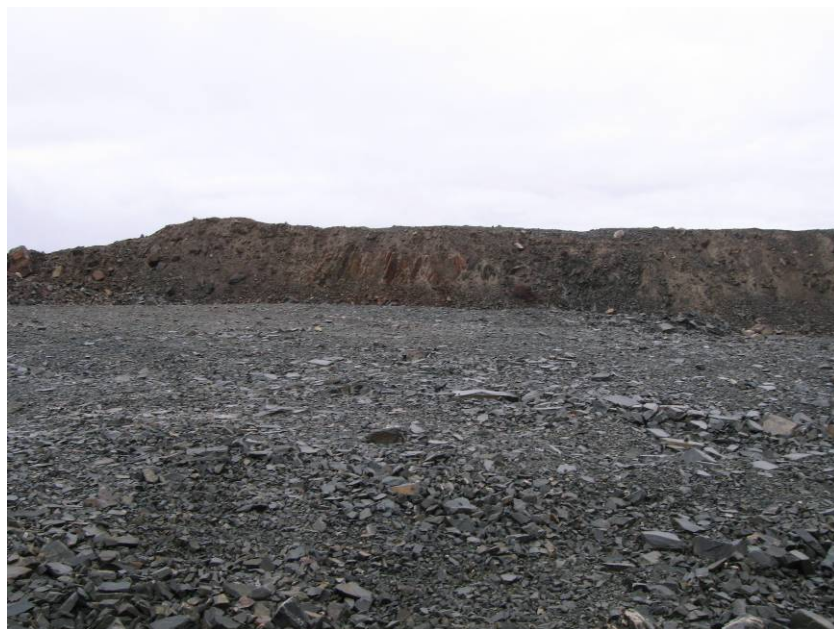
PHOTOGRAPH E-47 – Quarry 12

Description: Looking southeast.

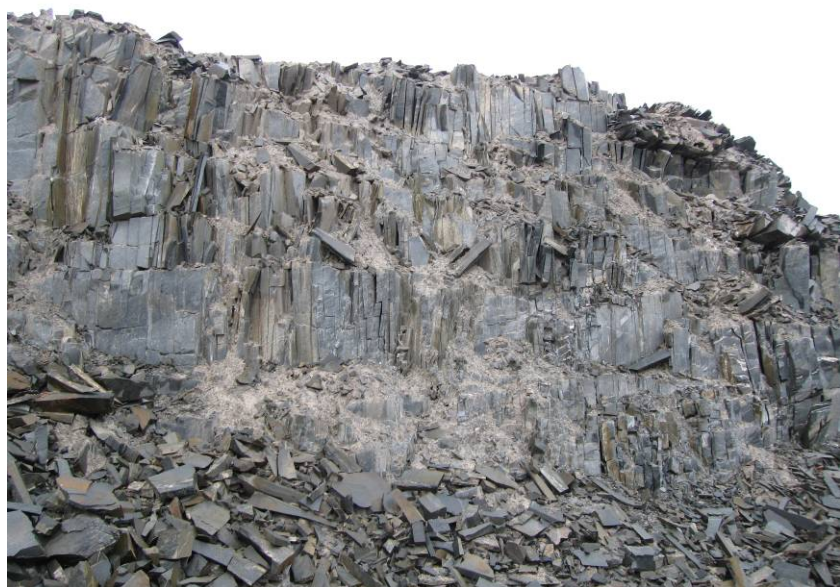
PHOTOGRAPH E-49 – Quarry 12

Description: View of northwest wall.

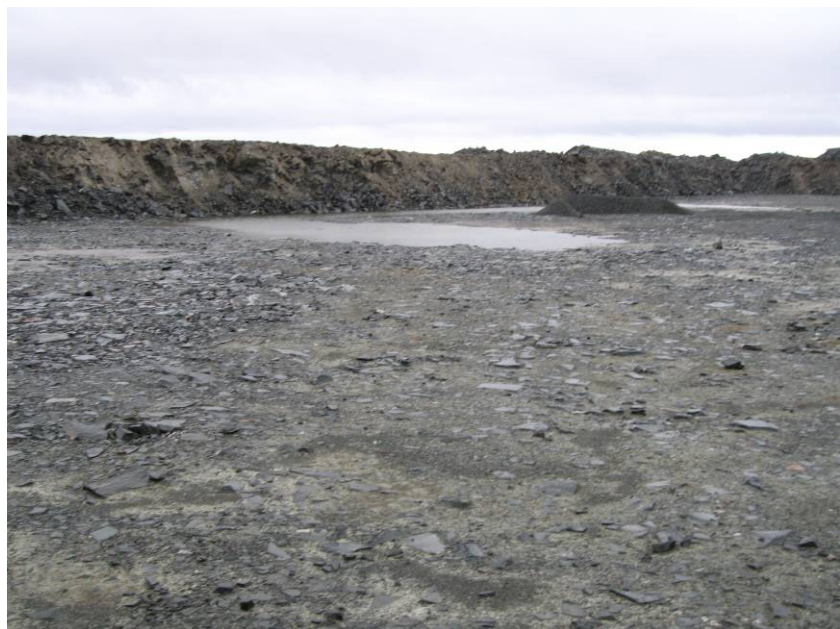
PHOTOGRAPH E-51 – Quarry 13

Description: View of northeast wall, looking north.

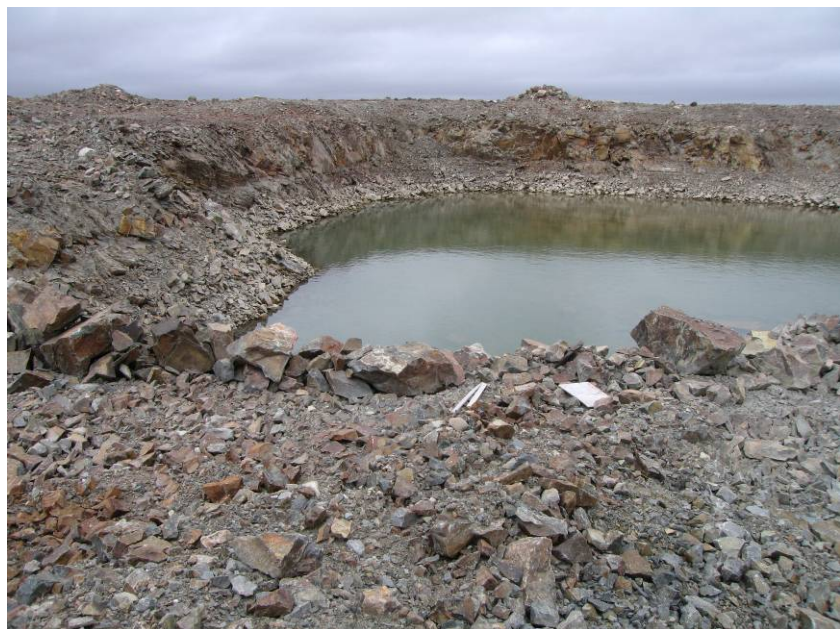
PHOTOGRAPH E-53 – Quarry 14

Description: Looking west.

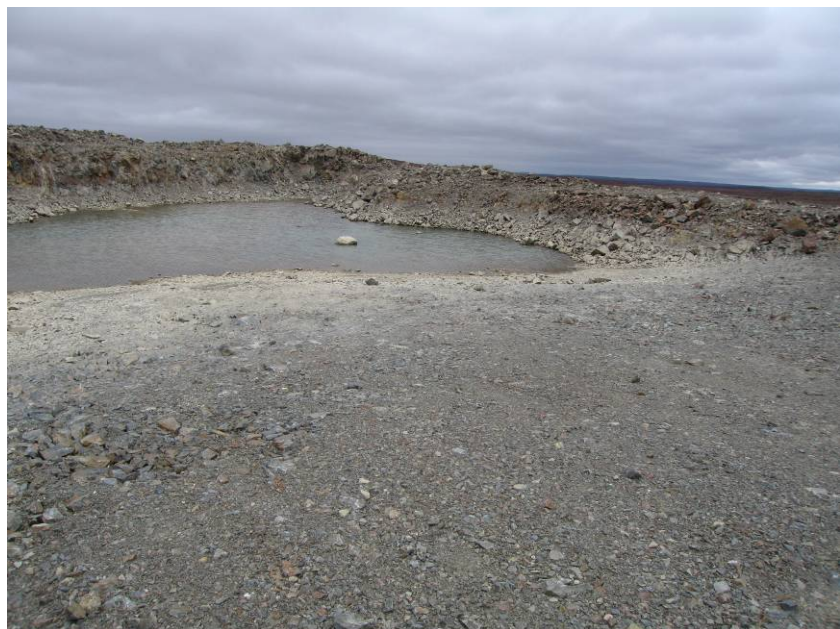
PHOTOGRAPH E-55 – Quarry 14

Description: Looking north.

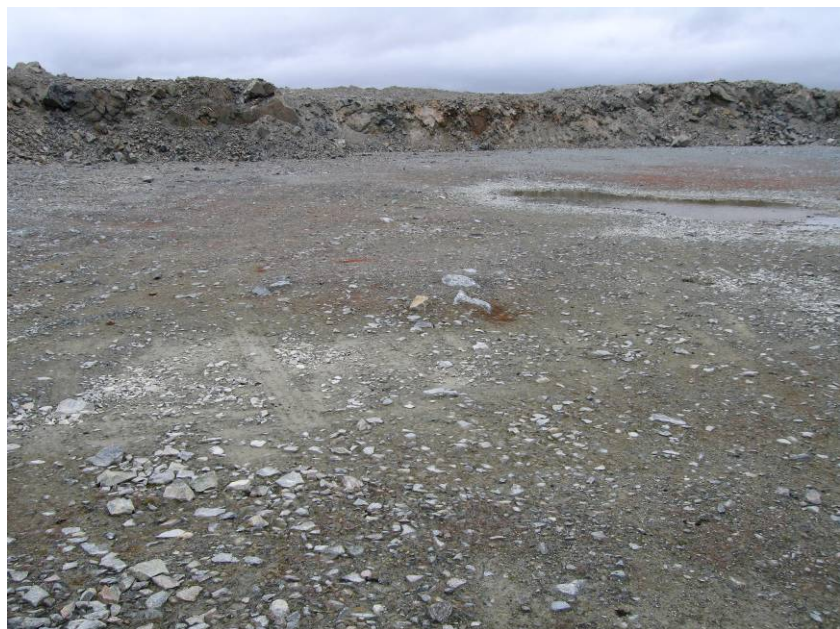
PHOTOGRAPH E-57 – Quarry 15

Description: Looking southwest.

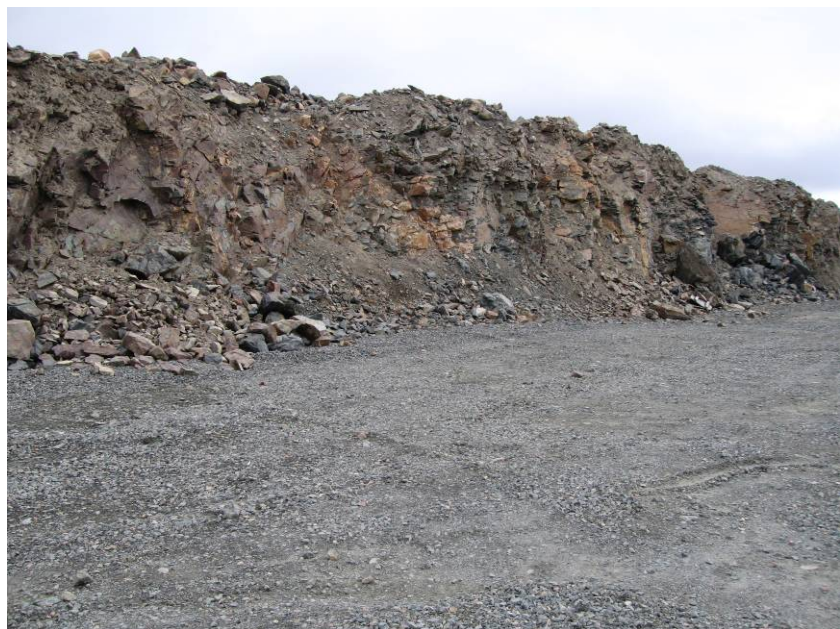
PHOTOGRAPH E-59 – Quarry 16

Description: View of east wall, looking south.

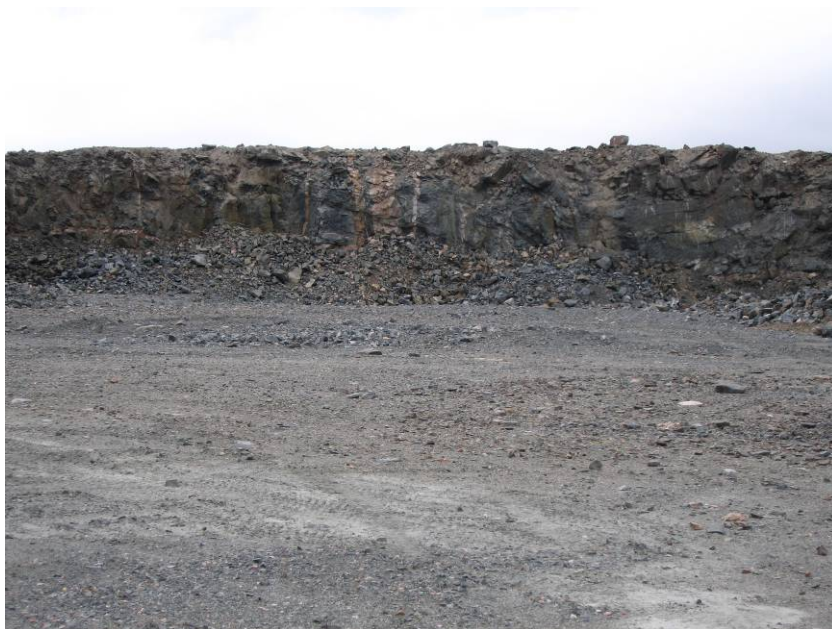
PHOTOGRAPH E-61 – Quarry 16

Description: View of southwest wall, looking southwest.

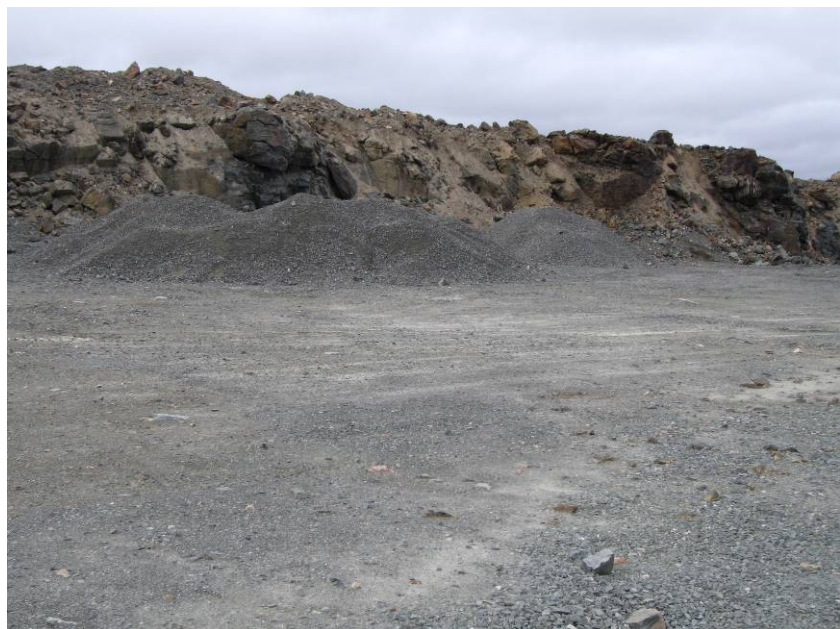
PHOTOGRAPH E-63 – Quarry 16

Description: View of west wall, looking north.

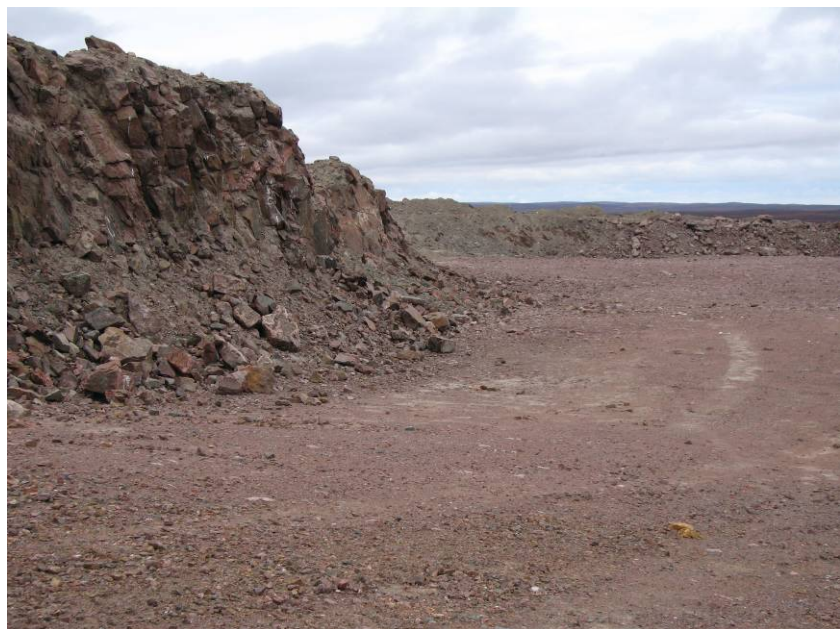
PHOTOGRAPH E-65 – Quarry 17

Description: Looking west.

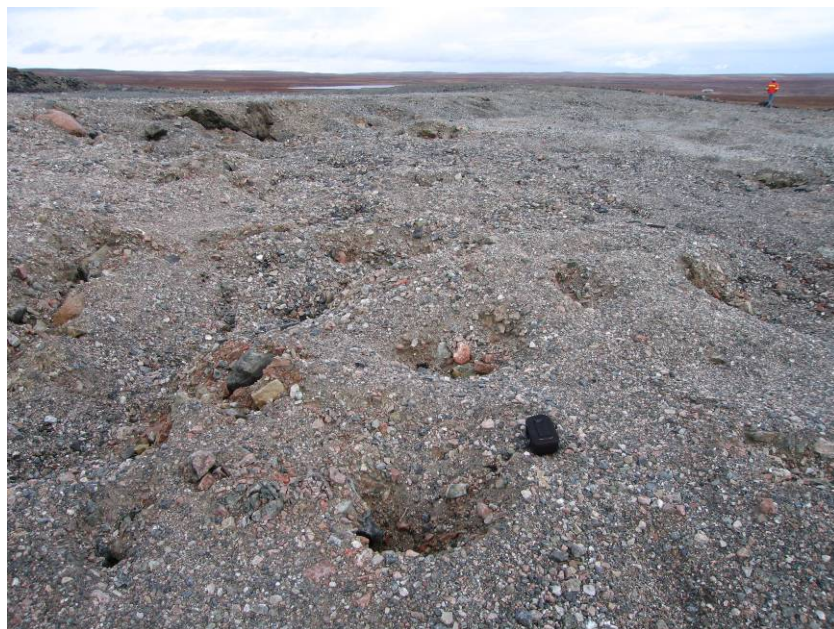
PHOTOGRAPH E-67 – Quarry 18

Description: Thermal degradation on access road at entrance to quarry.

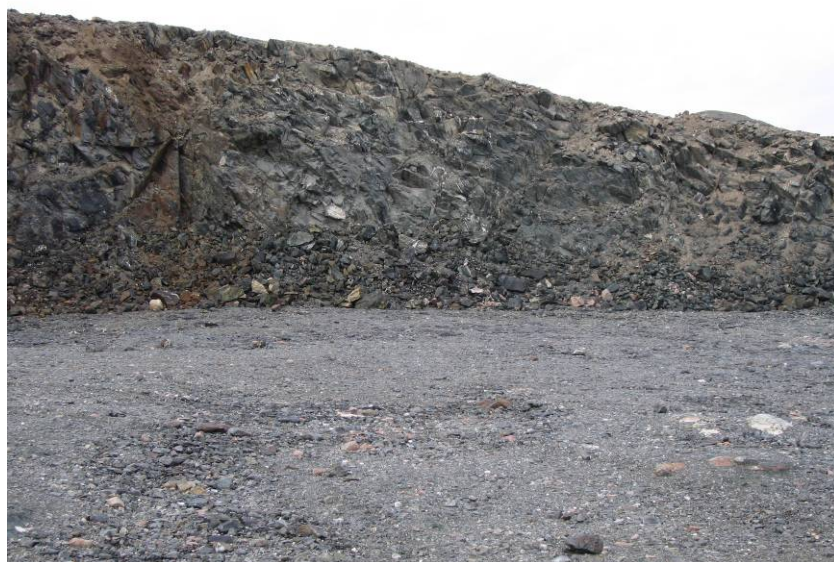
PHOTOGRAPH E-69 – Quarry 18

Description: View of north wall, looking northwest.

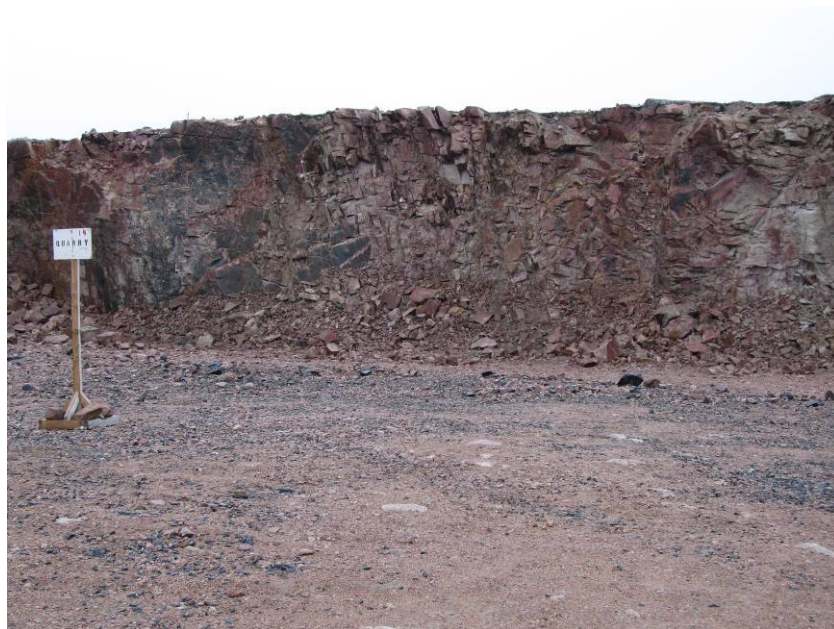
PHOTOGRAPH E-71 – Quarry 19

Description: View of north wall.

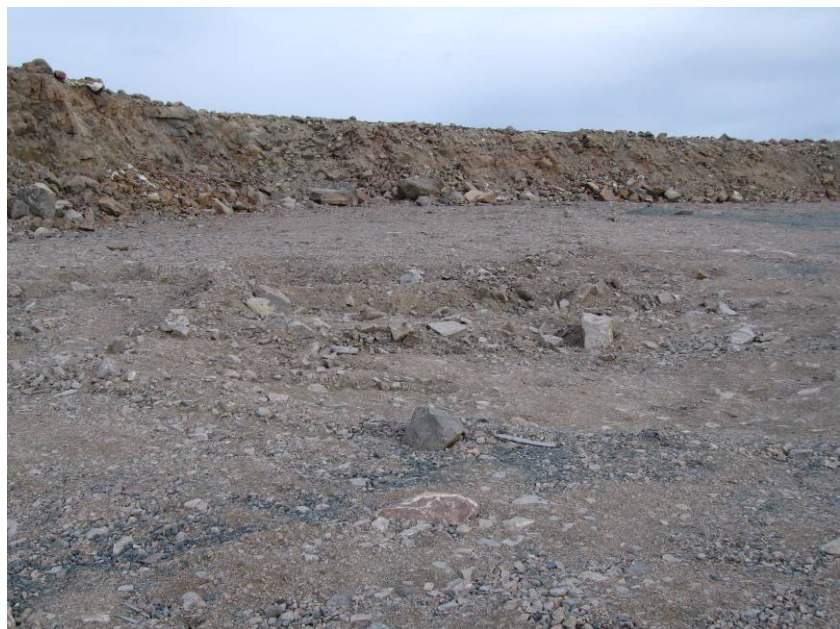
PHOTOGRAPH E-73 – Quarry 20

Description: View of northwest wall, looking north.

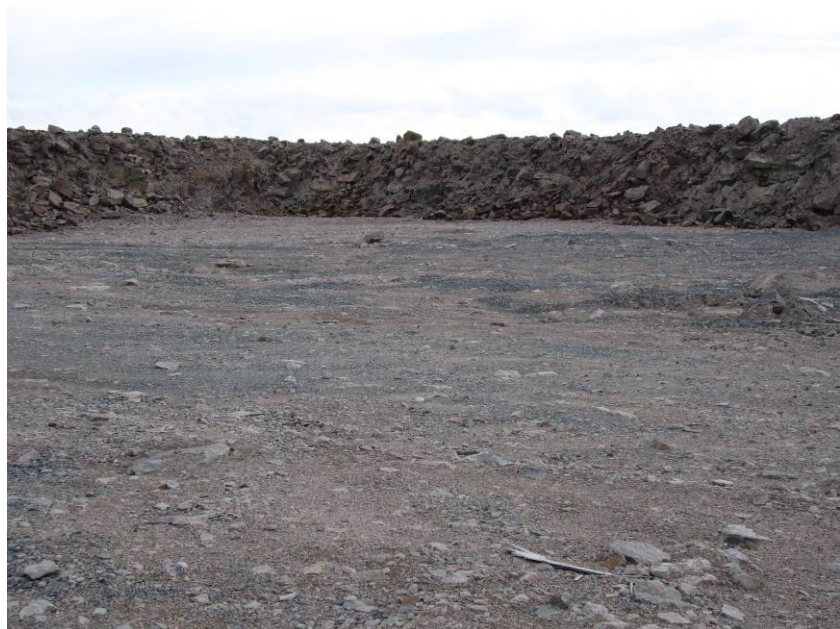
PHOTOGRAPH E-75 – Quarry 20

Description: Looking east.

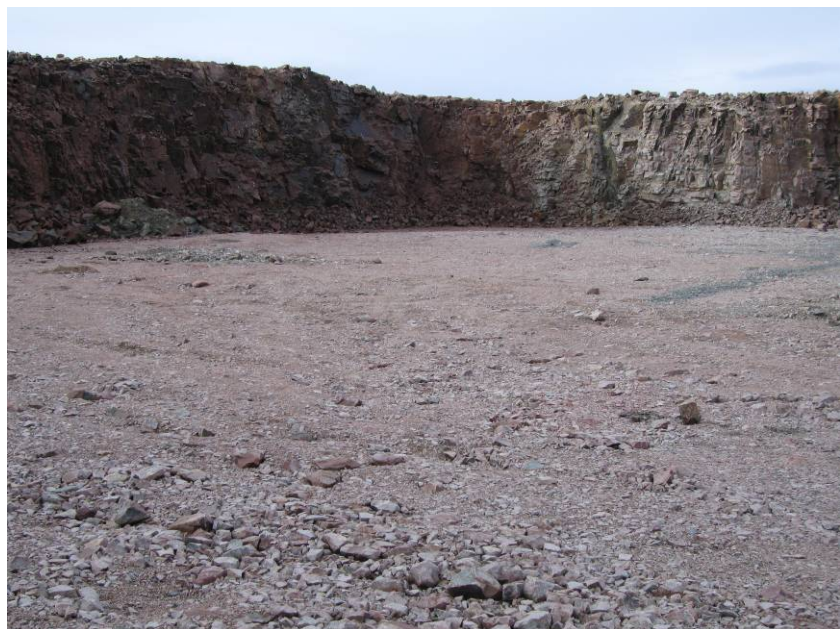
PHOTOGRAPH E-77 – Quarry 21

Description: Looking southwest.

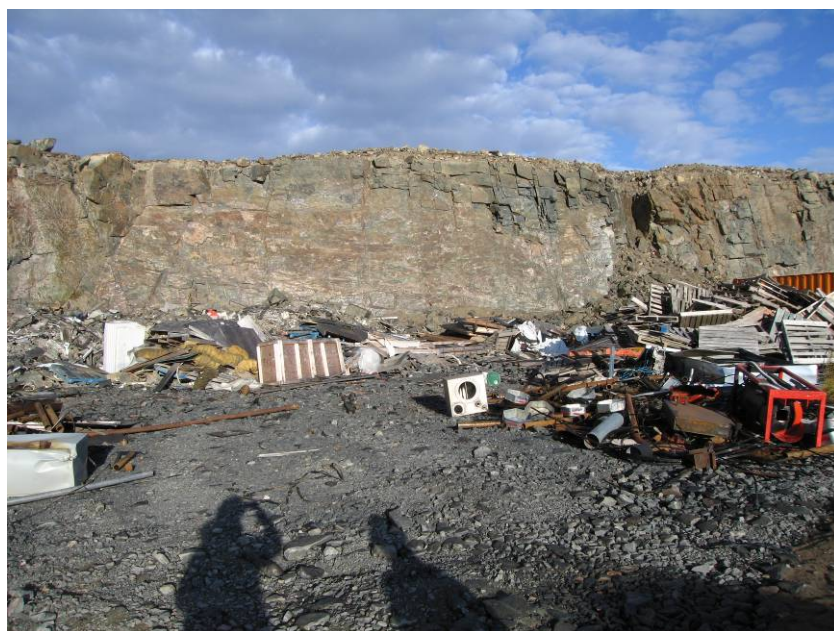
Description: Looking northwest.

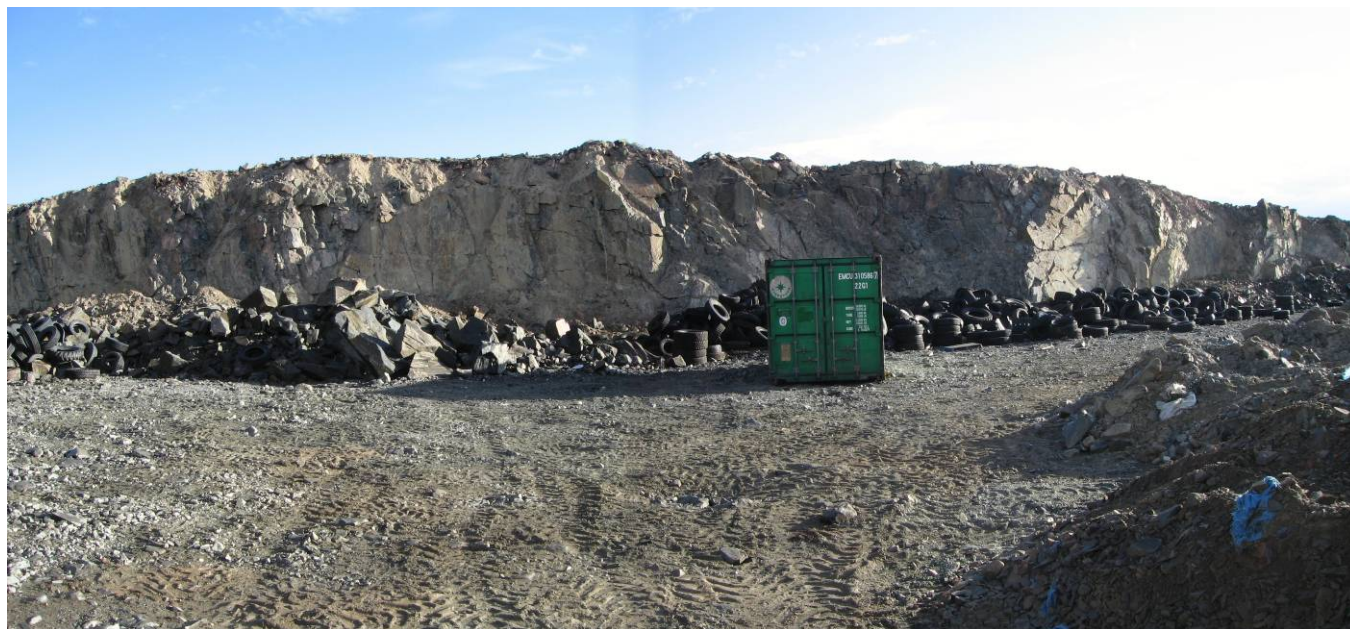
PHOTOGRAPH E-81 – Quarry 22

Description: Panoramic view of northeast wall.

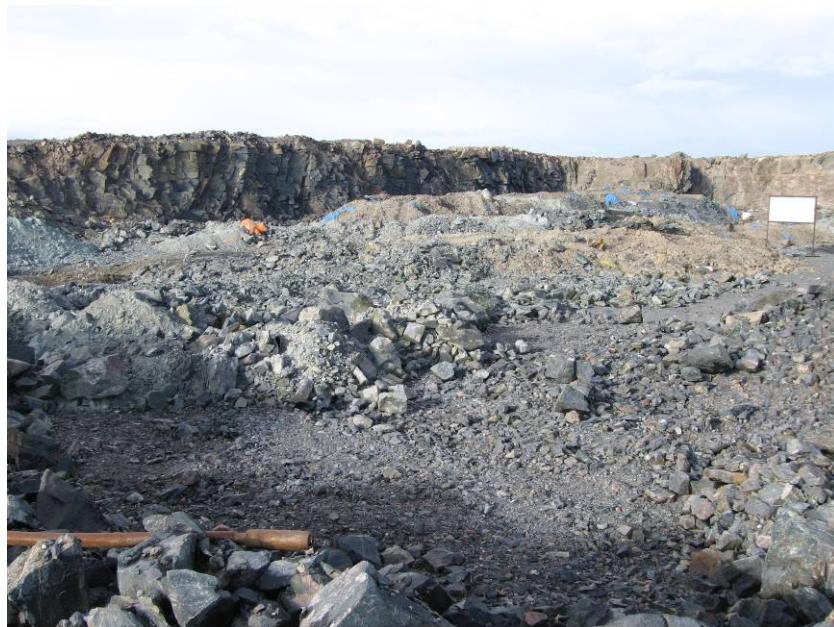
PHOTOGRAPH E-83 – Quarry 22

Description: Looking west.

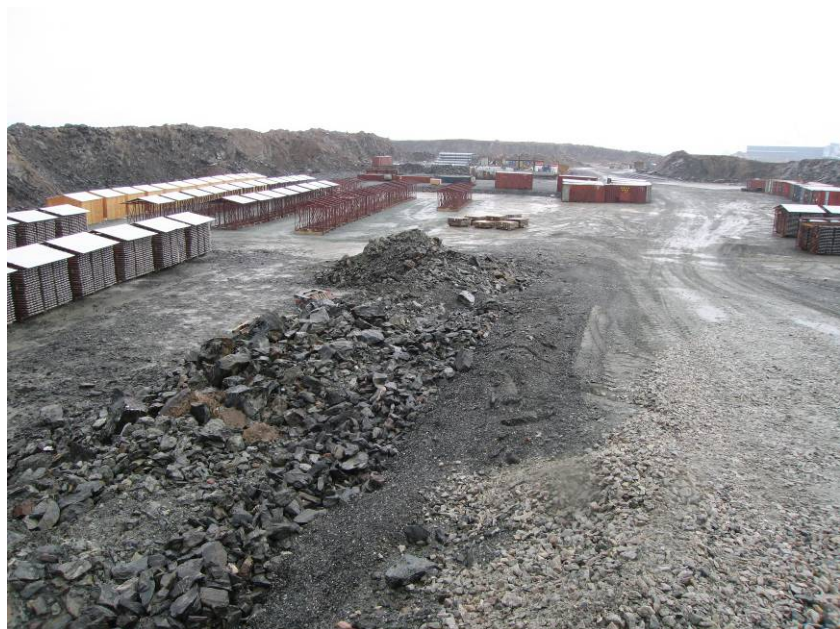
PHOTOGRAPH E-85 – Quarry 23 (Air strip quarry)

Description: General view of quarry, looking east.

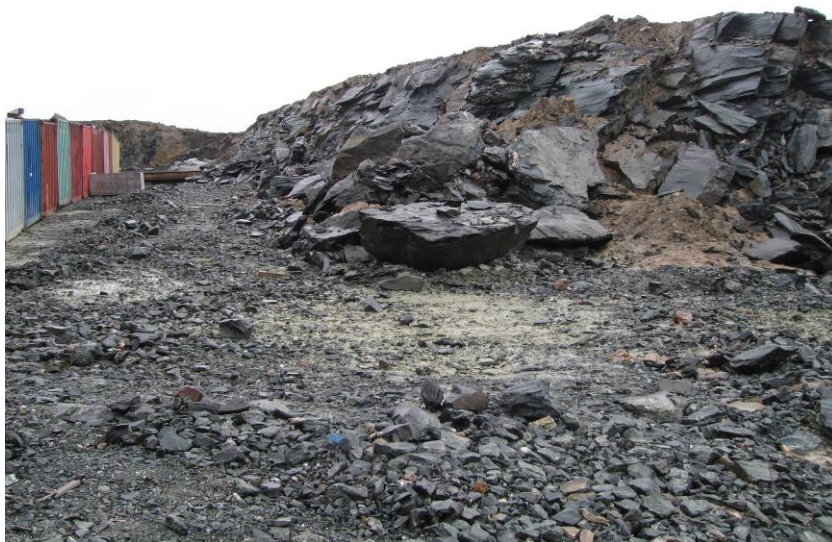
PHOTOGRAPH E-87 – Quarry 23 (Air strip quarry)

Description: View of southwest wall, looking southeast.

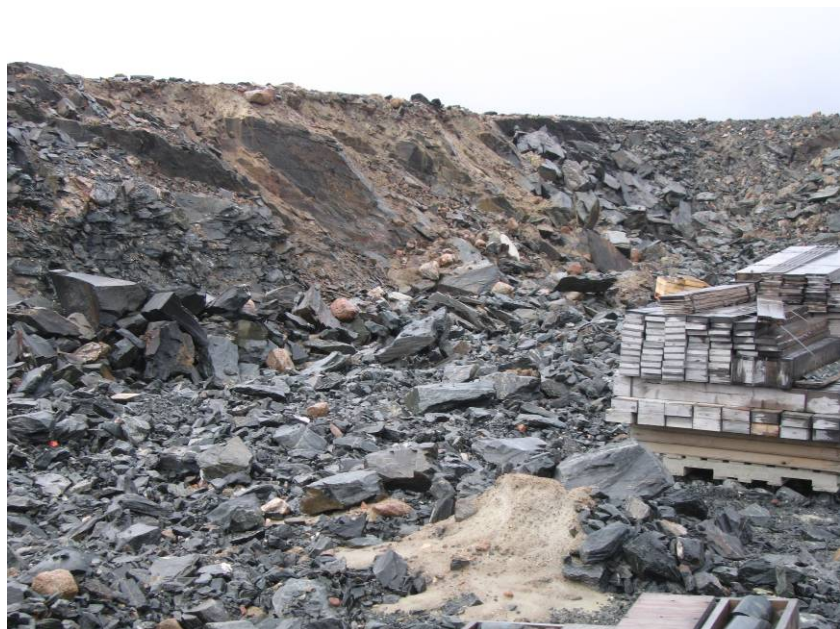
PHOTOGRAPH E-89 – Quarry 23 (Air strip quarry)

Description: View of northwest wall.

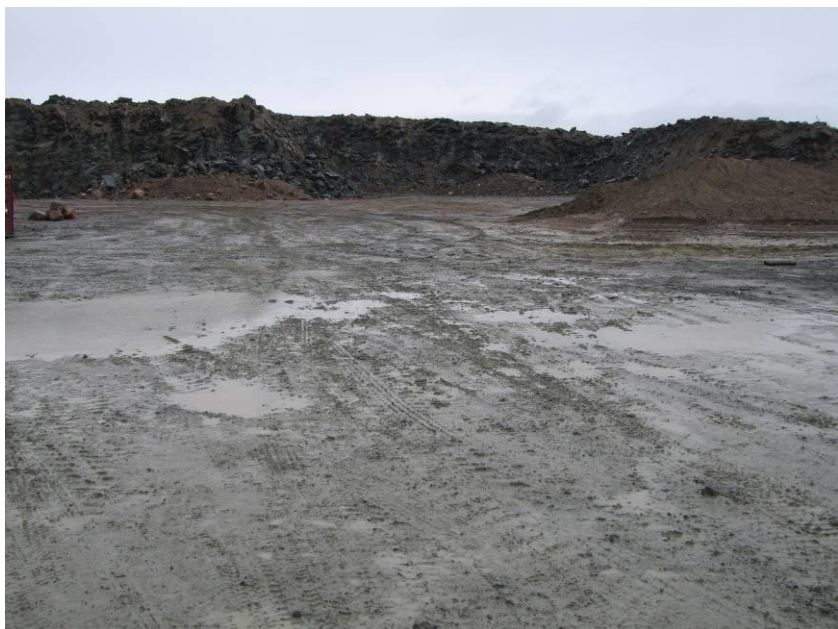
PHOTOGRAPH E-91 – Quarry 23 (Air strip quarry)

Description: View of southeast wall.

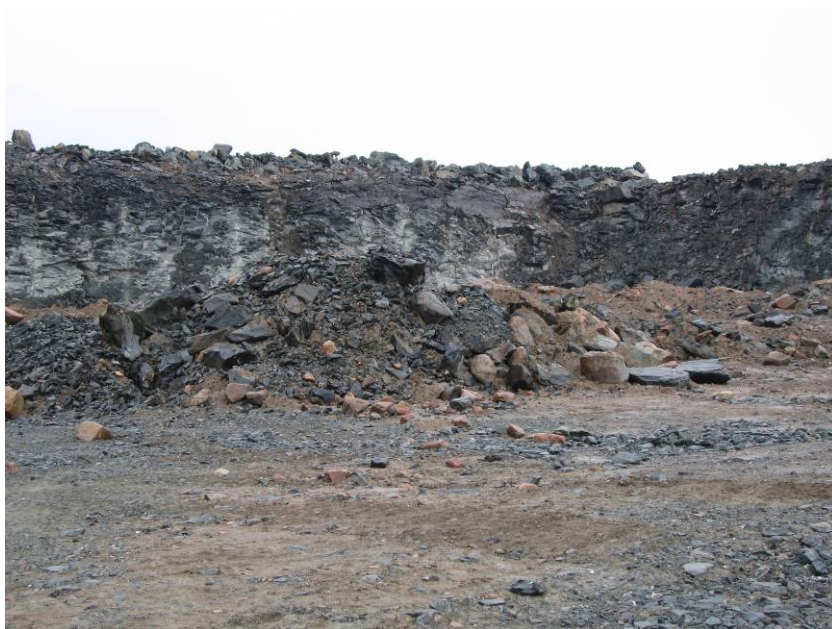
PHOTOGRAPH E-93 – Quarry 23 (Air strip quarry)

Description: Looking east.

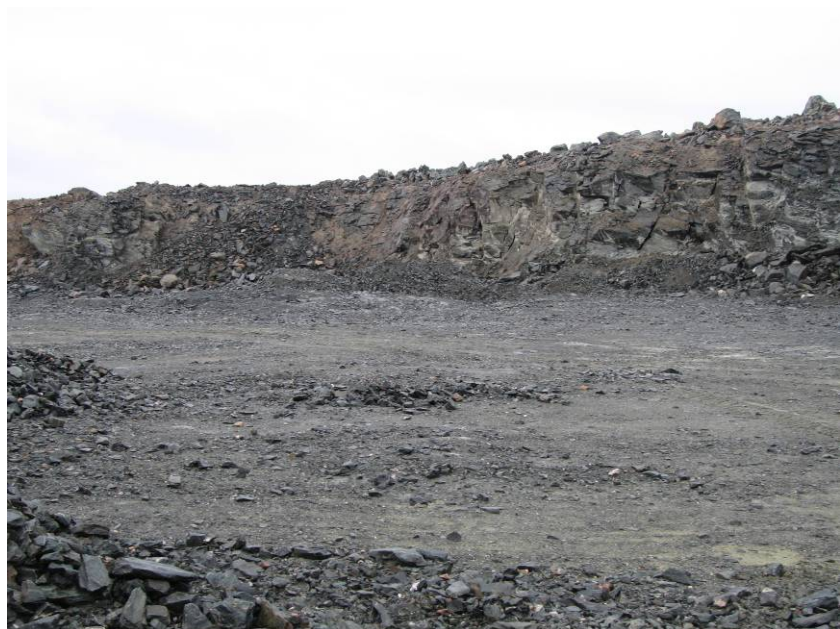
PHOTOGRAPH E-95 – Quarry 23 (Air strip quarry)

Description: View of northwest wall of quarry.

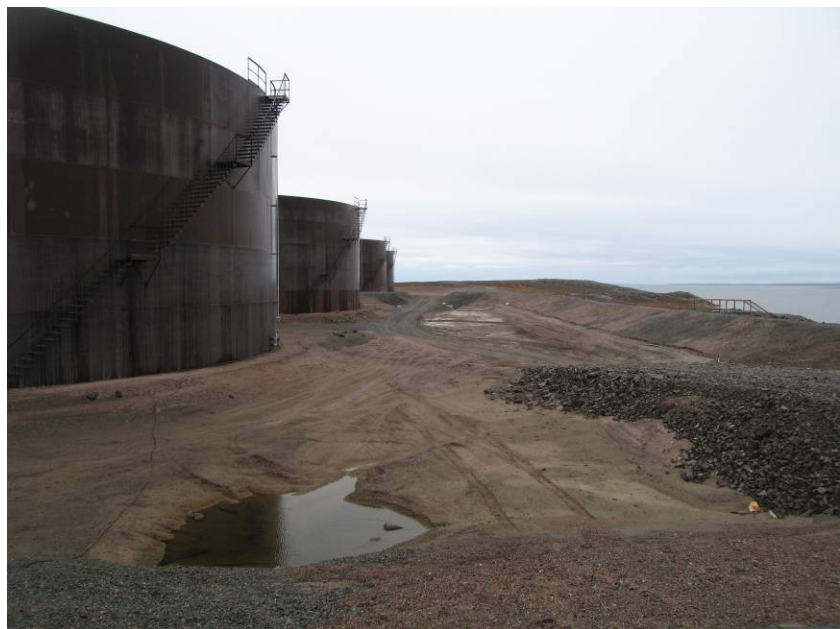
PHOTOGRAPH F1-1 – Baker Lake Tank Farm

Description: Looking southeast. View of Tank 1 in foreground then to Tanks 2, 3 and 4. Note access ramp on right of photo and small pond of fluid.

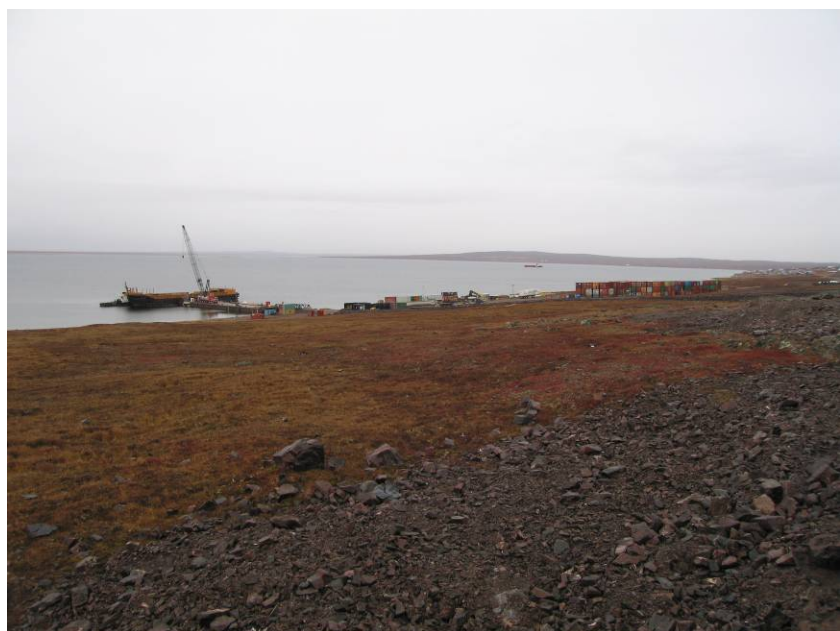
PHOTOGRAPH F1-3 – Baker Lake Tank Farm

Description: Barge unloading dock, looking southwest from tank farm containment berm.

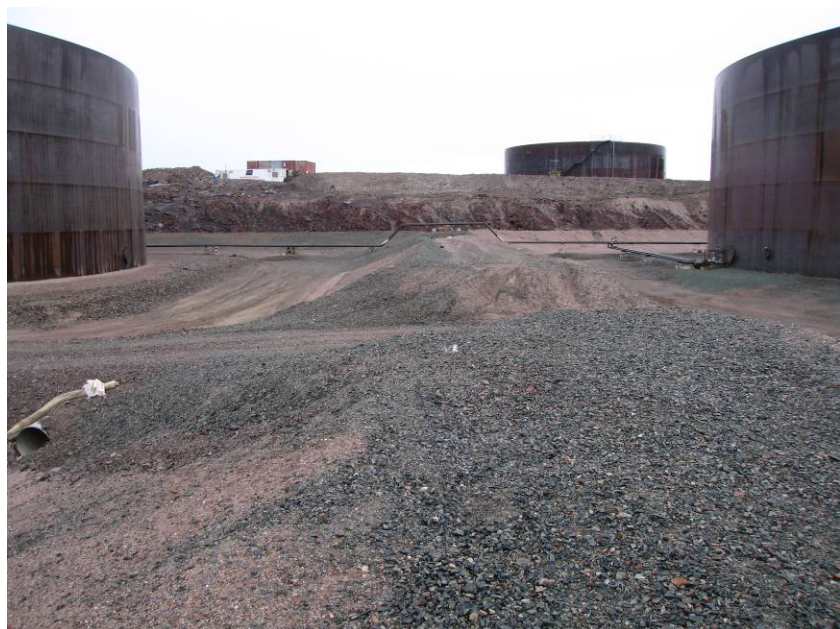
PHOTOGRAPH F1-5 – Baker Lake Tank Farm

Description: View of Tanks 2, 3 and 5, looking northeast along containment berm separating Tanks 1/2 and Tanks 3/4. Note benched slope on north side between lower Tanks (1-4) and new Tanks 5/6.

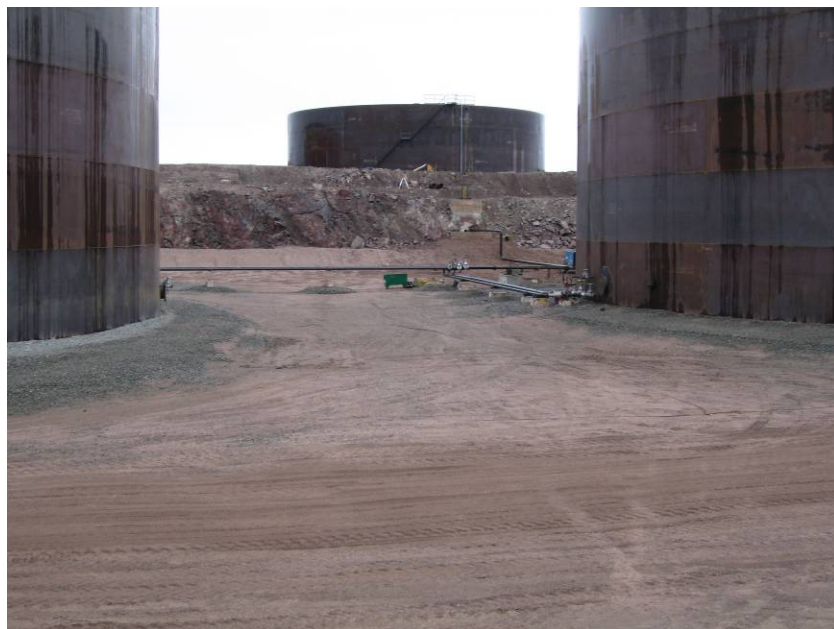
PHOTOGRAPH F1-7 – Baker Lake Tank Farm

Description: View of Tanks 3, 4 and 6, looking northeast.

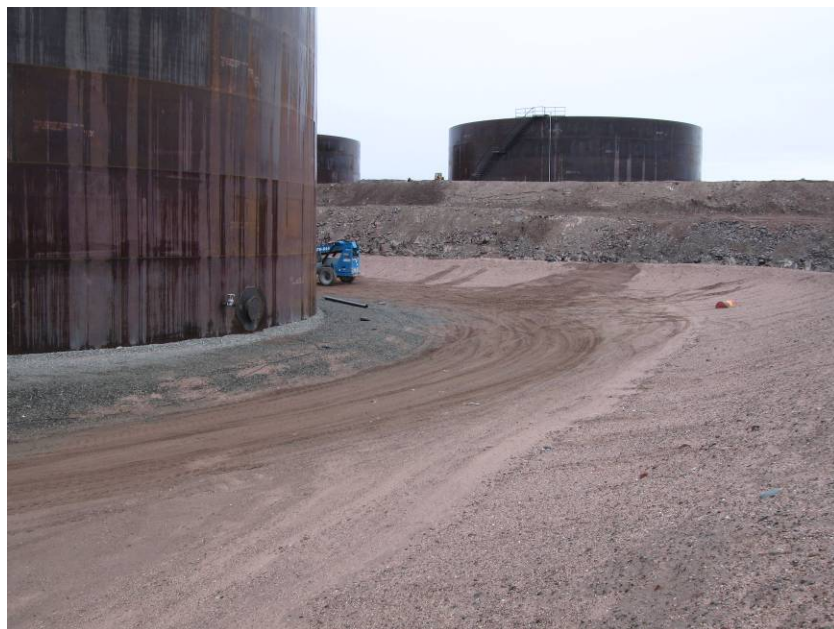
PHOTOGRAPH F1-9 – Baker Lake Tank Farm

Description: View looking north at Tank 4 in foreground and Tanks 5 and 6 upslope. Note benched slope between lower tank and upper tanks.

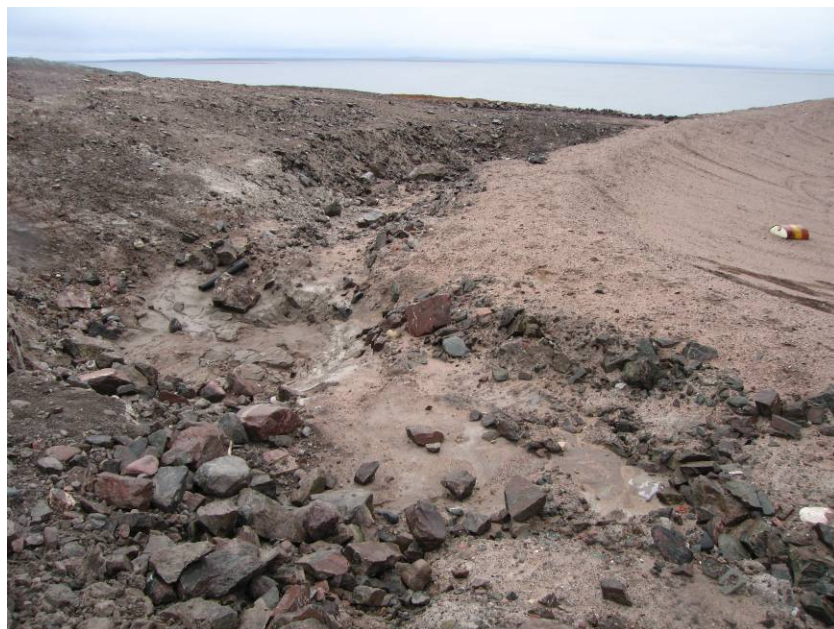
PHOTOGRAPH F1-11 – Baker Lake Tank Farm

Description: View looking south of northeast berm near Tank 4. Swale partially exists around perimeter, but is discontinuous.

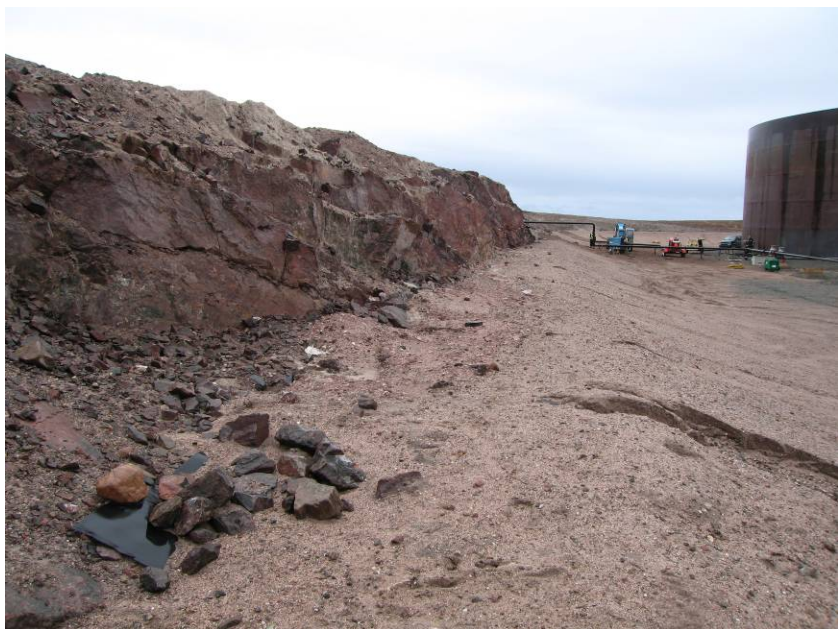
PHOTOGRAPH F1-13 – Baker Lake Tank Farm

Description: View of Tank 4 and northeast benched slope adjacent to Tanks 3/4, looking southeast.

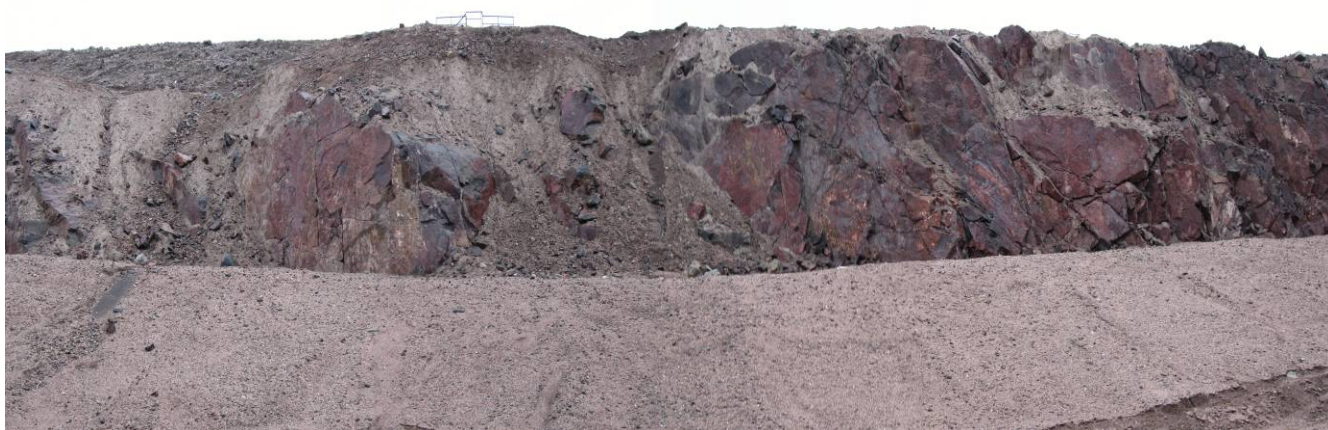
PHOTOGRAPH F1-15 – Baker Lake Tank Farm

Description: Panoramic view of rock/soil benched slope on the northeast side of Tanks 3 and 4. Note eroded and deposited soil in channels on slope with additional channels entering secondary containment area of tank farm.

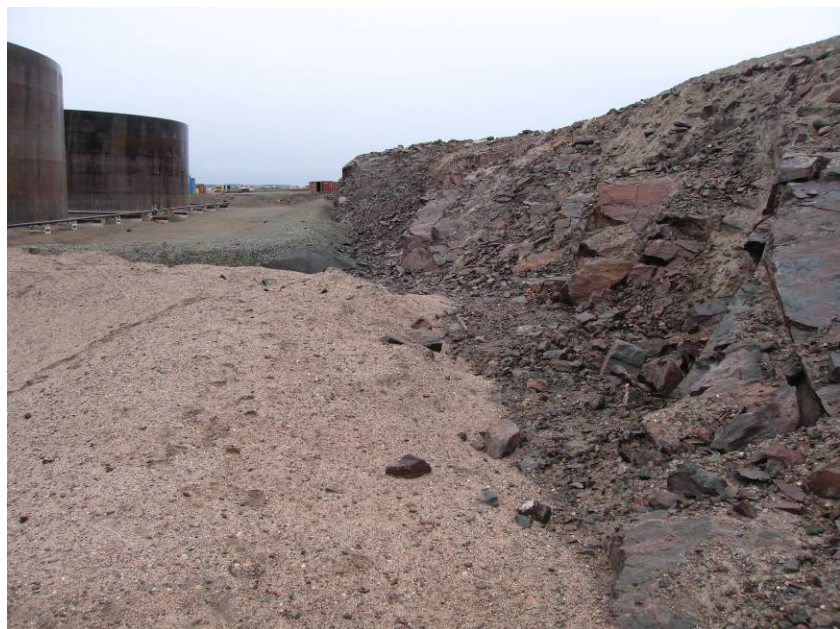
PHOTOGRAPH F1-17 – Baker Lake Tank Farm

Description: View of Tanks 1 and 2, looking northwest along benched slope on northeast side of the tank farm.

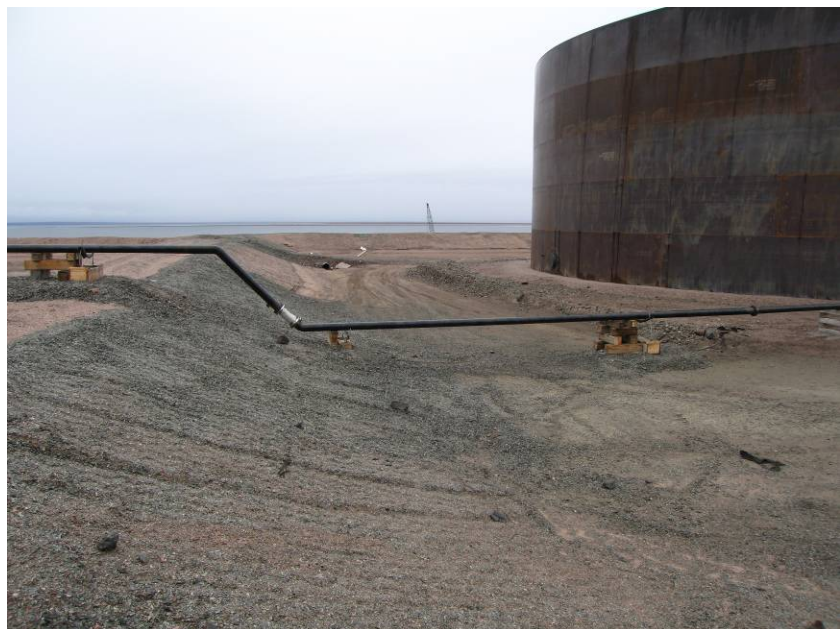
PHOTOGRAPH F1-19 – Baker Lake Tank Farm

Description: View of Tank 2, looking southwest and dividing berm within secondary containment area.

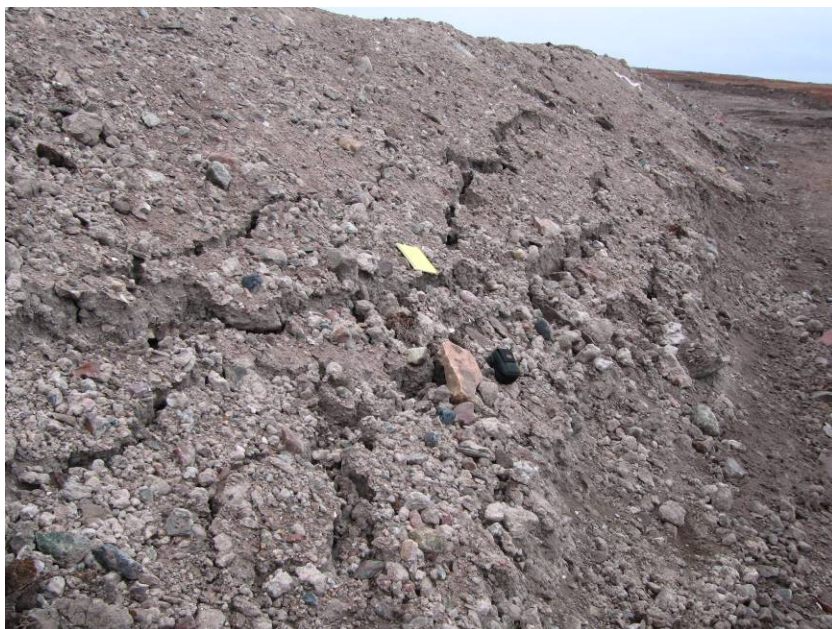
PHOTOGRAPH F1-21 – Baker Lake Tank Farm

Description: Looking east at tension cracks in upper soil slope between Tanks 3/4 and Tanks 5/6. Lower portion of slope appears to have been undercut.

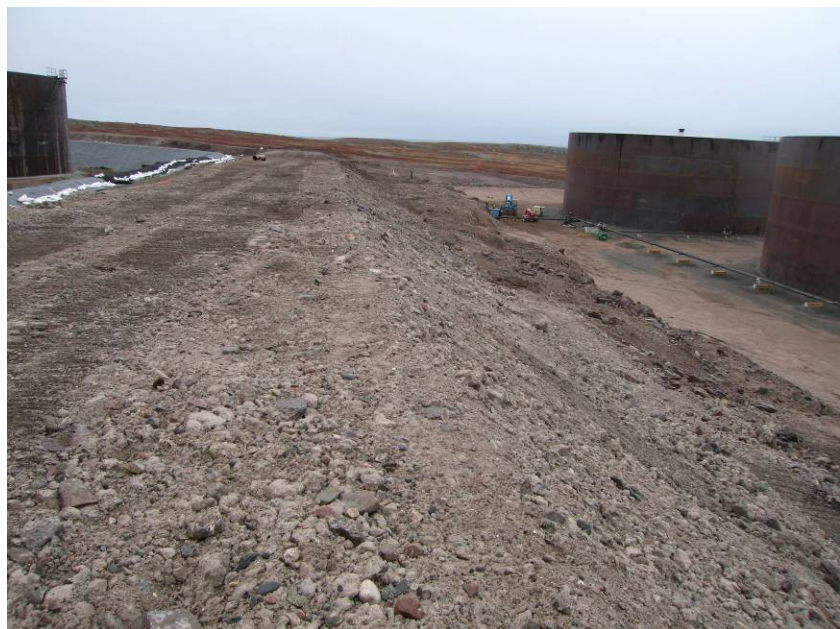
PHOTOGRAPH F1-23 – Baker Lake Tank Farm

Description: View of upper bench and slope, looking east. Lower Tanks 3/4 on right of photo and Tank 6 on left of photo.

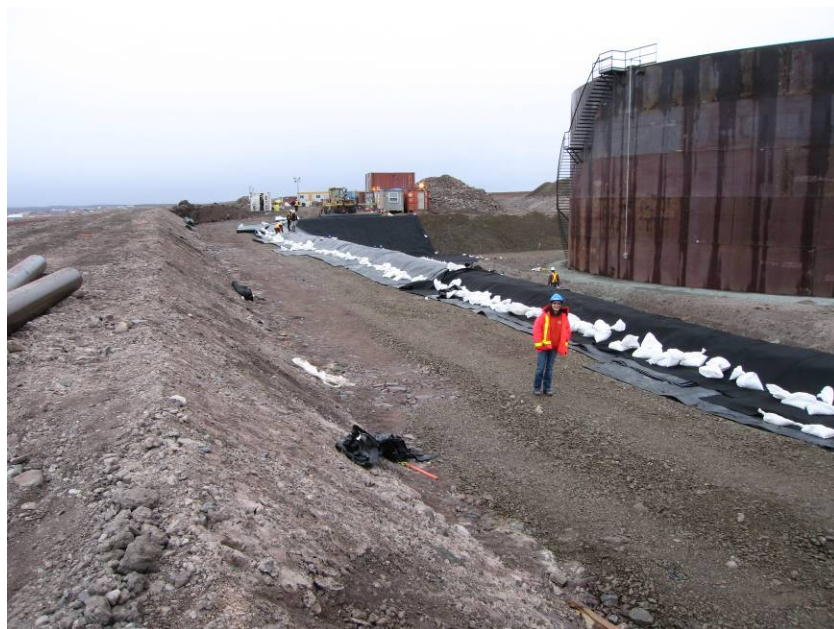
PHOTOGRAPH F1-25 – Baker Lake Tank Farm

Description: View looking northwest at Tank 5, installation of geomembrane liner in progress. Note access road around perimeter of secondary containment area.
