2010 Annual Geotechnical Inspection Meadowbank Gold Project, Nunavut

Submitted to:
Agnico-Eagle Mines Limited
Meadowbank Division
PO Box 540
Baker Lake, Nunavut
X0C 0A0

Project Number: 10-1428-0033/2000
Document Number: 1216 Ver. 0

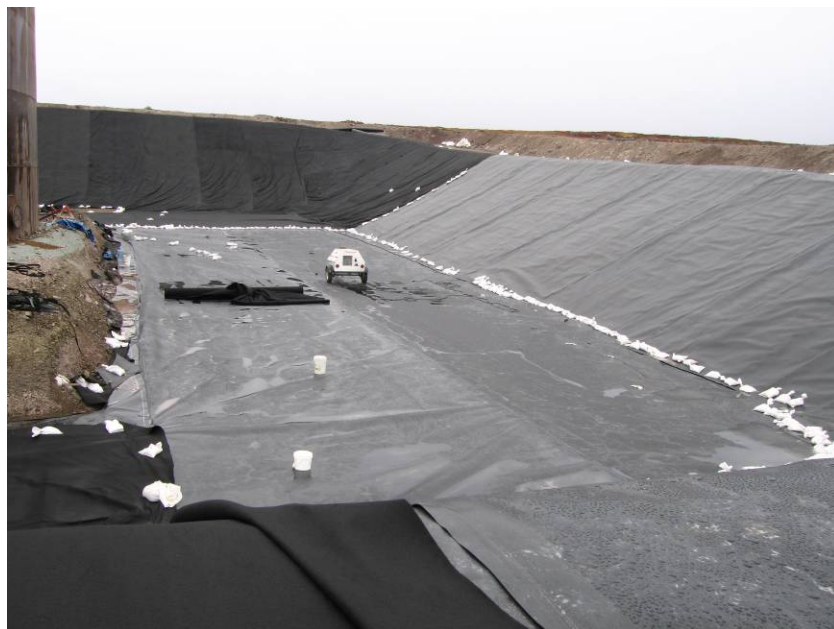
PHOTOGRAPH F1-27 – Baker Lake Tank Farm

Description: Southeast side of Tank 6, looking along slope of secondary containment. Installation of geotextile and geomembrane liner was observed.

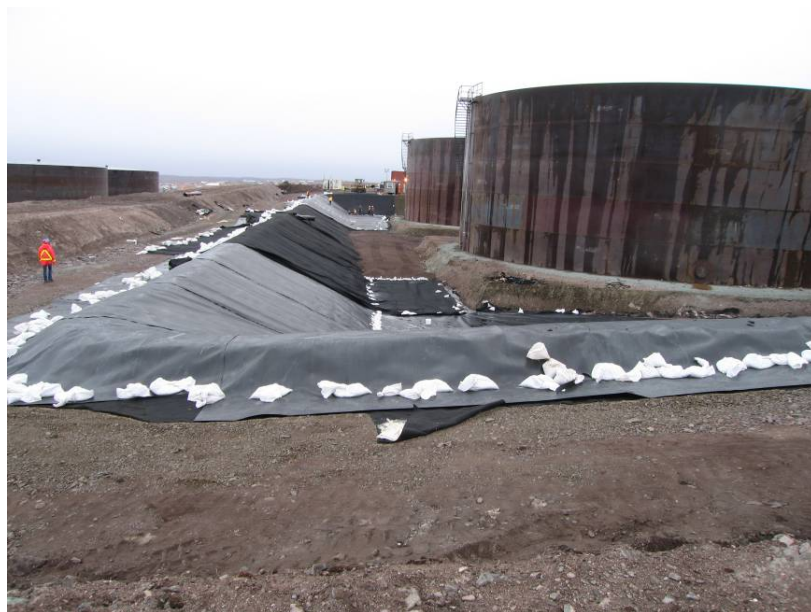
PHOTOGRAPH F1-29 – Baker Lake Tank Farm

Description: View of south slope of secondary containment for Tank 6 (foreground) and Tank 5 beyond. Lining of the secondary containment in progress at the time of the in Tanks 1 and 2 appear at the far left side of the photo.

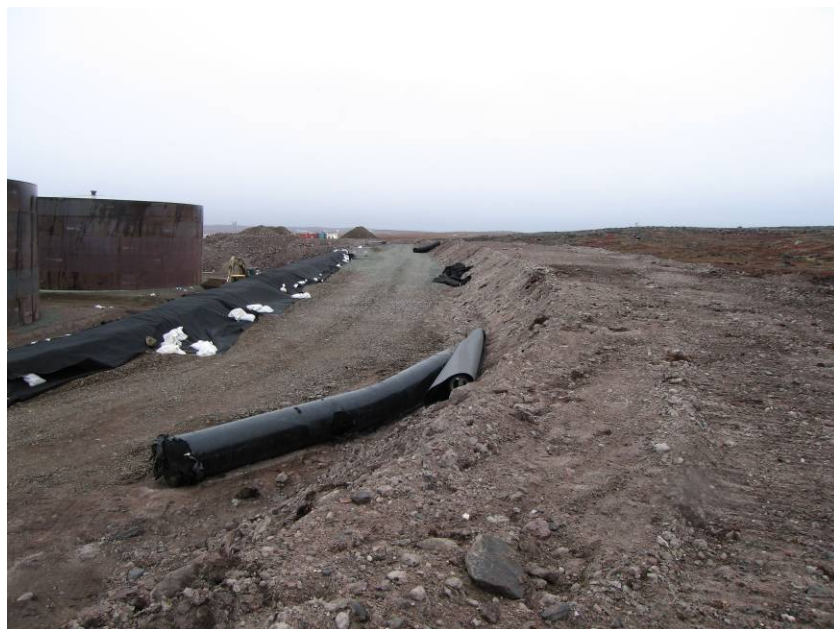
PHOTOGRAPH F1-31 – Baker Lake Tank Farm

Description: Looking northwest along road above slope for secondary containment area for Tanks 5/6.

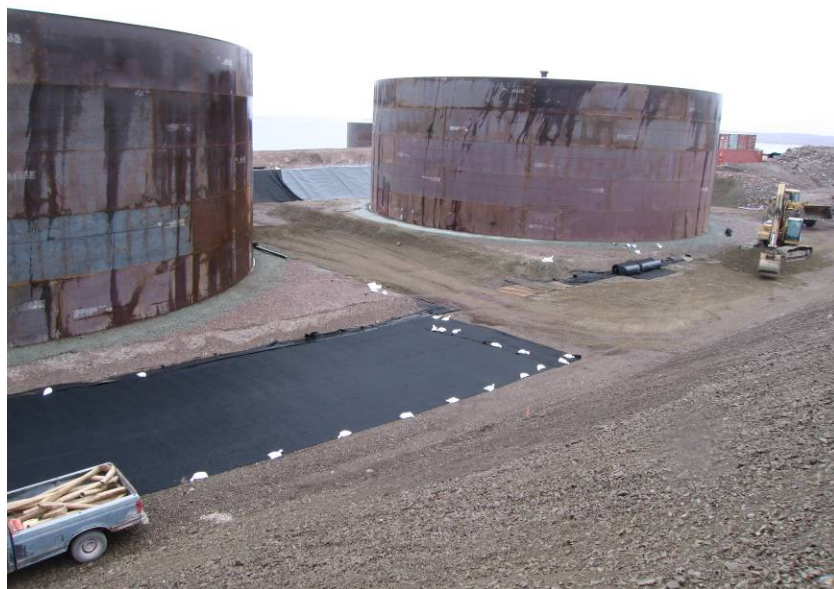
PHOTOGRAPH F1-33 – Baker Lake Tank Farm

Description: View of Tank 5 and 6, looking southwest down slope of secondary containment.

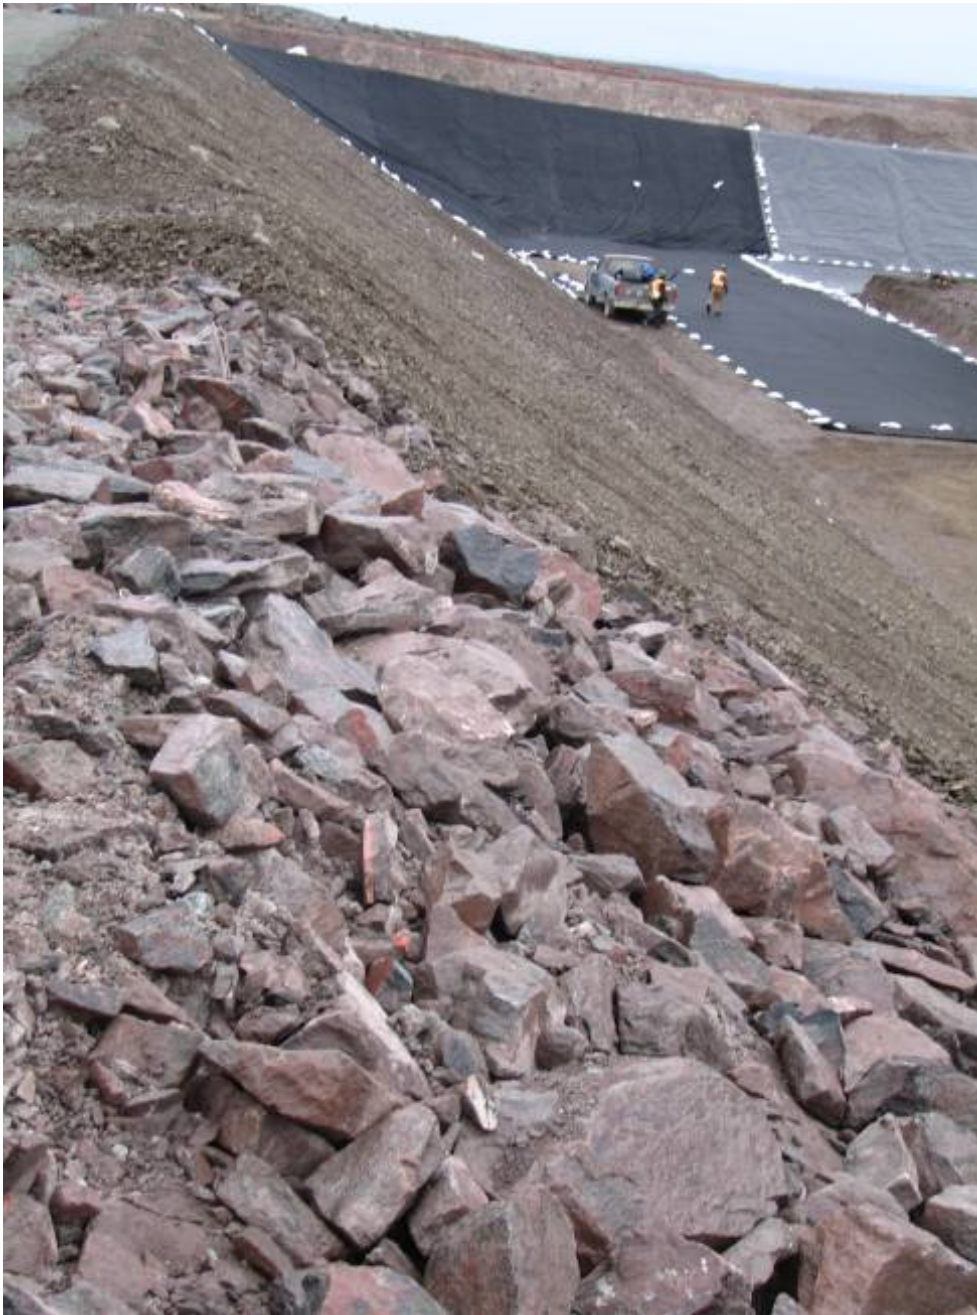
PHOTOGRAPH F1-35 – Baker Lake Tank Farm

Description: View of northeast slope down into the secondary containment. Note approximately a 10 cm thick layer of granular bedding material placed above rockfill prior to installation of the geotextile and geomembrane liner.

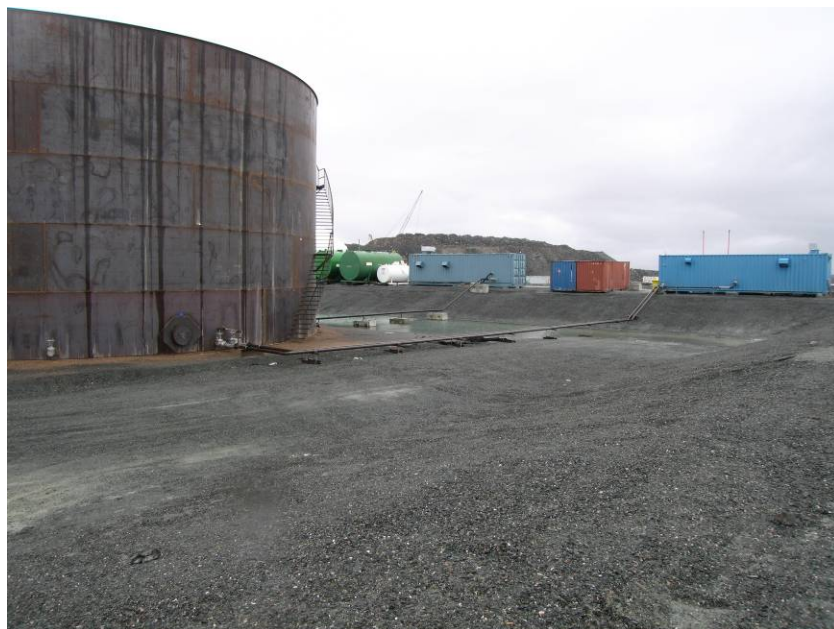
PHOTOGRAPH F2-1 – Meadowbank Tank Farm

Description: View of 4 diesel tanks (green), 1 gasoline tank (white), secondary containment area and fuel storage tank, looking north.

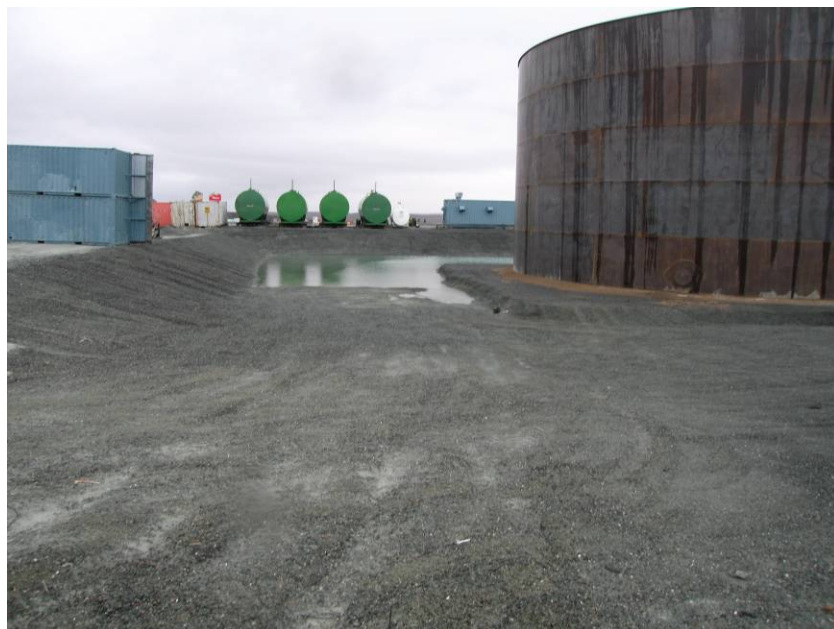
PHOTOGRAPH F2-3 – Meadowbank Tank Farm

Description: View of secondary containment area and tank, looking northeast. Ponded fluid within the tank farm area is visible.

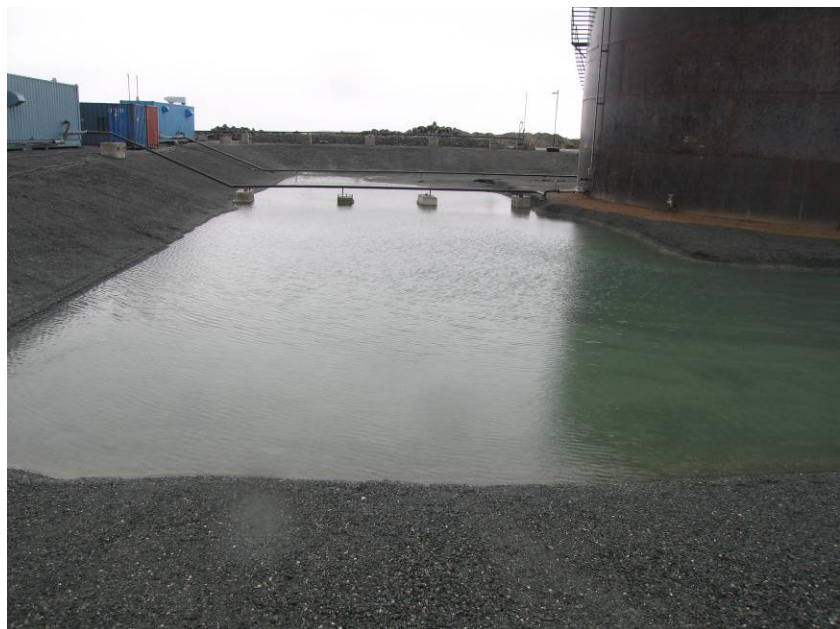
PHOTOGRAPH F2-5 – Meadowbank Tank Farm

Description: View of ponded fluid within the secondary containment area, looking southeast.

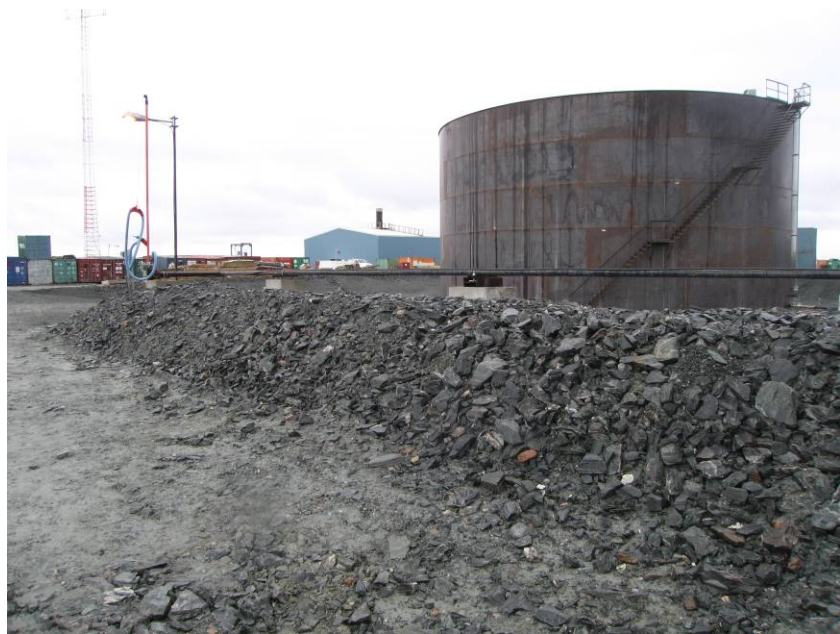
PHOTOGRAPH F2-6 – Meadowbank Tank Farm

Description: View of refuelling station berm, looking west.

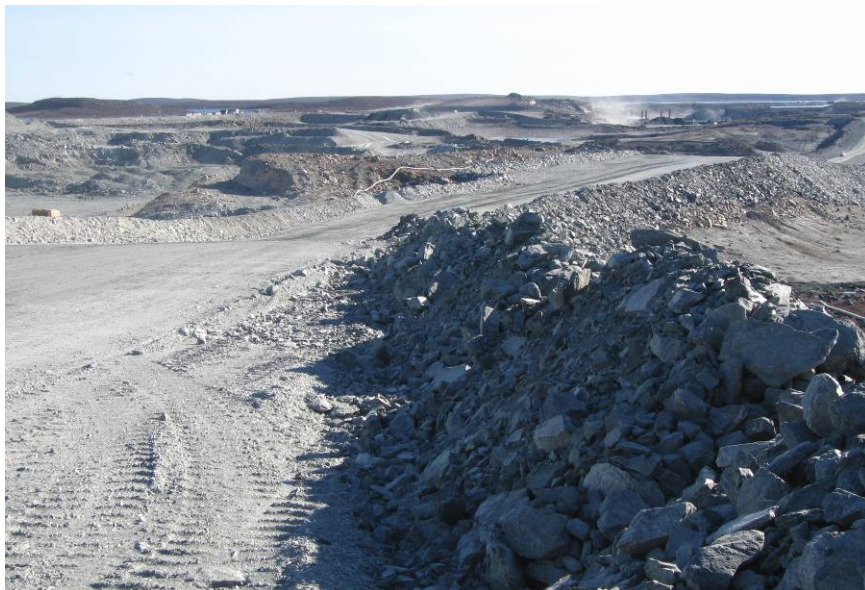
PHOTOGRAPH G1-1 – Site Roads

Description: Haul road crossing northwest arm of Second Portage Lake which has been dewatered. Haul road is approximately parallel to the proposed alignment of Central Dike and connects the north end of Portage Pit to the plant site.

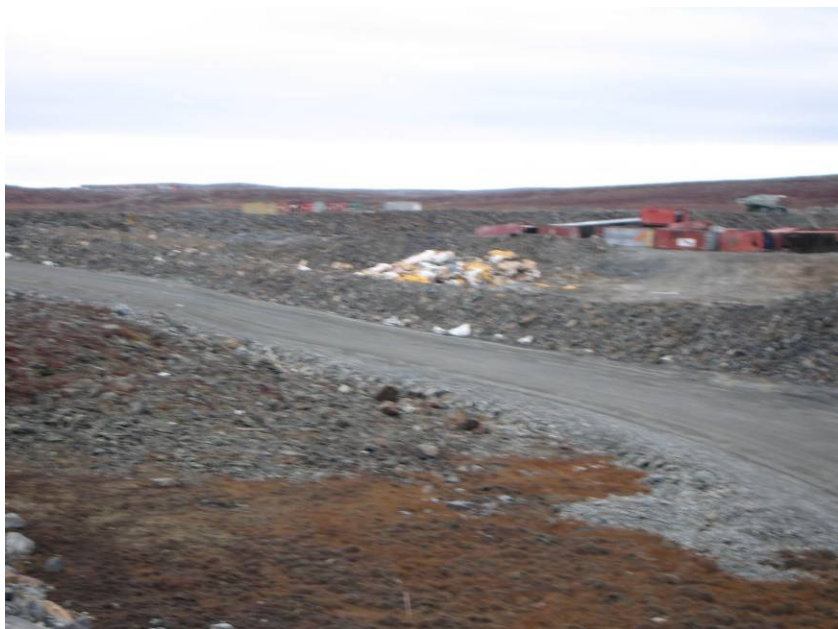
PHOTOGRAPH G2-1 – Landfill

Description: Looking north at waste in top of current cell.

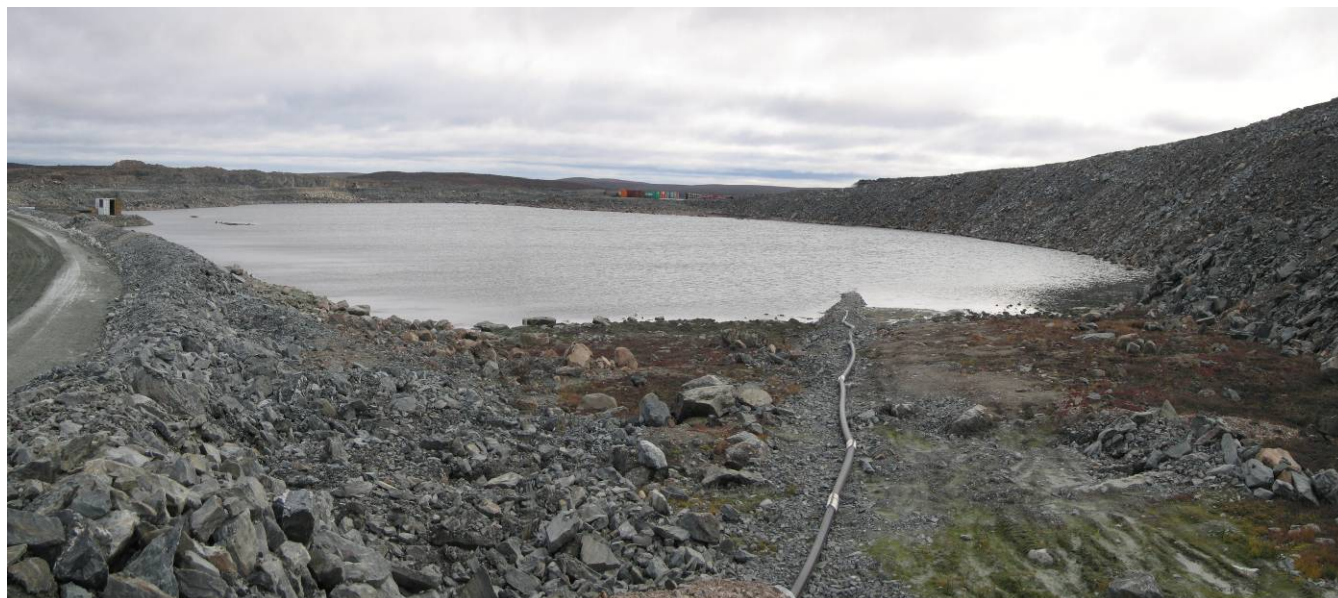
PHOTOGRAPH G3-1 – Stormwater Pond 1, Teardrop Lake

Description: View of Stormwater Pond 1, also referred to as Teardrop Lake, looking southeast.
